BGC ENGINEERING INC.
AN APPLIED EARTH SCIENCES COMPANY

DELOITTE & TOUCHE INC.

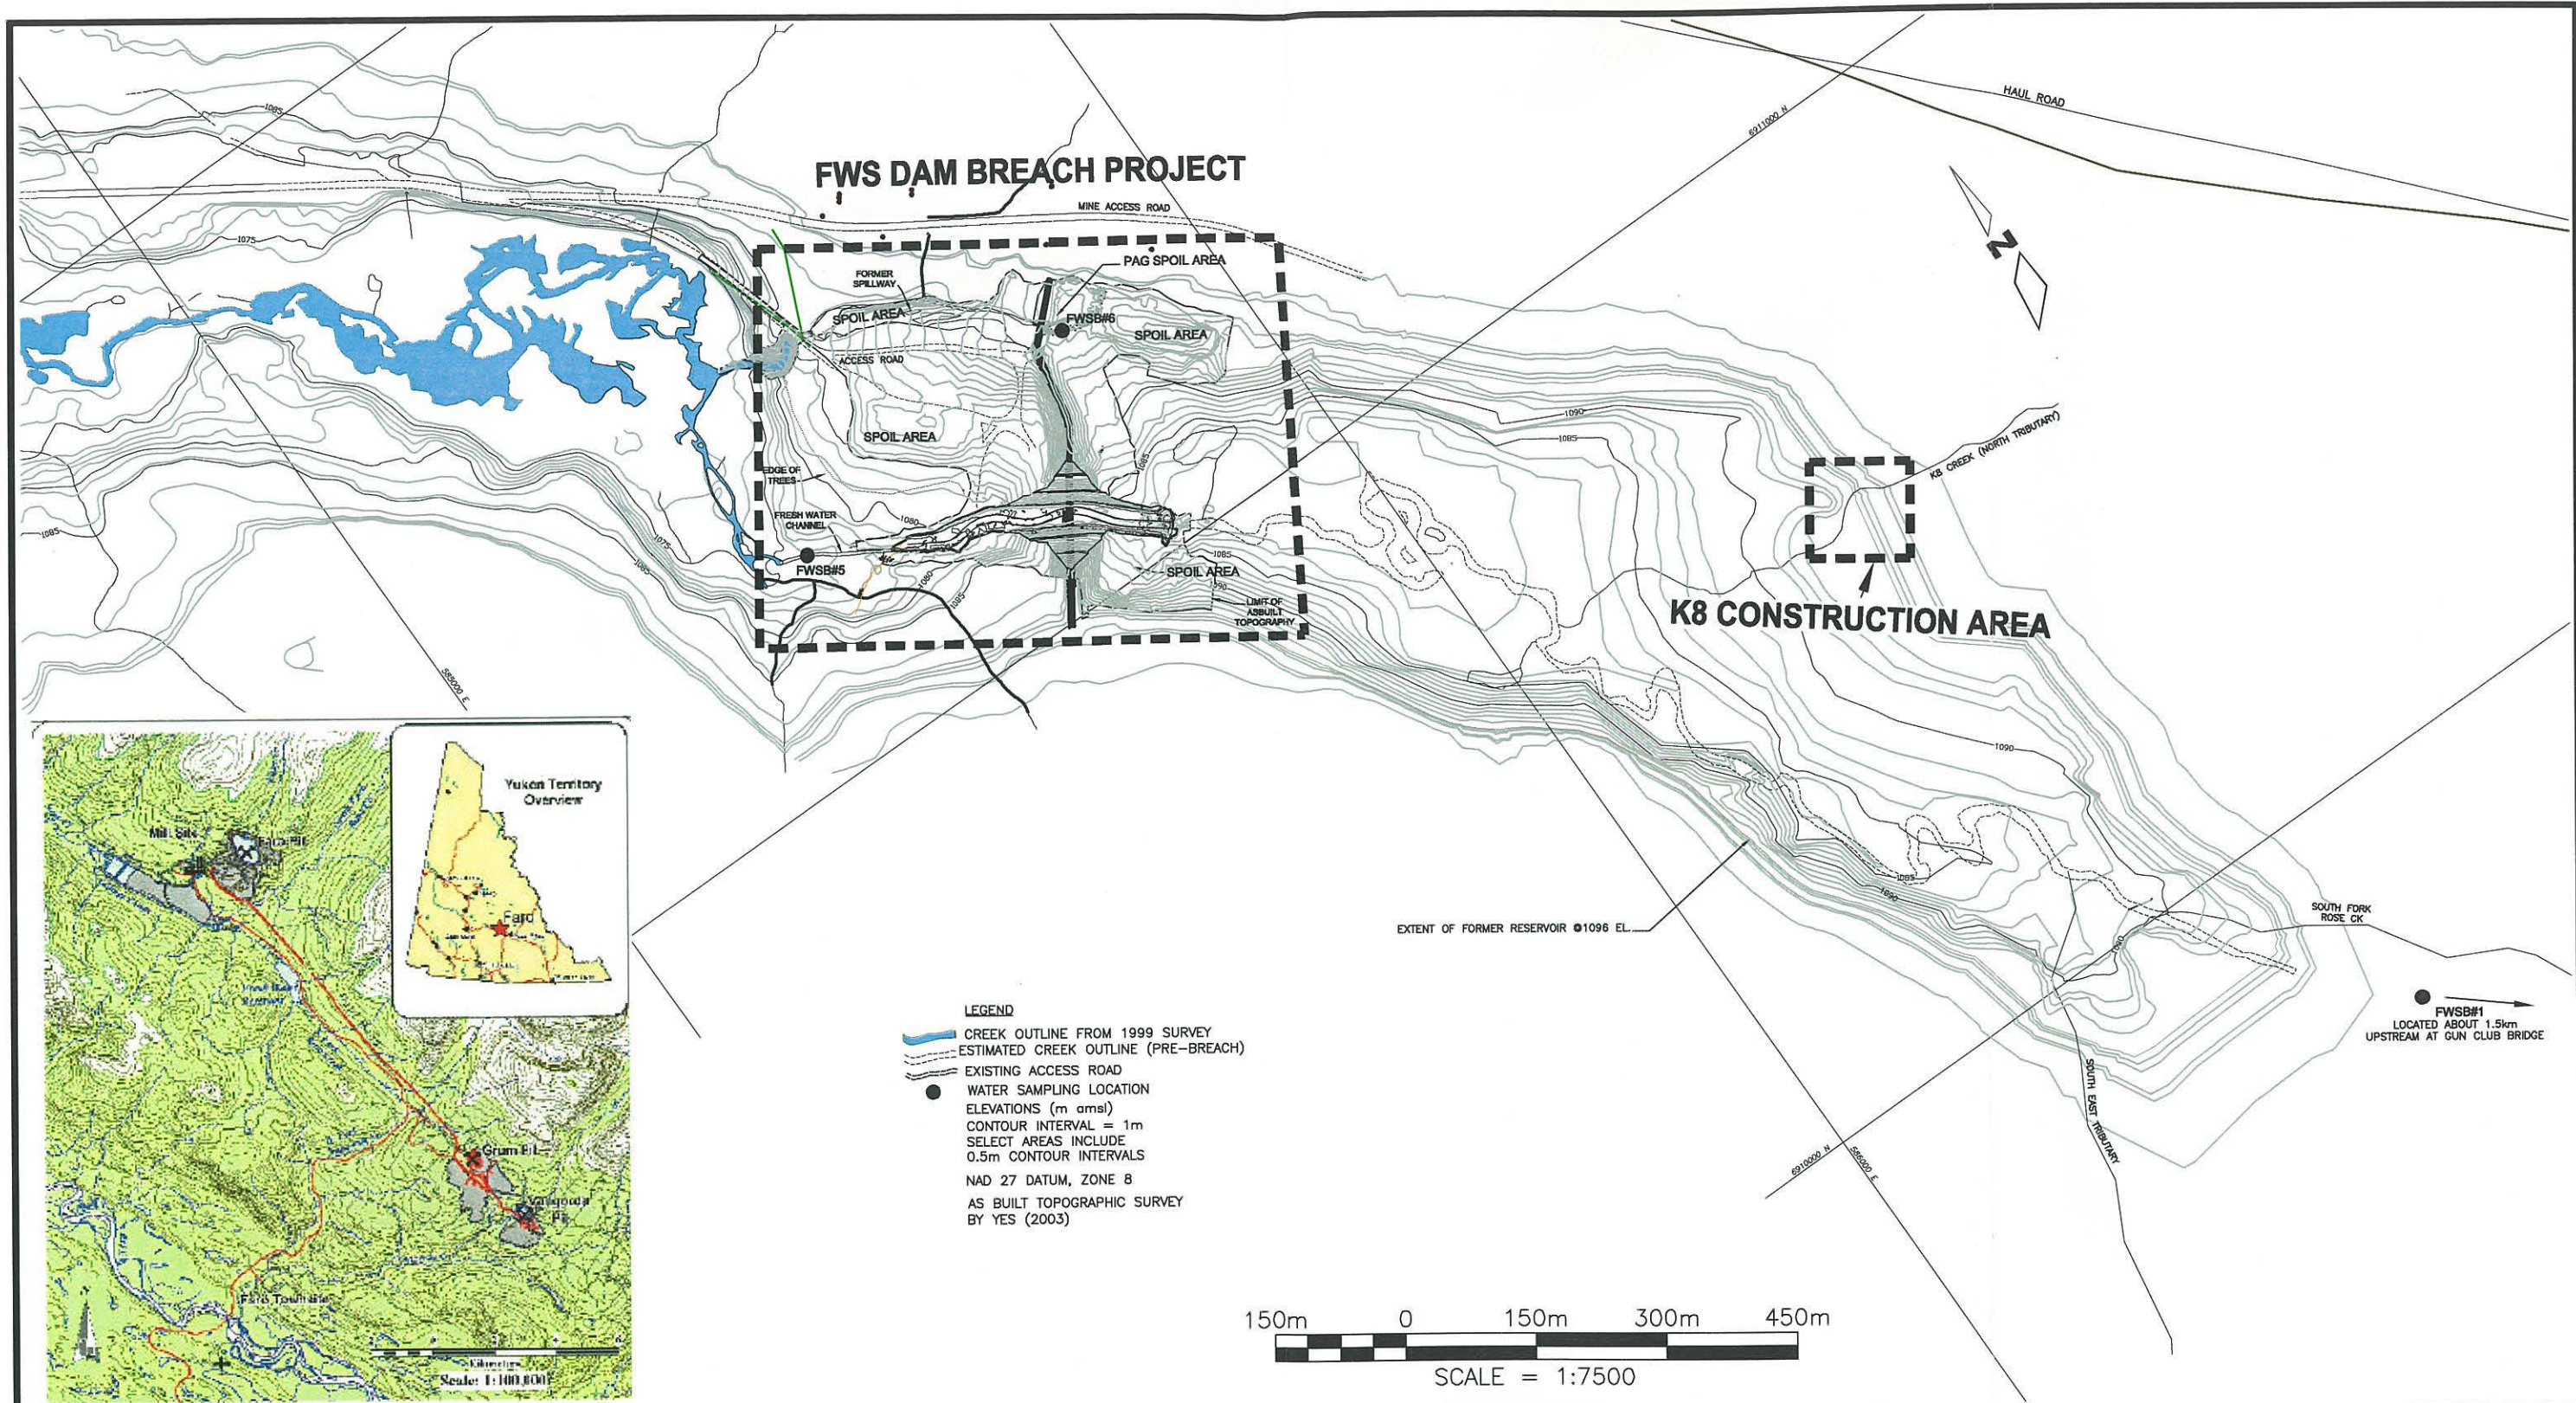
0257-024-03 001 FIGURE_1.dwg

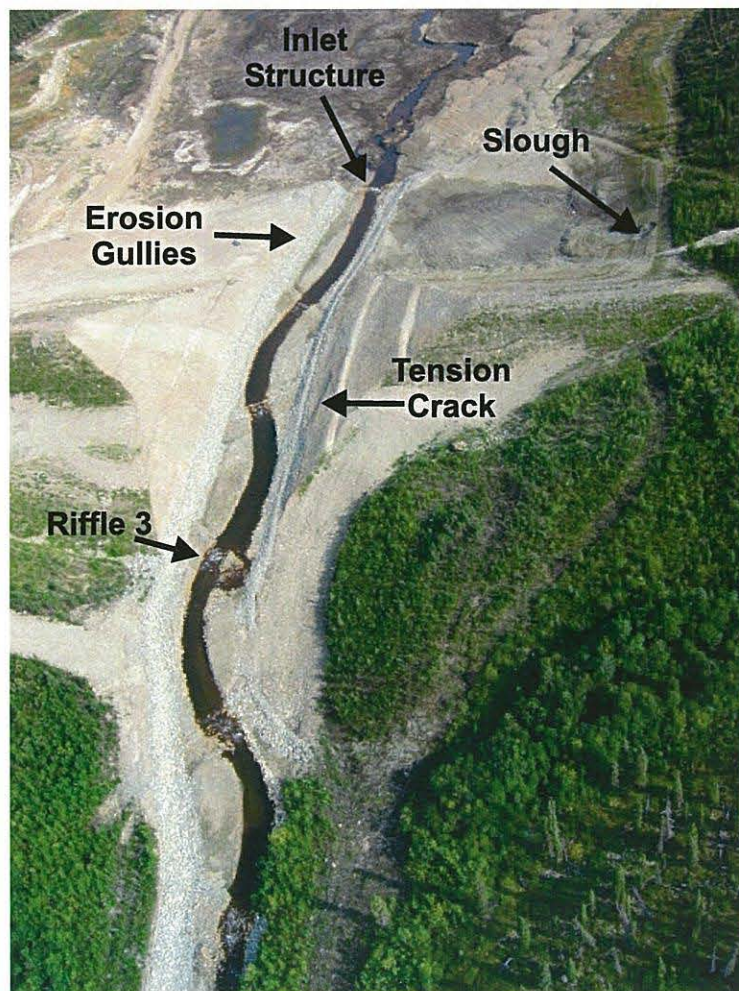
August: An aerial view of the breach section. This overview of the project shows the location of the breach and channel. Also shown is the slough on the former reservoir wall, the erosion gullies, the tension crack near riffle 2 and the water flowing around the left side of the channel at riffle 3.

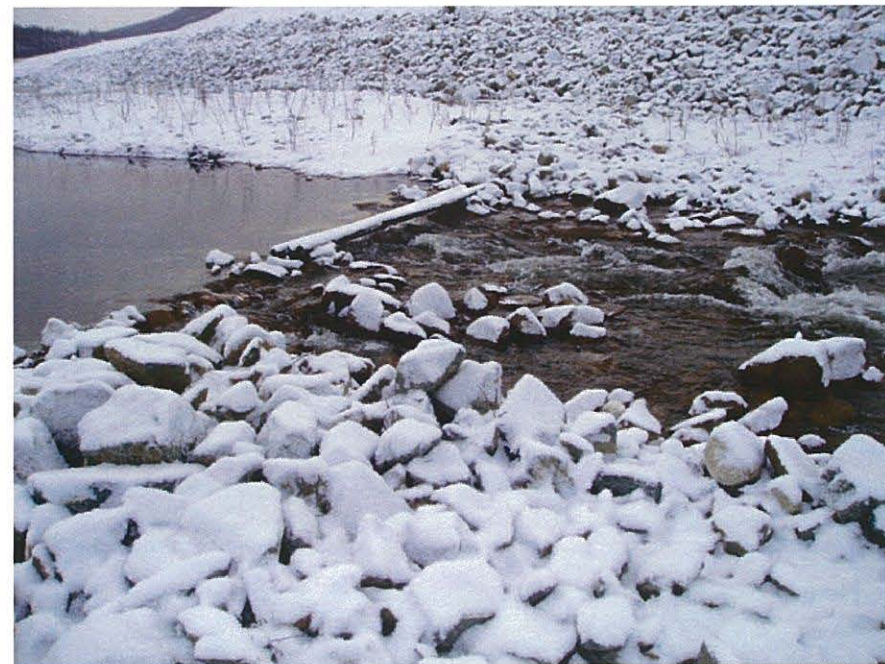
September: Shows Riffle 2 during normal flow condition. As can be seen, some of the routes from the riffle crest appears to have been moved downstream.

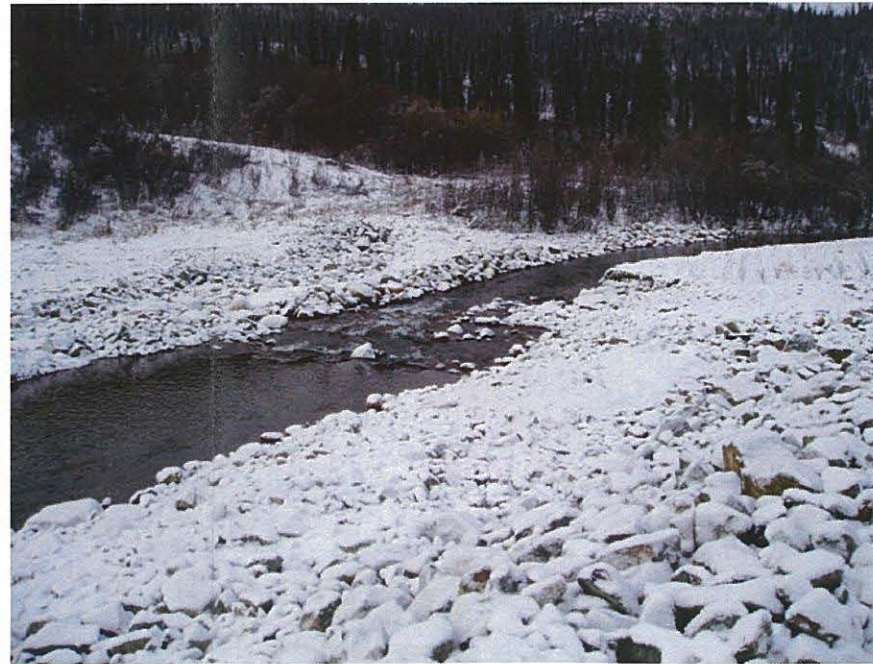
September: Shows Riffle 4 during normal flow. There appears to be some downstream movement of the larger fragments.

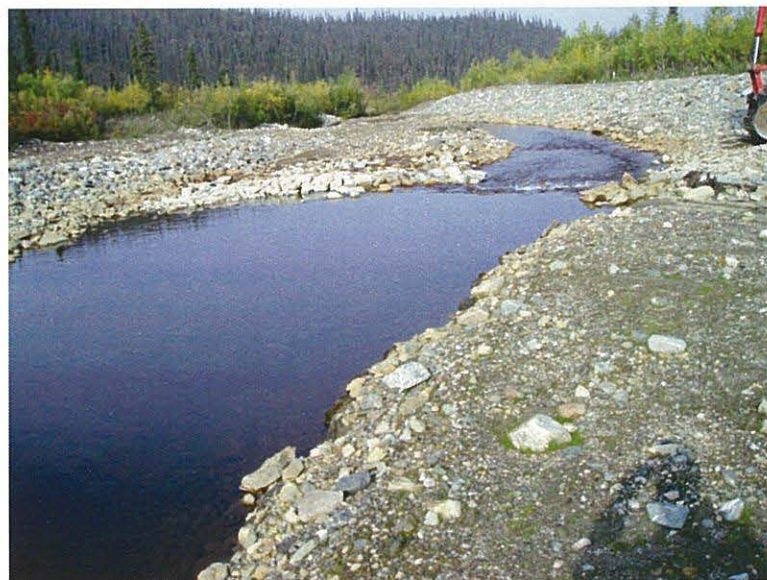
September: Shows a view of Riffle 3 looking in a downstream direction following repair of the lefthand side of the riffle. Approximately 8 m³ of riprap was used to repair this riffle.

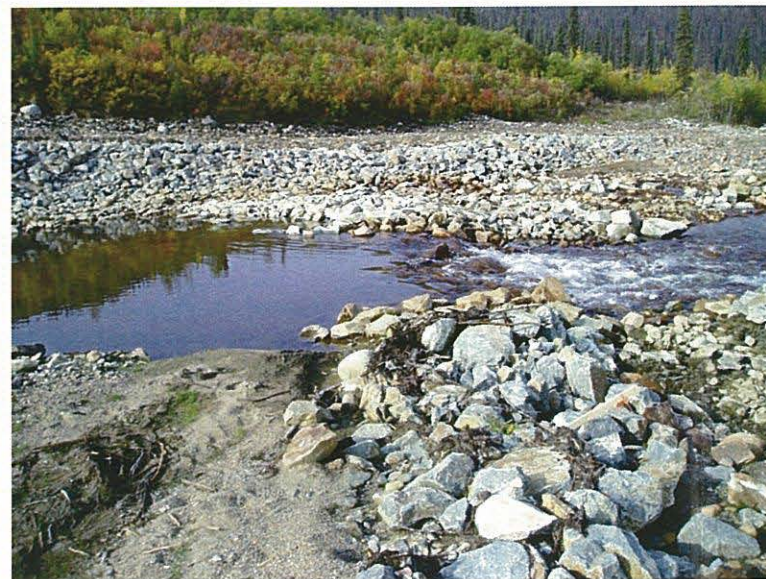
September: Shows a view of the left side of Riffle 3 following the repairs. Note the riprap placed to match the riprap elevation elsewhere.

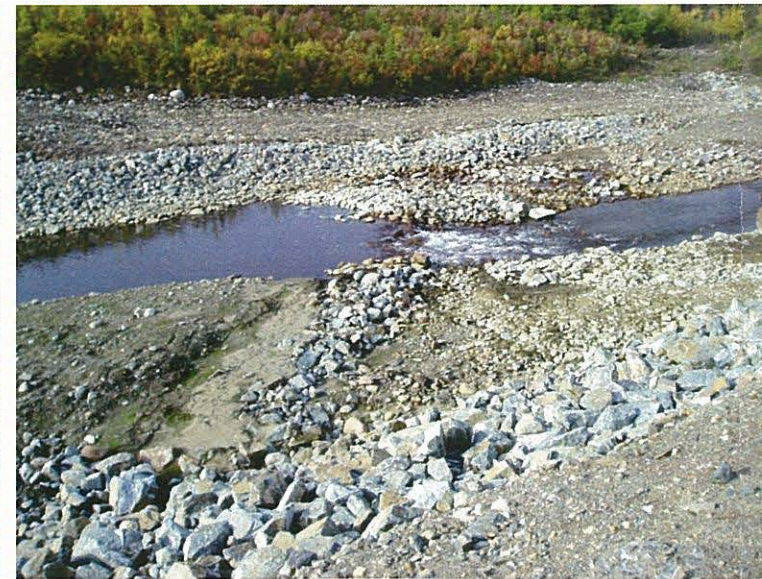
September: Shows an overview of the repaired Riffle 3. The newly placed riprap on the left side of the floodplain is high enough that the majority of the water is flowing in the centre of the channel.

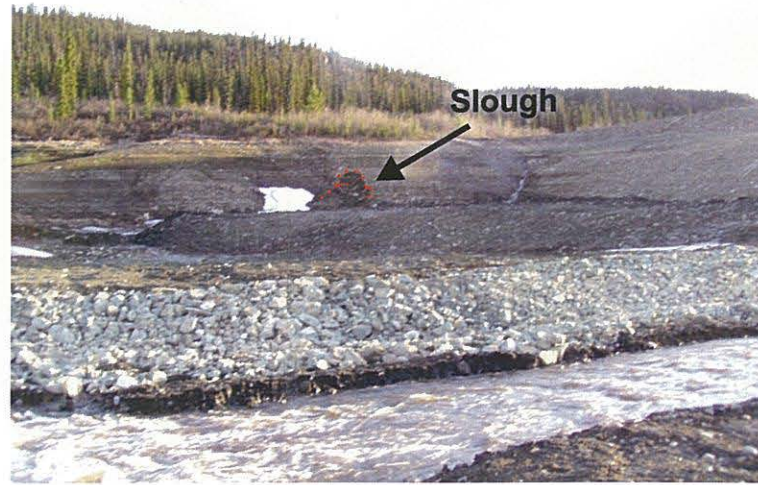
May: Shows a view of the slough near the south abutment. There is some standing water located at the toe of this slough, which is likely caused by seepage from the valley wall at this location.

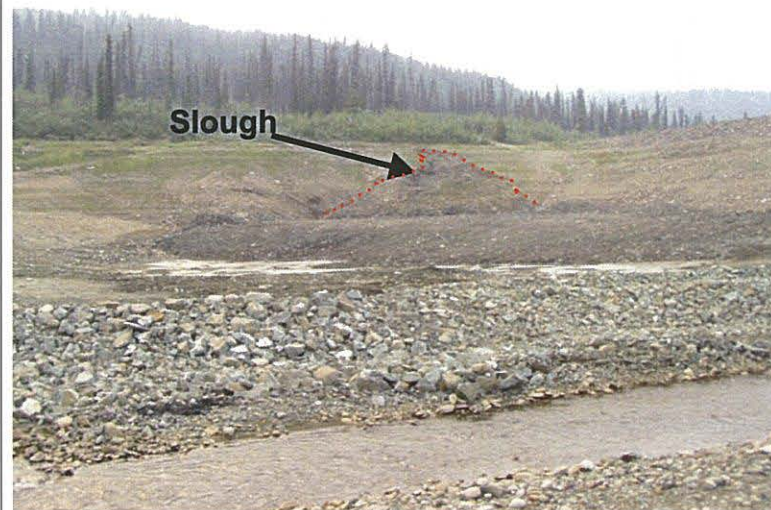
August: Shows the slough near the south abutment which appears to be increasing in size as compared to May. As noted before, there is some standing water at the toe perhaps indicating that the slough is driven by valley wall seepage.

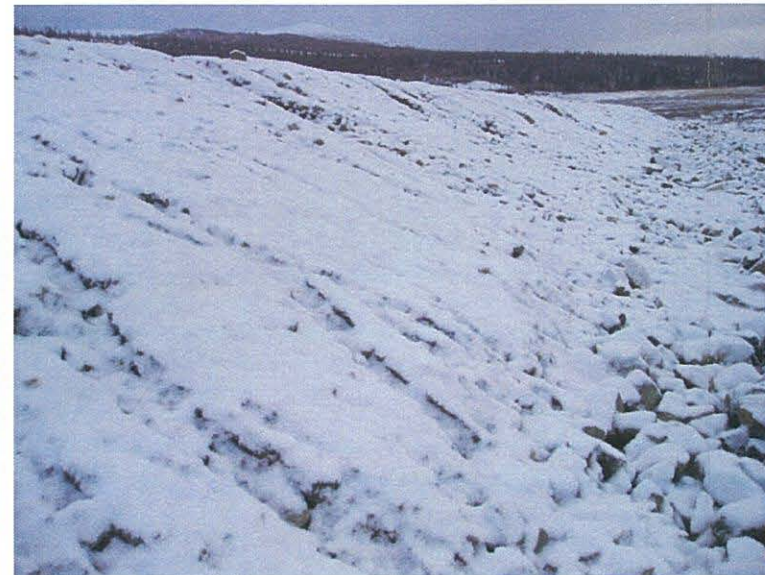
September: Shows a number of small erosional gullies which are formed higher up on the cut channel. The erosional gullies are relatively minor except for the occasional one which is perhaps 1 metre across by perhaps 1/3 to 1/2 metre deep.

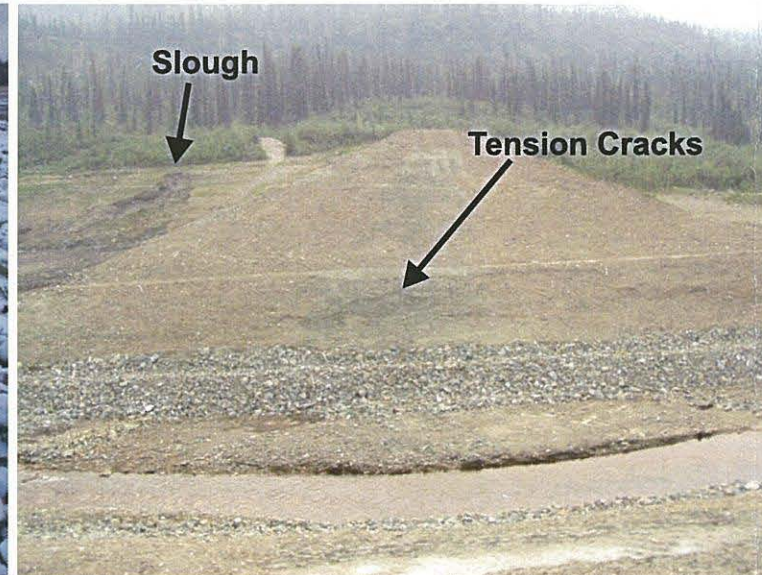
August: Shows a view of the cutslope on the south side of the breach. There is one scarp on this side of the channel, caused by some slumping of the material.

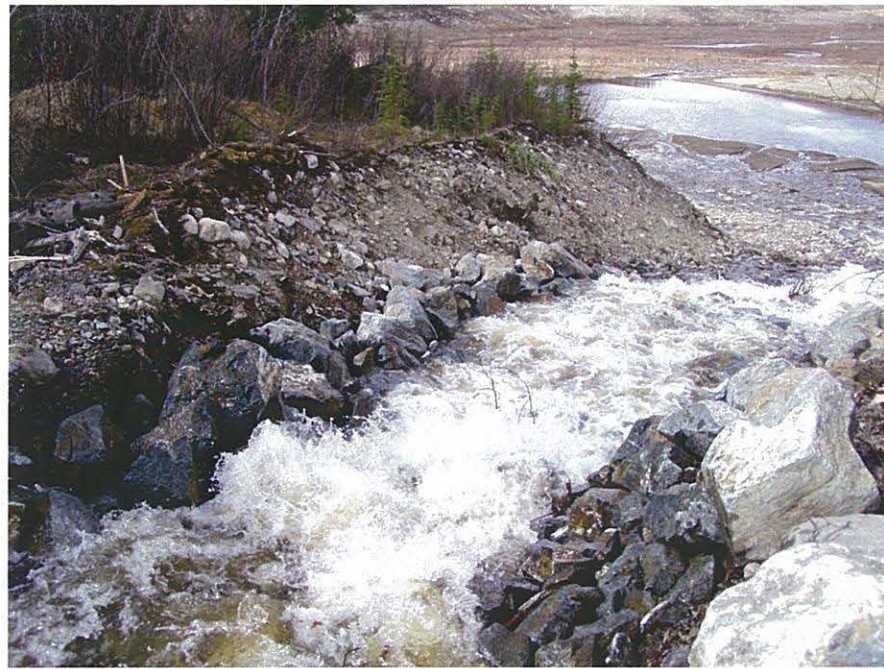
May: Shows a view, looking downstream at the water flowing across the repair portion of K8 creek.

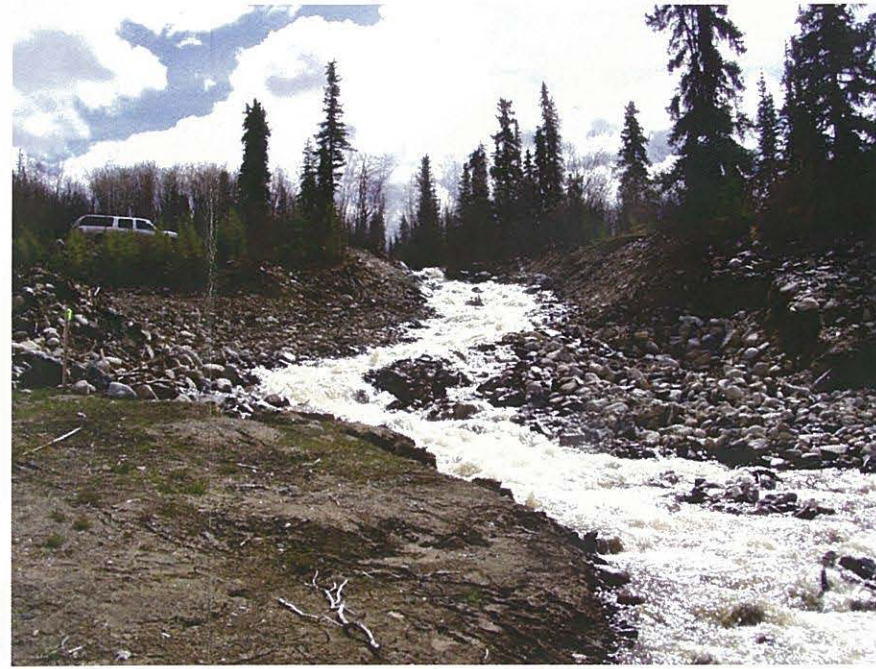
May: Shows a view looking upstream of K8 Creek, during freshet, of the water flowing over the riprap apron.
