**2005 ANNUAL REPORT**

**FRESH WATER SUPPLY DAM BREACH PROJECT  
FARO MINE, YUKON**

PROJECT NO.: 0257-033-01  
DATE: FEBUARY 16, 2006

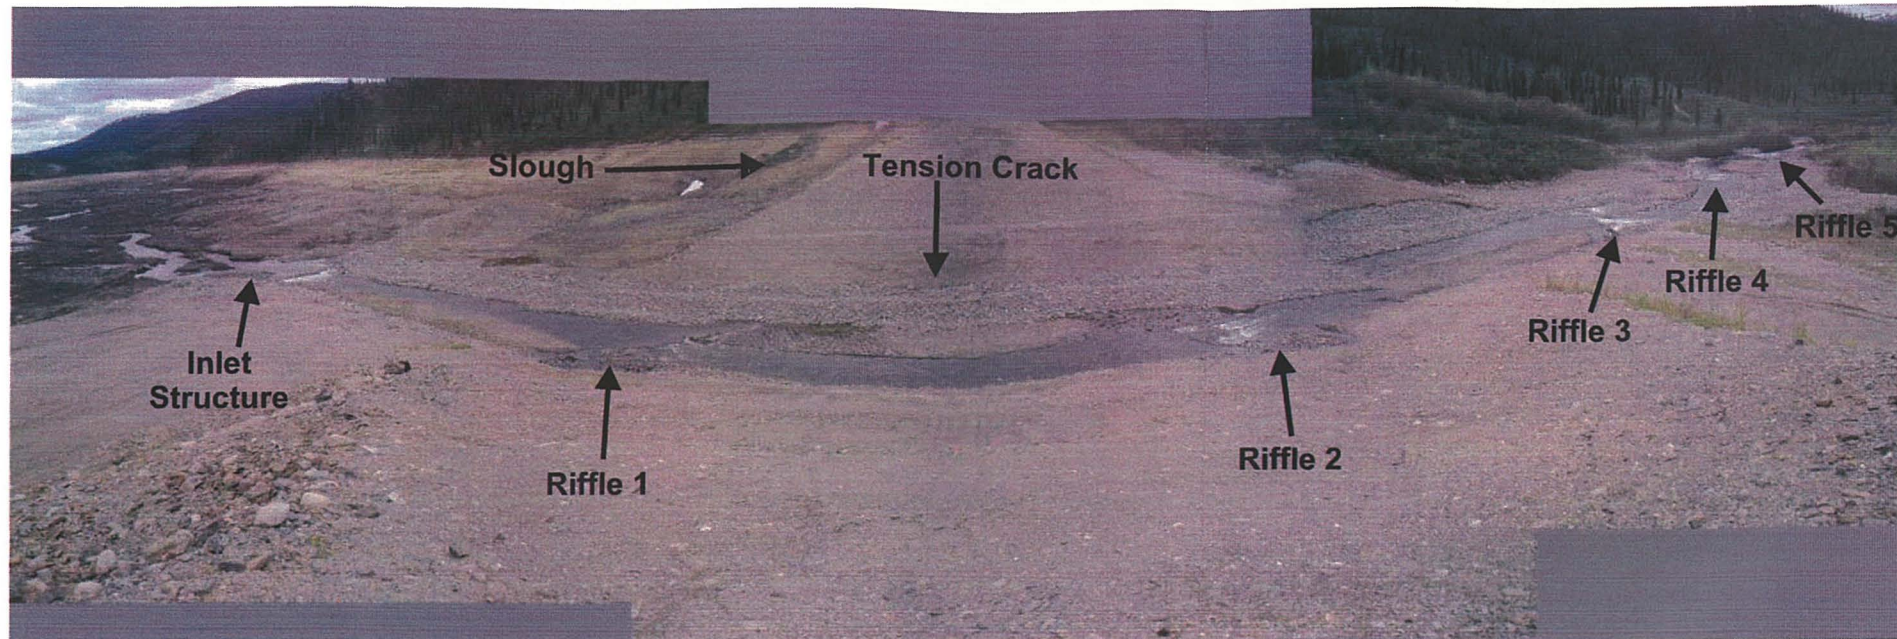
May: The breach channel through the dam. As shown at the far left, some stream braiding has occurred upstream of the inlet structure. This photo also shows the slough, the location of tension cracks in the core of the dam and the 5 riffles..

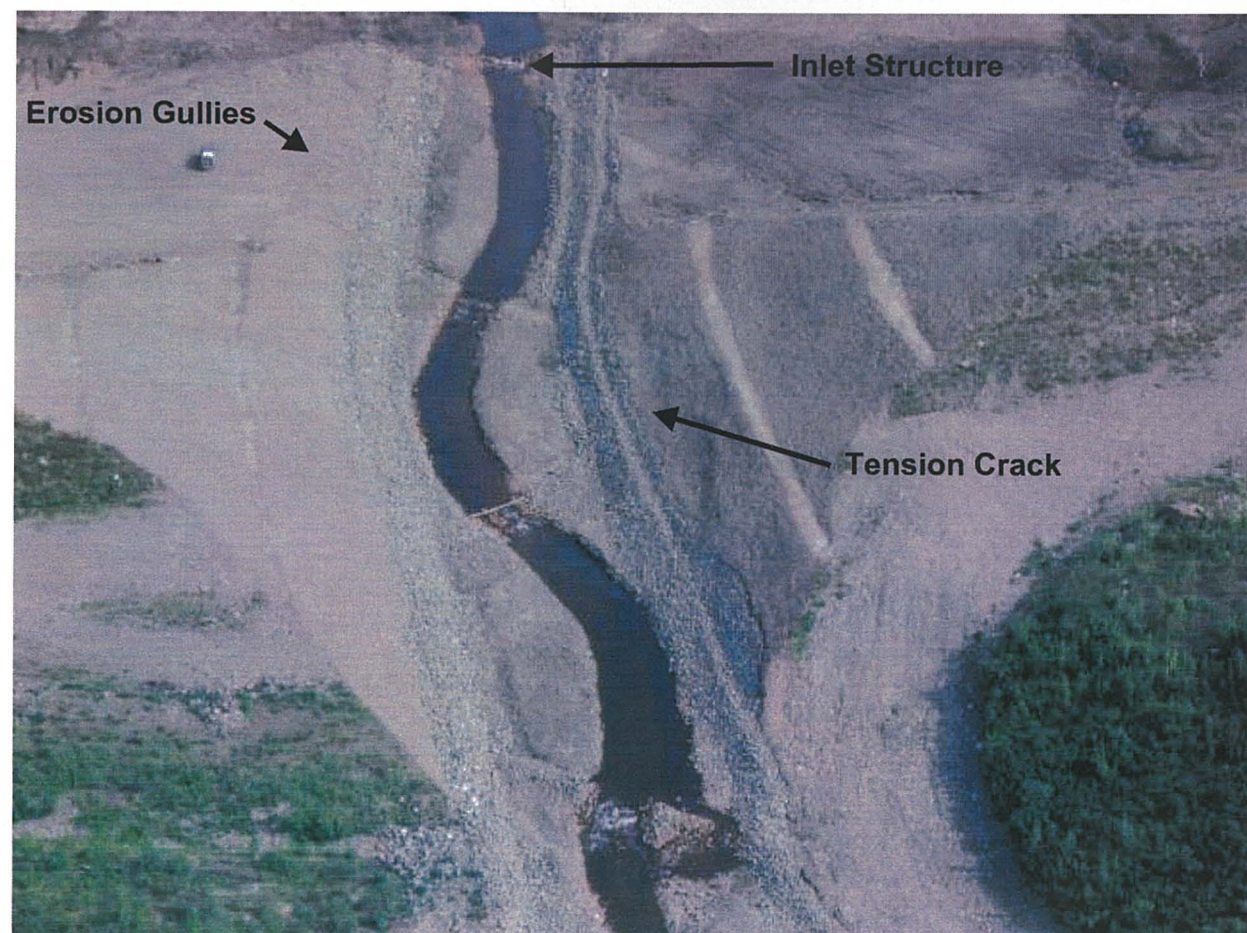
August 2004: An aerial view of the breach section. This overview of the project shows the location of the breach and channel. Also shown is the slough on the former reservoir wall, the erosion gullies, the tension crack located between Riffle 1 and 2. The water flowing around the left side of Riffle 3 shown in this photo was repaired in September 2004.

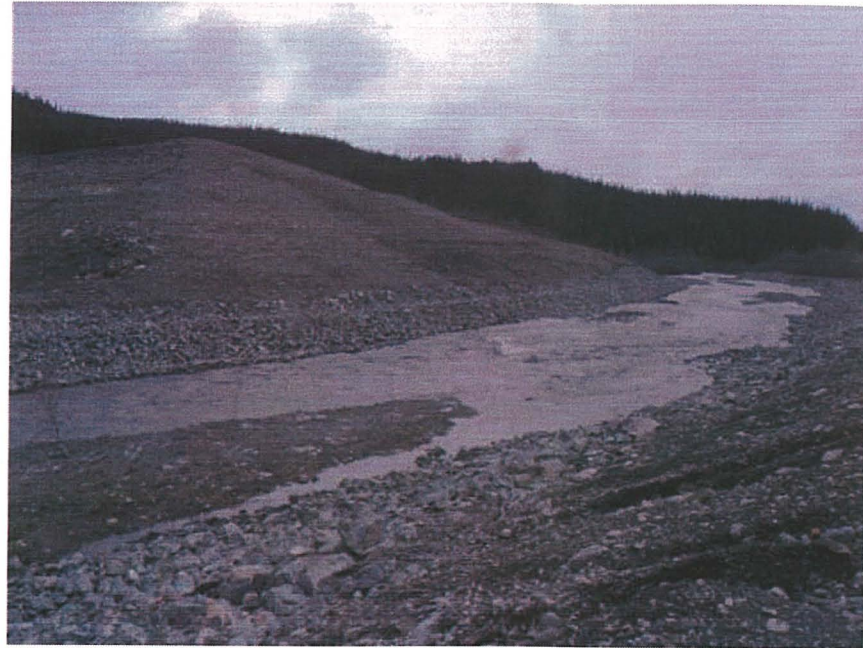
May: Flow in the channel and flood plain during the peak freshet flow of 2005.

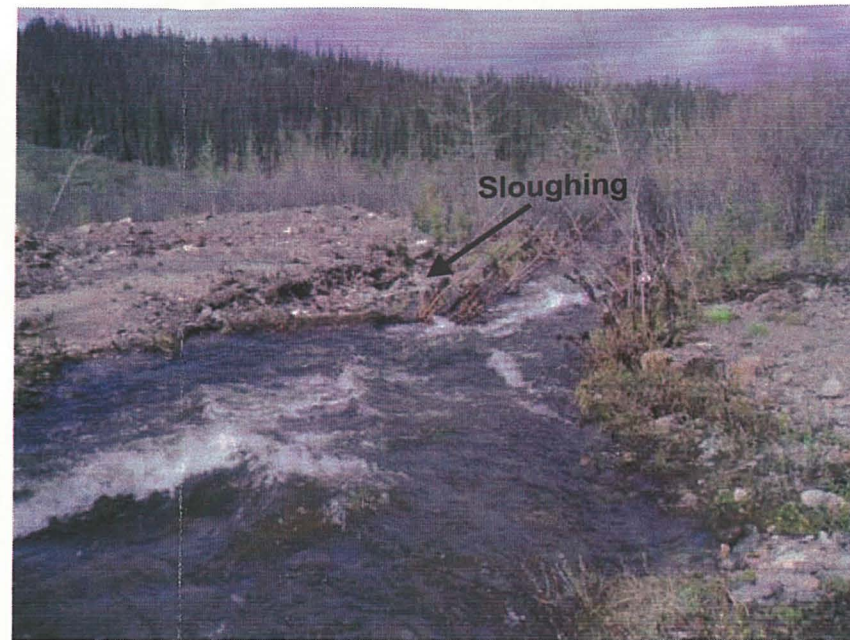
May: Erosion on left bank immediately downstream of the limit of the 2003 construction.

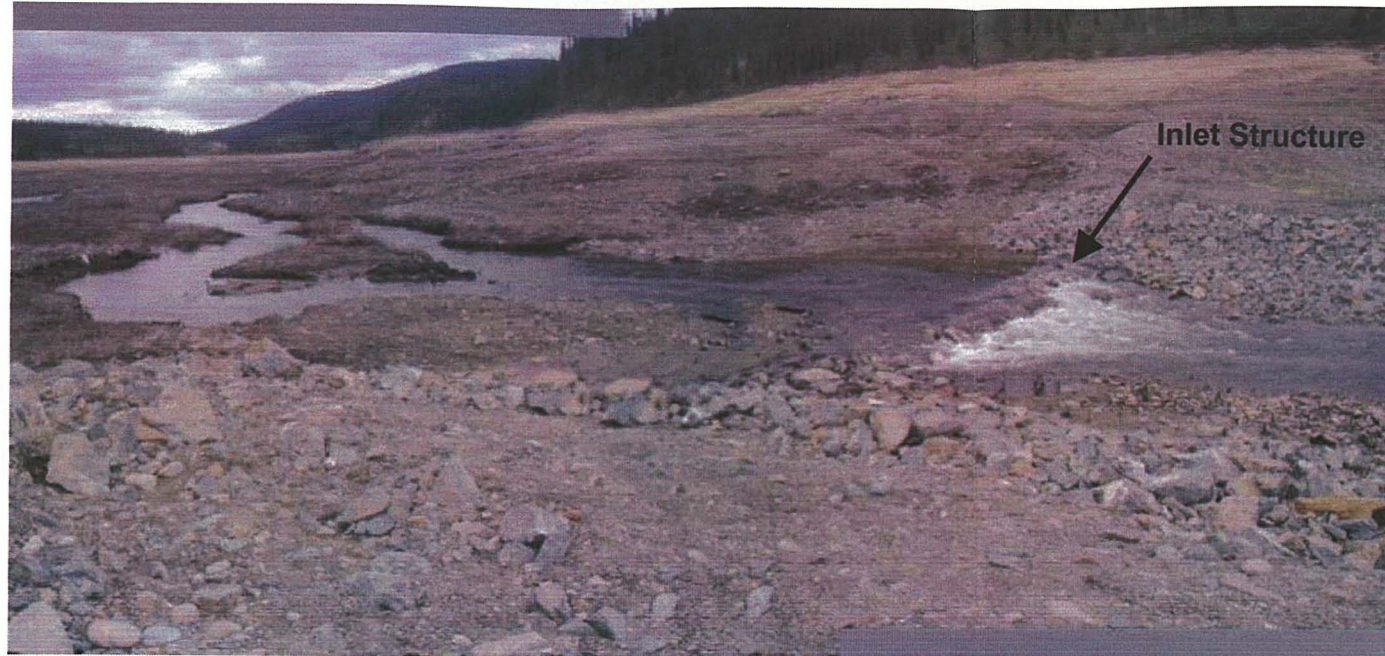
May: View of the inlet structure and the channel immediately upstream of the breach. The channel has formed into a braided stream upstream of the inlet structure.

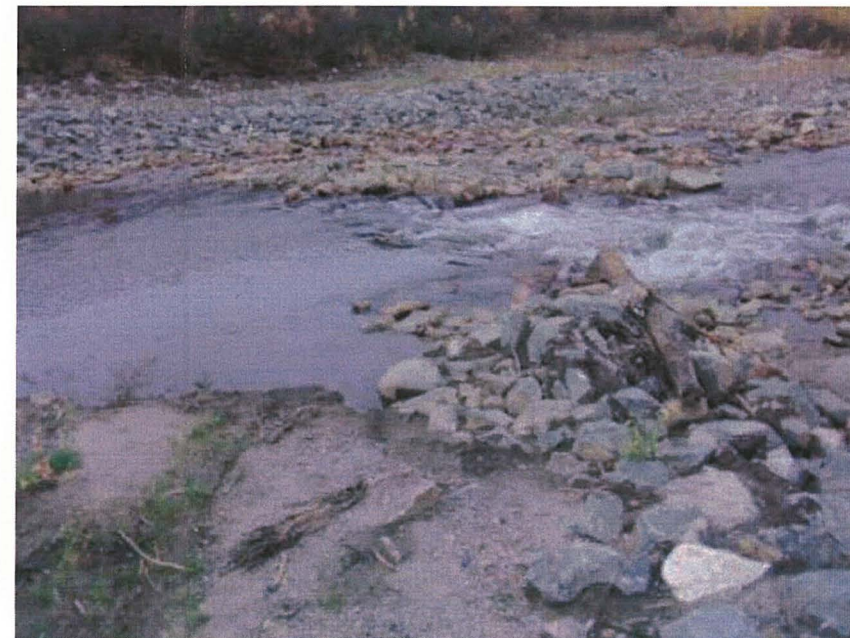
September: Shows the condition of Riffle 3. As can be seen, some of the boulders at the crest of the riffle have been pushed downstream and some of the water is escaping around the left side of the riffle.

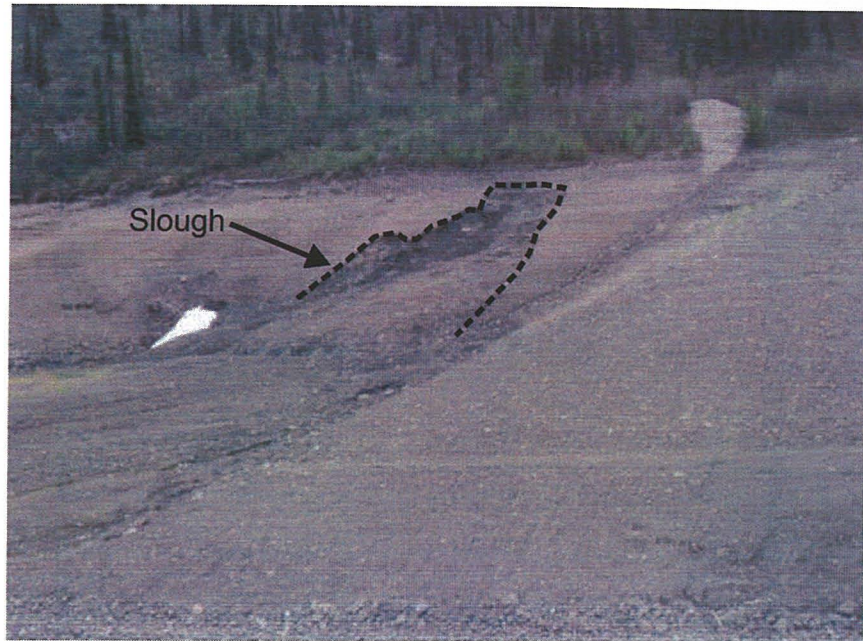
May: Shows a view of the slump located over towards the south abutment. The slump appears to be growing in size from last year.

- Portions of the floodplain and upstream of the inlet structure have eroded, but no concerns.
- Slough continues to occur at the south abutment. The soil within the slough will need to be excavated and replaced with rockfill to both buttress the slope and allow water drainage.

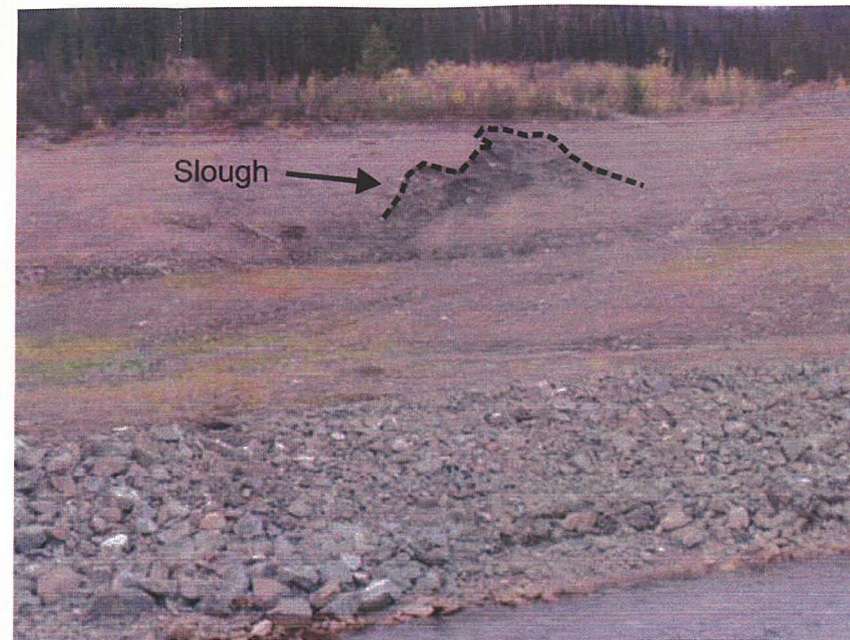
September: Shows a view of the slough at south abutment, which appears to be slightly larger than in 2004 but appears to be self buttressing.

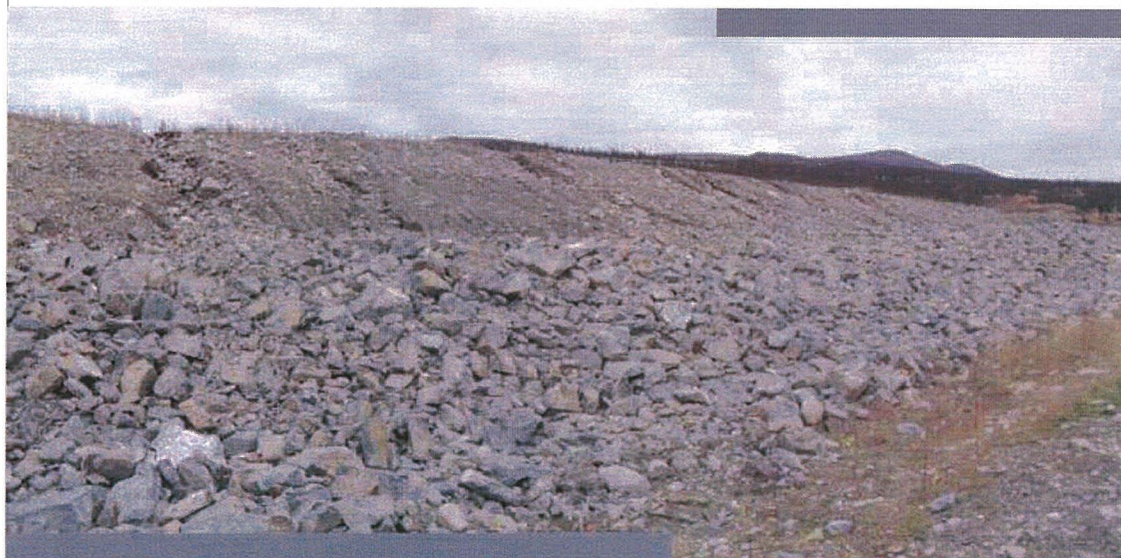
September: The erosional gullies which have formed on the right side of the breach. These gullies are the result of sheet flow across the upstream seepage blanket. The flow then coalesces into small channels and flows into the breach section. Some of these erosion gullies are self armoured.

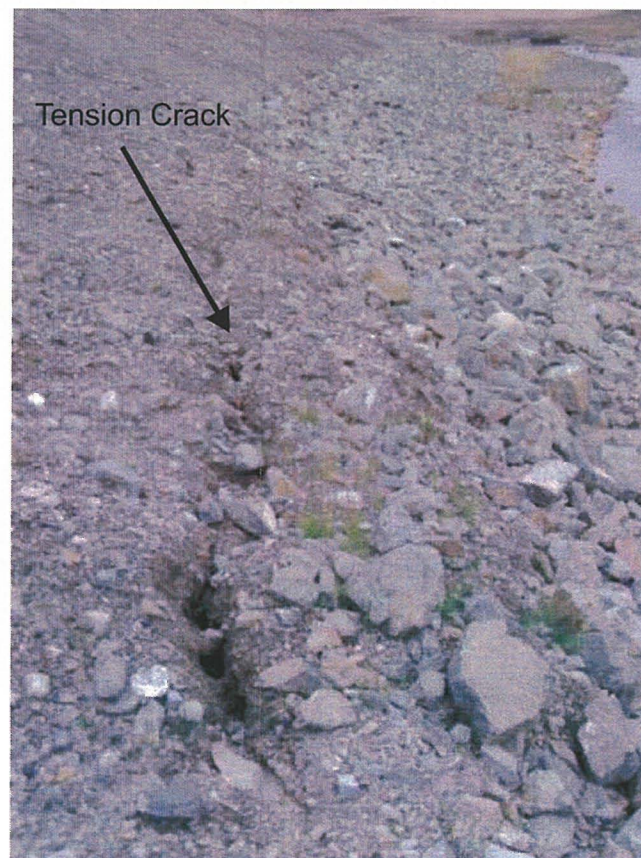
Some tension cracks have formed above the erosion protection (Figure 10). This is due to the over steeped slope created for the installation of the erosion protection.

September: Shows longitudinal tension cracks located behind the riprap.

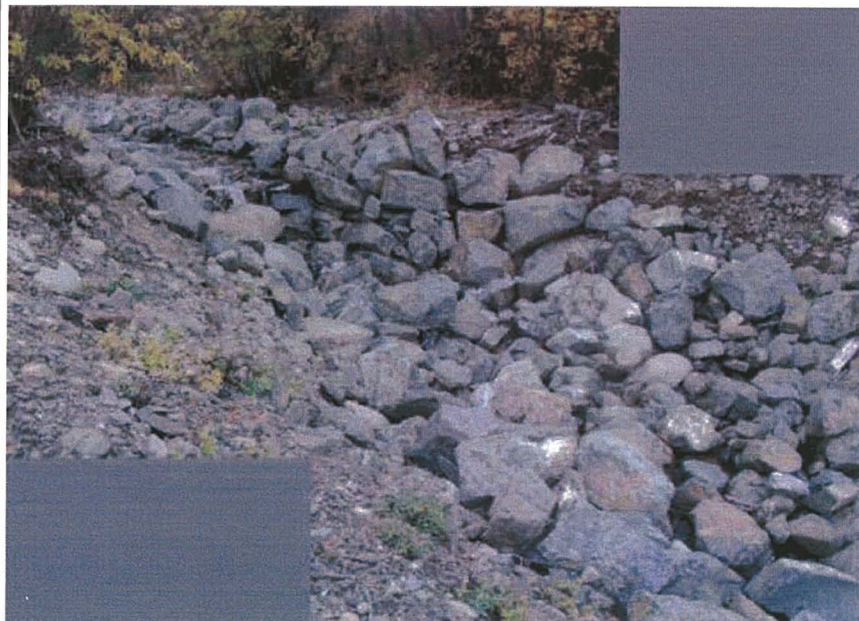
September: Shows the condition of the riprap within the upslope area.

- K8 Creek appears fine but one minor area of rip rap should be repaired by the placement of additional material.
- A distinct incised channel has not yet formed in the K8 Creek discharge downstream from the old borrow area.

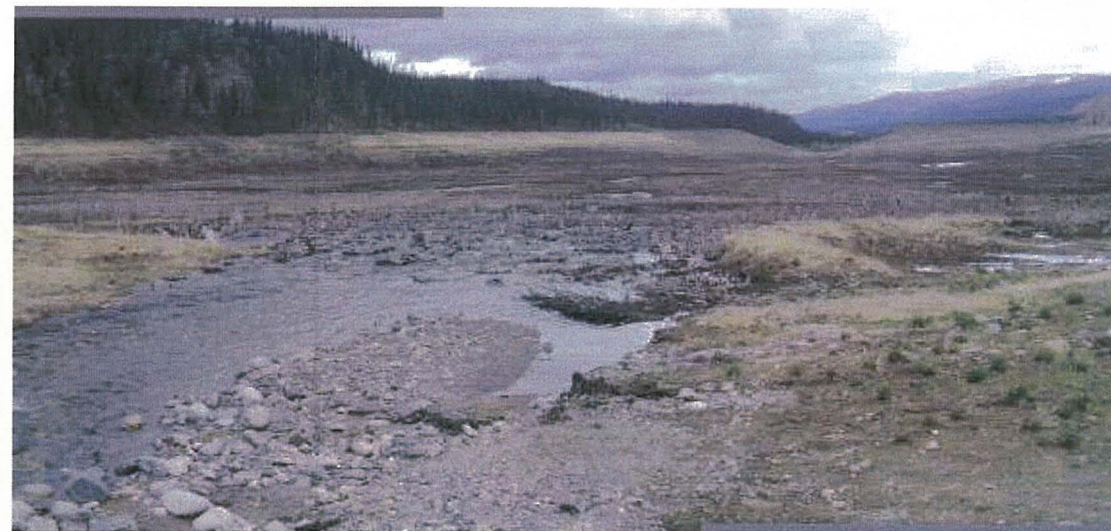
May: a view of the K8 Creek entering the reservoir area from the borrow pit. In this area, the water flow has not yet formed into a distinct channel.

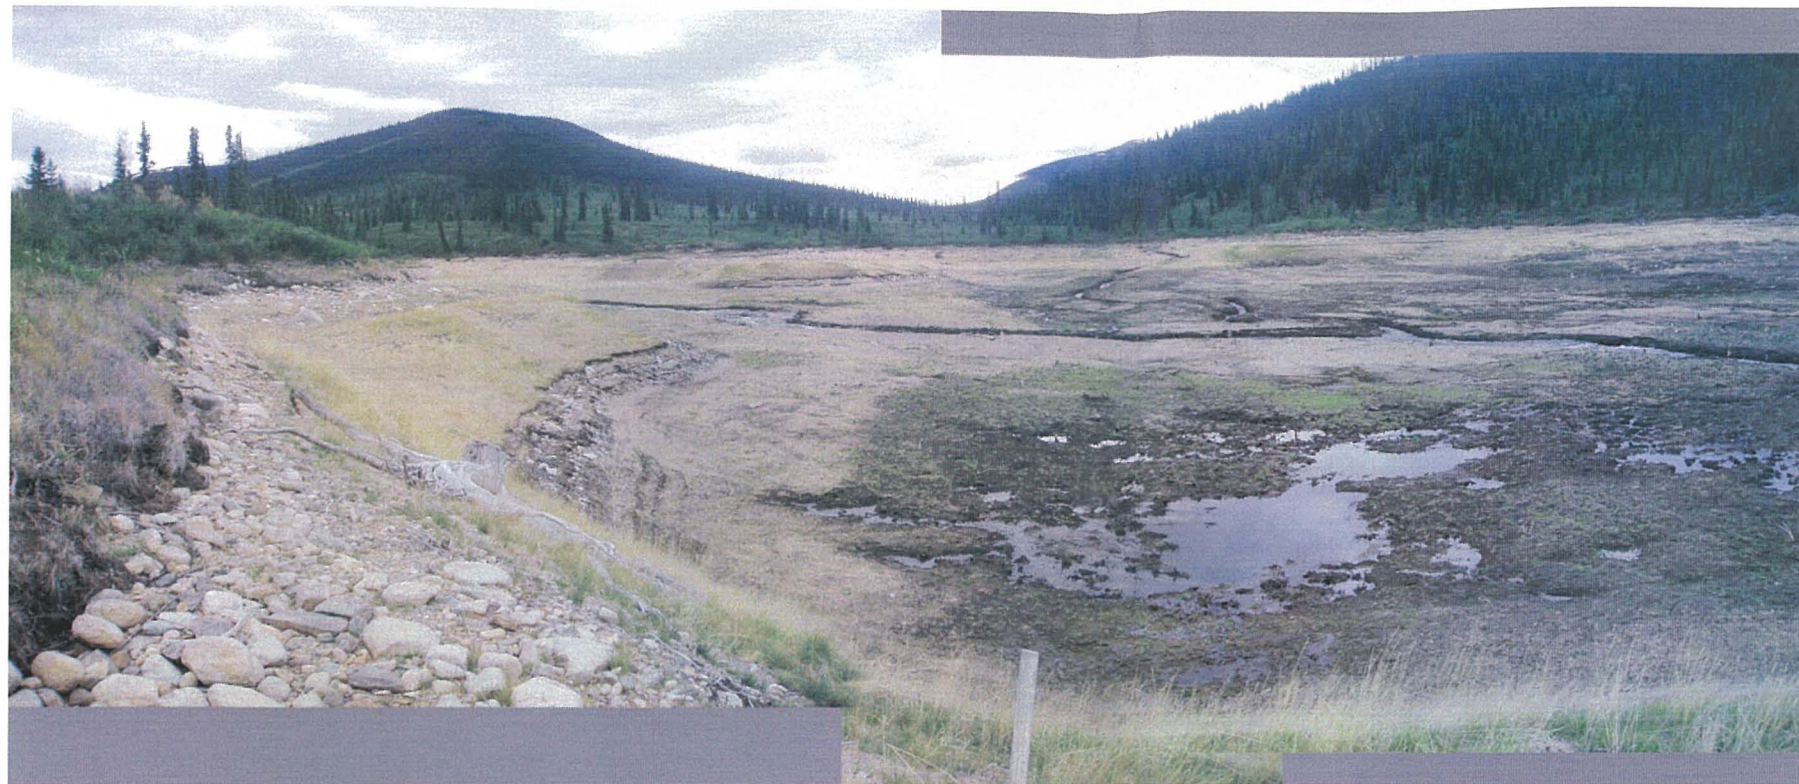
May: Shows a panoramic showing the condition of the vegetation and the two tributaries at the upstream end of the reservoir. The early phases of re-vegetation performed in the upper part of the former reservoir appears to be performing better than the later (lower) re-vegetation efforts.

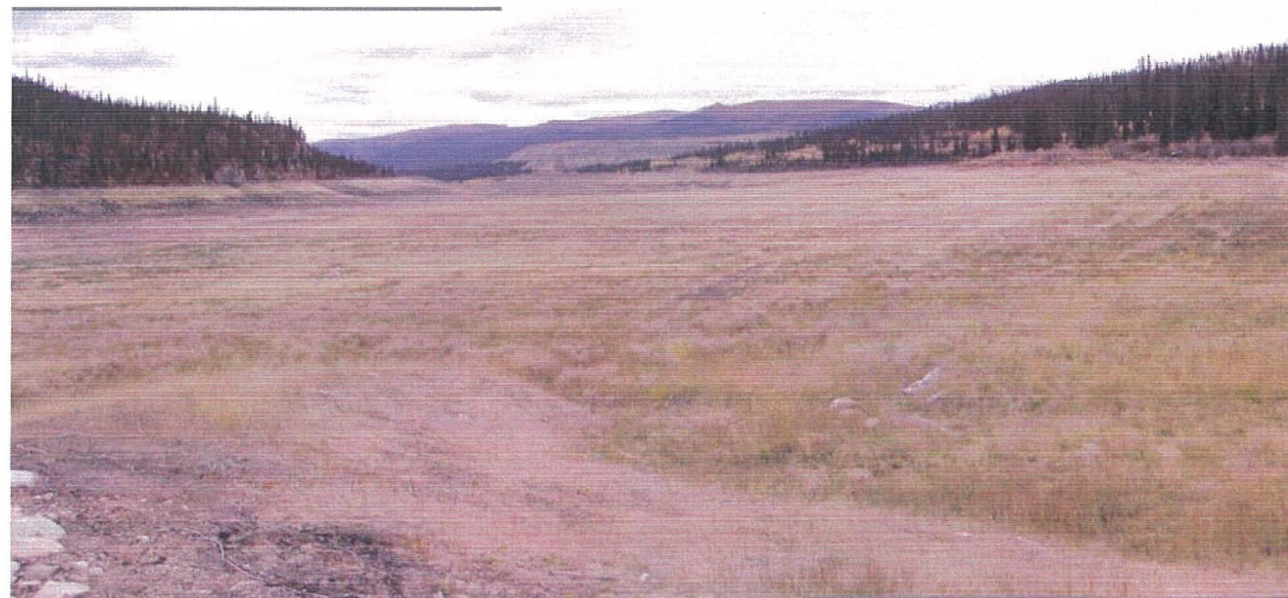
September: Shows an overall view of the vegetation in the former reservoir bottom. From this perspective there is good vegetative coverage. Vegetation is sparser on the south side of the channel.

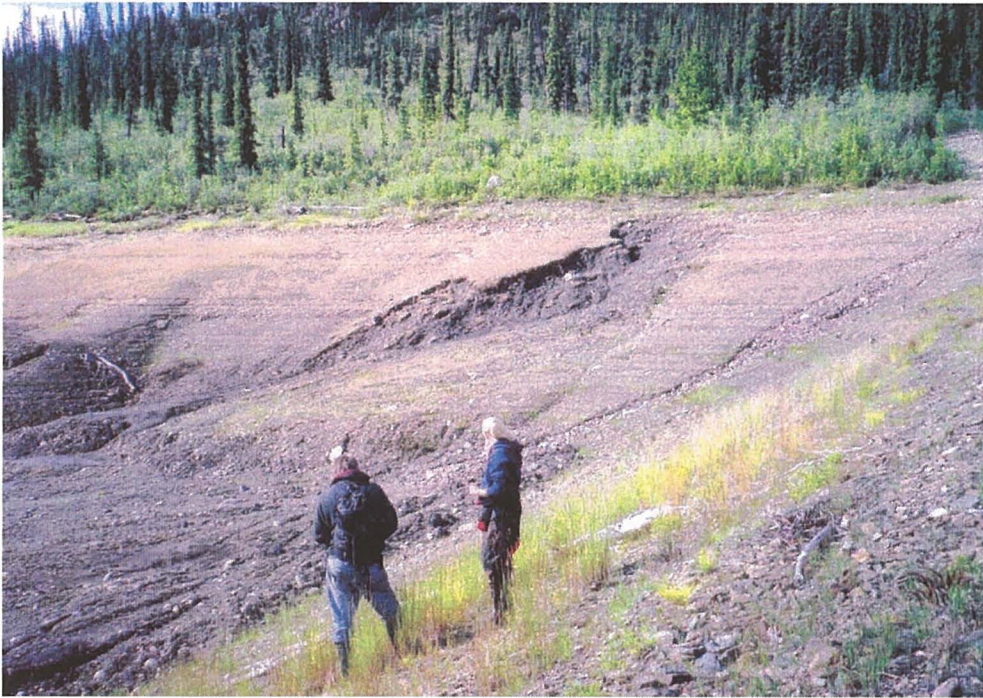
Photo #5: Eroded gully formed on south west side of reservoir.

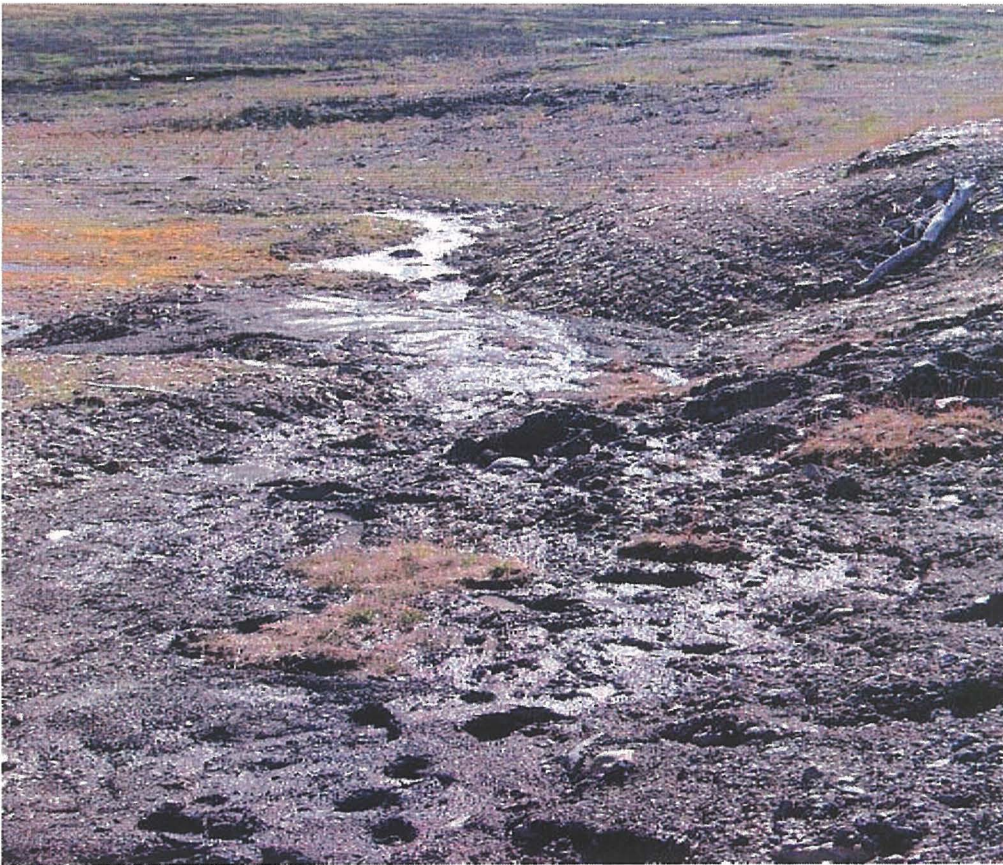
Photo #6 : Erosion in gully below groundwater seepage point, looking to valley floor.

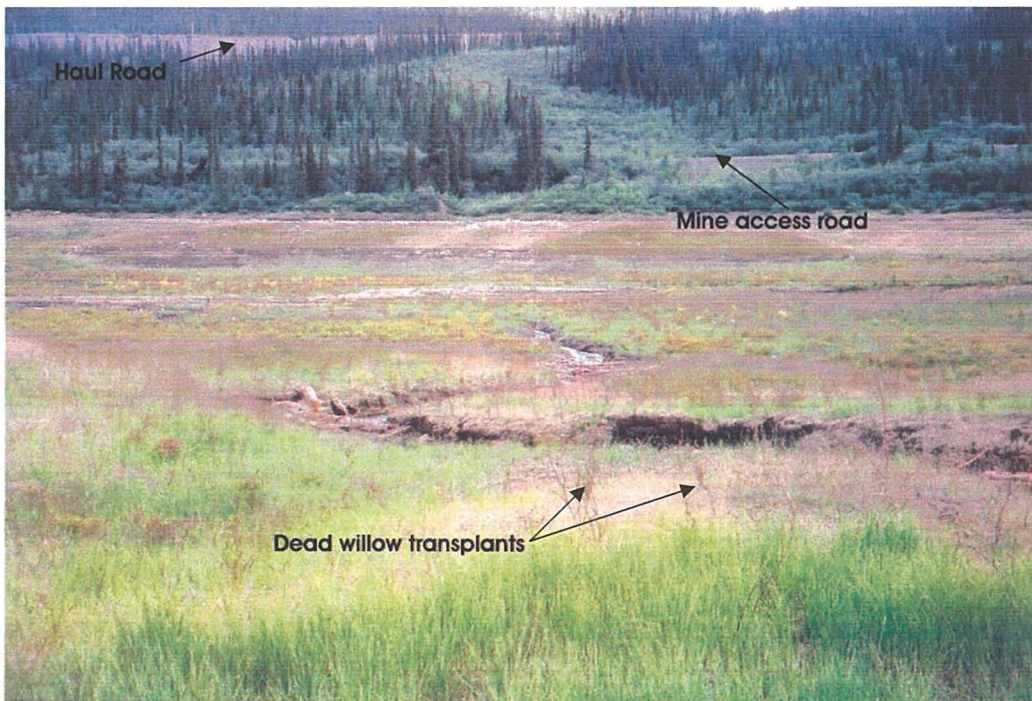
Photo #12 : Looking down S.E. tributary. Most of the willow transplants did not survive in this area.

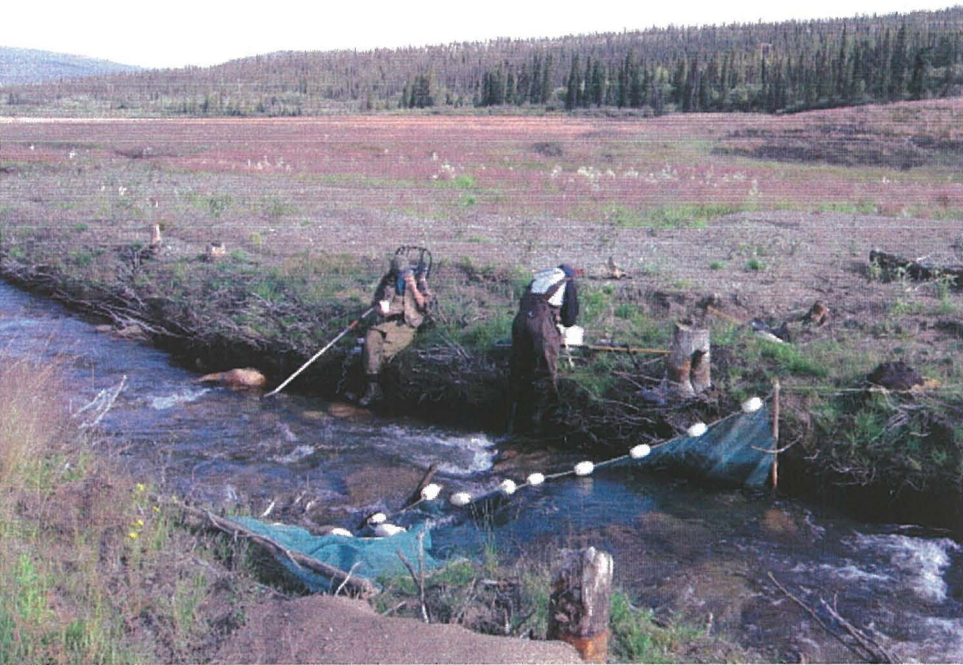
Photo #2: The downstream end of reach 1, August 2005, sediment accumulations from the 2004 freshet are still in evidence. Note vegetation development in comparison to photo #3.
