BGC ENGINEERING INC.
AN APPLIED EARTH SCIENCES COMPANY

DELOITTE & TOUCHE INC.

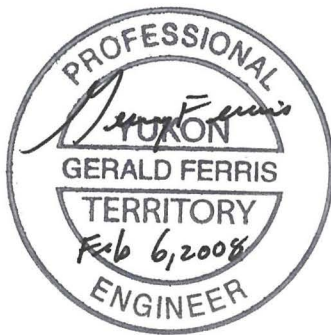
Gerry Ferris, M.Sc., P.Eng.
Geotechnical Engineer

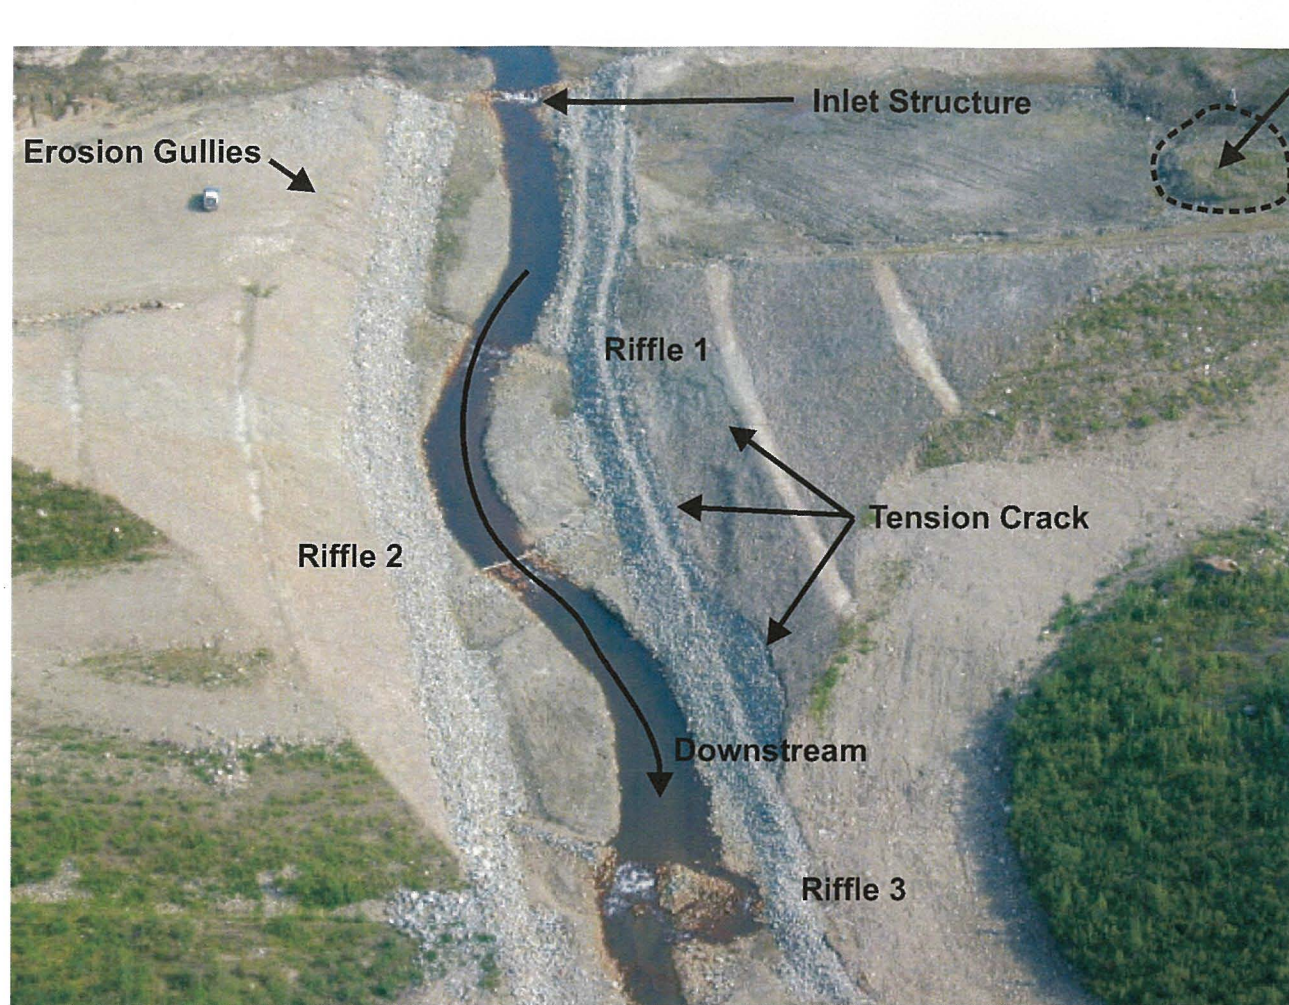
August 2004: An aerial view of the breach section. This overview of the project shows the location of the breach and channel. Also shown is the slough on the former reservoir wall, the erosion gullies, the tension crack located between Riffle 1 and 2. The water flowing around the left side of Riffle 3 shown in this photo was repaired in September 2004.

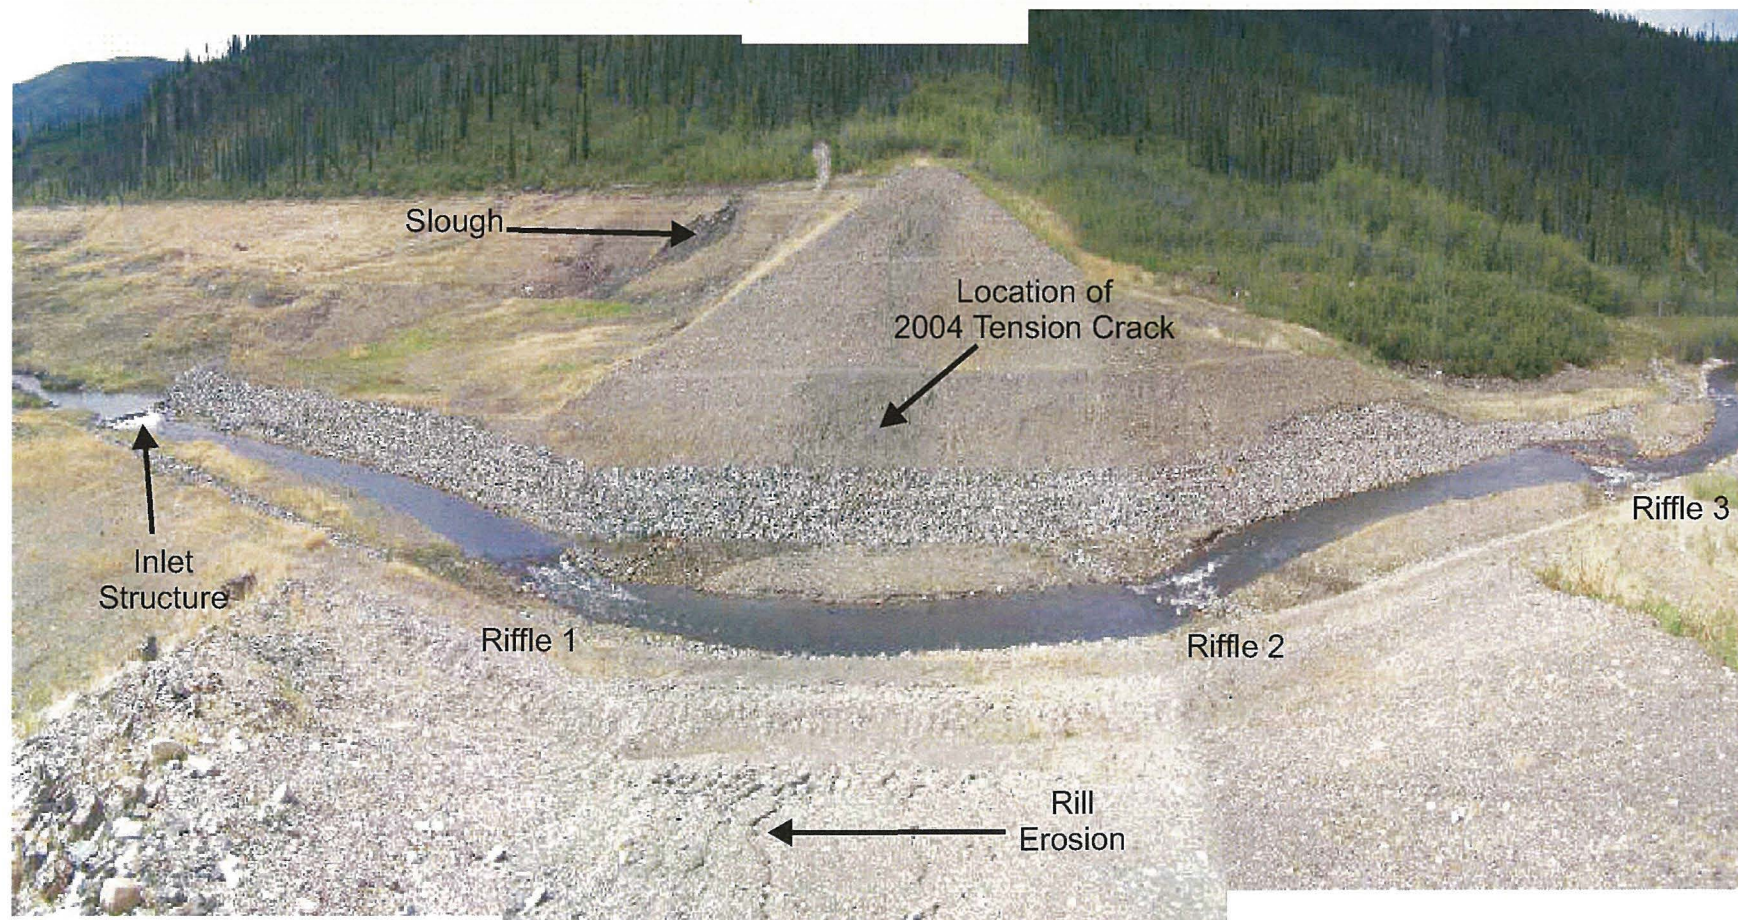
June 2007: Shows a current view of the breach project area; showing the slough and position of the 2004 tension cracks. Also note the appearance of rill erosion in the former dam core.

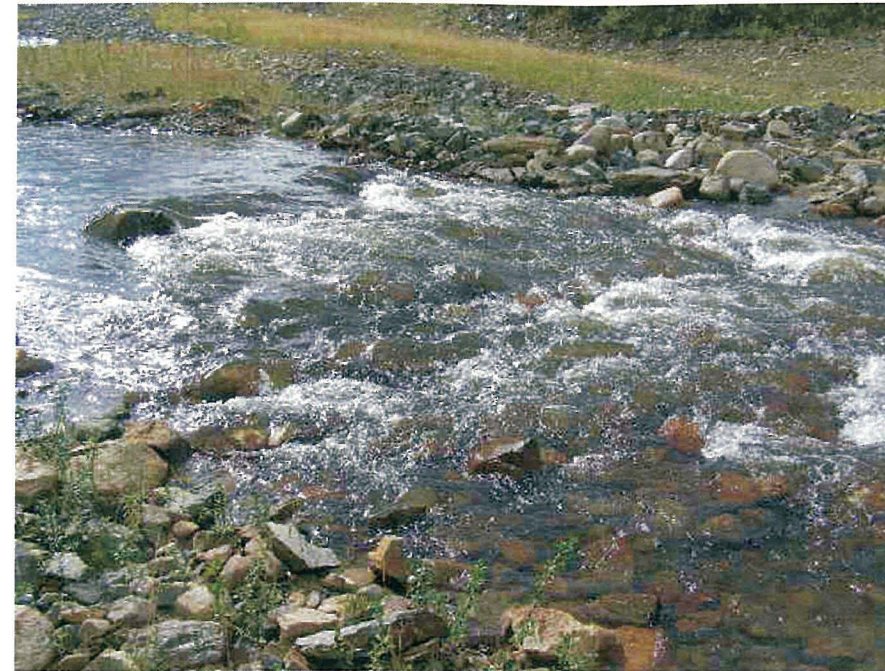
June 2007: Riffle 4 is shown here. This riffle has experienced some riprap movement which has lengthened the riffle and made it less distinct. No remedial action is recommended.

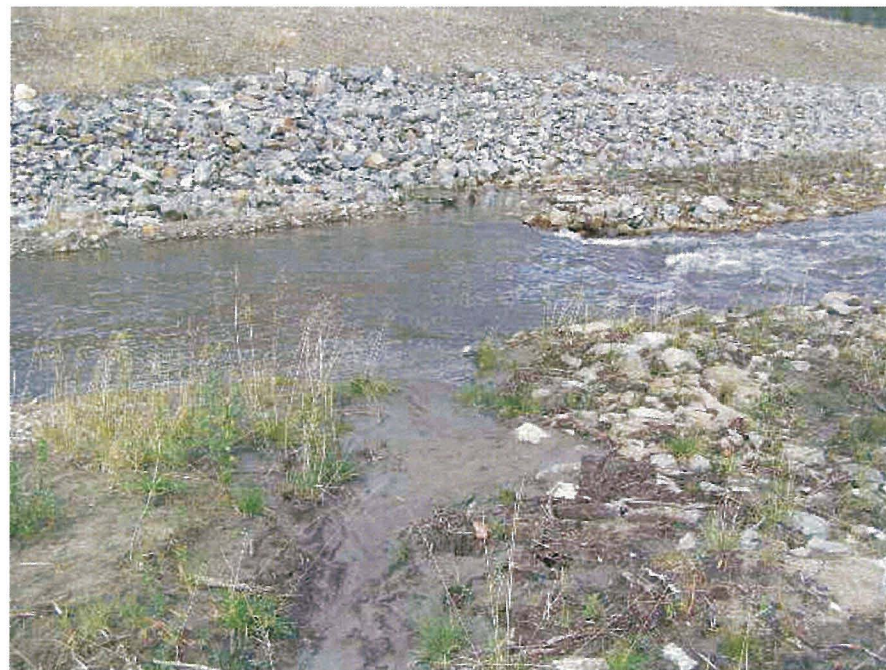
June 2007: Riffle 1 showing the nature of flow in this area. Some backwater effects and sediment deposition.

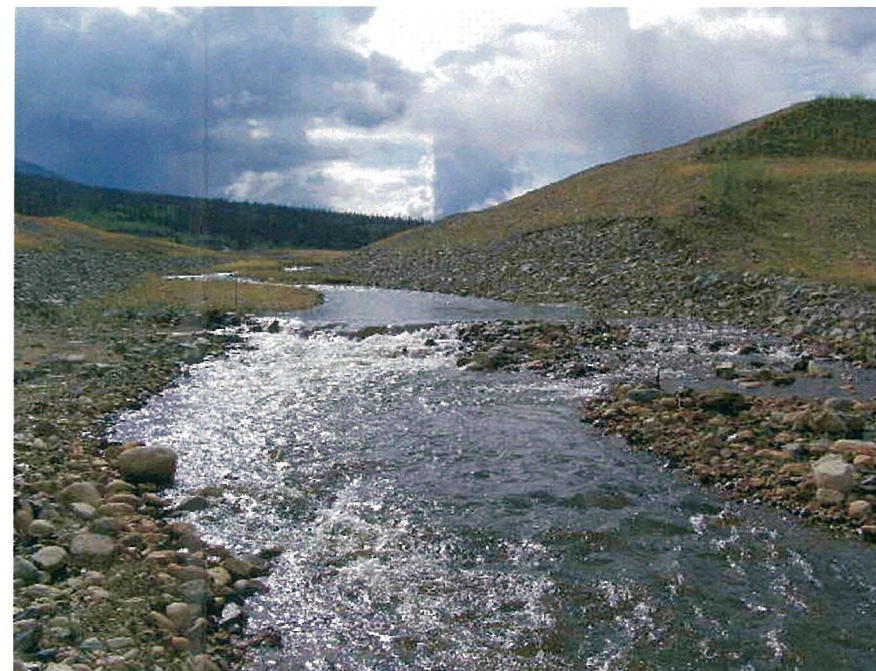
June 2007: Riffle 3 during high flow conditions.

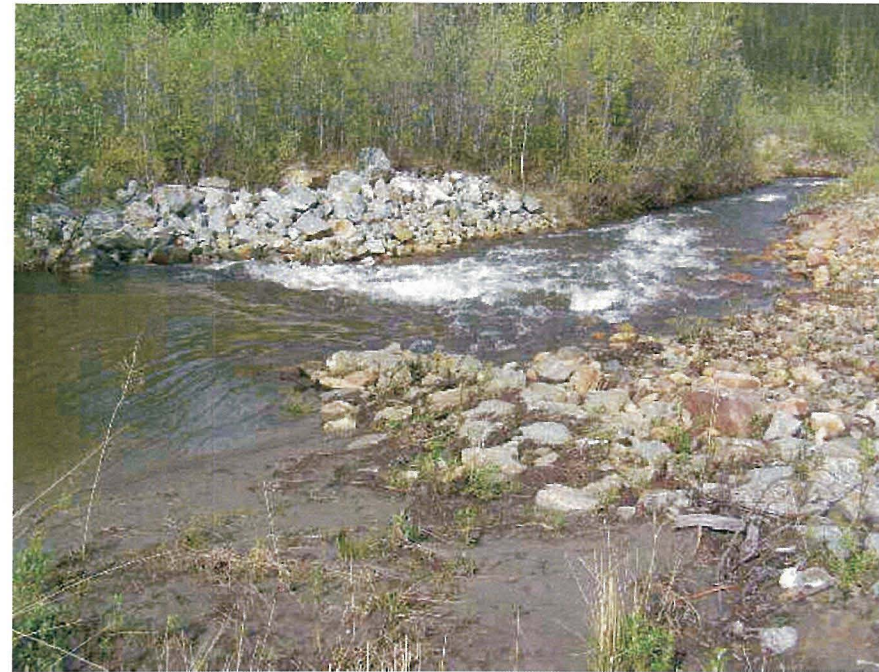
June 2007: Riffle 5 in high flow conditions. Note some silt and sand overbank deposition in the foreground of the photo.

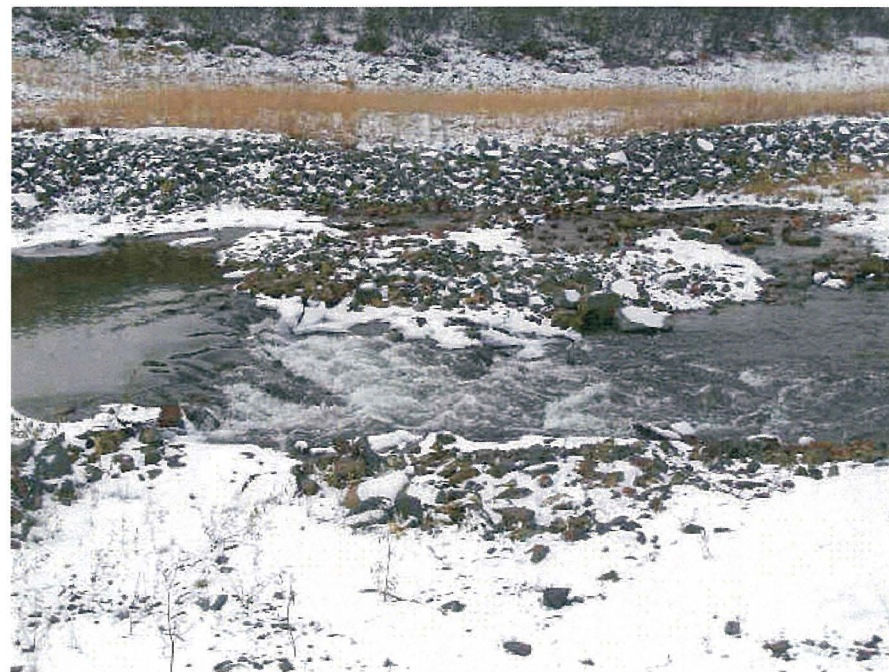
September 2007: View of Riffle 3 with the majority of flow in the center with minor flow on the left bank.

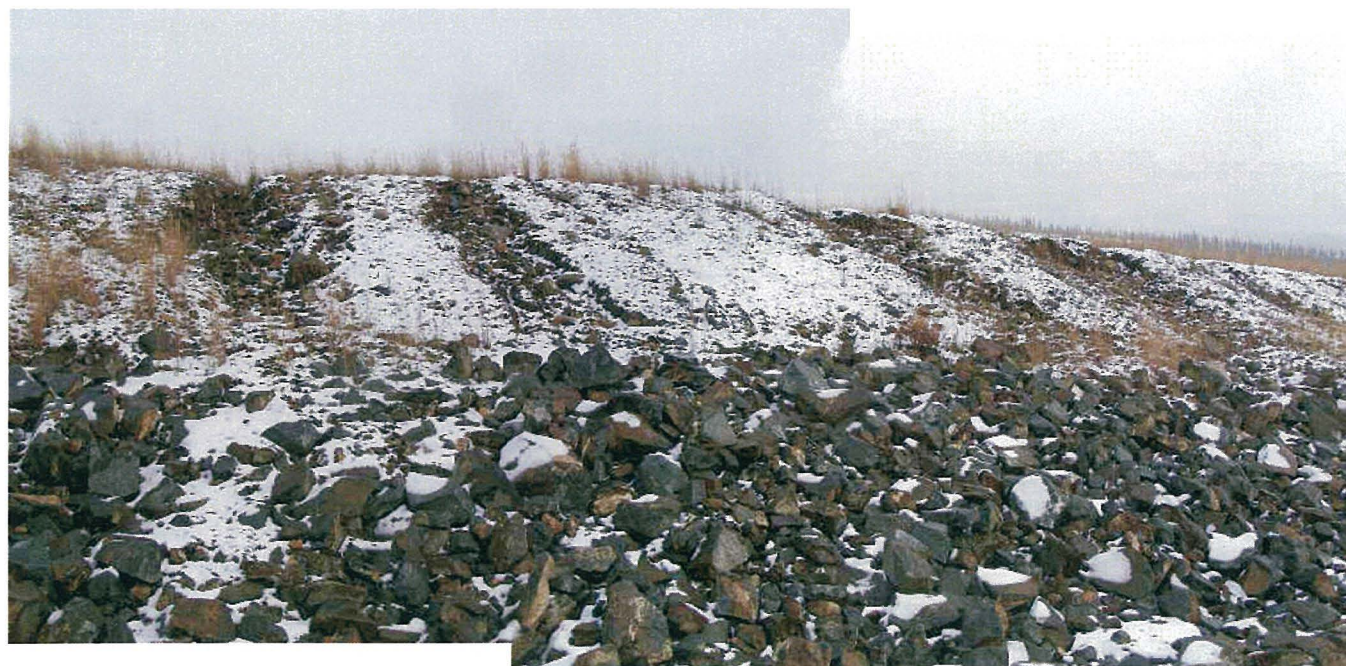
September 2007: A two shot panoramic showing the erosional gullies which has formed on the edge of upstream blanket on the upstream side. These gullies have been encountered since 2004, but have shown deterioration in 2007, which should be repaired.

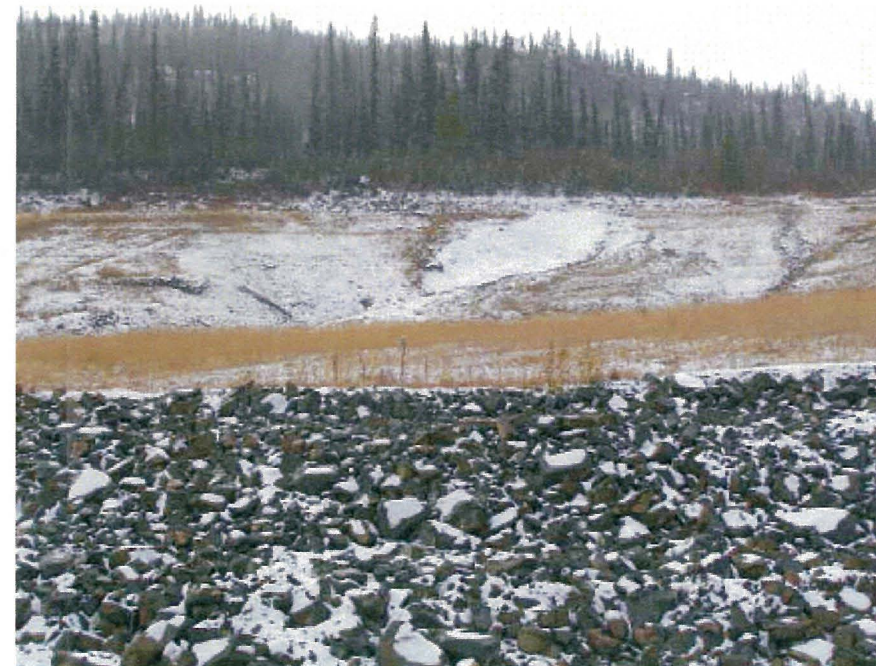
September 2007: Shows the slough within the former reservoir. The photo shows the condition following some minor hand powered grading and seeding of the slough performed by site staff in August 2007.

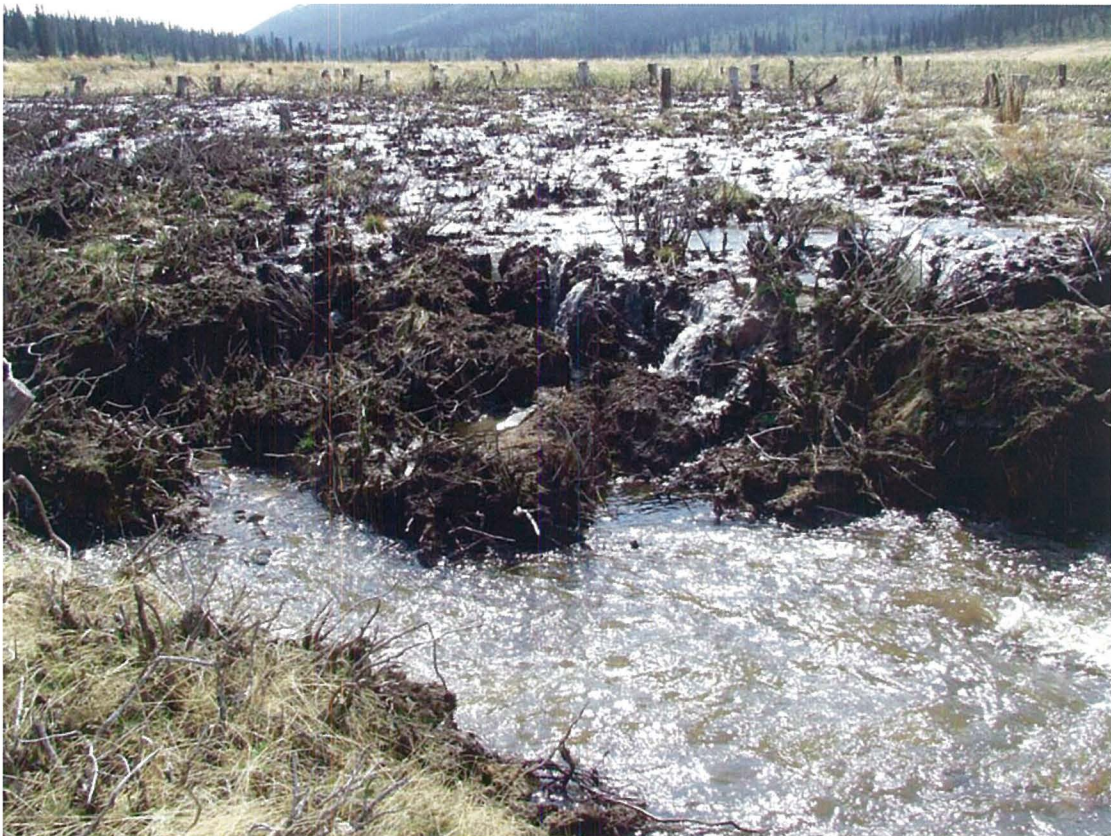
Photo #4: Retrogressive erosion of the North Tributary over and through loose soils and silt of the valley floor. June 5, 2007.

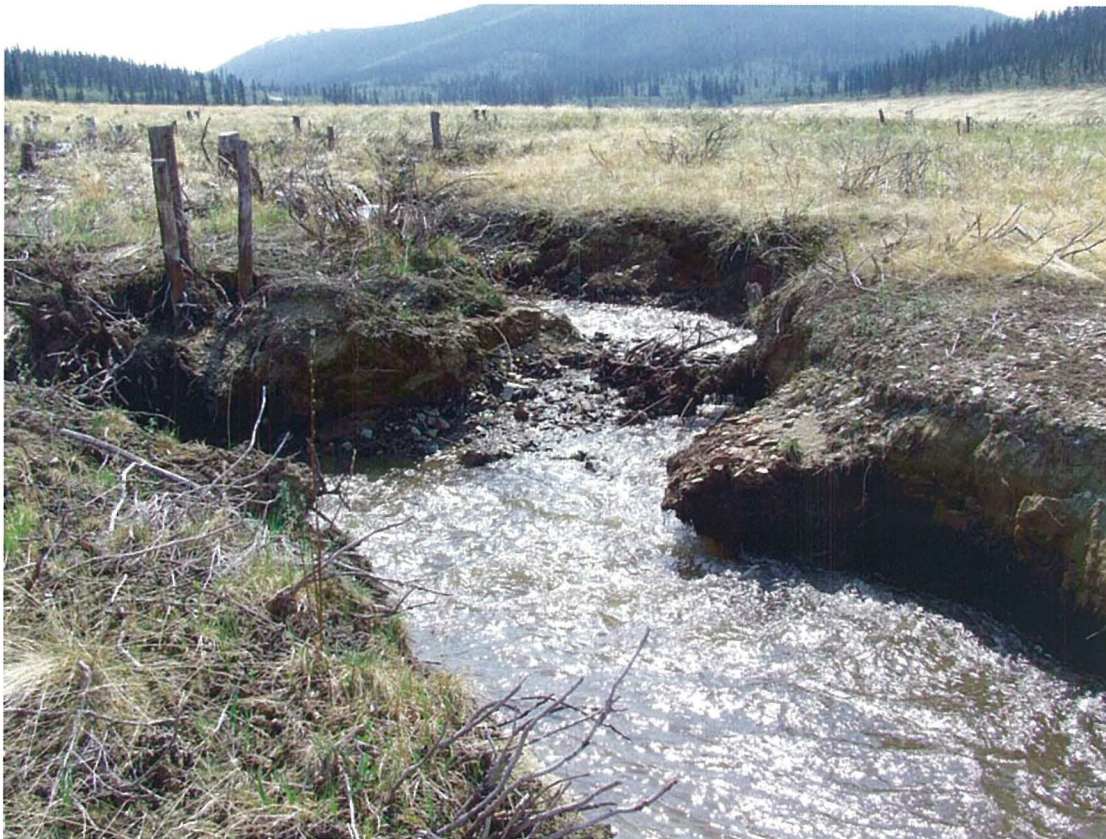
Photo #5: The North Tributary carving a channel through the reservoir to the South Fork of Rose Creek, June 5/07.
