Arctic Gold and Silver Tailings Site

Monitoring Report 2008

Prepared by:
**Indian and Northern Affairs
Waste Management Program
Yukon Region**

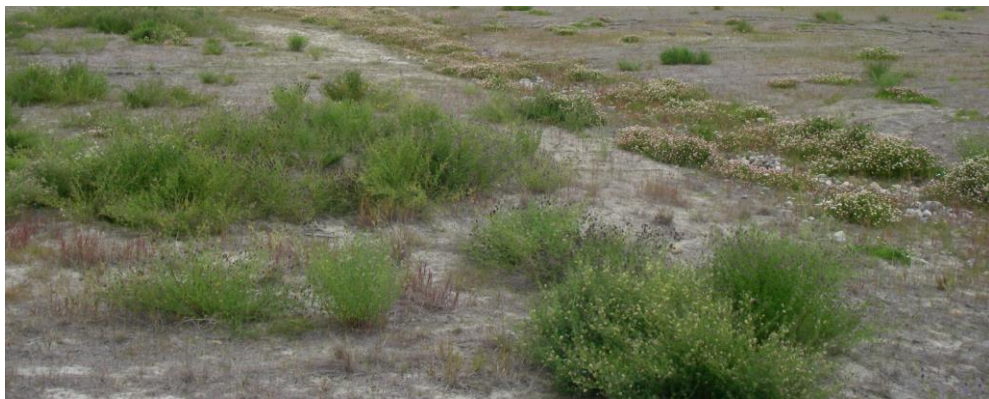
The vegetation on the tailings cover is lush and green, but remains in patches and is not as abundant as the natural vegetation around it (**Photo 1**).

Photo 1: Vegetation cover on tailings.

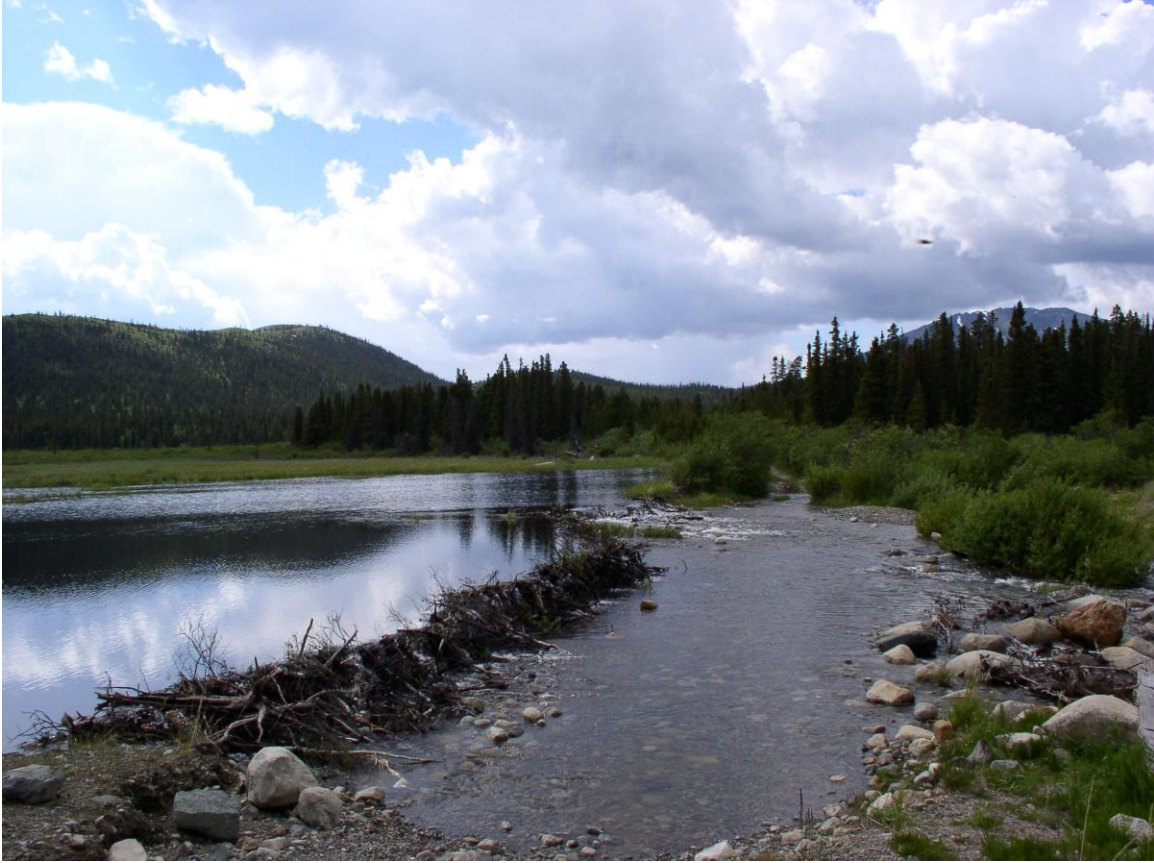
The beaver dam near the spillway (**Photo 2**) is for the most part still intact.

Photo 2: Beaver Dam near the Spillway

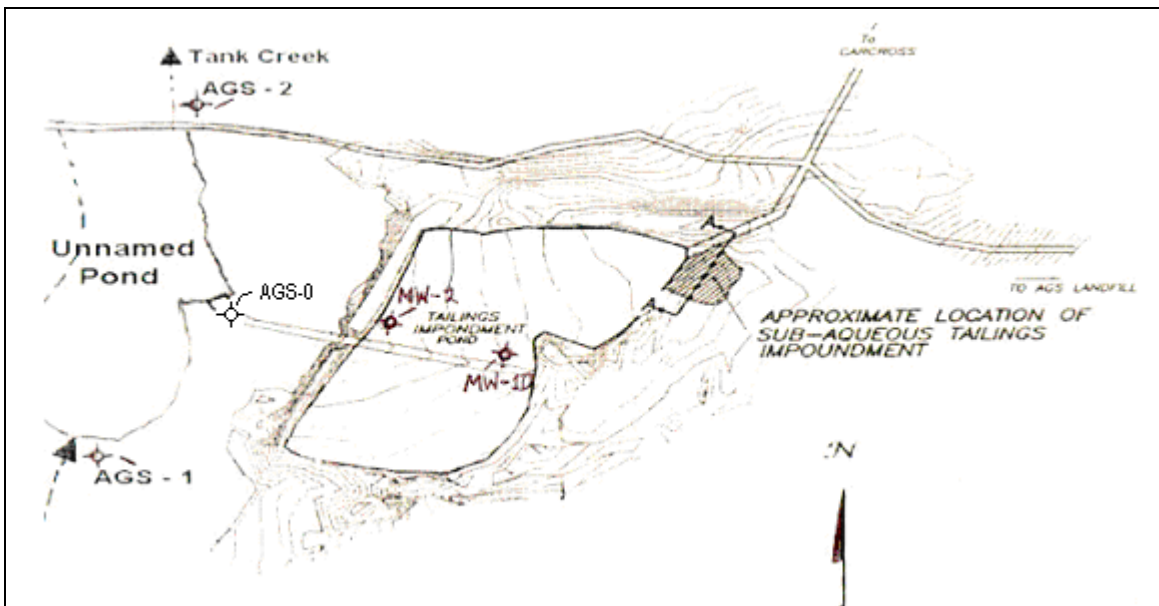
Figure 2: Water Sampling Locations

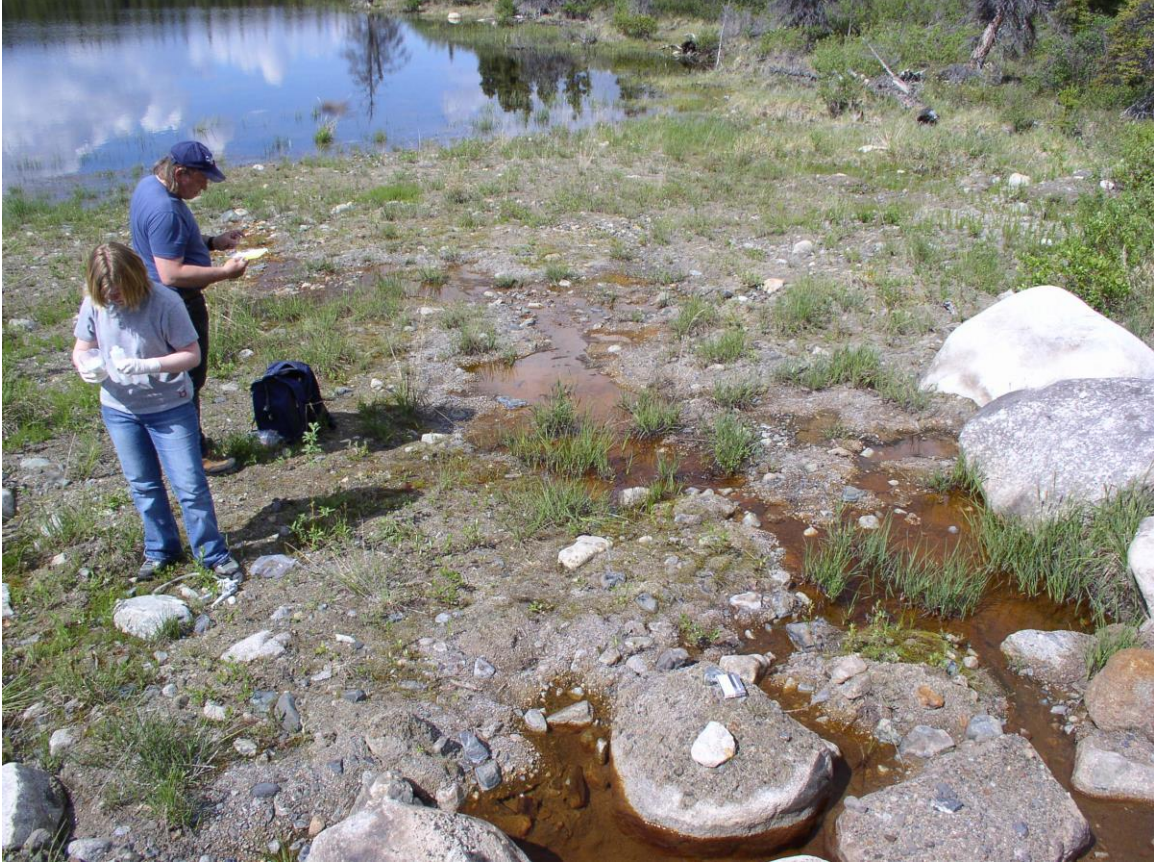
The analysis of the groundwater samples for dissolved metals showed elevated levels of several metals in monitoring well MW-2 which is located near the lowest area in the tailings impoundment, next to the drainage channel. The results are generally higher than the concentrations found in this well in 2004 (see **Table 2**). The water quality for this well (low pH and high conductivity – see **Table 1**) suggests that metals would be present in a dissolved state. Since the tailings are covered with a low permeable layer of clay capping material, acid generation should be strongly reduced or not happening at all. Outflow of water containing high levels of metals from the containment cell into the surface water of Tank Creek via the spillway or by seepage is evident in the lower portion of the spillway (see **Table 1**, sample AGS-0).

Photo 3: Seep from tailings into unnamed pond.
