Arctic Gold and Silver Tailings Site Monitoring Report TA005 October 2009

Prepared by:
**Indian and Northern Affairs
Waste Management Program
Yukon Region**

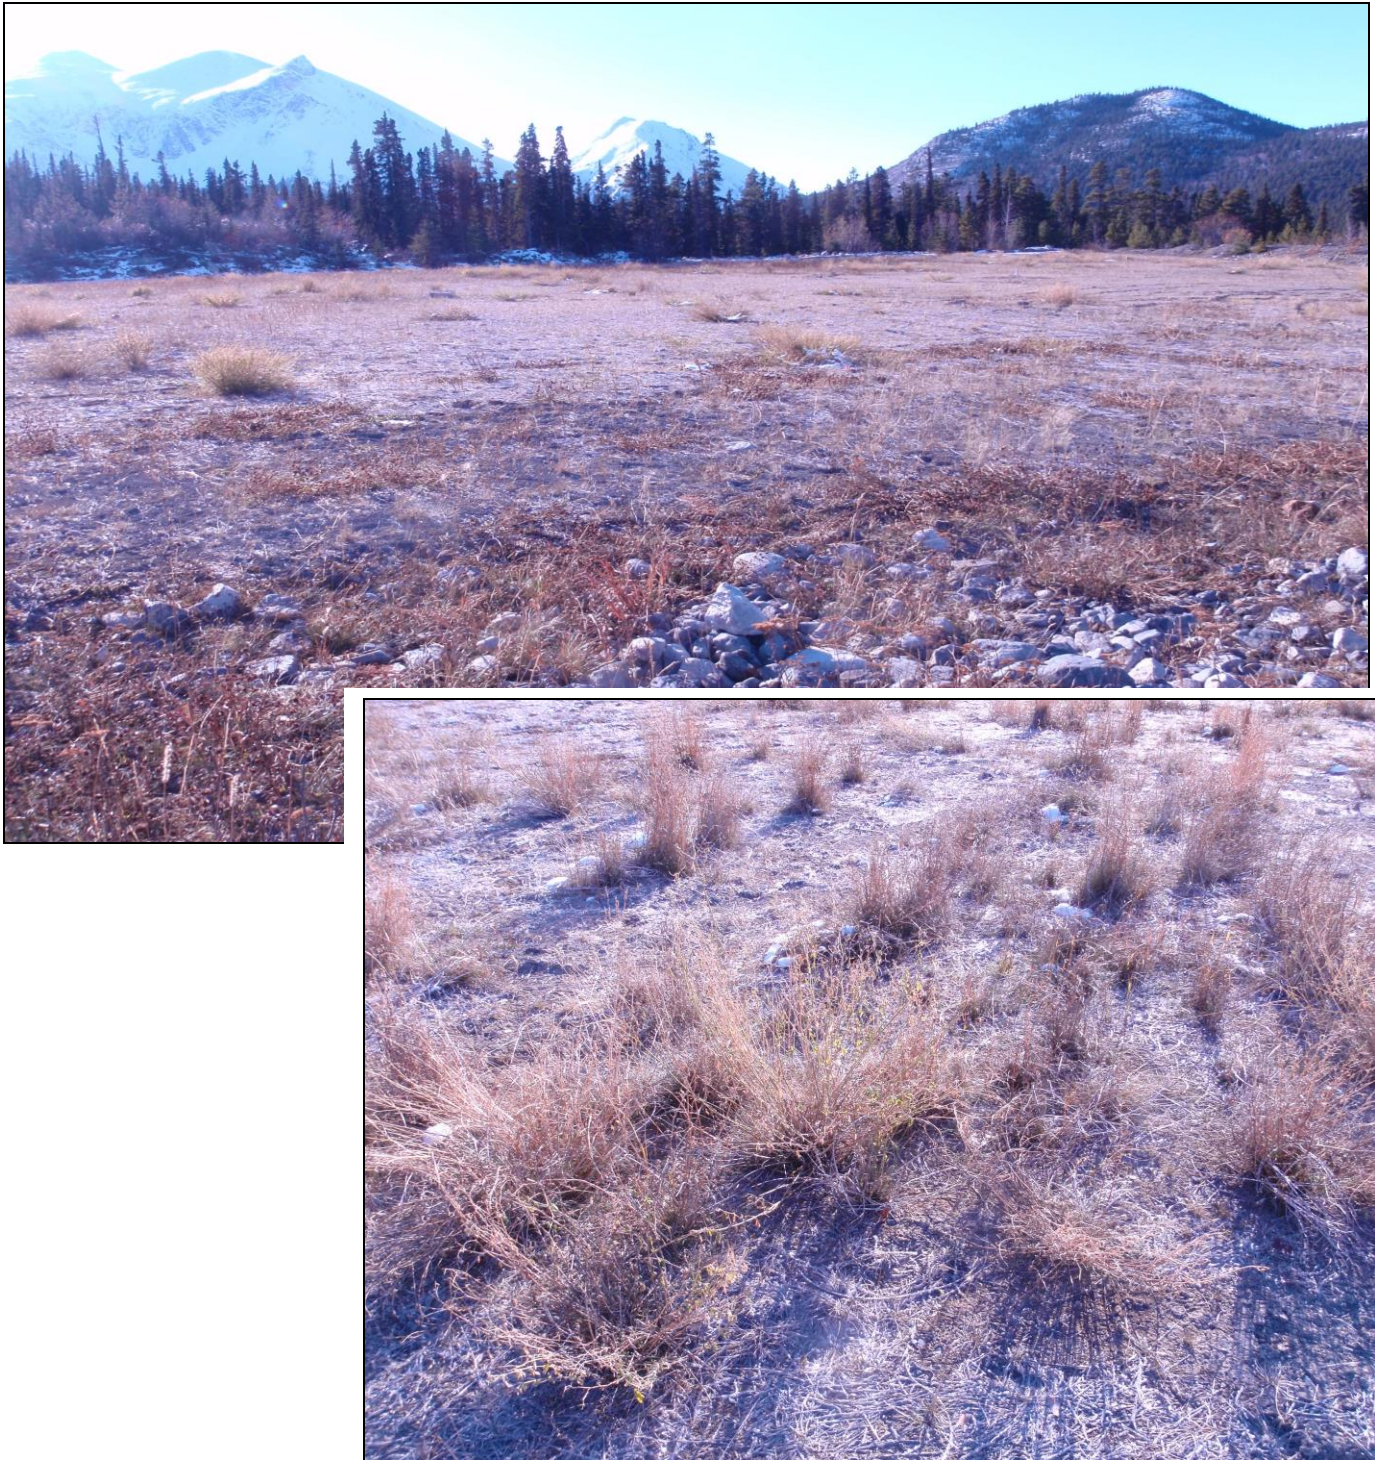
The abandoned mine site was visited by Waste Management Personnel on October 14th, 2009. Weather conditions were sunny, light winds and 8° Celsius. The overall state of the impoundment, tailings dam, drainage channel, diversion ditch, spillway and dam of the Unnamed Lake were satisfactory. The vegetation on the tailings cover was sparse and patchy (see Photo.1 & 2) and not as abundant as the vegetation around it.

Photograph 1 & 2: Top and Bottom-Vegetation on tailings cover.

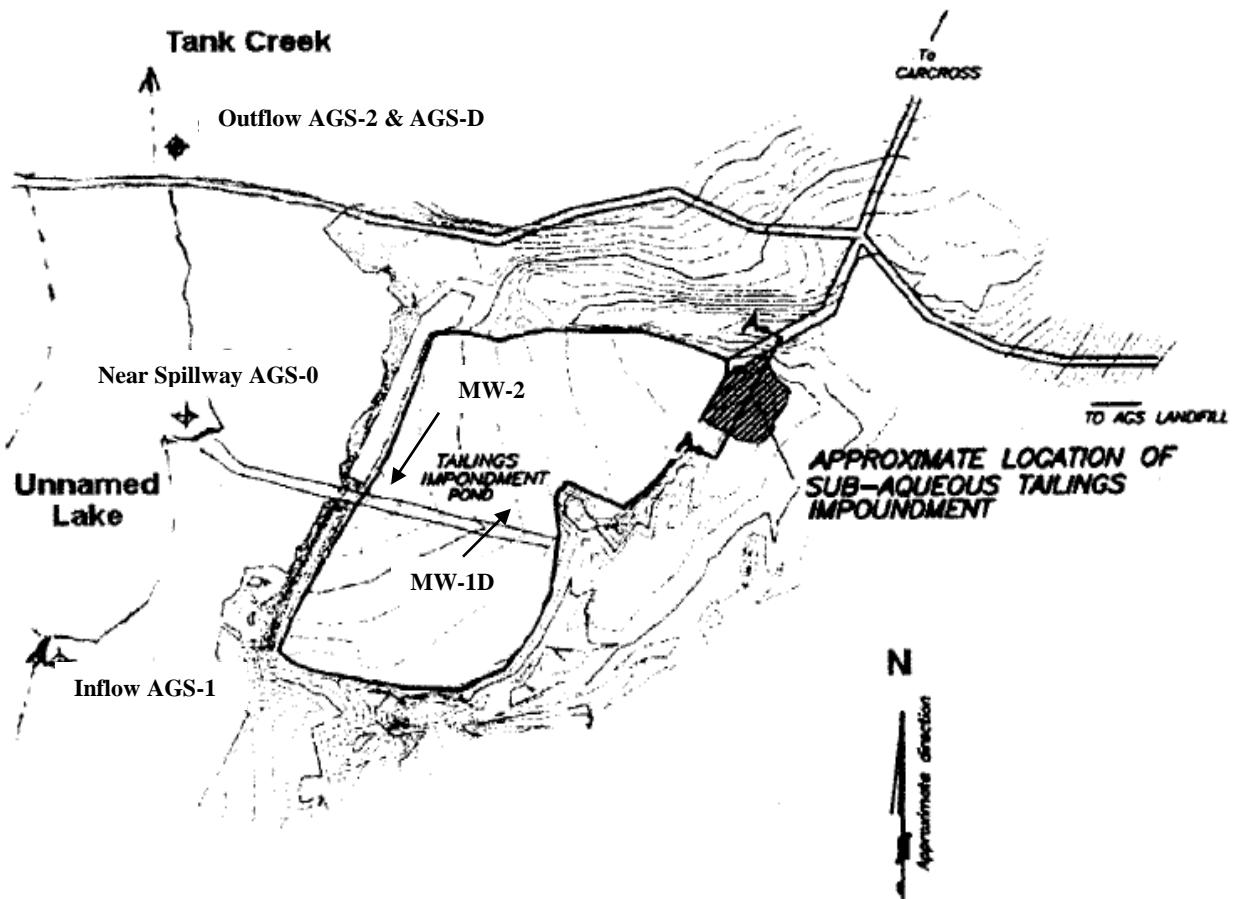
Figure 2: Water Sampling Locations modified from PWGS base drawing (EBA, 2001).

Surface water samples were taken from Tank Creek (See Fig.2) at the inflow (AGS-1) and outflow (AGS-2) of the Unnamed Lake and also at the point of seepage from the tailings pile (AGS-0). Water quality data recorded on site is shown in Table 1 and sampling locations on Figure 2. For quality assurance purposes, a second sample was collected from the outflow of the Unnamed Lake (AGS-D). All water quality data was measured using the HANNA waterproof Combo pH & EC multi-checker # H198129. All samples collected were filtered (0.45 μm) using a pressurized hand pump and preserved with nitric acid. Samples were sent to Taiga laboratory in Yellowknife, North West Territories for dissolved metals analysis.

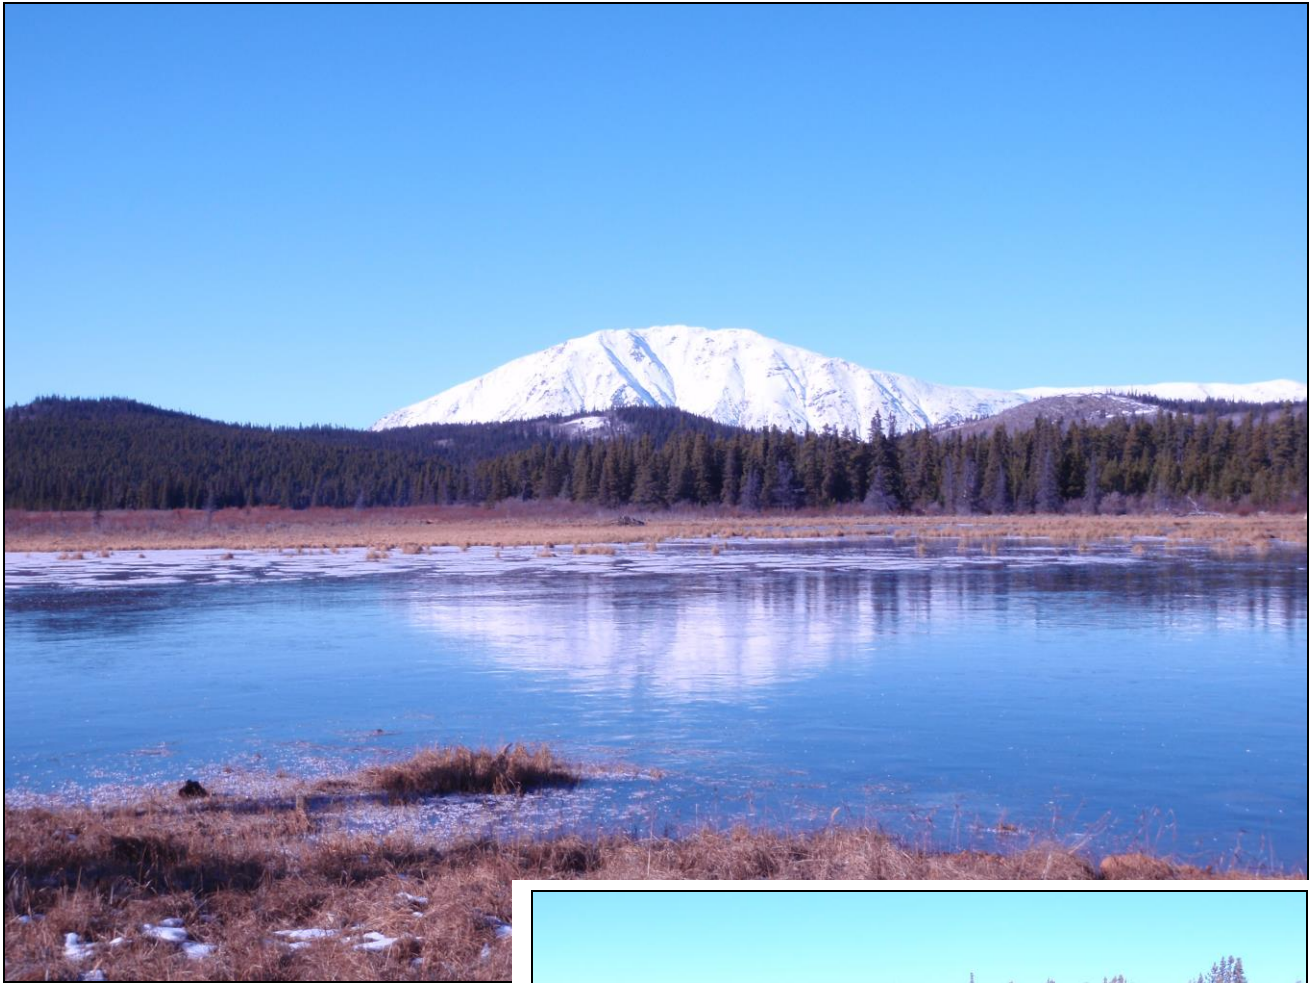
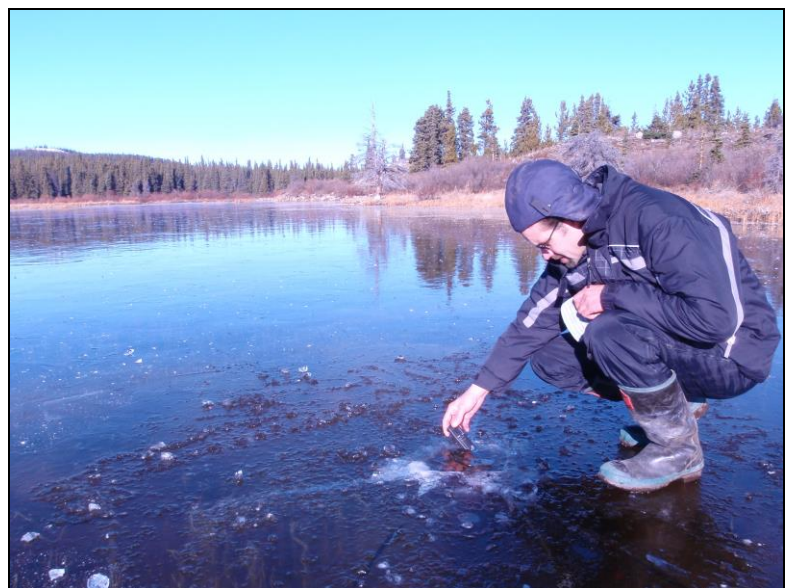
Photograph 6 & 7: Top-
Looking out onto the Unnamed
Lake at spillway. Bottom-
Waste Management Personnel
taking surface water readings
from the unnamed lake at the
tailings spillway area (AGS-0).

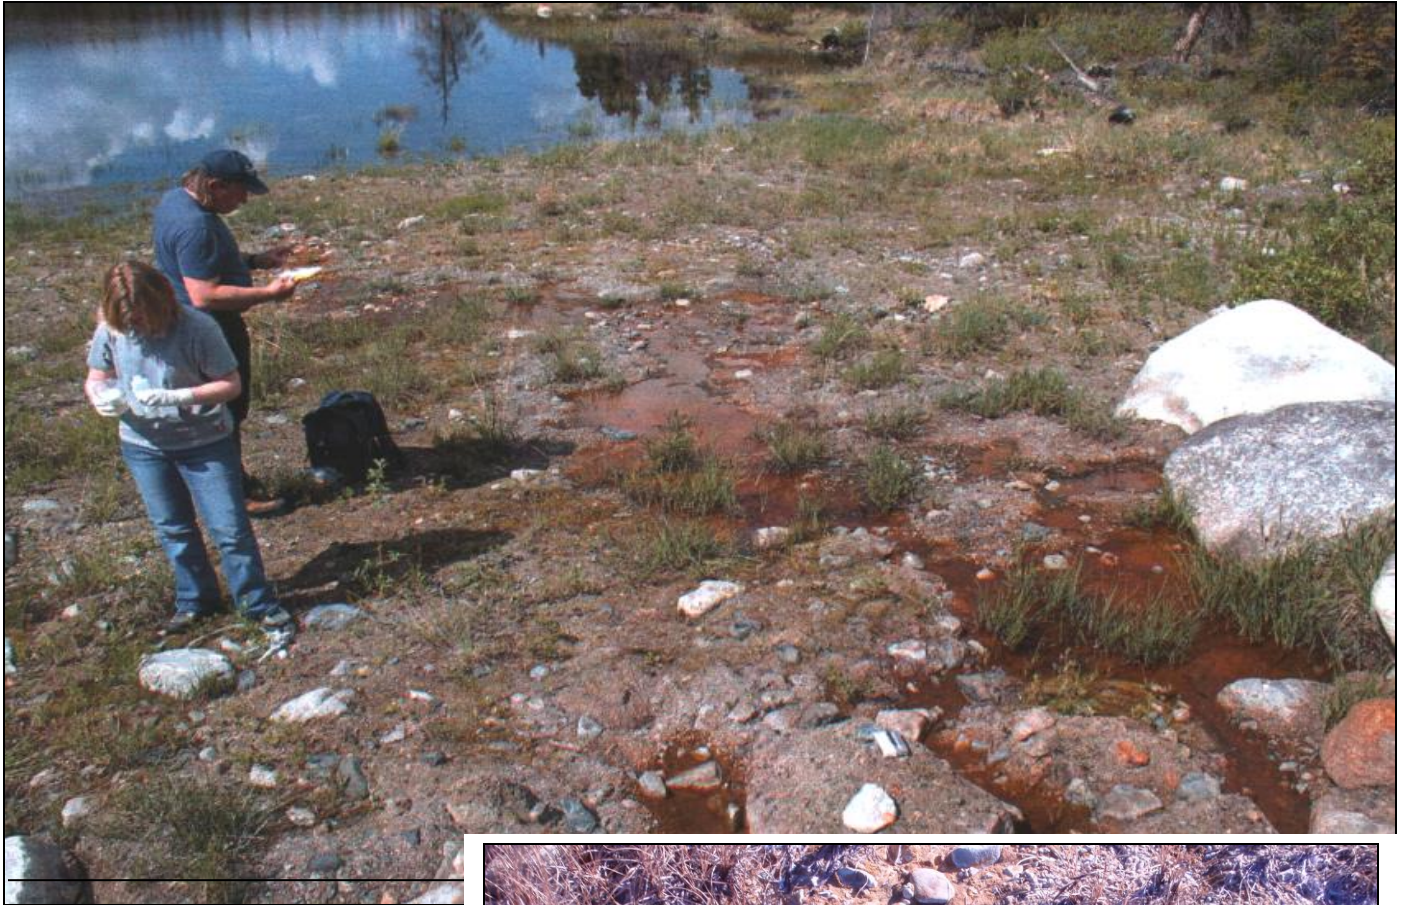
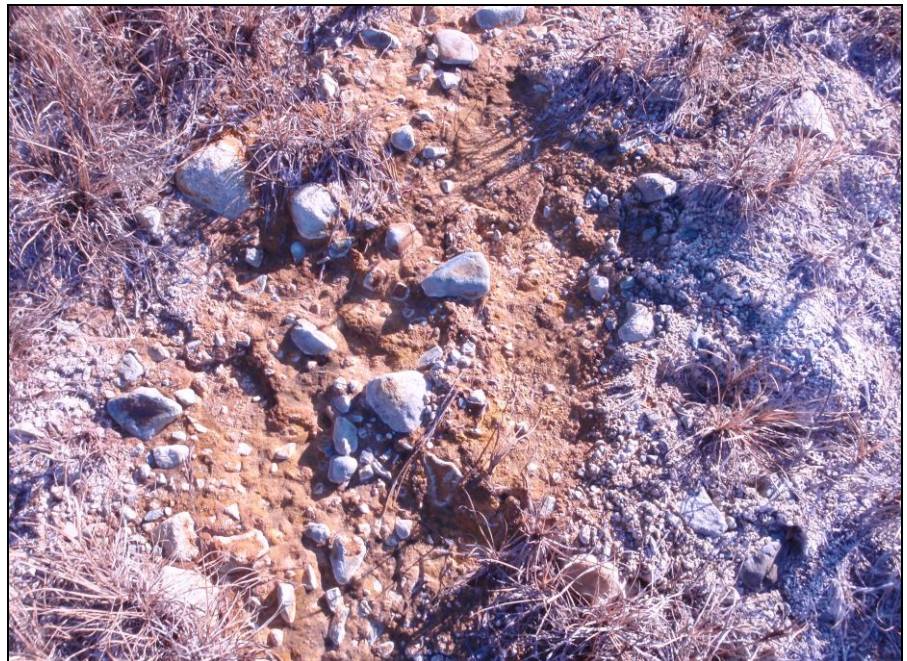
Water and/or seepage containing dissolved metals from the containment cell is, consequently, evident in the surface water at the spillway area of the Unnamed Lake (AGS-0), shown in Table 4. Fortunately, the levels do not exceed the Yukon Contaminated Sites Regulations and CCME guidelines for the protection of aquatic life. However, in 2005 an event occurred in which high levels of metals from the tailings impoundment was leaching towards the surface water of the Unnamed Lake (see Table 4). Elevated levels are seen in monitoring well MW-2, Tables 2 & 3 (highlighted), and surface water sample AGS-0, Table 4 & 5 (highlighted). On June 2005 the surface water of the Unnamed Lake was not tested as usual. Instead, a seepage pool was tested that was flowing into the Unnamed Lake (see Photo 8). The results showed that arsenic, copper and iron concentrations were higher than the guidelines for total metals in surface water. The conductivity of the sample reading (see Table 5) was 3300 µS and the pH was 3.01. A pH of 3.01 is more acidic than the recommend guidelines for the protection of aquatic life in Canada, which is 6.5 – 9 (CCME, 1999). Acid Rock Drainage occurs when sulphide minerals are exposed to air and moisture, resulting in oxidation. Microbial action also accelerates the process (Environment Canada, 2009). The spike of high metal

concentrations was detected in samples taken on June 16, 2005, prior to a rain event on June 15, 2005. The Carcross station near the site received 14.0 mm of rain (see Figure 3). In addition to this, on June 12, 2005 the Carcross station received 23.4 mm of rain. It may be possible that the high spike in the sample readings on June 16, 2005 may be correlated to the heavy rain event, which occurred on the previous day. However, no other sample readings are known to have been taken days after a major rain event to compare these findings.

Photograph 8 & 9: Top-
Seepage pool tested on
June 2005 (AGS-0).
Bottom- Evidence of
seepage pools near the
Unnamed Lake, Oct.
2009.
