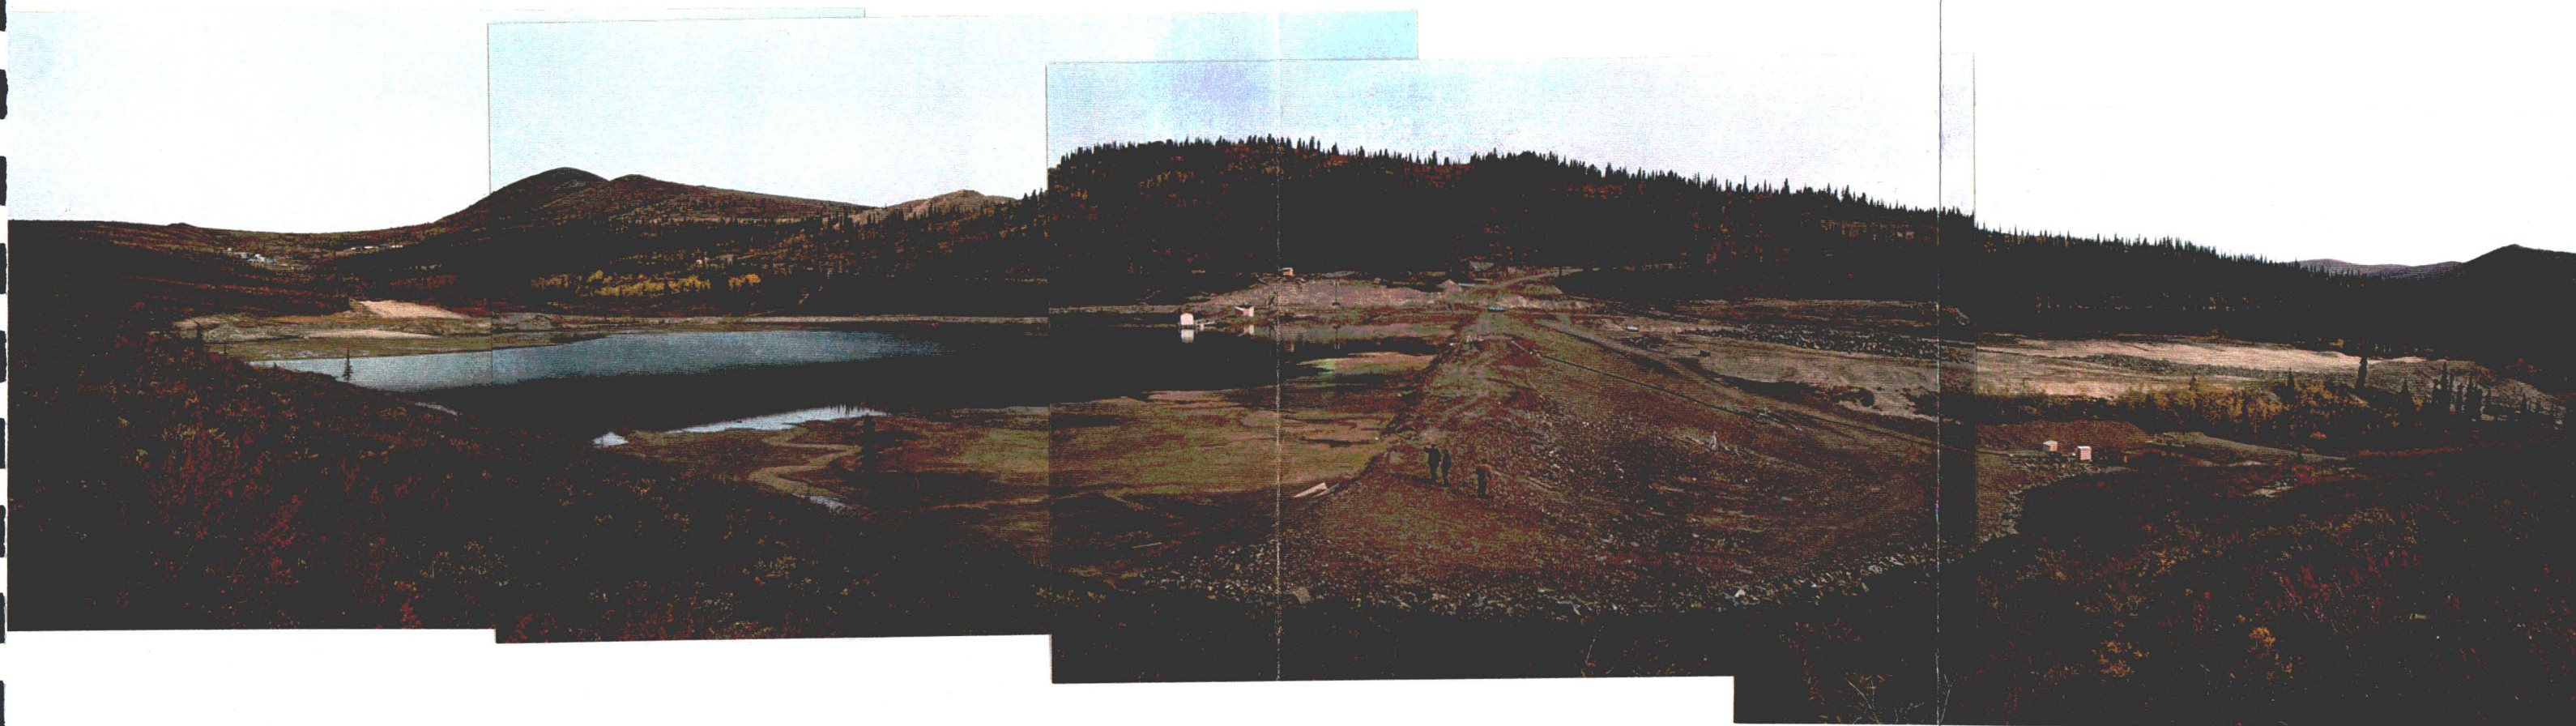
Photograph 2 Panoramic View of Tailings Impoundment - from south abutment of Tailings Dam.

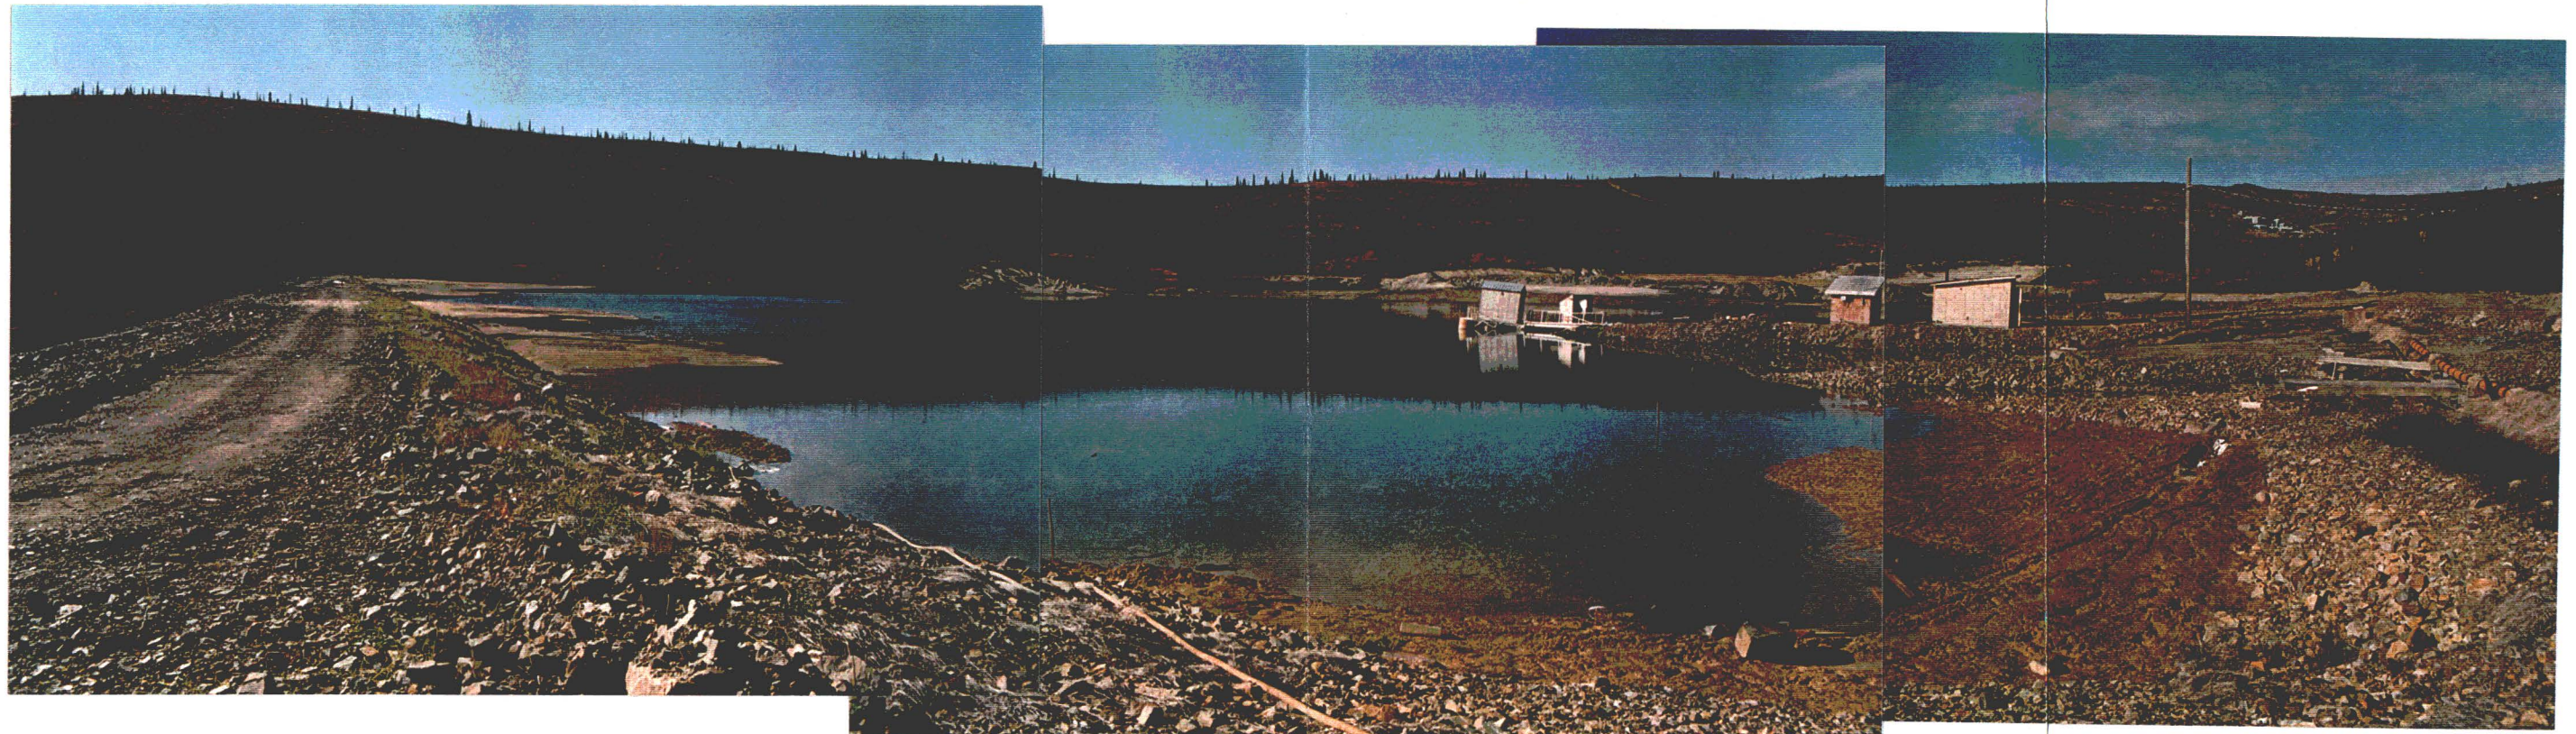
Photograph 3 Panoramic View of Tailings Impoundment - from north end of Tailings Dam crest.

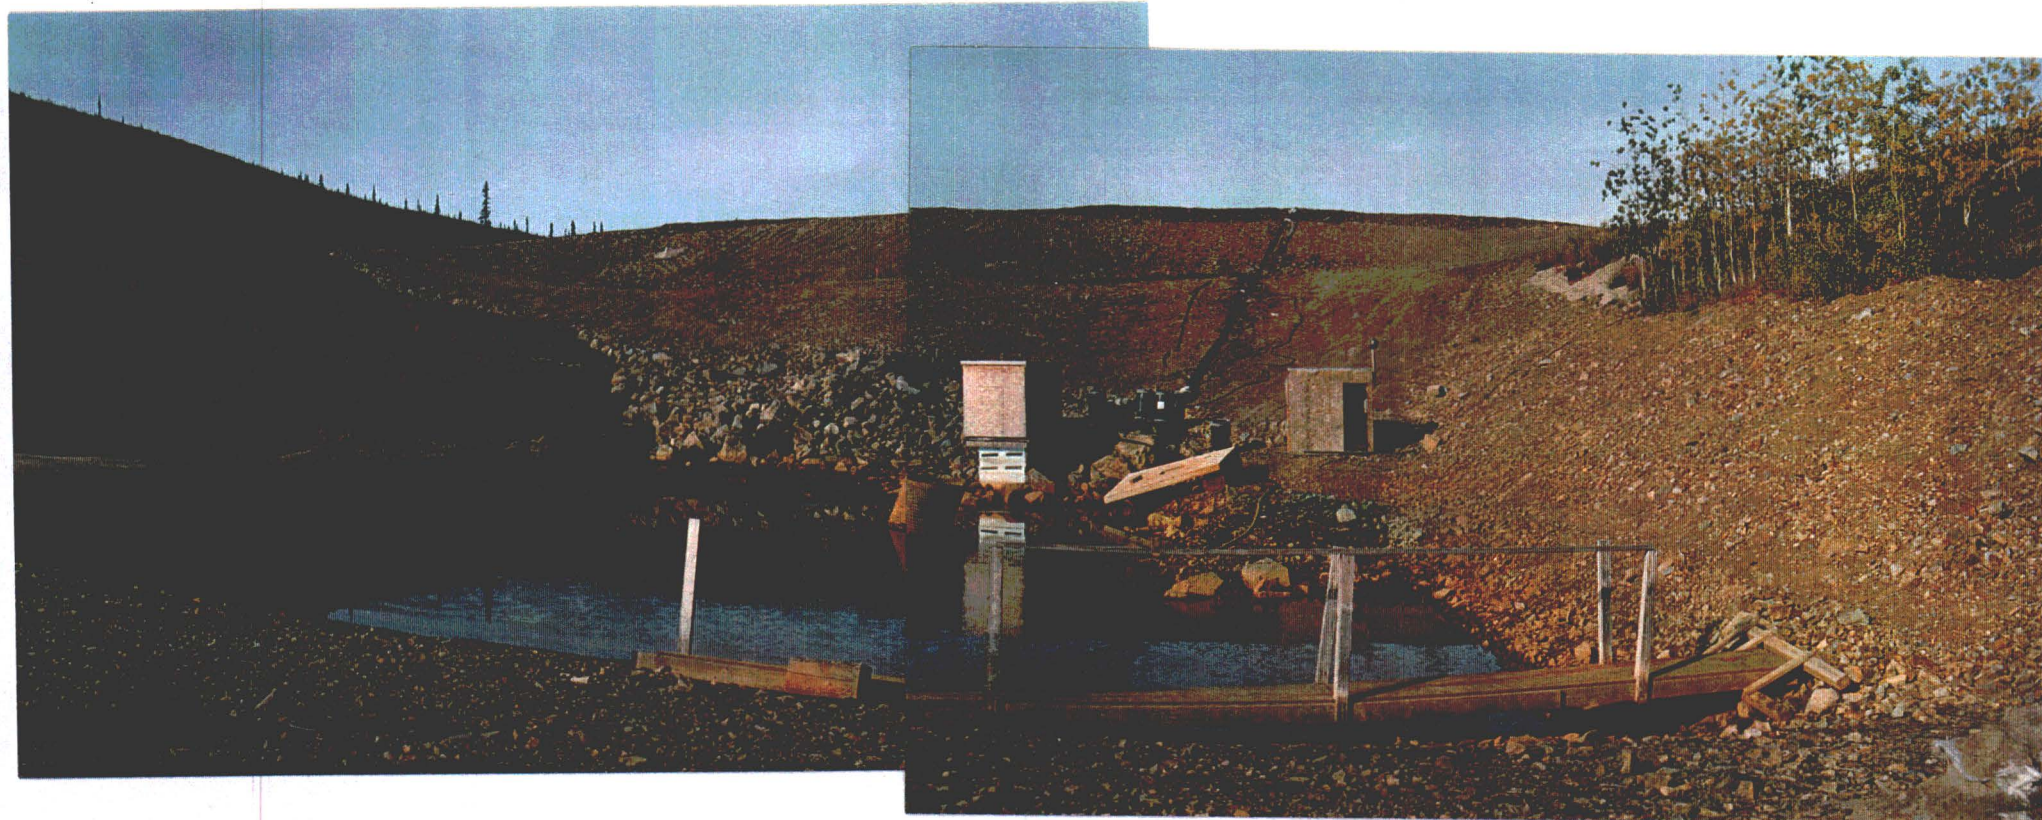
Photograph 4 Tailings Dam Downstream Slope and Seepage Recovery Pond.

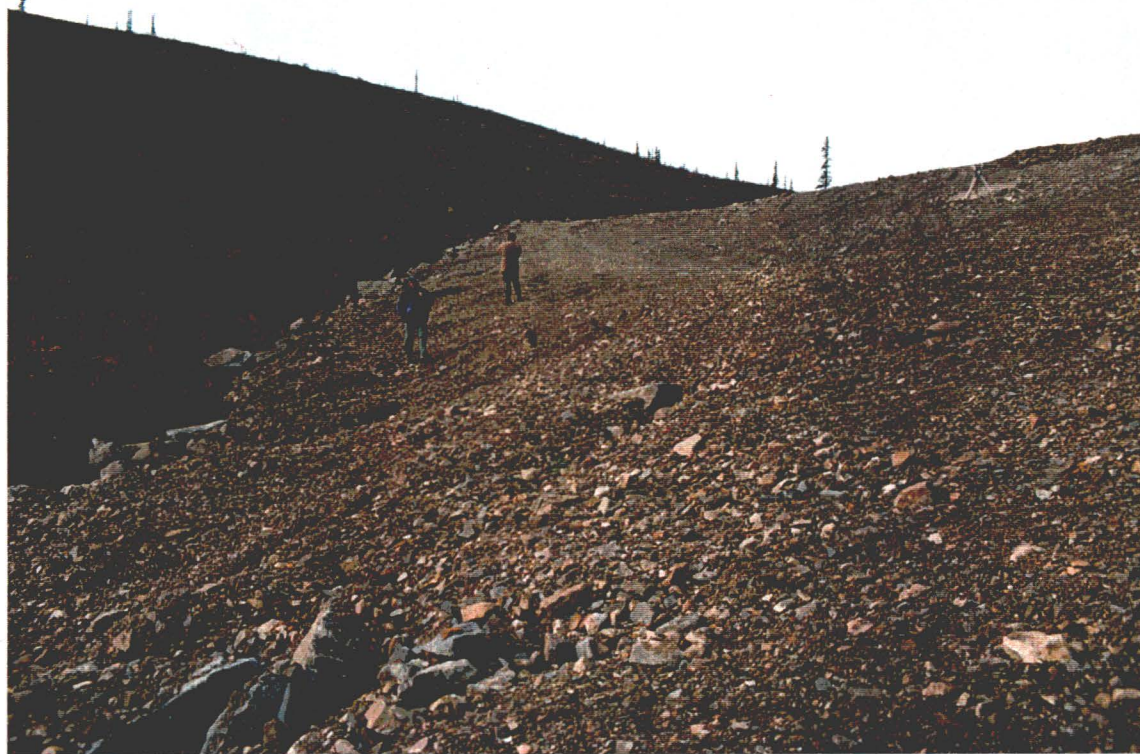
Photograph 5 Downstream Slope of Buttress Berm - looking upward towards south abutment.

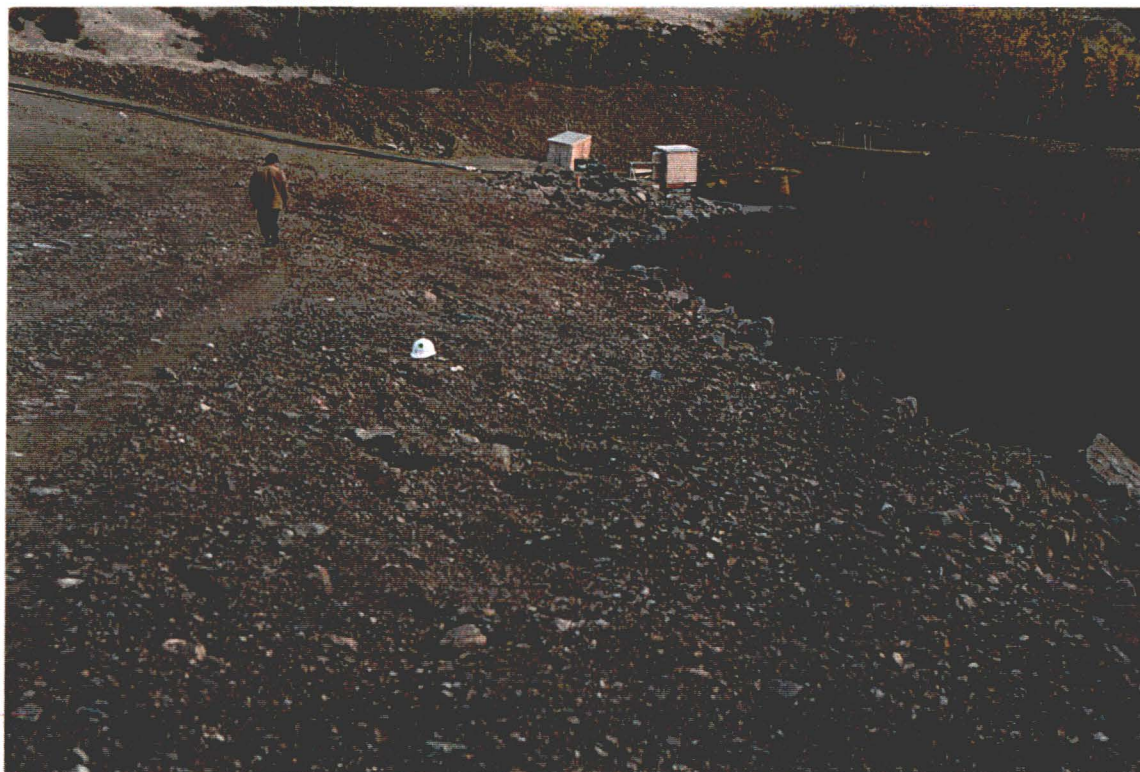
Photograph 6 Downstream Slope of Buttress Berm - looking downward towards Seepage Recovery Pond.

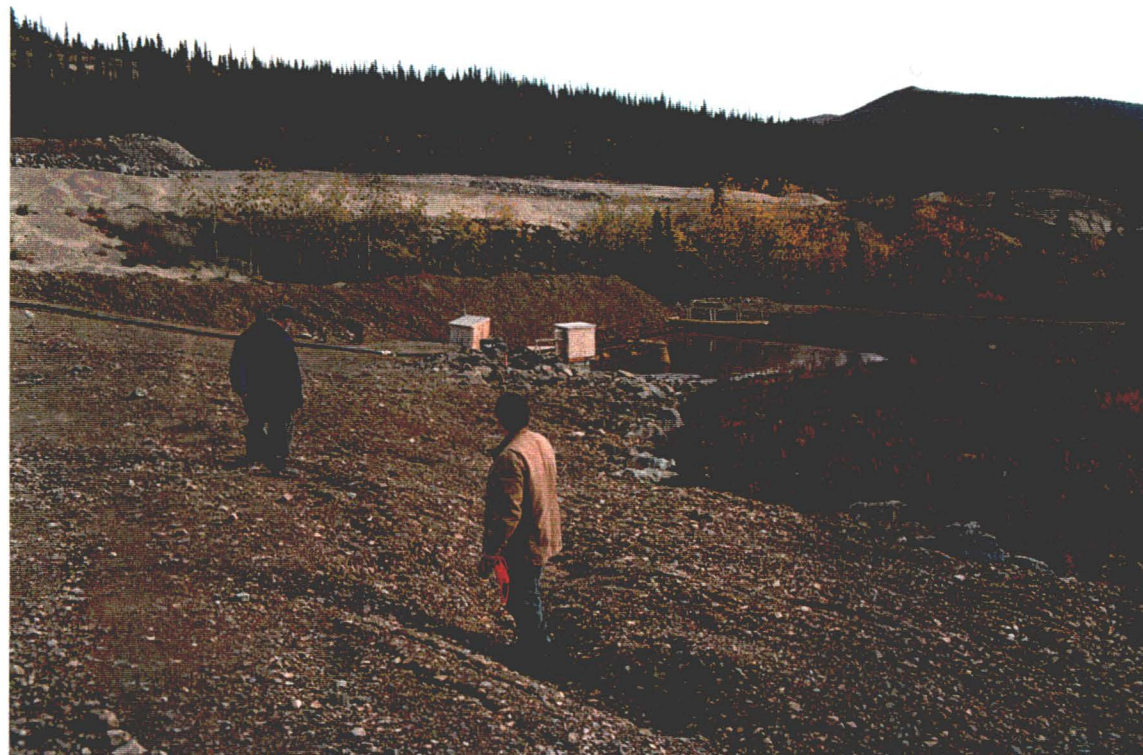
Photograph 7 Close-up of local depressions on buttress berm slope.

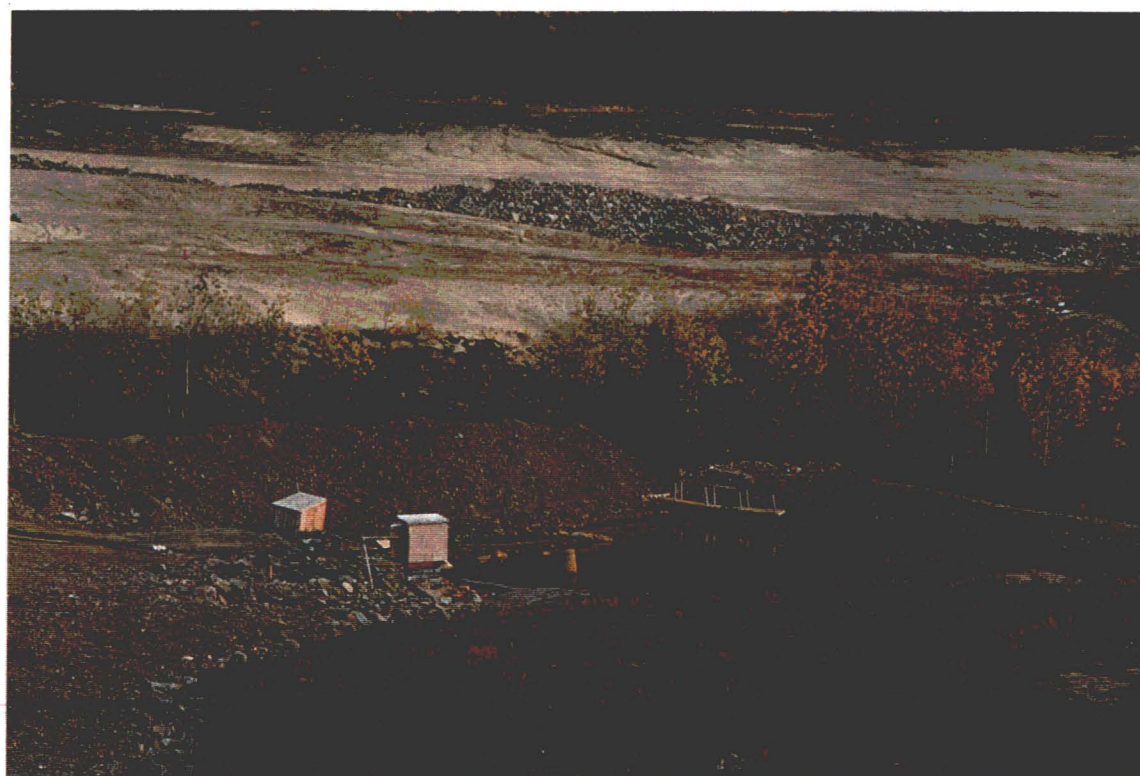
Photograph 8 Seepage Recovery Pond and Seepage Control Dam - looking northeast.

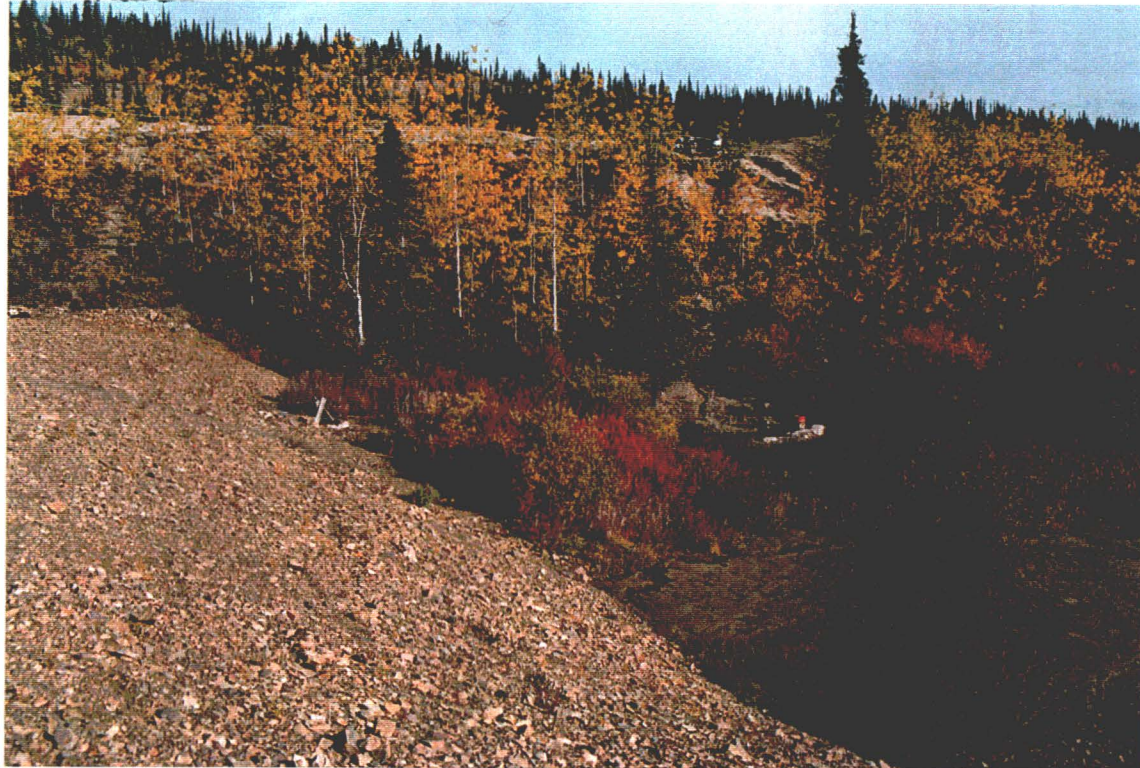
Photograph 9 Seepage Control Dam downstream slope - looking northeast (observable seepages exiting from the toe).

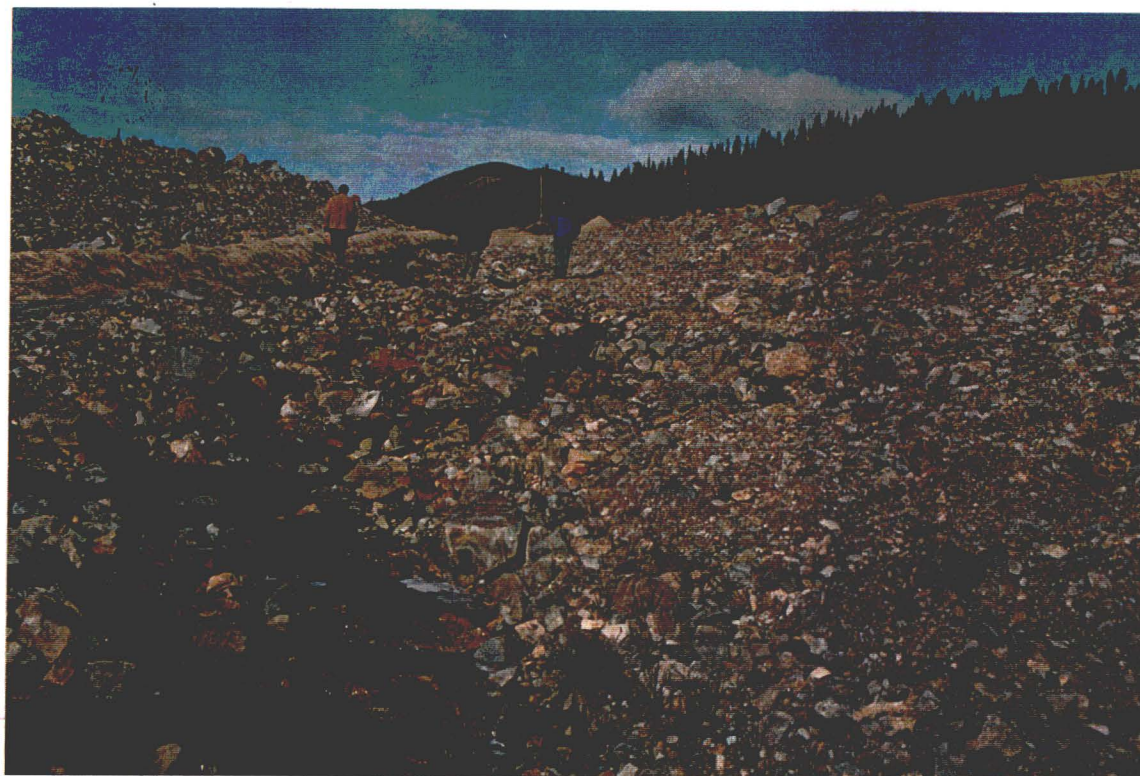
Photograph 10 Emergency Spillway Channel - lower segment (used also for conveying water from North Diversion Ditch).

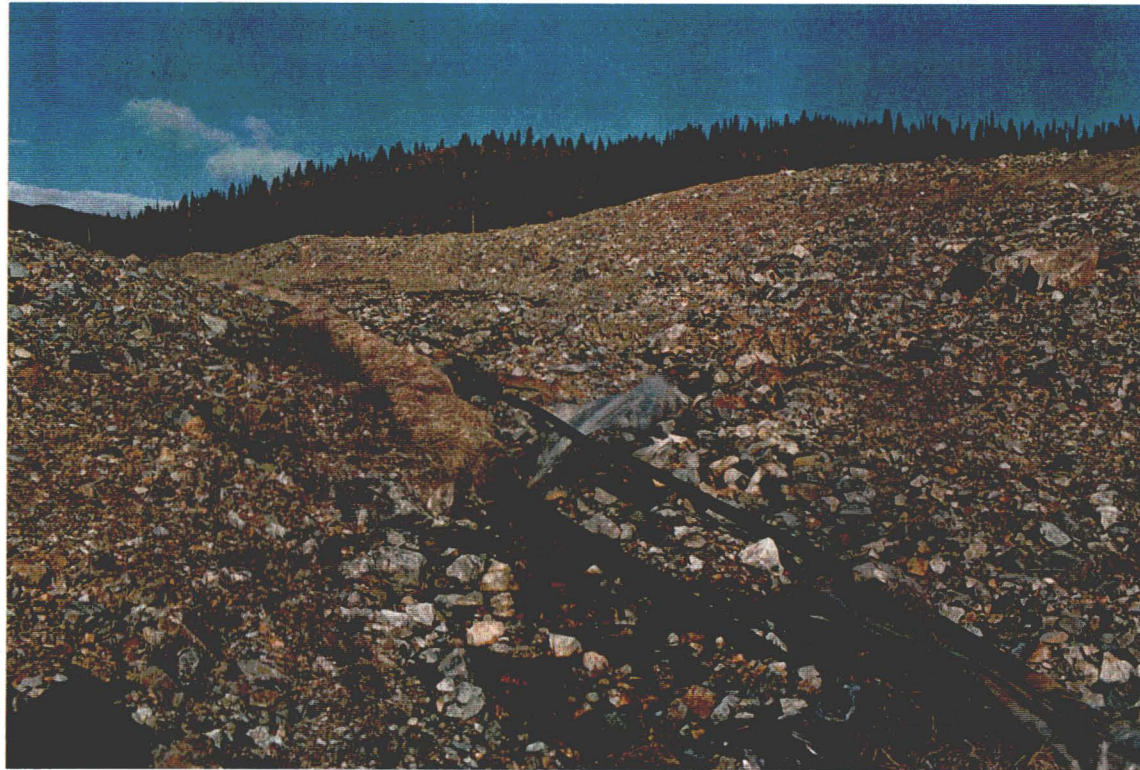
Photograph 11 Emergency Spillway Channel - upper segment (used also for conveying water from North Diversion Ditch).

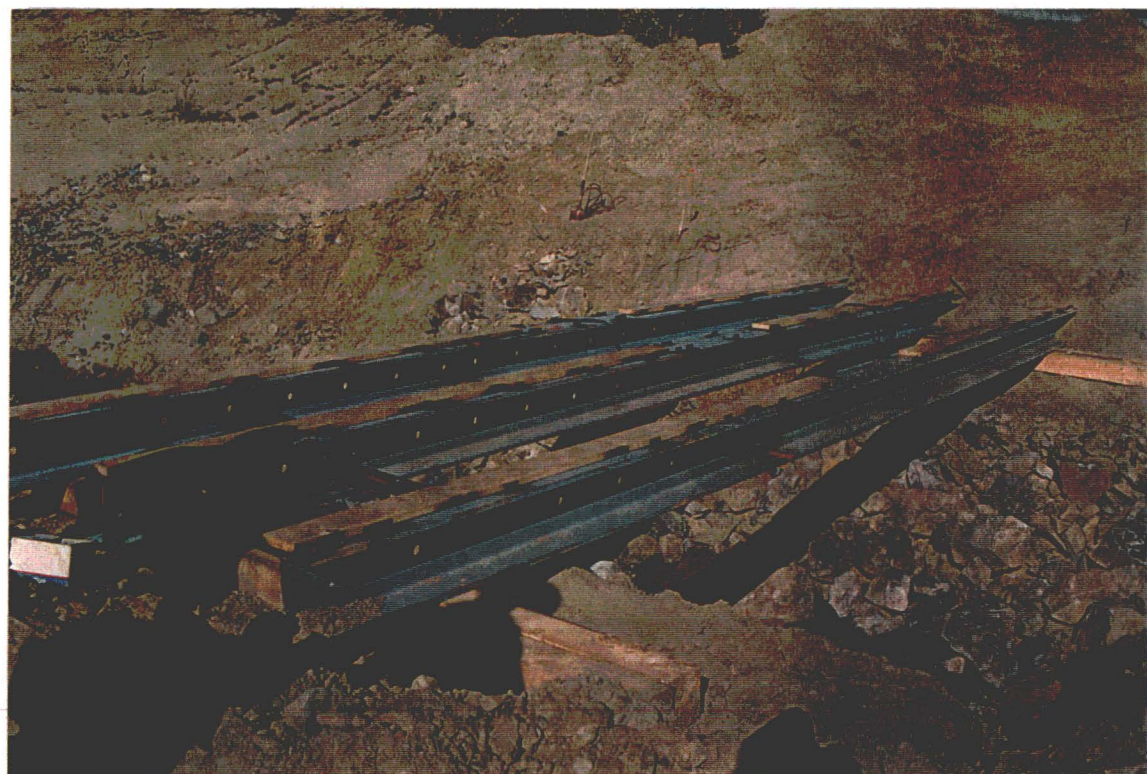
Photograph 12 Bridge construction in progress - across North Diversion Ditch.

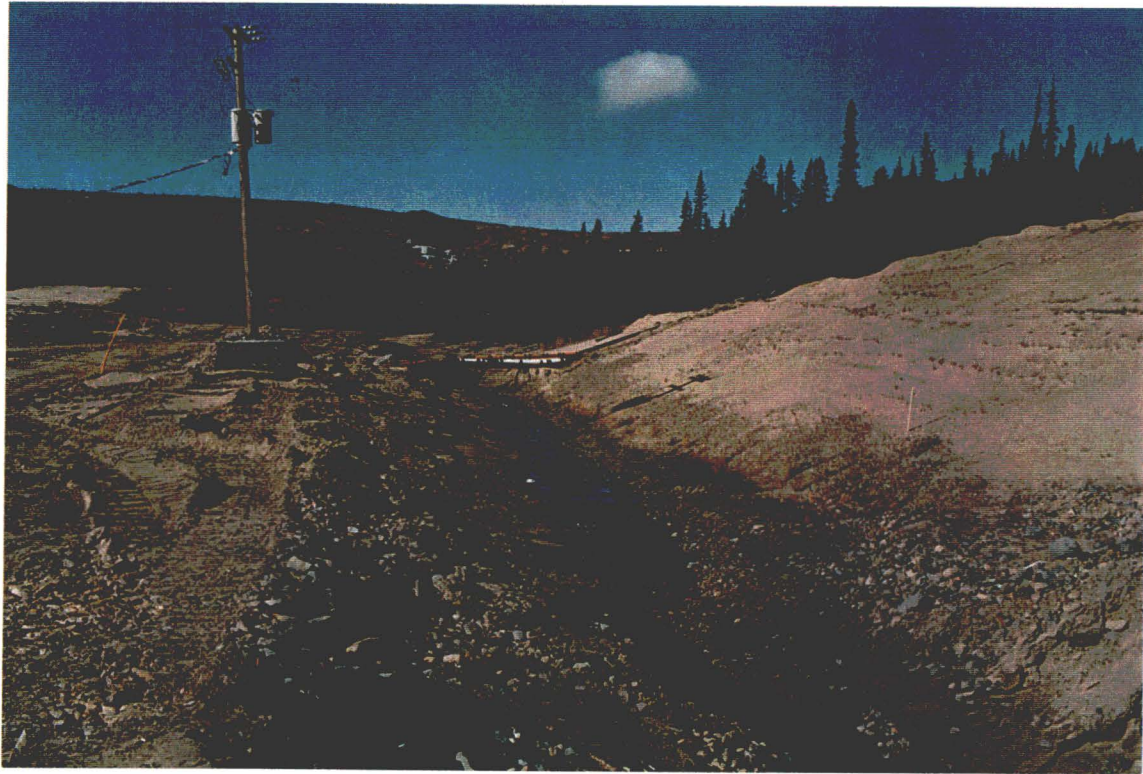
Photograph 13 North Diversion Ditch - looking west (pipelines crossings in background).

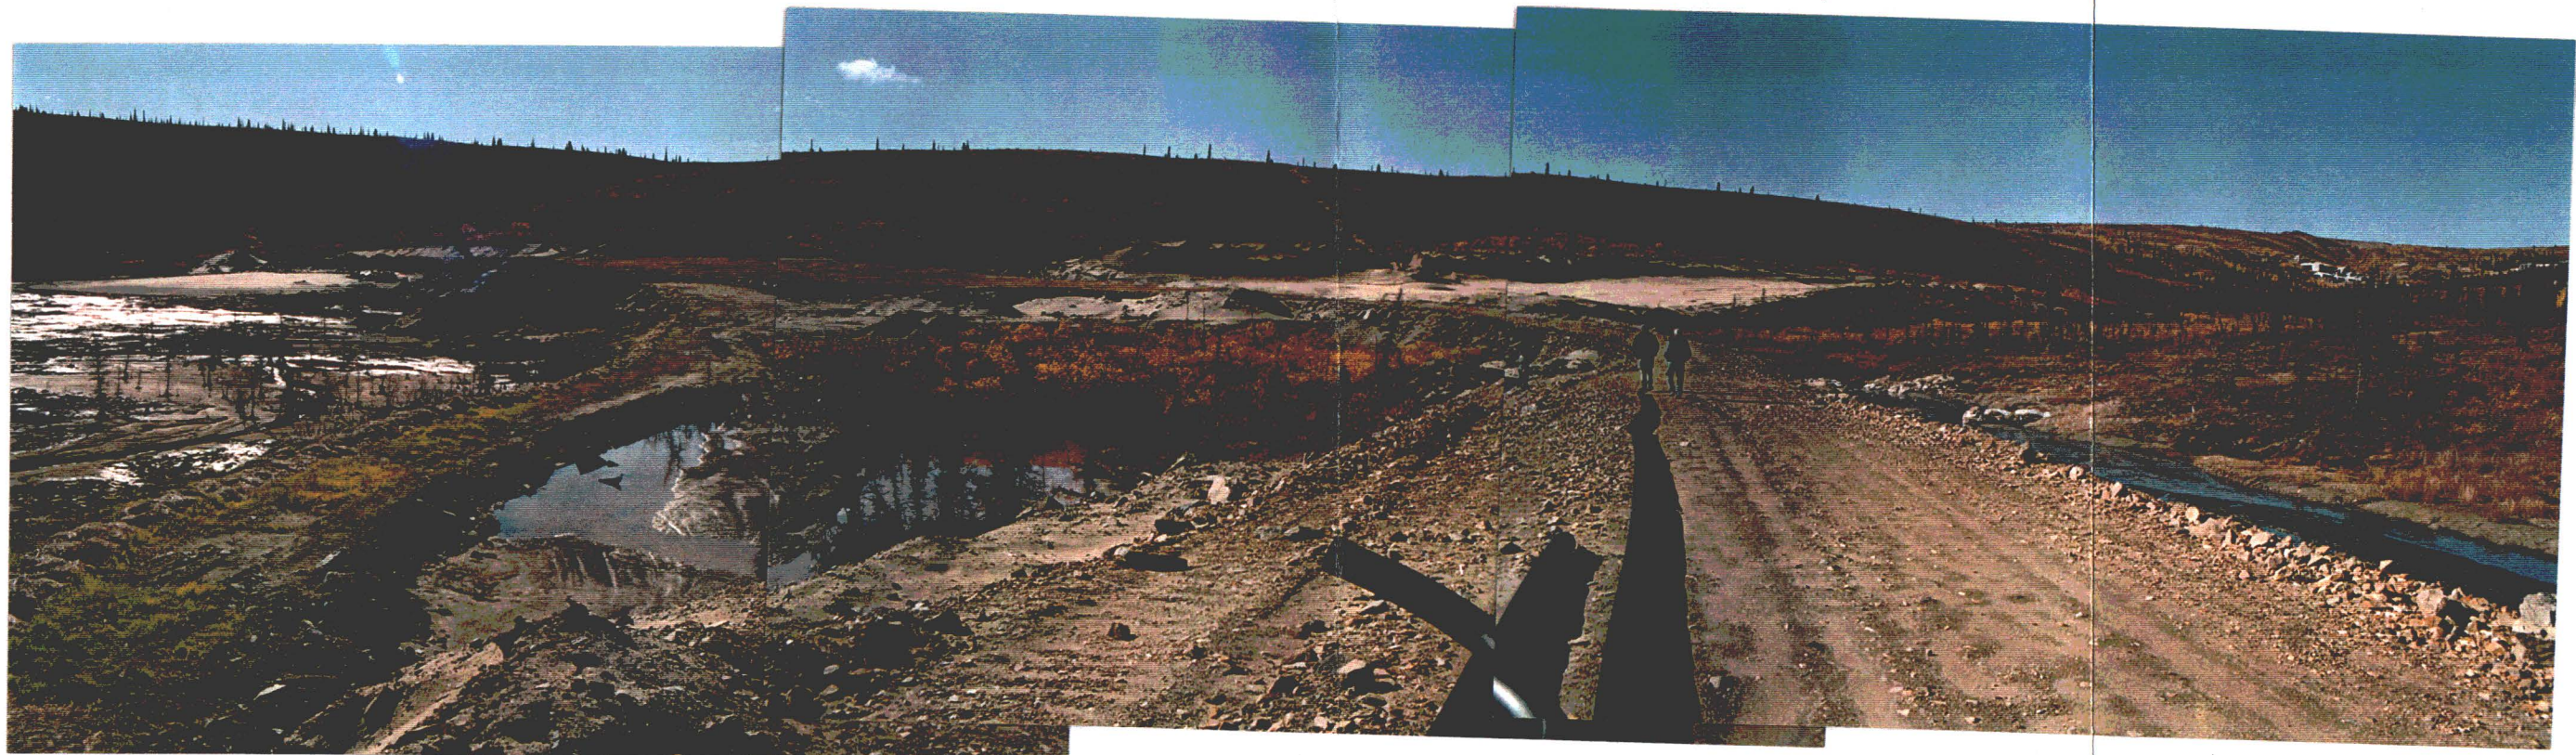
Photograph 14 North and West Diversion Ditches - looking north and northwest.
