Re: Final Report for 2004/05 Care and Maintenance Activities, Keno Hill Property

Care and Maintenance of Keno Hill Mining Property,

Keno Hill, Yukon

2004-2005 FINAL PROJECT REPORT

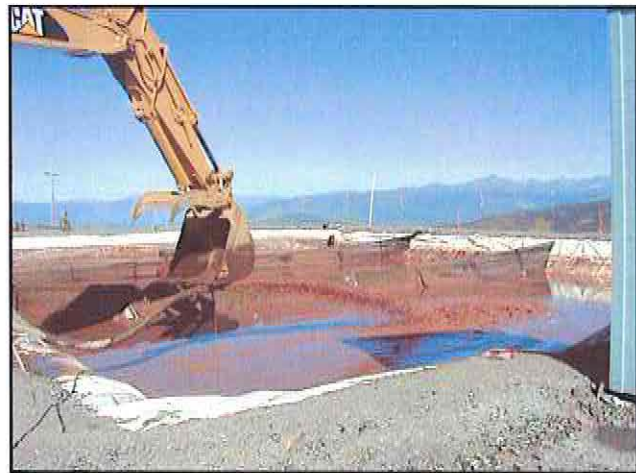
Plate 5 - De-sludging the Galkeno 300 treatment pond

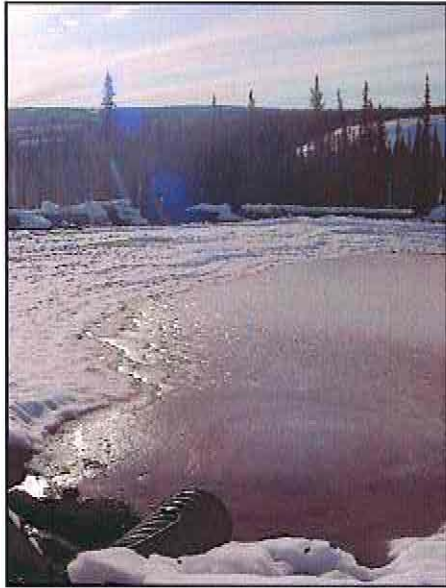
The treatment system at Silver King has operated well, and is expected to continue being the easiest site to keep in compliance. This is attributed to low flow levels and very low zinc content in the adit discharge (see Figure 6), as well as an operational secondary settling pond that

Plate 7- Silver King Treatment Pond

provides longer residency time for zinc and lime precipitation. Non-compliant zinc discharges observed in late May and early June of 2004 could be attributed to elevated flows associated with spring freshet, and an error in adjusting the lime addition rate at the adit on May 31st. Portal water flow rates at Silver King showed minor variation and were estimated using bucket/timing methods at 1.5 - 3 litres/sec. Mean untreated pH and total zinc levels were calculated at 7.5 and 1.10 ppm respectively, and the mean pH and total zinc concentrations of the treated water were 8.5 and 0.20 ppm respectively, over the contract period. The current lime slurry flow rate is 13.3 ml/sec.

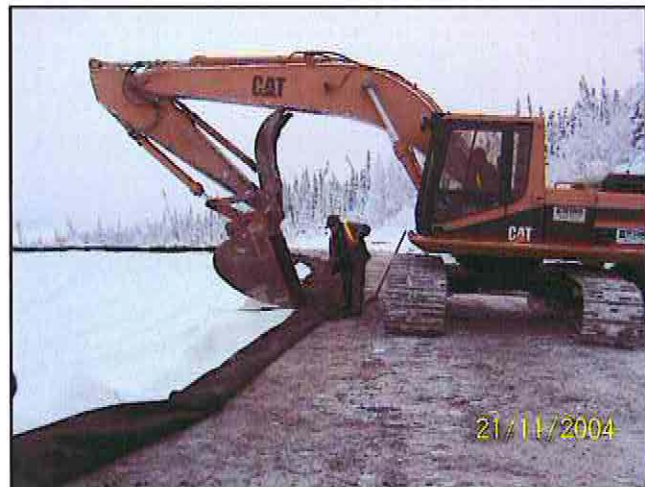
The liner installation project at the Galkeno 900 treatment pond was implemented during the week of November 14, 2004 to prevent failure of this single-pond system, in response to a leak that developed in the pond. The installation of an impermeable liner in the pond successfully stemmed the flow in the seep, and the seep has not since re-appeared. Appendix F contains EBA Engineering's full report on the Galkeno 900 Pond Liner Installation.

Plate 8 – Galkeno 900 treatment pond liner installation

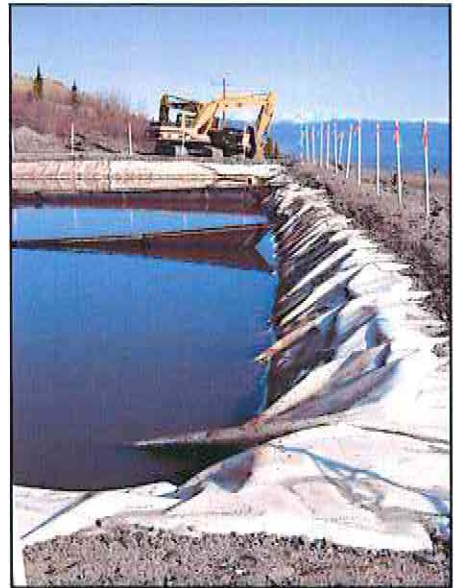
- Two geo-textile baffle curtains were installed in the pond during the June 2004 pond clean-out. The baffles provided a more circuitous route for the water in the treatment pond to follow, essentially increasing the pond water retention time;
- A windmill driven foot pump was installed onsite to provide greater air introduction to the treated water immediately upon entering the treatment pond. This system also reduced the draw on the generated power-supply at the site;
- Both the treatment shed and the lime slurry addition point were re-located in December 2004. The shed was moved to just outside the adit entrance, and the lime slurry pipe was routed into the adit. A mixing box was constructed to facilitate mixing of the adit discharge flow and the lime slurry, which is applied to the flow immediately before the mixing box.

Plate 11 - Baffles installed in Galkeno 300 Settling Pond

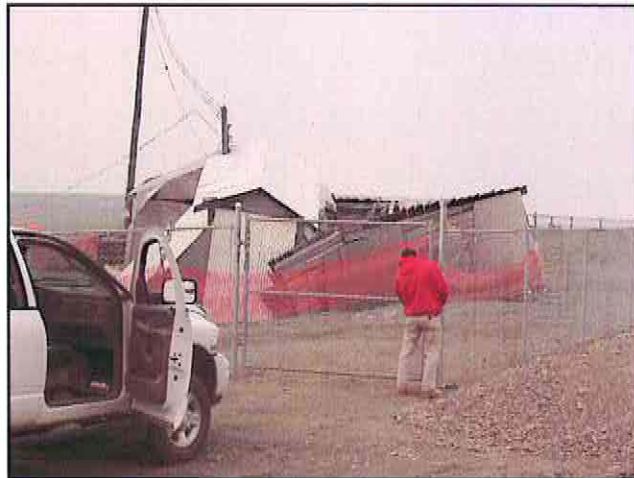
Plate 15 - Newly installed security fence surrounding partially-collapsed Shamrock 'J' Raise structure

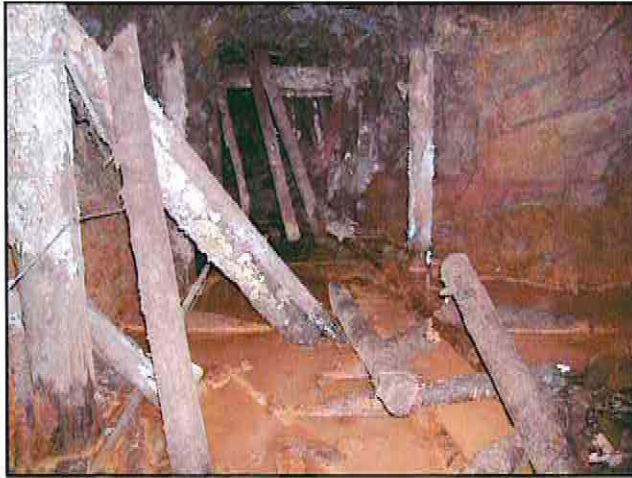
Plate 18 – Collapsed timbers in underground workings of G300 level

ACG contacted Main Street Mining and asked them to conduct an inspection in order to prepare a quote for building an underground dam to redirect the water over to the Sime workings/Sime vein. G. Turner of Main Street went into the adit and prepared a quote, which was submitted under separate cover to YG. During this inspection, he indicated that the workings were essentially safe for walking in, taking care to not disturb rotted overhead timbers.

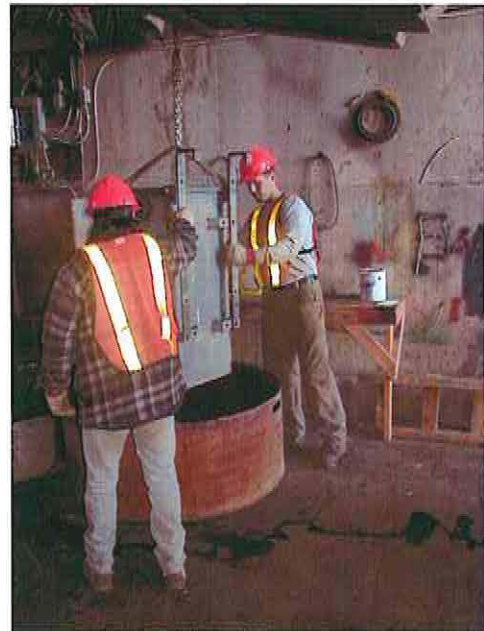
Plate 19 – Ewing employees placing PCB-contaminated electrical equipment in secondary containment

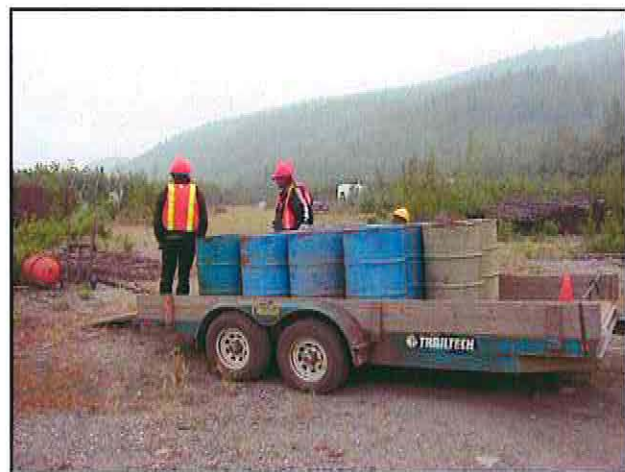
Plate 21 – Ewing employees moving waste hydrocarbon drums to bermed storage area
