**GOVERNMENT OF YUKON ENERGY, MINES AND RESOURCES -  
ASSESSMENT AND ABANDONED MINES**

# **Clinton Creek Engineering Review and Assessment**

## **Part 1**

307071-00997-00-SS-REP-0001

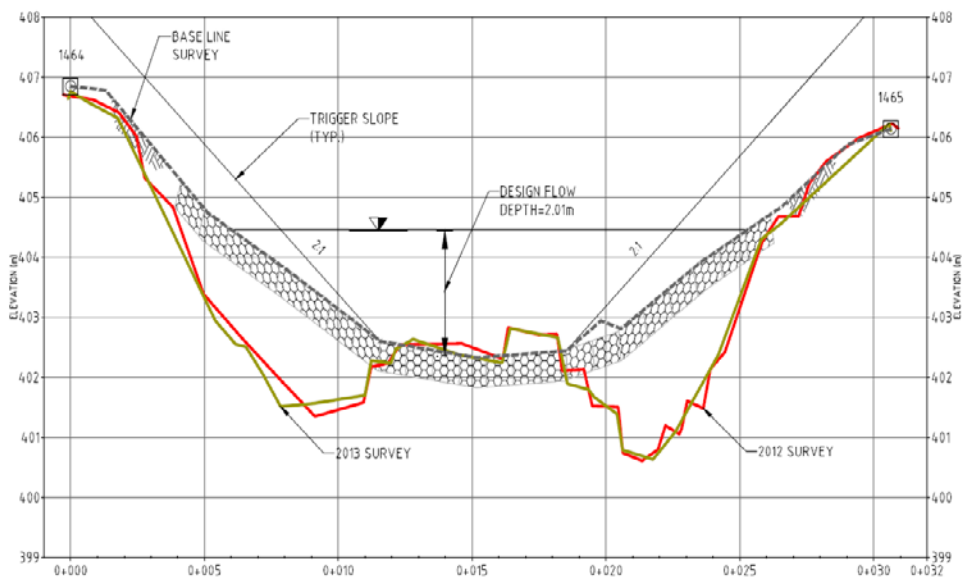
**Figure A DS4 Cross-Section**

A DS4 cross-section, based on survey results from previous survey programs, is presented as Figure A. Stationing increases from south to north (i.e., the north slope is located on the right hand side of the figure).

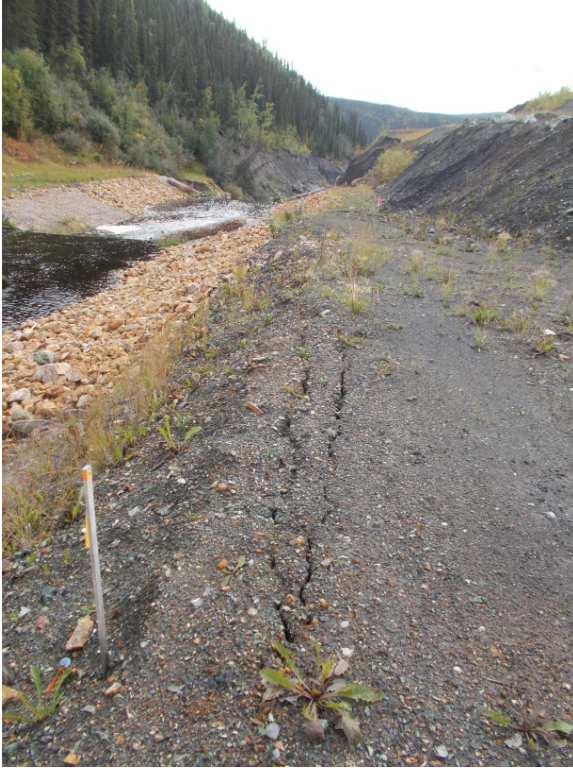
**Photo 26: Tension cracks located along south bank of DS1 looking east (downstream).**

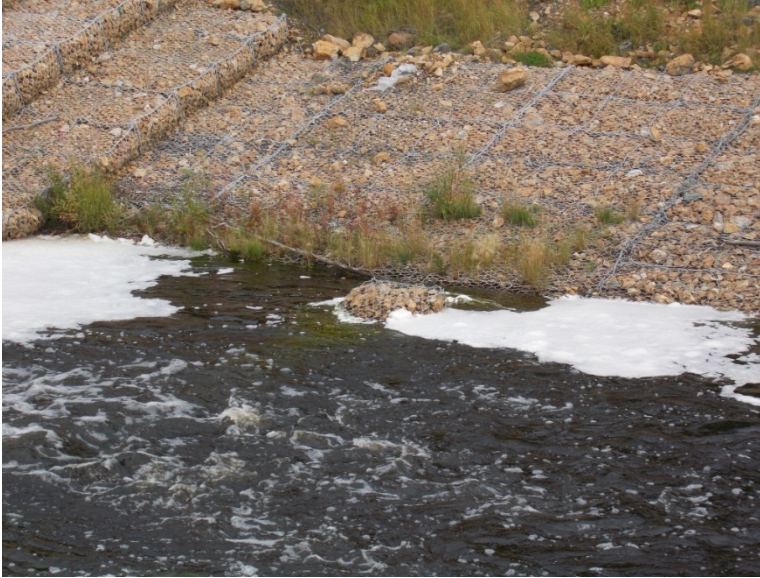
**Photo 32: Vertically displaced gabion basket at DS3 looking north.**

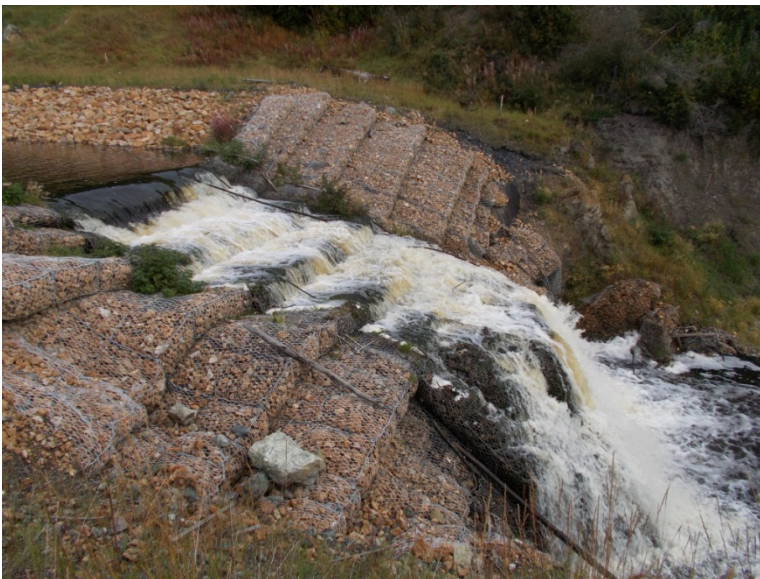
**Photo 33: DS4 looking north.**

<b>Location</b>	<b>Access Method</b>	<b>Observations</b>
Gabion DS4	On foot	Woody debris located in channel. In channel baskets significantly damaged beginning 3 m to 4 m above plunge pool. Baskets below this height have failed, including baskets on north and south banks. Failed basket material observed approximately 15 m downstream. Tension cracks (5 m to 6 m in length) located along south top of bank.  WorleyParsons completed a site visit in 2013 (attended by Lee Martin and Alex Timmis) to review the condition of DS4 and to inform the development of a repair strategy. The condition of DS4 does not appear to be significantly different than last year, based on a comparison of photos taken during the 2013 and 2014 site visit.
Clinton Creek Channel and Site Access Road	On foot and flyover	Slope failures along north and south banks. Significant tension cracks (6 m to 7 m in length) located along south top of bank. Undercutting of bedrock along toe of north bank.

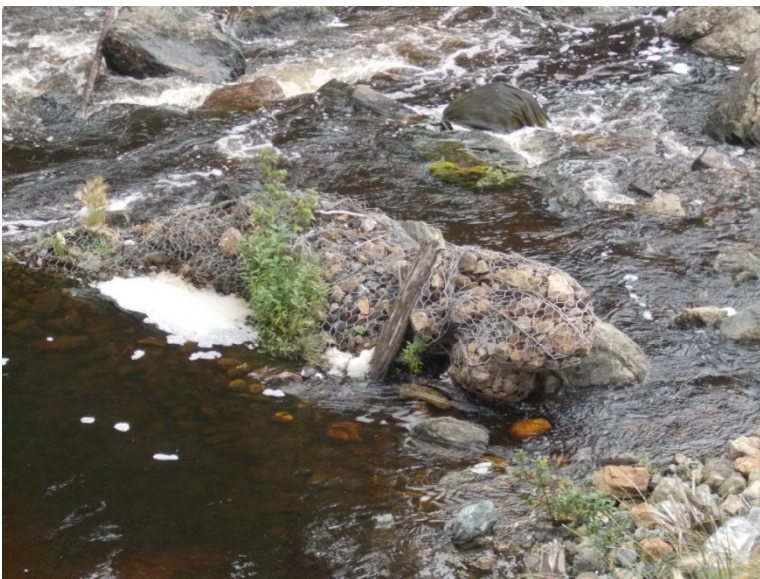
While DS4 is still in place, it has become destabilized due to the August 2010 flow event and the ongoing erosion of underlying granular material. This erosion has already resulted in the failure of some of the lower courses of gabion baskets. Due to the high energy of flow at the base of the drop structure, it is likely that erosion will continue during periods of low to moderate flows and that erosion will increase during periods of high and extreme flows. As additional courses of gabion baskets fail, the surface area exposed to high shear stresses will increase, further threatening other surrounding gabion baskets.

Furthermore, some gabion baskets at DS4 have shifted but have not failed as they are still held together by the metal comprising their cage. It is likely that at some point this metal will fail due to fatigue, further weakening the drop structure integrity.

**Photo 35: Failed gabion basket downstream (east) of DS4.**

A repair plan for DS4 was designed by WorleyParsons in 2014 consisting of the construction of a chute (integrated into the remaining gabion baskets) downstream of DS4 using articulated revetment mats and re-grading of the waste rock pile located south of DS4. During its development, it was assumed that site-wide remediation works to address slope instability and channel protection infrastructure would be underway within five years, including a permanent repair option for DS4. Consequently, the proposed repair plan was developed as a short-term protection measure.

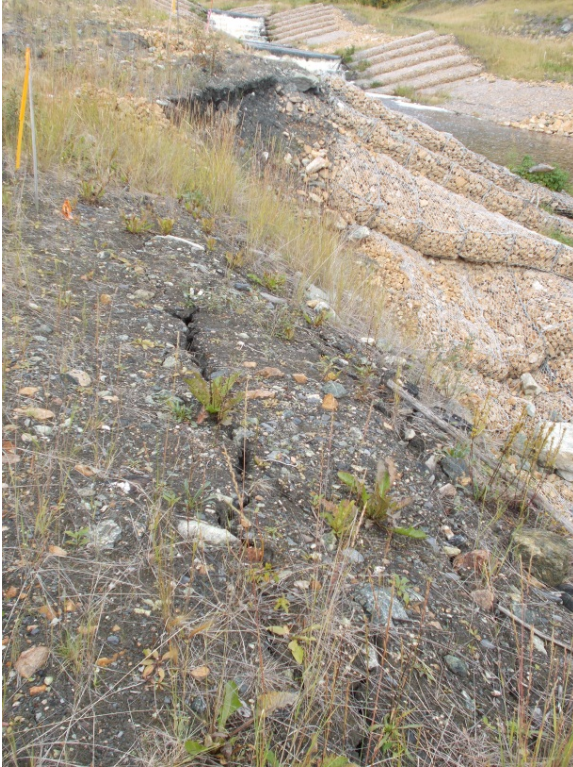
**Photo 36: Tension cracks along south bank of DS4 looking west (upstream).**
