**GOVERNMENT OF YUKON ENERGY, MINES AND RESOURCES -  
ASSESSMENT AND ABANDONED MINES**

# **Clinton Creek Engineering Review and Assessment**

## **Part 2**

307071-01014-00-SS-REP-0001

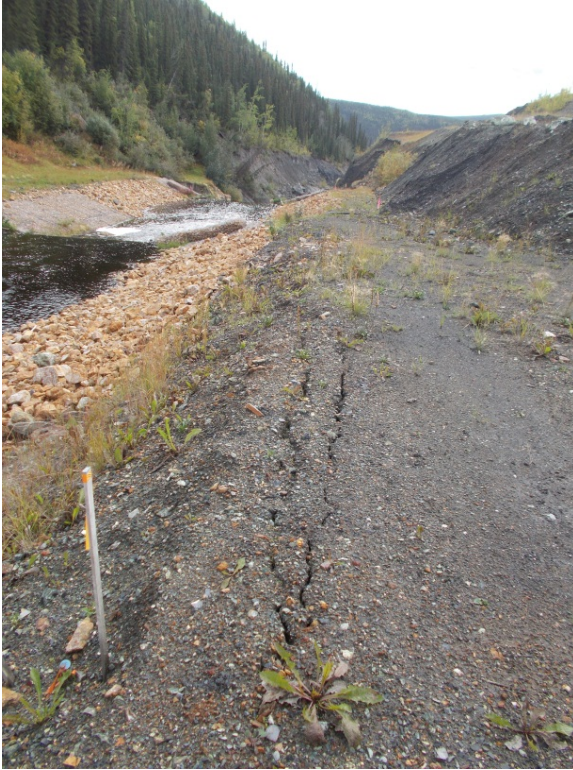
**Photo 26: Tension cracks located along south bank of DS1 looking east (downstream).**

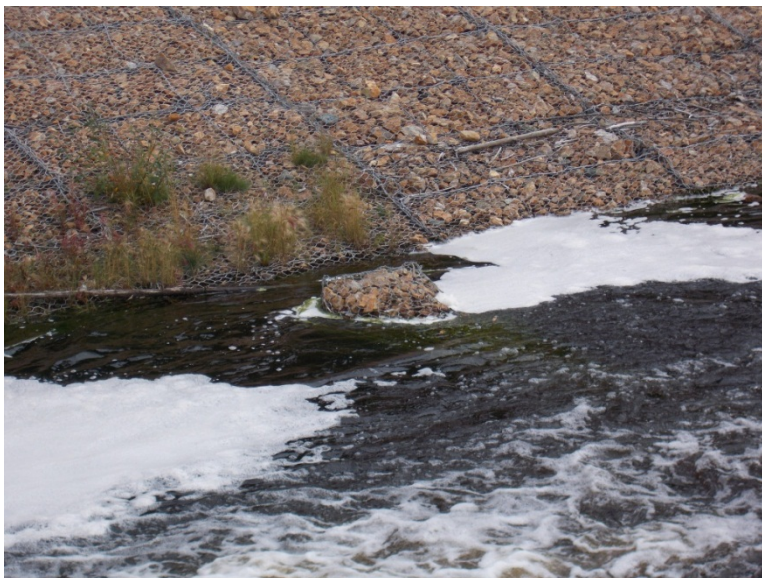
At the time of the site visit, large woody debris, located above the water line, was observed at each drop structure but was not obstructing flow. One gabion basket at both DS1 and DS3 were visibly displaced and tension cracks were observed along the south channel bank at DS1 and DS2; however, it did not appear that these deficiencies have significantly impacted the performance of the drop structure.

**Photo 29: Vertically displaced gabion basket at DS3  
looking northeast.**

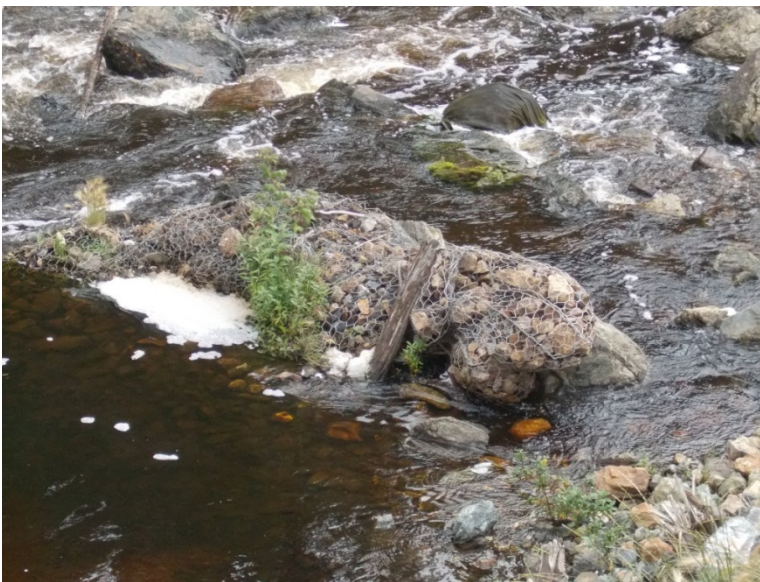
**Photo 35: Failed gabion basket downstream (east) of DS4.**
