Clinton Creek Long-Term Performance Monitoring Program

2016 Survey Results

December 12, 2016

307071-01132-00-GT-REP-0001

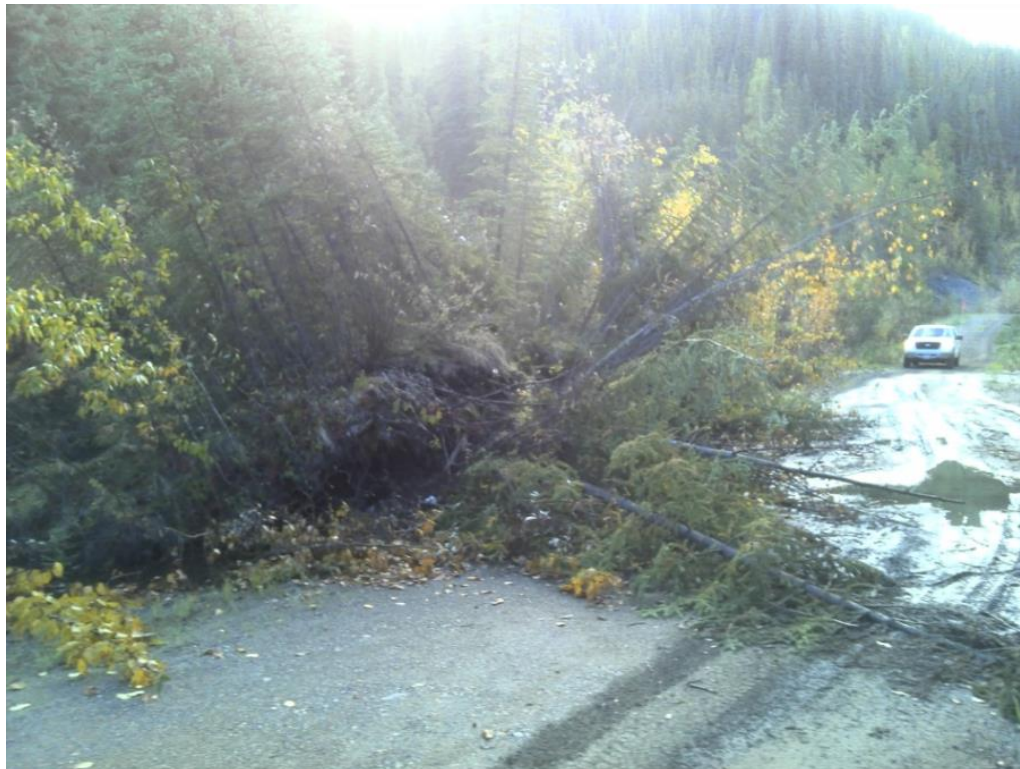
Based on photos taken by Underhill at the end of August, 2016, the site access road between the Forty Mile Bridge and the site gates has experienced several landslides (Photo A) and erosion caused by runoff across the road (Photo B).

Photo A Clinton Creek Site Access Road – Landslide (August 29, 2016)

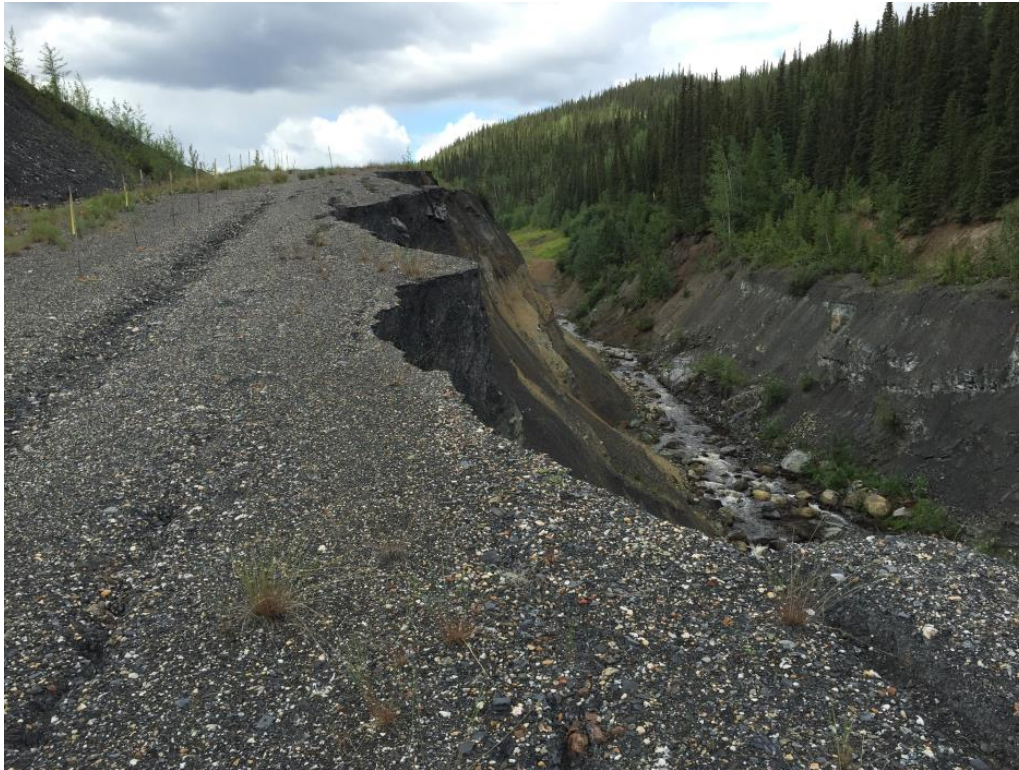
The condition of the closed section of the access road, on the south side of Clinton Creek 350 to 400 m downstream of Hudgeon Lake, does not appear to have worsened since 2015. This section of the road remains unstable and is expected to continue to fail, albeit at a slower rate than was first observed between 2012 and 2014.

Based on observations made during the 2012 program, a portion of the Clinton Creek site access road, from Clinton Creek Stations 0+340 to 0+410, was closed due to the presence of extensive tension cracks and embankment failures. This section of the site access road was blocked off using chains attached to concrete lock blocks at the east end and an earth berm at the west end (Photo C), with the site access road relocated across the waste rock pile.

Photo C Closed Section of Clinton Creek Site Access Road – Looking West (June, 2016)

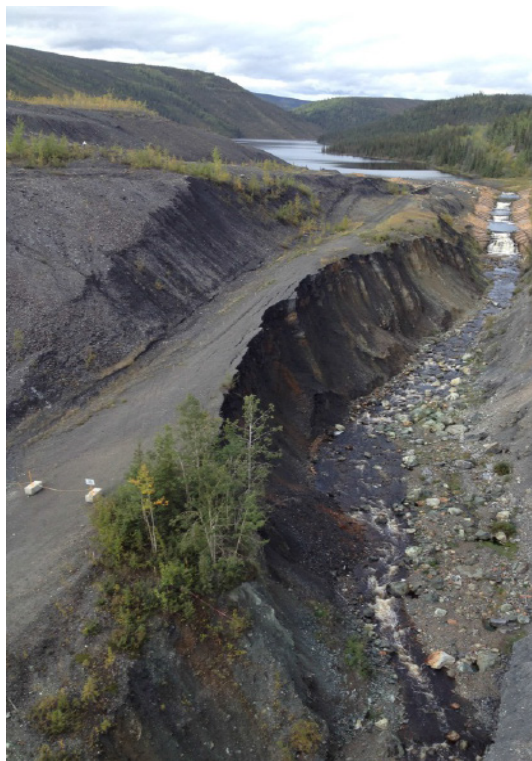
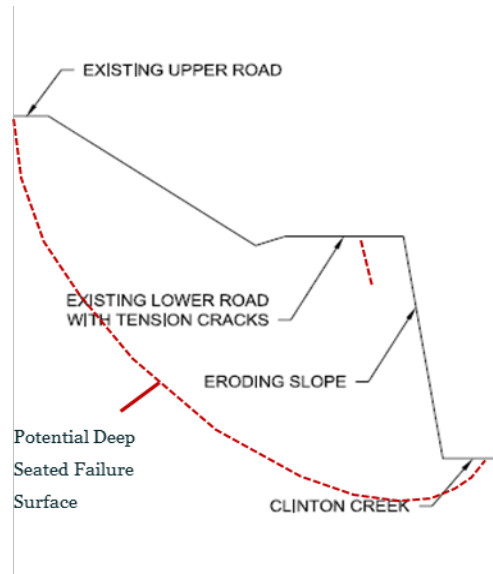
Based on in situ observations, and interpreted photographic and topographic data, it is concluded that further erosion of the access road embankment may destabilize the ground farther upslope (Figure E). This could trigger a larger landslide by removing the support that is being provided by the toe of the slope, and result in significant blockage of the Clinton Creek channel.

Figure E Decommissioned access road and Clinton Creek east of DS4 looking west (left) and potential deep seated failure mechanism (right)

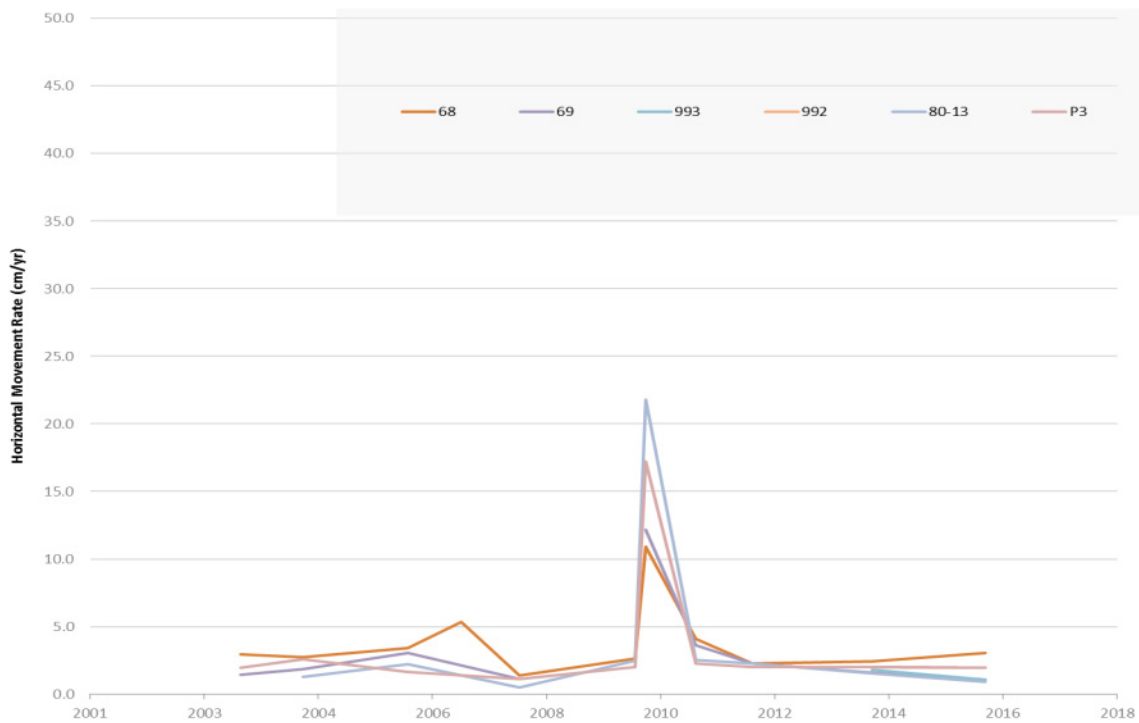
Analysis of the displacement direction was also carried out. The analysis shows that absolute displacement vectors of the monitoring points on the access (lower) road are towards the northeast, approximately perpendicular to the creek channel. In contrast, the displacement vector for the monitoring point on the upper road (68) is towards the northwest. Thus, displacement patterns are interpreted as two different zones that are deforming differently: a lower slope where deformation is predominantly surficial and an upper slope where deeper failure mechanisms are evident. Upper slope deformation rates are interpreted as being representative of global behaviour, while lower slope instabilities are interpreted as localized surficial accelerations that do not influence, at the present time, the entire landslide mass. As more monitoring data becomes available at this site, consideration should be given to the displacement model presented here and updated or modified as necessary.

Figure F Clinton Creek Access Road (Closed Portion) Horizontal Movement Rates

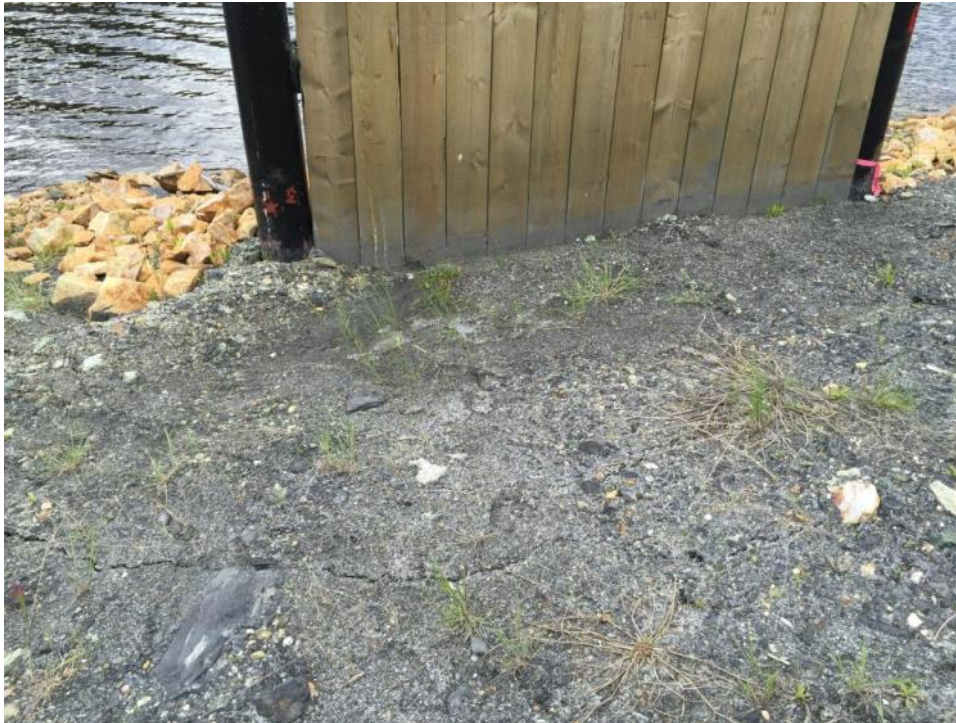
No loss of riprap was observed around the abutments. However, cracks in the soil were observed on the north side of the north log boom abutment at Hudgeon Lake outlet during a site visit completed on June 21, 2016. Survey data indicates that the north log boom abutment has moved 3.6 (± 2.7) cm horizontally towards the lake and 12.2 (± 3.7) cm up between 2014 and 2016. The south log boom abutment has moved 6.2 (± 2.7) cm towards the lake and 4.1 (± 3.7) cm up in the same period. The north log boom abutment exceeded Trigger HL-2, maximum vertical displacement of 10 cm.

Detailed observations of the 2016 site inspection are summarized in Section 2.1 (Table A). The log booms and abutments were generally in good condition. However, small cracks were observed in the soil around the north bank abutment (Photo D) and were thought to be an indication of movement or subsidence of the abutment area. These cracks were not noted in the 2015 LTPMP report.

Photo D North Boom Abutment, cracks in soil around abutment (June 21, 2016)

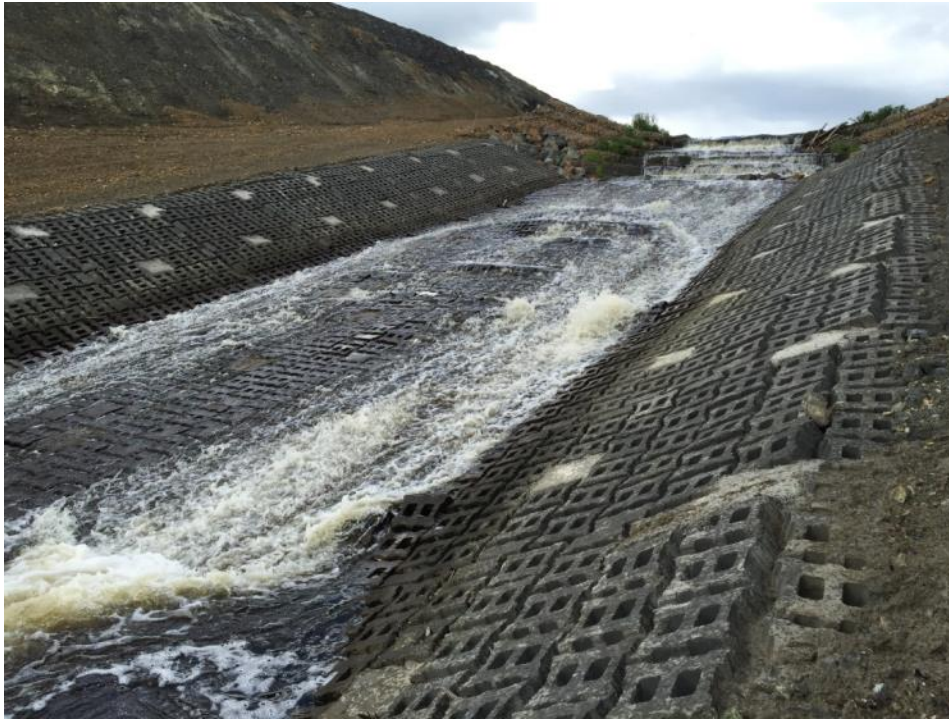
On the Drop Structure 4 (DS4) ACB channel, centreline mats fourth through eighth from the top have experienced some degree of sliding or buckling. This occurred in late April, 2016 during peak freshet flows. The duckbill anchors now appear to be engaged and securing the mats in place. Some erosion of the stabilized slope to the south of DS4 was observed in September, 2016 and was likely caused by either the heavy rain recorded on August 6, 2016 or an issue with the runoff diversion ditch at the crest of the slope. The hazard associated with this erosion is the subsequent deposition of eroded fines into Clinton Creek. A landslide was also observed in September and likely occurred during or shortly after the heavy rain on August 6, 2016. The landslide does not appear to have impacted the ACB channel.

Several potential issues with the DS4 articulated concrete block (ACB) mats, constructed in September, 2015, were noted. The condition of the ACB channel is described in Section 2.1 and shown in Table A.

Photo E Drop Structure 4 ACB Channel, looking southwest (June 21, 2016)

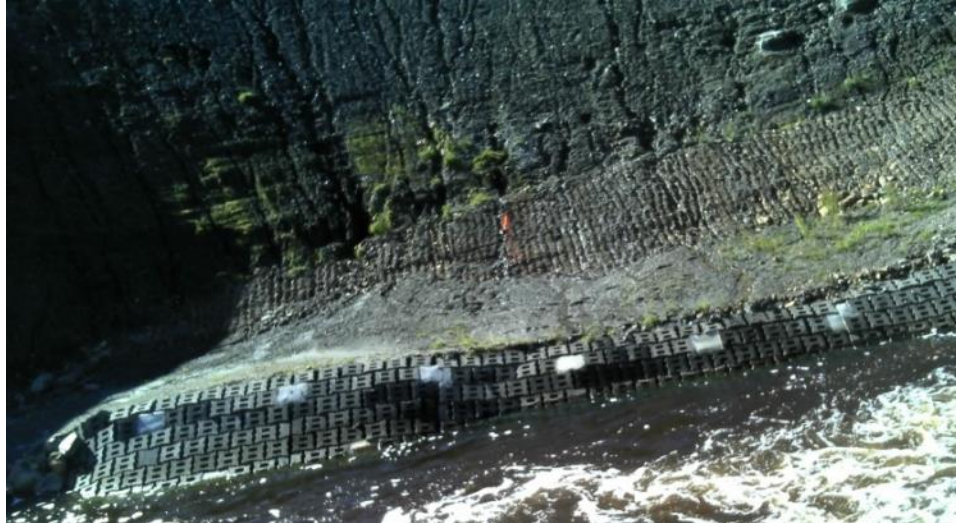
Based on the photos taken by Underhill in September, two additional potential issues were noted. The first is that there has been general erosion of the stabilized waste rock slope south of DS4 (Photo F). This could be due to either the significant storm event recorded on August 6, 2016 (23 mm in less than an hour at the meteorological station on Site), or issues with the stormwater diversion ditch at the crest of the stabilized slope. The second potential issue is a landslide on the natural valley slope north of DS4 (Photo G). This is likely a result of erosion of Clinton Creek banks between 2009 and 2015 as well as the heavy rainfall observed on August 6, 2016. The slide does not appear to have impacted the ACB channel.

Photo F Erosion of waste rock toe near DS4, looking south (September 3, 2016)

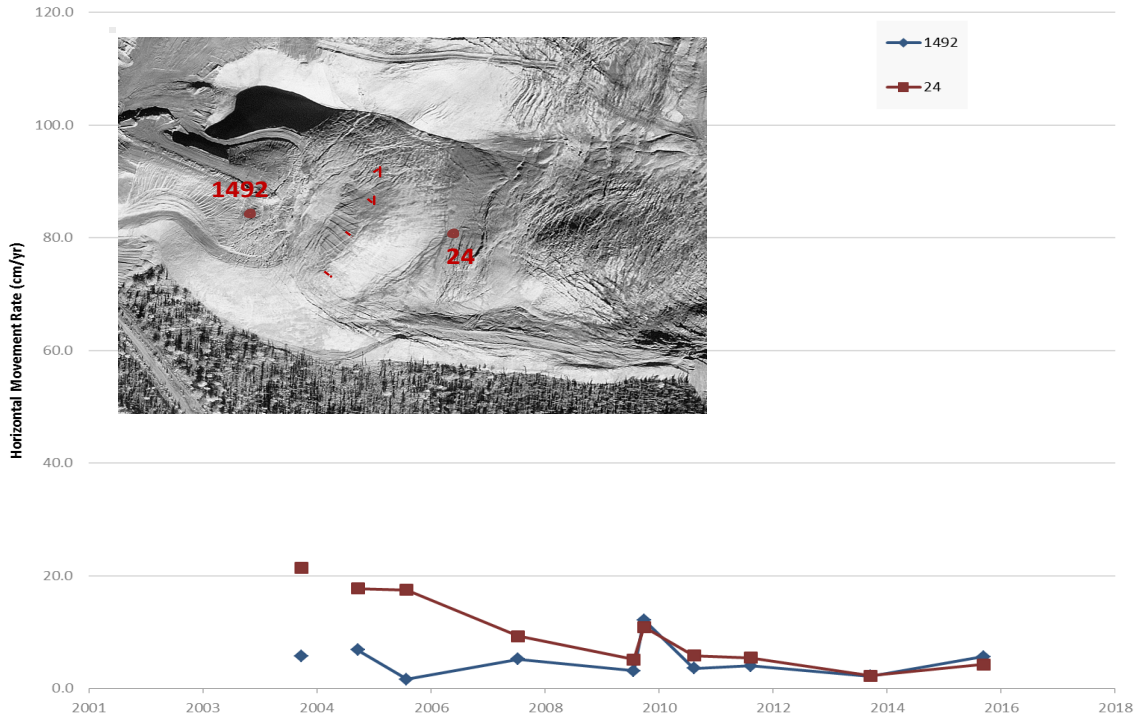
Although the original landslide did not encompass much of the upper slope area, displacements in the upper slope area are interpreted to be a secondary failure that was initiated by the main instability to the east. Therefore, displacement in the upper slope area is expected to remain as a result of continued displacement of the major slope failure body.

Figure H Tailings Pile South Lobe Horizontal Movement Rates – Upper Slope (Inset, monitors 24 and 1492 location and inferred displacement pattern)

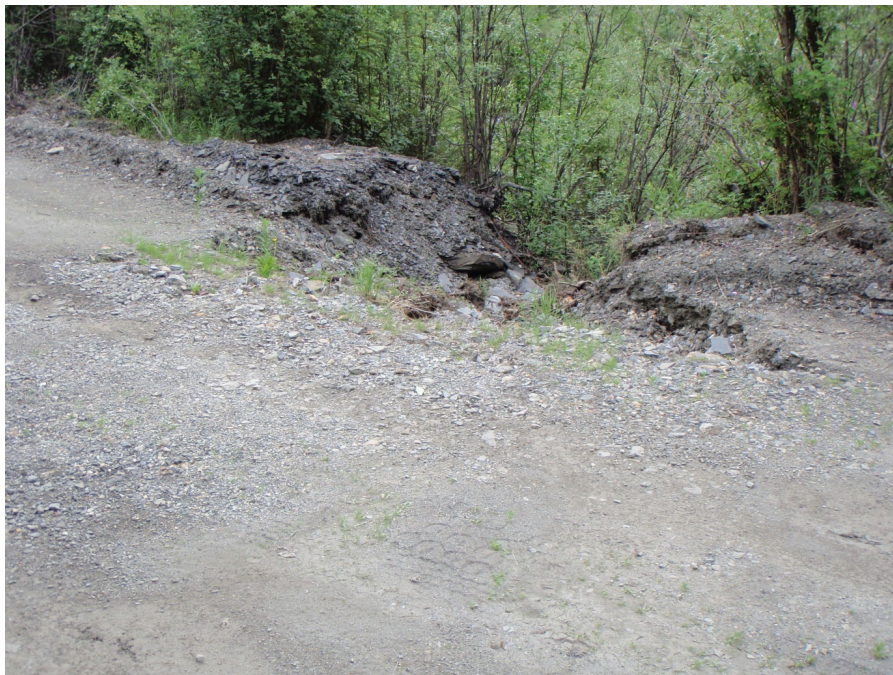
Photo 3 Washed out Culvert (looking at outlet) 5 km from the Forty Mile Bridge

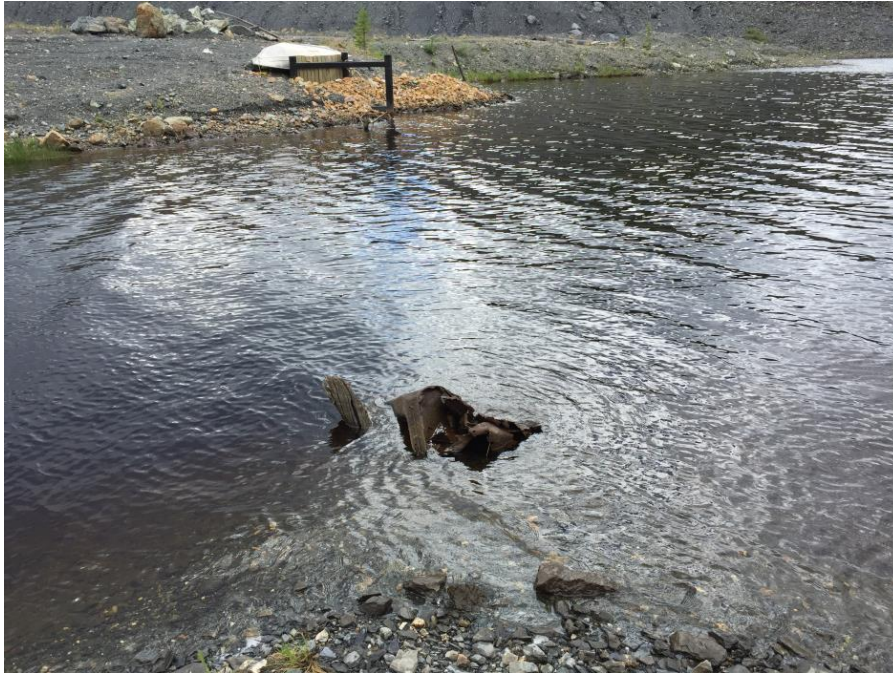
Photo 10 **Rusted Metal at Lake Outlet**

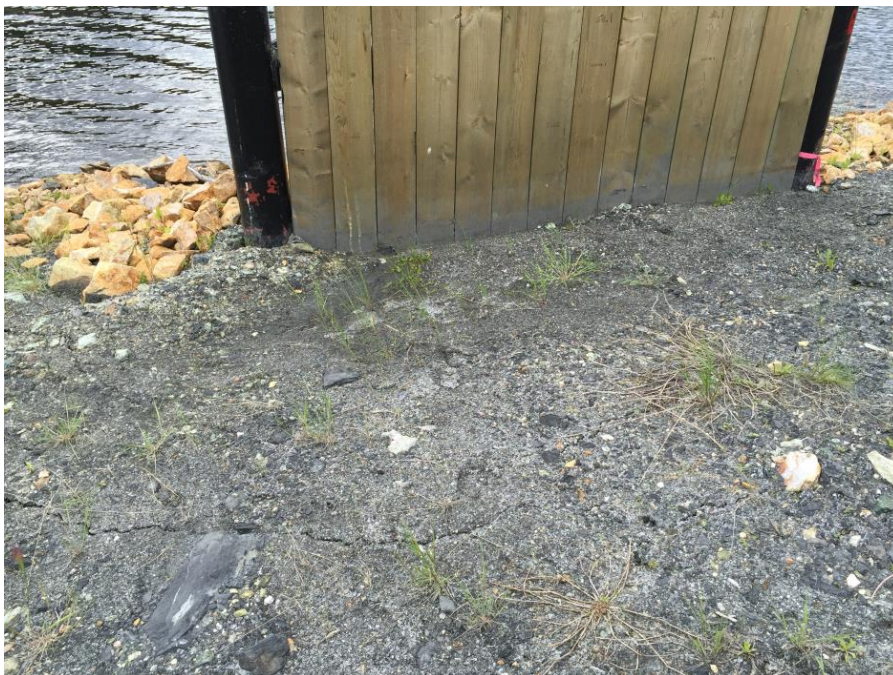
Photo 13 North Boom Abutment, cracks in soil around abutment

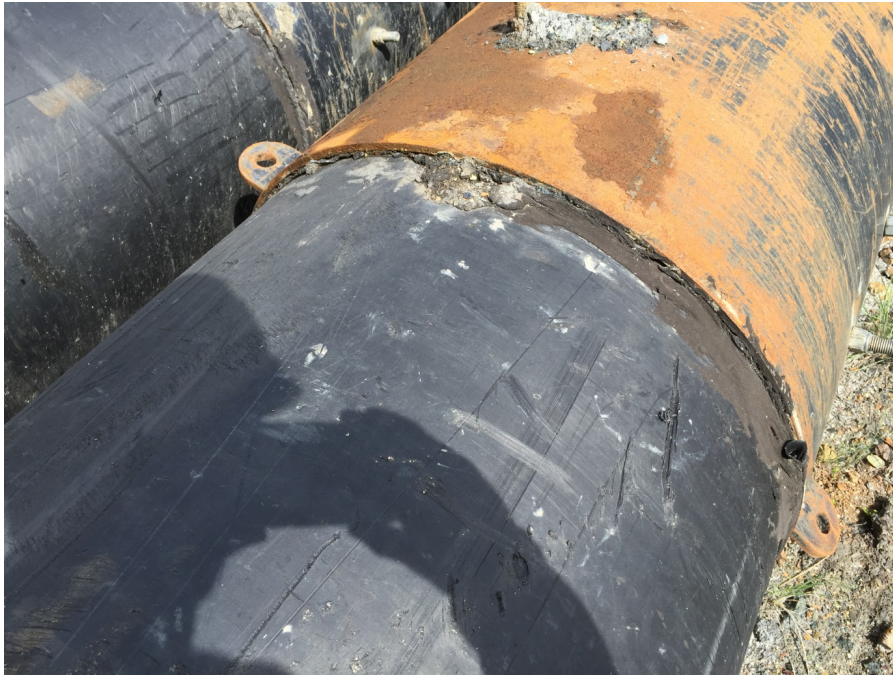
Photo 16 **Log Boom End – Cracking Seal**

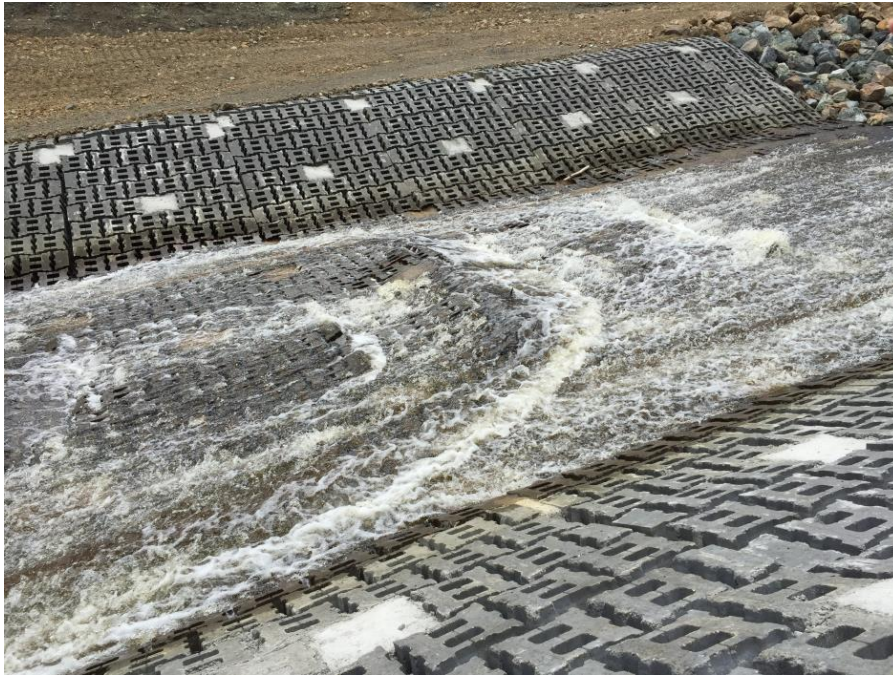
Photo 22 DS4 Repair – ACB Channel looking south at Mats 4, 5 and 6 from top

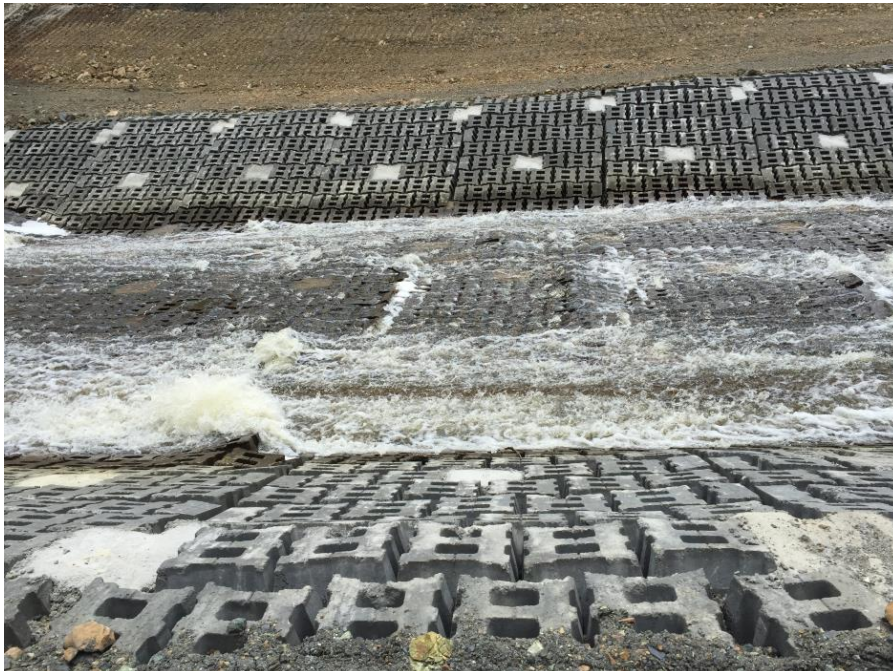
Photo 23 DS4 Repair – ACB Channel looking south at Mats 6, 7, 8 and 9 from top

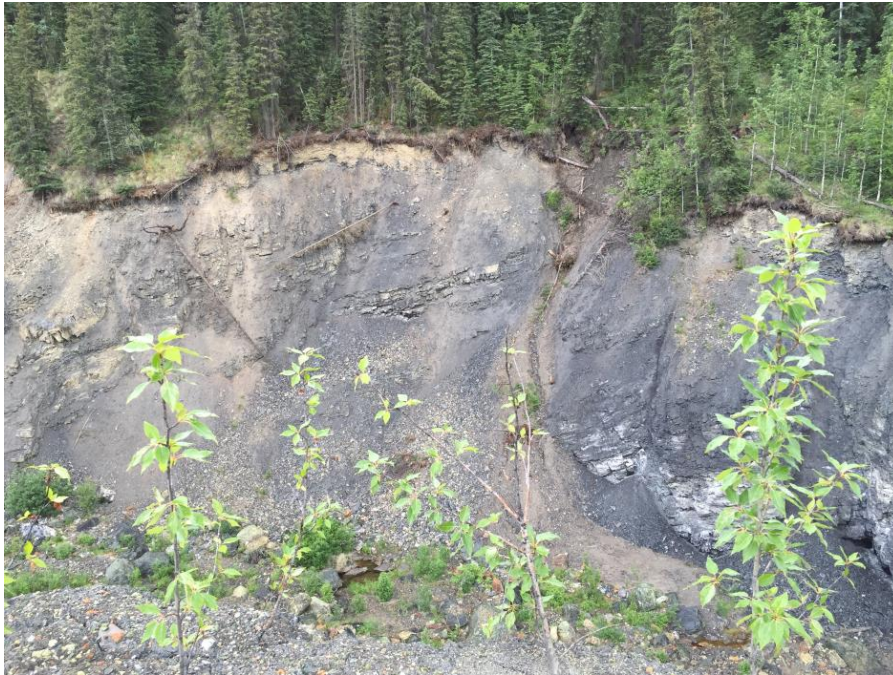
Photo 29 **Minor Slope Failure, looking north**

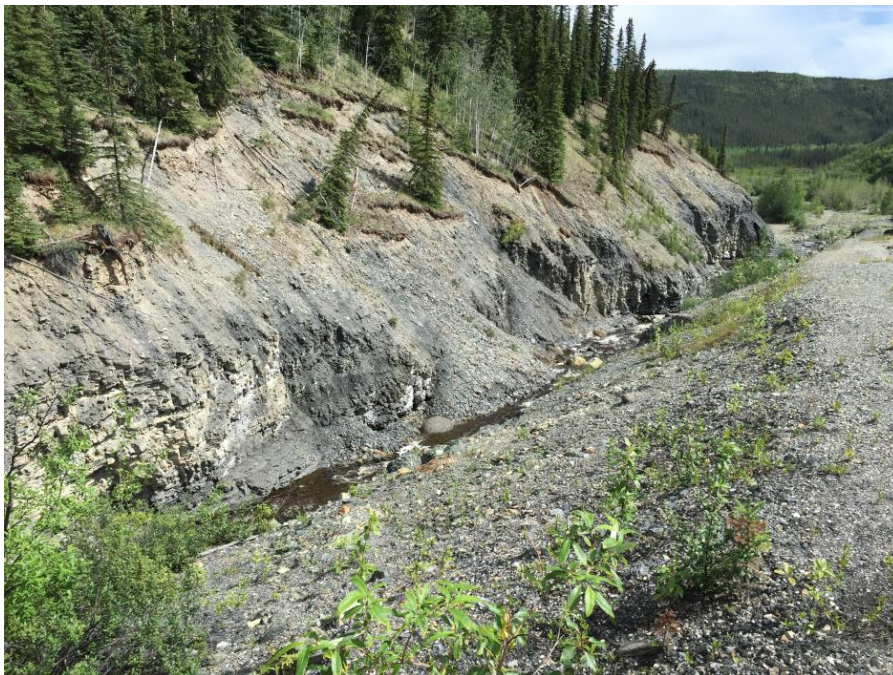
Photo 30 **Between closed road and Fording No. 1, looking downstream – failed slope encroaching on creek**

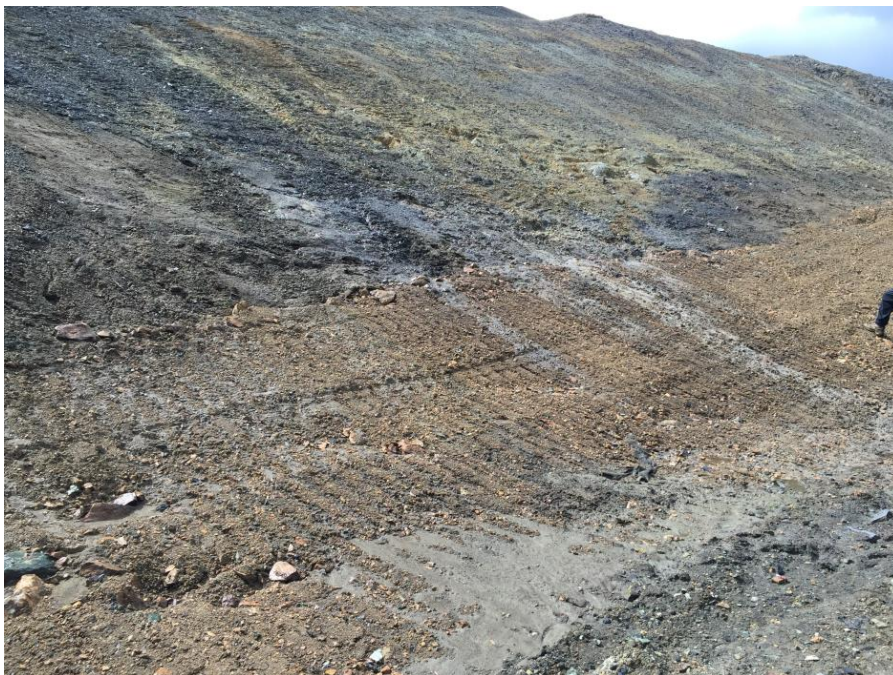
Photo 34 **Groundwater Seep at 2015 permafrost location (Slope south of DS4)**

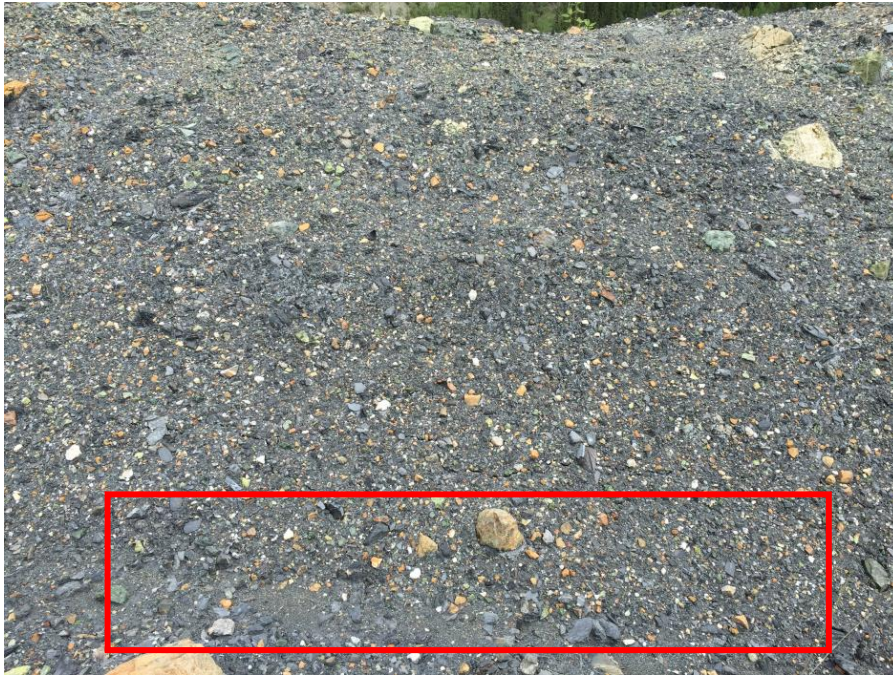
Photo 35 Cracks in soil at crest of slope south of Fording No. 1

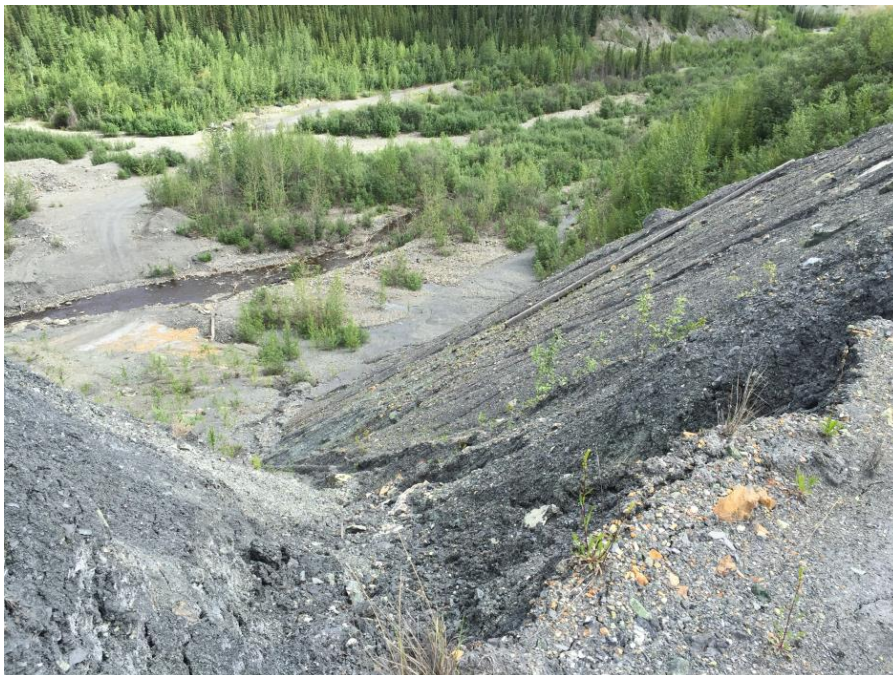
Photo 36 Erosion of slope south of Fording No. 1, delta of eroded sediment
