HARDY ASSOCIATES (1978) LTD.

Our Project No. **CG-04946**

July 13, 1982

Re: Cassiar Asbestos Mine,
Waste Dump and Tailings Pile Inspection

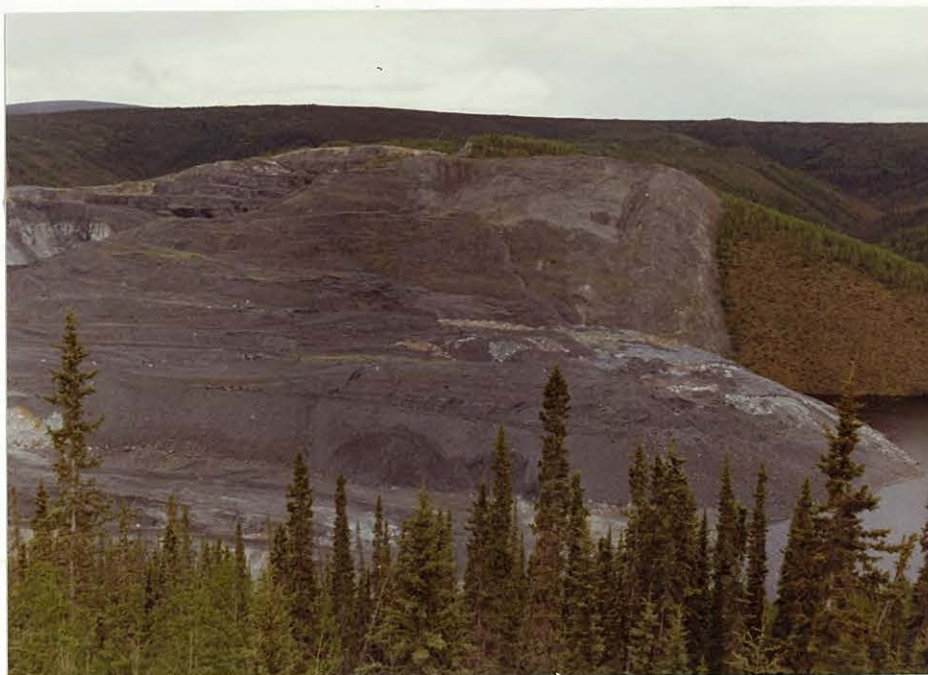
Relatively fresh tension cracks (not effaced by runoff) have been observed within the main dump segment, i.e. uphill from the access road and across the old trail leading to the open pit. Some of these cracks are located within areas where fissures were observed the previous year. Vertical displacement along some of the cracks produced quite prominent steps. In addition, relatively recent movement is indicated for the portion of the dump descending into the lake and for the dump uphill from this area. Typical dump conditions are shown on Photos^r 1 and 2.

Photo 1: Clinton Creek Waste Dump.

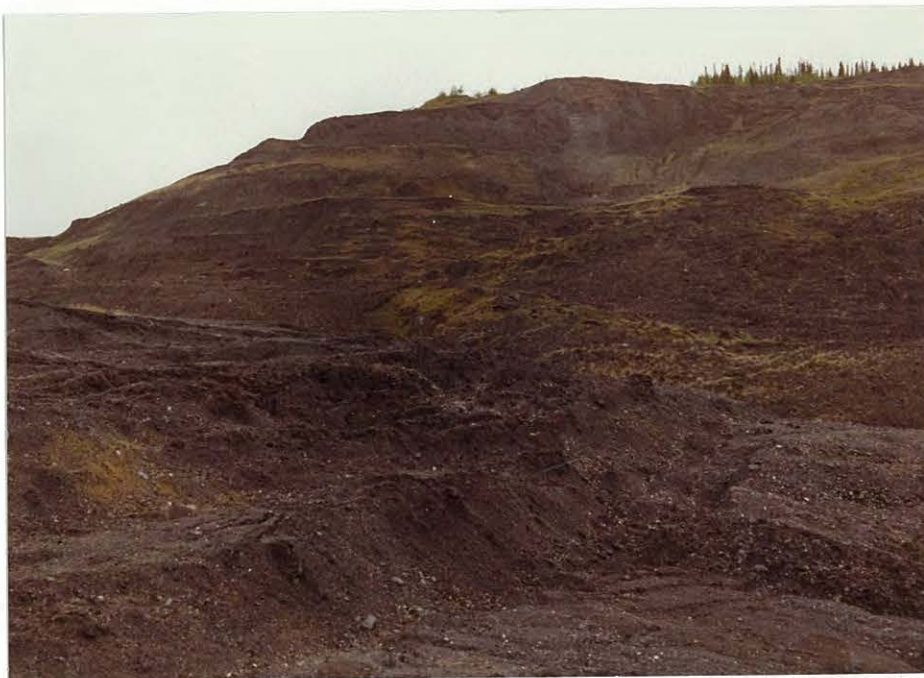
Photo 2: Continuing subsidence within the central portion of the dump.

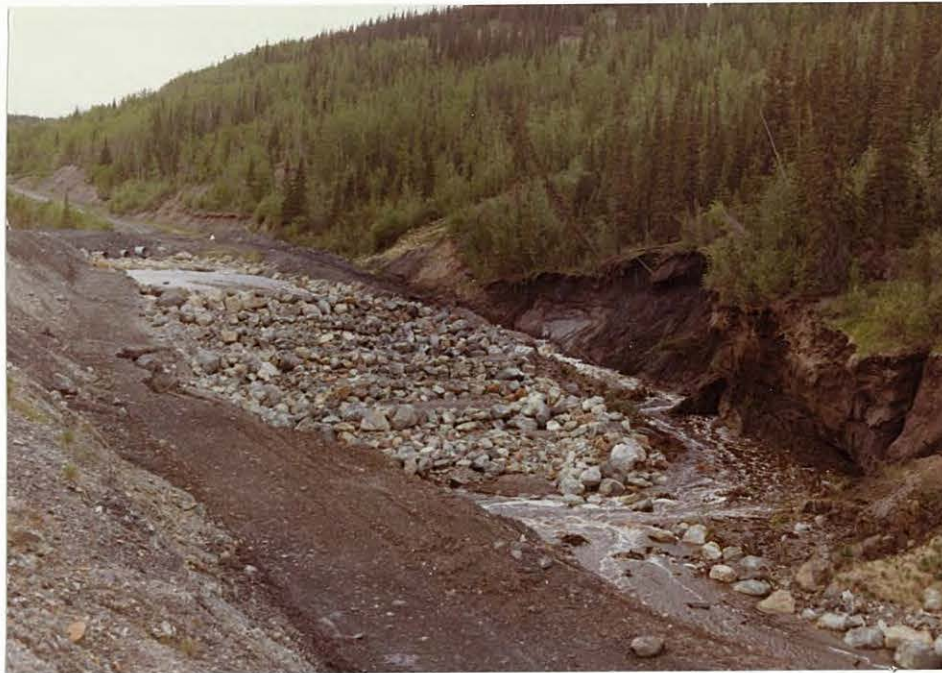
Notwithstanding well intended design measures and apparently careful construction of the weirs themselves, the freshet flow bypassed the weirs along the north valley wall (Photos 3 and 4) and cut a new channel outside of the weir system. This channel is seriously eroding the toe of the north valley wall at this location.

It appears that the flow followed the access road cut into the north bank. Field observations indicate that the elevation of the road has been about the same as the elevation of the top of the first weir. The bank armouring was apparently insufficient to control erosion. Mr. D. Acason reports that the failure of the north bank started due to piping. While this is difficult to confirm or reject, recent field evidence indicates that the bank was overtopped and that the flow followed the construction trail which was subsequently eroded. In this context, it is of interest to note undercutting of the south bank of the channel downstream of the weir system (Photo 5). This undercutting has obviously been caused by flow traversing the channel from the bypass route.

Photo 3: Clinton Creek weir system; stream bypassing the system and undercutting the bank.

It is obvious that rehabilitation of the channel during this summer season is required to ensure structural integrity of repaired weirs as well as to prevent erosion of the lake outfall.

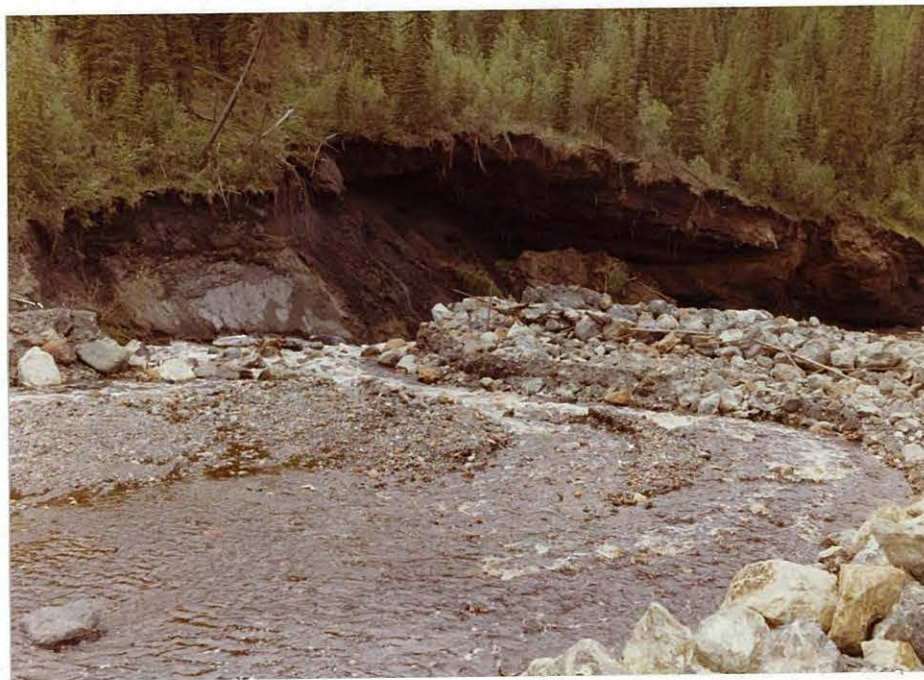
Photo 4: Detailed view of upstream weir section; note the height of breached bank relative the weir height and driftwood position.

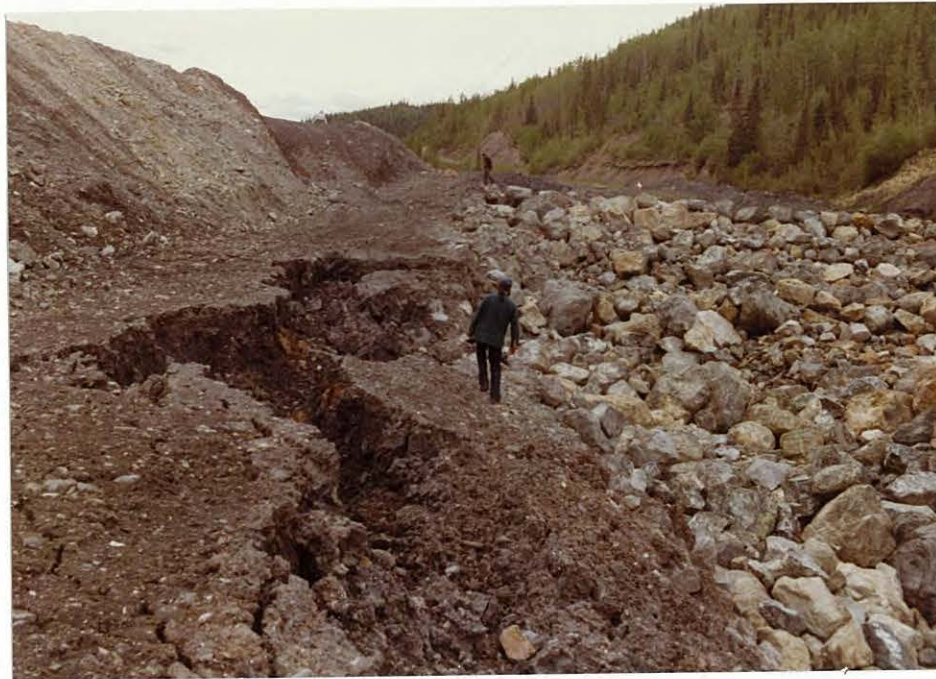
Photo 5: Sloughing of the undercut dump at the weir section.

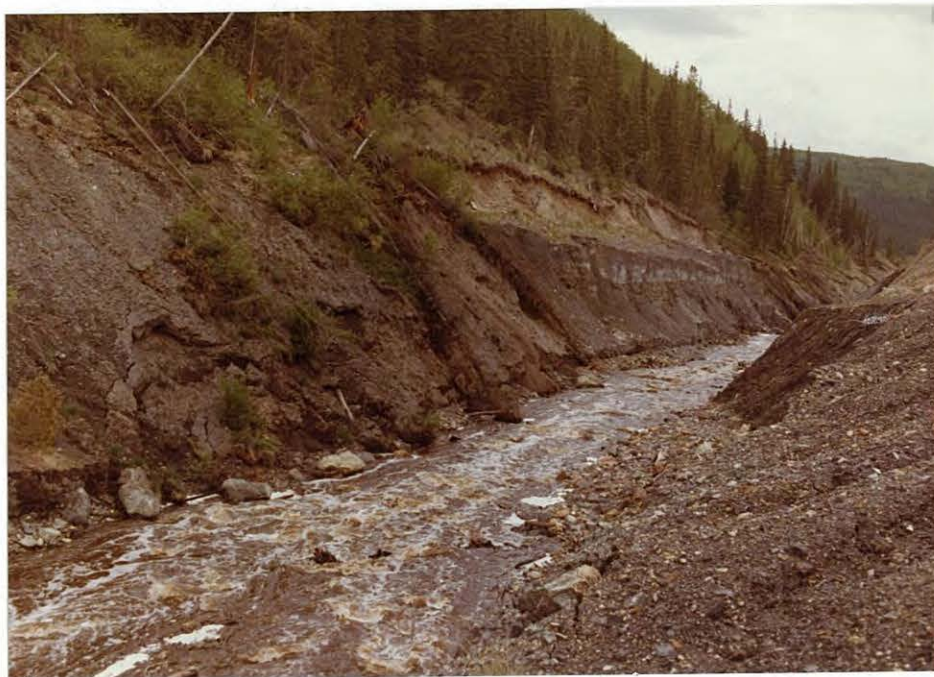
The banks of the creek channel show fresh sloughing and erosion scars (Photos 6 and 7). Despite the continuing erosion and undercutting, the slope made of waste material is steeper than the materials' angle of repose. This is indicative of a continuous movement of the dump into the creek channel.

Photo 6: Clinton Creek downstream of weirs - comparable to Photo 1 of 1981 report.

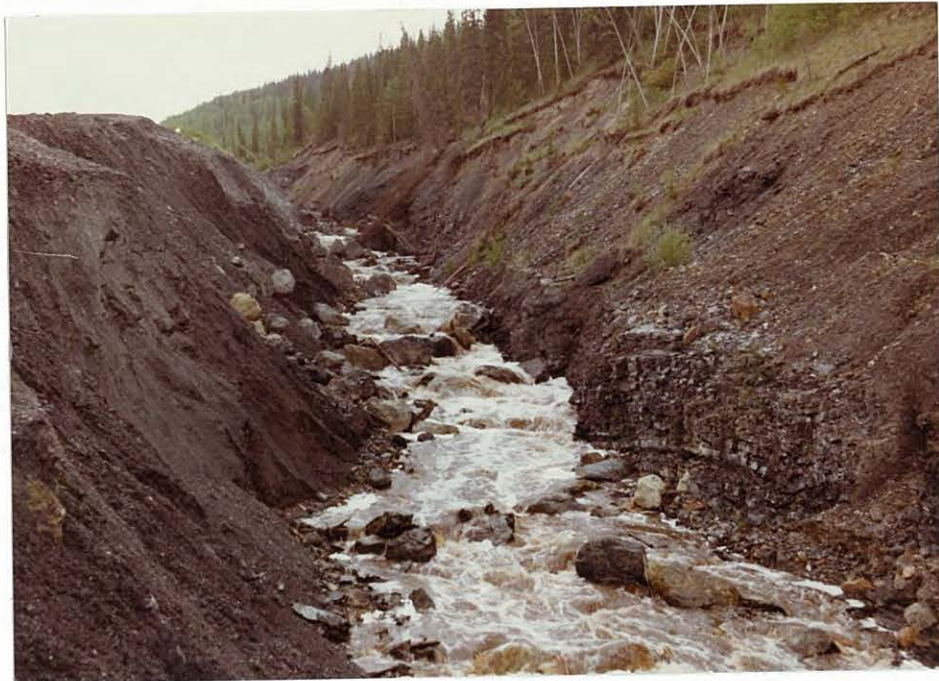
Photo 7: Downstream segment of Clinton Creek channel cut through waste dump and into the bedrock.

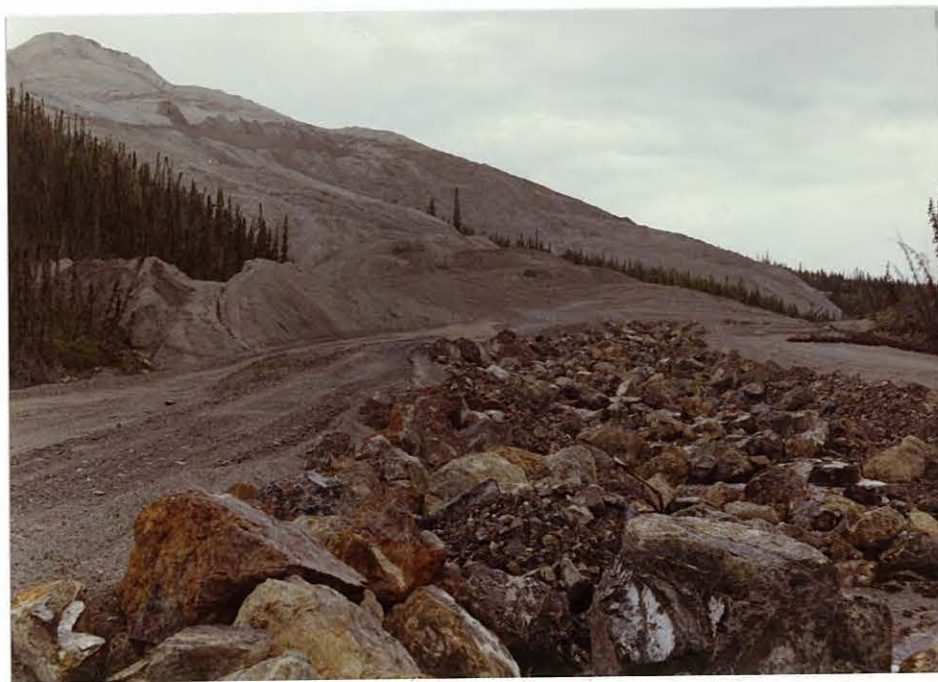
Photo 8: Wolverine Creek weir system and tailings pond.

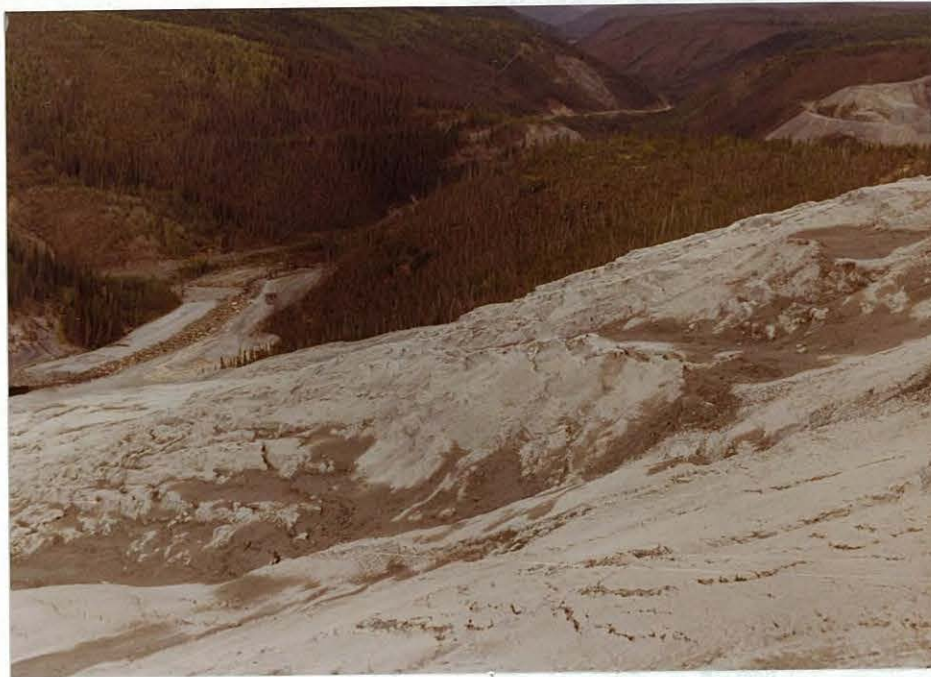
It appears that the north lobe experiences the greatest deformations. The differences and general configuration of the two key elements of the pile (i.e. the south and north lobes) is documented on Photos 9 and 10 which can be correlated with Photos 5 and 6 of our 1981 report. Visual observations indicate that the cracks, fissures and scarps became more pronounced during the last year. The cracking within the toe of the south lobe is more extensive. It is apparent that this area experiences spreading and heaving. The toe of the north slope continuous to override the natural terrain (Photo 16) and the toe itself has advanced further into the valley bottom.

Photo 9: Tailings pile, south lake. Photo taken from similar location as selected for Photo 5 of 1981 report.

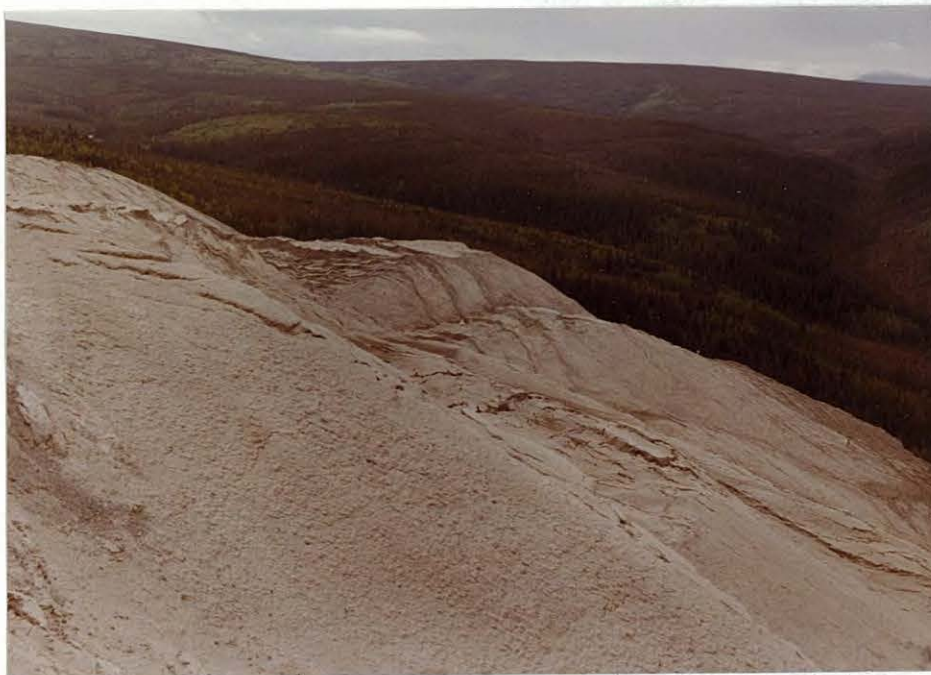
Photo 10: North lobe of the pile, photo comparable to No. 6 of 1981 report.

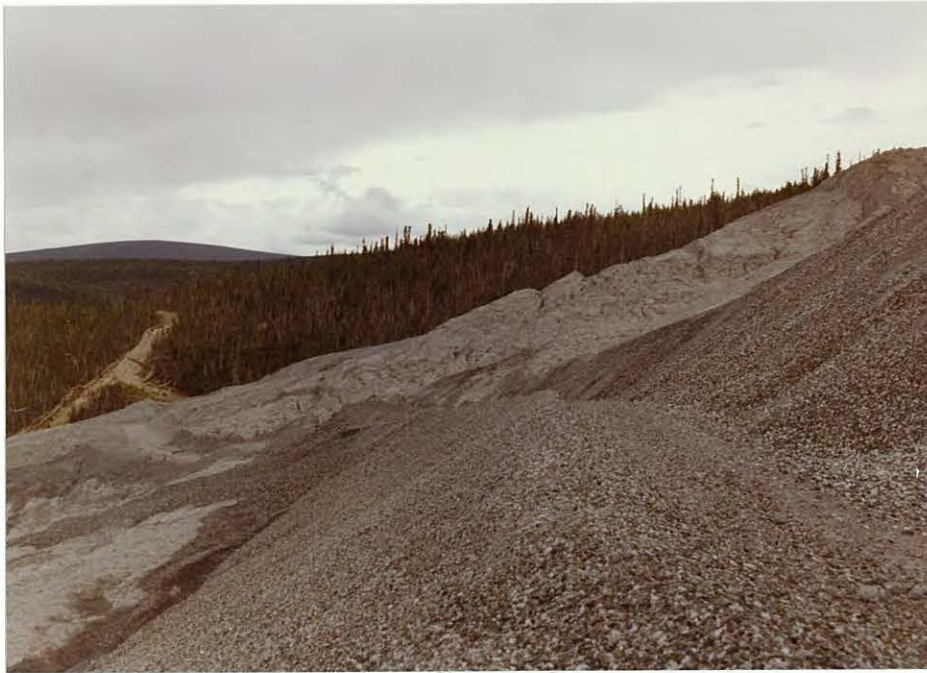
While monitoring data on the movement of the surface of the pile are not available the number of fresh cracks and scarps throughout the entire pile area is such that there is no doubt about a continuing and likely accelerating movement of main segments of the tailings pile (Photos 9 to 16 inclusive).

Photo 11: View of disturbances affecting the upper section of the south lobe.

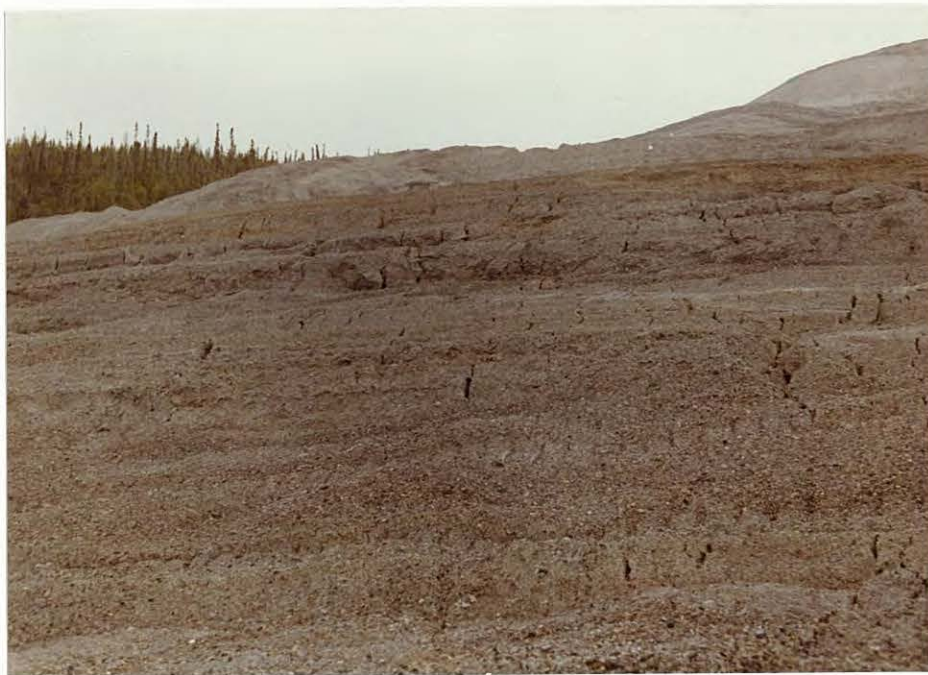
Photo 12: Extensive cracks within the toe area of the south lobe indicate bulging of toe material.

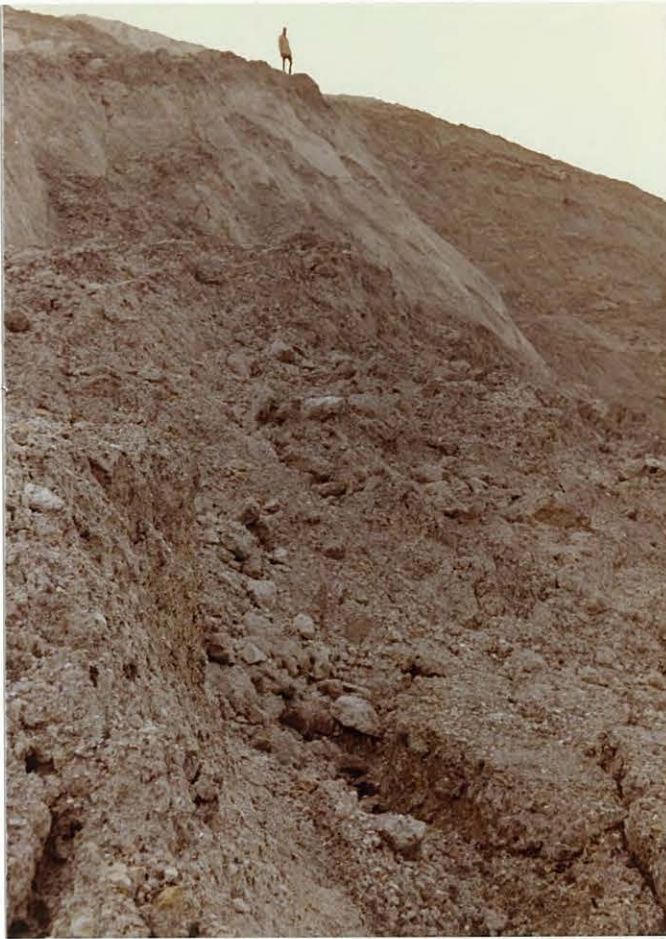
Photo 13: Uppermost section of the north lobe shows significant vertical displacement.

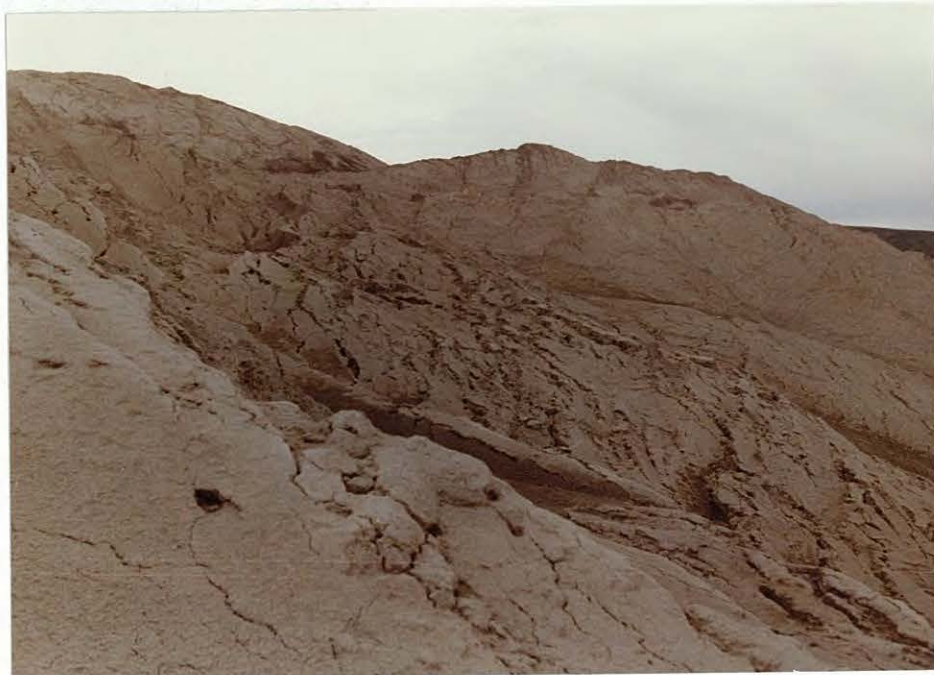
The north portion of the tailings pile within the headscarp area has been displaced to such an extent that its subgrade (comprising wet silty and sandy material) is exposed. It is apparent that the slip surface traverses through the pile foundation.

Photo 14: General view of the headscarp of the north slide lobe.

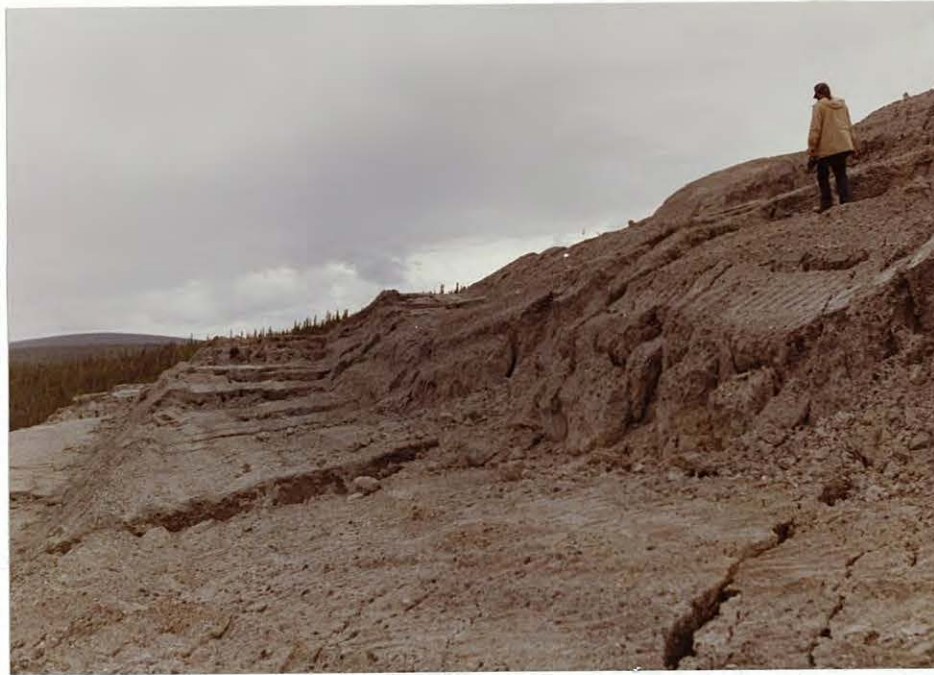
Photo 15: Destroyed terraces in the middle portion of the north lobe.

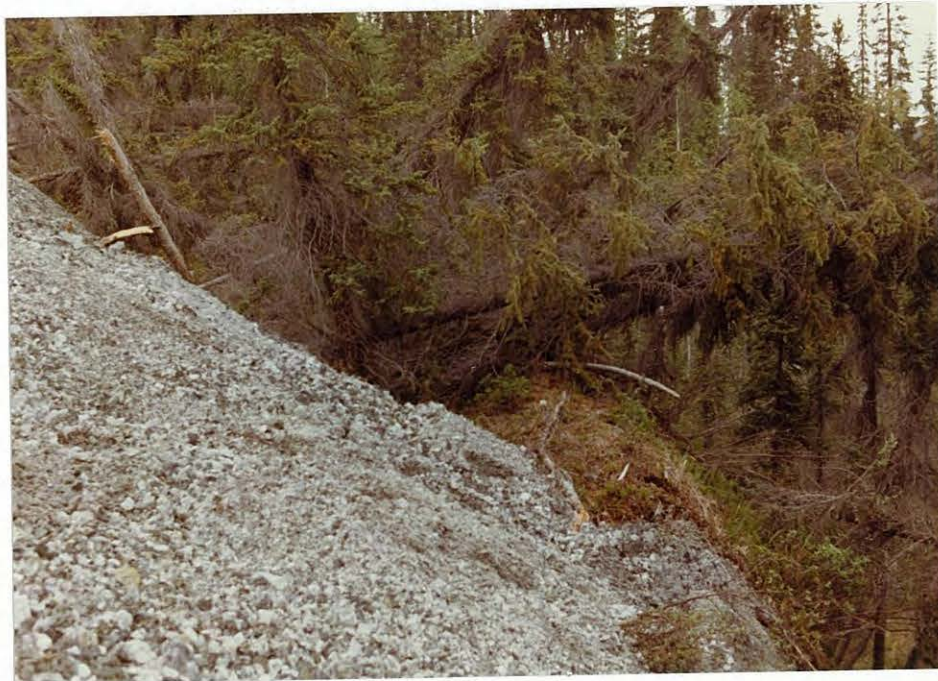
Photo 16: Toe of the north lobe bulldozing vegetation and soil cover.

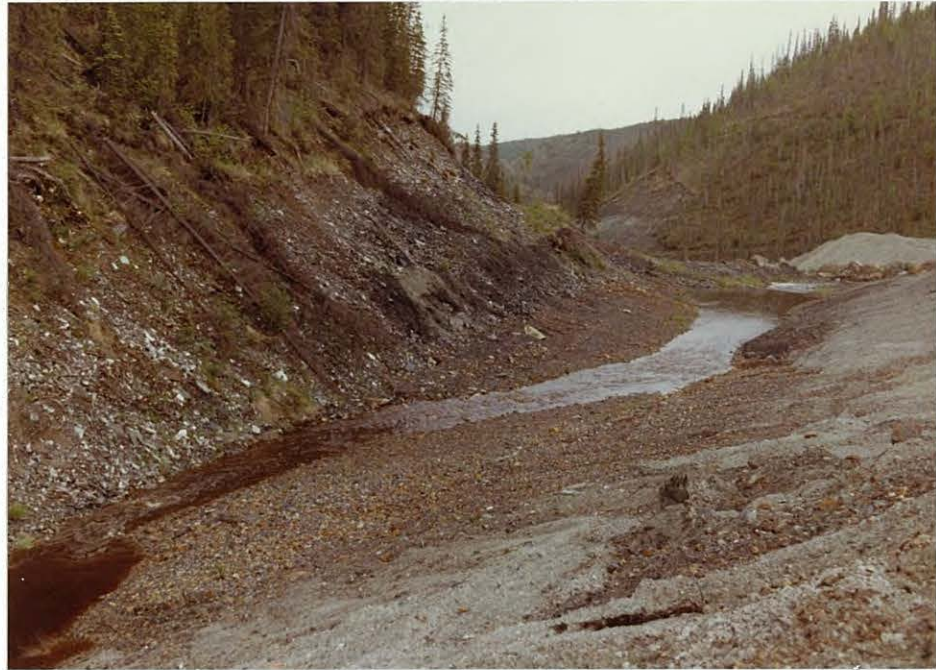
Visual inspection of the Wolverine Creek spillway system show that most of the weirs are in a good state of repair and that they are performing satisfactorily. In addition, several downstream weirs have been repaired and a rock apron placed below the lowermost weir.

Photo 17: Wolverine Creek upstream of weir spillway.

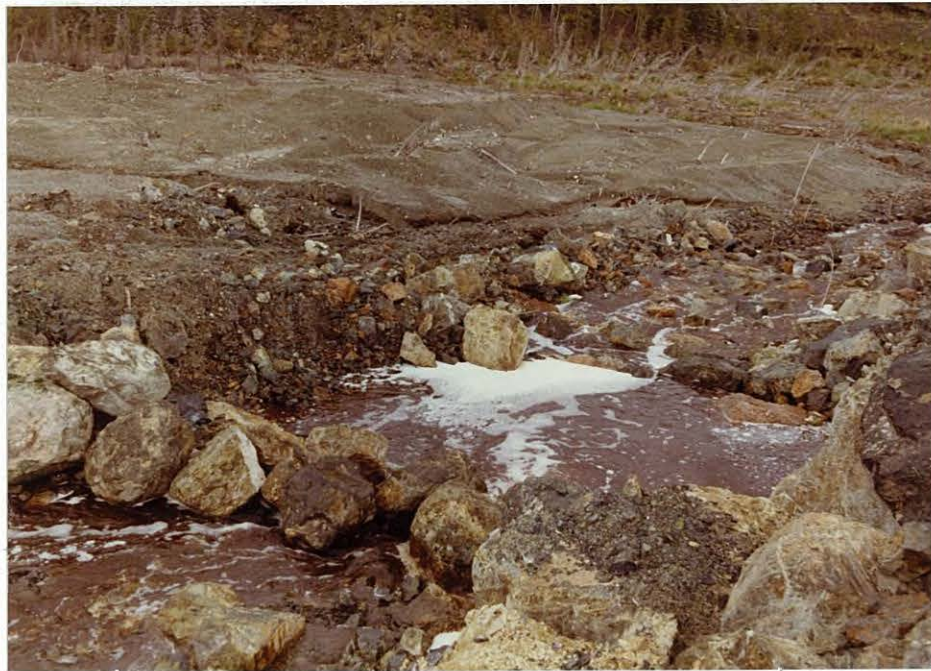
Photo 18: Reconstructed bottom weirs and rock apron below the weir floodway.
