Clinton Creek Waste Dump

### Inspection of the Clinton Creek Valley

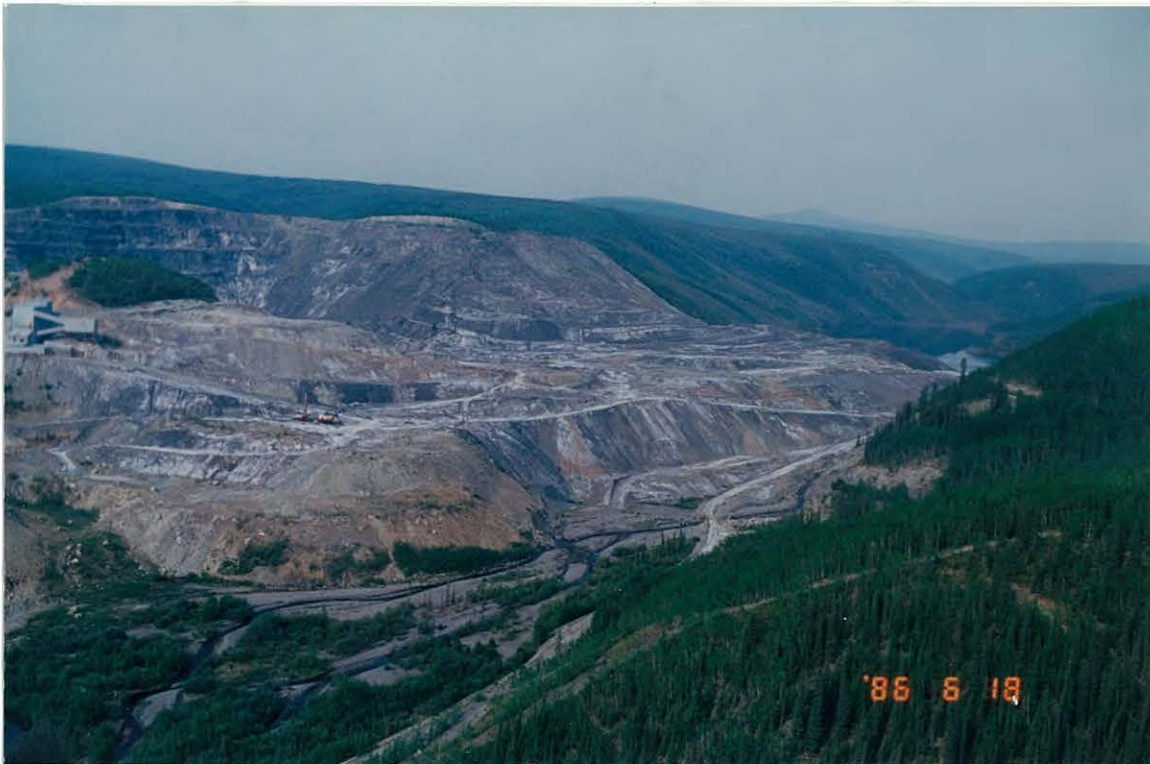
Most of the waste dump (Photo 1) is unstable and the rate of movement towards the creek channel appears to be in the same order of magnitude as previously determined by monitoring, i.e. 30 to 50 cm per year.

Photo 1: Clinton Creek valley, looking west.

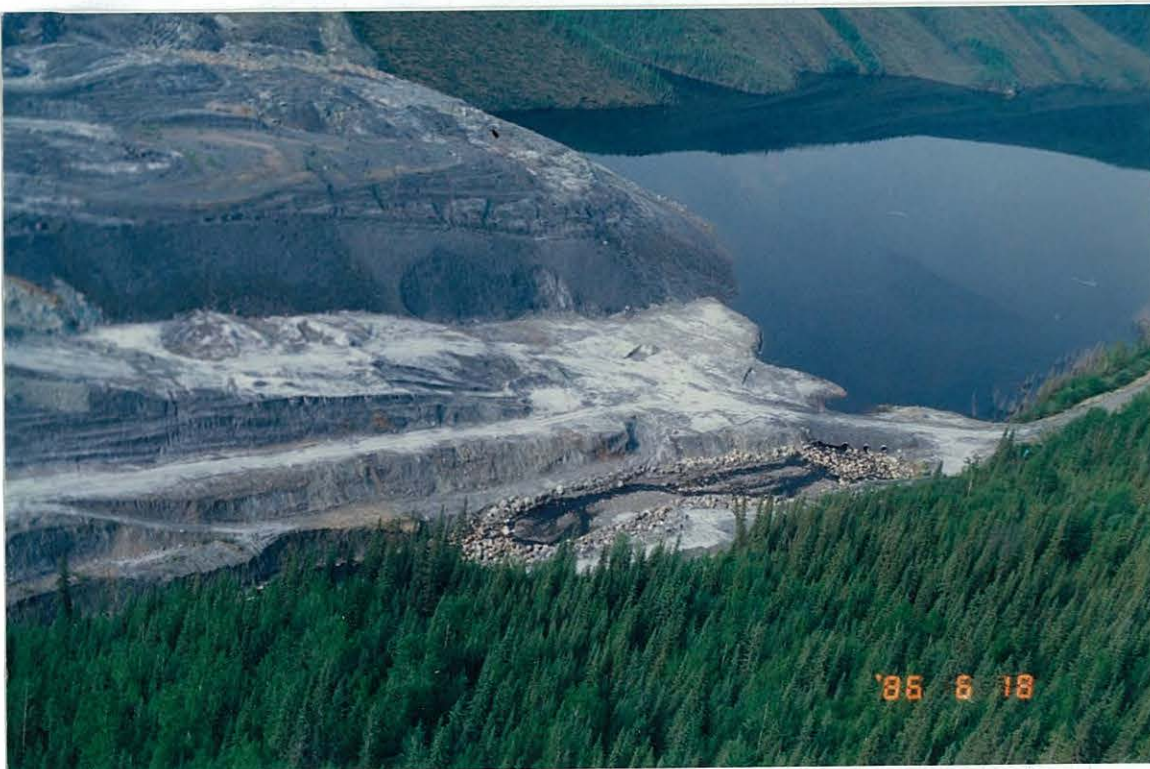
The aerial reconnaissance indicates that the dump segment descending towards the lake (Photos 2 and 3) is the most unstable and deformations (indicating movements) are clearly visible. Scarps and cracks in the lake facing portions of the dump are bigger and more prominent than those delineating movement towards the creek. The waste dump segment forming the south bank of the creek channel exhibits oversteepened slopes and freshly failed (scalloped) escarpments (Photo 4). The road paralleling the stream exhibits an uneven surface.

Photo 2: Upstream face of the dump and outfall from the lake.

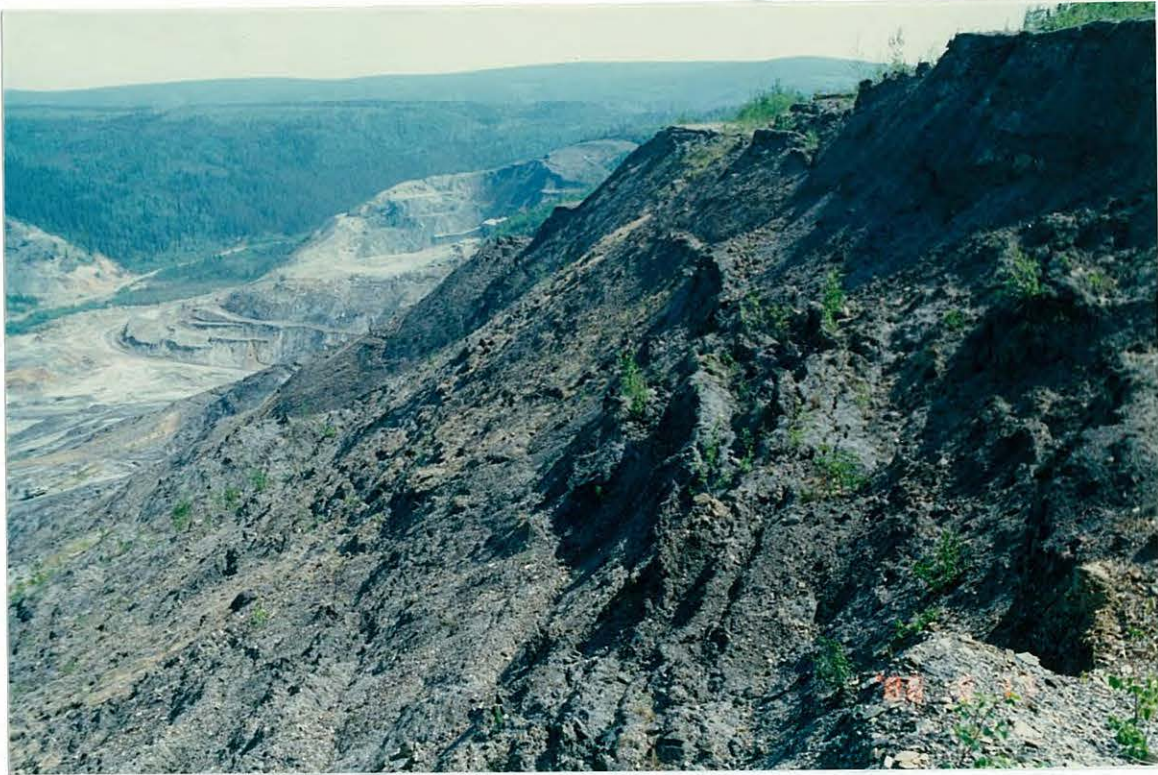
Photo 3: Fresh cracks in the headscarp of the waste dump confirm recent movements.

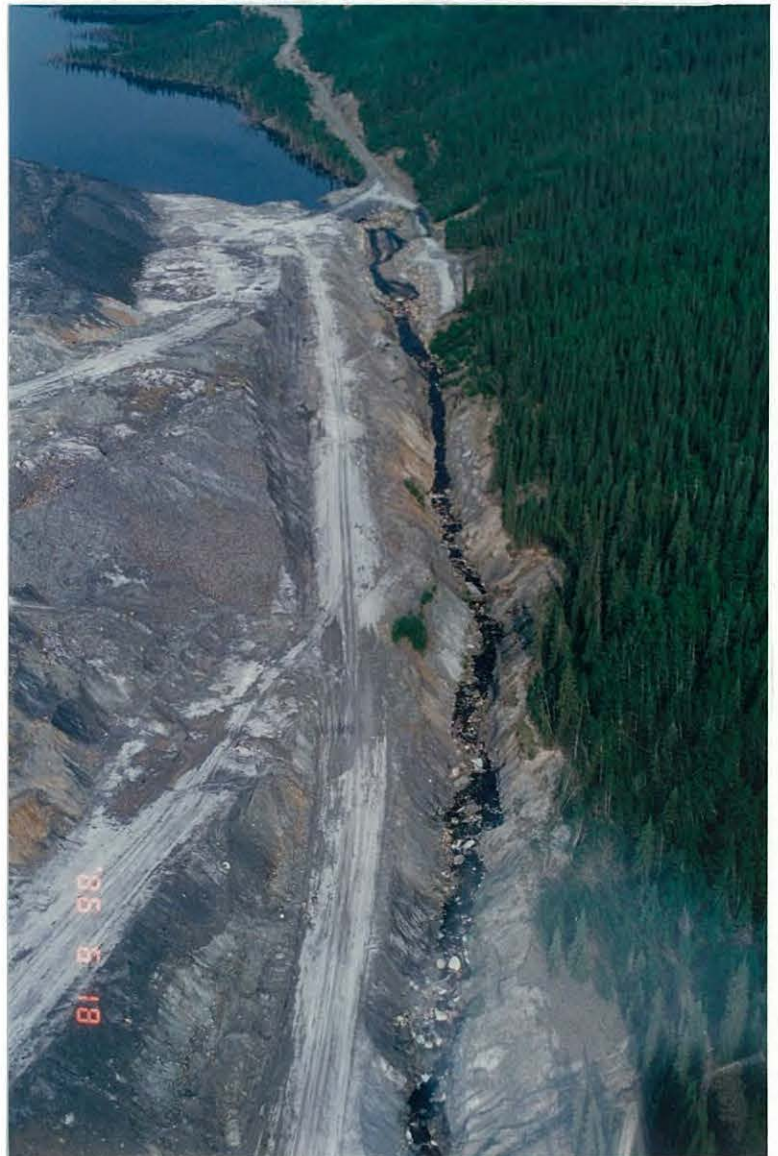
Photo 4: Clinton Creek channel cut into the north valley wall and eroding the waste dump toe.

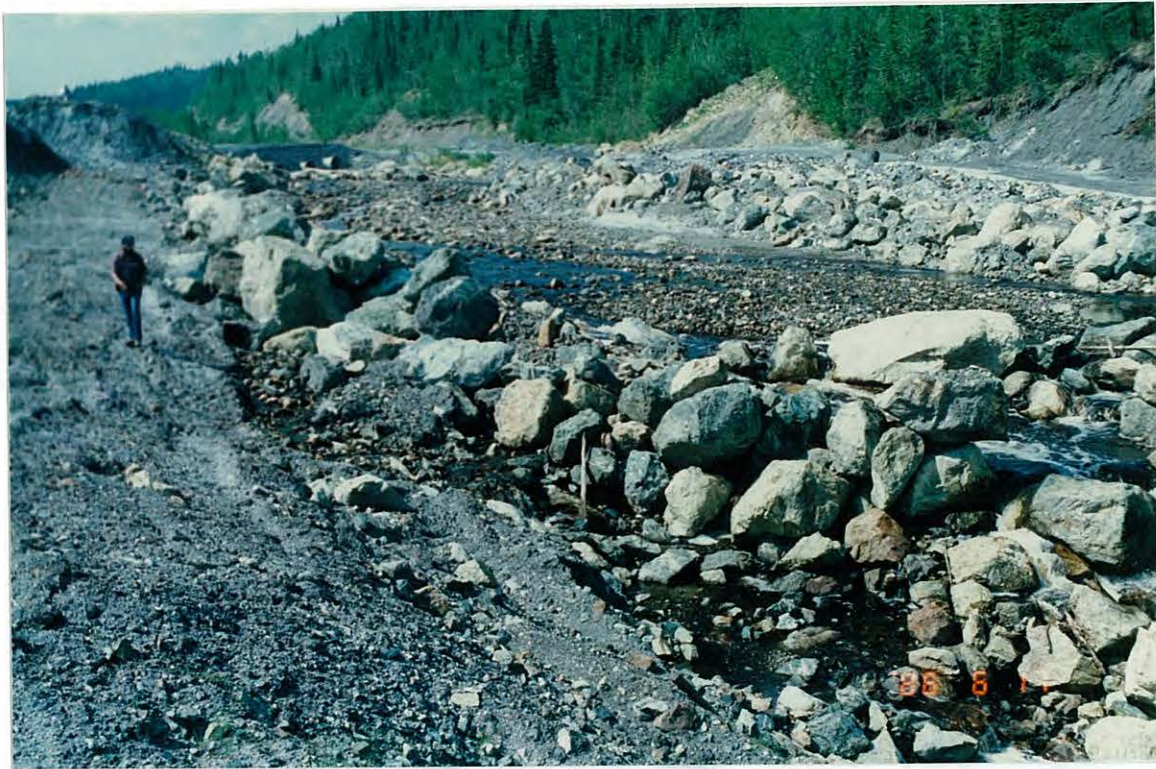
The channel weir, constructed in 1984, is gradually eroding and flow is cutting a new channel on the south side of the stream (Photo 5).

Photo 5: Rock weir constructed in 1984 shows deterioration and erosion along the south bank.

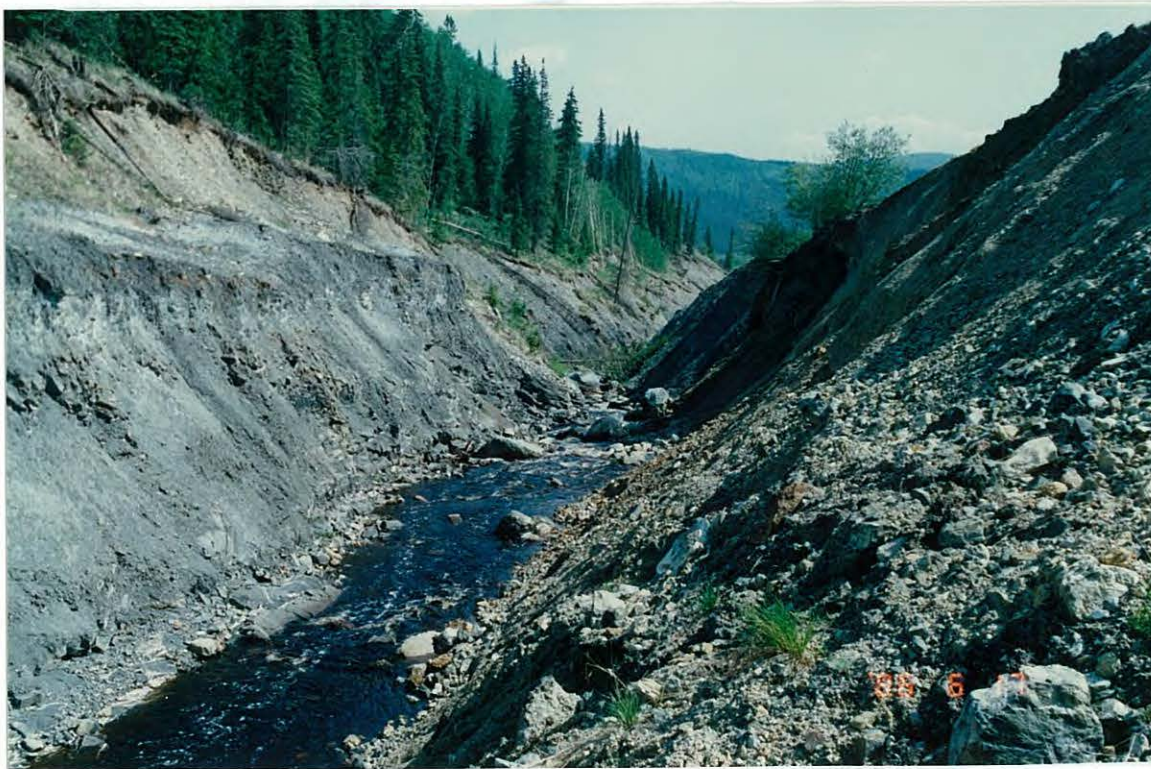
The creek channel (Photo 6) within the downstream dump segment appears to be somewhat narrower than during previous visits. There are several "steps" in the bottom of the channel, formed by large boulders. The retrogressive erosion, previously affecting primarily the creek segment within the downstream portion of the waste dump toe, has progressed further upstream, resulting in undercutting of the north, bedrock controlled, slope.

Photo 6: Oversteepened channel banks.

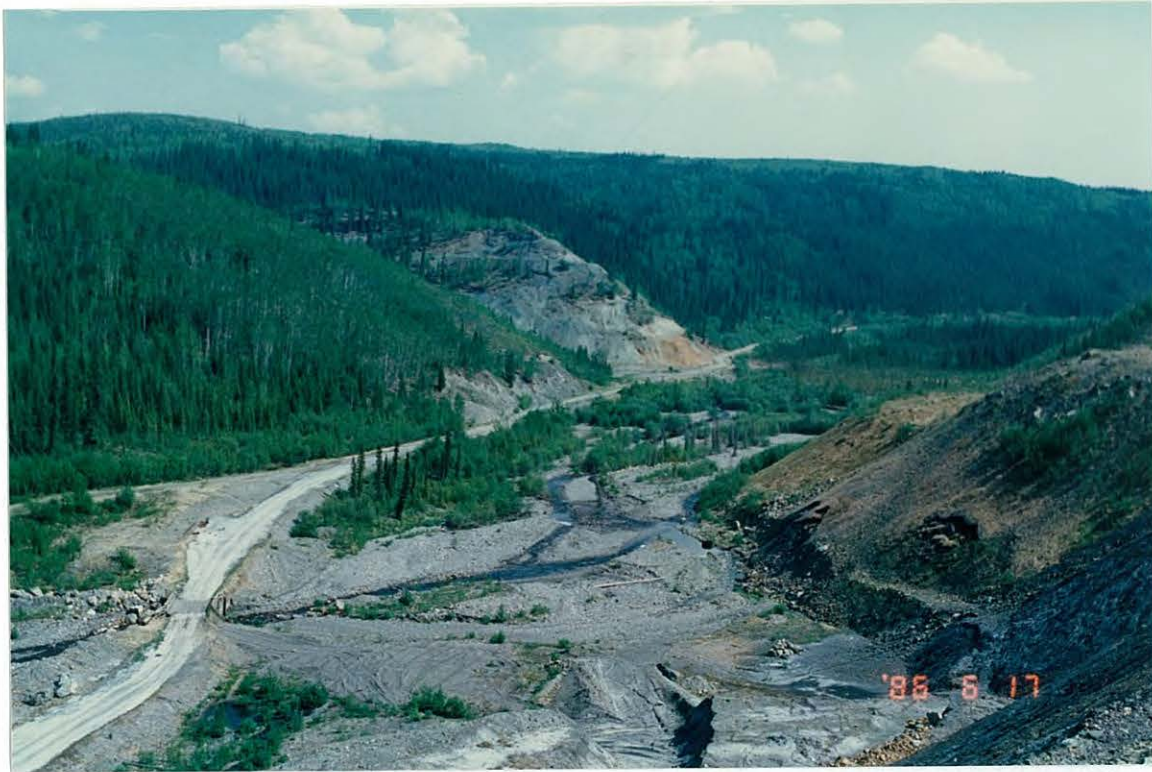
Deposition of eroded and transported material is evident in the area of the Wolverine Creek - Clinton Creek junction (Photo 7).

Photo 7: Deposition of eroded material downstream of the dump. Note braided channel.

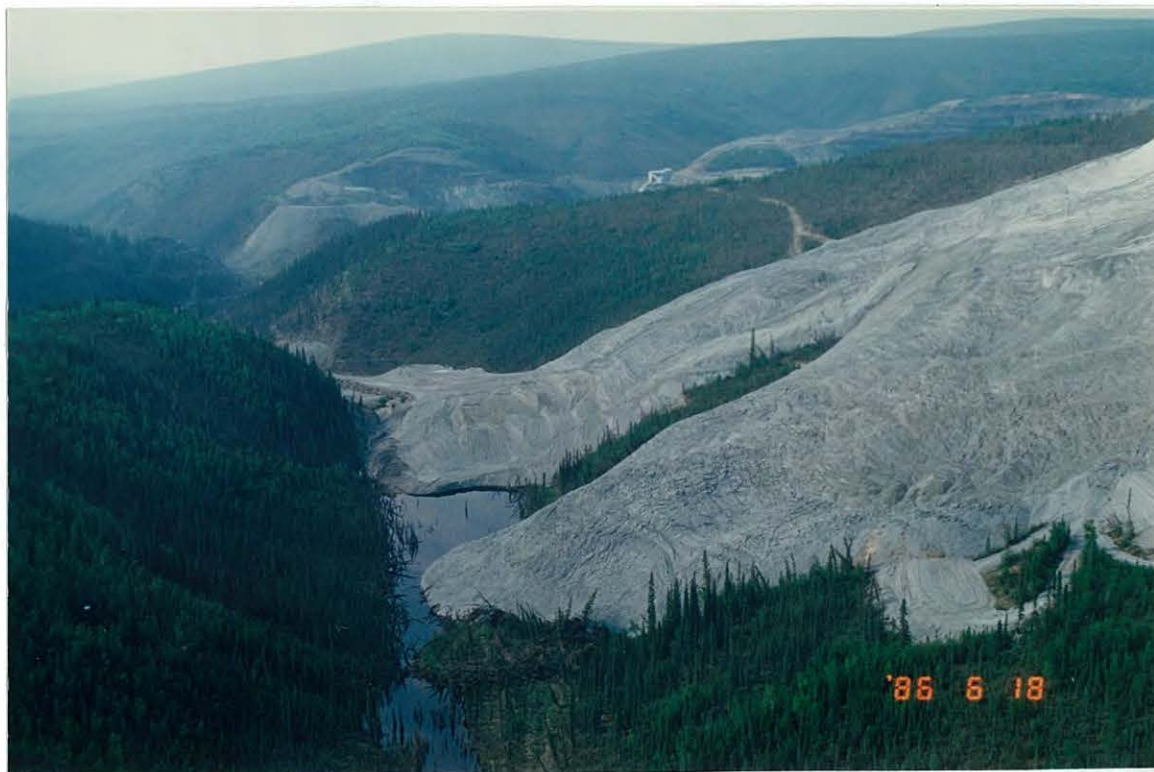
The north tailings lobe has reached the valley bottom (Photo 8) and is assuming a similar configuration to that of the south lobe. The toe of the dump rests against the east valley slope and the material is piling up. It will eventually block the valley, likely forming a new lake or modifying the existing one.

Photo 8: Tailings piles, looking south.

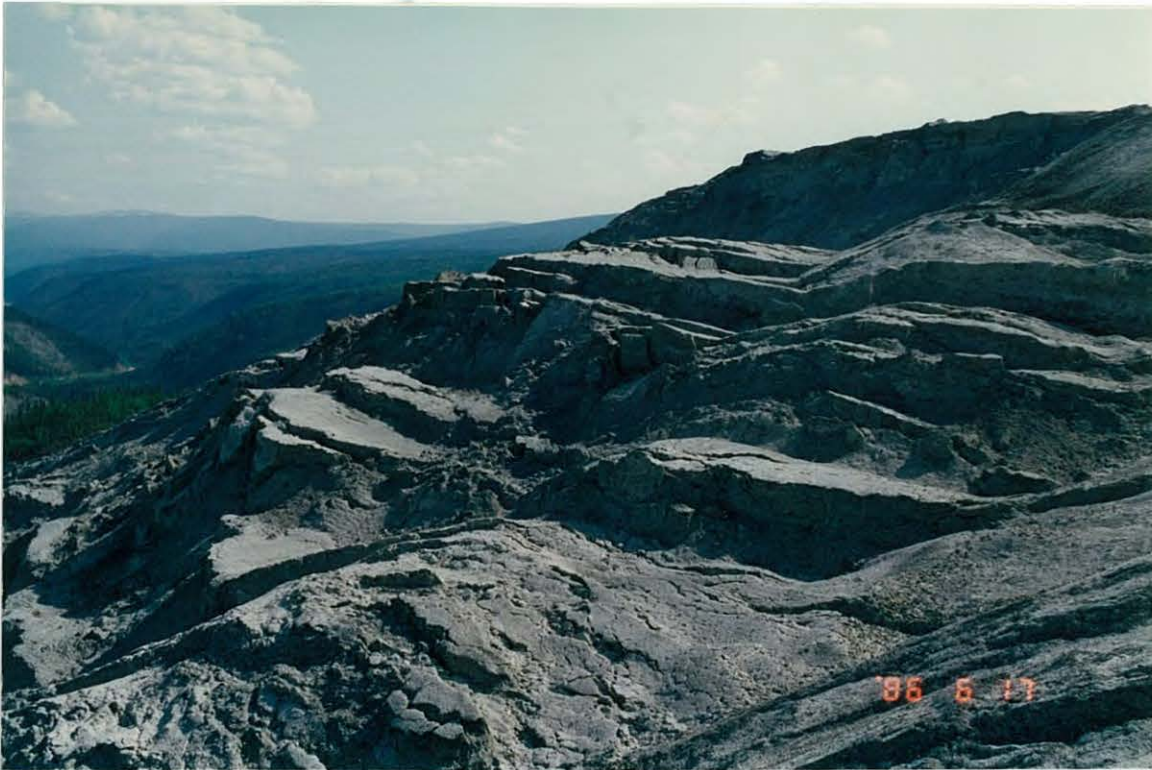
Maximum movements of the north lobe are apparently of the same order of magnitude as during previous years. Some decrease in the rate of movement will occur due to the support provided to the toe of the north lobe since it reached the valley bottom. The dump surface is highly distorted (Photo 9). Headscarp positions show that the movement is in the direction of the original slope fall lines, i.e. not only into the Wolverine Creek Valley, but also in the northerly and westerly directions. It is of interest to note that sliding occurs also towards the mill site, located on a relatively flat ground.

Photo 9: Scarps within the upper portion of north lobe.

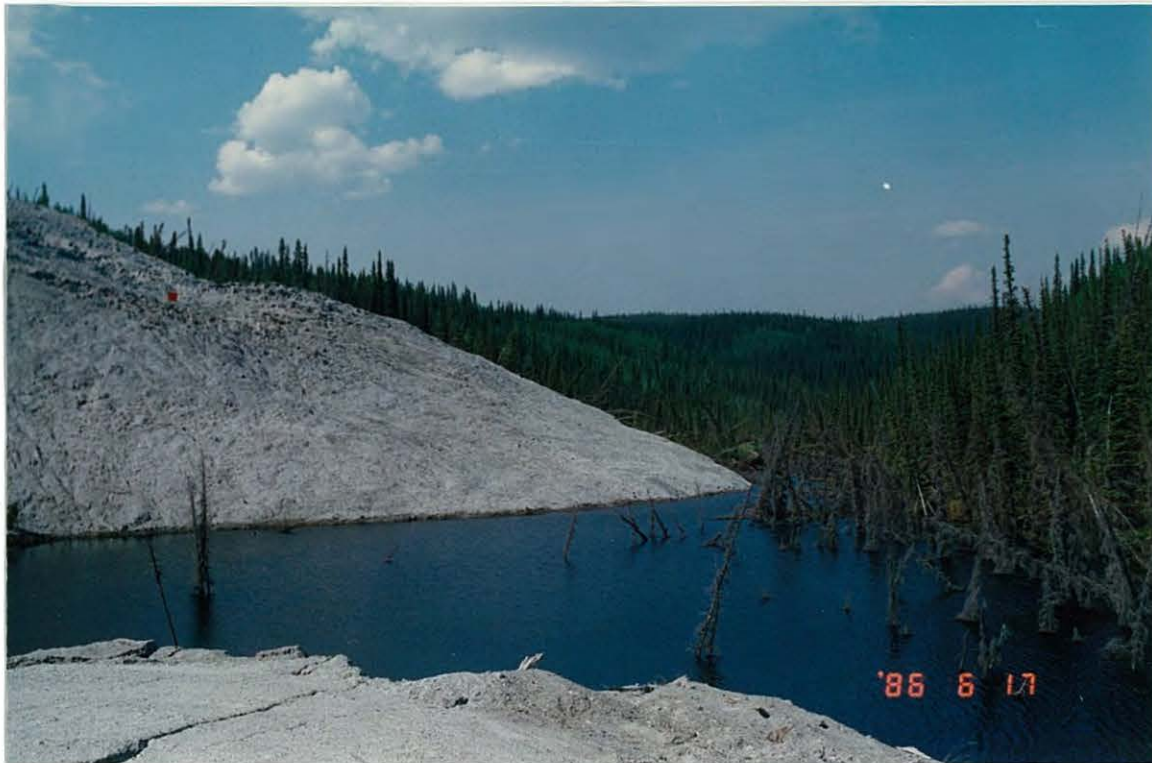
Photo 10: Toe of the north lobe resting against the east valley wall.

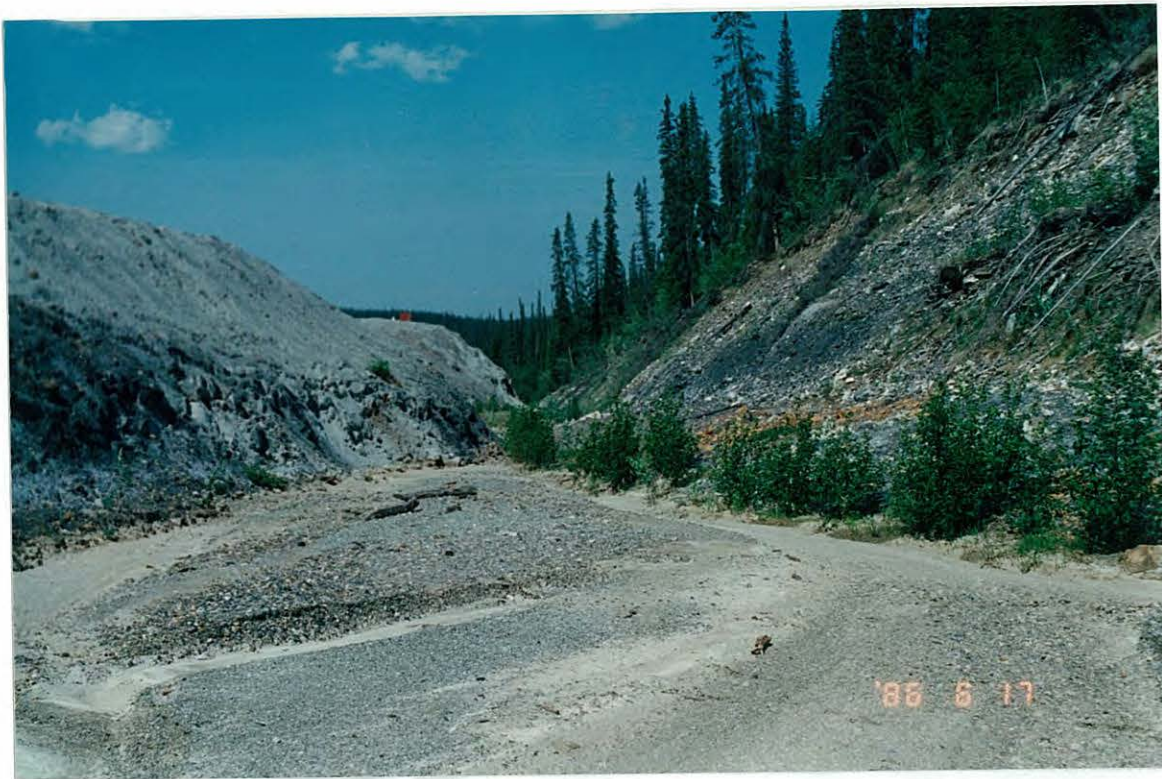
The south tailings lobe has deformed considerably since the 1984 site visit. Major deformations (and probably the highest rates of movement) exist in the lower portions of the dump. However, significant deformations exist at upper dump segments as well. The creek channel is practically blocked (Photo 11) by advancing the toe of the pile. Some flow occurs underground and is discharged at the bottom and east of the rock lined outfall channel. The channel, for its major length, is dry.

Photo 11: Wolverine Creek channel blocked by the southern lobe of the tailings pile.

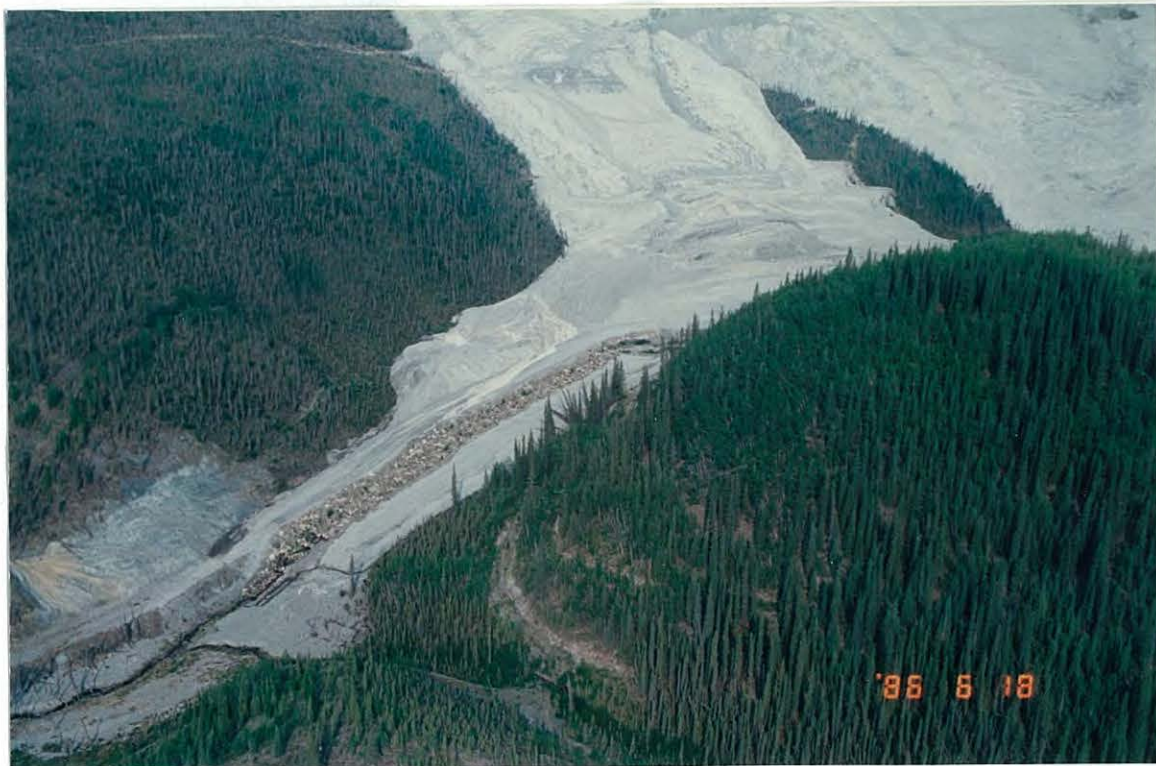
Photo 12: Rock lined outfall channel is dry. A new channel is developing along the east side of the valley fill.

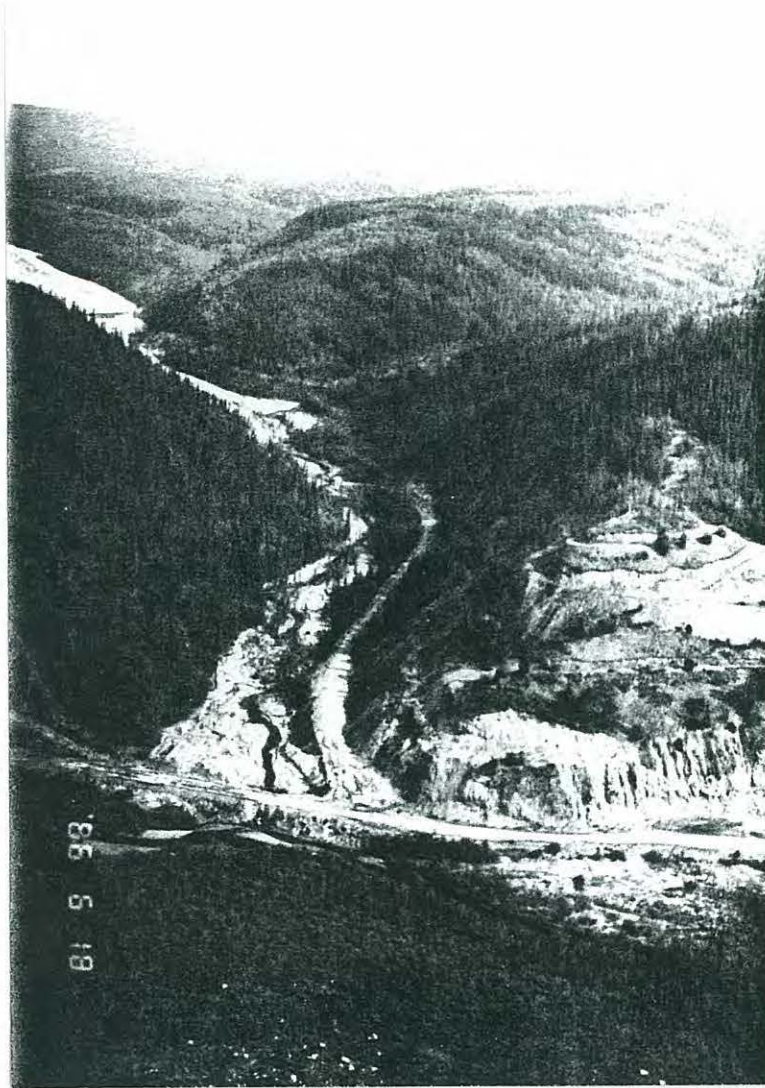
The Wolverine Creek Valley bottom up to its confluence with Clinton Creek has been covered with tailings (Photo 13) and the creek is currently downcutting through the sediment.

Photo 13: Tailings deposits cover the bottom of the Wolverine Creek valley upstream from its junction with the Clinton Creek.

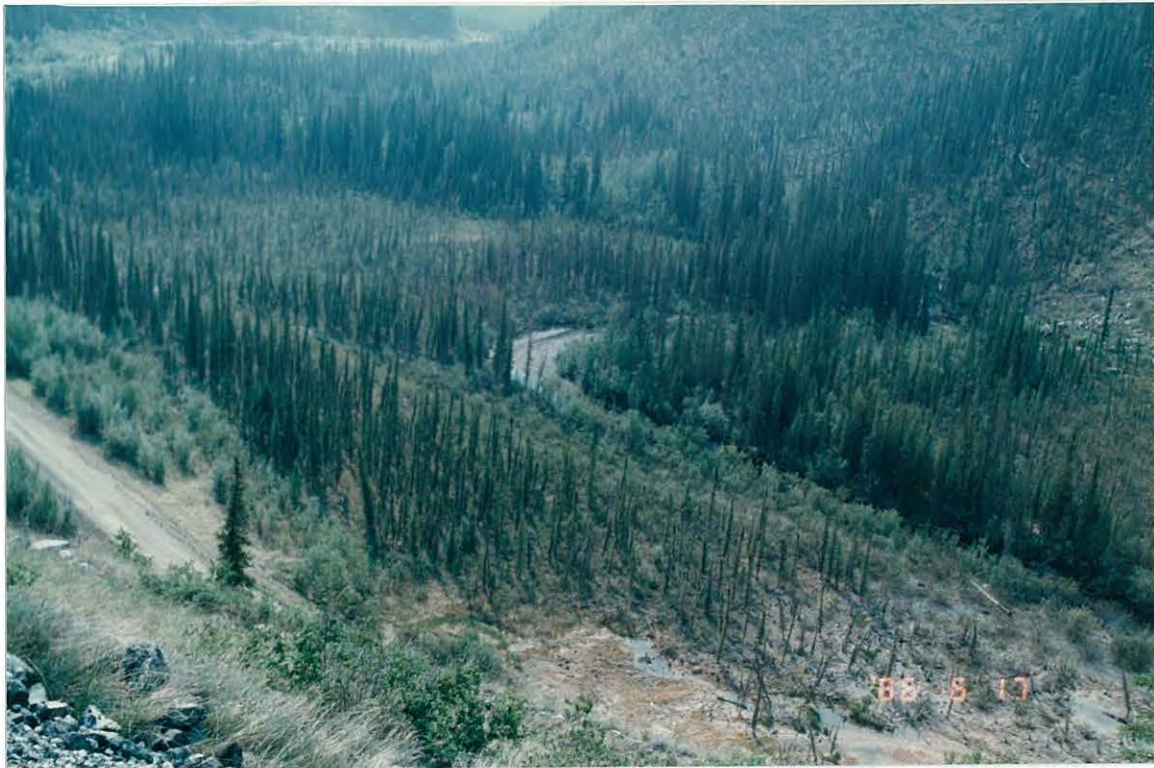
Extensive deposits of asbestos fibres and sand-sized tailings are encountered in the area located 0.5 km downstream from the creeks' confluence (Photos 14 and 15). The tailings deposits are several centimetres to 50 cm thick. The fibres on trees are approximately 2 to 3 m above the creek channel, indicating an unprecedented flood.

Photo 14: Clinton Creek valley, approximately 500 m downstream from the Wolverine Creek confluence. Note deposits covering the terrain between meanders.

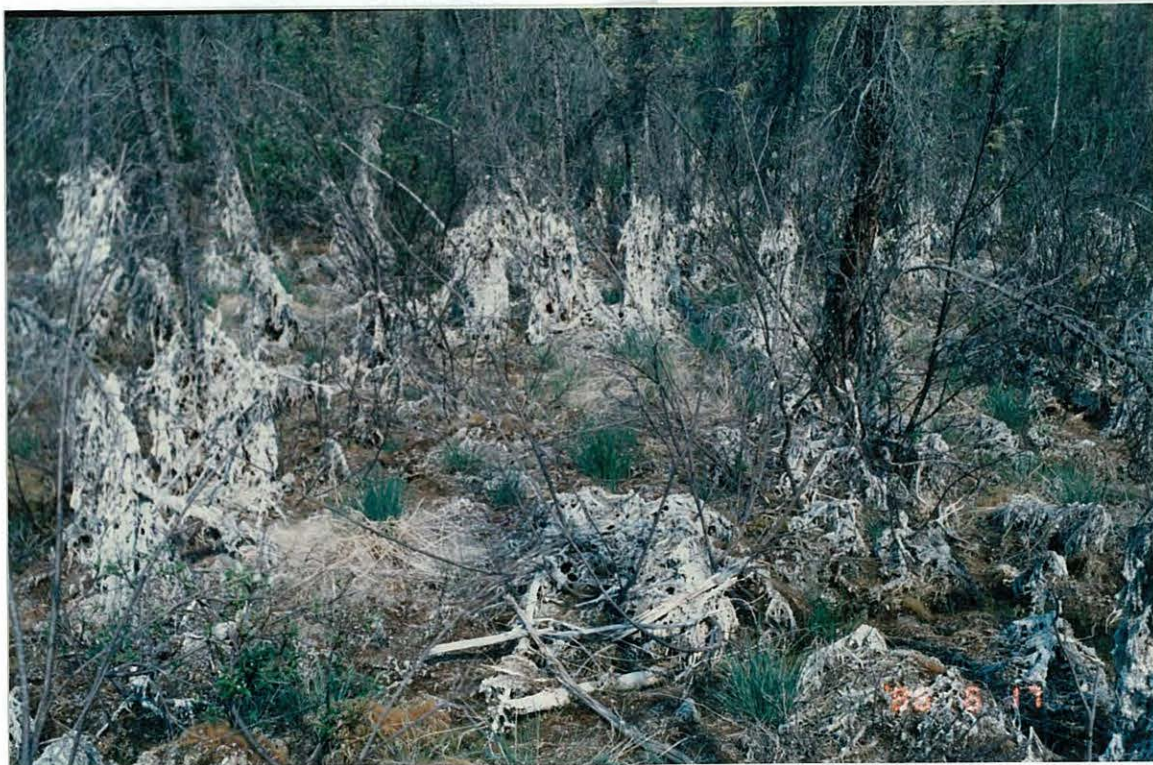
Photo 15: The same area, detailed view of asbestos fibre on trees.

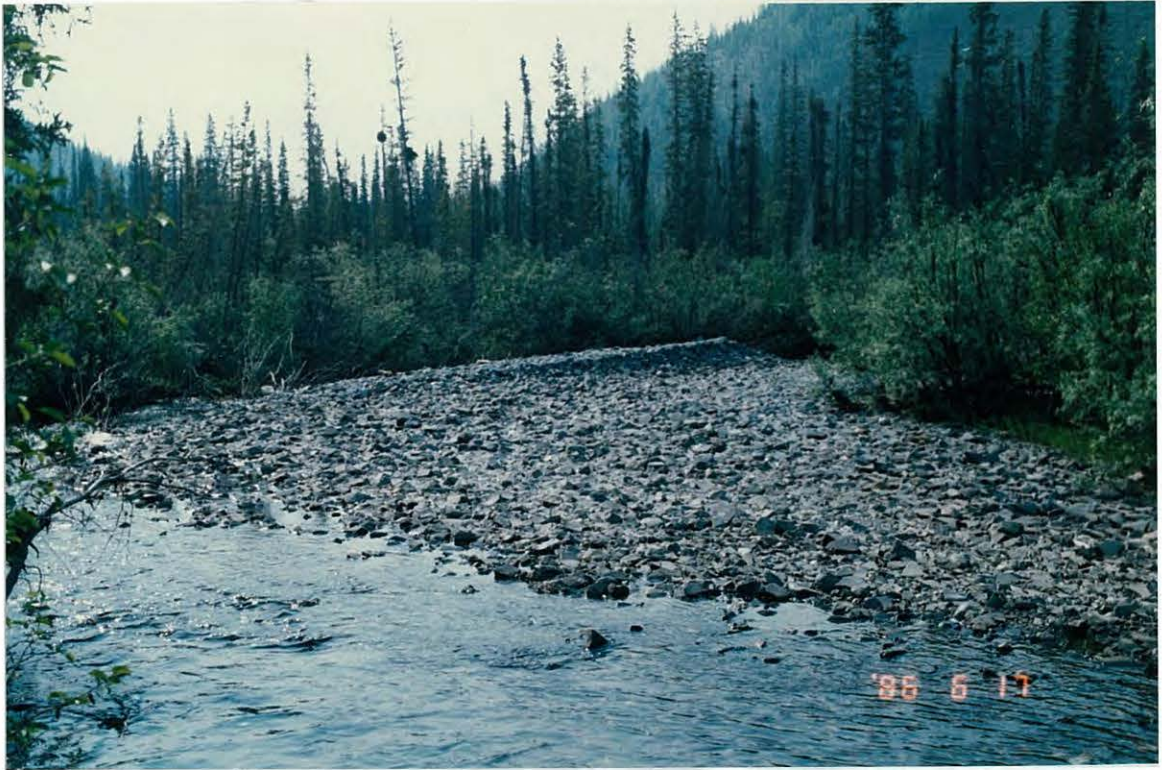
Formation of a gravel bar (Photo 16) and cutting of a new channel at this location indicates the impact of the additional bed load. The old channel is abandoned in favour of the new one located behind the gravel bar.

Photo 16: Clinton Creek, approximately 600 m downstream from the Wolverine Creek junction, changing its channel because of gravel bar.

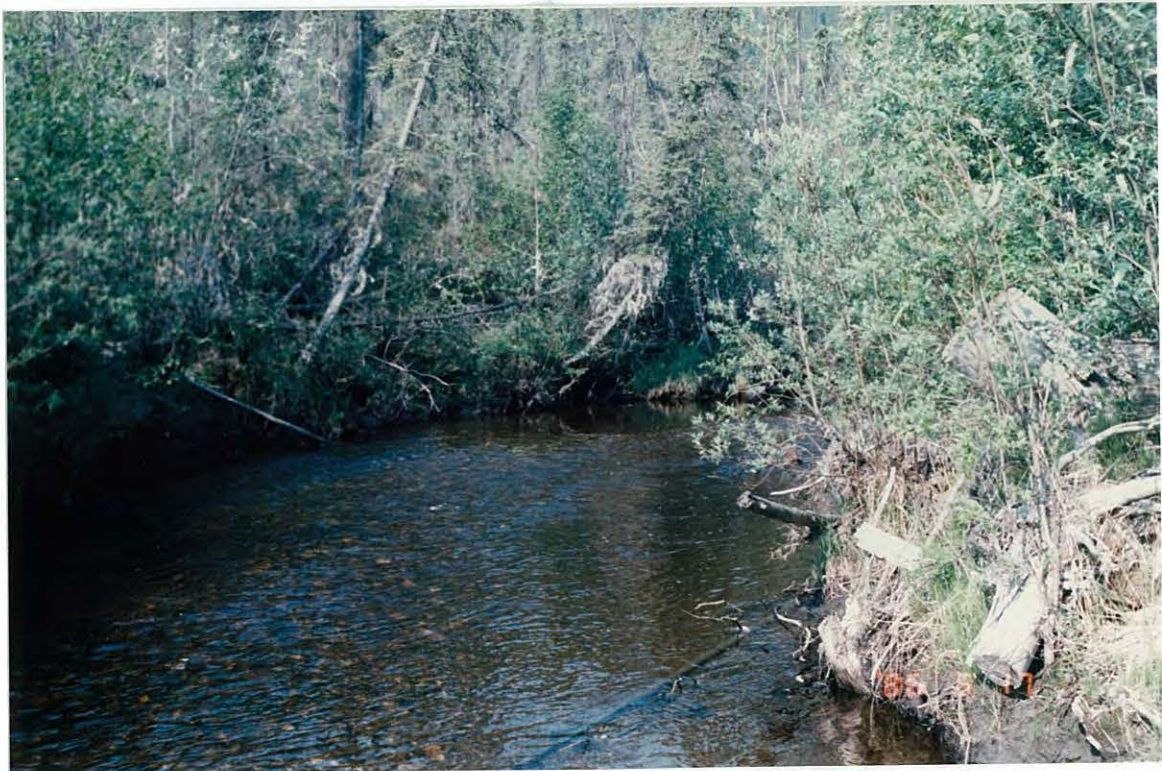
At locations depicted on Photos 17 and 18, the fibres mark the high flood elevation, which is about 2.0 m above the creek level.

Photo 17: Location some 1.2 km downstream from the Clinton and Wolverine Creeks' confluence.

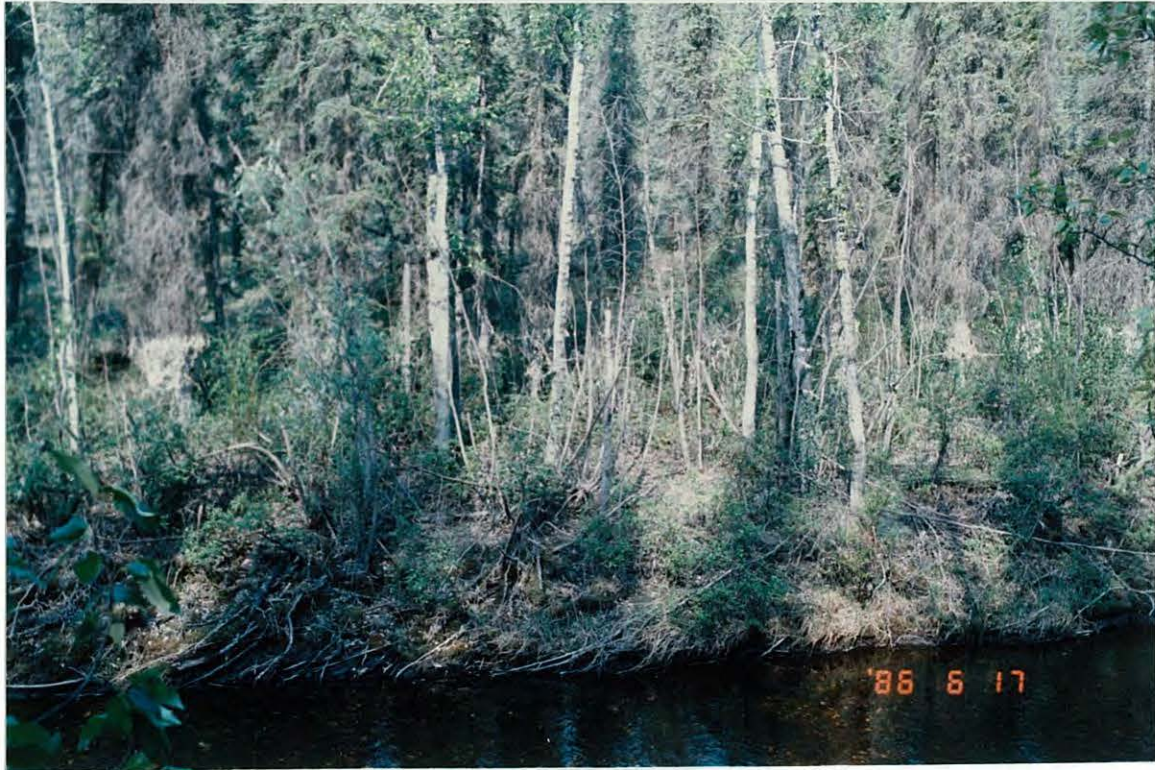
Photo 18: Clinton Creek, approximately 2 km downstream of the Wolverine Creek confluence. Asbestos fibre is some 3.5 m high above the current flow level (approximately 2.0 m above the floodplain elevation).
