CLINTON CREEK ASBESTOS MINE
Report
on
1987 Site Inspection

Prepared For:
NORTHERN AFFAIRS PROGRAM
Whitehorse, Y.T.

July, 1987
G052

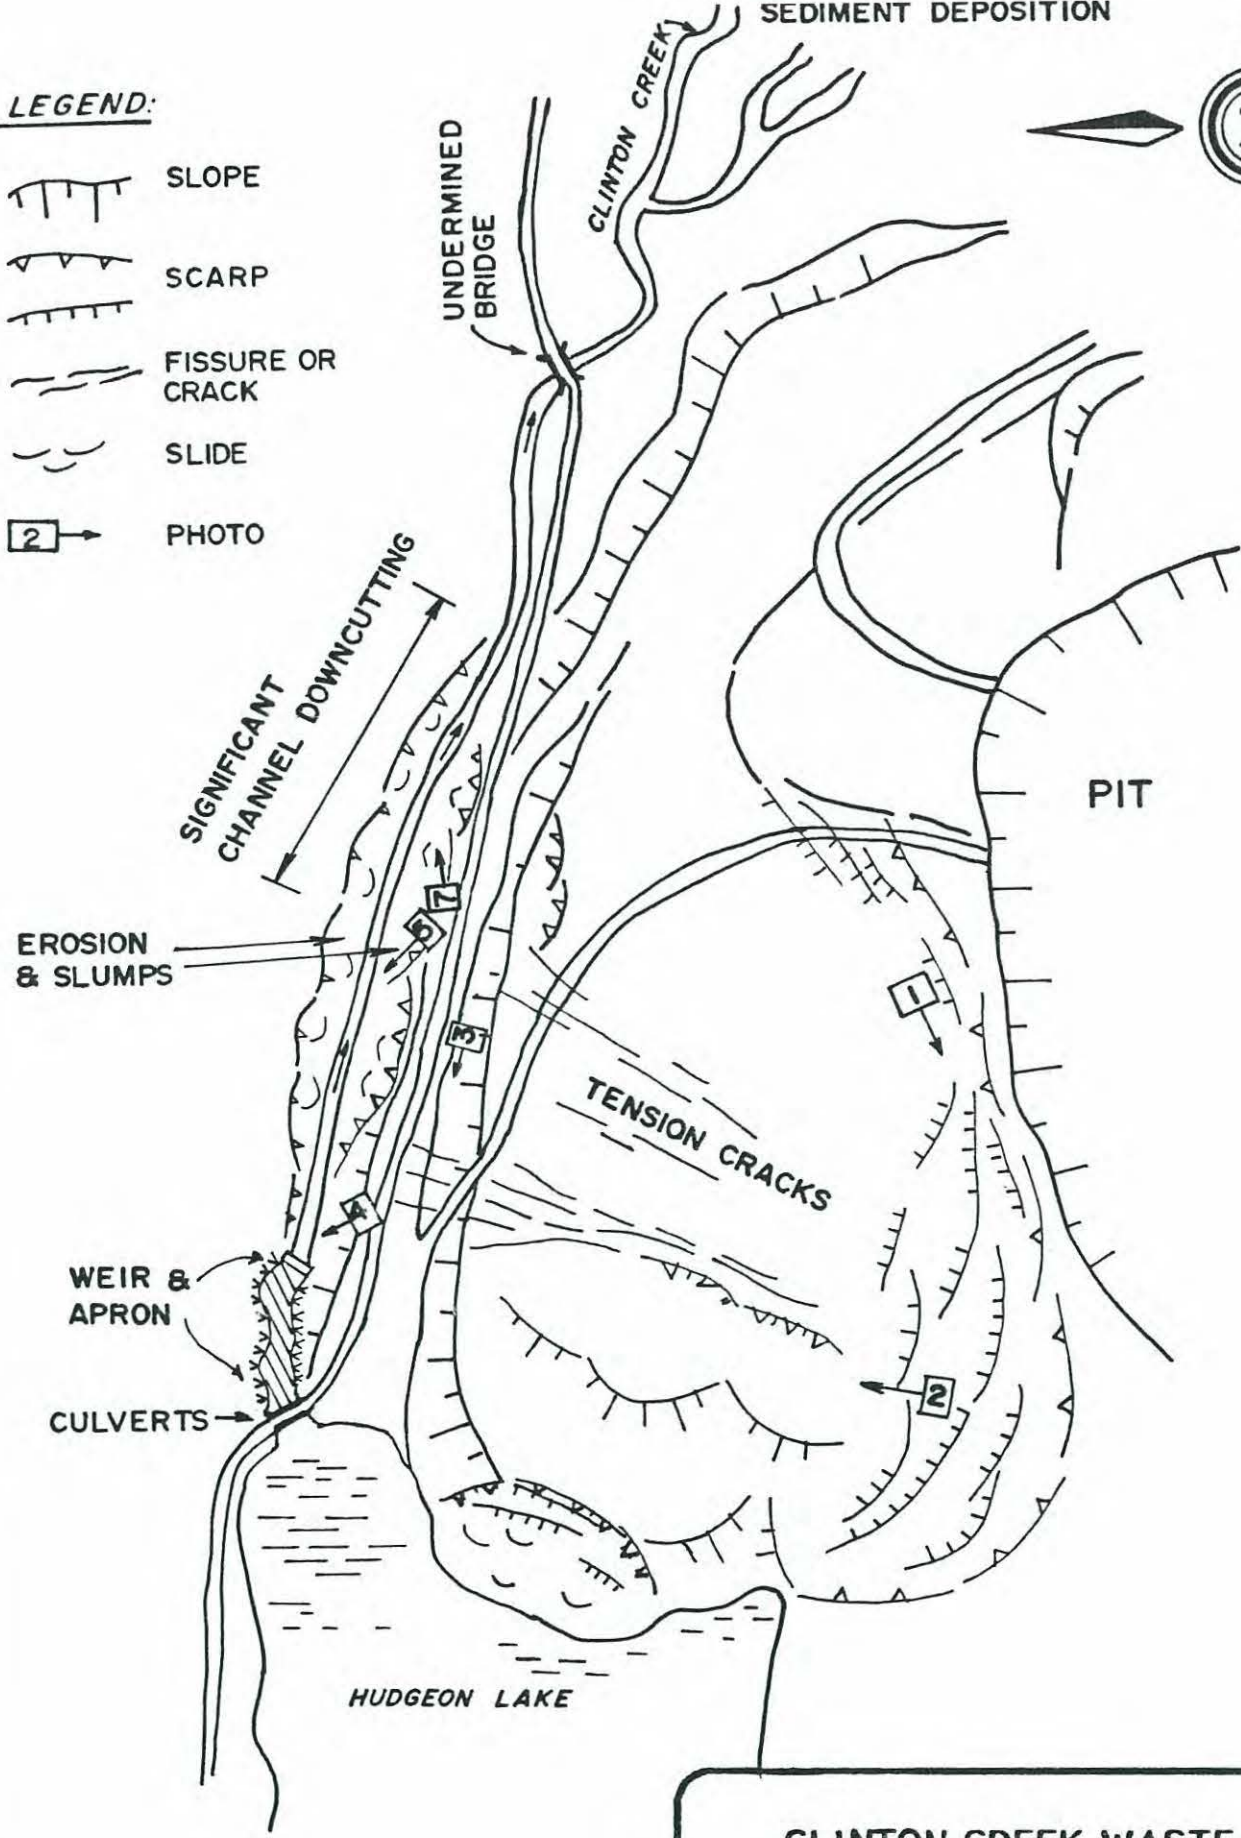
FIGURE 1.

Review of the current slide features (Figure 1) indicates that:

- a) the uppermost dump area is moving into the valley,
- b) the centre segment of the waste dump is either stationary or bulging,
- c) the toe of the dump is moving into available open space, i.e. into the lake, creek channel and towards the downstream flat area,
- d) major movement occurs towards the lake, and
- e) the dump movement into the creek channel appears to be presently in balance with the lateral erosion.

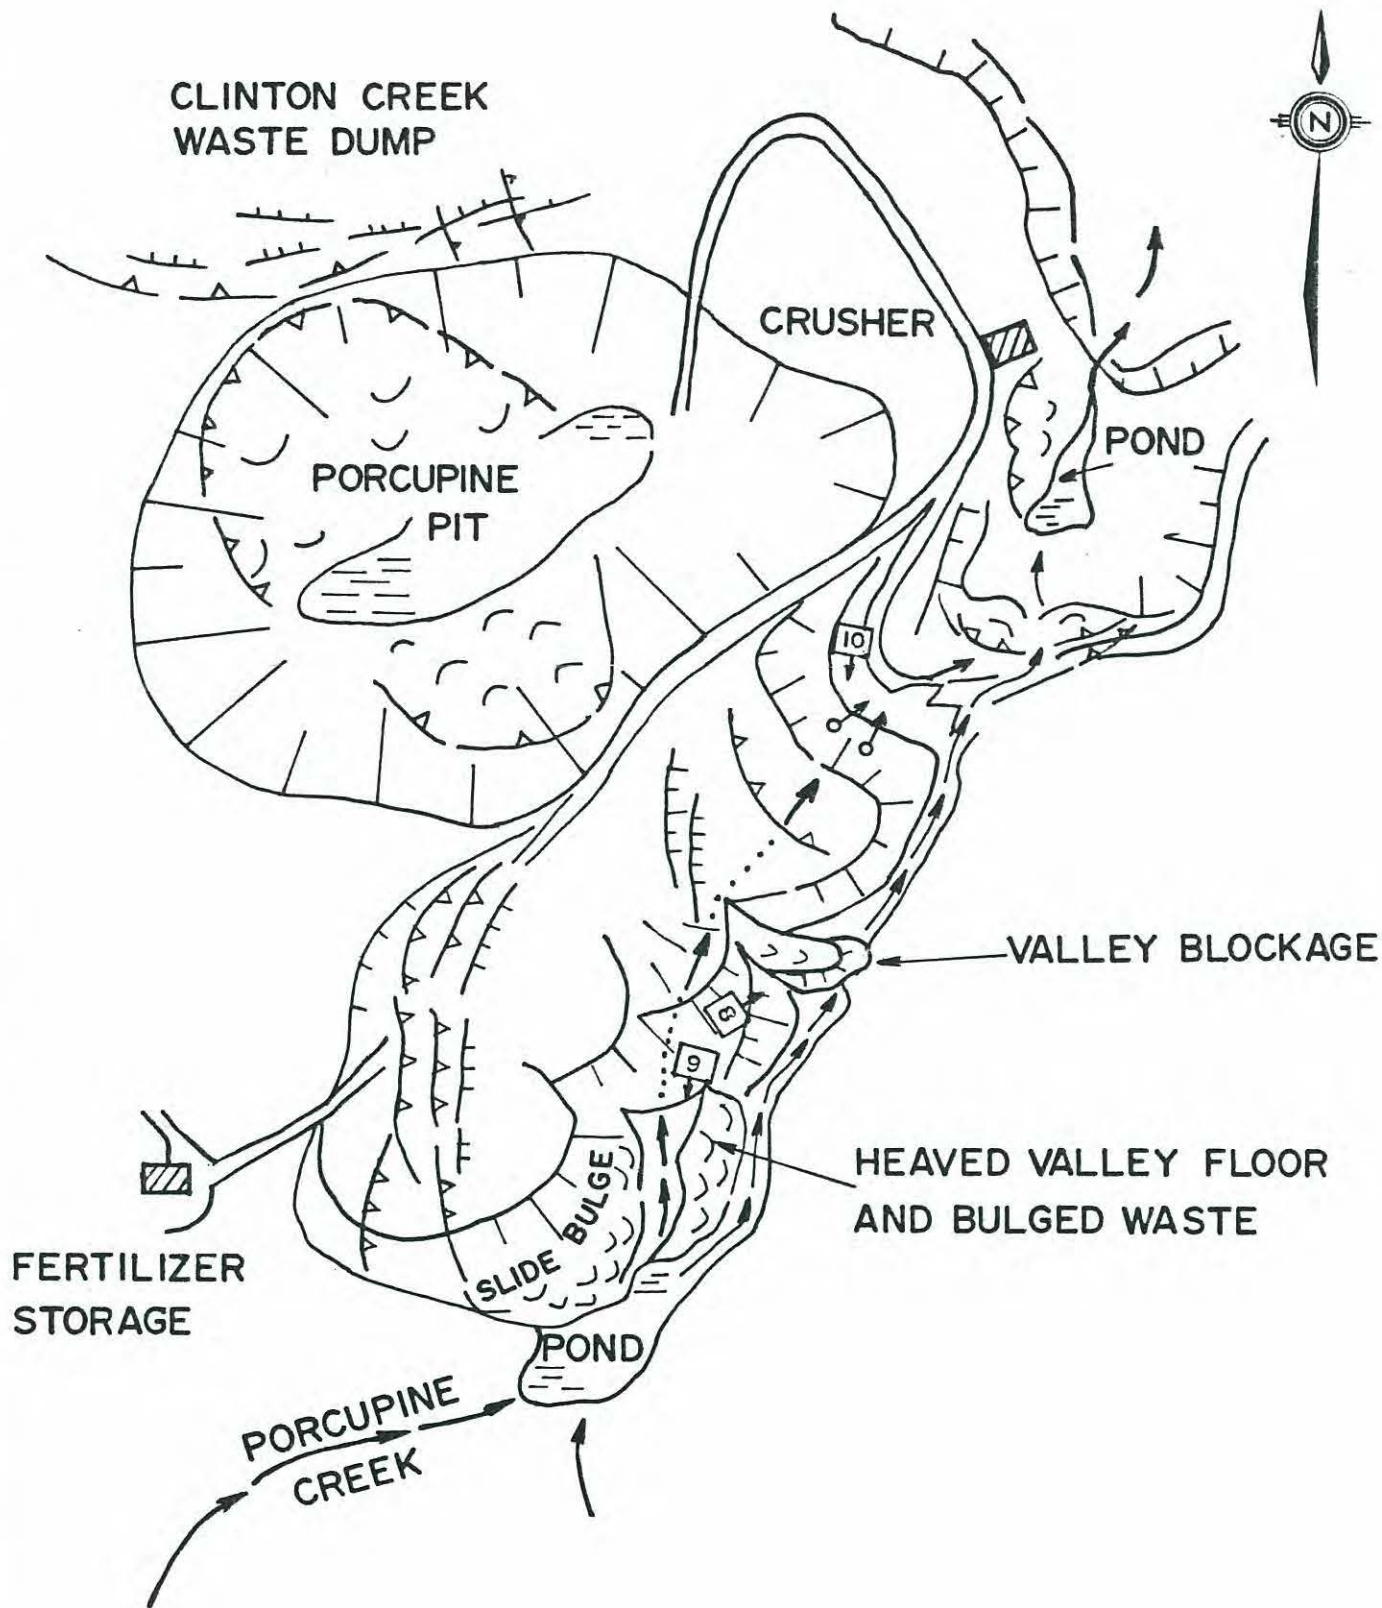
FIGURE 2.

The mine waste deposited into the Porcupine Creek valley remains unstable. The main instability features and drainage conditions are schematically shown on Figure 2.

Steep, fresh scarps outline the upper limits of individual slides which form a complex instability zone encompassing the entire waste dump.

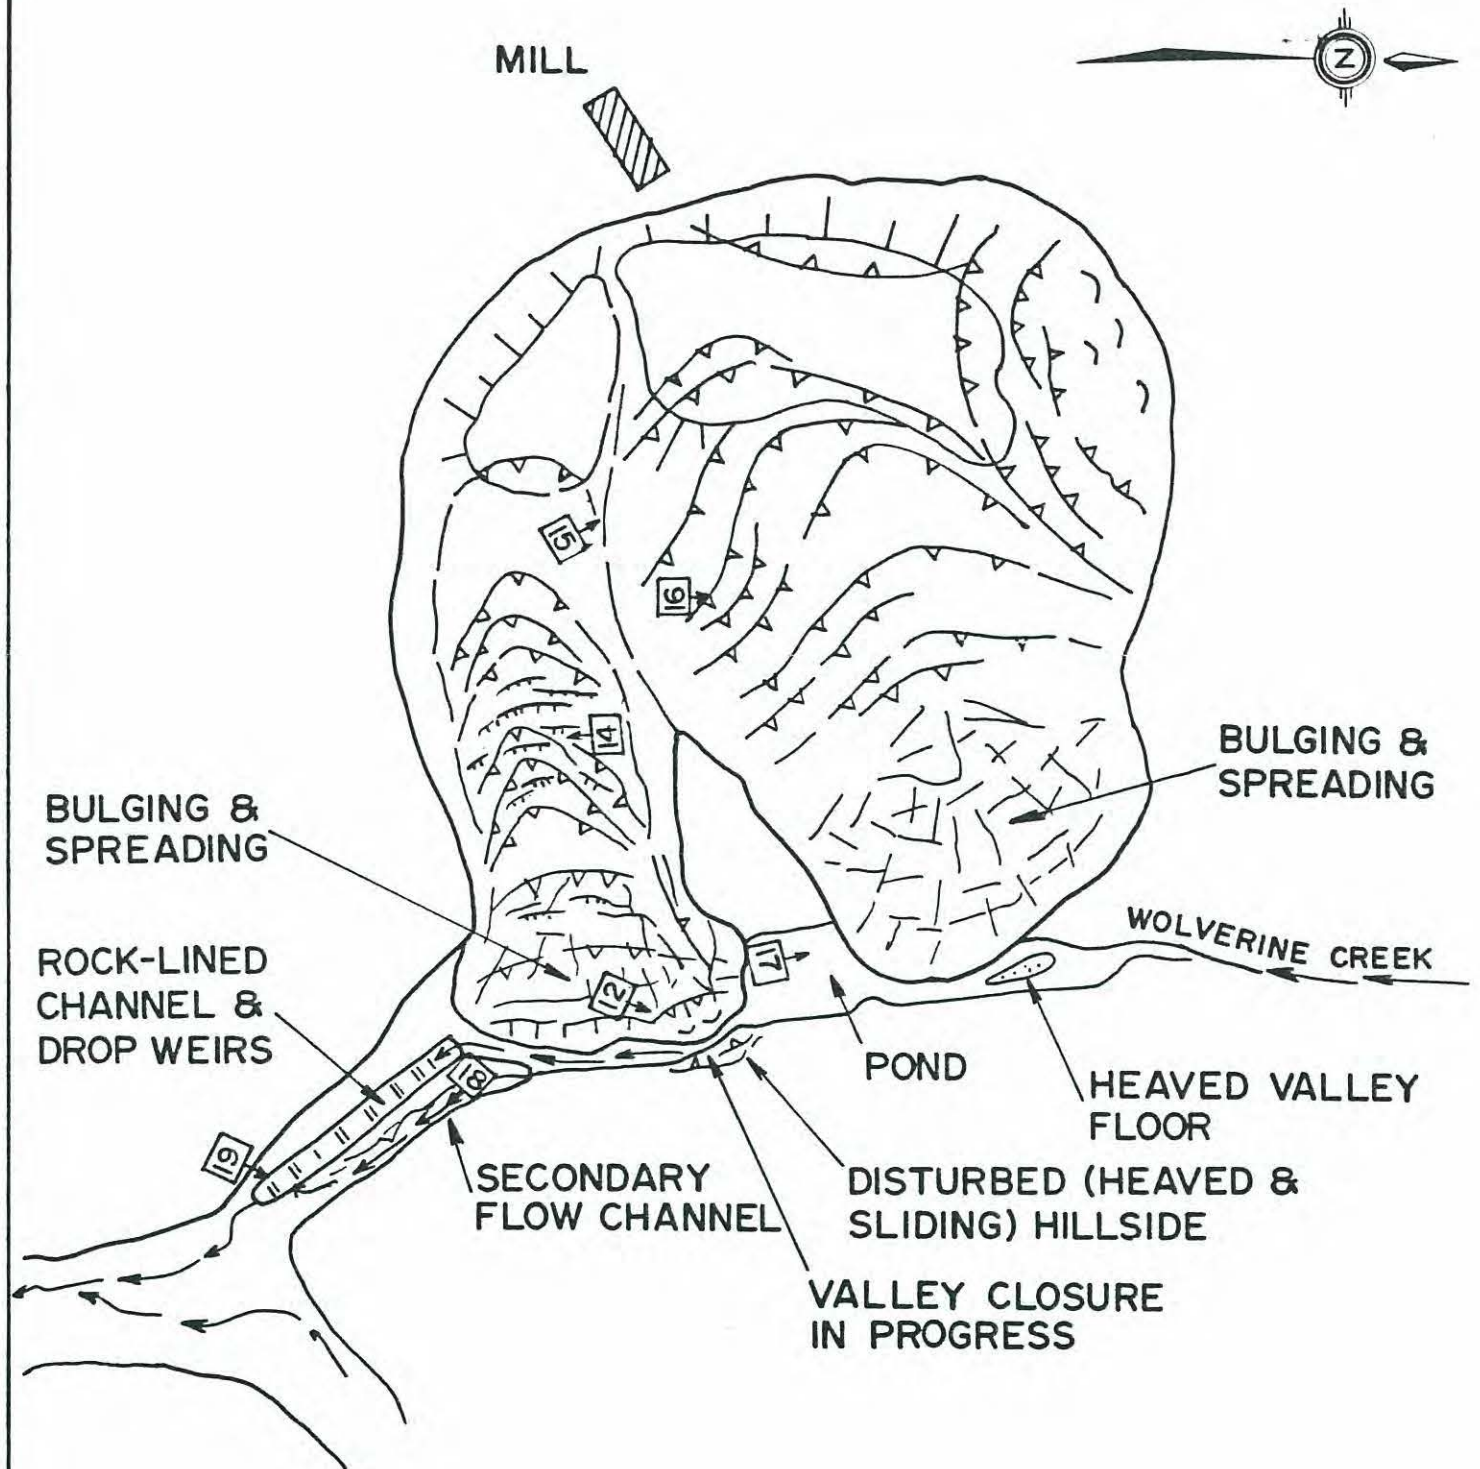
N.T.S. FIGURE 3.

The two tailings piles on the south slope of the Wolverine Creek valley continued to move downhill (Figure 3).

The uppermost sector of the north tailings pile shows more activity than the top of the south one (Photo 15). As illustrated on Figure 3, the top area of the north lobe is spreading in all directions.

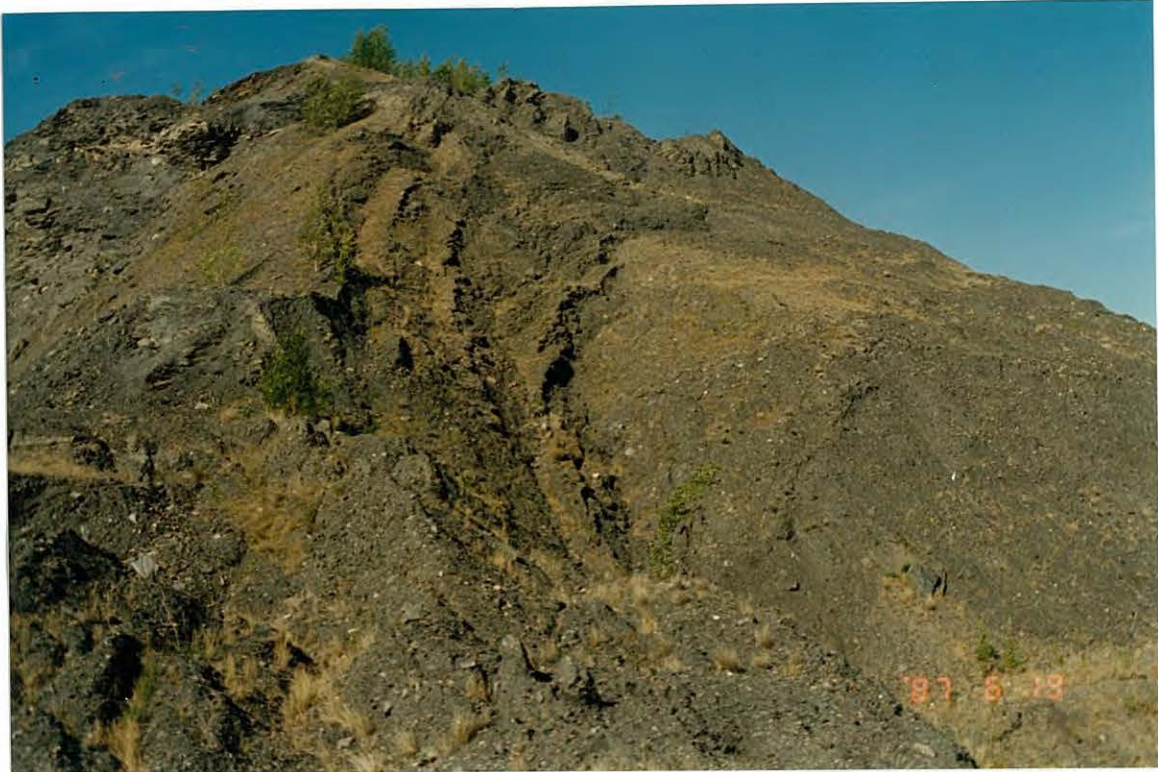
- The uppermost section of the dump outlines the slide headscarp and exhibits a series of arcuate fresh scarps (Photo 1). While the majority of these scarps are located in the same areas as previously encountered, there could have been some retrogression on the top of the hill affecting the natural ground.
- Fissures caused by the sliding of the Porcupine pit wall are intersecting the waste dump headscarp.
- A section of the dump forming the shore of Hudgeon Lake has failed.
- Tension cracks running perpendicular to the creek channel (Photo 2) are fresh and indicate recent movements.
- These tension cracks extend across the access road to the Clinton Creek channel (Photo 3).

Photo 1: Fresh scarps outline the uppermost sector of the Clinton Creek Dump. No significant change in slump characteristics since 1986.

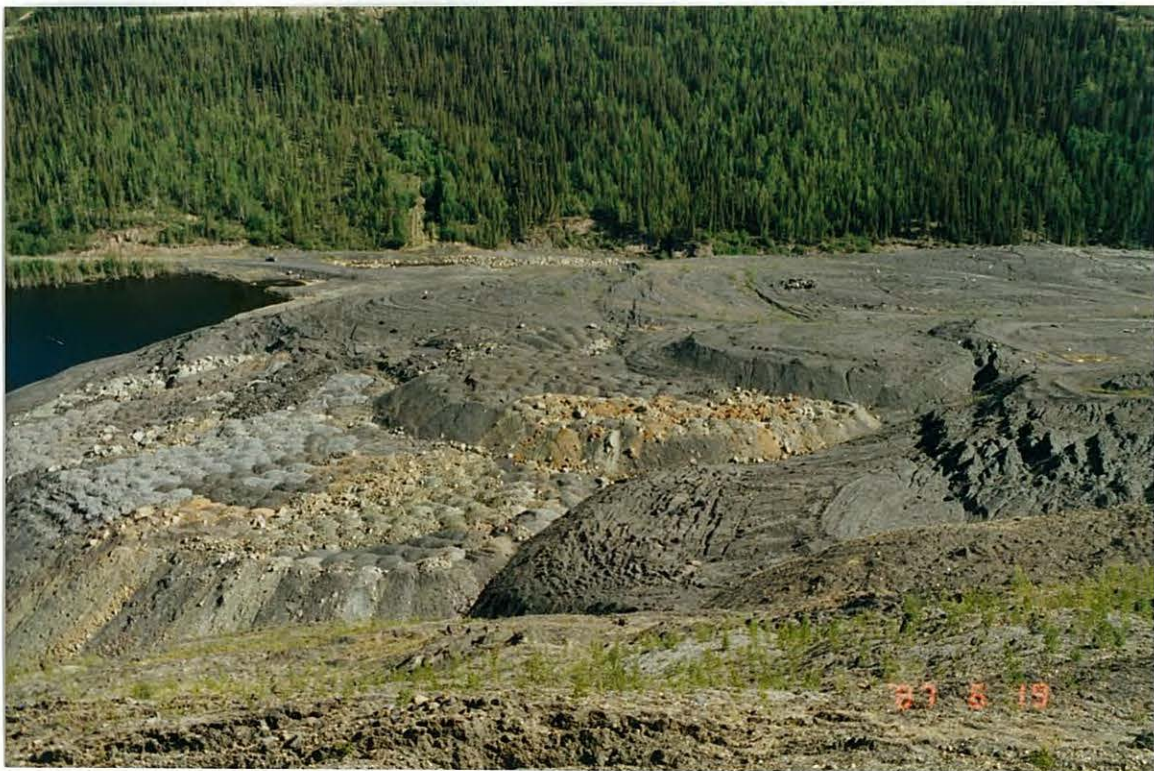
Photo 2: Waste dump - N.W. sector of toe area. Tension cracks run perpendicular to the creek. Recent slumping occurred on the lakeside.

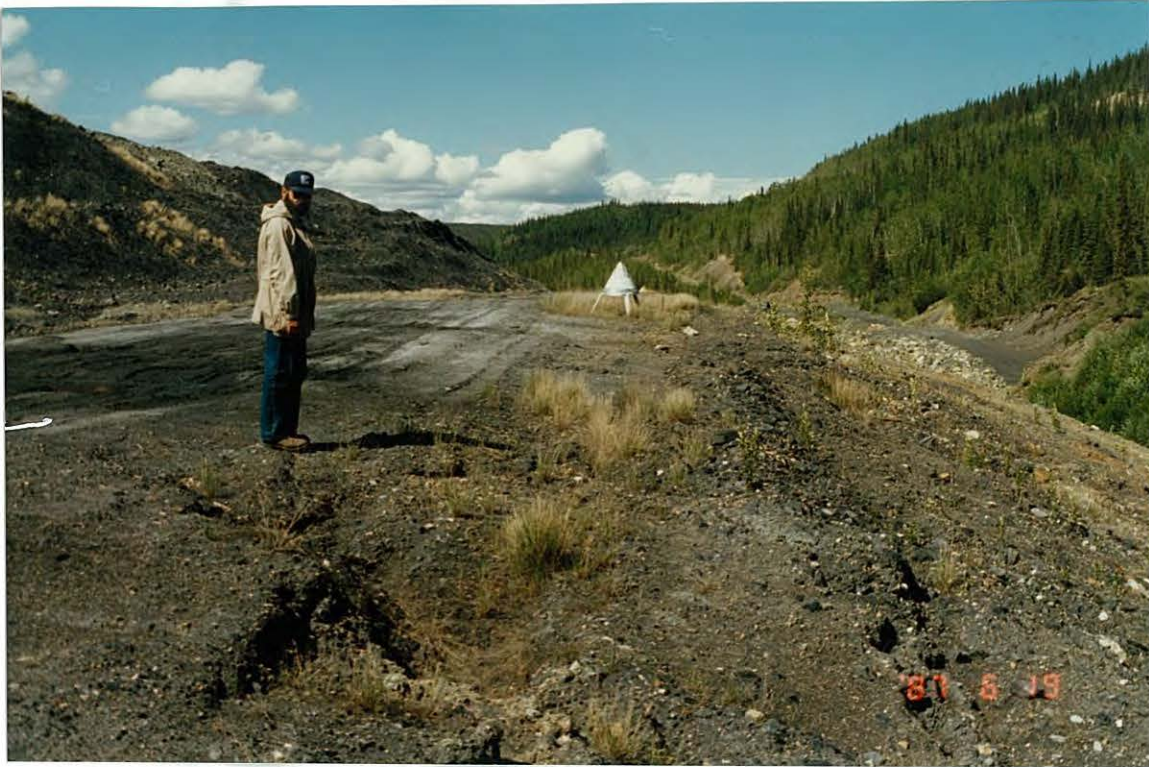
Photo 3: Tension cracks traverse the creek bank and access road. Sharp crack edges confirm recent movements.

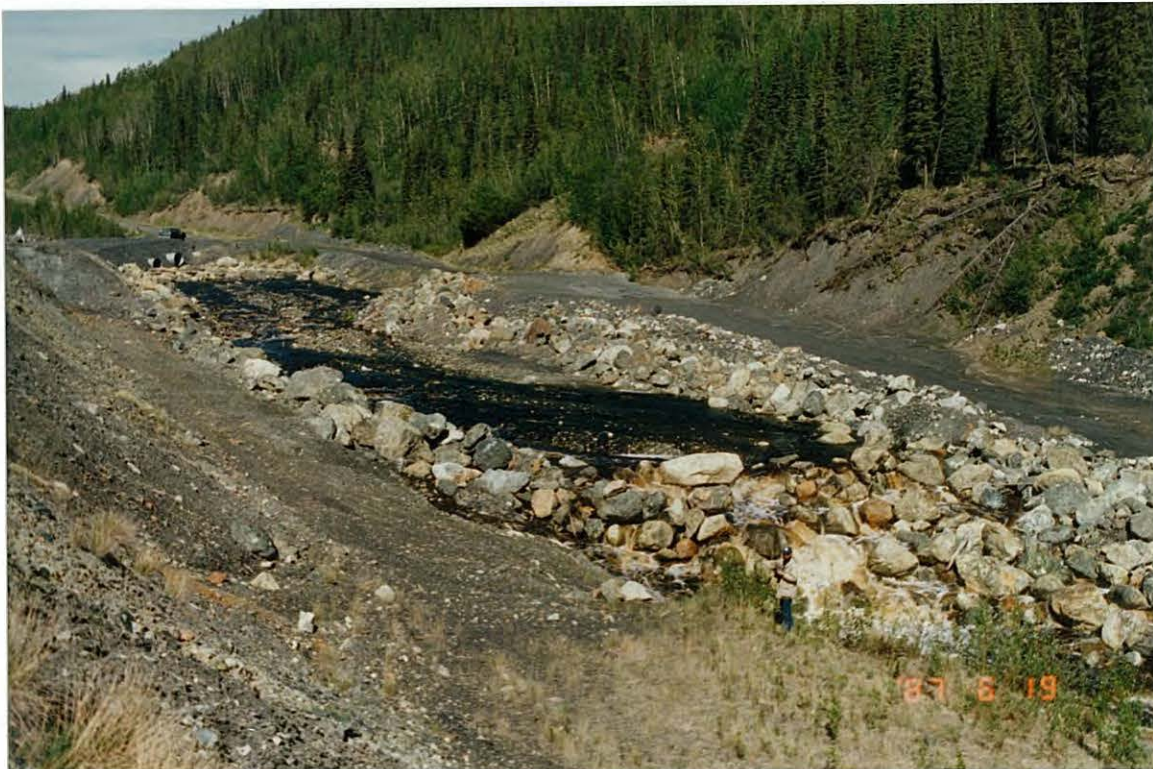
The armoured section of the creek channel downstream from the lake outfall and the drop weir (Photo 4) does not exhibit any major changes since the 1986 site visit. The exposed length of buried stumps indicates that some downcutting is possibly taking place upstream from the weir. Erosion of the south abutment at the drop weir continues.

Photo 4: Lake outfall, armoured banks and drop weir did not change since 1986.

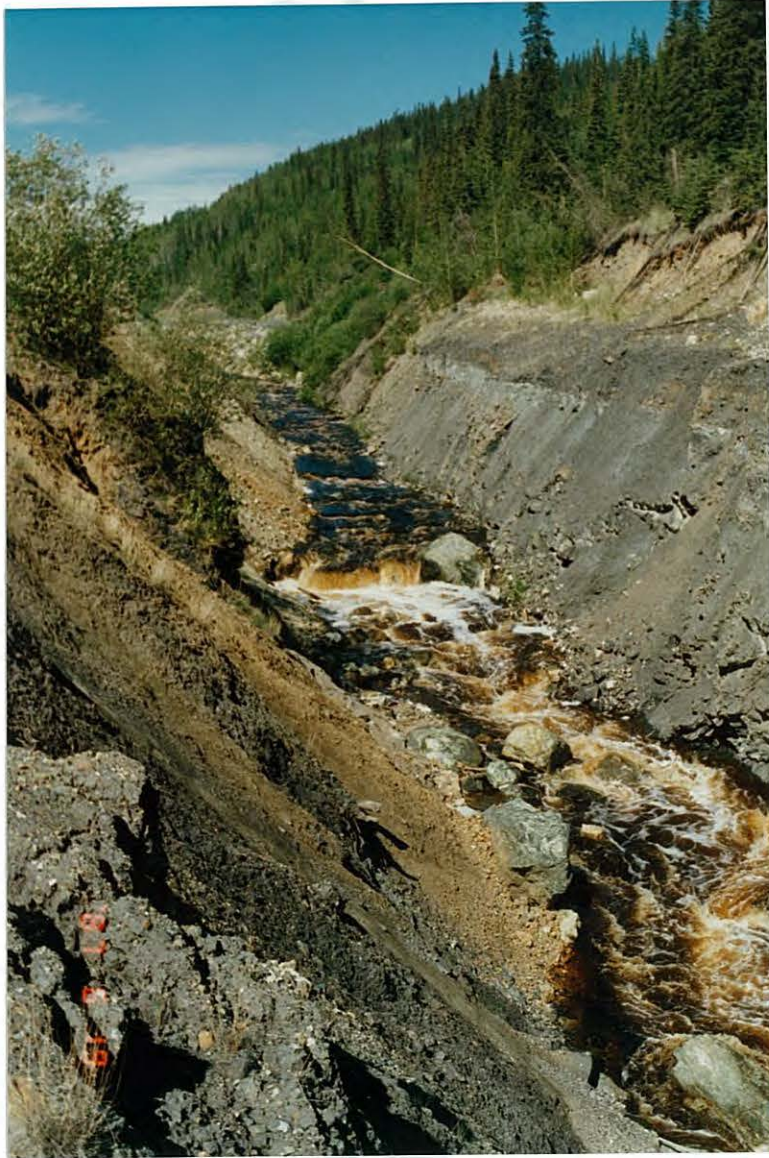
The channel downstream from the weir to a point approximately half way across the waste dump area has been also relatively stable since 1986. This channel section has a constant gradient (Photo 5) and contains a series of steps across the channel bottom. Erosion of the south bank continues at a relatively slow rate.

Photo 5: Upstream sector of the Clinton Creek channel experienced very little erosion since the 1986 site visit. North bank slumping appears to continue at a constant rate.

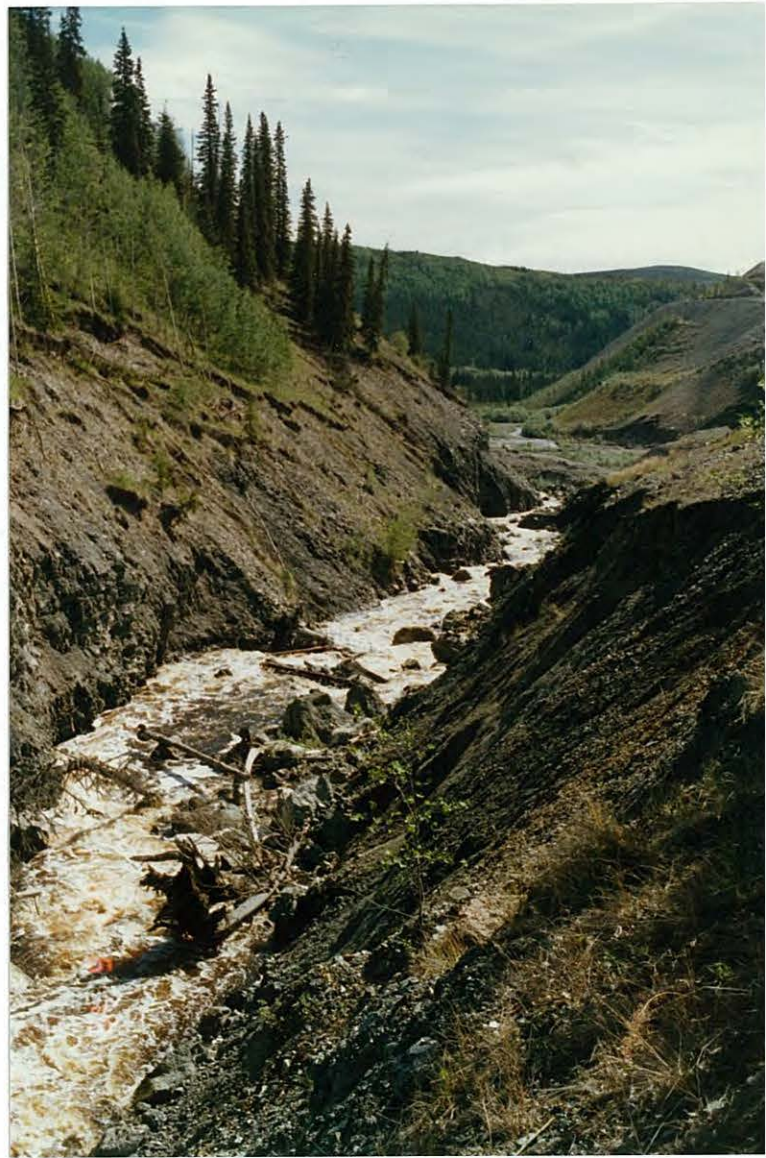
Photo 7: The same creek sector in 1986.

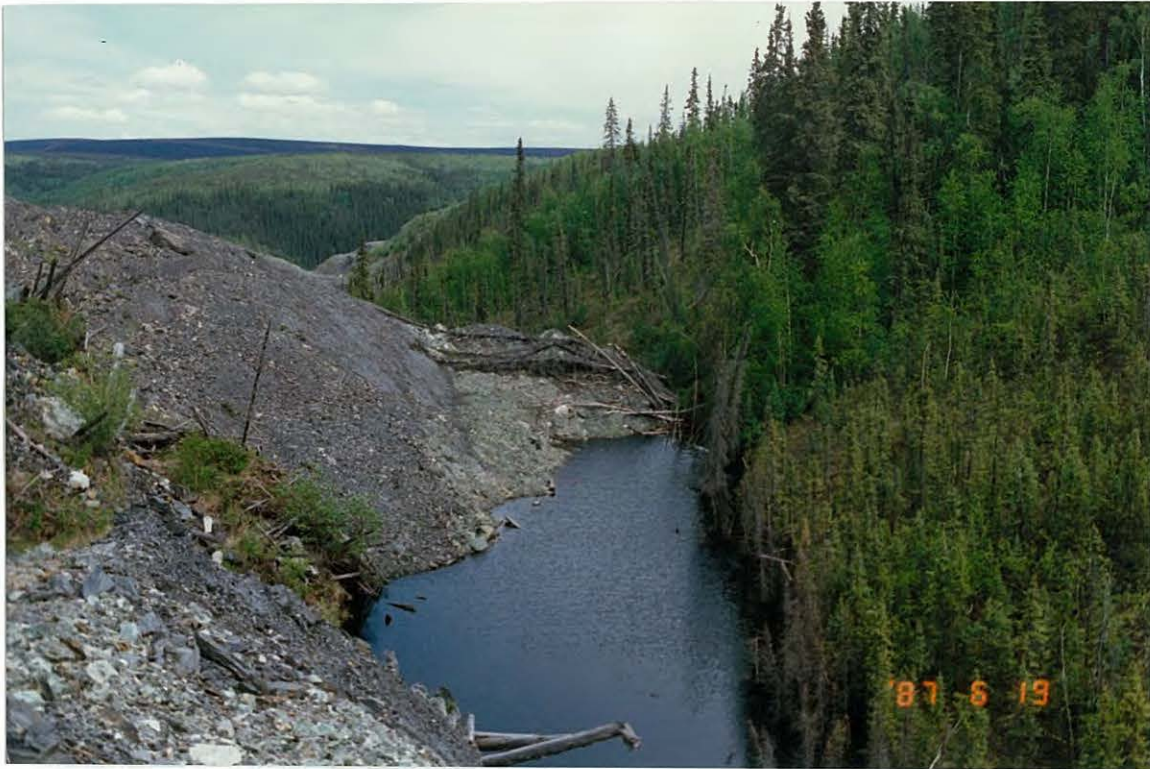
A relatively narrow slump, combined with ground heave, blocks the valley at about the mid-point of the dump (Photo 8). However, there is a flow through this approximately 10 m wide valley blockage.

Photo 8: Partial blockage of the Porcupine Creek valley.

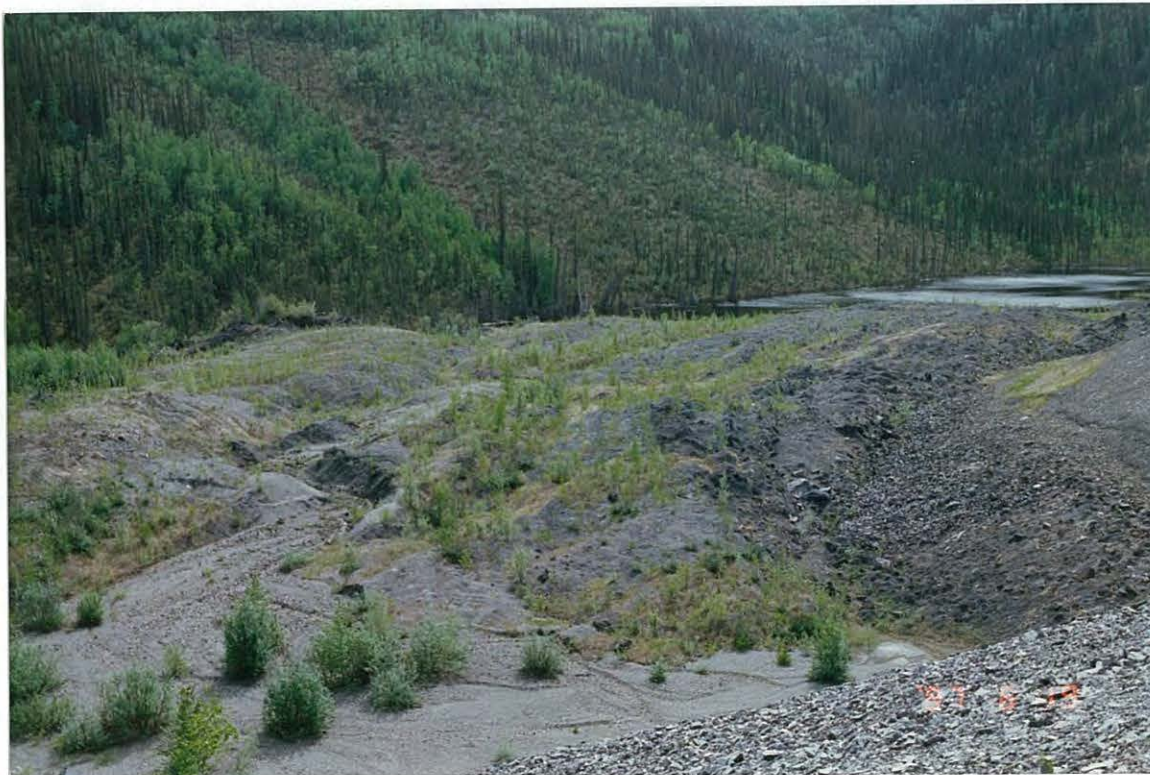
An overflow channel cut through the bulged toe of the waste dump directs water towards the dump. The channel widens in front of the dump forming a fan-like delta (Photo 9). Despite a considerable width of the entry area, some flooding occasionally occurs. Finer-grained sediments are deposited in this area.

Photo 9: View of the heaved valley floor and bulged waste along the upstream toe of the Porcupine dump. Note an overflow channel directing flow into the dump.

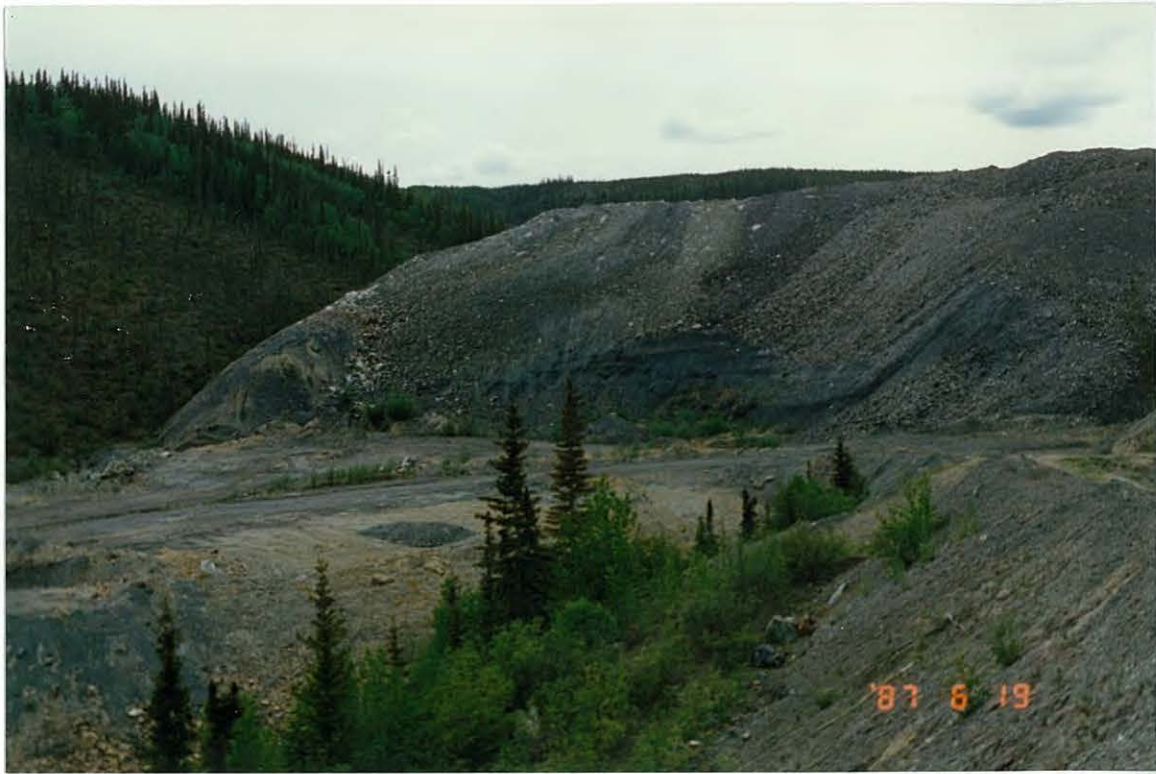
The underflow obviously follows more permeable zones within the dump and is discharged above the pile toe at its downstream end (Photo Nos. 10 and 11). The seepage, estimated in the order of 25 igpm (1.9 l/sec), is dispersed over a relatively wide zone.

Photo 10: The downstream section of the Porcupine Dump. The underflow is discharged above the toe of the dump, apparently following more permeable materials within the waste. Surface drainage channel is on the left.

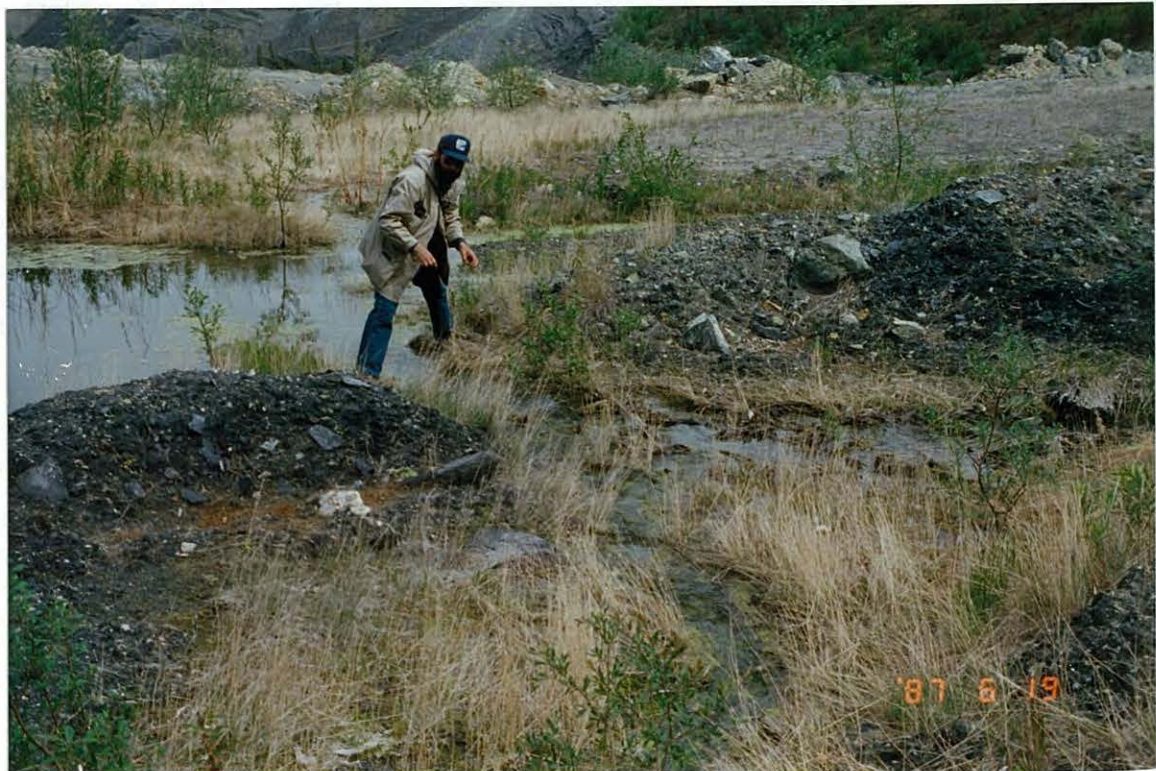
Photo 11: Seepage from the underflow.

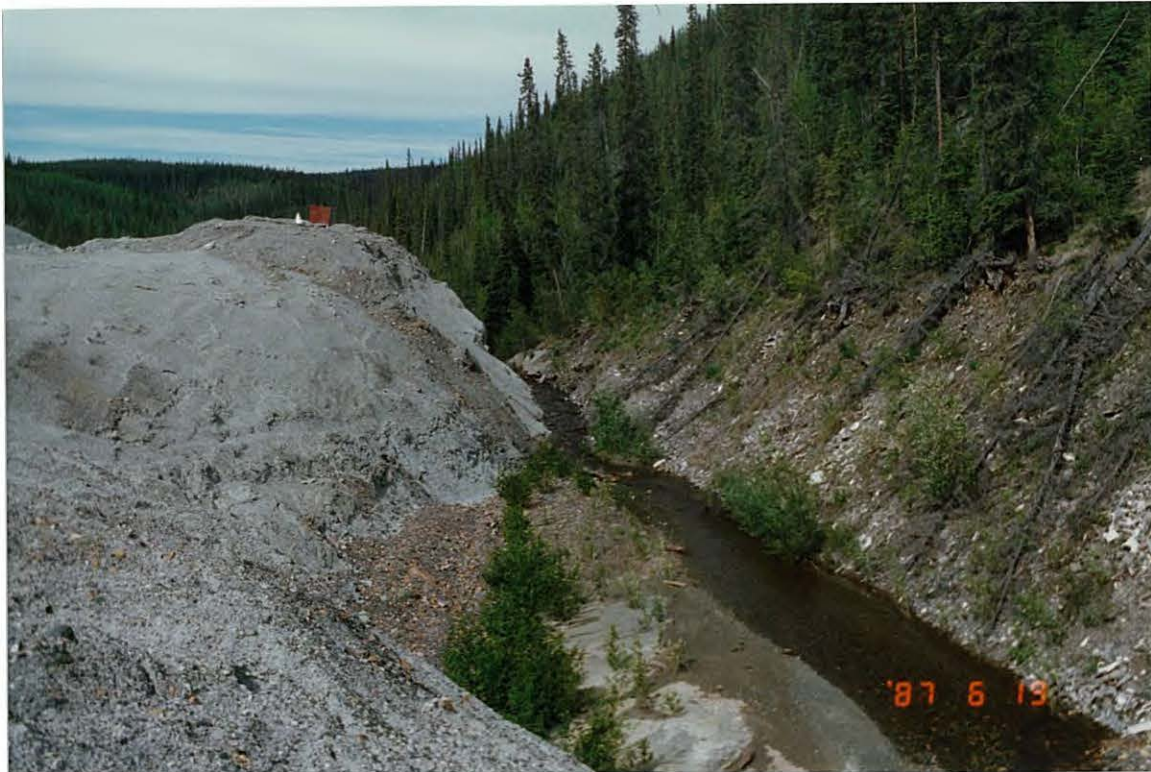
The material build-up along the stream channel is noticeable and the channel bottom is at least locally heaving (Photo 12). On the upstream side of this pile the original valley floor is being pushed up (Photo 13). The movement of the dump subgrade is apparently destabilizing the opposite hillside which shows extensive cracks and sliding.

A partial blockage which was observed in 1986 at the upstream end of the south pile has been washed away by the spring runoff (Photo 12).

Photo 12: Build-up of material in the toe area of the south tailings pile and squeezing of the Wolverine Creek channel.

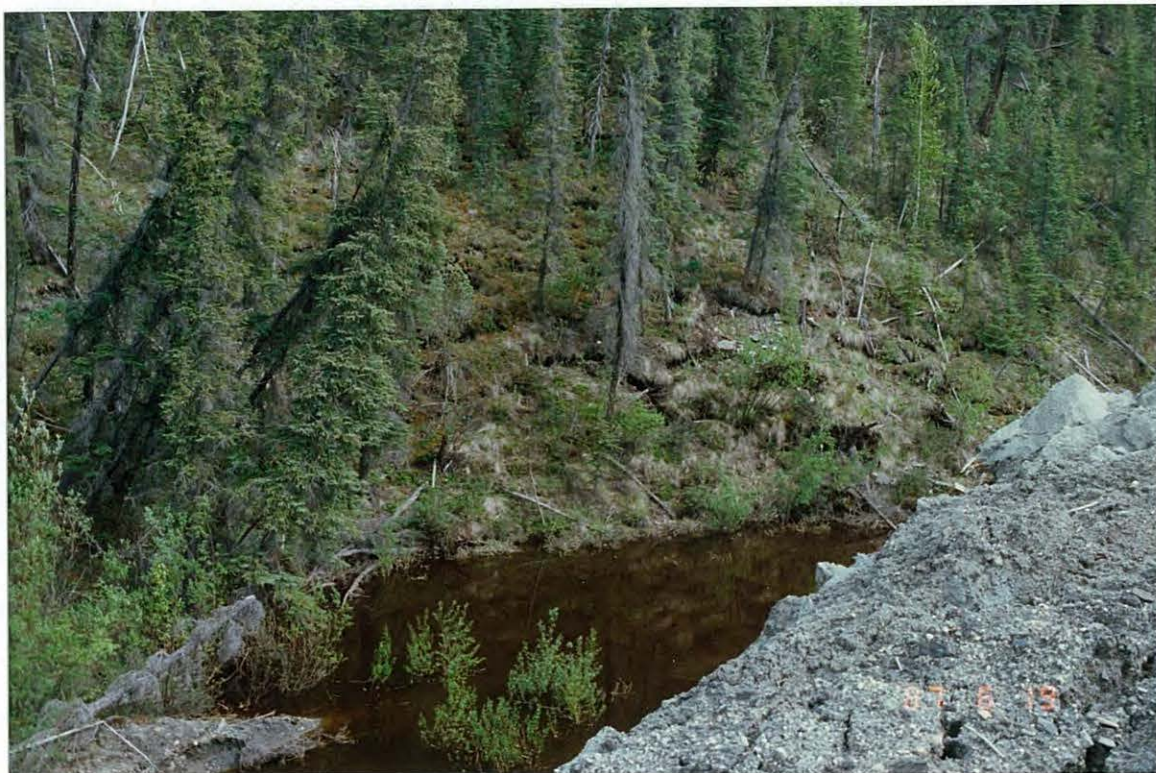
Photo 13: Upstream side of the south pile. The ground is pushed up disturbing the opposite hillside which is cracked and unstable.

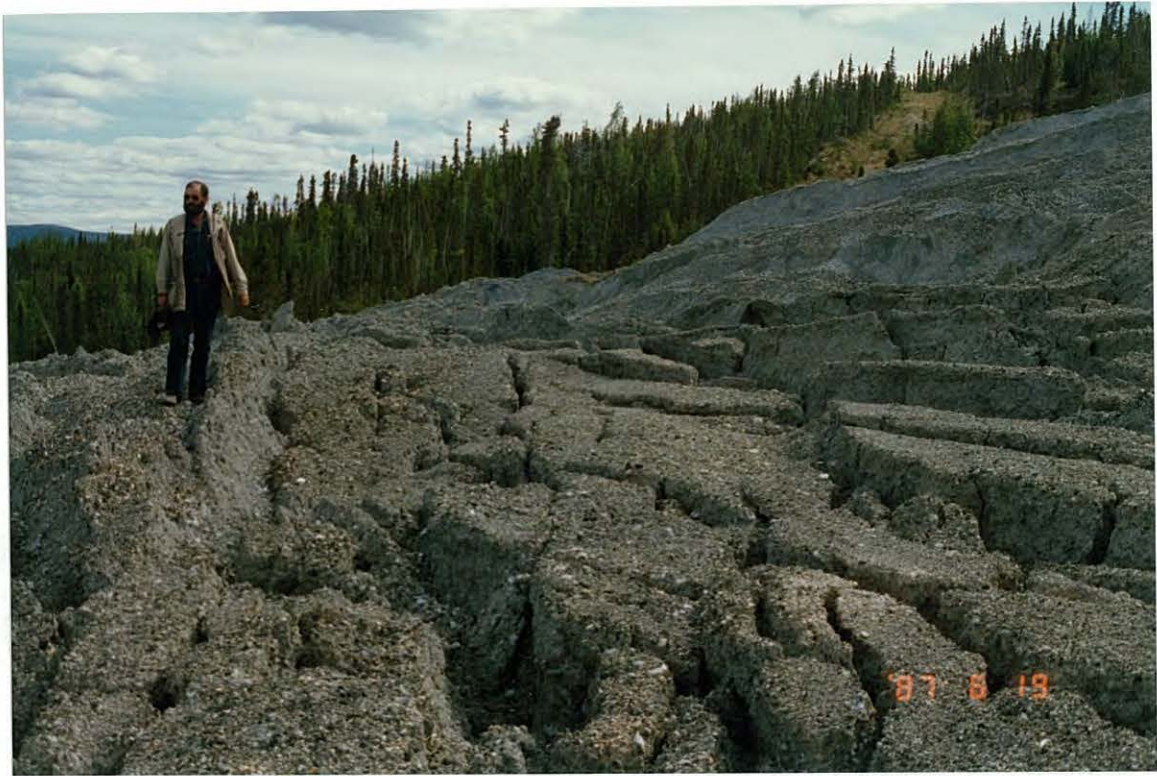
Significant deformations occur in the middle sector of the south pile (Photo 14). It is estimated that movements in this region have increased since our 1986 site inspection.

Photo 14: Middle sector of the south tailings pile shows fresh and deep tension cracks.

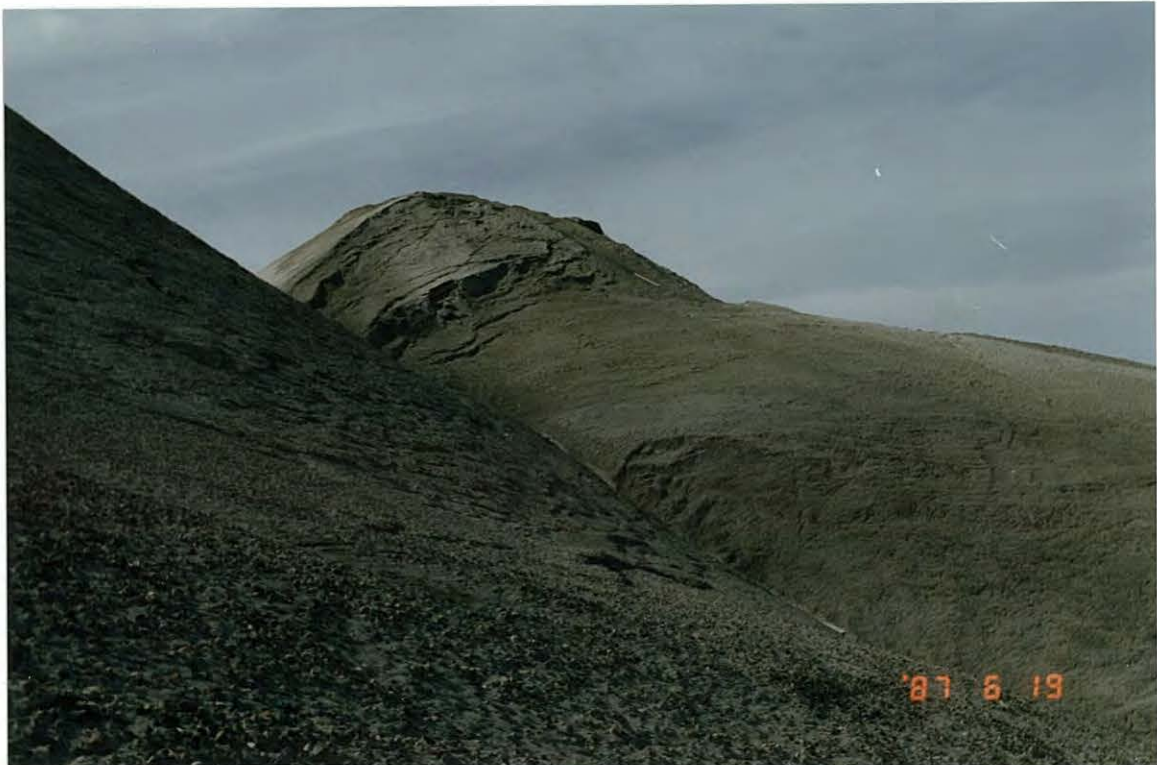
Photo 15: Upper sectors of the south pile (left) and north pile (right).

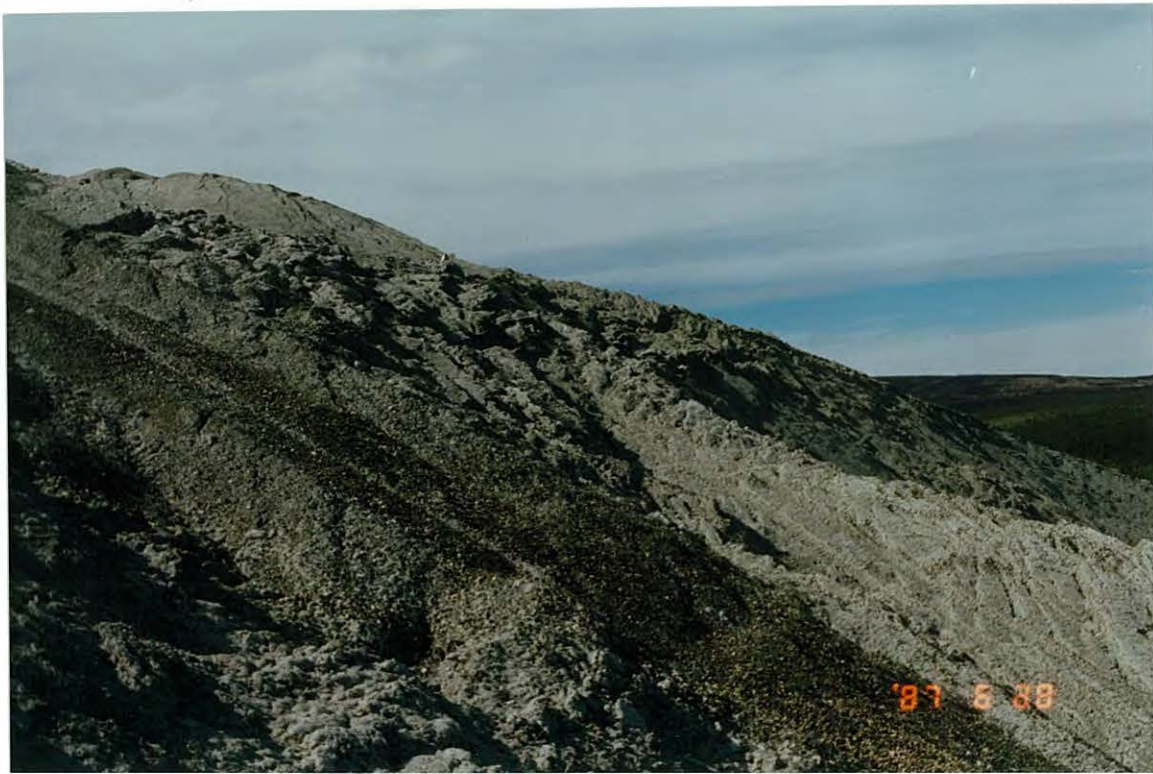
The middle sector of the north pile is badly disturbed (Photo 16) and it is very difficult to evaluate the relative rate of movement. However, there is no doubt that the horizontal displacements occurring in this area would be similar to those previously measured, i.e. in the range of 10 to 20 m per year.

Photo 16: Middle sector of the north pile exhibits extensive deformations and the rate of movement continues to be high.

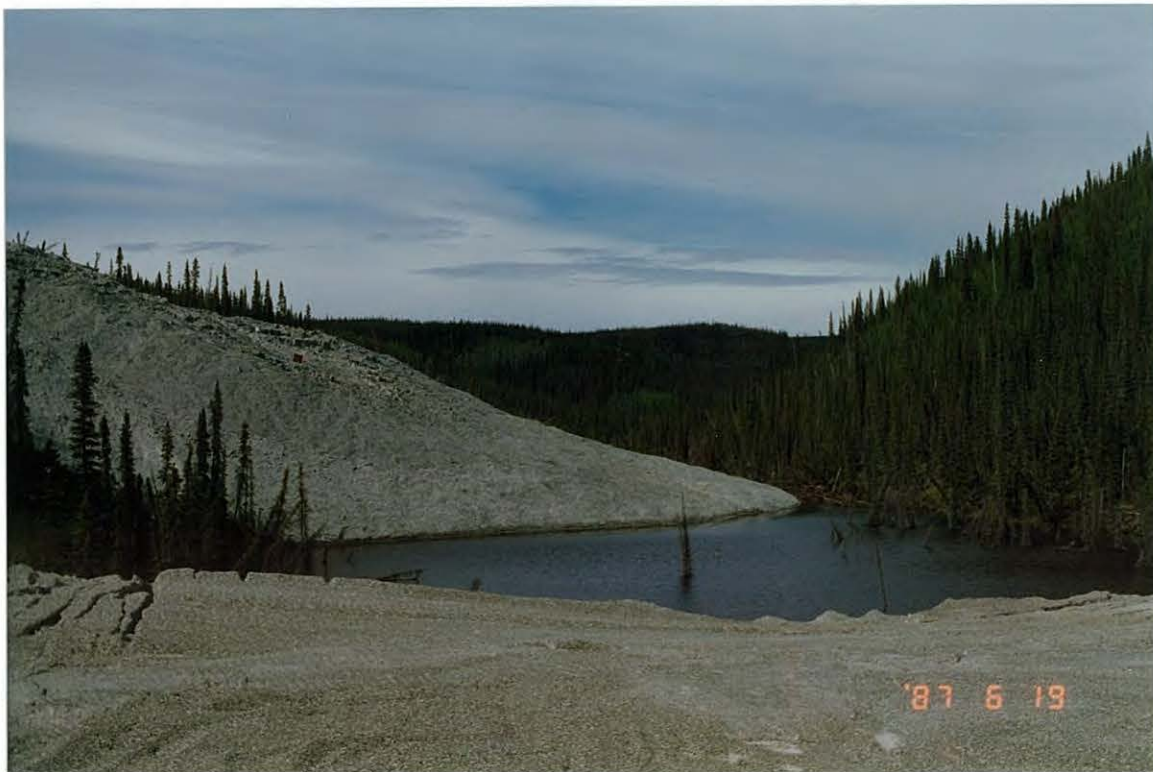
The displacement rate of the toe area (Photo 17) has decreased because of the support provided by the east valley wall. The toe bulge has a lower slope gradient than in 1986 and has advanced slightly towards the east valley wall. The heaving of the valley bottom in front of this toe continues.

Photo 17: The toe area of the north pile is flatter than it was in 1986 and advanced only slightly towards the east valley wall.
