CLINTON CREEK ASBESTOS MINE
Report
on
1987 Site Inspection

Prepared For:
NORTHERN AFFAIRS PROGRAM
Whitehorse, Y.T.

July, 1987
G052

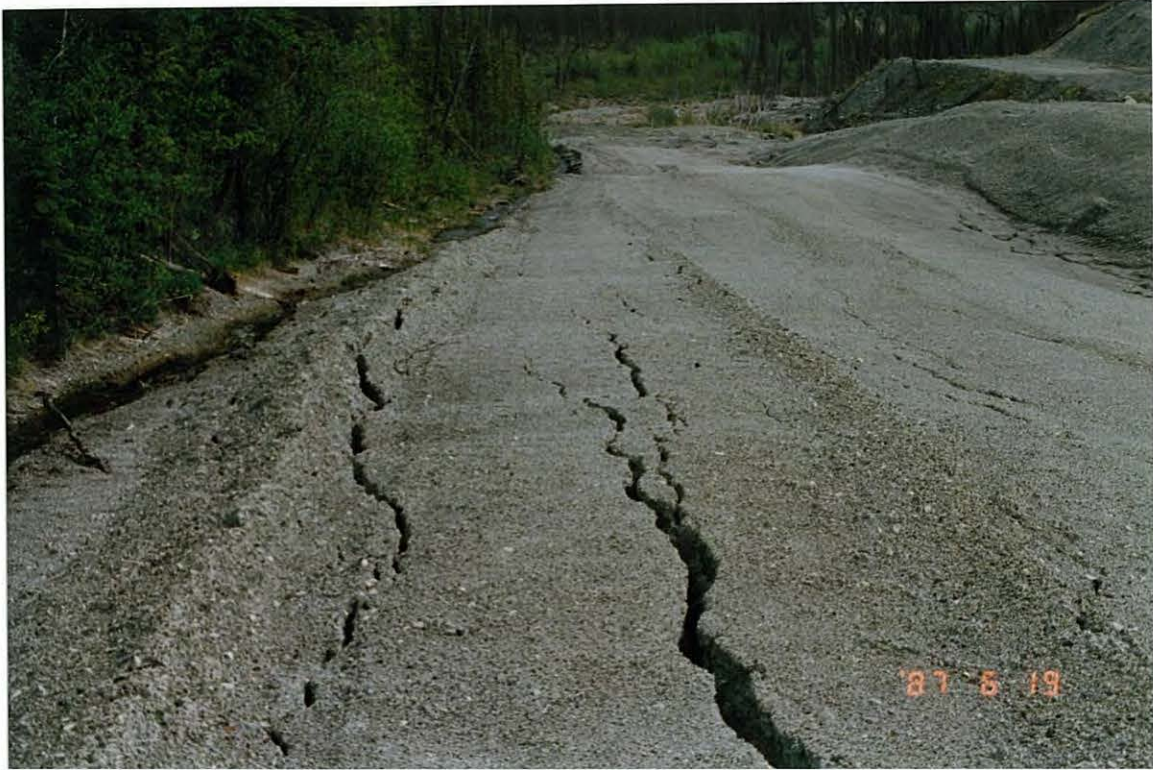
Flow through this new channel has increased since 1986 and the channel is deeper (Photo Nos. 18 and 19) than it was during the previous site inspection. The cracks between the spillway and the new channel (Photo 18) have a fresh appearance.

Photo 18: View of tension cracks developed between the armoured channel and secondary channel.

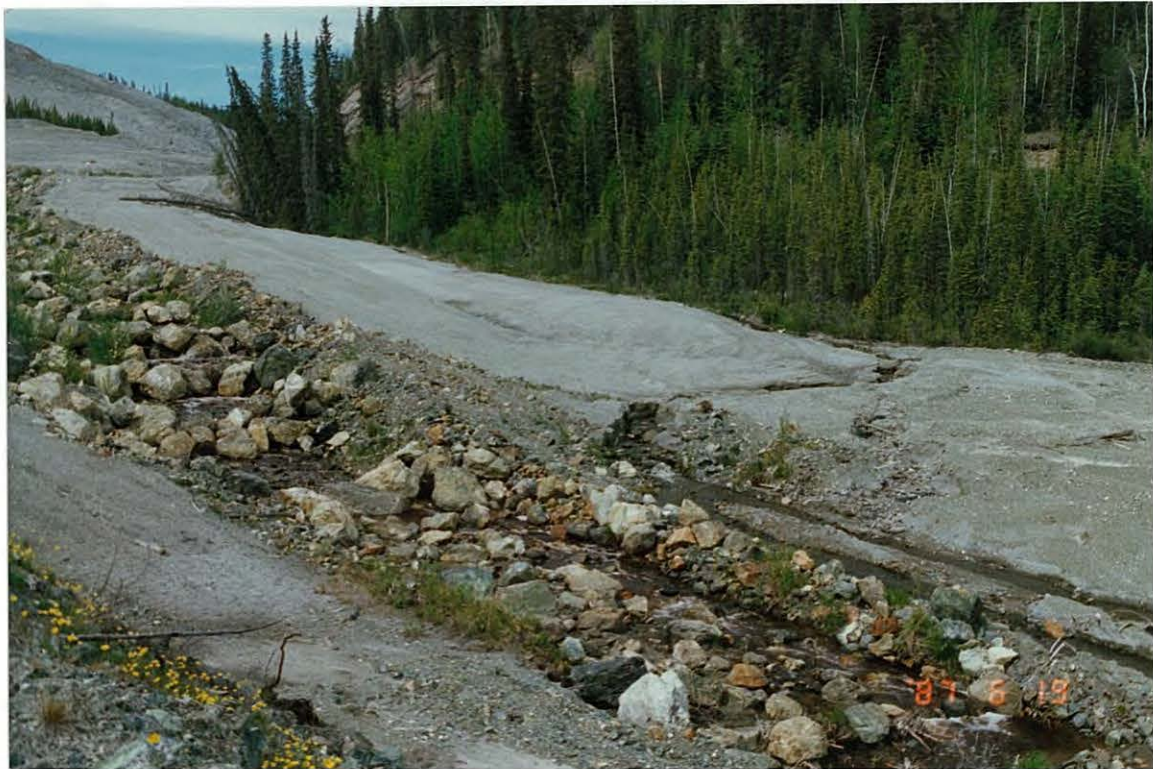
Photo 19: Junction of armoured and newly developed channels.
