ABANDONED CLINTON CREEK ASBESTOS MINE

**REPORT
ON
1990 SITE INSPECTION**

Prepared for:
NORTHERN AFFAIRS PROGRAM
Whitehorse, Y.T.

June 1991
G052

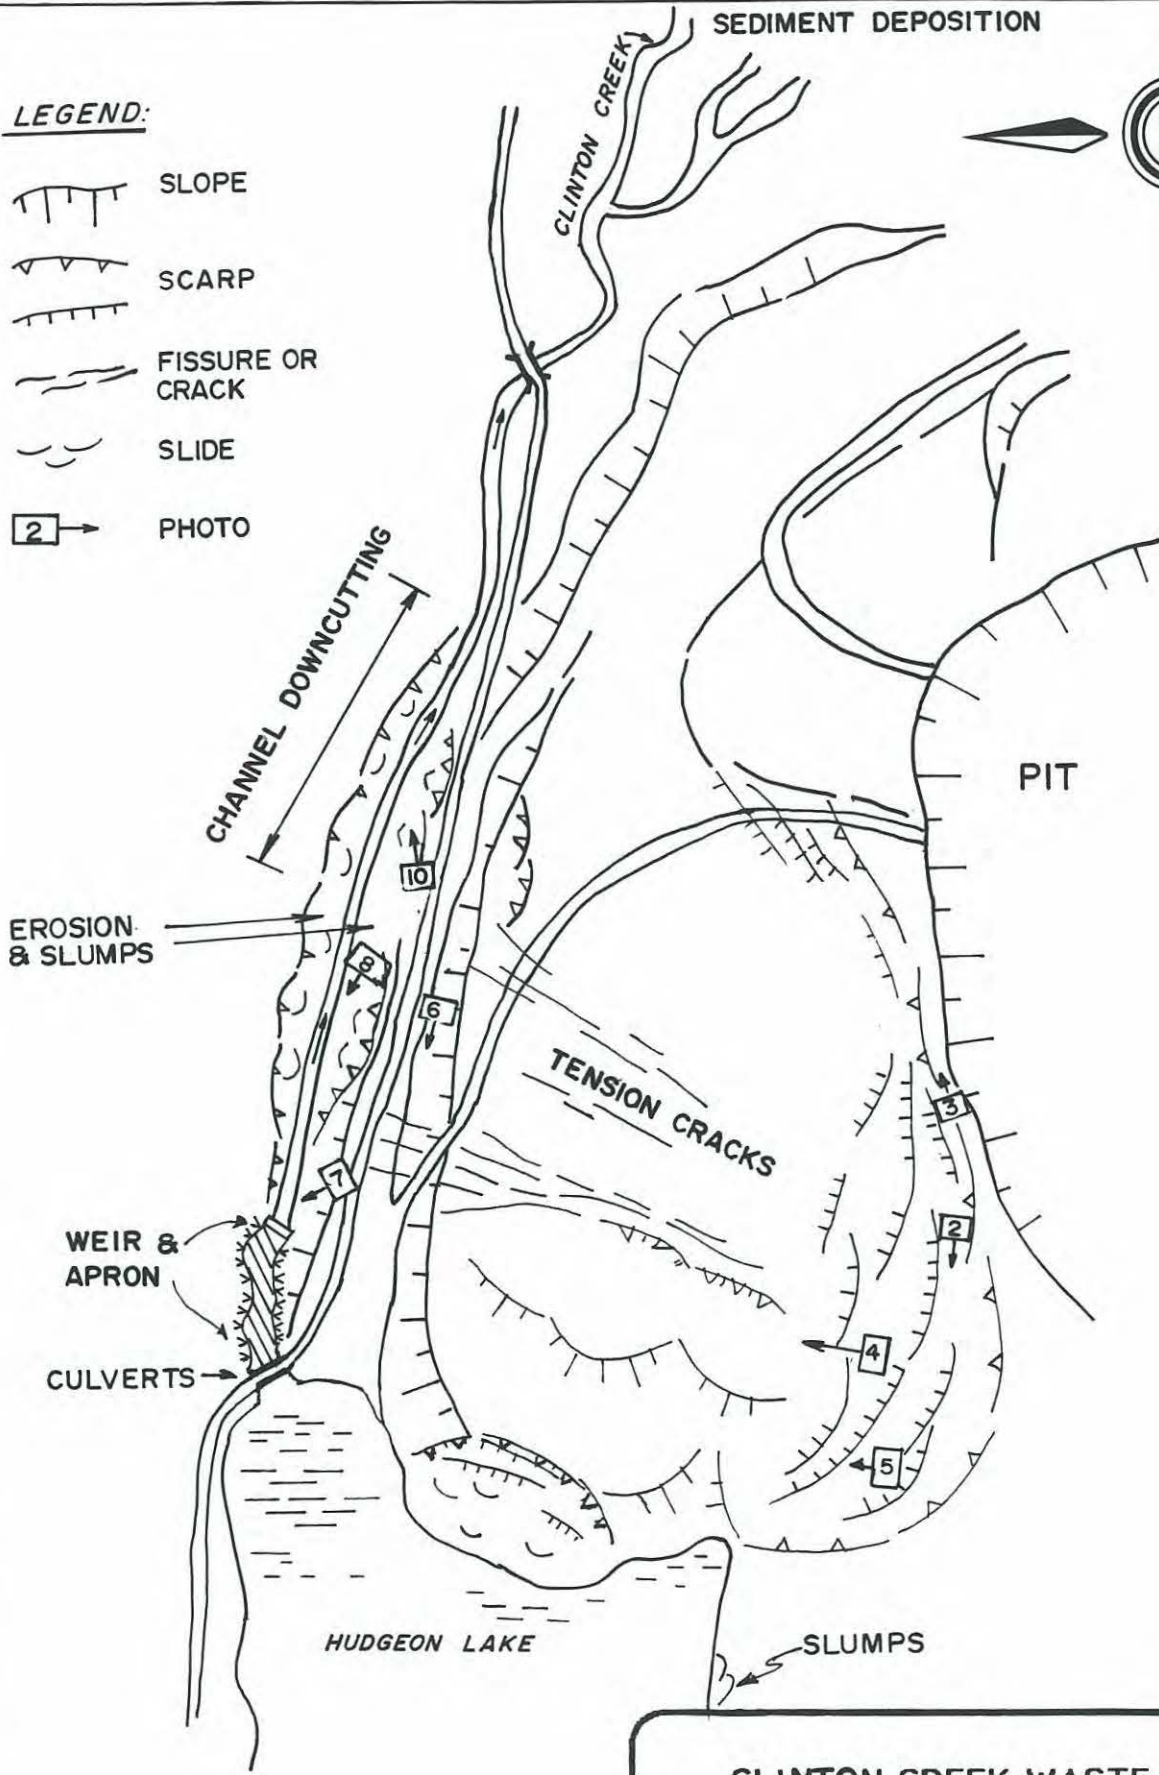
FIGURE 1.

Fresh cracks, scarps and fissures were observed in the upper segment of the waste dump and are indicative of recent and ongoing movement of wastes placed on the south slope of the Clinton Creek valley. The headscarp area has retrogressed upslope from the waste dump limit and localized segments of natural ground have become unstable. The dump toe has apparently advanced into the creek channel.

These features, schematically outlined on Figure 1, indicate that the dump movements continue to be pervasive.

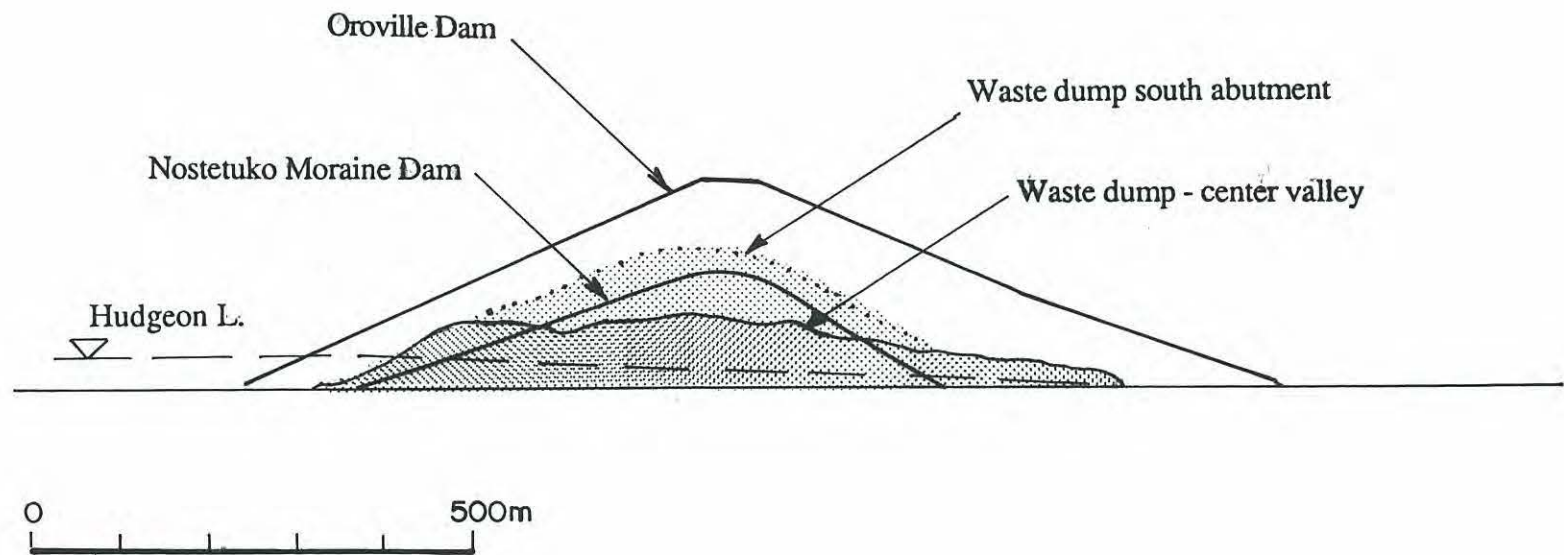
The waste dump volume is estimated at about 35 million m³. The valley bottom in this area used to be flat and about 240 m wide. The length of the dump in the valley bottom exceeds 700 m. It is believed that the dump triggered a deep-seated failure extending below the valley floor. This resulted in an upward movement and eventual displacement of the creek channel towards the north valley side. This valley blockage (or landslide dam, according to Coste J.E. and Schuster, R.L.) is more than 50 m high in the center of the valley and created a lake having a surface area about 72 ha (0.7 x 10⁶ m²) and a depth of water of about 26 m. It is estimated that the total volume of impounded water is in the order of 15 x 10⁶ m³. Table 1 summarizes some documented examples of other landslide dams and includes parameters of this valley blockage.

Figure 2: Cross section of Clinton Creek valley blockage, Nostetuko Moraine Dam and Oroville Dam (modified from Lee and Duncan, 1975).

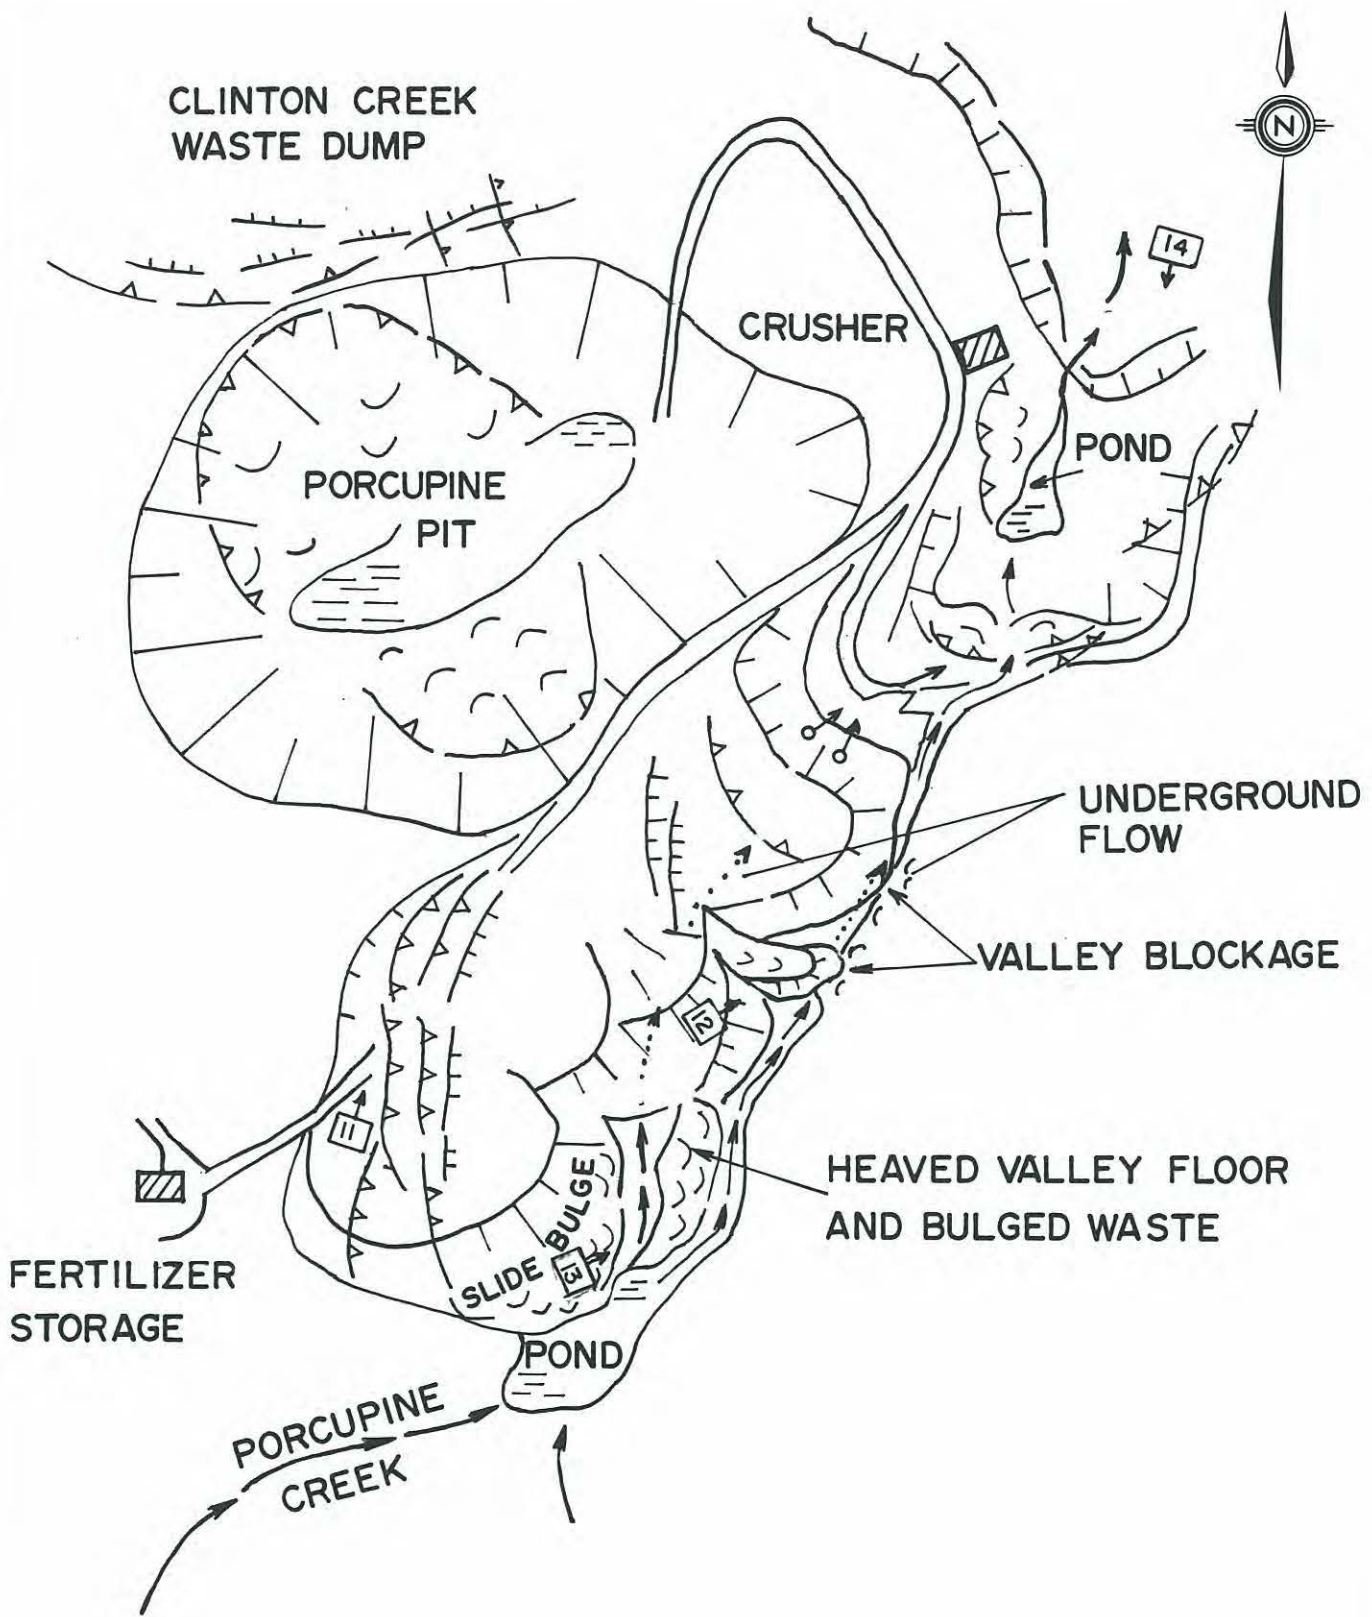
N.T.S. FIGURE 3

The displacement of the mine waste deposited into the Porcupine Creek valley continues. The main instability features and drainage conditions are schematically shown on Figure 3.

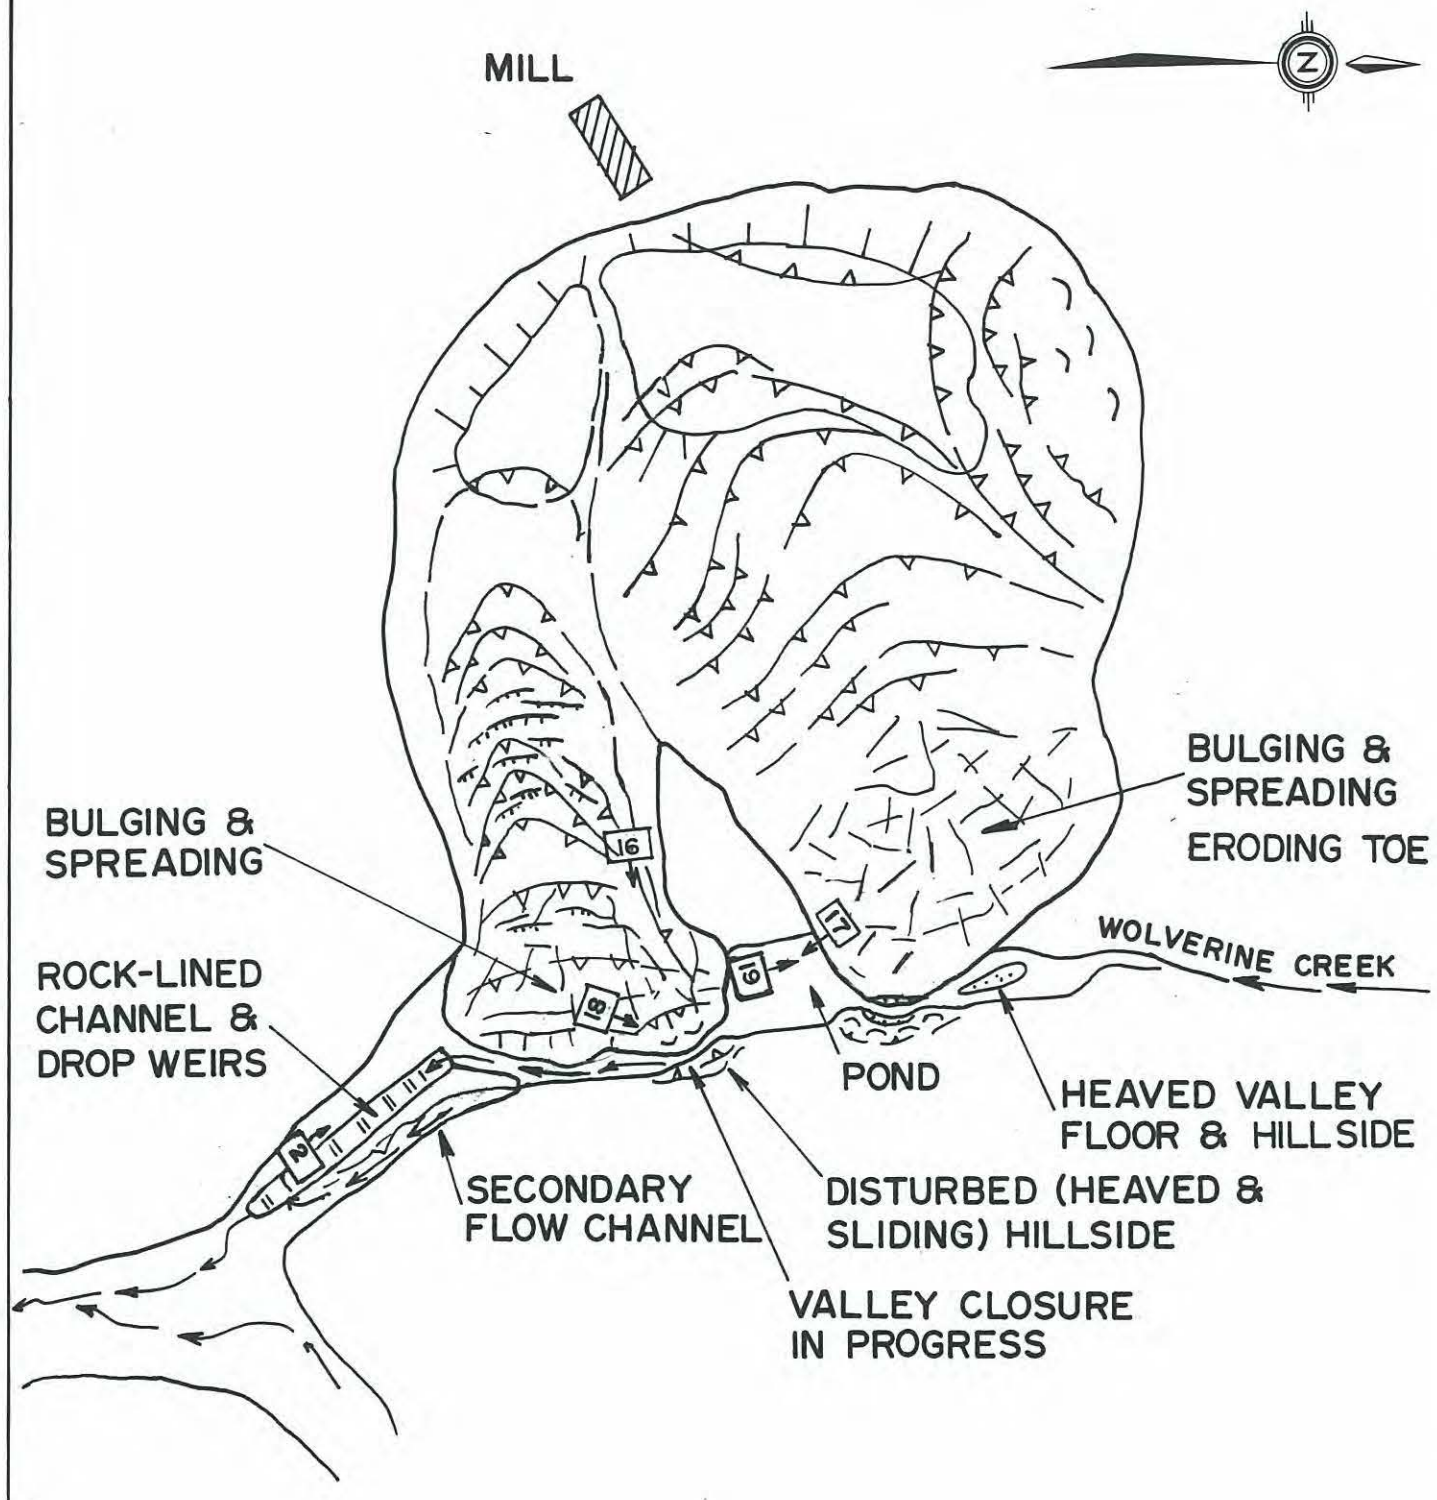
N.T.S. FIGURE 4

The general appearance of both south and north pile lobes is similar to that observed in 1988 (Figure 4). The pile movements continue and their rates are apparently irregular, reflecting the displacement of individual dump segments. For example, when a lower block moves, the adjacent upslope segment accelerates and the failure gradually progresses to the top of the pile.

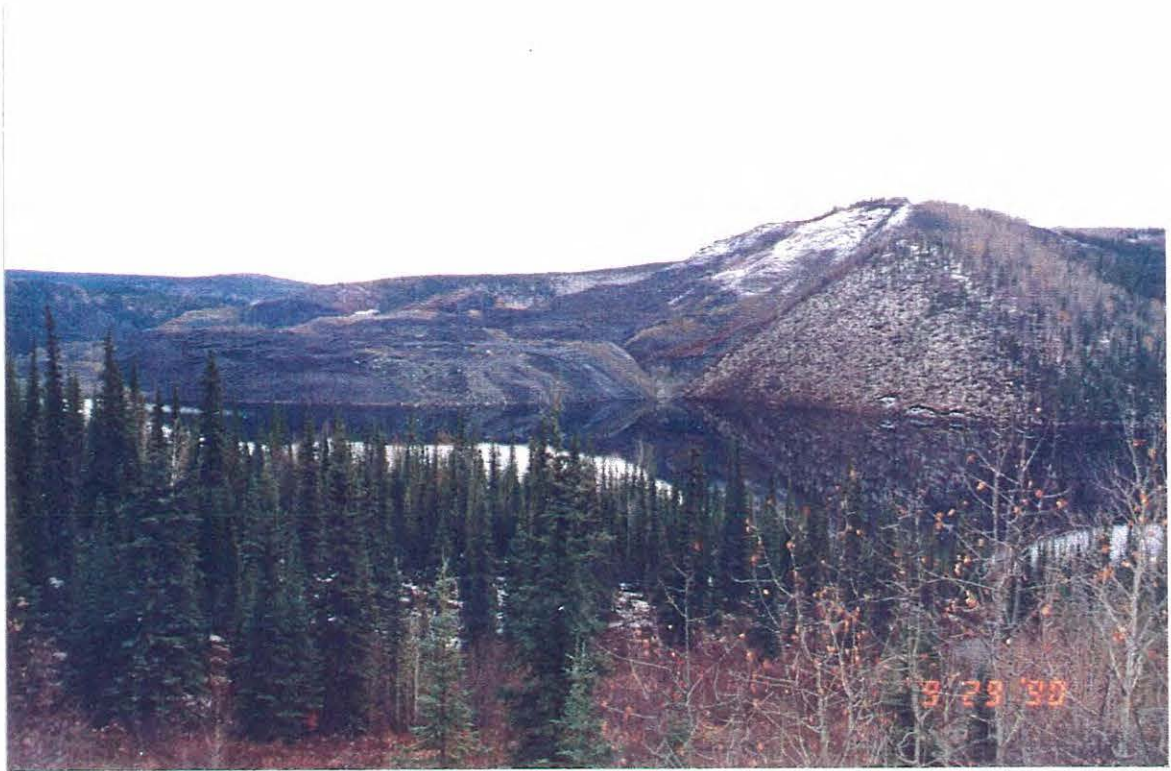
Photo 1: View of the Clinton Creek waste dump. Note small slumps along the lake shore upstream from the dump.

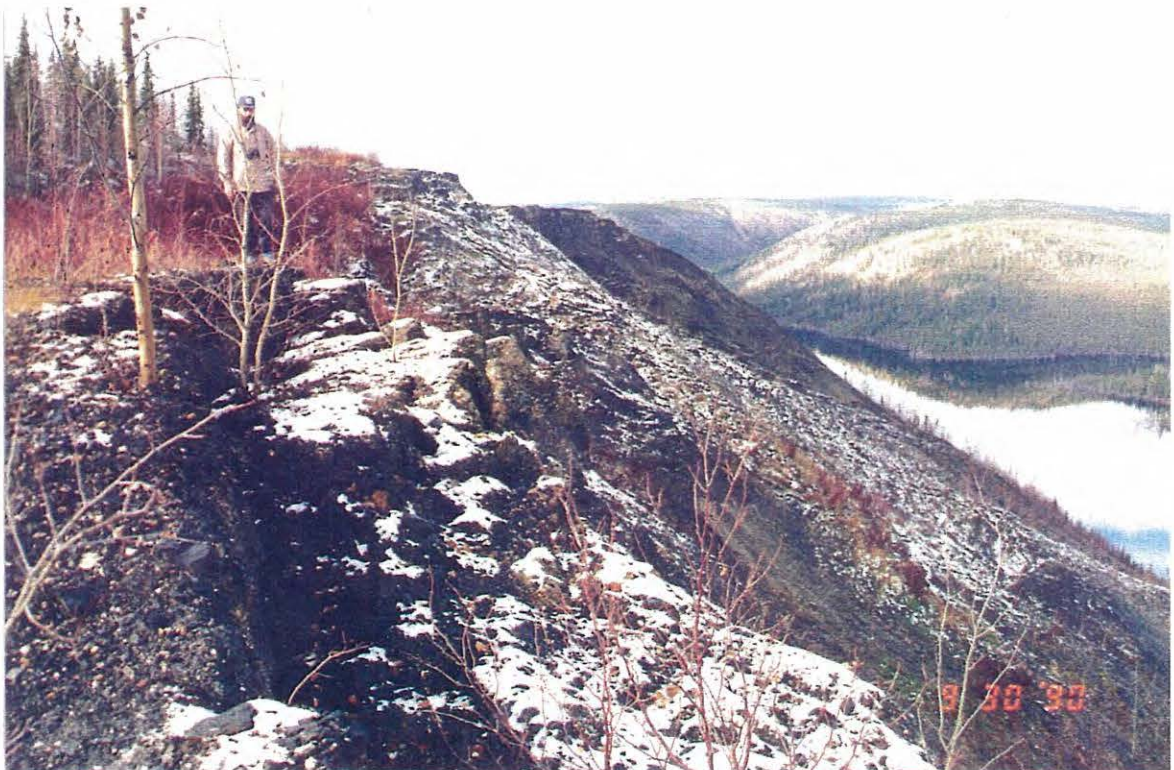
- The uppermost section of the dump (Photo 2) exhibits a series of steep and fresh-looking scarps, ranging in height from 100 to 600 mm. The uppermost slope gradient ranges from 40 to 45 degrees.
- The retrogressive character of the movement is indicated by ongoing vertical displacement and cracks extending beyond the upslope dump boundary. One scarp is about 2 m high.
- Fissures caused by the sliding of the Porcupine pit north wall extended into the waste dump (Photo 3). The rate of dump movement into the pit has possibly increased.

Photo 2: Fresh cracks along the waste dump headscarp.

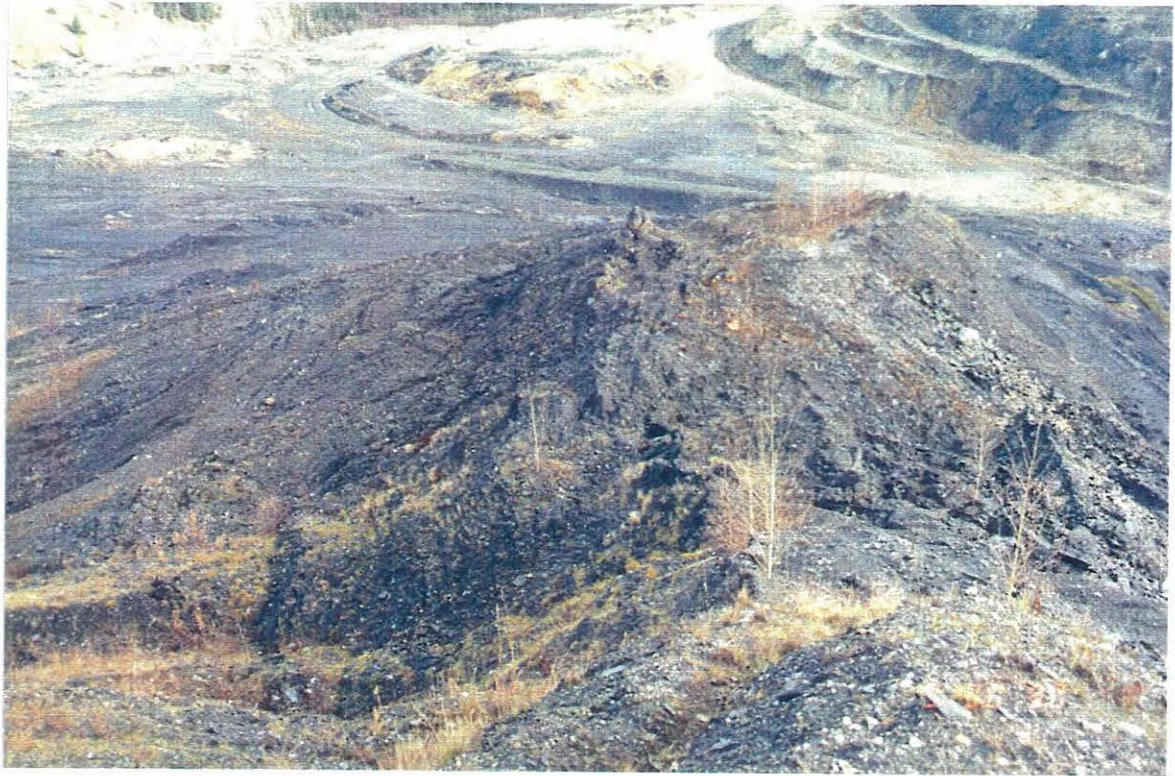
Photo 3: Unstable ridge bordering the north wall of the Porcupine pit. Refer to Photo 2 of the 1988 report.

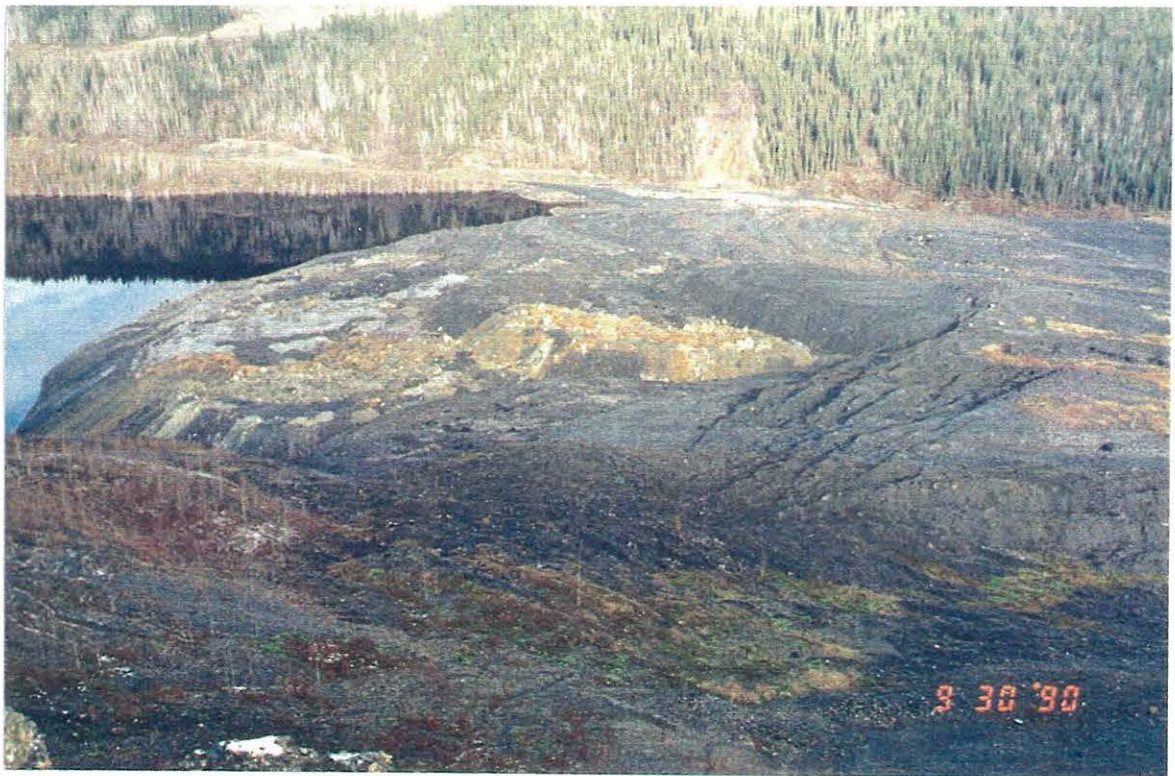
- A section of the dump forming the shore of Hudgeon Lake does not exhibit significant changes in the ground configuration along the shore line (Photo 4).
- Tension cracks running parallel to the Clinton Creek channel and traversing the access road are fresh and indicative of recent movements.

Photo 4: View of the western segment of the waste dump and the lake outlet. Refer to Photo 3 of the 1988 report.

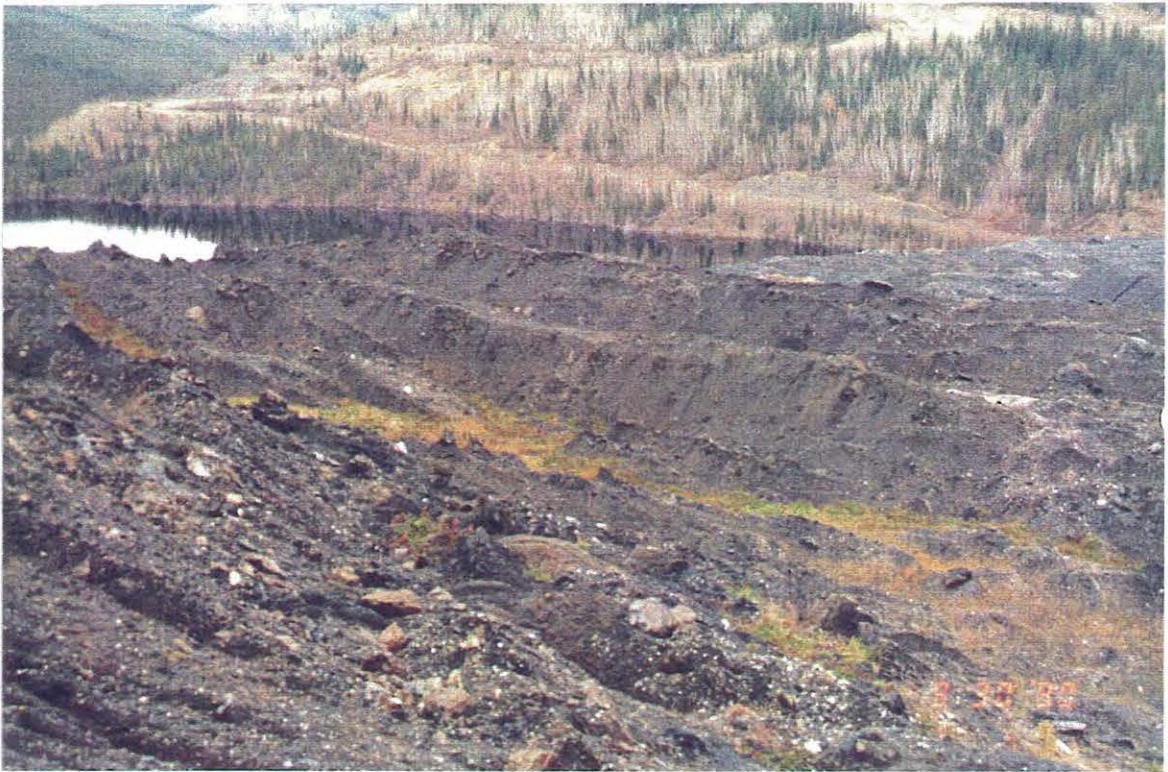
Photo 5: Prominent slide ridges parallel the toe of the hillside in the western segment of the dump.

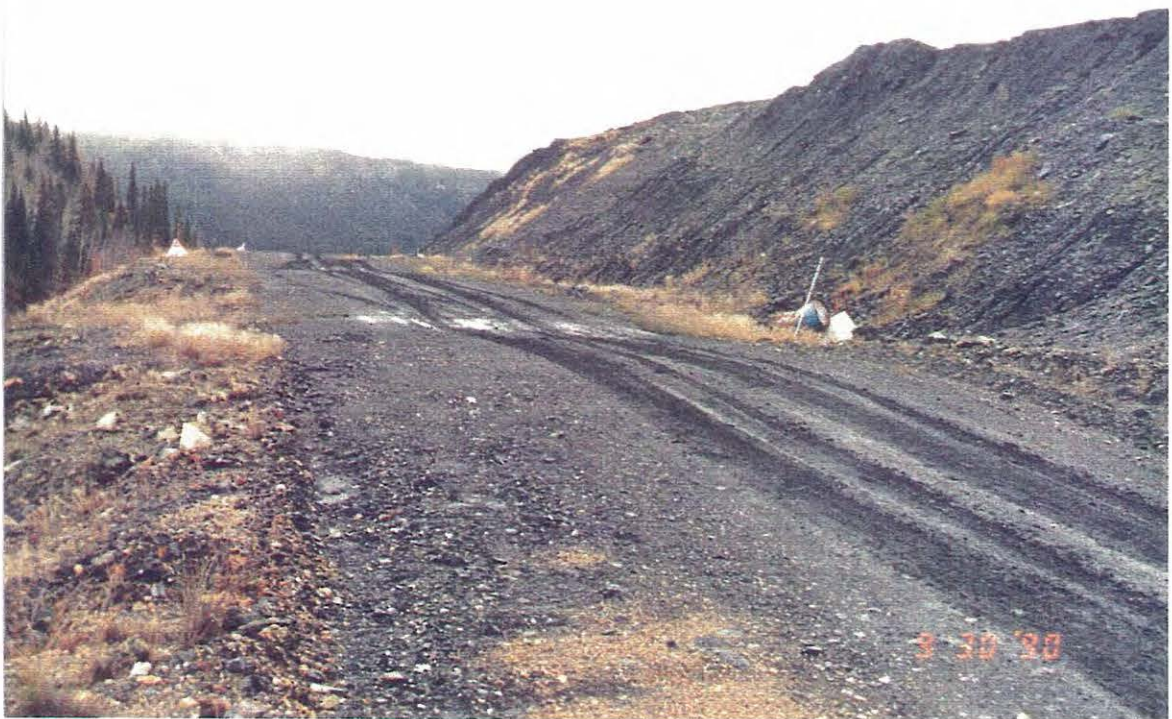
Photo 6: Uneven surface of the access road paralleling the Clinton Creek channel is indicative of ongoing movements.

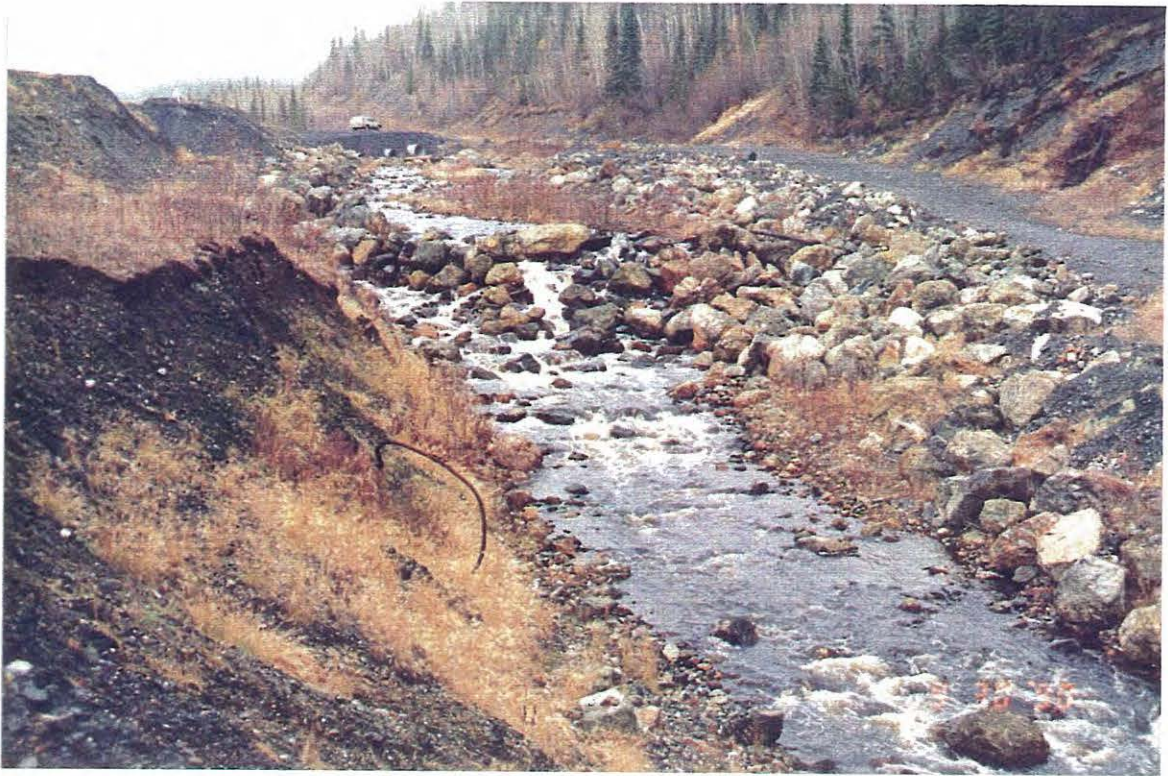
The armoured section of the creek channel between the lake outlet and the drop weir (Photo 7) exhibits only minor changes since the 1988 site visit. Minor downcutting of an incised channel upstream from the weir continues. A gravel bar deposited along the north bank upstream from the weir appears to be stable. Erosion of the south abutment at the drop weir continues without major impact on the weir.

Photo 7: View of the armoured section of the Clinton Creek channel. Refer to photos 5 and 6 of the 1988 report.

- Maintenance of the control weir at the outlet of Hudgeon Lake. This should include improvement of the weir stability and placement of additional rip-rap along the armoured channel.
- Visual monitoring of main dumps and creek channels (preferably twice a year) by a geotechnical specialist, as required.
- Maintenance of the water gauge on Clinton Creek.
- Installation and monitoring of water gauges in both lakes.
- Installation of reference points within the Clinton Creek channel and their yearly survey.
- Installation of survey prisms at selected areas of the Wolverine Creek waste dump and their yearly survey.
- Installation of properly-designed warning signs along the access road and at the creek channels.

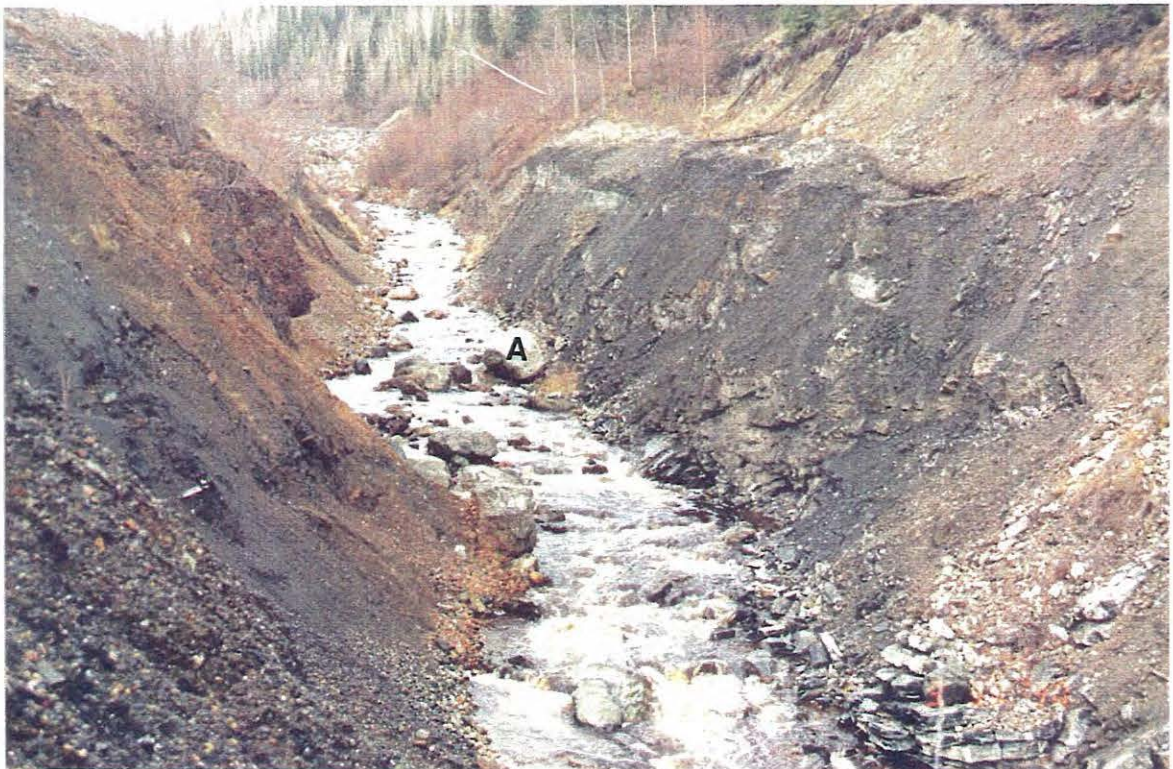
The channel downstream from the weir to a point approximately half way across the waste dump area has also been relatively stable since 1988. This channel section has a constant gradient (upstream from point A on Photo 8) and contains a series of small steps across the channel bottom. Erosion of the south bank is minor. Similarly, the channel downcutting and erosion of the north bank has slowed downstream from point A.

Photo 8: Clinton Creek channel downstream from the armoured segment. Refer to photos 7 and 8 of the 1988 report.

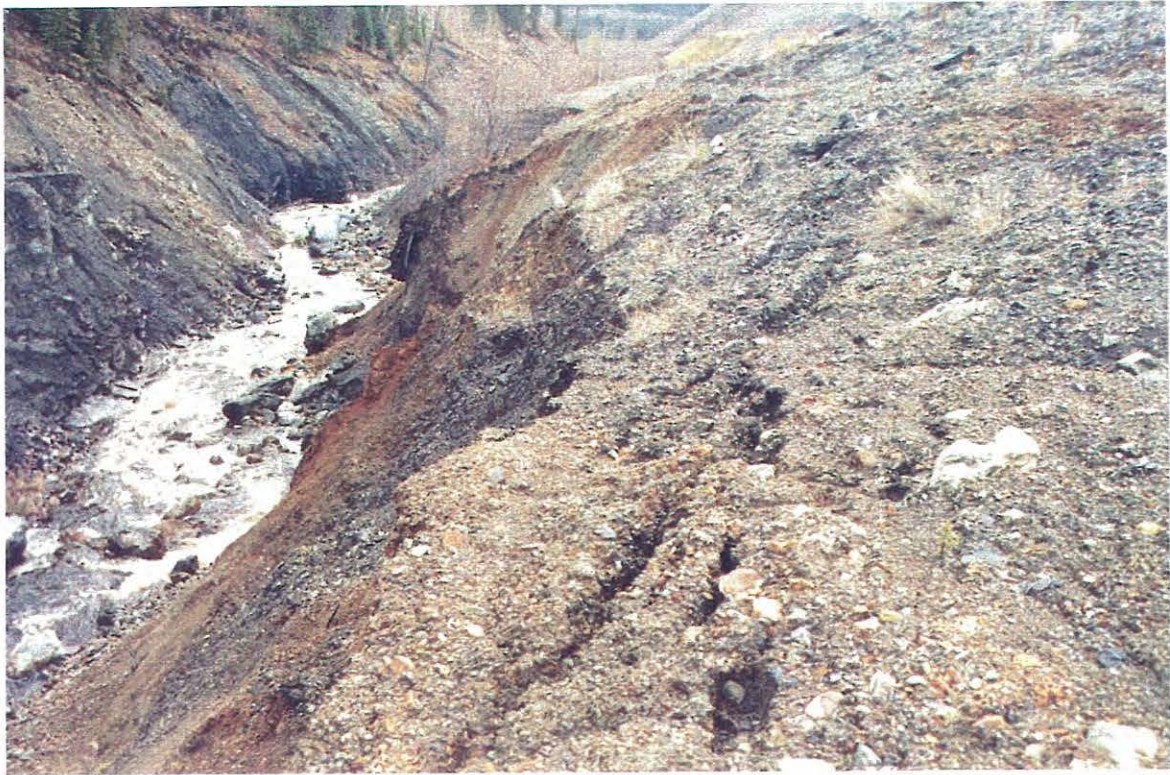
The south bank, comprised of mine waste, is eroding and the steep bank is sliding (Photo 9). There is obvious loss of material and dump movement into the creek channel.

Photo 9: View of the middle segment of the creek channel. Note sloughing of the bank formed by the waste material.

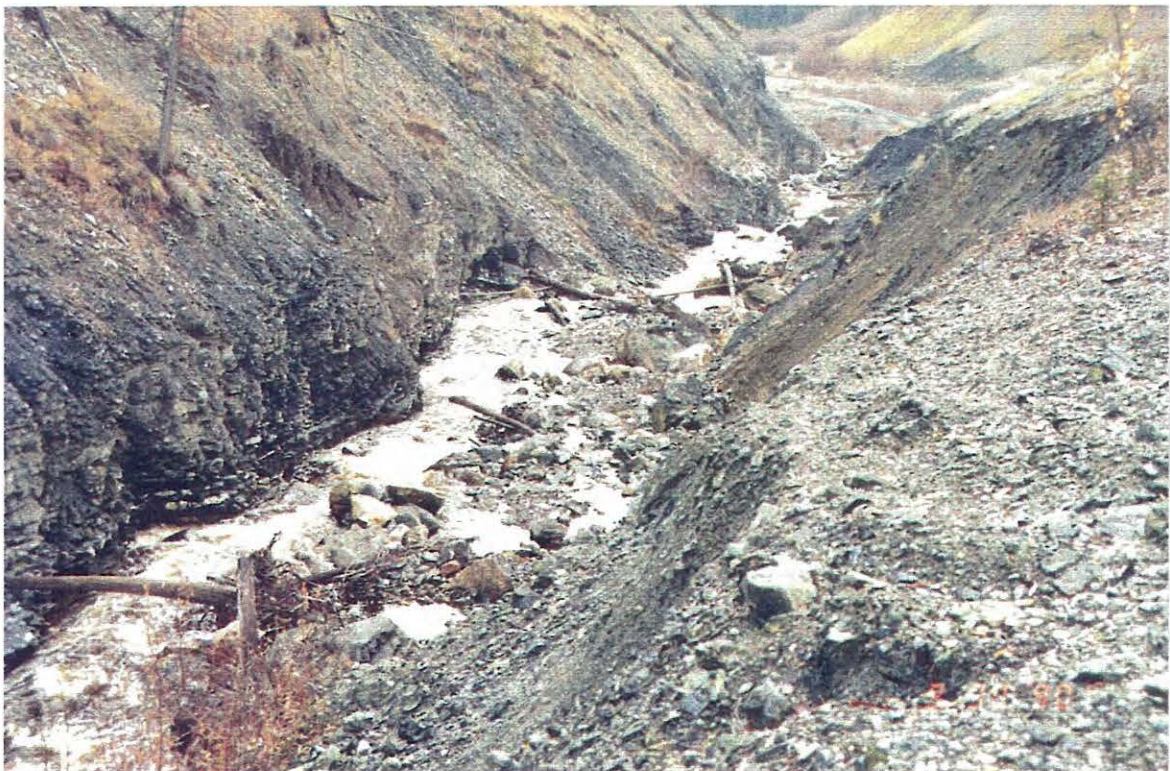
The downstream segment of the creek channel shows very little visually recognizable changes since 1988. Boulder pavement of the channel bottom is more consistent in this sector than further upstream. The bedrock forming the north side of the channel comprises thinly-bedded and jointed shale with some calcareous sandstone, locally. However, the bank morphology and the channel pattern is almost the same as observed in 1988 (Photo 10).

Photo 10: Downstream segment of the Clinton Creek channel does not exhibit major changes since 1988. Refer to photos 9 and 10 of the 1988 report.

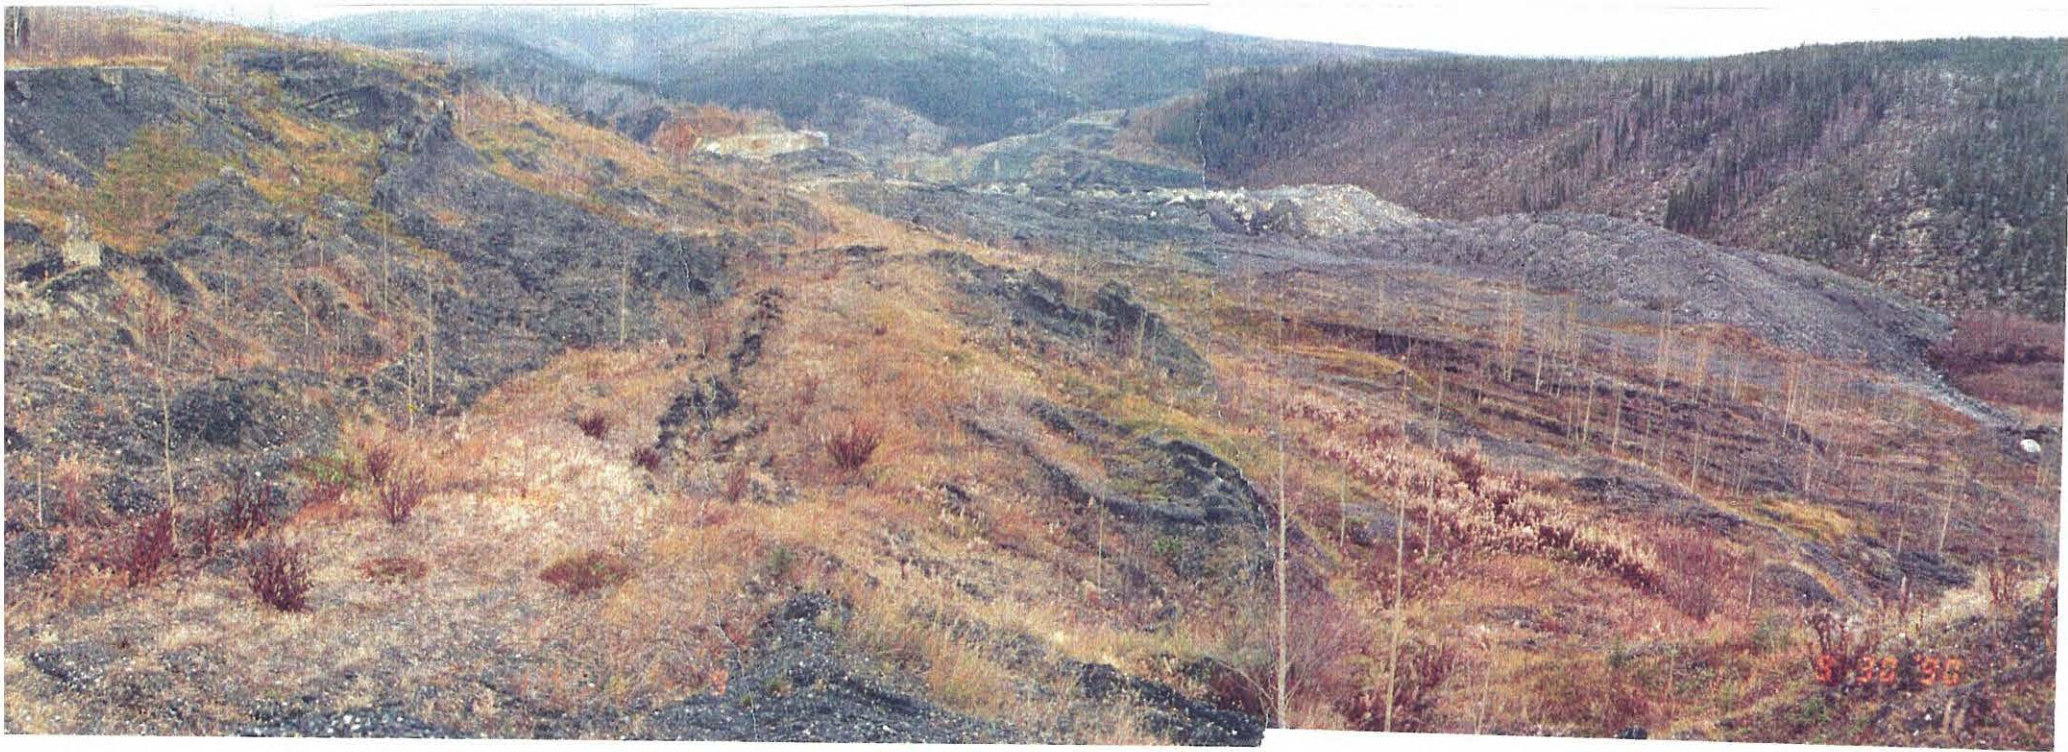
Steep, fresh-looking scarps outlining the upper limit of the slide area encompass the entire waste dump. The southern half of the dam appears to be considerably more active than the northern one (Photo 11). The slide toe also exhibits discernable changes since 1988.

Photo 11: Oblique view of the Porcupine Creek waste dump, looking north. Fresh appearance of the cracks in the headscarp area is indicative of current and ongoing movements. Refer to Photo 4 of the 1988 report.

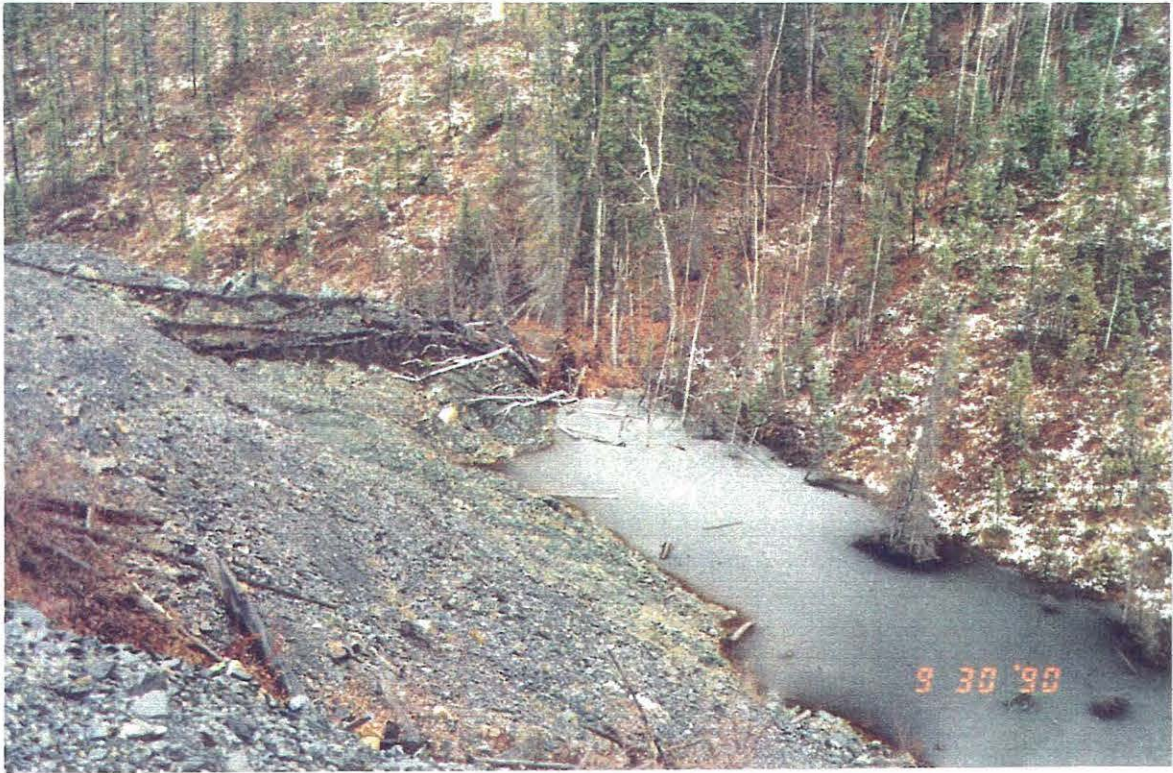
The valley blockage caused by a relatively narrow slump, combined with ground heave, did not significantly change since 1988 (Photo 12). However, the lake inlet leading to this blockage appears to be somewhat narrower. Its width ranges from about 5 to 15 m. At the narrowest point, the slide lifted up glaciolacustrine material originally covering the valley bottom. Water from this inlet seeps through the waste rock.

Photo 12: Eastern lobe of the pond formed by the sliding Porcupine dump appears to be narrower than in 1988. Refer to photo 12 of the 1988 report.

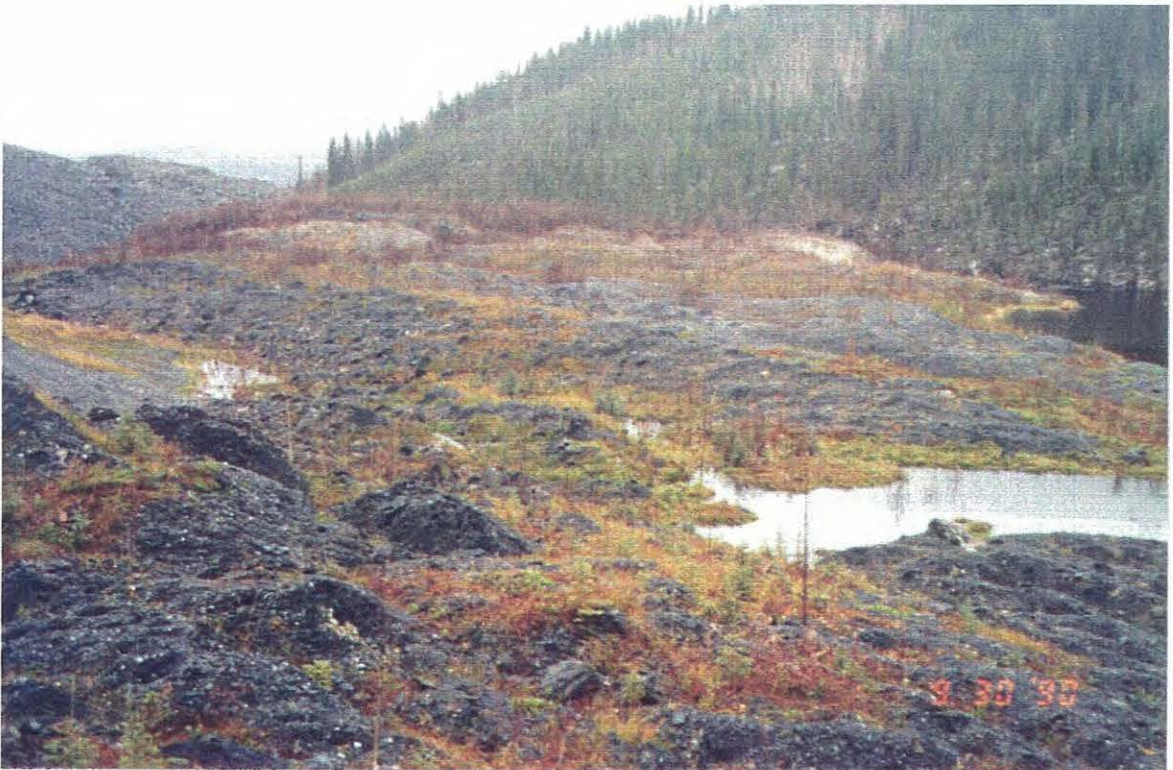
Photo 13: View of the western discharge channel. Water from this channel infiltrates into the waste, and further downstream, the channel is dry.

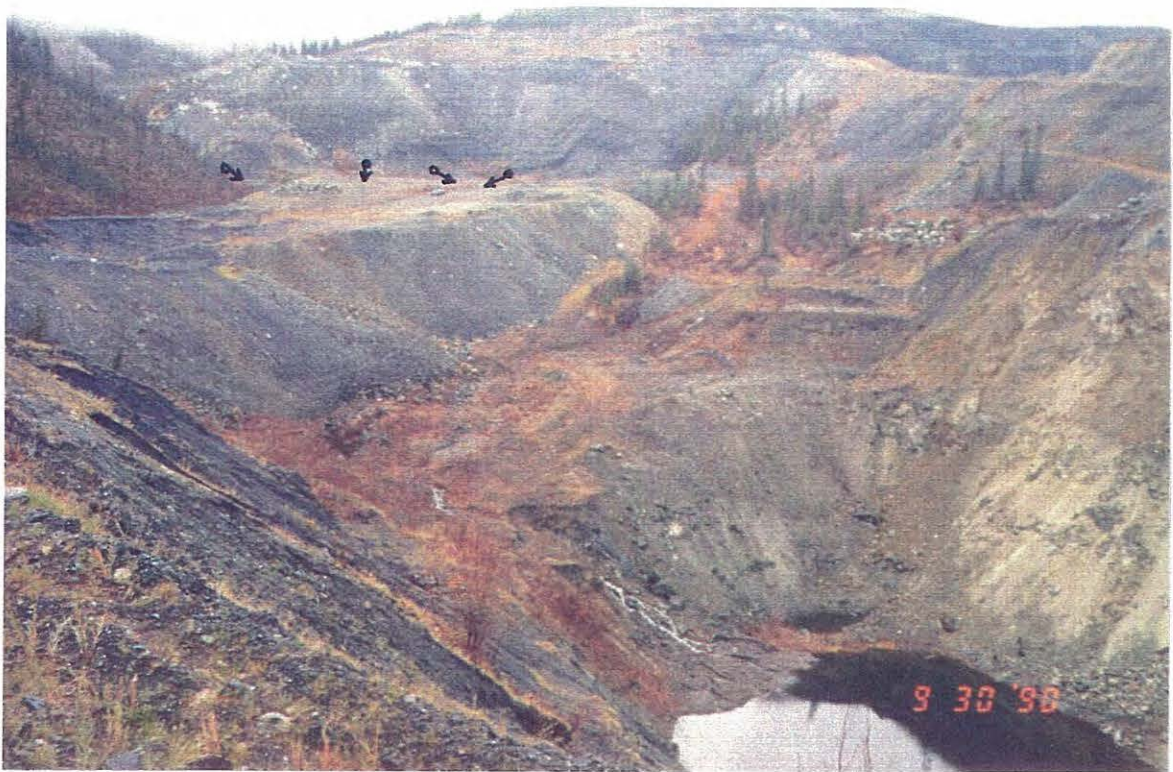
There is a significant amount of seepage discharged at the north end of the dump. This seepage is dispersed over a relatively wide zone and does not have any adverse impact on this dump sector (Photo 14).

Photo 14: Underground flow is discharged at several locations from the northern toe of the Porcupine dump. This seepage apparently contributes to the instability of the dump on the left.
