ABANDONED CLINTON CREEK ASBESTOS MINE

**REPORT
ON
1990 SITE INSPECTION**

Prepared for:
NORTHERN AFFAIRS PROGRAM
Whitehorse, Y.T.

June 1991
G052

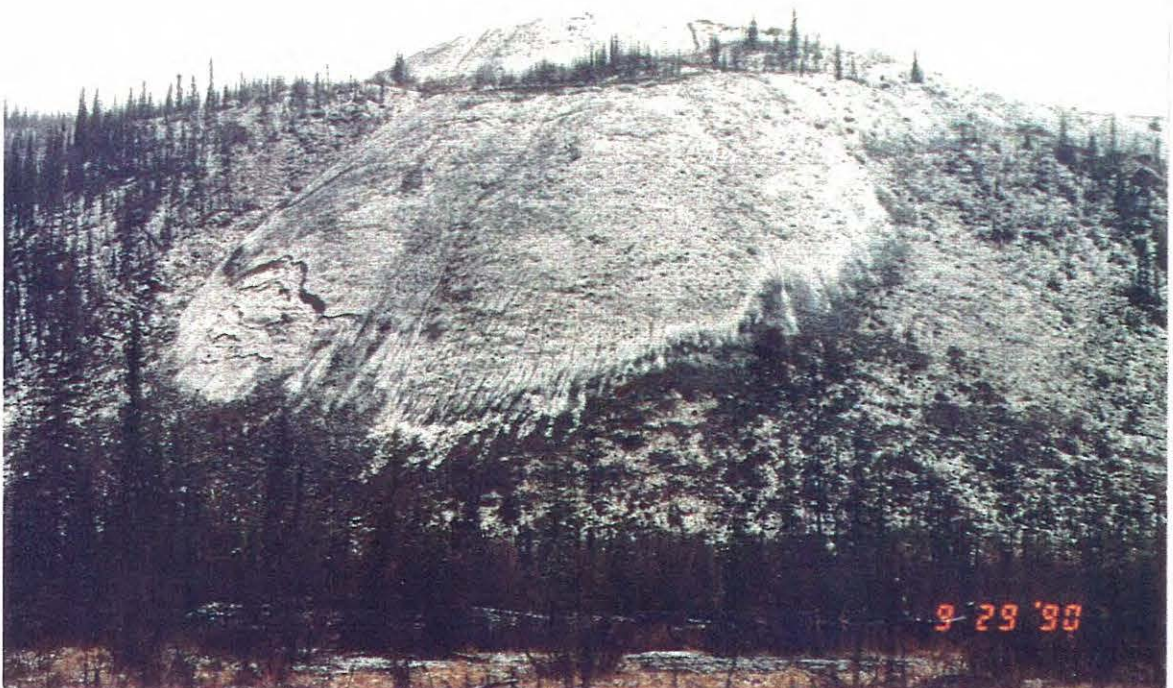
This dump, deposited on the south slope of the Clinton Creek valley, has a low volume. Its crest is only about 400 m long and 20 m wide. It rests on about a 25 degree slope and the dump surface gradients range from 37 degrees (west and center segments) to 42 degrees (eastern portion). The toe of the dump is located well above the valley bottom (Photo 15). Its position shows very little chance since 1986.

The dump is unstable, as evidenced by fresh headscarps along its crest and tension cracks, namely across its eastern segment. It appears that the toe of the dump, in its center and eastern segments, acts as a passive wedge controlling the movement of the upper portion of the dump.

Photo 15: View of the Snowshoe waste dump. Fresh cracks exist along the crest of the dump and at its toe.

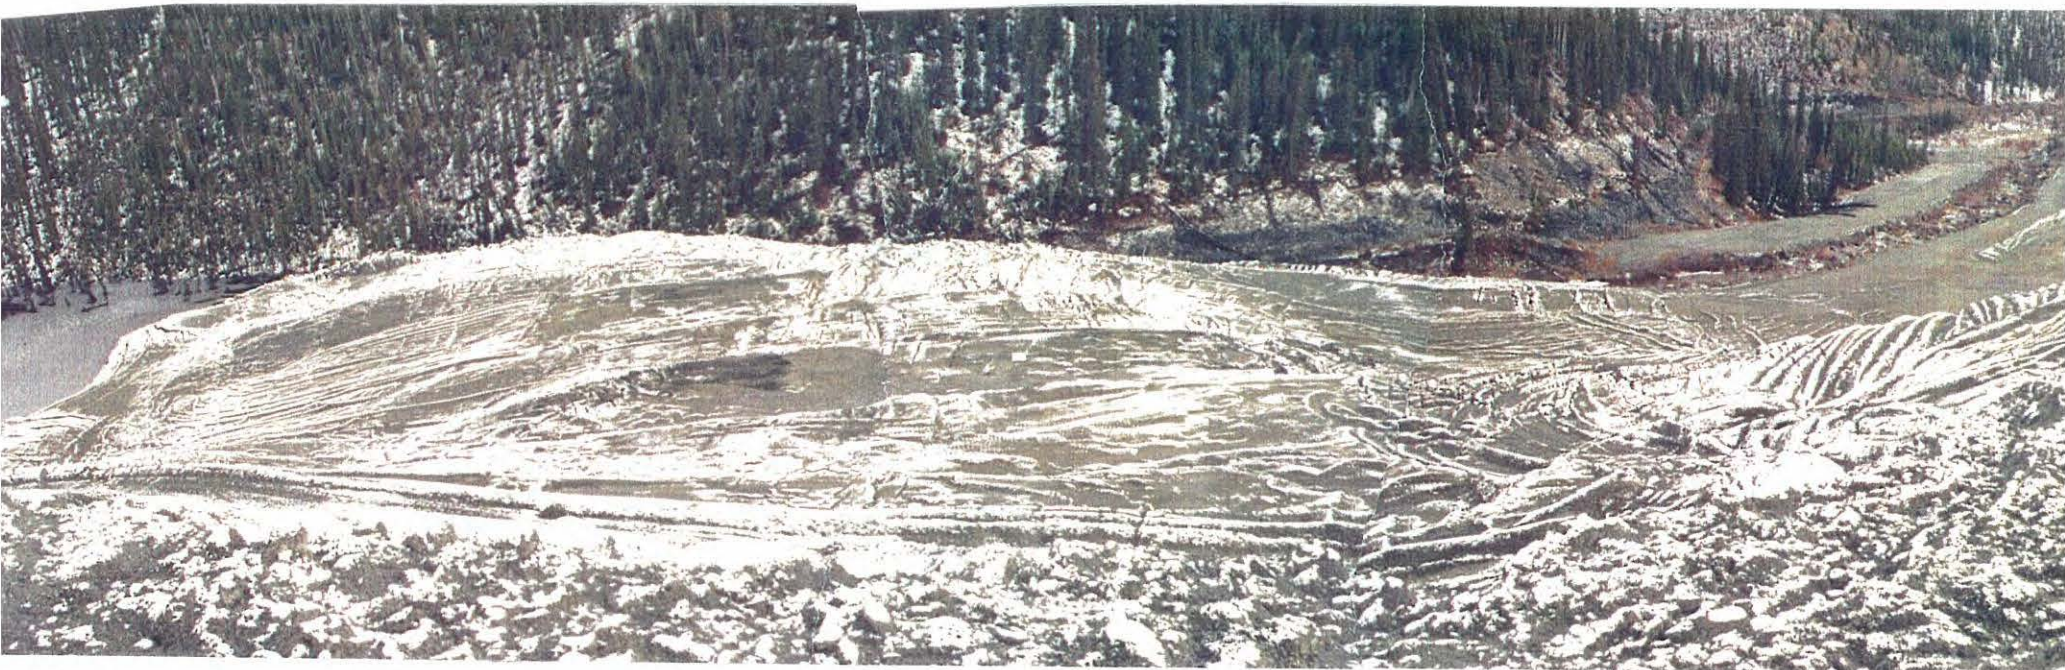
The toe of the south lobe has expanded northward and its height above the channel has increased significantly. Prevailing fissures in the toe area are oriented perpendicularly to the creek channel (Photos 16 and 17). Pieces of argillite and chunks of till found on the surface are indicative of a deep-seated nature of this failure. The toe is eroding and steep banks (ranging from 40 to 60 degrees) have been formed (Photo 18). The creek channel has been pushed up and against the east valley wall, which is also eroding. The downstream segment of the channel is cut within the argillaceous bedrock. More resistant rock blocks and fragments pave the channel bottom through this area (Photo 19).

Photo 16: View of the south lobe of the Wolverine valley tailings pile and the armored spillway. Note that the prevailing cracks are perpendicular to the channel, indicating bulging of the toe area.

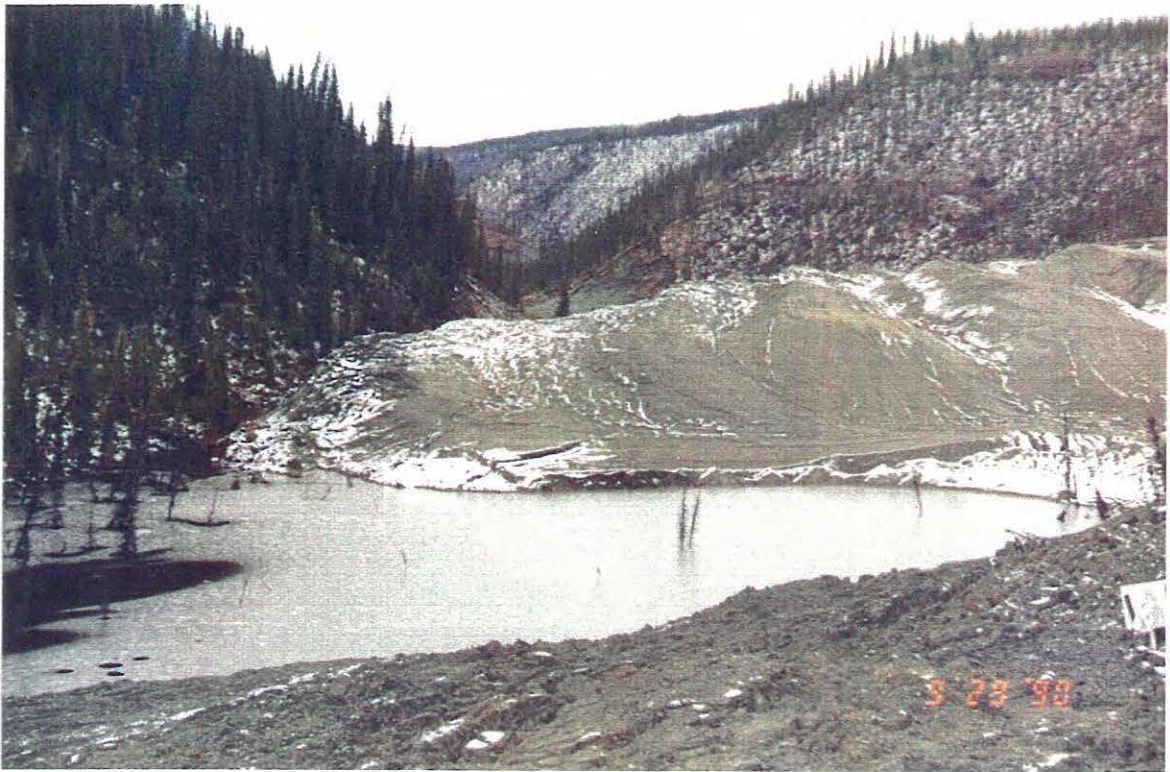
Photo 17: View of the upstream portion of the south lobe. Refer to photo 15 of the 1988 report.

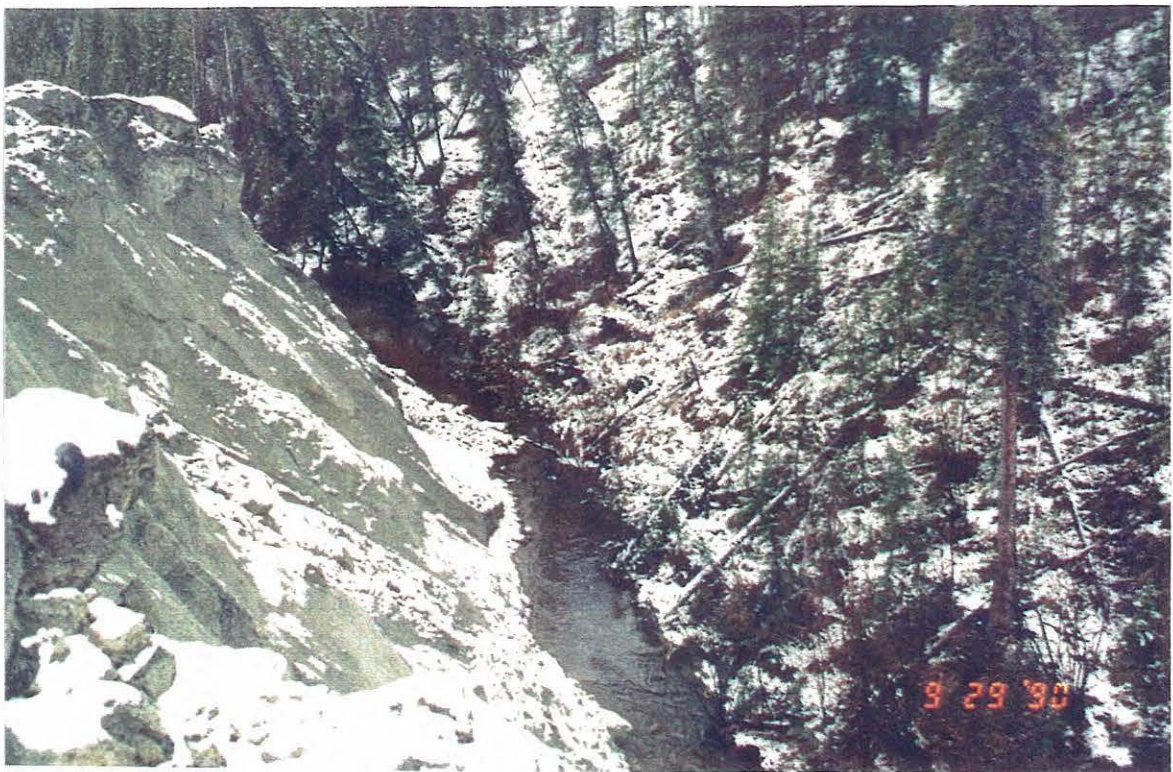
Photo 18: Outlet from the south lobe is quite narrow. The valley slope is locally sliding.

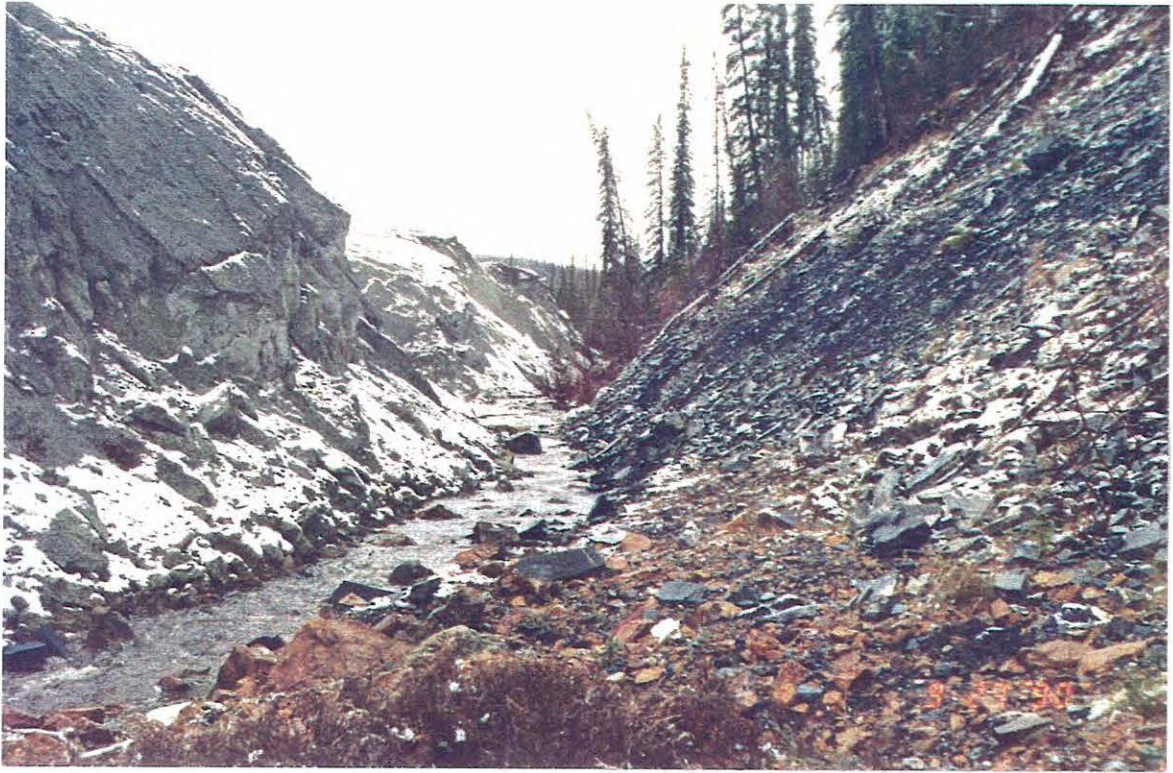
Photo 19: View of the outlet channel through the south lobe. Refer to photos 20 and 21 of the 1988 report.

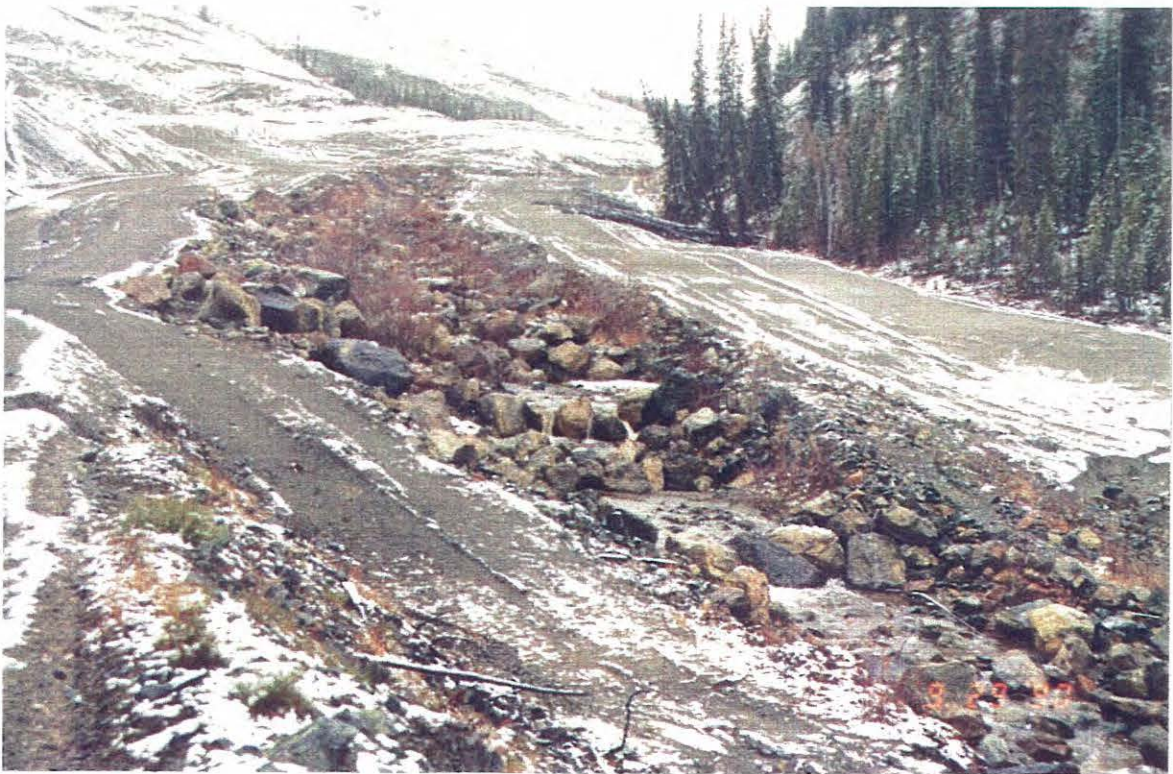
Since the armoured spillway channel does not extend into the outlet from the lake, it could be by-passed by a larger flow and possibly destroyed. This would lead, in our opinion, to retrogressive erosion and, in turn, the transportation of significant volumes of tailings downstream.

Photo 20: View of the armoured Wolverine Creek spillway. Refer to Photo 22 of the 1988 report.

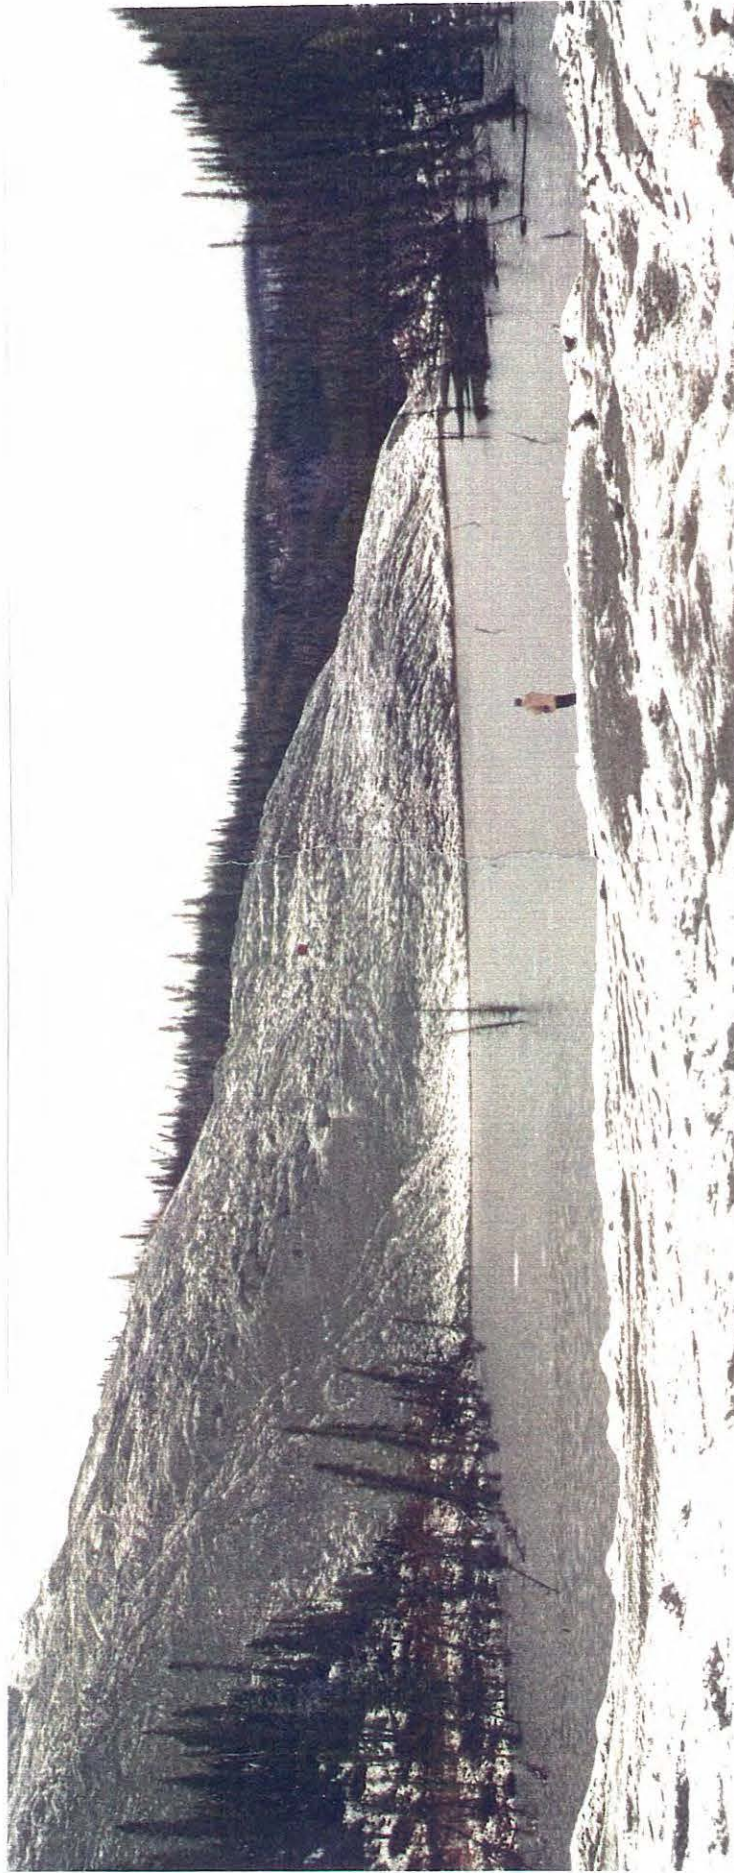
The height of the toe of the north pile lobe is increasing (Photo 21). This, in turn, has caused heaving of the original valley bottom along its east side. It is estimated that this terrain was lifted up by about 3 m. This lobe is also spreading upstream, pushing away and raising the original ground. The creek has cut its channel through the blockage within tailings, which are obviously more erodible than overburden or bedrock. The west bank, formed by tailings, is approximately 5 m high.

Photo 21: View of the north lobe of the Wolverine valley tailings pile. Refer to photos 17 and 18 of the 1988 report.
