ABANDONED CLINTON CREEK ASBESTOS MINE

**REPORT
ON
SITE INSPECTION**

Prepared for:
NORTHERN AFFAIRS PROGRAM
Whitehorse, Y.T.

May 1993
G052

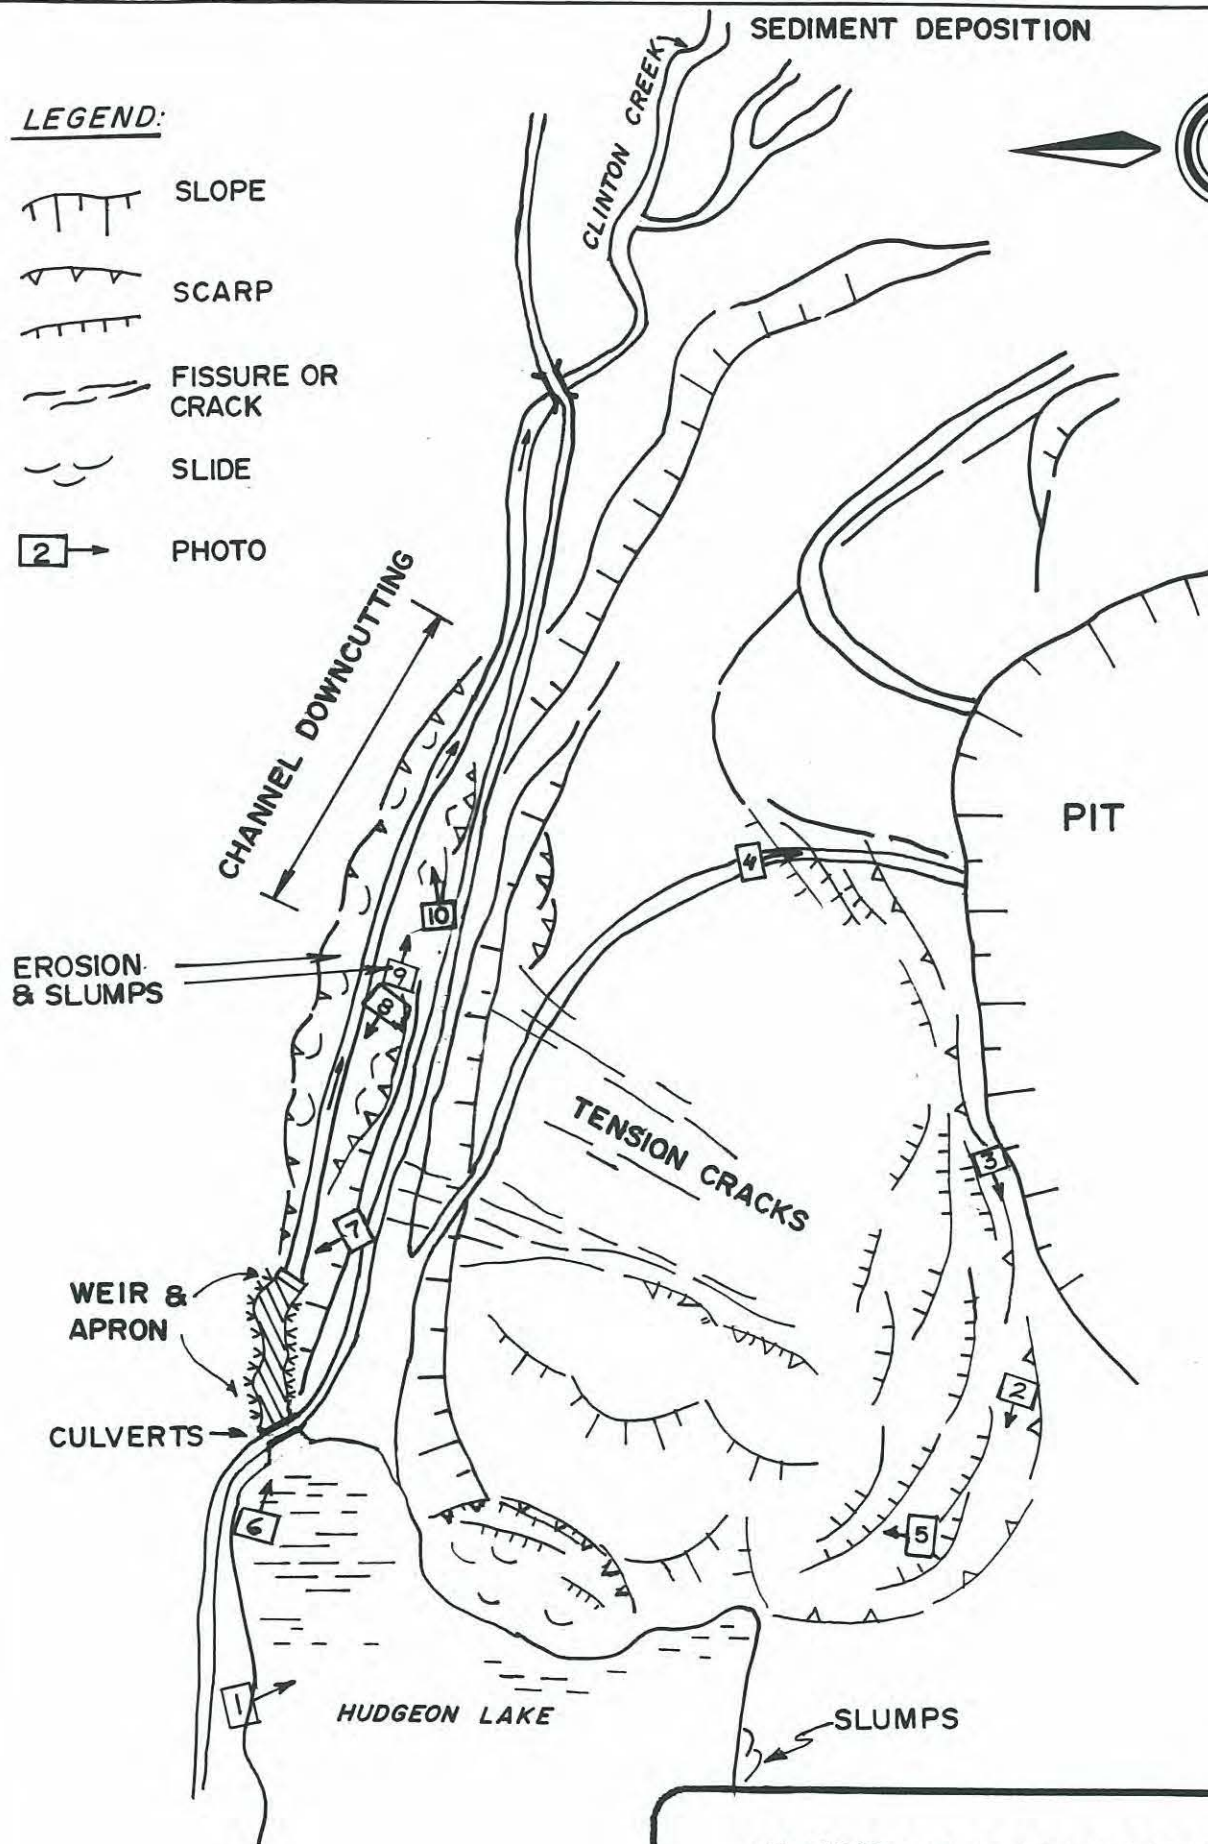
FIGURE 1

**CLINTON CREEK WASTE DUMP
SCHEMATIC PLAN**

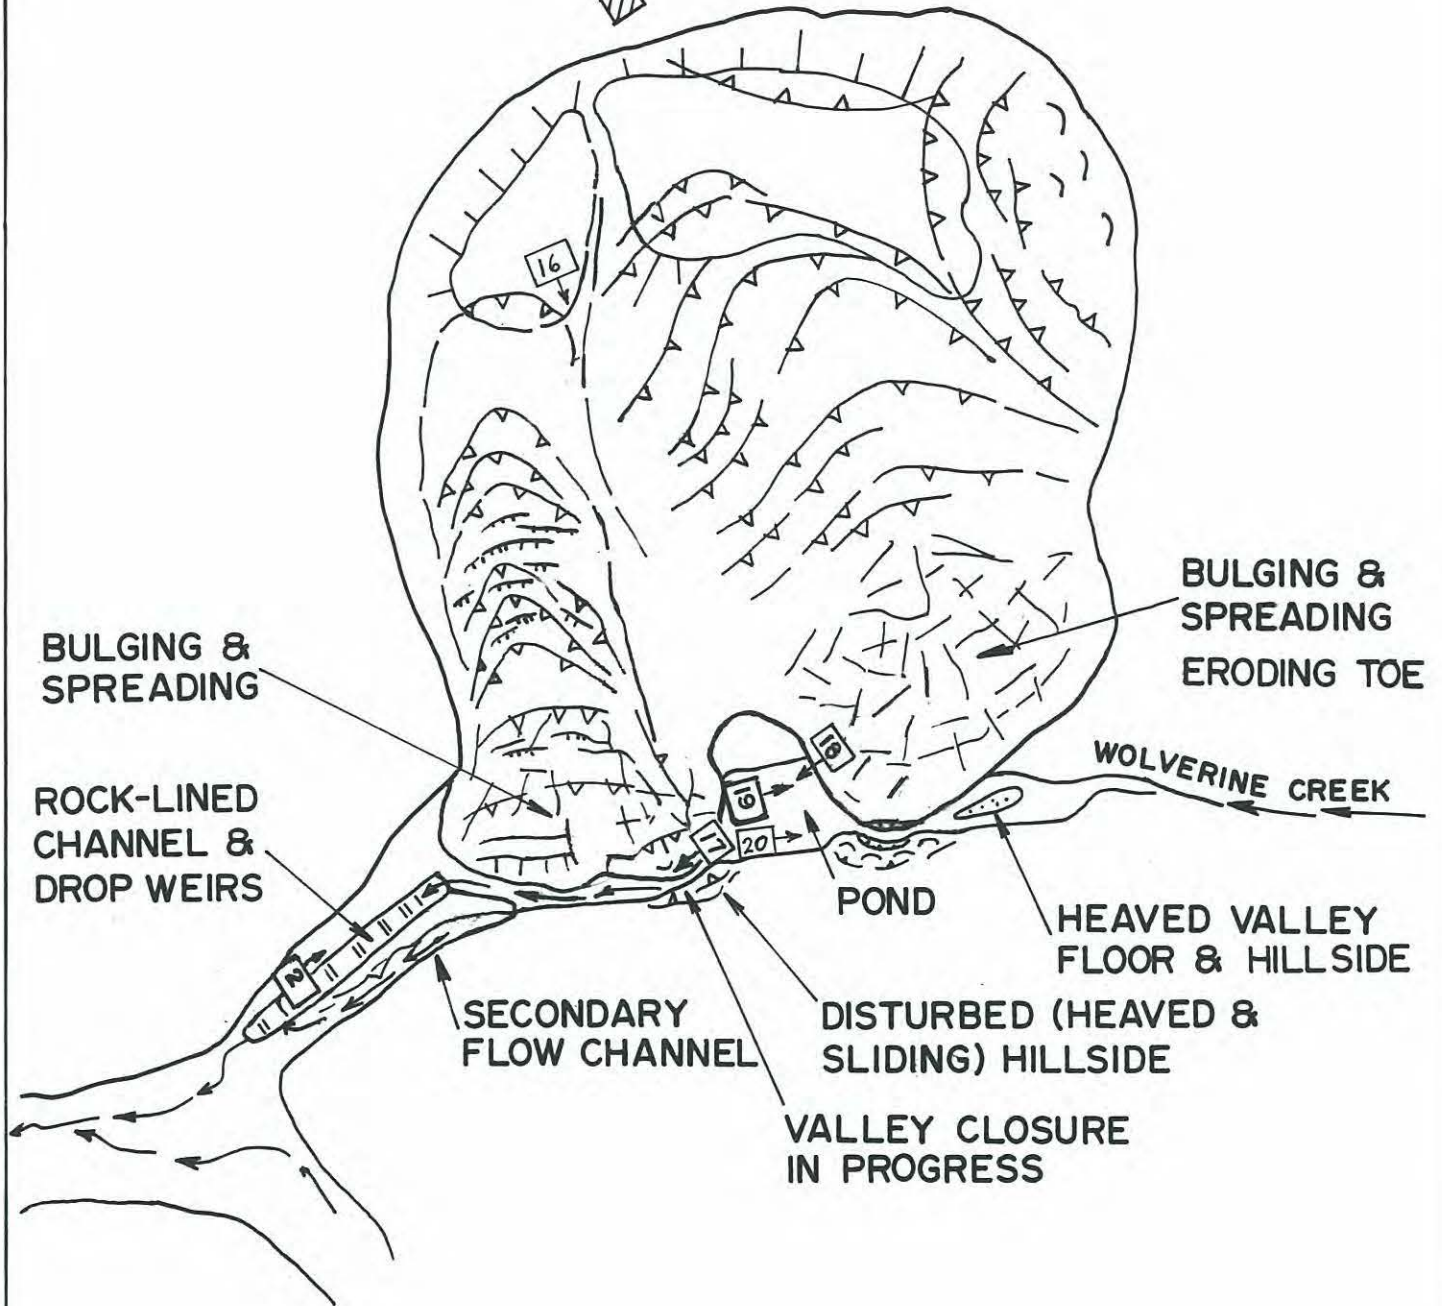
FIGURE 3

BULGING & SPREADING

BULGING & SPREADING
ERODING TOE

HEAVED VALLEY
FLOOR & HILLSIDE

DISTURBED (HEAVED &
SLIDING) HILLSIDE

VALLEY CLOSURE
IN PROGRESS

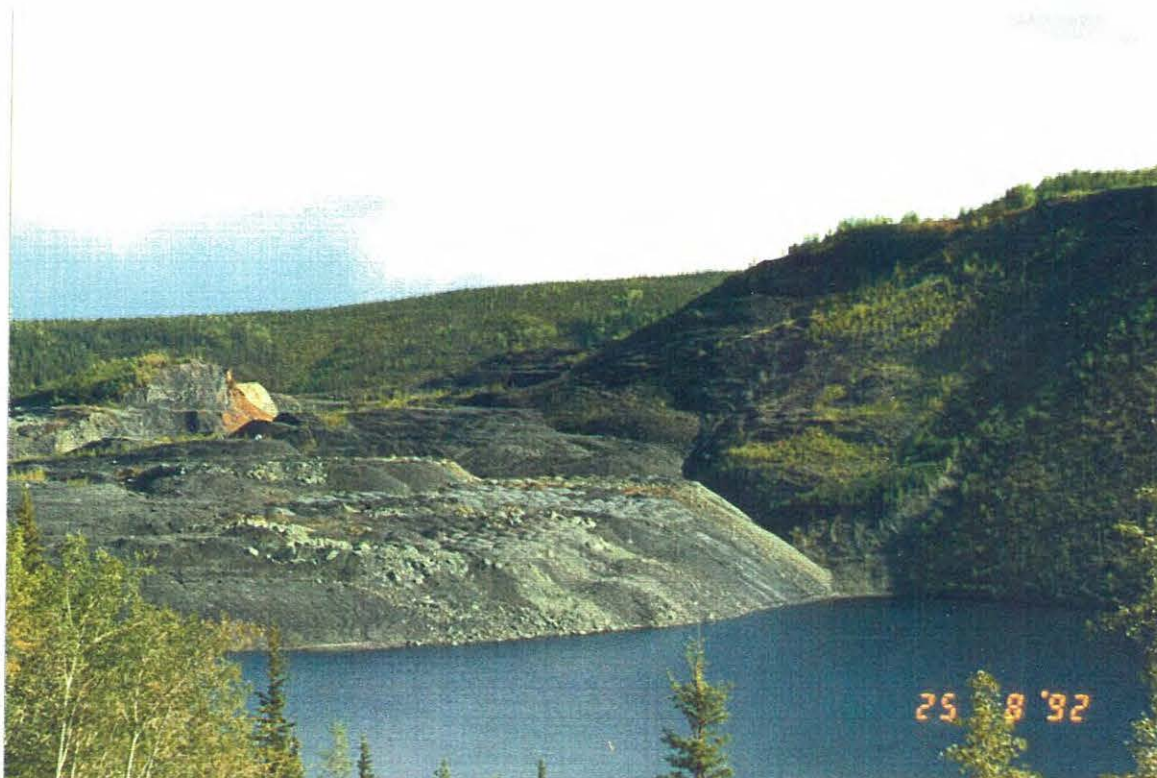
Fresh cracks, scarps and fissures were observed, similar to those noted during previous inspections, in the upper and middle segments of the waste dump. The waste dump toe, forming the valley plug, appears to be similar to its configuration in 1990 (Photo 1). The headscarp area has retrogressed further upslope from the waste dump limit and additional localized segments of natural ground have become unstable. While difficult to assess visually, it is obvious that the dump toe had to advance into the creek channel. However, because of creek erosion, the position of the toe of the dump relative to the creek channel appears to be the same as before.

Photo 1: Clinton Creek waste dump and Hudgeon Lake in the foreground. While the general configuration appears to be similar as in 1990, cracks and scarps confirm ongoing movement.

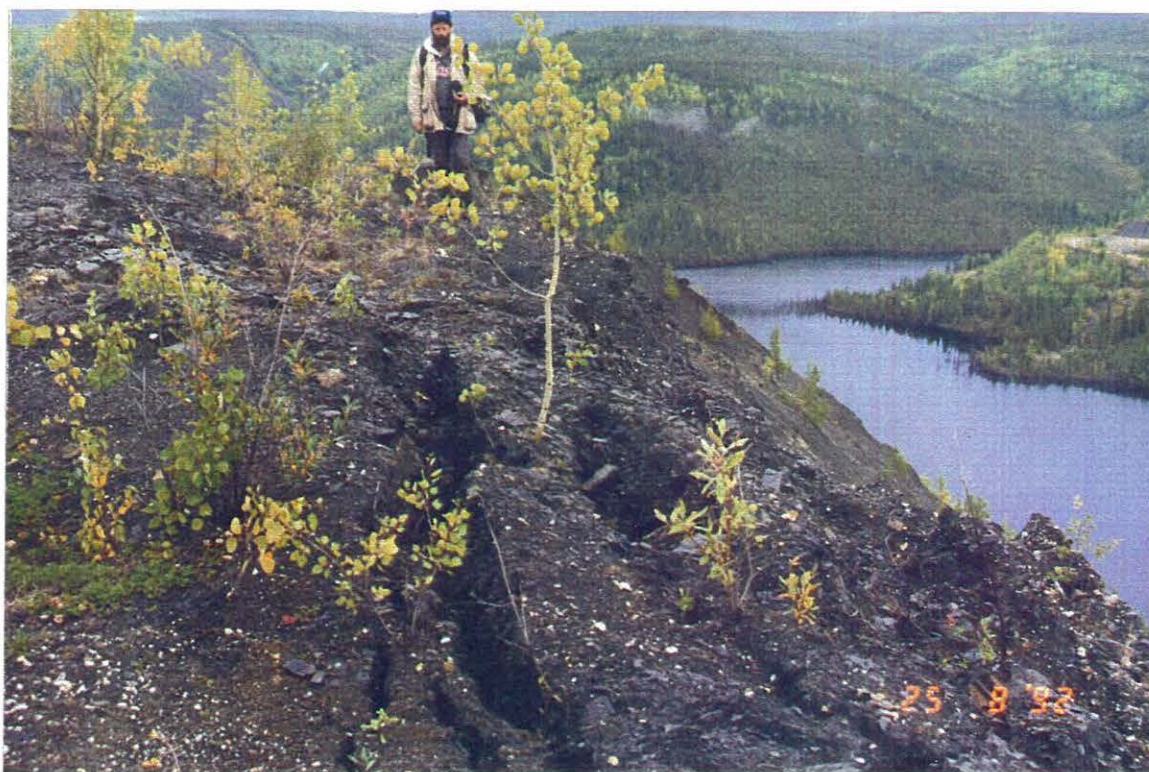
- The uppermost section of the dump exhibits a series of steep and fresh-looking scarps, ranging in height from 0.1 to 1.0 m. The uppermost slope gradient ranges from 40 to 45 degrees.
- The retrogressive character of the movement is indicated by ongoing vertical displacement and cracks extending beyond the upslope dump boundary (Photo 2). One scarp is about 2 m high.
- Fissures caused by the sliding of the Porcupine pit north wall extend into the waste dump and vice versa (Photo 3). The rate of dump segment affected by the pit wall instability has possibly increased.
- A step in the former access road to the Porcupine pit (Photo 4) indicates that the total vertical dump displacement at this location exceeded 3 m.

Photo 2: Fresh cracks parallel the headscarp of the Clinton Creek dump.

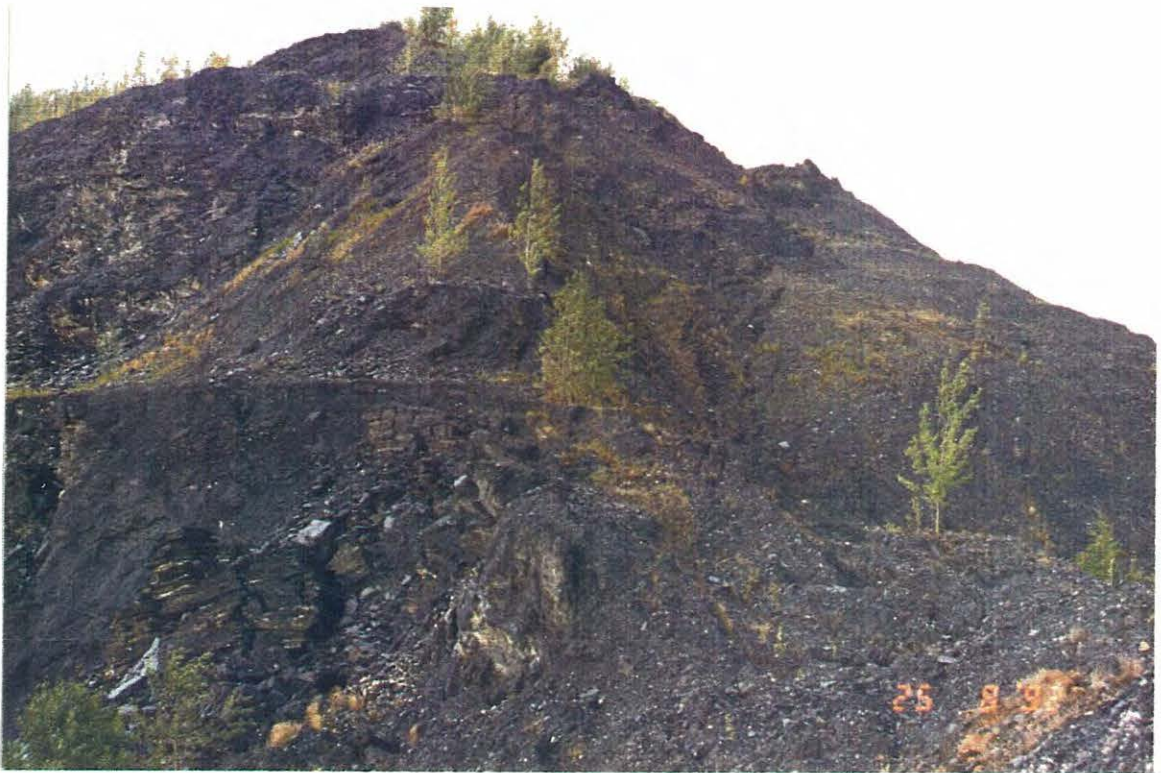
Photo 3: View of a ridge between the Porcupine pit and Clinton Creek waste dump. Slides from the pit wall extend into the dump material.

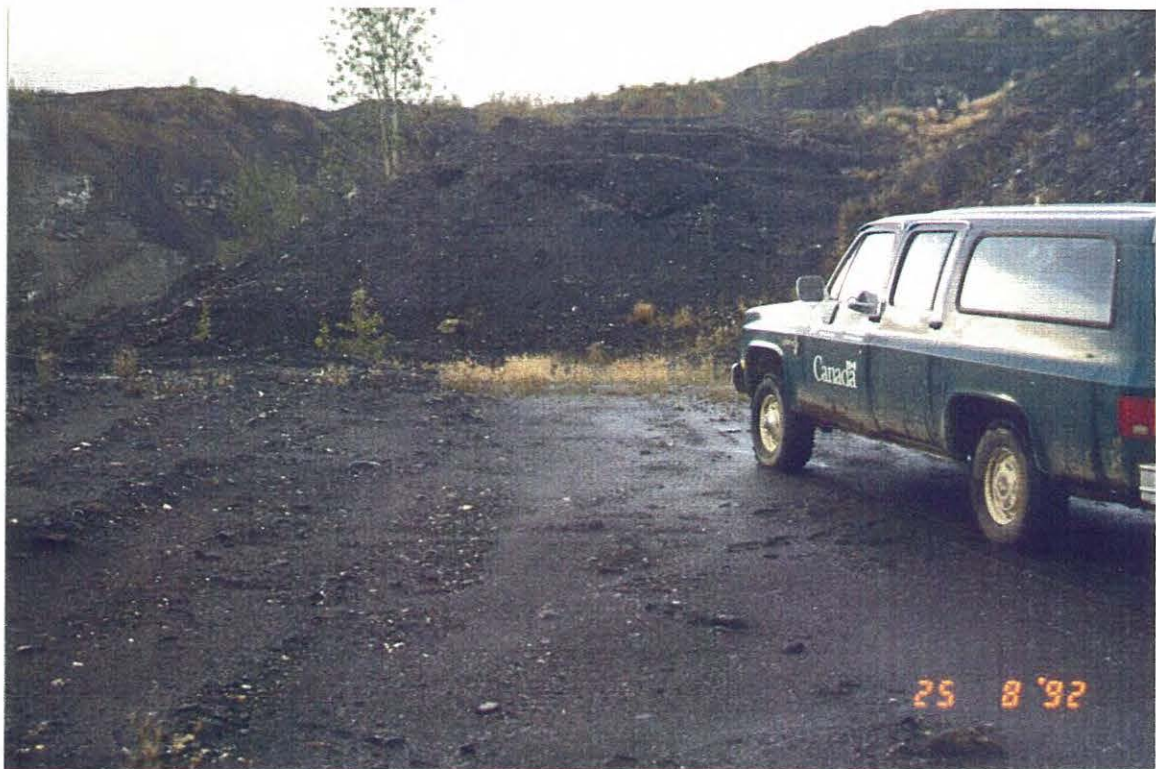
Photo 4: A step in the former access road into the pit indicates extent of the dump vertical displacement at this location.

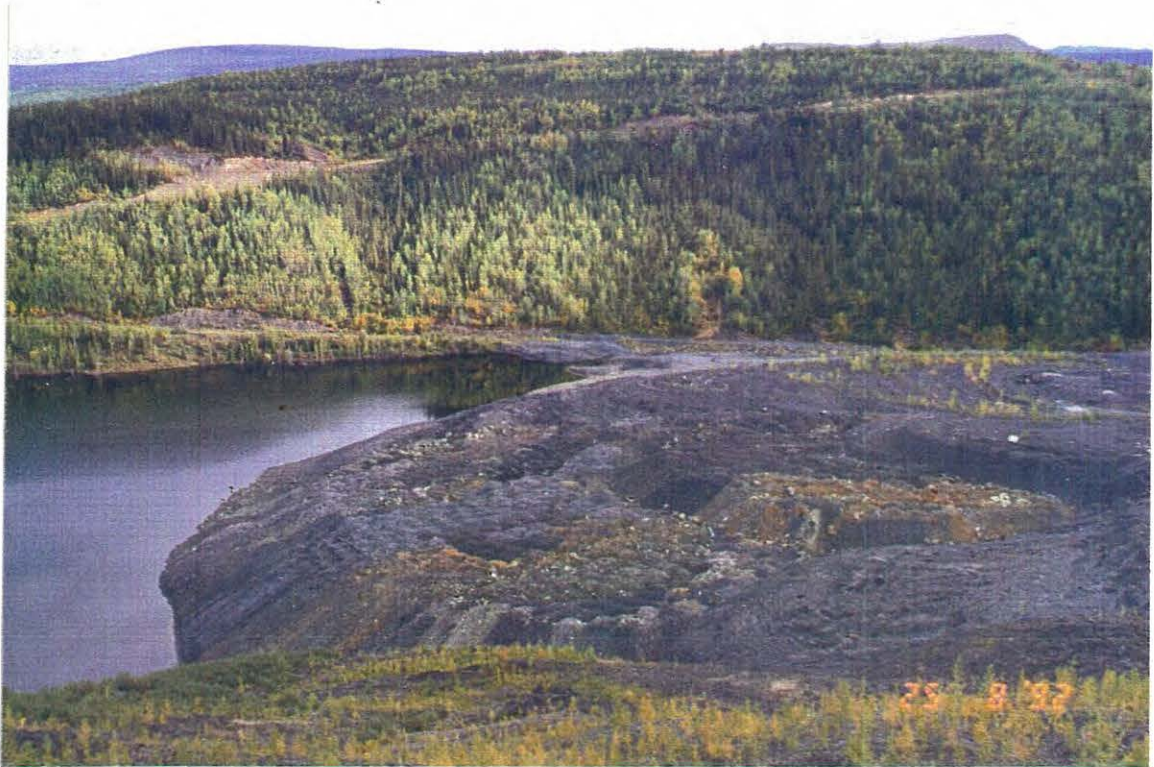
- The west segment of the dump, forming the valley plug, does not show significant changes in the ground configuration (Photo 5). The dump toe forming the lake shoreline appears to be somewhat flatter than before. No visually discernible terrain changes were observed along the Clinton Creek channel and the access road.

Photo 5: View of the Clinton Creek waste dump forming the valley plug. Hudgeon Lake outlet in background.

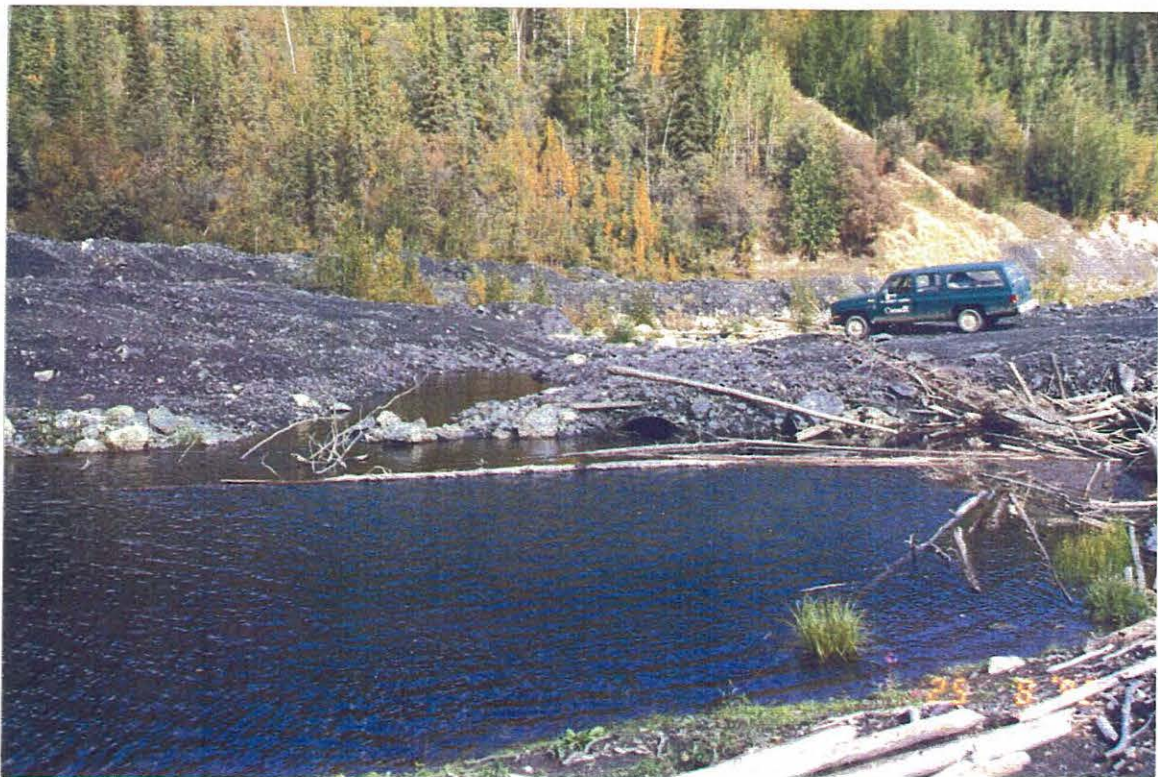
The lake outlet has been modified in the fall of 1991. Two culverts were removed from the north side of the outlet and an overflow section was excavated (Photo 6). The resulting "spillway" (approximately 6 m wide) was not armoured. While the channel gradient between this location and the armoured section is gentle, some erosion is likely to occur. Timber and other debris partially plug the remaining two culverts.

Photo 6: Modified Hudgeon Lake outlet; two culverts have been removed and an overflow channel excavated. The remaining two culverts are partially blocked.

- armouring (by rip-rap) of the Hudgeon Lake outlet,
- maintenance of the existing rock weir and armoured channel downstream from the Hudgeon Lake outlet,
- visual monitoring of main dumps and creek channels (at least once a year) by the Water Resources personnel and by a geotechnical specialist, as required,
- maintenance of the water gauge on Clinton Creek,
- consider installation and monitoring of water gauges in Hudgeon and Wolverine Lakes, and
- maintenance of warning signs along the access road and at the creek channels.

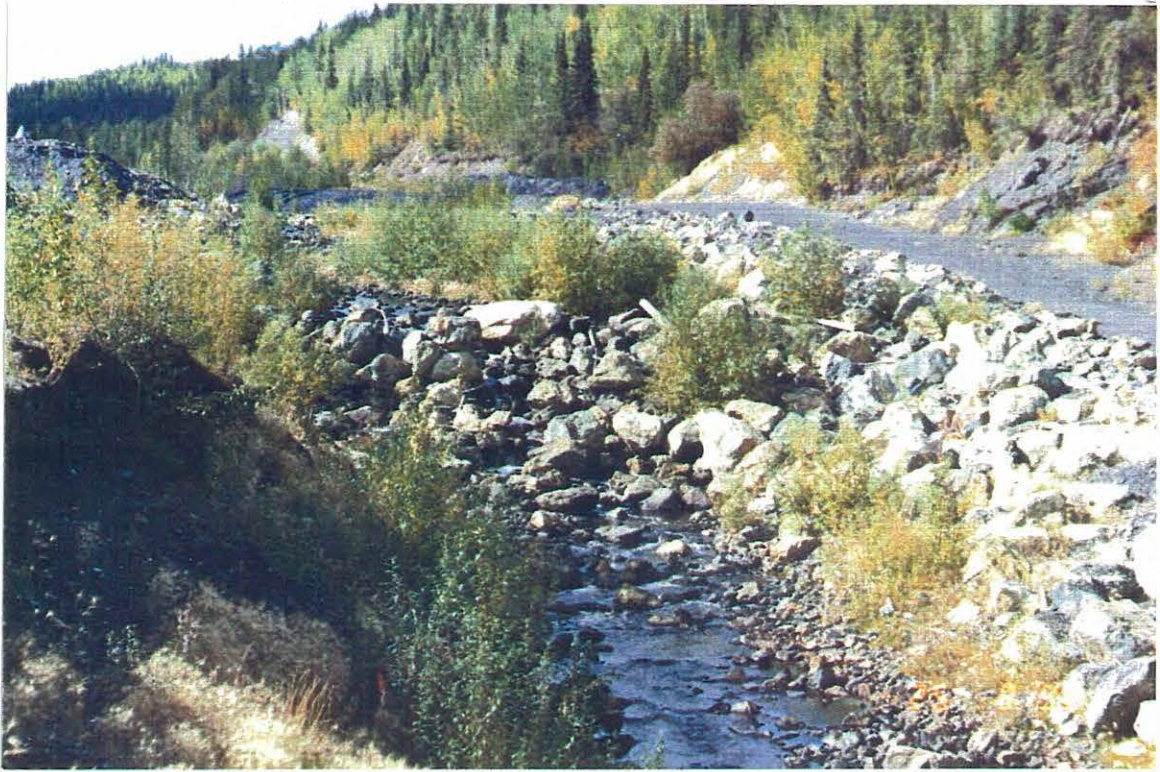
No significant changes of the armoured section of the creek channel between the lake outlet and the drop weir were visually discernible in 1992. A notch has developed in the rock plug at the downstream end of the armoured section (Photo 7). However, the overall stability of the weir foundation and the performance of the armoured channel upstream from the weir appears to be, at this time, satisfactory.

Photo 7: A notch was eroded into the armoured channel plug (left from the big boulder) since 1990.

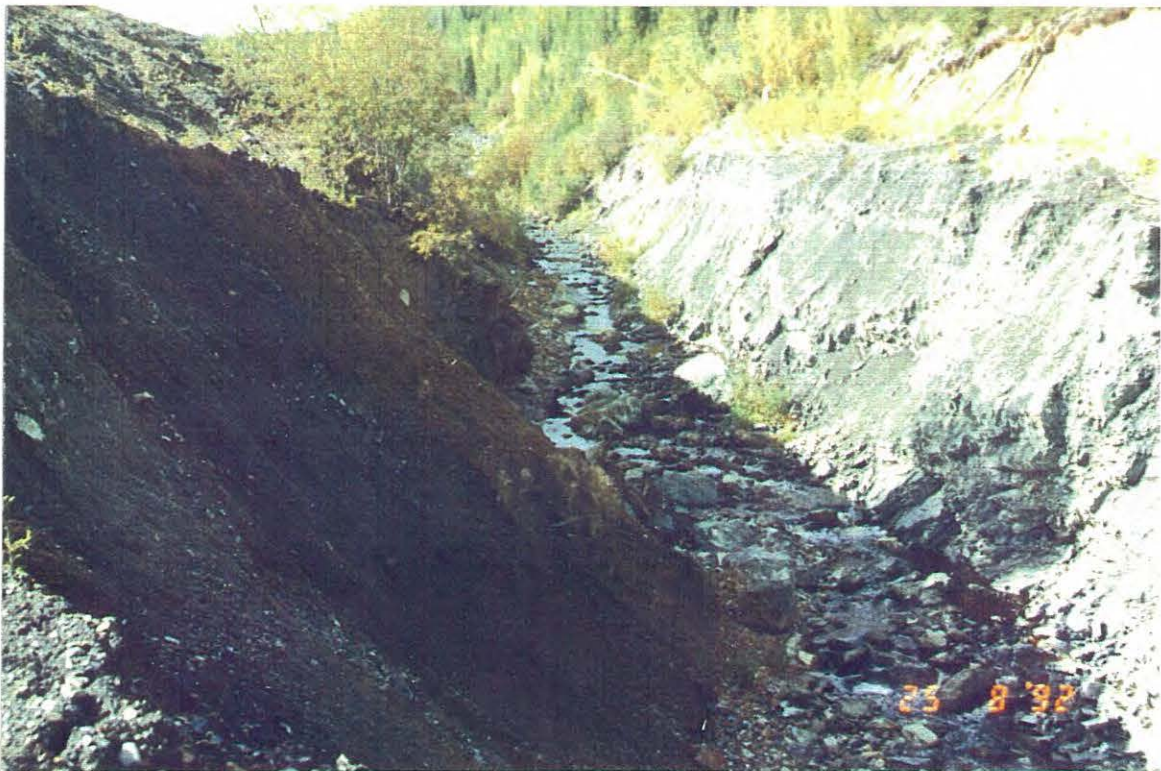
The channel downstream from the weir to a point approximately half way across the waste dump area has also been relatively stable since 1988 (Photo 8). Further downstream, the south bank, comprised of mine waste, is eroding and the bank is sliding (Photo 9). There is an apparent advance of the dump into the creek channel.

Photo 8: Clinton Creek channel within the upstream half of its length through the waste dump shows very little changes since 1988 (refer to Photo 8 of the 1990 report).

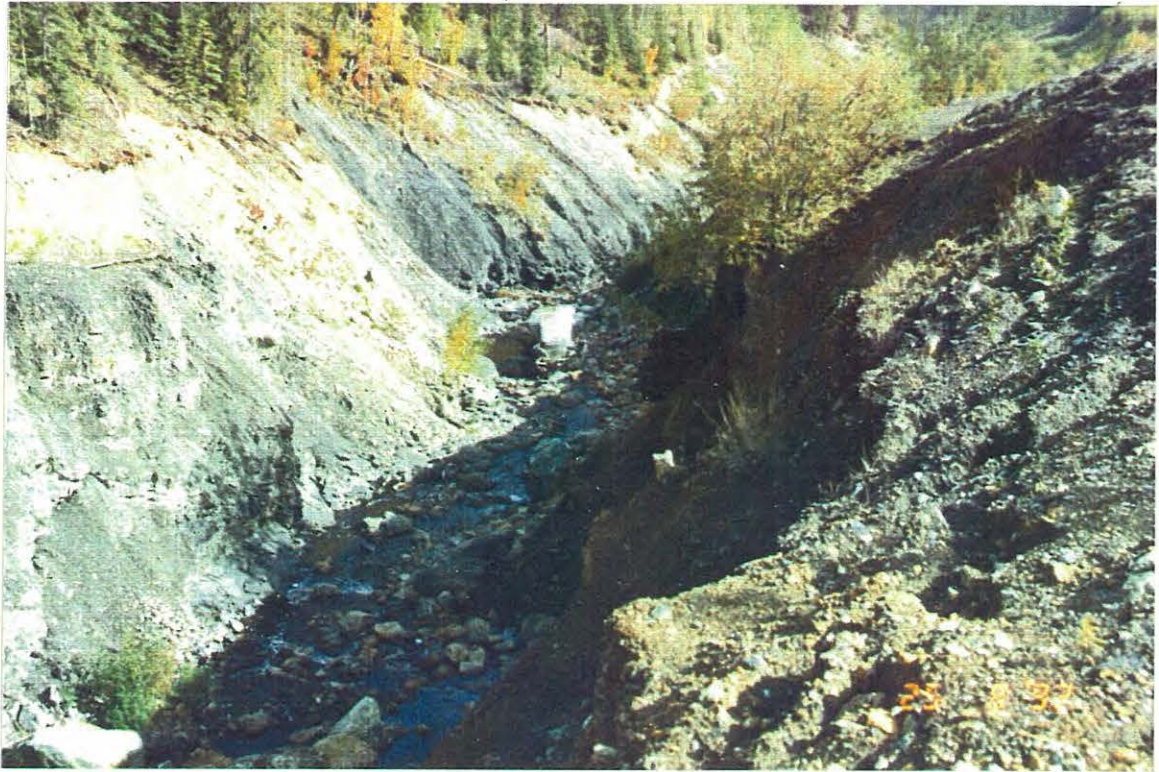
Photo 9: Middle segment of the Clinton Creek channel; south bank is sliding into the channel.

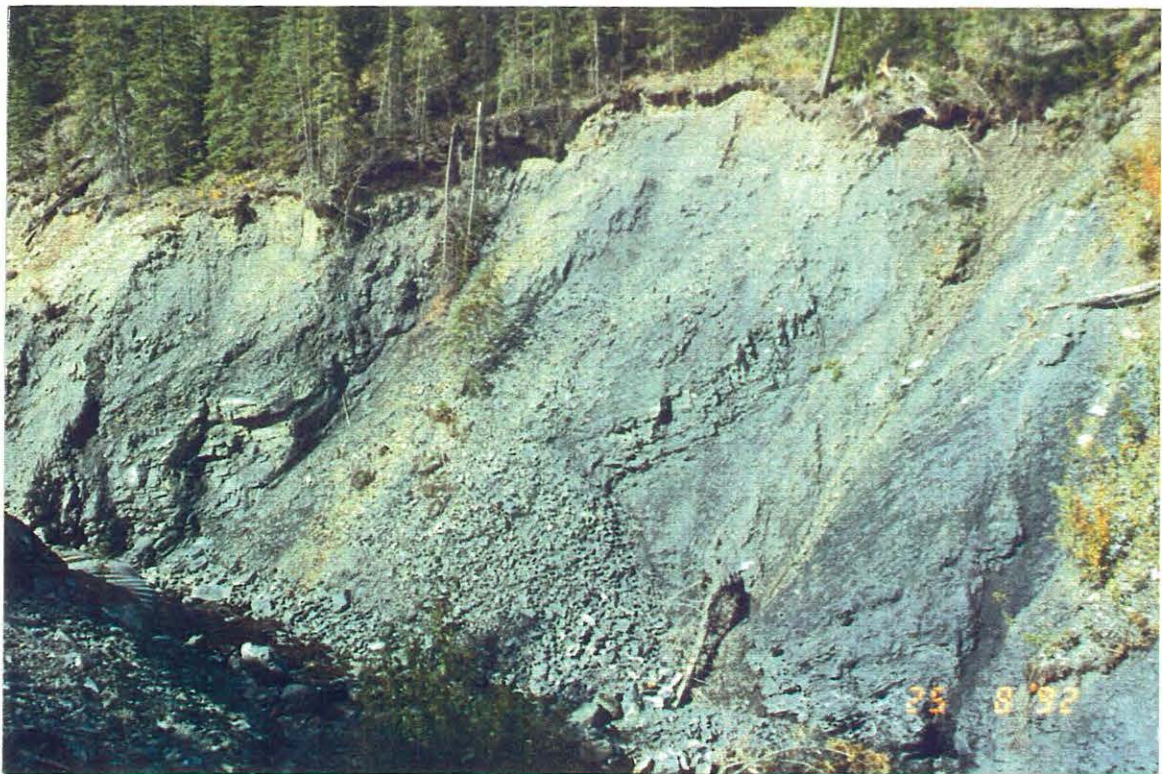
While the changes in the channel bottom in its downstream sector are difficult to establish (on the basis of visual observation and by comparing the photographs), changes of the bank configurations are more readily identifiable. In this channel sector, erosion has an adverse impact on the north bank. There is evidence of retrogressive failures and sloughing of undercut banks (Photo 10).

Photo 10: Undercut and sliding north side of the Clinton Creek channel in its downstream sector.

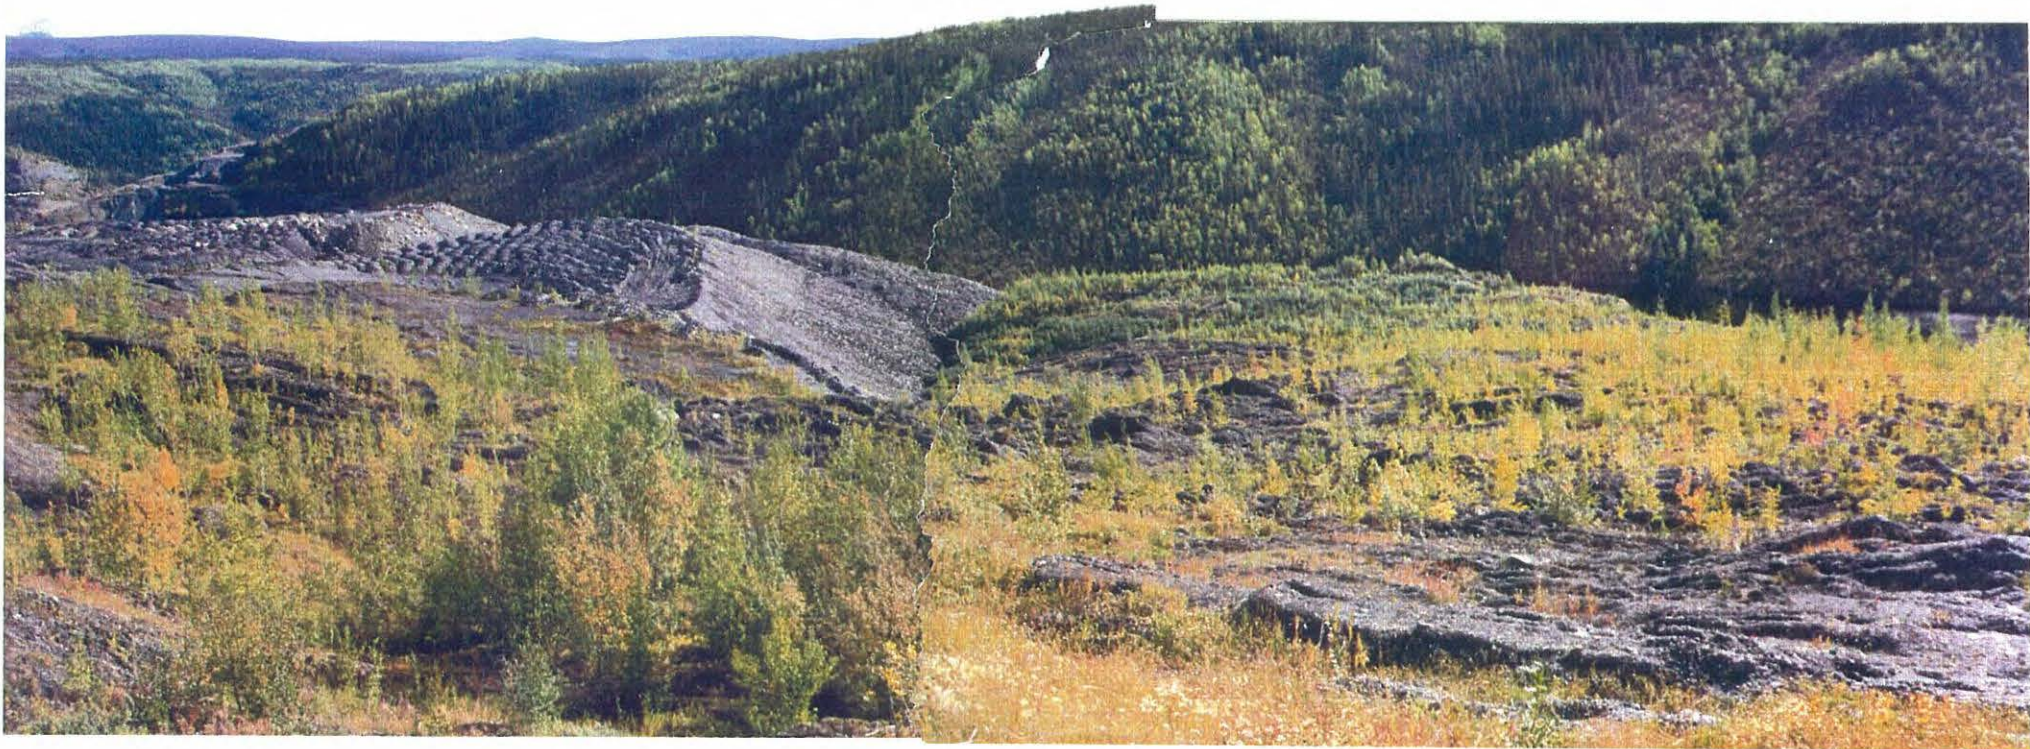
The movement of this waste dump into the Porcupine Creek valley continues. It is apparent that the rate of movement of its individual sectors varies. The southern segment of the dump appeared to be, at the time of the site visit, more active than the northern one (Photo 11). As usual, the movement is better defined (by fresh scarps and fissures) along the upper reaches of the dump than at its toe.

Photo 11: Oblique view of the Porcupine Creek waste dump, looking north. Movement of the dump is well illustrated by fresh fissures and scarps, widespread along the headscarp and throughout the southern dump segment.

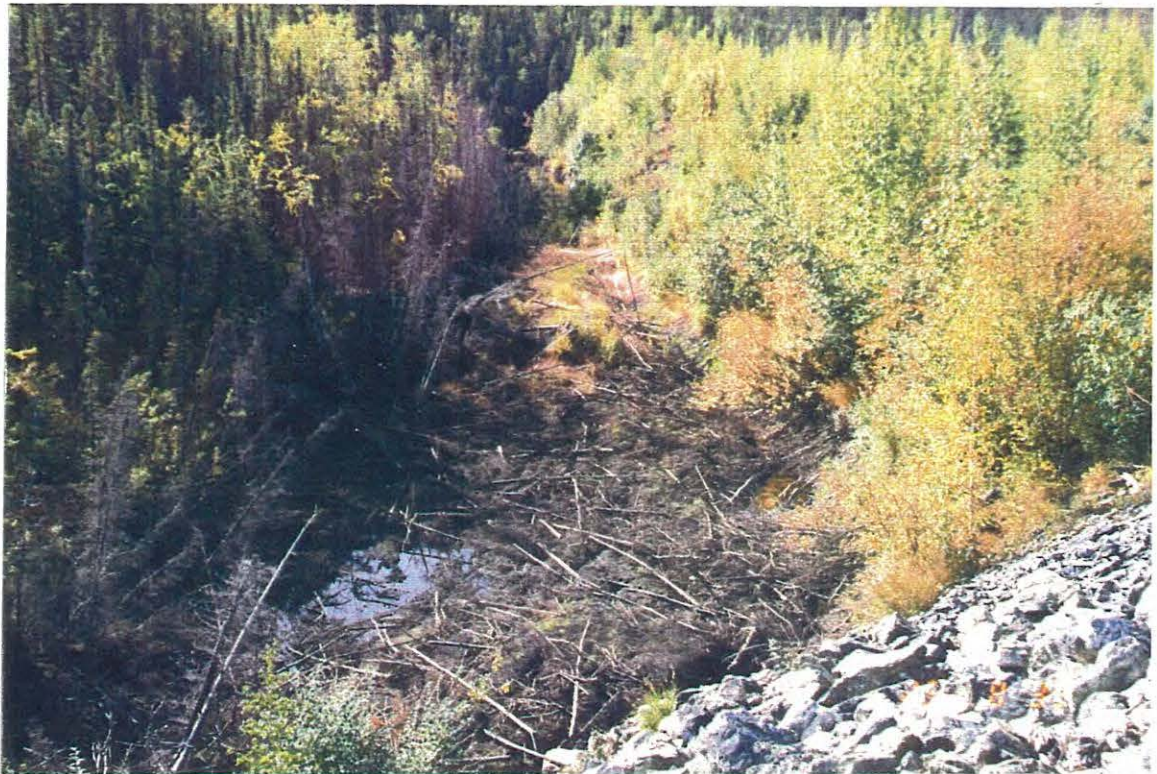
This notwithstanding, changes in the valley blockage, which occurred between 1990 and 1992, document the relatively high mobility of this dump. The valley blockage, until 1990, used to be comprised of a relatively narrow ridge (slump material and a heaved ground). During the recent site visit, a new valley blockage has developed south from the original one, chiefly due to the heaving of the valley bottom. High water level marks in front of this blockage indicate that water is seasonally ponded in front of the dump to a level some 1 m higher than the usual elevation of the lake. There was no overflow across this valley plug at the time of our site visit and the old channel upstream from the original blockage

was almost dry (Photo 12). However, there are high water level marks indicative of seasonal flow through the channel.

Photo 12: Looking upstream towards new blockage of the Porcupine Creek valley, caused by ground heaving.

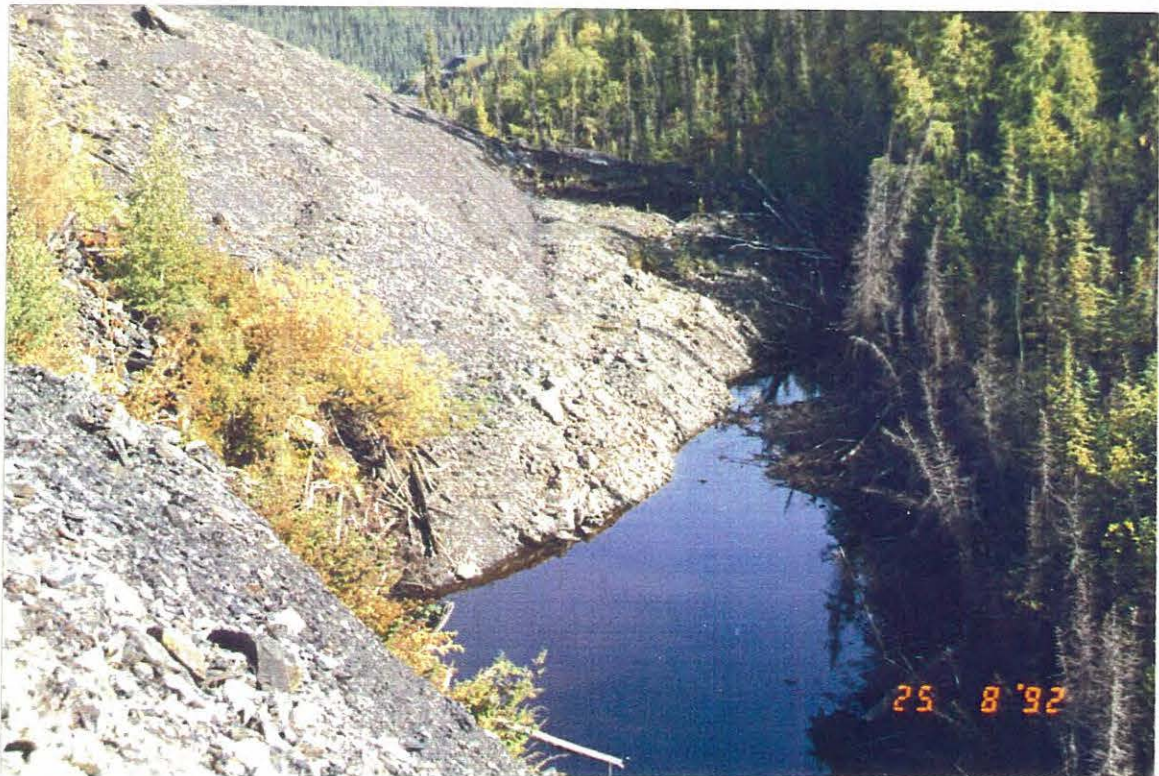
The original valley blockage appears to be wider than before and its crest is probably slightly higher than in 1990 (Photo 13). There was no surface flow through the old channel, downstream from the blockage and along the east side of the waste dump. All water discharging from the lake infiltrated, in August 1992, into the dump and seeped through the waste rock. The discharge points at the north end of the dump have changed as well. Previously observed springs located above the access road on the north slope of the dump were dry while heavy flow, forming a small stream (Photo 14), daylighted at the toe of the waste dump. This discharge is concentrated and occurs along the natural ground and waste material interface. The seepage path through the waste dump has been apparently modified and its overall gradient, near the discharge point, is now bigger. However, the discharge flow was clear without suspended solids.

Photo 13: Original valley blockage has been widened as a result of ongoing ground and dump movement.

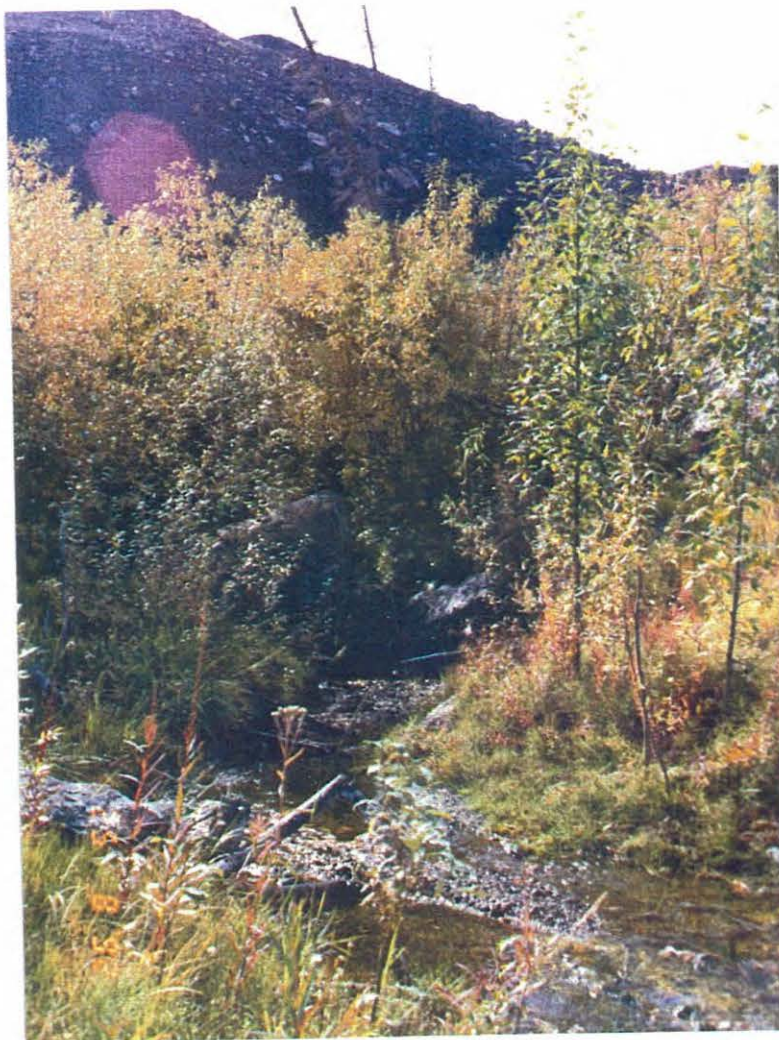
Photo 14: Seepage discharging from the north toe of the Porcupine Creek dump.

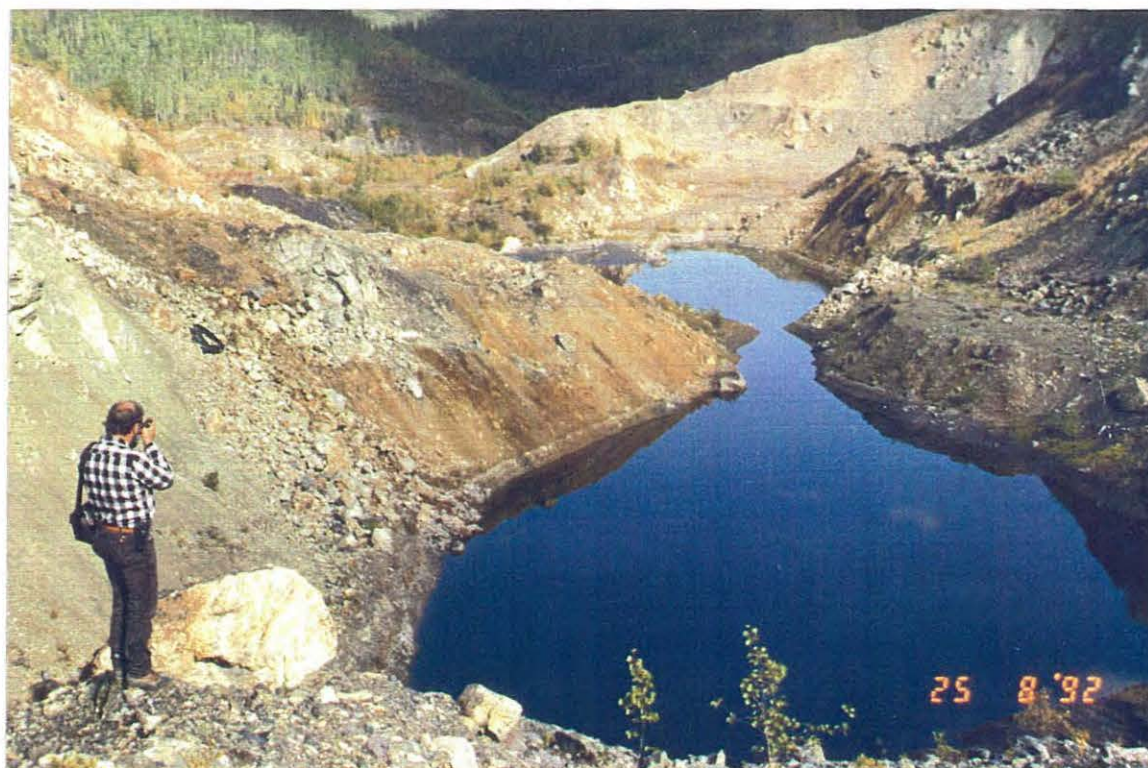
Photo 15: Seepage from the Porcupine Creek dump flows into a lake formed in the valley a short distance downstream.

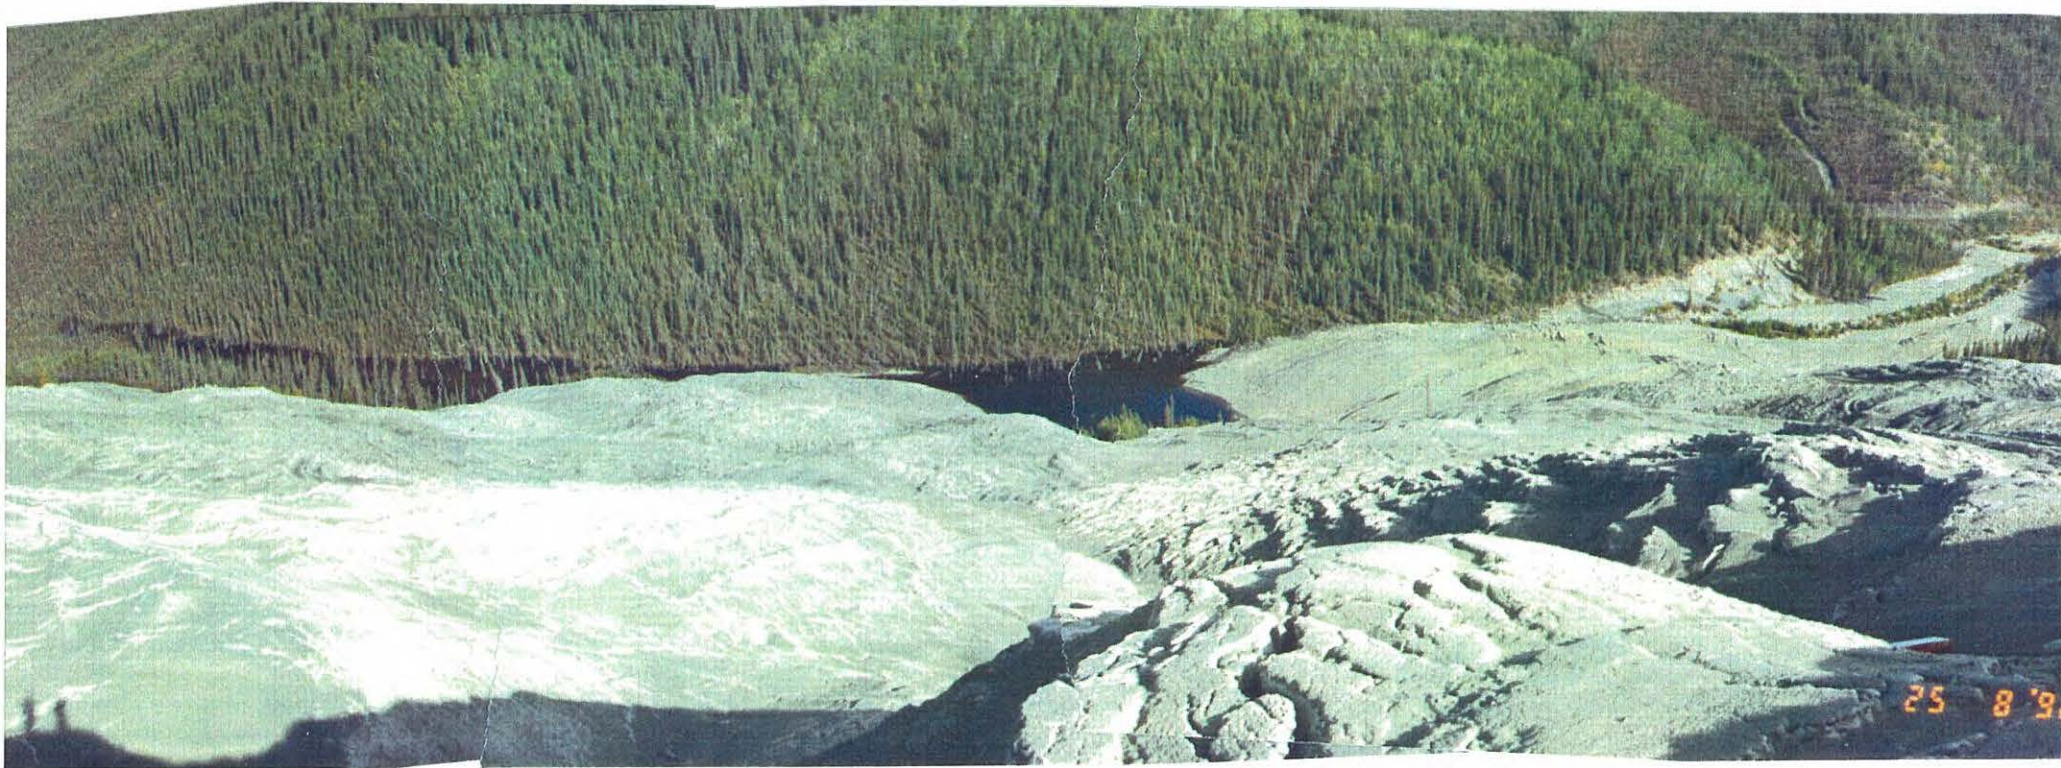
The tailings (approximate total volume of 7×10^6 m³) were placed over the valley slopes, dipping at an average angle of about 16 to 17 degrees to the valley bottom. The tailings, originally stacked in two piles, merged due to their sloughing into a single sheet covering the west valley wall. However, two original lobes are still in evidence in the valley bottom (Photo 16).

Photo 16: View of the Wolverine Creek valley from the top of the tailings pile. Note increasing size of the lobe, partially influenced by beaver dams.

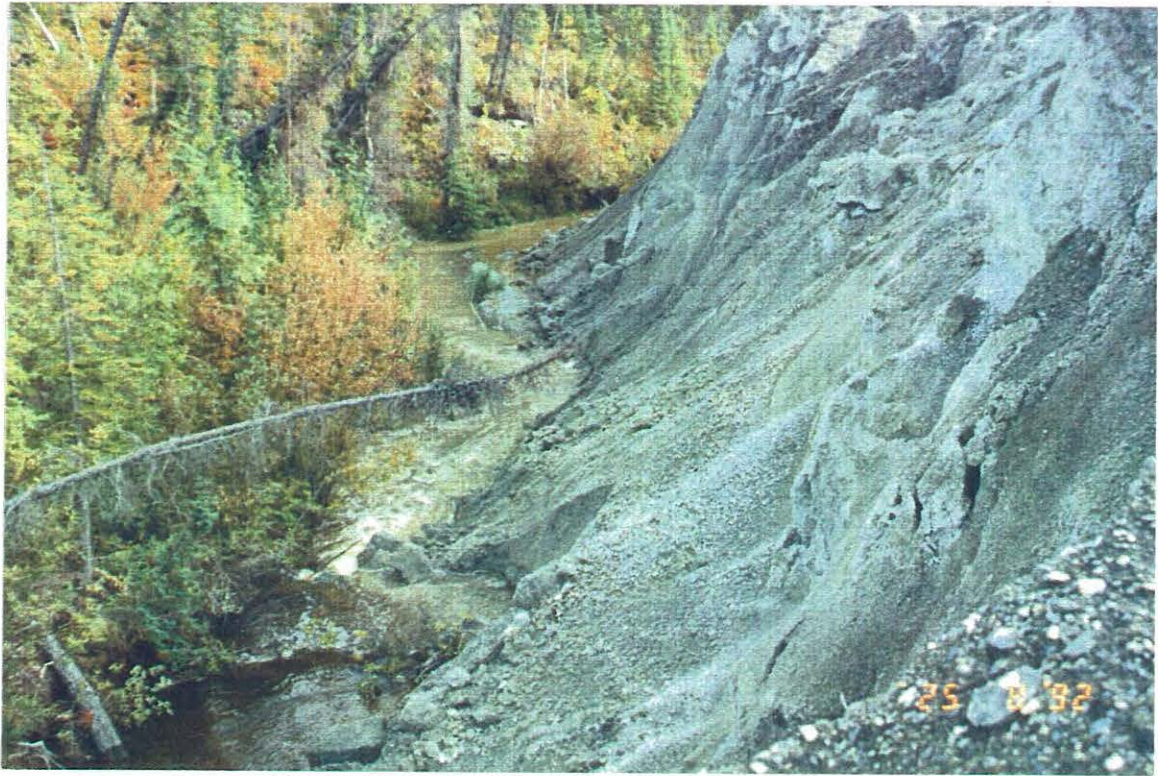
The southern lobe, which initially blocked the valley in 1974, continues to restrict the creek channel at its upstream end. Periodically, the channel is temporarily blocked due to the dump sloughing. This event occurred the first time in 1986 and its reoccurrence is more frequent recently. At the time of our site visit, erosion of such a stream blockage was in progress (Photo 17).

Photo 17: View of the upstream section of the south lobe impinging on the Clinton Creek channel. Note recent blockage being eroded.
