ABANDONED CLINTON CREEK ASBESTOS MINE

**REPORT
ON
SITE INSPECTION**

Prepared for:
NORTHERN AFFAIRS PROGRAM
Whitehorse, Y.T.

May 1993
G052

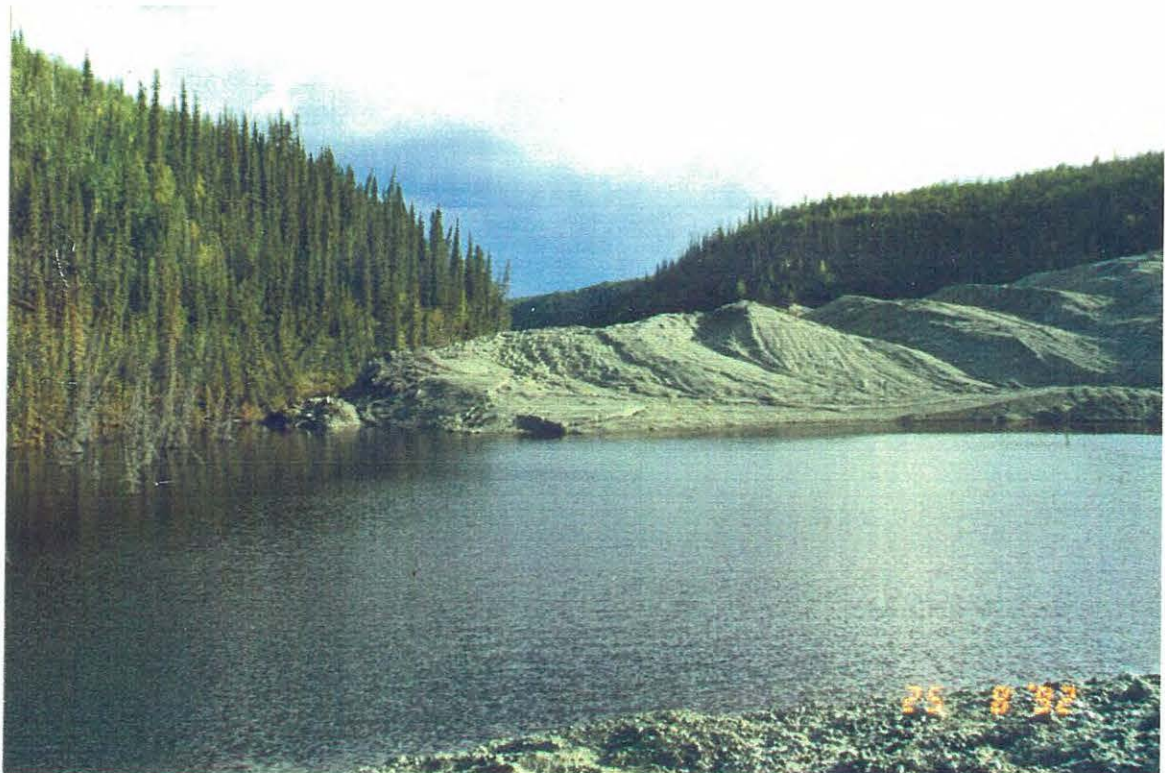
The southern segment of the tailings pile shows signs of relatively rapid movements. The cracks are fresh and wide opened. Its toe upstream from the rock-lined weir is generally steeper than 50 degrees and locally subvertical. More tailings are pushed up in the toe area and the height of the toe is gradually increasing (Photo 18).

Photo 18: Looking downstream at the southern lake.

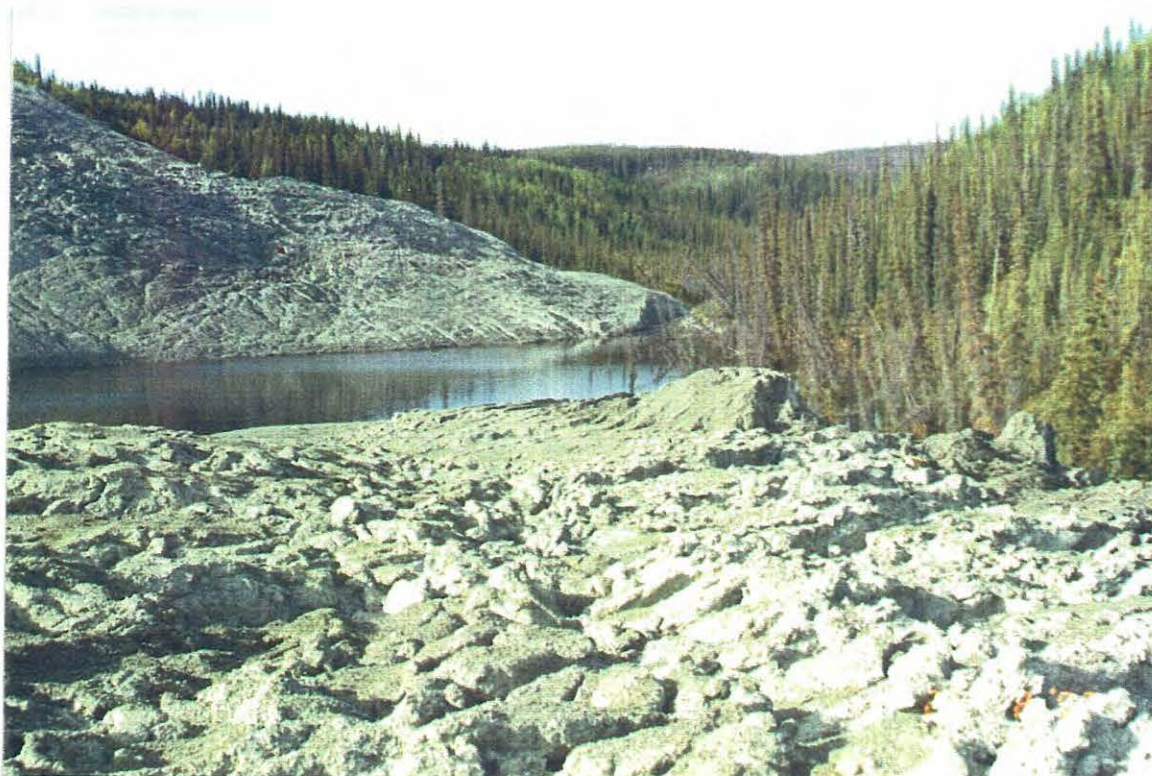
Photo 19: Overlooking the broken-up surface of the southern tailings pile lake. Toe of the north lake in the background.

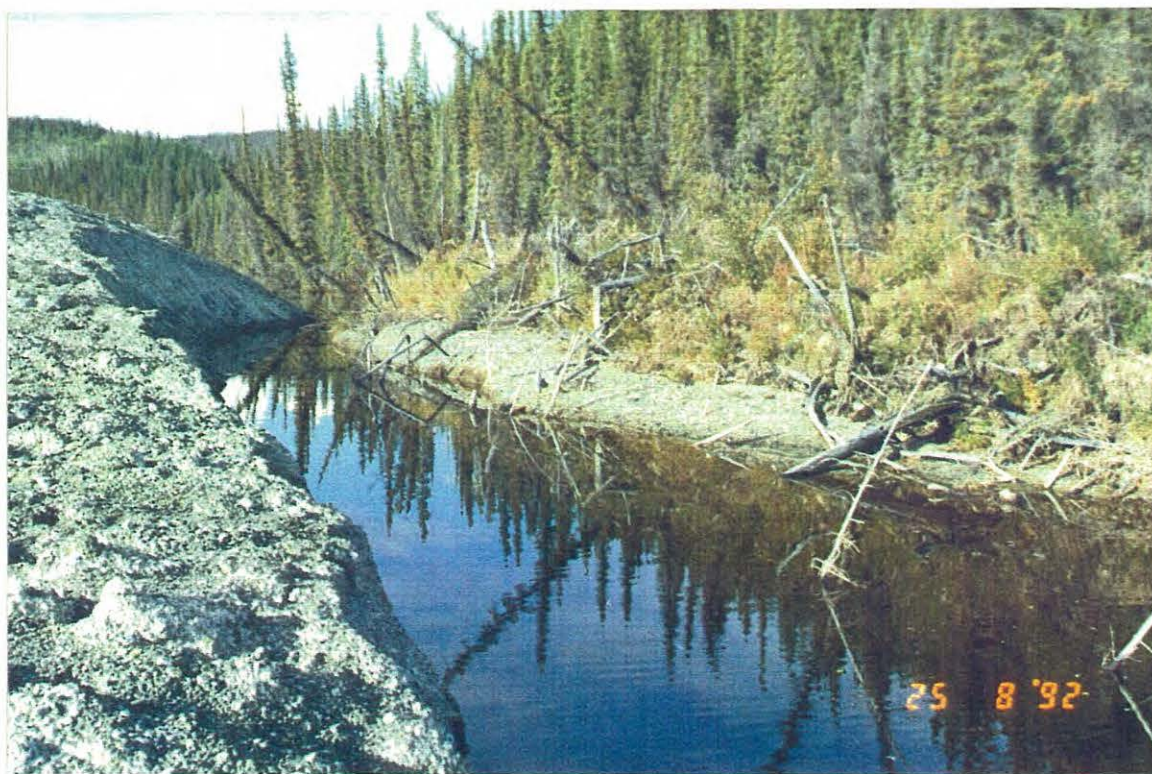
The north tailings pile lake is apparently less active than the southern one. While its height above the valley bottom has increased, there is no evidence of a recent valley blockage. However, the dump toe is spreading in an upstream direction and bulging of the original ground in front of the toe continues (Photo 20). Tailings on the east side of the channel indicate that at some time the drainage was obstructed.

Photo 20: Channel along the toe of the northern lake looking upstream. Note bulged-up ground on the east side of the channel.
