ABANDONED CLINTON CREEK ASBESTOS MINE

**REPORT
ON
1997 AND 1998 SITE INSPECTIONS**

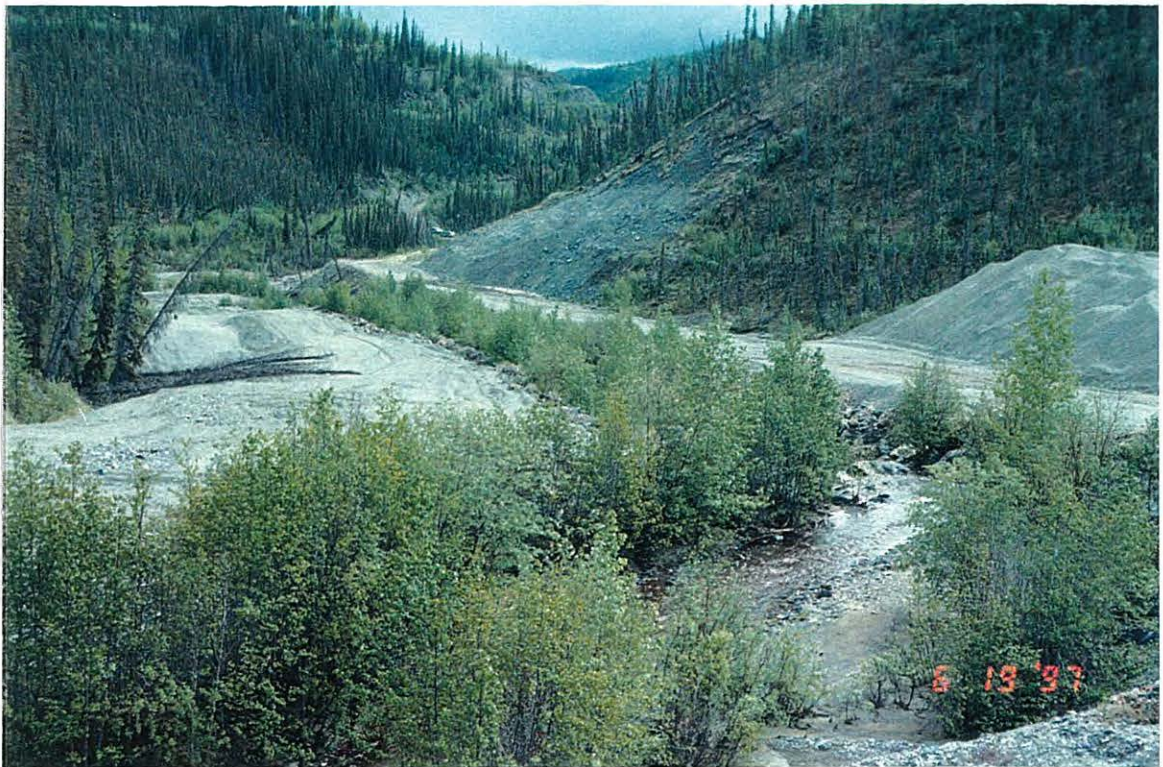
Photo 10: No significant deformations were observed on the Wolverine Creek spillway after the 1997 flood.

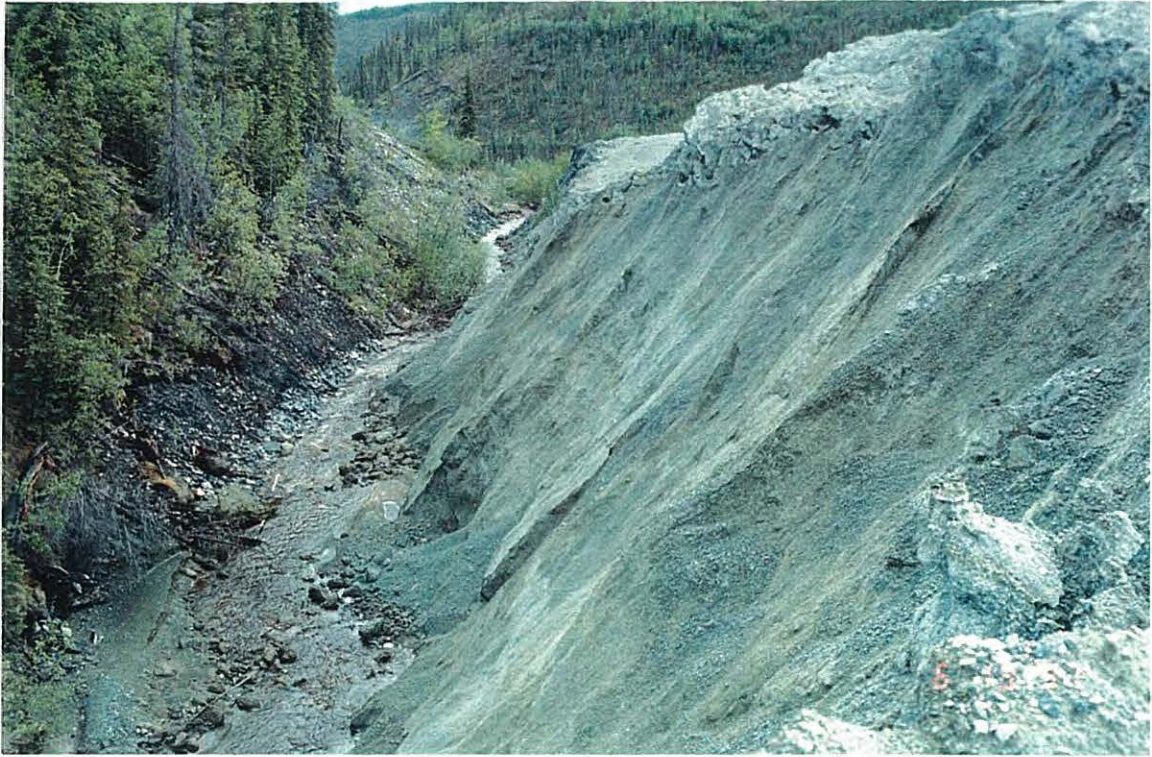
Photo 11: Looking downstream along the toe of the south lobe face.

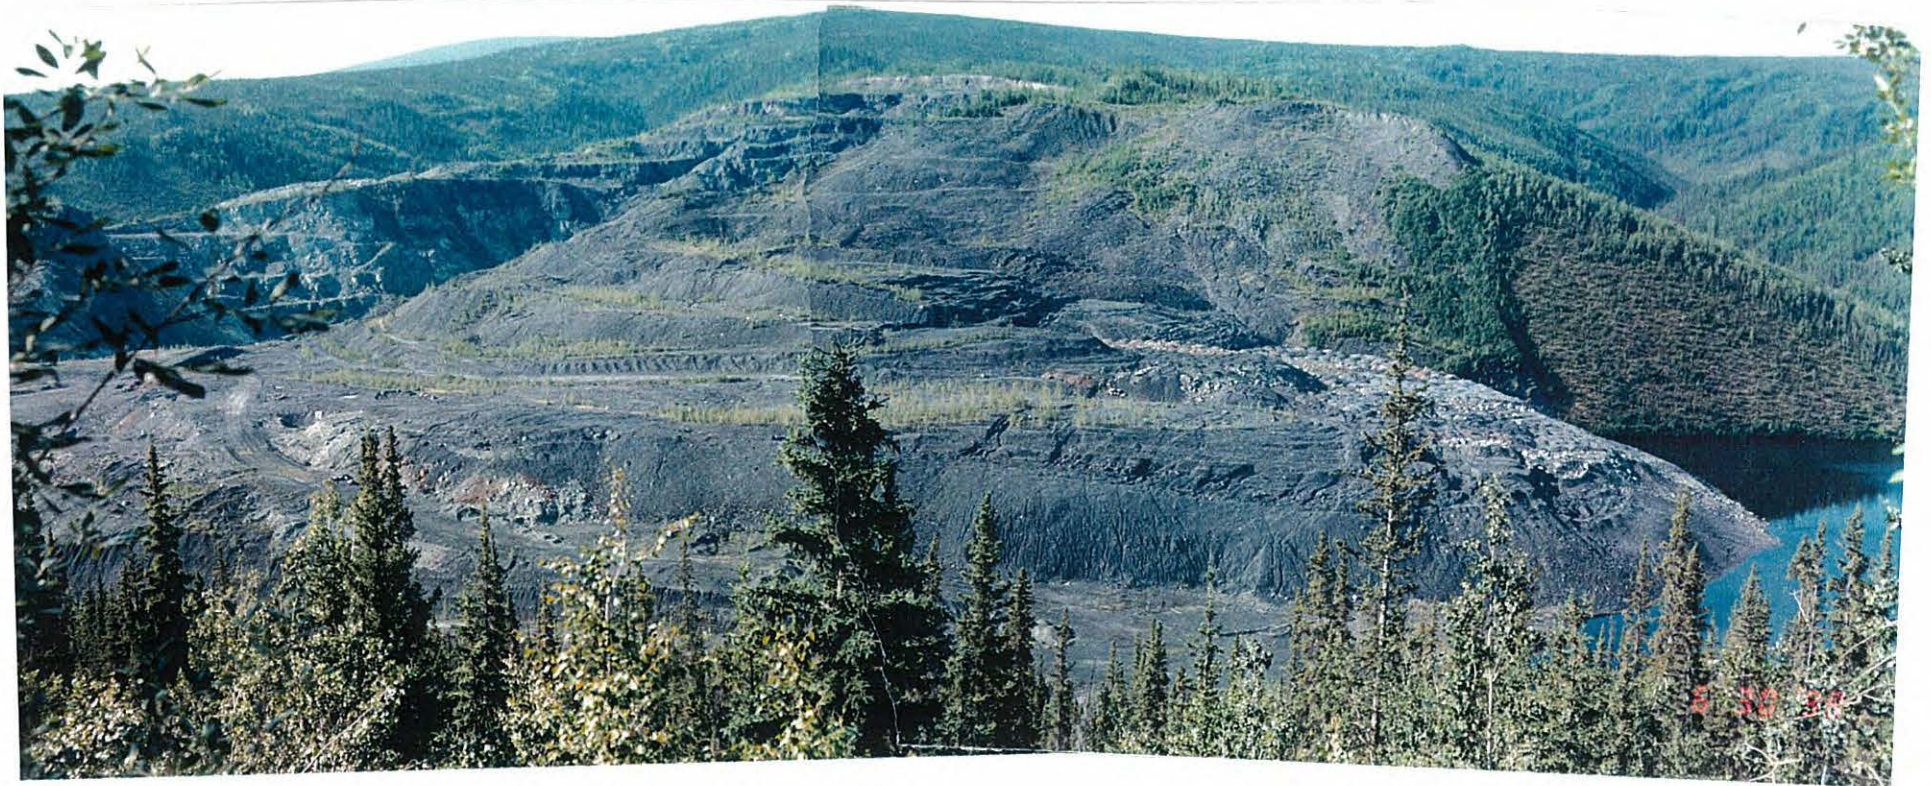
Photo 17: View of the Clinton Creek waste rock dump. Notice cracks and scarps indicative of recent dump movement.

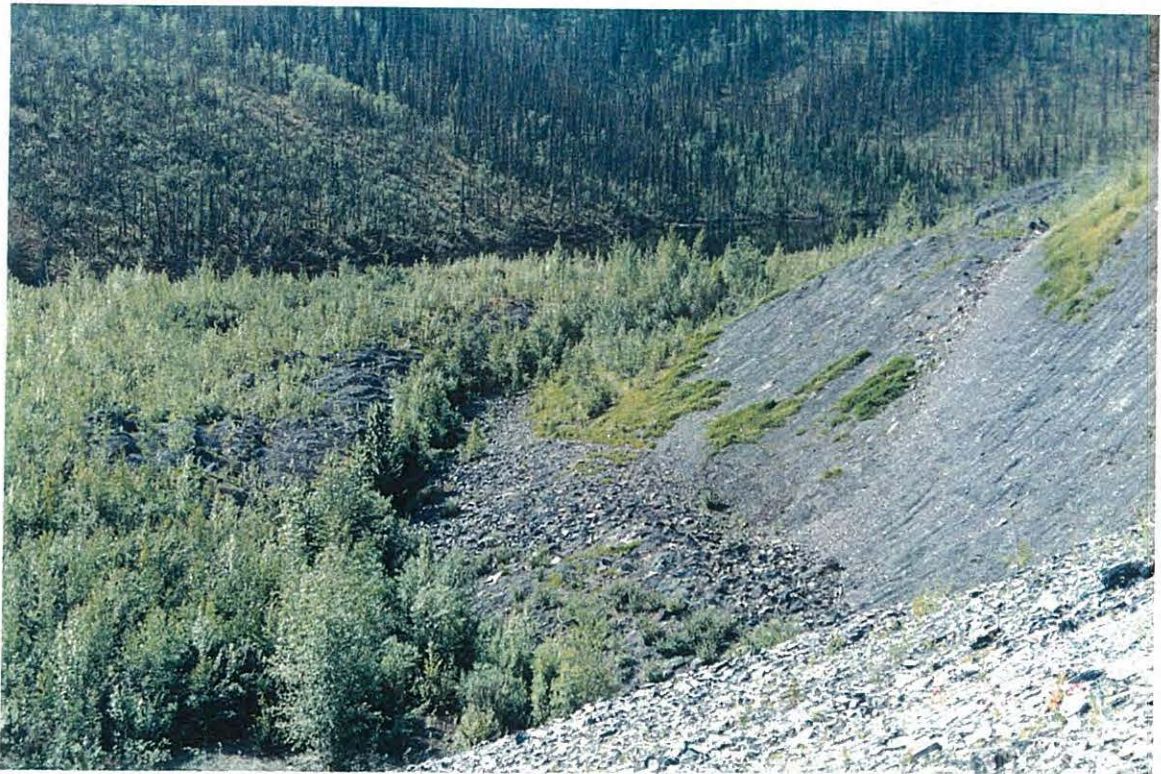
Photo 18: Southern segment of Porcupine Creek waste dump. Note steep slopes and bulging toe areas – indicative of active deformations.

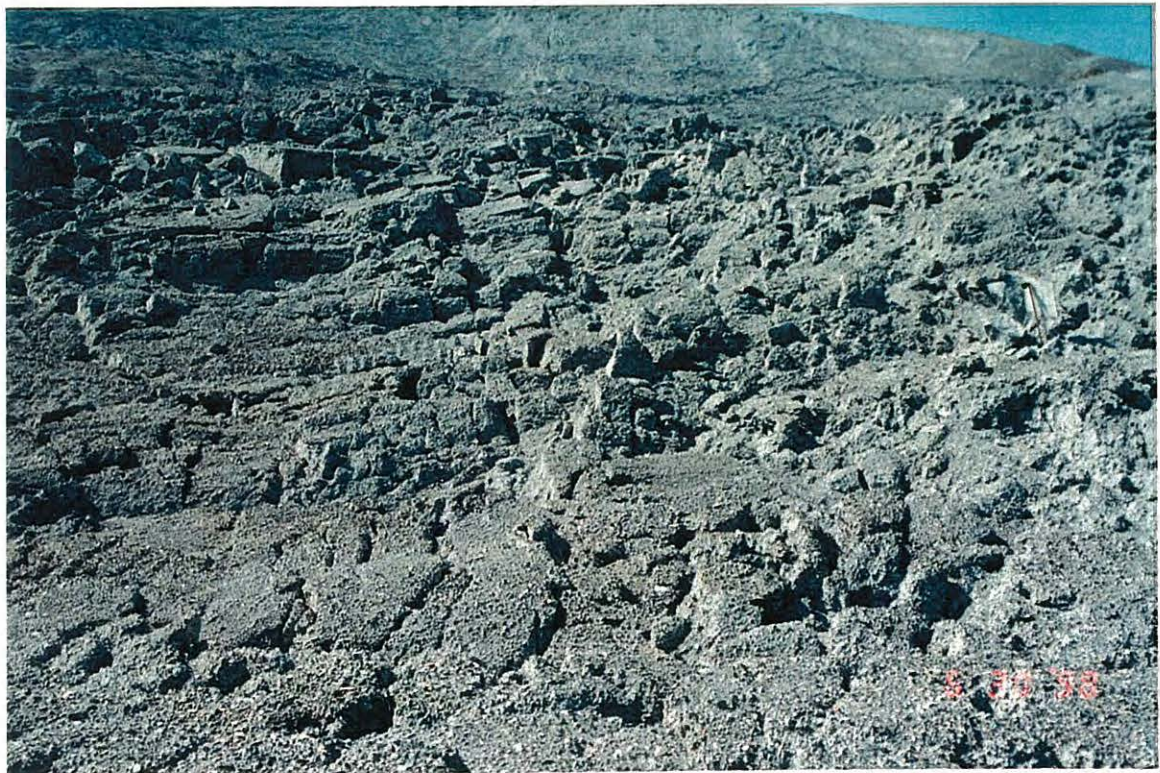
Photo 23: Detailed view of the broken surface of the north tailings pile lobe upslope from the toe area.
