ABANDONED CLINTON CREEK ASBESTOS MINE

**REPORT
ON
JUNE AND JULY 2000 SITE INSPECTIONS**

Prepared for
NORTHERN AFFAIRS PROGRAM
Whitehorse, Y.T.

August 2000
G1000

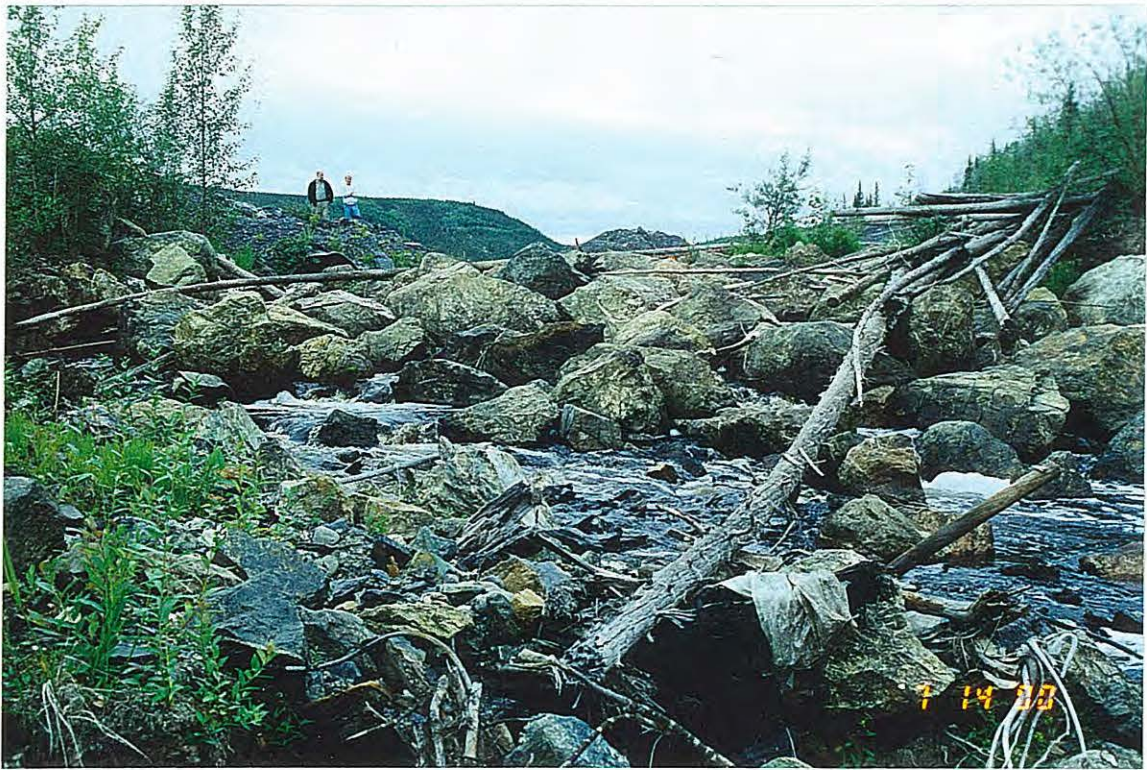
- erosion steps (only about 100 mm high) have developed in the lake outlet channel,
- the outlet channel bottom, covered with small to medium-sized shale/sandstone fragments is soft,
- the armoured section, immediately downstream from the lake outlet, sagged and some of the boulders were possibly dislodged (Photos 1 and 2),
- the channel bottom downstream from the rip-rap section was further downcut (by about 500 mm and slumps developed on the banks (Photos 3 and 4),
- total grade difference between the lake level and the channel downstream from the lake outlet is now estimated to be in the order of 3 m, and
- further downstream, lateral erosion triggers on-going instabilities of both channel banks (Photos 5 and 6).

Photo 1: Looking upstream at the rip-rap segment of the Hudgeon Lake outlet. The left side appears to sag relative to the right side.

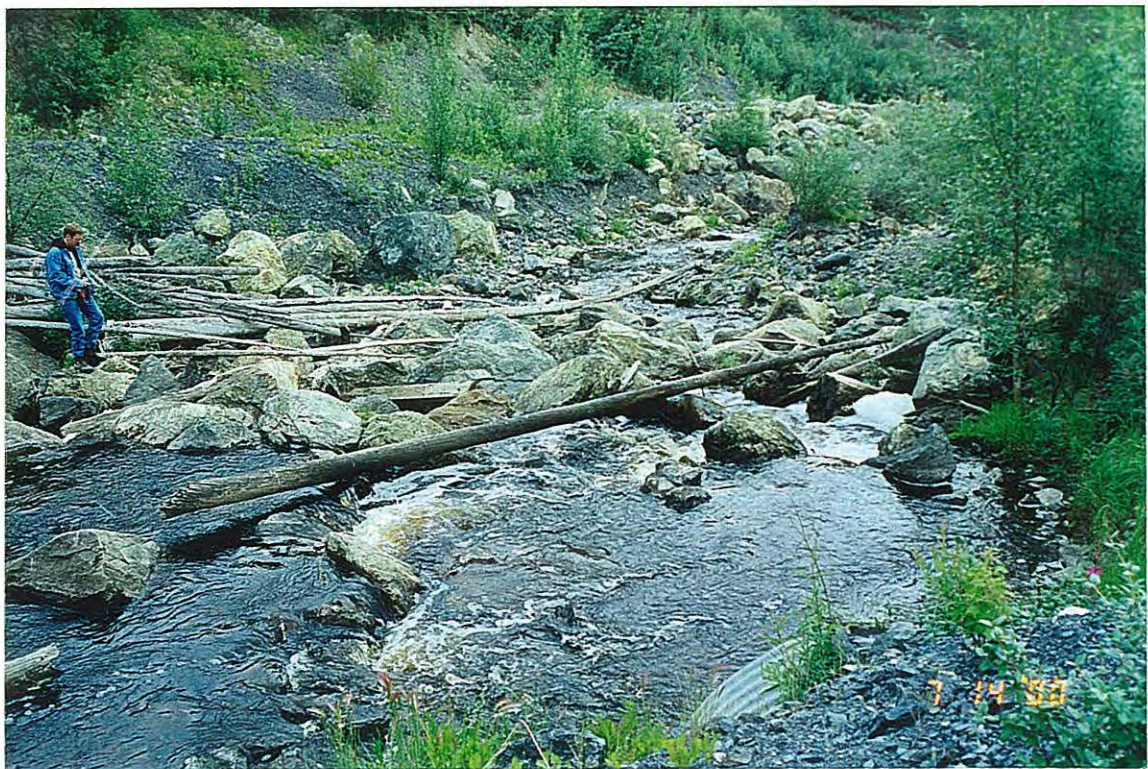
Photo 2: Hudgeon Lake outlet, looking downstream at the armoured section.

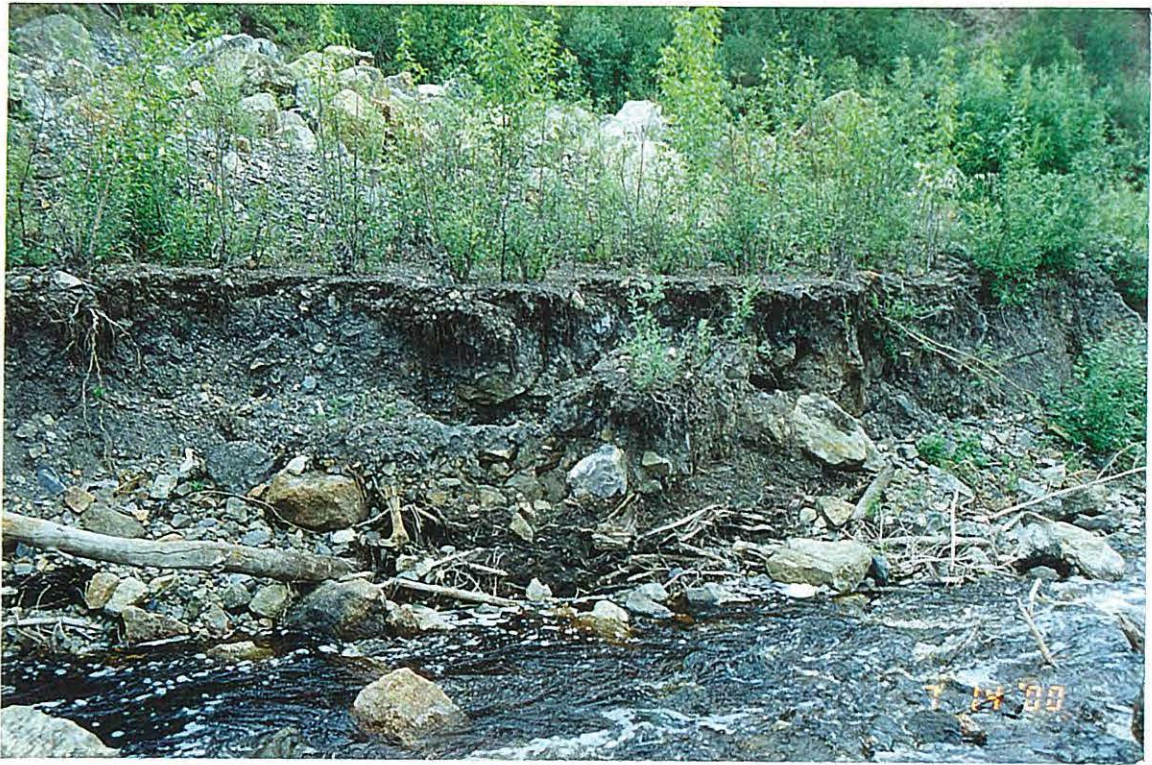
Photo 3: Downcutting of the channel (which occurred during this year's spring break-up) triggered slumping of creek banks downstream from the lake outlet.

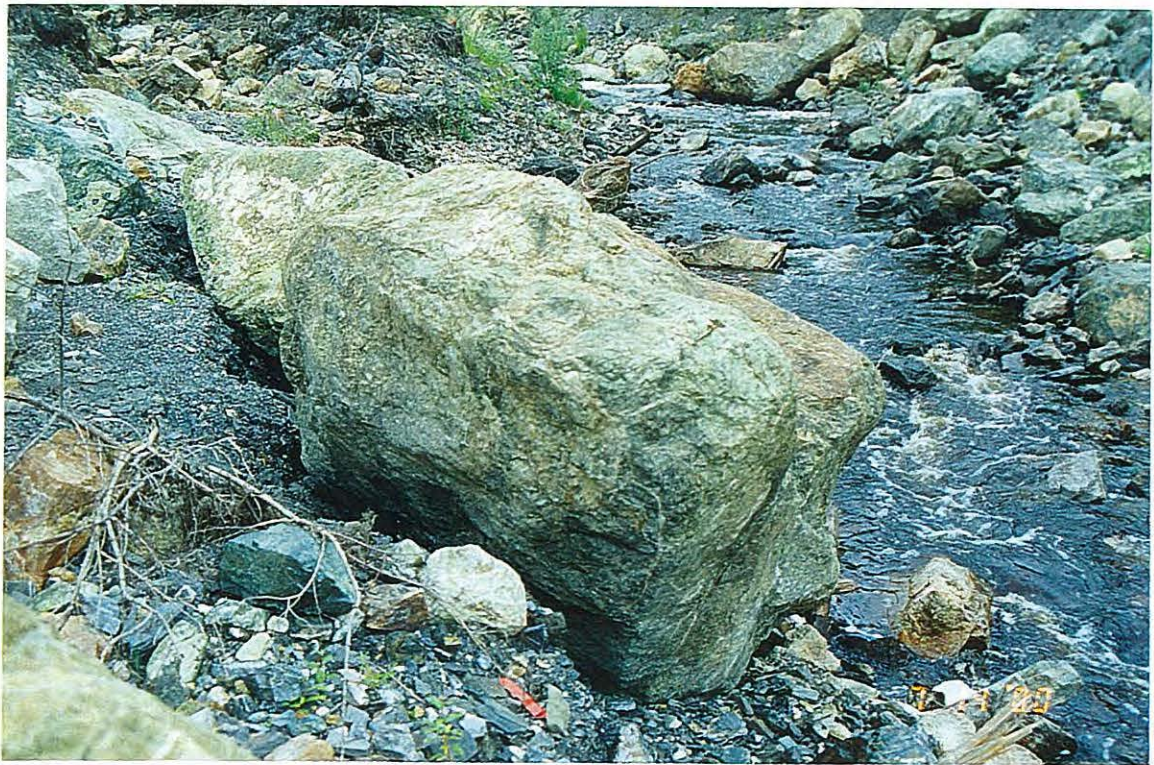
Photo 4: Downcutting dislodged large boulders on the channel banks.

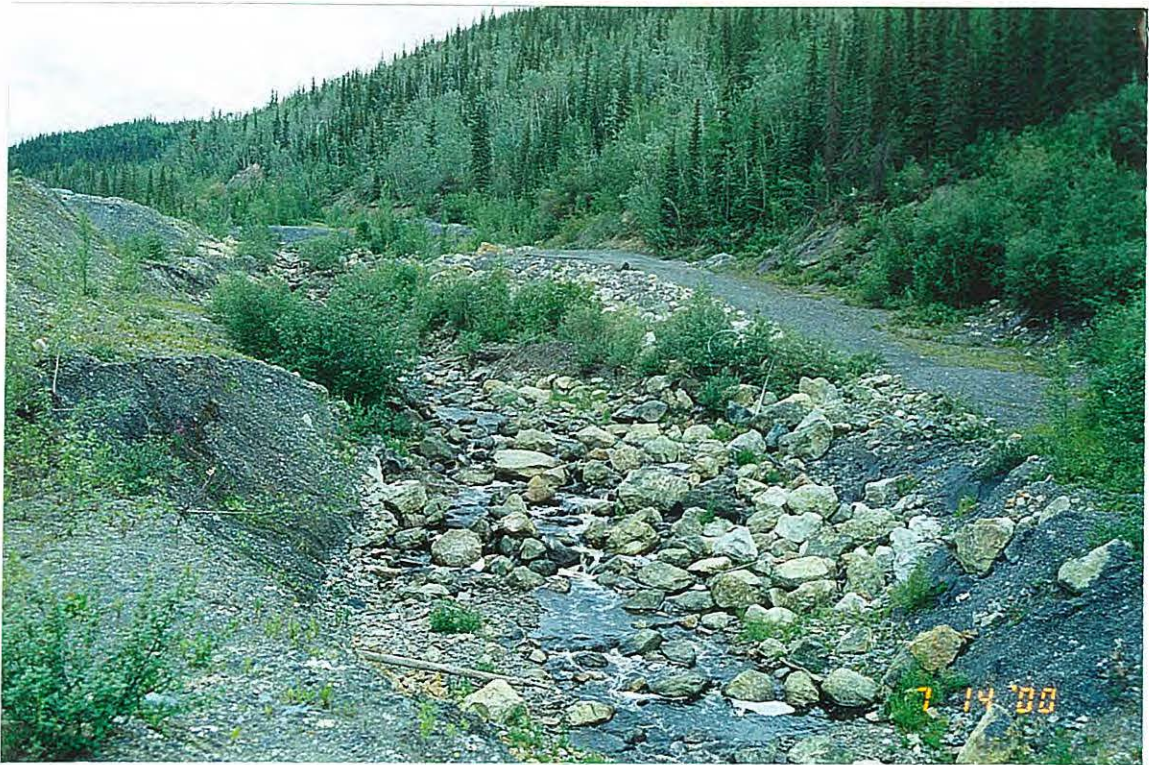
Photo 5: View of former rock weir and increased lateral erosion of both channel banks.

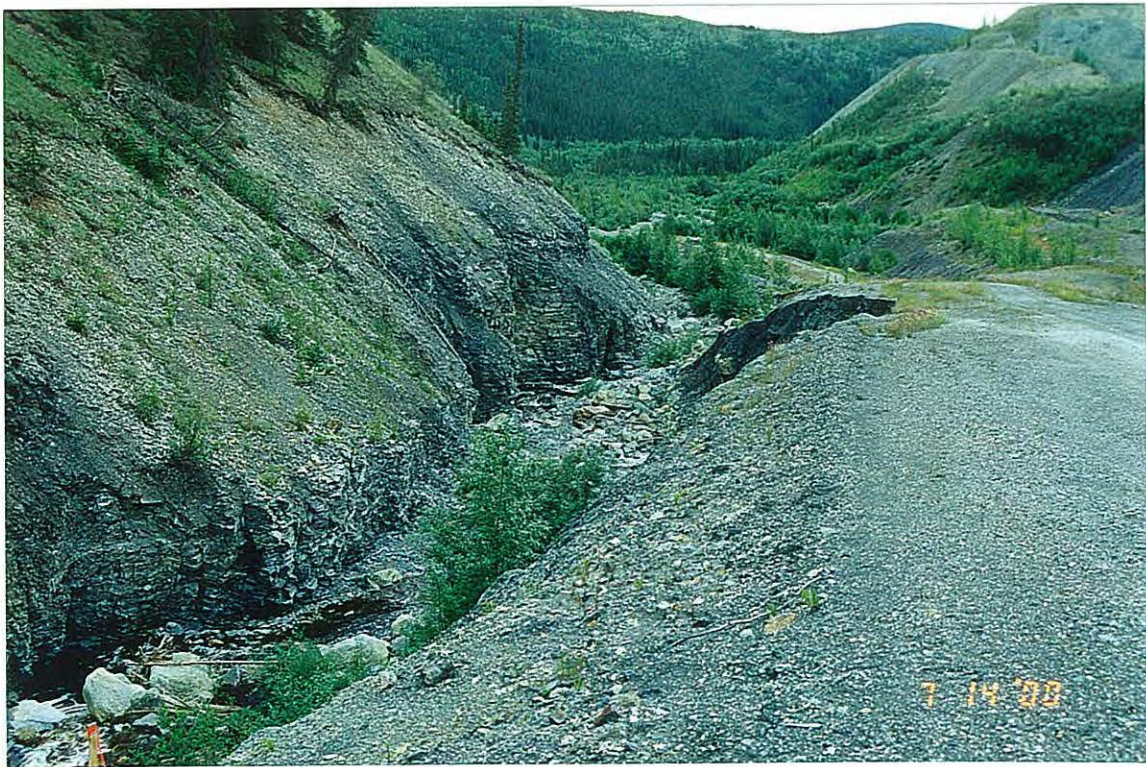
Photo 6: View of the downstream segment of the Clinton Creek channel. Note ongoing erosion of both channel banks.

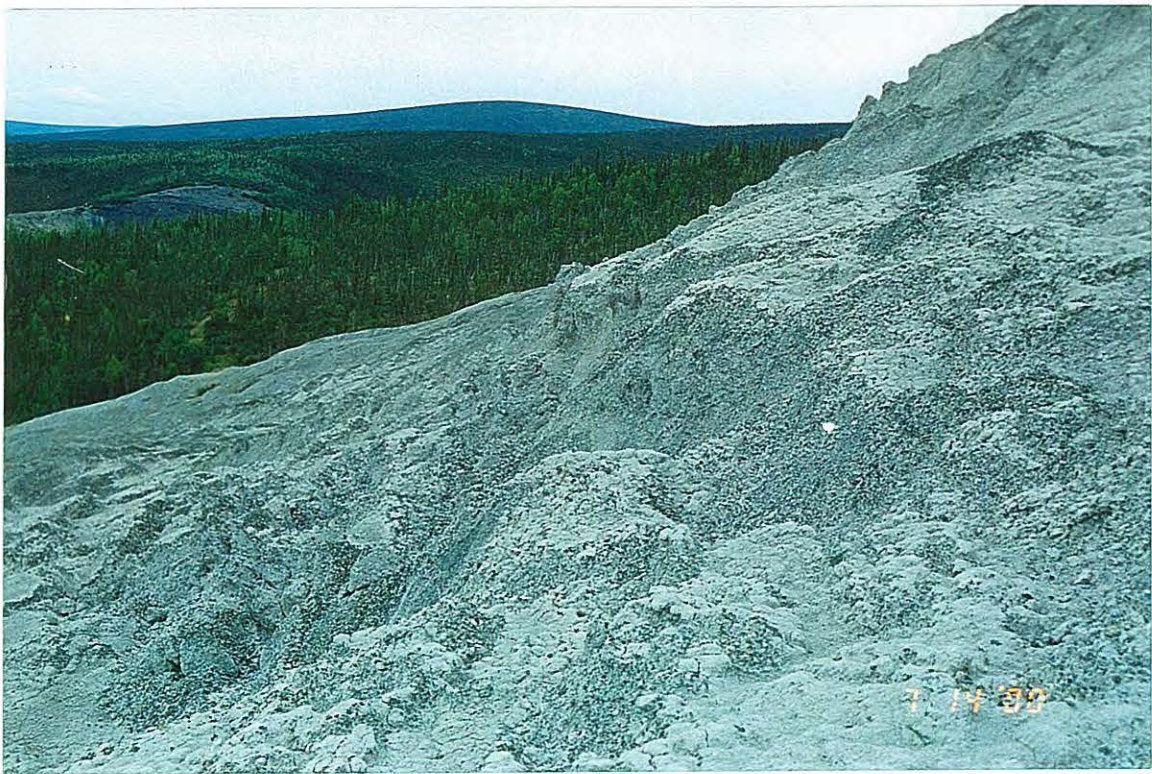
The general appearance of both south and north pile lobes is similar to that observed during previous site visits. However, the piles remain unstable and movements of these segments are irregular, reflecting the displacement of main dump blocks. For example, when a lower block moves, the adjacent slope segment accelerates and the failure gradually progresses to the top of the pile (Photo 7).

Photo 7: Wolverine Creek tailings pile. View of one of several active headscarps.

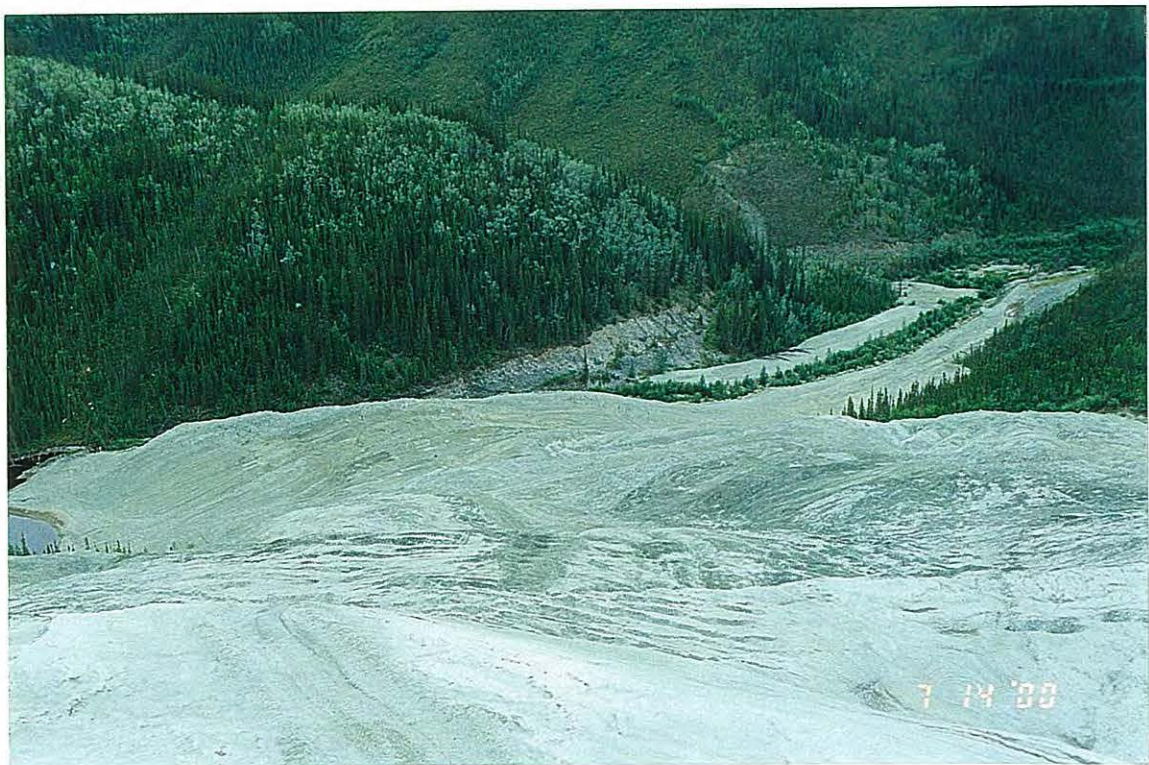
In 1997, the southern lobe (Photo 8) temporarily blocked the creek channel and the blockage has now been eroded away during larger flow events. It appears that the blockage may be a yearly event, reoccurring during the fall and winter low flow seasons. It appears that continuing movements discouraged or destroyed the local beaver colony. Their dam was pushed up and a new channel cut (Photo 9).

Photo 8: View of the south tailings pile lobe and the Wolverine Creek spillway weir.

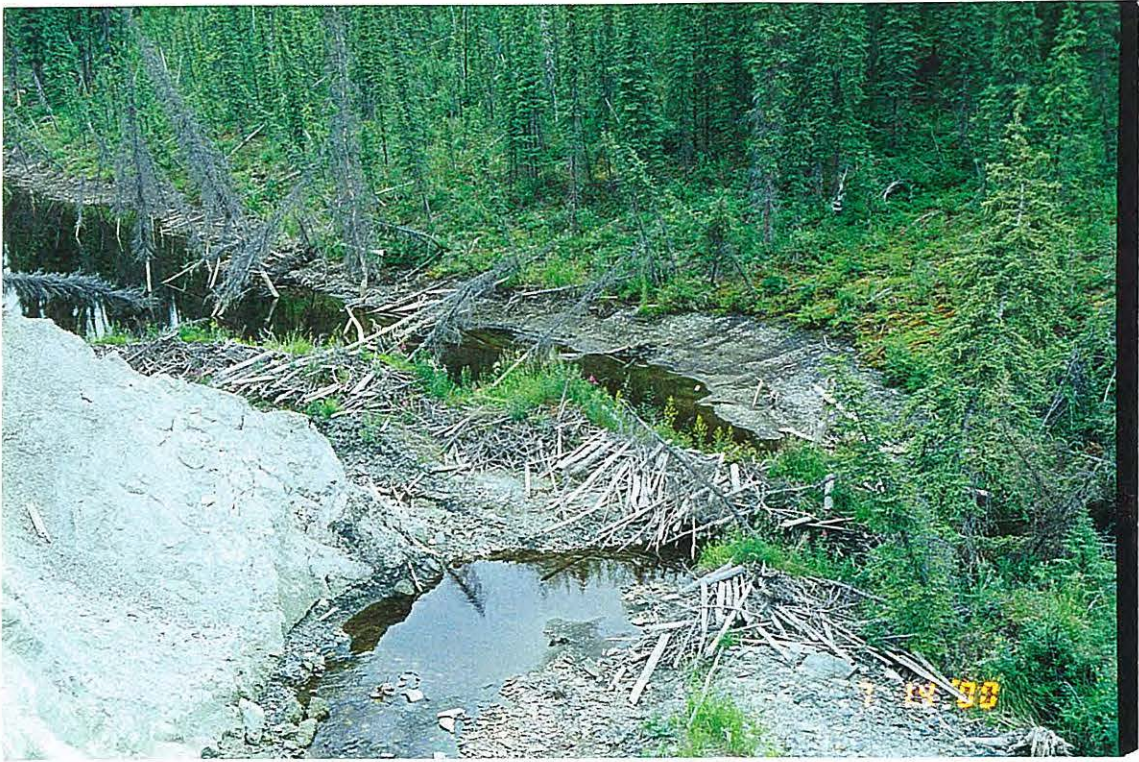
Photo 9: View of the beaver dam located at the upstream edge of the south tailings pile, uplifted by ongoing ground movements.

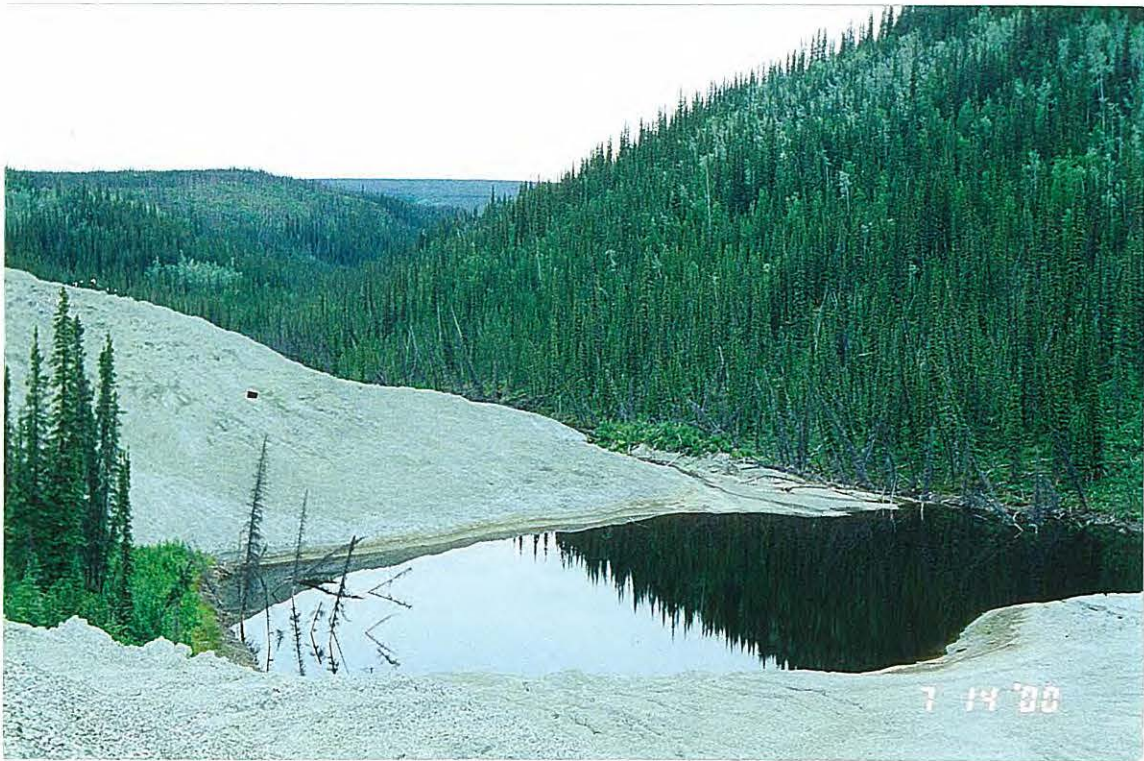
The north lobe reached the valley bottom in 1985 and temporarily blocked the creek flow in 1987. The original valley bottom was "bulldozed" up and against the east valley wall. This created another small lake. However, beavers now control its level. The flow from this lake overtopped easily erodible tailings and cut a new channel through the toe of the north lobe (Photo 10). The rate of the north lobe advance appears to be slower than the rate of the south lobe since the channel blockage did not reoccur at the north lobe. However, fresh cracks in the lower and middle segments of this lobe are indicative of the ongoing movement.

Photo 10: View of the toe of the north tailings pile lobe.

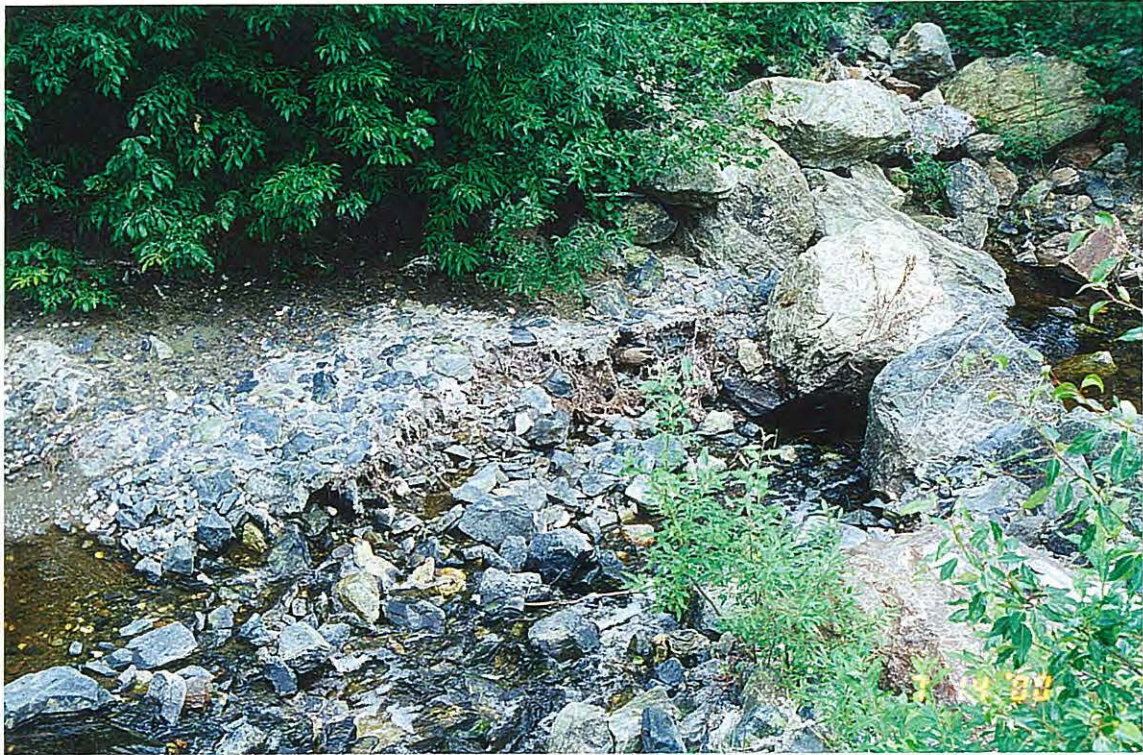
The Wolverine Creek spillway weir continues to perform well except for the lowermost weir which was dislodged and the channel undercut by about 300 mm (Photo 11).

Photo 11: View of the Wolverine Creek lowermost rock weir, currently dislodged. Note the channel erosion.
