Government of Yukon

Former Clinton Creek Asbestos Mine 2009 Site Inspection

AECOM

March, 2010

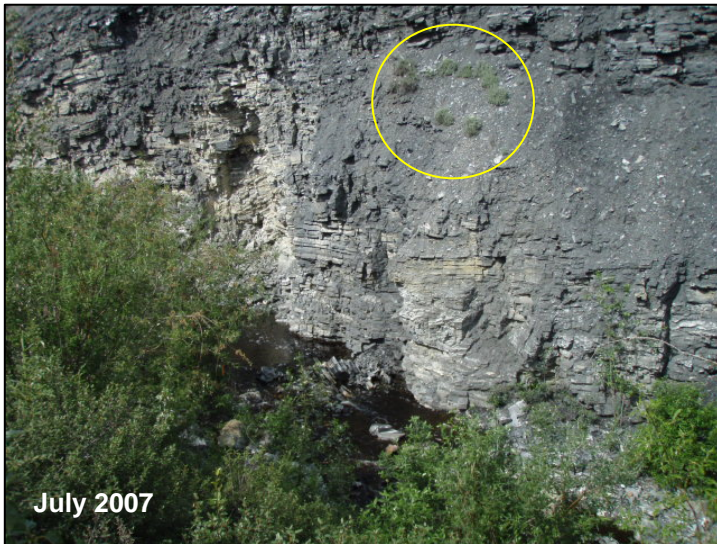
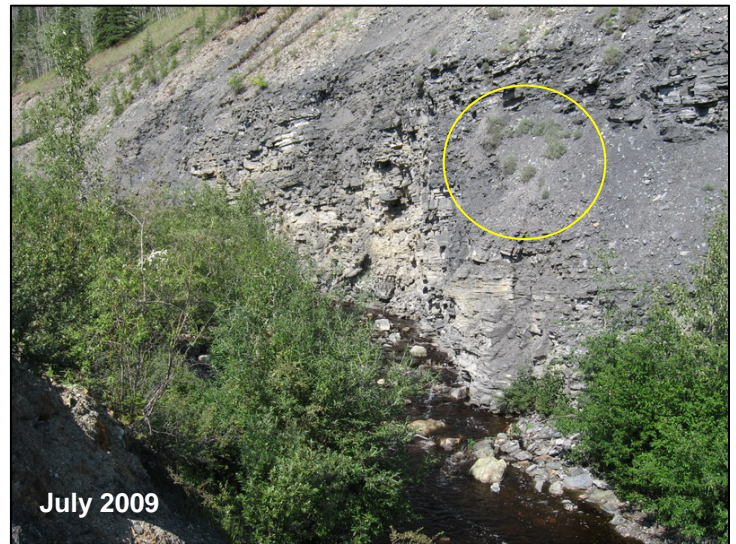
No significant changes are apparent along the creek channel between the channel outlet at the east end of the Clinton Creek Waste Rock Dump (Station 0+800) and the gabion drop structures at the Hudgeon Lake outlet at Station 0+000. Although a channel profile survey was not done as part of this year's inspection, a comparison of conditions with those visible in photographs from 2007 suggest that overall, very little channel erosion (down-cutting) or bank erosion has recently occurred. The bedrock channel bottom and outcrop visible on the LHS of the channel from approximately Station 0+600 (Drawing 01) in 2007 compare well with what was observed in 2009 from Waypoints 339 and 340 (Figures 03 and 04, respectively).

Figure 03 Station 0+600 in 2007 (left) and at WP 339 in 2009 (right), view U/S

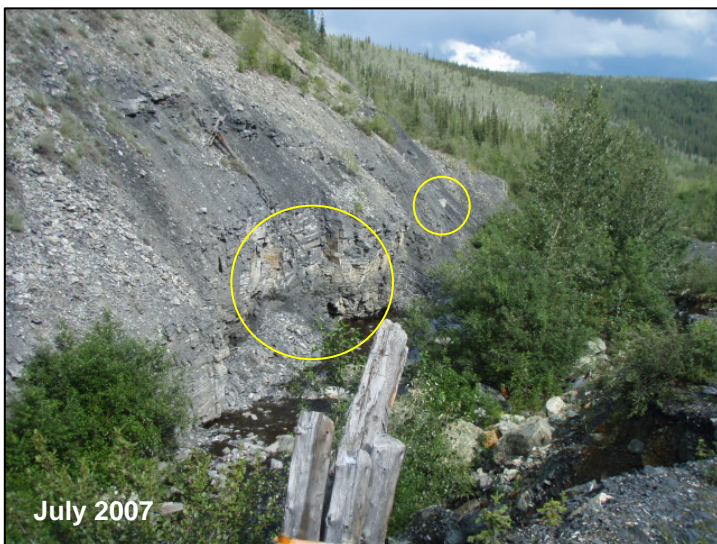
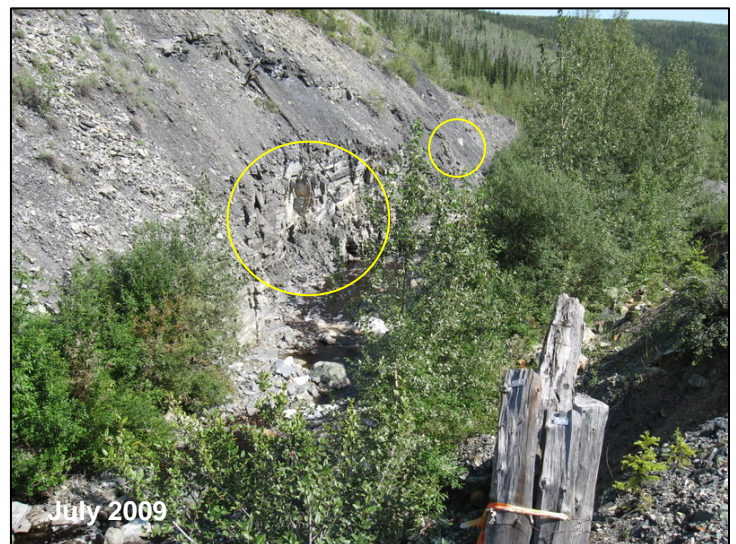
Figure 04 Station 0+600 in 2007 (left) and at WP 340 in 2009 (right), viewed D/S

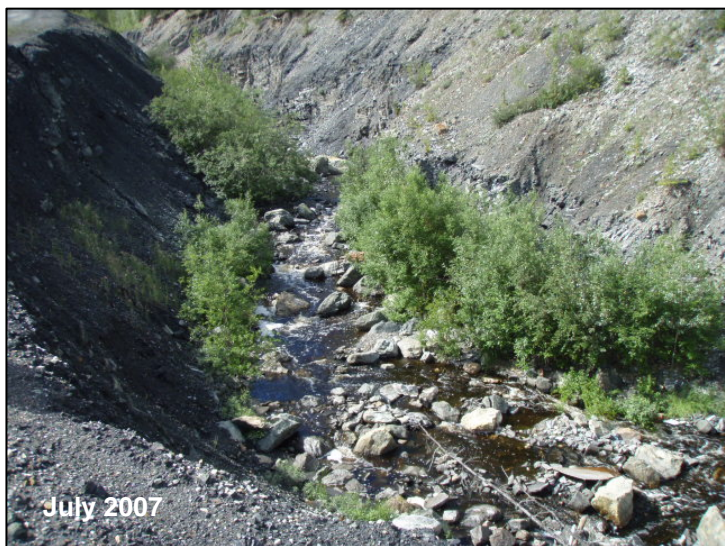
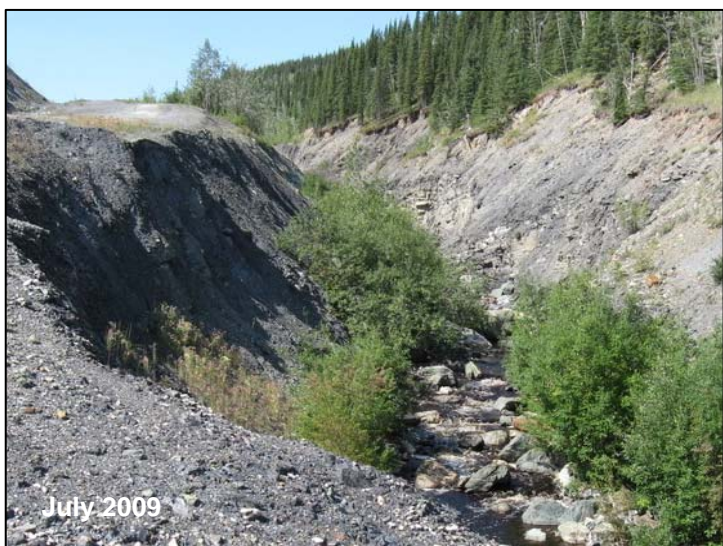
Farther upstream, at approximately Station 0+560, the physical features and vegetation along the LHS and RHS of the channel, as well as the channel bottom do not appear to have significantly changed from 2007 to 2009 as seen on Figures 05, 06 and 07 taken from WP 341. A similar set of photos were taken at WP 342, located at approximately Station 0+470 in the 2007 and 2009 in an upstream direction (Figure 08), cross-channel (Figure 09) and downstream (Figure 10); No significant changes in the condition of the channel over this time period were noted.

Figure 05 Station 0+560 in 2007 (left) and at WP 341 in 2009 (right), viewed U/S

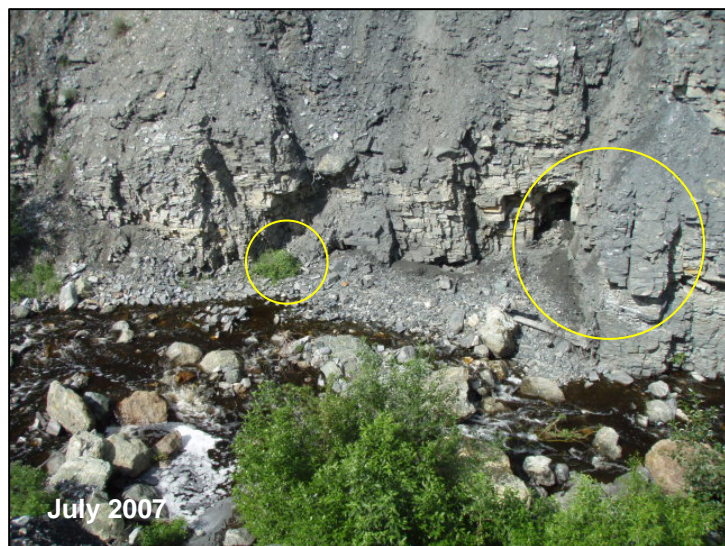
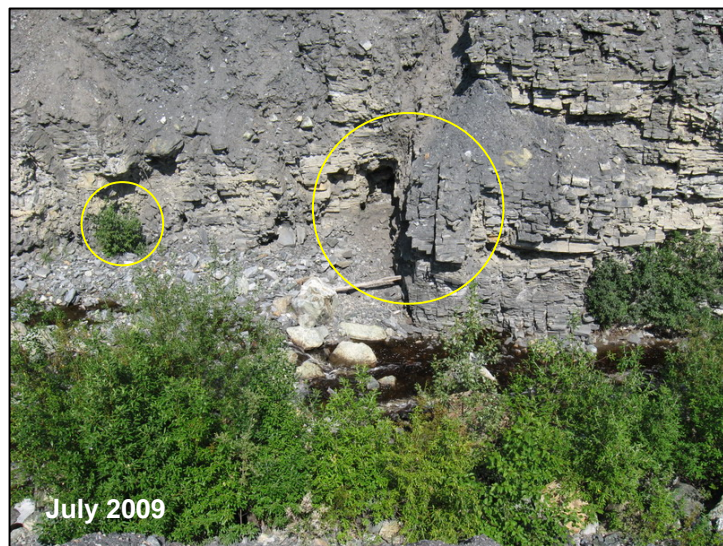
Figure 06 Station 0+560 in 2007 (left) and at WP 341 in 2009 (right), viewed cross-channel

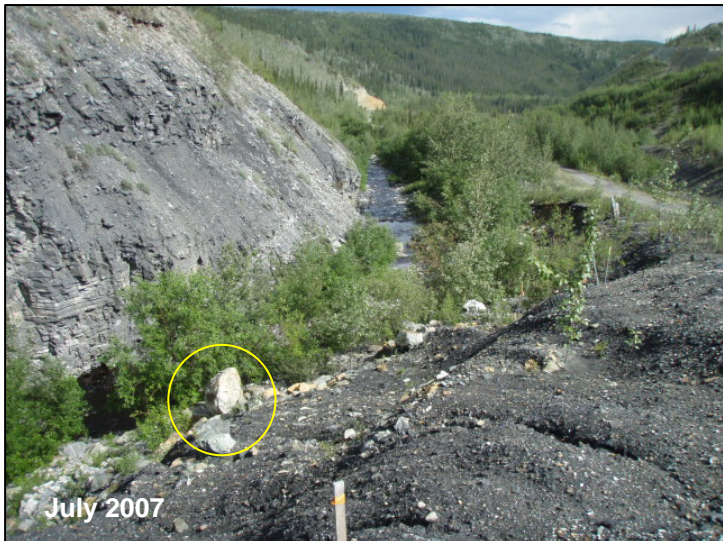
Figure 07 Station 0+560 in 2007 (left) and at WP 341 in 2009 (right), view D/S

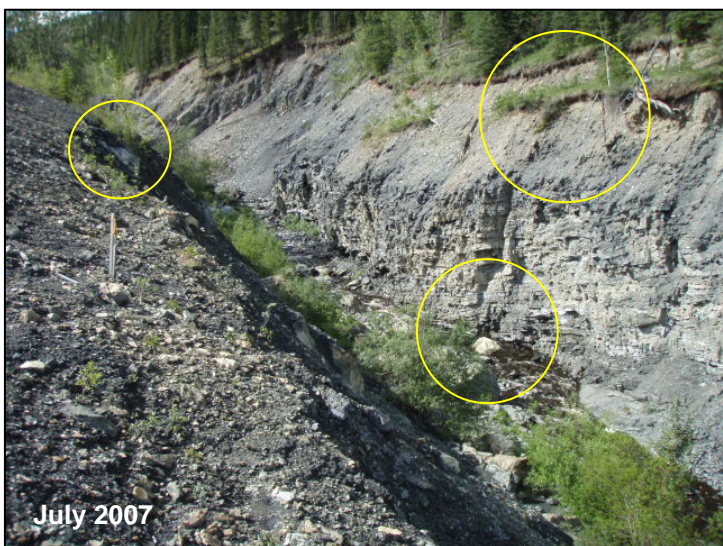
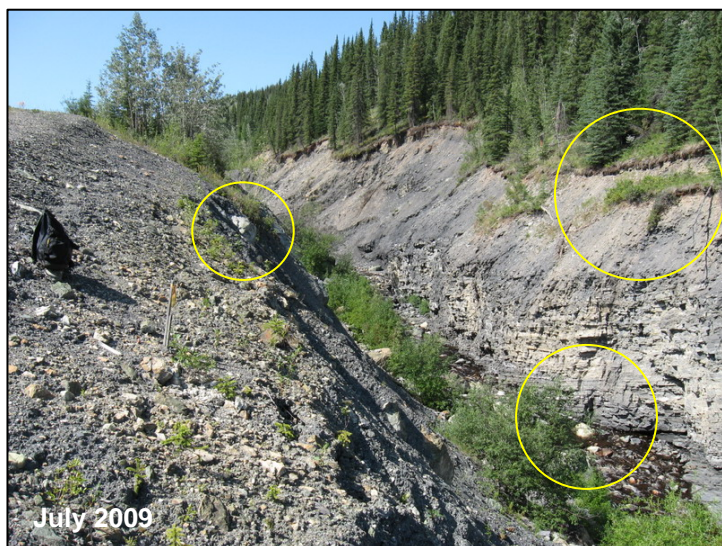
Figure 08 Station 0+470 in 2007 (left) and at WP 342 in 2009 (right), view U/S

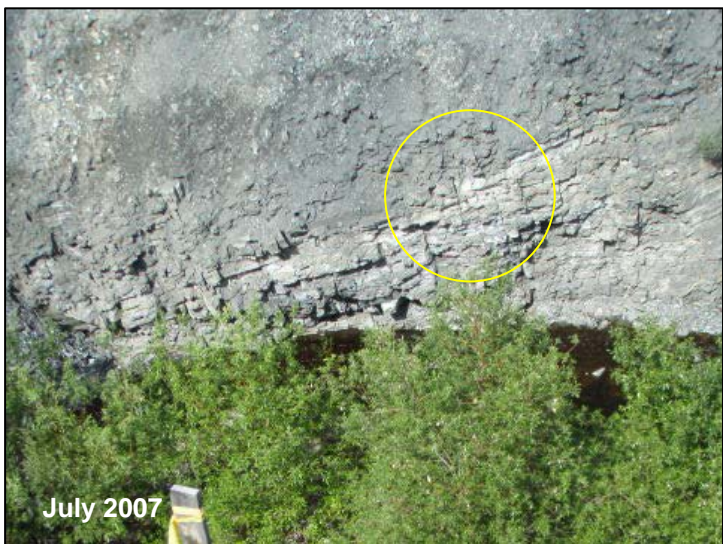
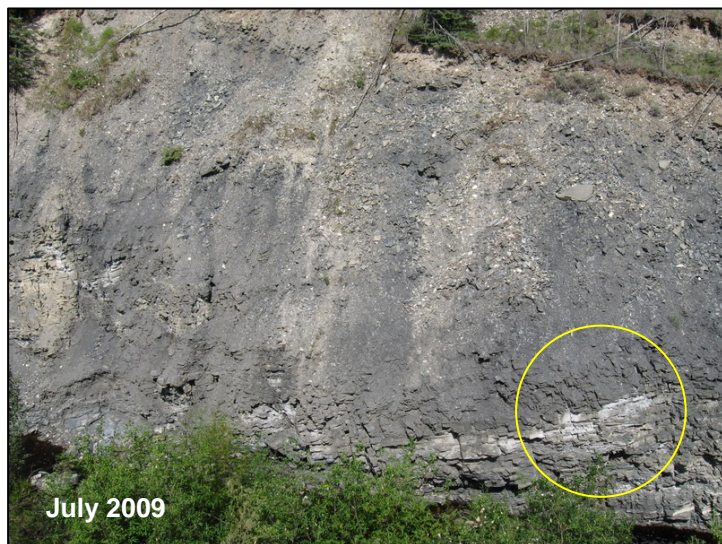
Figure 09 Station 0+470 in 2007 (left) and at WP 342 in 2009 (right), view cross-channel

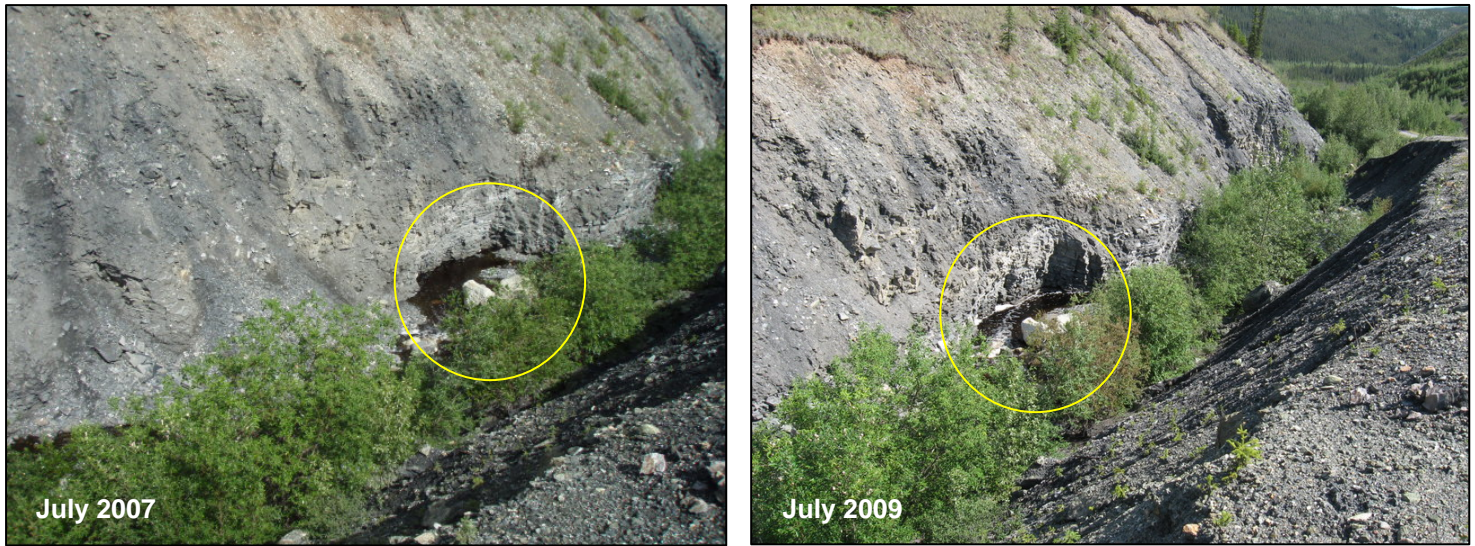
Figure 10 Station 0+470 in 2007 (left) and at WP 342 in 2009 (right), view D/S

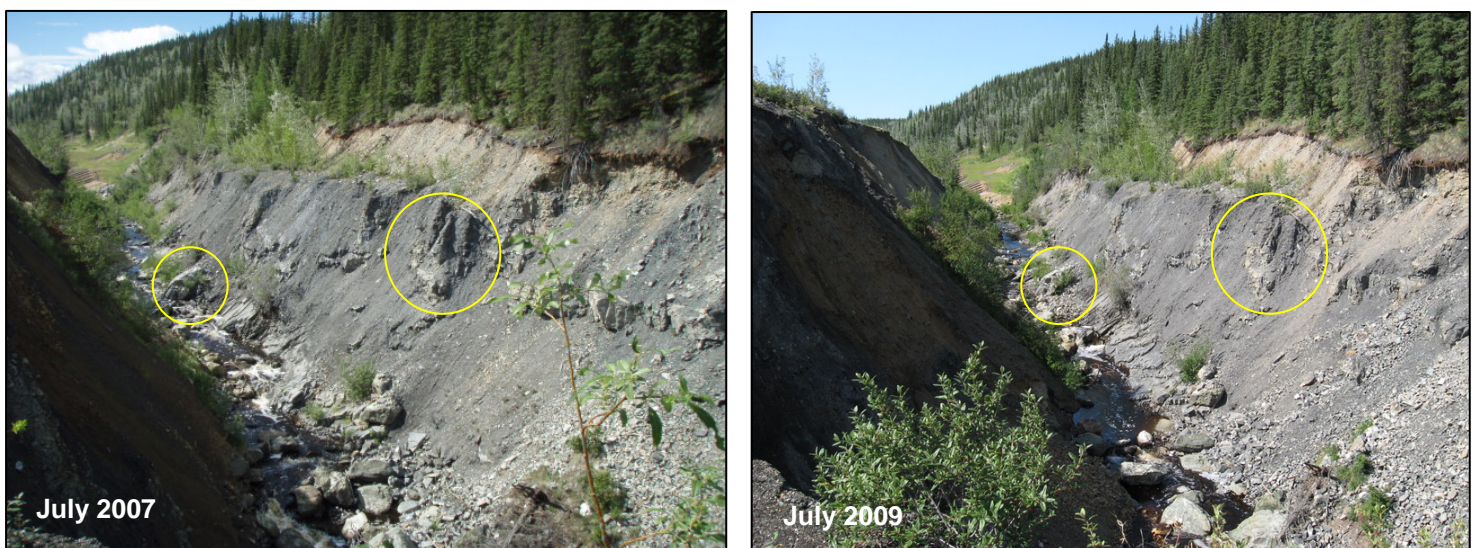
The last set of photos was taken 170 m downstream of the gabion drop inlet structures at about Station 0+370. The photos in Figures 11 and 12 were taken from the same location (WP 344) but at a different magnification. This is the portion of the channel where down-cutting could impact on the stabilization works (drop structures) and is therefore considered a critical component of the performance monitoring program. Examination of the photos from 2007 and 2009 does not reveal any significant changes in the channel over that time period which is consistent with the 2008 creek channel profile survey (AECOM, 2009). Several boulders and other channel features do not appear to have changed.

Figure 11 Station 0+360 in 2007 (left) and at WP 344 in 2009 (right), view U/S

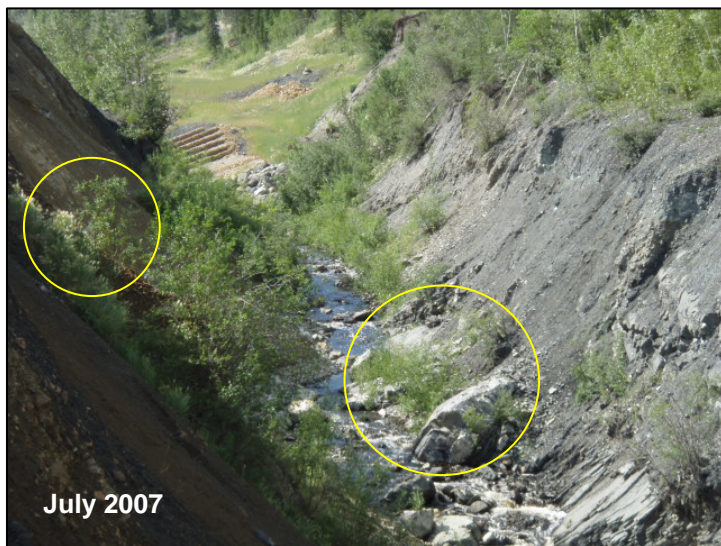
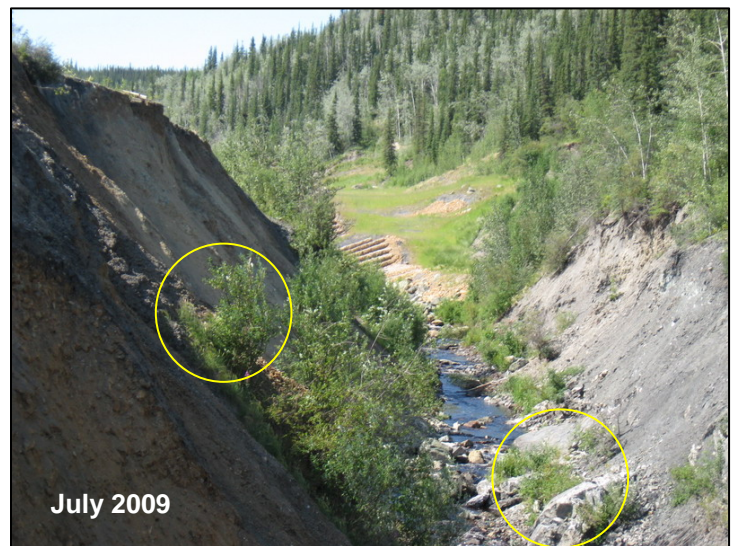
Figure 12 Clinton Creek Channel in 2007 (left) and at WP 344 in 2009 (right), view U/S at Hudgeon Lake Outlet

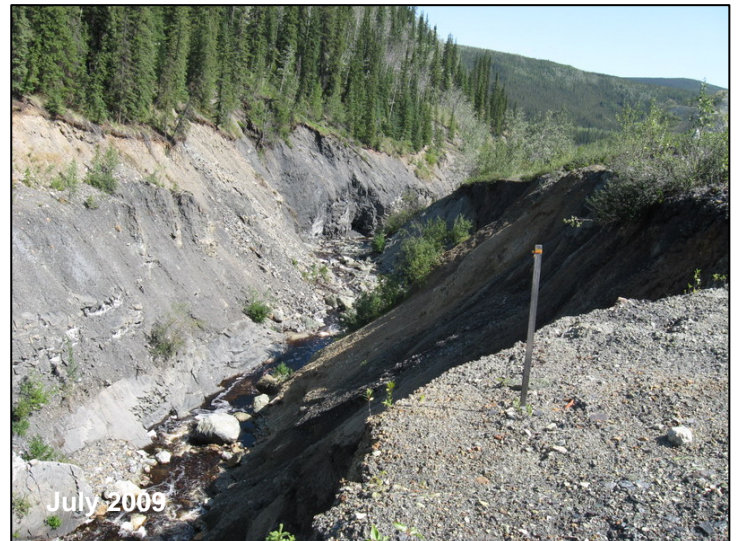
Figure 13 Clinton Creek Channel in 2007 (left) and at WP 345 in 2009 (right), view D/S

It is recommended that future photographs be taken in a downstream direction from WP 345 at approximately Station 0+290 as this location provides a good vantage of the waste rock and bedrock contact located about 50 m downstream of the drop structures at Station 0+225 (Figure 13). The extent of the recent slide activity visible in the right hand photo on Figure 13 should also be monitored in future inspections.

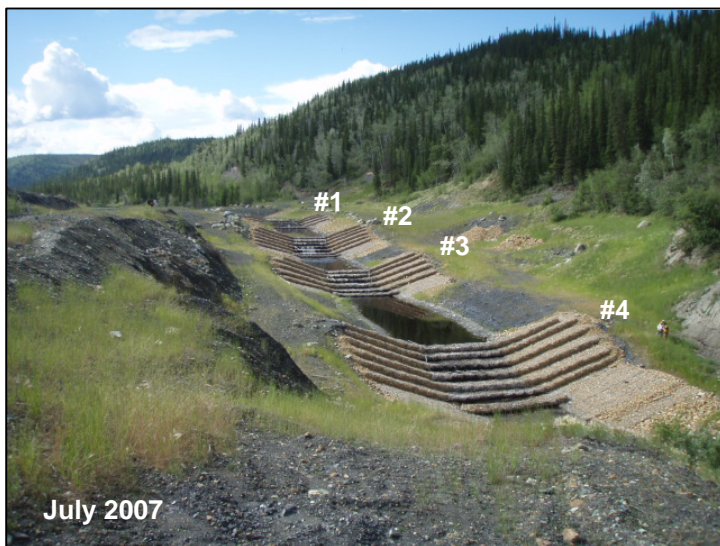
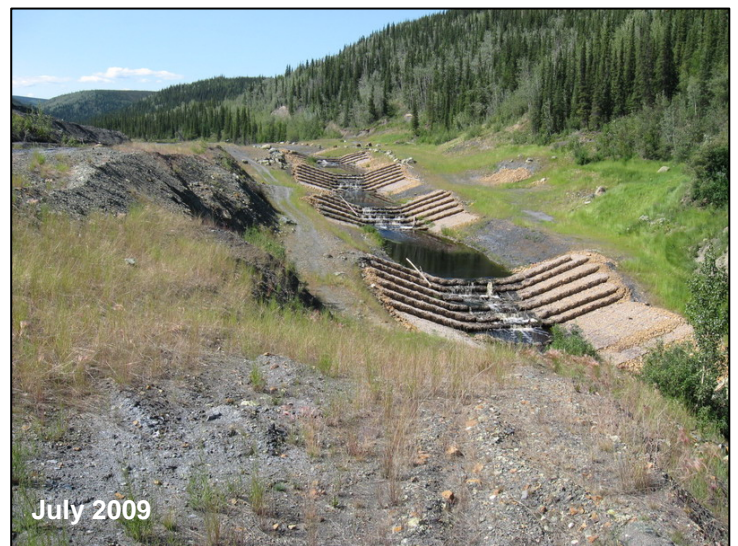
The gabion drop structures at the Hudgeon lake outlet were photographed in 2007 and 2009 from WP 346 at approximately Station 0+230. From this vantage point, no significant change in the overall condition of the channel or structures located between the lake outlet (Station 0+000) and Station 0+184 could be observed (Figure 14). Upon closer inspection however, it was evident that damage to the structures occurred during the 2009 spring freshet. It is suspected that this damage had already occurred but was not obvious on May 6, 2009 when the structures were inspected by the Government of Yukon during high flows (Figure 15). While the damage was severe enough to warrant repair before the next spring freshet, it was concluded that overall, the structures were performing as intended; They continued to provide erosion protection immediately downstream of the lake outlet and mitigate the risk of a breach and rapid lowering of Hudgeon Lake. It should be noted that repairs were subsequently carried out in the fall of 2009. A separate report has been prepared to document the completed repair work.

Figure 14 Gabion Drop Structures in 2007 (left) and From WP 346 in 2009 (right), view U/S

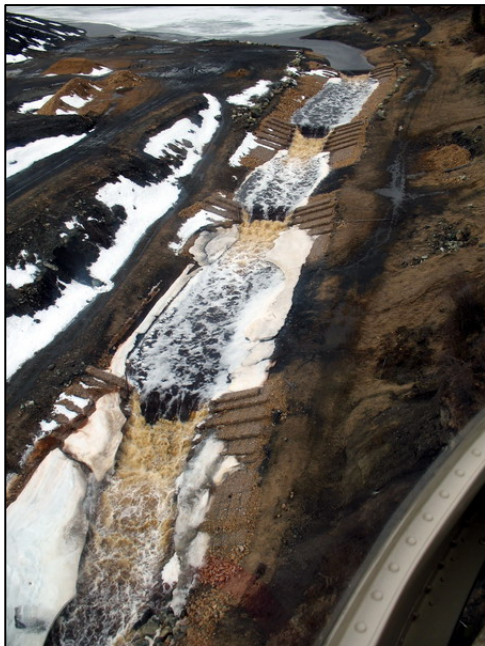
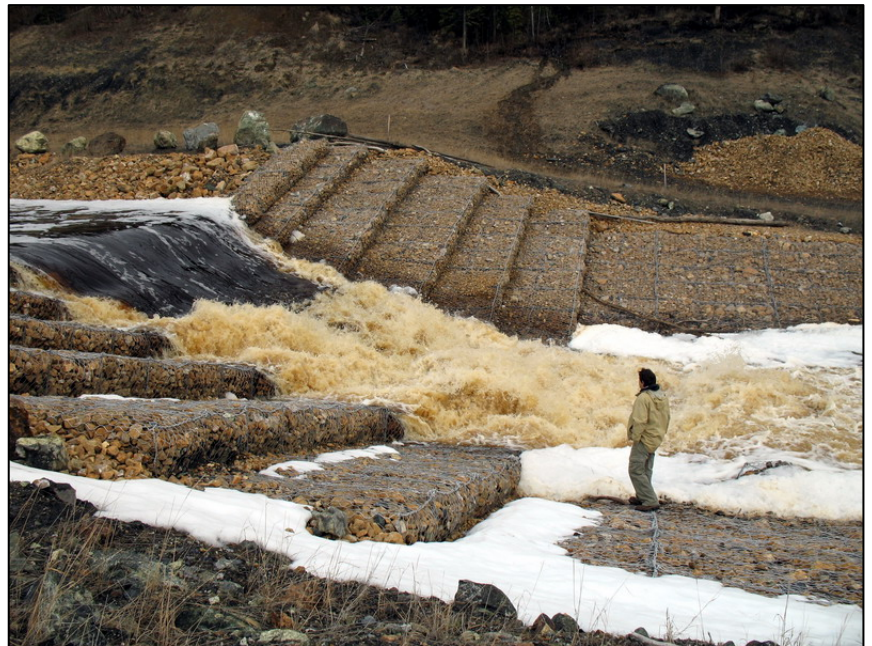
Figure 15 Gabion Drop Structures in May 2009 (DS # 2 on Right Hand Side Photo)

Overall, the damage to the gabion drop structures was more severe on the north side of the structures with the most significant damage occurring at Drop Structure #4 (DS #4). Less damage occurred at DS #2 and relatively minor damage occurred at DS #1 and DS #3. Photographs taken in May 2009 during the spring freshet suggest that the lower parts of the channel, which are shaded from direct sunlight due to the height of the waste rock pile to the south, may have been constricted by snow and ice build-up (Figure 15). The effect of the shading of the south side of the channel can be seen in the aerial photograph taken by the Department of Fisheries and Oceans in March 2008 (Figure 16). On Figure 15, erosion channels in the snow pack are visible on the south side of the channel at DS #3 and DS #4 indicating that the channel was not fully open at some point during the spring freshet and some water may have flowed around the snow and ice. This scenario is supported by reports that the spring thaw in

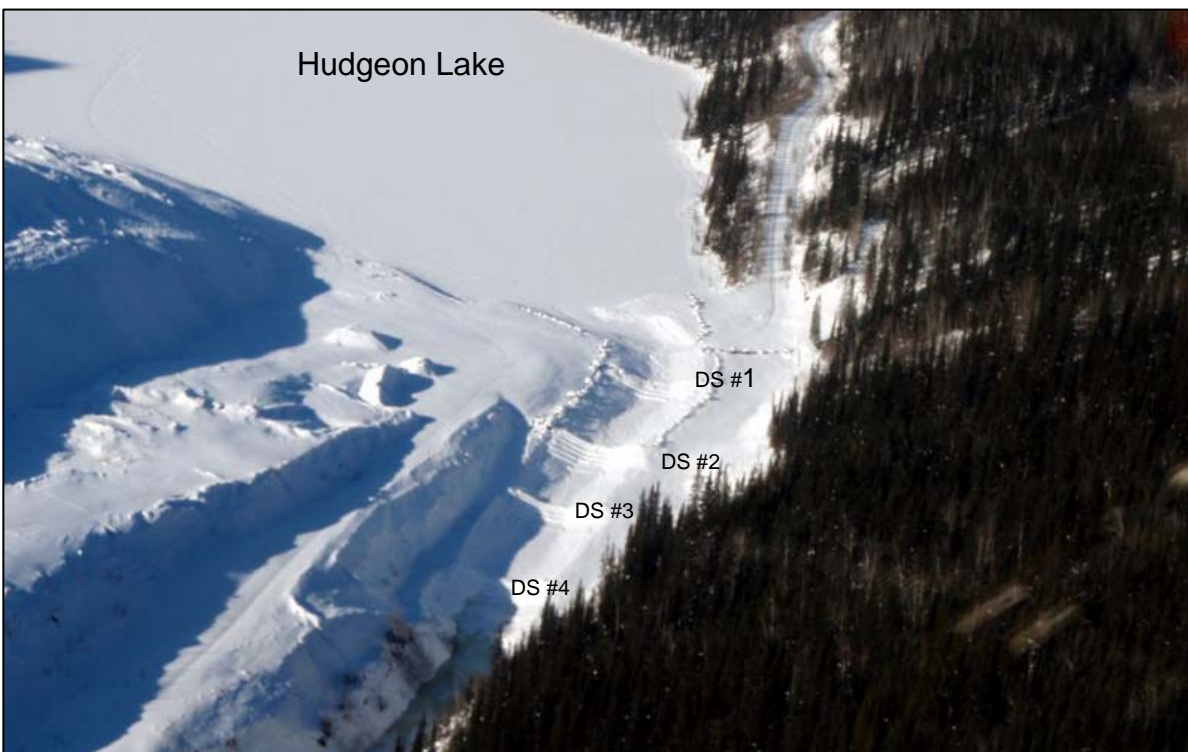
2009 was delayed by unseasonably cold temperatures followed by a rapid rise in temperatures and prolonged rainfall. A potential consequence of concentrated flow on the north side of the channel would be a higher unit discharge (per metre width of channel) than the drop structures were designed for, in particular at DS #4 which is in the shadow of the waste rock dump (Figure 16).

Figure 16 Hudgeon Lake Outlet in March 2008 (courtesy of DFO – Al von Finster)

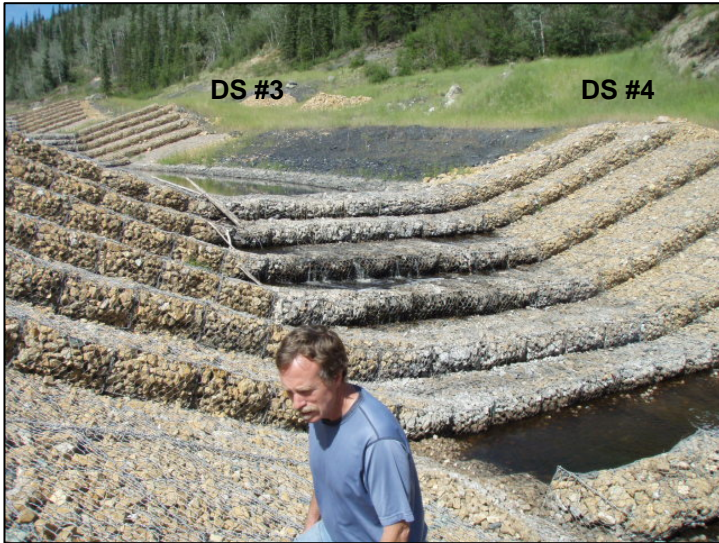
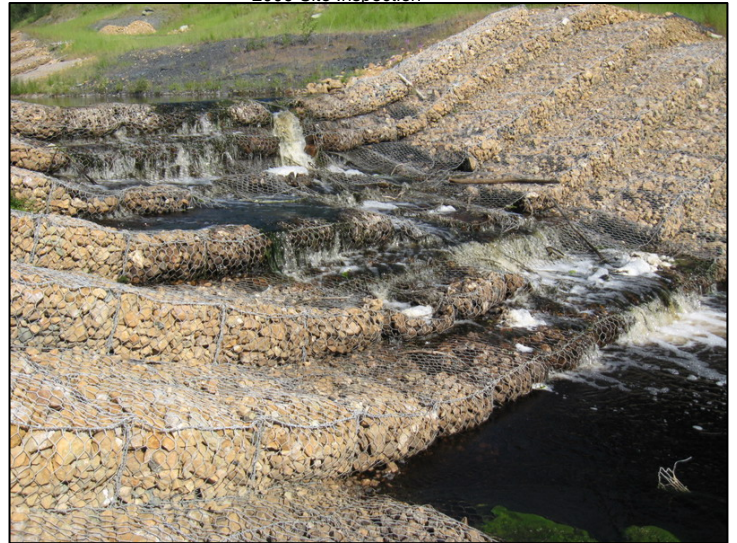
Drop Structure #4 consists of a drawdown weir with 6 tiers that provide a 2.5 m drop in channel grade and an end sill on the bottom tier. Figure 17 compares the overall condition of the structure in 2007 and the damage resulting from the spring freshet in 2009. Of the overall damage to the stabilized channel section, the most significant occurred to Drop Structure #4. Several of the wire baskets at the top of the structure including the drawdown weir and tiers 4, 5 and 6 were deformed with some of the baskets having been torn open with the rock fill partially or completely missing (Figures 18 and 19). In many cases, it appeared that some of the stainless steel retaining clips used to close the baskets failed allowing the seam along the downstream edge of the basket to open enough to allow the rocks to be pulled out by tractive forces during high flows.

Figure 17 DS #4 in 2007 (left) and 2009 (right), view U/S

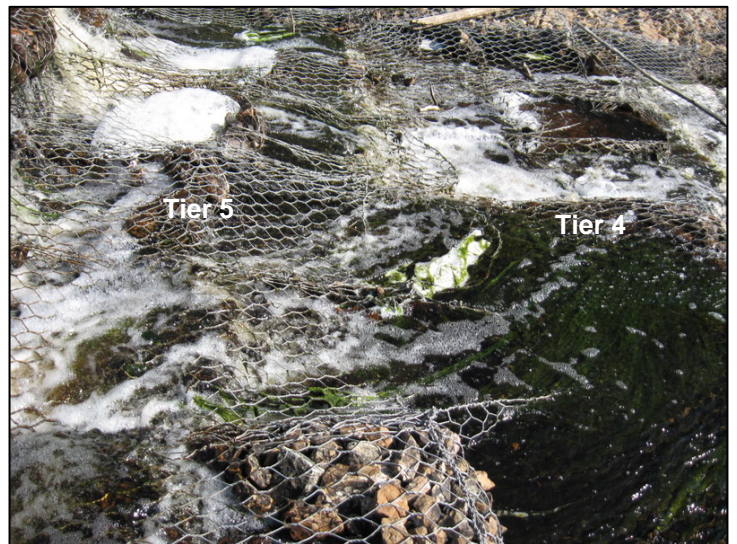
The damage extends across Tiers 2 and 3 where several baskets were open with rock missing. A section in the middle of the end sill was missing and presumed to have washed downstream. The condition of the lower section of the drop structure (Tier 1) and end sill in 2007 and after the spring freshet in 2009 is illustrated on Figures 20 (2007) and 21 and 22 (2009).

Figure 19 DS #4 Tier 4 and Tier 5 in 2009, view N

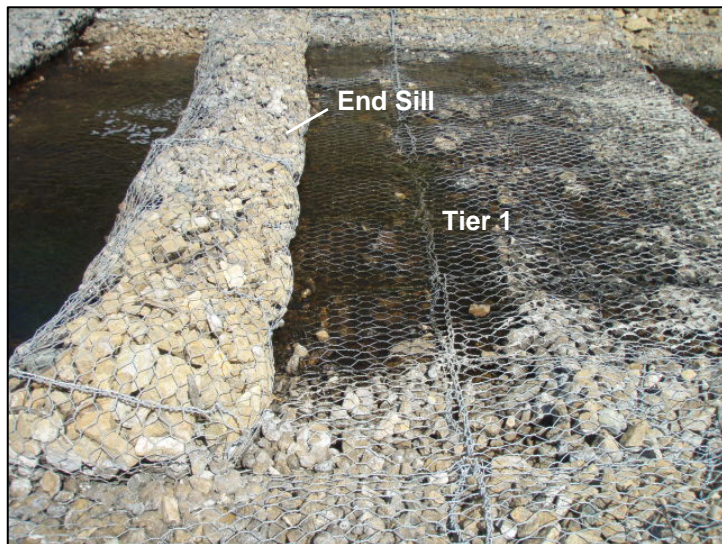
Figure 20 DS #4 Tier 2 and Tier 3 & End Sill in 2007, view N

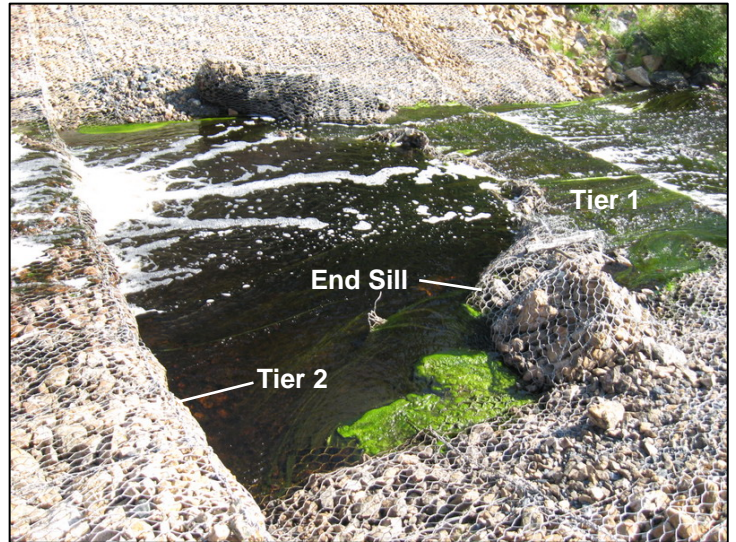
Figure 22 DS #4 Tier 2, End Sill & Tier 1 in 2009, view N

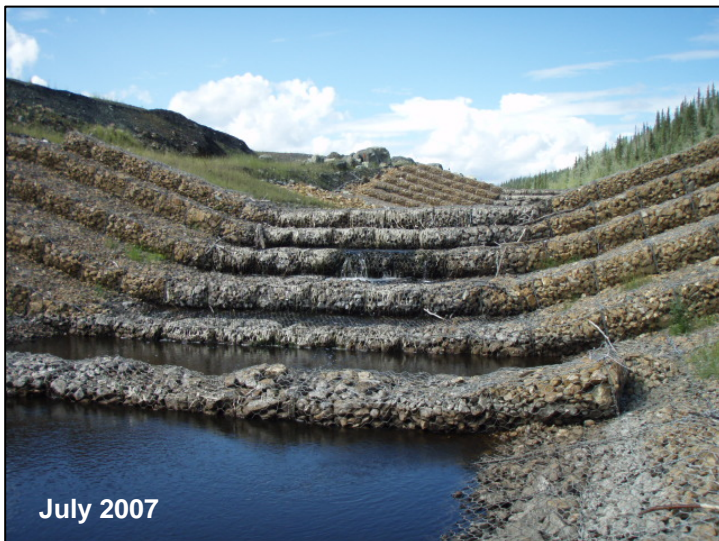
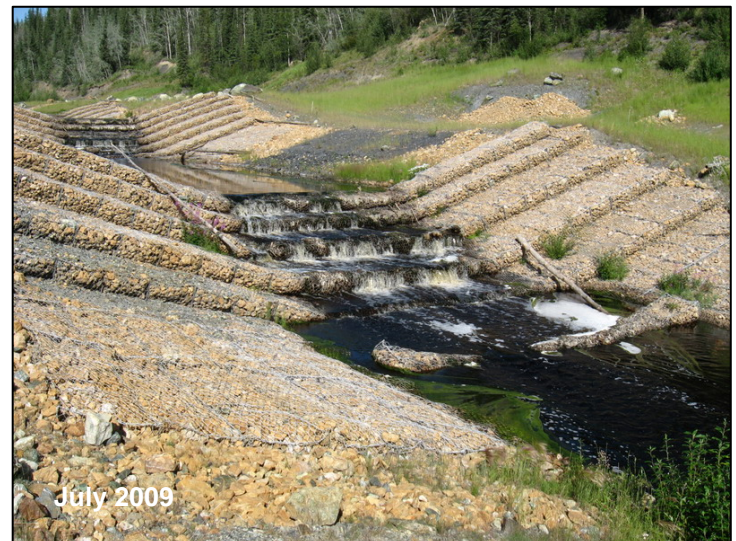
Drop Structure #3 consists of a drawdown weir with 5 tiers that provide a 2 m drop in channel grade and an end sill on the bottom tier. Figure 23 illustrates the overall condition of the structure in 2007 and the damage resulting from the spring freshet in 2009. A cross-channel view of the structure is shown on Figure 24. Most of the damage to Drop Structure #3 involved deformation of the baskets including the drawdown weir which was leaning forward with the downstream edge about 300 mm lower than as-constructed (Figure 25). There were some small holes in the tops or downstream sides of individual baskets in Tiers 2, 3 and 4 although most of the rock was still inside of the baskets (Figure 26). The end sill was badly deformed but intact, having bulged at least 300 mm downstream as shown on Figure 27. The channel banks between DS#3 and #4 are in good condition. It appears that the high water mark on the channel side slope was about 1.5 m higher than observed at the time of the inspection (Figure 28).

Figure 23 DS #3 in 2007 (left) and 2009 (right), view U/S

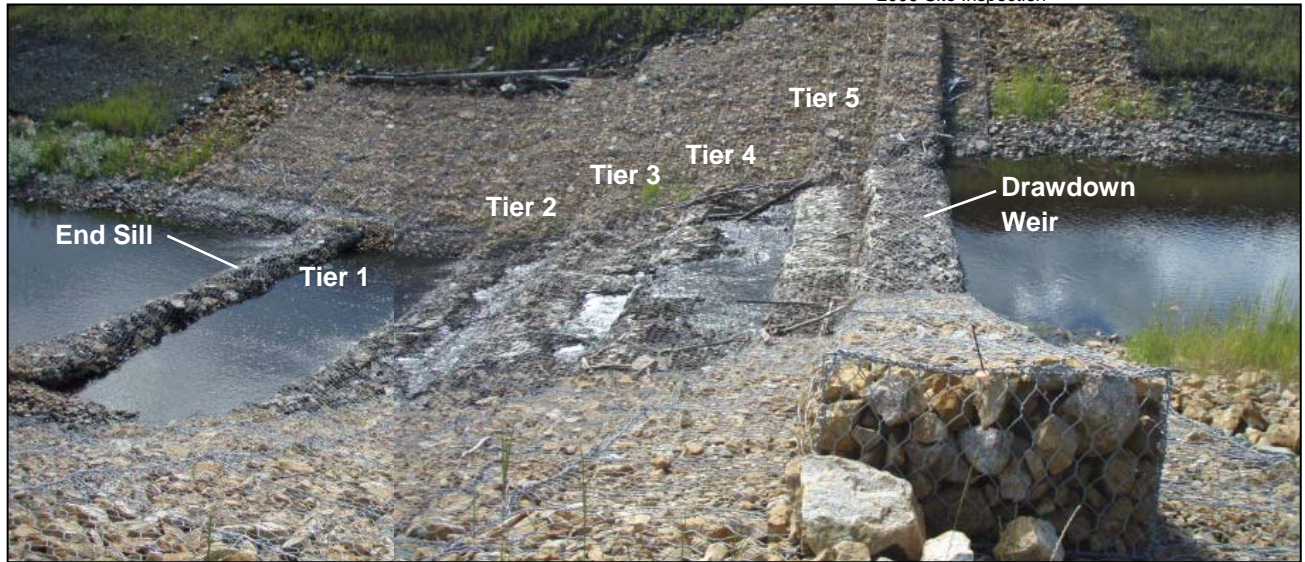
Figure 24 DS #3 in 2007, View Cross-Channel From LHS Bank

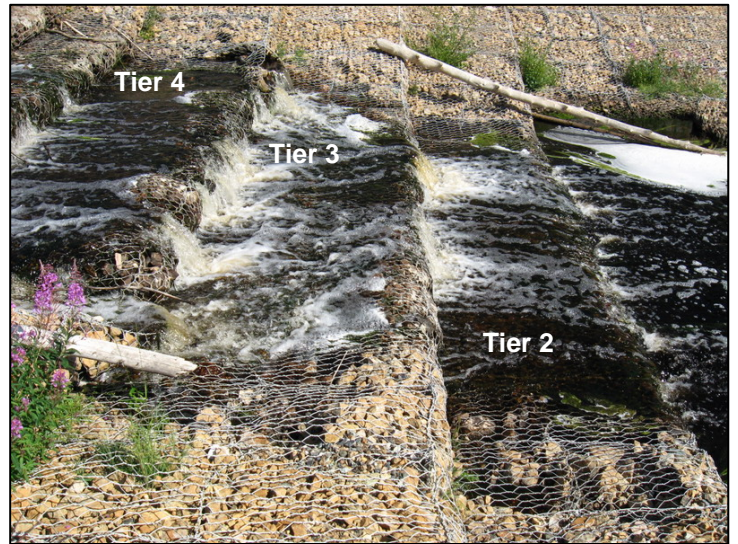
Figure 26 DS #3 Tier 4, Tier 2,3 and 4 in 2009, view N

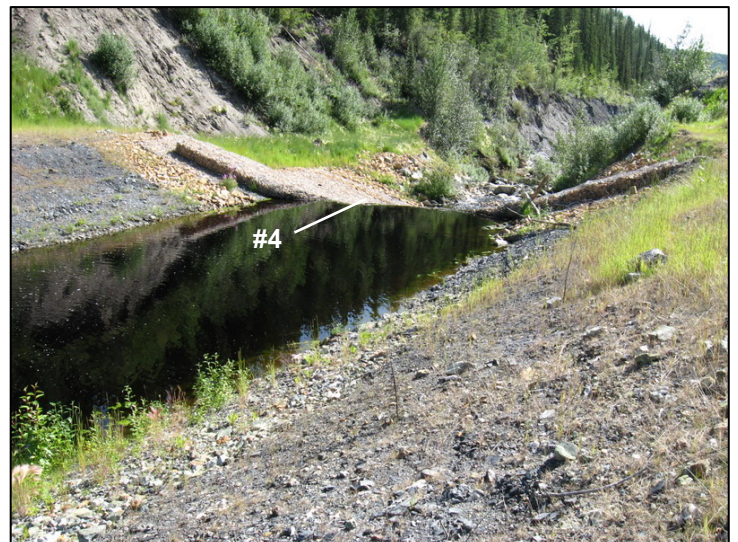
Figure 28 Pond Between DS #3 & #4 in 2009, view D/S

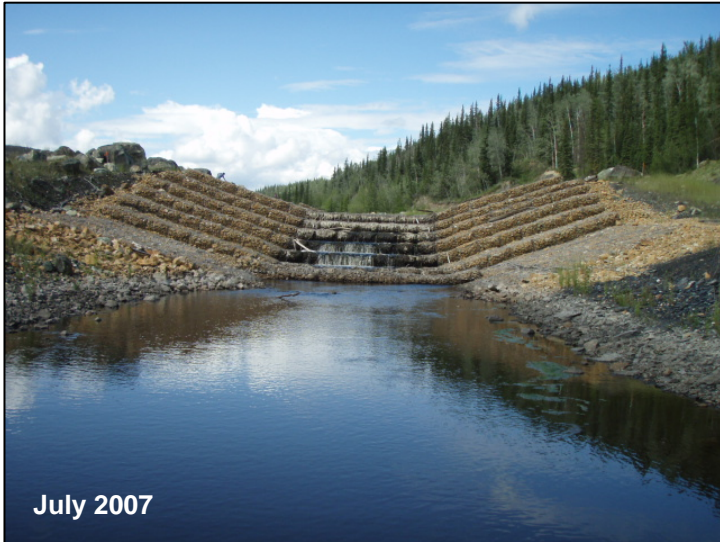
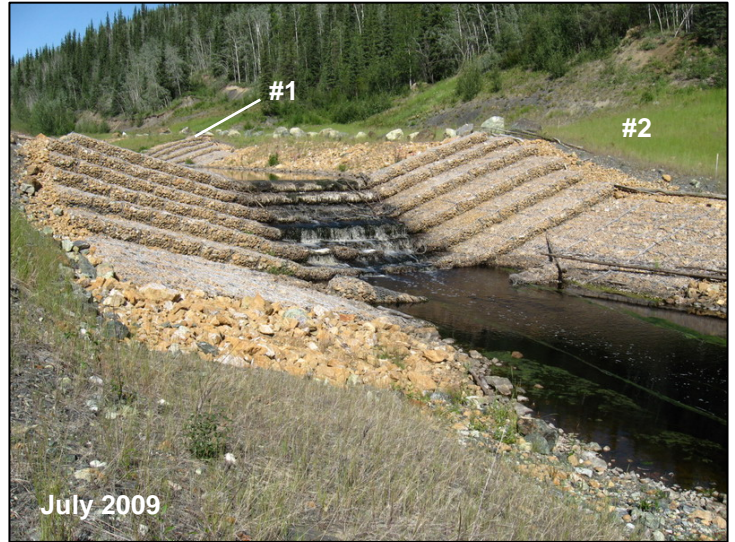
Drop Structure #2 consists of a drawdown weir with 6 tiers that provide a 2.5 m drop in channel grade and an end sill on the bottom tier. A comparison of the structure in 2007 and 2009 is illustrated on Figure 29. The observed damage includes the drawdown weir which was leaning downstream by about 200 mm (Figure 30) and several of the baskets on Tiers 2, 3 and 5 which were opened up with some loss of the rock fill material (Figures 30, 31 and 32). The end sill was partially submerged but appeared to be deformed with considerable loss of rock fill (Figure 33).

Figure 29 DS #2 in 2007 (left) and 2009 (right), view U/S

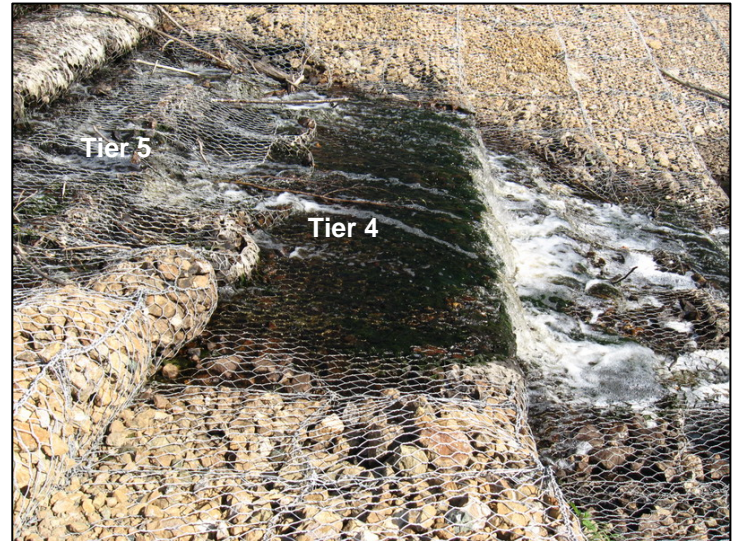
Figure 31 DS #2 Tier 4 and 5 in 2009, view N

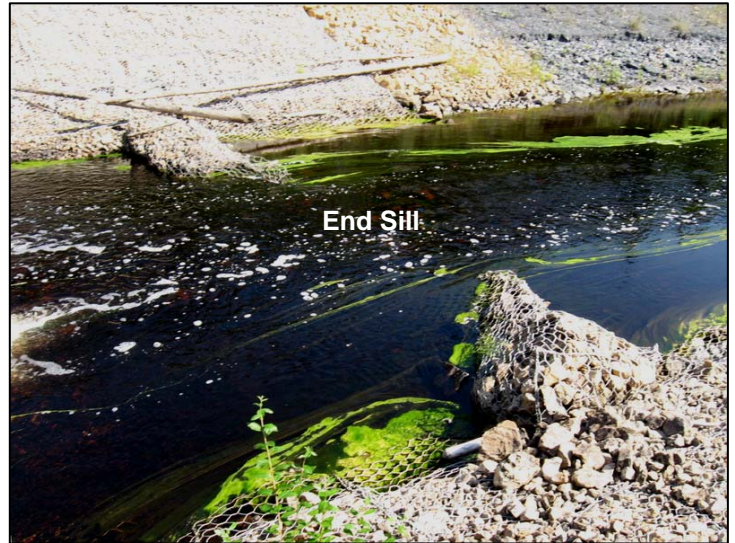
Figure 33 DS #2 End Sill in 2009, view N

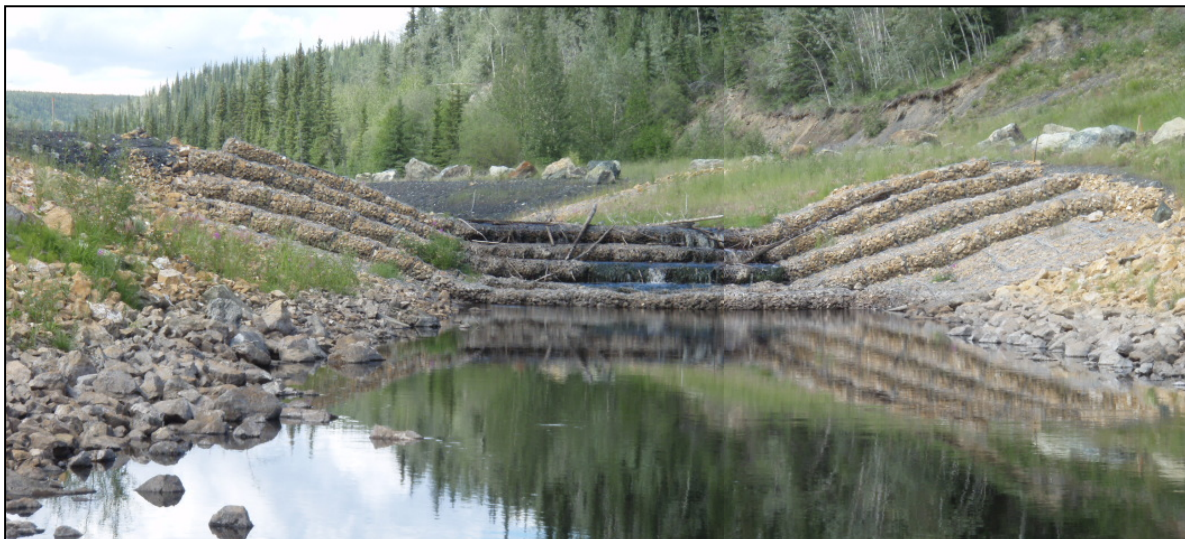
Drop Structure #1 consists of a drawdown weir with 4 tiers that provide a 1.5 m drop in channel grade and an end sill on the bottom tier. An upstream and cross-channel view of the structure in 2007 is illustrated on Figures 34 and 35, respectively. The drawdown weir was leaning downstream by about 200 mm and several of the baskets on Tiers 2, 3 and 4 had opened up with the baskets either empty or about half full (Figures 36 and 37). The end sill was partially submerged but appeared to be deformed with considerable loss of rock fill (Figure 38 and 39). The opening in the drawdown weir was created by design in 2007 to allow the elevation in Hudgeon Lake to drop during low flow periods and prior to freeze-up.

Figure 34 DS #1 in July 2007, view U/S

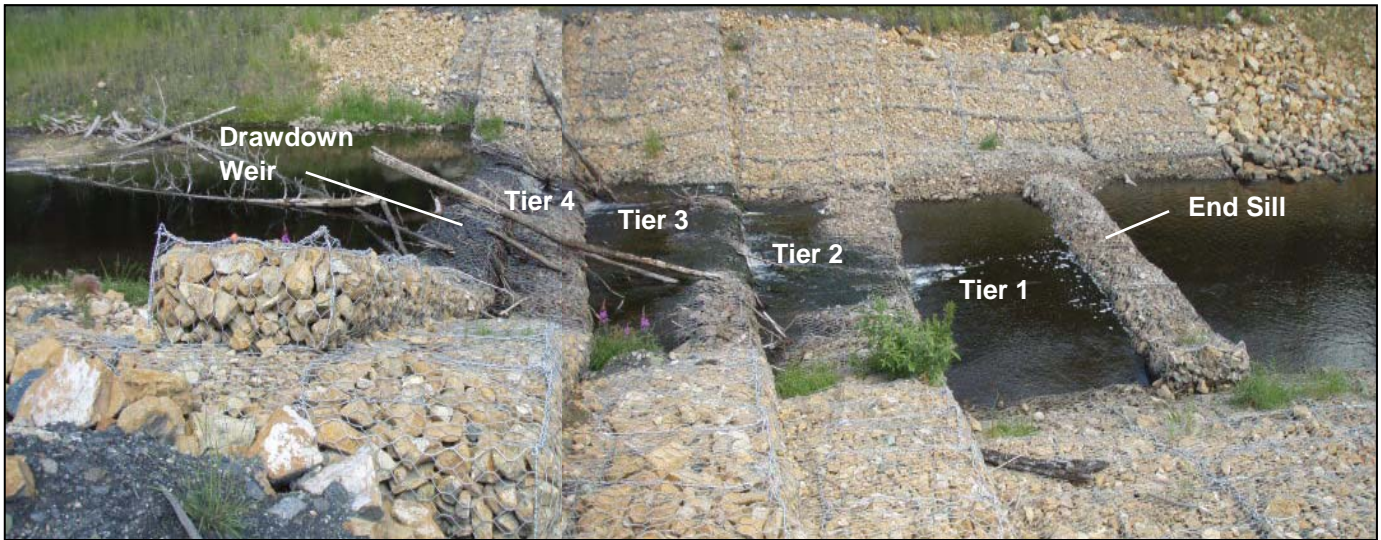
Figure 35 DS #1 in July 2007, view Cross-channel to North

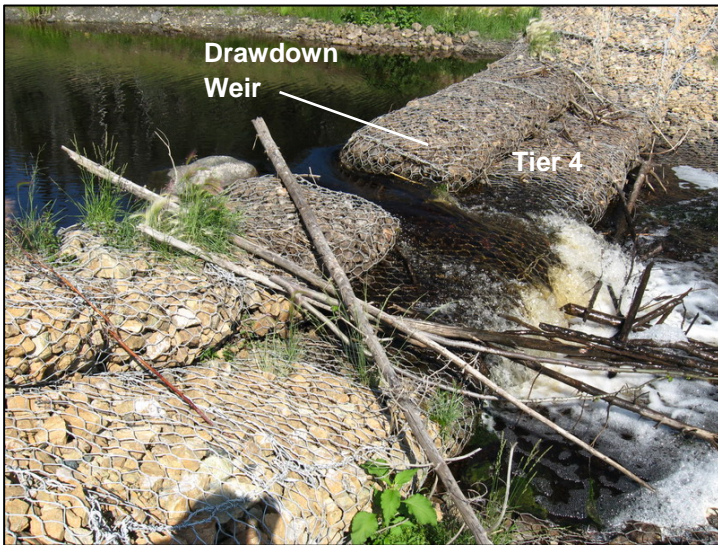
Figure 36 DS #1 Drawdown Weir & Tier 4 in July 2009, view N

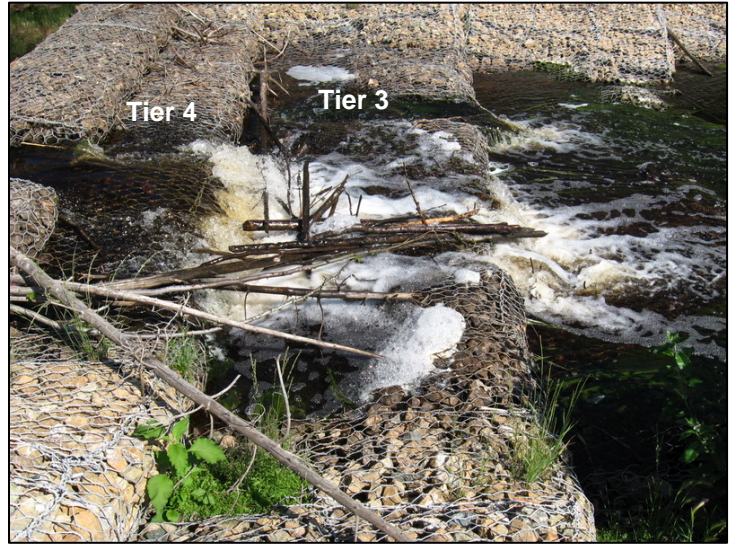
Figure 37 DS #1 Tier 3 and 4 in 2009, view N

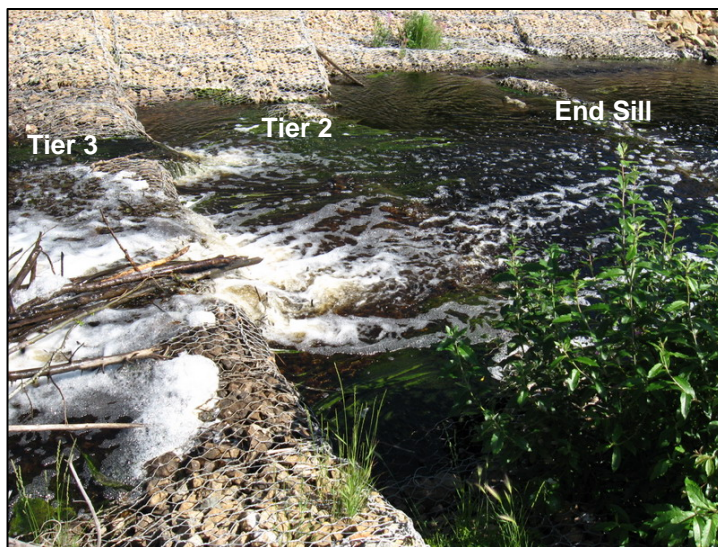
Figure 38 DS #1 Tier 2 and 3 & End Sill in July 2009, view N

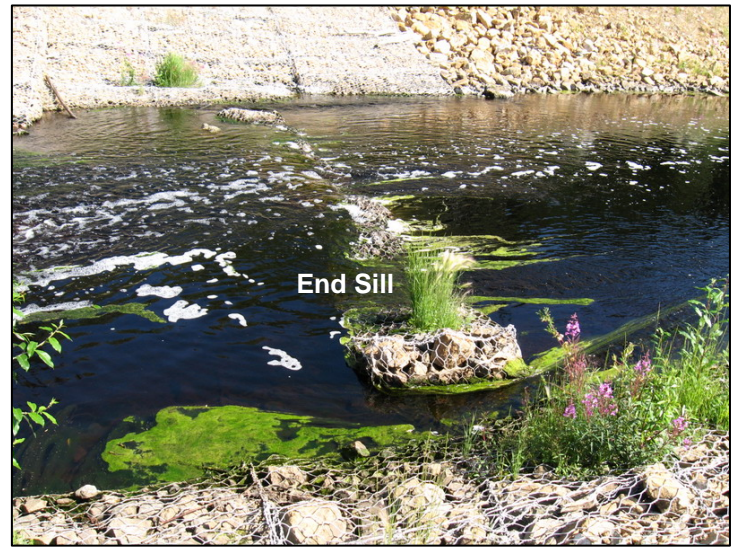
Figure 39 DS #1 End Sill in July 2009, view N
