Government of Yukon

Former Clinton Creek Asbestos Mine 2009 Site Inspection

AECOM

March, 2010

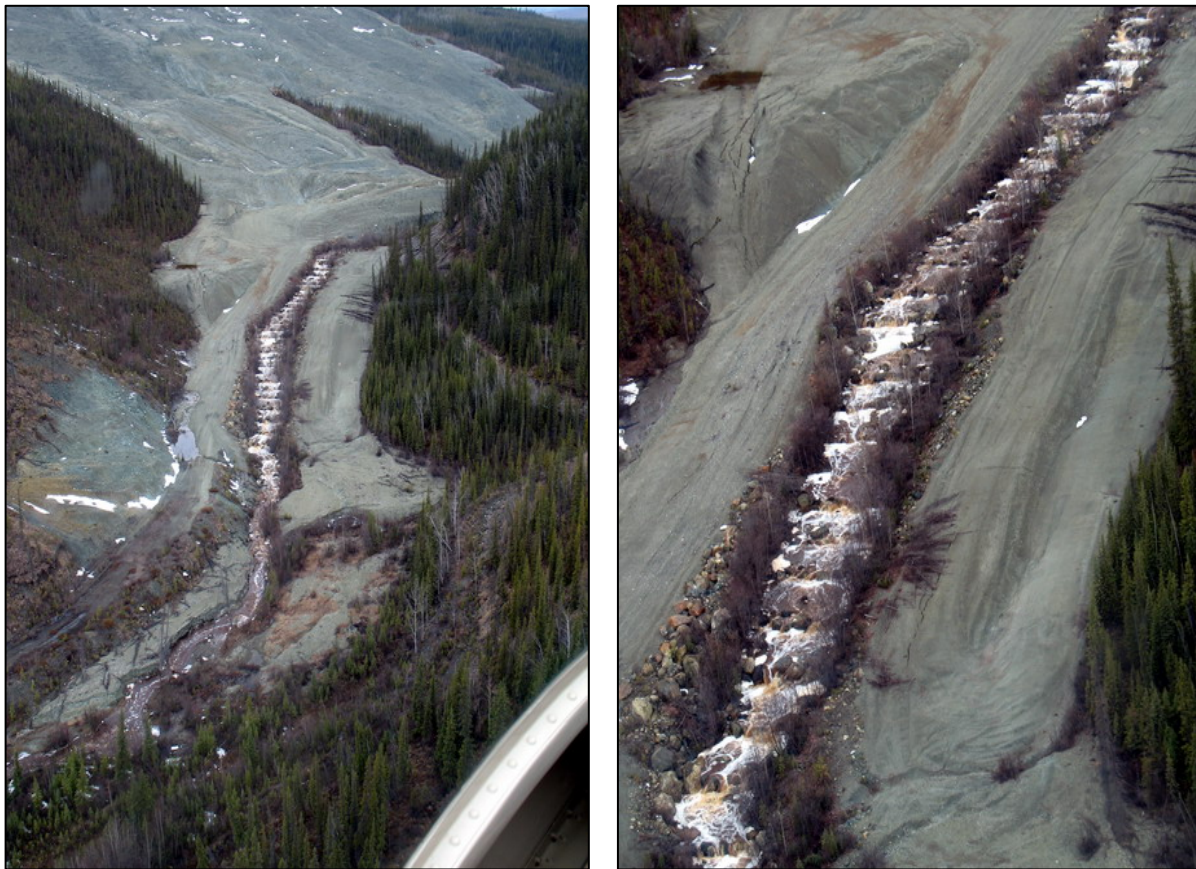
An armoured section of the Wolverine Creek channel is located on the downstream (south) end of the south tailings lobe. It consists of a rock lined channel with a series of rock weirs constructed over about 5 to 10 m of tailings and its integrity is a critical component of the risk management of the site. Although normal summer flows through the channel are small, the spring freshet produces relatively higher albeit short term flows as seen in the aerial photo taken in May 2009 (Figure 40).

Figure 40 Rock Lined Channel in May 2009

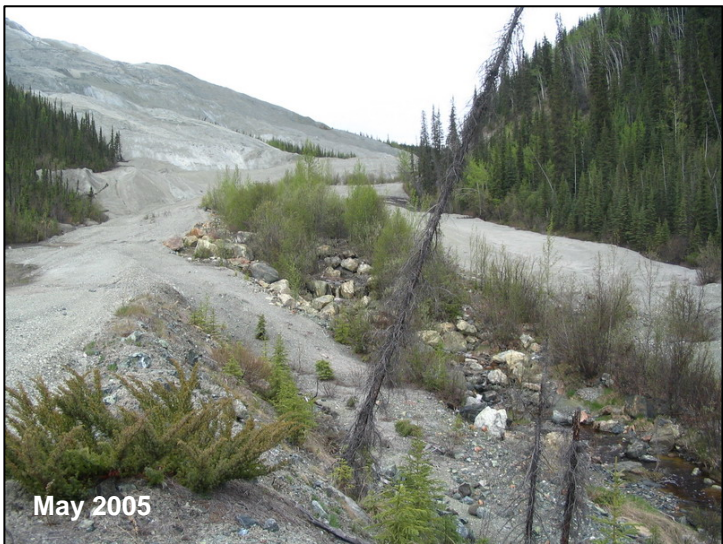
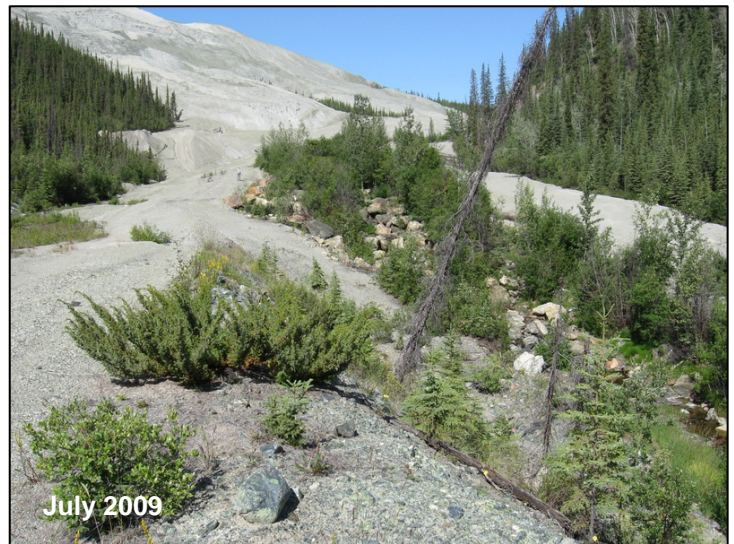
A comparison of the channel in 2005 and 2009 and 2007 and 2009 is shown on Figures 41 and 42, respectively. There are no significant changes in the condition of the channel from 2005 to 2009 although heavy vegetation, including trees, is gradually encroaching on the channel after brushing work was carried out in 2007 (note that the photos in Figure 42 are not taken at exactly the same location). Brush clearing work was limited to the removal of the trees and brush from the bottom of the channel only and not the channel banks. The rock weirs are in good condition and there is minimal erosion along the bottom and sides of the channel.

Figure 41 View U/S at Rock Lined Channel in 2005 (left) and 2009 (right), From UGL Tag 482

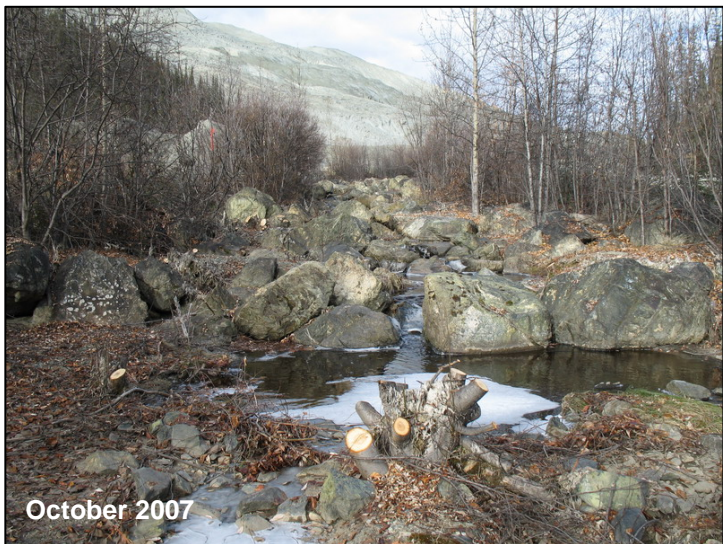
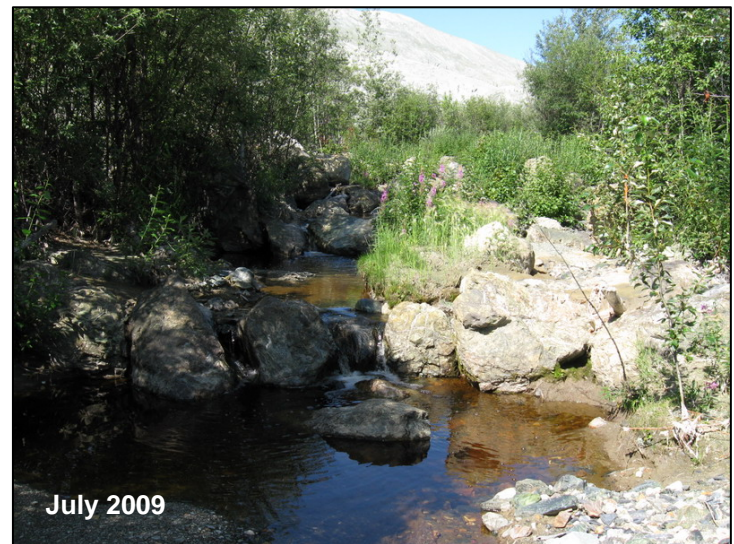
Figure 42 View U/S Along Rock Lined Channel in Wolverine Creek in 2007 (left) and at WP 335 in 2009 (right)

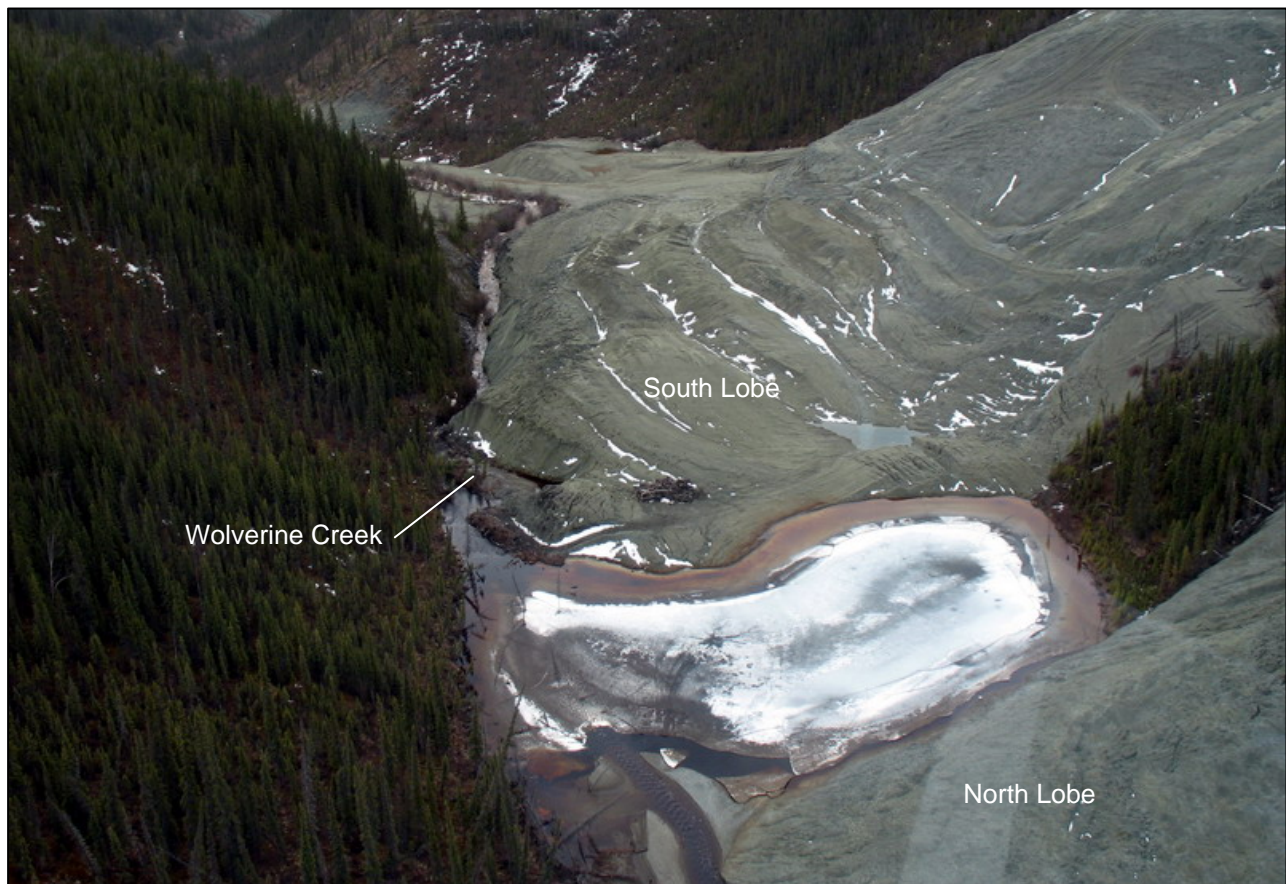
The creek channel across the tailings can be seen on the aerial photograph taken in May 2009 (Figure 43). A view of the leading edge of the south lobe just downstream of the pond separating the two lobes from 2007 and 2009 is shown on Figure 44. It does not appear that there has been any significant change in the physical features of the tailings or channel. The vegetation in the 2009 photo is more prominent due to the time of year the photo was taken. Within the channel across the south lobe, there does not appear to have been any significant changes between 2007 and 2009 with trees and vegetation apparently undisturbed (Figure 45). The leading edge of the lobe however, consists of freshly exposed tailings with numerous slumps confirming that there is ongoing erosion of the tailings and deposition of this material downstream.

Figure 43 Wolverine Creek Channel Through Tailings (May 2009)

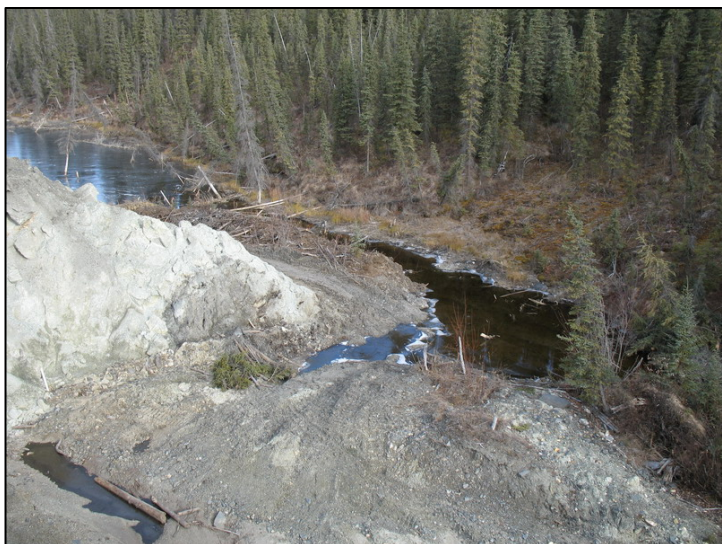
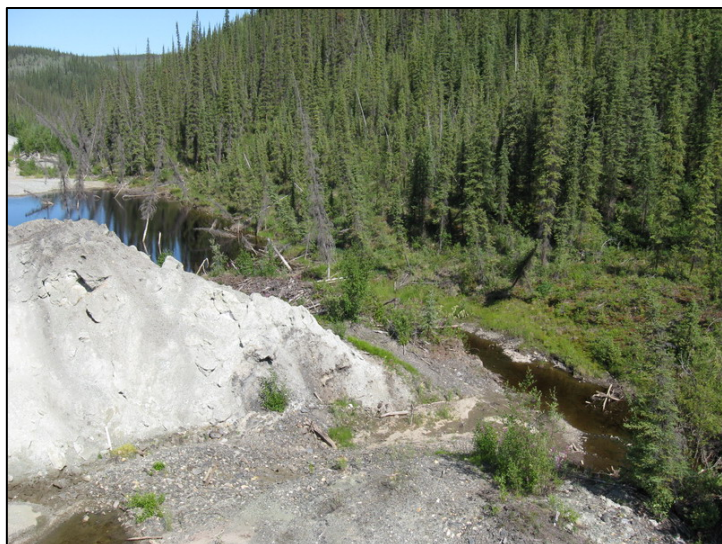
Figure 44 View of Toe of S Tailings Lobe in 2007 (left) and From WP 338 in 2009 (right)

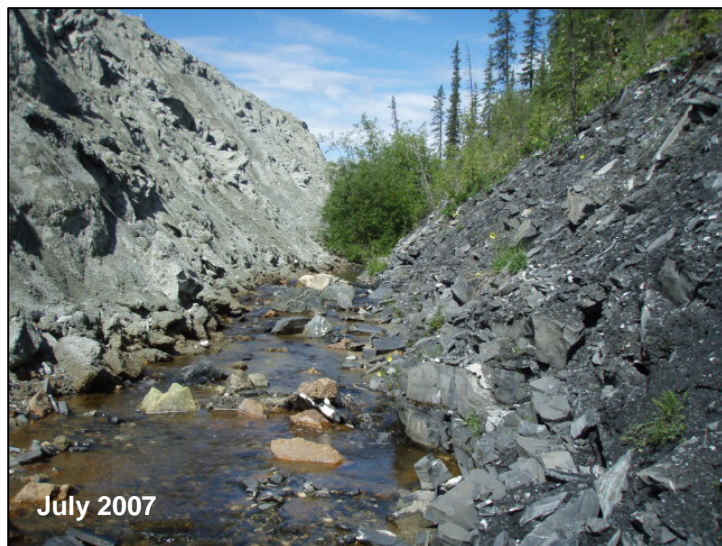
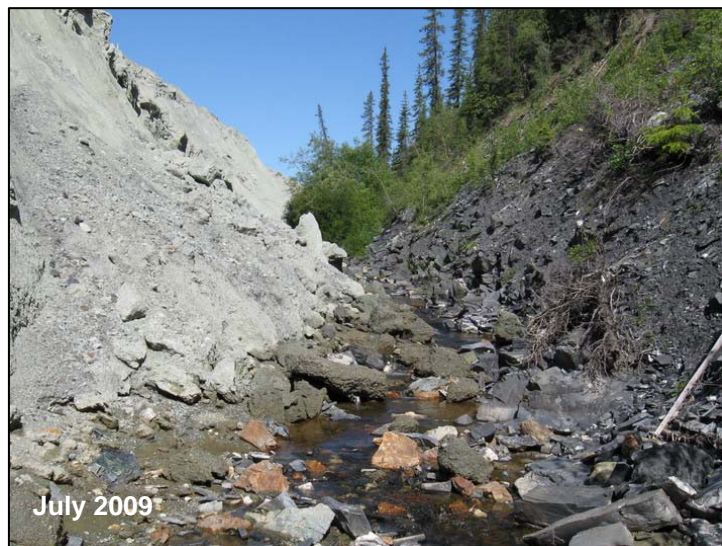
Figure 45 View U/S Along Wolverine Creek Across S Lobe in July 2007 (left) and at WP 337 in July 2009 (right)

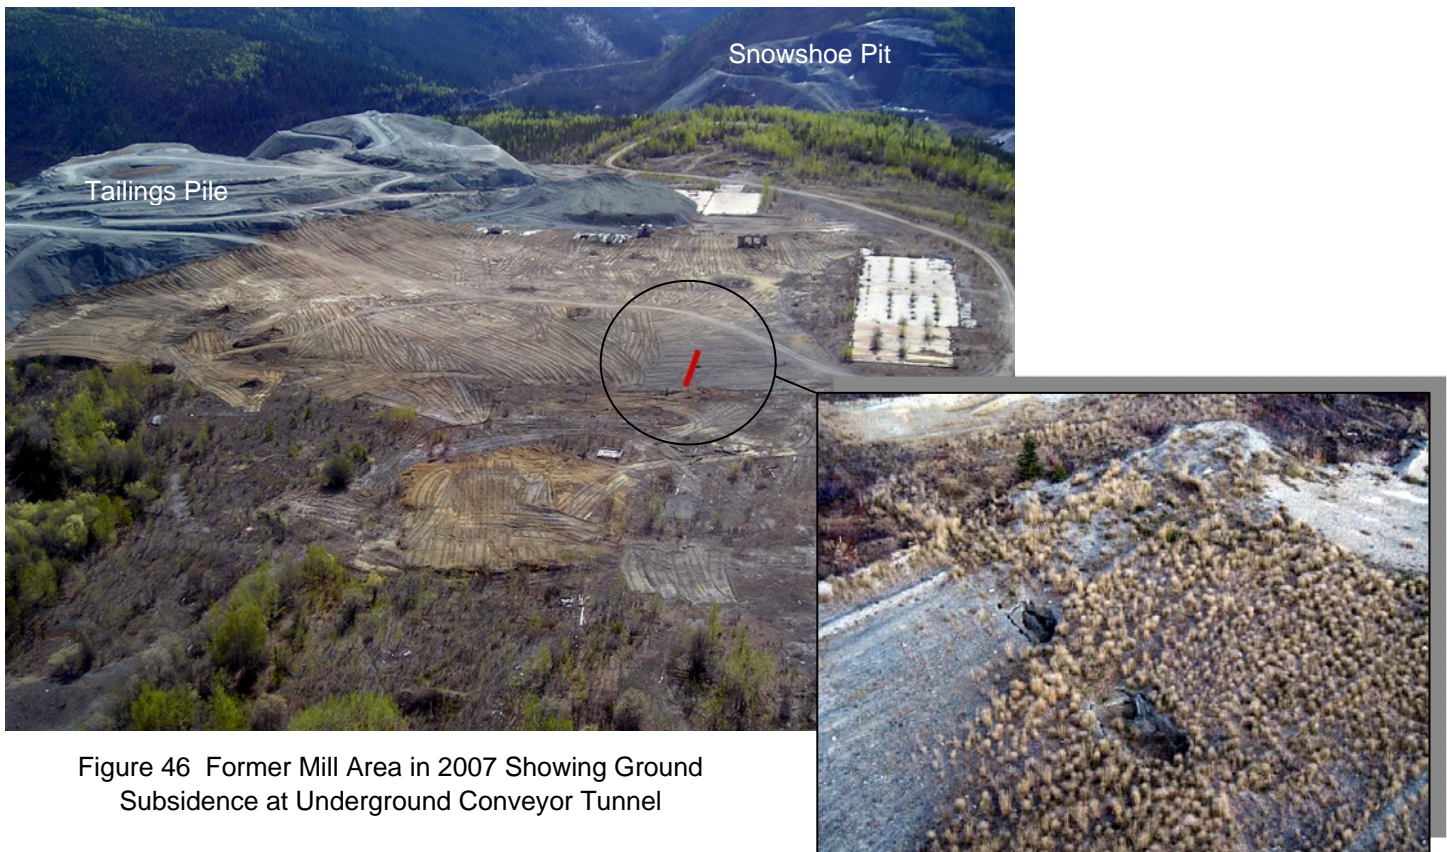
A brief inspection of the mill site was carried out by Rachel Pugh of the Government of Yukon. The ground subsidence reported in 2007 along the alignment of the former underground conveyor tunnel appears to have been filled in (personal communication, R. Pugh). An aerial view of the Mill Site and the area of the reported ground subsidence is shown on Figure 46.

Figure 46 Former Mill Area in 2007 Showing Ground Subsidence at Underground Conveyor Tunnel

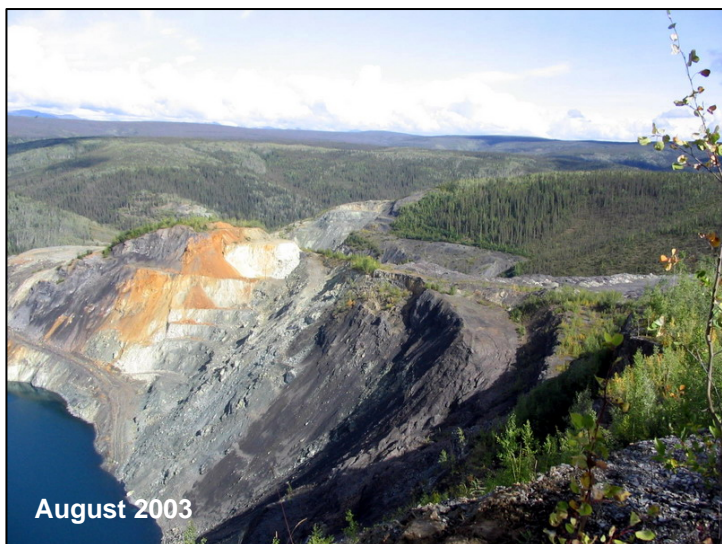
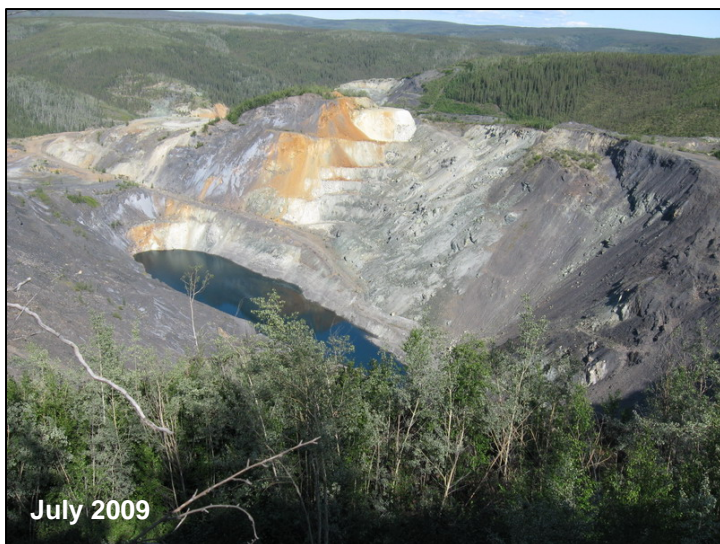
No significant changes in the condition of the open pit were noted although gradual ravelling of the pit walls is ongoing. A series of photographs taken in 2003 and 2009 illustrate the overall condition of the open pit (Figures 47, 48 and 49). Waypoint (WP) locations for the photographs are shown on Drawing 02. A ditch has been excavated around the south and west side of the open pit to restrict access. The approximate alignment of the ditch is shown on Drawing 02. Excavated material from the ditch has been placed as a berm and warning signs have been posted (Figures 50 and 51). Warning signs have also been posted around the northeast portion of the pit perimeter which is readily accessible (Figure 52). Many areas along the open pit perimeter are over-steepened, overhanging and unsafe, for example at WP 349 as shown on Figure 53.

Figure 47 View NE Across Porcupine Pit in August 2003 (left) and From WP 358 in July 2009 (right)

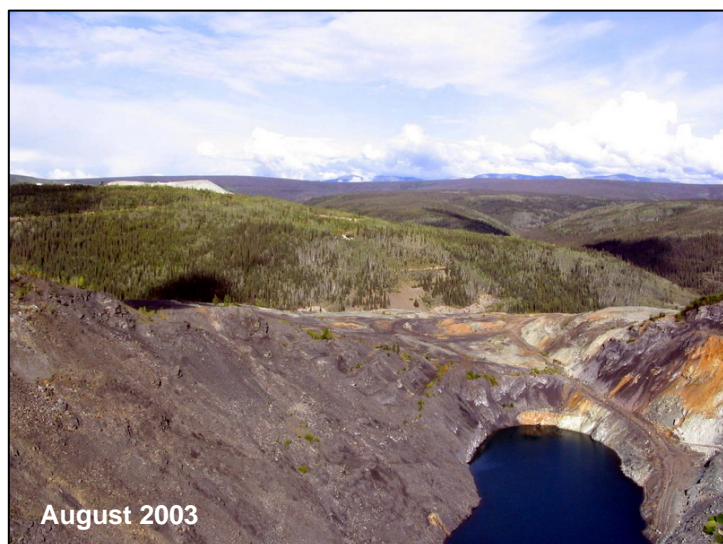
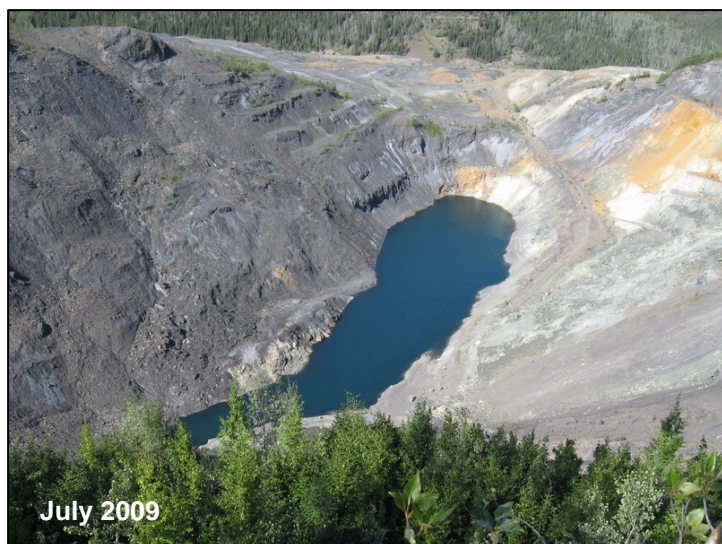
Figure 48 View N Across Porcupine Pit in August 2003 (left) and From WP 357 in July 2009 (right)

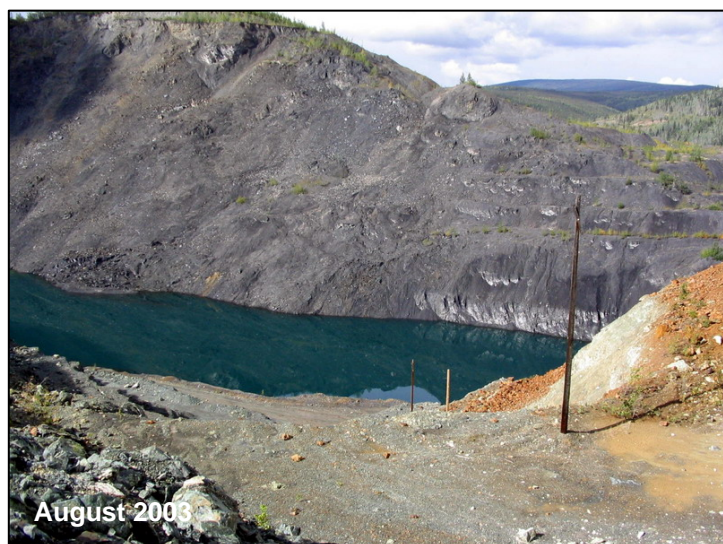
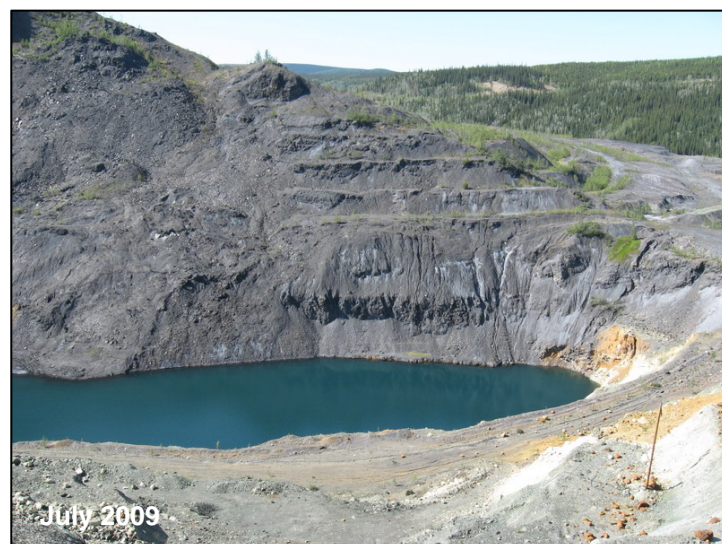
Figure 49 View W Across Porcupine Pit in August 2003 (left) and From WP 353 in July 2009 (right)

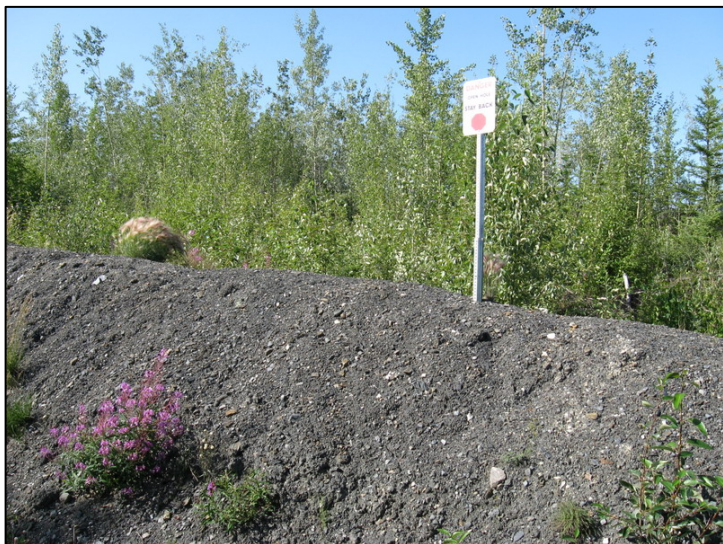
Figure 50 Warning Sign on Berm at WP 356

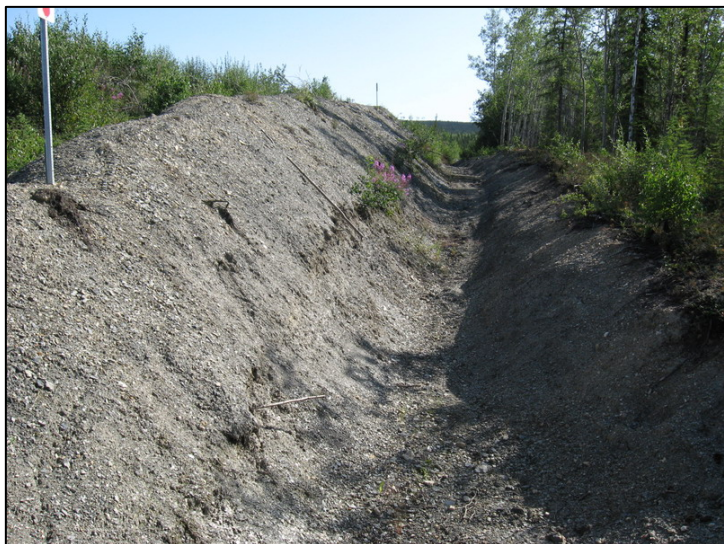
Figure 51 Ditch and Berm at WP 359

Ravelling of the over-steepened pit walls is continuing. Vegetation is beginning to encroach on the ditch and berm around the west side of the open pit. Consideration should be given to tree cutting along the ditch as part of routine maintenance.

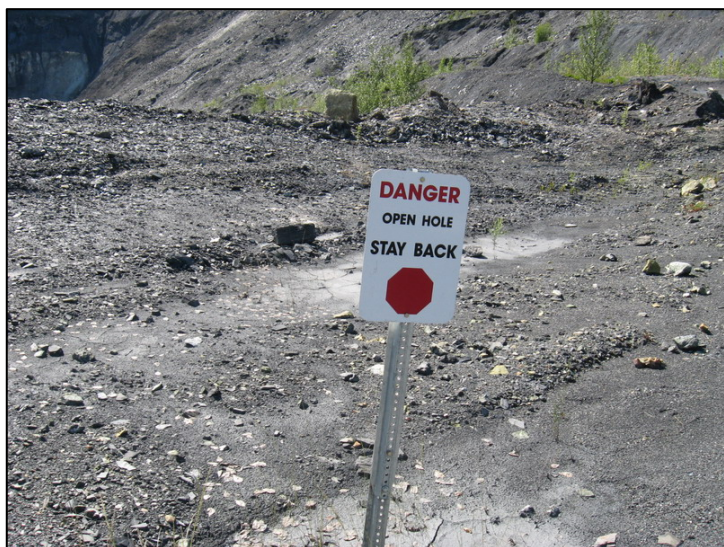
Figure 52 Warning Sign at Open Pit

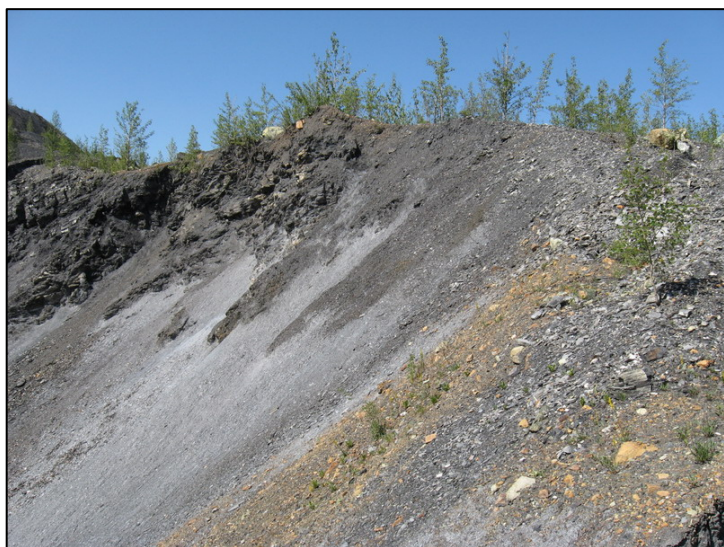
Figure 53 Open Pit Perimeter at WP 349
