File Number: Clinton Creek

Inspection Report

Date of Report: October 12, 2010

Location: Clinton Creek minesite near Dawson City

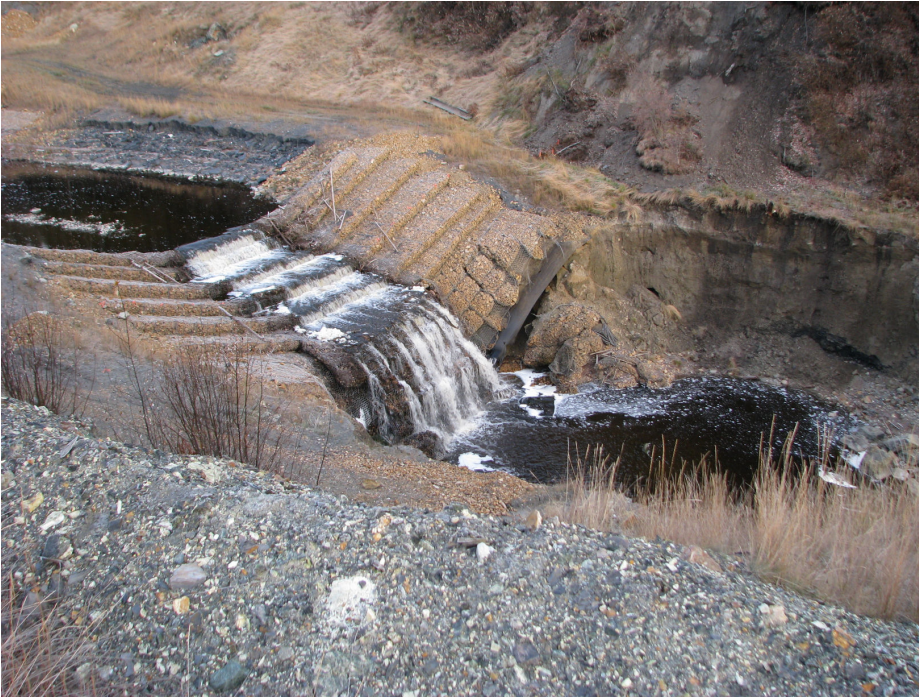
A large flood during July of 2010 resulted in severe down cutting of the stream channel directly below the last gabion drop structure. This 4 to 5 metre drop and resultant undercutting has caused the end gabions to begin to fall into the void below the structure. The flood and associated heavy rains also eroded the canyon below the gabions and the access to the lake outlet. The access road below the canyon where it crossed Clinton Creek has changed course and is now impassable. This event may have been made worse by debris blocking the lake outlet and storing water which released when the pressure became to great.

The condition is such that the gabion structures could fail during spring freshet allowing the lake storage to release into Clinton Creek and the 40 Mile River causing downstream damage to the environment and property. This has been documented in previous reports on the Water Resources Clinton Creek file.

Lower drop structure Oct 7, 2010

- Some form of reinforcing of the structures as outlined in AECOM's letter report entitled "AECOM Sept 10 Inspection Report" is required this fall before the ferry closure at Dawson prevents equipment from reaching the site.
- In order to gain access for these repairs to the gabion structure work will also need to be completed on the access road.
- Woody debris from the flood event should be removed from the gabion structure.
- Old culverts in the stream channel below the gabions should be removed and stored well away from the channel for removal summer 2011.
- As soon as possible a boom should be installed in the lake above the outlet to prevent debris from blocking the outlet.
- It is my opinion that this work should be completed this fall under section 35.1 of the Waters Act.

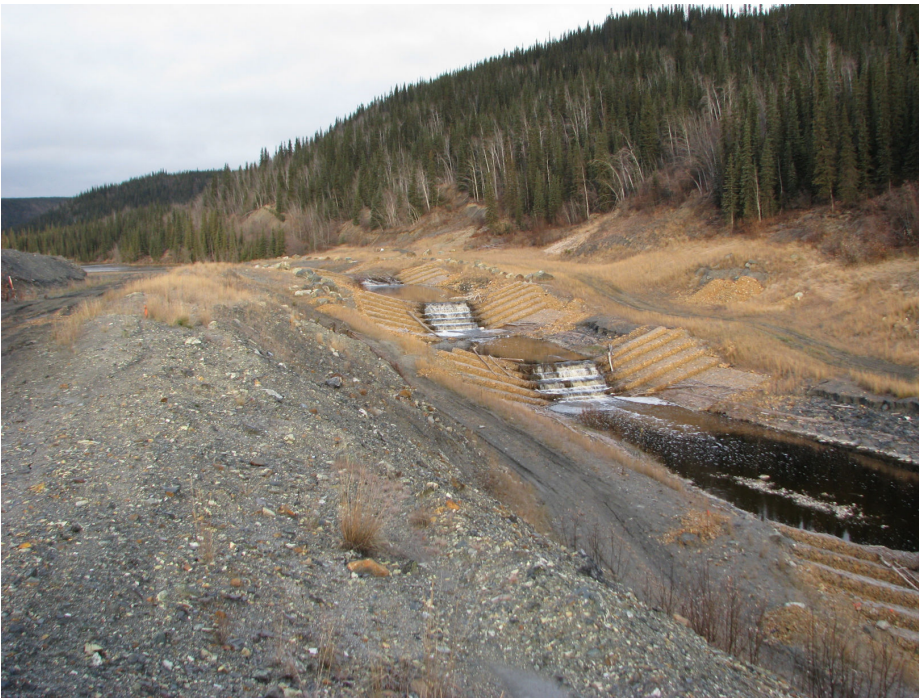
Upper three drop structures

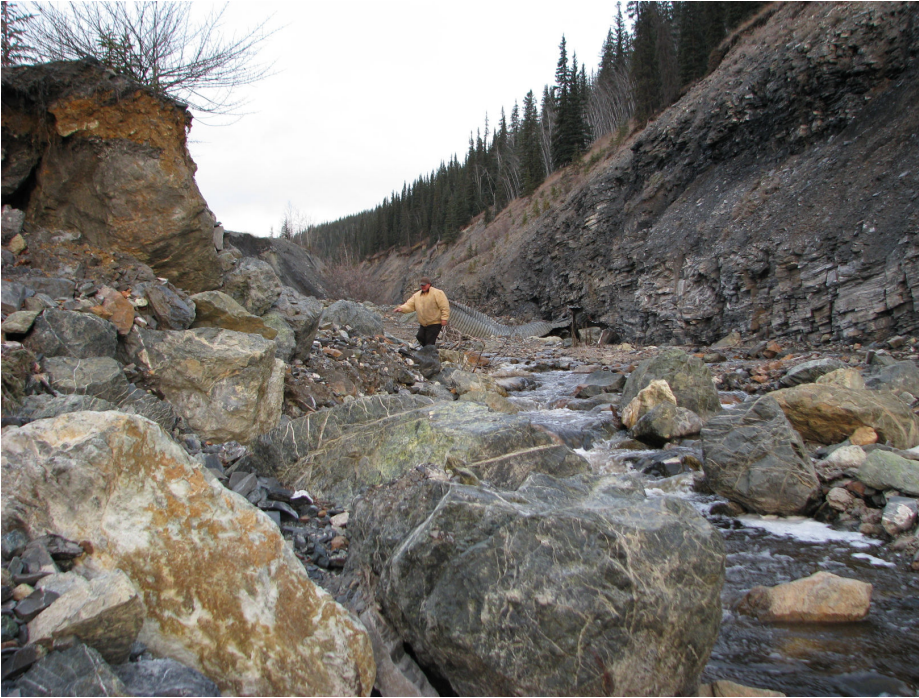
Canyon formed through waste rock below gabion drop structure

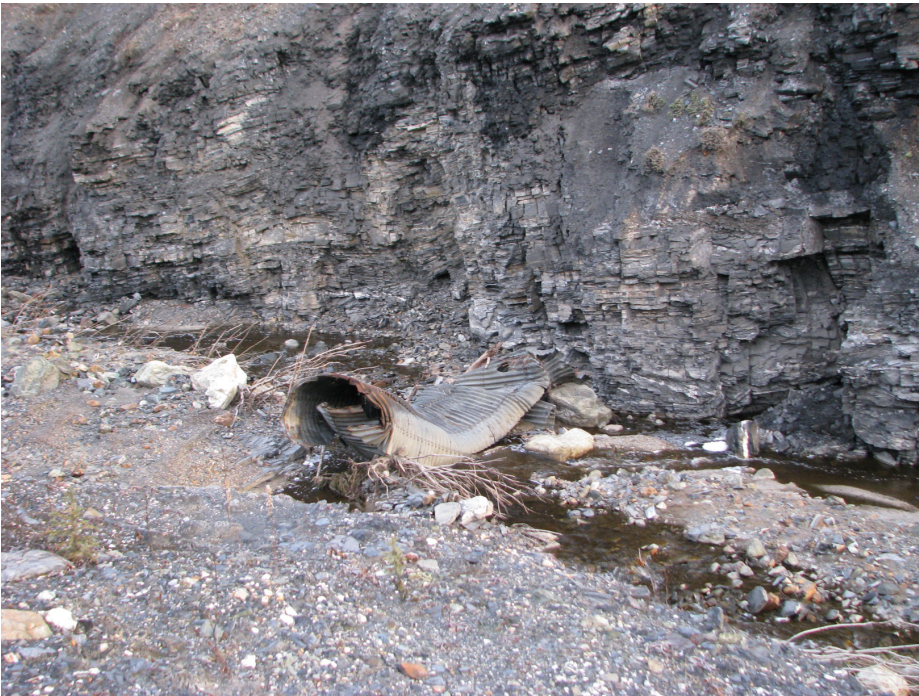
Old culvert in canyon below gabion drop structures.

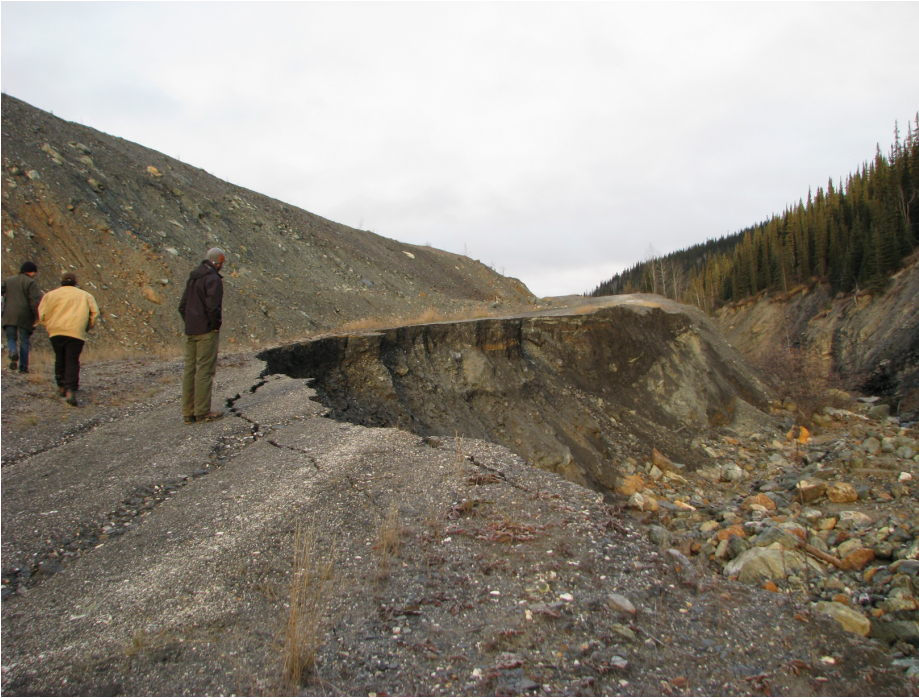
Erosion of road leading to lake outlet
