KENO HILL PROPERTY

ADIT DISCHARGE SURVEY

2007

March 2008

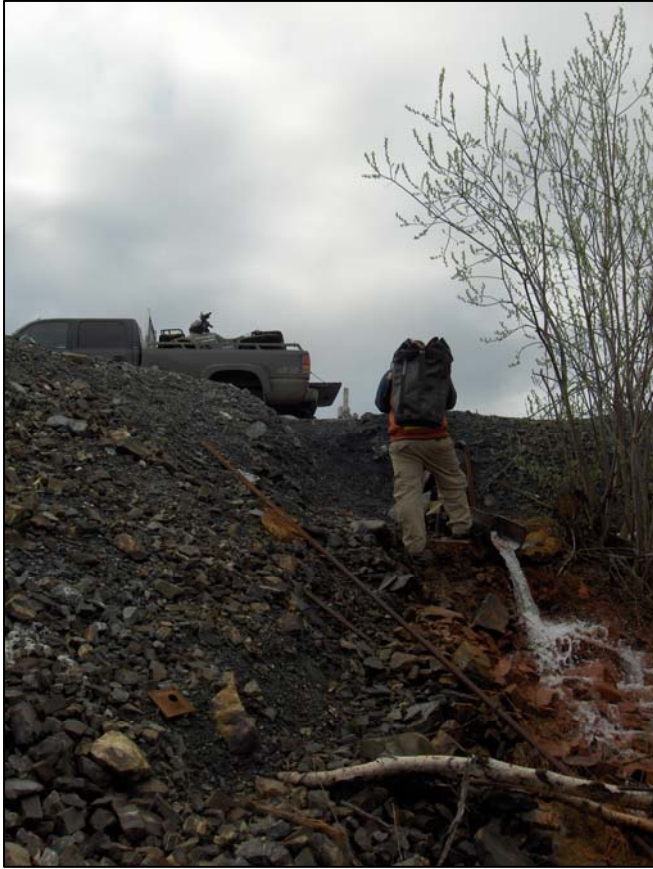
Plate 1: Silver King 100 treatment pond decant

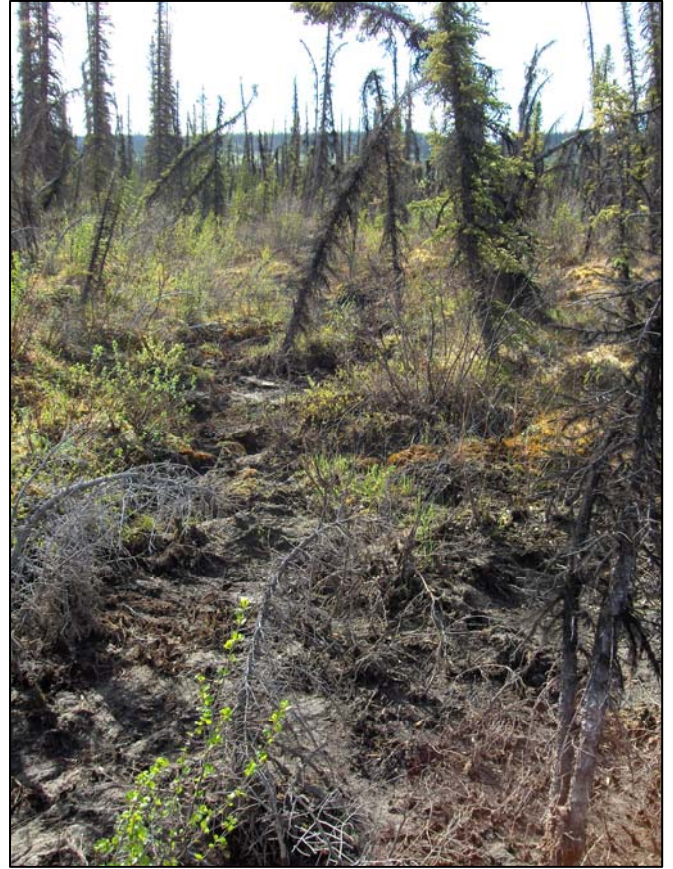
Plate 2: Evidence of flow over permafrost

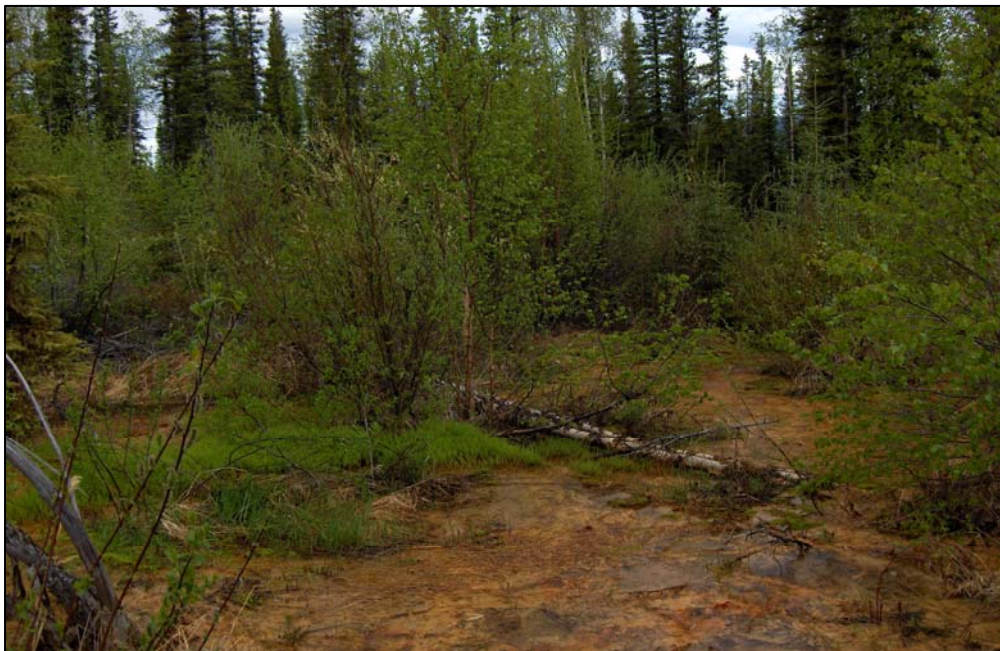
Plate 3: Silver King 100 down gradient of waste rock pile

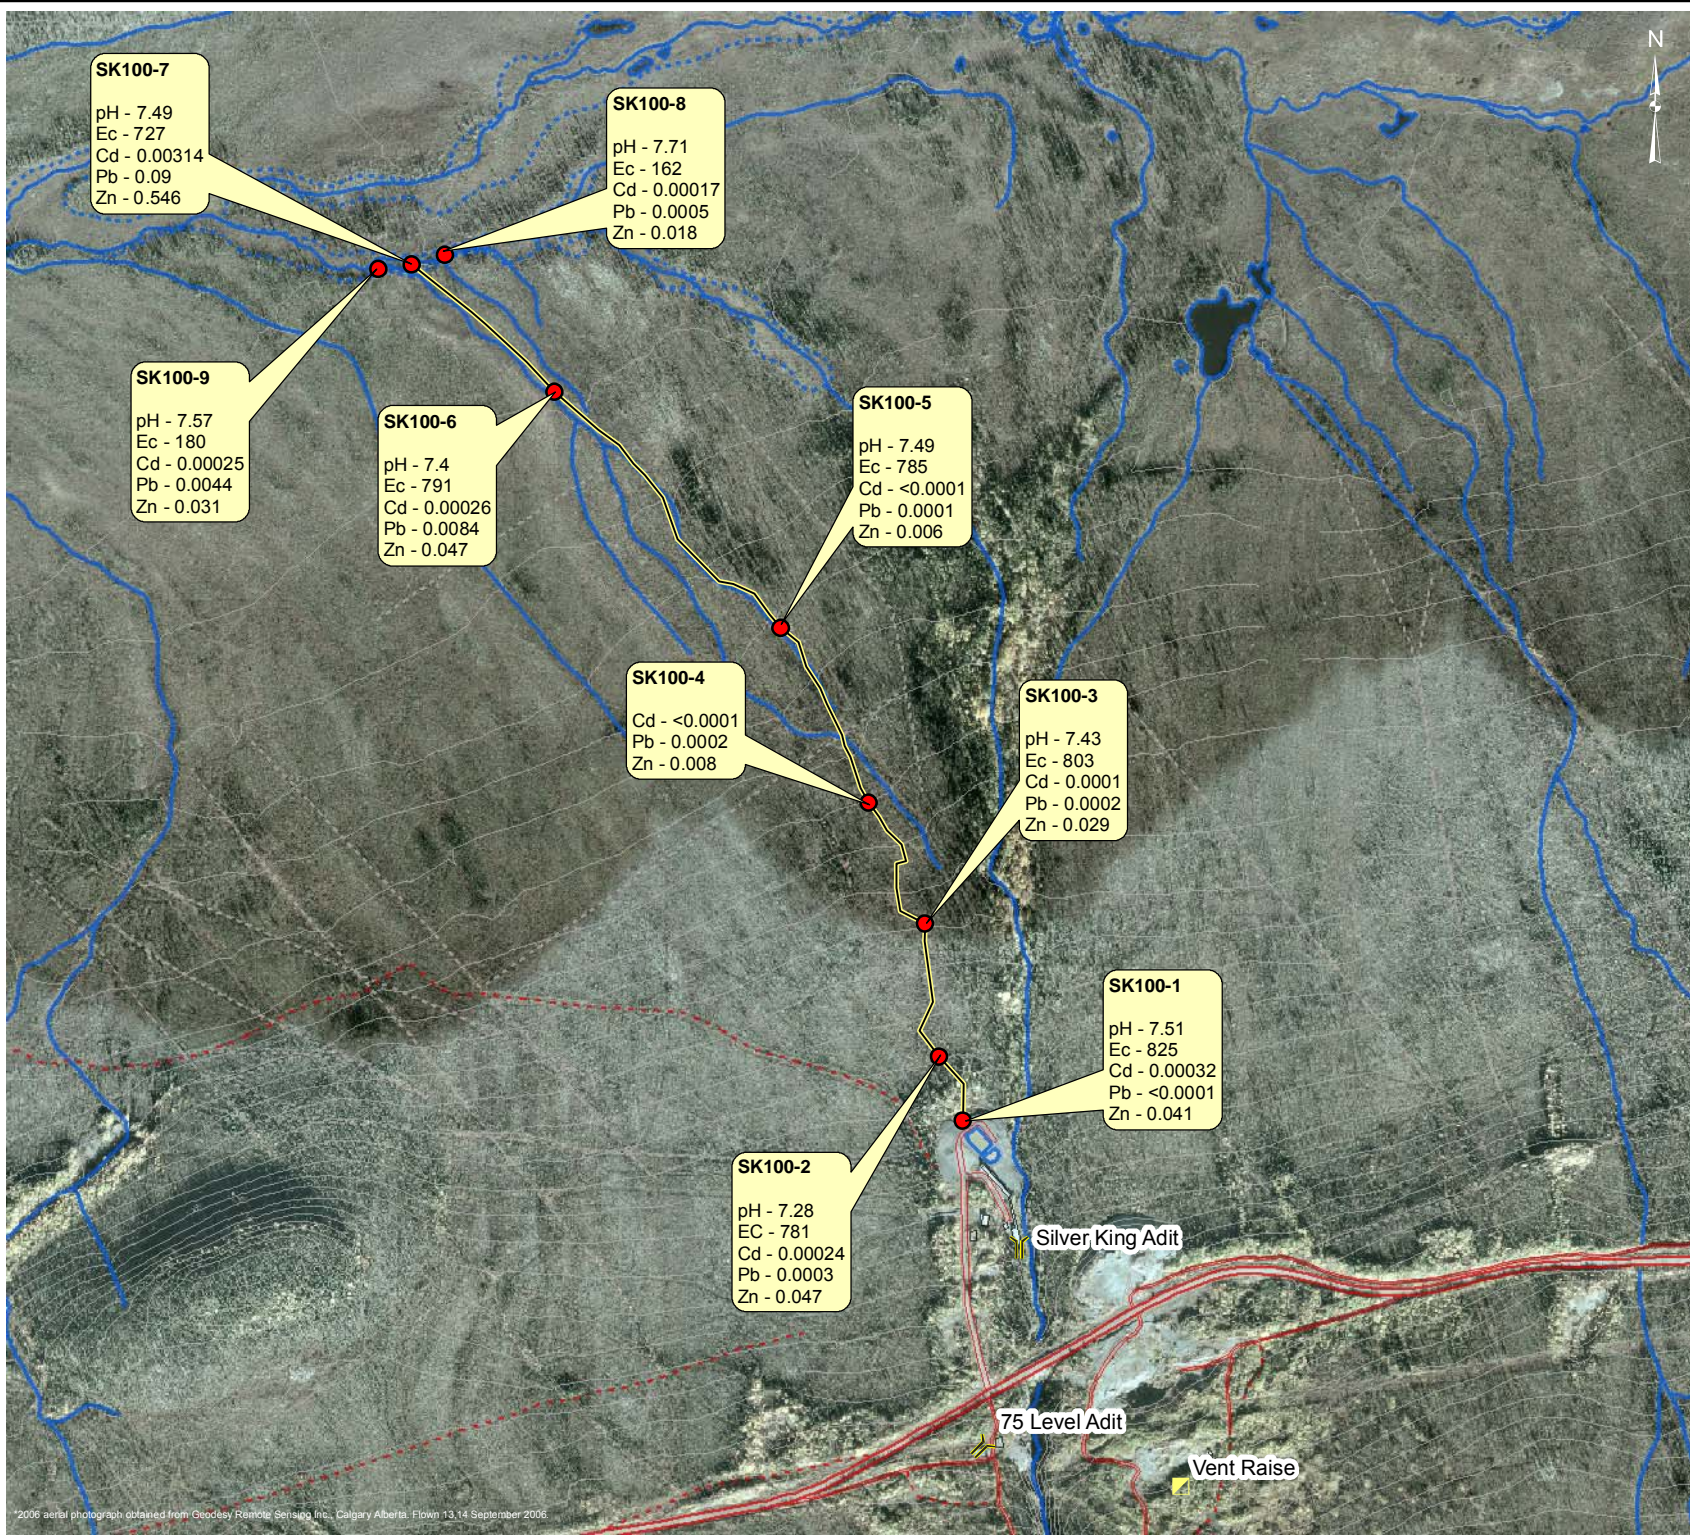
Figure 3

There were nine sample stations along the Silver King 100 adit discharge flow path. A number of stations exceeded CCME guidelines, especially in cadmium in zinc. Cadmium exceeds the CCME guidelines at station SK100-1, SK100-2, SK100-3, SK100-6, and SK100-7. At none of these stations does cadmium concentration exceed the Water Use Licence (WUL) standard 0.05 mg/l. Zinc exceeds the CCME guideline of 0.03 mg/l at five stations (1, 2, 6, 7 and 9). The elevated zinc value at station 7 is due to the discharge's flow emerging to surface from traveling between permafrost and surface debris. These concentrations do not however, surpass WUL standards. The parameters arsenic, copper and lead are above CCME guidelines at stations 6 and 7. There is a single instance of silver being 0.0021 mg/l, above the 0.0001 mg/l CCME standard. However, this appears to be an isolated case as all other silver levels are within the acceptable range.

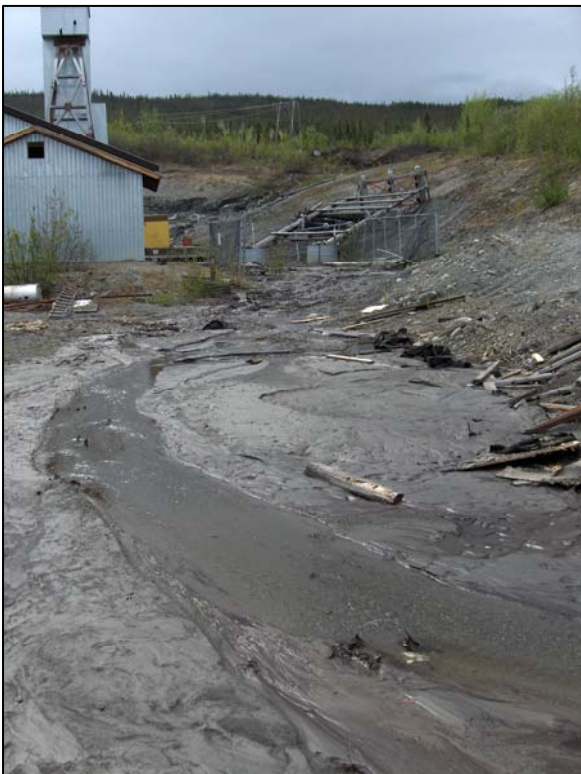
Plate 5: Husky South West surface flow

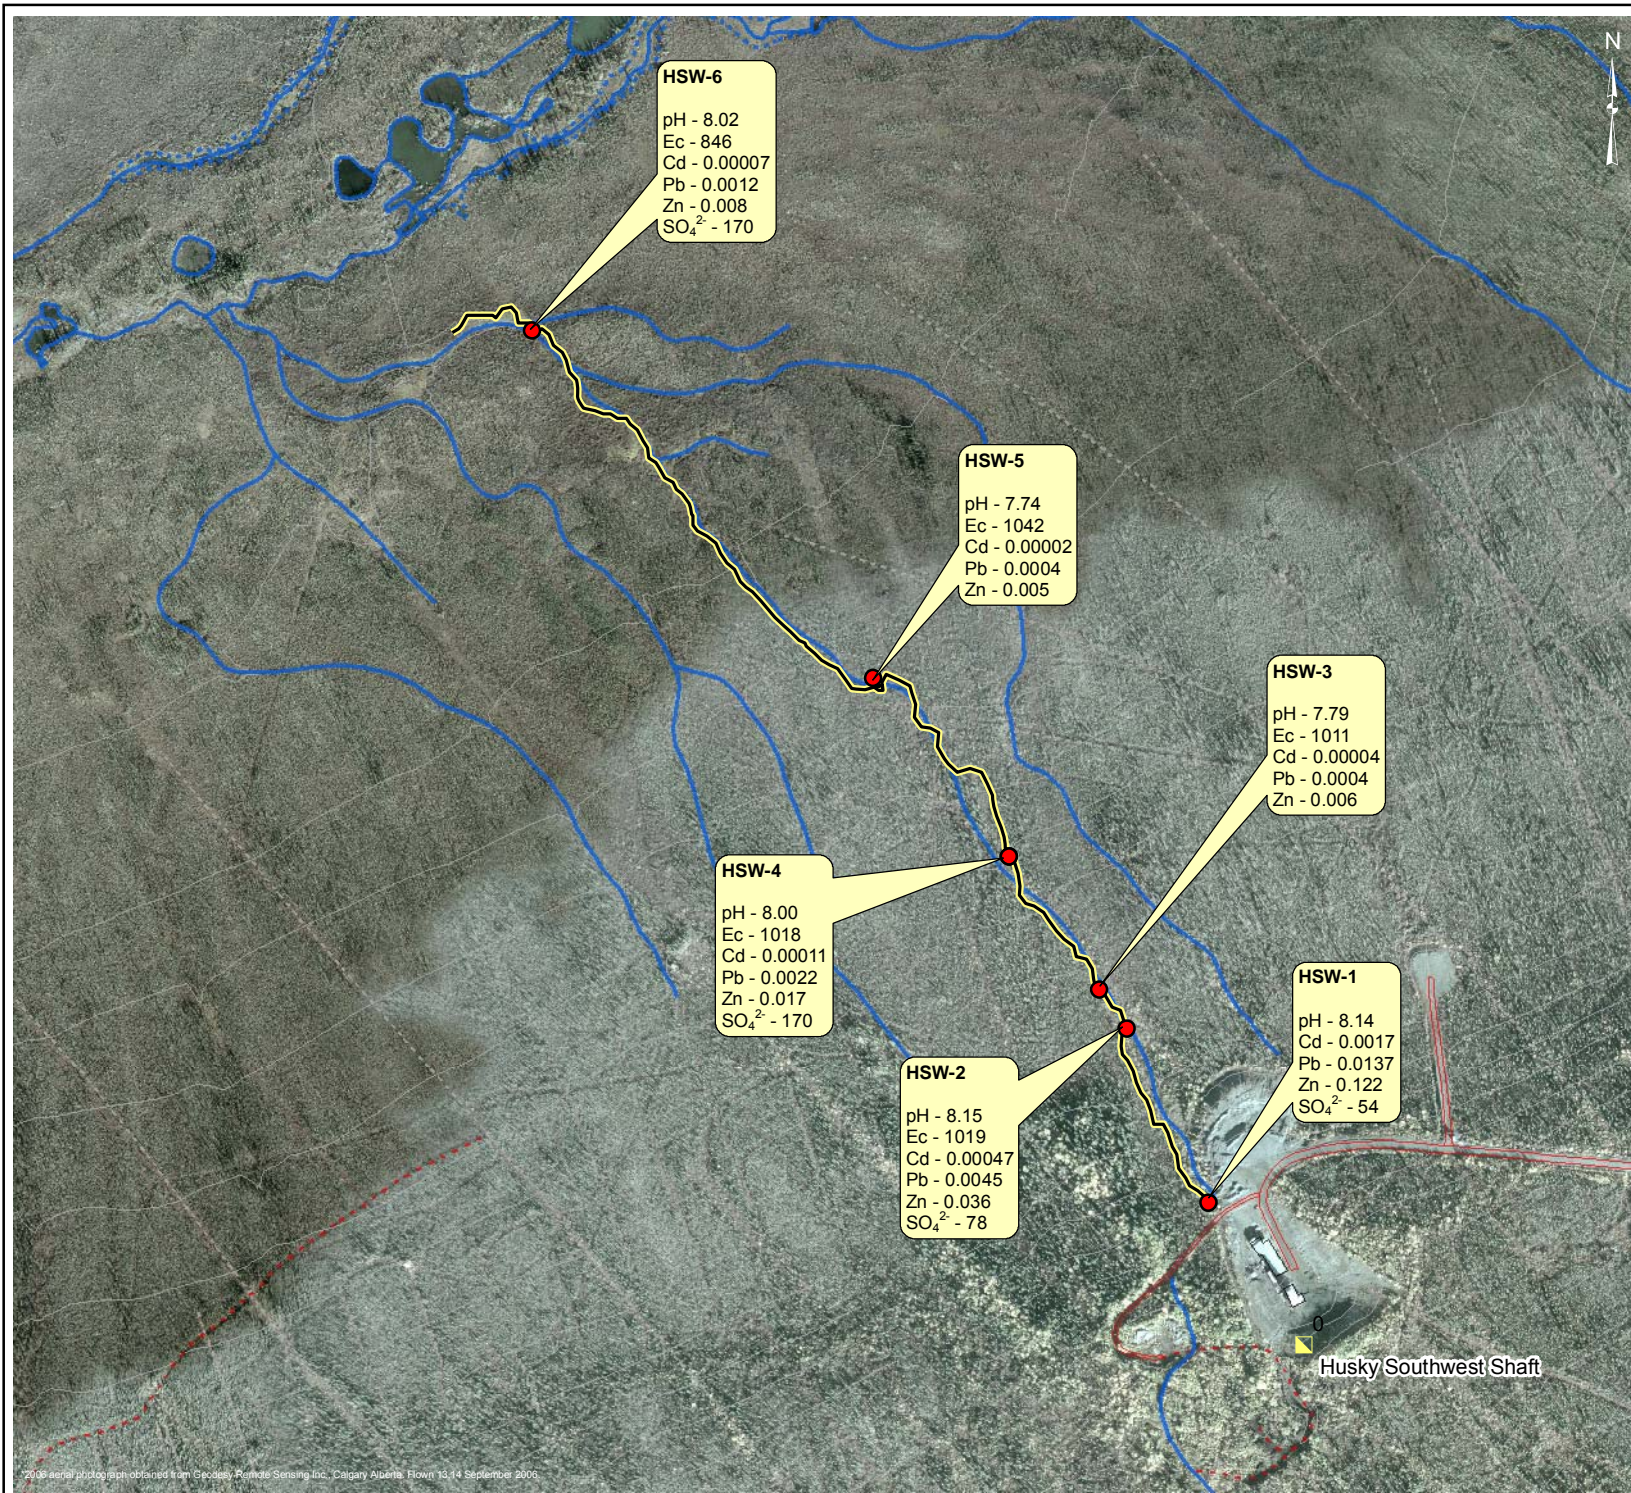
Figure 4

There were five sample stations along the Husky South West adit discharge path. Cadmium concentrations were above CCME guidelines at all of these stations, fluctuating between 0.00002 – 0.0017 mg/l. Two parameters (Nickel and pH) remain below both CCME and WUL guidelines at all stations. The rest of the parameters (with only a couple exceptions) fall well below both guidelines after the first sample station. All parameters, apart from cadmium, are below guidelines by the final two stations.

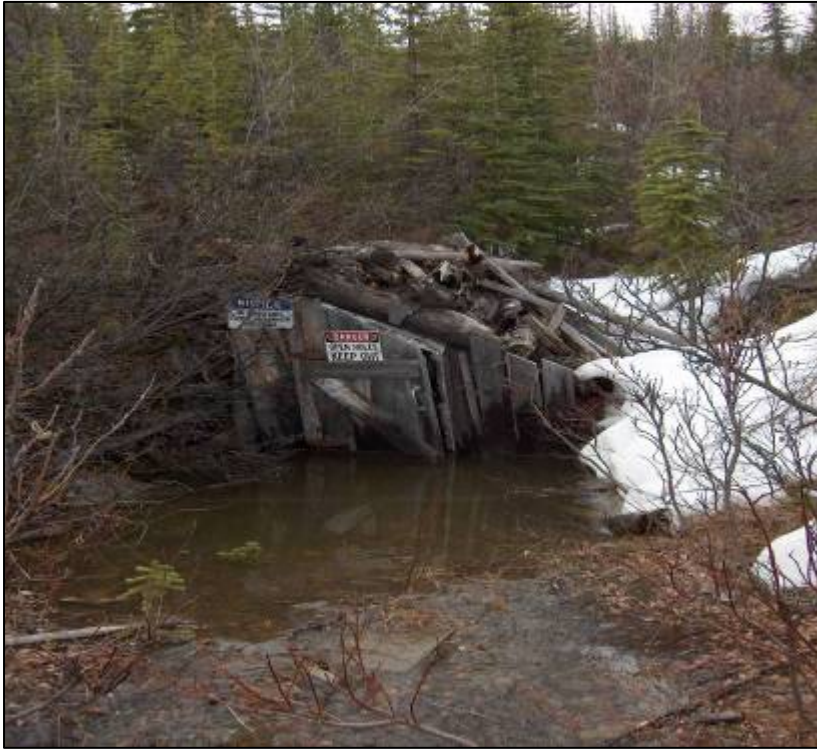
Plate 9:
Bermingham Adit

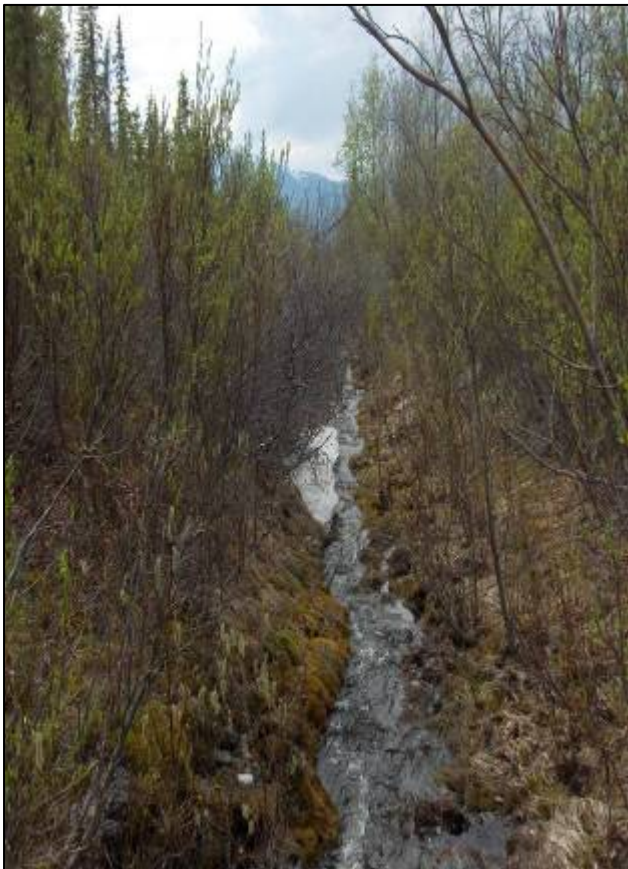
Plate 10: Bermingham discharge running parallel to Calumet Drive

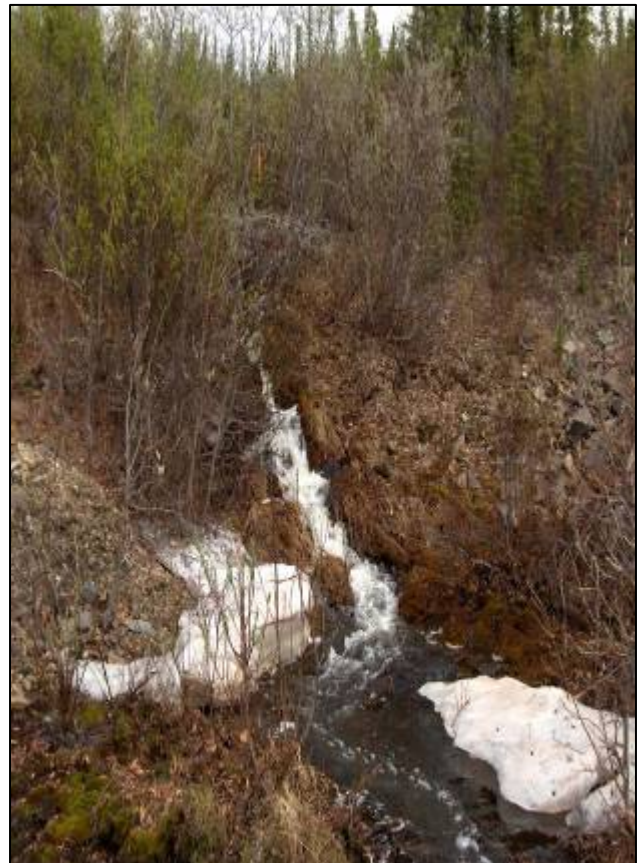
As shown in Plate 11 the flow path travels through approximately 800m of surface vegetation before draining into No Cash Creek. The discharge intersects a large patch of glaciated ice and turns away from the depression where it spreads out into multiple channels. Without the ice, the discharge from the Birmingham adit would most likely continue along the depression and join with the discharge from the Ruby adit which drains into Star Creek. Results from the samples obtained along the discharge path are summarized in Table 3. It is suggested that field personnel revisit and review the flow discharge path at Birmingham later in the summer 2008 field season.

Plate 11: Bermingham discharge upstream of Calumet Drive culvert

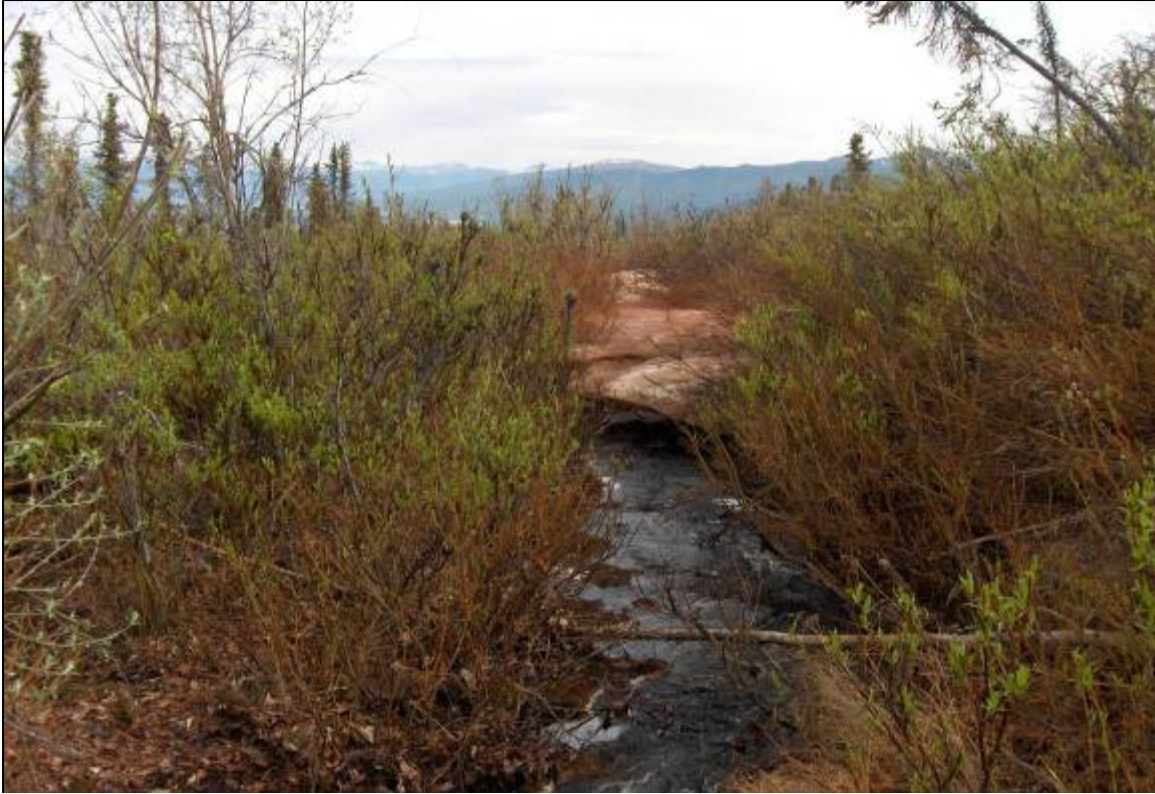
Plate 12: Bermingham discharge path redirected by glacier

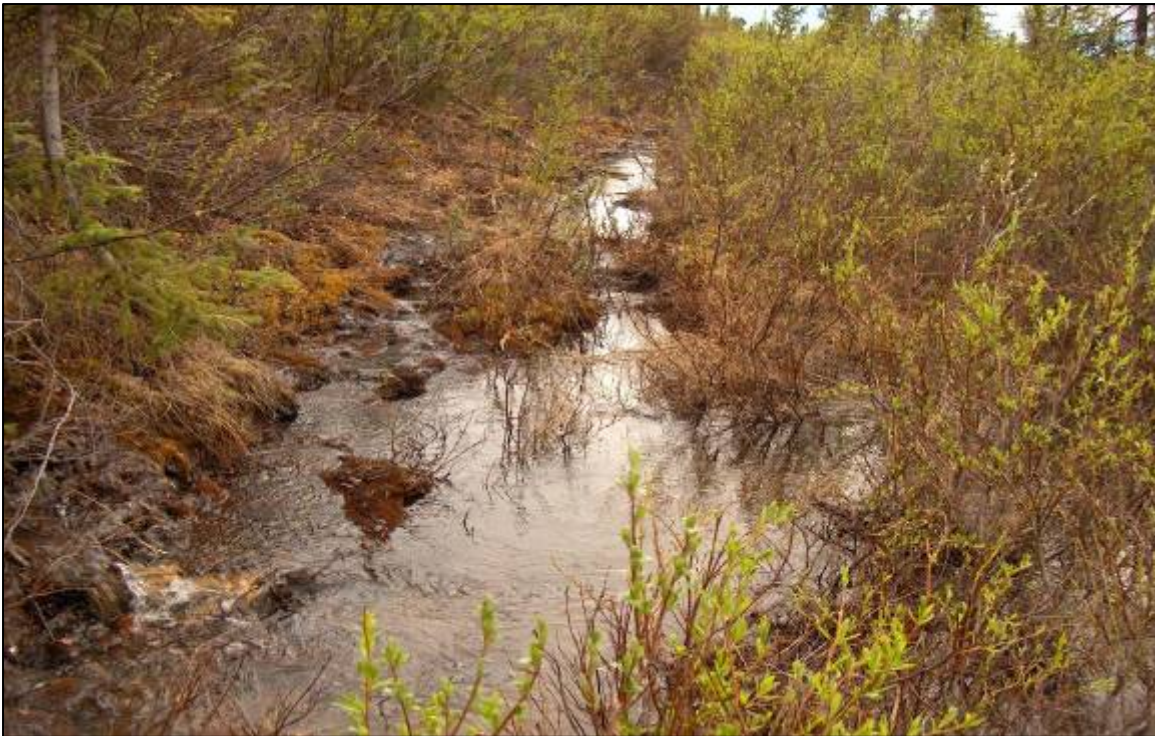
Plate 13: Bermingham discharge entering unknown source

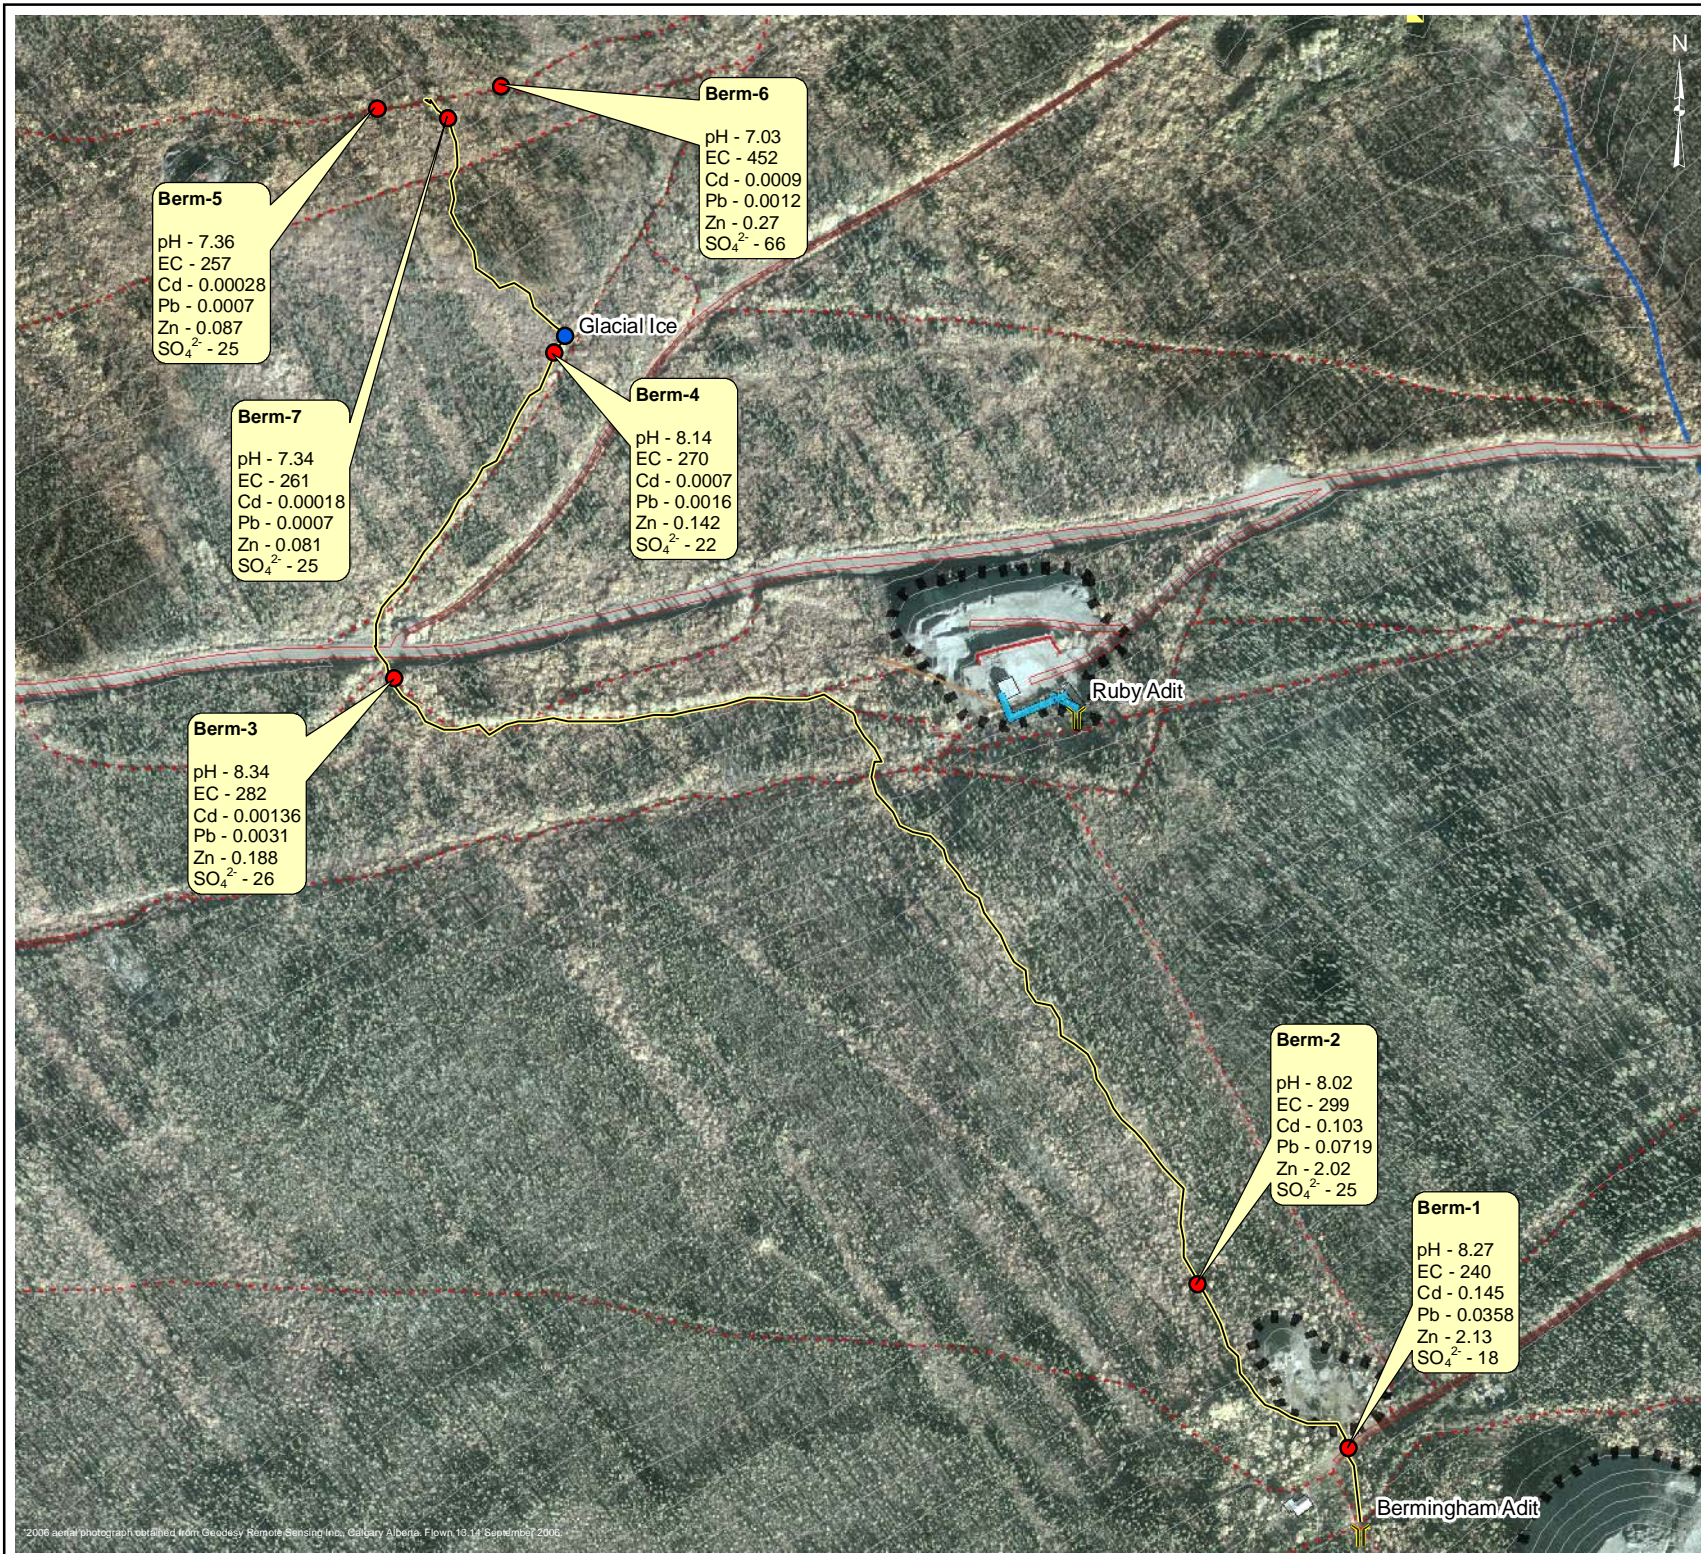
Figure 5

Of the 7 sample stations along Bermingham's adit discharge flow path, only two of the parameters shown in the table below exceeded guidelines at all stations. There were four parameters (arsenic, copper, lead and silver) whose concentrations exceeded CCME guidelines at the site of the adit and by the second sample station (Berm-2). Levels of pH fell below the accepted range 6.5-9.5 by 0.71 pH units at Berm-6. Excluding these instances, water quality met guidelines for both the CCME and WUL standards.

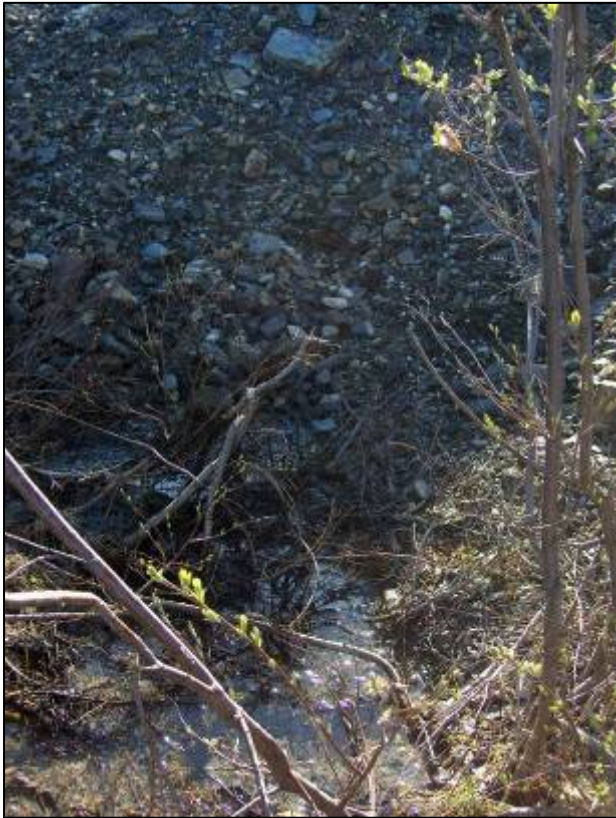
Discharge exits from the Ruby adit and flows down gradient over the waste rock storage area (Plate 14). Field personnel continued to follow this flow down hill toward the culvert at Calumet Drive, as shown in Plate 15. The discharge is collected in the culvert flowing under Calumet Drive and continues down gradient. Once it passes Calumet Drive the discharge flows under an ice surface (Plate 16 - 18) for approximately 500 m. It emerges from under the ice surface and empties into head water of Star Creek.

Plate 14: Ruby discharge at toe of waste rock pile

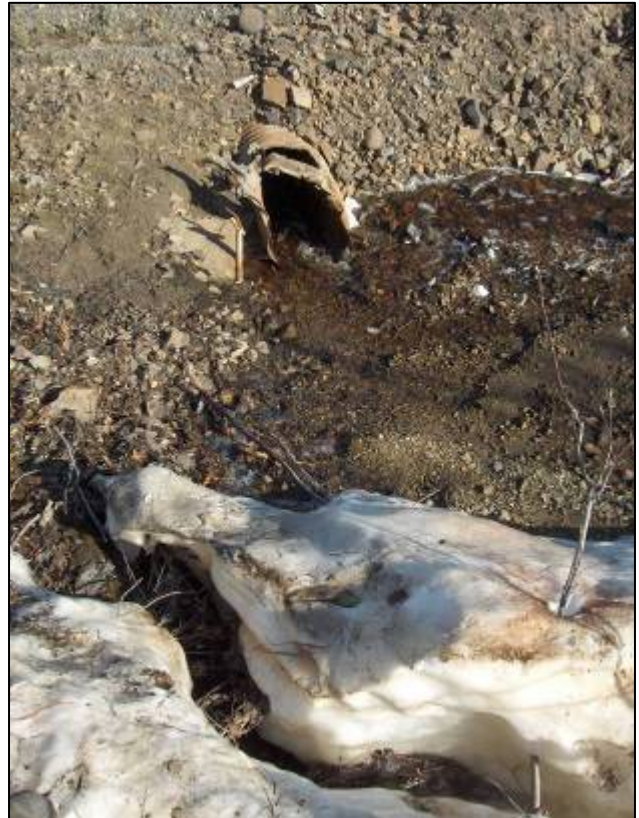
Plate 15: Ruby discharge at Calumet Drive

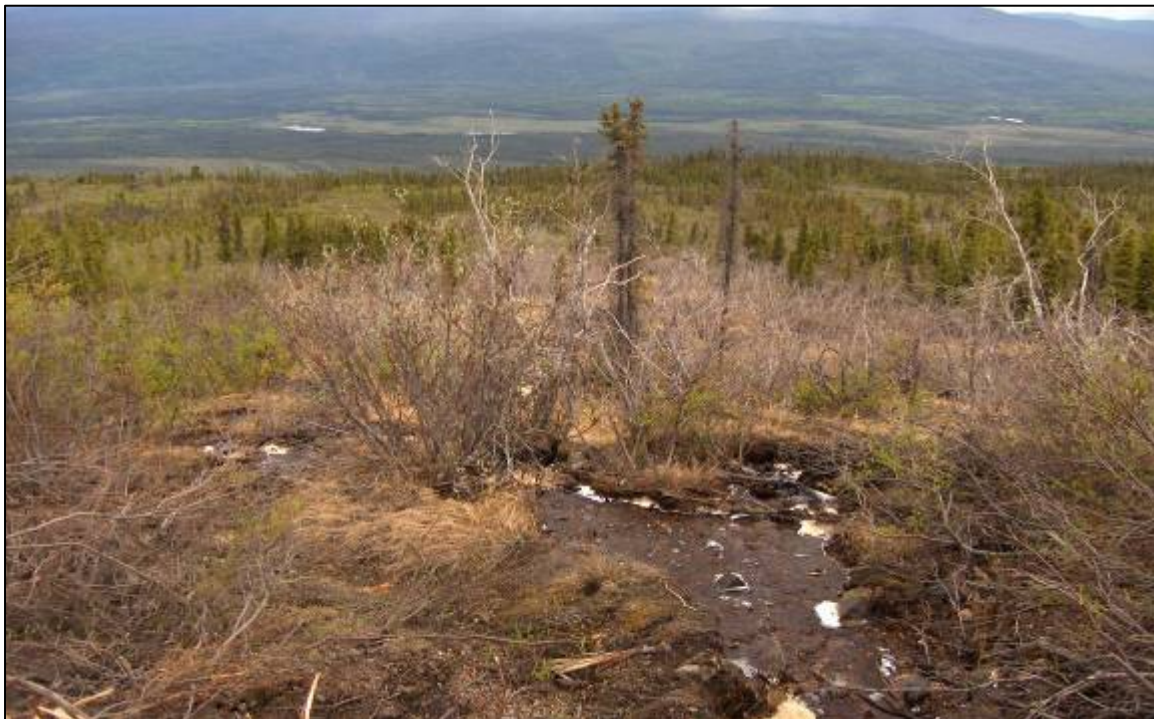
Plate 16: Ruby discharge down gradient of Calumet Drive culvert

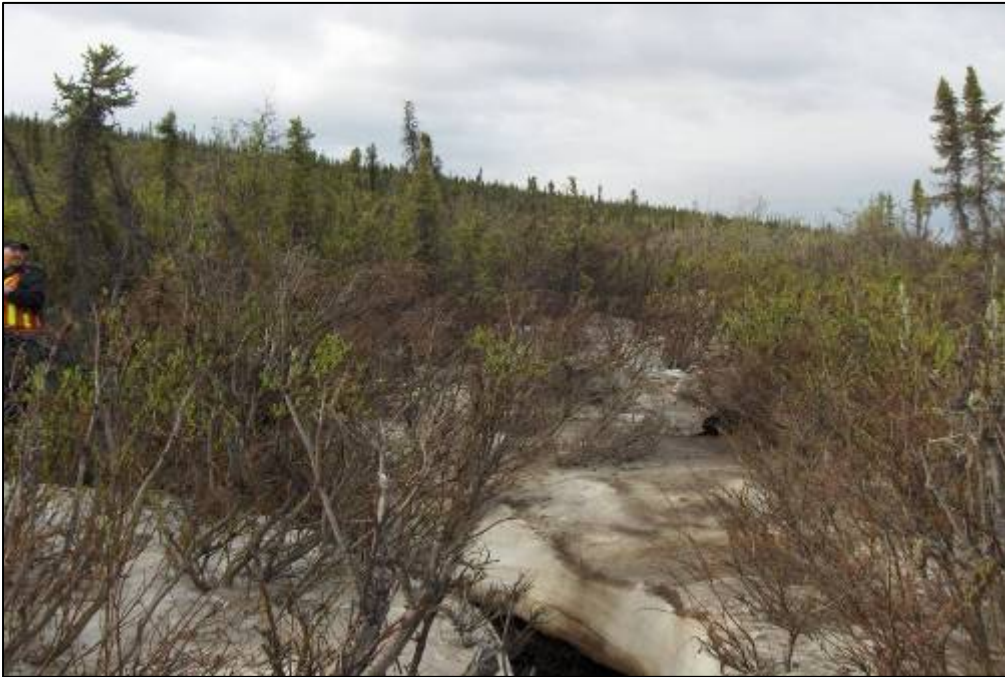
Plate 17: Ruby discharge flowing under ice down gradient from Calumet Drive

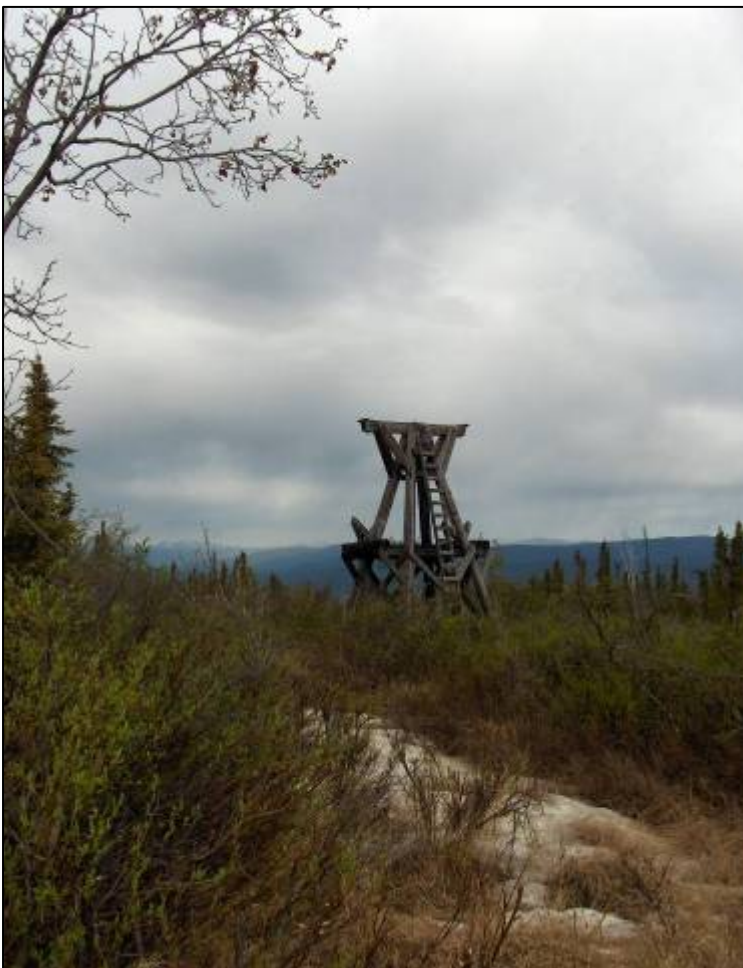
Plate 18: Ruby discharge by tram line tower

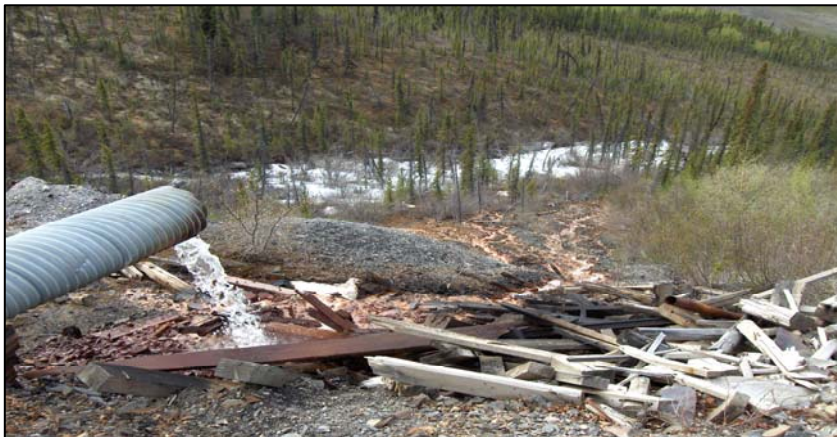
The adit discharge survey for No Cash 500 was straightforward. Not only was the discharge path short, but it was clearly visible from the waste rock pile as shown in Plate 19. The discharge from the No Cash 500 adit travels via an underground pipe from the adit to the waste rock pile. There the discharge flows downhill over the waste rock pile and enters into No Cash Creek approximately 100 m away. Results from the samples obtained along the discharge path are summarized in Table 5.

Plate 19:
No Cash 500
discharge path

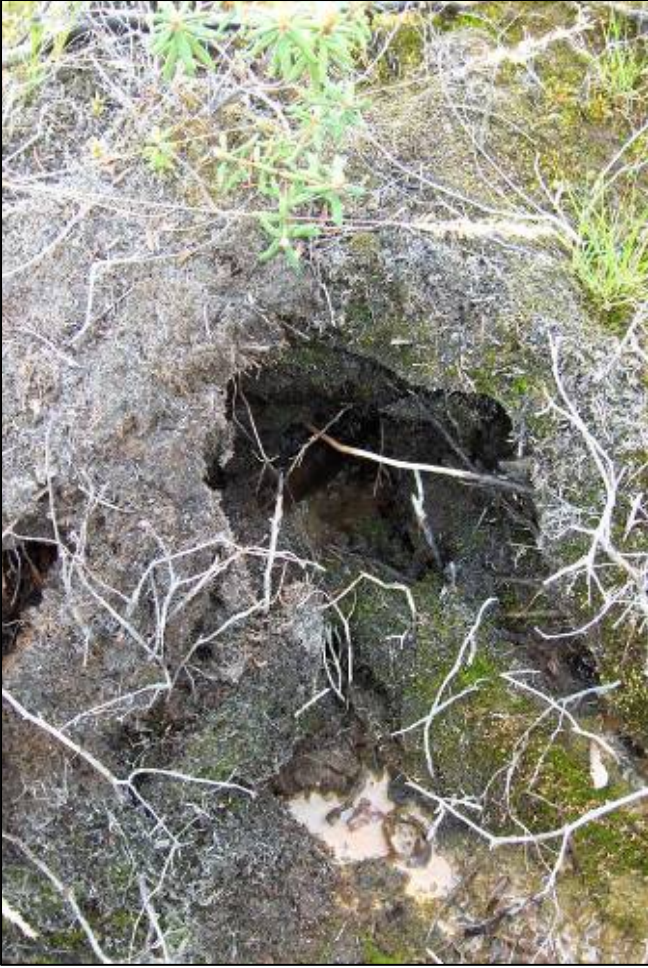
Plate 20: Galkeno 300 discharge going to ground

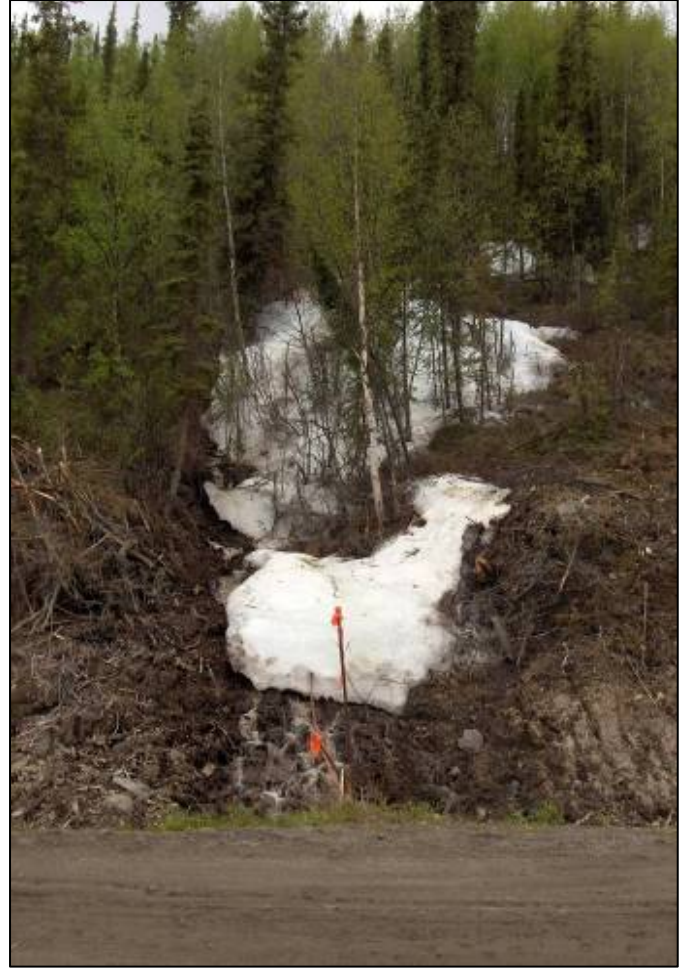
Plate 21: Galkeno 300 discharge at Silver Trail Highway

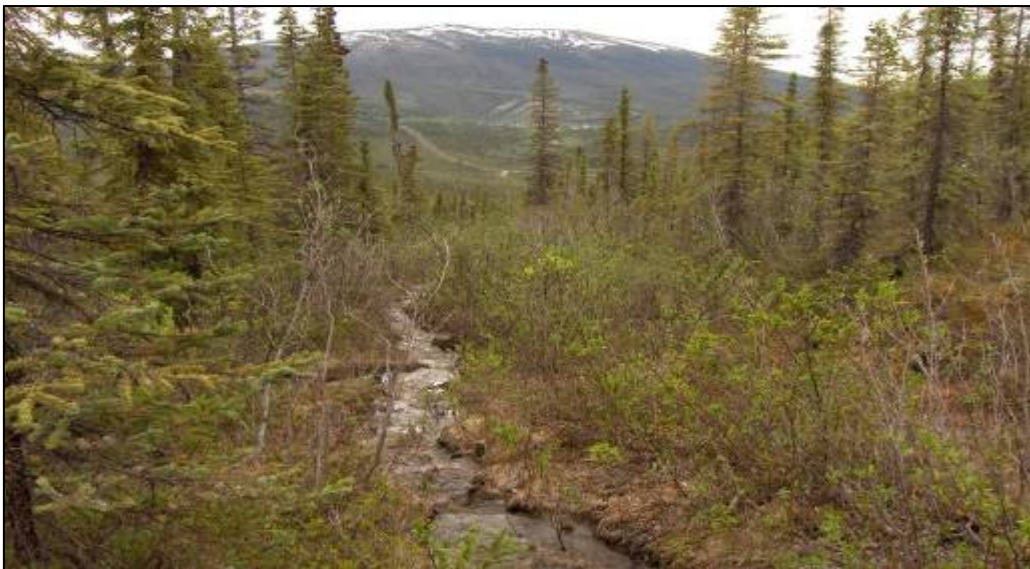
Plate 22: Galkeno 300 discharge turned southwest following an old Cat trail depression

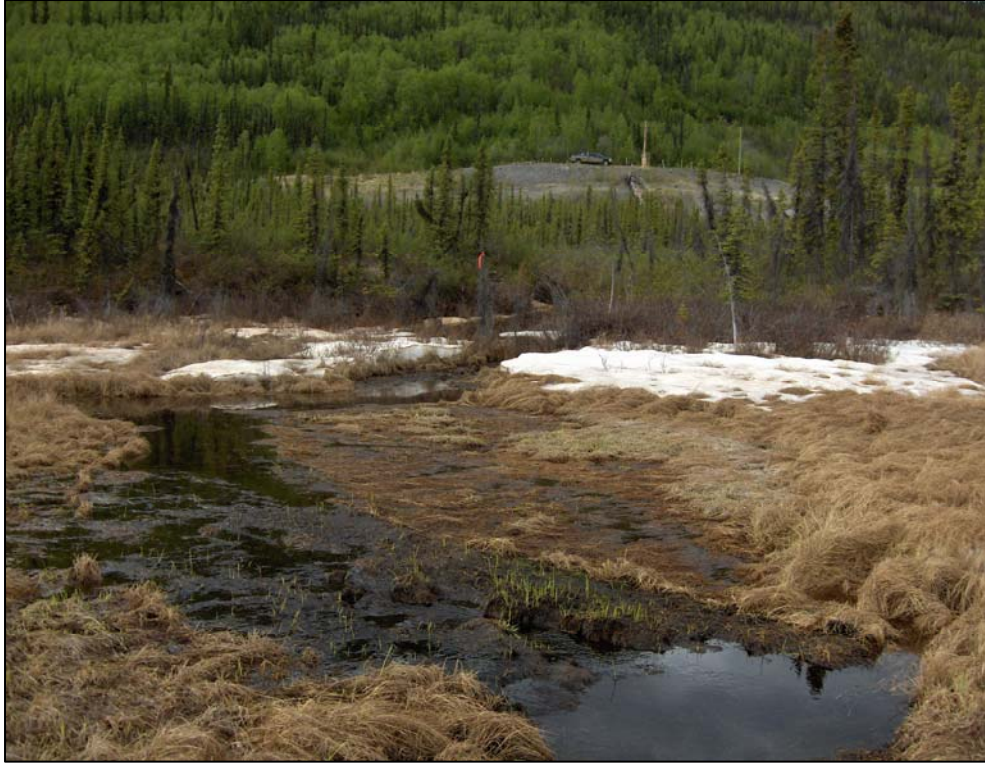
Plate 23: Galkeno 900 discharge into Christal Lake

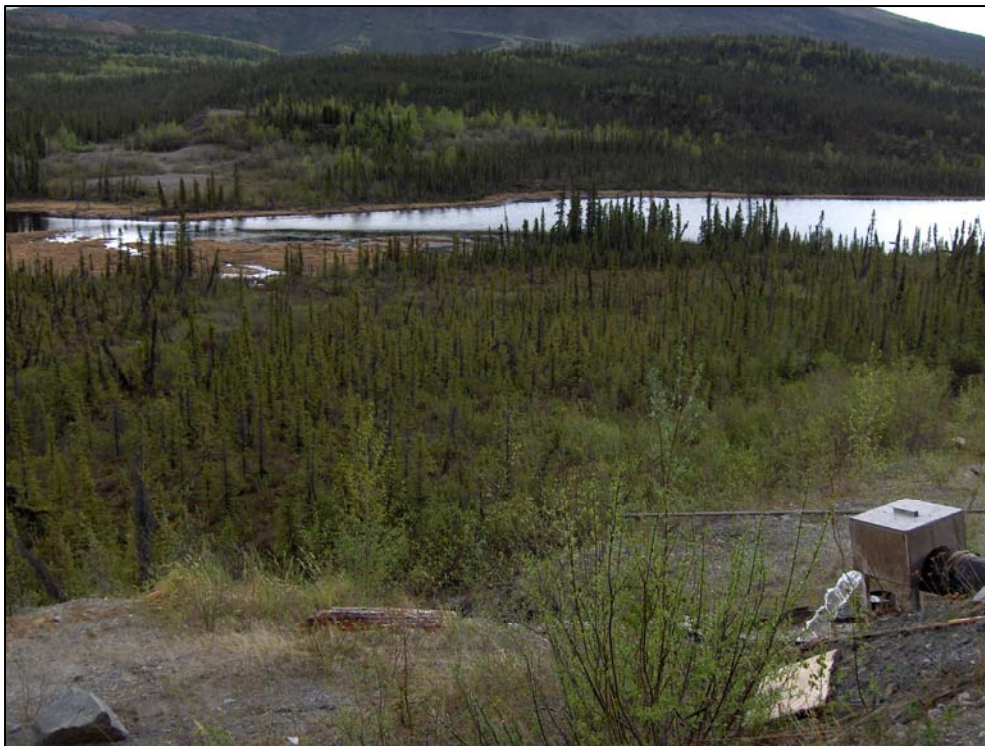
Plate 24: Galkeno 900 upon treatment pond decant

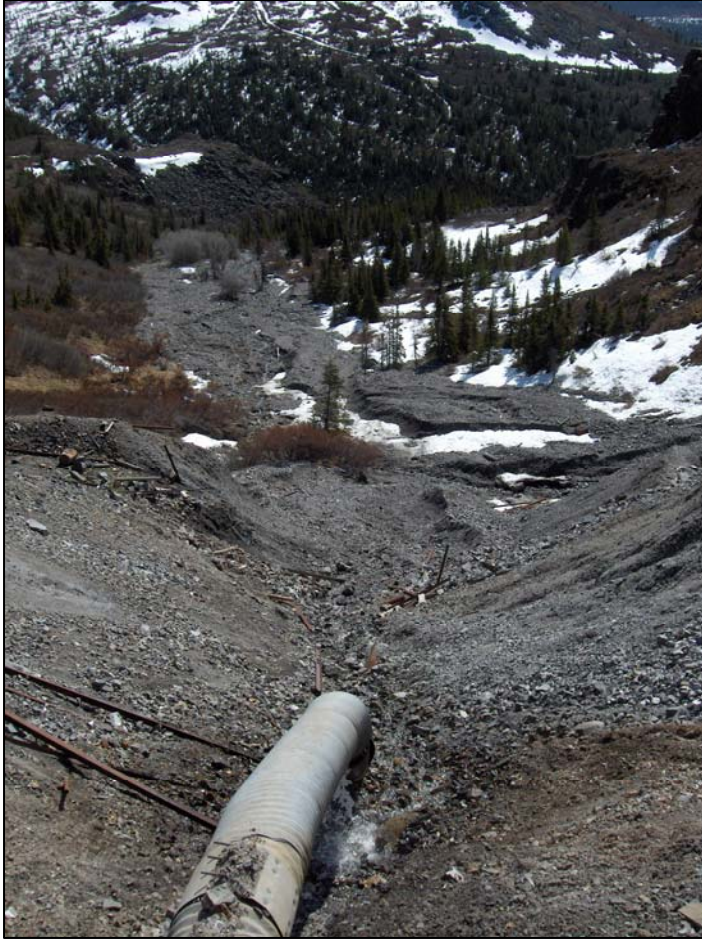
The adit discharge path for Keno 700 is particularly straightforward. The flow emerges from the adit and enters a steel pipe. Flow continues traveling within this steel pipe through the waste rock storage area. It emerges from the steel pipe and enters into the Hope Gulch. Please see plate 25 below for a visual reference of Keno 700 adit's discharge path.

Plate 25: Keno
700 discharge
path

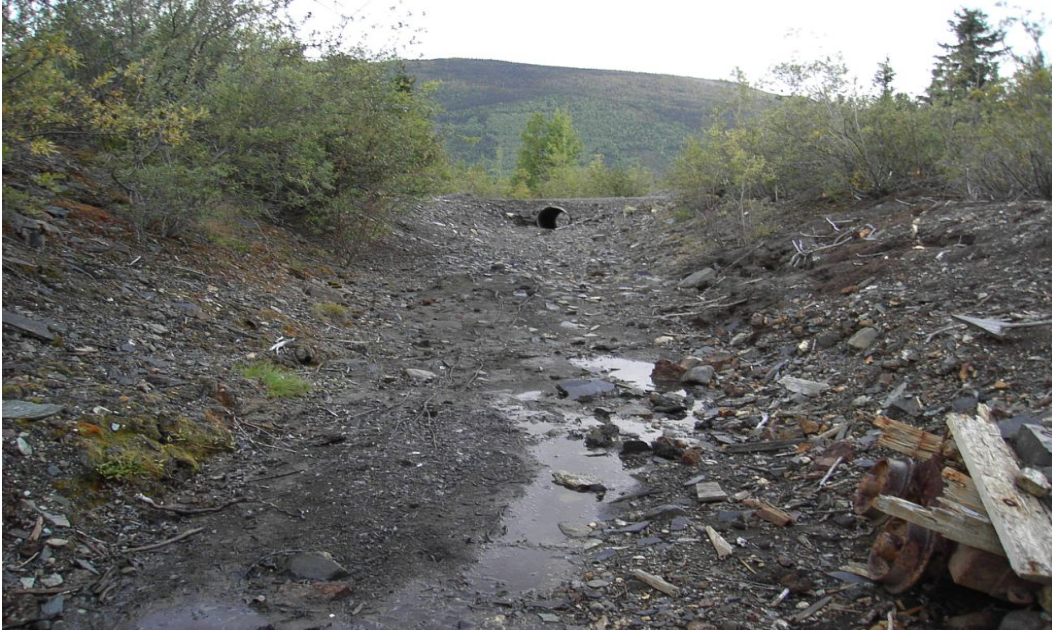
Plate 26: Onek drainage looking toward Gambler Gulch Trail
