KENO HILL PROPERTY

ADIT DISCHARGE SURVEY

2007

March 2008

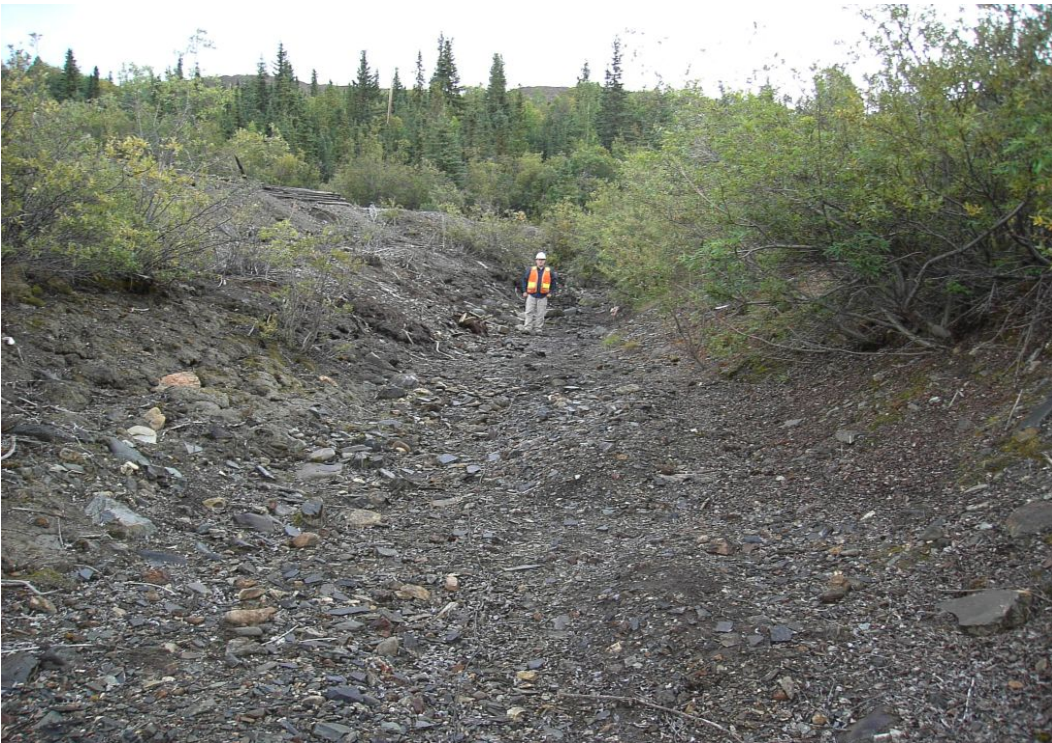
Plate 27: Onek discharge path

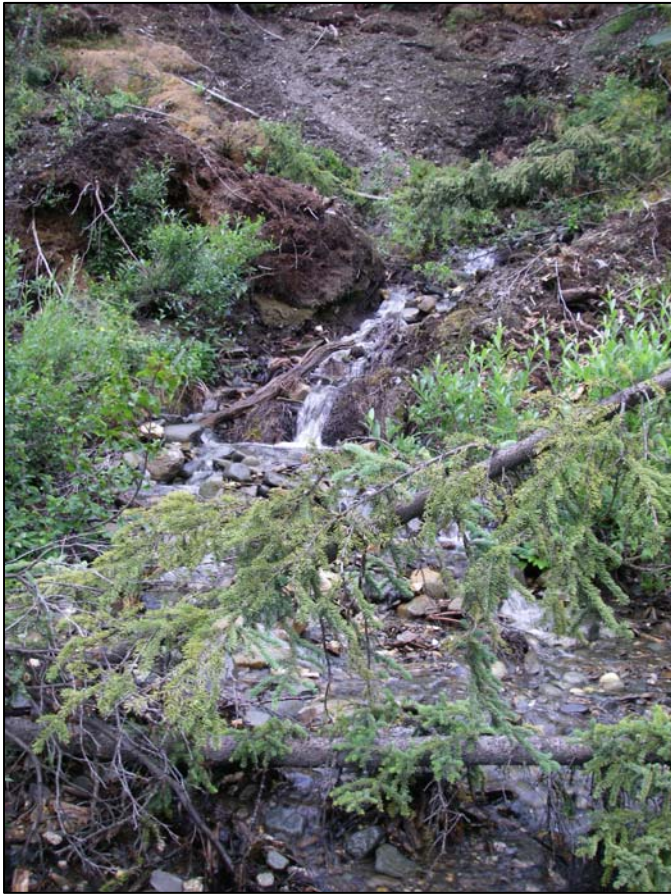
Plate 28: Sadie Ladue
adit discharge

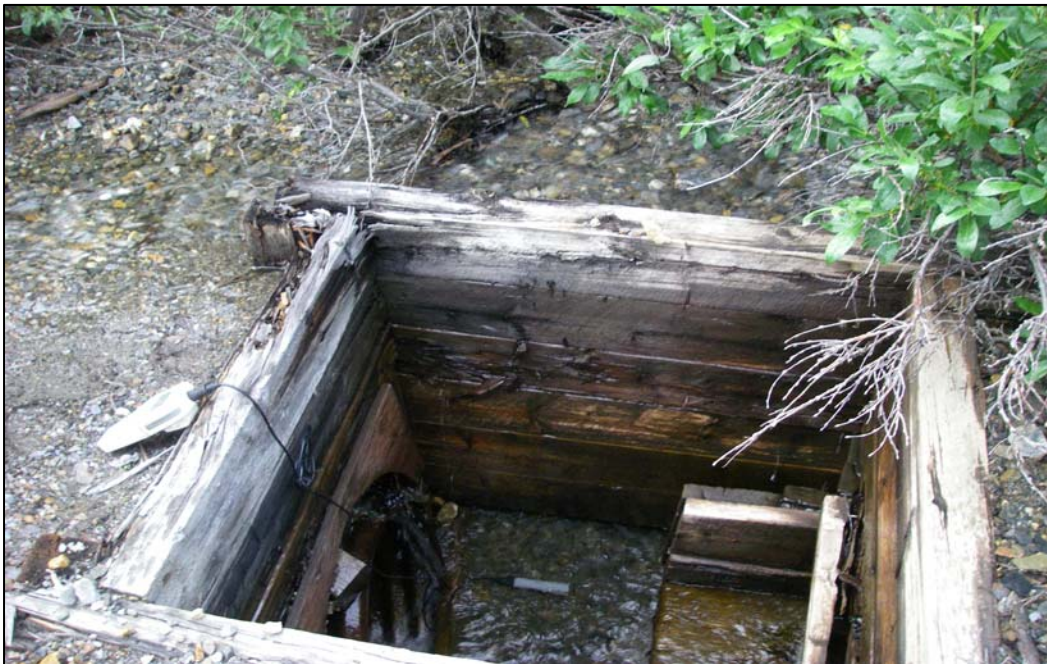
Plate 29: Sadie Ladue flow from adit through culvert
