MEMORANDUM

RE: Physical Hazard Assessment

Keno Hill Silver District Heritage Resources

August 26th 2008 Stakeholders Meeting

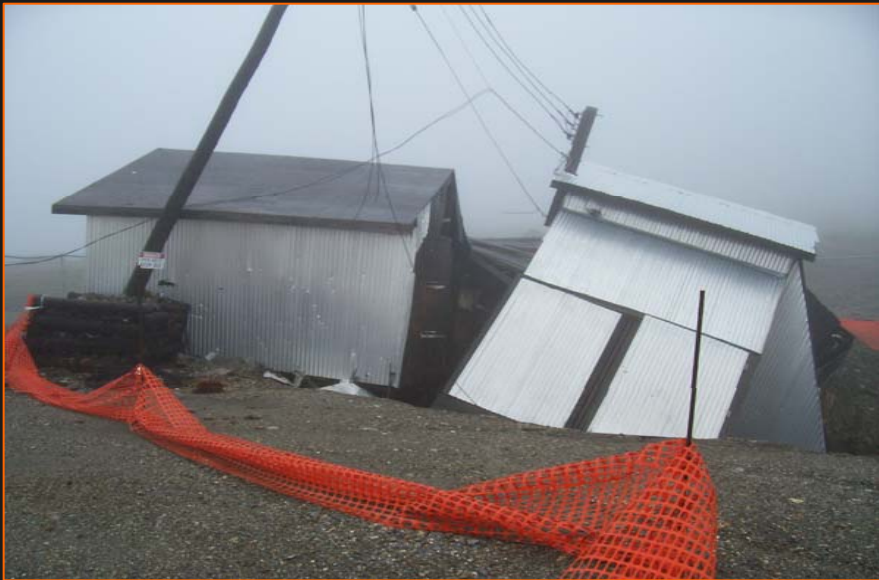
Shamrock J Raise Before

Risk Management – clean up of high risk sites;

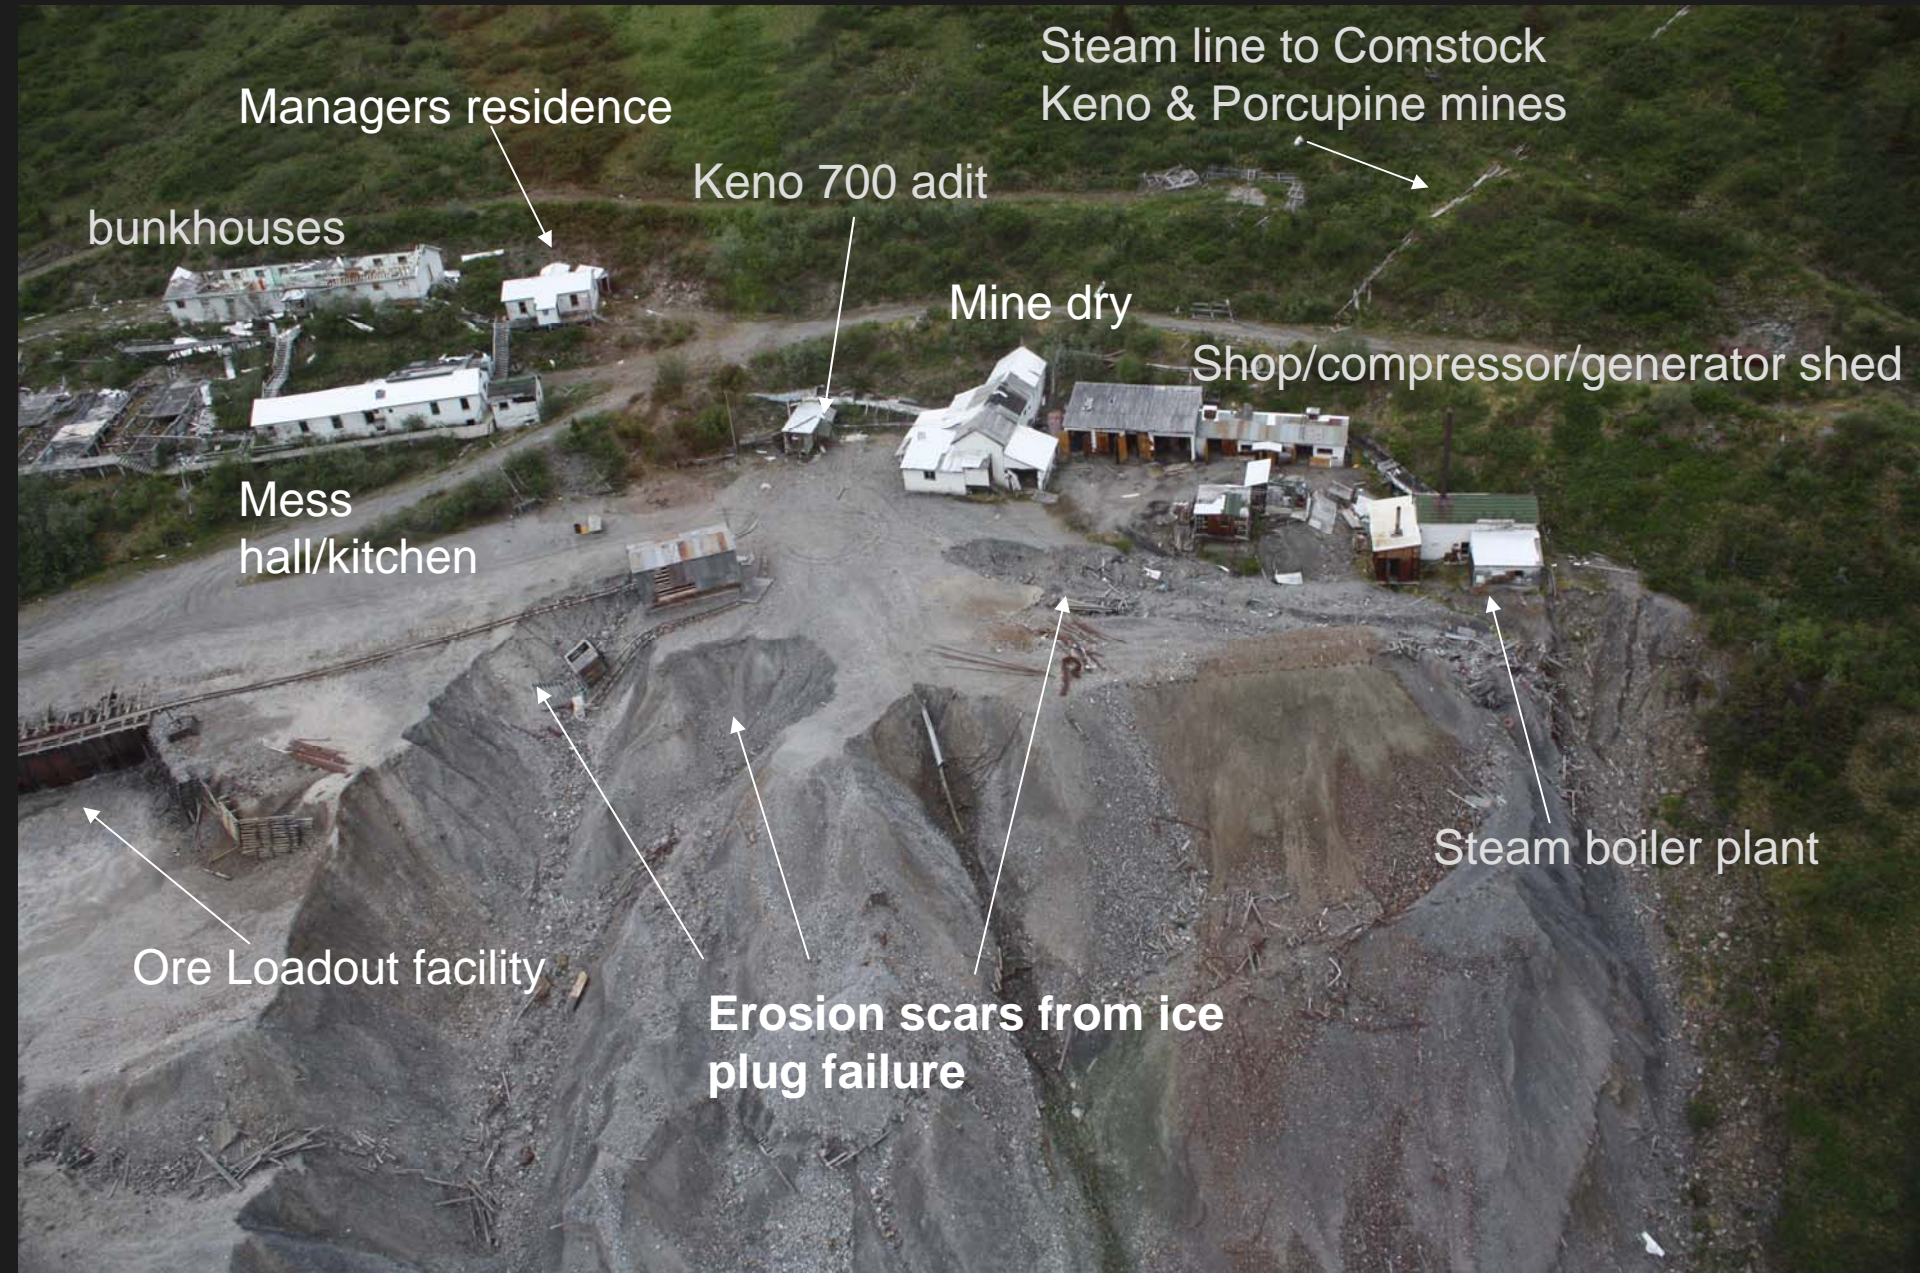
Keno 700 mine site

Erosion scars from ice
plug failure
