December 14, 2012

ISSUED FOR USE
EBA FILE: W14103083-01
Via Email: Kirsten.Hulstein@gov.yk.ca

Subject: Final Report - Fall 2012 Geotechnical Drilling and Instrumentation Installation Program
Mount Nansen Site, Yukon

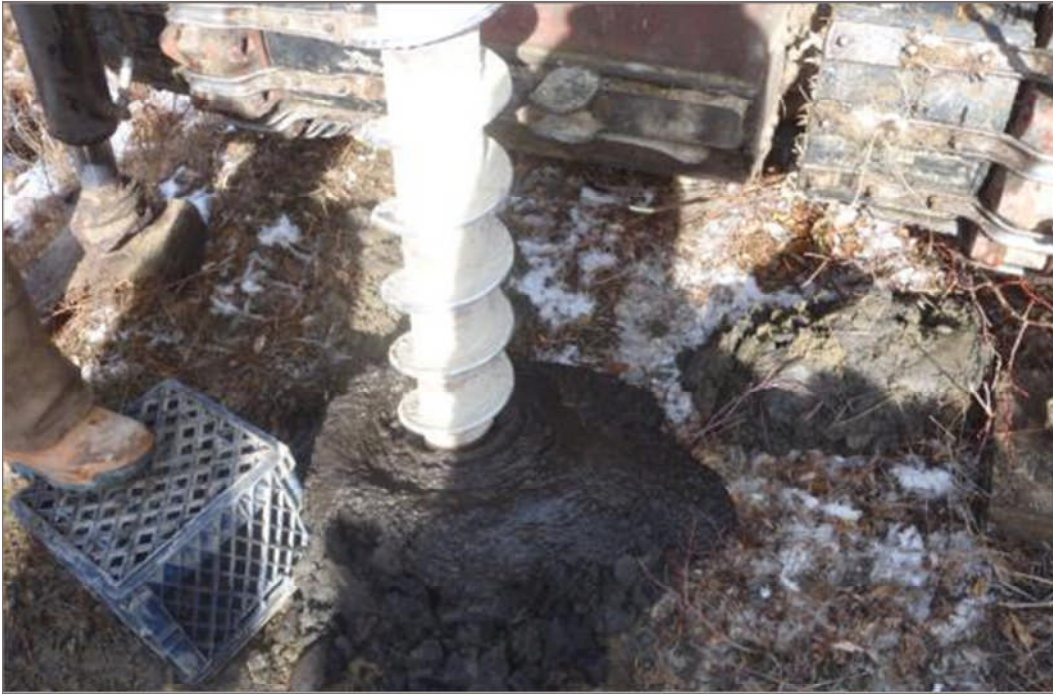
General subsurface conditions in BH03 consist of 1.0 m of sand fill, over 2.0 m of sand, over 1.8 m of frozen silt, over frozen sand. BH03 ended at 13.0 m due to auger refusal on possible bedrock. A complete borehole log for BH03 is included in Appendix B of this report.

Photo 3: Frozen silt encountered in BH03
(October 2, 2012)

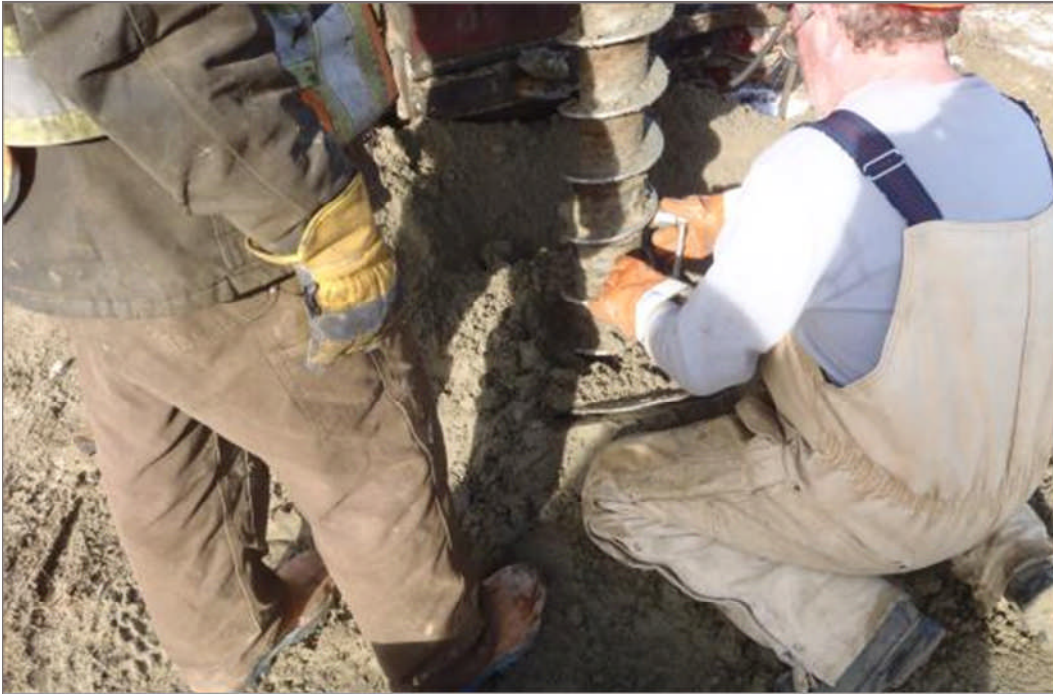
General subsurface conditions in BH01, BH02, and BH04 consist of 5.2 m of unfrozen sand, over about 8.8 m of frozen sand, over frozen silt. BH04 ended at 18.3 m due to auger refusal on possible bedrock, BH02 ended at the target depth of 14.0 m, and BH01 ended at 14.6 m due to auger refusal in frozen silt. Complete borehole logs and particle size test results are included in Appendix B of this report.

Photo 5: Frozen sand encountered in BH01, BH02, and BH04
(October 3, 2012)

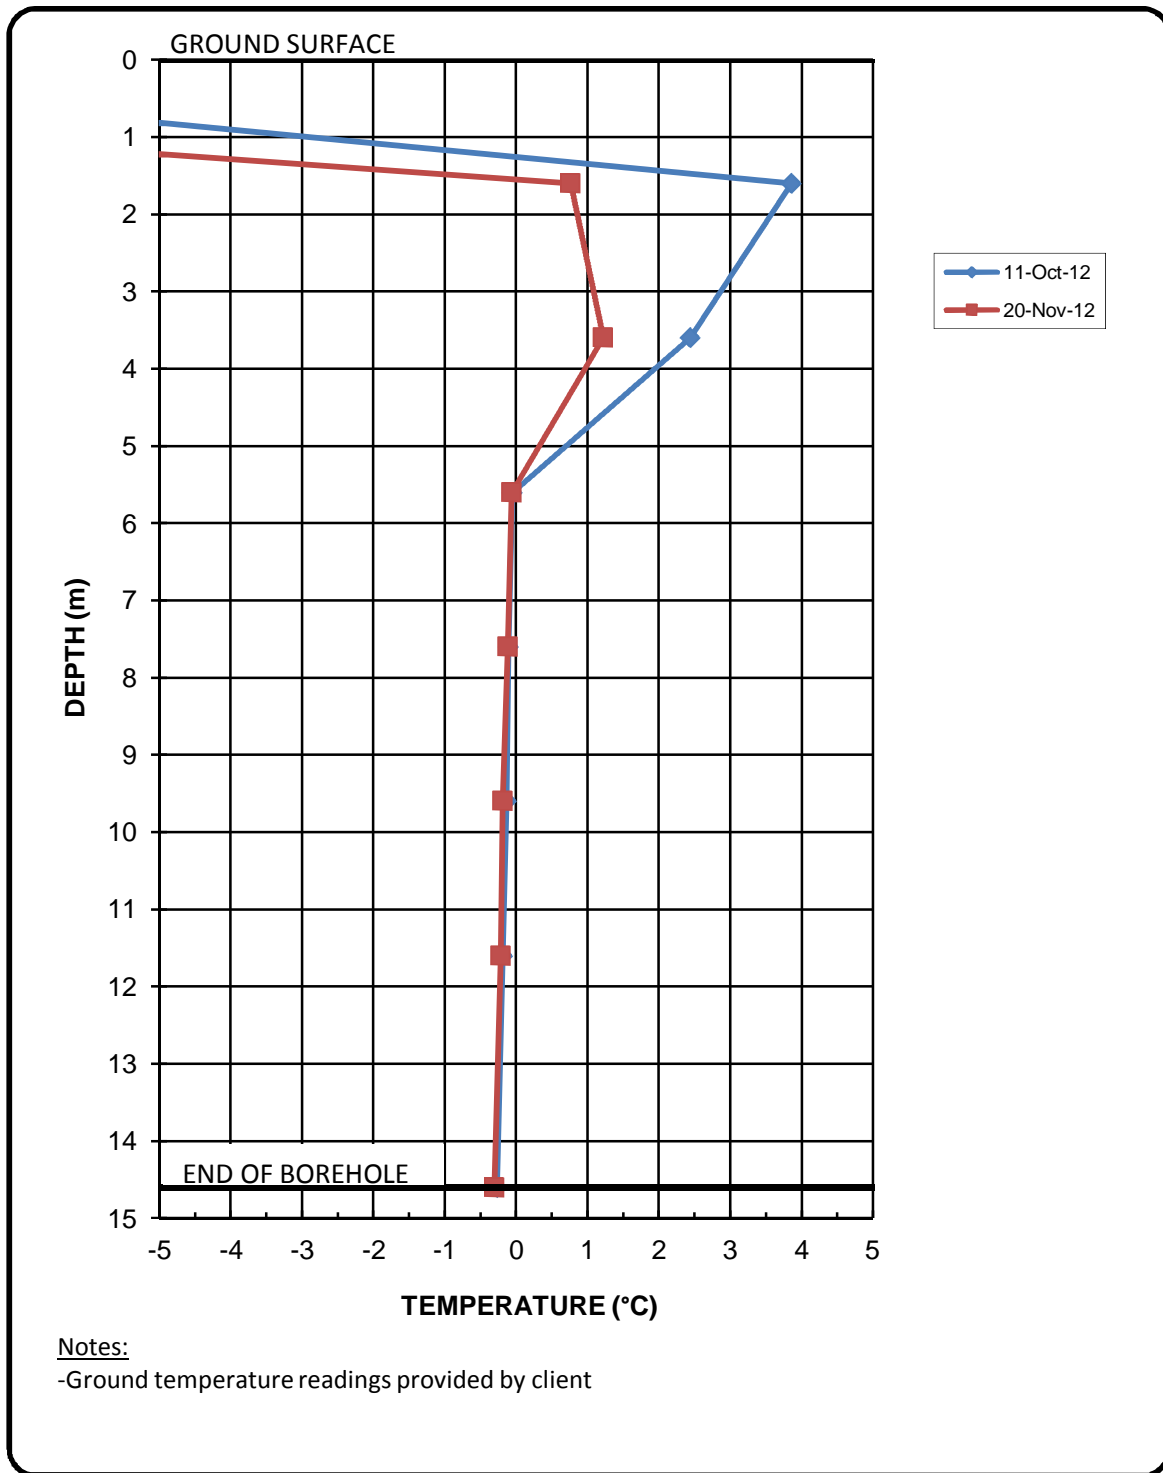
GTC 2364
Ground Temperature Profile
W14103083-BH01
Mount Nansen Mine Site

geotechnical drill program, permafrost was noted at a depth of 5.2 m. Initial ground temperature readings also confirm the permafrost has thawed to about 5 m. The subsurface soil conditions downslope of the north abutment consist of sand, underlain by frozen sand, underlain by silt. The unfrozen sand is sufficiently coarse to allow for groundwater flow. It is likely that the increased seepage and glaciation events observed recently in the seepage collection pond are a result of water travelling from the unlined Dome Creek diversion spillway along the top of permafrost through the unfrozen sand terrace.

EBA recommends the ground temperature cables be read monthly. Data sheets that can be used to record ground temperature data have been included in Appendix E of this report.

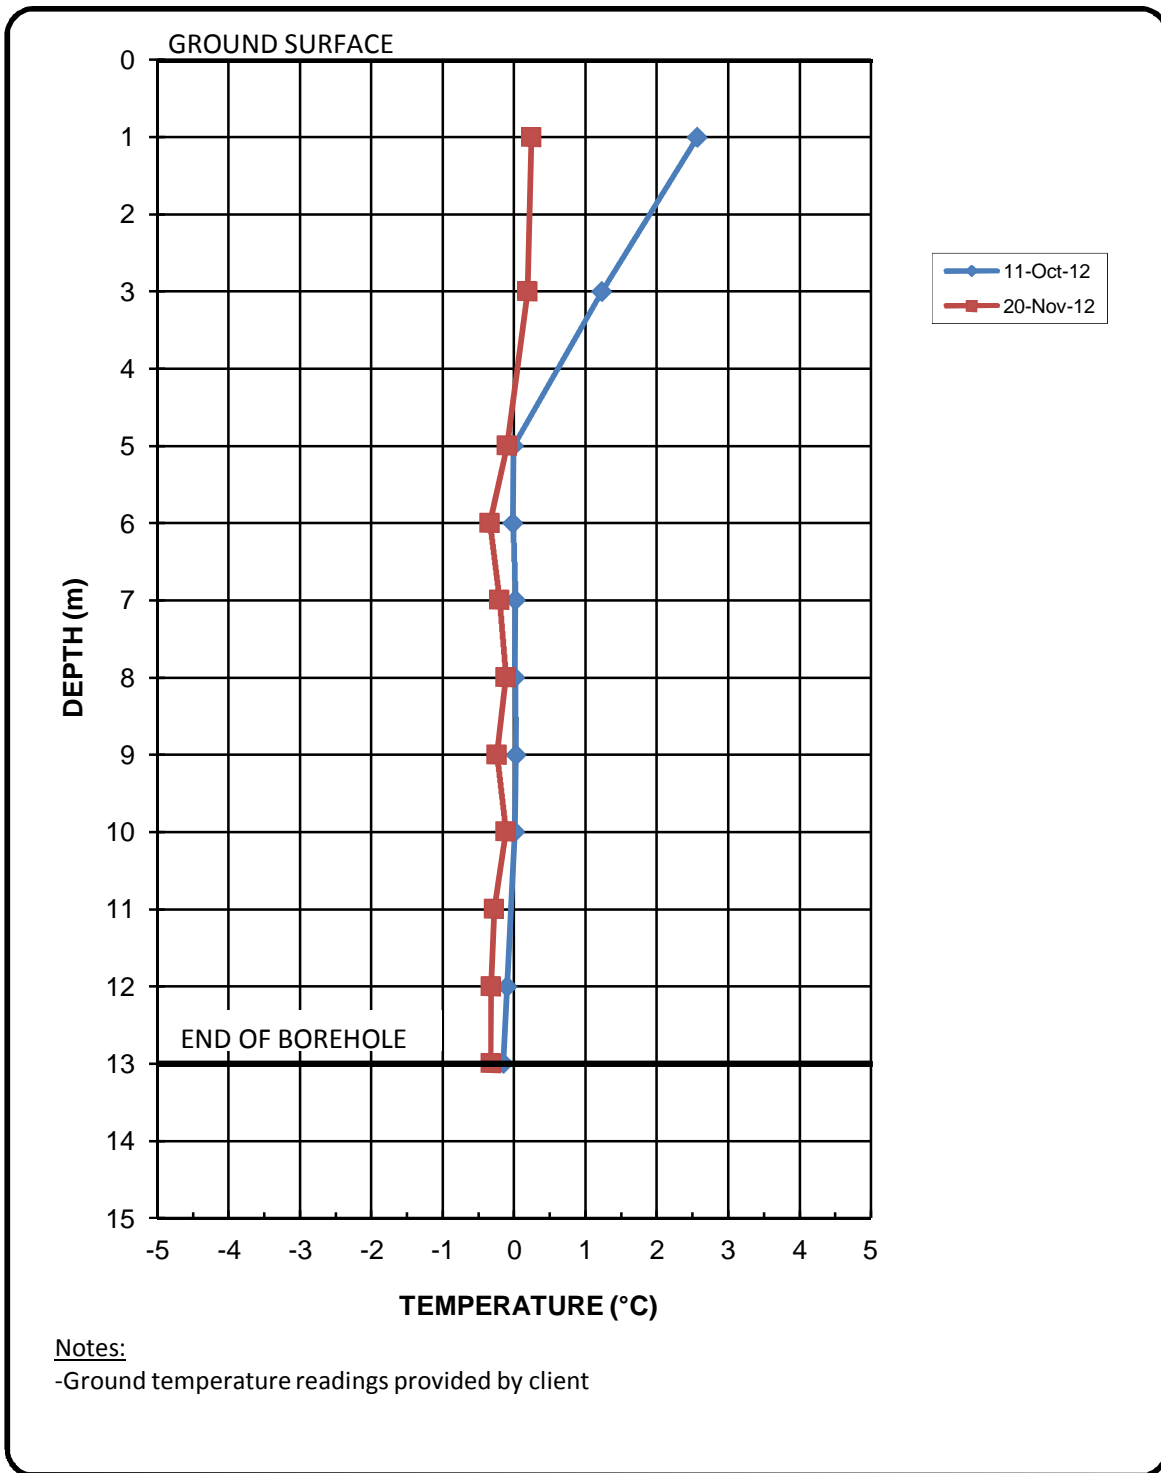
GTC 2362
Ground Temperature Profile
W14103083-BH03
Mount Nansen Mine Site

The organics noted below the surficial sand fill in BH03 provide insulation to the underlying permafrost. No organics were noted in the other boreholes advanced during the geotechnical drill program. Permafrost is likely closer to the surface in BH03 because of this insulating organic layer.
