February 29, 2012

File #: 11-5475

Re: Field Notes - Visit To Mount Nansen Mine, Yukon

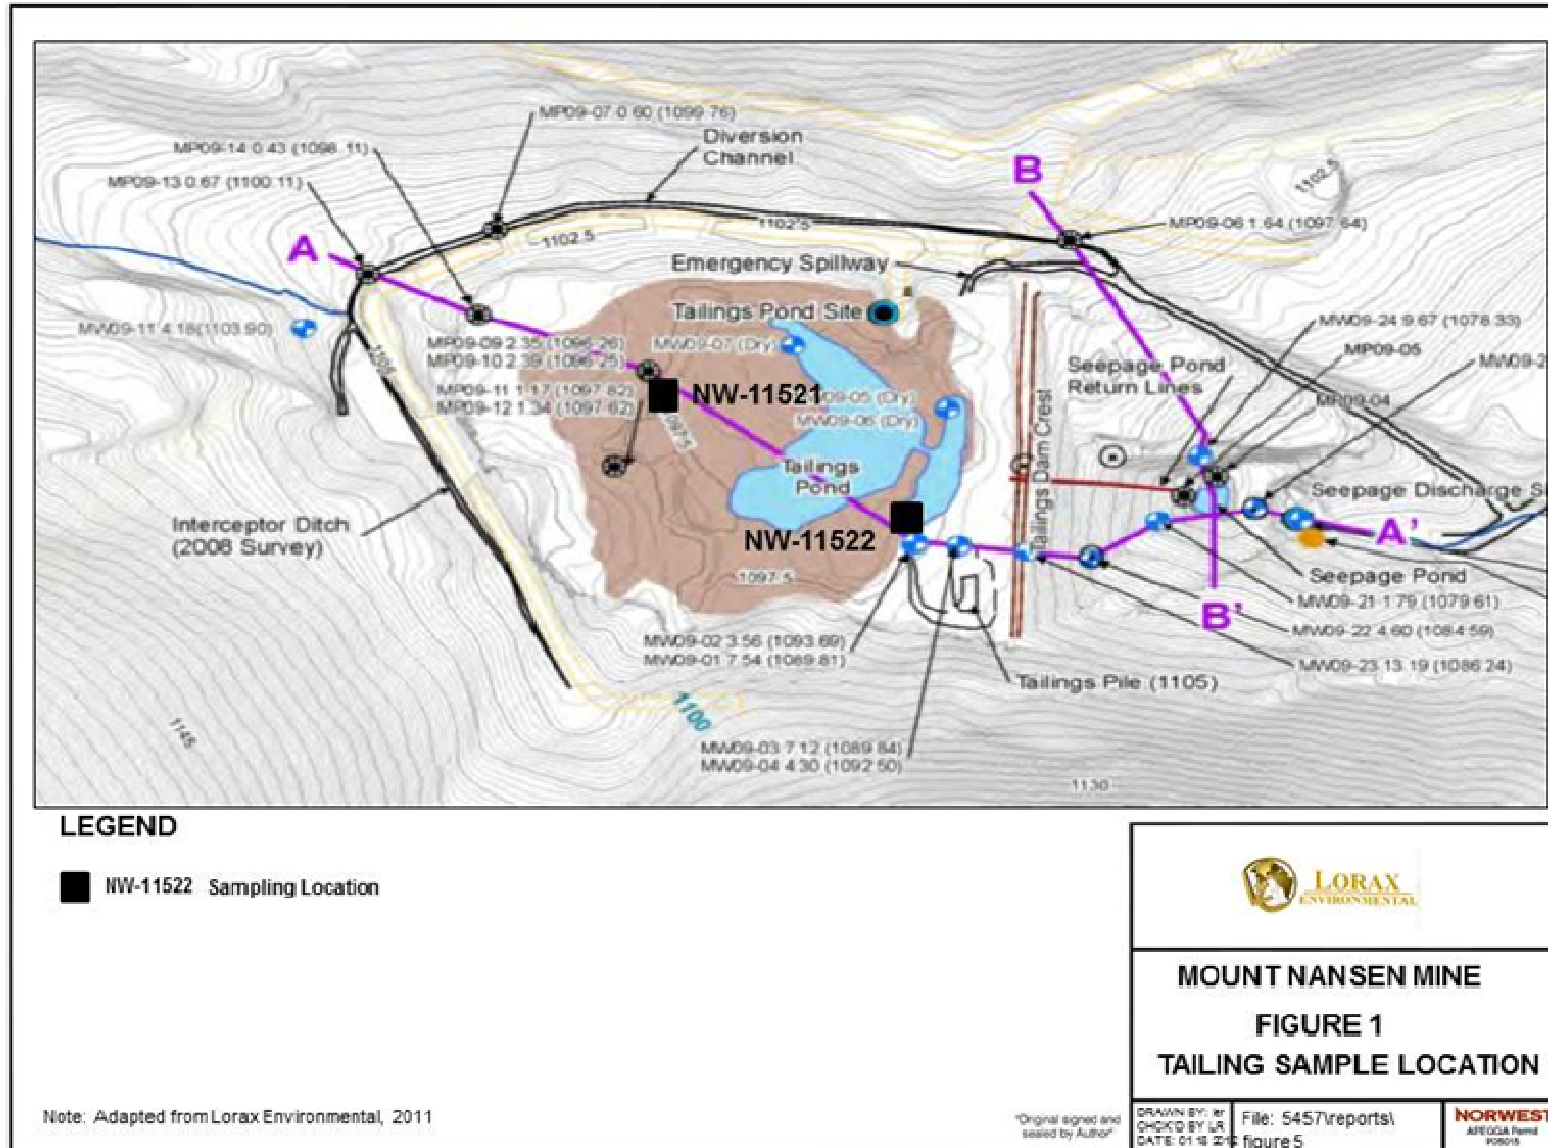
FIGURE 1
TAILINGS SAMPLE LOCATIONS

Two samples were collected from within the tailings pond. The sample locations are shown in Figures 1 and photo 1 and brief descriptions of the samples are provided in Table 1. The samples were collected with a small shovel, placed in a large plastic sample bags marked with the sample number and transported to Norwest Corporation's Calgary office.

Sample	Details
NW-11521	<ul style="list-style-type: none"> About 3.5 kg in weight. Location 6,880,682 N, 389,240 E (NAD83, Zone 8) and 1,097.20 meter above sea level (masl). See Figure 1 and Photo 1. Collected from four spots within 5 m of drill hole MP09-09 and MP09-10. Samples collected at a depth between 0 and 20 cm with frozen ground from 1 – 5 cm, tailing material was dry with some ice crystals. Closer to the tailings pond the tailing material was frozen to 20 cm depth and not sampled.
NW-11522	<ul style="list-style-type: none"> About 5.5 kg in weight. Location 6,880, 0559 N, 389,395 E (NAD83, Zone 8) and 1,096.25 masl. See Figure 1 and Photo 1. Collected from three spots, adjacent to well NW09-01 and MP09-02 and two spots 5 and 10 m to the NW of the wells. Material was light brown at depth, toward surface material, becoming darker brown with a thin white crust.

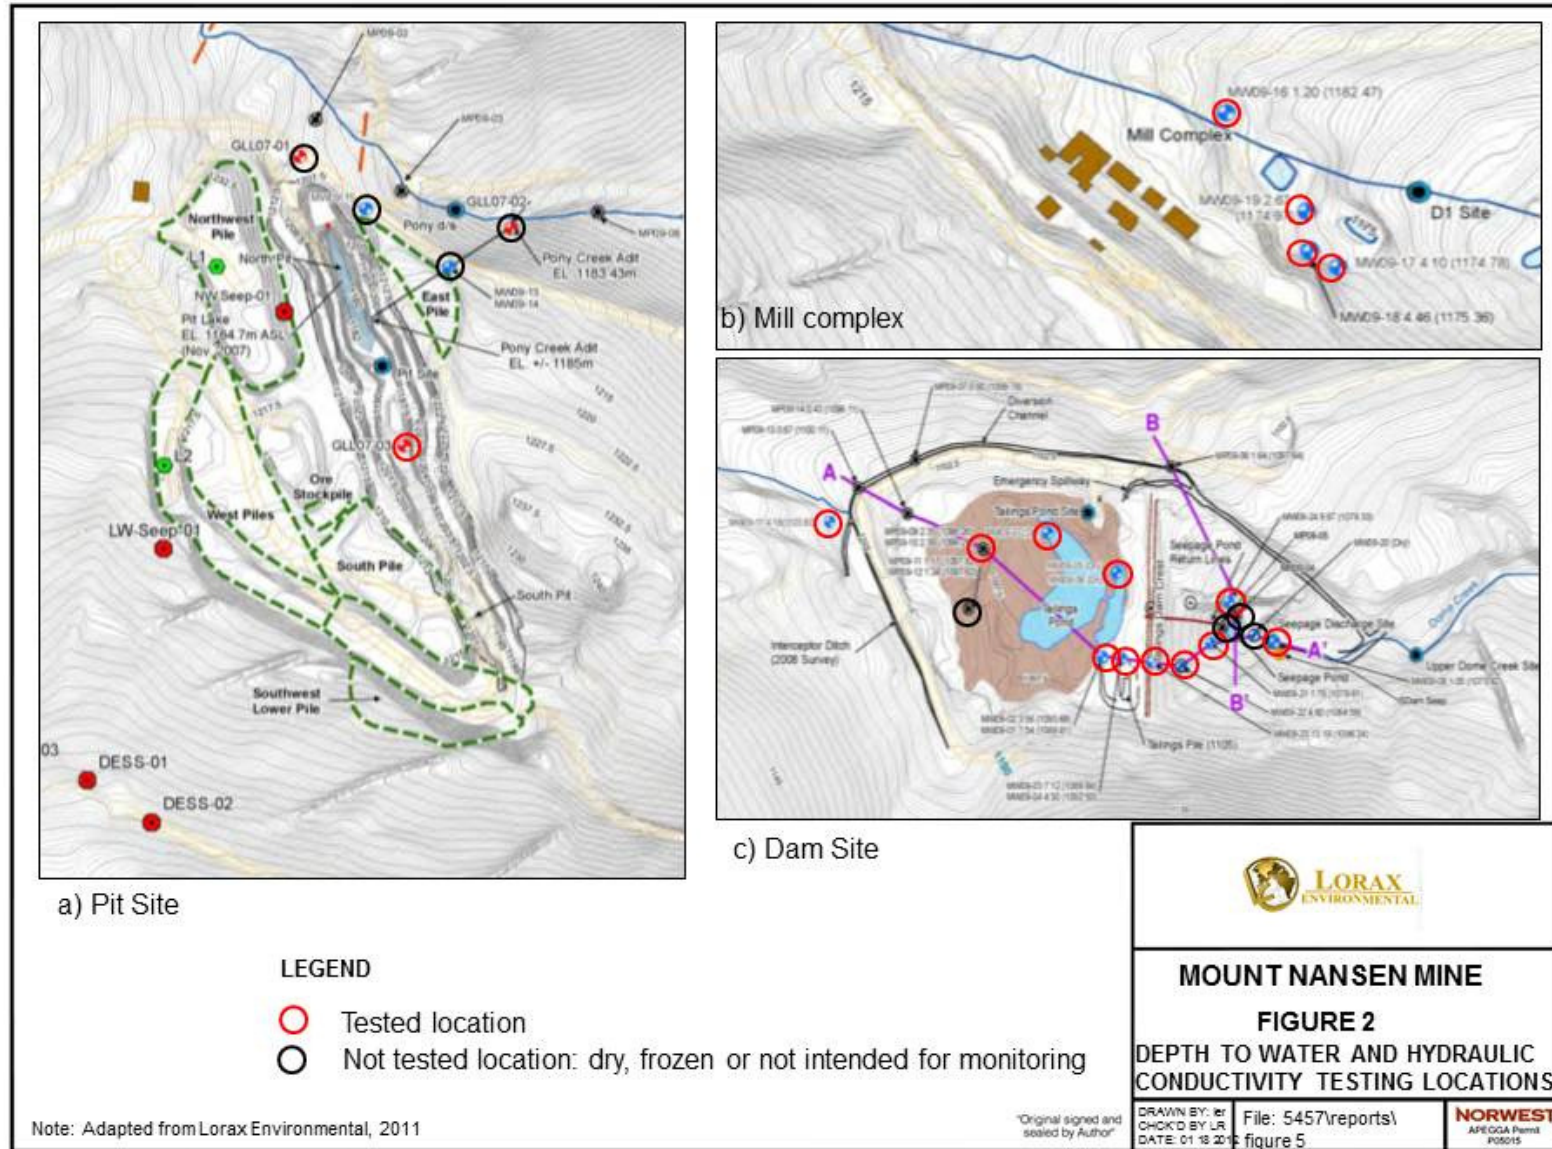
FIGURE 2
DEPTH TO WATER AND HYDRAULIC CONDUCTIVITY LOCATIONS

Depth to water (DTW) and total depth (TD) was measured from top of casing (TOC) using a Solinst water meter probe and the results are provided in Table 3. A total of 30 wells were identified as candidate wells for monitoring of DTW and TD. Of these, mini-piezometer MP09-05 was reportedly intended for water quality (seep) sampling, not water level monitoring. Of the remaining 29 wells, six (6) were frozen and two (2) were dry, as summarized in Table 3 and illustrated in Figure 2.

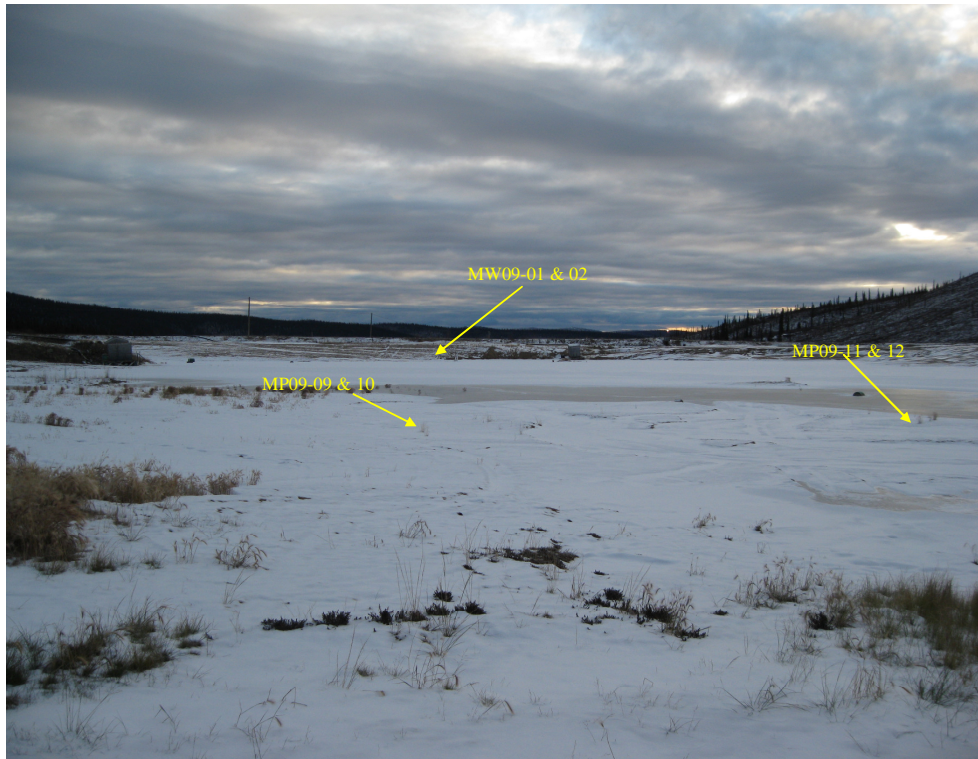
PHOTO 1. TAILINGS SAMPLE LOCATIONS LOOKING EAST FROM UPSTREAM END OF THE TAILINGS POND

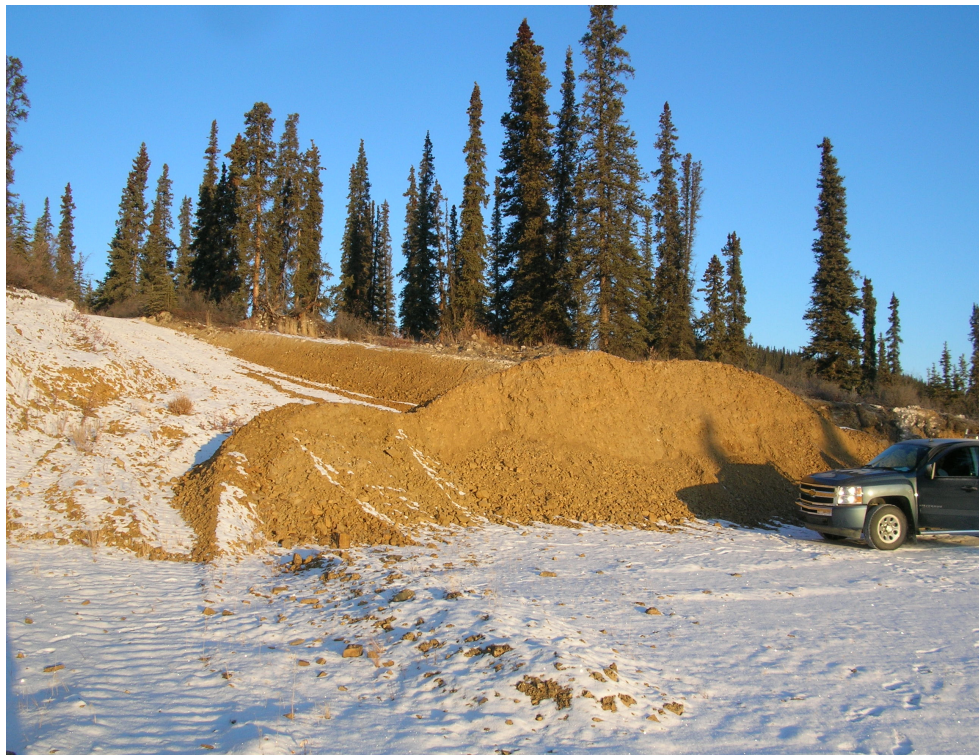
Sample	Details
NW-11523	<ul style="list-style-type: none"> Colluvium sample collected along the Mt. Nansen road, south of the water well turn-off and NW of Victoria Creek crossing. See Photo 2. Location 6,880,795 N 391,056 E (NAD83, Zone 8) and 1,059 masl About 4.7 kg sample weight. Sample taken from a colluvium road building stock pile. Appears that the material in the pile was collected from the immediate area and pushed into the pile for road fill. Colluvium in this area starts at a depth of 10 to 20 cm and ends at the top of bedrock at a depth of 1-2 m. Finer grained near surface with sand, silt and clay. Becomes courser grained at depth and as proximity to bedrock approaches, eventually turning into angular bedrock with clay/silt along fractures.

PHOTO 2. COLLUVIUM PUSH PILE ALONG MT NANSEN ROAD, AT SAMPLE SITE NW-11523, PICTURE LOOKING NORTH

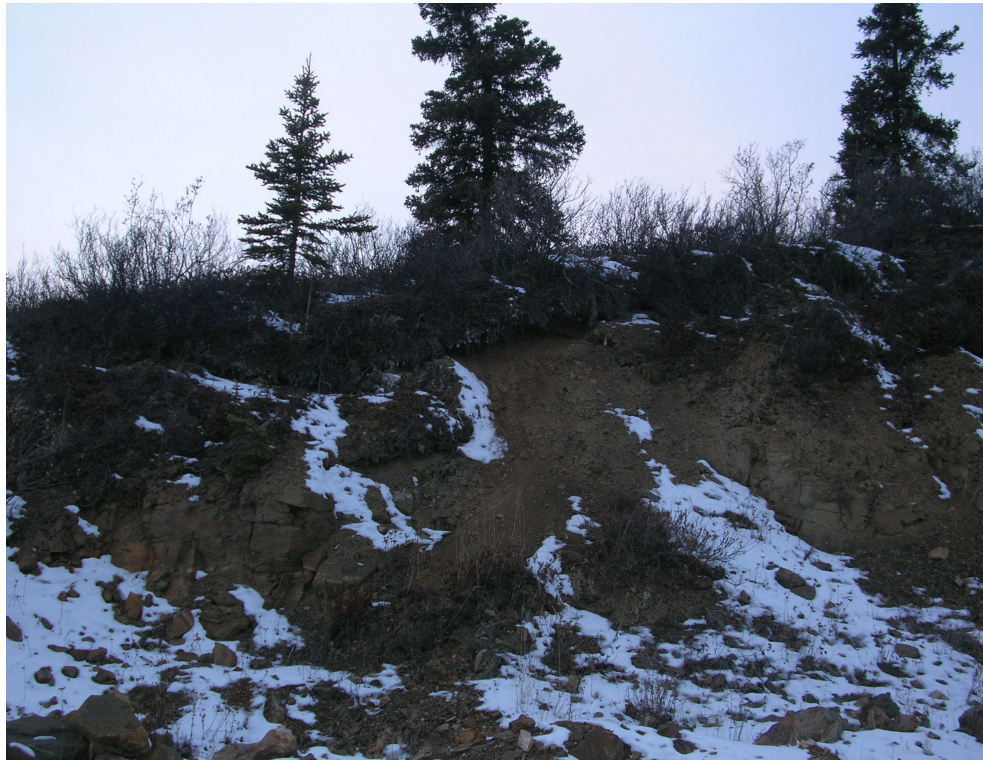
NW-11526	<ul style="list-style-type: none"> • Colluvium sample collected along north access road, west of the Mt. Nansen Pit in an exploration trench. See Photo 3 • Approximate coordinates, due to bad GPS reception. 6,881,700 N, 388,450 E (NAD83, Zone 8) and 1,245 masl • Typical colluvium material collected between 10 cm depth and top of bedrock at about 1 m depth. • About 4 kg sample weight.

PHOTO 3. COLLUVIUM ON TOP OF THE WEATHERED BEDROCK AT SAMPLE SITE NW11526, PICTURE LOOKING WEST
