Government of Yukon
Former Clinton Creek Asbestos Mine
Long Term Performance Monitoring - 2007

UMA Project No.: 6029 009 00 (4.6.1.1)

July 2008

Re: Former Clinton Creek Asbestos Mine – Long Term Performance Monitoring - 2007

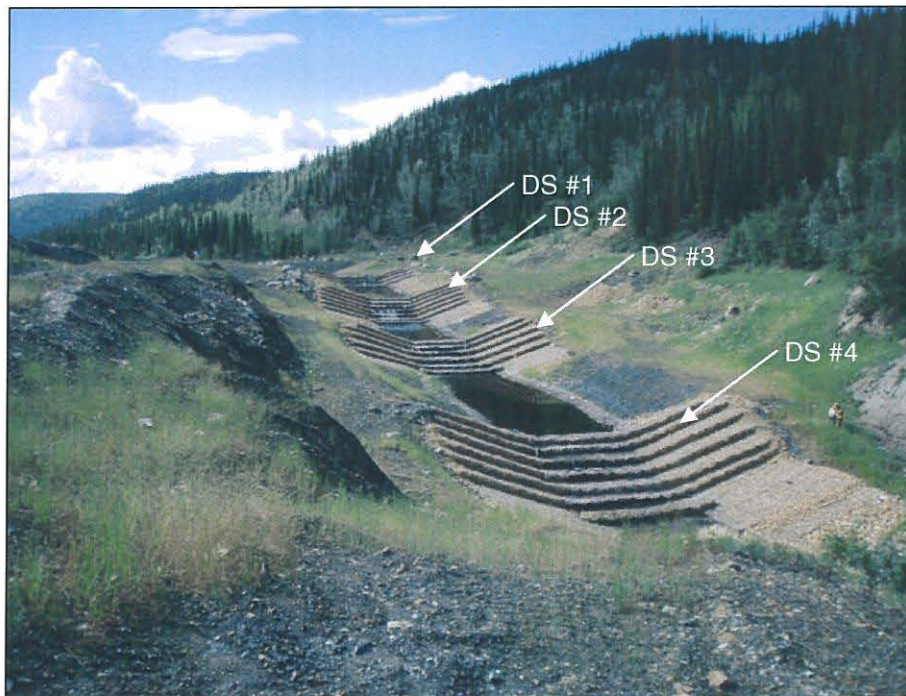
Figure 2.1 General Site Conditions

In general, the structures within the reconstructed channel reach are performing well as evidenced by the photo in Figure 2.1. Grass and other vegetation are becoming established around the channel which will help to reduce surface erosion due to runoff into the channel.

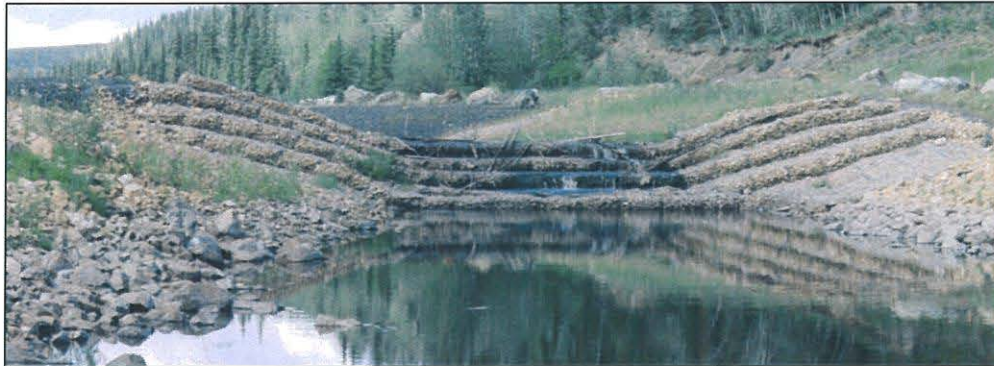
Figure 2.2 General Condition of Drop Structure #1

Although some settlement of Drop Structure #1 (DS #1) was experienced in the first year following construction, its condition has not visibly changed since the May 2005 Site Inspection (UMA 2006). The gabion baskets are in good shape and do not require any infilling. Figure 2.2 illustrates the general condition of DS #1.

As noted in the previous performance monitoring report (UMA 2006b), the cross-section survey of DS #1 taken in 2006 (Drawing 01) shows that there is less than 0.2 m of free board at the design flow depth of 2.01 m. During the site inspection it was decided that some additional baskets should be added to the upper most row of baskets on either side of the channel.

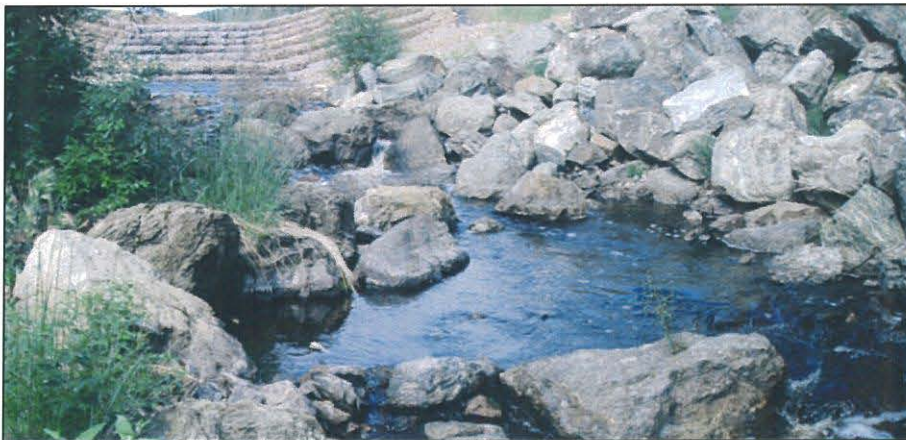
Figure 2.3 Pool of Water Downstream of DS #4

A critical stretch of the channel with respect to the long term performance of the stabilization works is the transition between DS#4 and the bedrock outcropping at Station 0+225 m. The channel survey from 2006 (Drawing 06) showed that some erosion occurred between Stations 0+195 and 0+215 m since the previous survey which was completed in 2004. The 2007 survey of this channel stretch confirmed that about 0.2 to 0.3 m of channel erosion has occurred. The eroded channel section is characterized by deep pools of water as illustrated on Figure 2.3. The boulders lining the left hand (north) side of the channel directly downstream of DS #4 also showed signs of movement, possibly due to some erosion of the fine grained soil behind the boulders during high flow events (e.g. spring freshet). Minimal, if any, erosion occurred on the right hand side of the channel in this area.

A short stretch of the channel between the last drop structure and the point where bedrock is exposed in the channel needs to have some scour holes filled in with rock to prevent further deterioration. This section of the channel is critical to minimize channel degradation and the potential for undermining of the last drop structure.

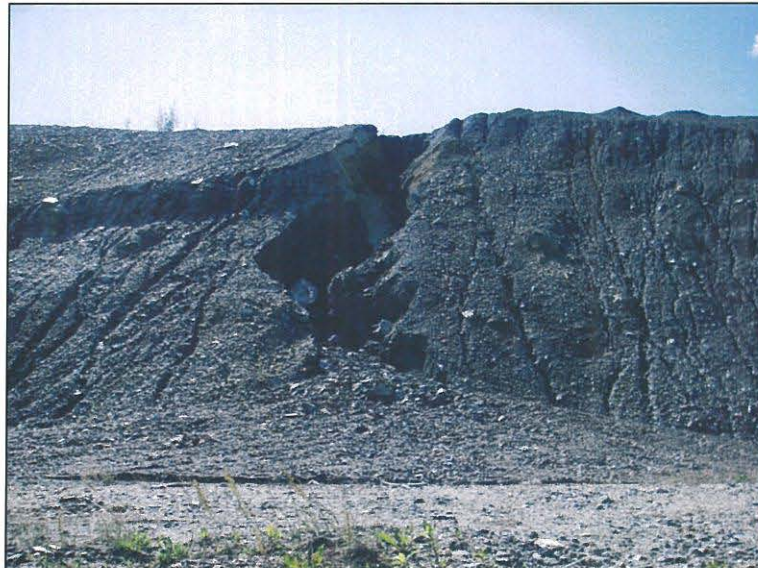
Figure 2.4 Erosion Gully

During a site visit by GY in October 2007, a significant erosion gully was observed on the north side of the mine access road between Drop Structures 2 and 3 (Figure 2.4). The erosion gully extends down from the mine access road to the access road located on the south side of the stabilized creek channel. The gully is confined to the waste rock material and does not appear to have impacted the side slopes of the stabilized creek channel. This particular location along the mine access road is subject to ponding and the gully likely formed during a period of high run-off.

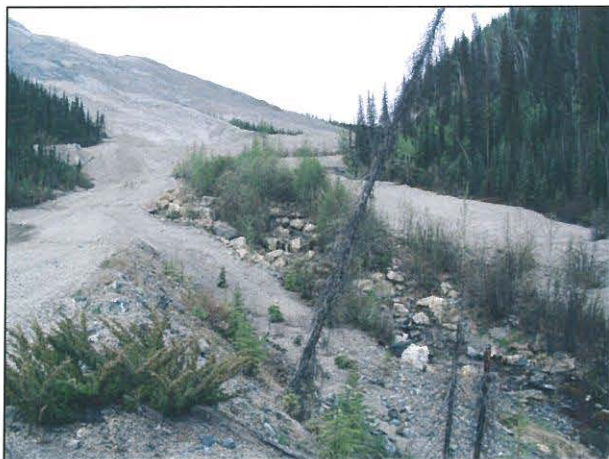
Figure 3.1 Vegetation Along Rock-Lined Channel

The rock-lined channel is generally stable and the bed is well armoured by boulders and vegetation (e.g. trees and brush). At a number of locations, the right bank (when facing downstream) of the channel appeared to be higher and better armoured than the left bank. Therefore, a channel bank breach is more likely to occur along the left bank during high flows. Some vegetation (e.g. trees and brush) is well established in and around the channel (Figure 3.1) and may be affecting the hydraulic capacity although there were no obvious signs that flow had overtopped the banks. No significant channel blockages were identified although there are some signs of sedimentation taking place and some shifting of boulders that form the rock weirs in the channel (Figure 3.2).

The root systems of the well established vegetation in the channel bonds the channel surface and should not be disturbed. However, large brush and trees in the channel tend to accumulate floating debris and could direct flow jets toward the channel banks, which could cause bank erosion and possibly lead to a bank breach.

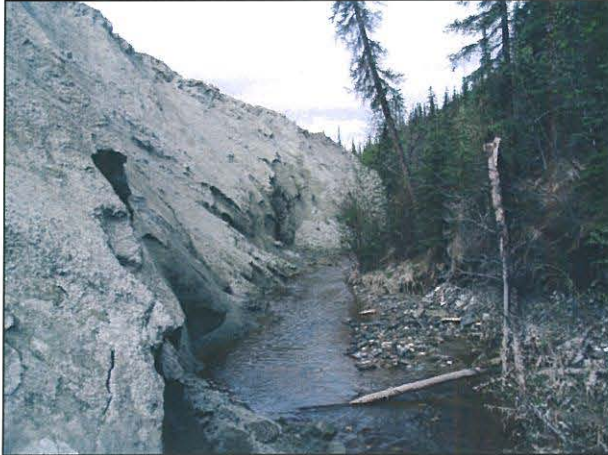
Figure 3.3 Wolverine Cr Along S Lobe in 2005

Up stream of the rock-lined channel, the channel across the South Lobe of the tailings (Station 1+050 to 1+300 m on Drawing 09) is in a similar state as observed during our 2005 site inspection. The main difference illustrated in Figures 3.3 and 3.4 is the amount of tailings that has sloughed into the channel.

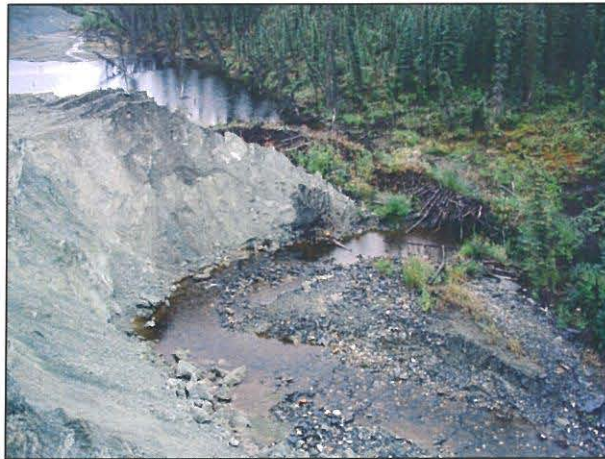
Figure 3.5 Wolverine Cr at U/S End of S Lobe

There does not appear to be any significant erosion on the valley side of the channel. The creek profile survey completed in 2007 (Drawing 09) suggests there has been little change in the profile of the creek in this area since 2003. Near Station 1+300 m the creek channel turns back into the tailings and has resulted in some localized erosion, as shown on Figure 3.5.

At the time of the site inspection an old beaver dam was located in Wolverine Creek at the upstream end of the South Lobe and was redirecting the creek flow directly back at the tailings pile resulting in some erosion of the tailings in this area. The beaver dam was removed to allow the creek flow to run parallel to the edge of the tailings. The maintenance work completed in 2007 is illustrated in Figure 5.4. The original conditions are illustrated in Figure 3.5.

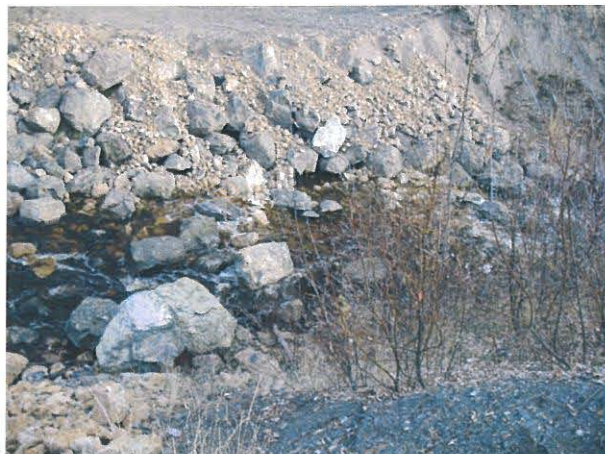
Figure 5.3 North Side of Channel d/s of DS #4

Rocks and boulders were placed on the bottom of the channel to tie into the rocks lining the north side of the channel. The boulders on the north side of the channel were to be infilled with smaller rocks (100 to 200 mm diameter) to protect the underlying fine grained soil from erosion during high flow events. The maintenance work completed in 2007 is illustrated in Figure 5.3. Some voids still exist however, and these should be filled.

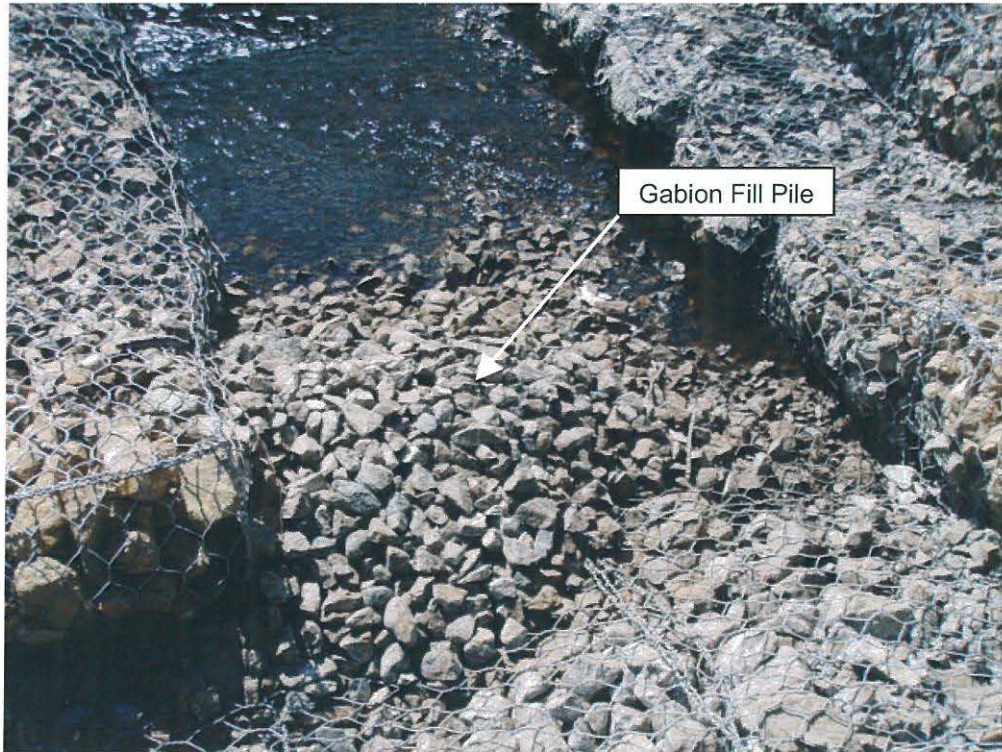
Figure 01: Remove deposit of gabion fill at outside corners of end sills.

- Drop Structure #3: remove the cobbles and boulders resting against the outside edges of the end sill. Water flowing over the drop structures, particularly at higher flows, may produce a 'rocking action' of the cobbles and boulders that could result in abrasion of the PVC coating on the gabions and expose the wire mesh leading to abrasion of the galvanized wire and premature corrosion.

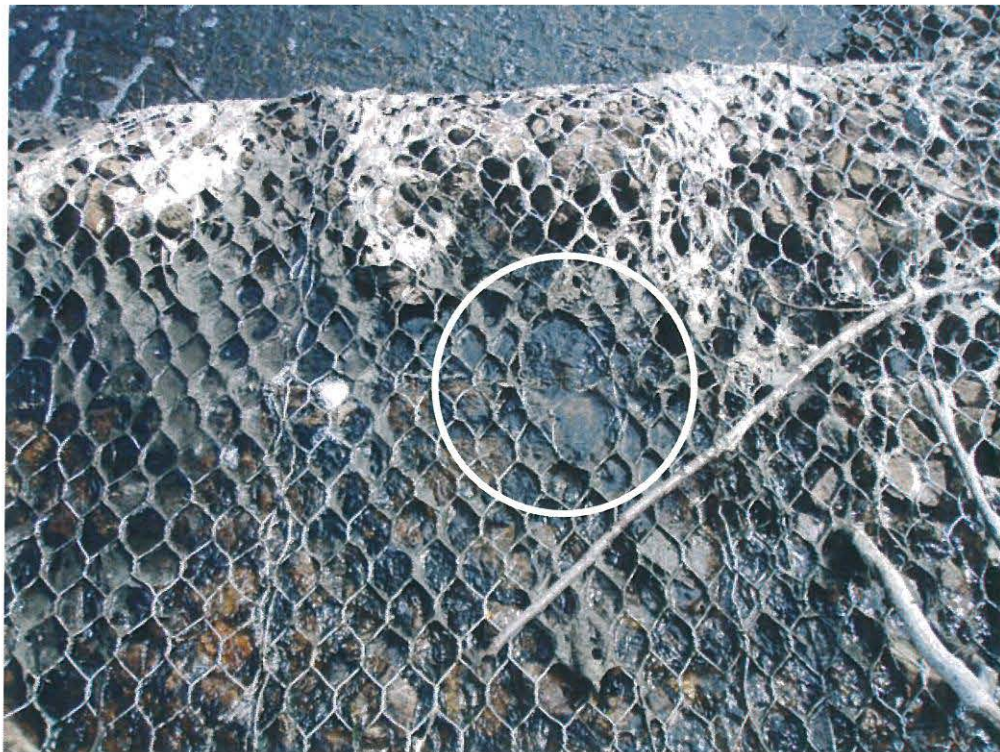
Figure 02 - Drop Structure #2, Middle Tier: Hole in basket to be patched.

- Drop Structure #2: place a patch over the hole on Tier #4 (middle step of the drop structure). The hole is located on the flat section of this row of baskets to the right of centerline (when facing downstream), as illustrated on Figure 02. The patch can be made by cutting a 1m x 1m panel from one of the leftover gabion baskets and should be fastened to the damaged basket using the C-rings used to assemble the gabion baskets.

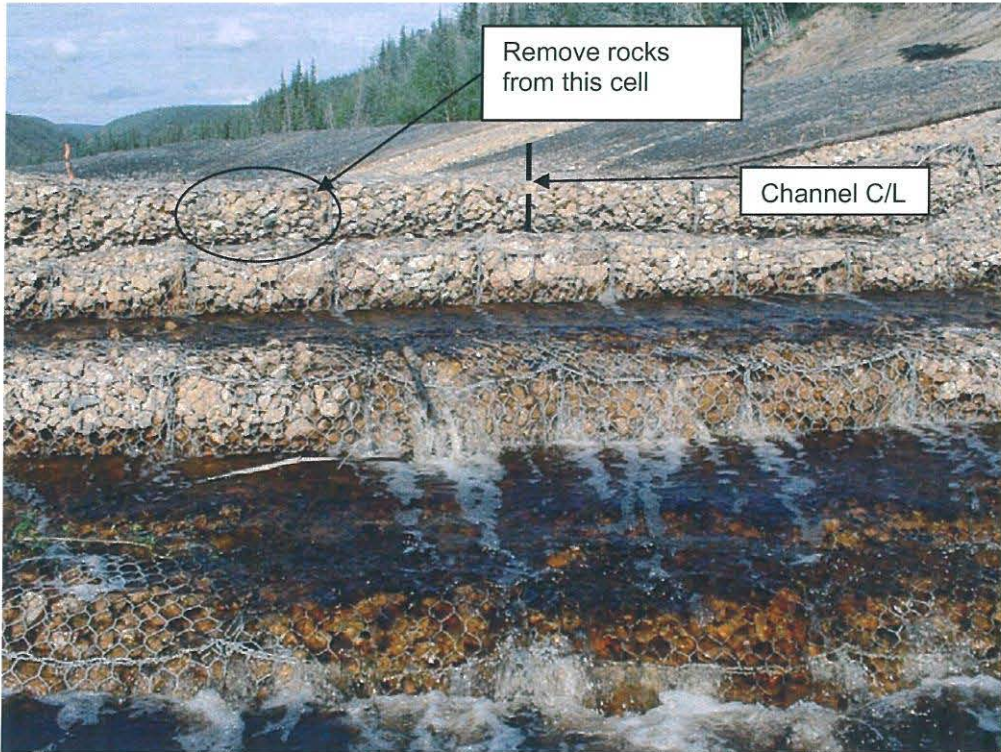
Figure 03 - Drop Structure #2, draw down weir: Remove rocks from the cell shown in the photograph.

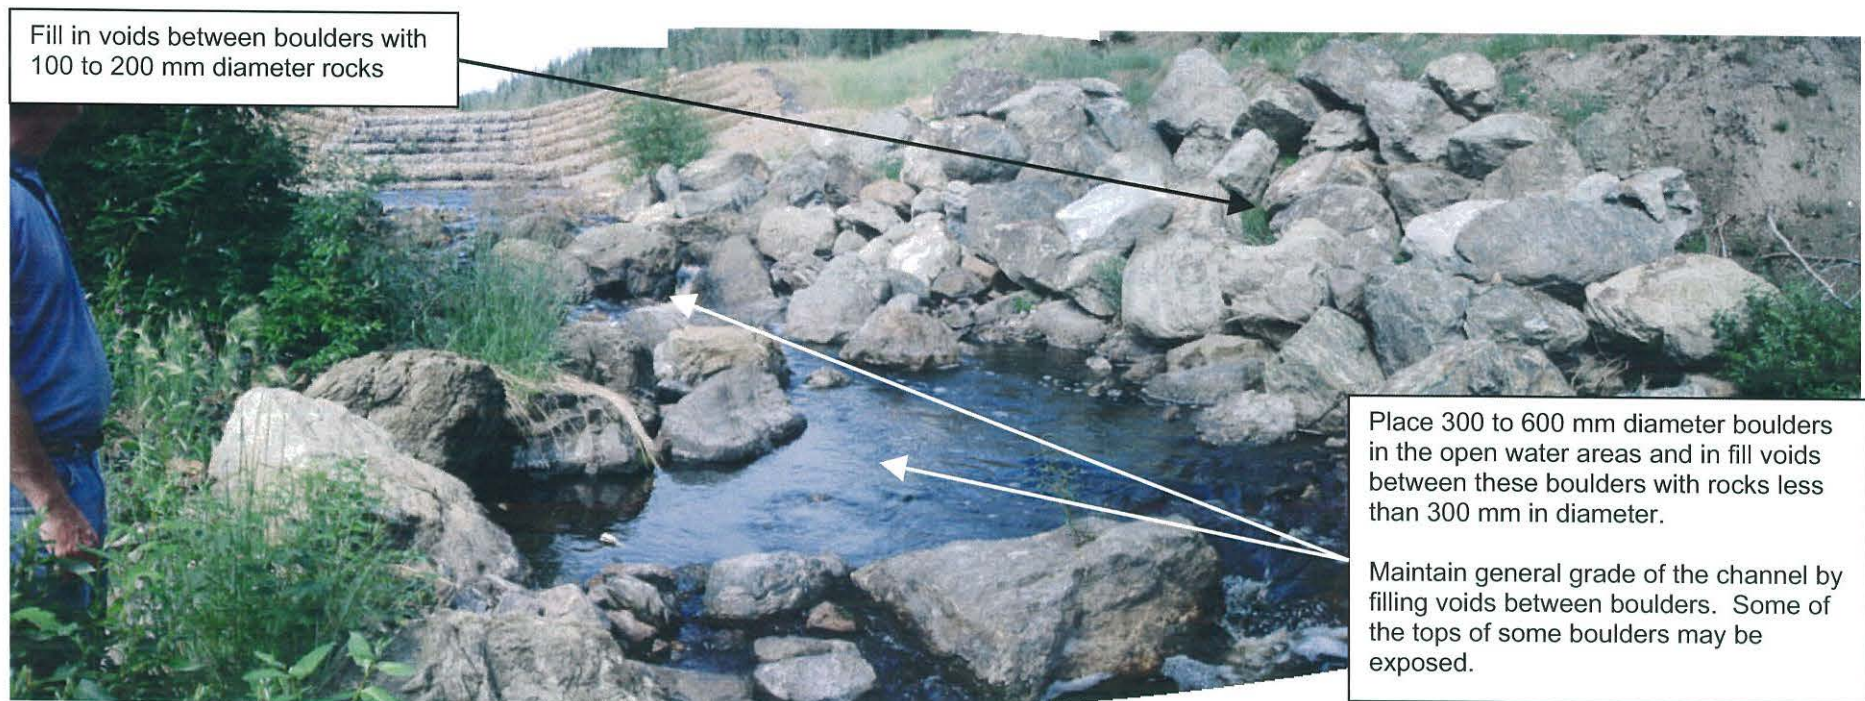
Figure 05 - Channel transition downstream of Drop Structure #4: Channel armoring required.

- A short stretch of the channel between the last drop structure and the point where bedrock is exposed in the channel needs to have some scour holes filled in with rock to prevent further deterioration. This section of the channel is critical to minimize channel degradation and the potential for undermining of the last drop structure. Figure 05 illustrates where the work is to be done. The open water areas in the creek

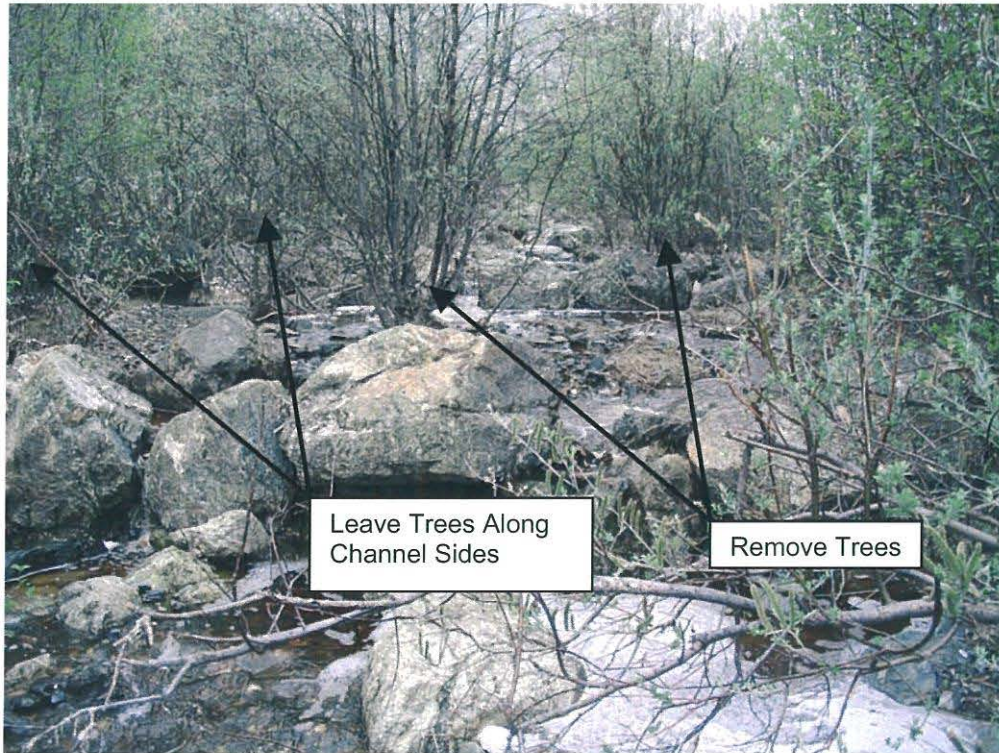
Figure 06 - Wolverine Creek – rock lined channel: remove debris and trees growing in the channel, leave trees growing along the outer 2 m width of the channel.

In general the rock lined section of the Wolverine Creek channel is in good repair after about 30 years of use. Based on the site inspection observations, the only work recommended at this time is to remove debris (e.g. wood posts) and trees from the middle area of the channel (Figure 06) because they may restrict flow during high flow events and increase the likelihood of water overtopping the channel sides and eroding the tailings in the adjacent area. The trees located within 2 m of the boulders forming the sides of the channel should be left in place. The trees to be removed should be cut-off about 200 mm above the creek channel base. Place the cut portion of the tree amongst the trees to be left in place along the outside edges the channel.

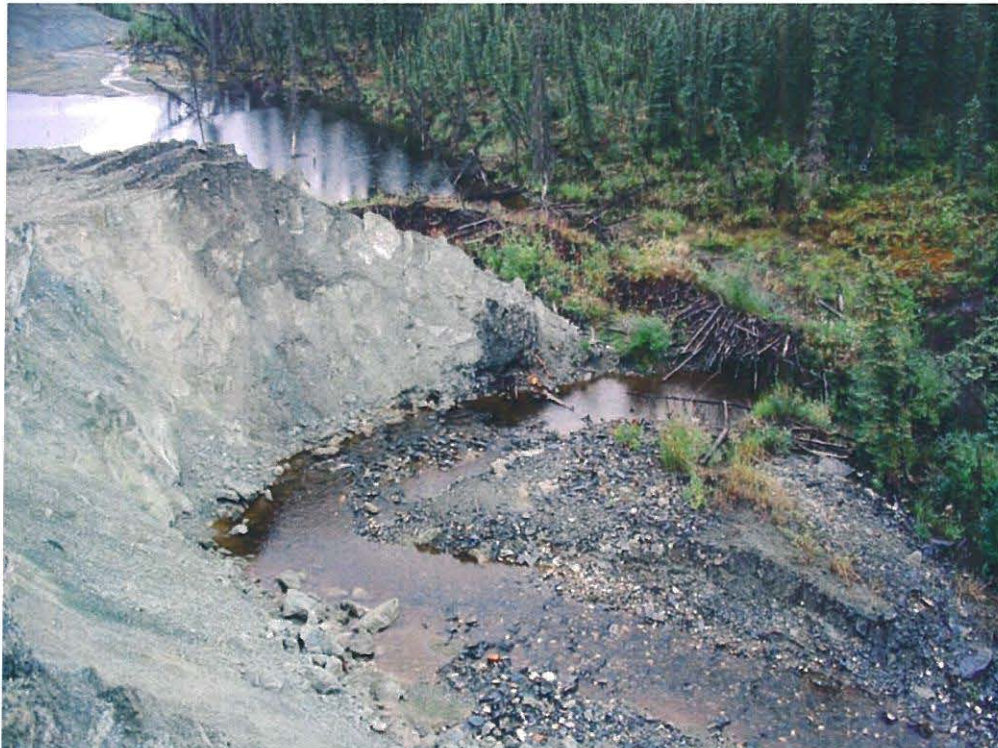
Figure 07 - Wolverine Creek along south lobe of tailings pile: Beaver dam to be removed if possible.

The channel across the South Lobe is in a similar condition to that observed in previous site inspections. There is an old beaver dam at the upstream end of the South Lobe that redirects the creek flow directly back at the tailings pile and has resulted in some erosion of the tailings in this area, as illustrated on Figure 07. If feasible, the beaver dam should be removed to allow the creek flow to run parallel to the edge of the tailings. There have been no signs of recent beaver activity in the last two site visits so it is not expected that the dam will be reconstructed.
