**Government of Yukon  
Former Clinton Creek  
Asbestos Mine  
Overview Report**

**AECOM Canada Ltd.**

6029 013 00 (4.6.1)

July, 2009

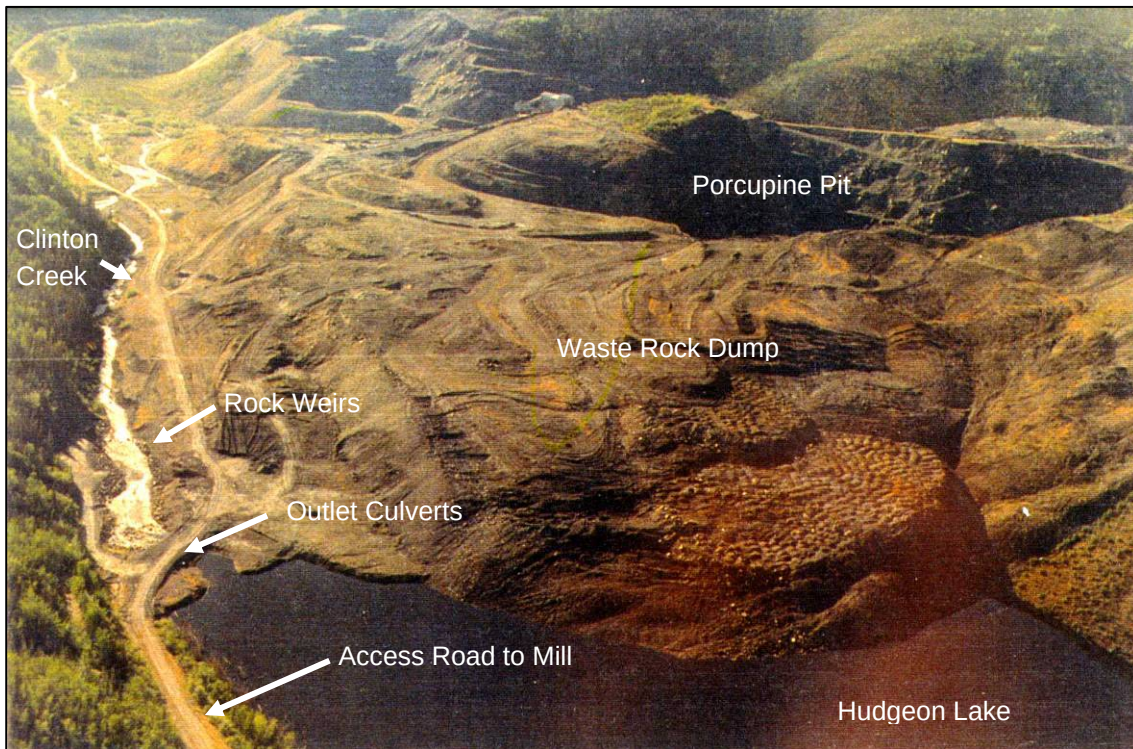
Placement of waste rock in the Porcupine Creek valley created a blockage of Porcupine Creek leading to minor ponding upstream of the waste rock dump. Shortly after dumping of waste rock into the Clinton Creek valley commenced, failures of the waste rock face occurred and the waste rock spread across the valley as more material was added. The failure history is not well documented, however, continued dumping and movement of the waste rock across the valley resulted in the eventual blockage of Clinton Creek and the formation of Hudgeon Lake upstream of the waste rock dump (Figure 03).

**Figure 03 Clinton Creek Waste Rock Dump (1985)**

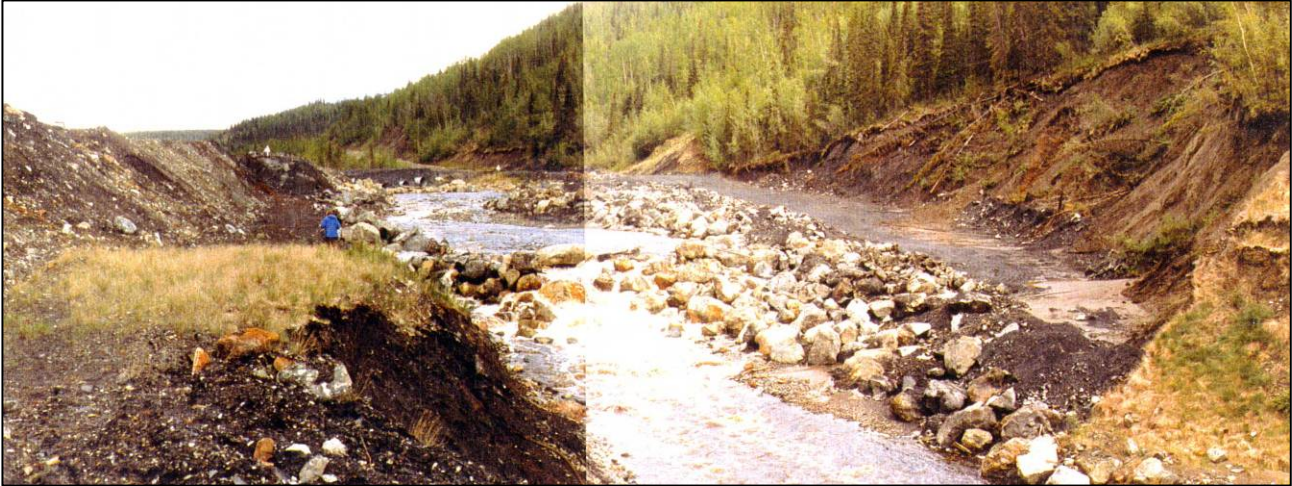
By 1978, Hudgeon Lake was about 26 m deep comprising an area of approximately 73 ha (RRU, 1999). The elevated creek channel formed along the edge of the waste rock material and bounded by the north valley slope was about 0.8 km long with an overall gradient of 4.5 percent (Stepanek and McAlpine, 1992). Recognizing the potential for a breach of the waste rock plug at the outlet from Hudgeon Lake, the mining company initiated erosion control measures that included excavation of a channel and the installation of four culverts and a rock apron at the northeast edge of the waste rock where the access road to the mill crosses the channel. In 1981, rock weirs were constructed in the channel downstream of the culverts at the location shown on Figure 04. During the 1982 freshet, the creek escaped the armoured channel section and down-cut into the north valley slope. The armoured section was reconstructed in 1984 and during a high flow event in 1997, was almost completely destroyed.

**Figure 04 Rock Weirs at Hudgeon lake Outlet (1985)**

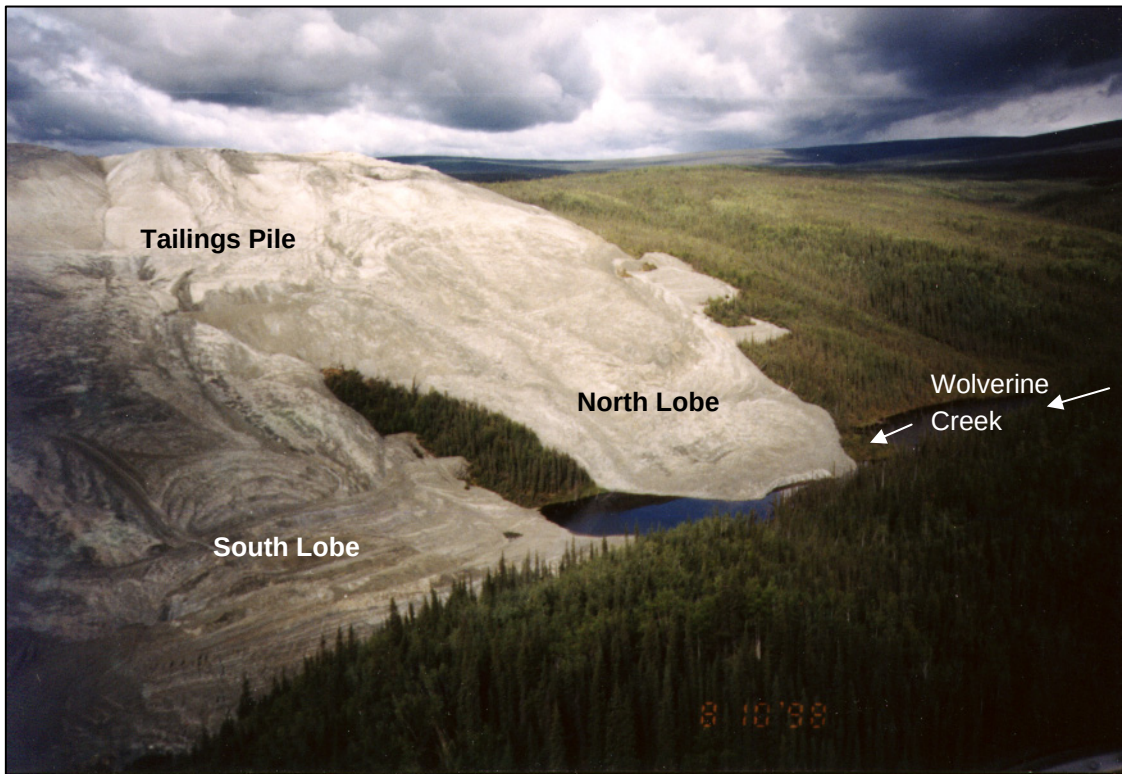
**Figure 05 Wolverine Creek Tailings Pile (1998)**

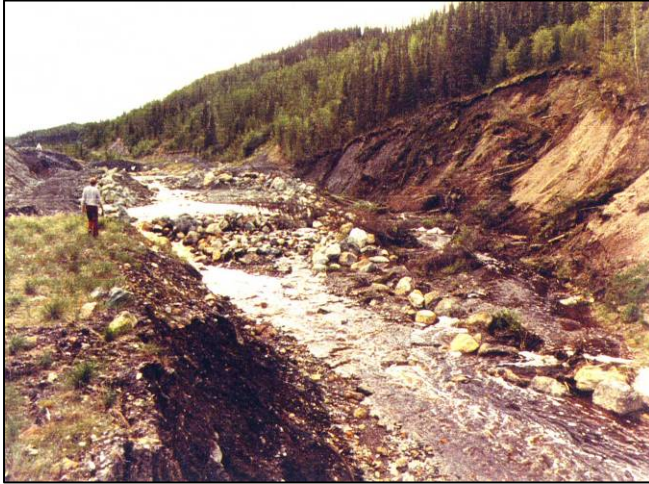
**Figure 06 View U/S at Hudgeon Lake Outlet (1984)**

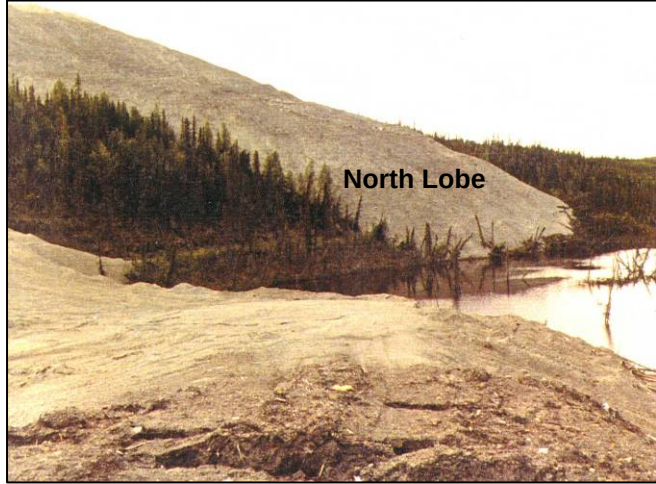
**Figure 07 Tailings Pile (1984)**

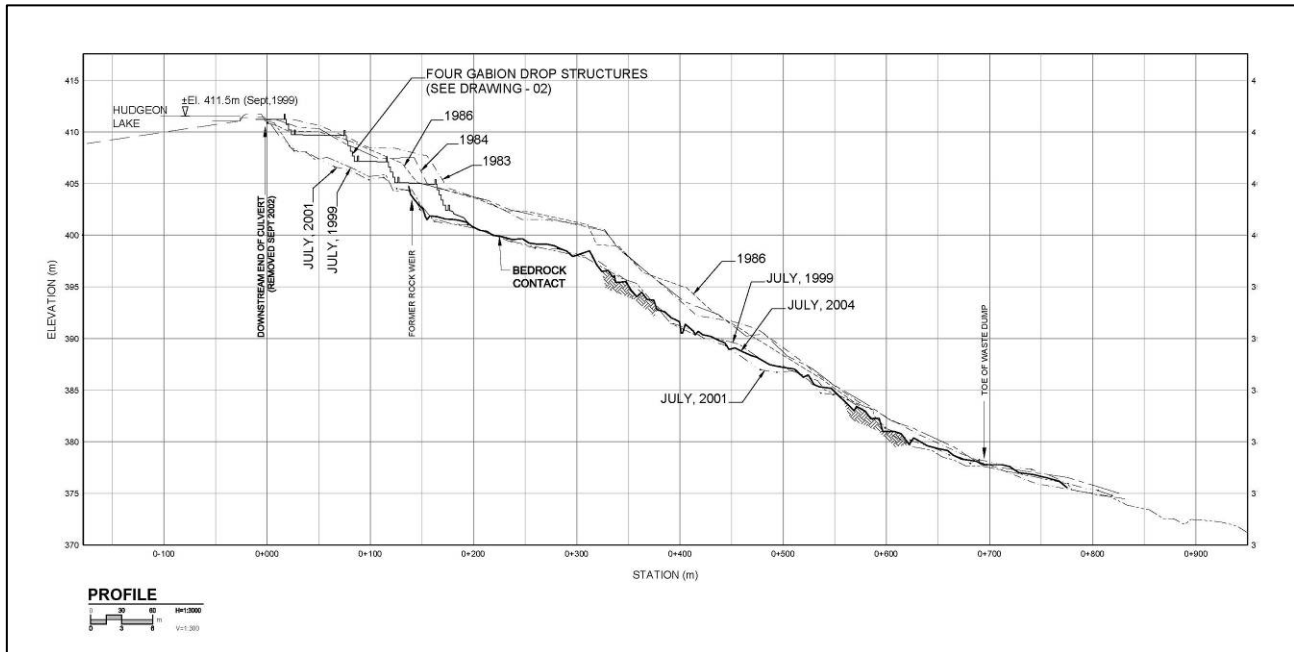
The Clinton Creek channel profile along the toe of the waste rock dump was surveyed to assess rates of erosion and down cutting of the channel. Figure 16 shows the creek profiles surveyed between 1983 and 2004. The surveys from 1999 and 2001 were completed before the channel stabilization works were undertaken. The 2004 survey includes the gabion drop structures in the creek profile. The survey was considered sufficient to identify changes in channel bottom elevation in the order of tenths of a metre. Repeatability in surveyed elevations is impacted by the location of survey shots, shifts in the creek thalweg due to sloughing of the waste rock pile and valley slope and erosion of the channel. A comparison of the creek profiles suggested that a significant amount of down-cutting occurred sometime between 1986 and 1999. The 1997 flood event that washed out the last remnants of the boulder drop structure at Station 0+140 m was likely responsible for the majority of erosion seen between the 1986 and 1999 creek profiles. The surveys in 1999, 2001 and 2004 suggested that minimal erosion had occurred in recent years.

**Figure 16 Clinton Creek Channel Profile**

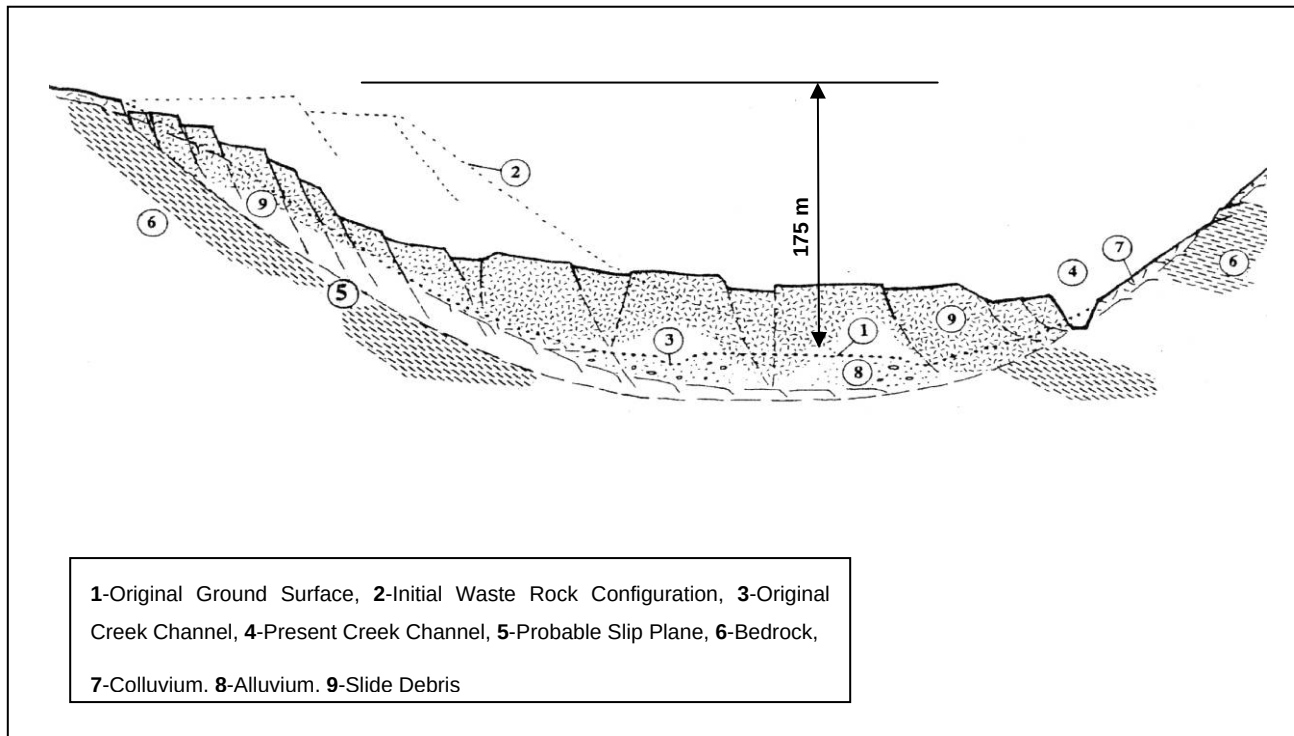
**Figure 19 Channel Cross Section After Waste Rock Slide (View Upstream)**  
(Reference: Stepanek & McAlpine, 1992)

As illustrated in Figure 19, a new creek channel was subsequently formed along the interface between the landslide material and north valley slope, some 25 m above the original valley bottom at the Hudgeon Lake outlet. Within the area now occupied by the waste rock dump, the creek channel was approximately 700 m long with a gradient ranging from about 3 to 6 percent compared to its natural gradient of approximately 0.08

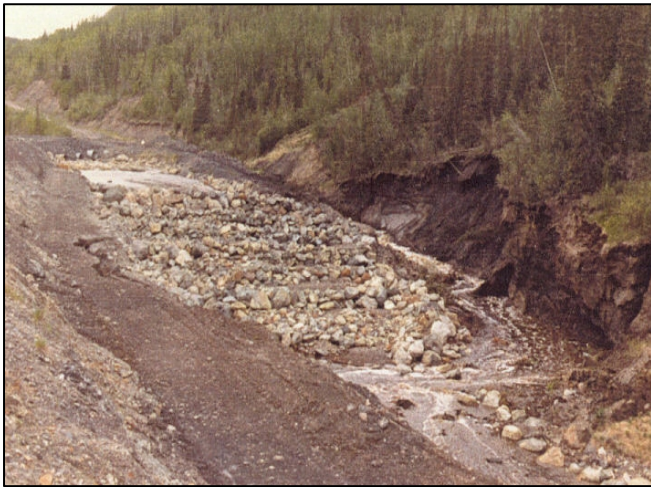
percent. The original channel erosion protection measures constructed just downstream of the Hudgeon Lake outlet in 1981 included a series of small rock weirs, which were by-passed in the spring of 1982 (Figure 22). The erosion control works, which were constructed using large boulders recovered from the open pits, have proven to be largely unsuccessful and by 1984 had been re-constructed twice. The erosion control works re-constructed in 1984 (Figure 23) were by-passed in a significant flood event in the spring of 1997 (Figure 24). Approximately 3 m of channel erosion (i.e. down-cutting) occurred immediately downstream of the outlet between 1986 and 1999. Farther downstream, less down-cutting was evident, where the creek channel had cut into the bedrock.

**Figure 22 Hudgeon Lake Outlet (1982)**

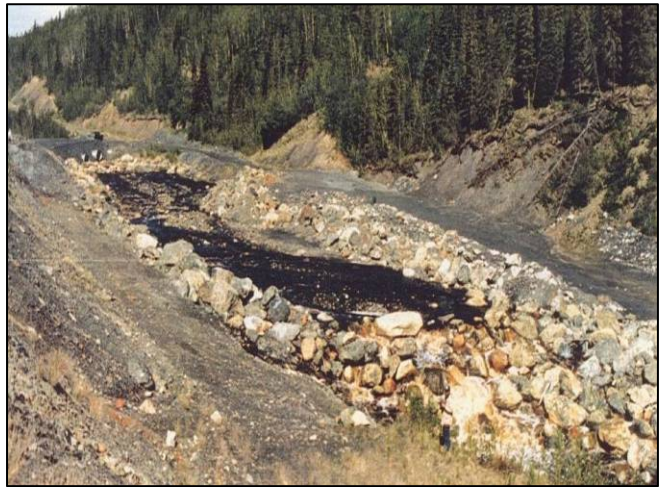
**Figure 23 Hudgeon Lake Outlet (1986)**

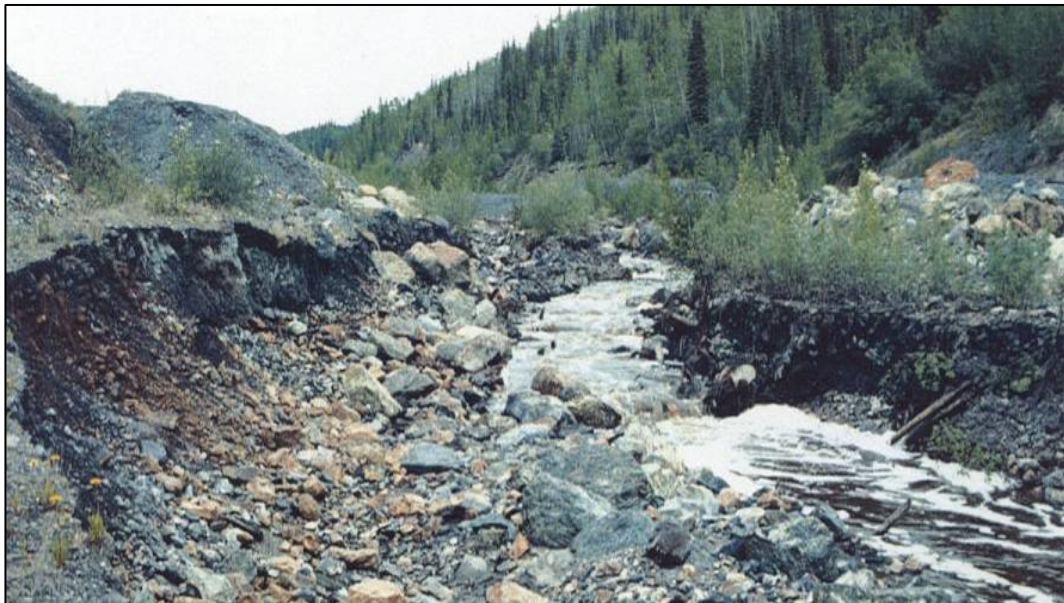
**Figure 24 Hudgeon Lake Outlet (1997)**

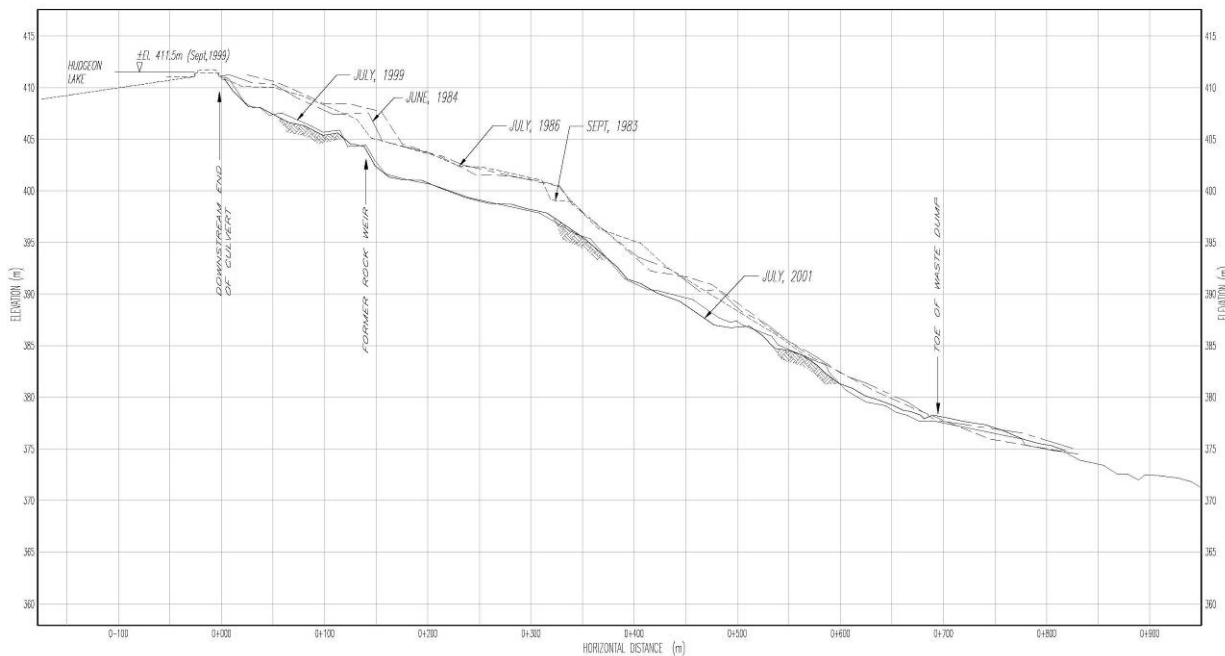
Progressive erosion (i.e. down-cutting) of the Clinton Creek channel immediately downstream of and towards the Hudgeon Lake outlet increased the likelihood of the development of a full breach of the landslide dam. Figure 25 shows the channel bottom in 1986 and 1999 after the 1997 flood event when the erosion control works were effectively destroyed. It was feared that the retrogressive incising would rapidly continue and a full breach at the lake outlet could be triggered. The breach was not considered susceptible to any particular precipitation event i.e. a relatively minor flow event could trigger the failure mechanism necessary to initiate a breach. It was estimated that a full breach of the waste rock blockage at the Hudgeon Lake outlet would result in significant downstream flooding and debris flows.

**Figure 25 Clinton Creek Channel Profile**

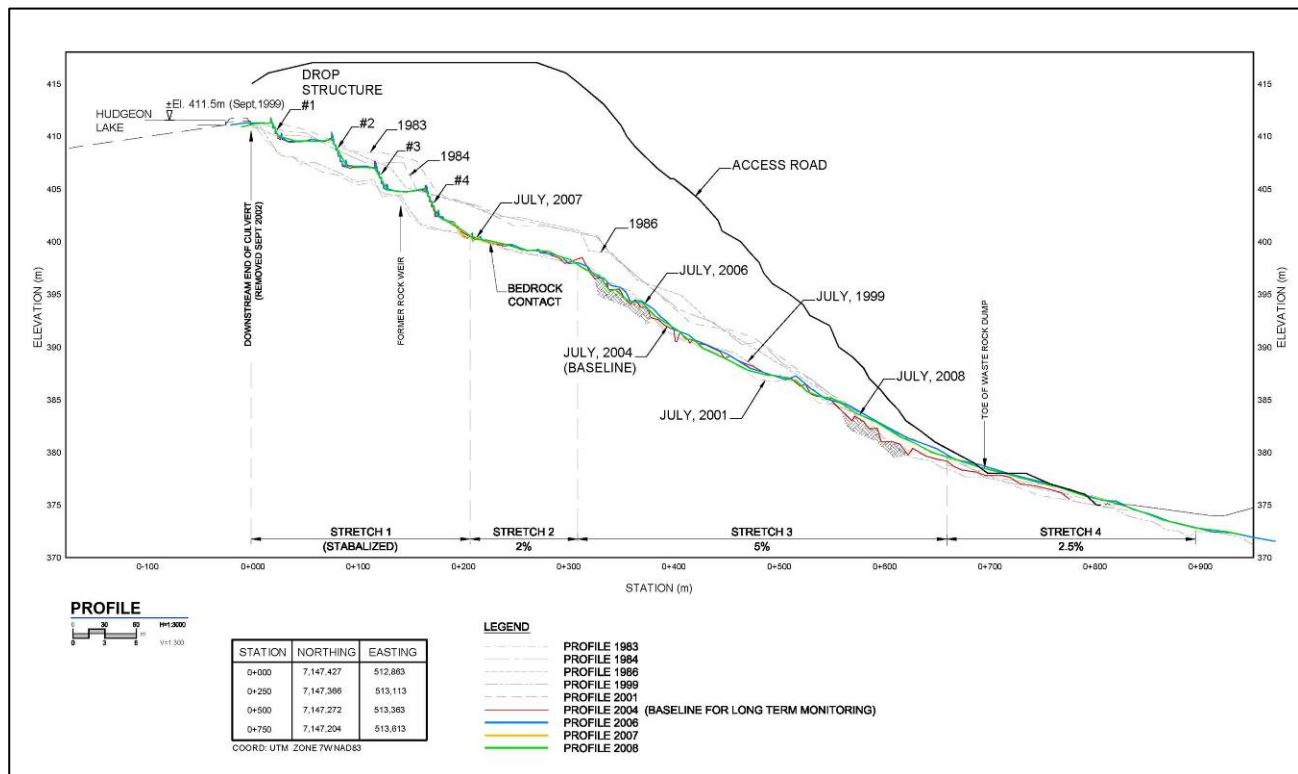
**Stretch 4 (Station 0+660 to 0+800):** This is the channel stretch at the downstream end of the waste rock dump where it transitions into the natural creek channel. It is relatively straight with an average grade of about 2.5%. There is no evidence of down-cutting, and in fact, deposition may be occurring along this stretch.

**Figure 27 Clinton Creek Channel Profile**

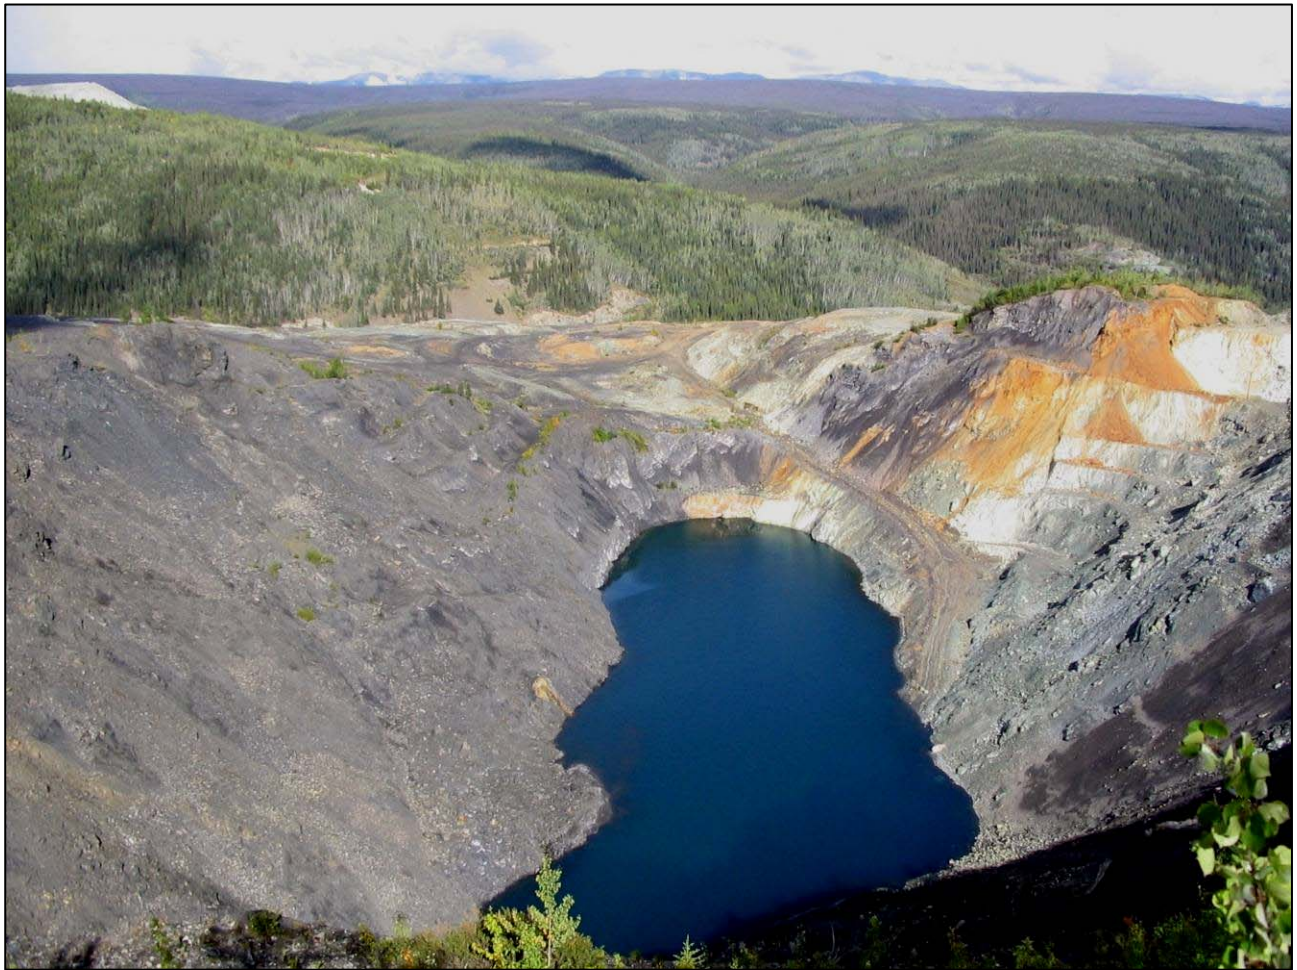
The physical condition of the open pits has not been evaluated as frequently as the waste rock dumps and tailings piles. The last physical inspection was carried out during the hazard assessment program completed in 2003 (UMA 2004). The most recent survey of a few existing pit wall monitors at the Porcupine Pit was completed in 2008 as part of the Long term Performance Monitoring program (AECOM 2009). Pit wall instabilities are evident at all three pits with visible tension cracking and slumping of large sections of ground around the pit perimeters (Figures 30, 31 and 32). In 2003, many of these instabilities and associated movements appeared recent and during the site reconnaissance, small active slides were observed in the northwest corner of the Porcupine Pit. All three pits have ponded water.

**Figure 30 Porcupine Pit in 2003 (view N)**

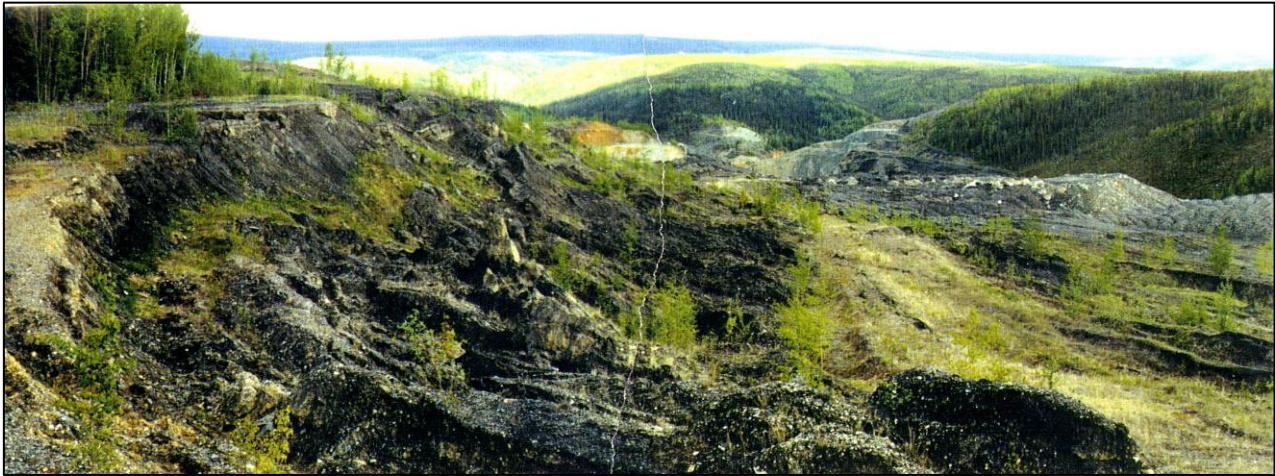
The southern area of the waste rock dump has undergone extensive movement at the crest and toe due to both the volume of waste rock and the method of placement. Dumping probably would have begun at or near the crest of the original valley slope but was only advanced across a portion of the valley. Instabilities of the waste rock pile heaved the valley floor several metres resulting in the primary impoundment seen today. Near the crest of the waste rock dump, movement has resulted in numerous tension cracks and slump blocks as shown on Figure 34 (Geo-Engineering, 1988).

**Figure 34 Upper Area of Waste Rock Dump (1988)**

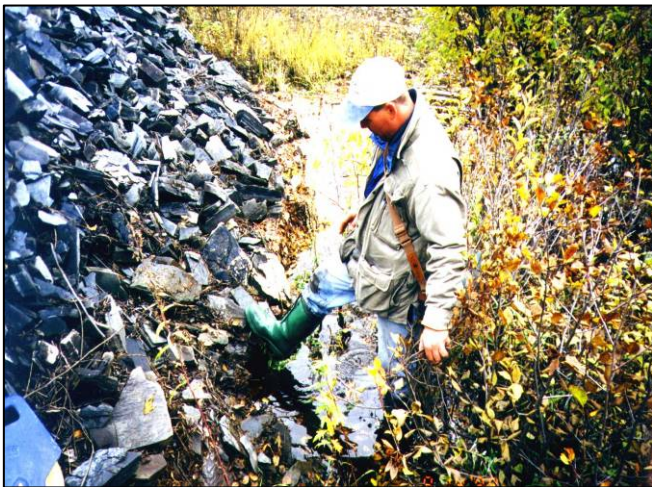
At present, considerable downslope movements are continuing in the upper portion of the waste rock dump. Impounded water upstream of the waste rock dump continues to flow either below or through the waste rock or along the east valley slope in subterranean channels. The majority of flow occurs via a drainage channel incised through the slide debris from the unstable southern portion of the waste rock where it enters the waste rock pile (Figure 35). Water draining through the dump has been observed to discharge through the waste rock about 5 m above the toe of the north slope, approximately 550 m to the north of the inlet. Localized slumping of the waste rock is evident at the discharge point as illustrated in Figure 36. Water is subsequently conveyed along a drainage channel incised along the south edge of the road where it eventually spills into the Creek Pit. Creek flow is also occurring via subterranean flow along the toe of the waste rock and east valley slope where flowing water is visible below the organic mat on the valley slope. Discharge from the subterranean flow system occurs as a small spring near the northwest corner of the waste rock dump.

**Figure 35 Creek Flow Entering Waste Rock (1998)**

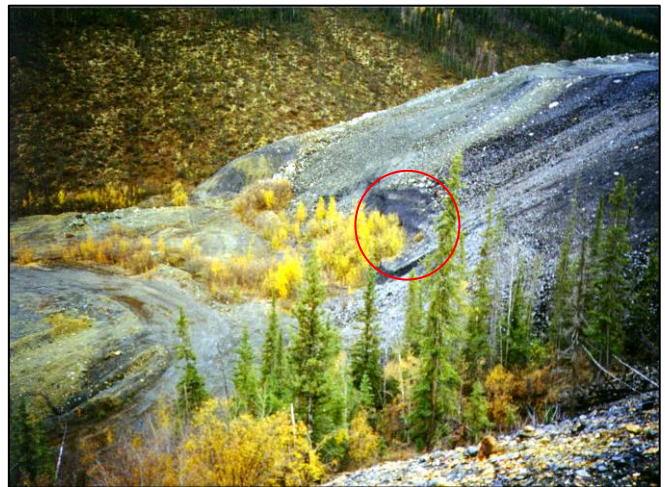
**Figure 36 Creek Flow Outlet in Waste Rock (1998)**

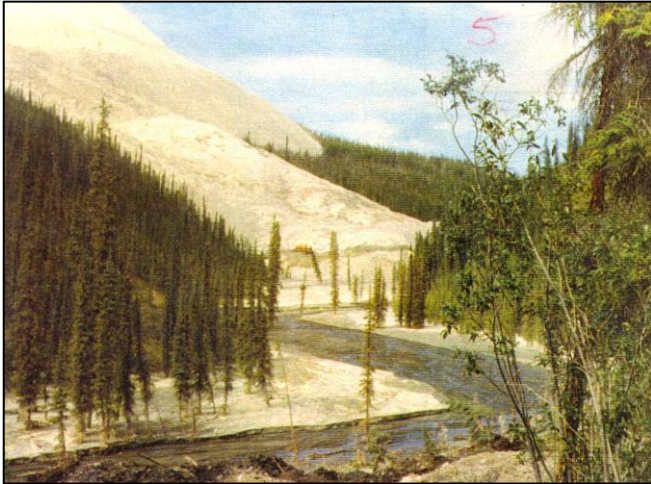
**Figure 37** Cr. Channel D/S of Breach (1974)

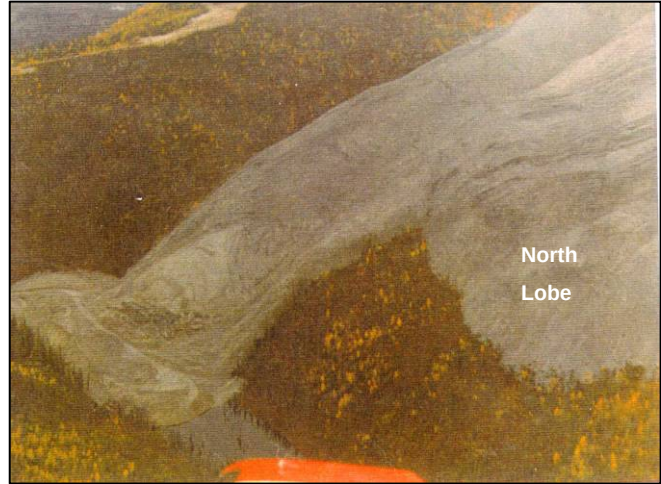
**Figure 38** Advancing N Lobe (1977)

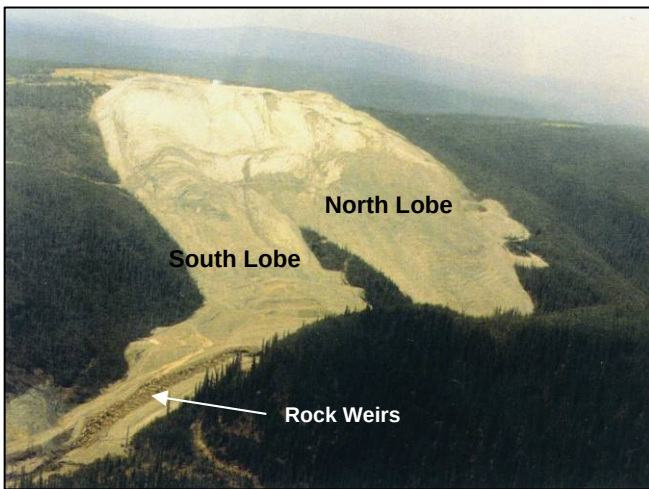
series of rock weirs was constructed immediately downstream of the south lobe in 1978 to prevent down-cutting of the channel over the tailings. The weirs are visible in Figure 39.

**Figure 39** Failed N & S Lobes (1986)

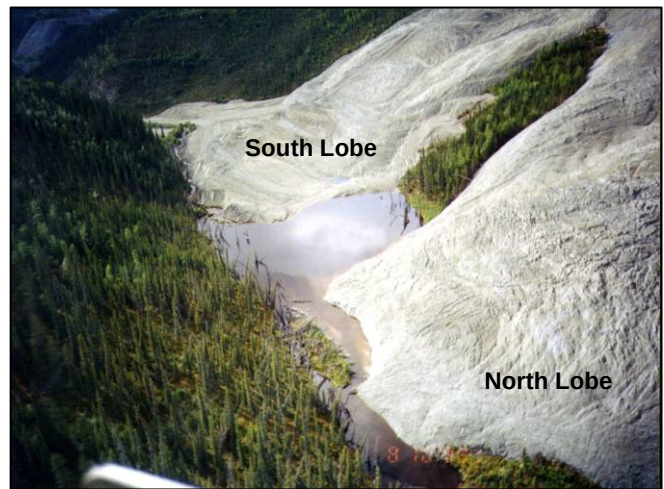
**Figure 40** Pond Between N & S Lobes (1998)

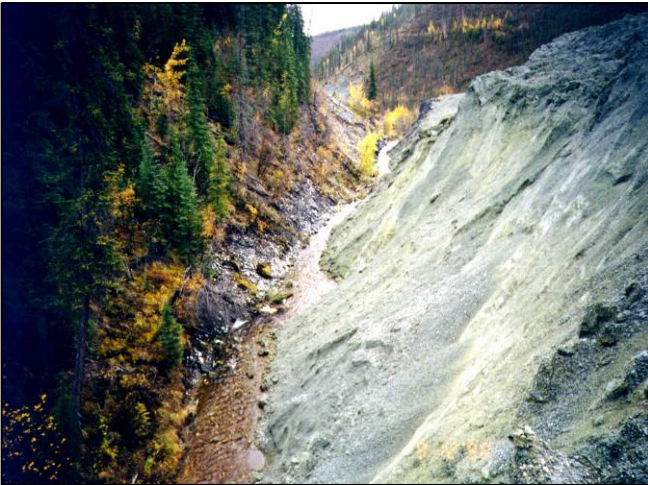
tailings has greatly reduced air-borne asbestos. Seeding trials on the tailings have not proved very successful, likely due to the poor growth medium (personal communication, R. Pugh). The rock lined portion of the channel downstream of the south lobe is currently in reasonably good condition.

**Figure 41 Toe of Tailings in 1998 (view D/S)**

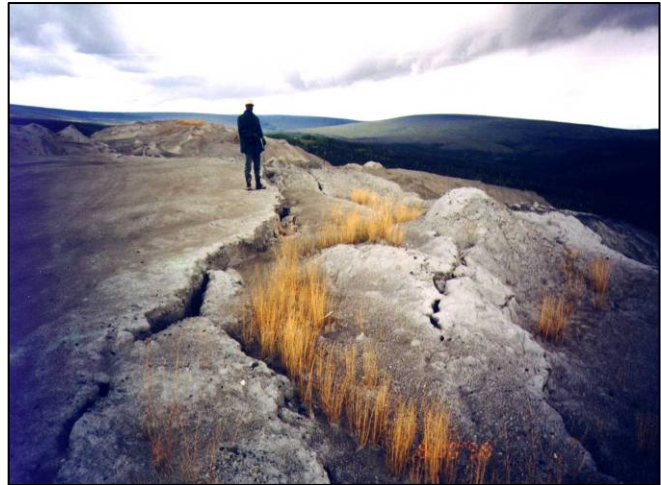
**Figure 42 Crest of S Lobe (1998)**

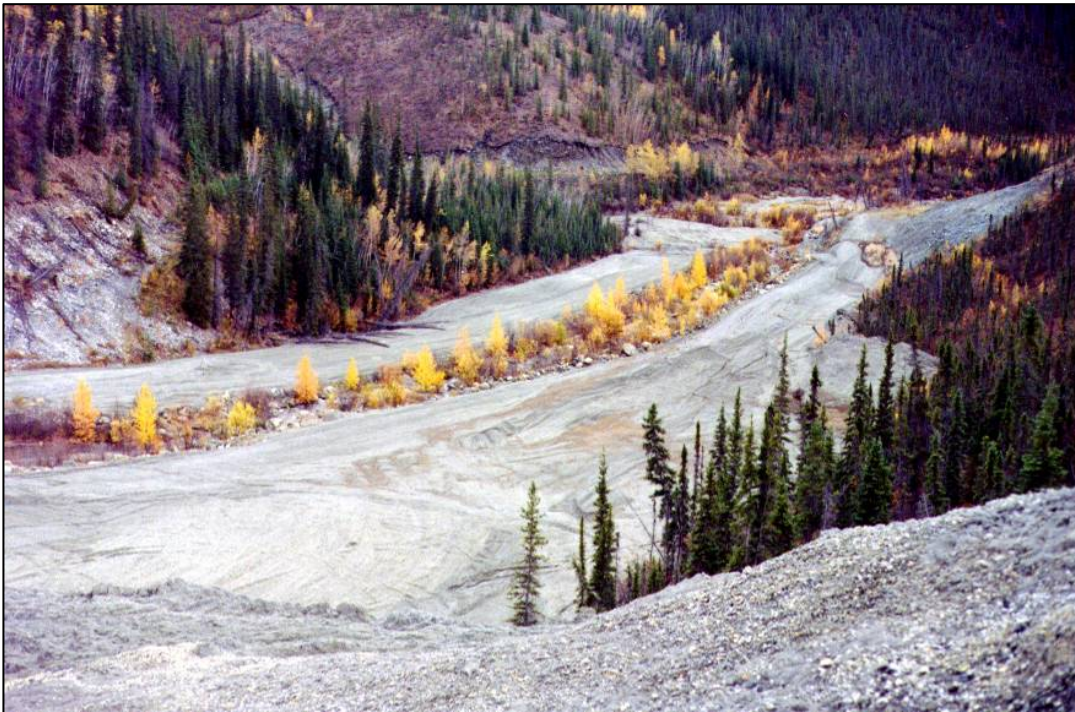
The tailings on either side of the channel would be graded smoothly towards the rock-lined channel and any existing gullies filled with tailings. Run-off water could be slowed down by placing small check dams made of rocks across the tailings in a 'V' pattern pointing down slope. The presence of vegetation along the rock lined portion of the channel suggests that it may be possible to establish vegetation in the tailings adjacent to the rock-lined channel if moisture can be preserved to support plant growth (Figure 43). Since the establishment of vegetation would help to provide long-term stabilization of the tailings, growth could be encouraged by spreading organic matter such as wood chips, mulch or coniferous trees over the tailings in this area. Rehabilitation of the channel outlet at the confluence with Clinton Creek should also be considered to prevent future overtopping and potential washout of the mine access road and erosion at the downstream end of the culverts.

**Figure 43 Vegetation Along Rock-Lined Channel (1998)**
