Government of Yukon

Former Clinton Creek Mine Emergency Drop Structure Repairs Construction Activity Report - 2009

AECOM

May, 2010

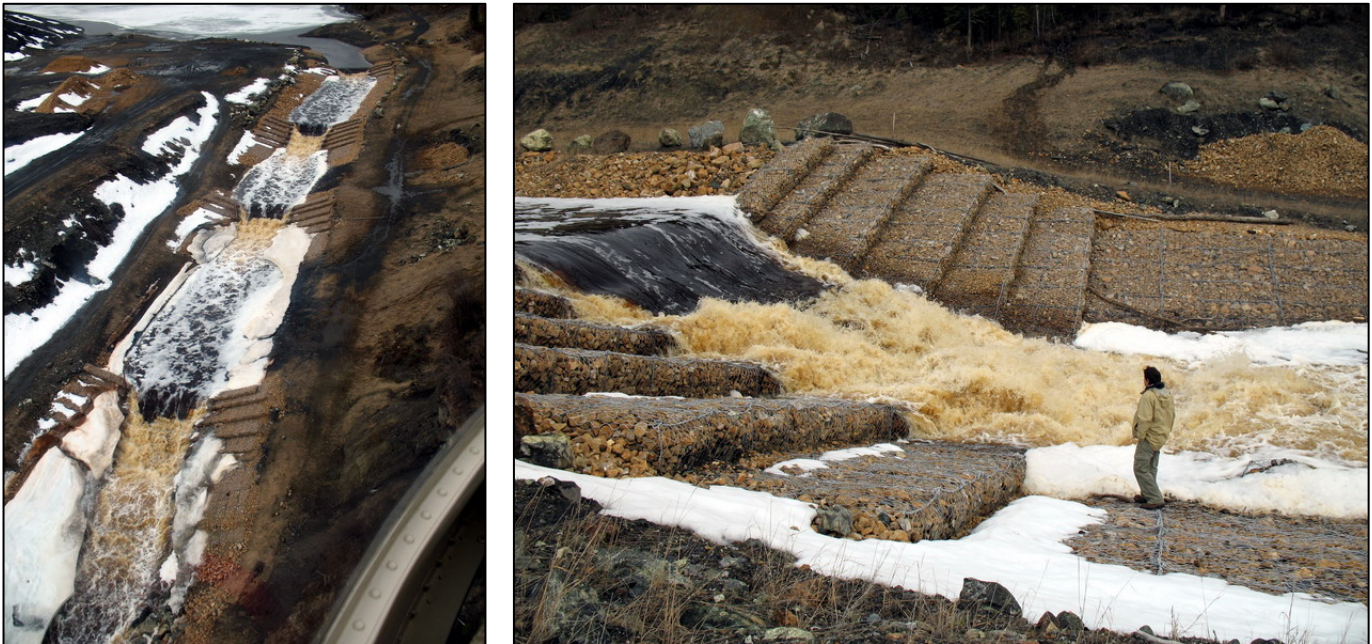
Figure 2: Gabion Drop Structures in May 2009 (DS#2 on Right Hand Side of Photo)

Overall, the damage to the gabion drop structures was more severe on the north side of the structures with the most significant damage occurring at Drop Structure #4 (DS #4). Less damage occurred at DS #2 and relatively minor damage occurred at DS #1 and DS #3. Photographs taken in May 2009 during the spring freshet suggest that the lower parts of the channel, which are shaded from direct sunlight due to the height of the waste rock pile to the south, may have been constricted by snow and ice build-up (Figure 02). The effect of the shading of the south side of the channel can be seen in the aerial photograph taken by the Department of Fisheries and Oceans in March 2008 (Figure 03). On Figure 02, erosion channels in the snow pack are visible on the south side of the channel at DS #3 and DS #4 indicating that the channel was not fully open at some point during the spring freshet and some water may have flowed around the snow and ice. This scenario is supported by reports that the spring thaw in 2009 was delayed by unseasonably cold temperatures followed by a rapid rise in temperatures and prolonged rainfall. A potential consequence of concentrated flow on the north side of the channel would be a higher unit discharge (per metre width of channel) than the drop structures were designed for, in particular at DS #4 which is in the shadow of the waste rock dump (Figure 02).

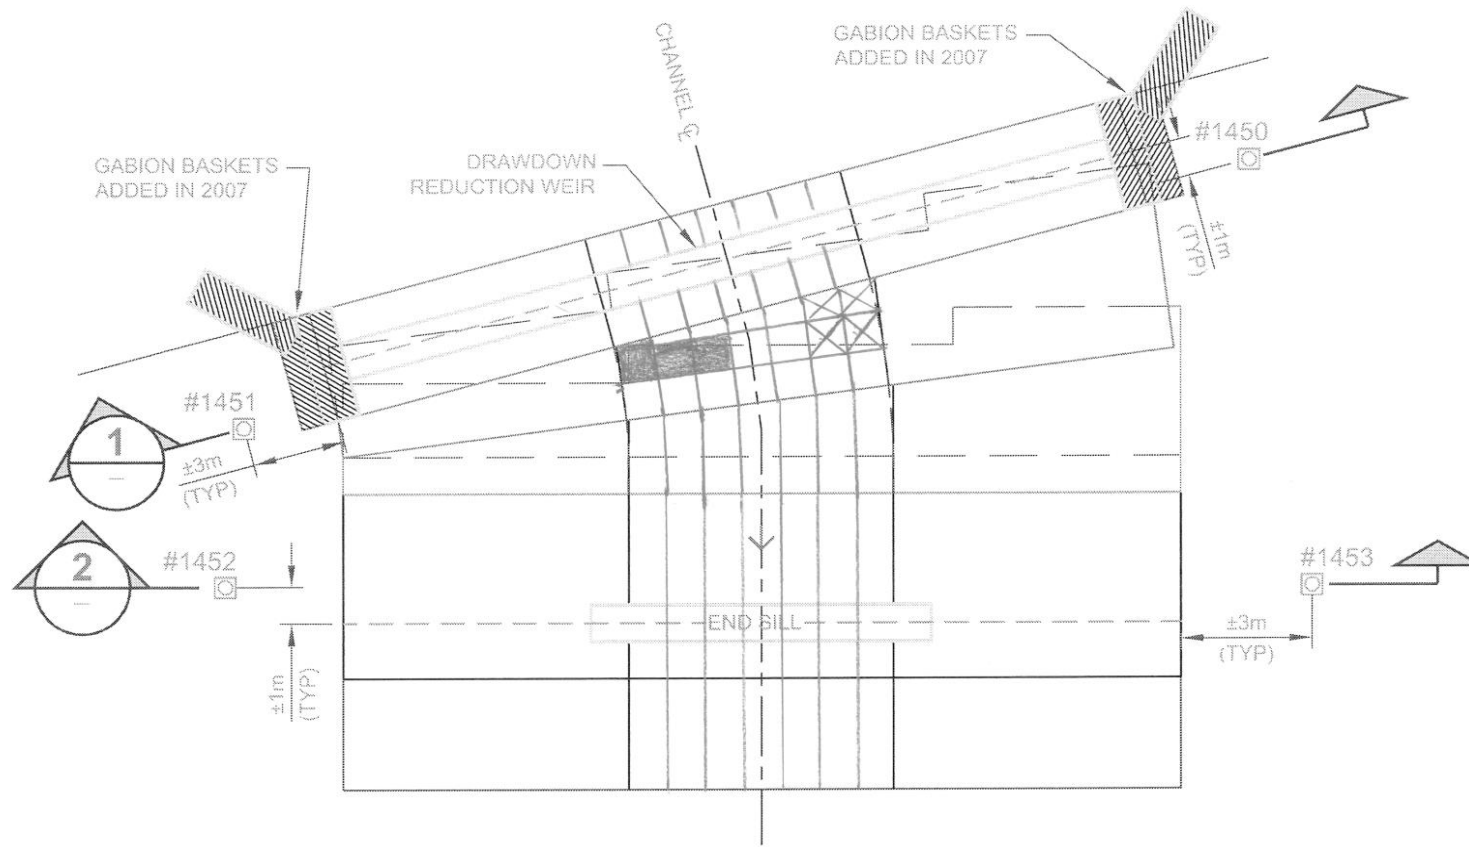
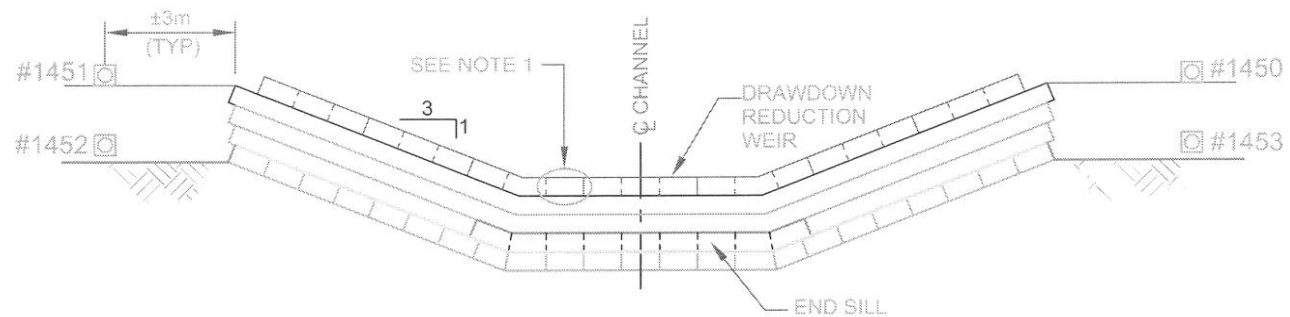
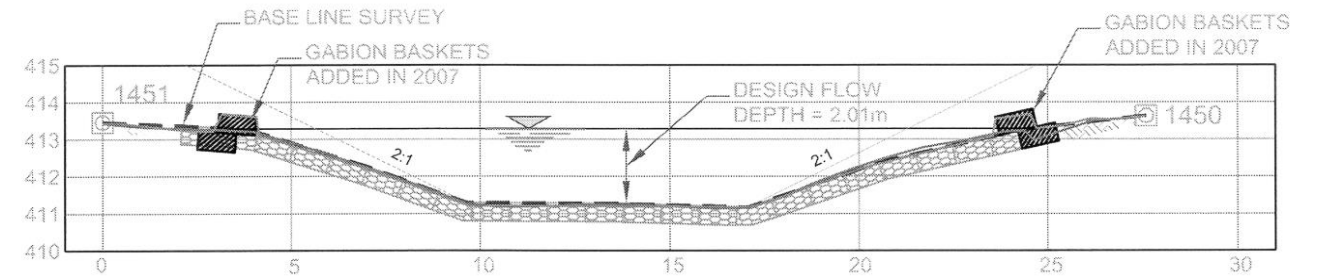
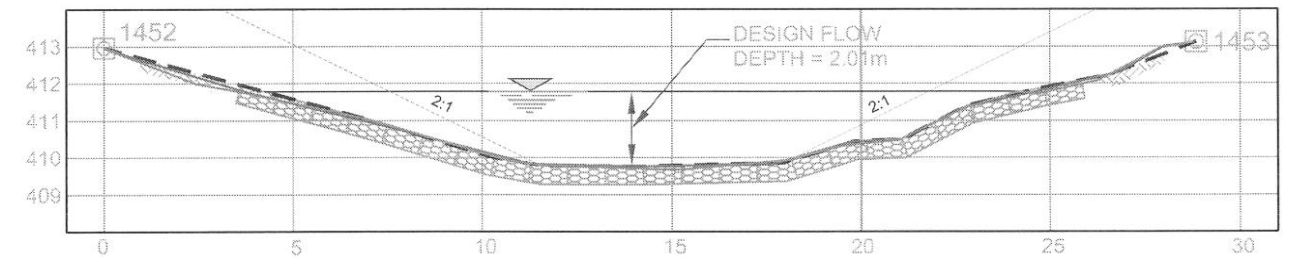
Drop Structure #1 is a 1.5 m high 3-step structure. The rock fill was lost from the two downstream gabion basket compartments on the gabion on the left side of the floor of Step 2 up from the basin floor. Several gabions, especially downstream of the low flow notch in the upstream weir, had lost a part of the rock fill through the gabion mesh openings leaving the gabions only partly filled. The floor jet sill was deformed but was generally intact and no channel bed erosion was detected downstream of the structure. The depth of flow at the downstream end of the apron was approximately 0.5 m at the time of inspection.

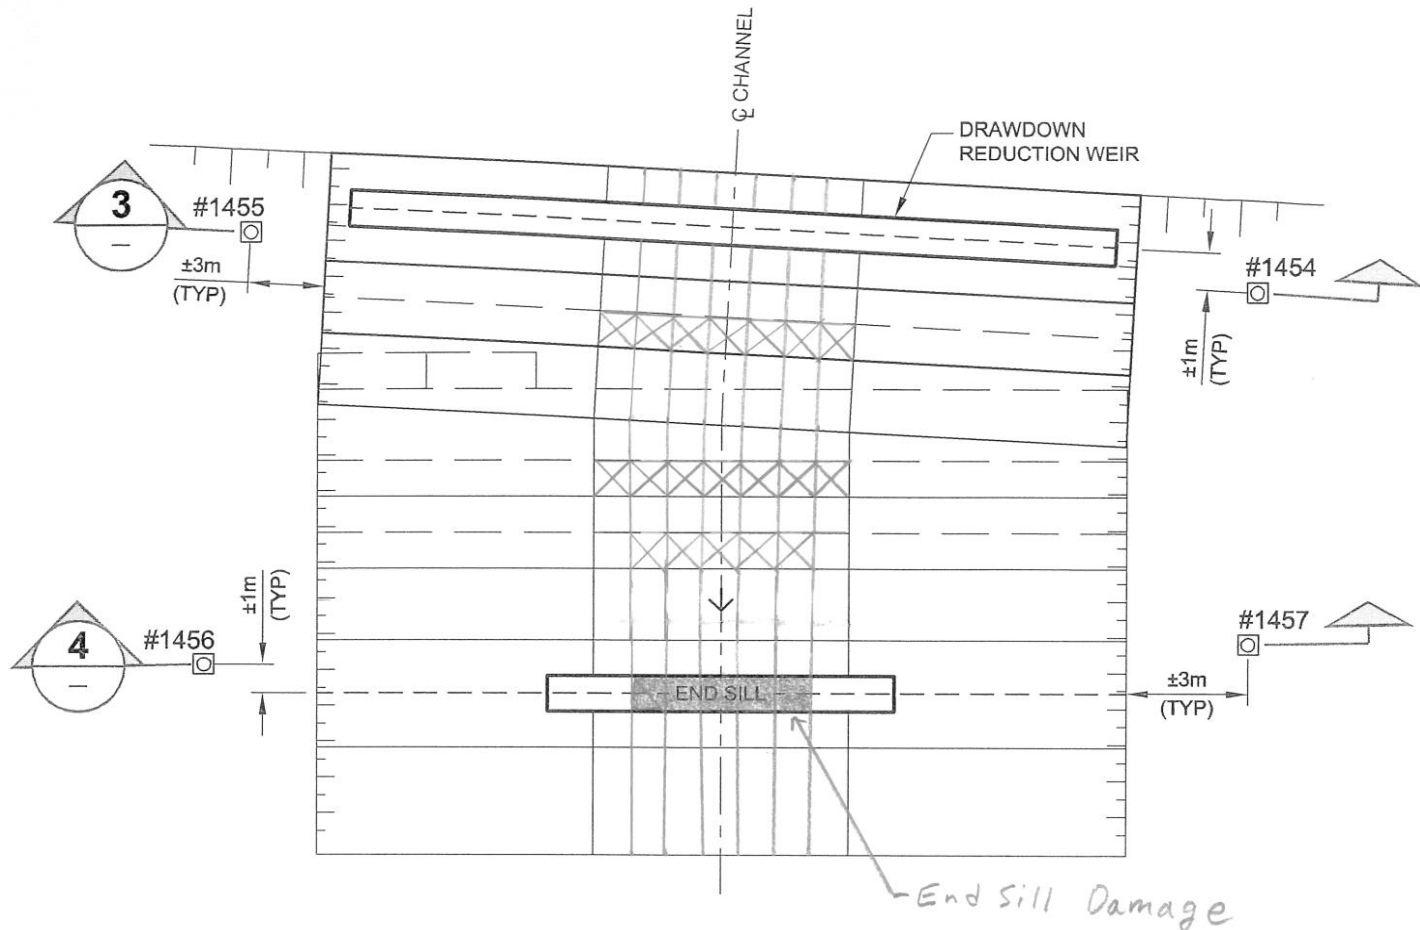
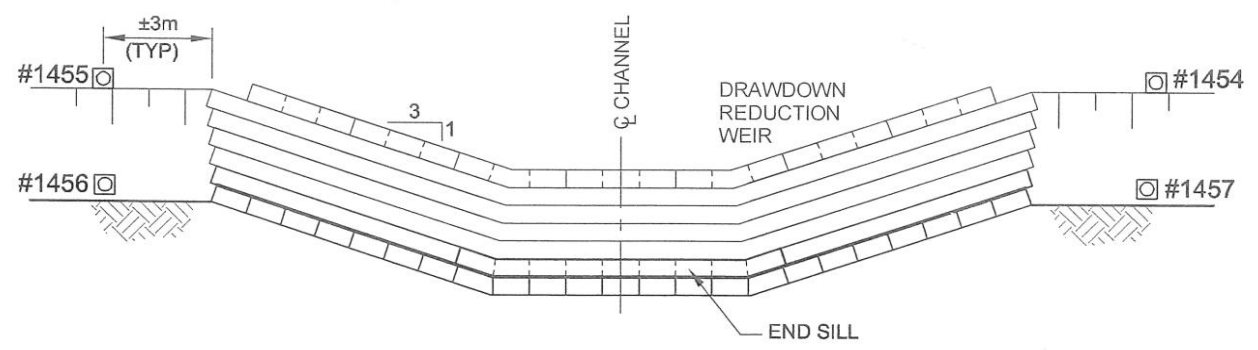
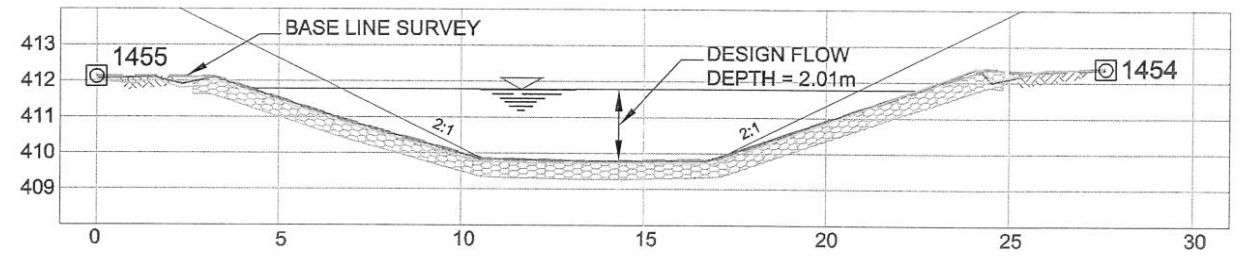
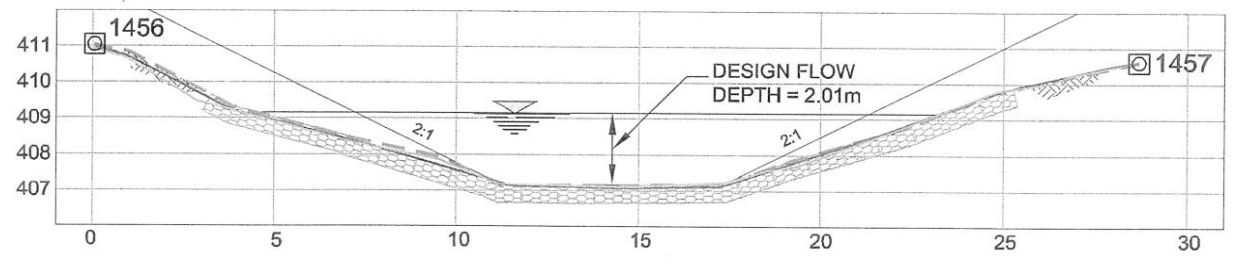
Drop Structure #2 is a 2.5 m high 5-step structure. Drop Structure #2 suffered damage to the gabions on Steps 2 and 4 from the apron and some damage to the gabions on Step 1. At Step 1, one of the gabions appeared to have lost its end wall and several gabions had lost parts of the gabion fill material through the gabion mesh. One gabion appeared to be on the verge of breaking open along the C-ring clamped edge and spilling the remainder of the gabion fill that was pushed against the downstream gabion end wall. On Step 2, the gabions on the left side of the floor were split open along the C-ring clamped downstream gabion edges and rock fill had discharged from the downstream compartments of the gabions. On the right side of the same step, one gabion edge was partly open. The second compartment of all floor gabions appeared to be partly filled. The gabions on Step 3 of the structure appeared to be intact but all floor gabions had lost part of the fill through the gabion mesh openings.

On Step 4 from the apron, all floor gabions except for the gabion farthest to the right had opened up along the downstream edges with loss of rock fill in the downstream gabion basket compartments. All of the downstream gabion end walls appeared to be in place. At the floor gabion farthest to the right, the gabion was partly open along the downstream edge and three C-rings were seen hanging from the lid edge. The 3.4 mm diameter edge wire in the lid was also broken. There were two elongated holes (approximately 0.25 x 0.60 m) with rounded upstream and downstream edges in the lid suggesting it may have been pierced by debris. Step 5 appeared to be in generally good condition. The floor jet impact sill on the apron was breached but no erosion was evident on the channel bed downstream of the structure.

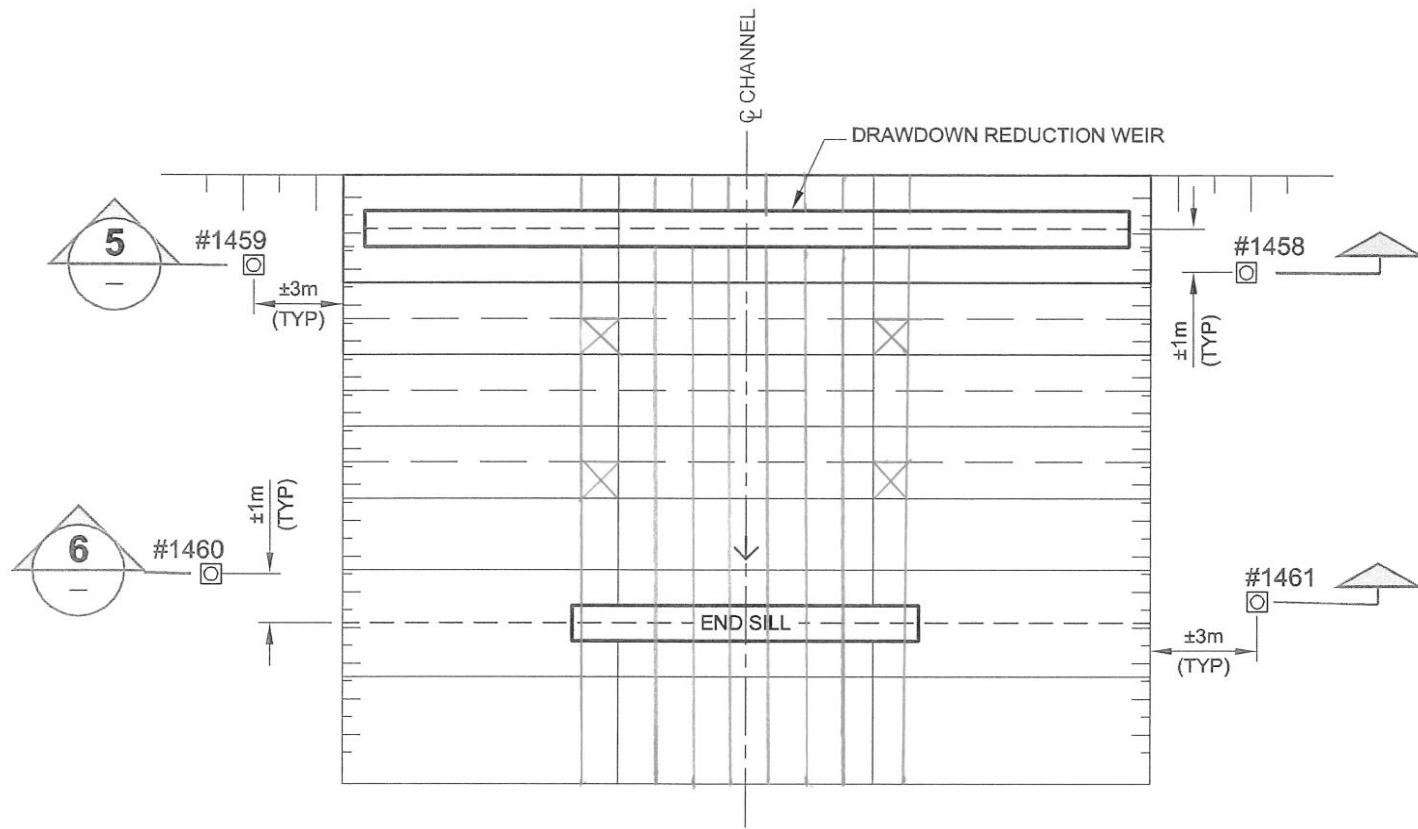
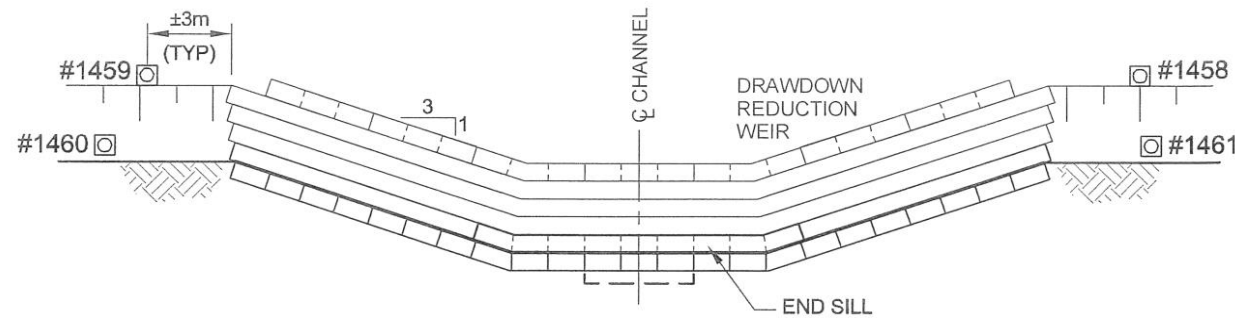
Government of Yukon
Former Clinton Creek Asbestos Mine
Long Term Performance Monitoring – 2008
Drop Structure #3

Drop Structure #3 is a 2.0 m high 4-step structure. The damage to Drop Structure #3 consisted of open gabion baskets on the floor of Step 3, total loss of gabion fill in the downstream compartments of the gabions at the toe of the side slopes on Step 3 and partial loss of gabion fill from several gabions on the floor and at the toe of the side slopes. The floor jet impact sill on the apron was deformed but still in place and no channel bed erosion was evident downstream of the structure. Deposition of gabion fill material extended from just inside the structure to approximately 2 m downstream of the structure.

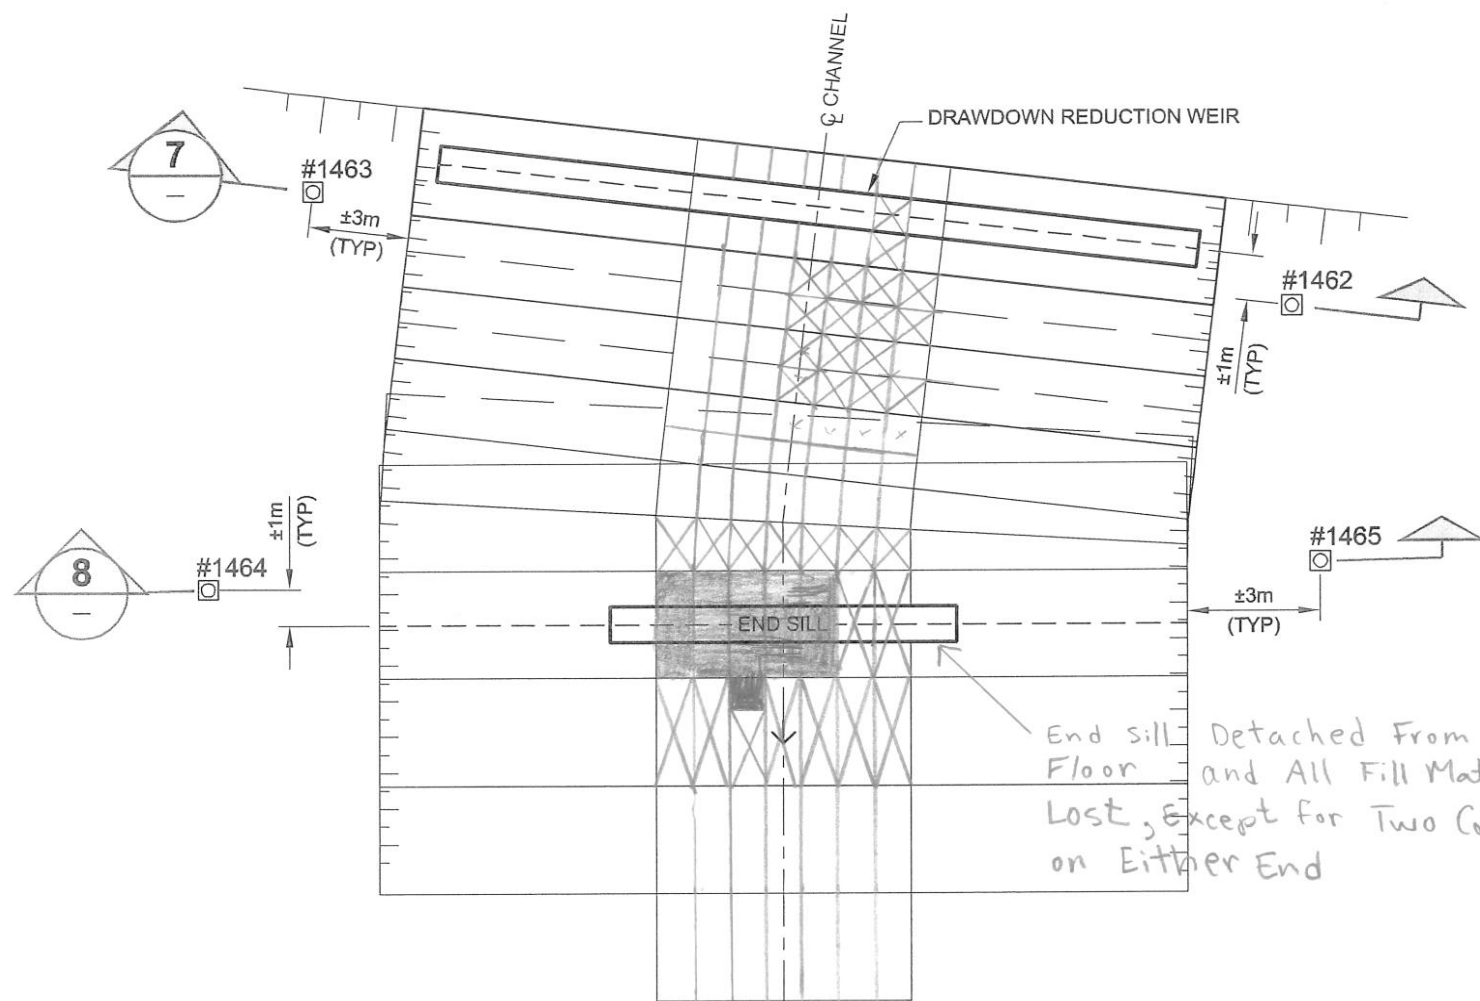
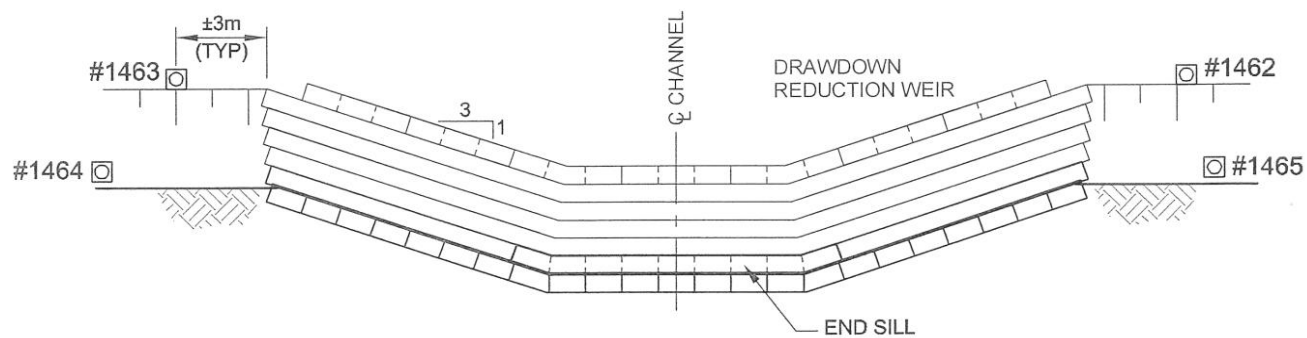
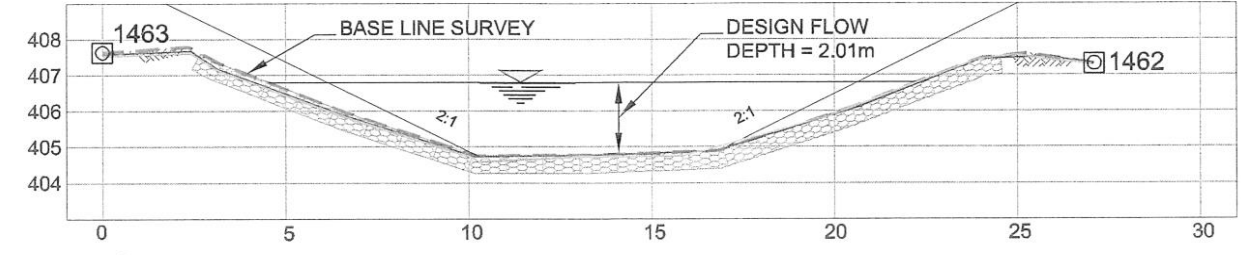
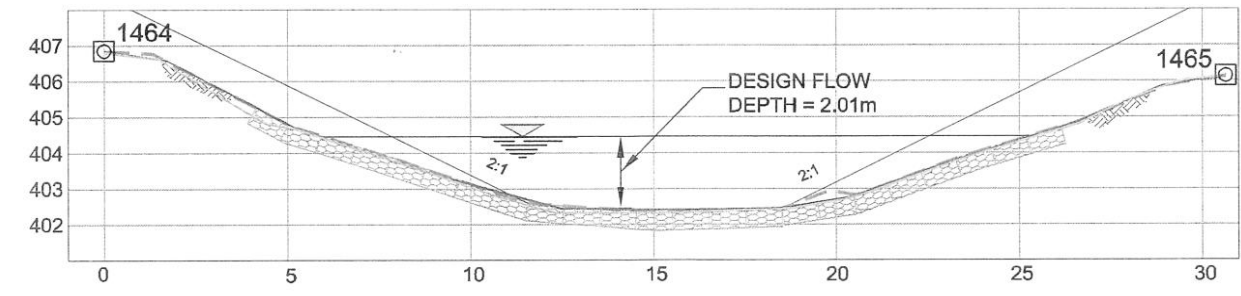
Drop Structure #4 is a 2.5 m high 5-step structure. Drop Structure #4 suffered significant damage during the 2009 spring runoff event but then primarily along the left (north) half of the structure. Along the right half of the structure, some gabion basket edges on the structure floor were opened with subsequent loss of gabion fill and some partial loss of fill material through the gabion mesh openings in other gabions on the structure floor.

Along the left half (four gabions wide) of the structure, all gabions on the structure floor had opened up and discharged the gabion fill in the two downstream compartments of the gabions on Steps 2, 3 and 4 from the apron. In addition, the fill in a large part of the apron floor had been lost. The gabions on Step 5 were generally intact and the weir across Step 5 was damaged in the left half of the structure.

The most significant damage to Drop Structure #4 was the damage to the apron floor. The lids, interior partitions and gabion fill had been lost, leaving a 5 m wide and 3 m long hole in the apron floor. The bottoms of the gabions were still in place over the geotextile that was placed below the structure during the construction. Two compartments at each end of the sill were still in place but the rest of the sill had been lost. The edges of the gabions on Step 1 were intact and the floor gabions had only suffered partial loss of fill through the gabion mesh openings.

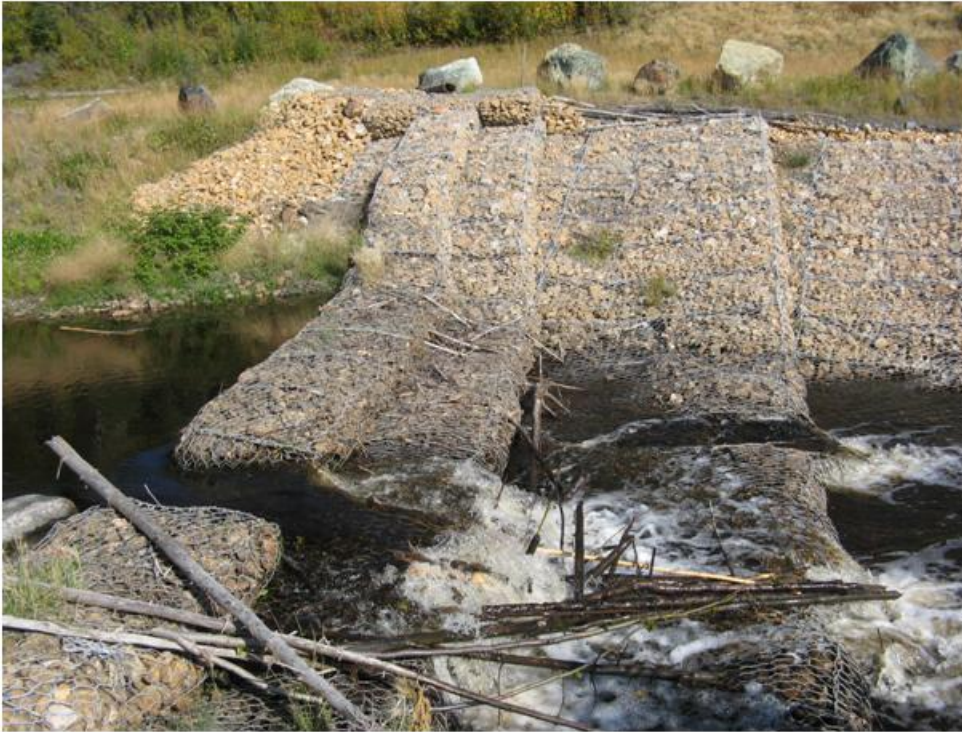
Photo 1: Drop Structure #1, looking to the left bank prior to construction. Debris has accumulated in the drop structure and one gabion compartment is open along the downstream top edge.

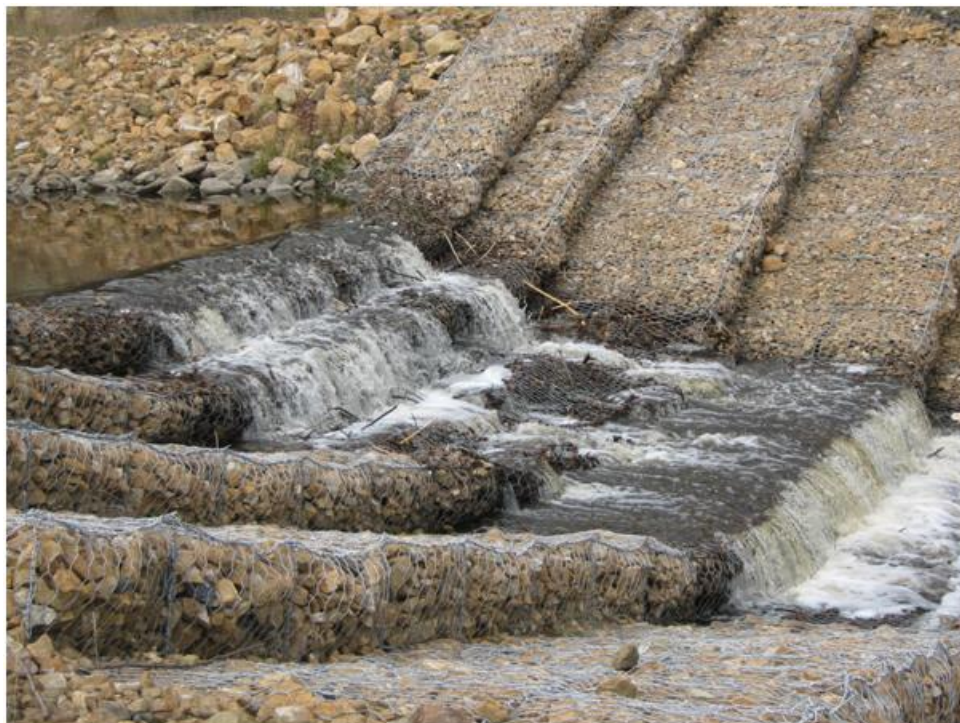
Photo 5: Drop Structure #2 prior to construction. Gabion compartments are open and partially full to empty.

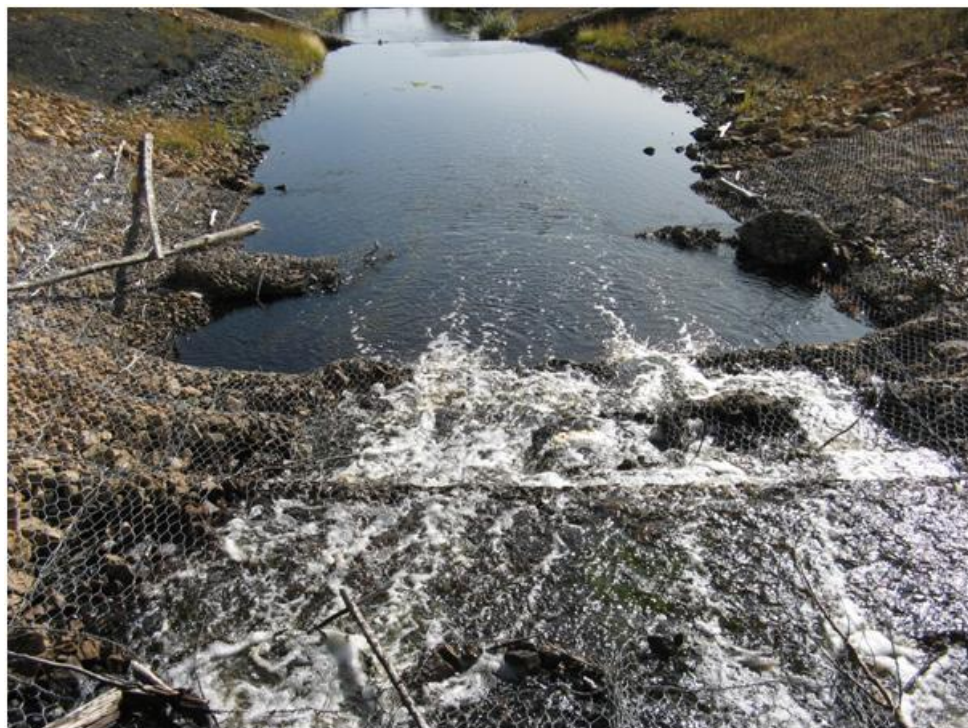
Photo 6: Drop Structure #2 prior to construction. Middle section of the downstream sill has been damaged.

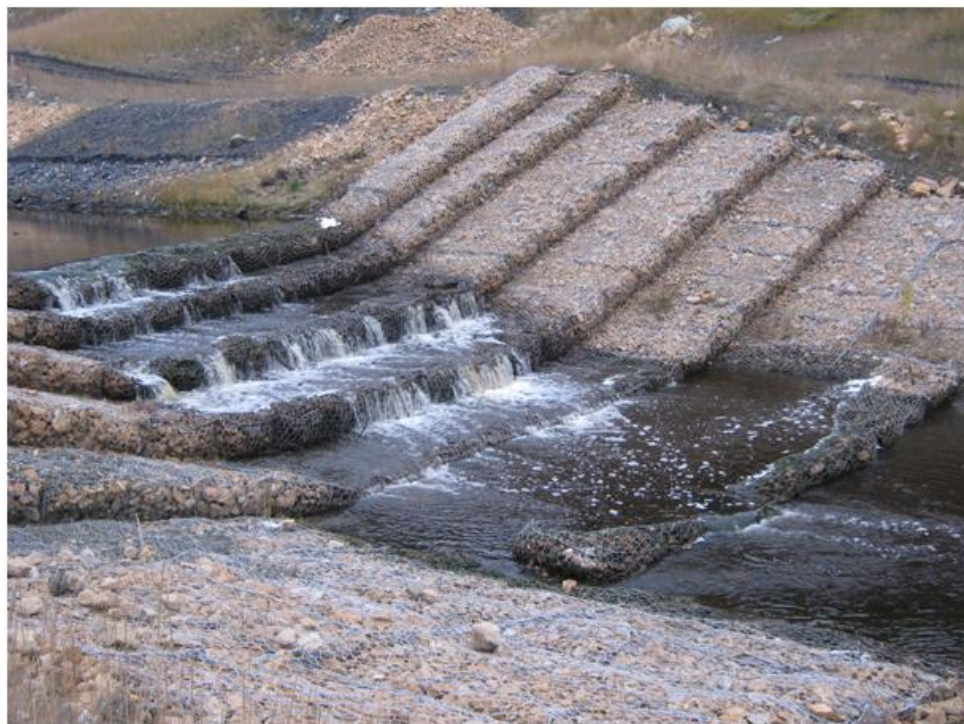
Photo 10: Drop Structure #3 prior to construction. A hole on the top of a gabion basket can be seen on the far back midway up the structure. Some basket repair and some gabion fill is required.

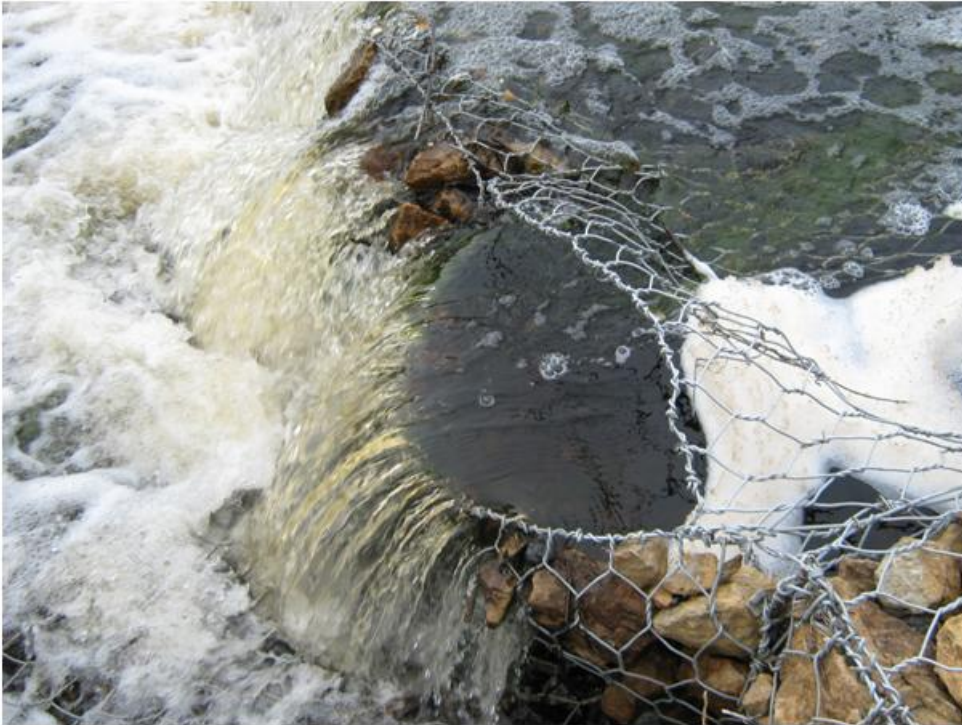
Photo 11: Drop Structure #3 prior to construction. The downstream top edge of a gabion basket as come open.

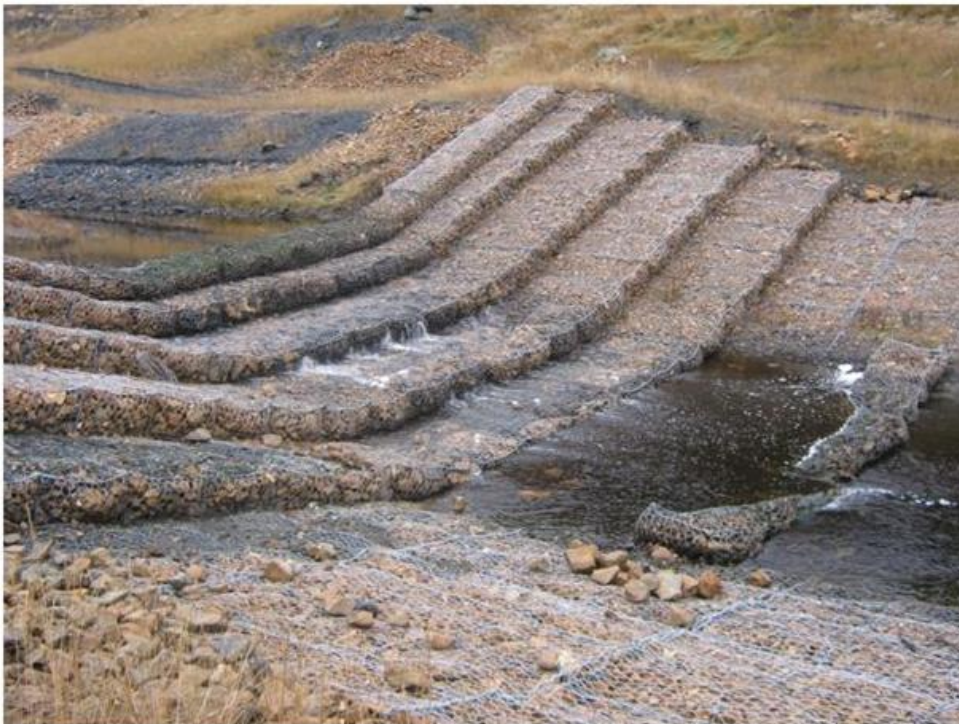
Photo 12: Drop Structure #3. All compartments have been filled with rock and closed. The end sill is deformed a little but is still intact and attached to the gabions below.

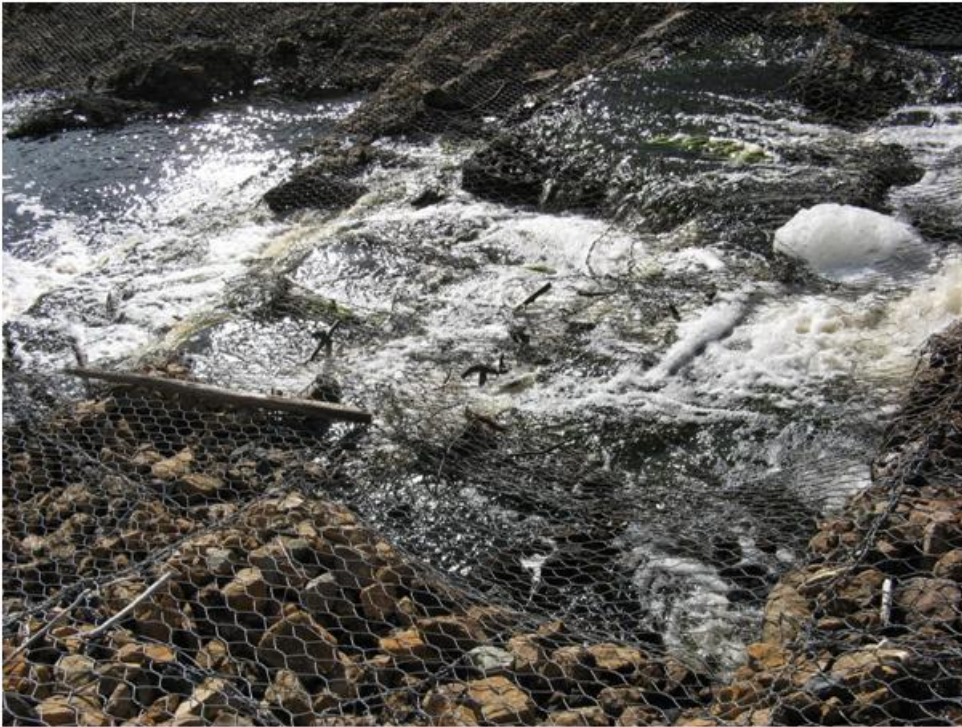
Photo 13: Drop Structure #4 prior to construction. Empty baskets along the bottom width.

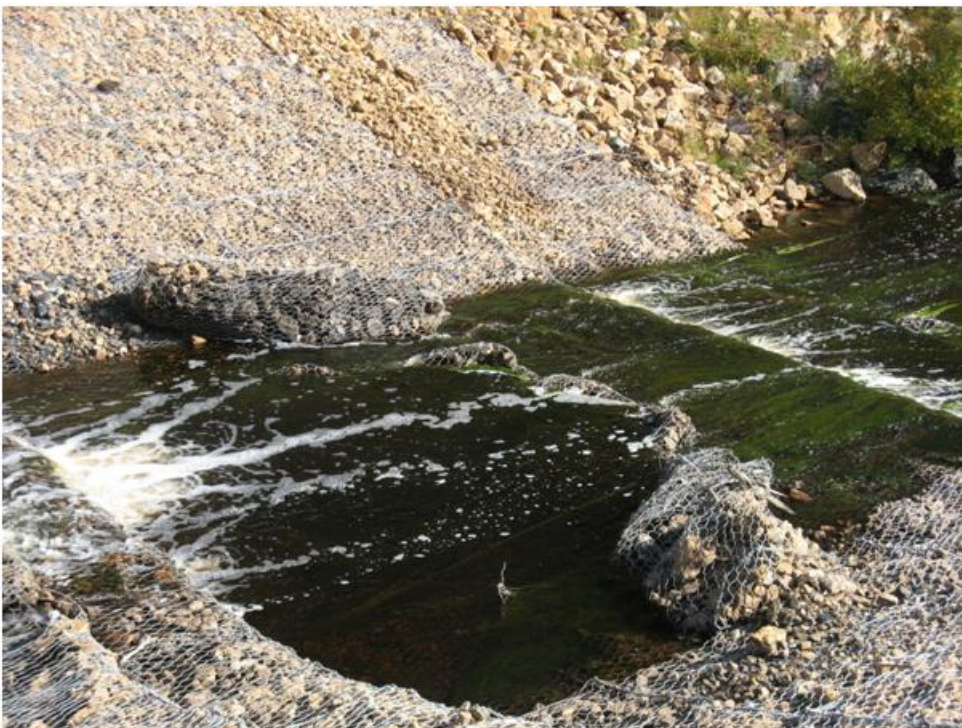
Photo 14: Drop Structure #4 prior to construction. The downstream sill has been damaged.

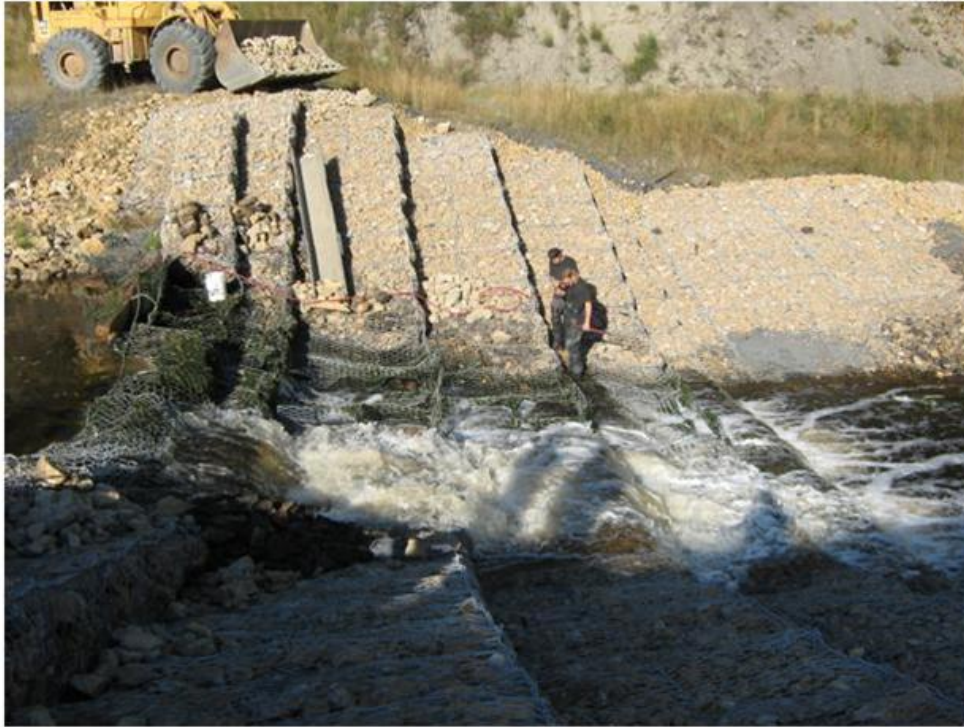
Photo 15: Drop Structure #4. Empty baskets within the structure.

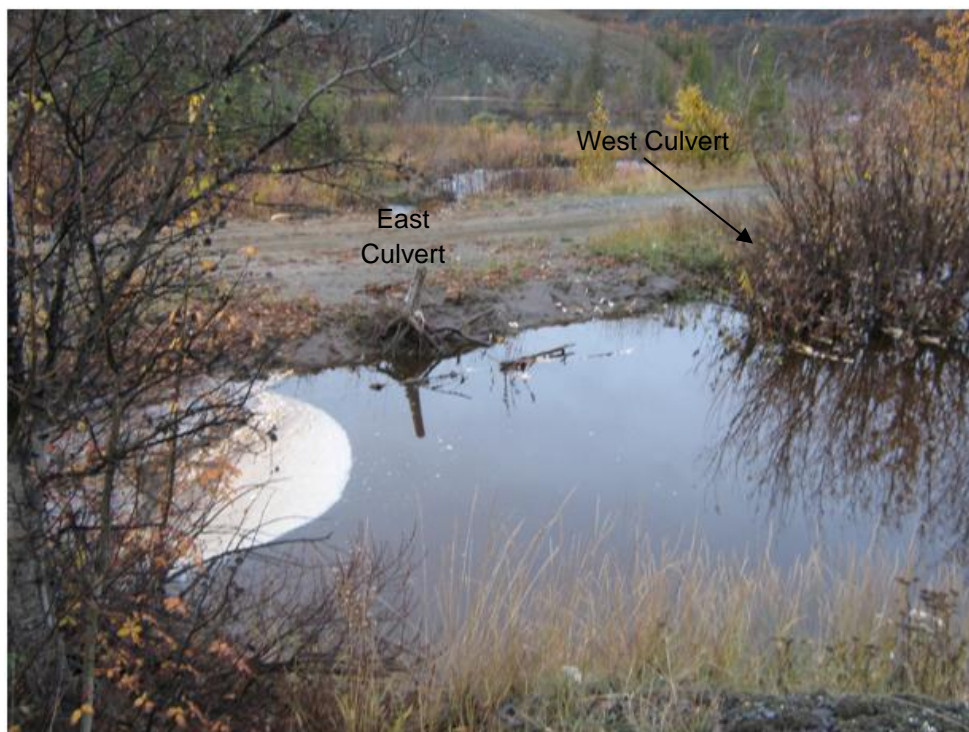
Photo 22: Wolverine Creek Road Crossing. Existing culvert inlets blocked by debris.
