Government of Yukon

# **Former Clinton Creek Mine Emergency Drop Structure Repairs Construction Activity Report - 2011**

AECOM

February, 2012

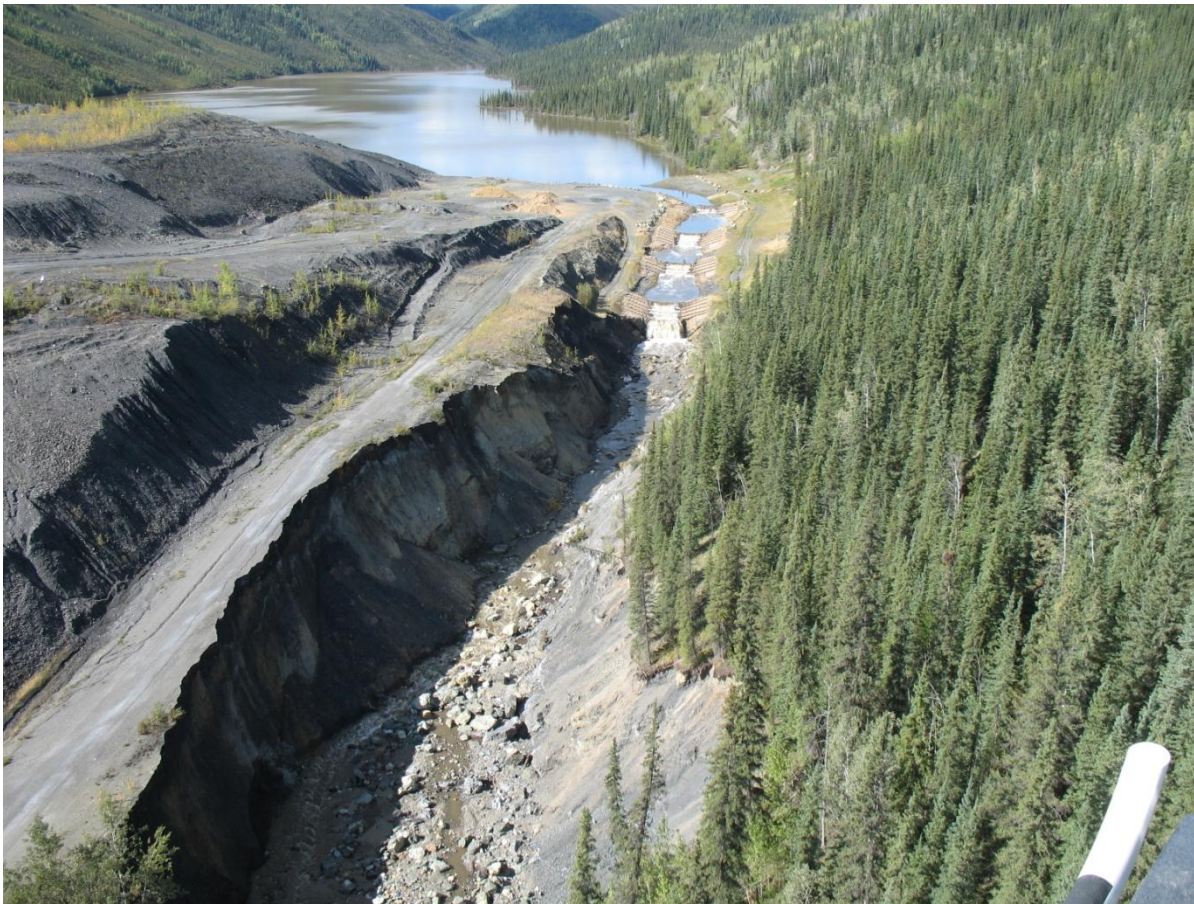
The most significant damage at the outlet had occurred at Drop Structure #4. Immediately downstream of the structure, the channel had downgraded 4 to 5 metres and undercut the structure's apron. The apron was hanging from the structure and appeared to be supported by the waste rock underneath closest to the original lowest step. A plunge pool had developed where water drops from the structure to the new bed elevation below. No significant damage at the other three drop structures was observed, though the higher flow in the channel made it difficult to assess each structure.

**Figure 2: Hudgeon Lake Outlet, August 19th, 2010**

The proposed solution was to create a ramp at the downstream end of Drop Structure #4, from the top of the hanging apron to the downstream bed. The ramp would consist of waste rock fill overlain by a 2 metre thick cap of boulders.

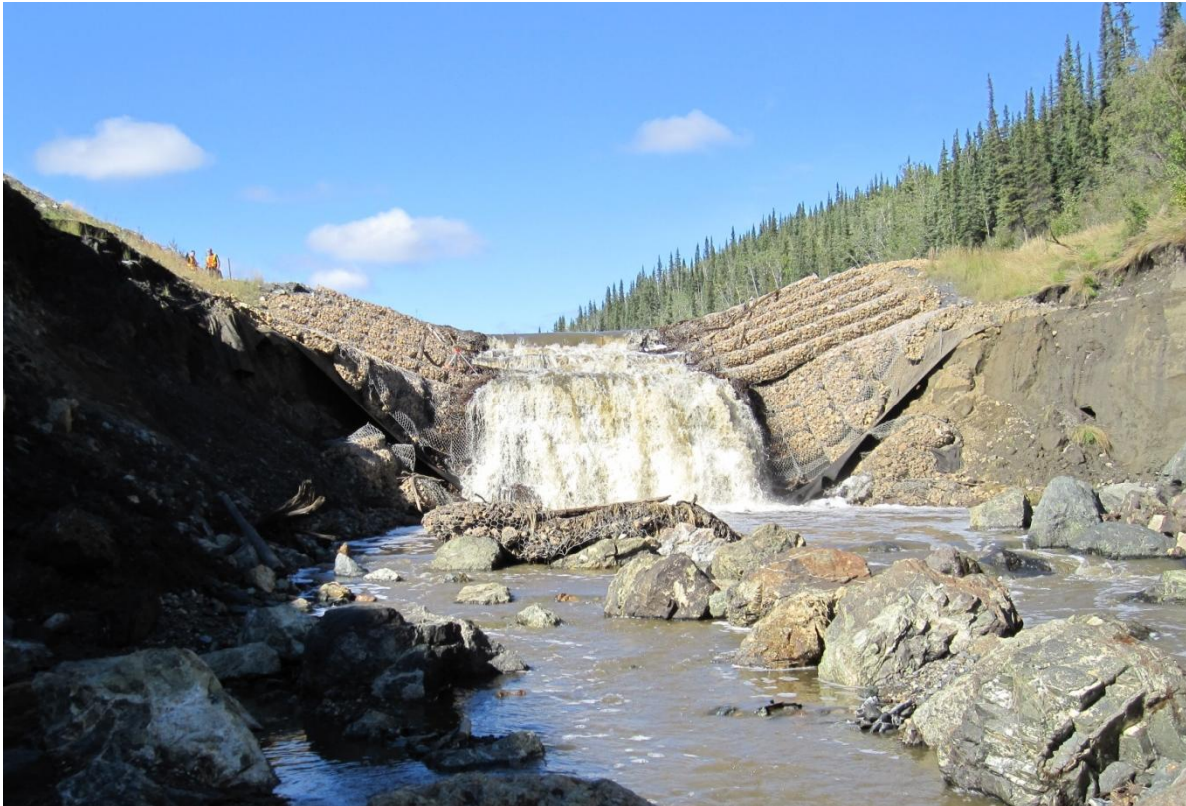
**Figure 3: Looking Upstream at Drop Structure #4, August 19th, 2010**

- No significant damage to the gabion steps was seen.
- Immediately downstream of the structure, the channel has degraded 4-5 m and undercut the structure apron. The undercutting extends to approximately 1-2 m downstream of the original lowest step. The material observed under the now hanging gabion apron appeared to consist of waste rock material that was surprisingly dry – minor seepage were observed in a few isolated spots. The 1-2 m of the apron closest to the original lowest step appeared to be supported by waste rock material.

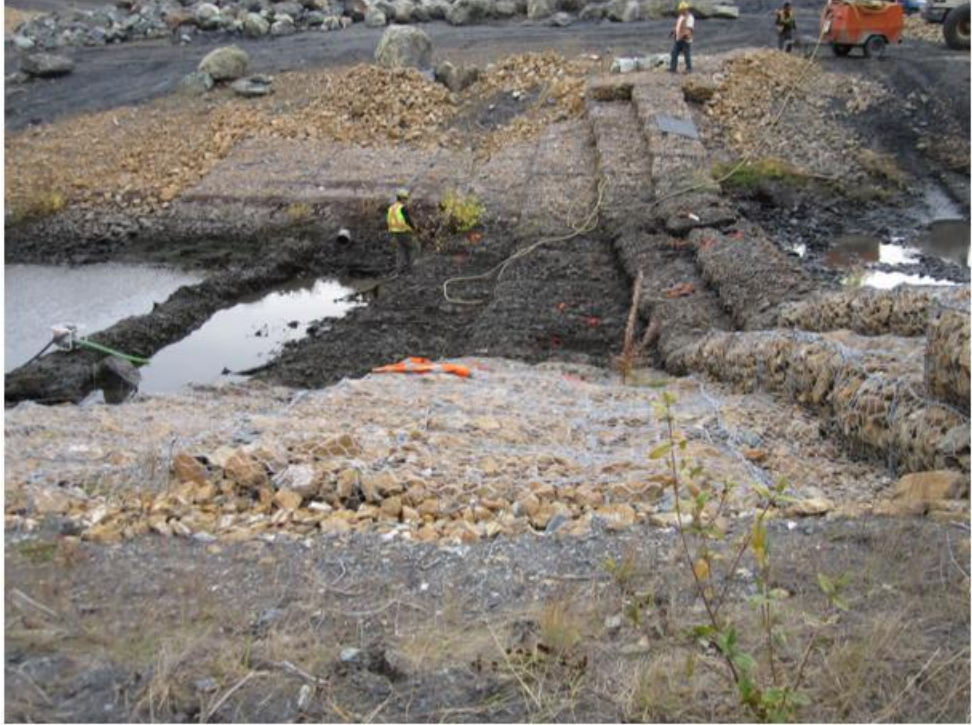
**Photo 1.** Drop Structure #1, looking to the right bank as construction begins. Minor Rock fill and repair to the gabion mesh at the drops and floor required.

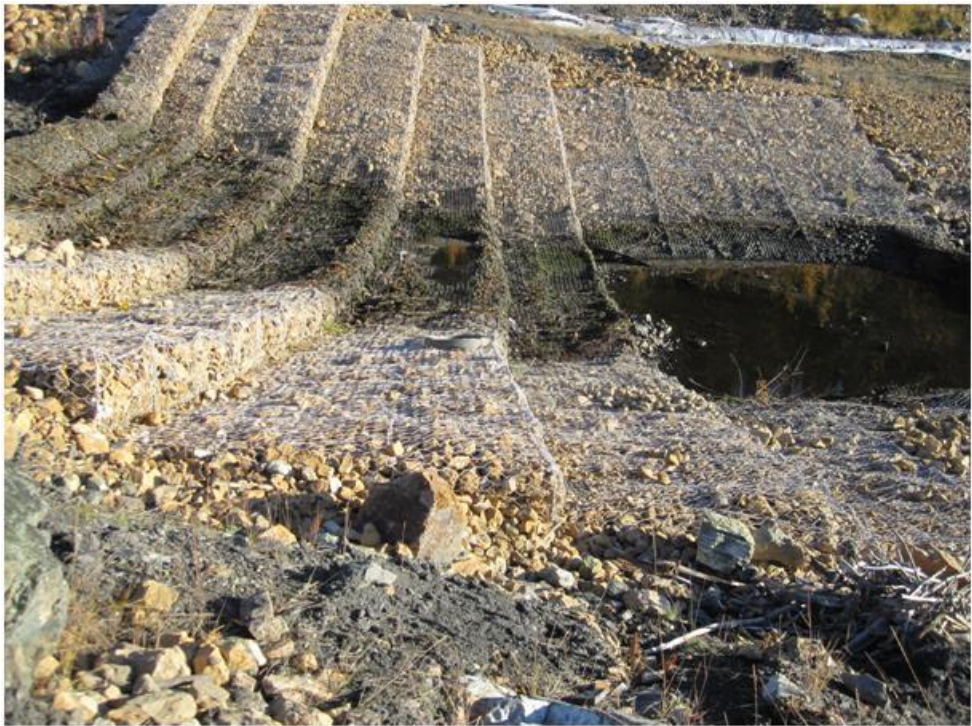
**Photo 2.** Drop Structure #2, looking to the left bank before construction. Gabions within the steps and at the floor require rock fill and patching of the wire mesh.

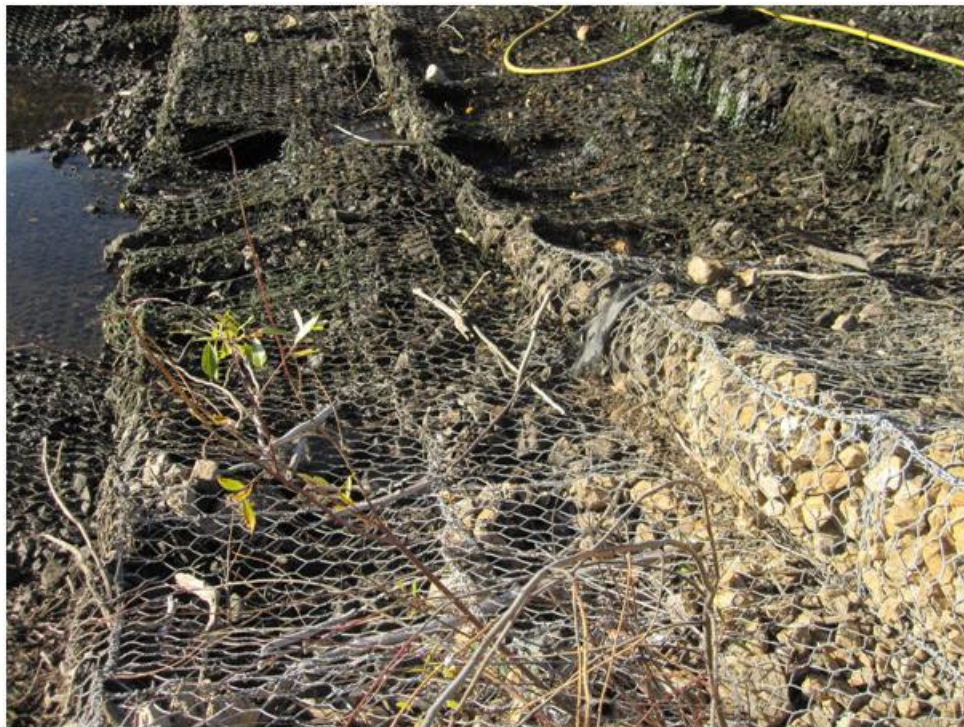
**Photo 3.** Drop Structure #3, looking to right bank. Partially empty compartments and damaged wire mesh prior to construction.

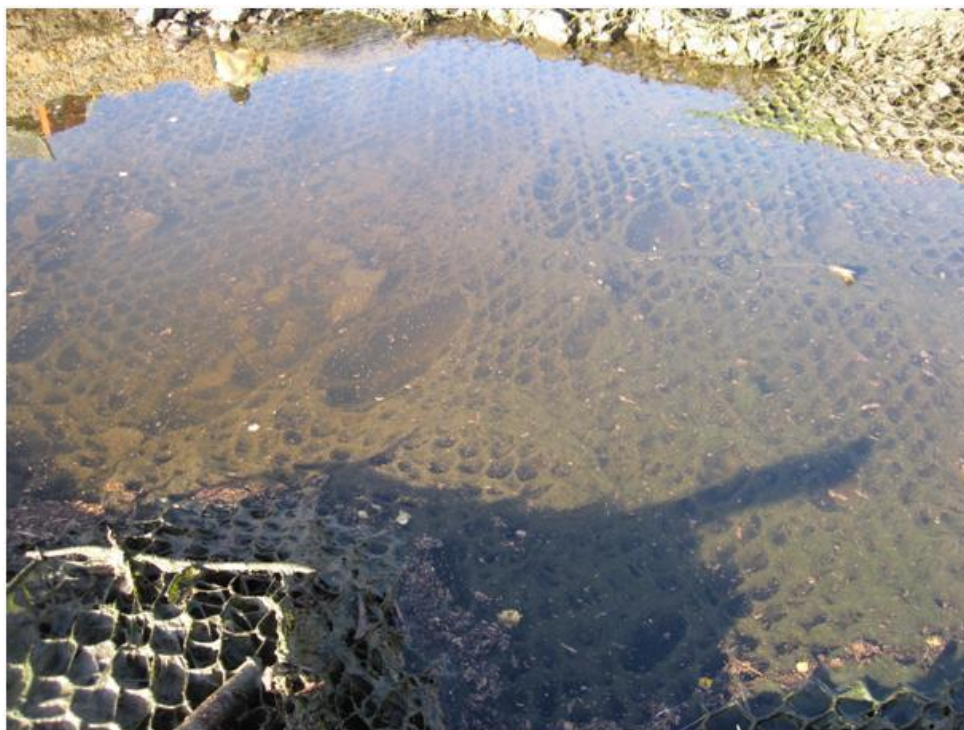
**Photo 4.** Drop Structure #3. Partially empty gabions and damaged wire mesh at the structure floor.

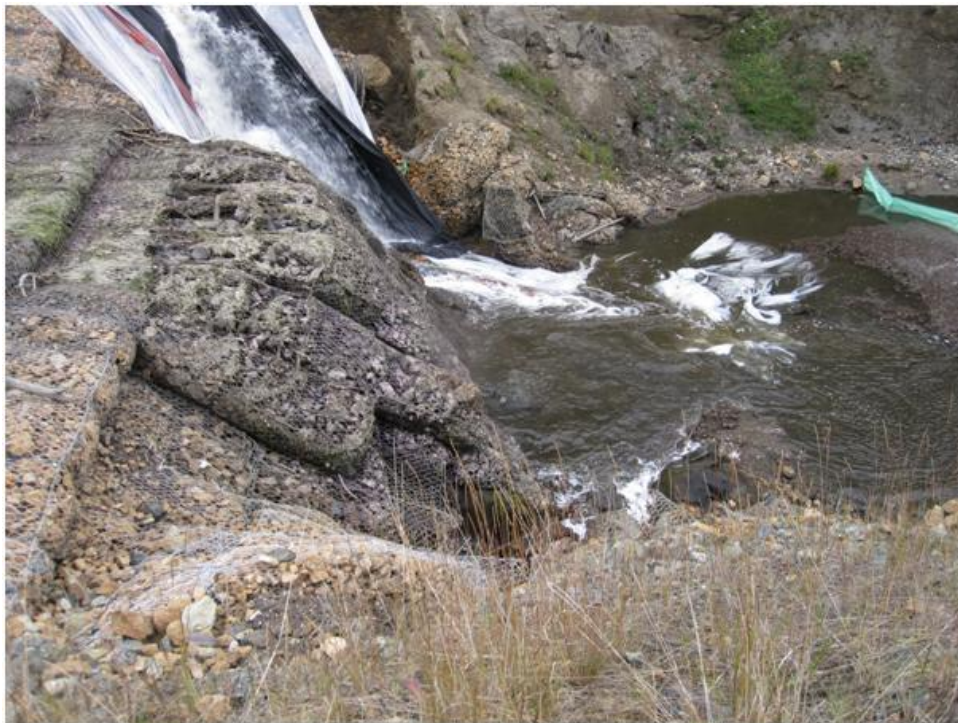
**Photo 5.** Drop Structure #4 looking to the left bank. The right channel bank had slumped in. No construction occurred at Drop Structure #4

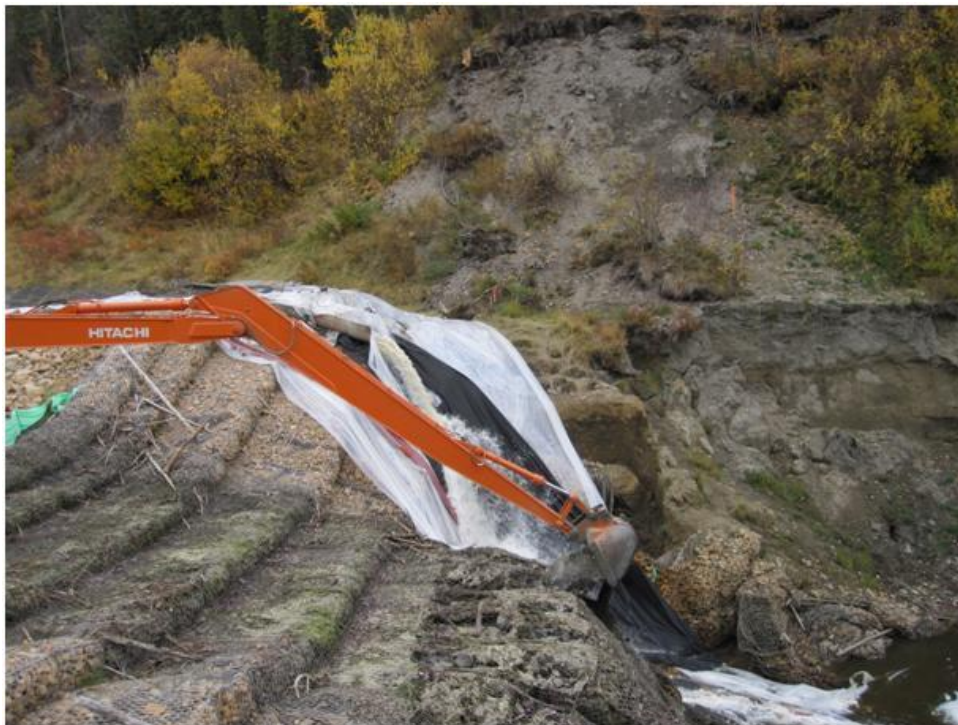
**Photo 13.** 200 Hitachi Excavator placing boulder material at the downstream end of Drop Structure #4. Other than two test boulders, no material was placed at the downstream end of Structure #4.
