Report No. 118014/1

**2008 GROUNDWATER REVIEW**  
**ANVIL RANGE MINING COMPLEX, YUKON TERRITORY**

**Faro Mine Closure Planning Office**

**February 2009**

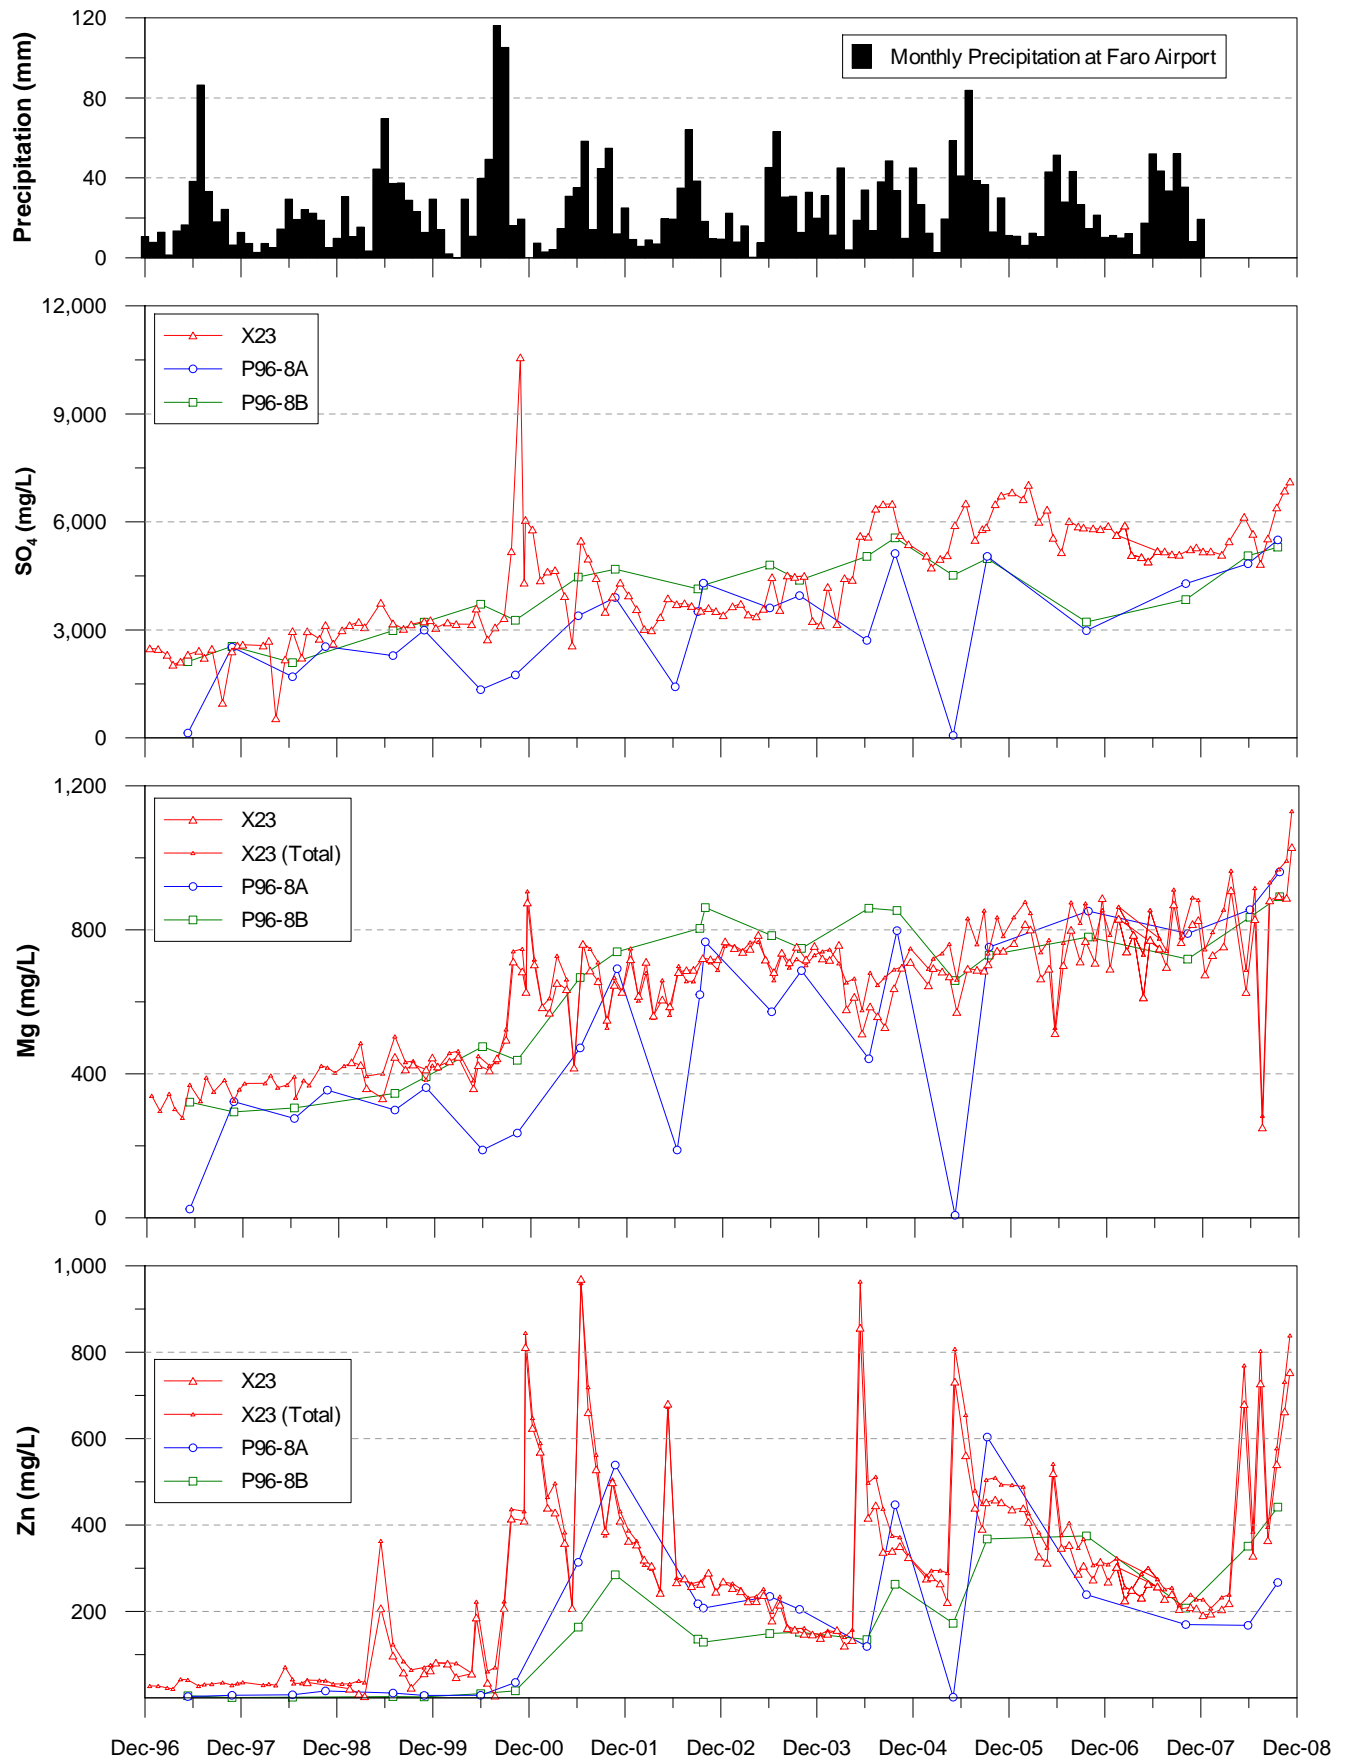
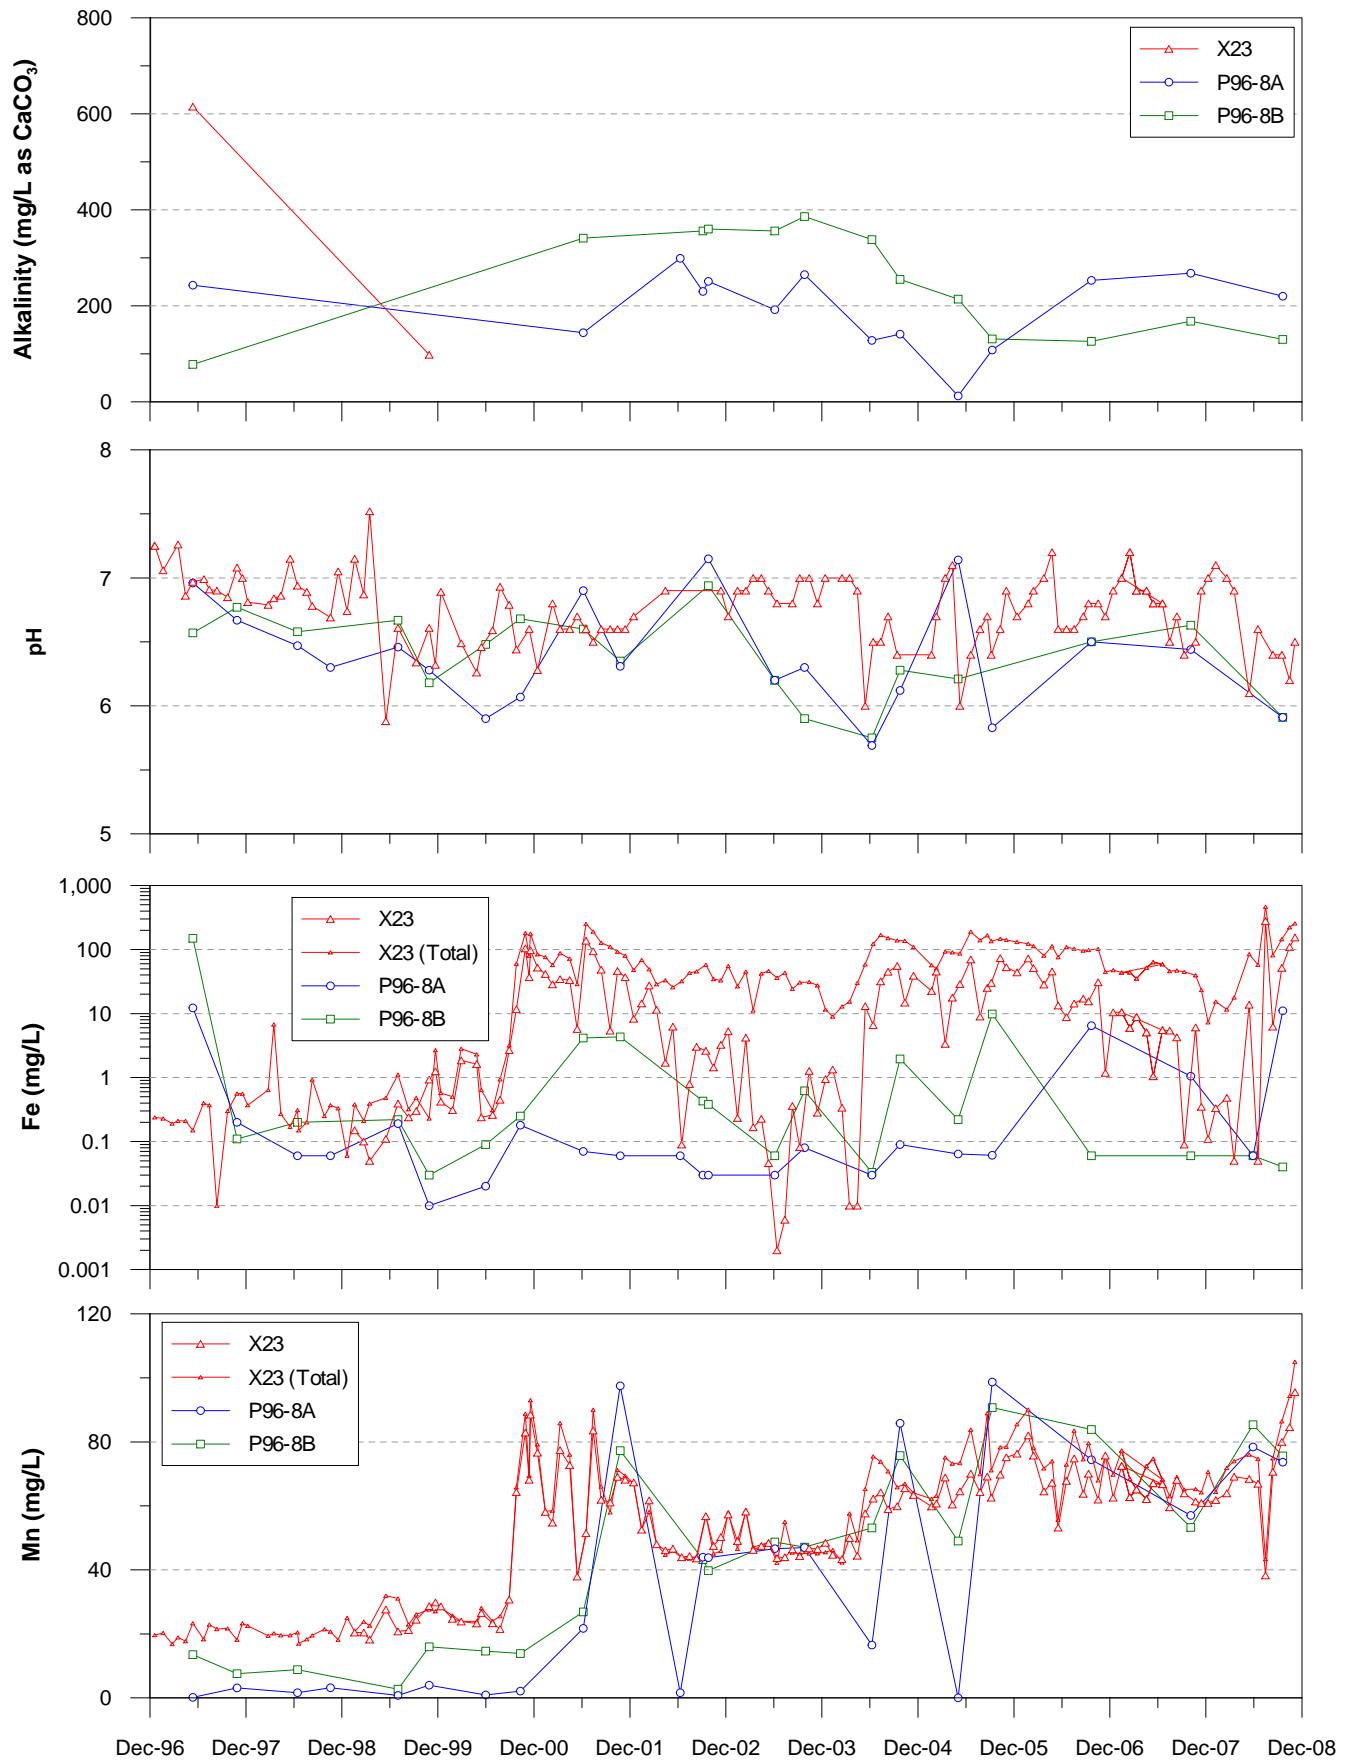
The concentrations of SO<sub>4</sub>, Mg, and key metals of interest (Zn, Fe, Mn) have increased considerably in X23 over the last year. Historically, a rapid increase in the concentrations of metals in X23 is related to the 'flushing' of accumulated oxidation products from the WRD in response to the infiltration of precipitation (Figure 2-3a). In the two nested piezometers P96-8A/B, temporal variation in the concentrations of major ions and metals of interest generally mimicked the trends observed in surface seepage at X23. Historic trends suggest that it can take a year or more for dissolved metal concentrations, such as Zn, to return to 'normal' levels after a 'flushing' event, yet major ions appear to be less susceptible to short-term changes. In 2008, precipitation was well above average suggesting that recent increases in water quality parameters are related to several 'flushing' events from the Main Dump.

Figure 2-3a. Precipitation and water quality ( $\text{SO}_4$ , Mg and Zn) in X23 and P96-8A/B.

Figure 2-3b. Water quality (alkalinity, pH, Fe and Mn) in X23 and P96-8A/B.

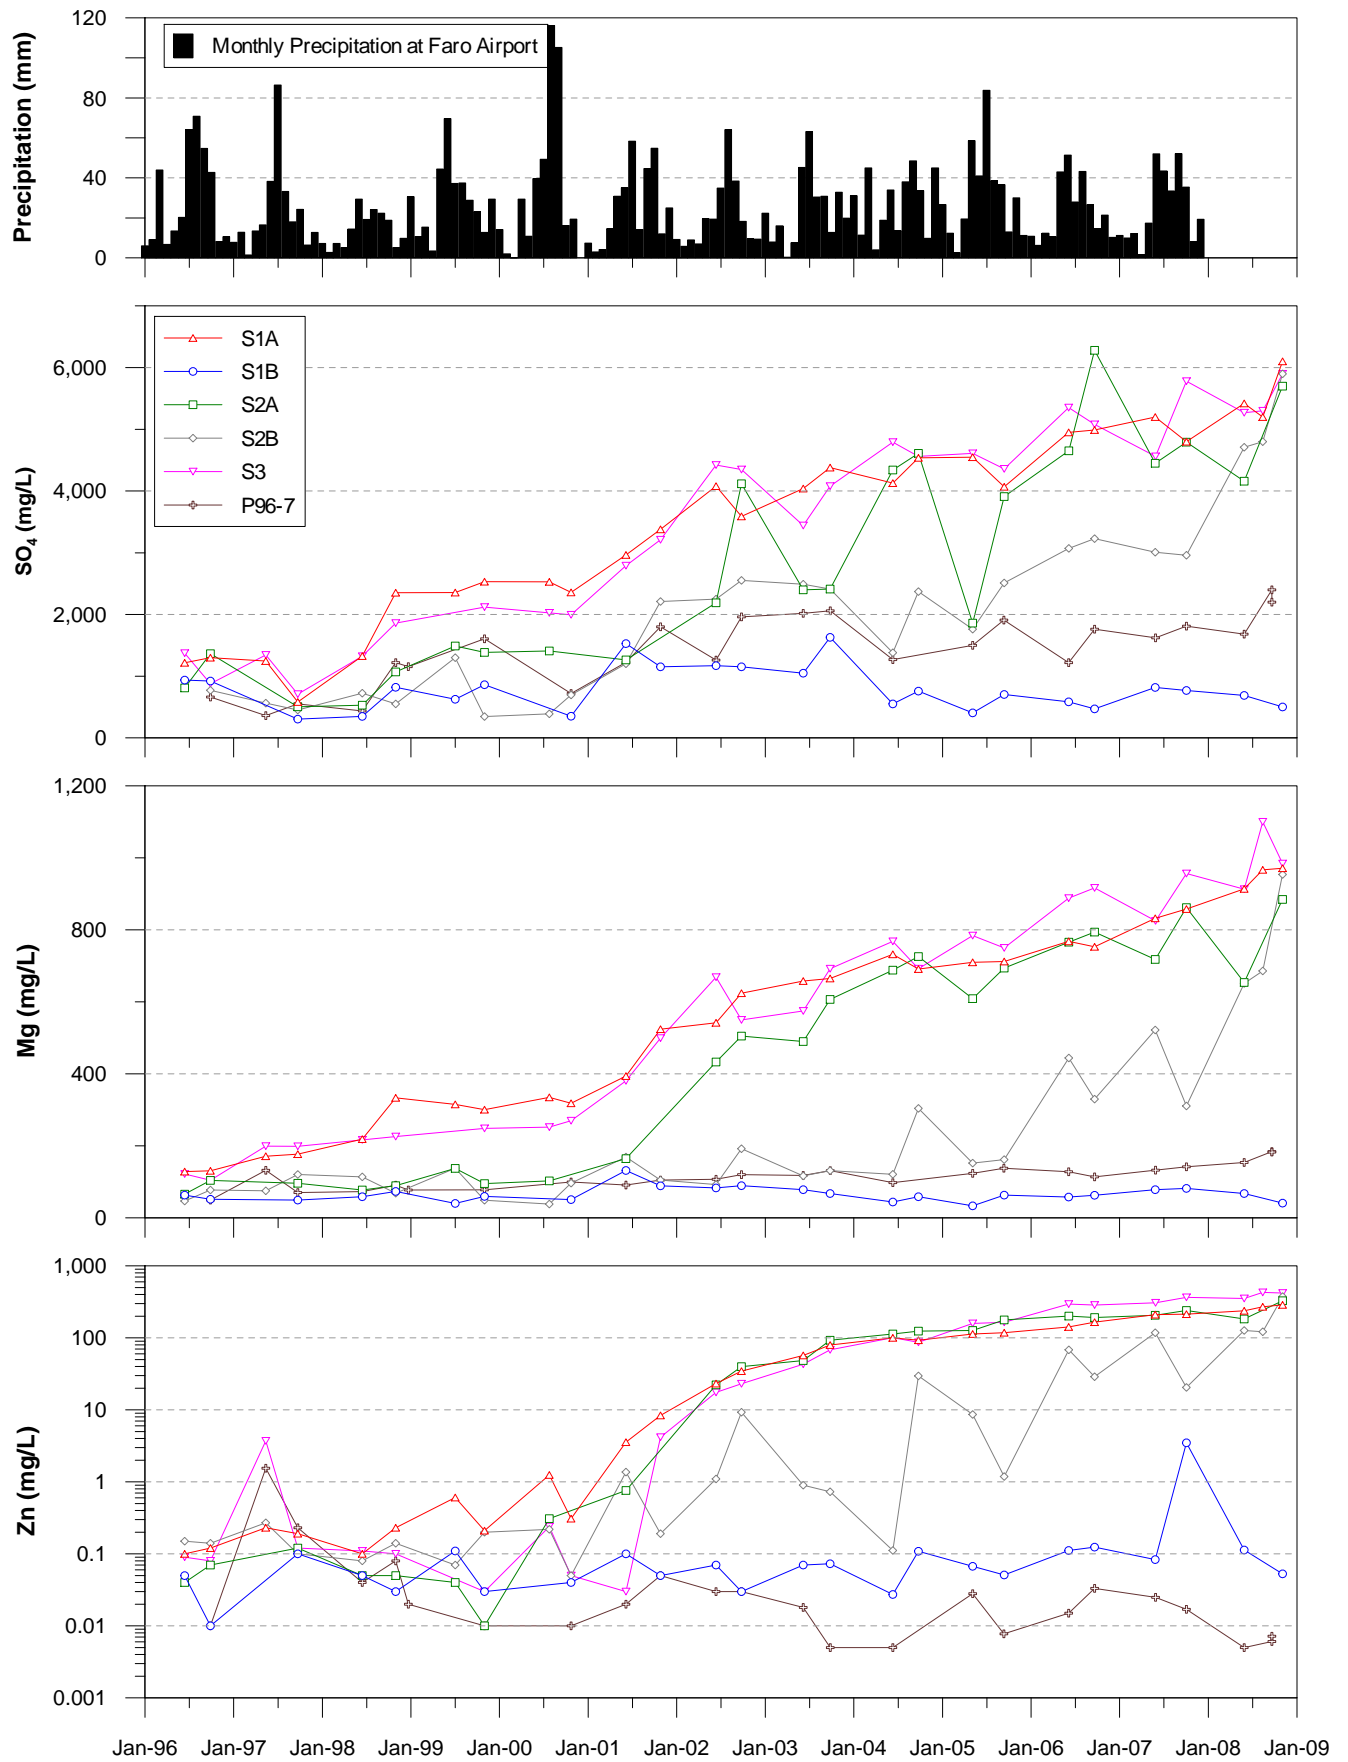
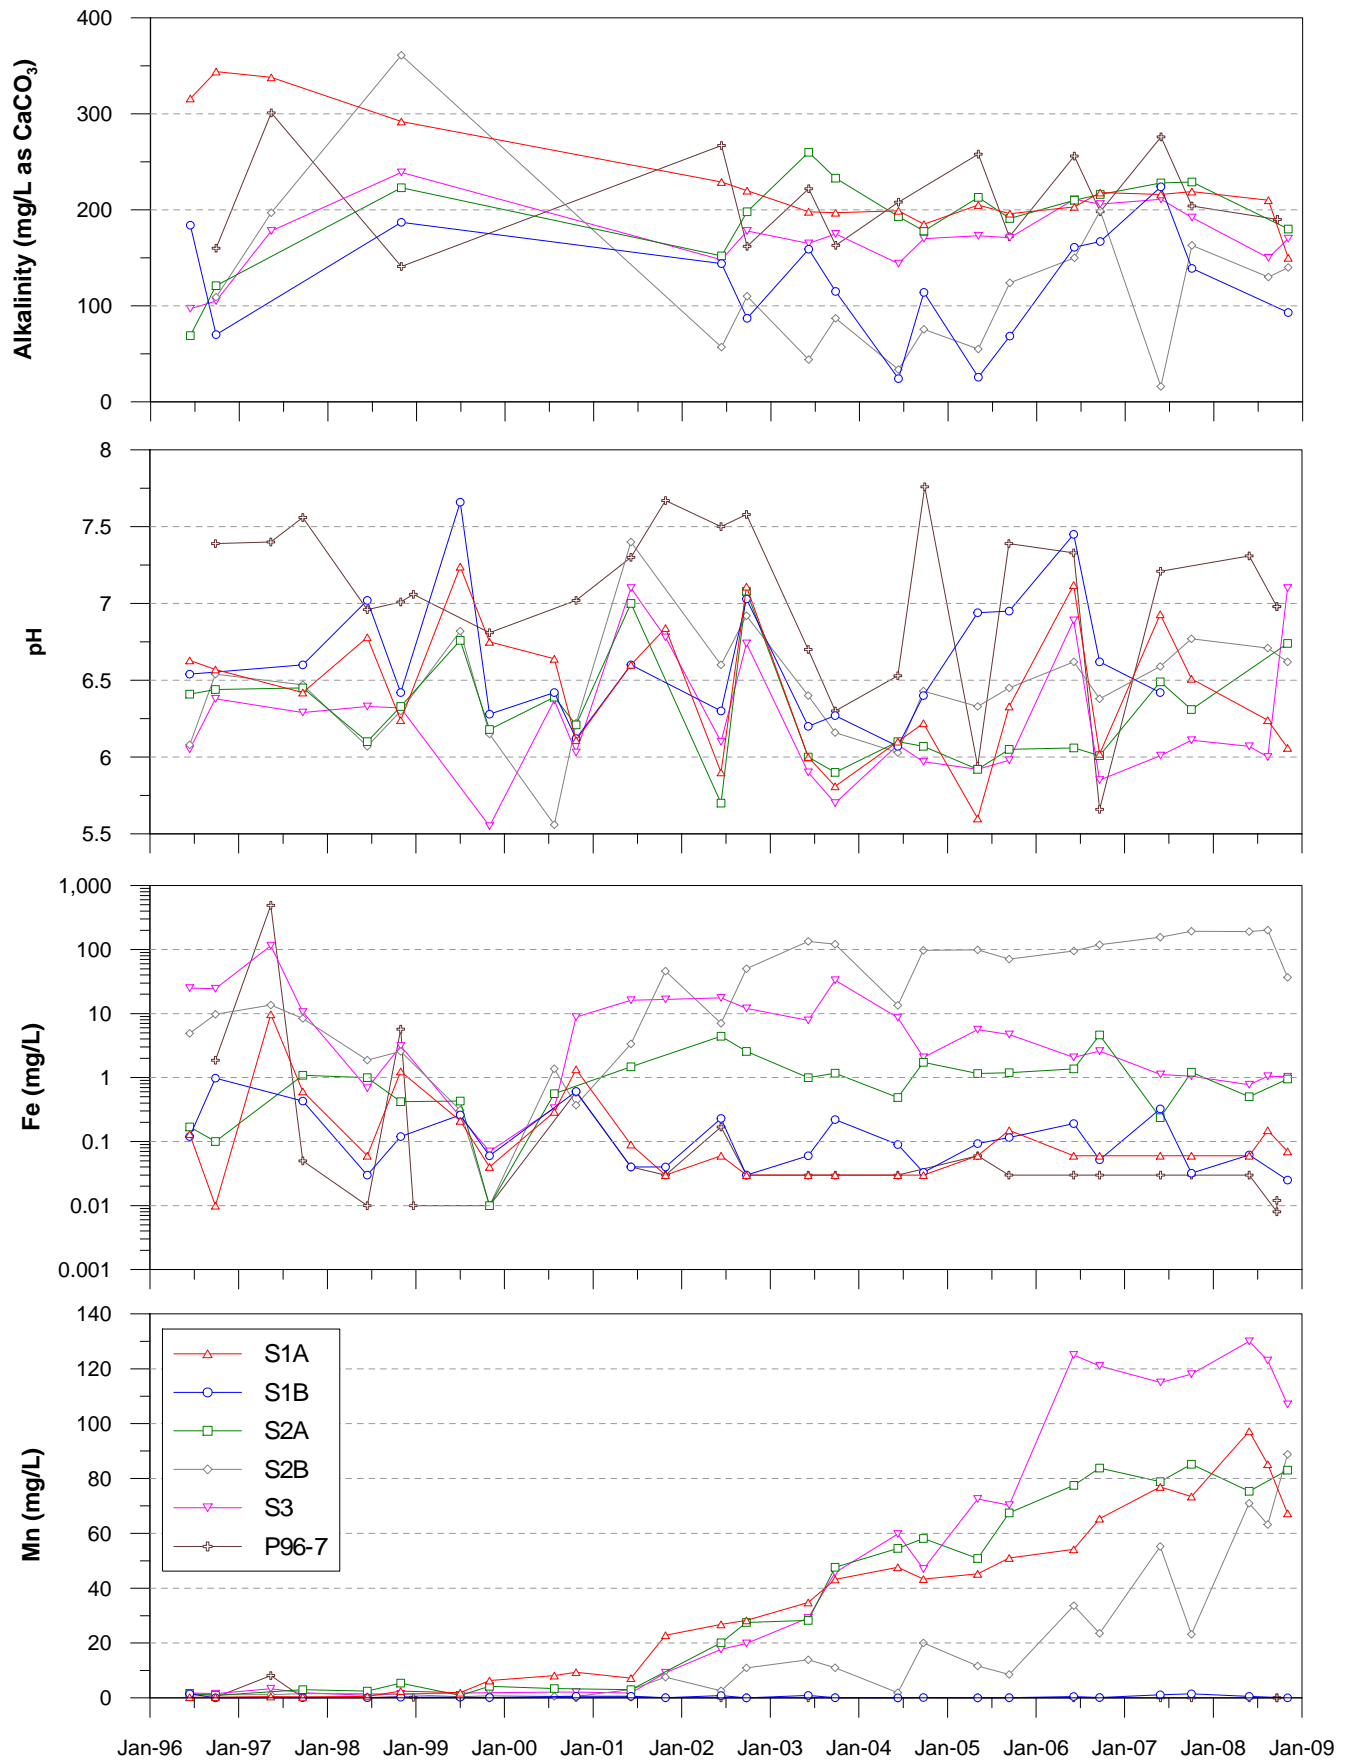
Piezometer S2B is reportedly a shallow piezometer (screened at 4 to 7m depth; Table 2-2). The recent breakthrough of highly-impacted seepage in this piezometer suggests that the shallow (perched) seepage first identified further east at SP-4B (SRK, 2006) may be laterally more extensive than originally thought. Alternatively, the breakthrough of waste rock seepage at SP2B may be an indication of deeper seepage (e.g. observed at SRK05-SP5) upwelling further down-slope.

Figure 2-6a. Precipitation and water quality (SO<sub>4</sub>, Mg and Zn) in S-Cluster Wells.

Figure 2-6b. Water quality (alkalinity, pH, Fe and Mn) in S-Cluster Wells.

The continued deterioration of groundwater quality along this reach of the NFRC, including breakthrough of highly elevated Zn concentrations, represents an increasing risk of contaminant loading to the nearby North Fork of Rose Creek. As a result, a seepage interception system consisting of a shallow interception trench and several recovery wells was installed in the fall of 2008 to intercept this highly impacted groundwater in this area (SRK, 2009). Start-up of operation of this SIS is planned for early 2009. Continued monitoring of groundwater quality downstream of this SIS will be required to assess the effect of this new seepage interception system on groundwater quality in this reach of the NFRC.

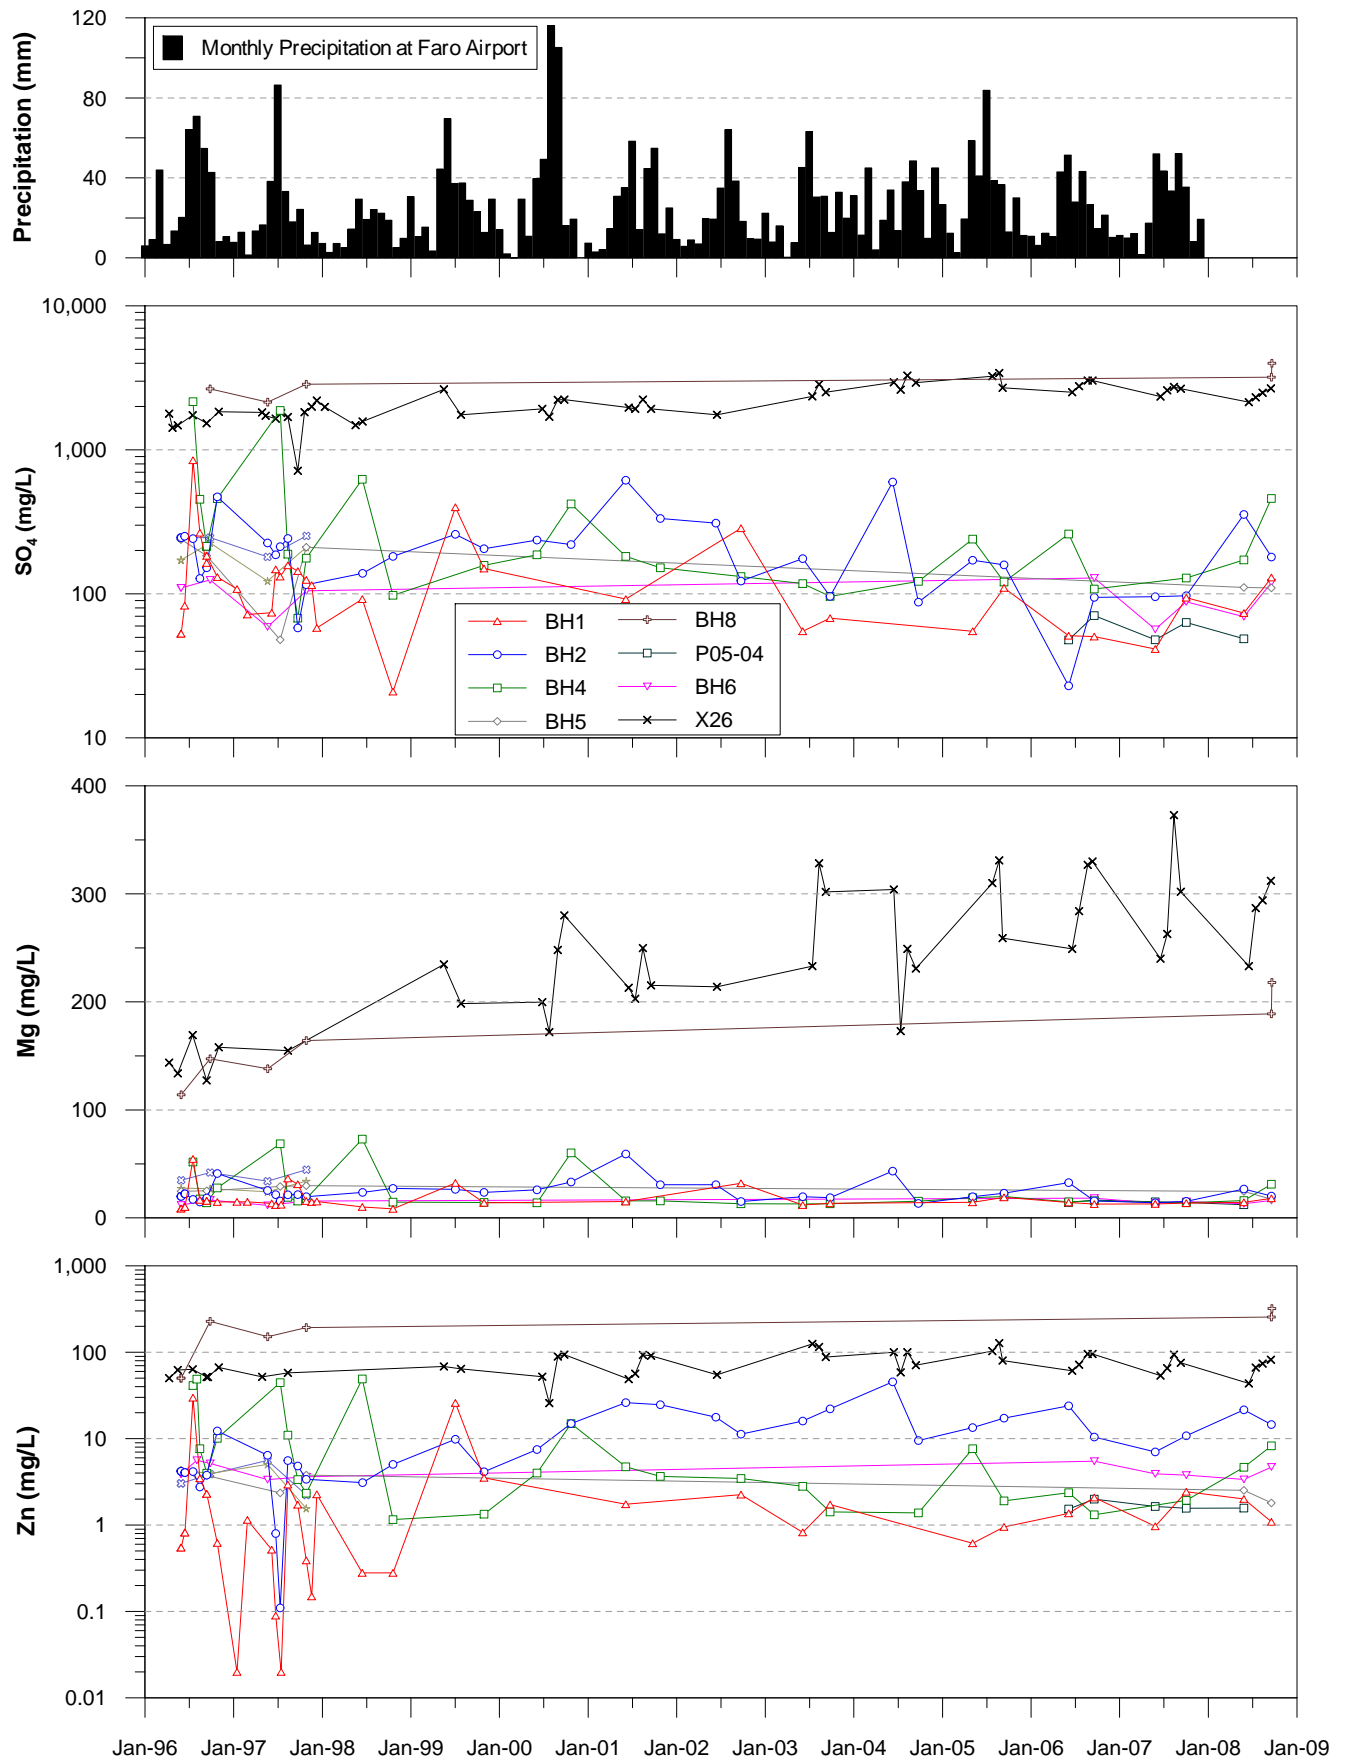
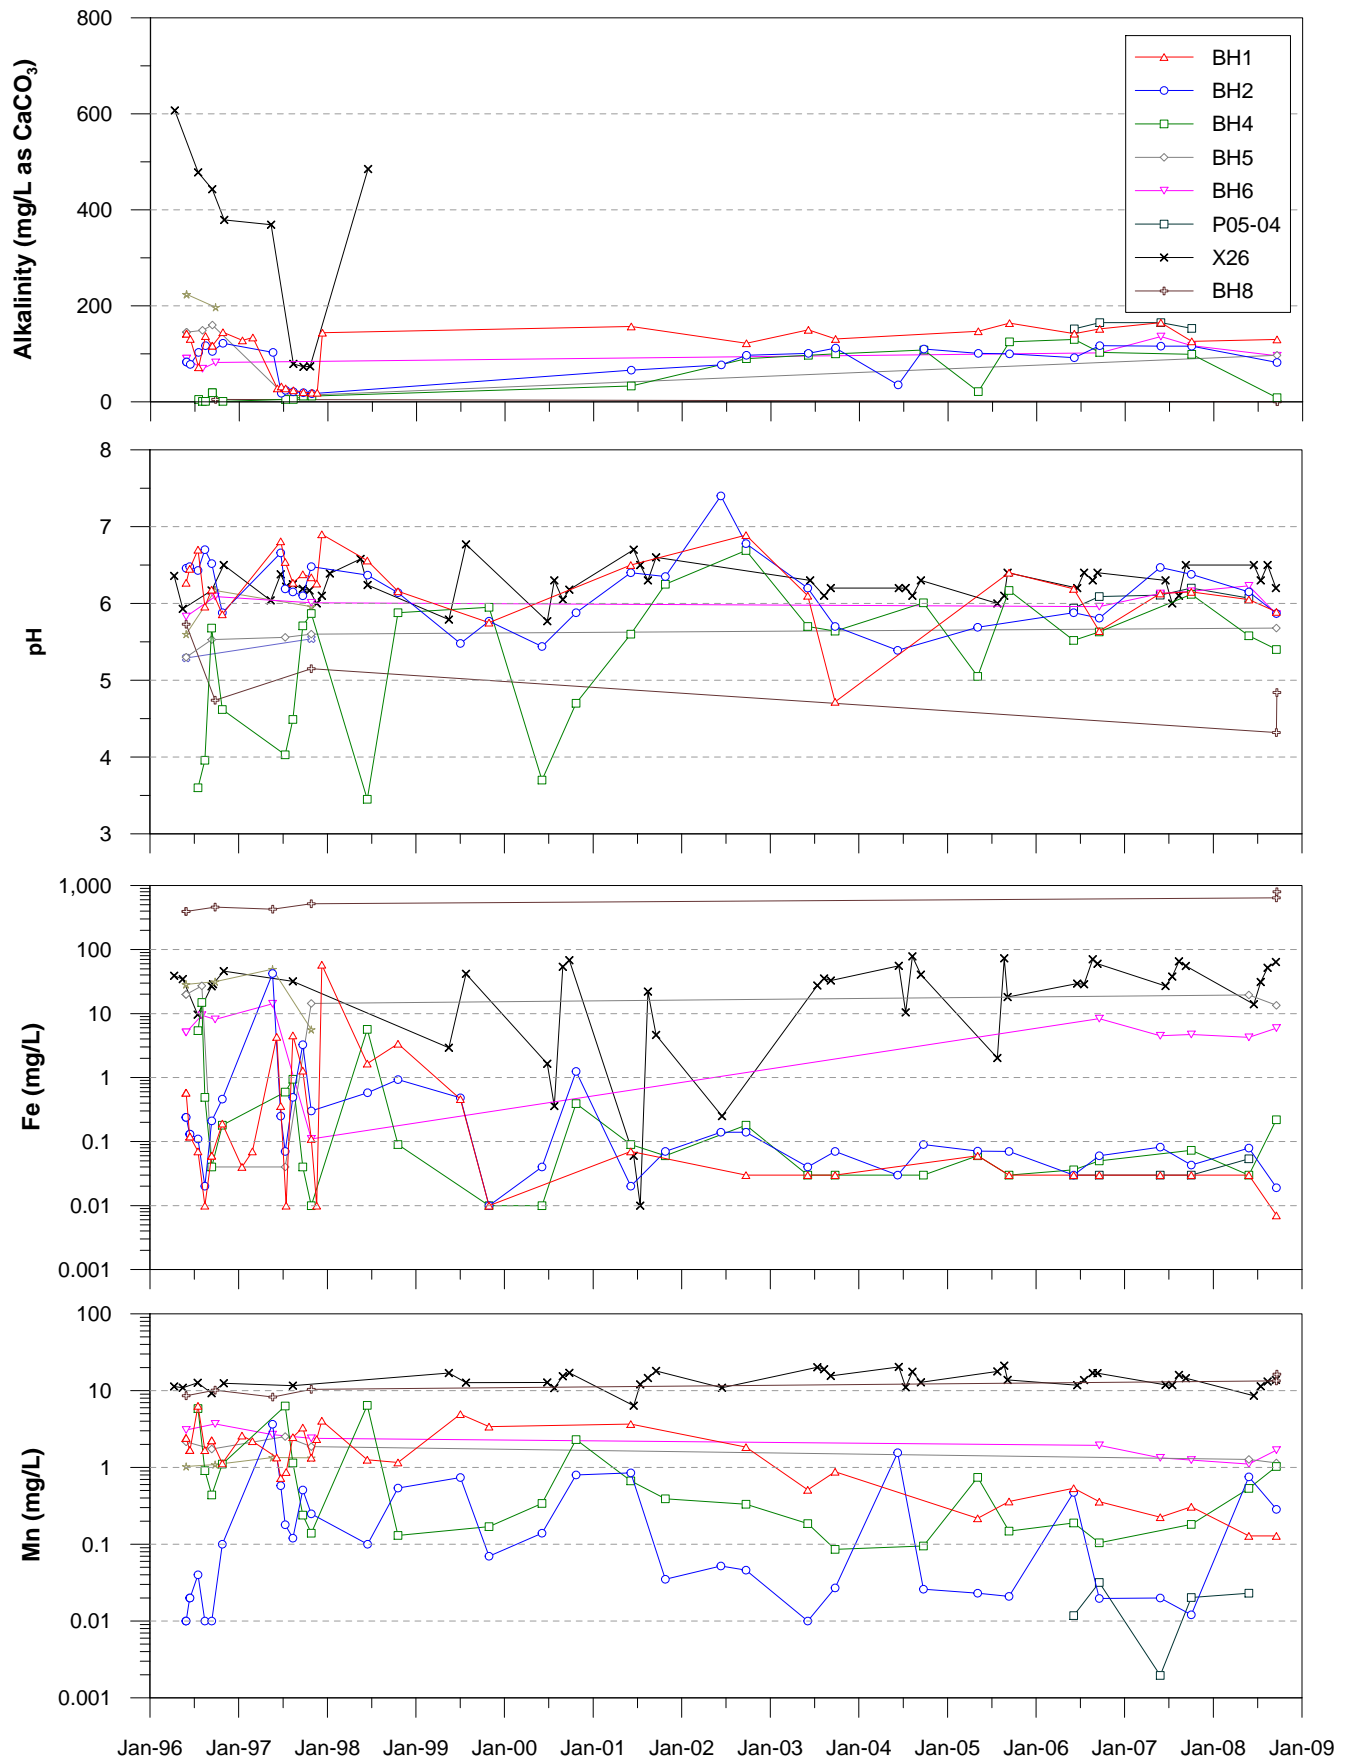
Trends in groundwater quality in the Zone 2 Outwash area for the current monitoring period were generally similar to those observed in previous years. The shallow wells (BH1, 2 and 4), at least partially screened in the outwash sediments, continued to show a very similar general water quality (or "fingerprint") to that observed in the deeper wells screened in the alluvial sediments (BH5, BH6, P05-04). The groundwater quality in this area differs from other seepage areas (e.g. ETA and S-cluster) in that elevated Zn concentrations are observed in groundwater with relatively low concentrations of SO<sub>4</sub>, Mg, iron and manganese.

Several shallow wells (e.g. BH2 and in particular BH4 located near the NFRC) showed a gradual increase in Zn, manganese and SO<sub>4</sub> during calendar year 2008. Similar increases in contaminants had been observed in previous wet years. These increases are therefore likely temporary in nature and not related to an overall long-term increase in contaminant loading in this area.

Figure 2-10a. Precipitation and water quality ( $SO_4$ , Mg and Zn) in Zone 2 Outwash Area.

Figure 2-10b. Water quality (alkalinity, pH, Fe and Mn) in Zone 2 Outwash Area.

Pumping tests conducted in this area have demonstrated that the local NFRC sediments are very permeable, that zinc loading to the NFRC sediments is significant and seepage interception may be required in this area (SRK, 2007). In preparation of such design work, we recommend that additional geochemical characterization work be completed (including geochemical finger-printing, mixing calculations and potentially use of isotopic tracers) to determine the relative contribution of Zone 2 pit seepage, waste rock seepage and leakage from the outwash sediments in this reach of the NFRC.

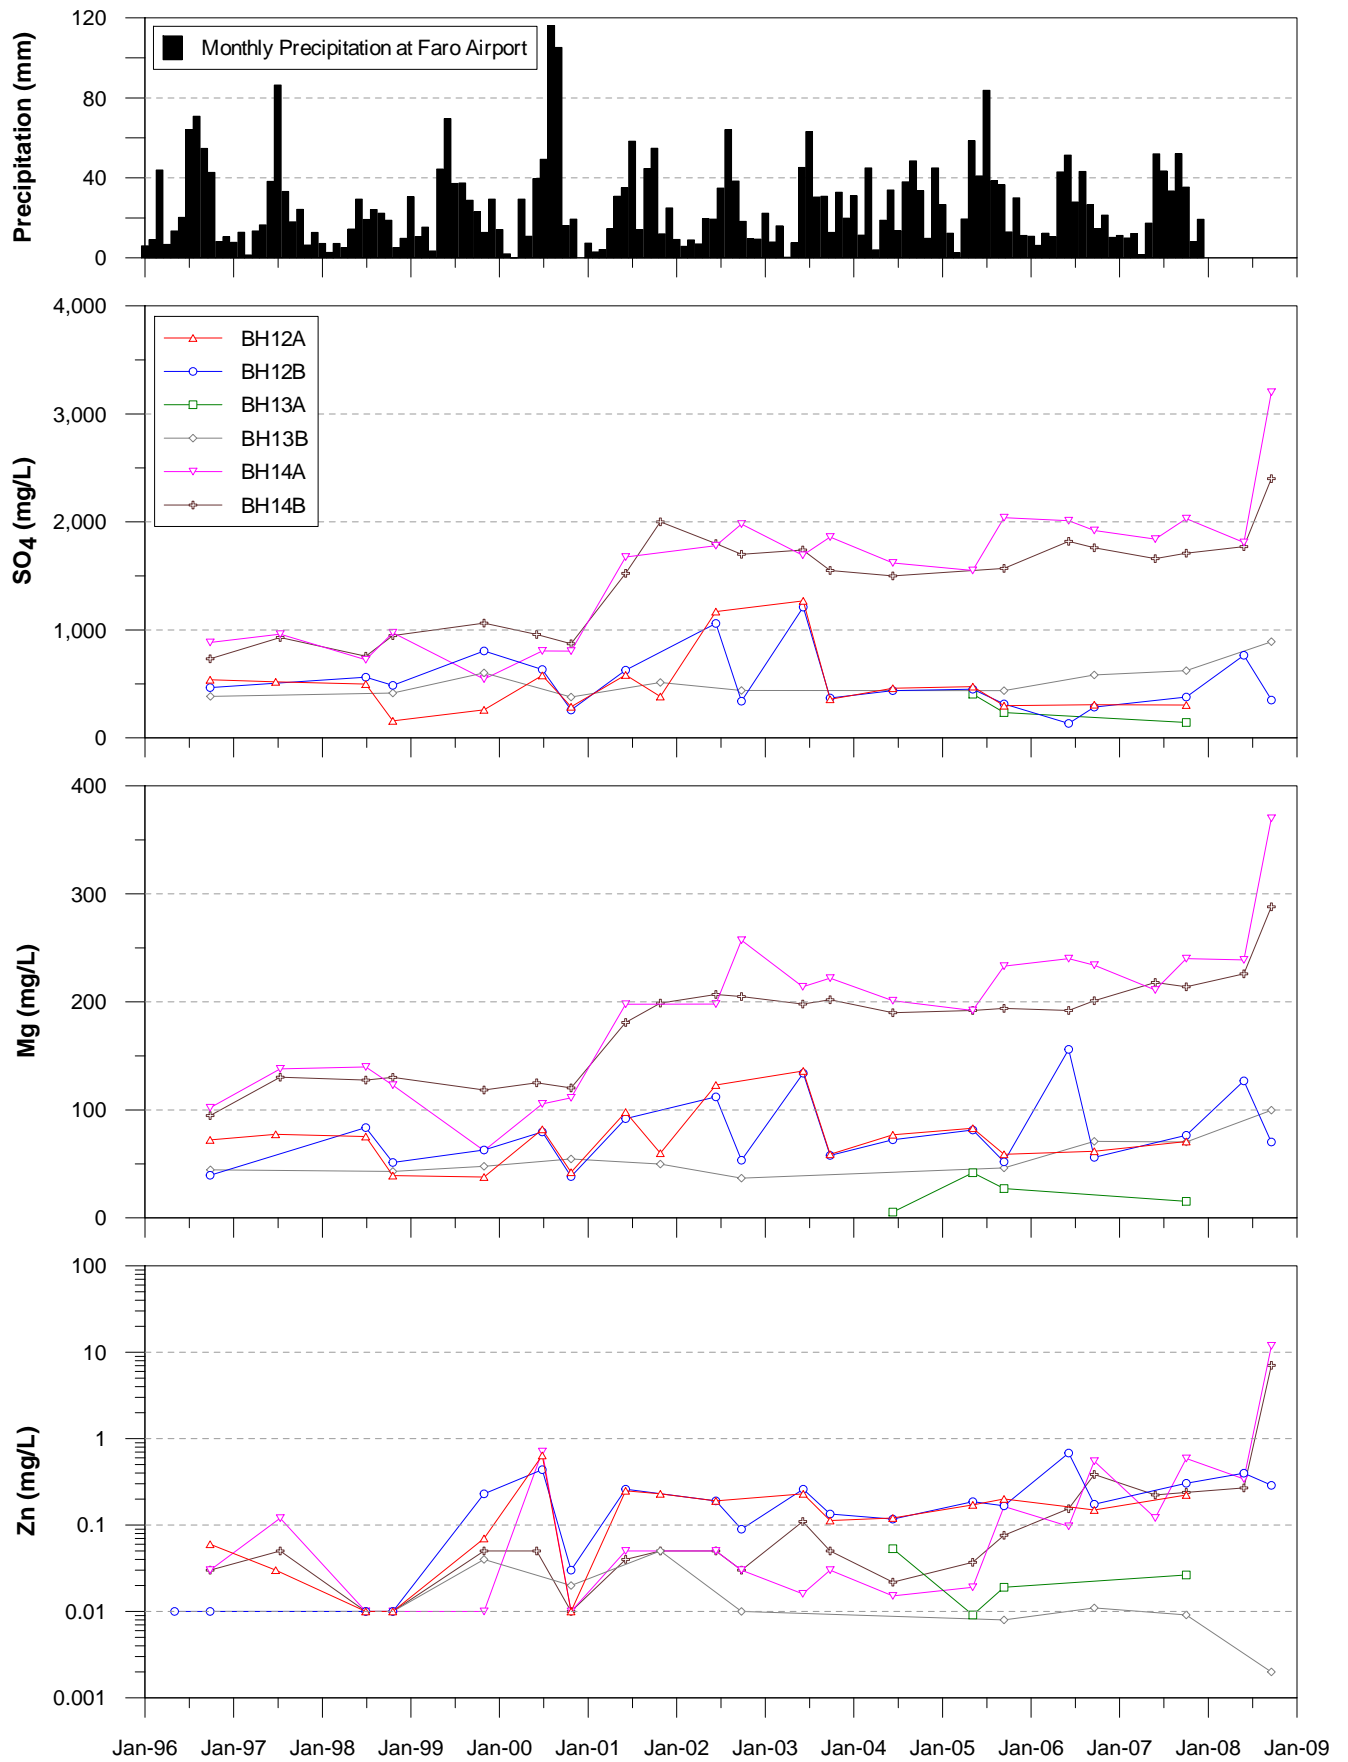
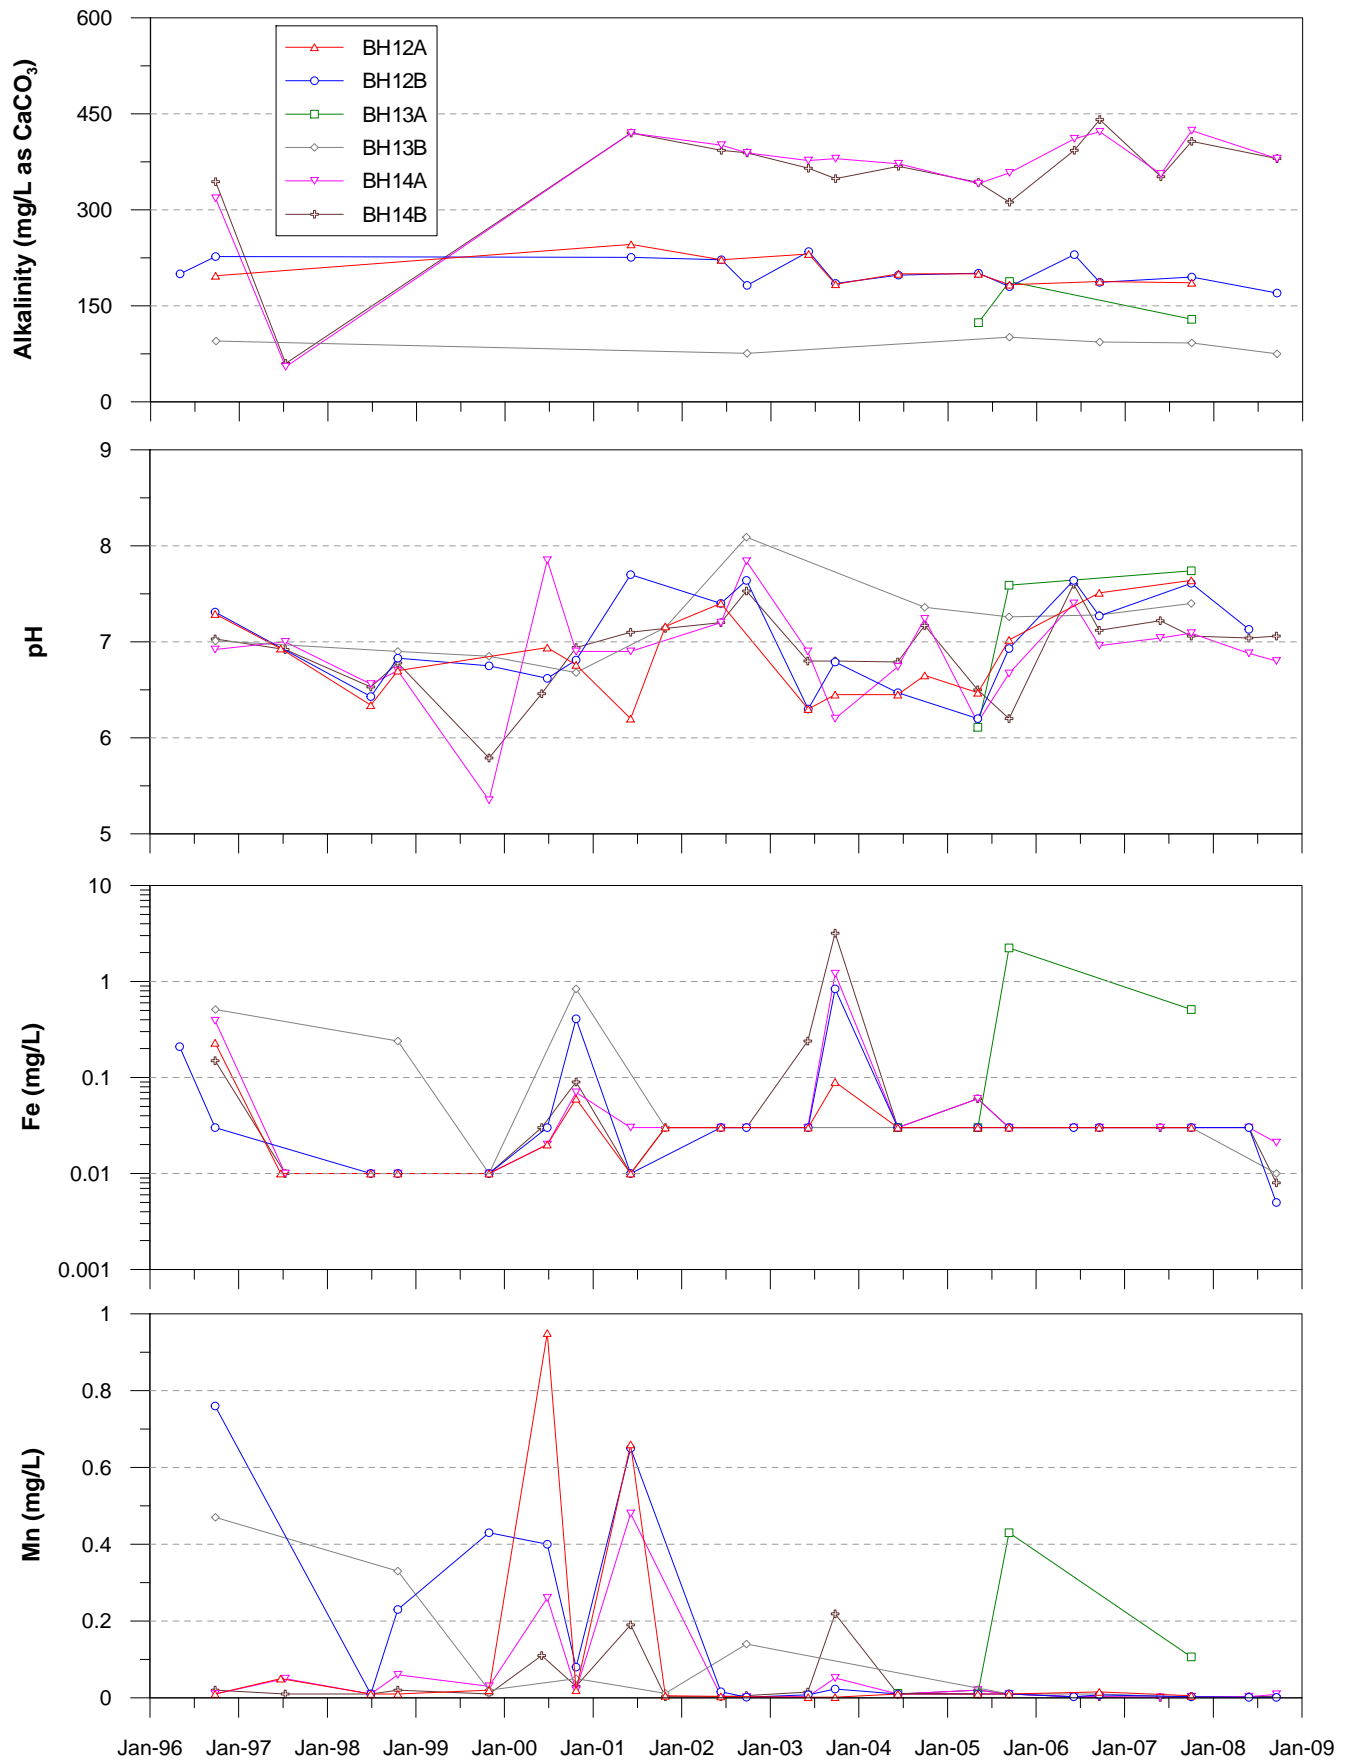
BH14A/B has historically shown the greatest impact of WRD seepage in this area and groundwater quality in these wells deteriorated significantly in 2008. For example, in the latest round of sampling (August 2008) SO<sub>4</sub> and Zn concentrations in BH14A jumped to 3,200 mg/L SO<sub>4</sub> and 11.9 mg/L Zn, respectively. Similar increases were observed in the deeper piezometer BH14B. The observed increases in major ions (SO<sub>4</sub> and Mg) are consistent with elevated field EC readings during this sampling date suggesting that these results are not caused by a sample handling or laboratory error.

Groundwater collected from wells BH12A/B and BH13A/B has remained relatively dilute in terms of major ions and dissolved metals compared to those observed at BH14A/B. However, monitoring well BH13B has shown a recent increase in concentrations of SO<sub>4</sub> and Mg indicative of waste rock seepage.

Increases in the concentrations of SO<sub>4</sub>, Mg, and Zn in these wells (in particular at BH14A/B) are cause for concern because their increase are likely indicative of seepage related to the sulphide-rich waste rock that has been identified in this portion of the Northeast Dumps (RGC, 2008). If seepage continues, it is likely that groundwater quality in this reach will deteriorate further until concentrations of SO<sub>4</sub>, Mg, and Zn reach the levels observed in the ETA and S-cluster areas. Extrapolating historic time trends observed at the S-cluster area, zinc concentrations in BH14 may exceed 100 mg/L in groundwater within the next 2 to 5 years. Over time, such seepage could negatively impact on the water quality of the NFRC in the reach upstream of the Zone 2 area.

Figure 2-11a. Precipitation and water quality ( $\text{SO}_4$ , Mg and Zn) at toe of Northeast Dumps.

Figure 2-11b. Water quality (alkalinity, pH, Fe and Mn) at toe of Northeast Dumps.
