Report No. 118014/1

**2008 GROUNDWATER REVIEW**  
**ANVIL RANGE MINING COMPLEX, YUKON TERRITORY**

**Faro Mine Closure Planning Office**

**February 2009**

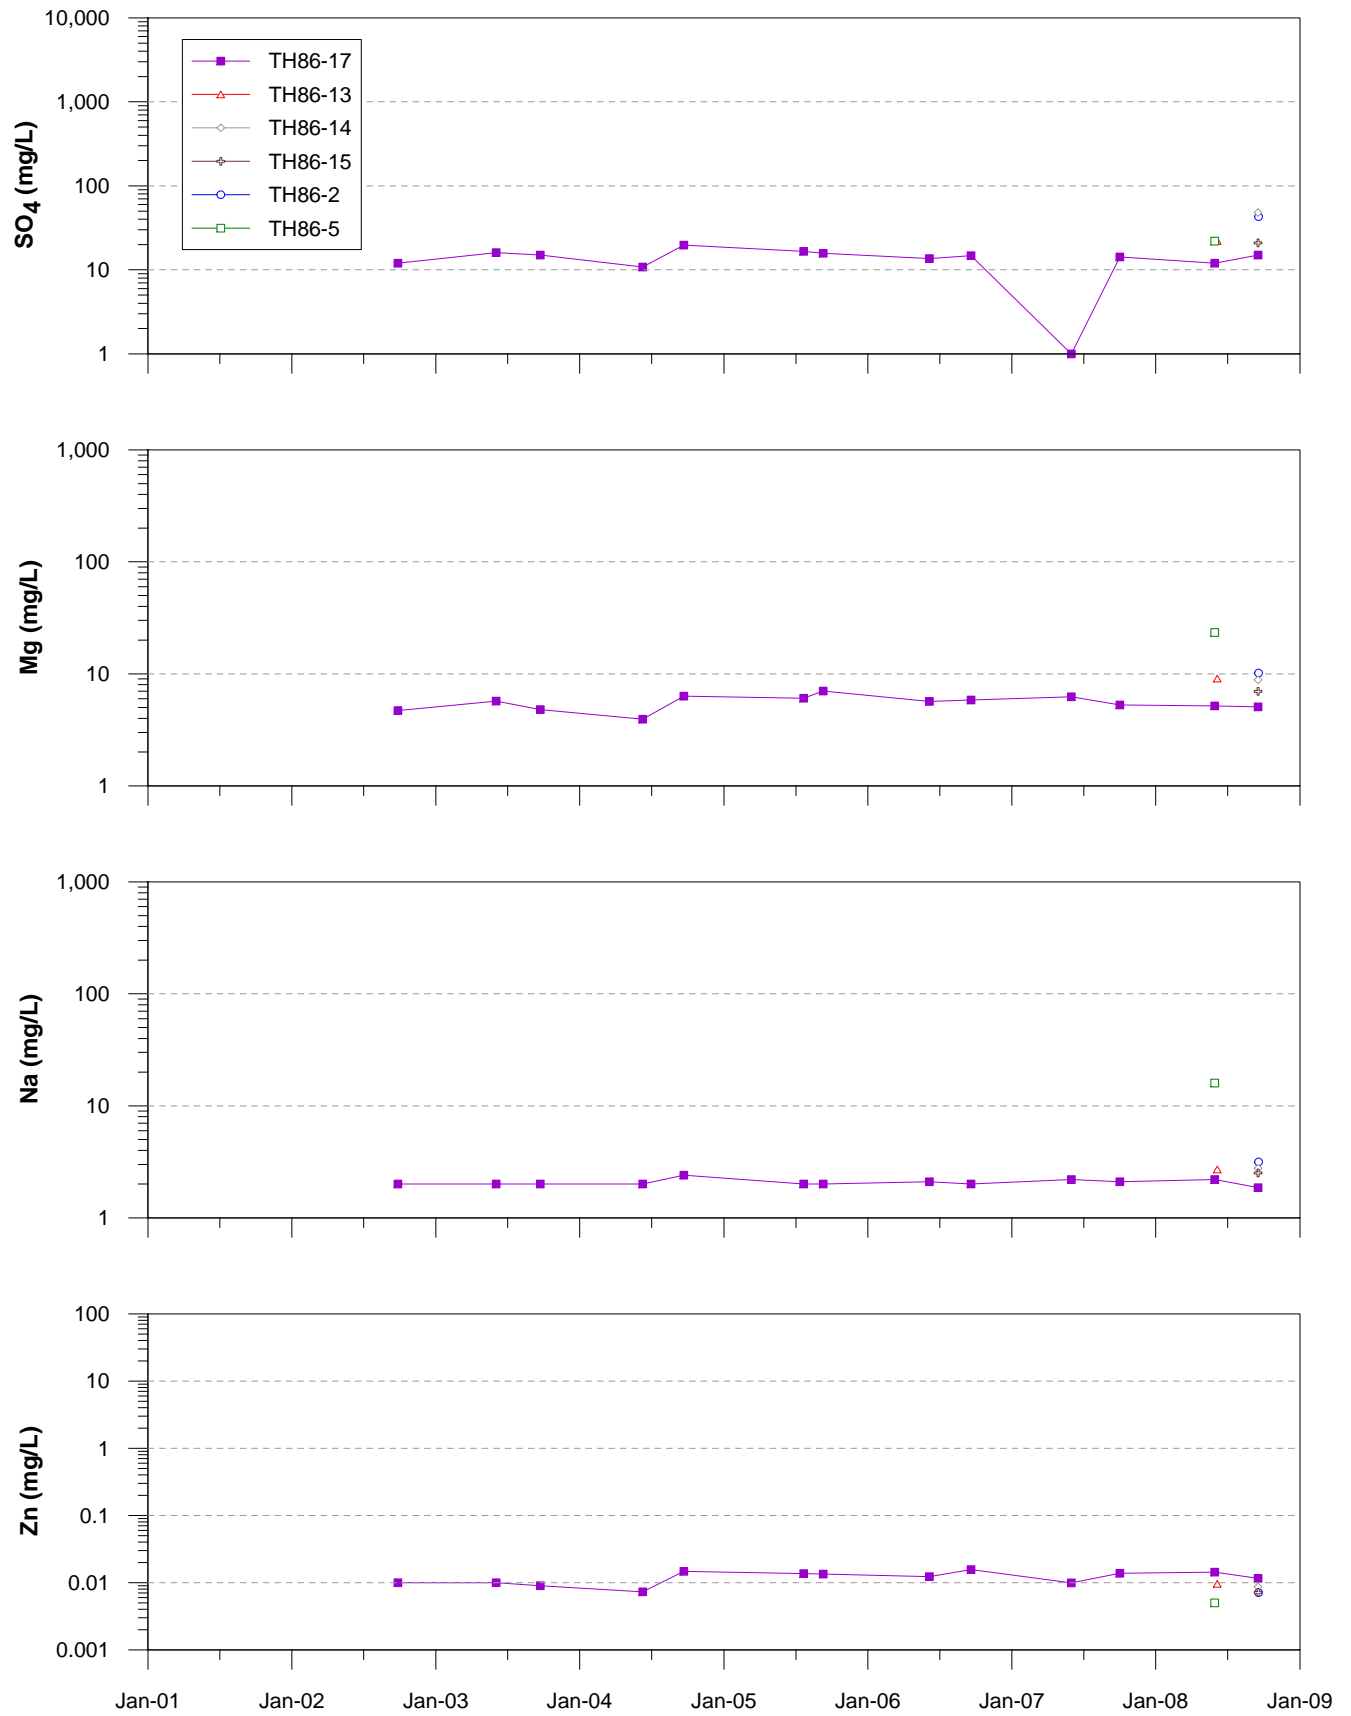
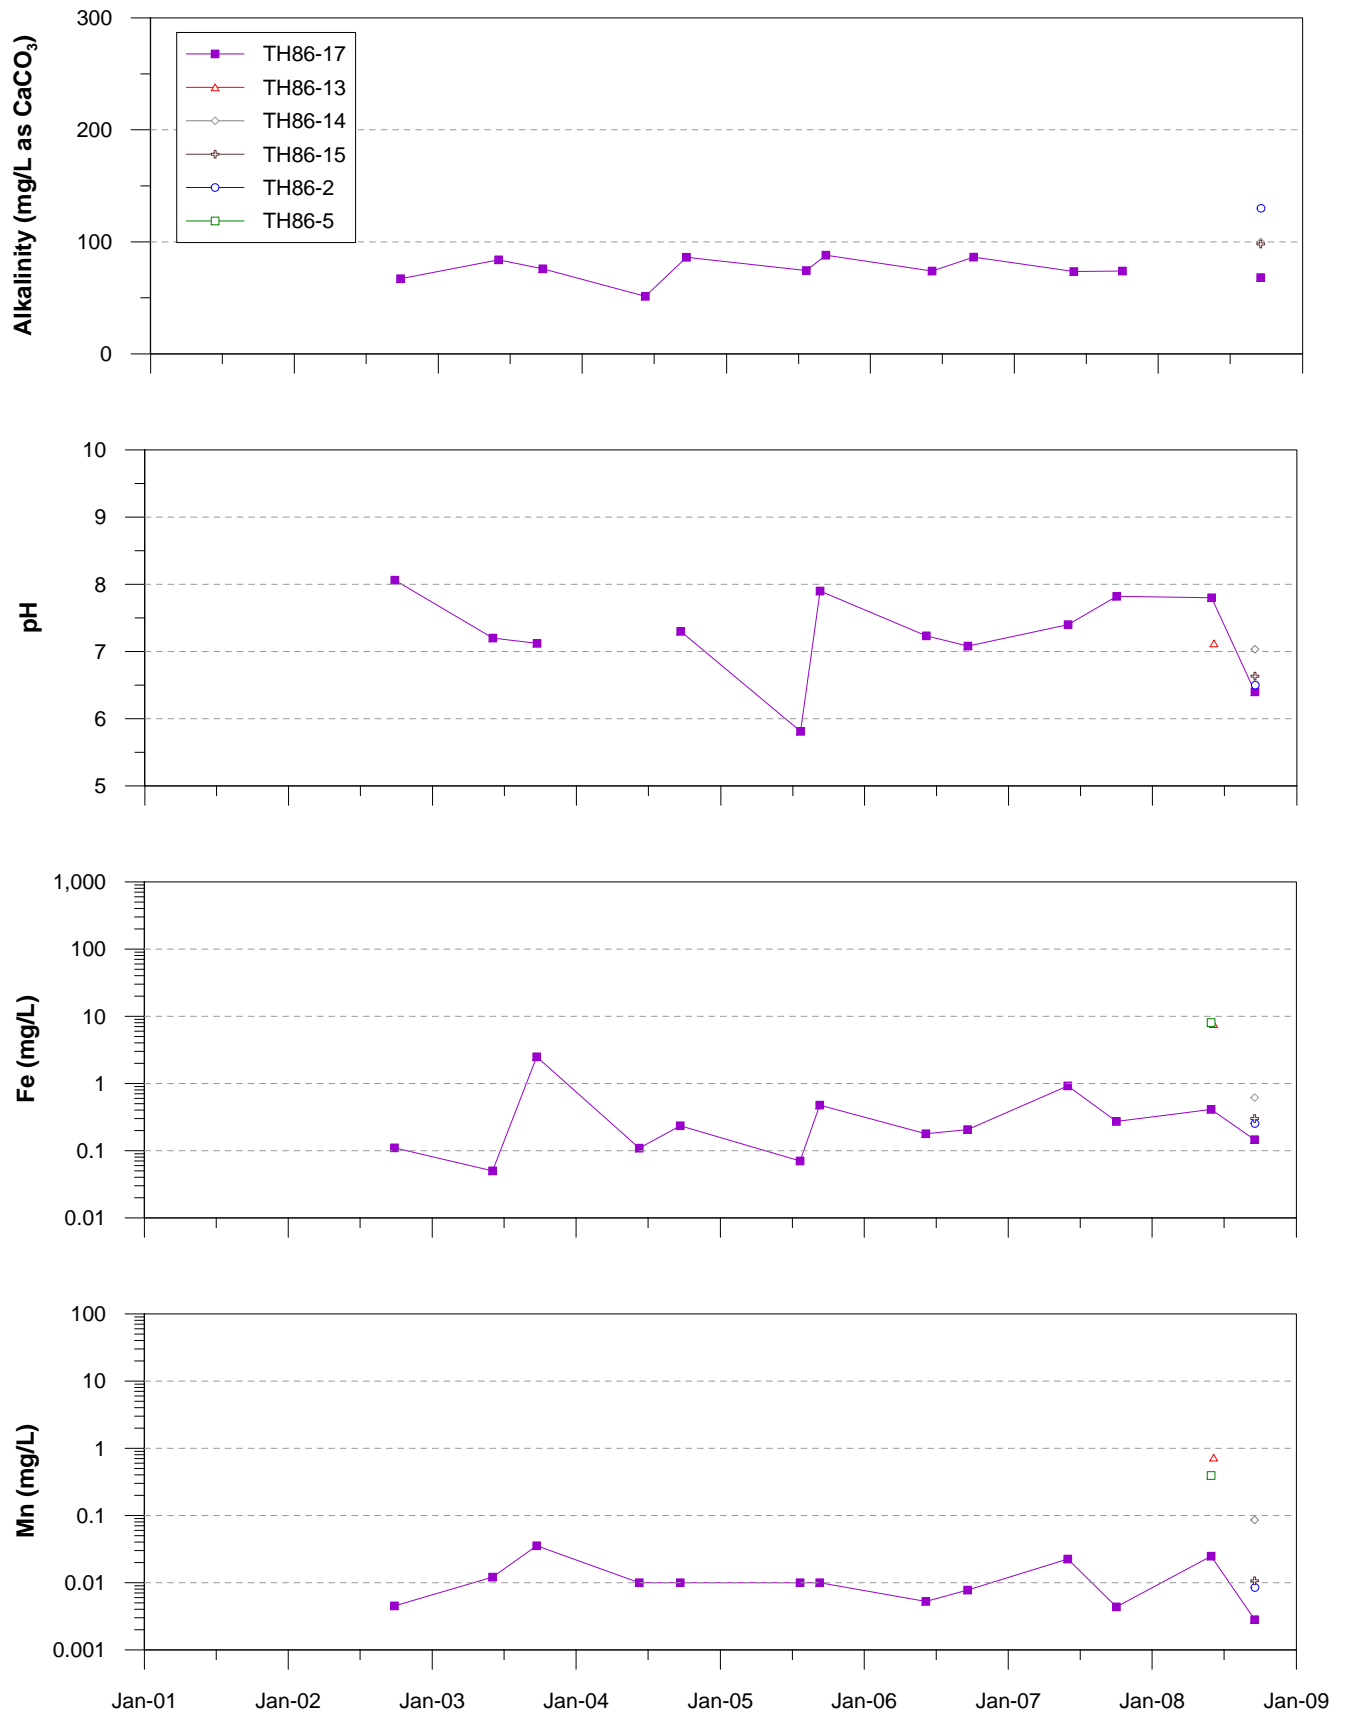
Figure 3-2a/b shows selected water quality time trends for TH86-17 and other piezometers measured once in 2008. Groundwater quality in TH86-17 reflects natural base-line conditions in the Rose Creek valley sediments. Groundwater from TH86-17 remains relatively dilute in terms of major ions and dissolved metals and there continues to be no indication of mine waste seepage impact on groundwater quality at this location.

Figure 3-2a. Water quality (SO<sub>4</sub>, Mg, Na and Zn) in TH86-17 and other upgradient wells.

Figure 3-2b. Water quality (alkalinity, pH, Fe and Mn) in TH86-17 and other upgradient wells.

compared to 0.017 mg/L in TH86-17. The lower SO<sub>4</sub> concentrations (and higher Zn concentrations) observed at TH86-17 may be a result of recharge from the nearby NFRC to the Rose Creek sediments. We recommend that monitoring wells TH86-2 and TH86-5, screened in shallow and deep alluvial sediments, respectively, be included in future routine monitoring as additional background wells for the Rose Creek valley.

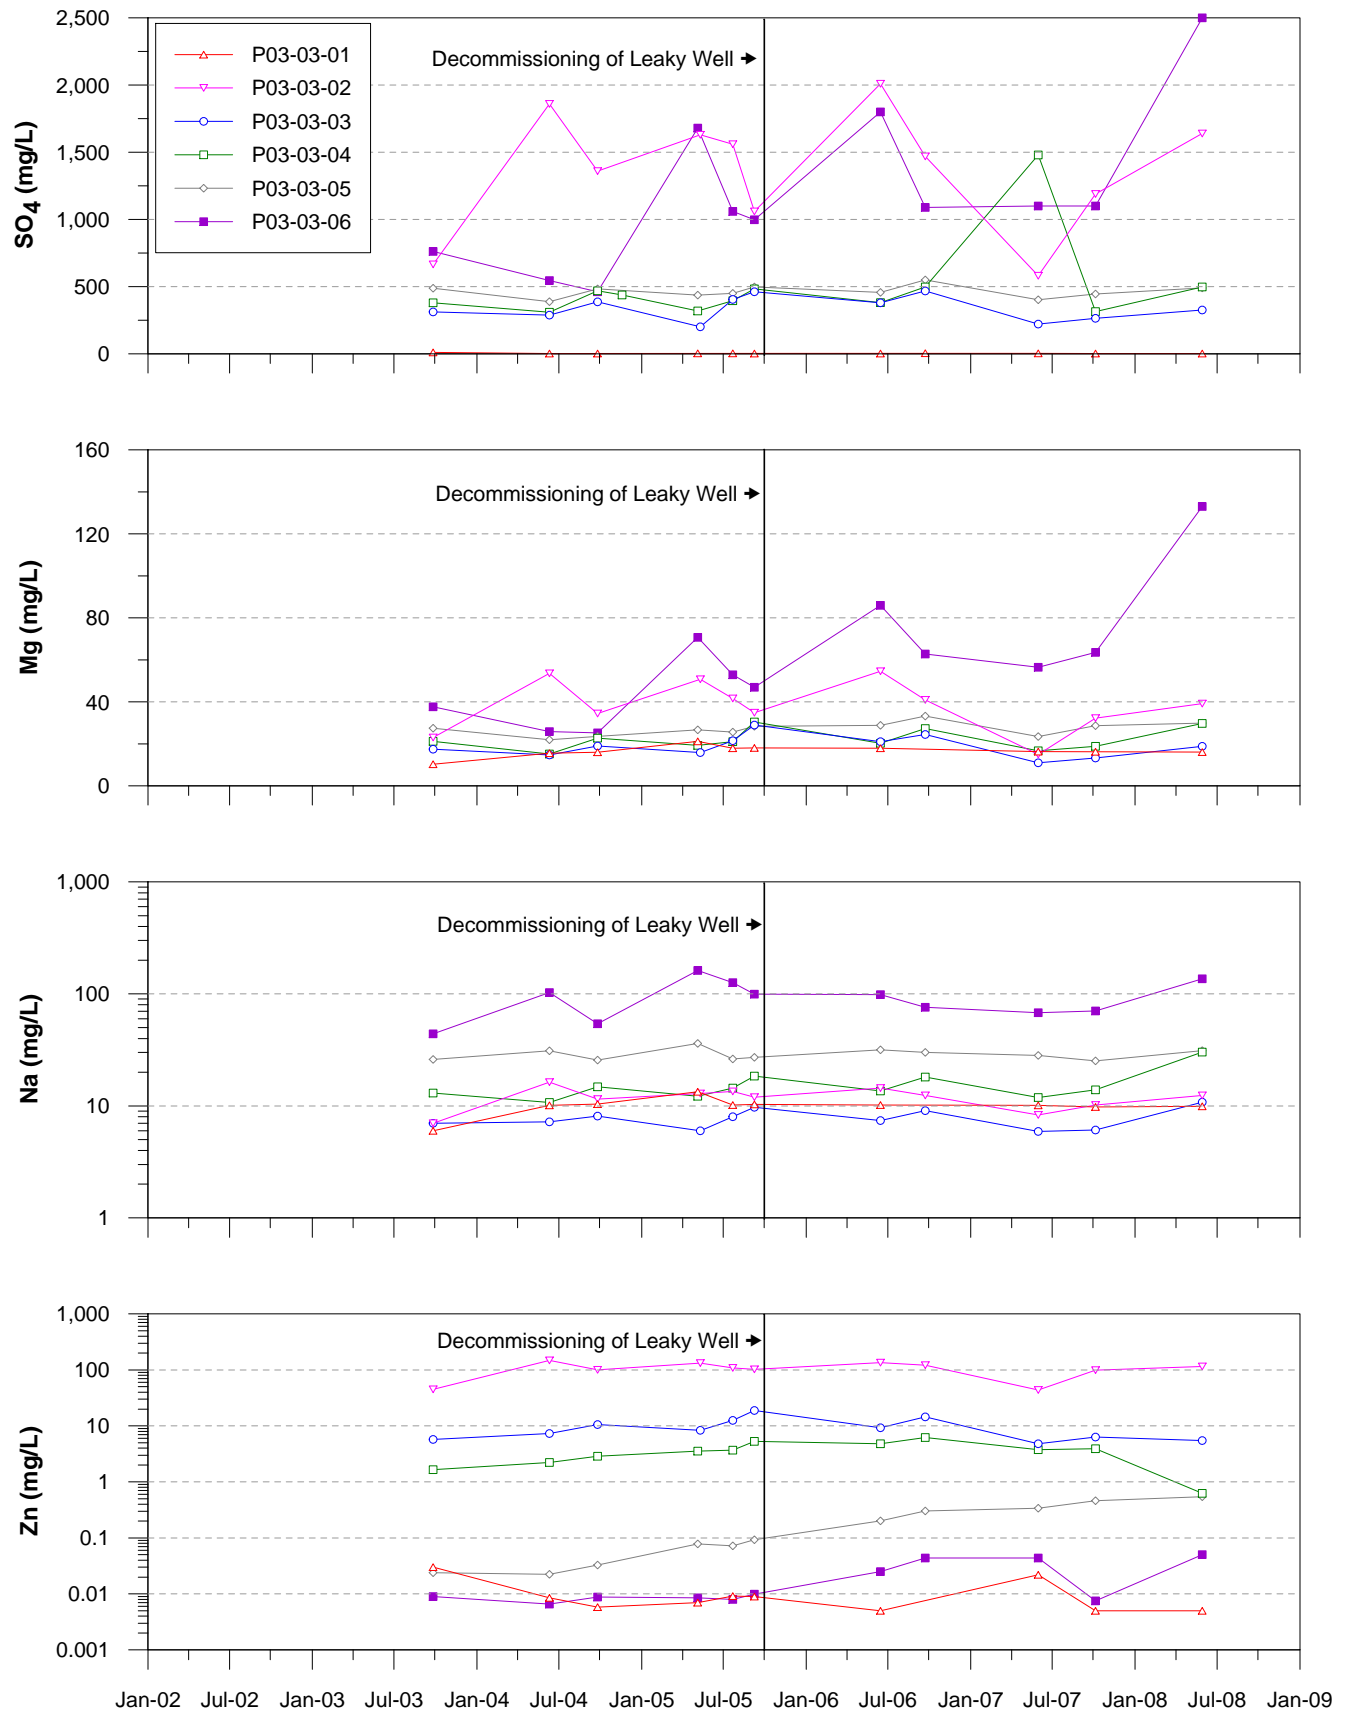
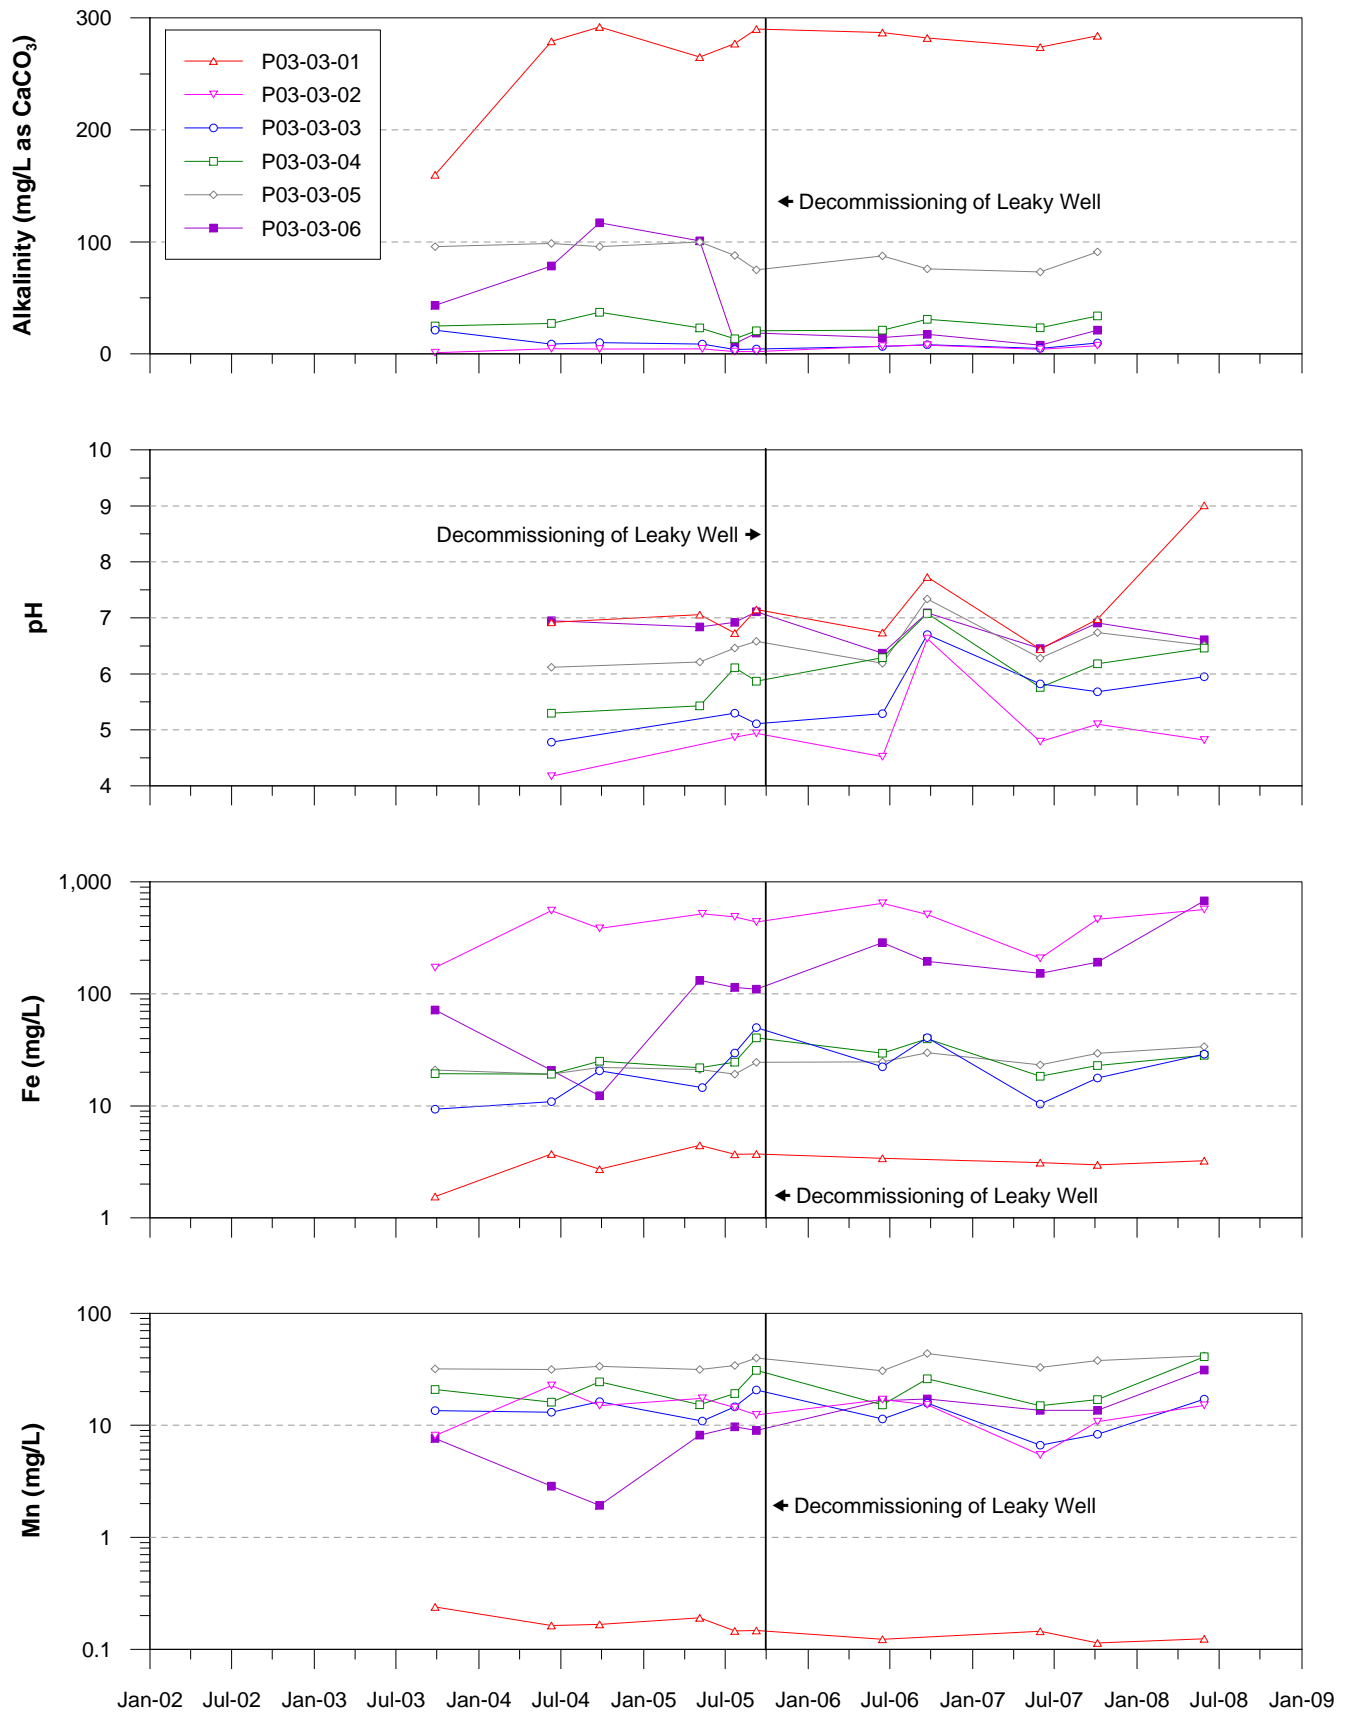
Figure 3-9a/b shows the time trends of selected water quality parameters for P03-03, located about 140-m downgradient of the decommissioned wells P01-09A/B/C/D. Previous analyses had suggested that leakage from P01-09 (in particular from P01-09E) is the most likely cause for the highly elevated SO<sub>4</sub> and Zn at depth at this location (RGC, 2006a; RGC, 2008). However, current time trends at this location are inconclusive. While a notable decrease in Zn concentrations since decommissioning has been observed in some piezometers (P03-03-03 and -04), other piezometers have shown an increase in Zn concentrations (P03-03-05 and -06). The most impacted piezometer (P03-03-02) initially showed a decrease in Zn (and SO<sub>4</sub>) concentrations but those contaminant concentrations rebounded in 2008. The lack of a rapid and consistent recovery in this highly impacted, deep piezometer after well decommissioning could be due to a slower than expected flushing of the residual contaminant plume. Alternatively, tailings seepage from further upgradient (unrelated to "leaky wells") could be the source of the highly elevated Zn concentrations observed at depth at this location.

Figure 3-9a. Water quality (SO<sub>4</sub>, Mg, Na and Zn) in P03-03 (aquifer only).

Figure 3-9b. Water quality (alkalinity, pH, Fe and Mn) in P03-03 (aquifer only).

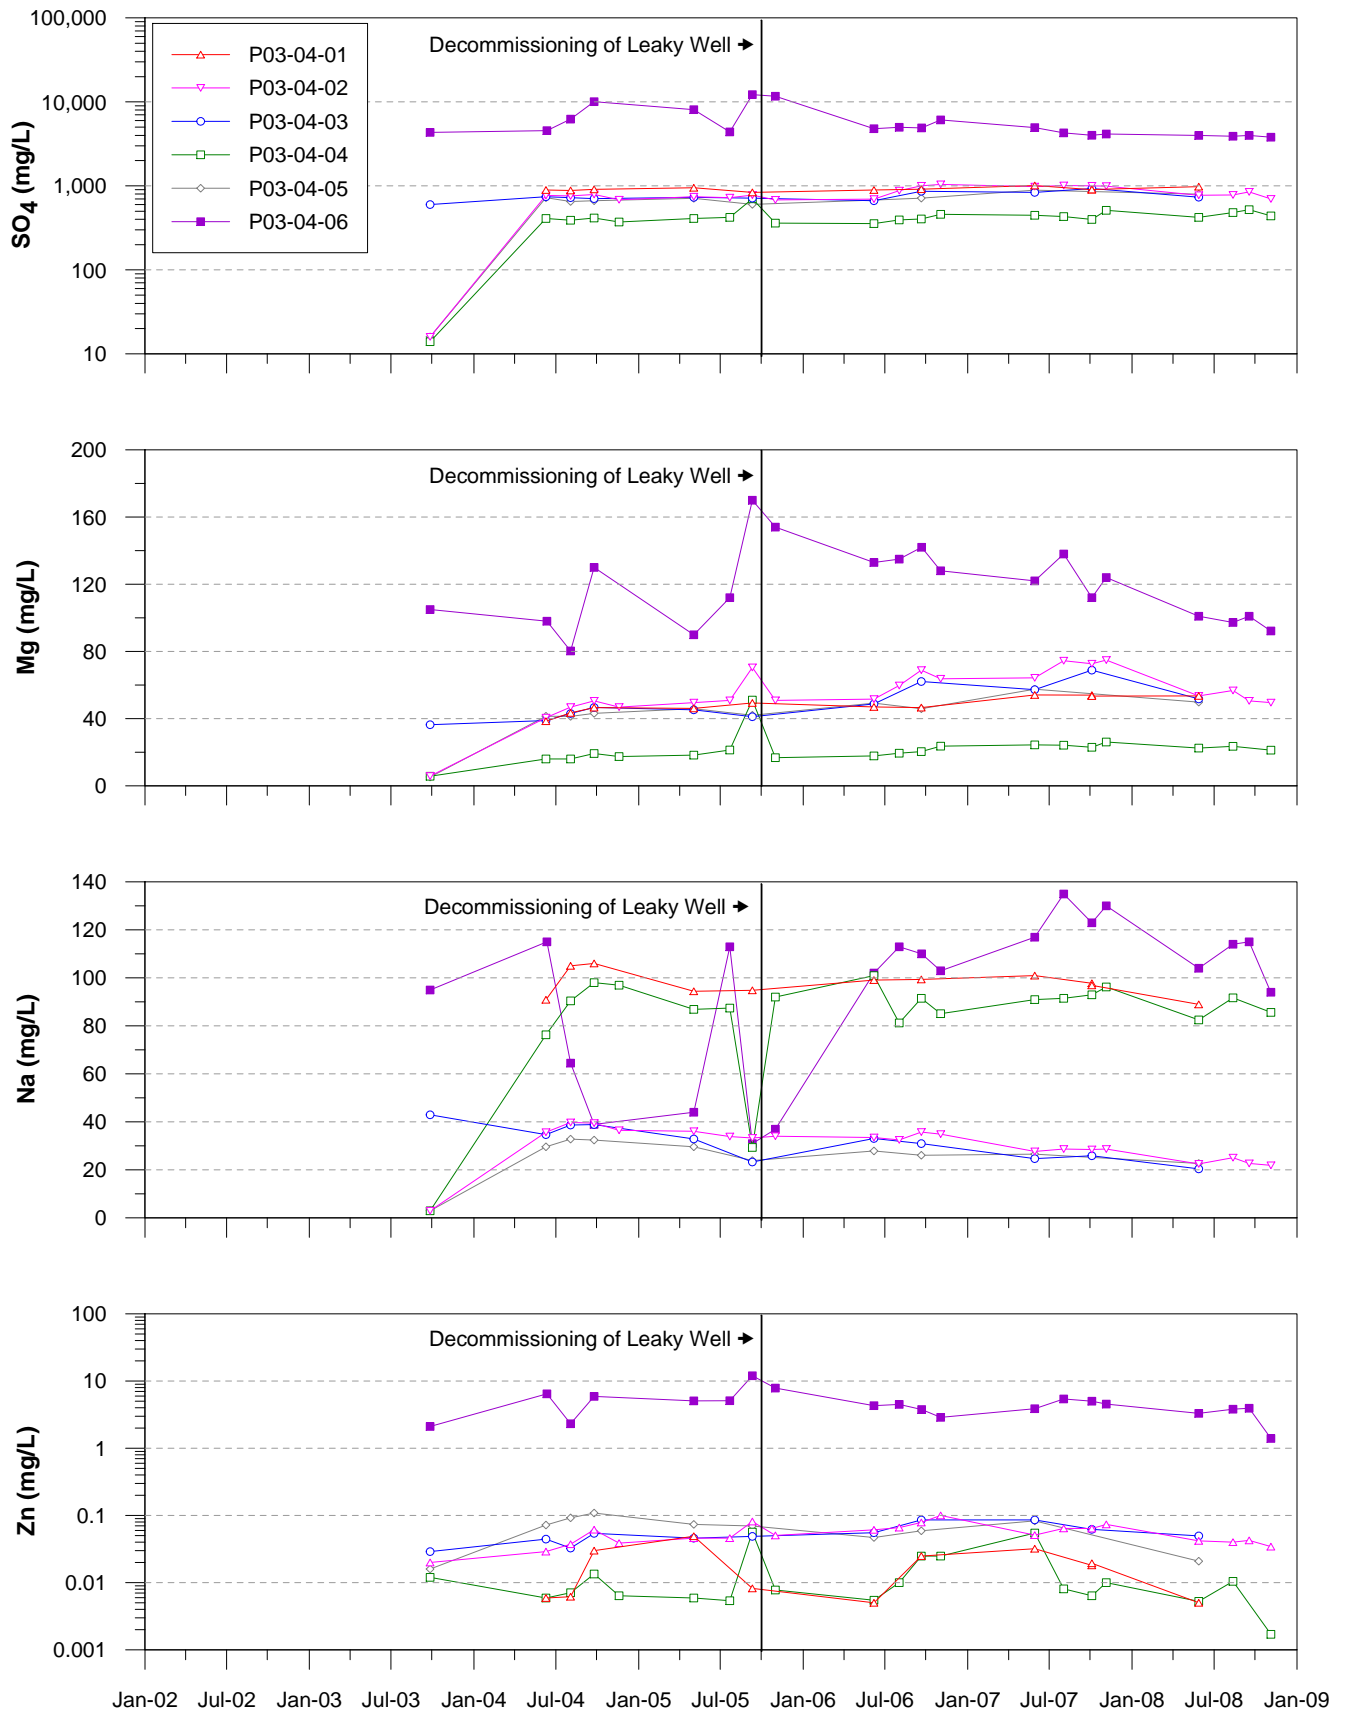
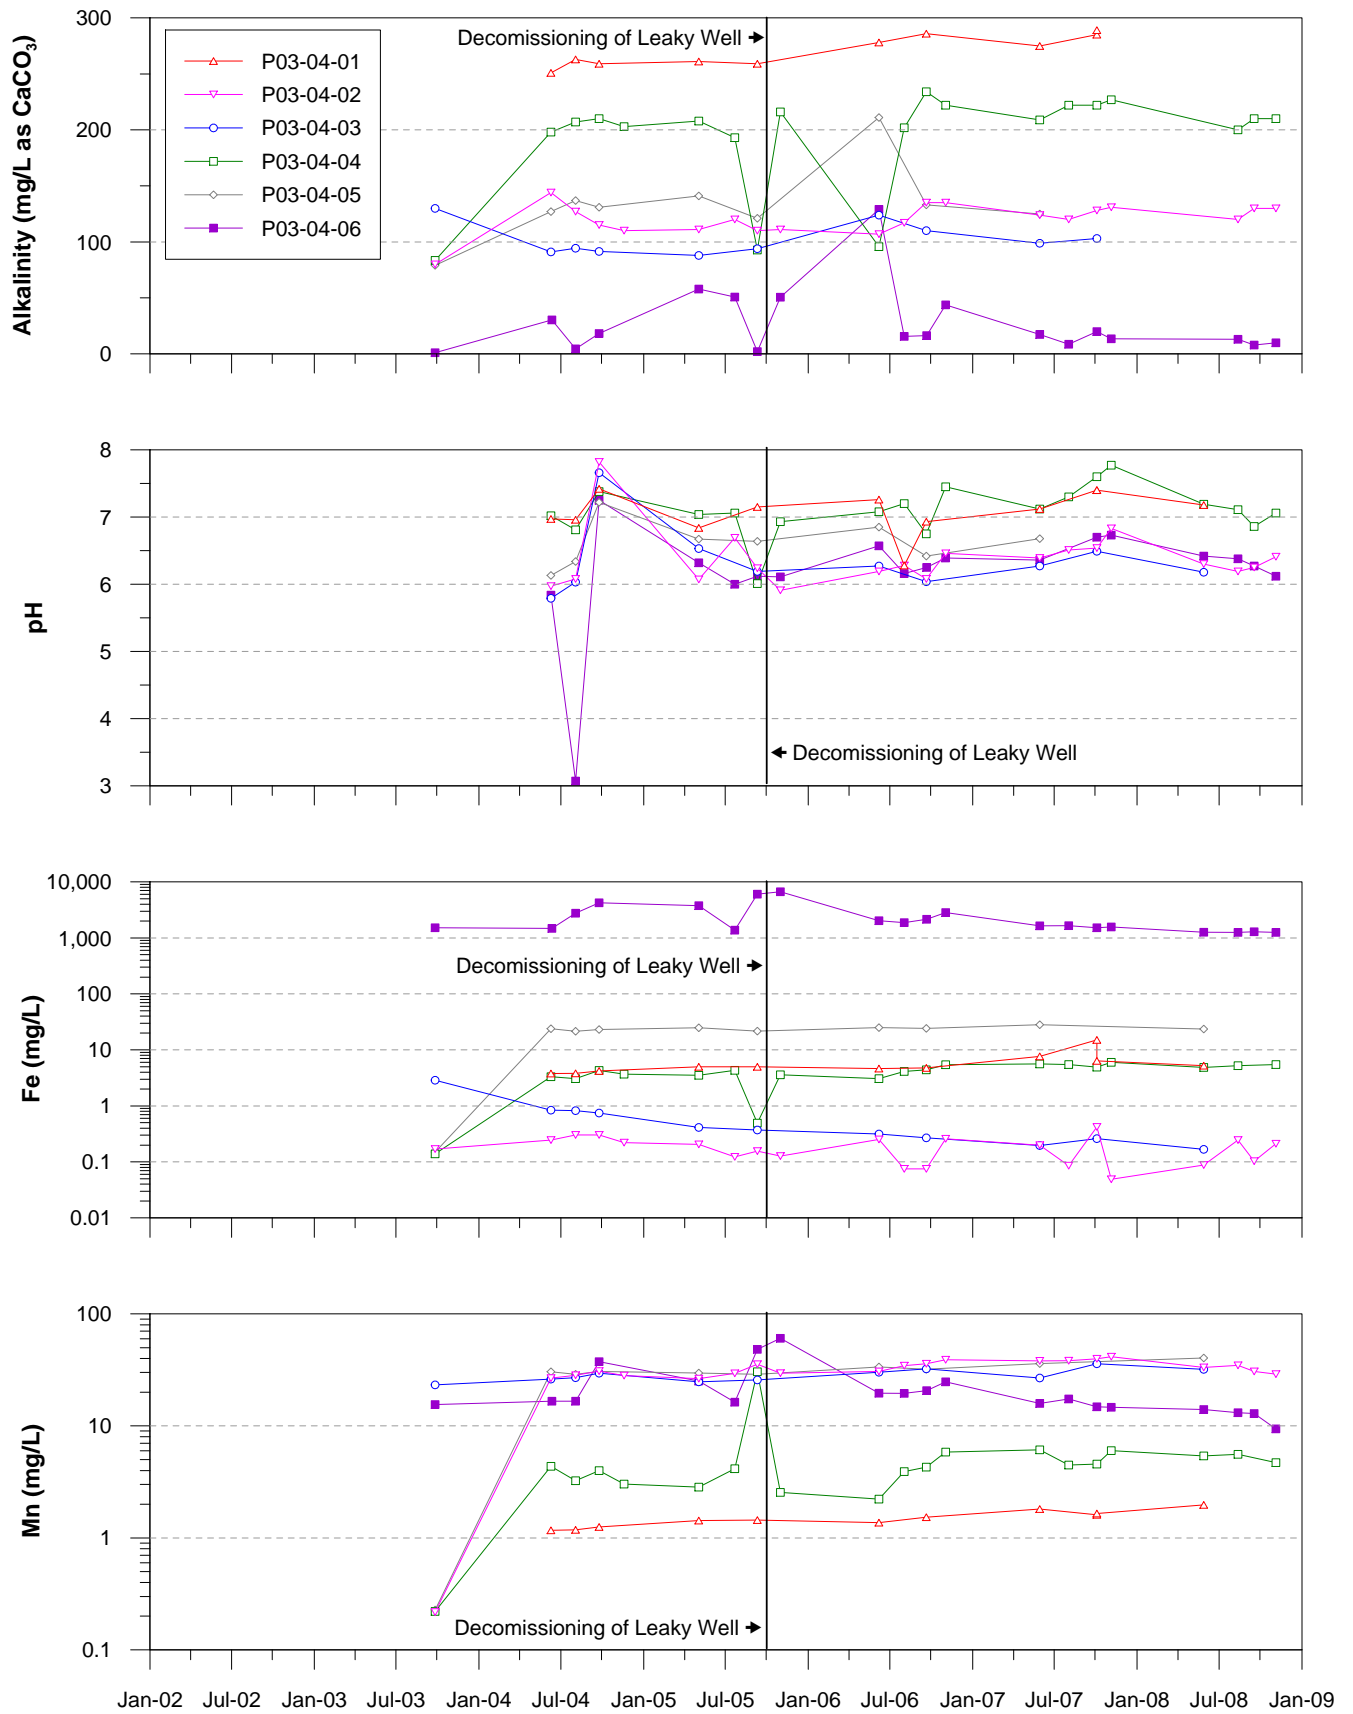
Figure 3-10a/b shows the time trends of selected water quality parameters for P03-04, located about 140-m downgradient of the decommissioned wells P01-07A/B/C/D/E. At this location, the shallow piezometer P03-04-06 (screened near the interface with the tailings) has shown a significant decrease in Zn and other ARD products (SO<sub>4</sub>, Mg, Mn and Fe) since decommissioning of the leaky wells. Contaminant concentrations in the deeper piezometers at this location (P03-04-01 to -05) all peaked around 2007 and started to decline in 2008. These observations would suggest that sealing of the leaky wells indeed reduced the contaminant loading and improved groundwater quality in the Rose Creek aquifer at P03-04.

Figure 3-10a. Water quality (SO<sub>4</sub>, Mg, Na and Zn) in P03-04 (aquifer only).

Figure 3-10b. Water quality (alkalinity, pH, Fe and Mn) in P03-04 (aquifer only).

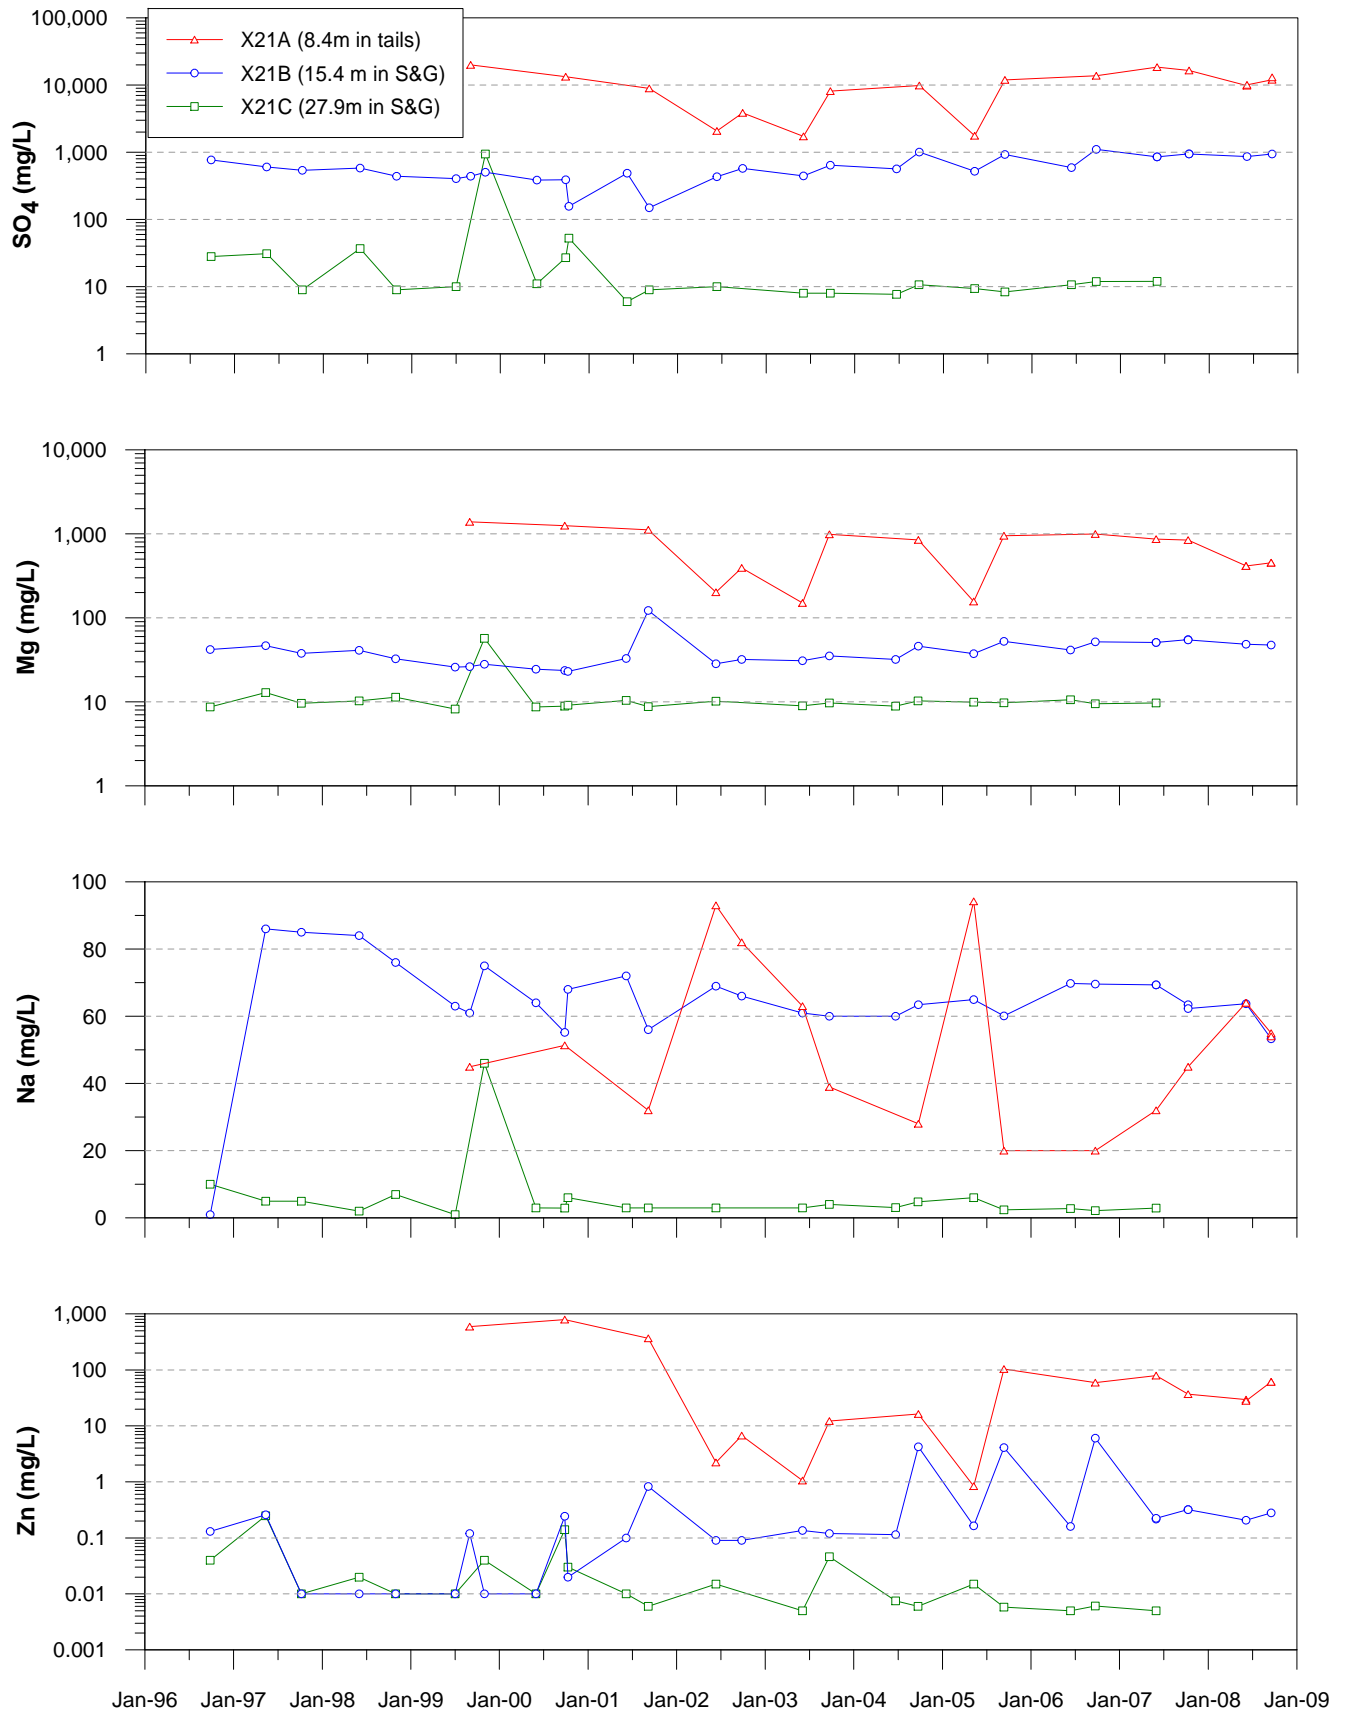
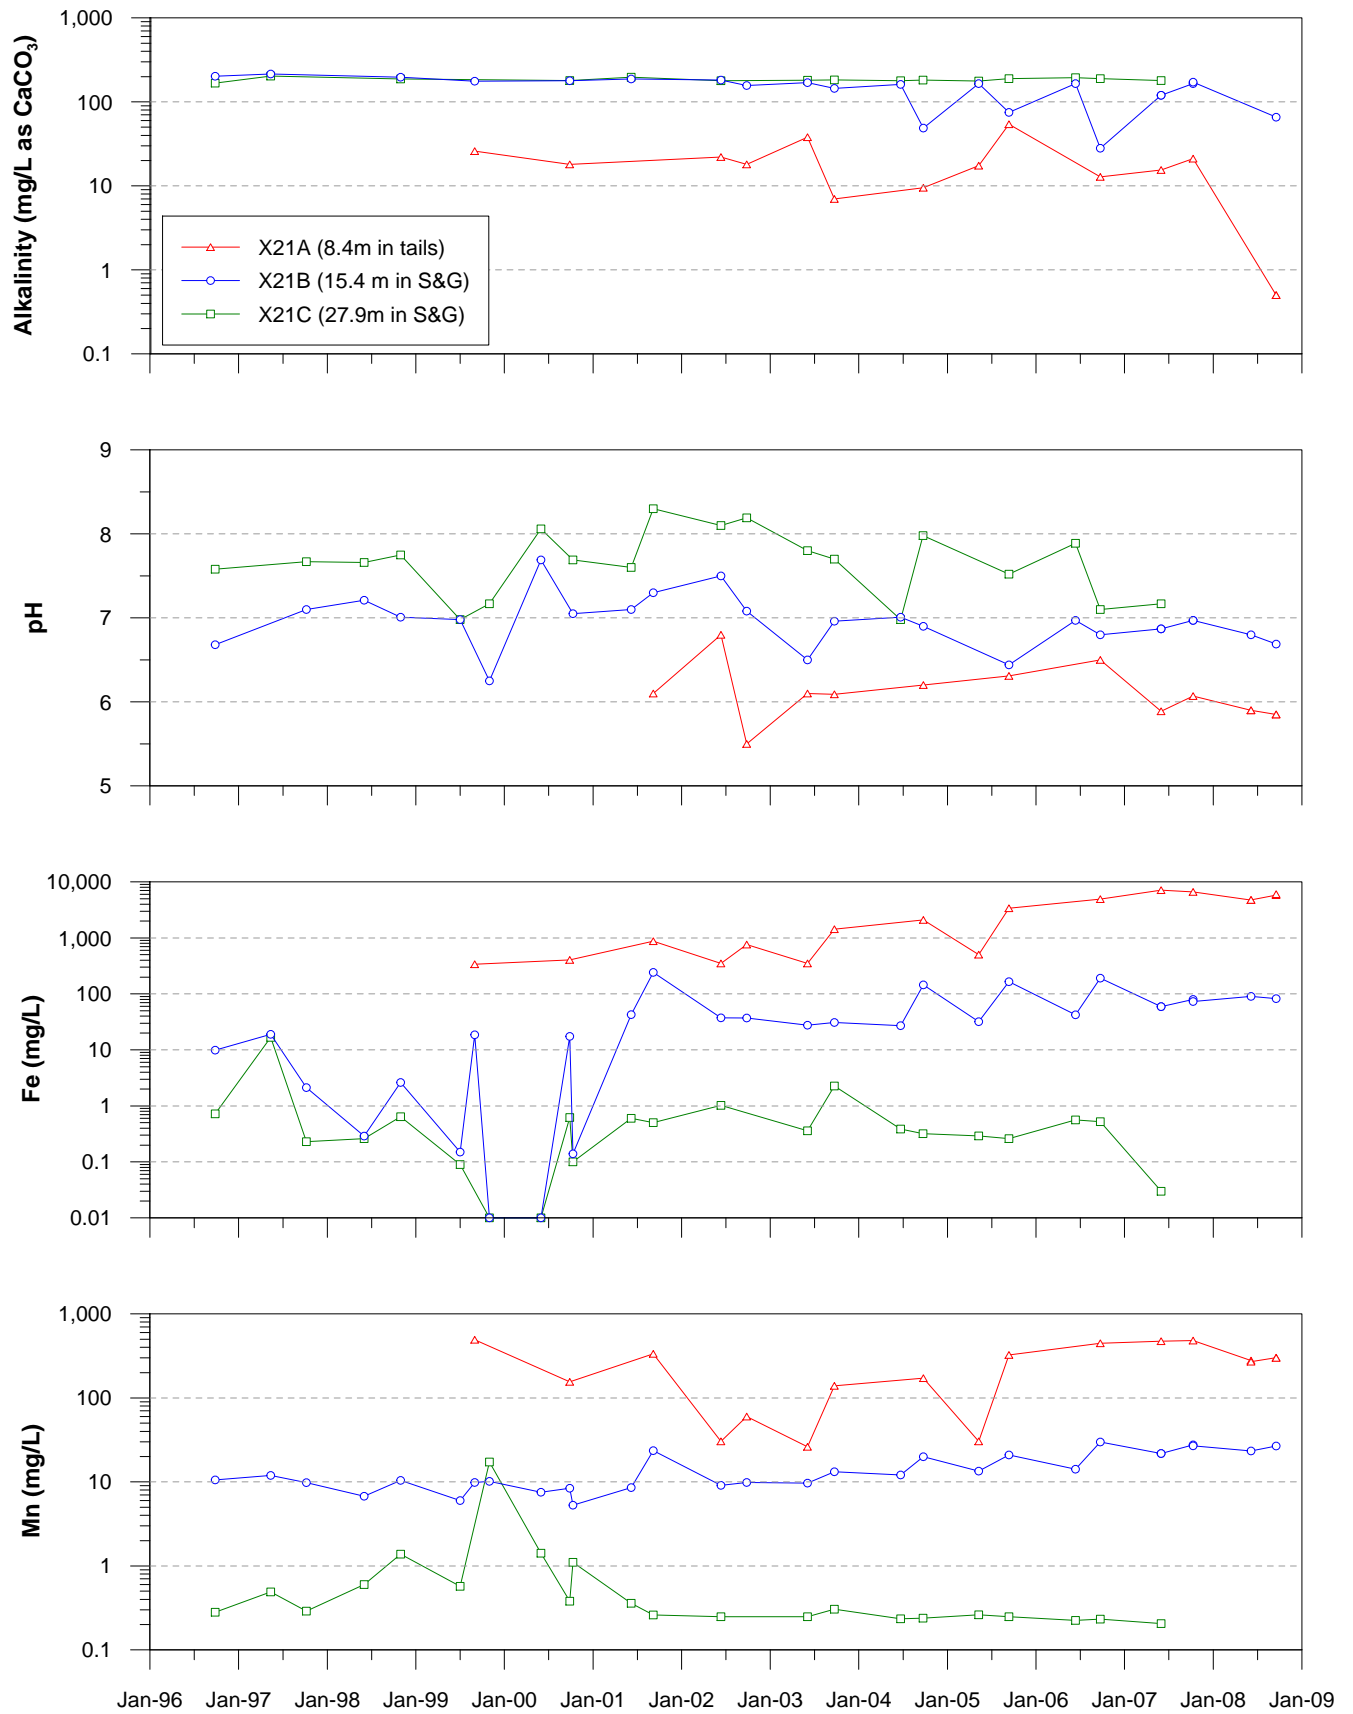
Water quality time trends for the X21 well series are shown in Figures 3-11a/b. Aside from the increase in Na concentration observed in X21A, groundwater quality in X21A and X21B did not change during the current monitoring period and no new data for X21C was available.

Note that monitoring wells X21A/B have not shown the same increase in  $\text{SO}_4$  and Zn concentrations in the aquifer that have been observed in recent years at P03-06. Assuming a direct hydraulic connection in a contiguous aquifer, a similar breakthrough (at least of  $\text{SO}_4$ ) would be expected at X21A/B in about 2 to 10 years.

Figure 3-11a. Water quality ( $\text{SO}_4$ , Mg, Na and Zn) in X21(96) (Intermediate Impoundment).

Figure 3-11b. Water quality (Alkalinity, pH, Fe and Mn) in X21(96) (Intermediate Impoundment).

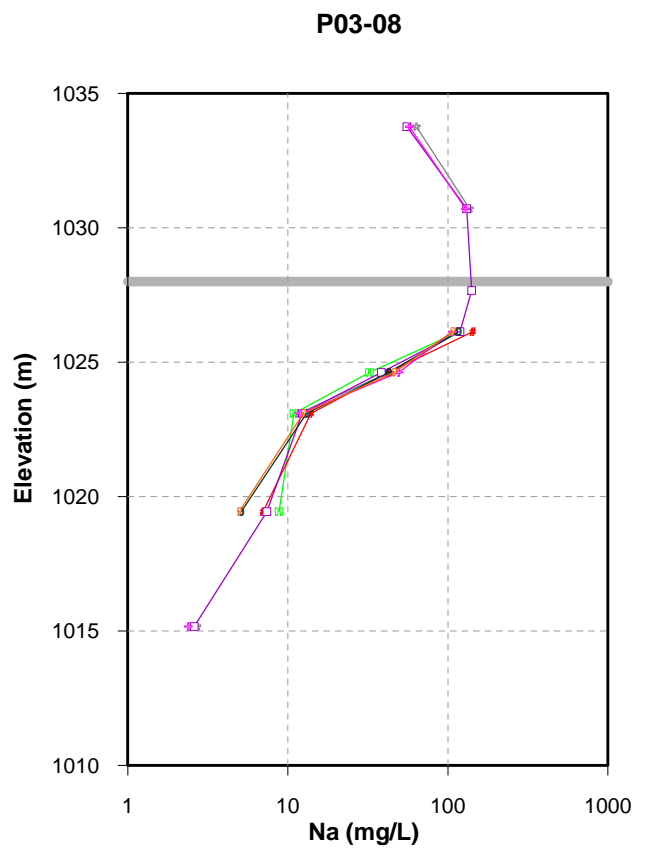
Water quality depth profiles for P03-08 are shown in Figure 3-12a/b. Depth profiles for the current monitoring period were similar to those defined by previously-collected data and no appreciable changes in water quality were observed.

Figure 3-12a. Water quality depth profiles of SO<sub>4</sub>, Mg, Zn and Na in P03-08 (Intermediate Impoundment).
