Report No. 118014/1

**2008 GROUNDWATER REVIEW**  
**ANVIL RANGE MINING COMPLEX, YUKON TERRITORY**

**Faro Mine Closure Planning Office**

**February 2009**

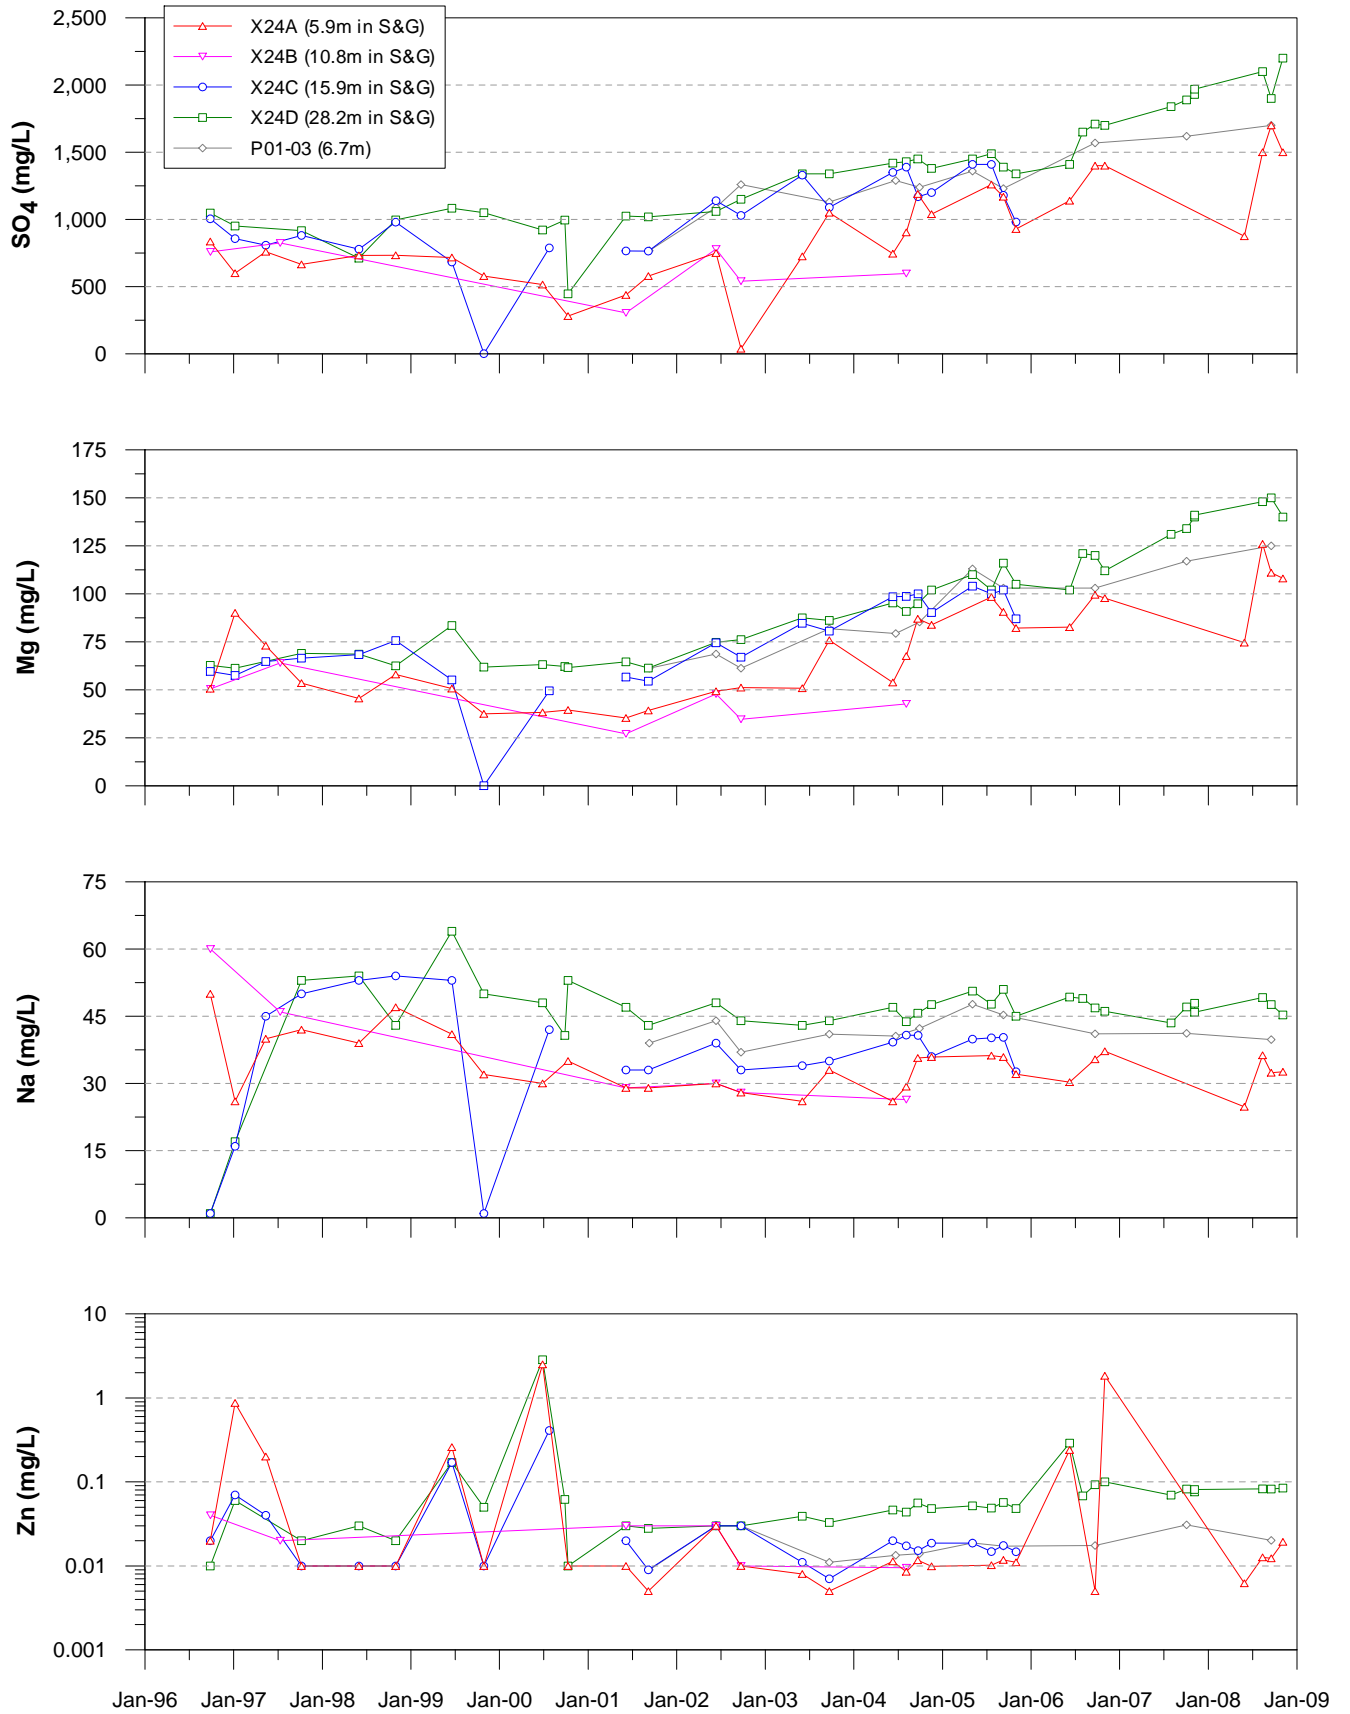
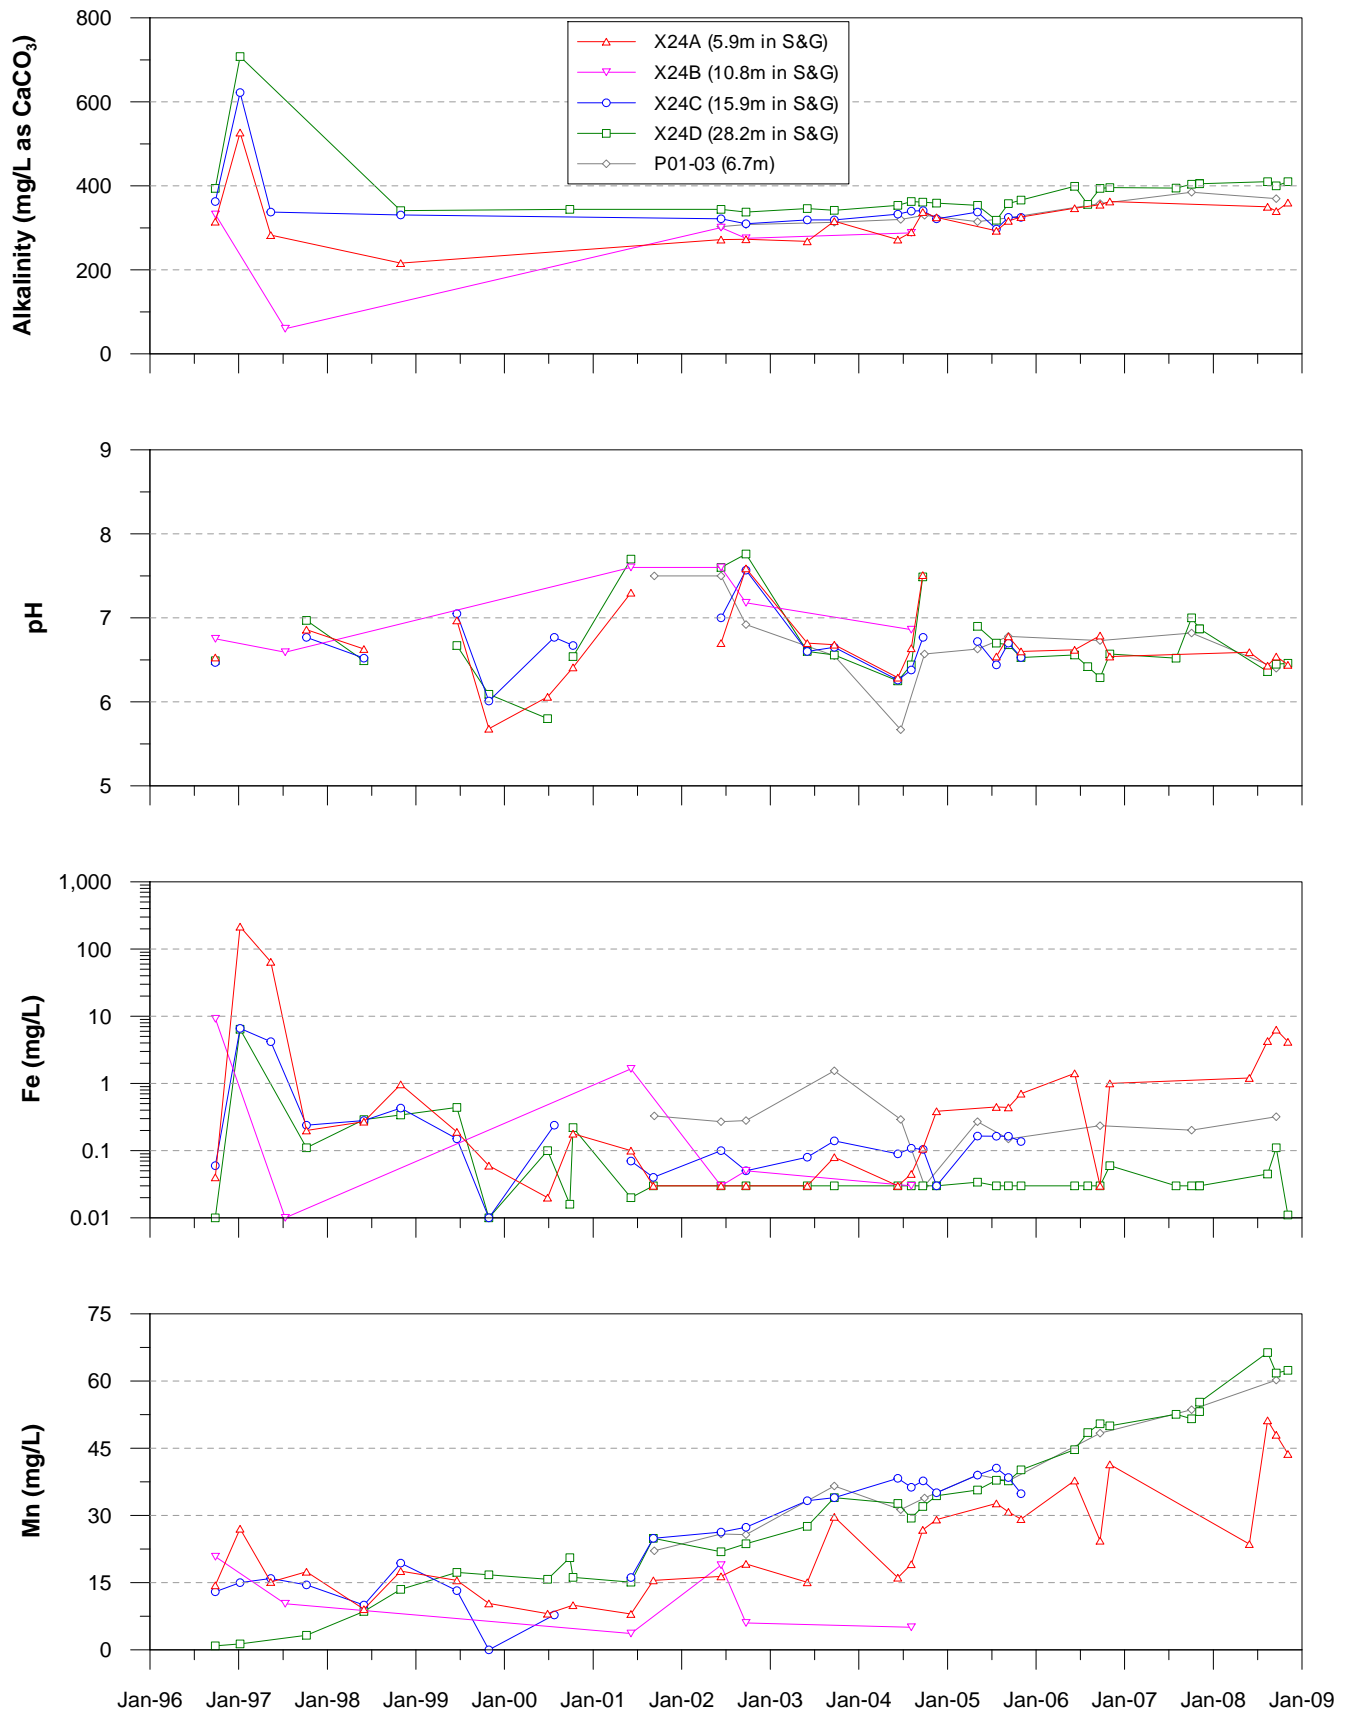
Figure 3-13a/b illustrates the water quality time trends for wells located in the northern section of the Intermediate Dam (X24A/B/C/D and P01-03). Since 2001, SO<sub>4</sub>, Mg, Zn and Mn concentrations have increased in each of these wells. This trend continued throughout most of the current monitoring period. Note that the highest contaminant concentrations have been consistently observed in the deepest well (X24D).

Figure 3-13a. Water quality (SO<sub>4</sub>, Mg, Na and Zn) in X24(96) and P01-03 (north side of Intermediate Dam).

Figure 3-13b. Water quality (alkalinity, pH, Fe and Mn) in X24(96) and P01-03 (north side of Intermediate Dam).

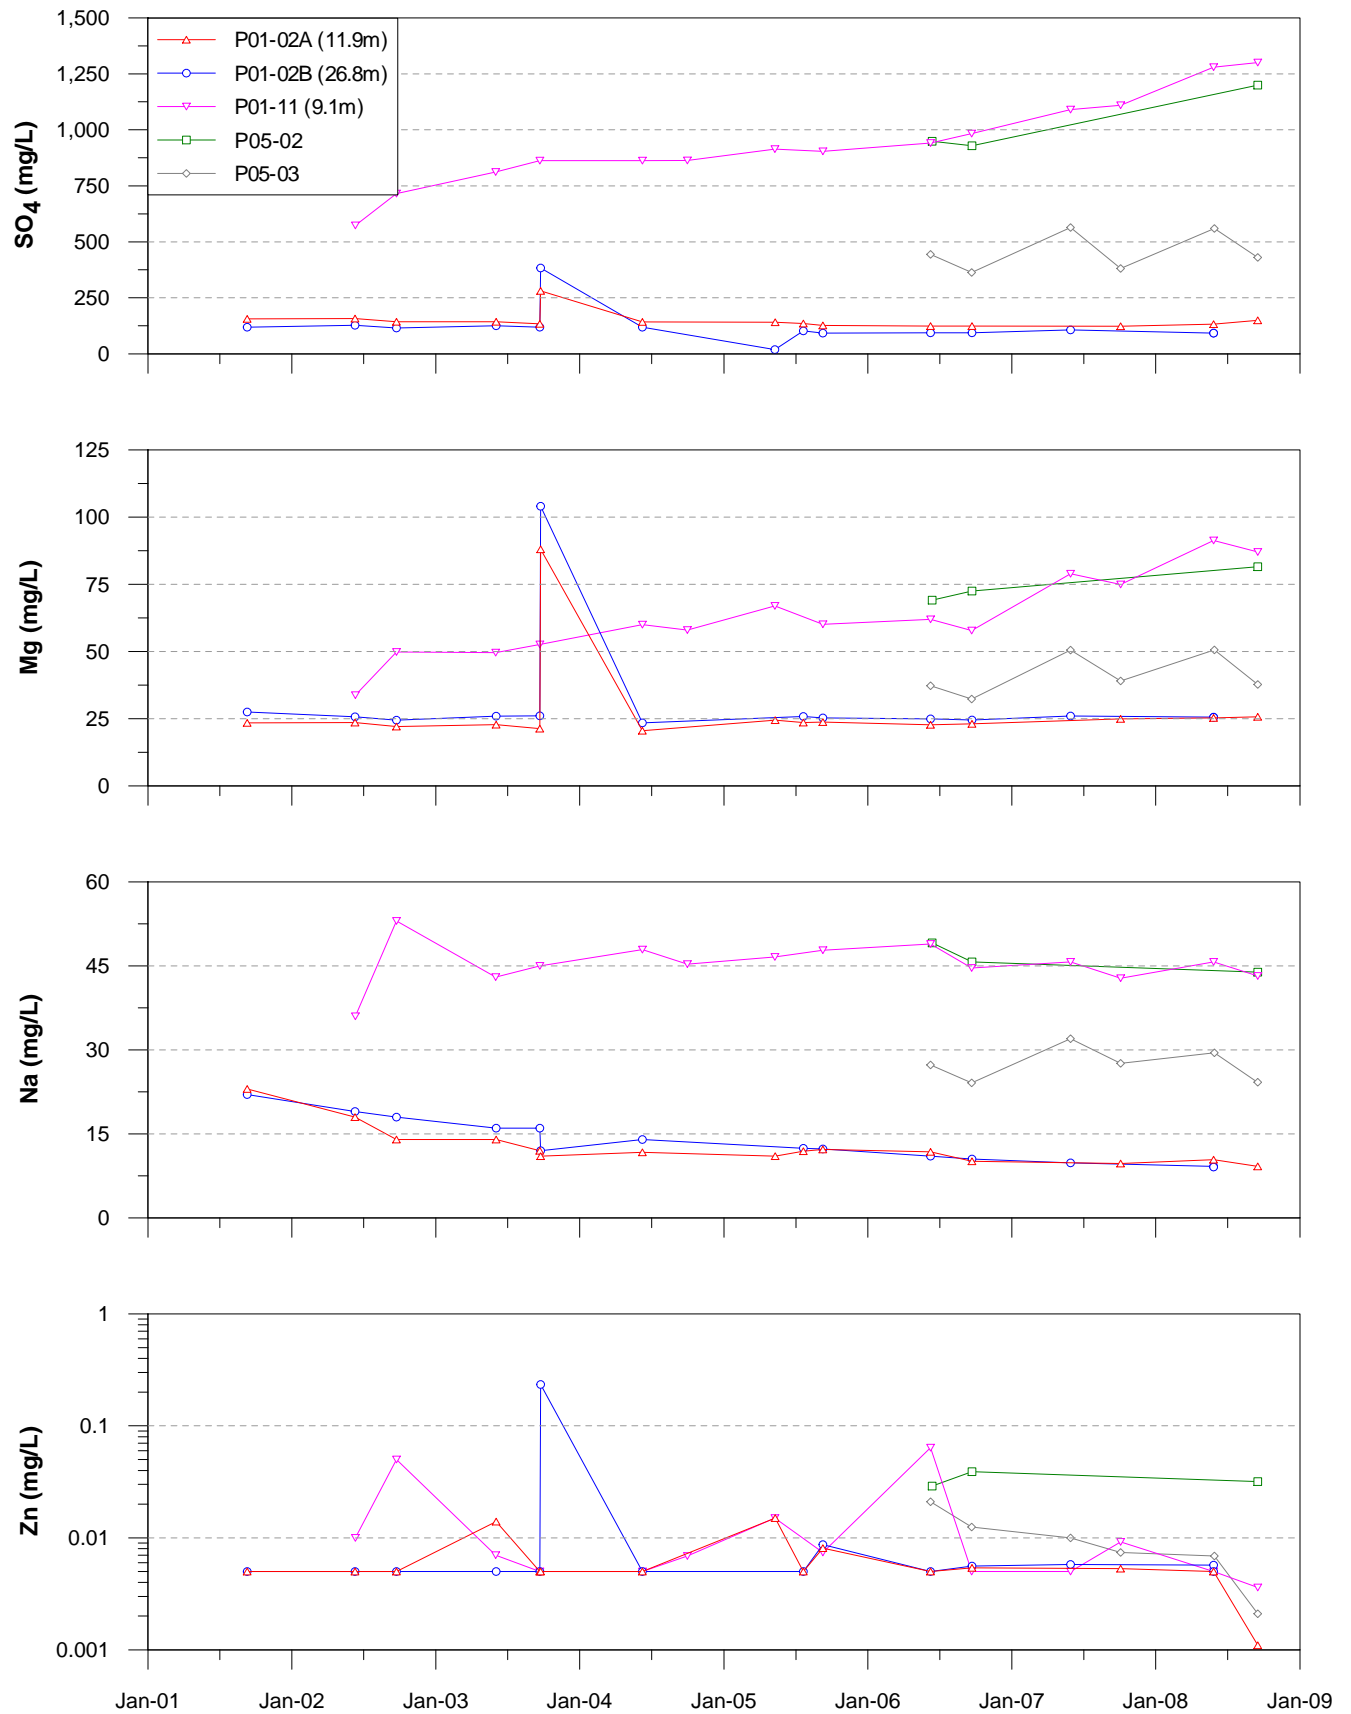
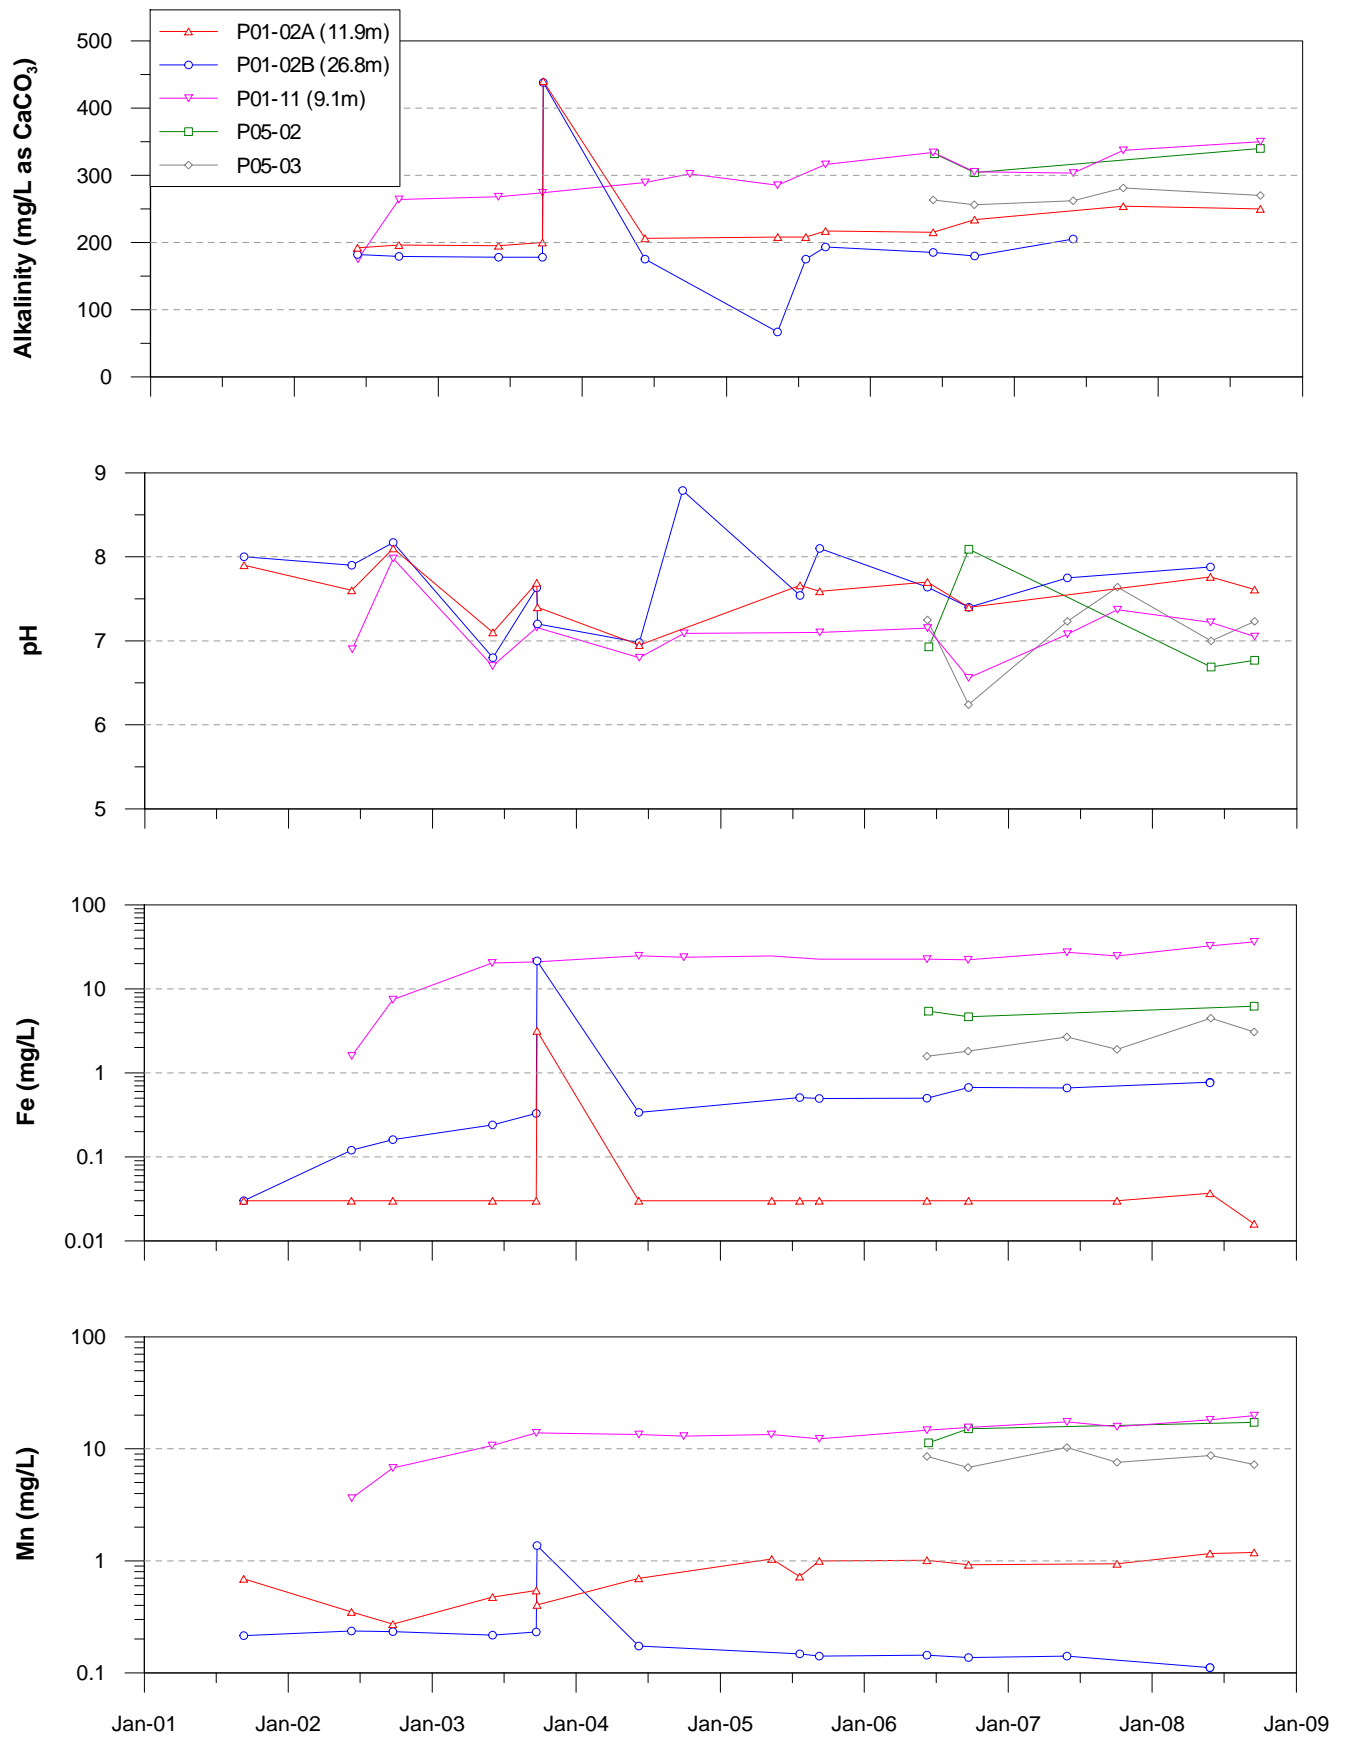
Water quality time trends in the wells screened at the toe of the Cross Valley Dam are shown in Figures 3-15a/b to 3-17a/b. Concentrations of oxidation products (i.e. SO<sub>4</sub>, Mg, and alkalinity) and Mn continued to increase in wells located along the northern toe of the Cross Valley Dam (P01-11, P05-01 and P05-02). This gradual increase in oxidation products (primarily SO<sub>4</sub> and Mg) on the north side of Cross Valley Dam mimics the breakthrough of those constituents observed further upgradient at the Intermediate Dam (at X24), except for a delay by about 3-4 years.

Figure 3-15a. Water quality (SO<sub>4</sub>, Mg, Na and Zn) in wells along toe of Cross Valley Dam.

Figure 3-15b. Water quality (alkalinity, pH, Fe and Mn) in wells along toe of Cross Valley Dam.

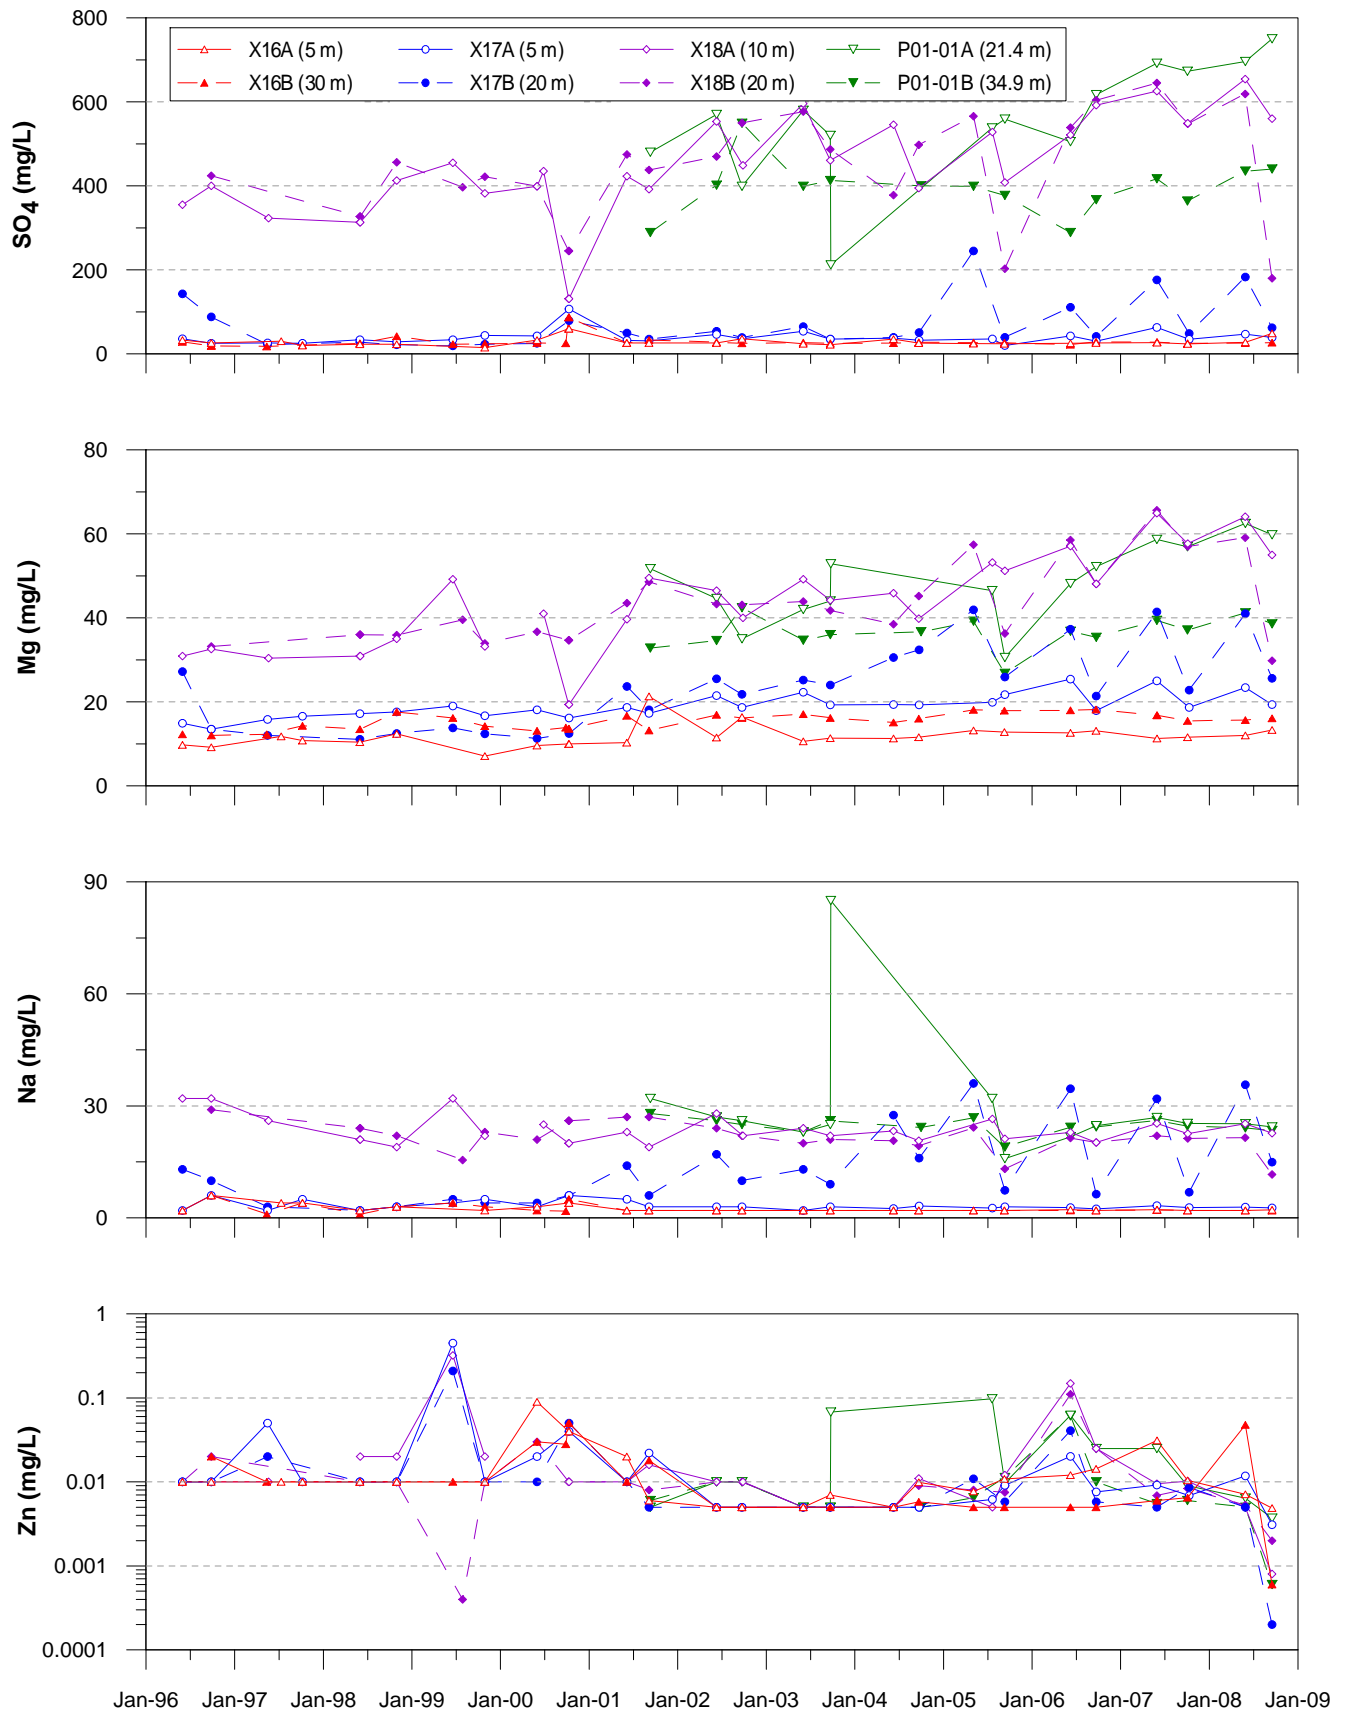
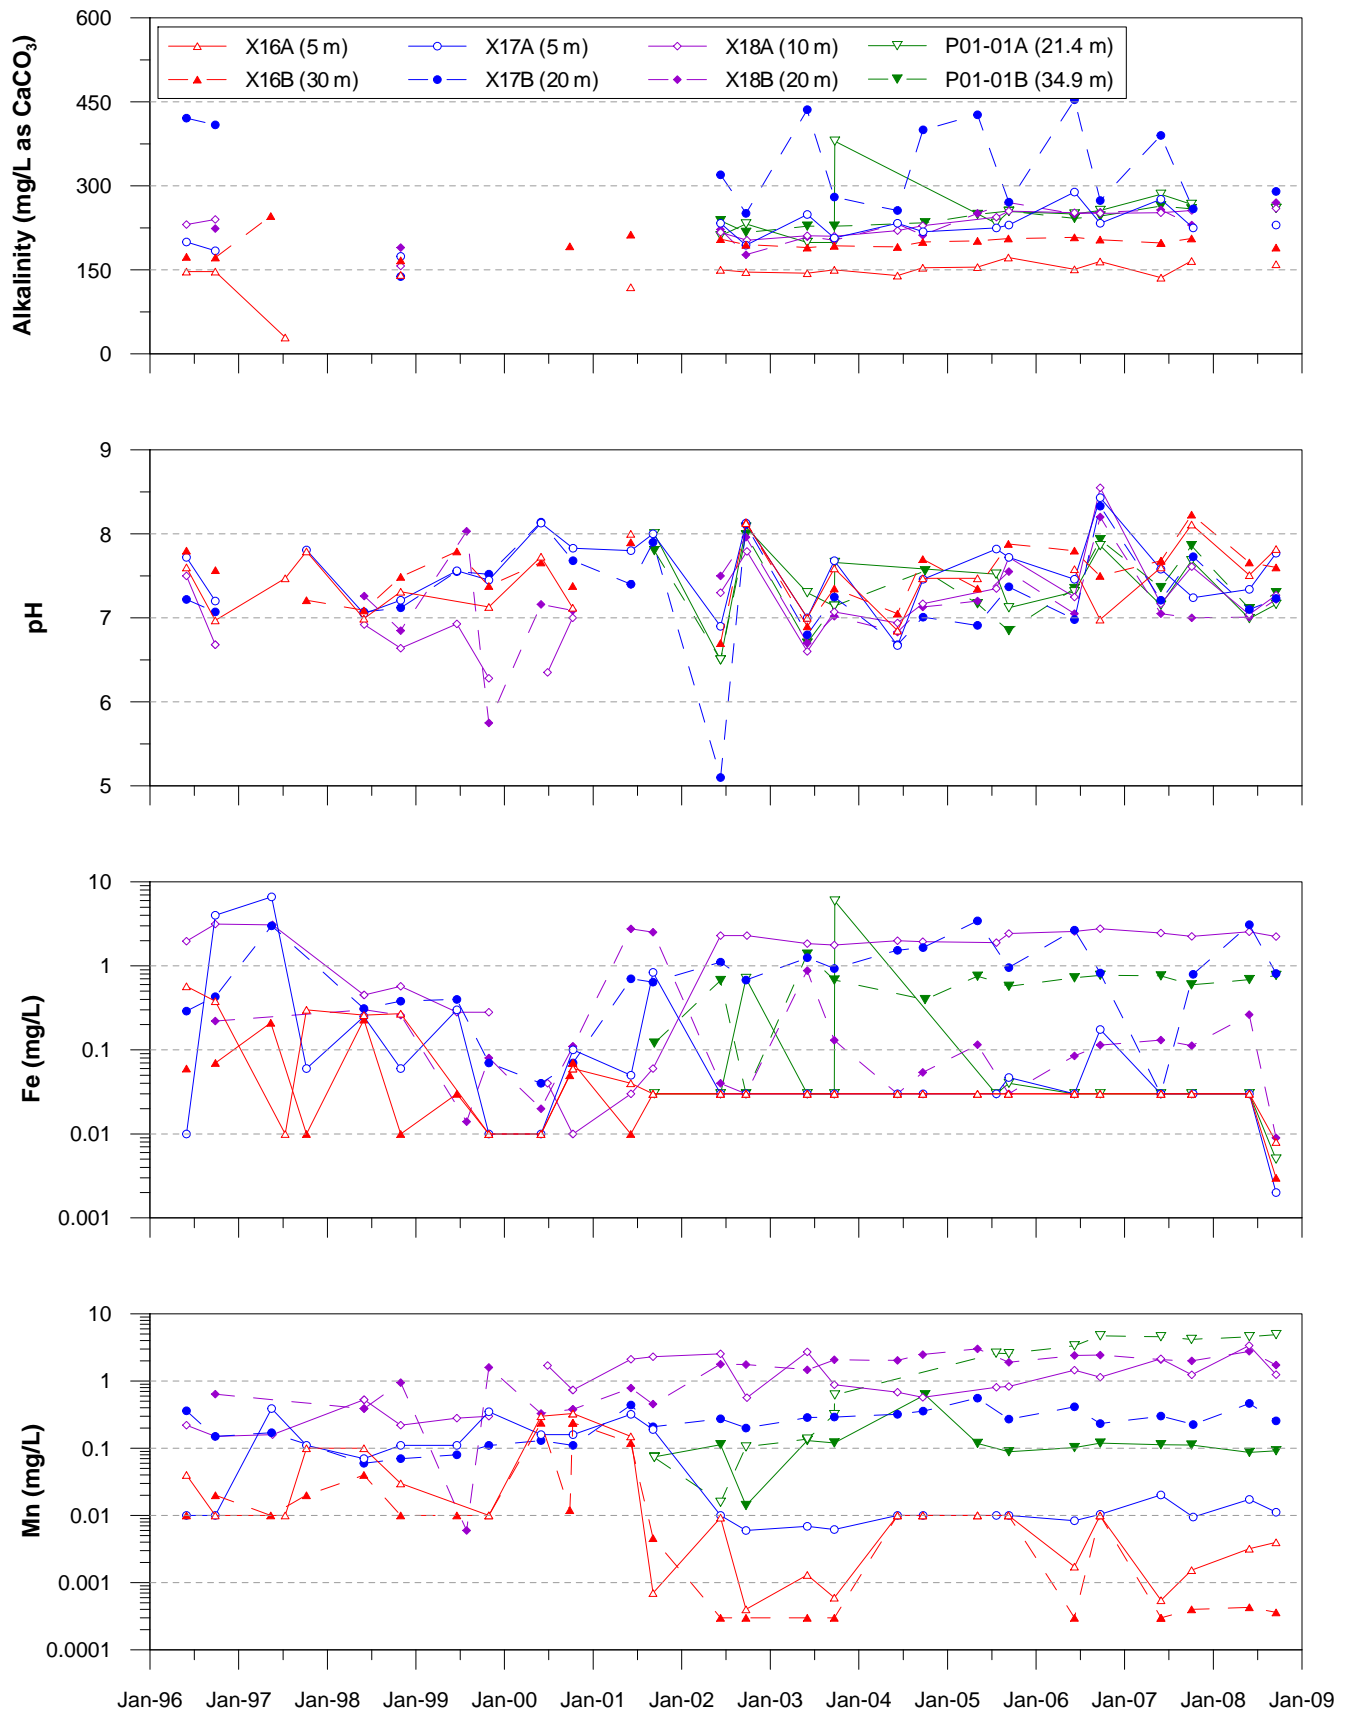
Figures 3-18a/b show the water quality time trends in wells (X16A/B, X17A/B, X18A/B and P01-01A/B) located at some distance down-gradient of the Cross Valley Dam. Monitoring wells located on the northern side of Rose Creek Valley (X18A/B, P01-01A/B) continued to show an increase in oxidation products (SO<sub>4</sub> and Mg) during the current monitoring period. As observed near the Cross Valley Dam, Zn concentrations remained constant or actually decreased in 2008.

This gradual increase in oxidation products (primarily SO<sub>4</sub> and Mg) on the north side of Rose Creek aquifer is believed to represent the leading edge of the breakthrough of those constituents observed further upgradient at the Cross Valley Dam (P01-11, P05-01) and ultimately at the Intermediate Dam (at X24). It is therefore anticipated that concentrations of SO<sub>4</sub> and Mg, and eventually Zn and other metals (Fe, Mn) will continue to increase over time.

Figure 3-18a. Water quality (SO<sub>4</sub>, Mg, Na and Zn) in wells downgradient of Cross Valley Dam.

Figure 3-18b. Water quality (alkalinity, pH, Fe and Mn) in wells downgradient of Cross Valley Dam.

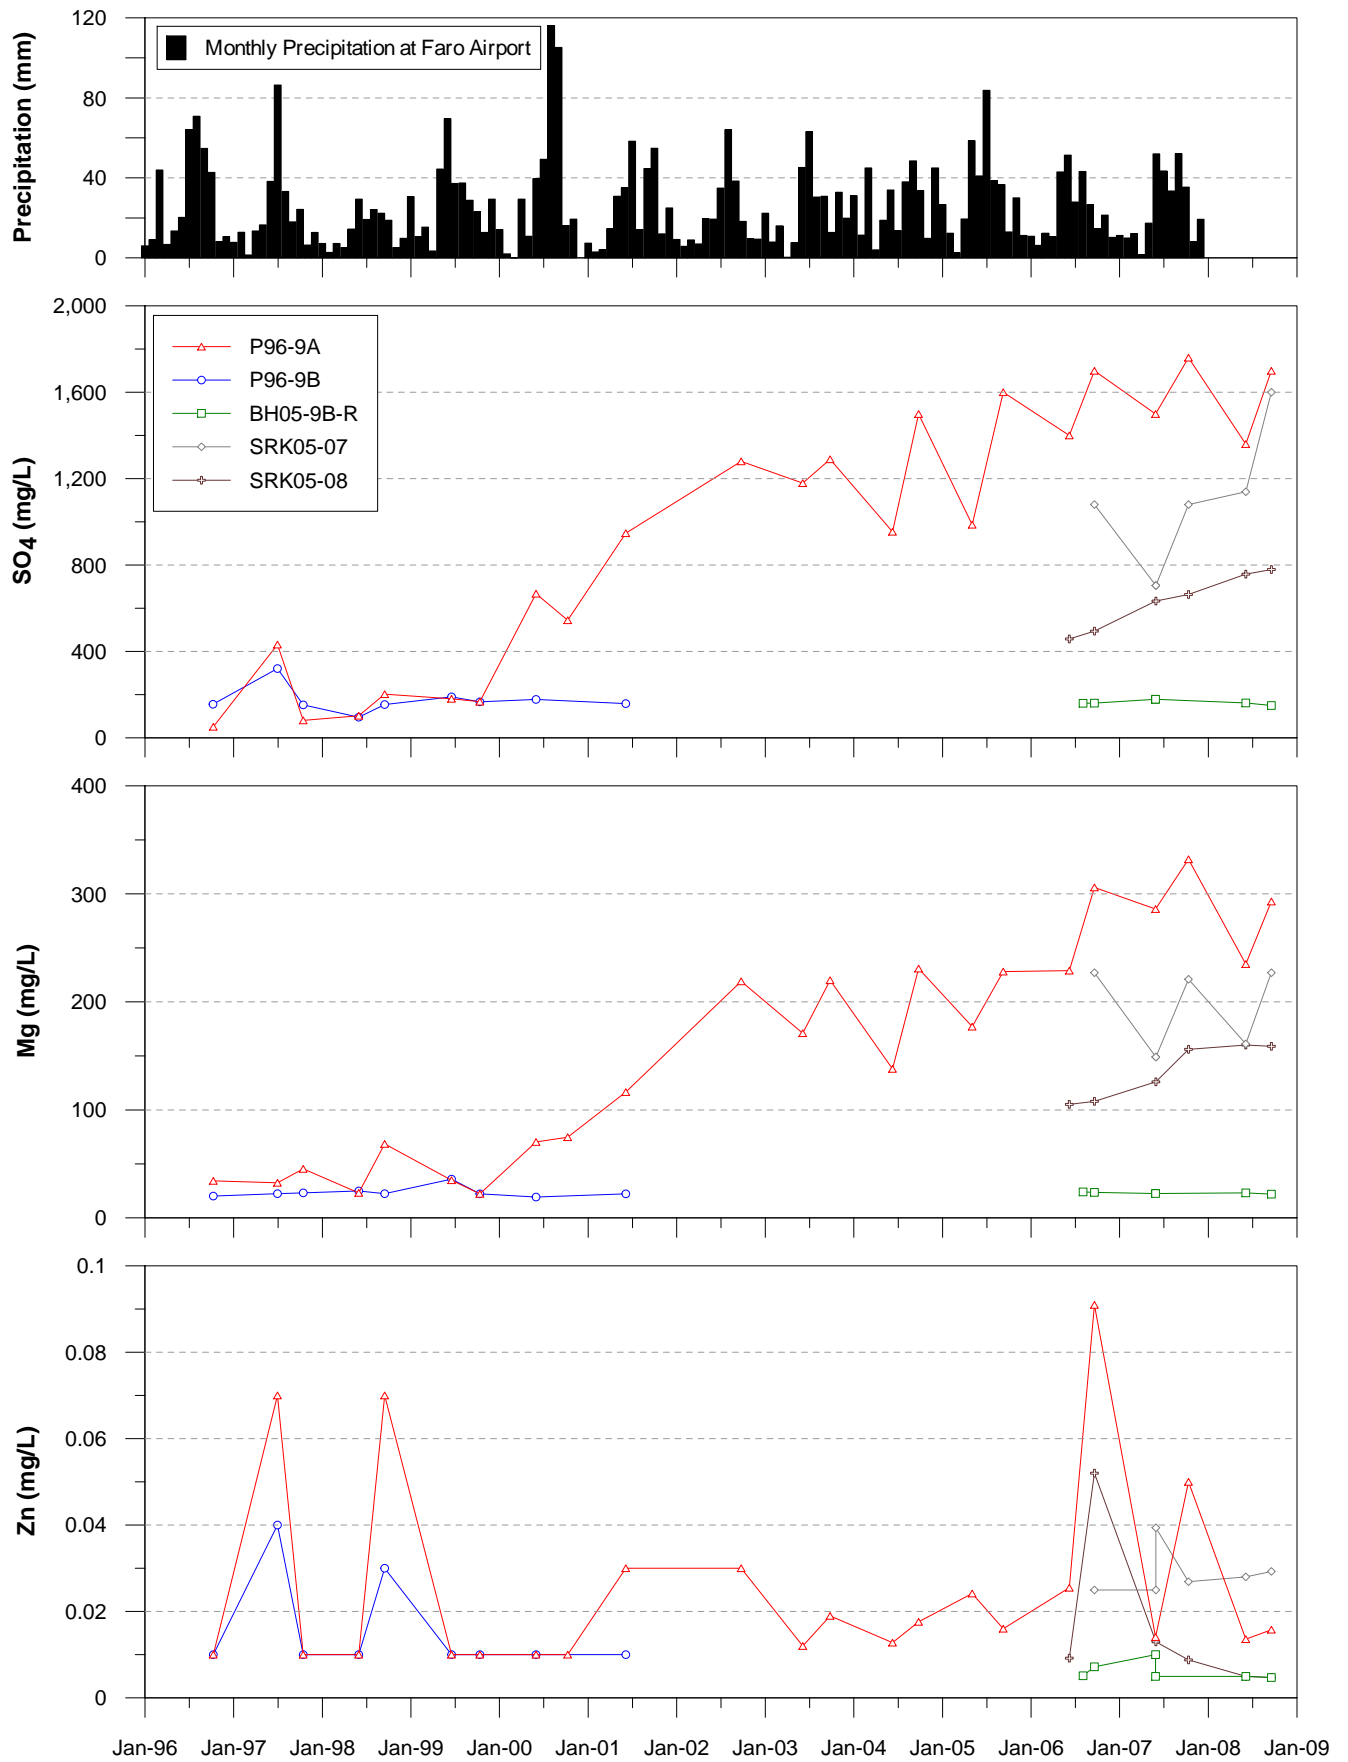
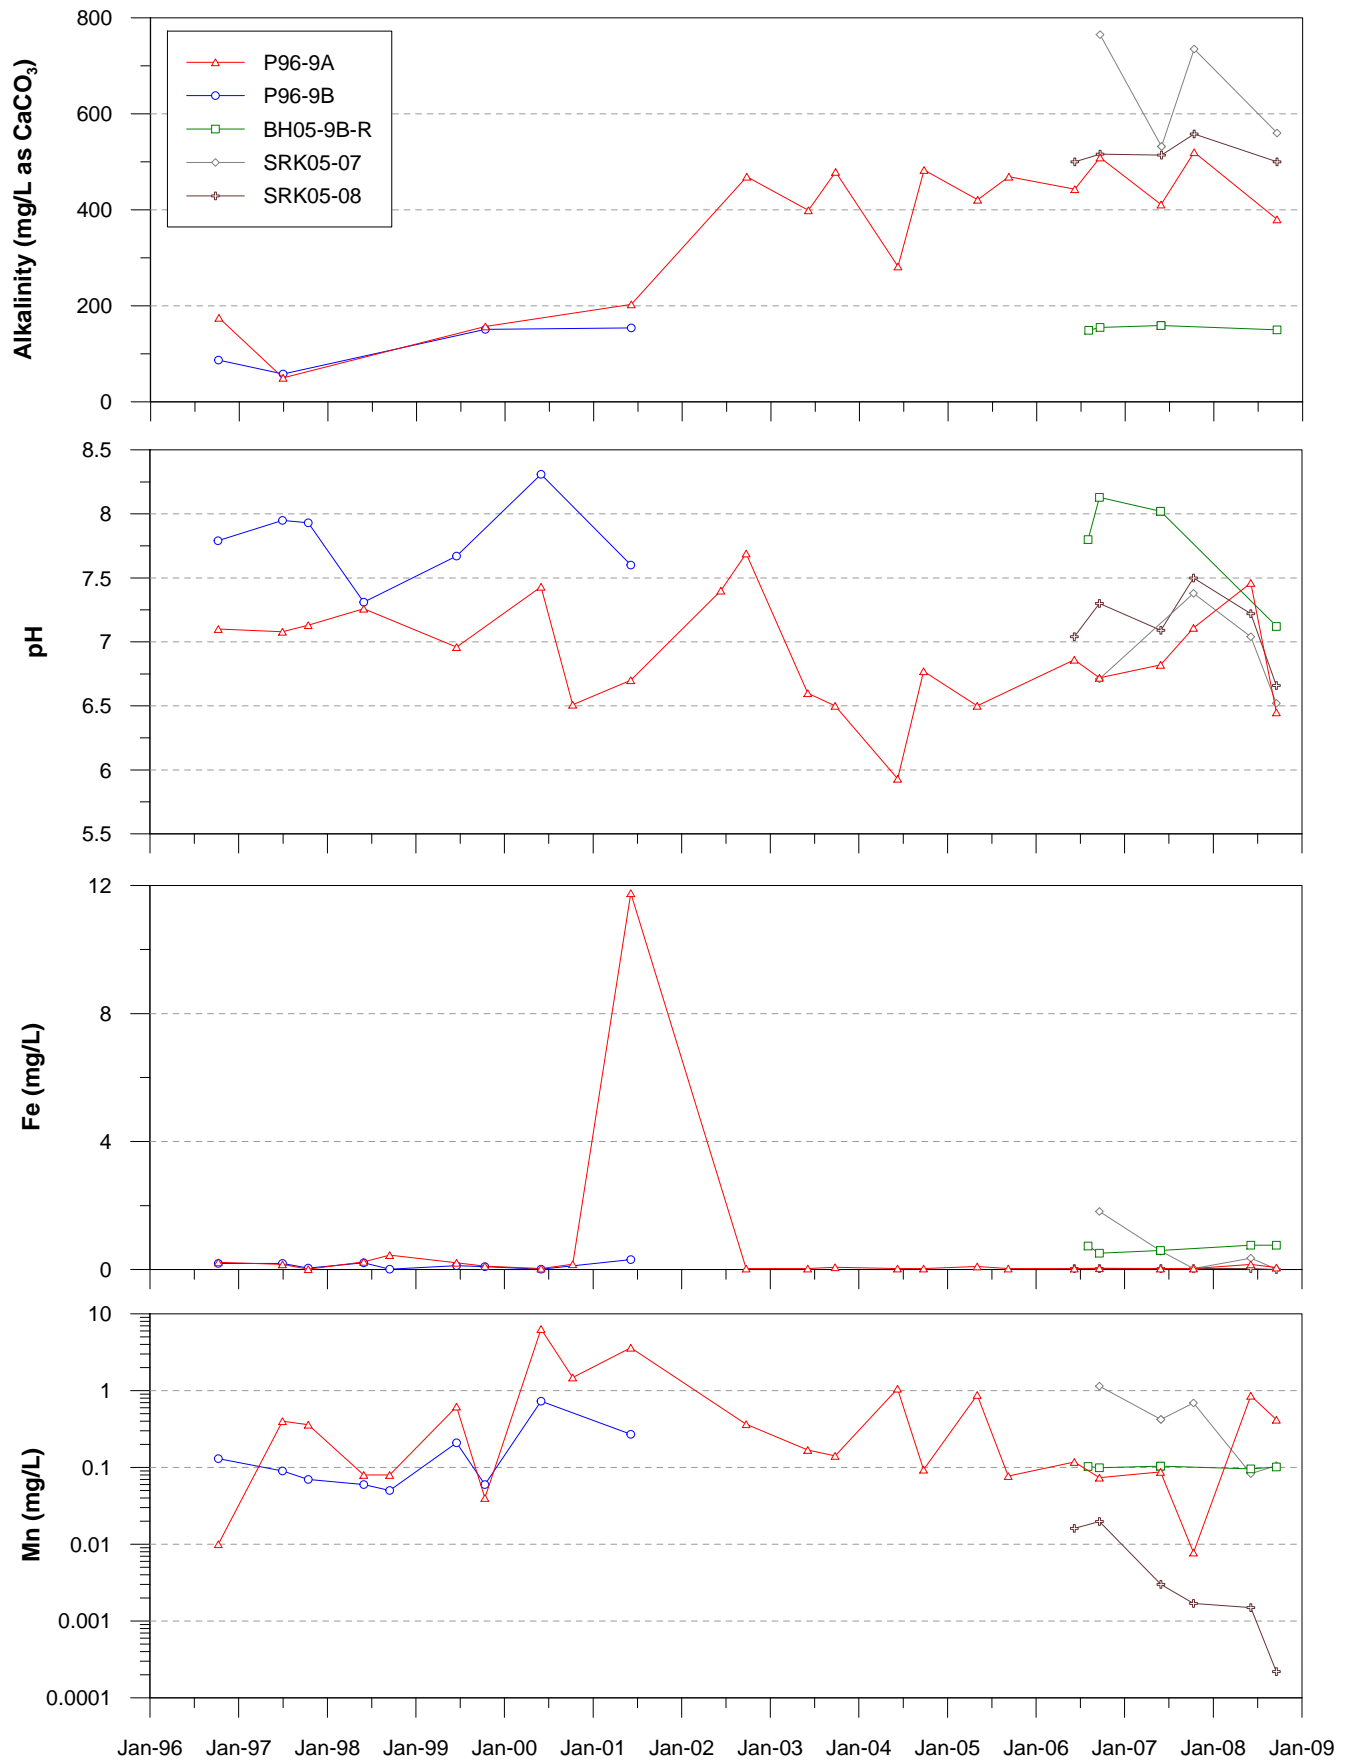
Water quality time trends for monitoring wells located west of Grum Creek are shown in Figure 4-4a/b. Concentrations of oxidation products (SO<sub>4</sub>, Mg and alkalinity) in P96-9A, screened in alluvial sediments in a narrow side drainage, appeared to reach a plateau in 2007 and did not further increase in 2008. Zn concentrations in this well remained below peak concentrations observed in previous years.

Figure 4-4a. Precipitation and water quality (SO<sub>4</sub>, Mg and Zn) in wells located west of Grum Creek.

Figure 4-4b. Water quality (alkalinity, pH, Fe and Mn) in wells located west of Grum Creek.
