Report No. 118014/1

**2008 GROUNDWATER REVIEW**  
**ANVIL RANGE MINING COMPLEX, YUKON TERRITORY**

**Faro Mine Closure Planning Office**

**February 2009**

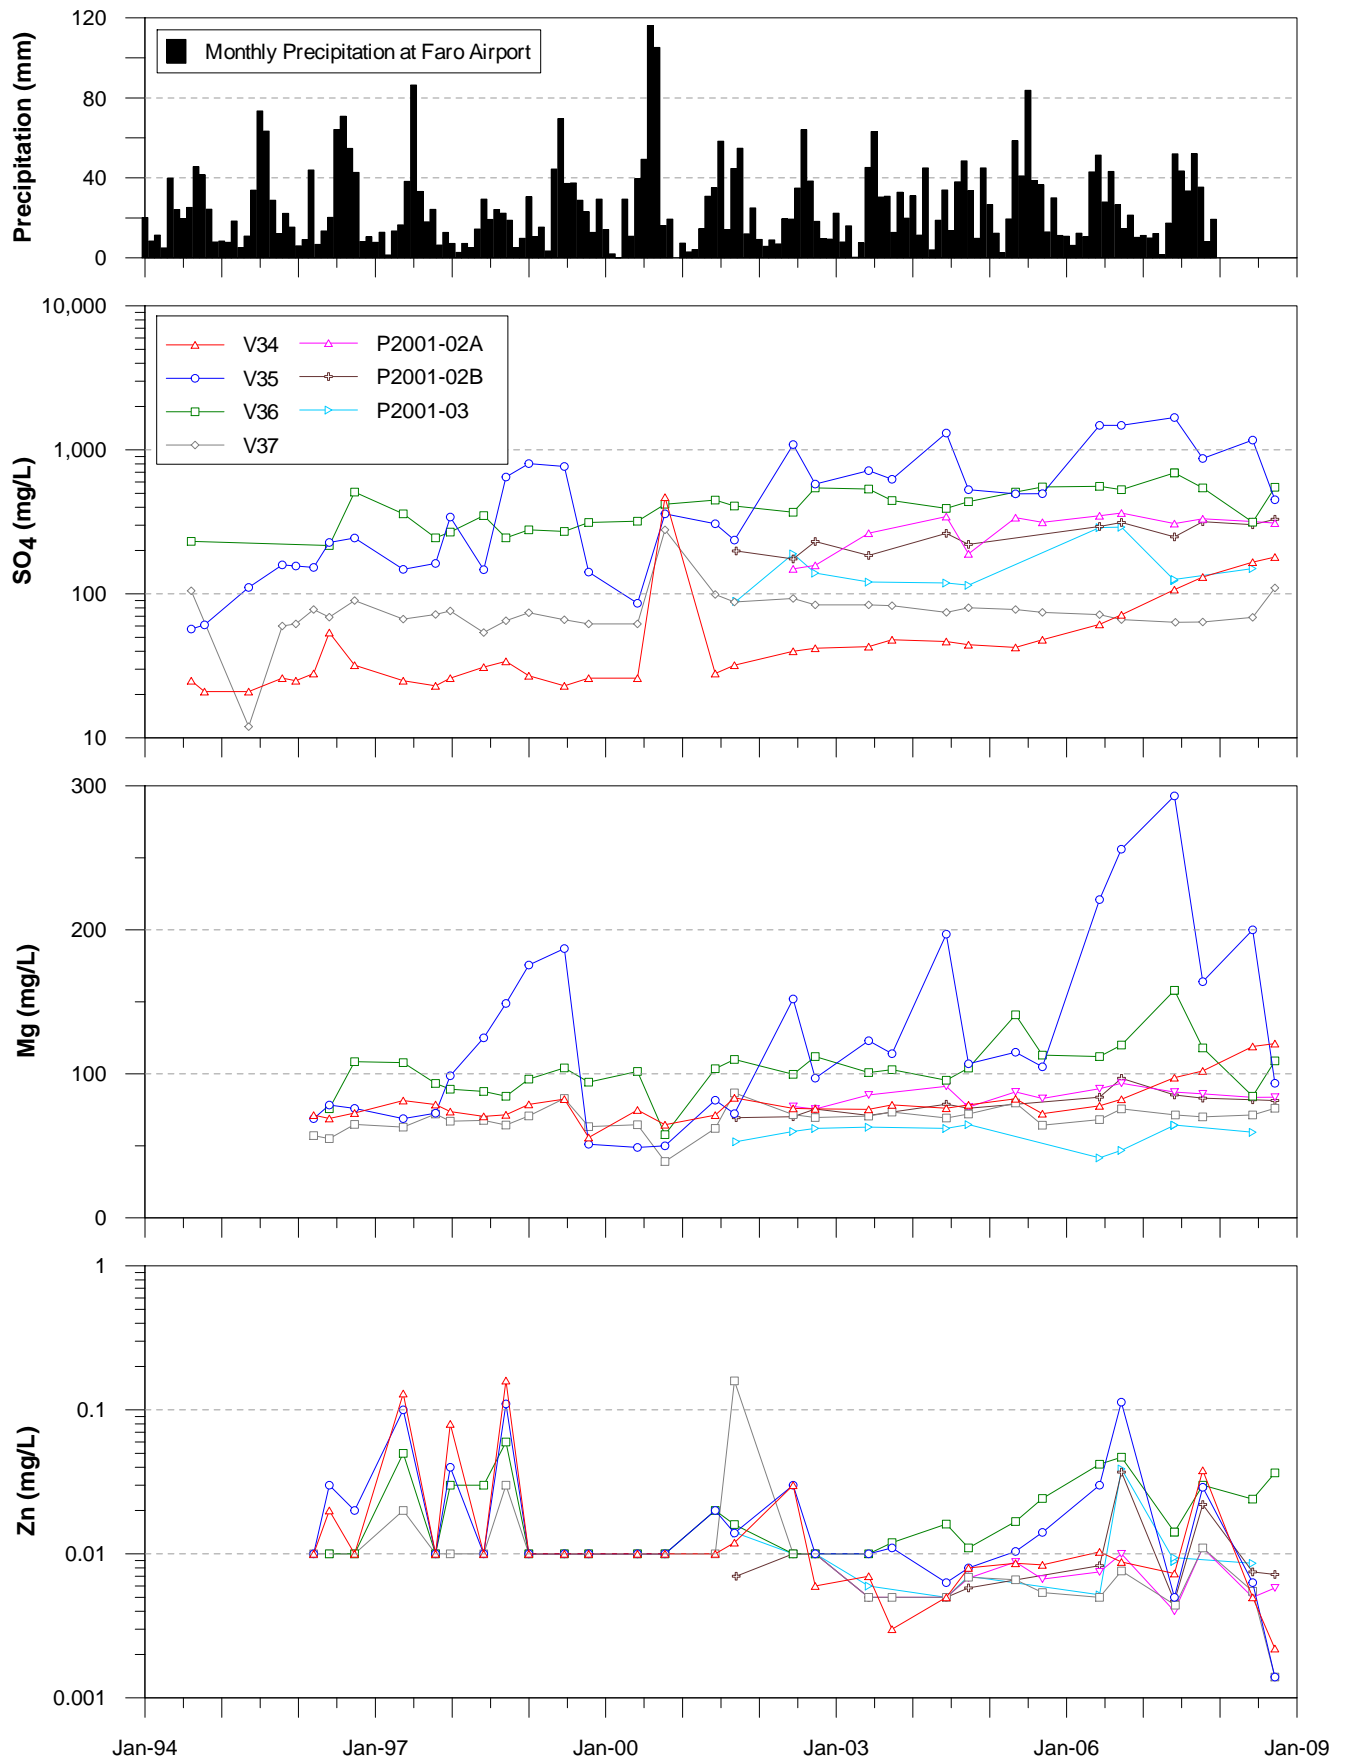
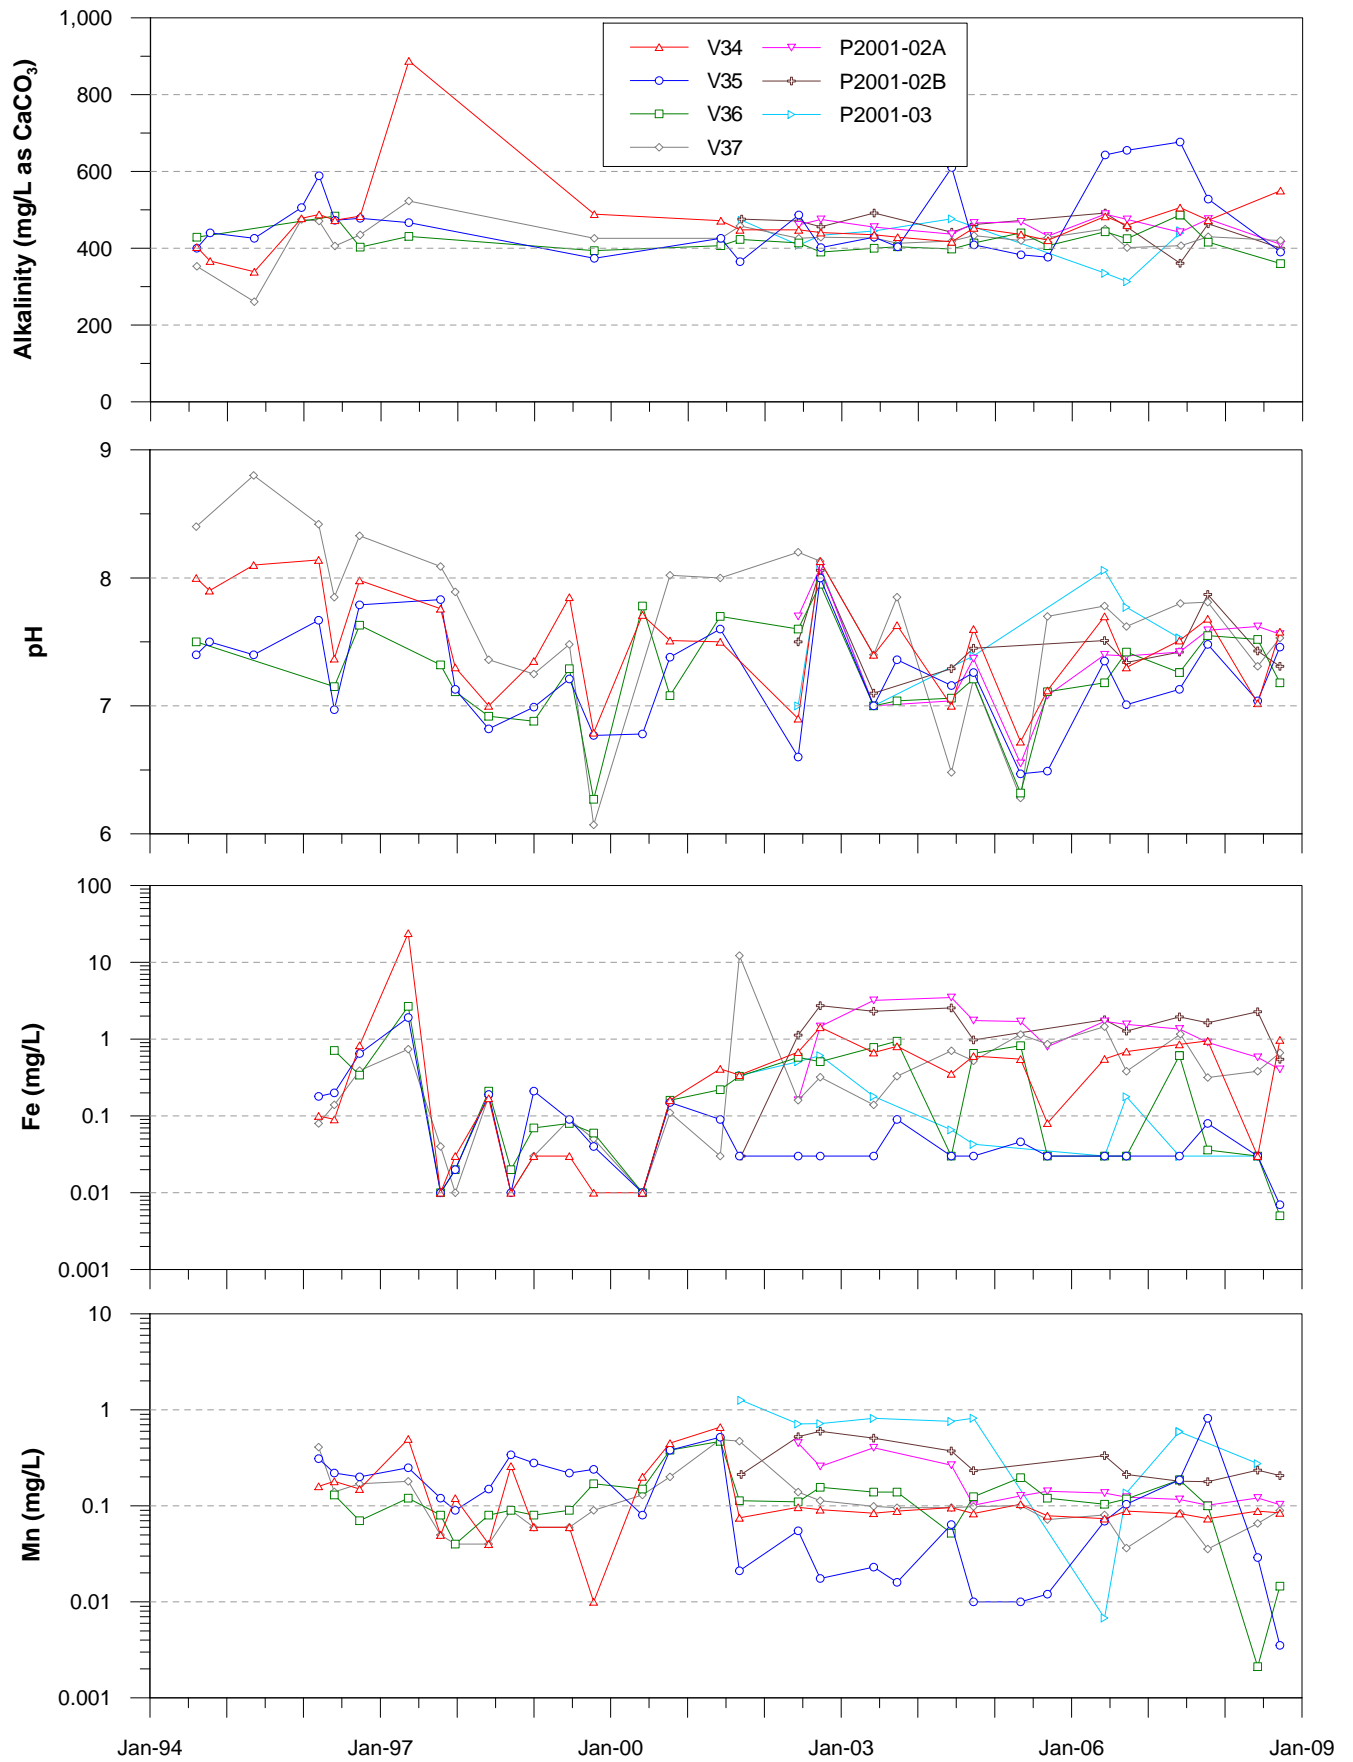
Figure 4-6a/b shows selected water quality time trends for the monitoring wells located down-gradient of the Vangorda Rock Dump. No significant changes in groundwater quality were observed for the wells in this area. Note, however, that monitoring well V34, located to the southeast of Vangorda Rock Dump, continued to show a gradual increase in concentrations of SO<sub>4</sub>, Mg and alkalinity suggesting a gradual breakthrough of neutralized waste rock seepage.

Figure 4-6a. Precipitation and water quality (SO<sub>4</sub>, Mg and Zn) in wells downgradient of Vangorda Rock Dump.

Figure 4-6b. Water quality (alkalinity, pH, Fe and Mn) in wells downgradient of Vangorda Rock Dump.
