Report No. 118017/1

**2009 GROUNDWATER QUALITY REVIEW
ANVIL RANGE MINING COMPLEX, YUKON TERRITORY**

Faro Mine Closure Planning Office

February 2010

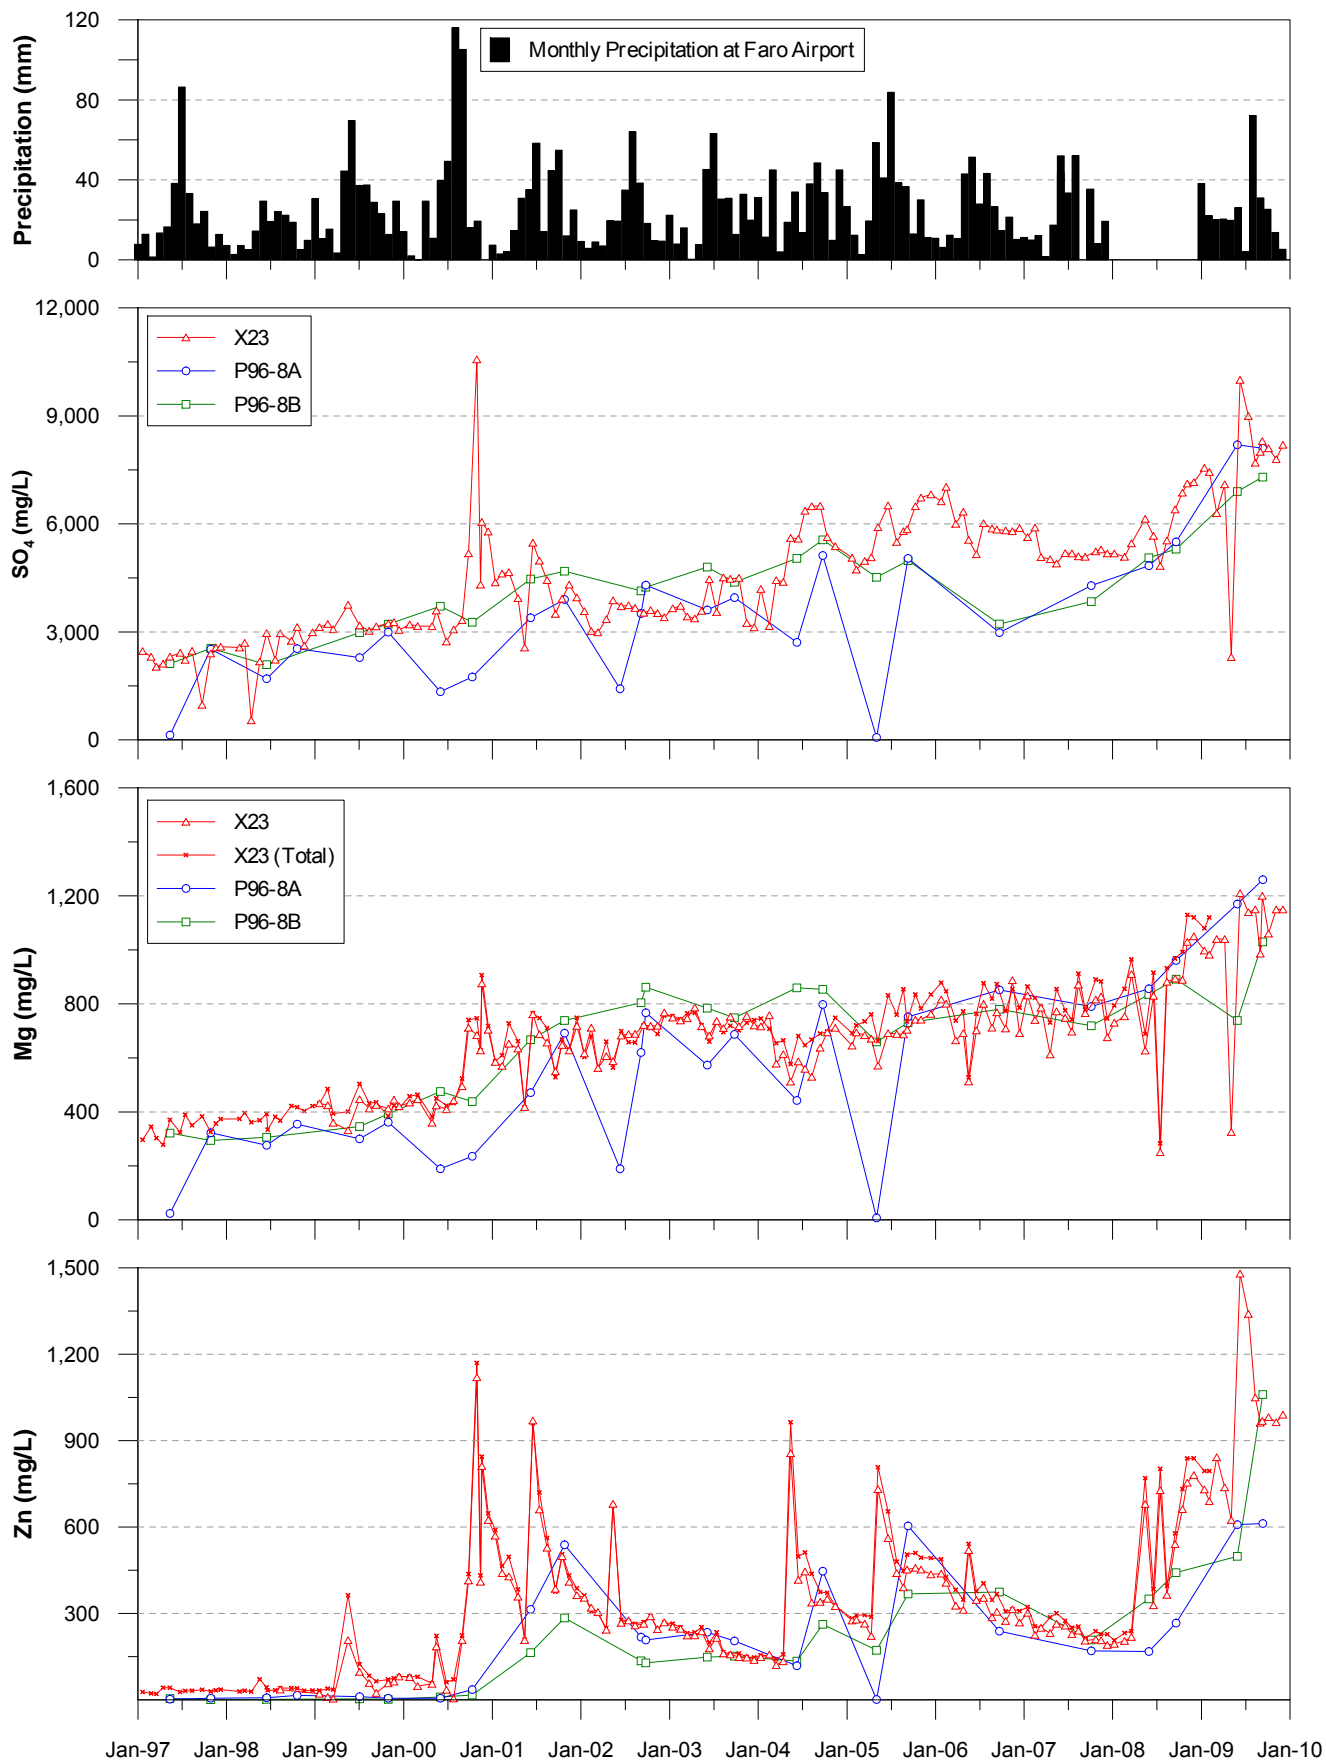
Figure 2-3a. Time trends for SO_4 , Mg and Zn at X23 and P96-8A/B

In seepage at X23, the concentrations of SO₄, Mg, and metals of interest (Zn, Fe, and Mn) increased in 2009. This increase follows a trend of increasing concentrations that began in early 2008. The Zn concentration at X23, for instance, increased from ~150 mg/L in January 2008 to ~1,000 mg/L at the end of 2009. The recent trend towards higher concentrations of major ions and key metals of interest in seepage at X23 is also observed in wells P96-8A/B. Short-term changes in the concentrations of major ions and metals of interest in wells P96-8A/B have often mimicked the trends observed in surface seepage at X23 and have previously been attributed to the 'flushing' of accumulated oxidation products from the Main WRD to groundwater during high rainfall periods (RGC, 2008). This apparent 'flushing' effect was particularly evident during a period of high rainfall in the year 2000.

Because precipitation has not been unusually high over the past two years, recent increases in major ions and metals of interest are unlikely to be related to 'flushing' events. Instead, it seems more likely that some breakthrough of more highly-contaminated seepage from the Main WRD (and other dumps draining towards X23) has occurred. The breakthrough of this more contaminated seepage explains deteriorating water quality conditions at X23 and in groundwater downgradient at wells P96-8A/B. Note that highly acidic conditions have been observed at X23 on several occasions in 2008/2009, which suggests a gradual depletion in buffering capacity along the flowpath in the WRD. More acidic

If seepage water quality were to continue to deteriorate, concentrations of SO₄, Mg, and metals of interest in seepage at X23 may continue to increase in the future. In turn, groundwater quality in wells P96-8A/B would also deteriorate further until the contaminant load from the Main WRD is reduced and current contaminant levels are flushed from the area. Future/additional monitoring data is required to confirm that seepage from the Main WRD is deteriorating and that groundwater quality downgradient is being affected.

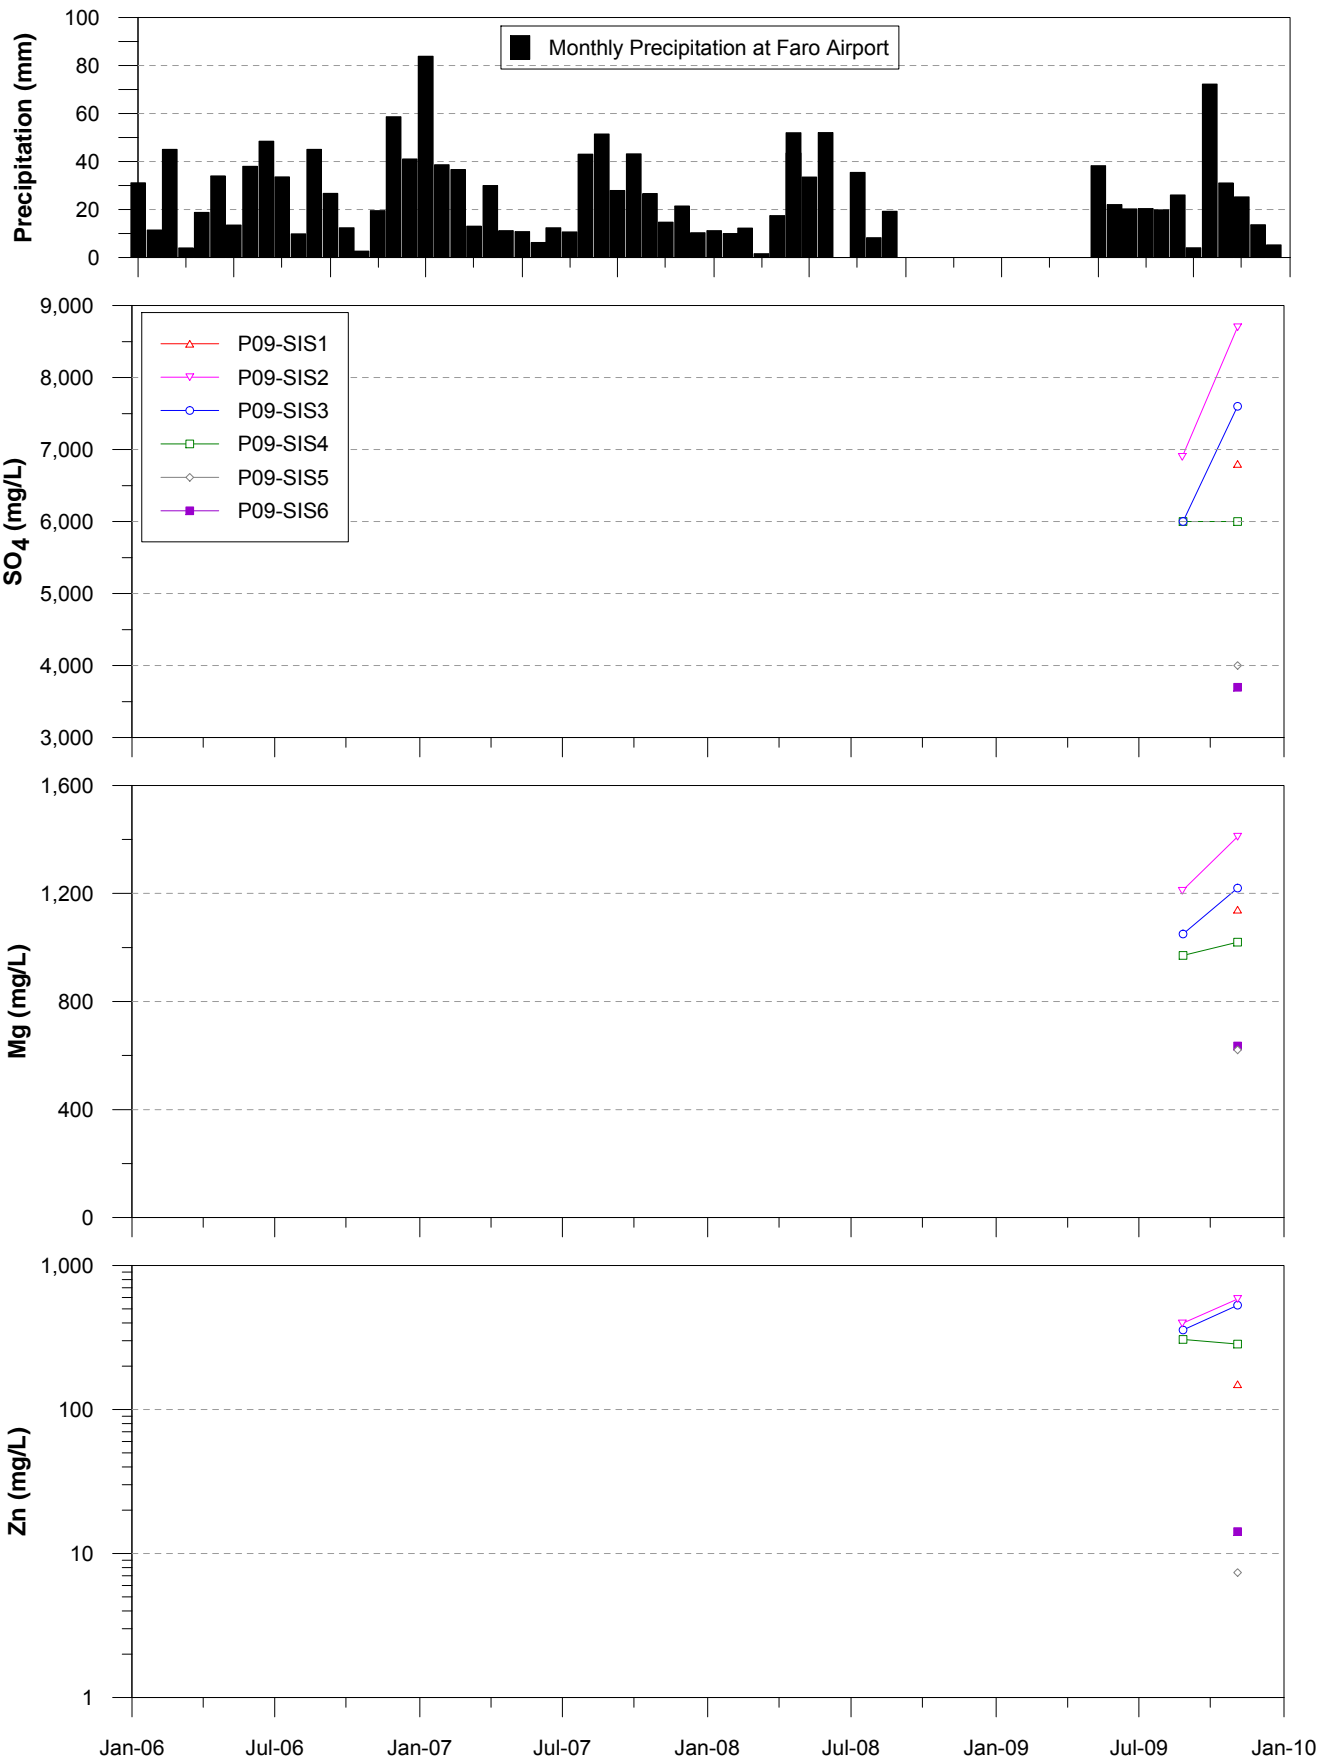
Figure 2-7c. Time trends for SO₄, Mg, Na and Zn in P09-SIS wells, S-Cluster Area

The "P09-SIS" series of wells assisted in better delineating the eastern limit of "highly-impacted" groundwater. Based on the initial 2009 data, it appears that concentrations of SO₄, Mg, and metals of interest are much lower in the wells located to the southeast end of the primary interceptor trench (wells P09-SIS5 and P09-SIS6) than in wells immediately downgradient of the trench (wells P09-SIS1 to P09-SIS4). It was further noted that concentrations of SO₄, Mg, and metals of interest in several wells (P09-SIS1 and P09-SIS3) showed a significant increase from September 2009 to November 2009. Additional monitoring in those wells will be required to determine if there is a trend towards higher concentrations or if concentrations will decrease as expected.

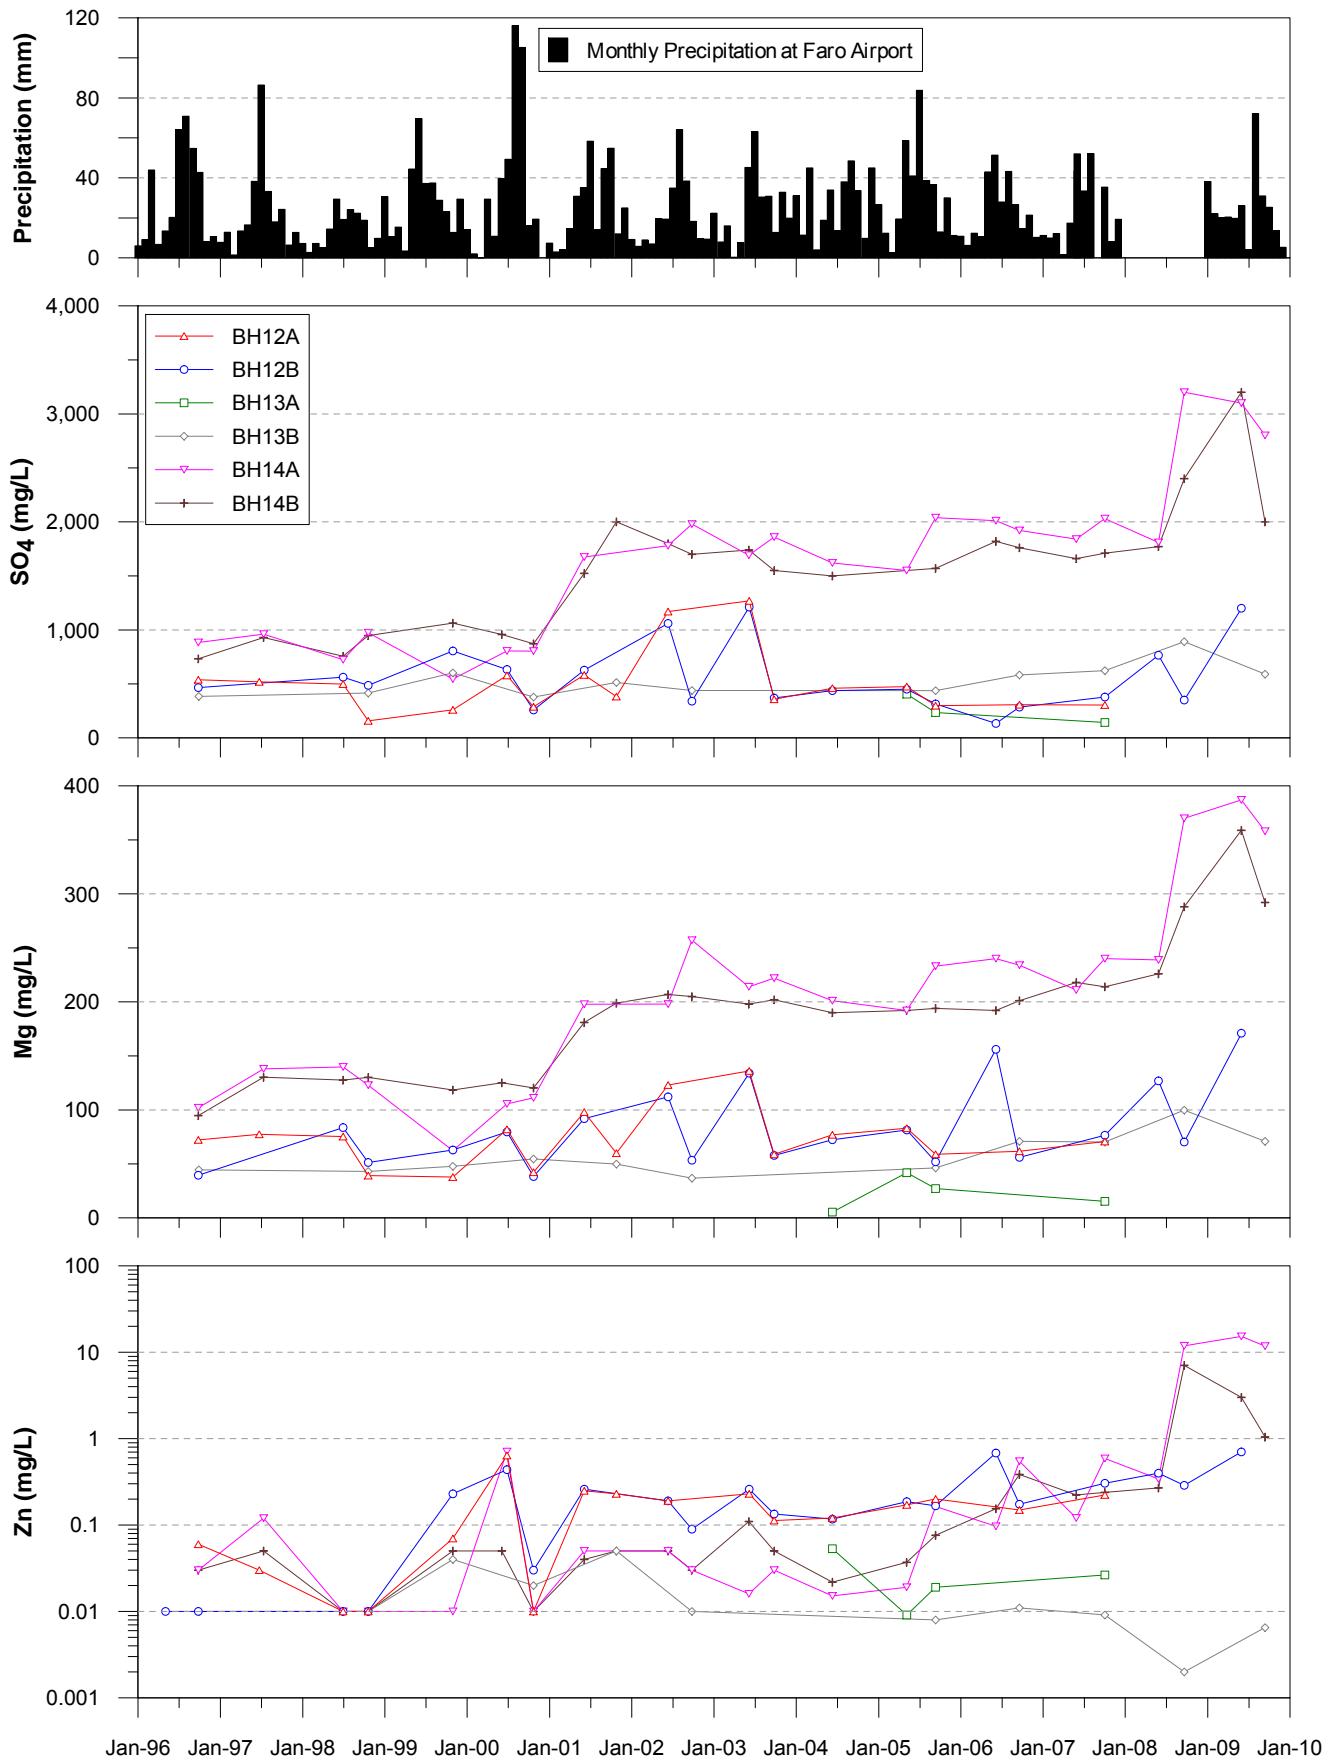
Figure 2-12a. Time trends for SO₄, Mg and Zn in wells at the toe of Northeast Rock Dump

Historically, groundwater from well BH14A/B has been more impacted by seepage than groundwater from wells BH12A/B and BH13A/B. In 2008, SO₄, Mg, Mn, and Zn concentrations in wells BH14A/B increased substantially and this trend continued in early 2009. Some improvement in water quality was observed in late 2009 but concentrations of SO₄, Mg, Mn, and Zn in wells BH14A/B were higher by the end of 2009 than in 2008. Groundwater collected from wells BH12A/B and BH13A/B did not deteriorate considerably in 2009.

The trend towards higher concentrations of SO₄, Mg, Mn, and Zn in wells BH14A/B is likely indicative of seepage from the sulphide-rich waste rock that has been identified in the Northeast Rock Dump (RGC, 2008). If seepage from this source continues to impact groundwater at BH14A/B, groundwater quality in this reach could potentially deteriorate further and concentrations of SO₄, Mg, and Zn may reach the levels observed in the ETA and S-Cluster areas.

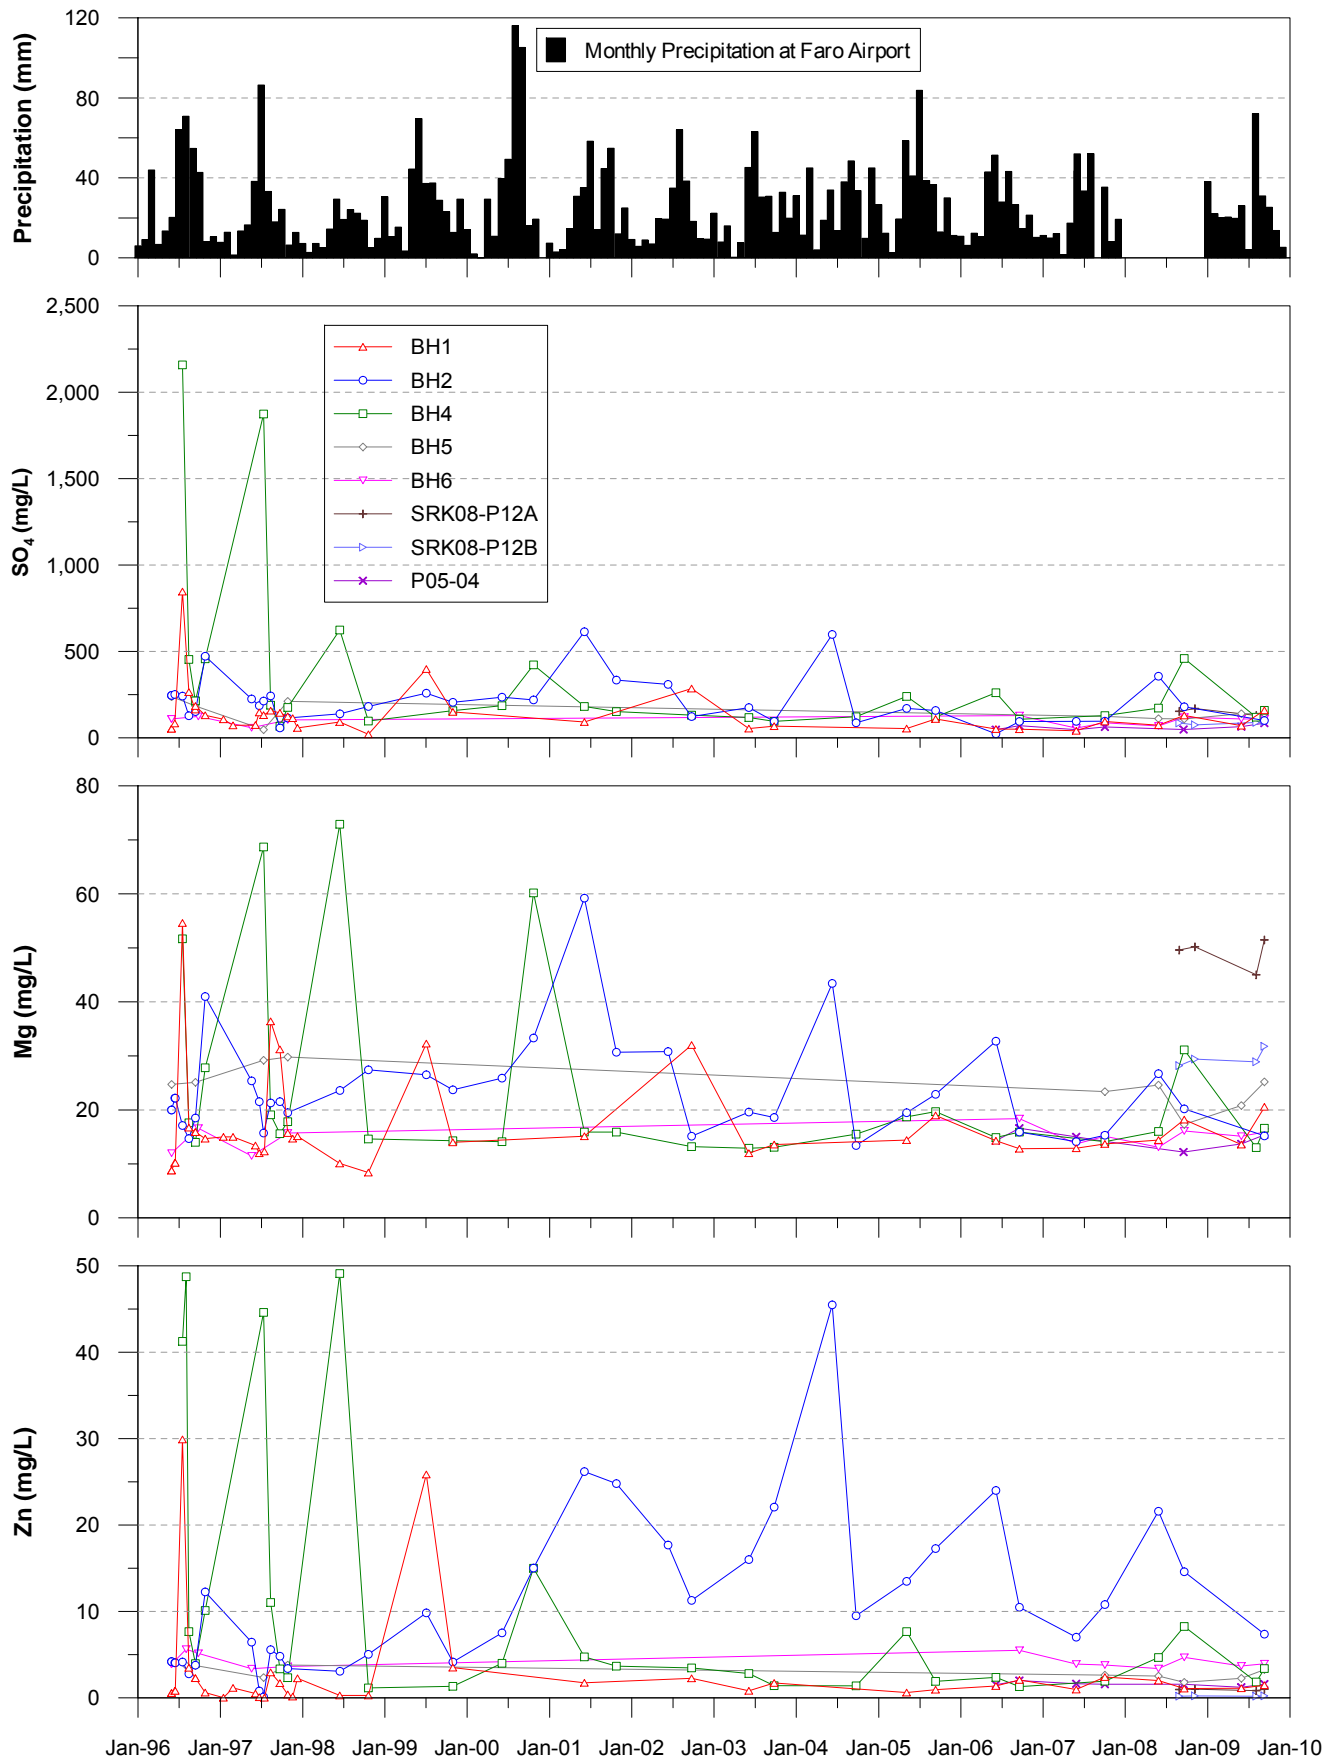
Figure 2-13a. Time trends for SO₄, Mg and Zn for wells in Zone 2 Pit outwash area

In 2009, the concentrations of major ions and metals of interest in groundwater within the Zone 2 Pit outwash area were consistent with historic time trends. For instance, concentrations in wells that are screened at least partially in outwash sediments (wells BH1, BH2 and BH4) remain similar to concentrations observed in the deeper wells screened in the alluvial sediments (BH5, BH6, P05-04).

Groundwater quality in the Zone 2 Pit outwash area differs from other areas that are impacted by waste rock seepage (e.g. ETA and S-cluster) in that elevated Zn concentrations are observed but the concentrations of SO₄, Mg, Fe, and Mn remain relatively low by comparison. This characteristic of groundwater quality could be related to a different metals content of sulphide-rich waste rock in the Zone 2 Pit and/or the *in situ* oxidation of sulphides in outwash sediments (RGC, 2010a). Note that modest increases in Zn and several other ARD products in the NFRC alluvial aquifer along the Zone 2 Pit outwash reach (i.e. between wells SRK-P12A and BH5) suggests some incremental loading from the Zone 2 Pit area.

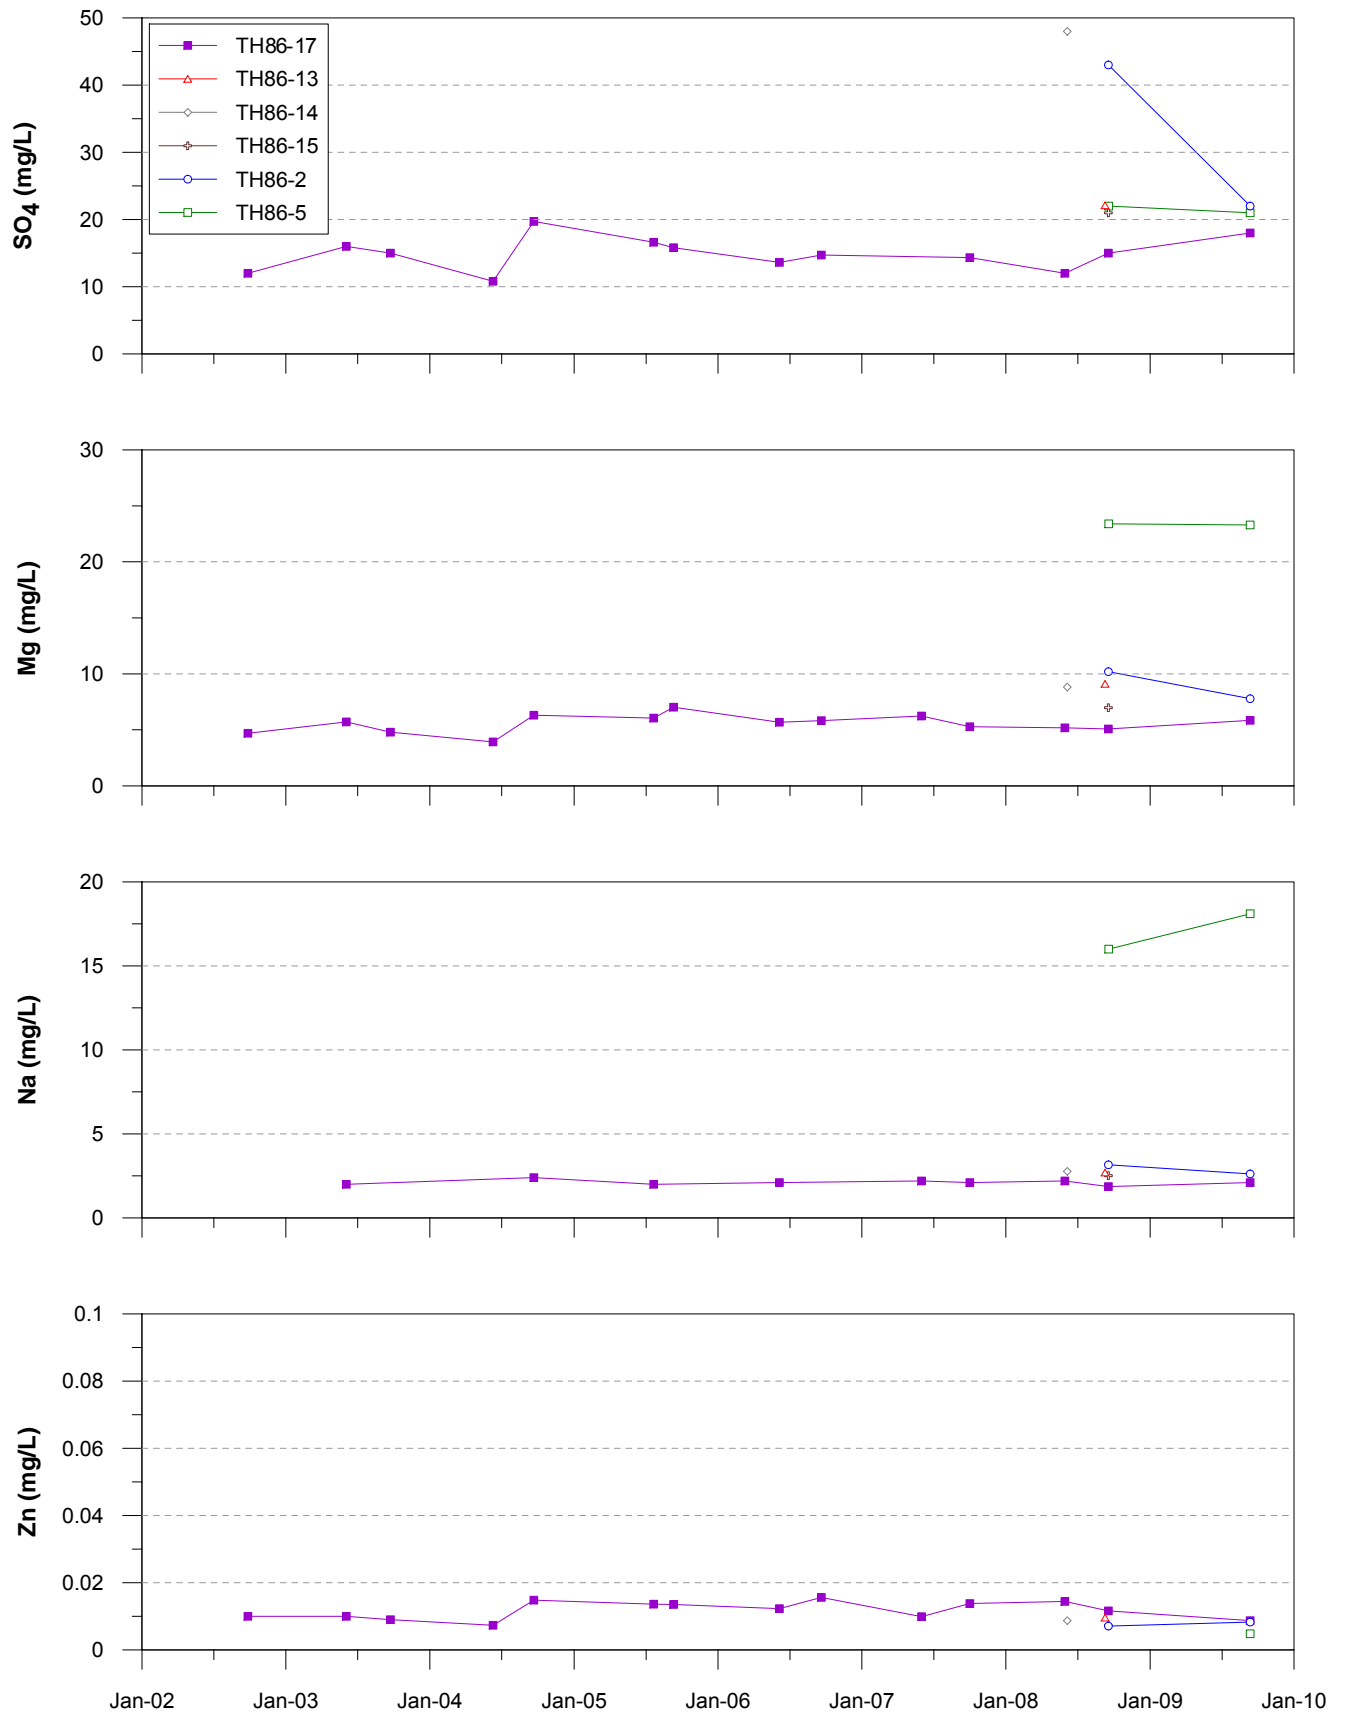
Figure 3-2a. Time trends for SO₄, Mg, Na and Zn in Rose Creek Alluvial Aquifer upgradient of RCTF

Figure 3-2a/b shows time trends for pH, alkalinity, selected major ions, and metals of interest in groundwater from well TH86-17 and other nearby piezometers. Groundwater quality in TH86-17 reflects natural base-line conditions in the Rose Creek valley sediments. Groundwater from well TH86-17 remains dilute in terms of major ions and dissolved metals and there is still no indication that mine waste seepage is present in groundwater at this location. This is supported by similarly low concentrations of SO₄, Mg, Mn, and Zn in most of the nearby piezometers.

Concentrations of major ions and some metals of interest (Fe, Mn) are higher in well TH86-5 than in the other wells in the area. SO₄ concentrations, however, are very low in well TH86-5 and other metals of interest are still at or near the detection limit (e.g. < 0.02 mg/L Zn). Well TH86-5 is screened in the deeper portion of the RCAA that is isolated from the upper aquifer by a till layer. The water quality in well TH86-5 is therefore believed to be representative of natural baseline conditions in the deeper sediments of the RCAA.

Note that the 'TH' wells are located downgradient of the NFRC aquifer that is influenced by seepage from the Faro WRDs (e.g. in the S-Cluster area). The pristine groundwater quality conditions observed in these wells suggests that this portion of the RCAA is not yet influenced by waste rock seepage from the Intermediate WRD.

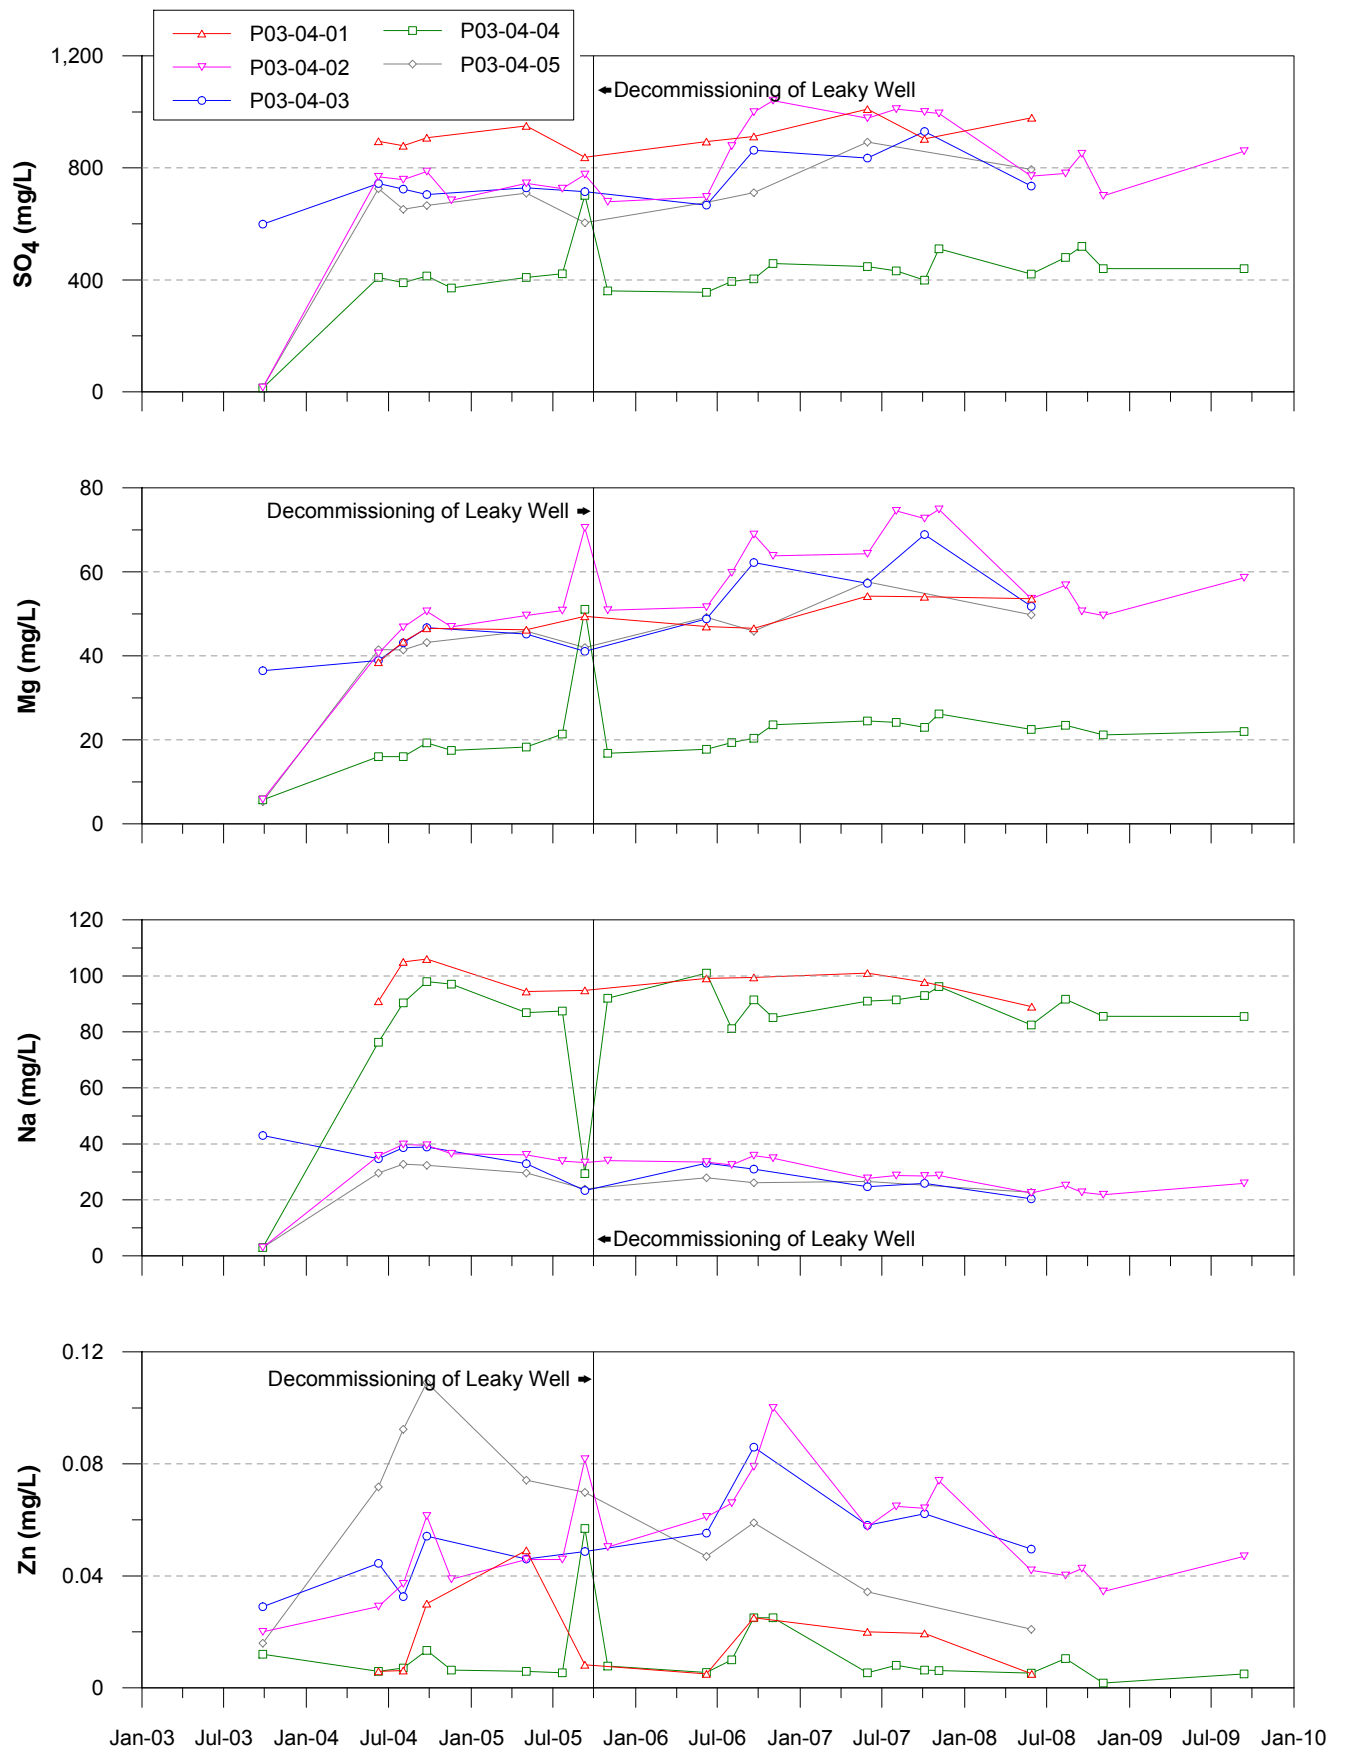
Figure 3-10a. Time trends for SO₄, Mg, Na and Zn in P03-04 (aquifer only)

Figure 3-10a/b shows time trends for pH, alkalinity, selected major ions, and metals of interest in well P03-04 (located ~140 m downgradient of the decommissioned wells P01-07). At this location, the shallow piezometer P03-04-06 (screened near the interface with the tailings) had shown an improvement in groundwater quality since decommissioning of well P01-07 but this trend did not continue in 2009. Instead, slight increases in the concentrations of SO_4 and each of the metals of interest were observed. These increases were small in magnitude and future monitoring will be required to assess whether groundwater quality in this reach of the RCAA is further deteriorating over time.

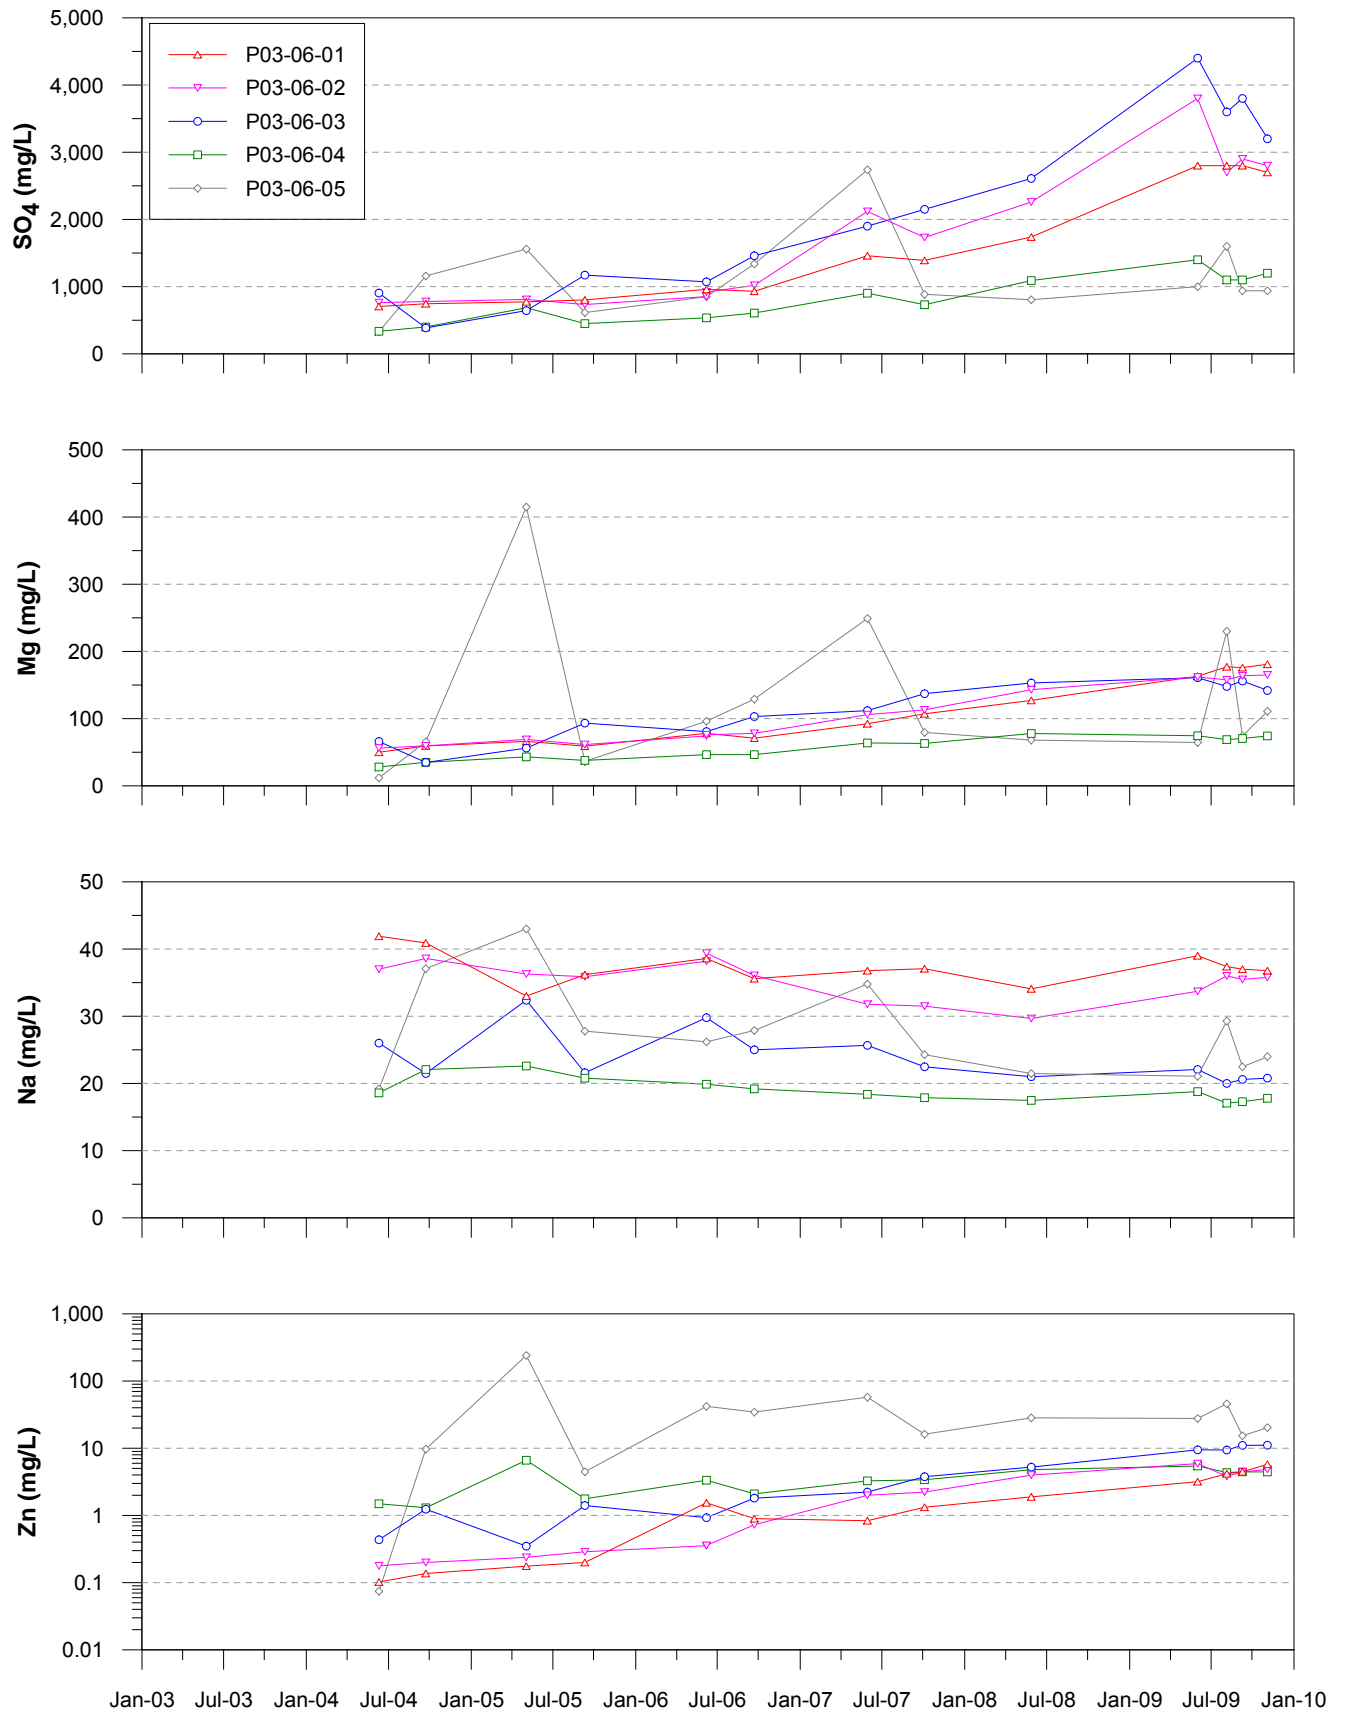
Figure 3-10c. Time trends for SO₄, Mg, Na and Zn in P03-06 (aquifer only)

SO₄ and Zn in the Rose Creek aquifer at well P03-06 are likely the result of the recent deterioration of water quality in FCS (see Section 2.2.2).

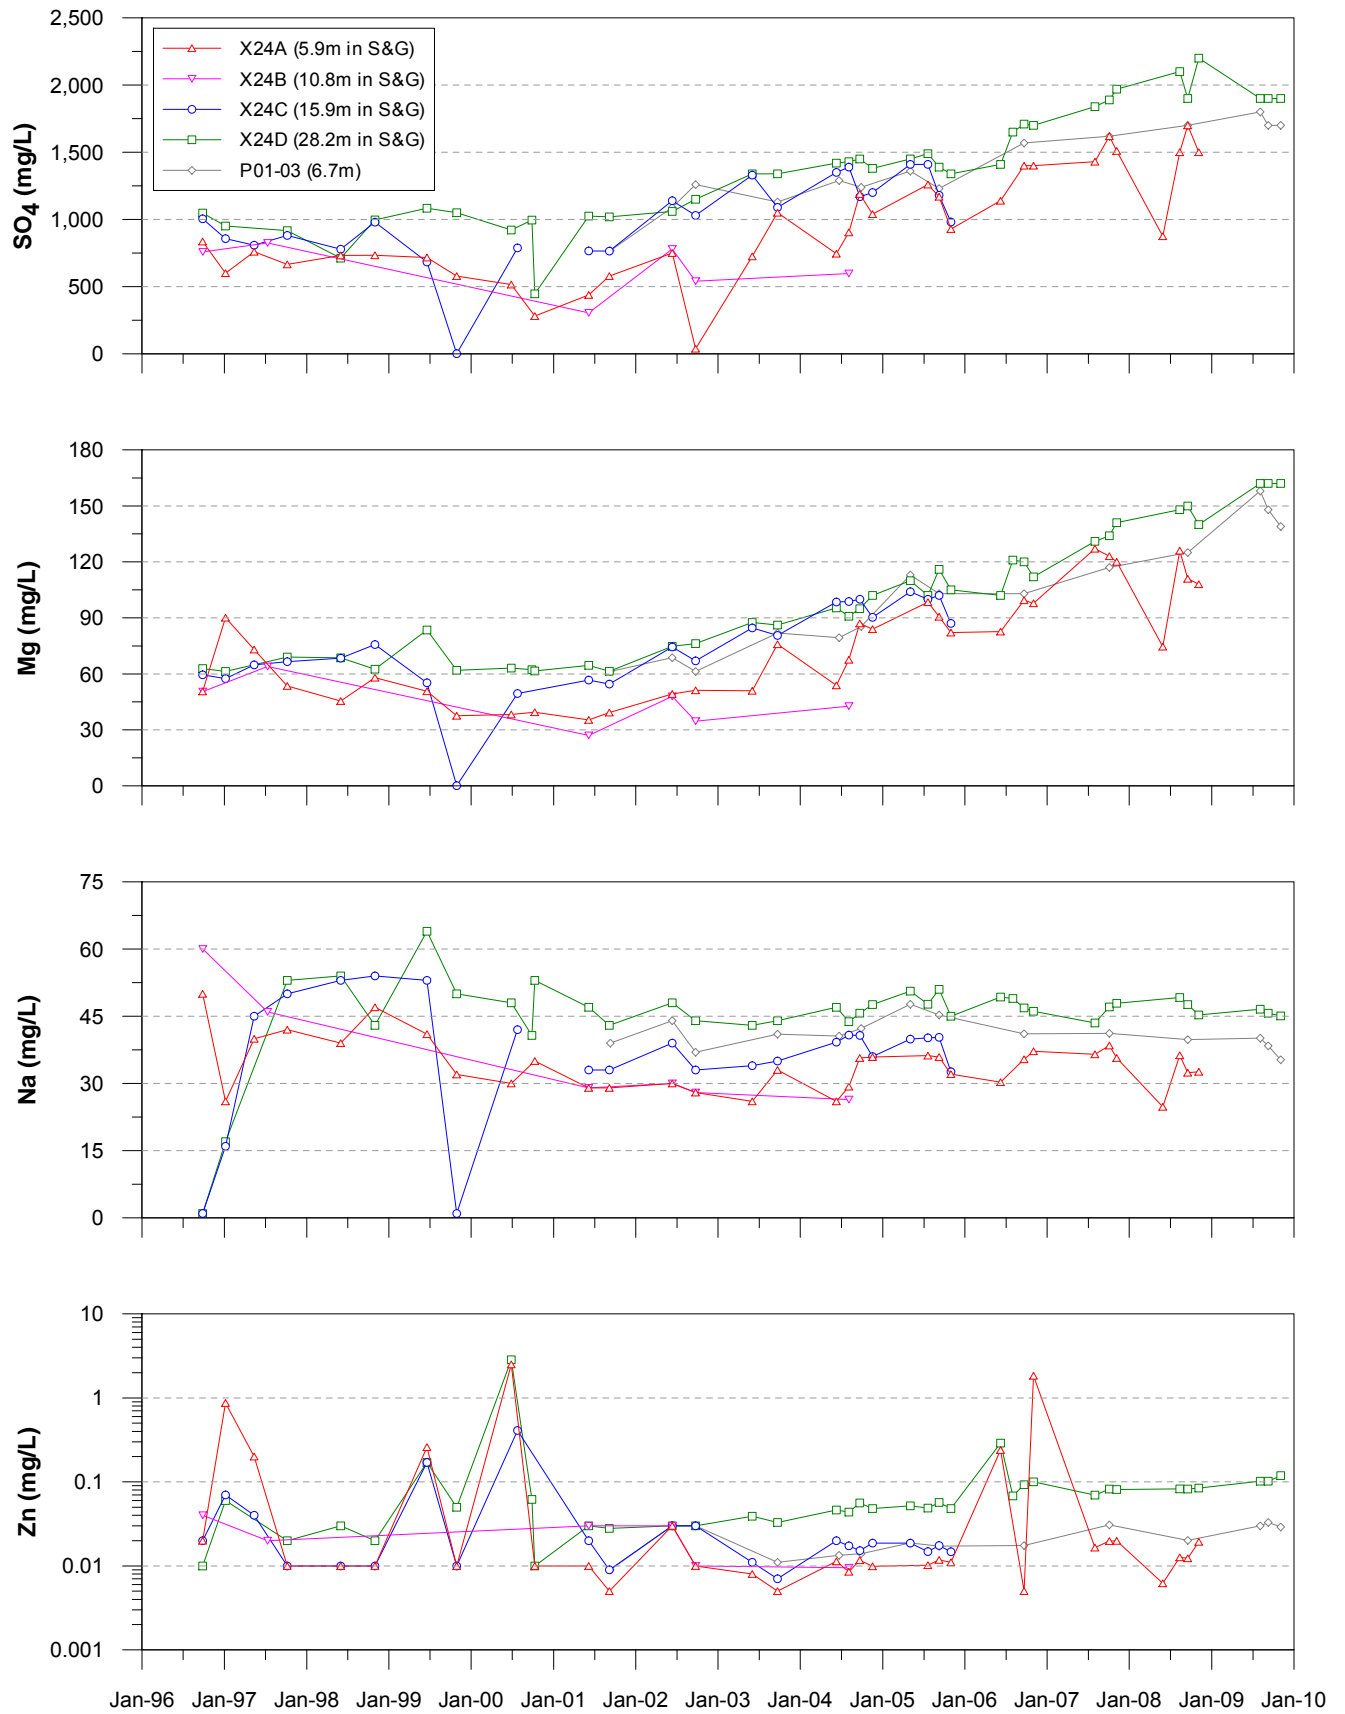
Figure 3-13a. Time trends for SO₄, Mg, Na and Zn in X24(96) and P01-03 (northern side of the Intermediate Dam)

Time trends for pH, alkalinity, selected major ions, and metals of interest are shown in Figure 3-13a/b for wells located near the northern end of the Intermediate Dam (wells X24A/B/C/D and P01-03). SO₄, Mg, Zn and Mn concentrations have increased in each of these wells since 2001 and this trend generally continued in 2009. Note that the highest concentrations of major ions and metals of interest have been consistently observed at well X24D (the deepest well in this area). Notably, Mn concentrations at X24D consistently exceeded 75 mg/L in 2009 and Zn concentrations exceeded 0.1 mg/L.
