Report No. 118017/1

**2009 GROUNDWATER QUALITY REVIEW
ANVIL RANGE MINING COMPLEX, YUKON TERRITORY**

Faro Mine Closure Planning Office

February 2010

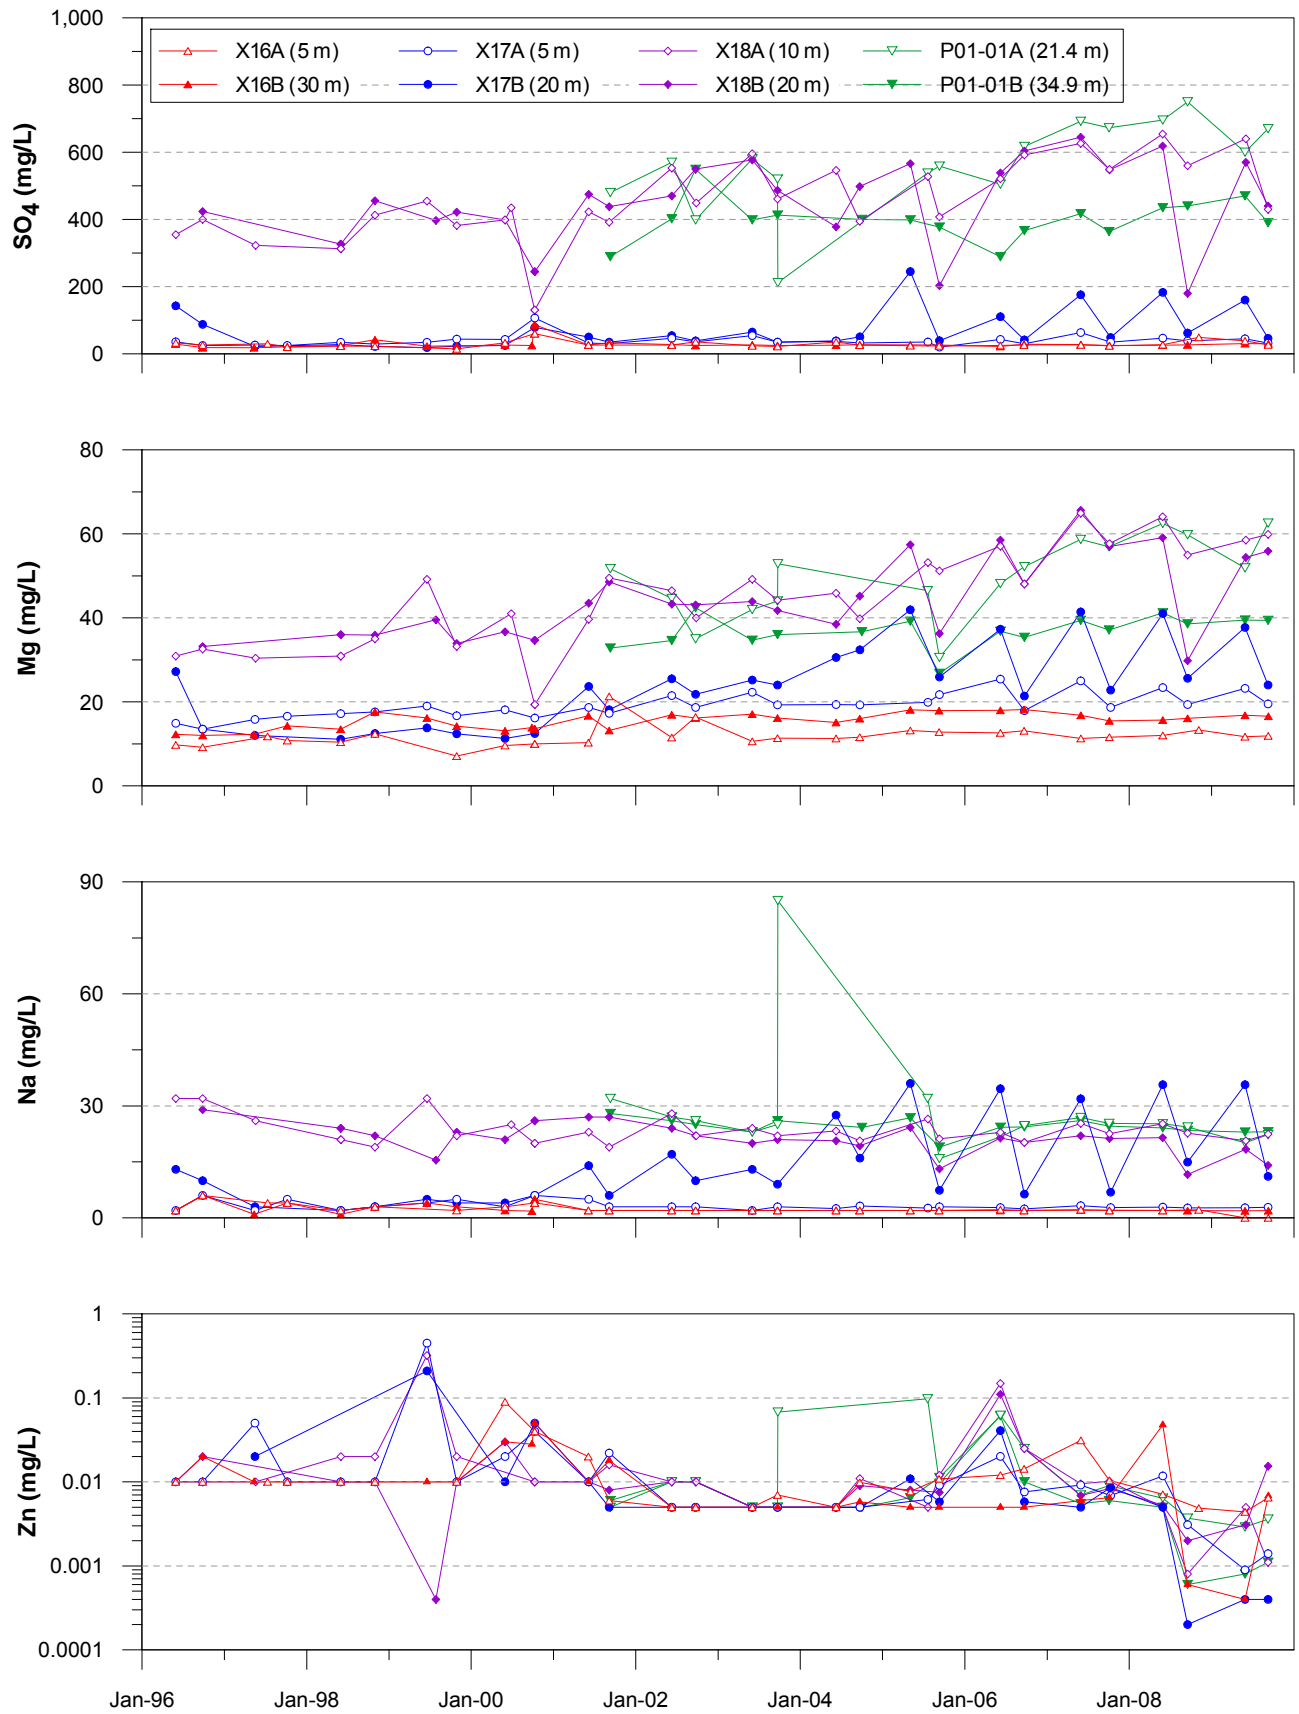
Figure 3-19a. Time trends for SO₄, Mg, Na and Zn in wells down-gradient of Cross Valley Dam

Figures 3-19a/b show time trends for pH, alkalinity, selected major ions, and metals of interest in wells X16A/B, X17A/B, X18A/B and P01-01A/B. In wells X18A/B and P01-01A/B (both located on the northern side of Rose Creek valley), concentrations of SO₄ and Mg continued to increase in 2009, yet concentrations of Zn remained low (< 0.1 mg/L). The increase in SO₄ and Mg in this area is thought to be caused by the leading edge of the breakthrough that has been observed upgradient near the northern end of the Cross Valley Dam (at wells P01-11, P05-01) and near the Intermediate Dam at well X24.

No evidence of impacted groundwater is evident near the center of the Rose Creek valley at X16A/B and X17A/B. This suggests that the impact of tailings seepage is limited to groundwater closer to the Cross Valley Dam and near the northern side of Rose Creek valley. Slightly-elevated Zn concentrations observed in the shallow well X16A (~0.01 mg/L zinc) are believed to be a result of recharge from the Rose Creek diversion (which shows slightly elevated zinc concentrations) and/or leaching of historic tailings close to well X16.

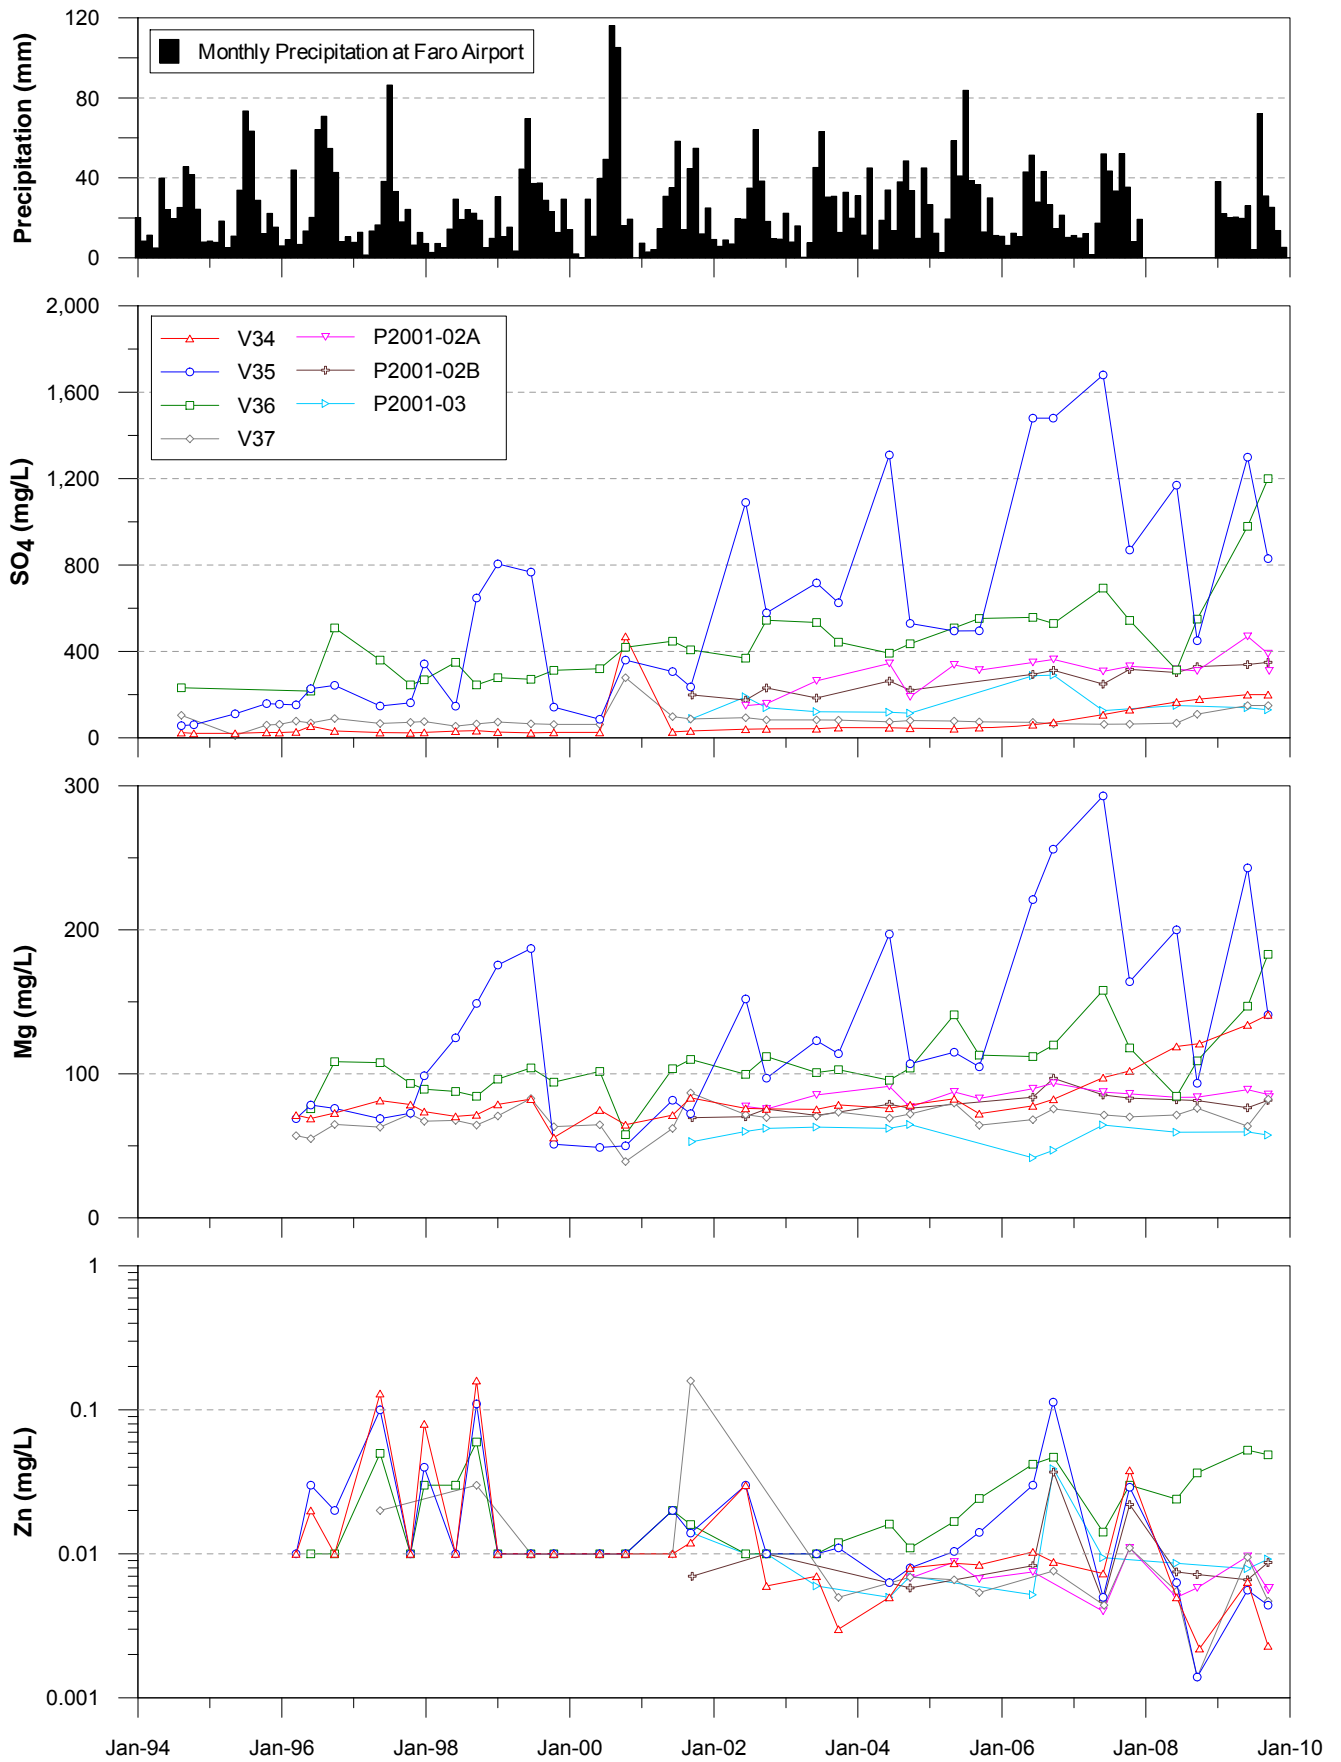
Figure 4-7a. Time trends for SO₄, Mg and Zn in wells downgradient of Vangorda Rock Dump

Time trends for pH, alkalinity, selected major ions, and metals of interest in monitoring wells located down-gradient of the Vangorda Rock Dump are shown in Figure 4-7a/b. In general, groundwater quality time trends observed in 2009 generally conformed to previously-established time trends. Specifically, SO_4 , and Mg concentrations continued to increase in all monitoring wells located downgradient of the Vangorda Rock Dump. However, these gradual increases in major ions (and sometimes alkalinity) were typically not associated with an increase in the concentrations of any metals of interest. This suggests the ongoing attenuation of metals along the groundwater flowpath. The notable exception is well V36, which is located on the western side of Vangorda Rock Dump and continued to show a gradual increase in Zn concentrations over time. Zn concentrations are relatively low (~ 0.05 mg/L) in this area but concentrations are expected to increase over time and should be monitored closely.
