Report No. 118018/1

**2010 GROUNDWATER QUALITY REVIEW  
ANVIL RANGE MINING COMPLEX, YUKON TERRITORY**

**Assessment and Abandoned Mines**

March 2011

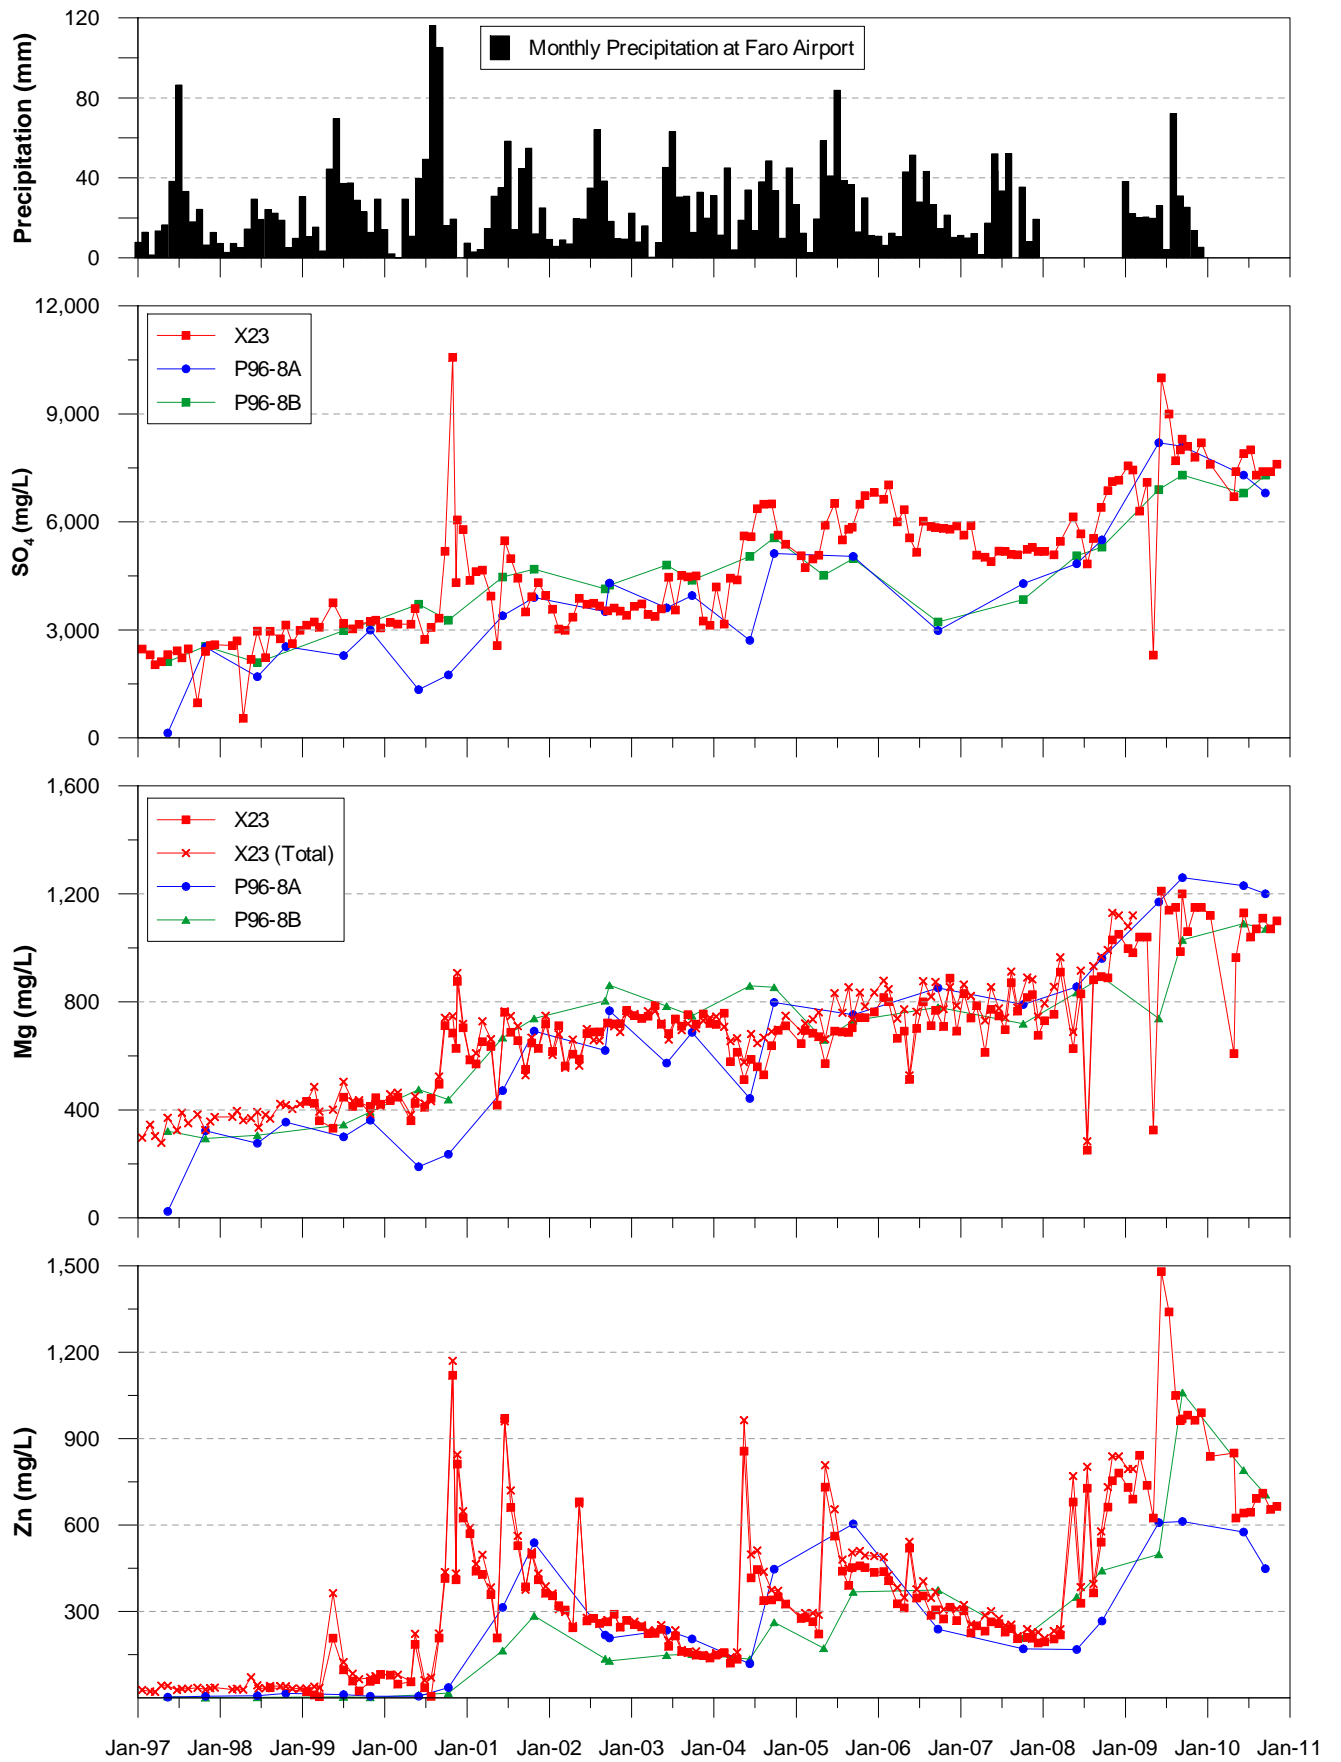
Figure 2-3a. Time trends for SO<sub>4</sub>, Mg and Zn at X23 and P96-8A/B

The concentrations of SO<sub>4</sub>, Mg, and Zn in seepage collected at X23 decreased during the current monitoring period (Figure 2-3a). These decreases are consistent with a trend towards improved seepage water quality observed over the latter half of the previous monitoring period (RGC, 2010b). Of particular interest are Zn concentrations at X23, which had reached close to ~1,500 mg/L in early 2009 but had decreased to less than 1,000 mg/L by the end of that year. During the current monitoring period, Zn concentrations at X23 decreased even further to ~600 mg/L. Similar "flushes" of zinc and to a lesser extent other metals (e.g. manganese) have been observed in the past (e.g. in 2000/01 and in 2004/05) and suggest a cyclical leaching pattern likely controlled by the precipitation pattern and advance of wetting fronts through the waste rock dumps.

Note that SO<sub>4</sub> and Mg concentrations did not show the same strong cyclical trends that are observed for zinc. Although some inter-annual variability is observed these less reactive constituents show a clear increasing trend over time, suggesting a gradual "breakthrough" of ARD products at X23.

Historically, groundwater quality conditions near the toe of the Main WRD (at wells P96-8A/B) have mimicked changes in seepage water quality at X23 and this trend continued over the current monitoring period (see Figure 2-3a/b). As observed at X23, zinc concentrations showed a significant recovery in these two monitoring wells whereas  $\text{SO}_4$  and Mg levelled off from last year's peak concentrations but remained significantly higher than in earlier years.

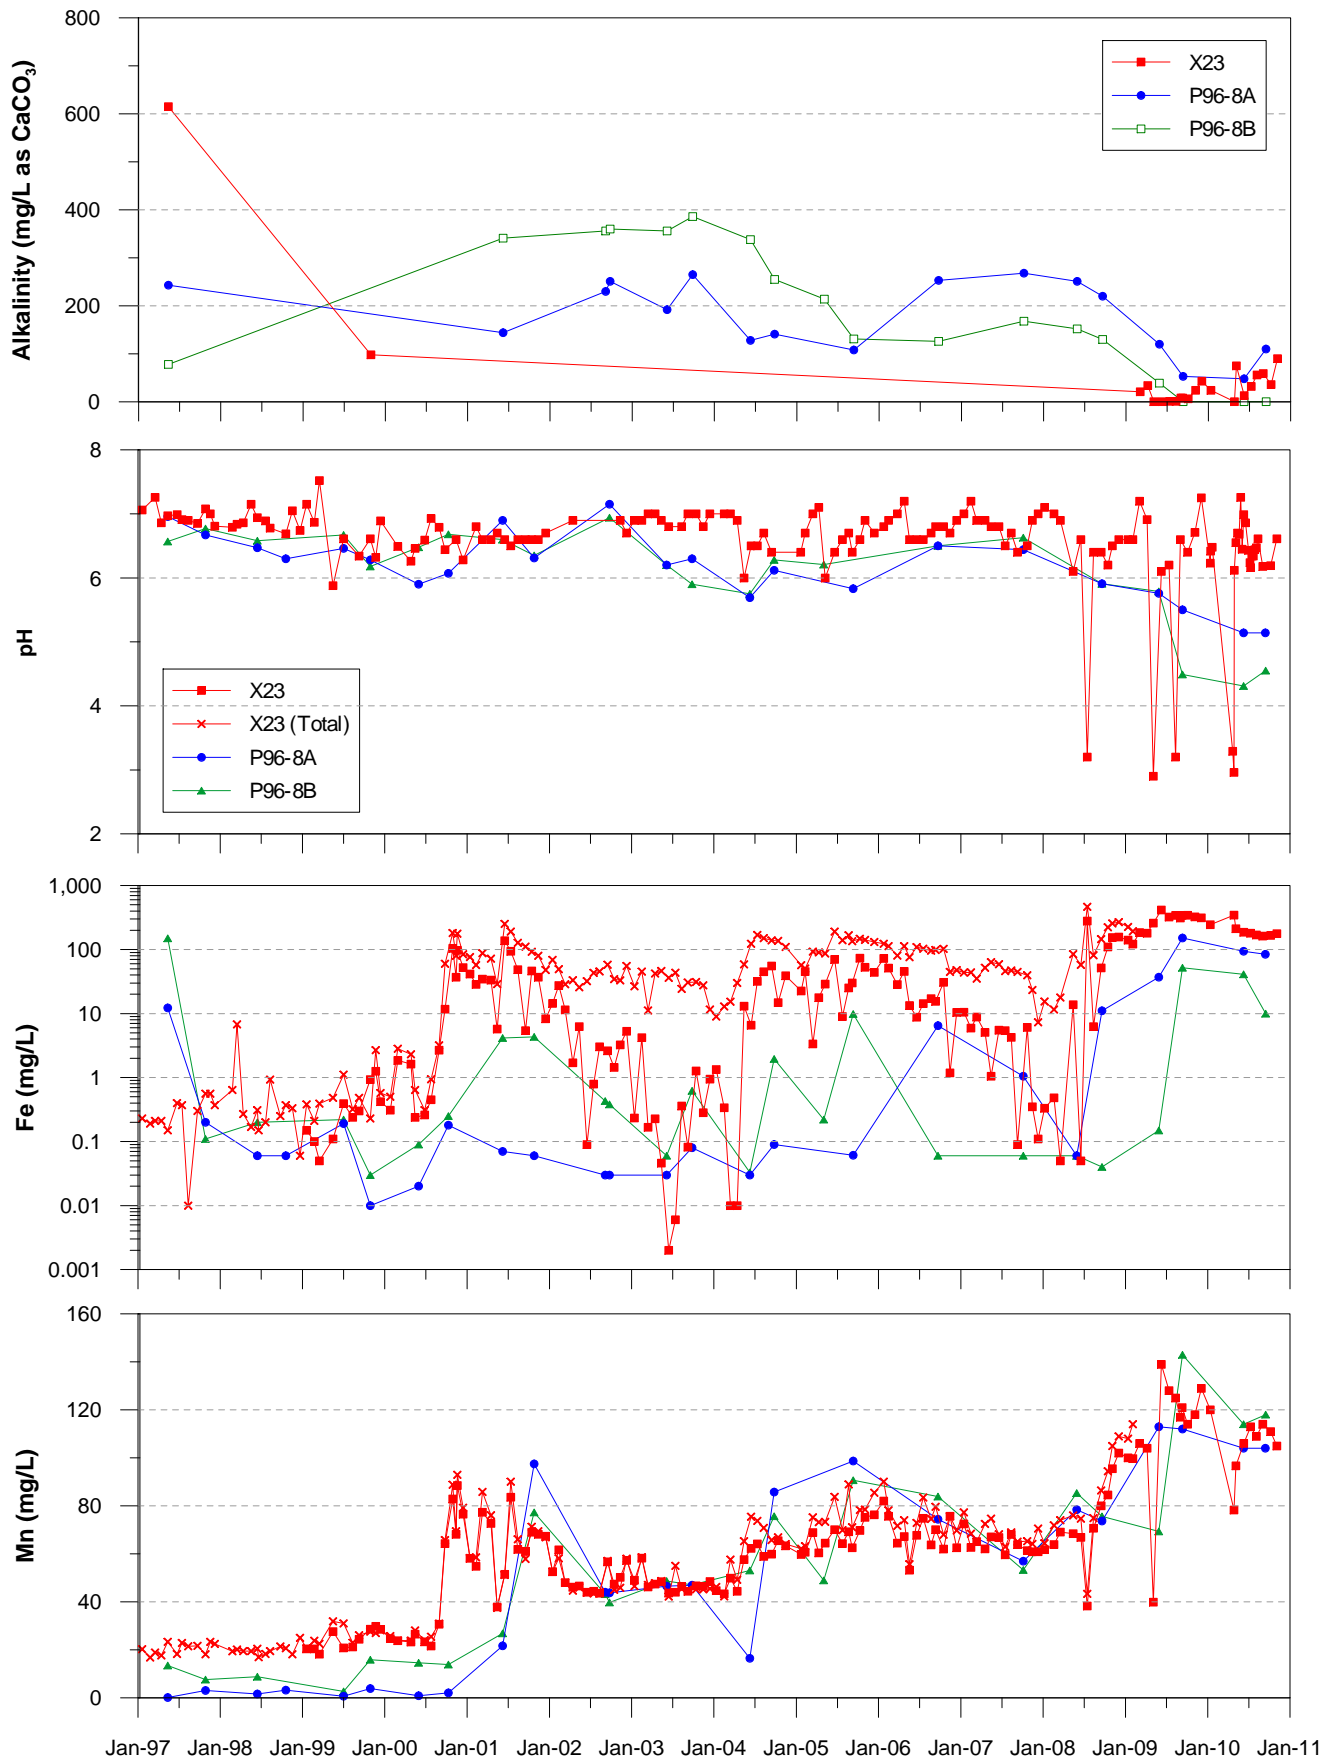
Figure 2-3b. Time trends for alkalinity, pH, Fe and Mn at X23 and P96-8A/B

Note also that highly-acidic conditions (pH<3.5) were again observed during the current monitoring period indicating that the buffering capacity within the waste rock dump and the local soils continues to be limited and occasionally be depleted.

Note that groundwater in these alluvial wells continued to show a declining trend in pH throughout this monitoring period (Figure 2-3b). According to the database, the deeper alluvial well (P96-8B) showed more acidic conditions (pH <4.5 and no alkalinity) than the shallow alluvial well (P96-8A). This trend is not expected since earlier time trends consistently showed higher metal and lower pH in the shallow well P96-8A. Field notes on total depth recorded during sampling should be checked to determine whether there is a mix-up between those two wells. In any case, the observed decrease in groundwater pH at P96-9A/B could be the first sign of an acid front in the alluvial soils of the ETA area and should therefore be monitored carefully.

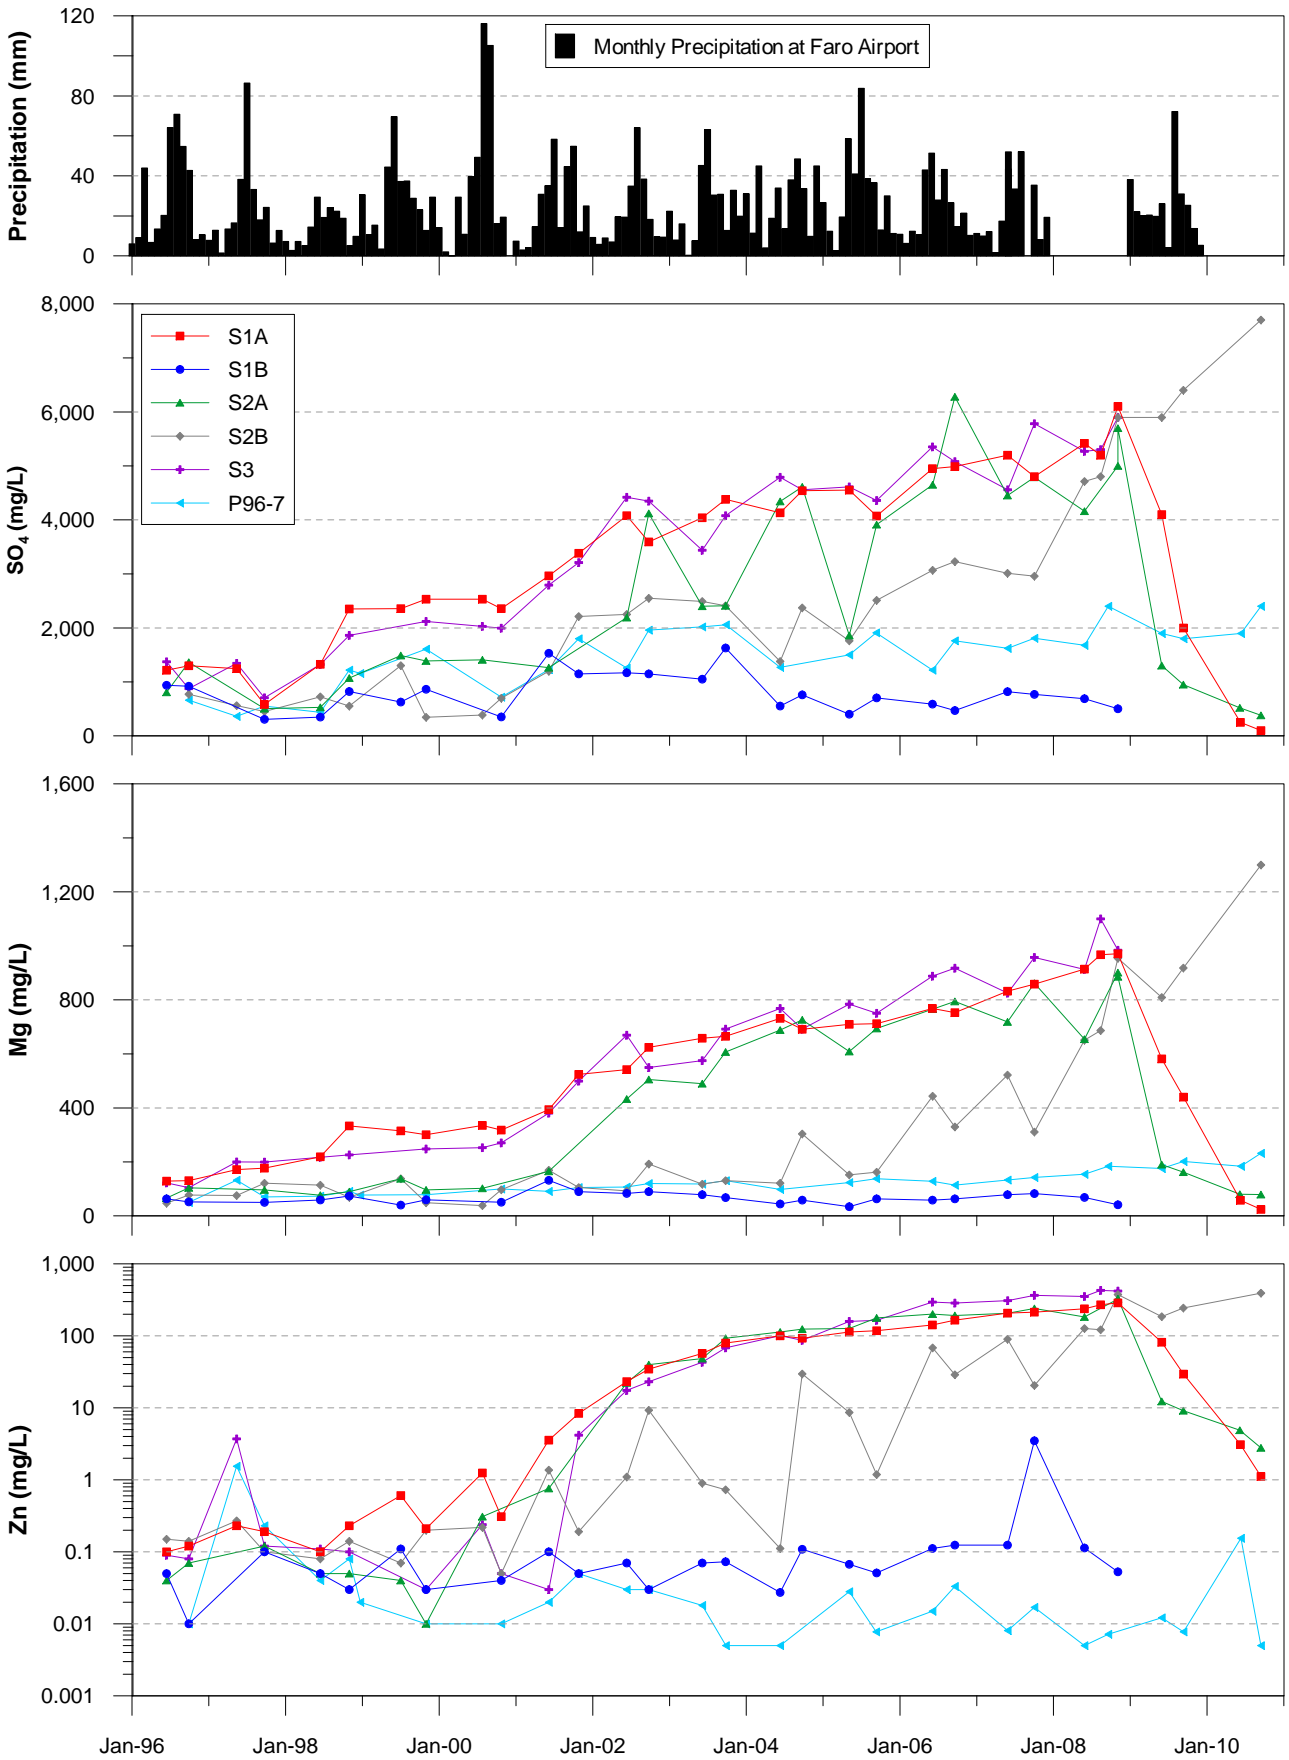
Figure 2-6a. Time Trends for  $\text{SO}_4$ , Mg and Zn in S-Cluster Wells

In contrast, significant changes were observed in groundwater quality in immediate vicinity of the SIS where highly impacted groundwater is present. Recall that concentrations of major ions and metals of interest in the immediate vicinity of the SIS in highly-impacted groundwater had generally increased since 2000 and had reached their highest levels to date during the previous monitoring period, i.e. in mid-2009 (RGC, 2010b). For instance, water quality data for wells S1A, S2A, and S2B typify highly-impacted groundwater in the S-Cluster area (see Figure 2-6a/b).

During the current monitoring period the condition of highly-impacted groundwater at wells S1A and S2A (both screened in bedrock) improved significantly due to seepage recovery upgradient via recovery well SRK05-SPW2. Note also that the groundwater quality in the bedrock screened at SRK08-SBR4 did improve since the last monitoring period indicating a strong hydraulic connection within the bedrock aquifer.

In contrast, groundwater quality in the overlying overburden soils (e.g. at well S1B) continued to deteriorate significantly. For example,  $\text{SO}_4$  concentrations in S1B reached nearly 8,000 mg/L and over 100 mg/L Mn and Zn in September 2010. This lack of improvement in water quality at well S2B suggests a poor hydraulic connection between the overburden till (screened by S2B) and the bedrock screened by recovery well SRK05-SPW2 (and wells S1A and S2A).

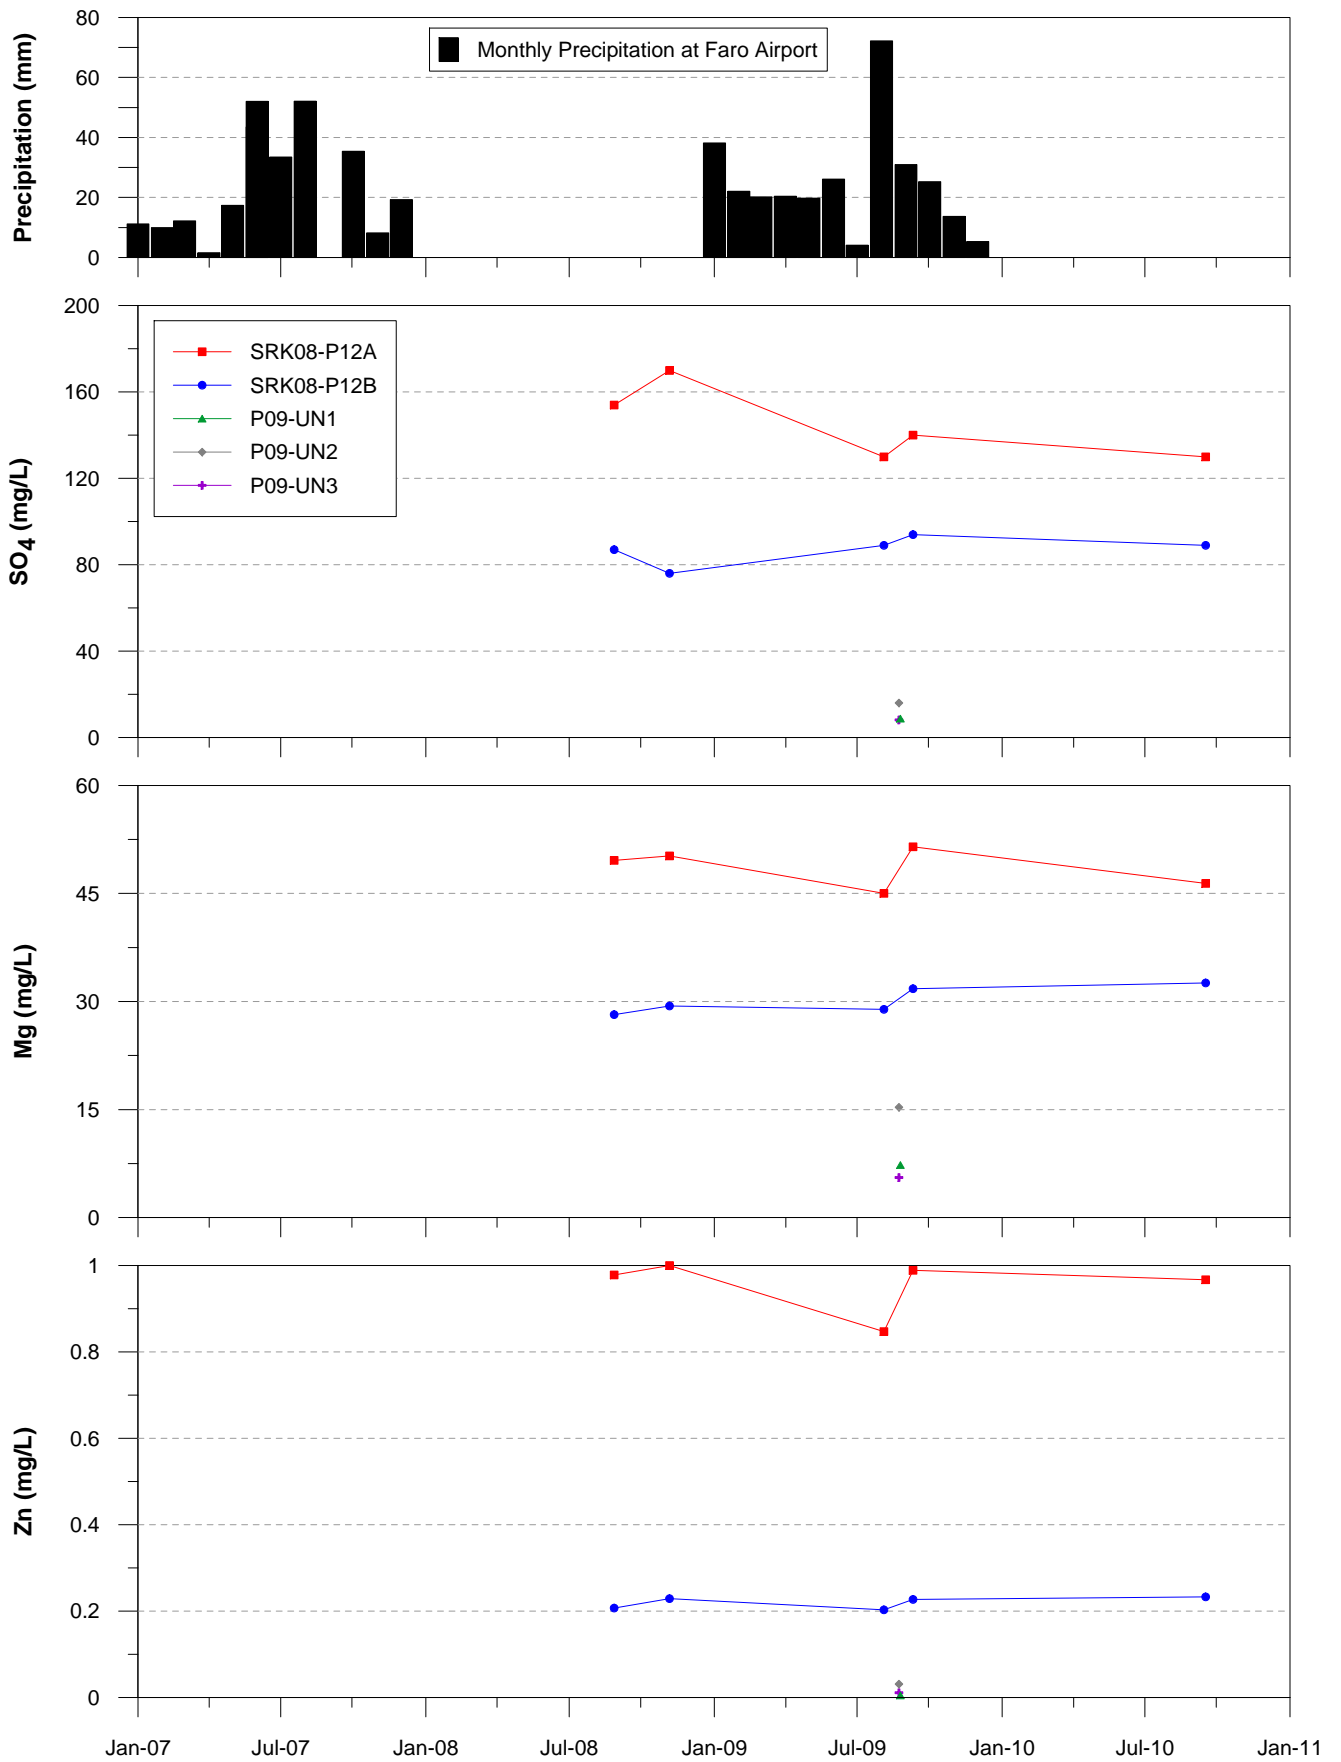
Figure 2-11a. Time trends for SO<sub>4</sub>, Mg, Na and Zn in P09-UN wells and SRK08-P12A/B

Water quality data for the 'P09-UN' wells series and wells SRK08-P12A/B are shown in Figure 2-11a/b. Note that each of 'P09-UN' wells is screened in the NFRC alluvial aquifer ~50 m downstream of the NFRC-Faro Creek diversion channel confluence whereas wells SRK08-P12A/B are screened in weathered bedrock/alluvial sediments upstream of the Zone 2 Pit outwash area (and are shown in Figure 2-11a/b for purposes of comparison). Samples were not collected from the 'P09-UN' wells during the current monitoring period as groundwater quality in each of these wells is known to reflect background conditions for the Faro site.

No significant changes in groundwater quality were observed in the two wells SRK08-P12A/B located immediately upstream of the Zone 2 outwash area. Groundwater from these wells remains slightly impacted by ARD (Figure 2-11a/b). Specifically,  $\text{SO}_4$  concentrations are slightly elevated (80 to 160 mg/L) and Zn concentrations are ~0.2 mg/L in well SRK08-P12B and 1 mg/L in well SRK08-P12A. Note that SRK08-P12A and -P12B are screened in permeable weathered bedrock and highly permeable alluvial sediments suggesting a substantial zinc load in the NFRC valley. The location of these wells (just upgradient of the Zone 2 outwash area) suggests that seepage from the NE waste rock dumps (rather than seepage from the Zone 2 pit and/or leaching of the outwash sediments) is the primary source of this contaminant load (see below).

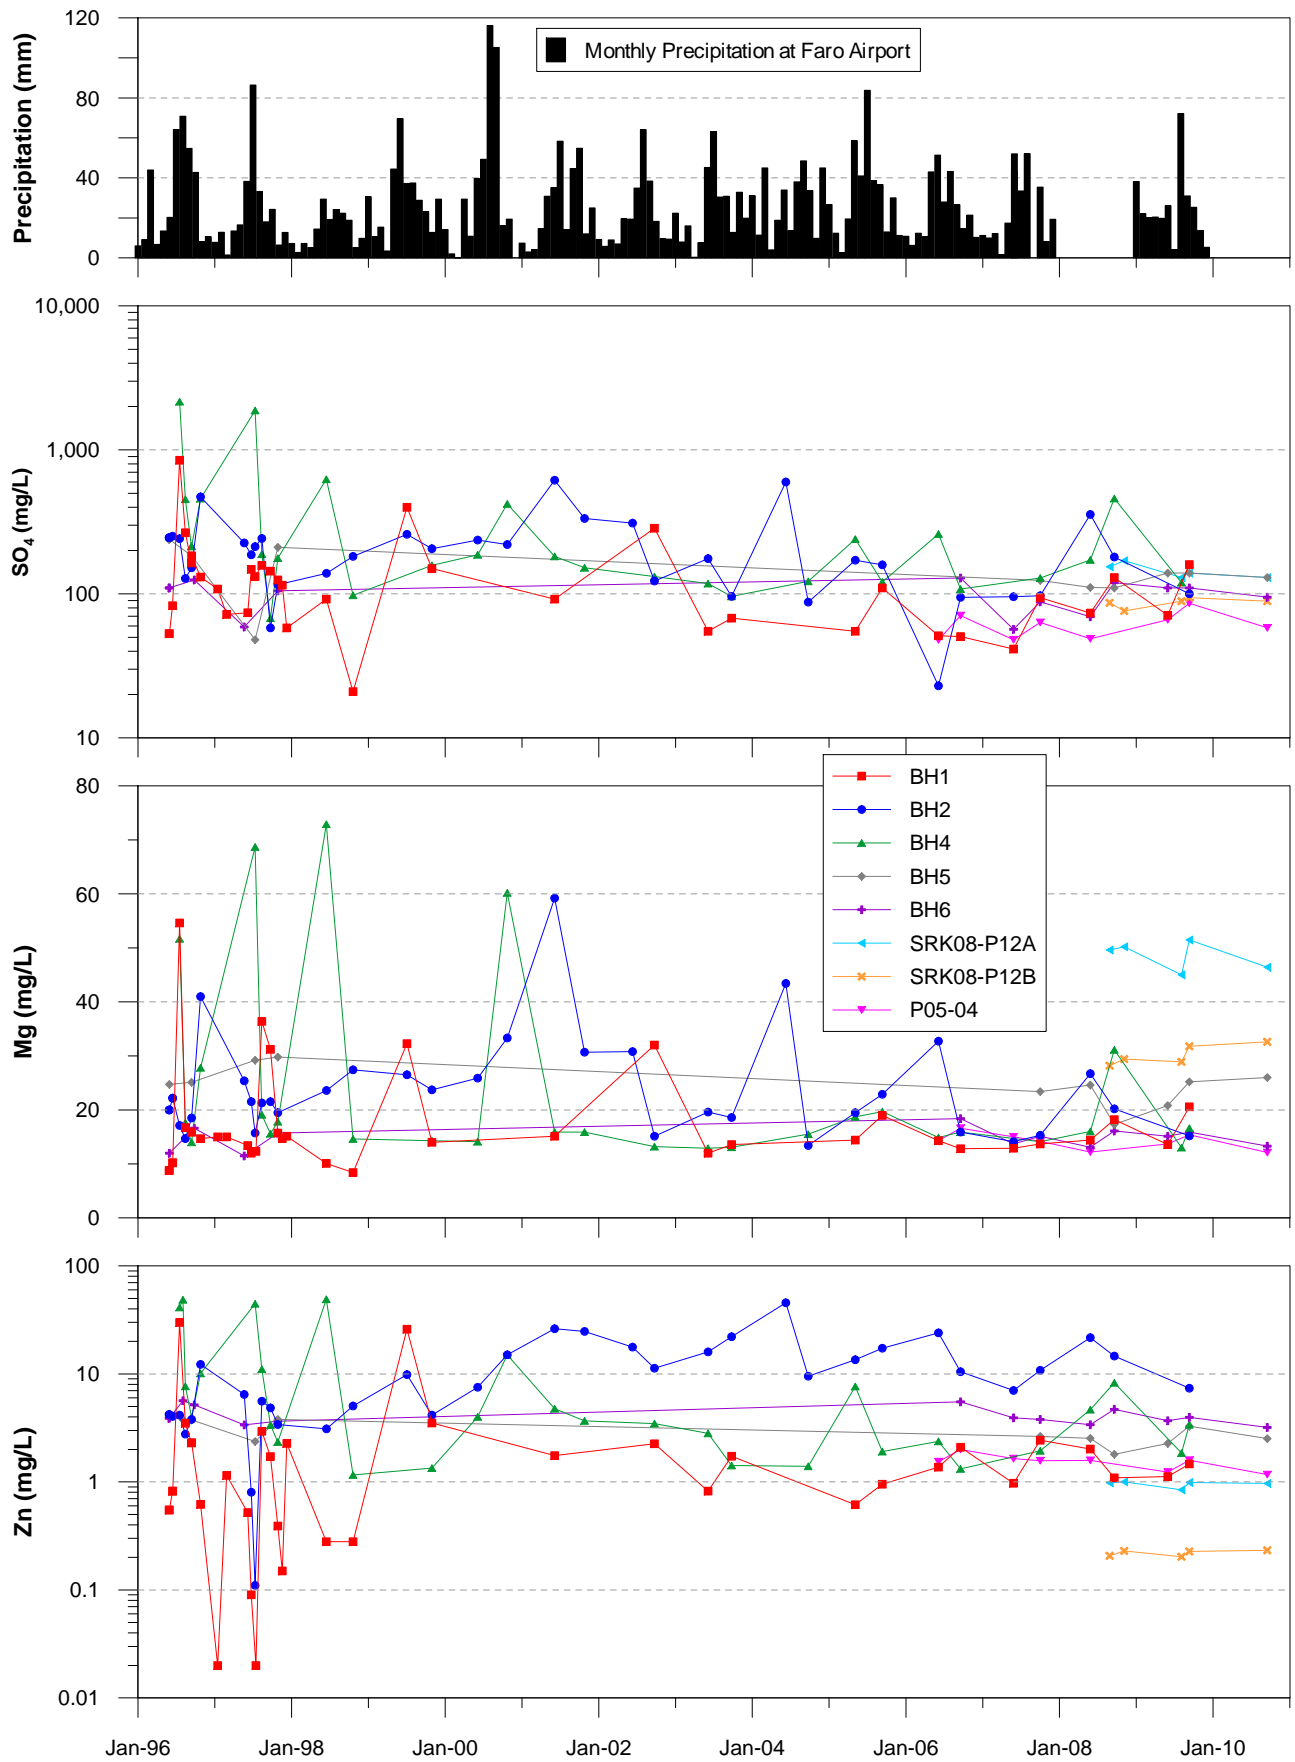
Figure 2-14a. Time trends for SO<sub>4</sub>, Mg and Zn for wells in Zone 2 Pit outwash area

Well BH8 is screened in weathered bedrock immediately downgradient of the Zone 2 Pit and has been included in the routine monitoring program since 2008. Groundwater in the vicinity of this well remains highly-impacted by seepage from the Zone 2 Pit but SO<sub>4</sub>, Mg, and metals of interest concentrations are not increasing over time (see Figure 2-13a/b). Groundwater quality conditions at wells BH10A/B are similarly stable although much less impacted than groundwater at well BH8 (i.e. SO<sub>4</sub><200 mg/L and 2 to 3 mg/L Zn). Further downgradient in the Zone 2 Pit outwash area itself, no appreciable changes in groundwater quality occurred during the current monitoring period as concentrations of SO<sub>4</sub>, Mg, and metals of interest were generally consistent with historic time trends (see Figure 2-14a/b).

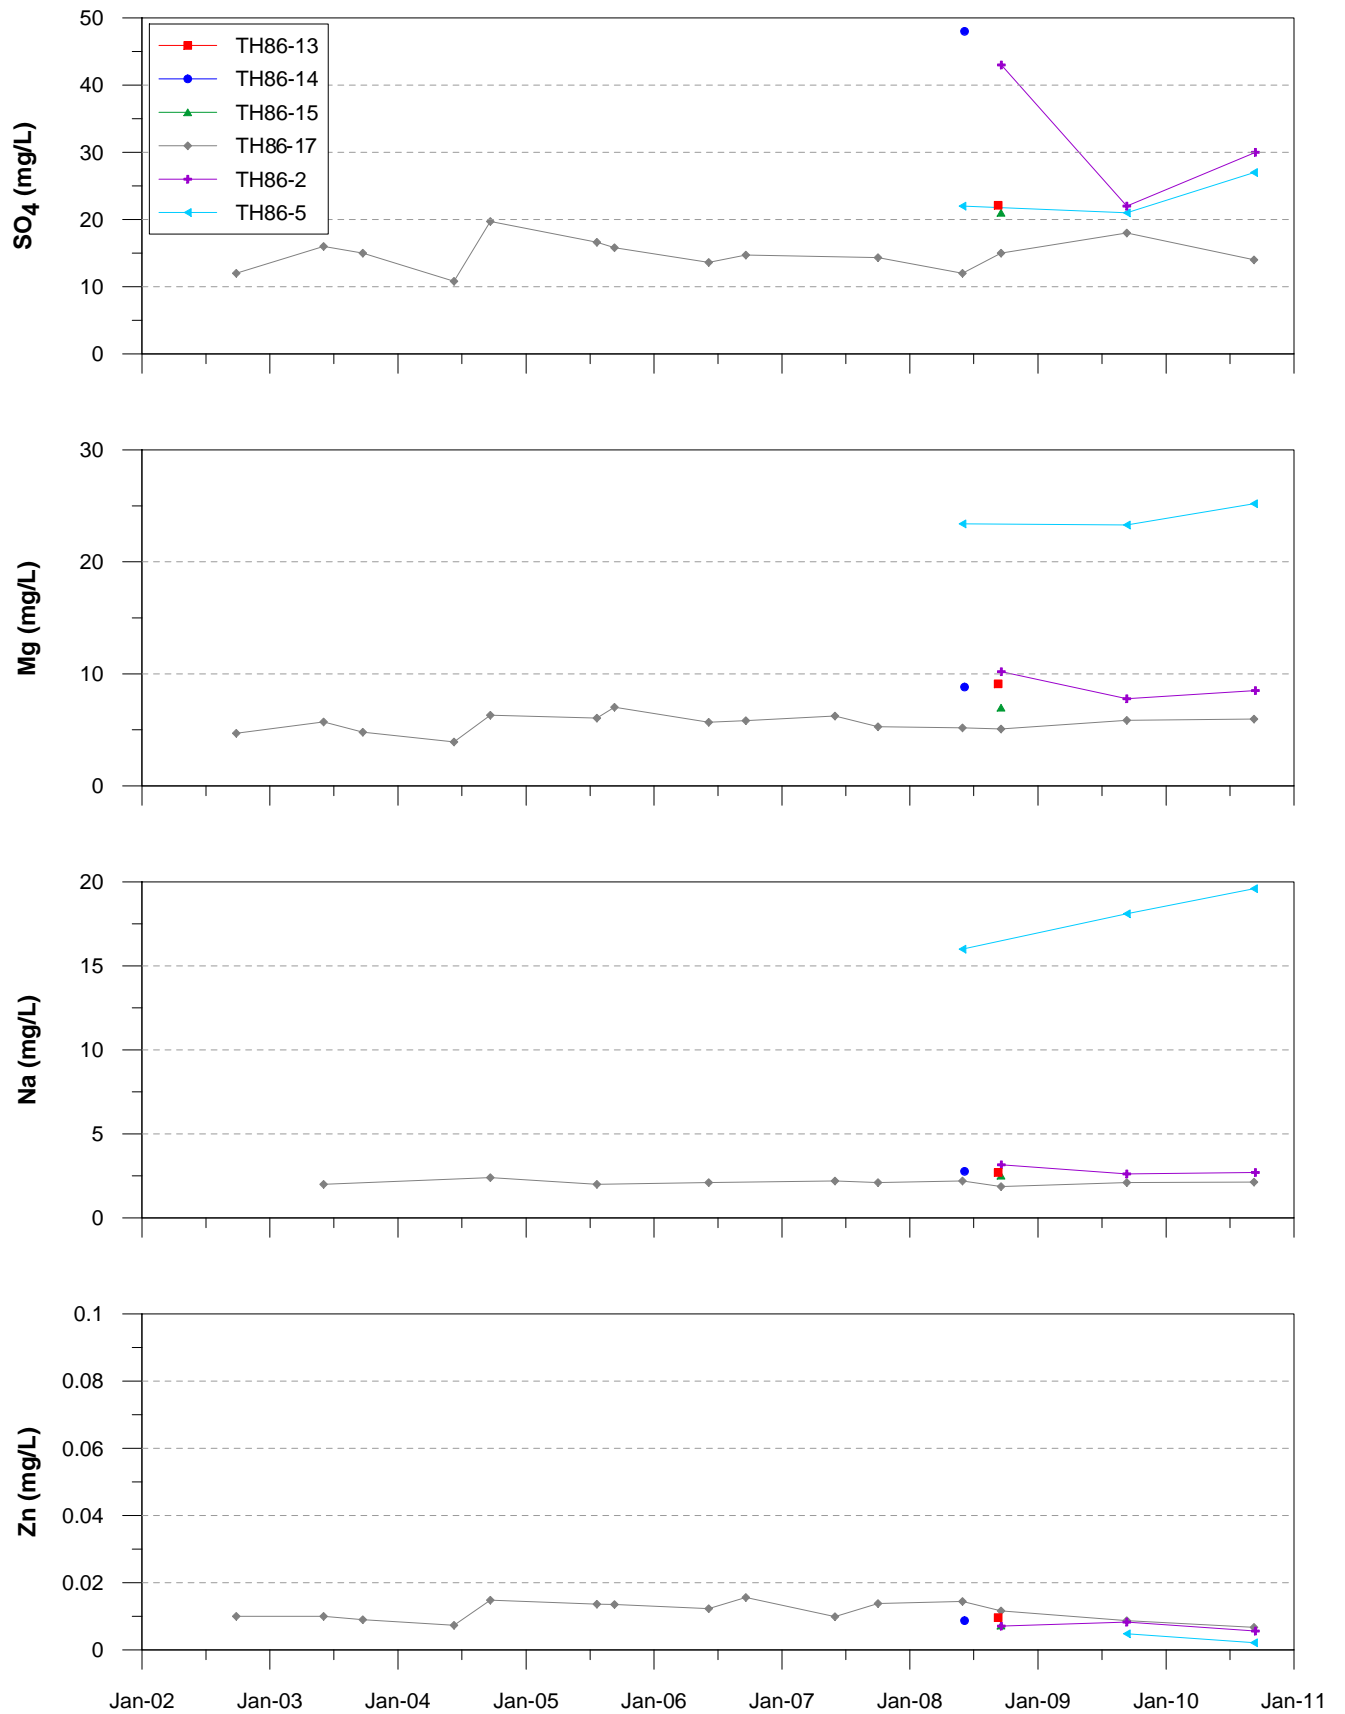
Figure 3-2a. Time trends for SO<sub>4</sub>, Mg, Na and Zn in Rose Creek Alluvial Aquifer upgradient of RCTF

Figure 3-2a/b shows time trends for pH, alkalinity, selected major ions, and metals of interest in groundwater from well TH86-17 and nearby piezometers. Very low concentrations of SO<sub>4</sub>, Mg, and metals of interest in groundwater from well TH86-17 reflect 'background' conditions in the RCAA. Hence there remains no indication that mine waste seepage is present in shallow groundwater southeast of the Original Impoundment.

Note from Figure 3-2a/b that groundwater from well TH86-5 is characterized by appreciably higher concentrations of Mg, Na, and alkalinity than groundwater from well TH86-17 but low concentrations of SO<sub>4</sub> and dissolved metals. These data reflect natural water quality conditions in deeper sediments of the RCAA and support the assertion that neither shallow nor deep groundwater in this area is affected by mine waste seepage from the Main or Intermediate WRDs (nor the NFRC aquifer).

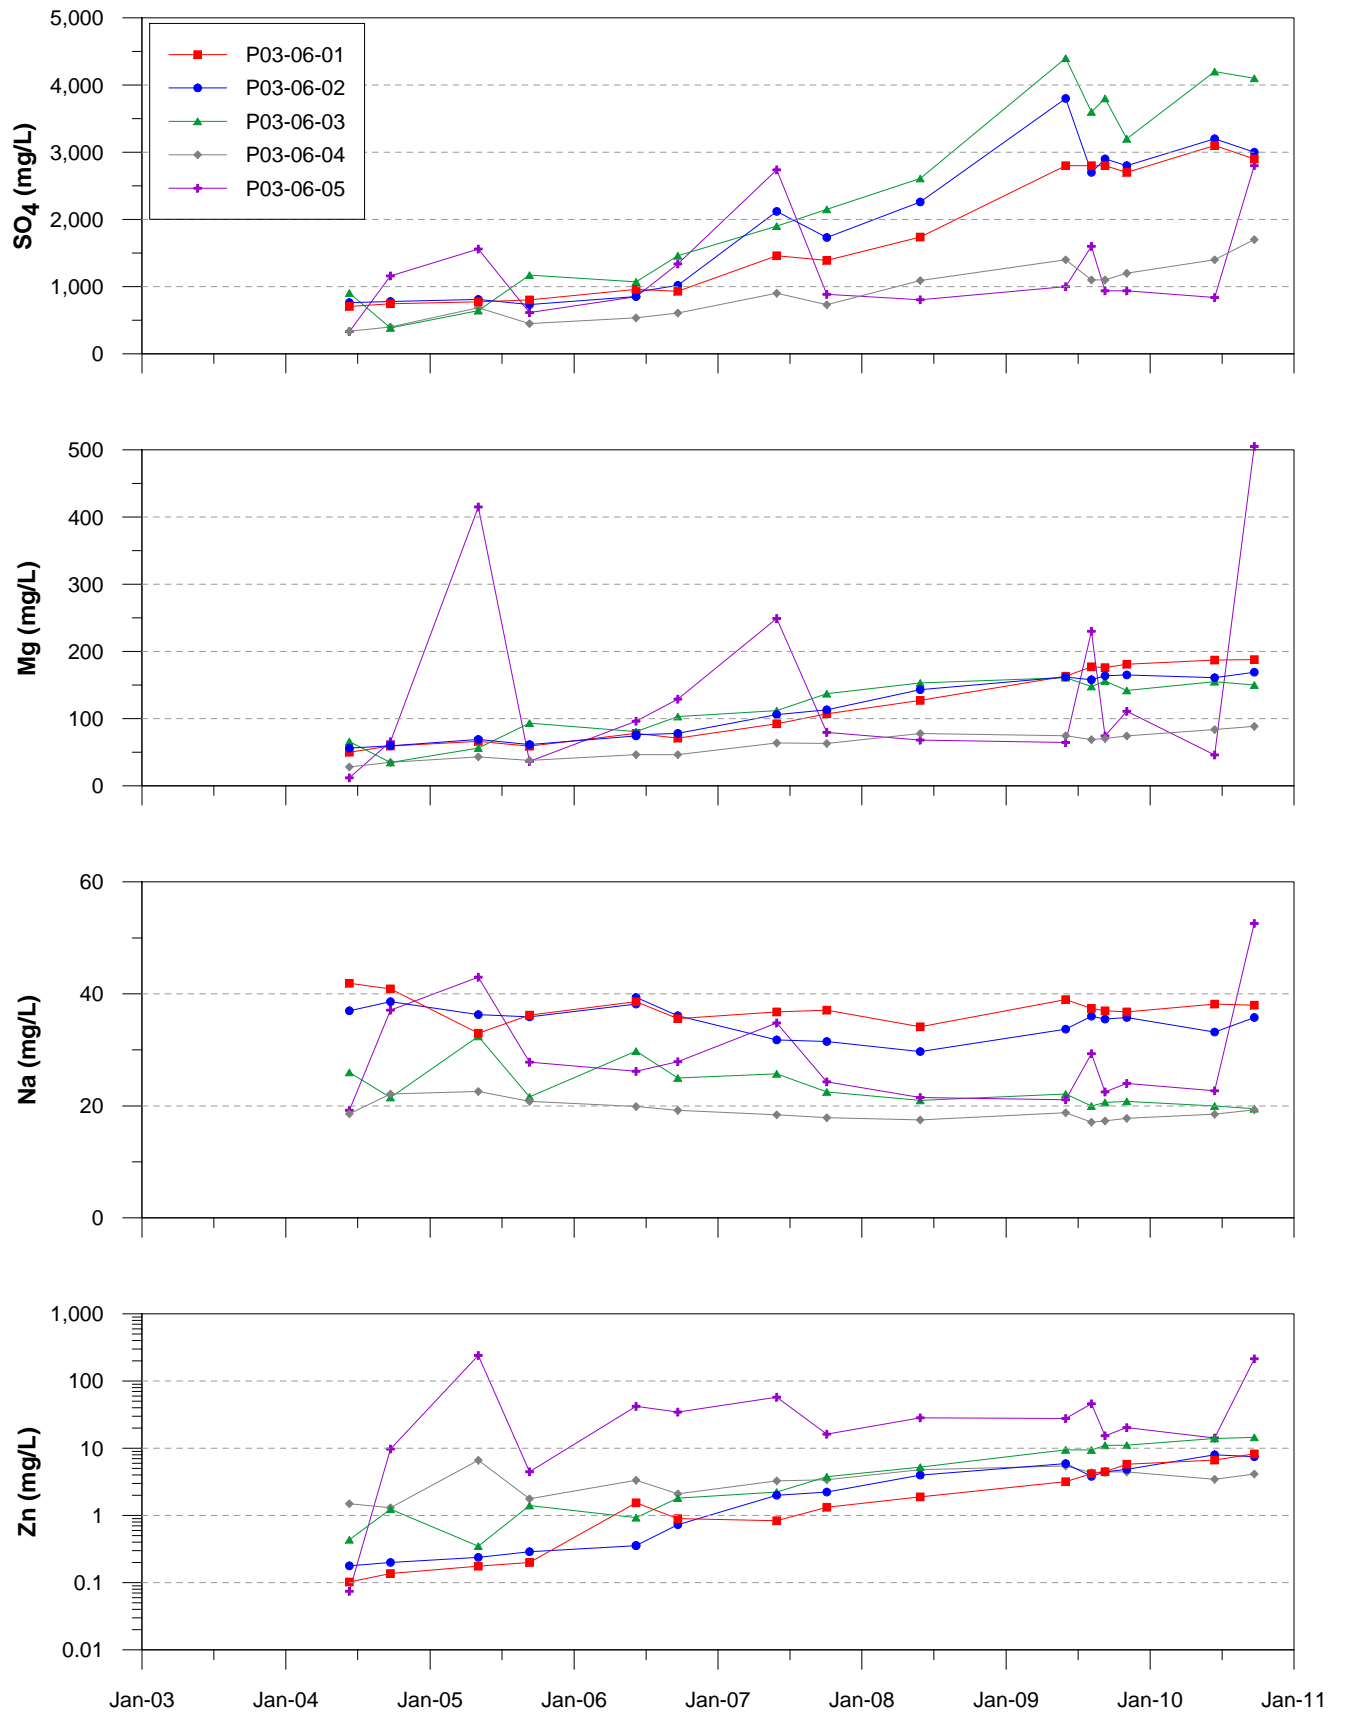
Figure 3-10a. Time trends for  $\text{SO}_4$ , Mg, Na and Zn in P03-06 (aquifer only)

Figure 3-10a/b shows the time trends for pH, alkalinity, selected major ions, and metals of interest in groundwater at P03-06. This well is located in the northwest portion of the Second Impoundment near the mouth of Faro Creek canyon. Previous reports have identified substantial increases in the concentrations of  $\text{SO}_4$  and metals of interest (and decreasing level of alkalinity) in this area since 2005 and have emphasized that most of the deterioration in water quality has occurred deeper in the aquifer at P03-06 (RGC, 2008; 2009, 2010b). This increasing trend of contaminants at greater depth in P03-06 continued during the current monitoring period (Figure 3-10a/b). Note that contaminant concentrations increased rather abruptly in the shallowest piezometer at P03-06 in late 2010 and that increases of the same magnitude were not apparent in deeper groundwater. These abrupt increases likely reflect a sampling artefact or some contamination of shallow groundwater by seepage from surface but additional monitoring data is needed to confirm either scenario.
