Report No. 118022/1

**2011 GROUNDWATER QUALITY REVIEW
ANVIL RANGE MINING COMPLEX, YUKON TERRITORY**

June 2012

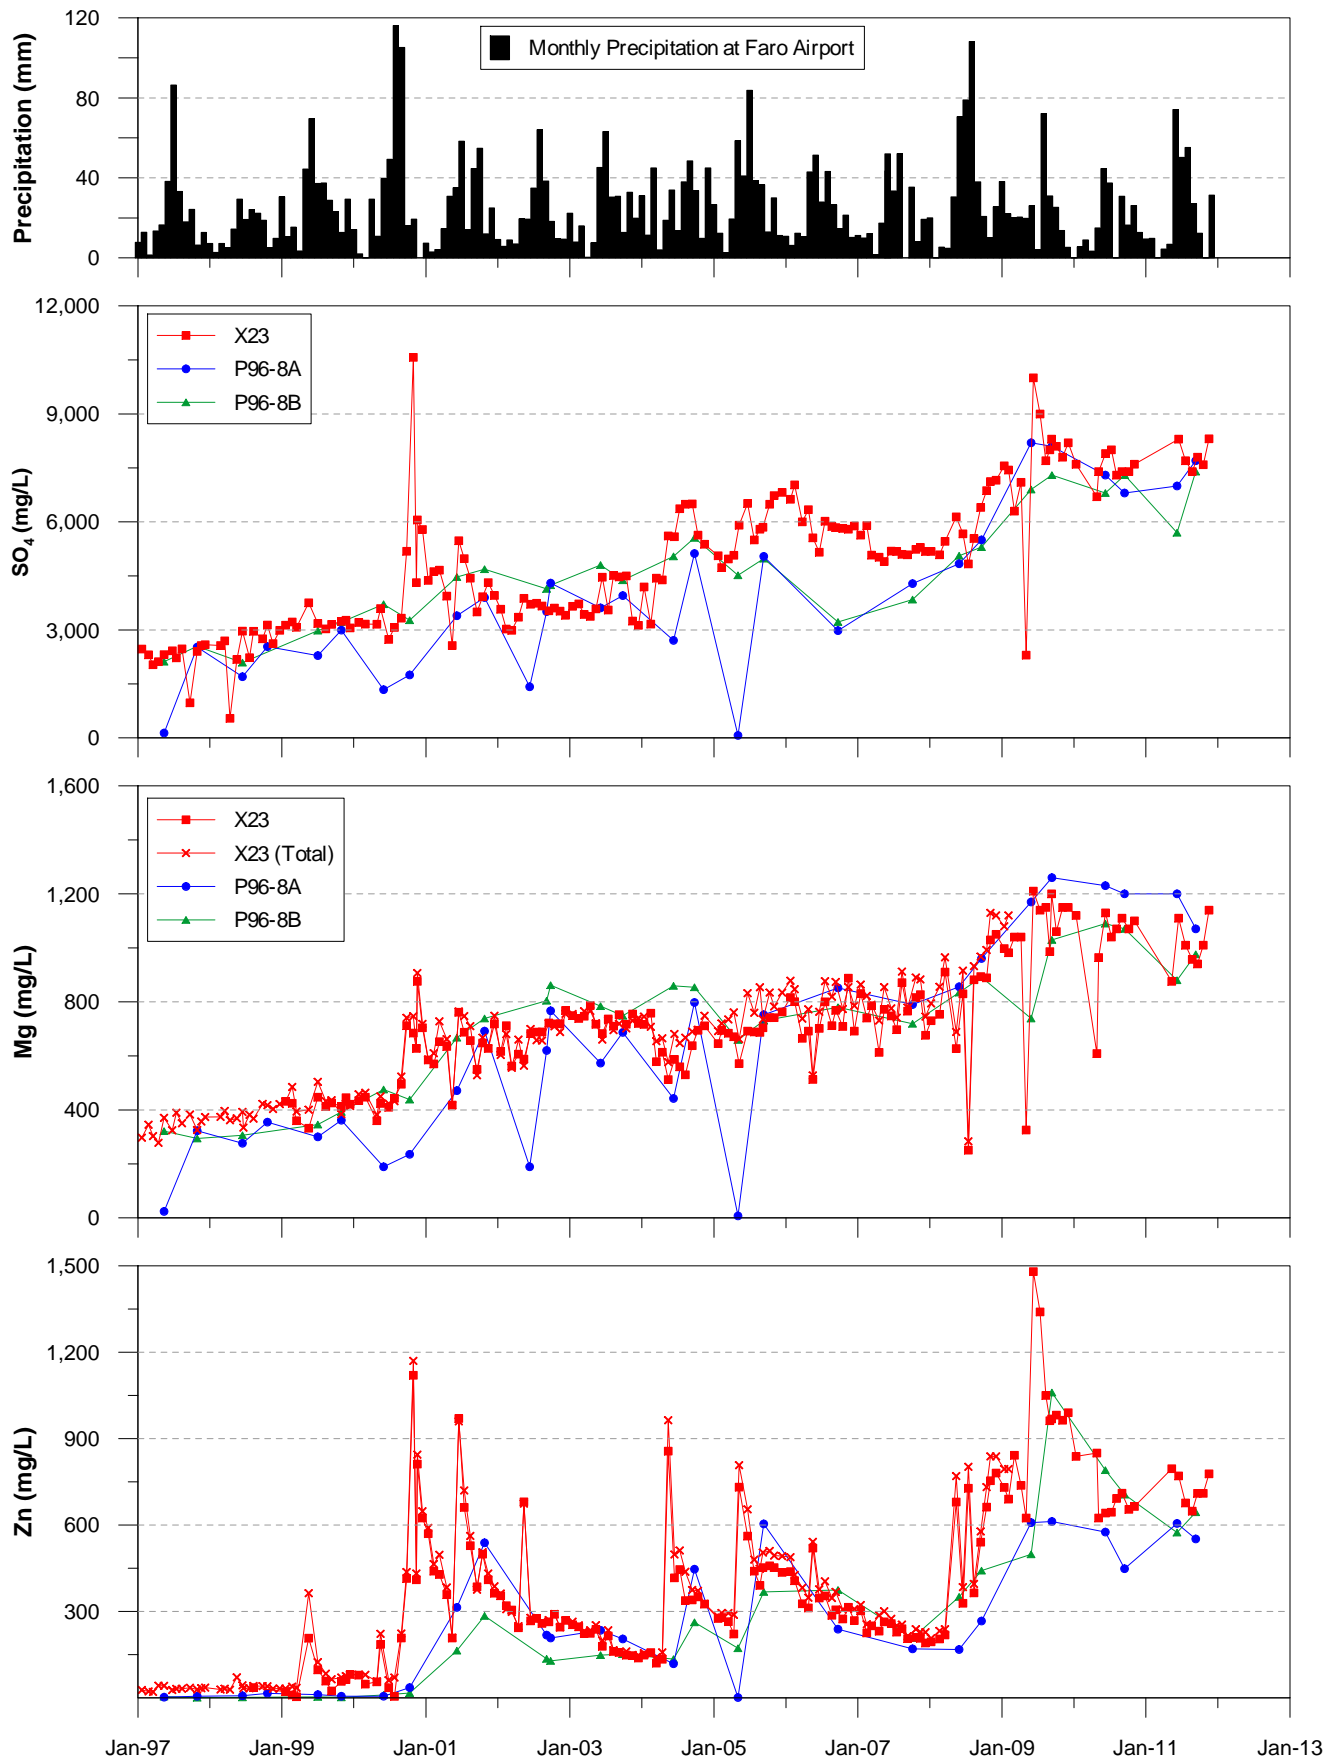
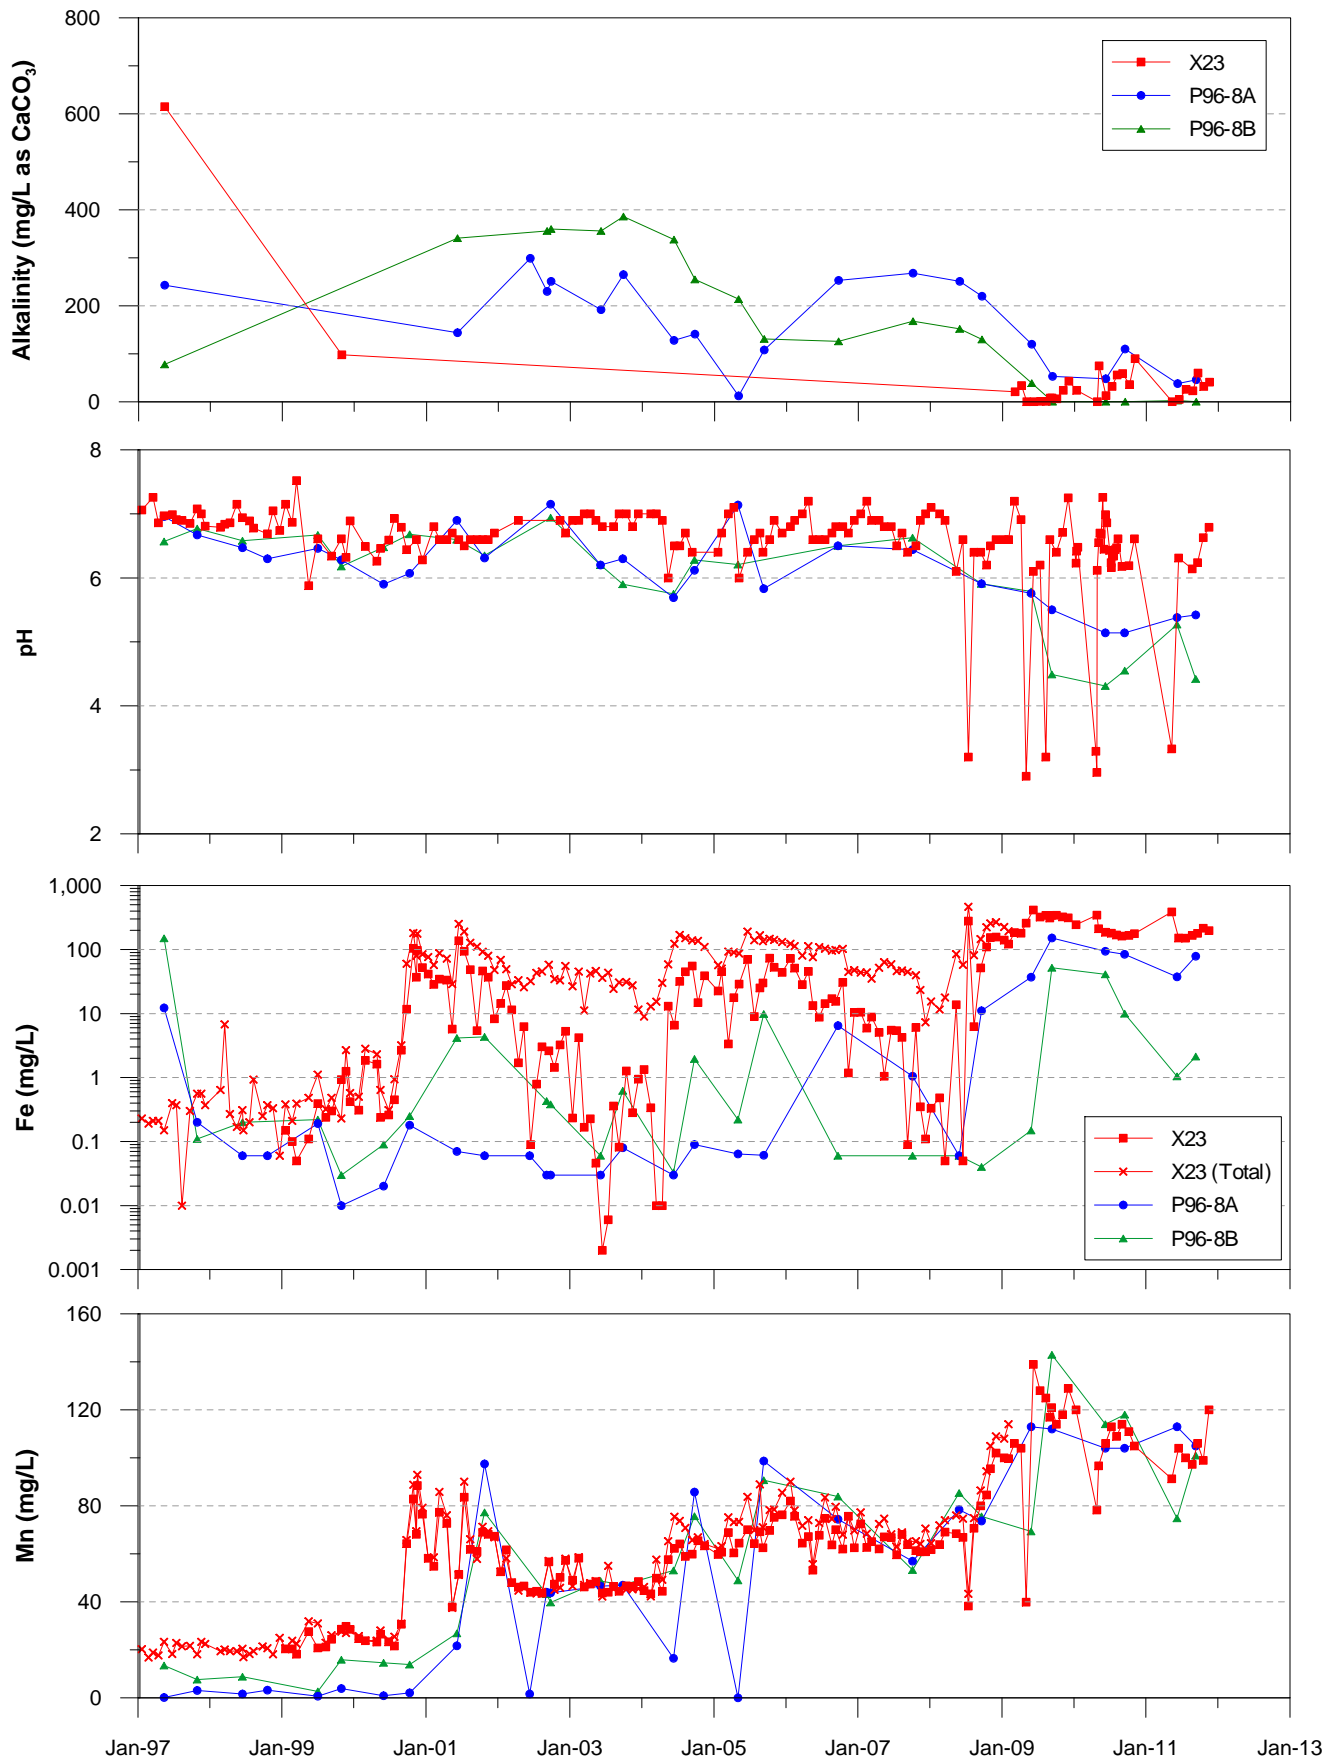
Figure 2-3a. Time trends for SO₄, Mg and Zn at X23 and P96-8A/B

SO₄, Mg, and Zn concentrations in seepage at X23 are lower than they were in 2009/2010 after a particularly large ‘flush’ of contaminants occurred in 2009 (see Figure 2-3a/b). Water quality results are, however, consistent with a long-term trend towards higher contaminant concentrations that has been observed over the last 15 years. Seepage from the Main WRD has also become noticeably more acidic over the last 2 to 3 years and alkalinity levels have decrease substantially over this period. Higher contaminant concentrations, lower pH conditions, and decreasing alkalinity levels suggest the ongoing ‘breakthrough’ of ARD products at X23 and a decline in the buffering capacity of waste rock within the Main WRD.

More acidic conditions in groundwater at P96-8A/B suggest a significant reduction in the buffering capacity of alluvial soils in this area due to increasing contaminant loads from the Main WRD. Higher concentrations of SO₄, Mg, and dissolved metals in groundwater are expected in the coming years as a result.

trends observed further upgradient (at P96-8A/B). These data suggest that groundwater in the ETA area is continually deteriorating in response to higher contaminant loading from the Main Dump (X23).

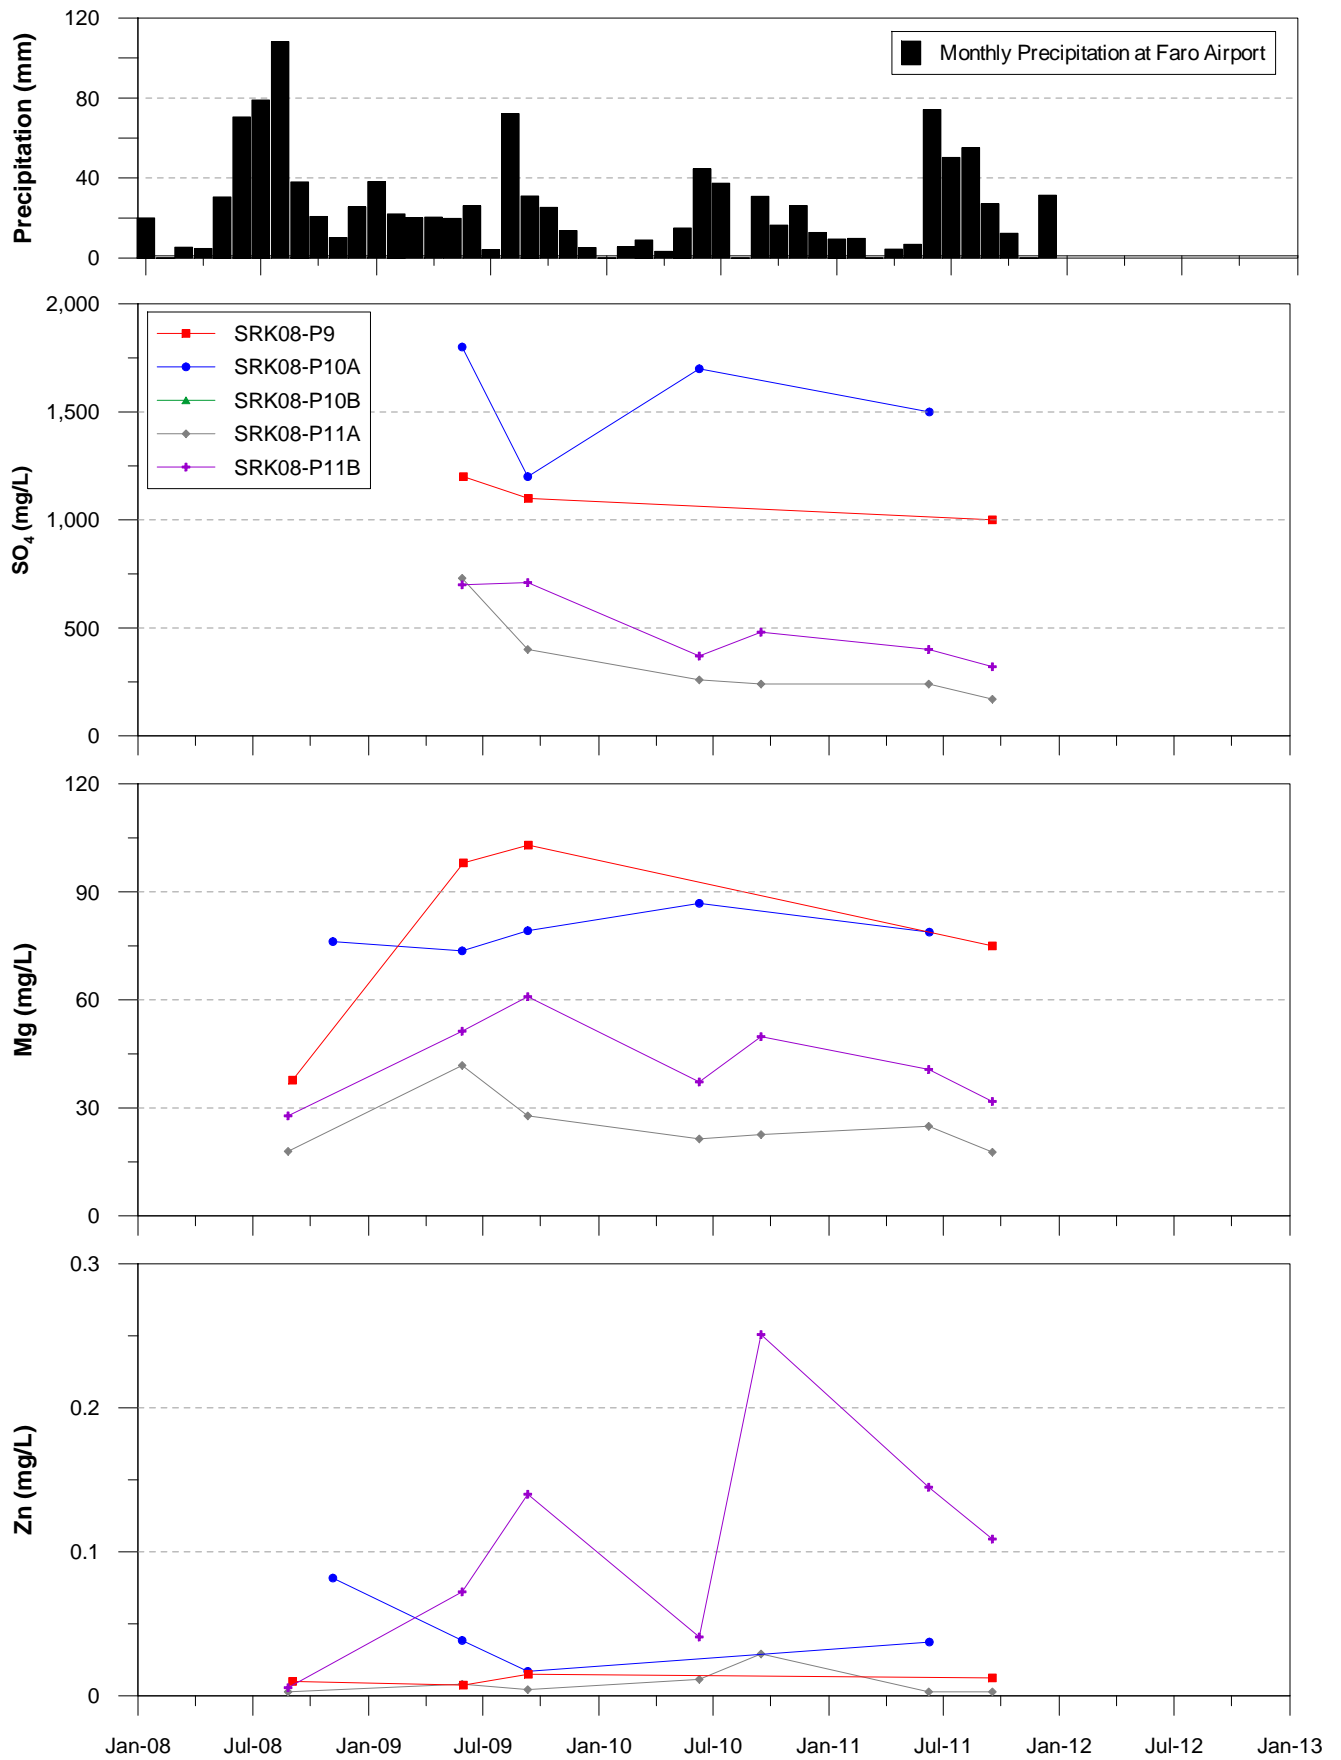
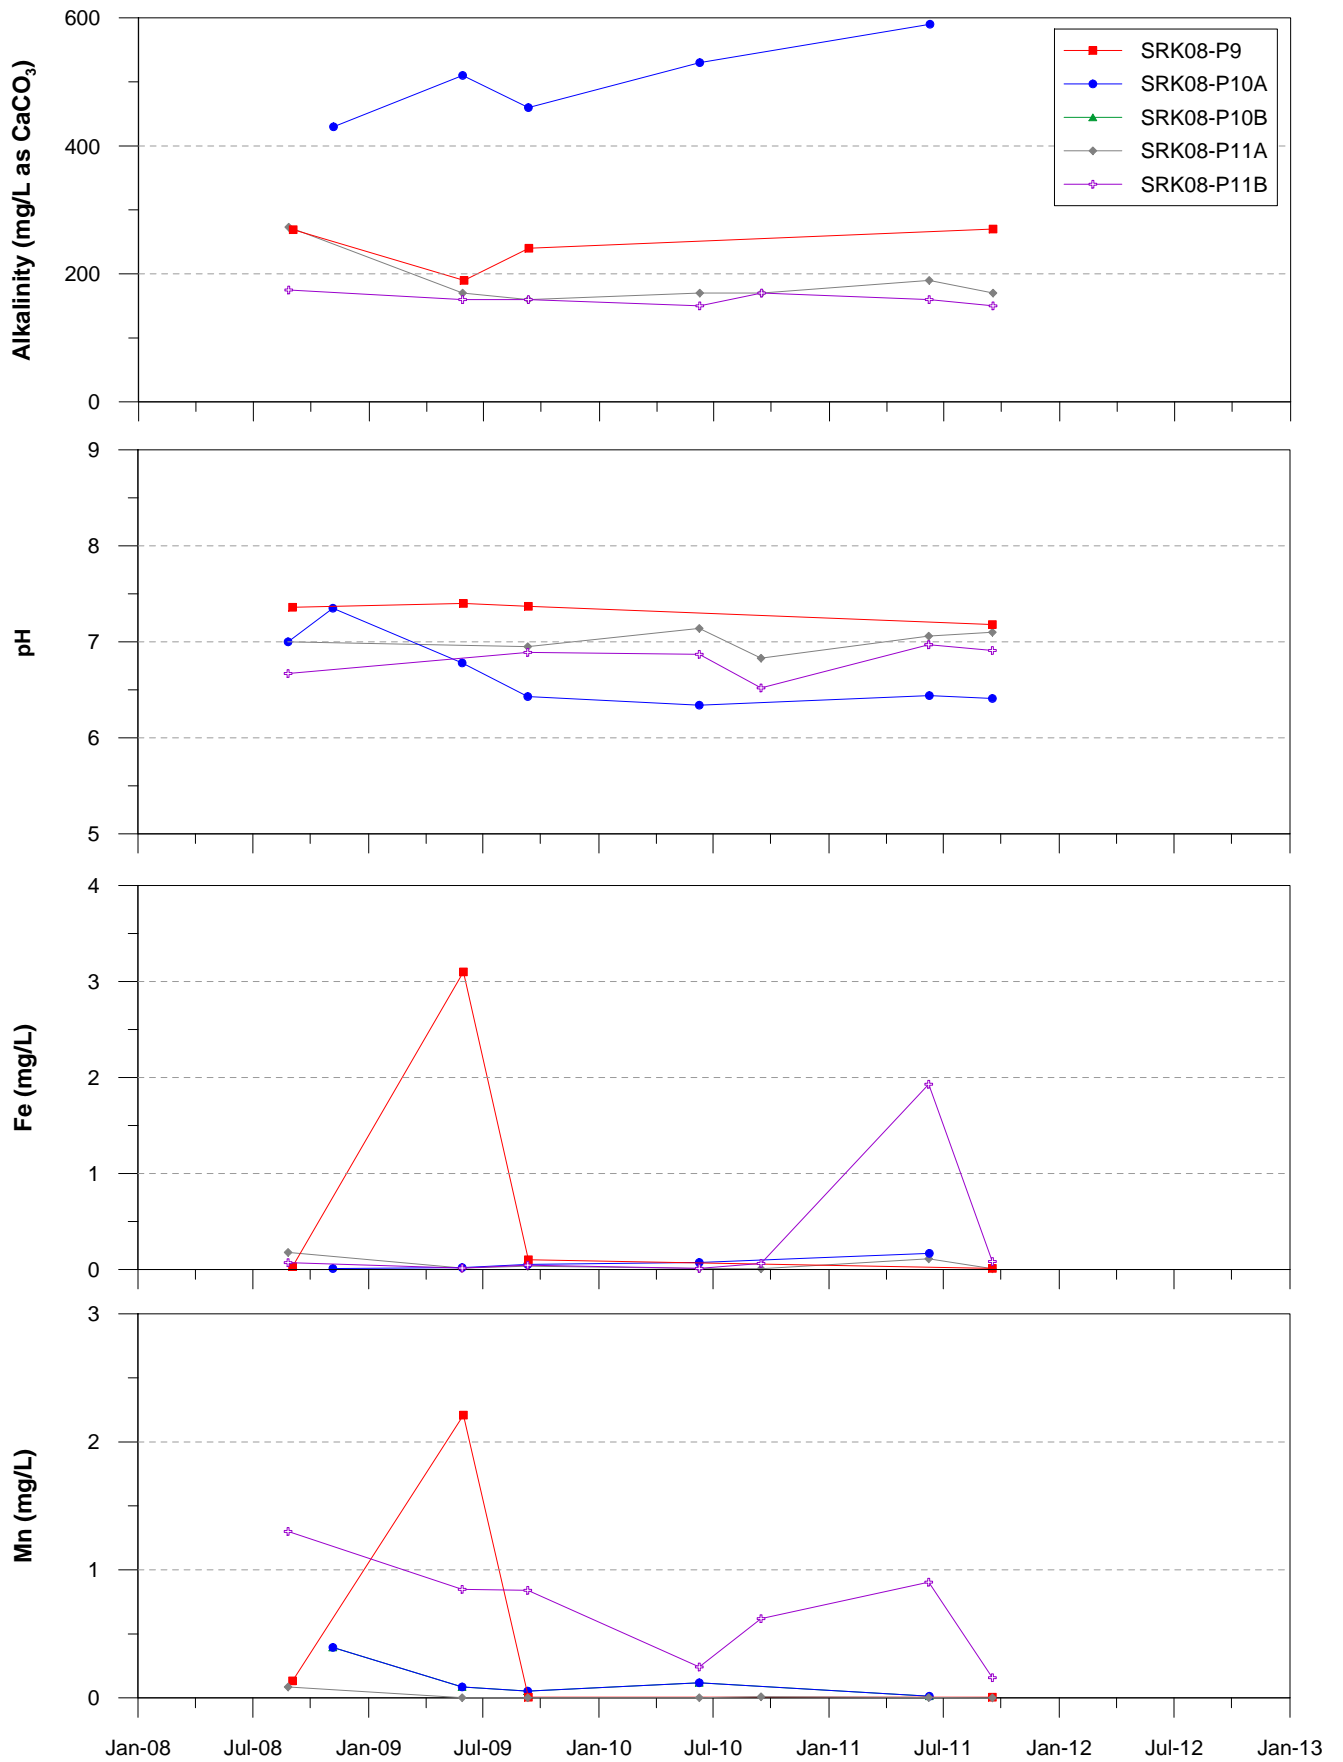
Figure 2-3c. Time trends for SO₄, Mg and Zn in SRK08 wells located in Main Rock Dump and Mill Site areas

- Groundwater at wells SRK08-P11A/B (near Guardhouse Creek) is characterized by elevated SO₄ and Mg concentrations at wells but relatively low concentrations of Zn (and other metals of interest) (see Figure 2-3c/d); these data, high alkalinity levels, and near-neutral pH conditions suggest that groundwater in this area is only modestly-affected by seepage from the Main WRD and water quality conditions did not change during the current monitoring period;

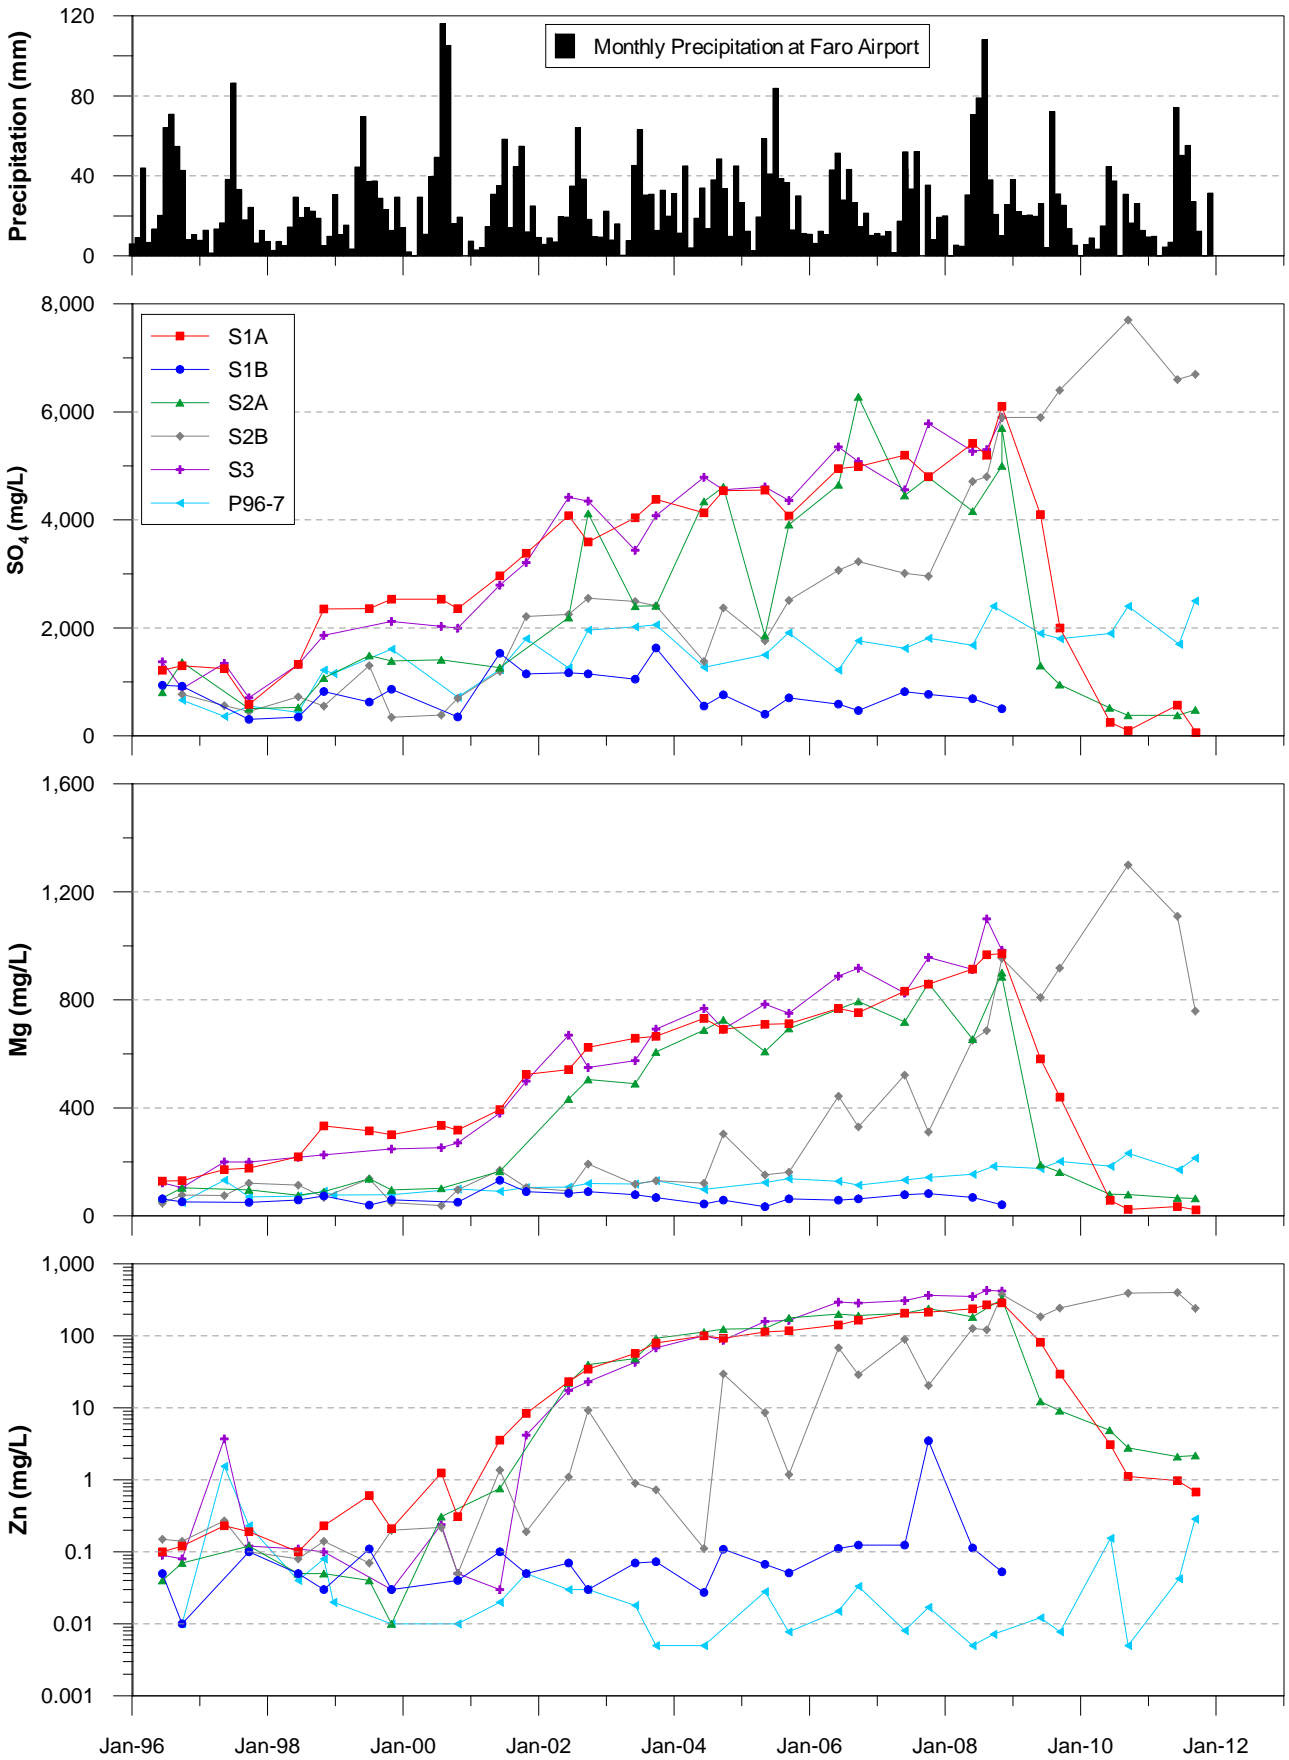
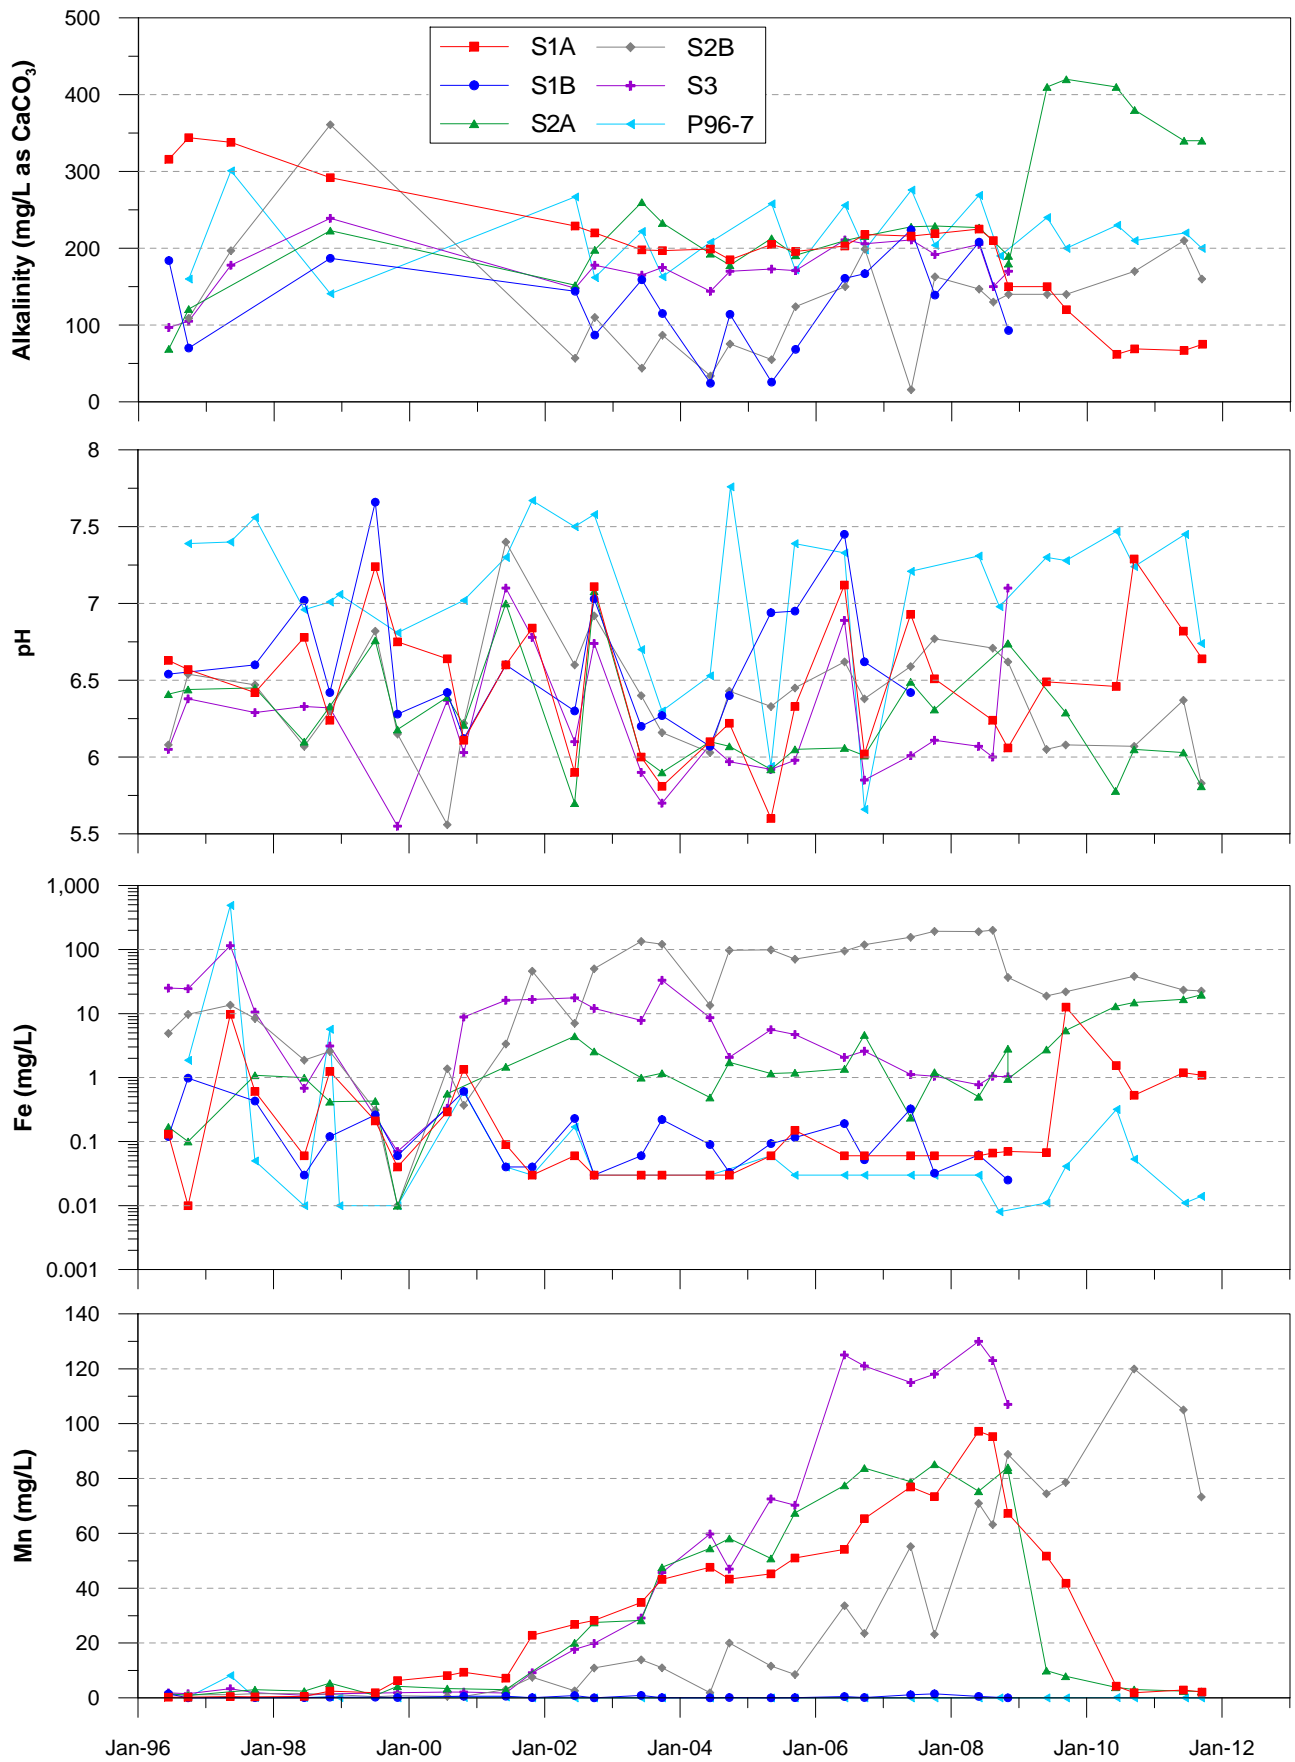
Figure 2-6a. Time Trends for SO₄, Mg and Zn in S-Cluster Wells

- Operation of the seepage recovery well SRK08-SPW2 (screened in bedrock) has significantly reduced contaminant levels in 'highly-impacted' groundwater in the bedrock aquifer at wells S1A and S2A (see Figure 2-6a/b); SO₄, Mg, and Zn concentrations in groundwater from these wells are now more characteristic of 'moderately-impacted' groundwater (i.e. less than 250 mg/L SO₄ and 1 to 3 mg/L Zn); groundwater quality conditions in the bedrock aquifer have also improved at well SRK08-SBR4 (see Figure 2-8a/b), suggesting that well SRK08-SPW2 is drawing water from at least 75 m away (and has caused a cone of depression to develop); however, pumping in bedrock (at SPW2) has not improved groundwater quality in the overlying sediments (see SRK05-SP5)

- Groundwater quality conditions at well S2B continued to deteriorate in 2011 (see Figure 2-6a/b); this well is screened in till (and hence not affected by seepage recovery via well SRK05-SPW2) and is located west of the shallow interceptor trench; SO₄ concentrations in well S2B now exceed 6,000 mg/L (and Zn concentrations reached 400 mg/L in June 2011); these concentrations suggest substantial bypass towards the NFRC via the shallow overburden soils west of the interceptor trench;

This review of water quality time trends suggests that groundwater quality in the bedrock aquifer of the S-Cluster area is improving as a result of seepage recovery from the bedrock (at SRK08-SPW2) but that the interceptor trench has not led to any significant improvement in shallow groundwater quality in this area. The implication is that groundwater-borne contaminants may continue to reach the NFRC via shallow overburden and adversely affect surface water quality conditions in the creek. Possible explanations for the apparent lack of water quality improvement in the shallow aquifer include (i) the limited lateral extent of the seepage trench, (ii) inadequate hydraulic control, and/or (iii) insufficient capacity during high flow periods (see SRK, 2011a).

We recommend that a detailed performance review of the S-Cluster SIS be completed (which was beyond the scope of this review) to determine how the system could be improved or if replacement would be necessary to ensure water quality in the NFRC is not affected by loads from the Intermediate WRD (see recommendations).

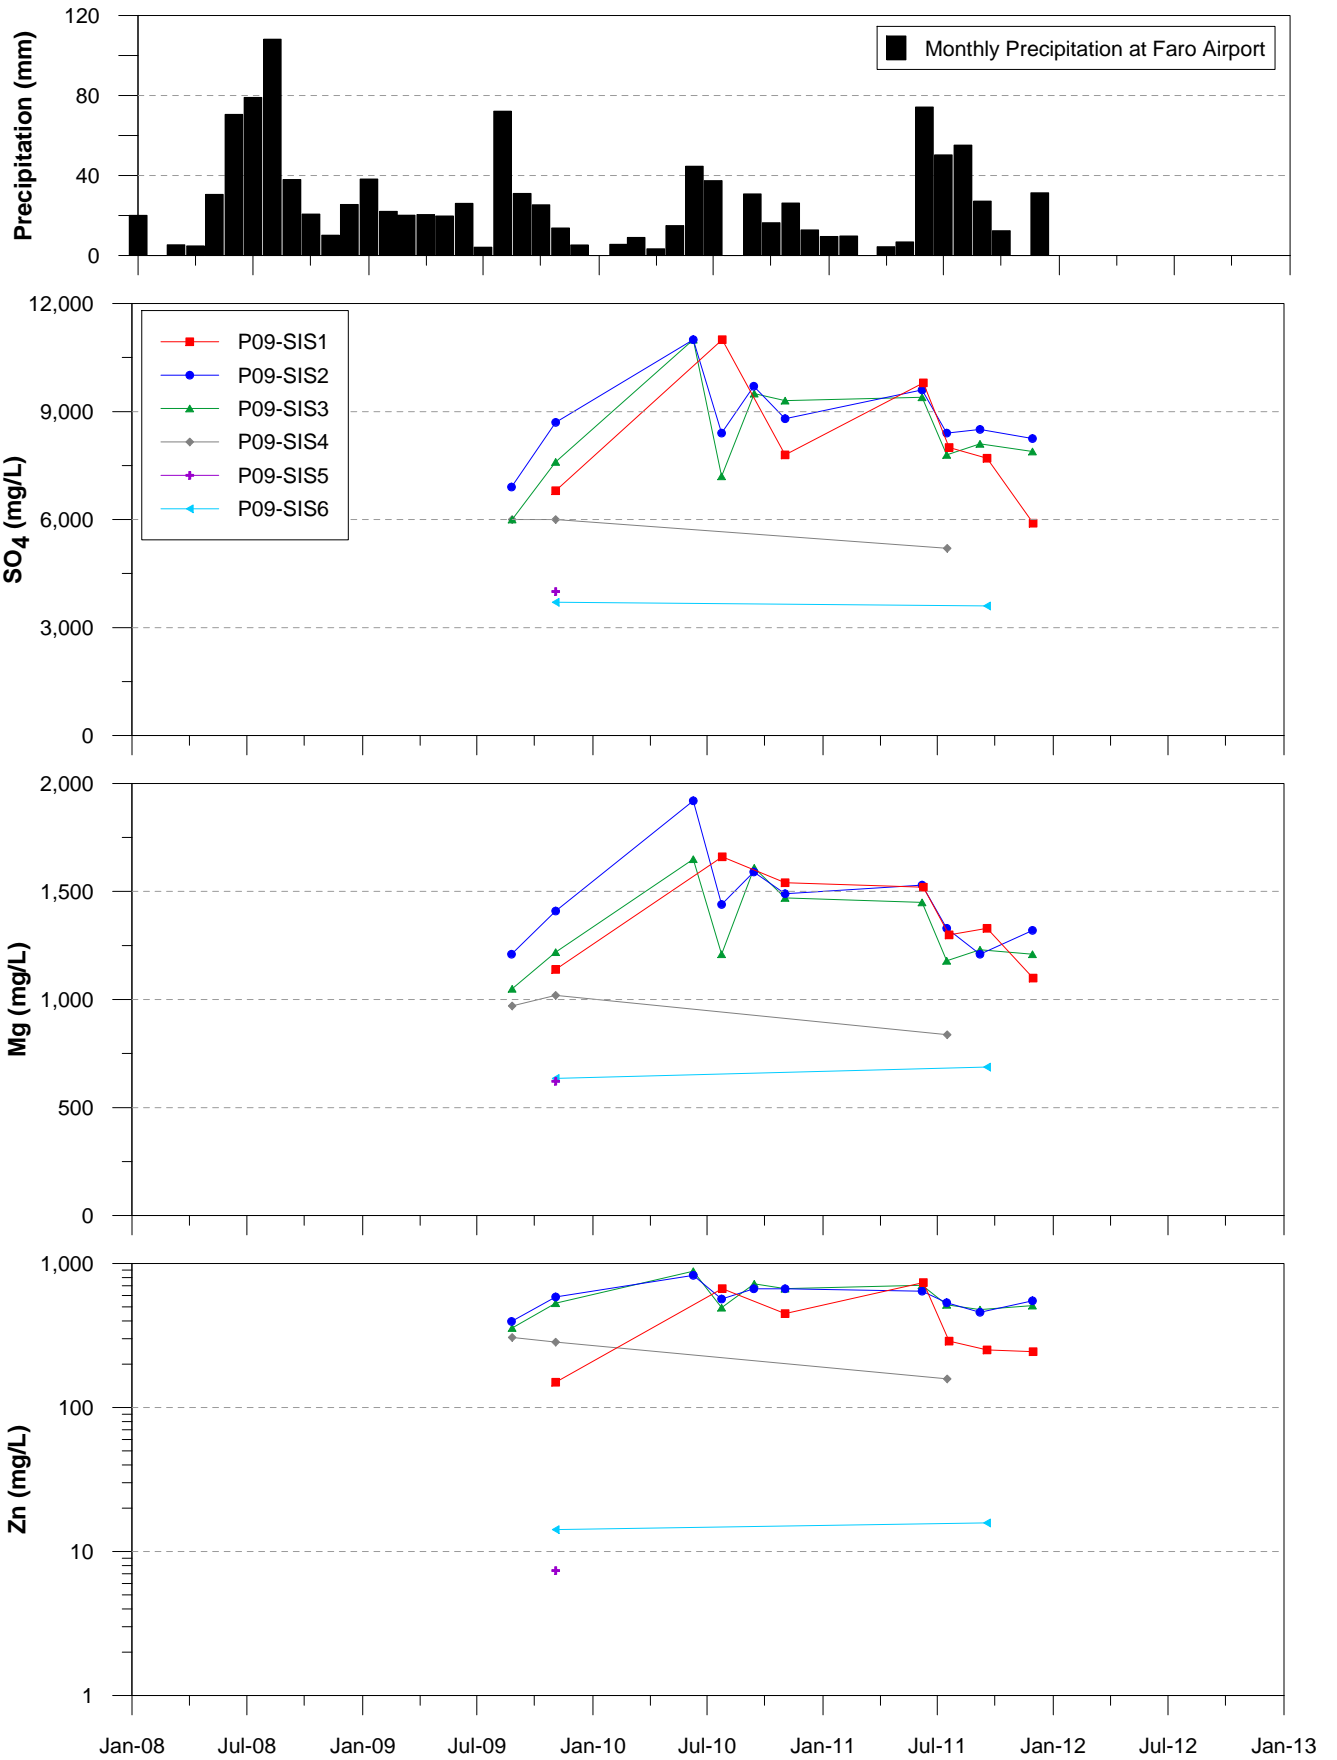
Figure 2-7c. Time trends for SO₄, Mg, Na and Zn in P09-SIS wells, S-Cluster Area

- Groundwater quality conditions in shallow overburden immediately downgradient of the interception trench (at wells P09-SIS1, -SIS2, and -SIS3 and SRK05-SP4B) remain

- comparable to those observed in 2009 (see Figure 2-7c); hence there is no definitive evidence that the interceptor trench is working as intended;
- Further downgradient of the SIS near the NFRC, groundwater quality conditions at wells SRK08-SP7A/B have improved significantly in recent years and contaminant levels remained low during the current monitoring period (see Figure 2-8c/d); the pronounced improvement in groundwater quality conditions in shallow overburden (at well SRK08-SP7B) is clearly caused by operation of the S cluster SIS; the relatively abrupt decrease in contaminant concentrations at SP7B would suggest that this area is fed by deeper groundwater which is now intercepted effectively by SPW2 (located 200m upgradient); groundwater in the deeper bedrock well SP7A shows a more gradual recovery suggesting poorer hydraulic connection to contaminated groundwater intercepted at SPW2¹.

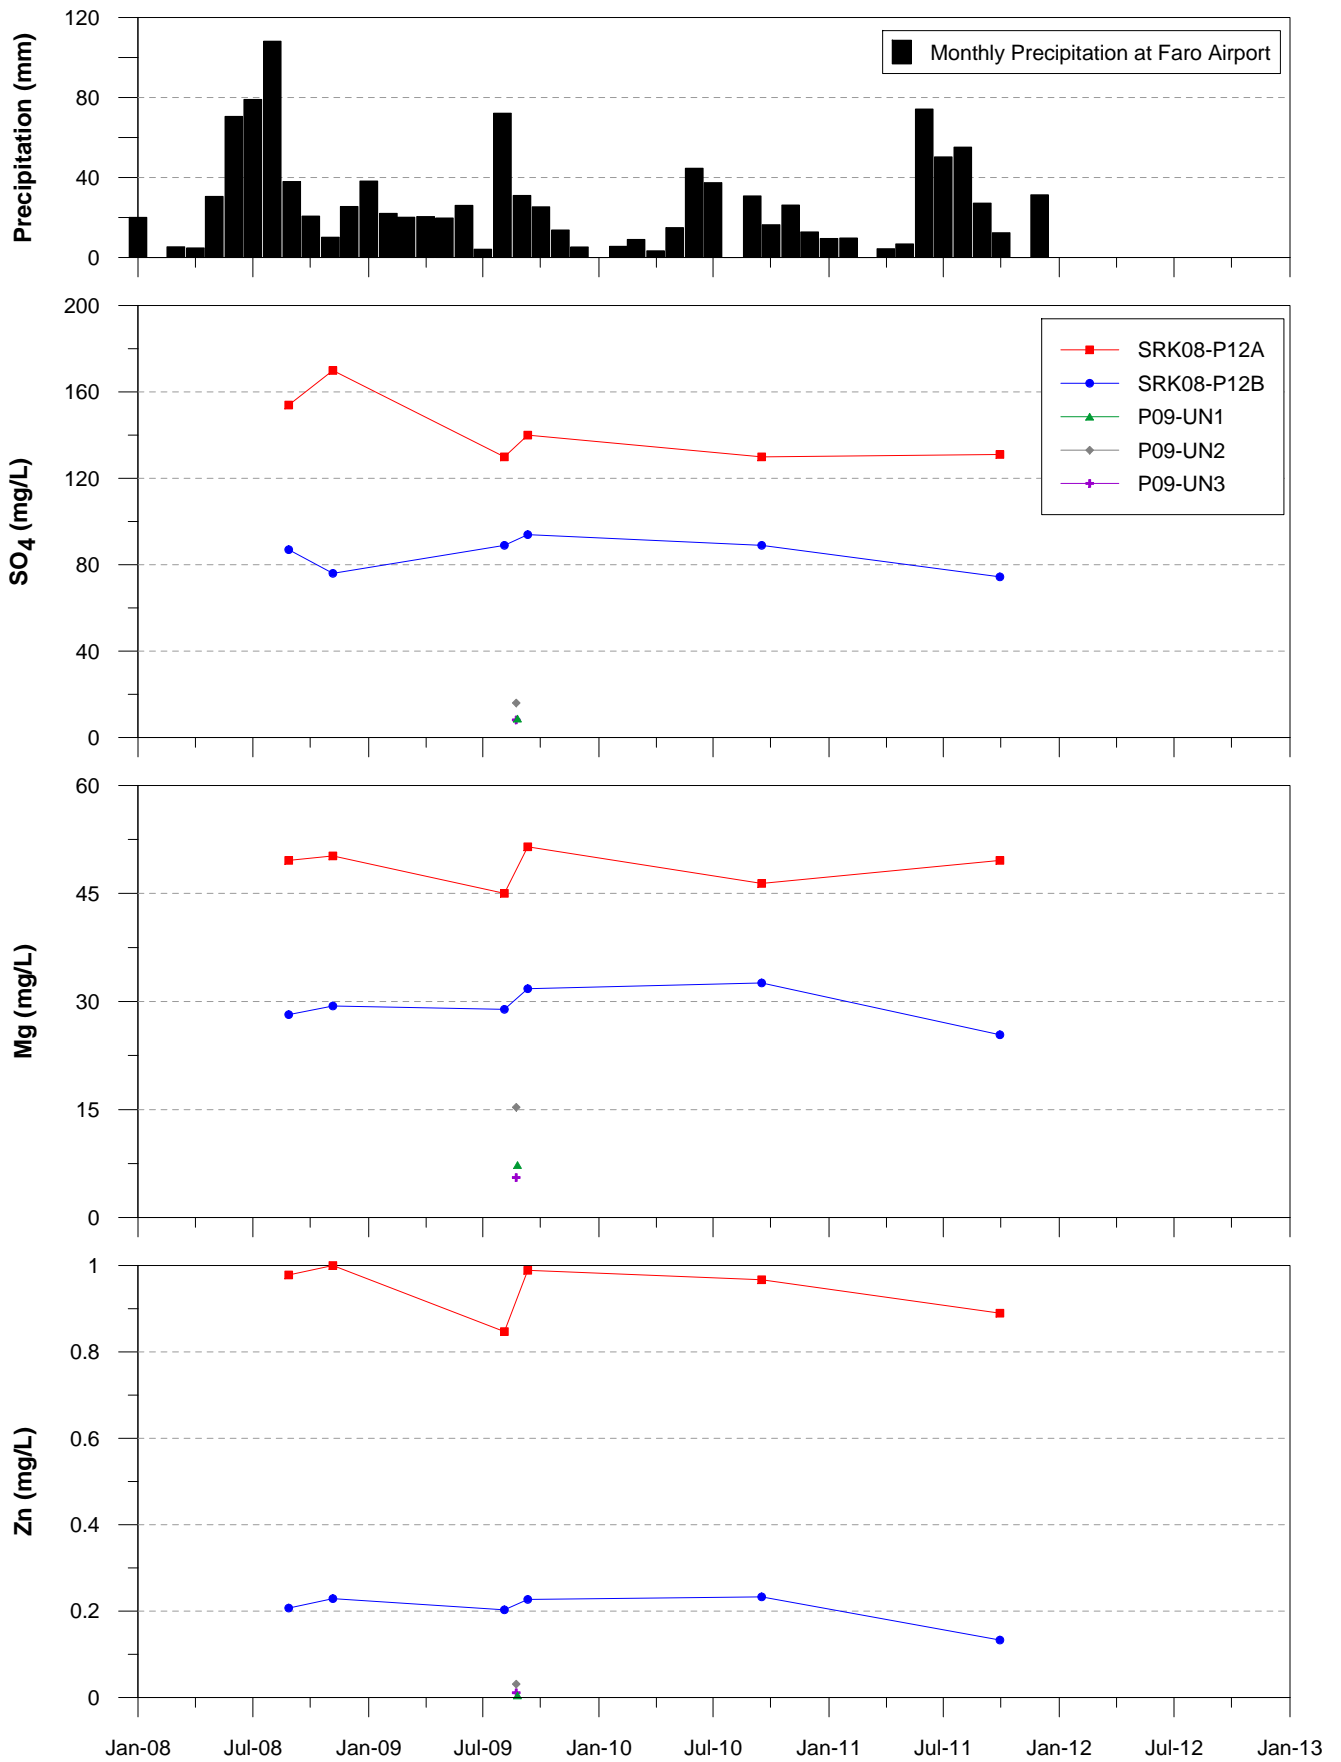
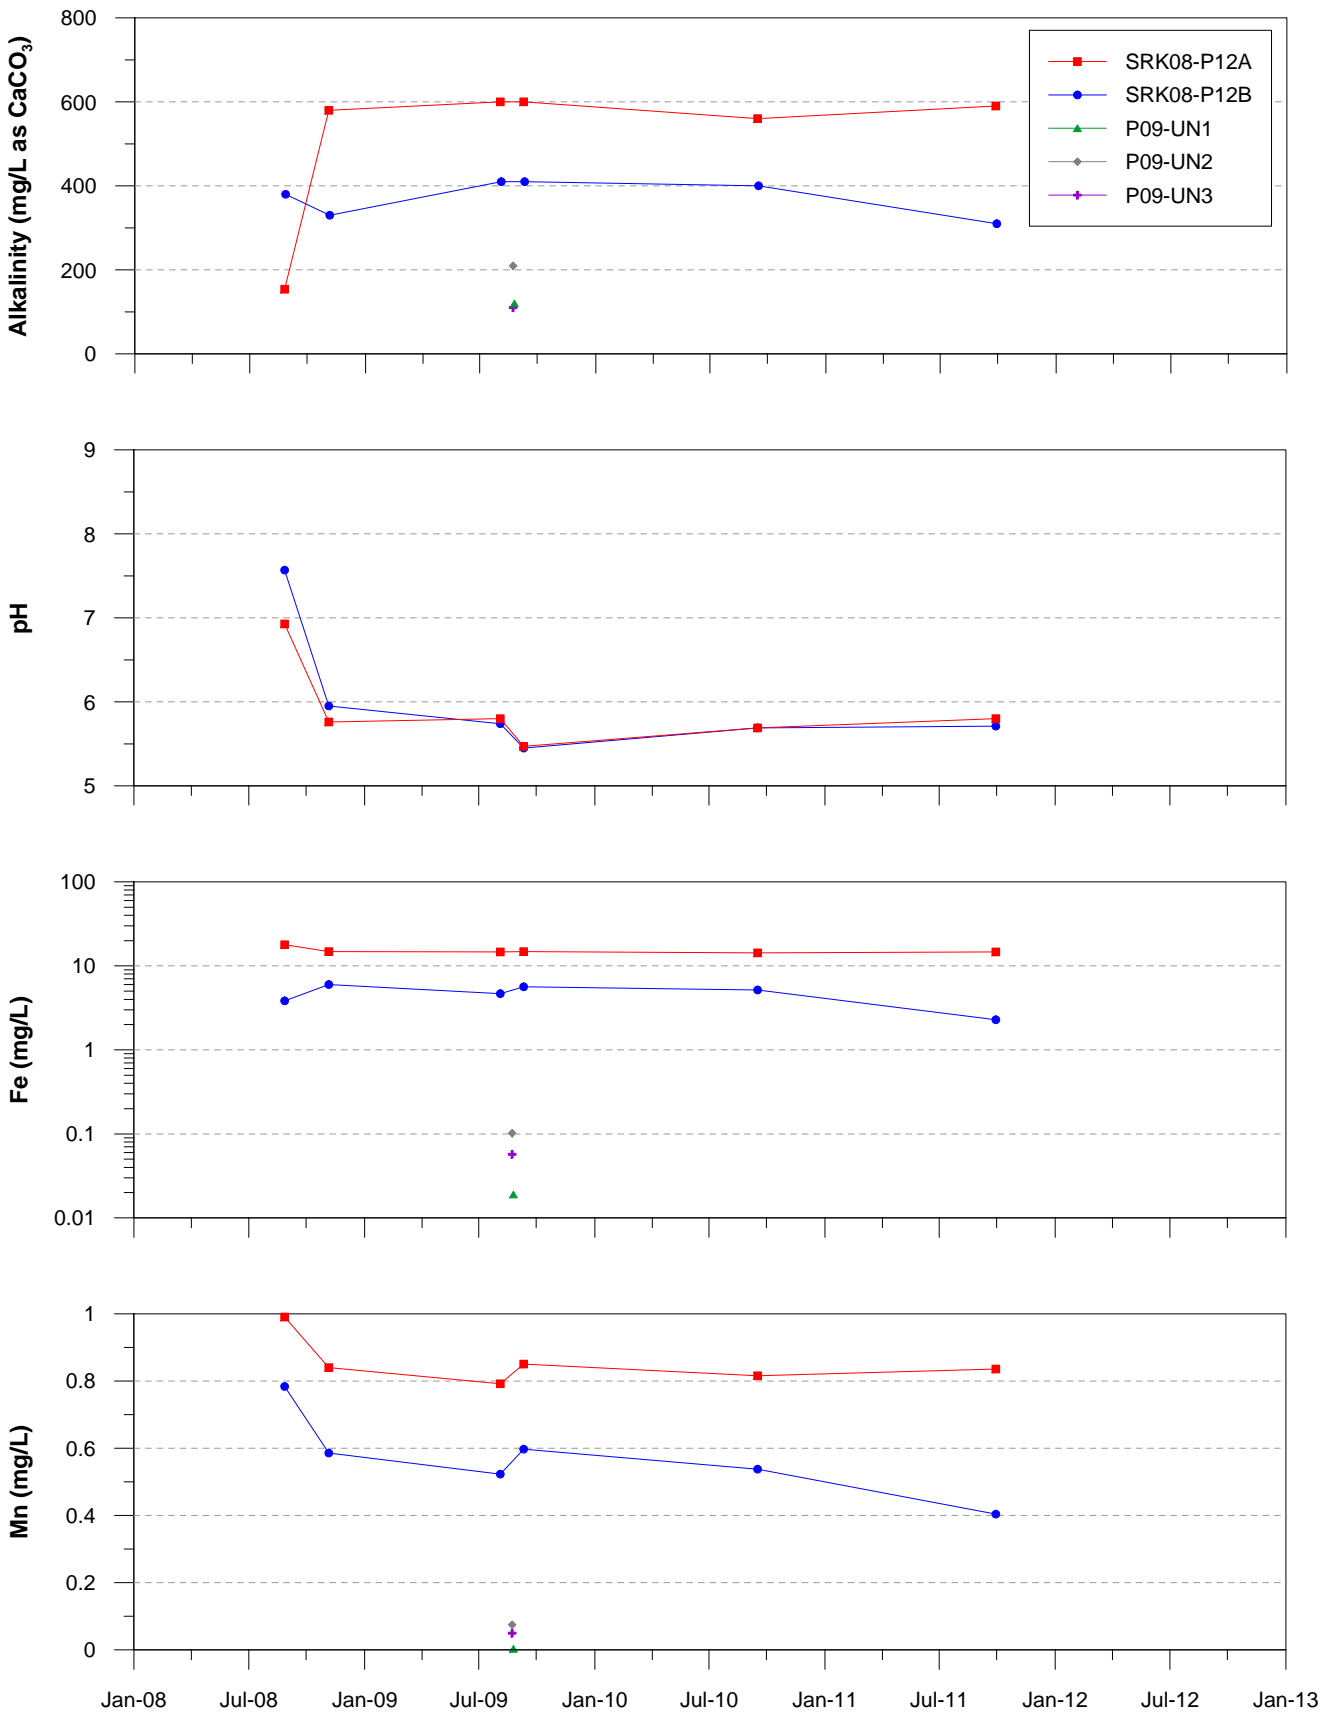
Figure 2-11a. Time trends for SO₄, Mg, Na and Zn in P09-UN wells and SRK08-P12A/B

The 'P09-UN' wells are screened in the NFRC alluvial aquifer about 50 m downstream of the confluence between the NFRC and the Faro Creek diversion channel. These wells were not sampled during the current monitoring period but groundwater quality in each is known to reflect background conditions for the ARMC.

Groundwater from wells SRK08-P12A/B is characterized by SO_4 concentrations of less than 200 mg/L and Zn concentrations up to 1 mg/L (at well SRK08-P12A). These wells are screened in permeable bedrock or alluvial sediments upgradient of the Zone 2 Pit outwash area so elevated Zn concentrations suggest a substantial Zn load to the NFRC valley from the Northeast WRD. No changes in groundwater quality conditions in this area were evident during the current monitoring period.
