Report No. 118022/1

**2011 GROUNDWATER QUALITY REVIEW
ANVIL RANGE MINING COMPLEX, YUKON TERRITORY**

June 2012

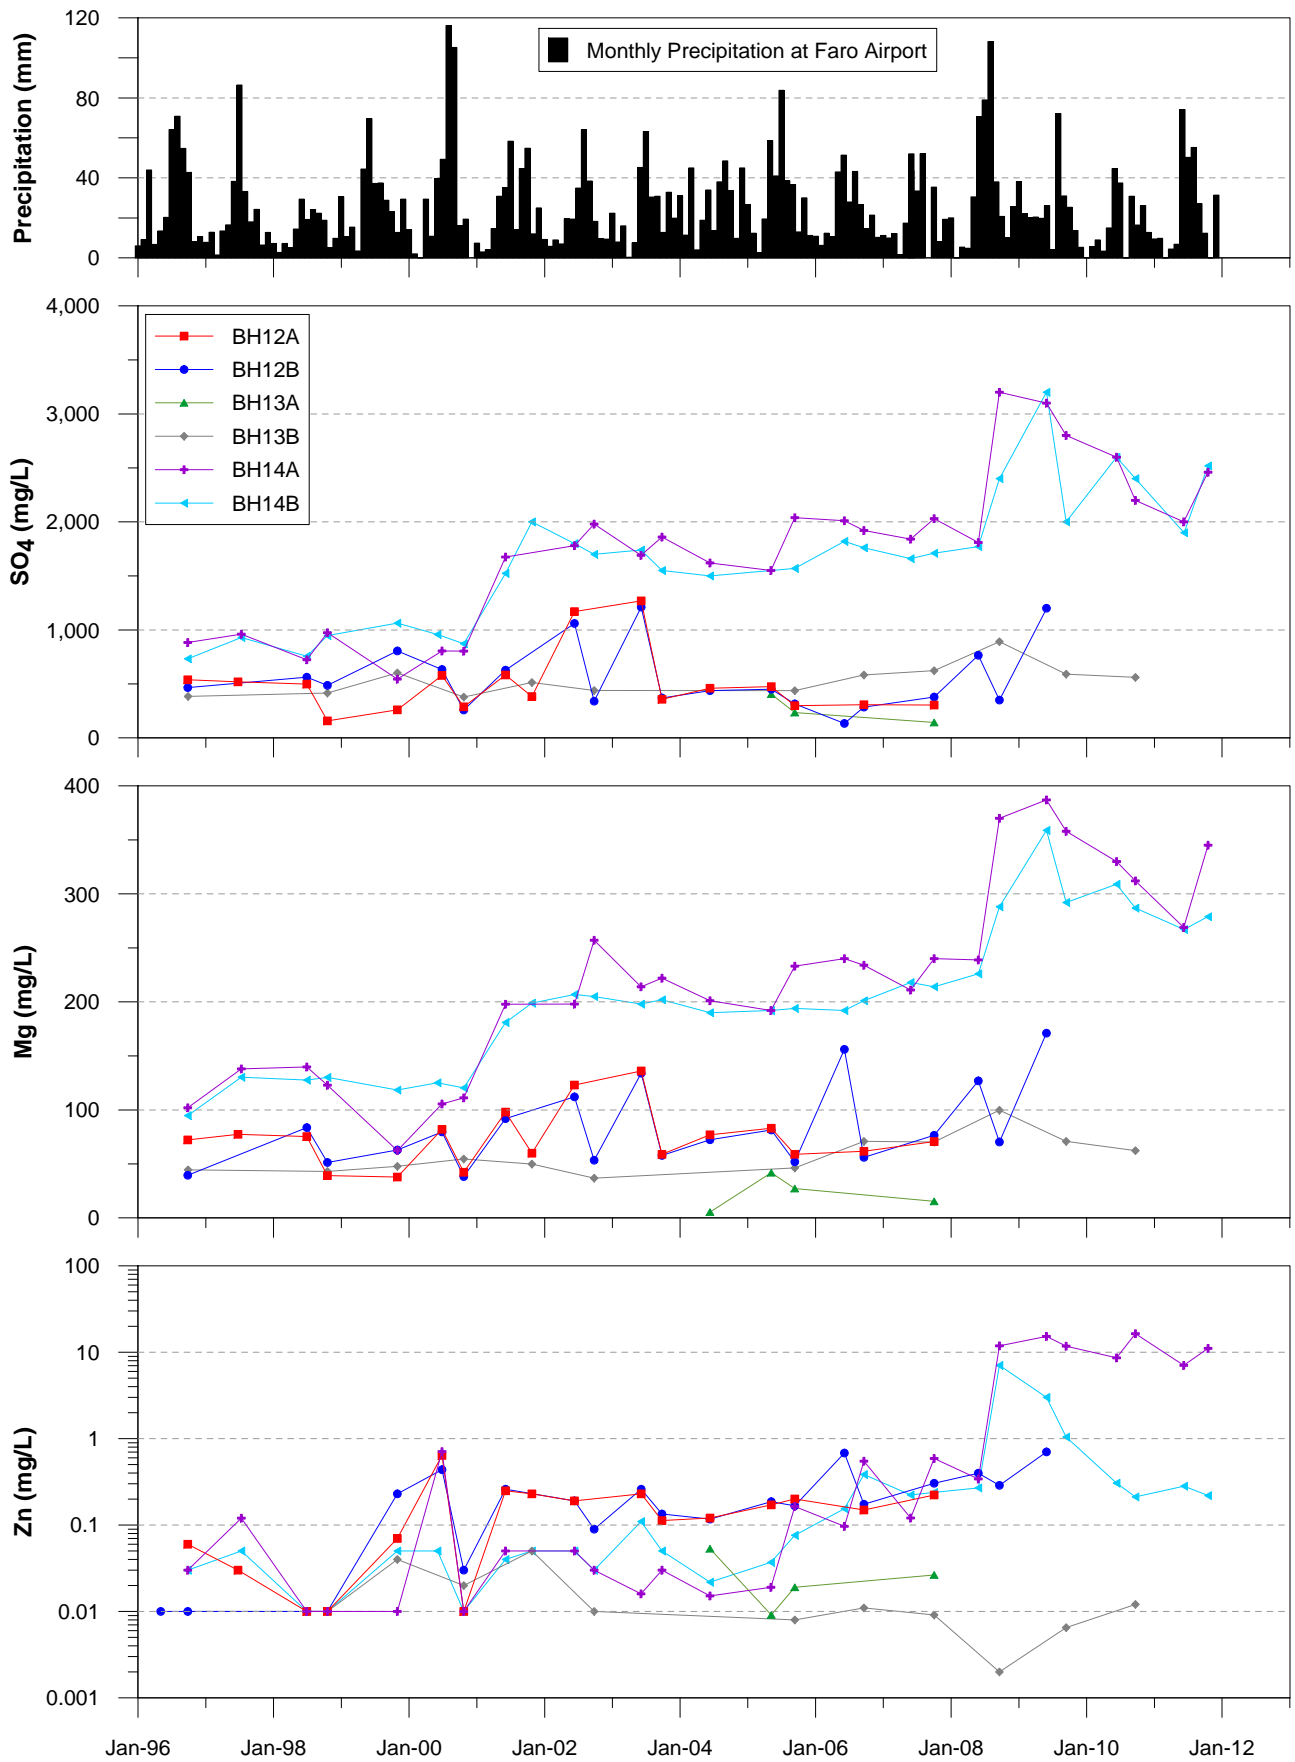
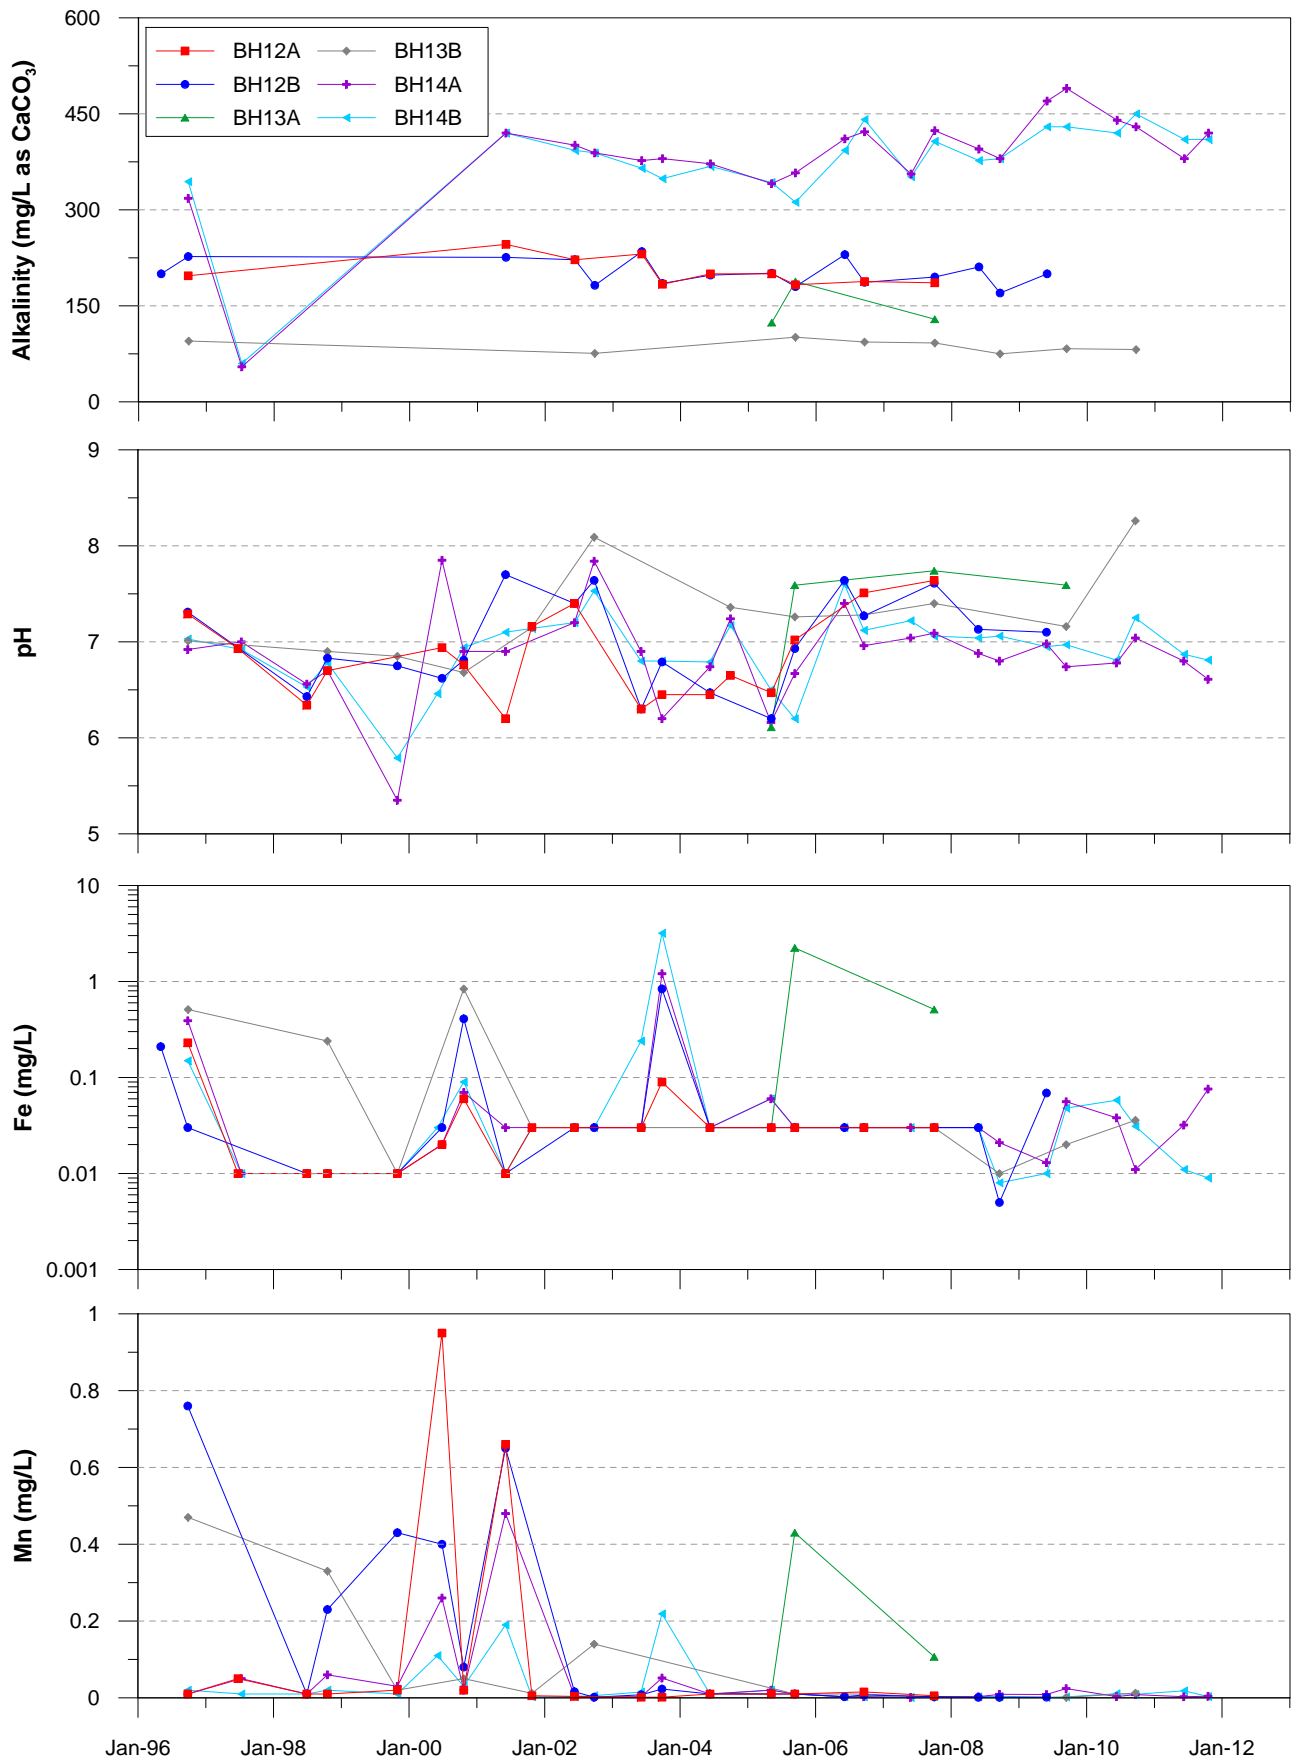
Figure 2-12a. Time trends for SO₄, Mg and Zn in wells at the toe of Northeast Rock Dump

Groundwater quality conditions at wells BH14A/B have deteriorated significantly over the last 10 years and data for the current monitoring period are consistent with a long-term trend towards higher concentrations. Of particular interest are high Zn concentrations (~10 mg/L) in groundwater from well BH14A (screened in weathered bedrock) that have persisted since 2008. These high concentrations suggest the breakthrough of more highly-impacted seepage from the Northeast WRD continues in this area and that a condition of steady-state has not yet been reached. Note that Zn concentrations

in this area are much lower than in the S-Cluster area but water quality conditions in the NFRC could eventually be affected (as seepage is not intercepted in this area).

Trends towards higher contaminant concentrations in groundwater from wells BH14A/B are indicative of seepage from sulphide-rich waste rock that has been identified in the Northeast WRD (see RGC, 2008). Seepage from this sulphide-rich waste rock does not (yet) appear to have affected groundwater quality to the northeast at wells BH12A/B and BH13A/B, as contaminant concentrations in this area are relatively low and not increasing (see Figure 2-12a,b). Note, however, that monitoring wells BH12A/B and BH13A are no longer monitored (broken or frozen). Installation of additional monitoring wells at the toe of the Northeast WRD is recommended to improve monitoring of seepage from the NE dump and potential loading to the NFRC alluvial aquifer.

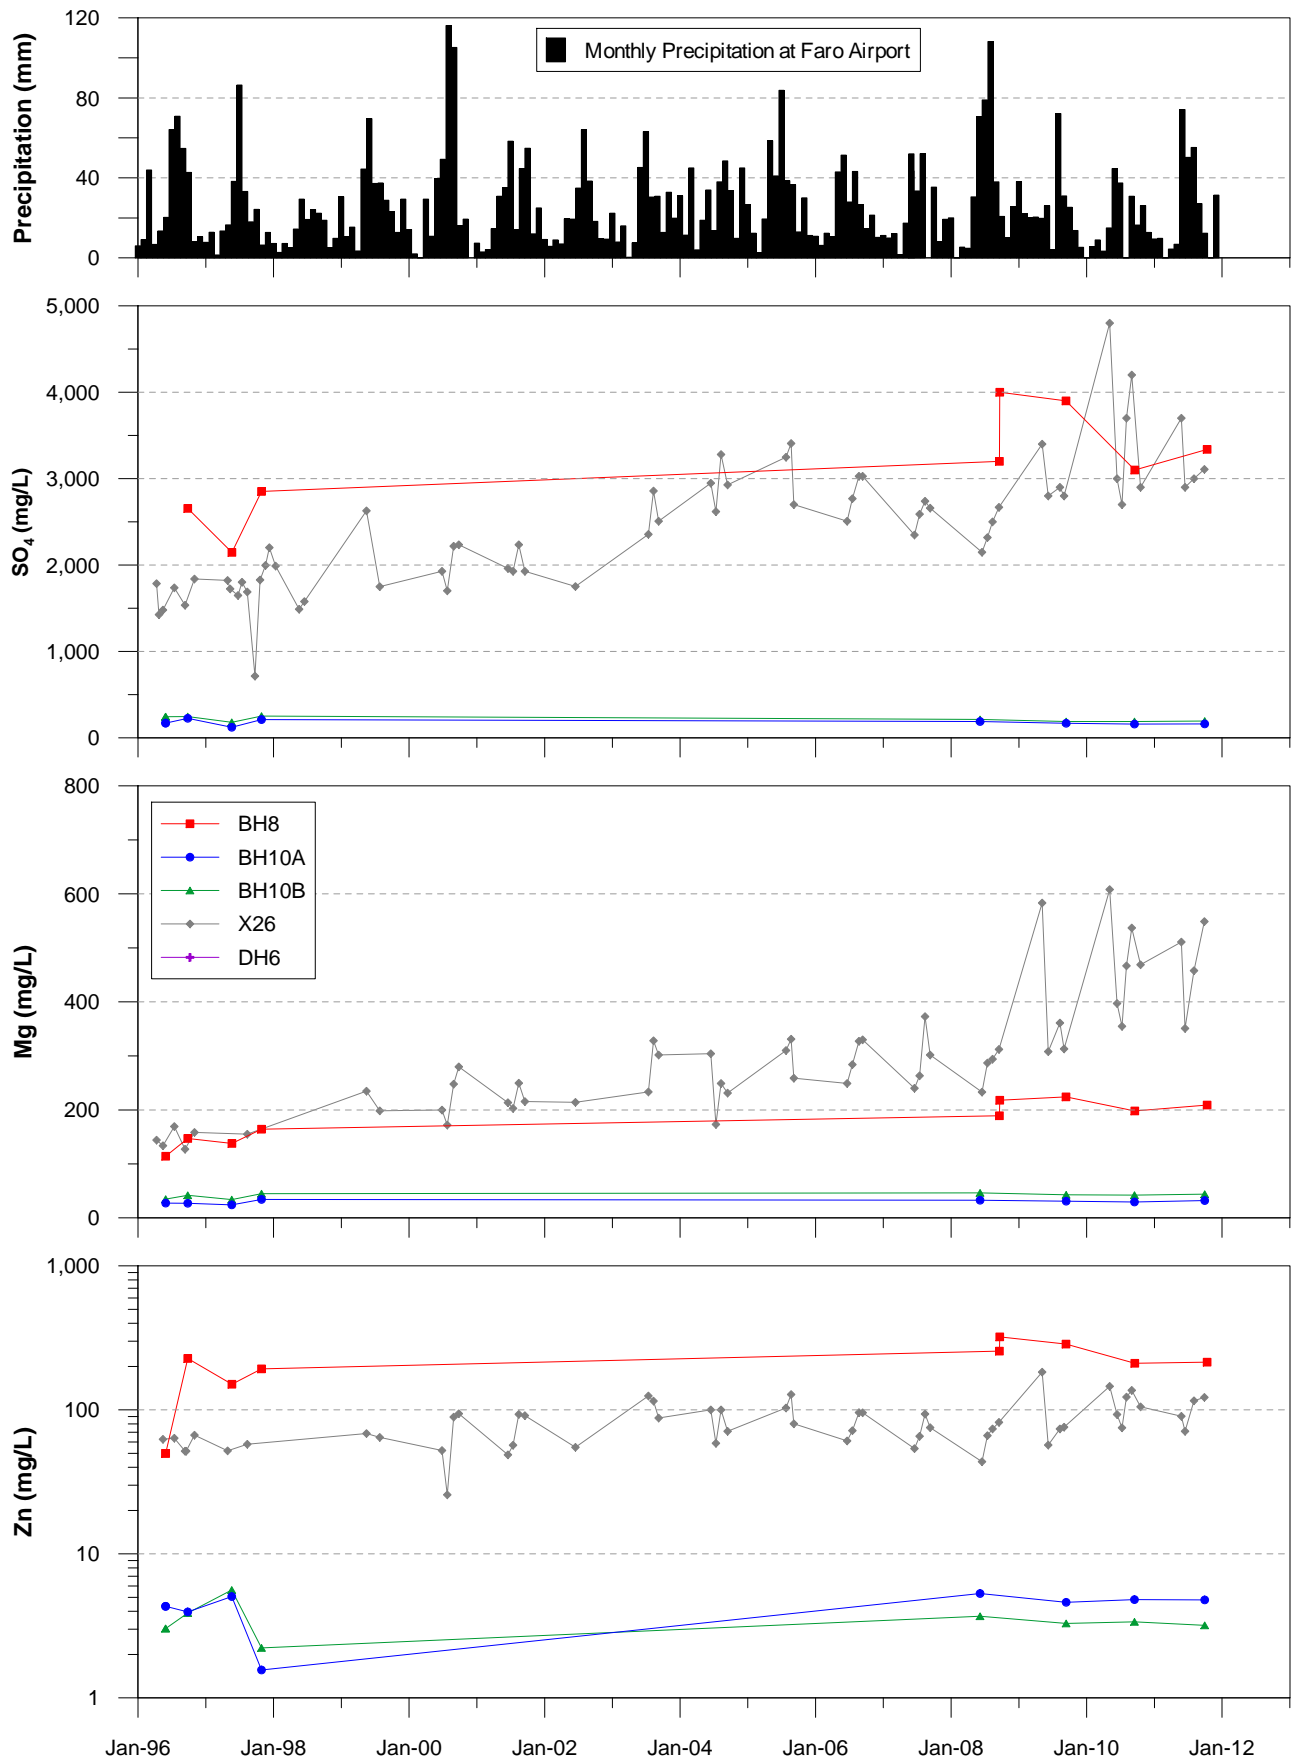
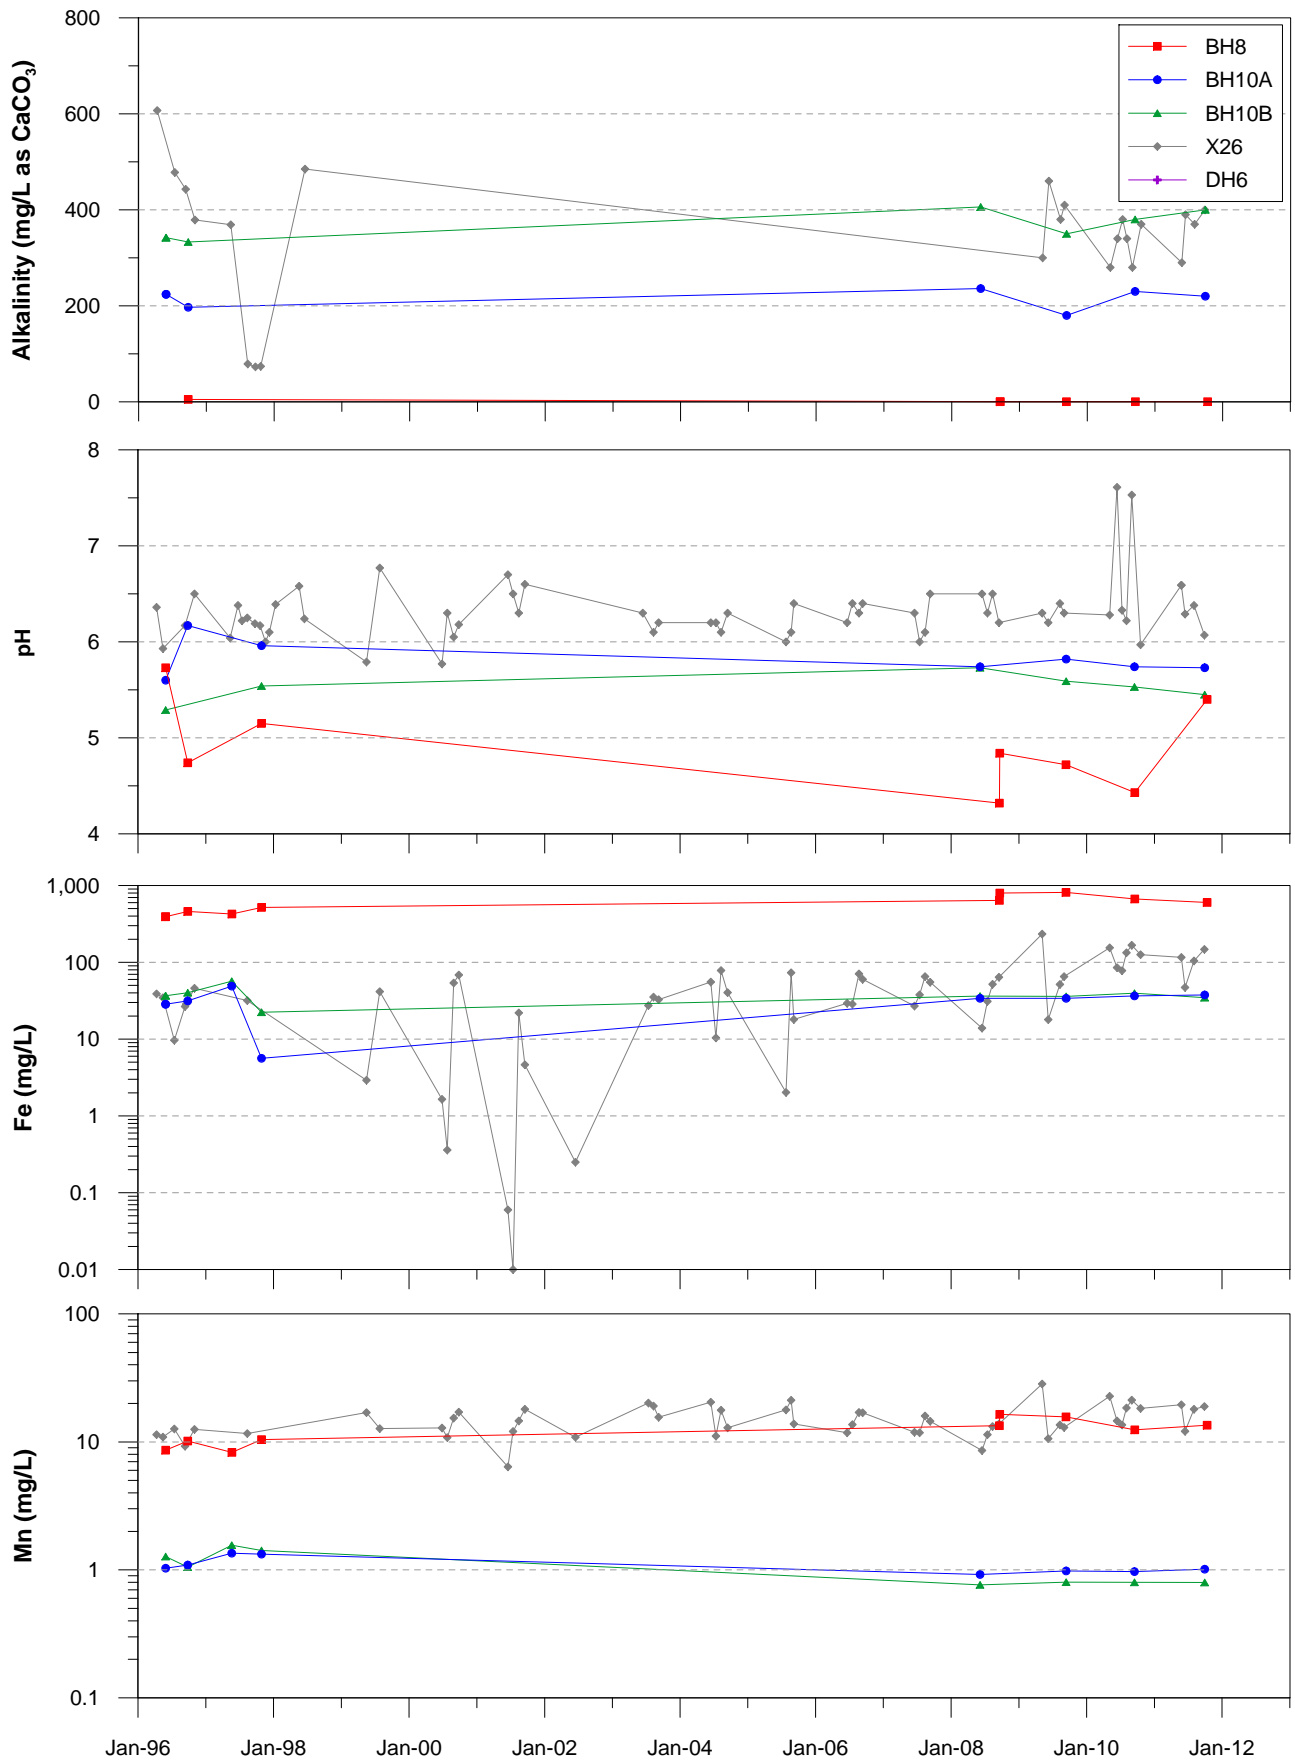
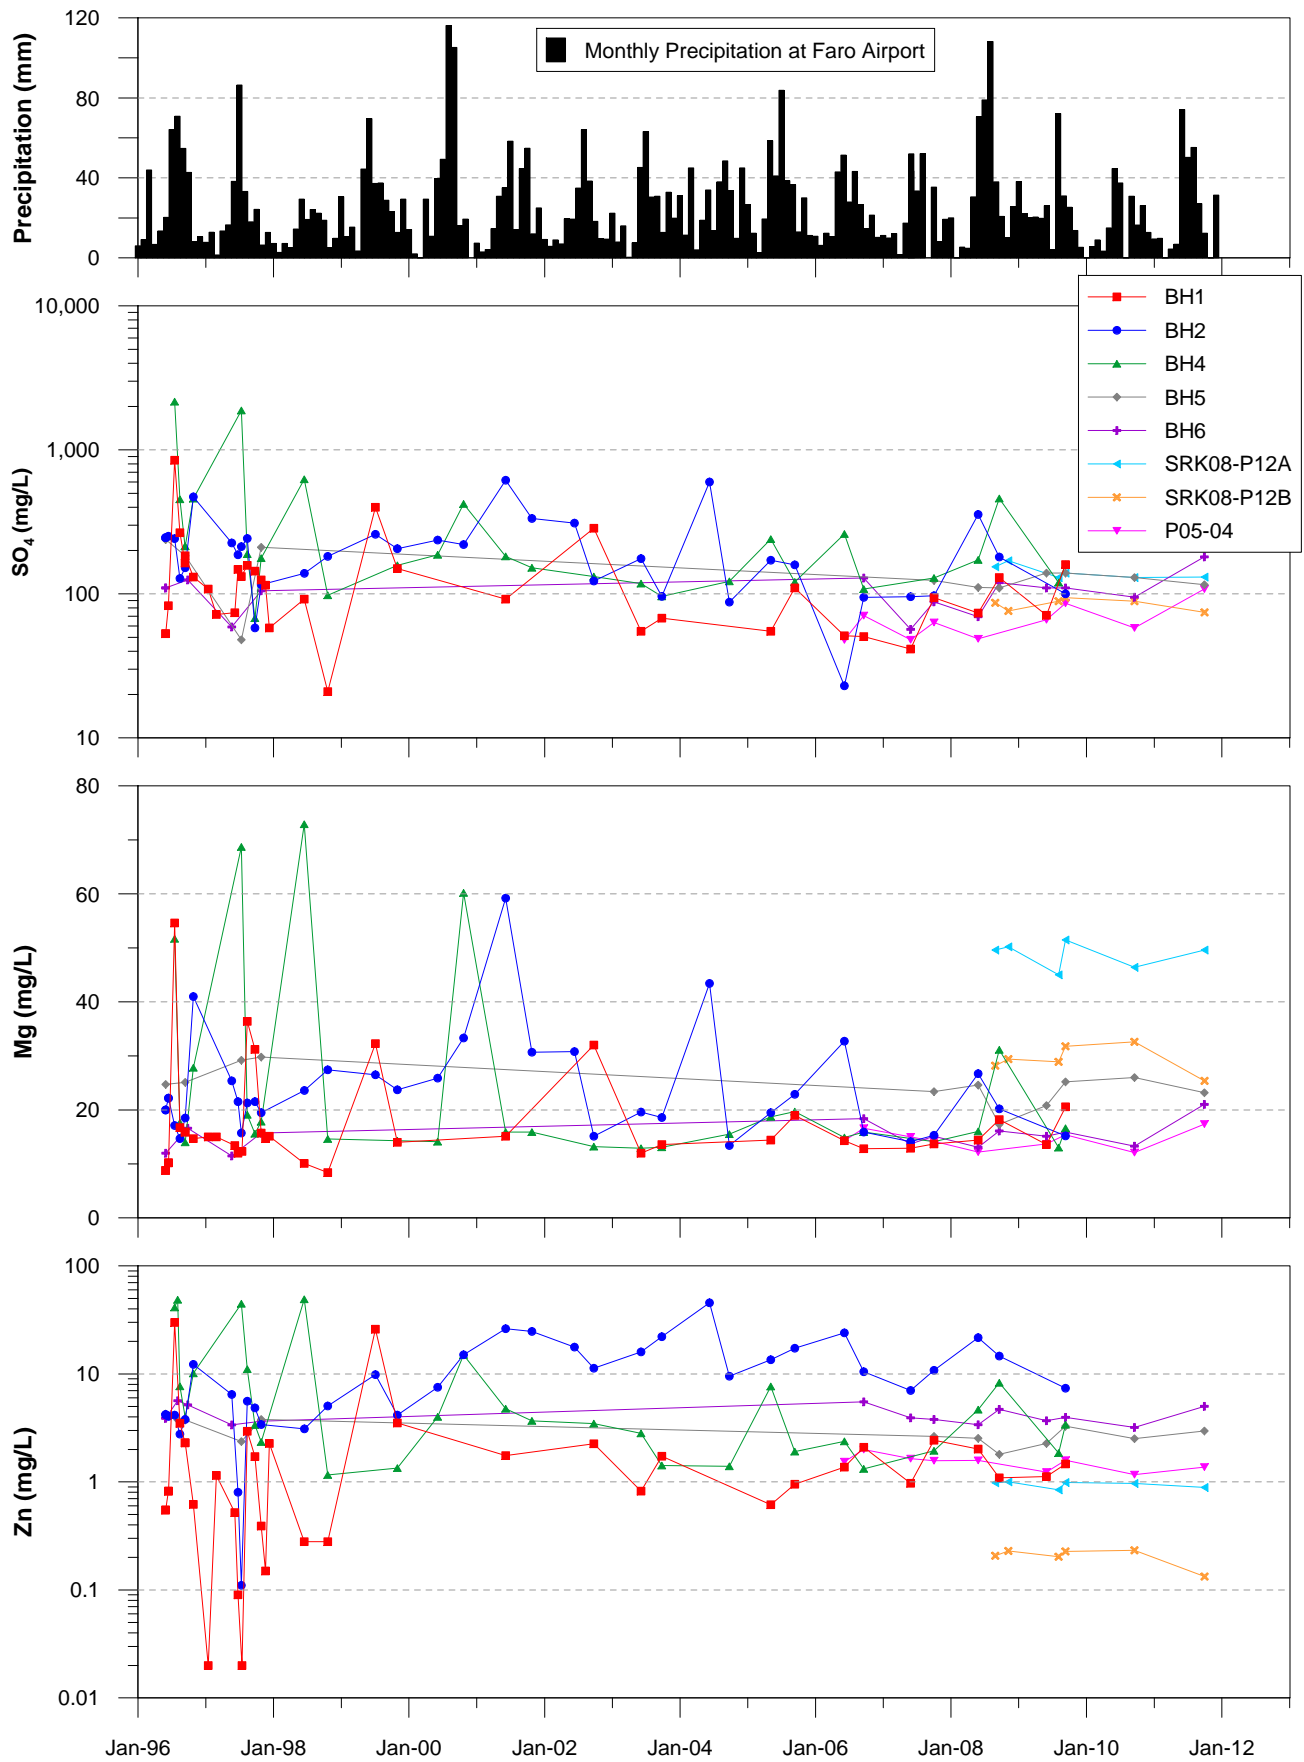
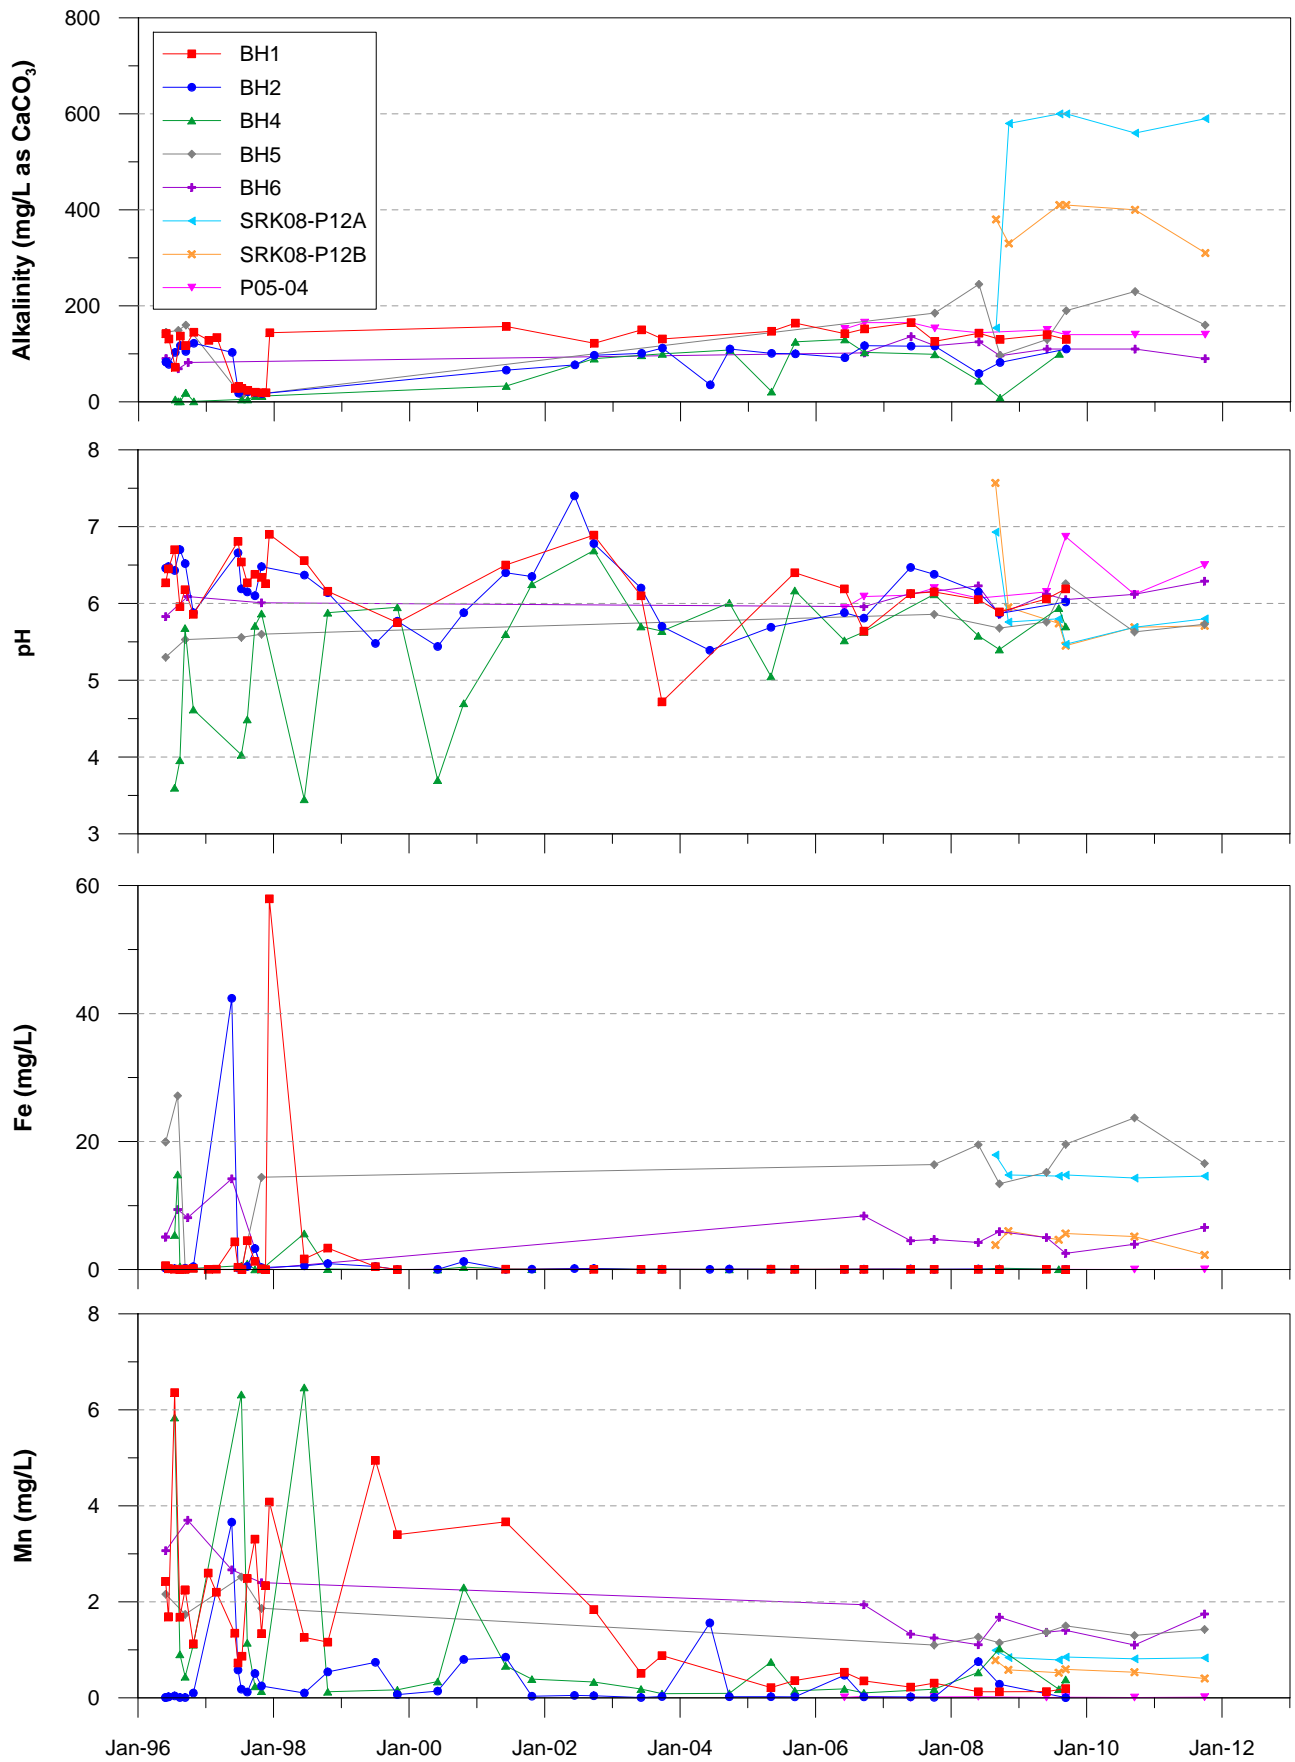
Figure 2-13a. Time trends for SO₄, Mg and Zn for Zone 2 Pit and bedrock wells

Samples from X26 reflect the condition of water that accumulates in the backfilled Zone 2 Pit. Water from X26 is typically characterized by SO₄ concentrations of ~3,000 mg/L but SO₄ (and Mg) concentrations have been more variable since 2008 (possibly due to more aggressive pumping from X26 over this time period).

Contaminant concentrations at X26 tend to be lower during periods of high recharge in the spring but water quality conditions (Zn in particular) have remained relatively stable over the last ten years. This trend continued during the current monitoring period as no appreciable increase in the concentrations of SO₄ or metals of interest was evident. Similarly, no appreciable changes in groundwater quality in the Zone 2 Pit outwash area or downgradient were evident during the current monitoring period as data was generally consistent with historic time trends (see Figure 2-13a/b and 2-14a/b).

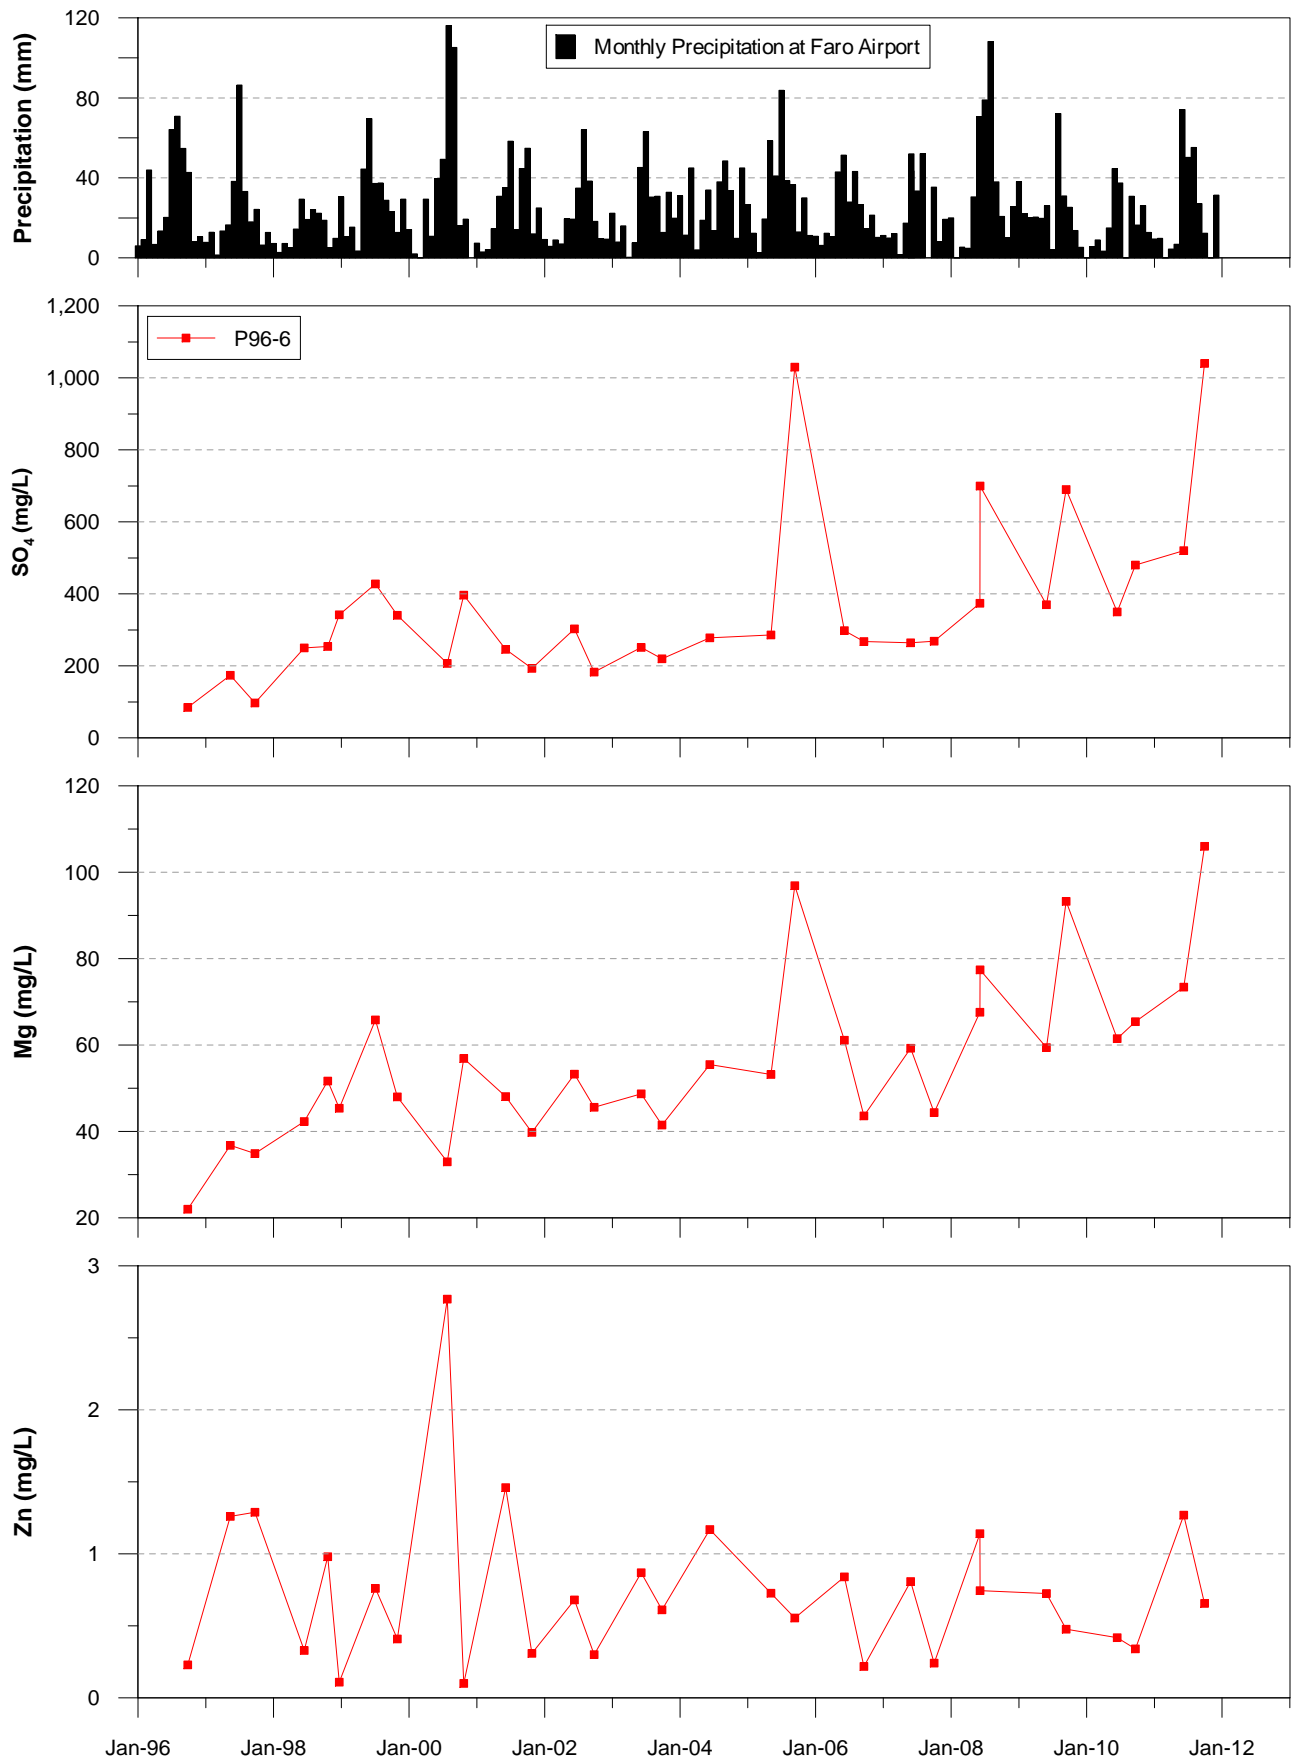
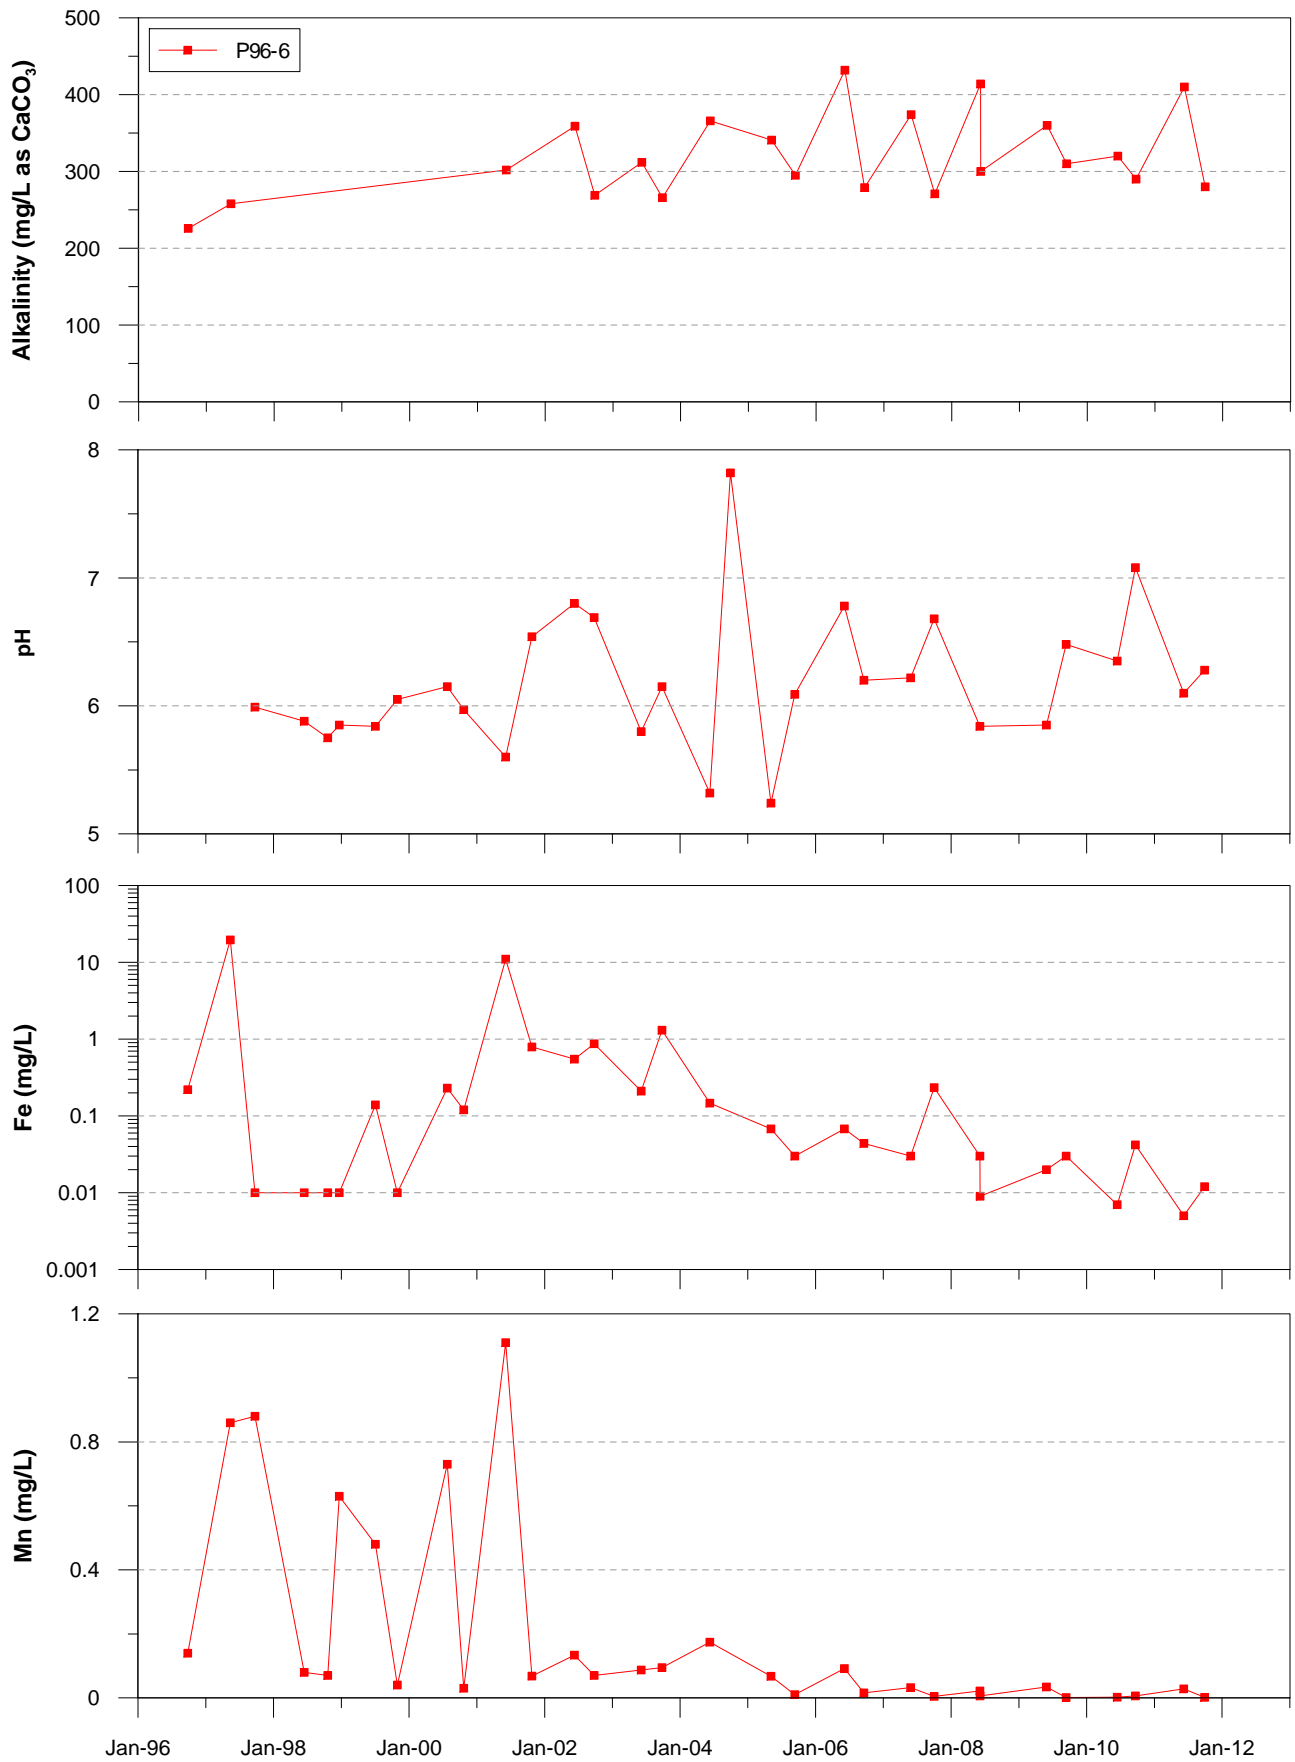
Figure 2-15a. Time trends for SO₄, Mg and Zn in P96-6 at the toe of Intermediate Rock Dump

Figure 2-15a/b shows time trends for pH, alkalinity, selected major ions, and metals of interest in groundwater from well P96-6. This well is located along the toe of the Intermediate WRD and is used to monitor the condition of groundwater flowing from this area towards the NFRC.

Groundwater in this area is moderately-impacted by waste rock seepage and concentrations of SO₄ and Mg have increased gradually over the last decade or so. Zn concentrations are, however, typically less than 1 mg/L and not increasing over time. Elevated contaminant levels at P96-6 are thought to reflect a small seepage load from the Intermediate WRD but no recent changes in the intensity of this load have occurred that would cause a substantive change in groundwater quality.
