Report No. 118022/1

**2011 GROUNDWATER QUALITY REVIEW
ANVIL RANGE MINING COMPLEX, YUKON TERRITORY**

June 2012

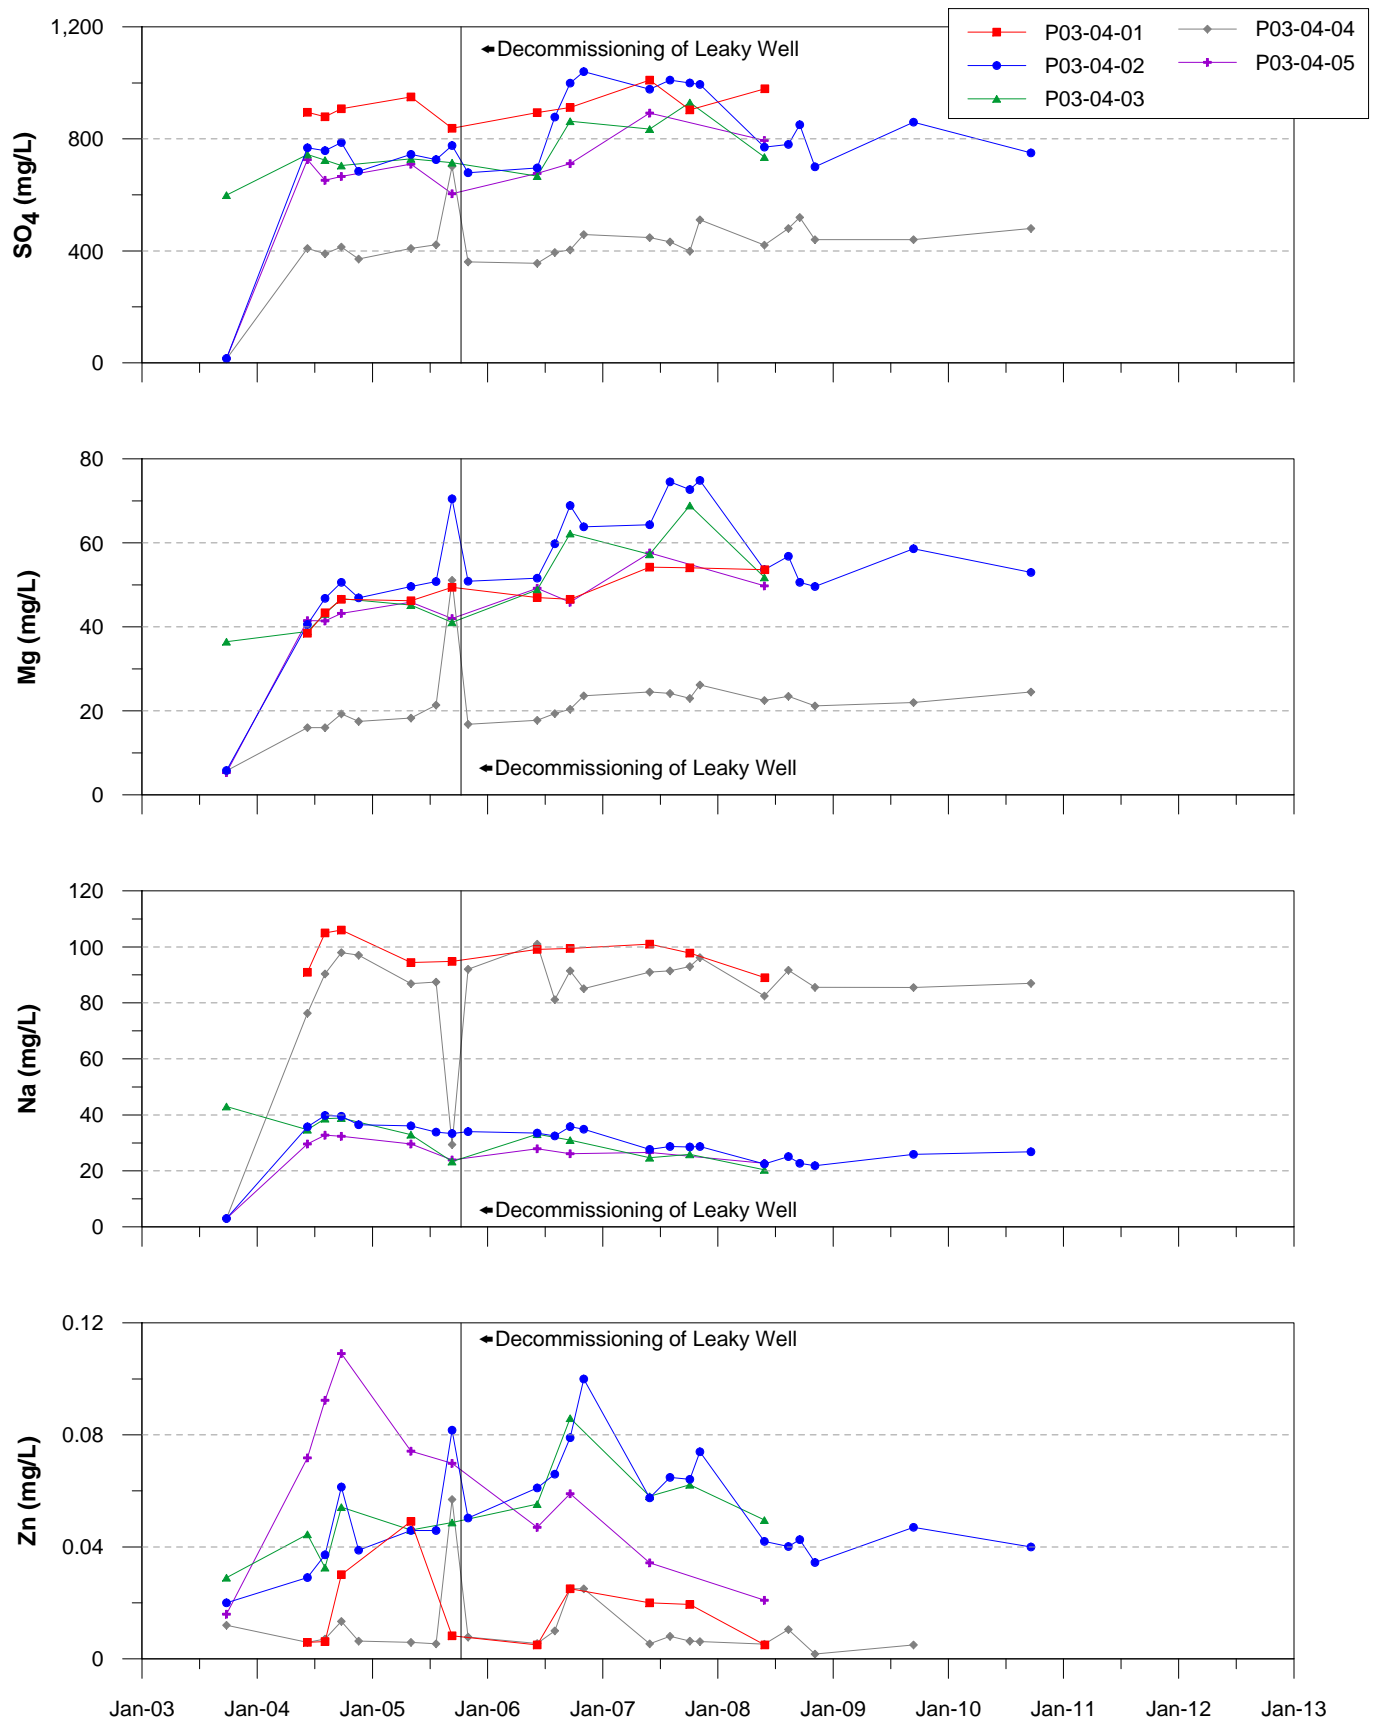
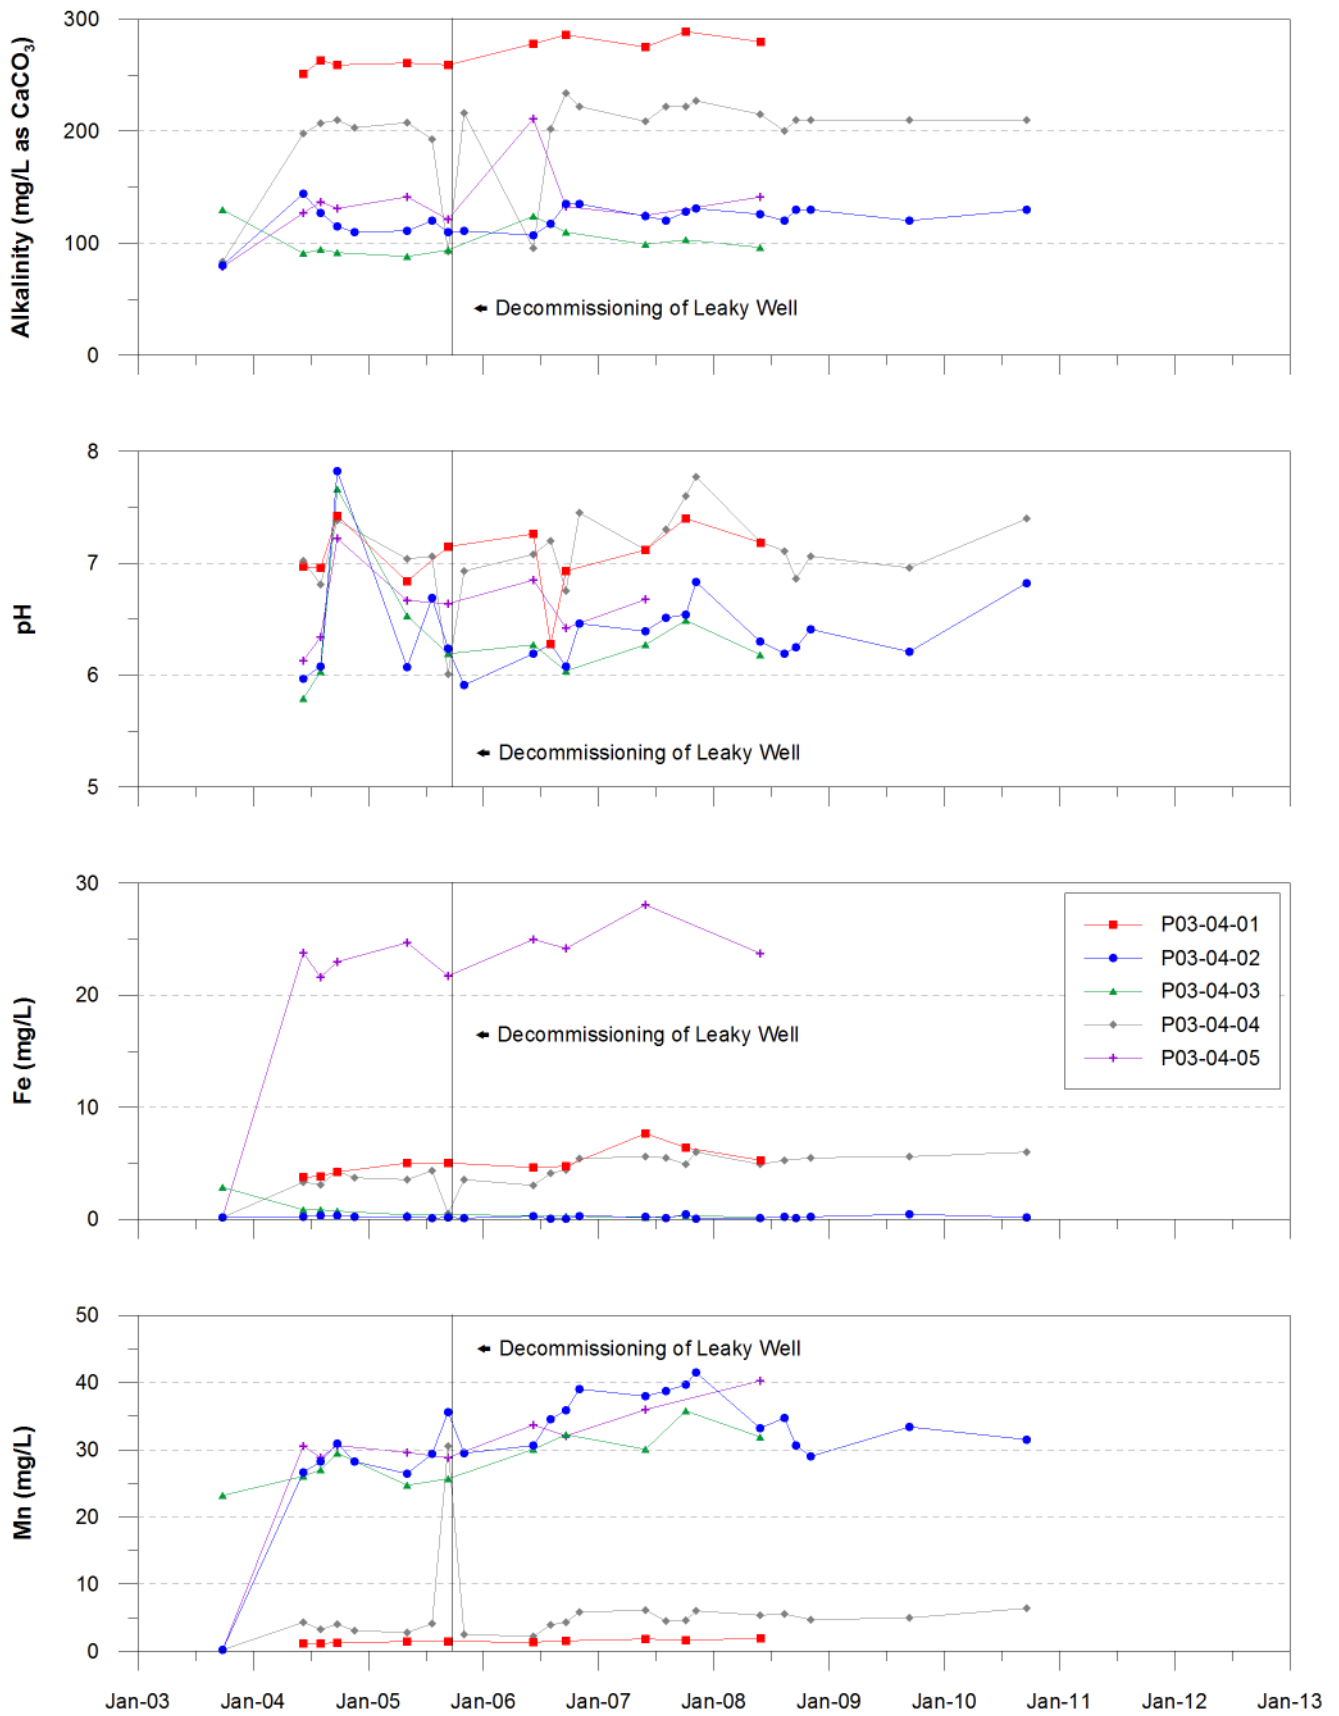
Figure 3-10c. Time trends for SO₄, Mg, Na and Zn in P03-04 (aquifer only)

- At P03-04 (located ~140 m downgradient of the "leaky well" P01-07 and roughly cross-gradient of P03-06), groundwater quality in this area has remained unchanged since well P01-07 was decommissioned (see Figure 3-10c/d); groundwater in this area therefore remains moderately-impacted by ARD.

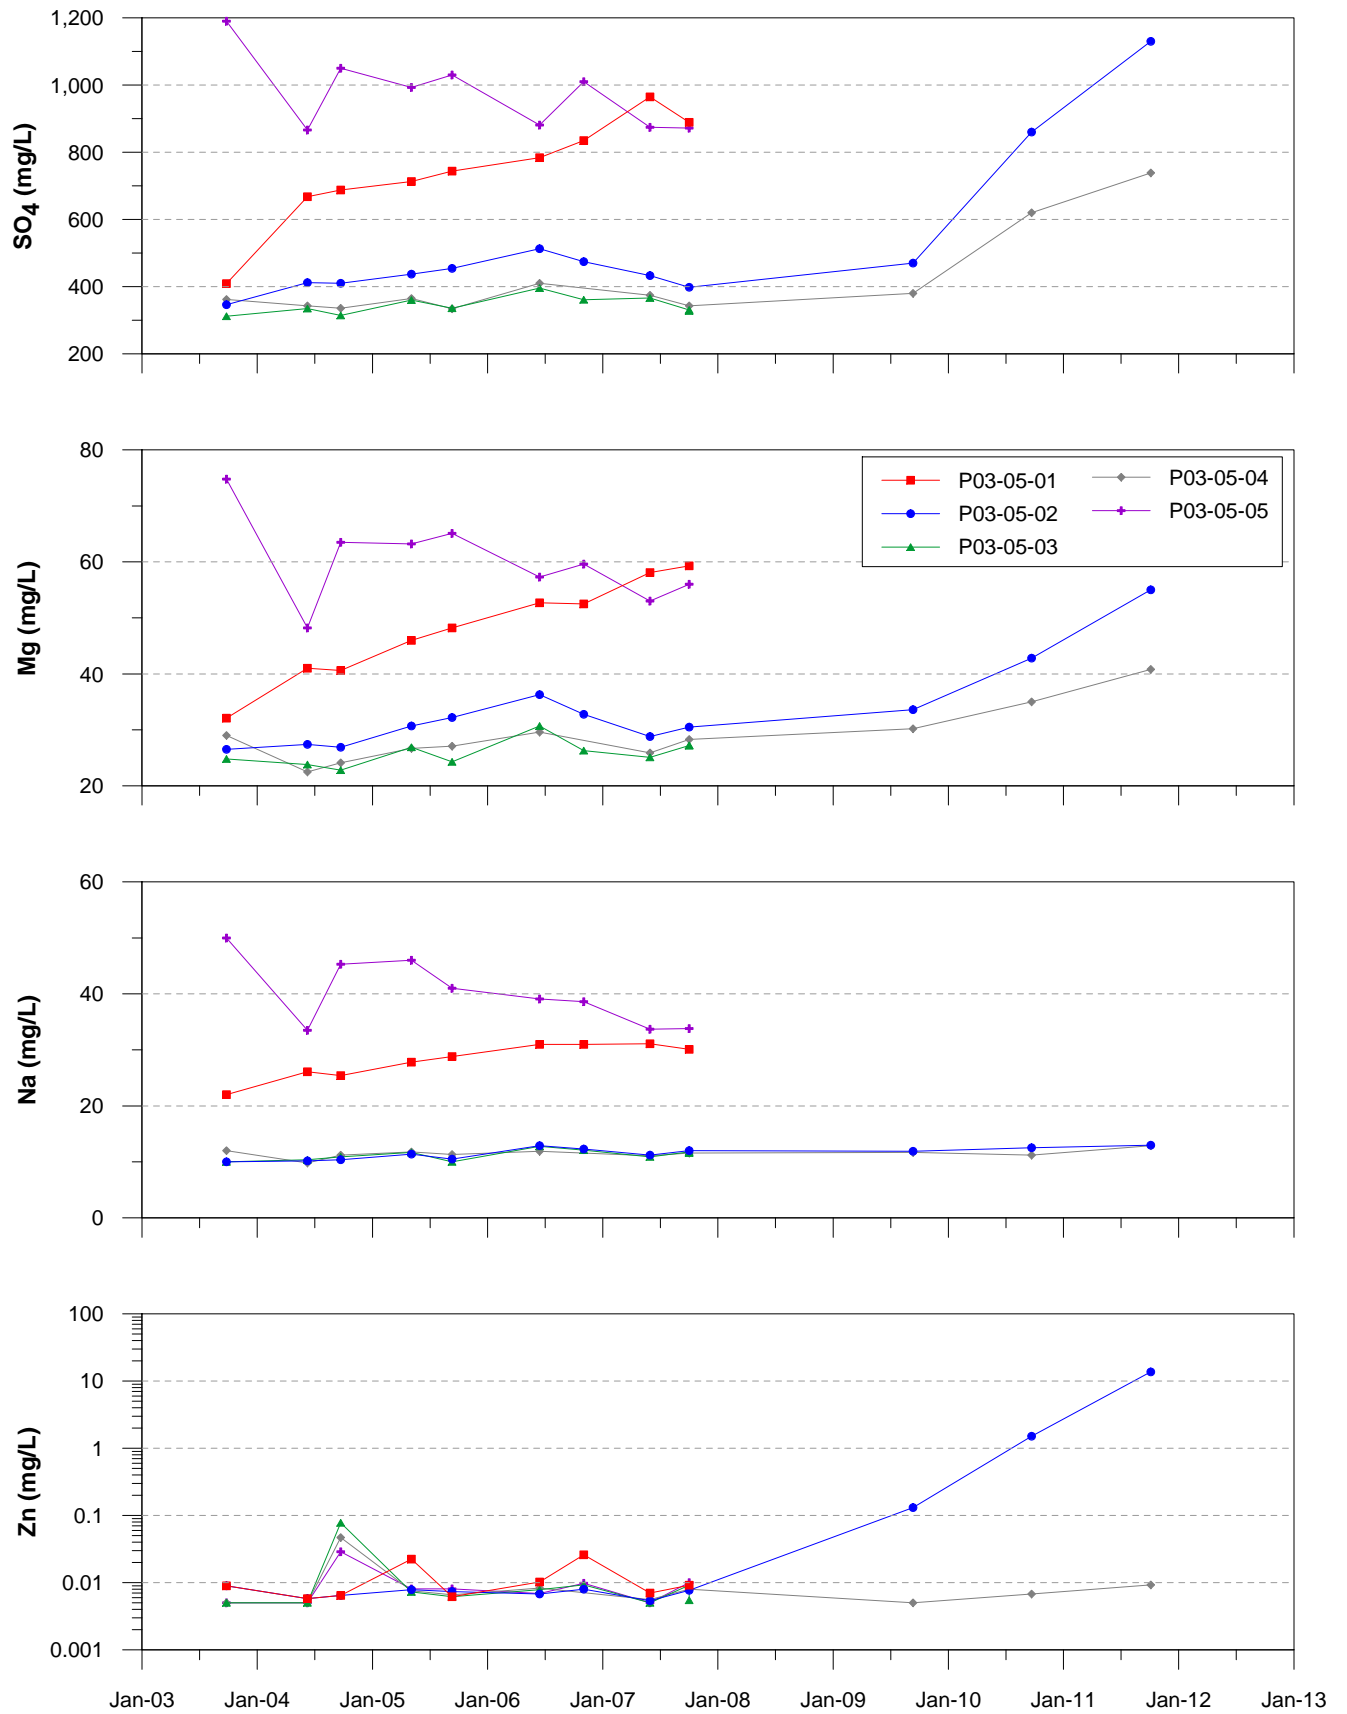
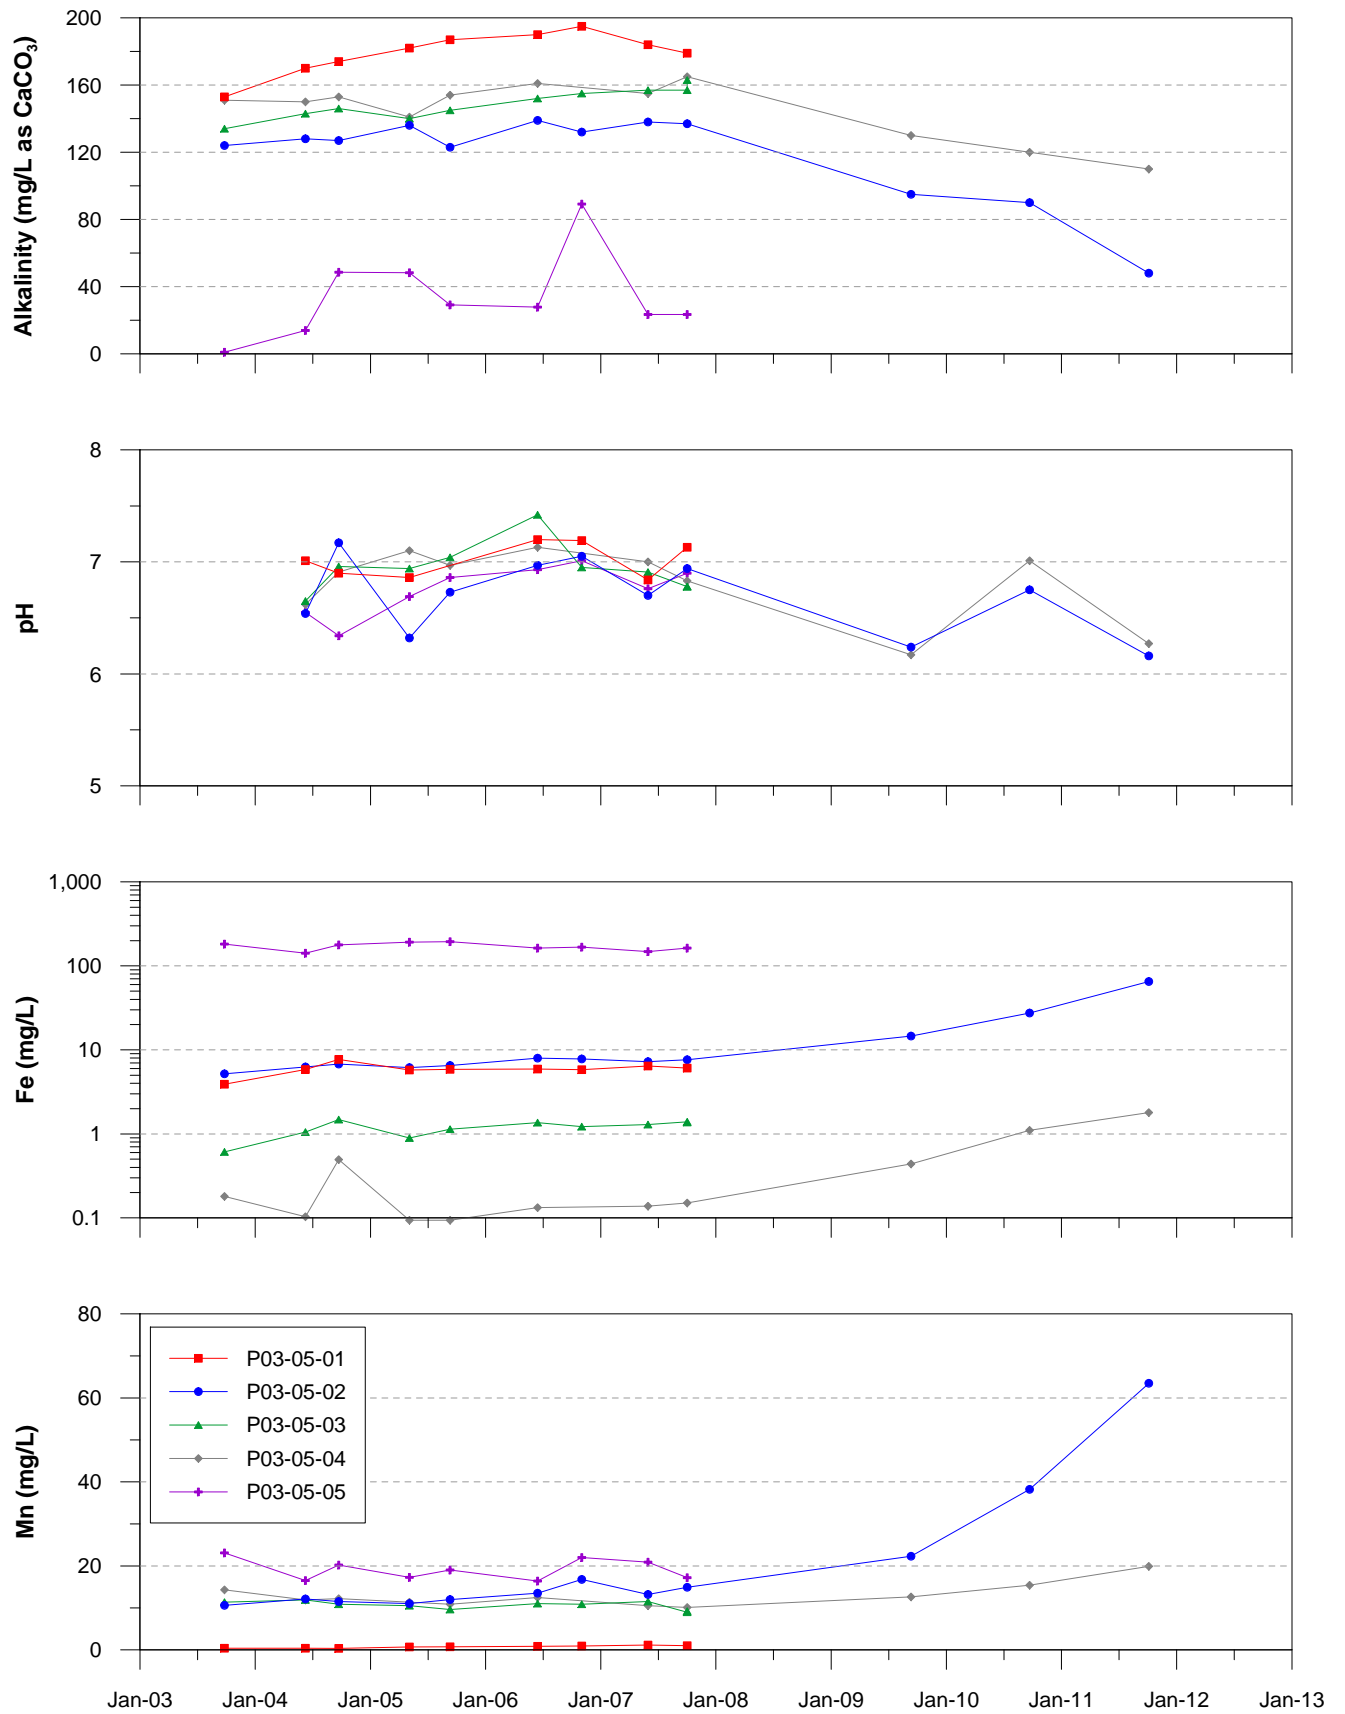
Figure 3-10e. Time trends for SO₄, Mg, Na and Zn in P03-05 (aquifer only)

- At P03-05, SO₄ and Zn concentrations continued to increase during the current monitoring period and thereby continued a trend that has been observed for several years (see Figure 3-10e/f); the 'breakthrough' of SO₄, Mg, and some metals of interest suggests that the leading edge of the contaminant plume observed at similar depths at well P03-03 has reached well P03-05 (i.e. 500 m downgradient).
