## **YUKON GOVERNMENT**

### **GRUM SULPHIDE CELL COVER, FARO MINE**

### **2013 REVIEW**

PROJECT NO.: 0533-005  
DATE: December 9, 2013

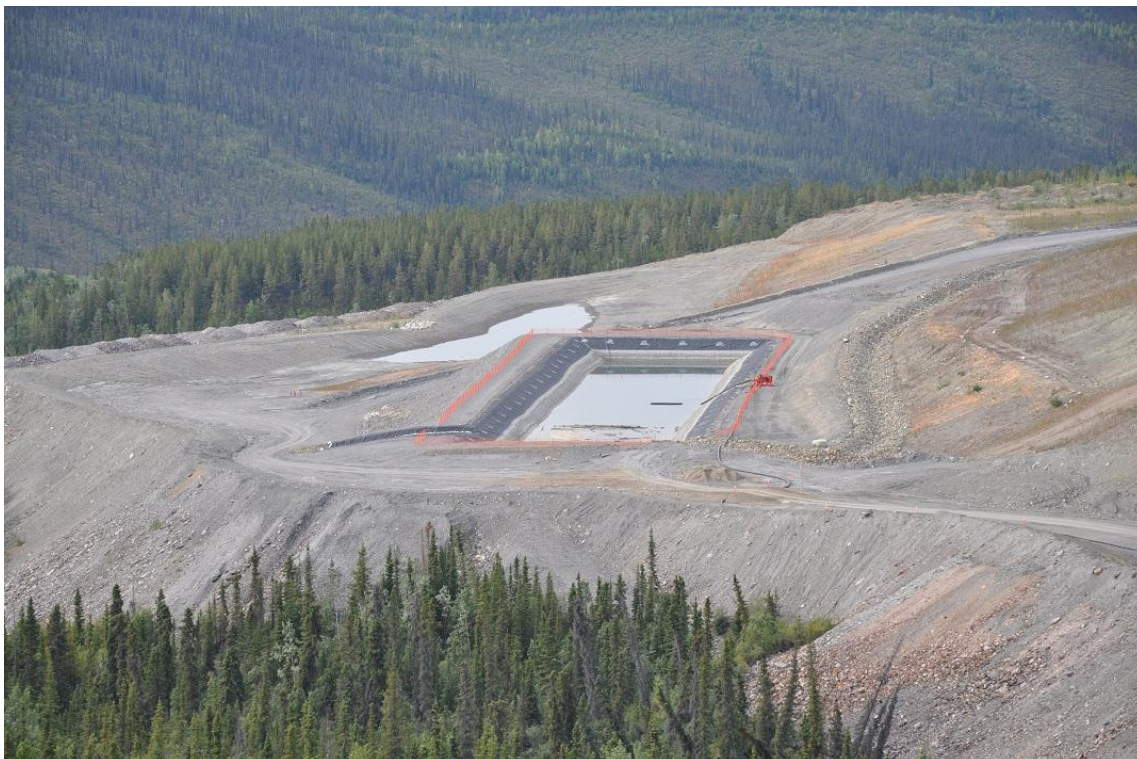
**Photo 2-1. View of the rectangular lined pond in the mid-ground and the unlined pond in the background at the toe of the GSC cover (Aug. 22, 2012).**

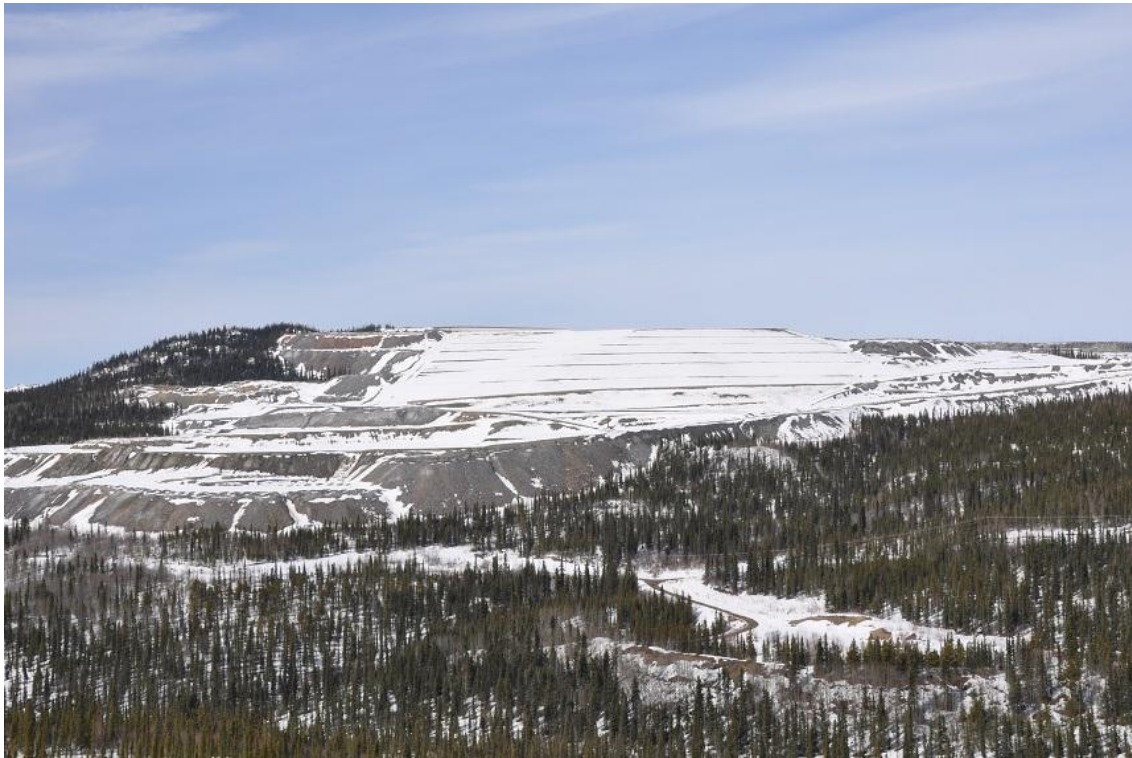
- YG staff were on site on Friday May 10, 2013 and noted spring run-off had begun but most of the GSC cover was still covered with snow with up to 1.5 m thick snow drifts in some locations, as shown on Photo 2-2.

**Photo 2-2. View of the snow covered GSC cover (May 10, 2013).**

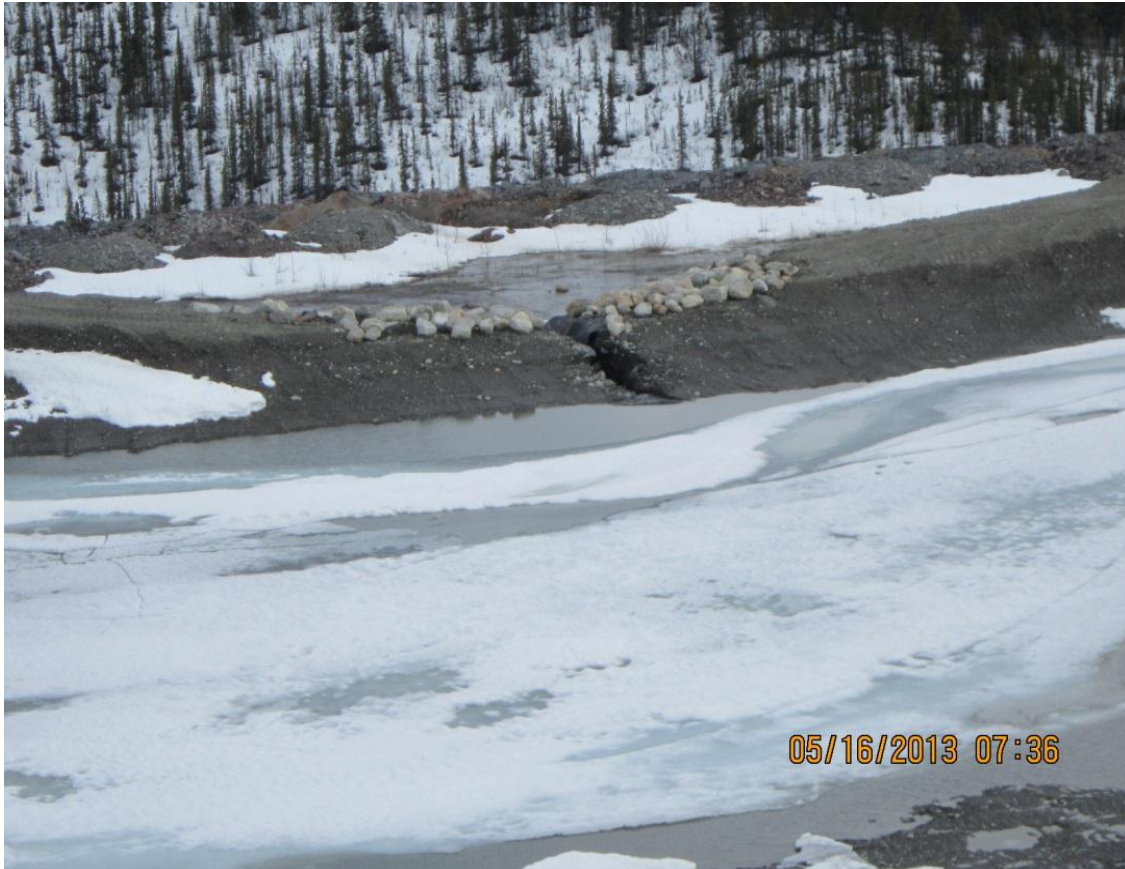
- YG staff noted that Godwin Pump for the GSC pond had been removed for other site purposes. A replacement pump arrived on Sunday May 12<sup>th</sup>, which was started on Monday May 13<sup>th</sup>. Tlich Engineering and Environmental Ltd. (TEES), the site care and maintenance contractor, noted that water was overflowing from the lined pond (via its emergency spillway) and flowing to the unlined pond on that morning.
- Water levels in the unlined pond were rising due to the spring runoff, which was problematic due to snow and ice blockages in the various conveyance channels.
- The unlined pond failed in overtopping, or by piping, on May 15<sup>th</sup>, as shown on Photo 2-3, taken early the next morning.

**Photo 2-3. View of the breach on the unlined pond berm (May 16, 2013).**

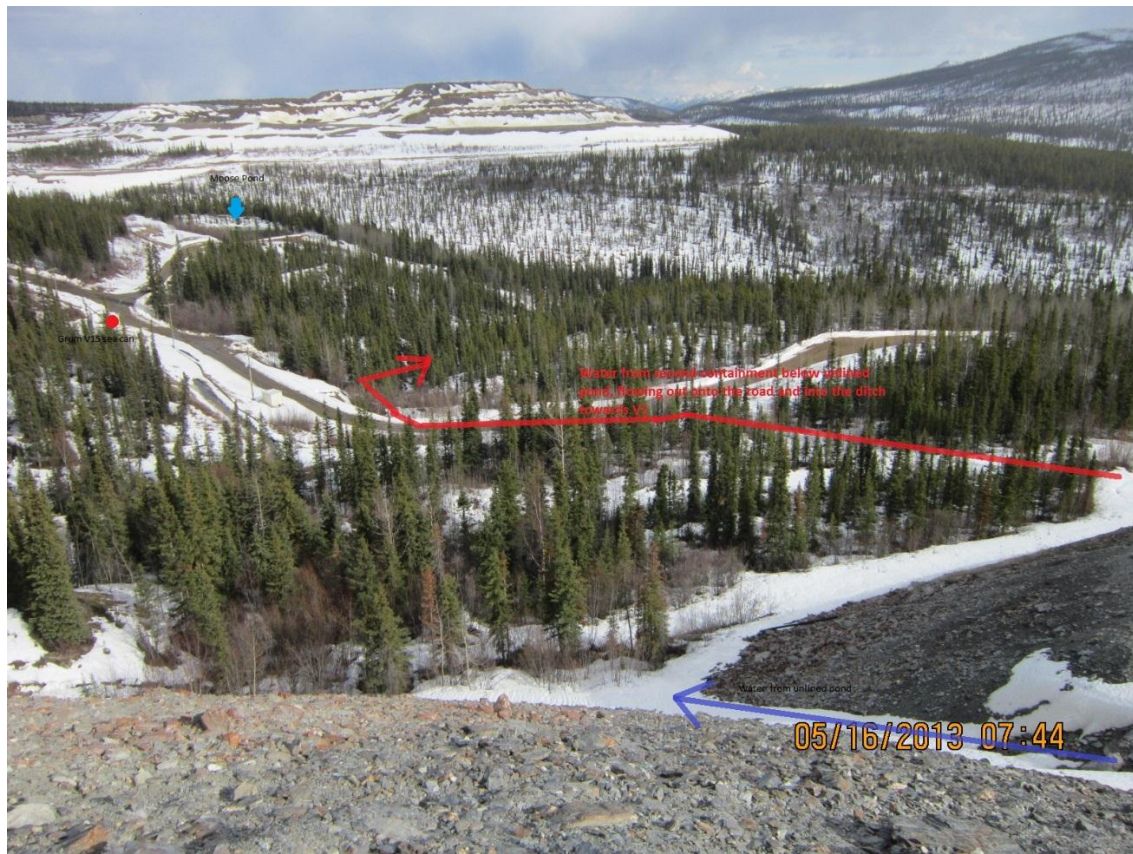
- The breach allowed the water to flow down the dump face and flow into two downstream areas, shown on Photo 2-4. Most of the flow entered the collection ditch along the Station V15 seepage collection system while a lesser amount entered the historic drainage channel and flowed through Station V2.

**Photo 2-4. Two seepage discharge paths approximately delineated by blue and red arrows (May 16, 2013). Vangorda Creek in the mid-ground of the photo.**

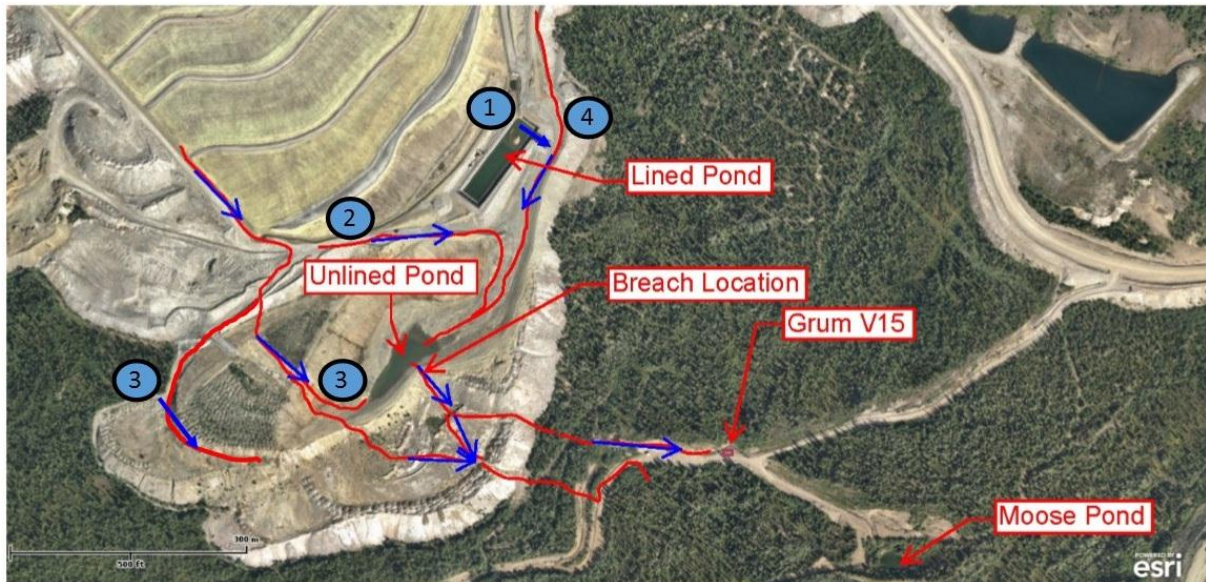
**Figure 3-2. Run-off Source Locations from May Event (after YG 2013a)**

This figure shows that discharge water came directly for GSC cover sources, along with other sources in the surrounding dump areas.

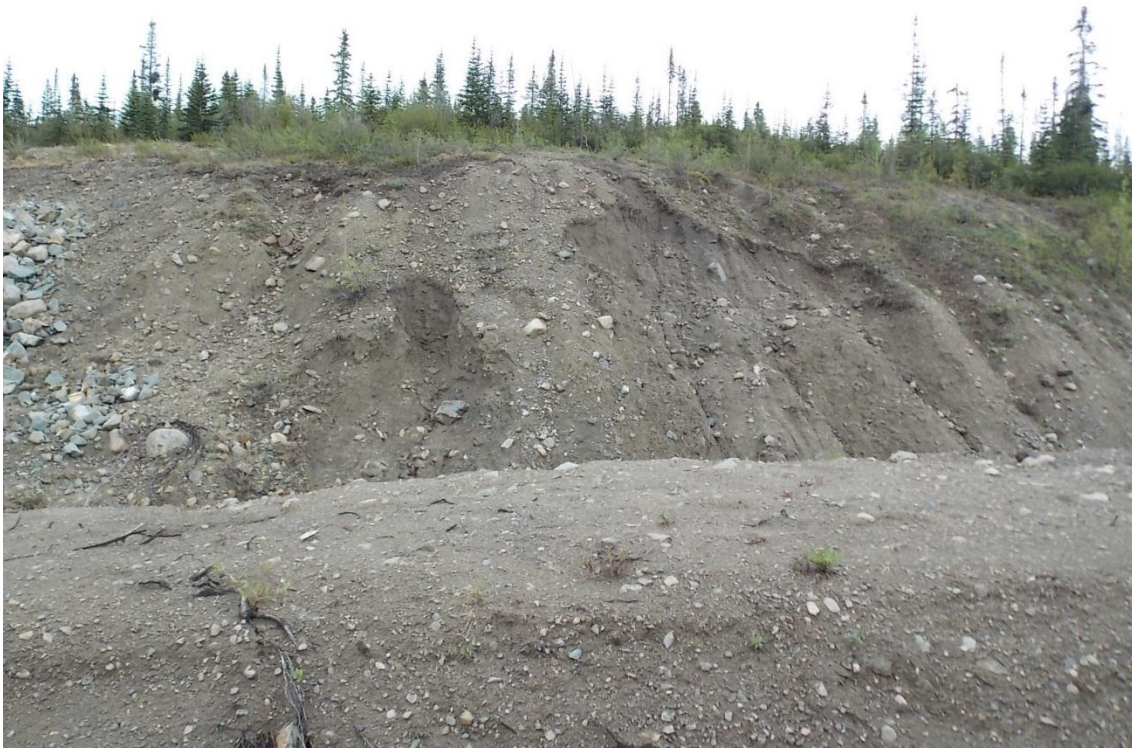
5. Several sloughs (small landslides) have been observed in select places in the cover, although they are generally associated with steeper sections of the cover. Other cut slopes on the Faro Creek Diversion and Rose Creek Diversion Channels also experienced sloughing, as shown on Photo 3-1.

**Photo 3-1. Sloughs located on the backslope at the Faro Creek Diversion Channel (June 13, 2013).**

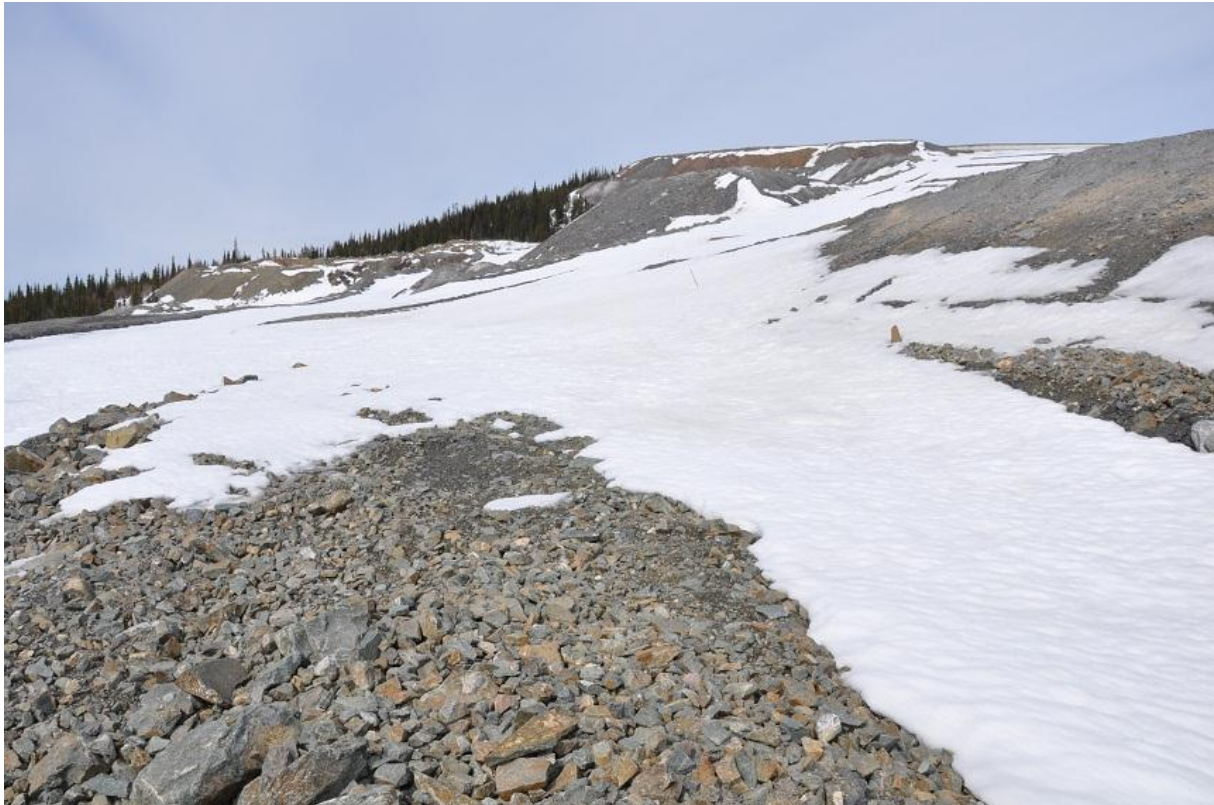
**Photo 3-2. View looking south onto West Dissipation Pond (mid-ground) and perimeter ditch heading uphill to the right background (May 10, 2013).**

As can be seen in the photos, even though snow melt has been initiated, and bench edges and slopes toes are clear of snow, the collection ditches and dissipation ponds are filled with snow. This snow (or ice) could act as an impediment to flow, causing a loss of capacity of the channel; leading to some of the water being deflected from the collection channel. If the spring melt was rapid versus slower, as noted in Section 3.3, there is a higher chance of occurrence that run-off flows would be impacted by snow and ice blockages.

Given that the perimeter ditches and dissipation ponds appears to block and divert water during rapid snowmelt events, there are two courses to suggest. Firstly, YG and TEES should be prepared to remove all snow blockages from these ditches and dissipation ponds in the period immediately preceding run-off occurrence. Access for equipment may be an issue here. Secondly, it may be possible to modify the ditch design with some form of widening so that slough and snow blockage are less problematic. The perpendicular bend at the bottom of the two downhill ditches is likely also problematic and these hard bends in water direction should be avoided. Given the cost and construction aspects of channel modification in the short term, YG should be expecting to clear the perimeter ditch and ponds of any snow and ice blockages over the next few years until a final cover landform and channel design can be formulated and constructed.

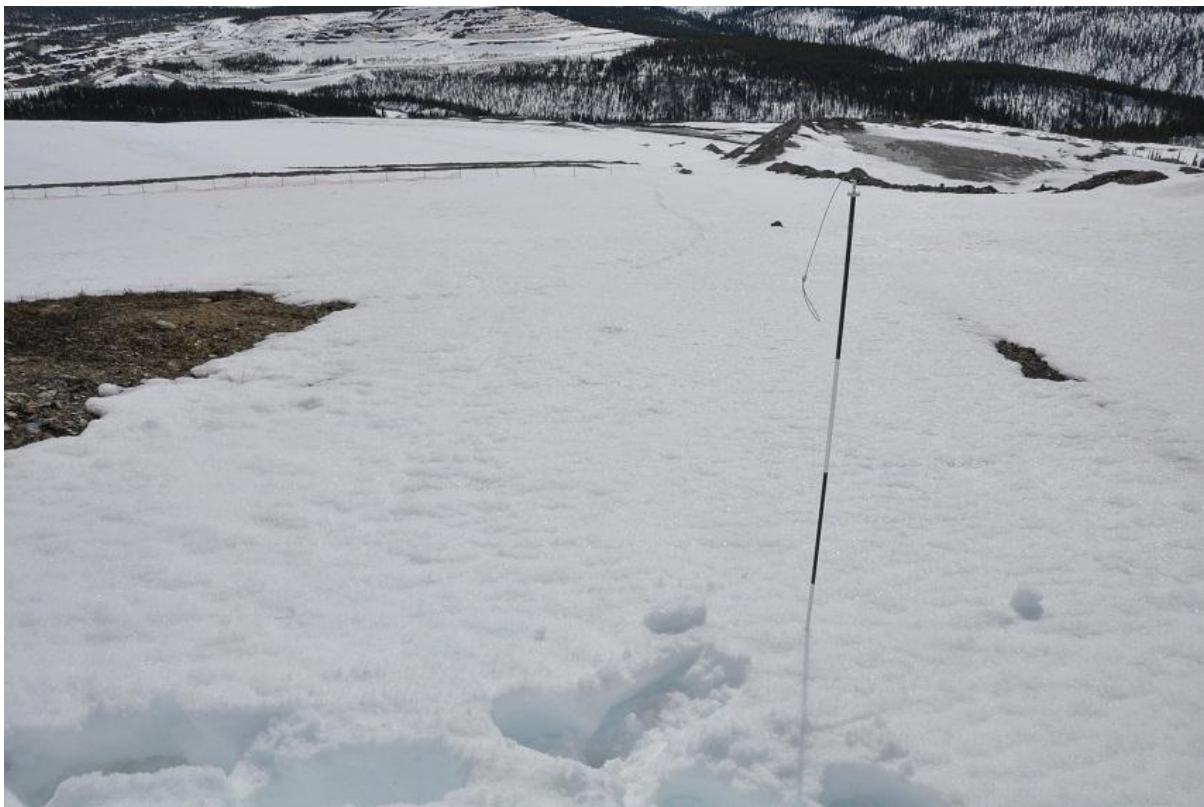
**Photo 3-3. View looking down the perimeter ditch along the southwest side of the GSC cover; 1 m of snow indicated by probe (May 10, 2013).**

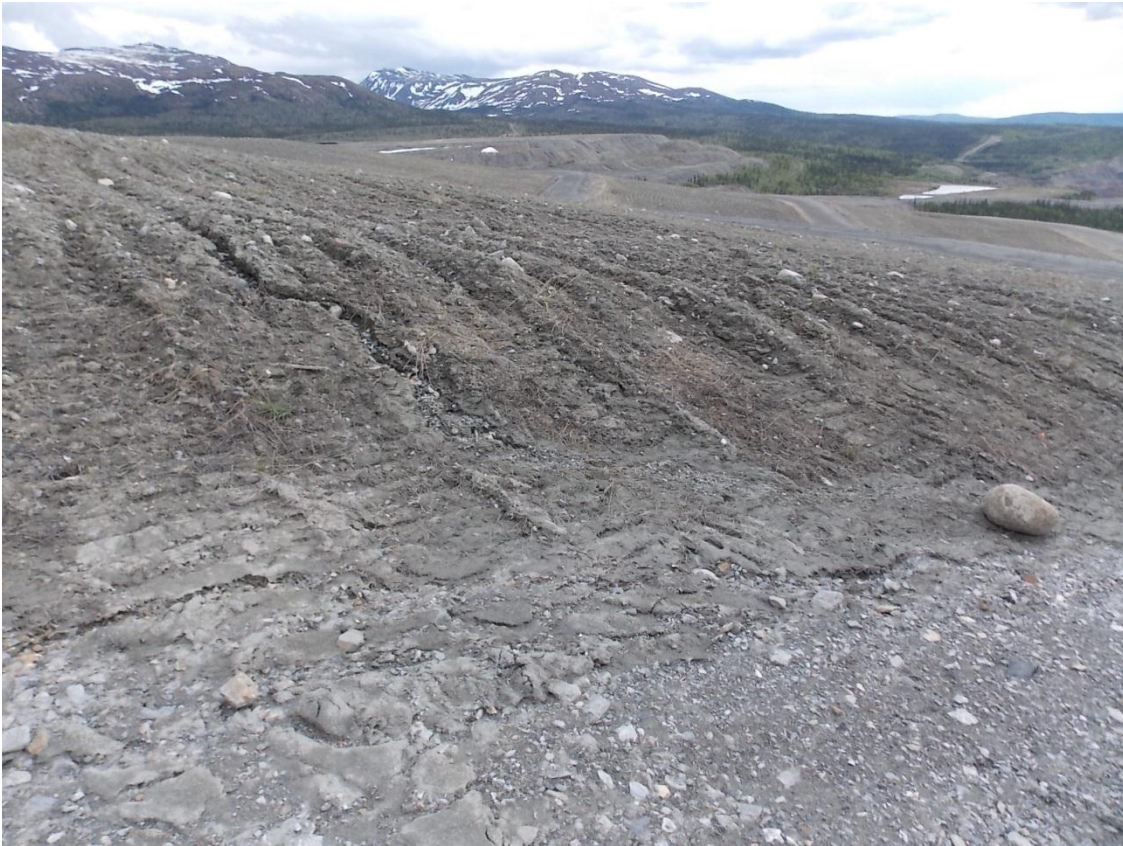
**Photo 3-4. Longitudinal gully on cover surface near south perimeter ditch (June 13, 2013).**

These rills and sloughs are a function of water generated during freshet, the saturation of the subgrade caused by the previous climate and the local steepness of the slopes as they deviate from the 5:1 design slope. Not including the localized rills shown on Photos 3-4 and 3-5, the erosional rills and sloughs are generally located on slopes ranging from 3H:1 to 2H:1V on the toe berm downstream slope to perhaps as steep at 1H:1V on the side slope for the perimeter ditches.

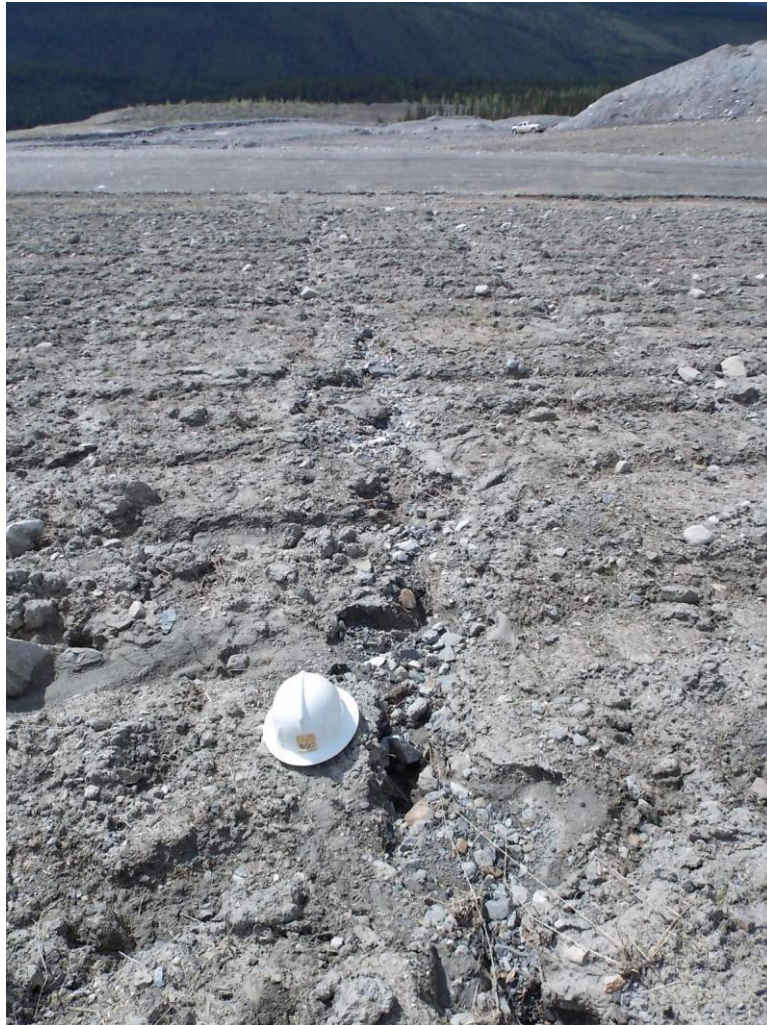
**Photo 3-5. Transverse gully on cover surface (June 13, 2013).**

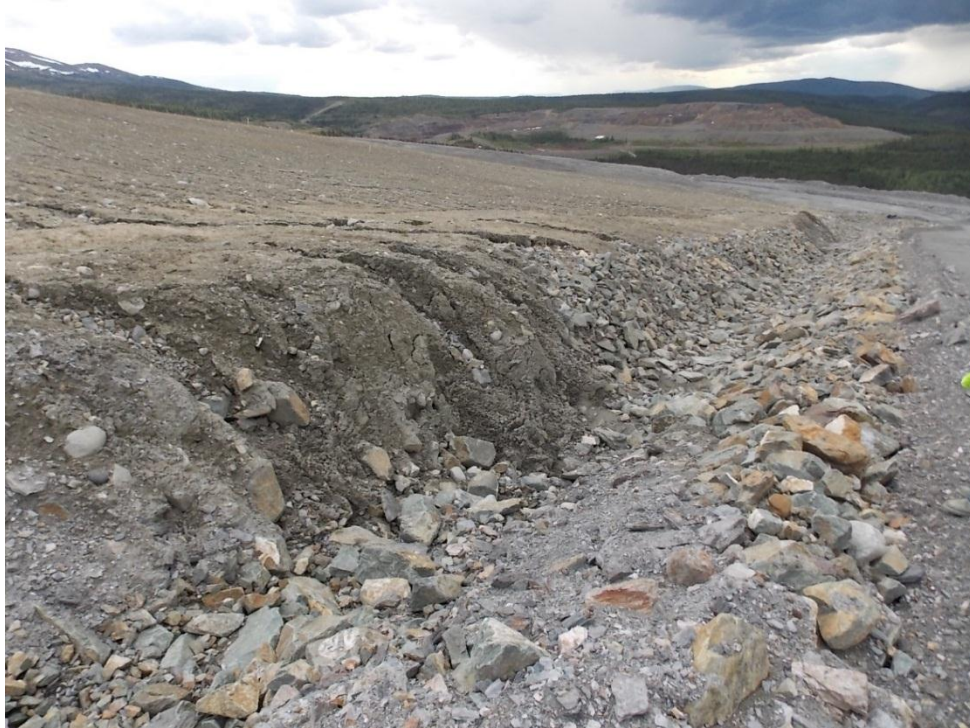
The as-built ditch section displays a wide ditch with at least one side slope of 3H:1V. As displayed in Photo 3-6, the side slope for the ditch section is much steeper in select locations, potentially approaching 1H:1V with a narrow bottom width. Such a narrow ditch is more easily blocked by slough material on the “cover” side and there are a few locations where this sloughing has occurred, see Photo 3-6. If this slough does not fully block the channel, it does restrict the flow which would be more easily affected by snow and ice blockages.

- Erosional gullies and some slough material on the inside of the south perimeter ditch, as shown in Photo 3-6.

**Photo 3-6. Gullies and local cover slough on the inside of the south perimeter ditch (June 13, 2013).**

- Remove and regrade any slough material causing localized "choke points" (as shown in Photo 3-6) in the perimeter ditches. Regrade any localized tension cracks and rills close to these locations to prevent further erosion this year.

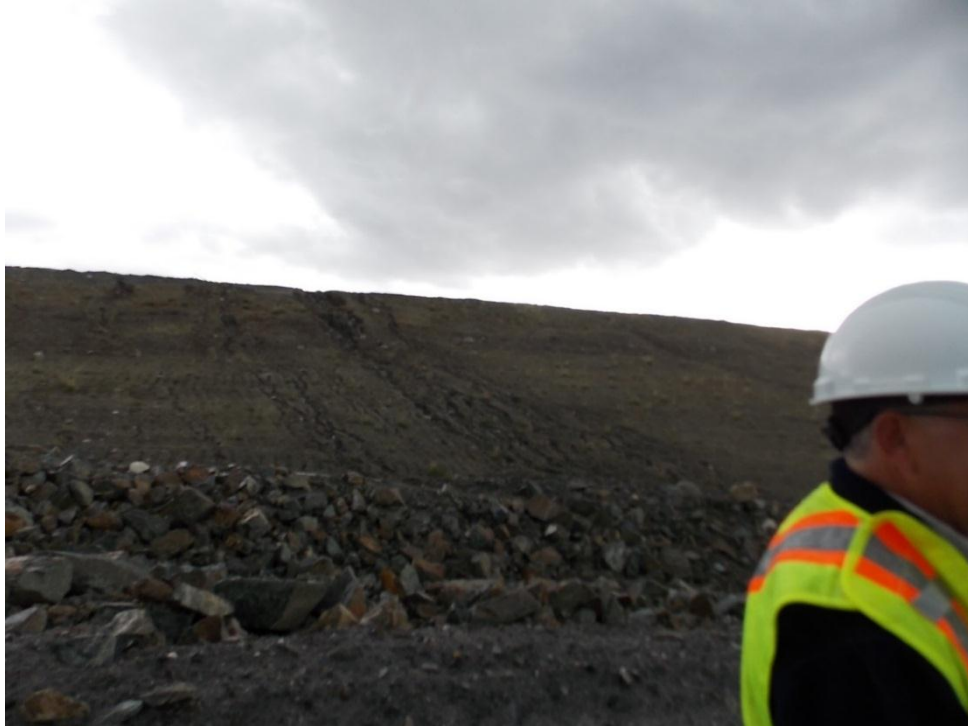
- Erosional gullies on the downstream face of the toe berm, as shown in Photo 3-7.

**Photo 3-7. Gullies on the toe berm slope (June 13, 2013).**

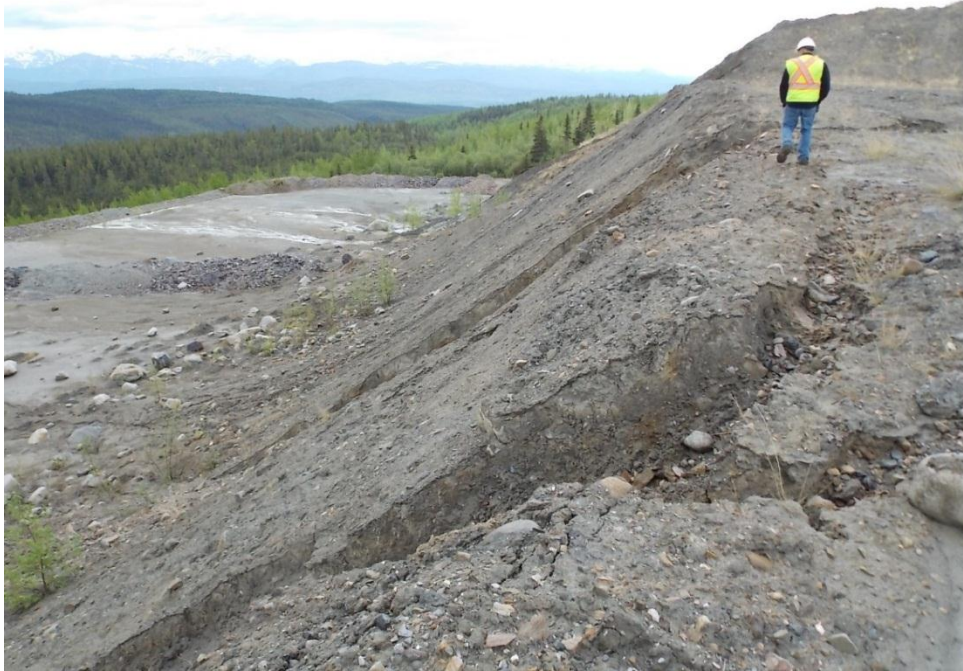
- Deep erosional gully on the steep dump toe located south of the unlined pond shown on Photo 3-8.

**Photo 3-8. Deep incised gully on the toe of the dump face (June 13, 2013).**

- Regrade and repair localized erosional gullies located on the dump faces to the southwest of the unlined pond area (example shown in Photo 3-4). These gullies are generated by run-off that come down from the "old rock quarry" location higher up in the dump section.

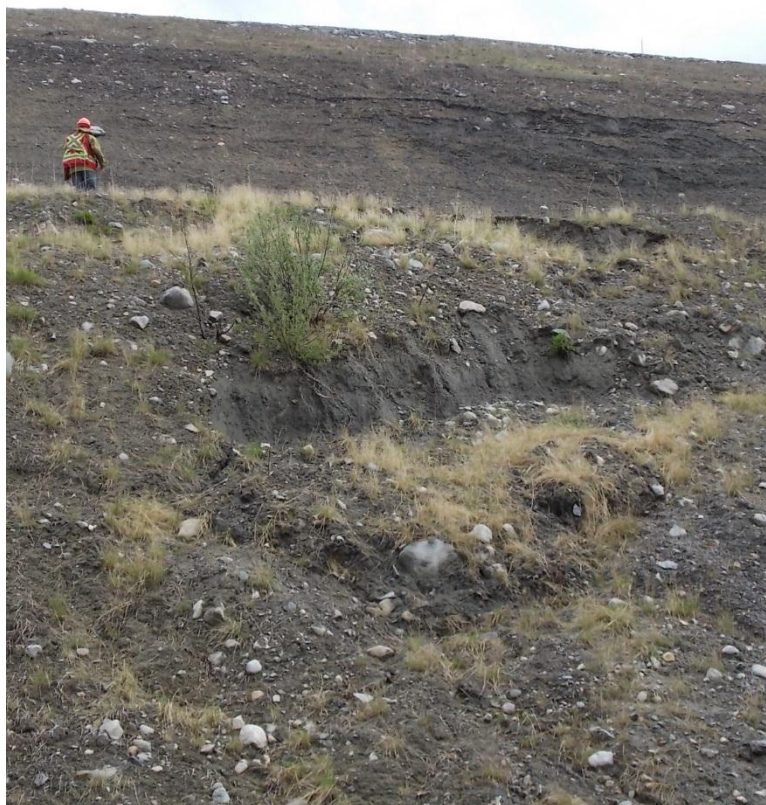
- Three sloughs located on the slopes directly over top of the lined pond. Two of these sloughs are shown on Photo 3-9.

**Photo 3-9. Two sloughs on the toe berm slope, just above the lined pond area (June 13, 2013).**

- Regrade three sloughs on the slope near the toe berm, above the lined pond area. Two sloughs are located in the area where toe berm erosional gullies were previously repaired in 2011. Repairs must be carefully done to ensure minimal disturbance to the remaining slope and prevent further channelization of run-off and associated erosion. Erosion gullies should be filled with coarse material, to prevent further erosion of the fine grained till soil.

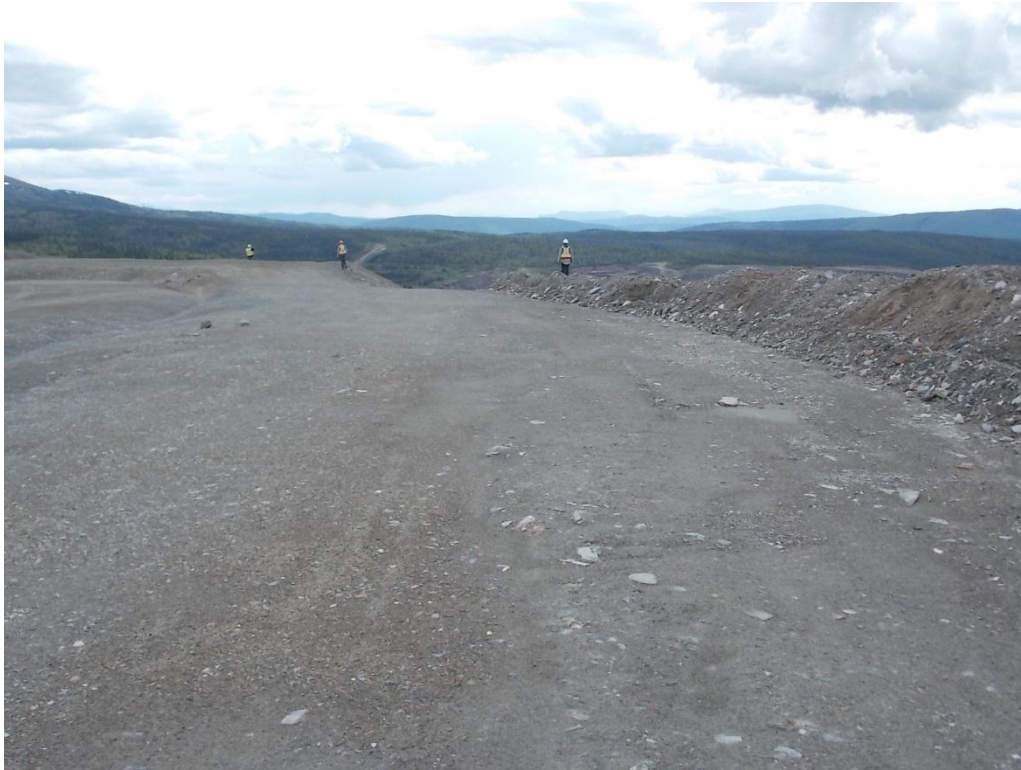
**Photo 3-7. Extend gentle swale in left background across road crest (June 13, 2013).**

- Extend crest edge swale across road access to prevent any water from entering the upper crest edge, as shown on Photo 4-1.
