YUKON GOVERNMENT

GRUM SULPHIDE CELL COVER, FARO MINE

2015 REVIEW

PROJECT NO.: 0533-012
DATE: February 29, 2016

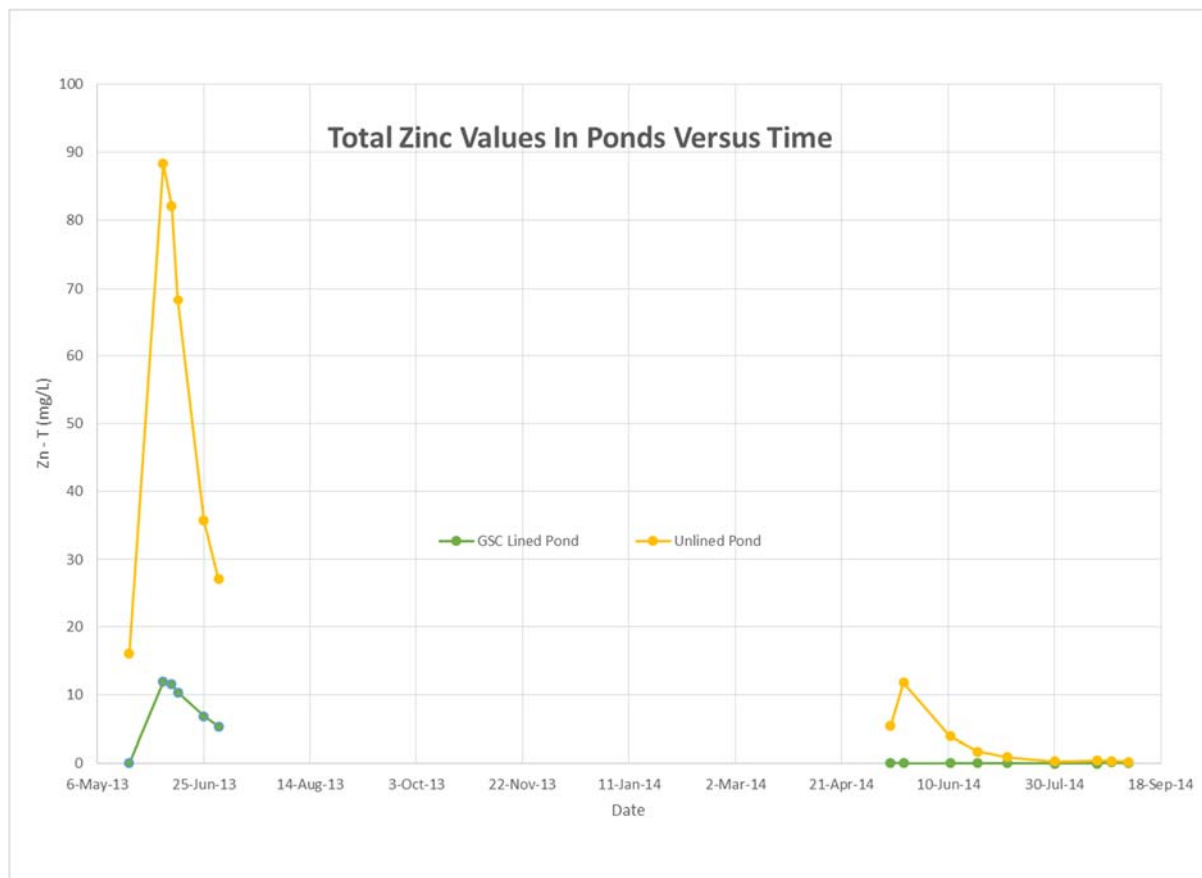
Figure 2-3. 2013 and 2014 Total Zinc Concentrations for Both Ponds

Comparing the total zinc values for the two ponds for 2014, the Lined Pond values were generally lower than 0.1 mg/L (compliant) while the Unlined Pond values ranged from greater than 5 mg/L (non-compliant) to a range of 0.23 to 0.4 mg/L (compliant). These zinc values demonstrate that the Lined Pond has lower concentrations and its run-off comes from the remediated cover surface while the Unlined Pond water comes from the unremediated waste dump surfaces. The zinc concentrations in 2014 were both lower than observed in 2013 and were considered compliant for discharge (although not for TSS on occasion), likely driven by either changes to cover water balance (current understanding is limited) and/or to a reduced amount of cover erosion and vegetative cover taking hold. If the cover contact water was compliant for discharge for all discharge parameters (total zinc and TSS), it would make sense to discharge compliant water to the toe of the dump rather than mixing with non-compliant water in the pit for treatment.

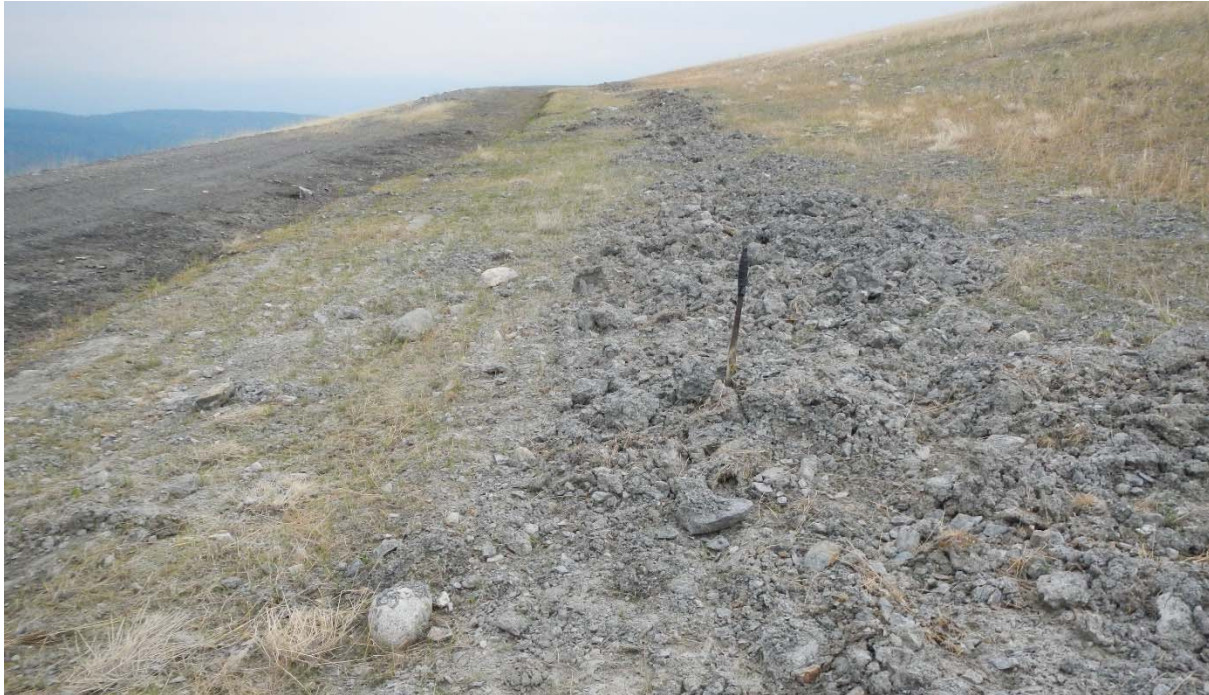
Photo 3-7. View of loose ditch cleaning debris placed on vegetated slope above fourth bench; loose material may erode easily in the future (May 27, 2015).

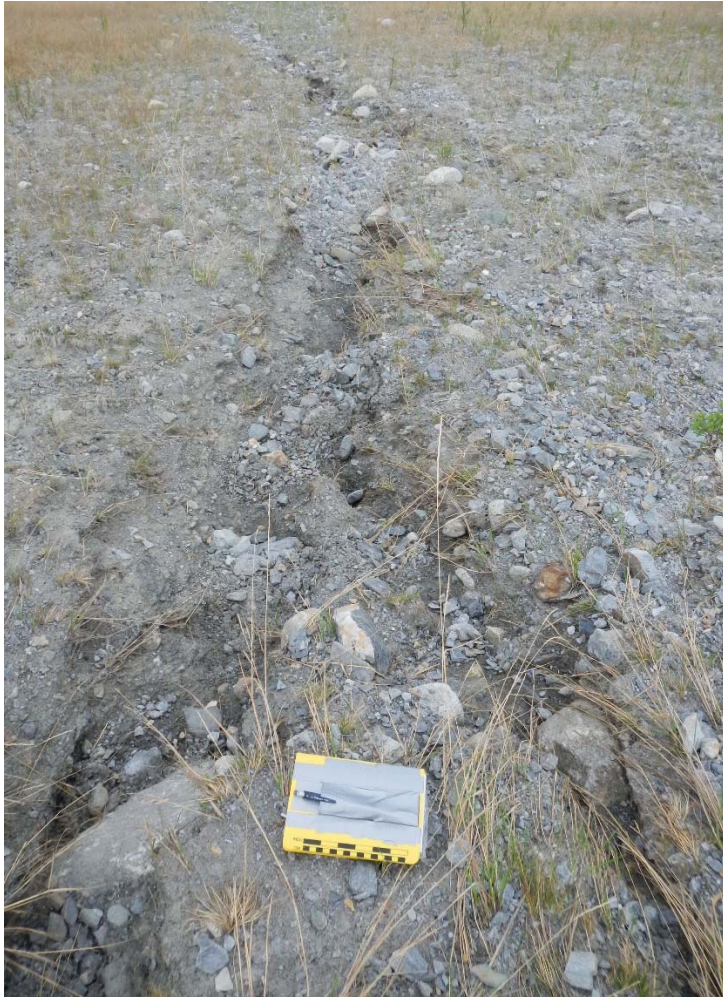
5. New erosional gully formed from fourth bench down onto fifth bench; approximately 0.5 to 1 m wide and 0.3 m deep. This gully should be regraded at upper end to prevent further erosion.

Photo 3-8. View of erosional gully from fourth bench (May 27, 2015).

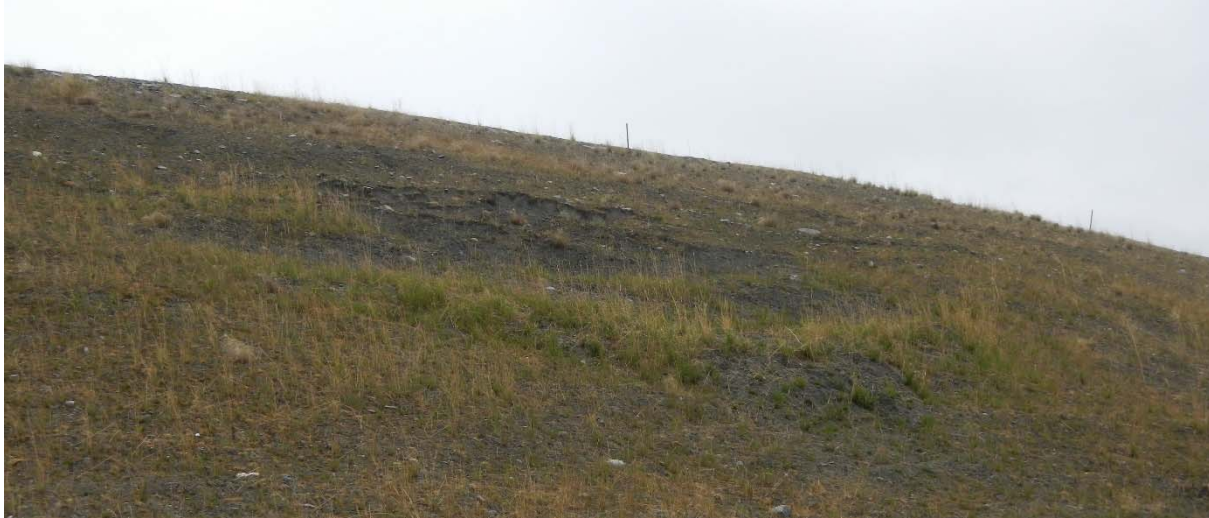
6. New significant erosional gully (0.6 to 0.7 m wide and 0.3 m deep) formed from fifth bench onto toe berm; gully should be regraded to prevent further erosion.
7. Three small sloughs continue to be active with cracking along the eastern side of the Toe Berm, above the Lined Pond; one shown on Photo 3-9. In addition, some longitudinal cracking noted in base area of the Toe Berm, just above diversion ditch.

Photo 3-9. View of the small slough (one of three) on slope above diversion ditch (May 27, 2015).

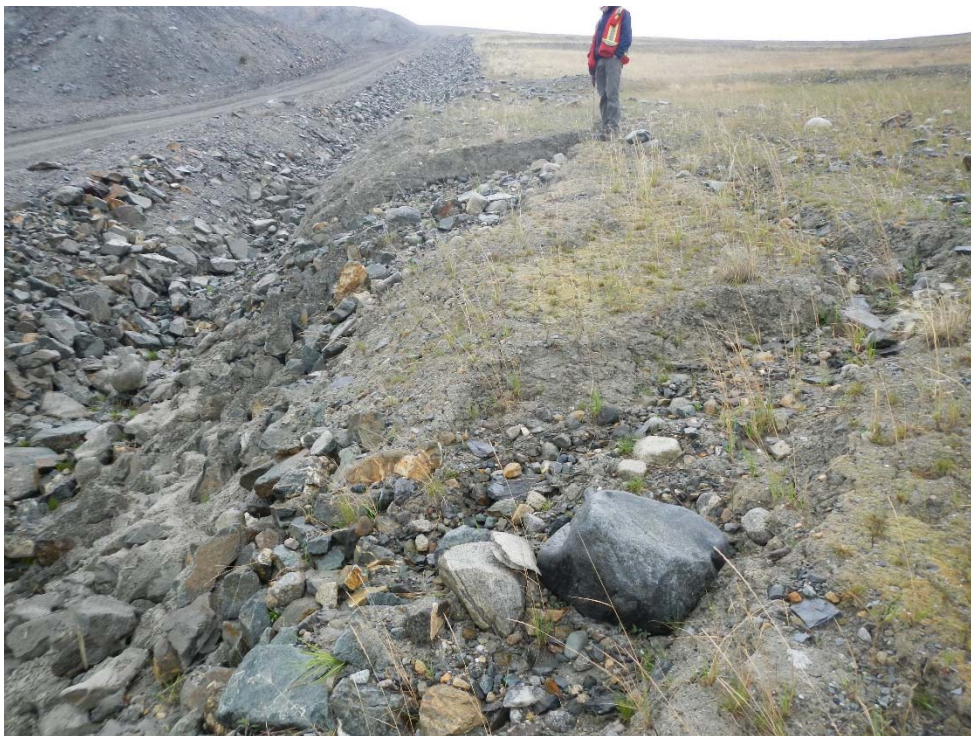
8. New significant erosional gulley formed at base Toe Berm slope; requires repairs.
9. Two erosional gullies continue to exist on the eastern side of the West Access Ditch, as shown in Photo 3-10. Minor vegetation beginning to establish in the gullies but gullies appear to be widening.

Photo 3-10. View of two erosional gullies that run into the West Access Ditch (May 27, 2015).

10. Erosional gulley on fourth bench may be source zone for gullies in West Access Ditch.
11. Geotextile exposed in West Access Ramp above first bench, as shown in Photo 3-11.

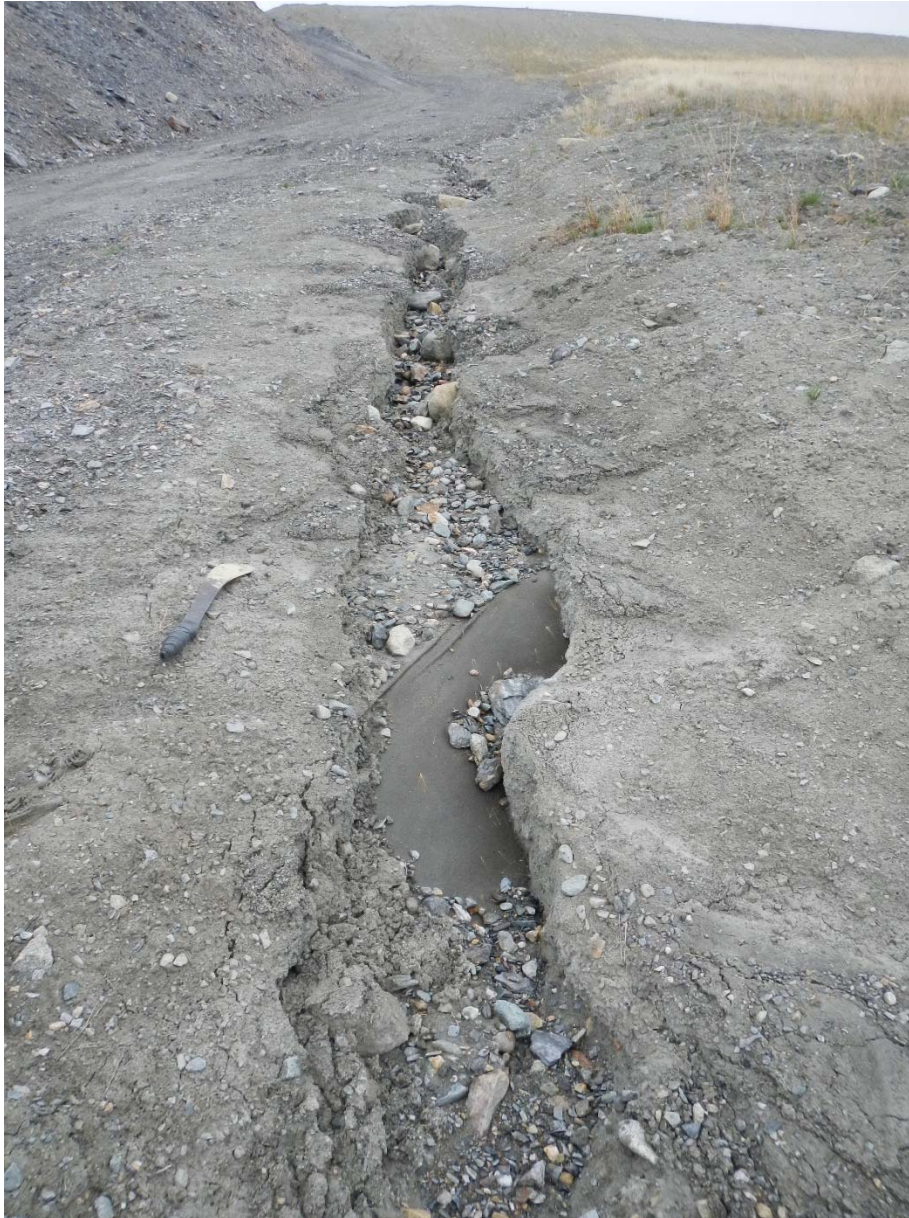
Photo 3-11. Underlying geotextile exposed in West Access Ramp (May 27, 2015) which should be repaired.

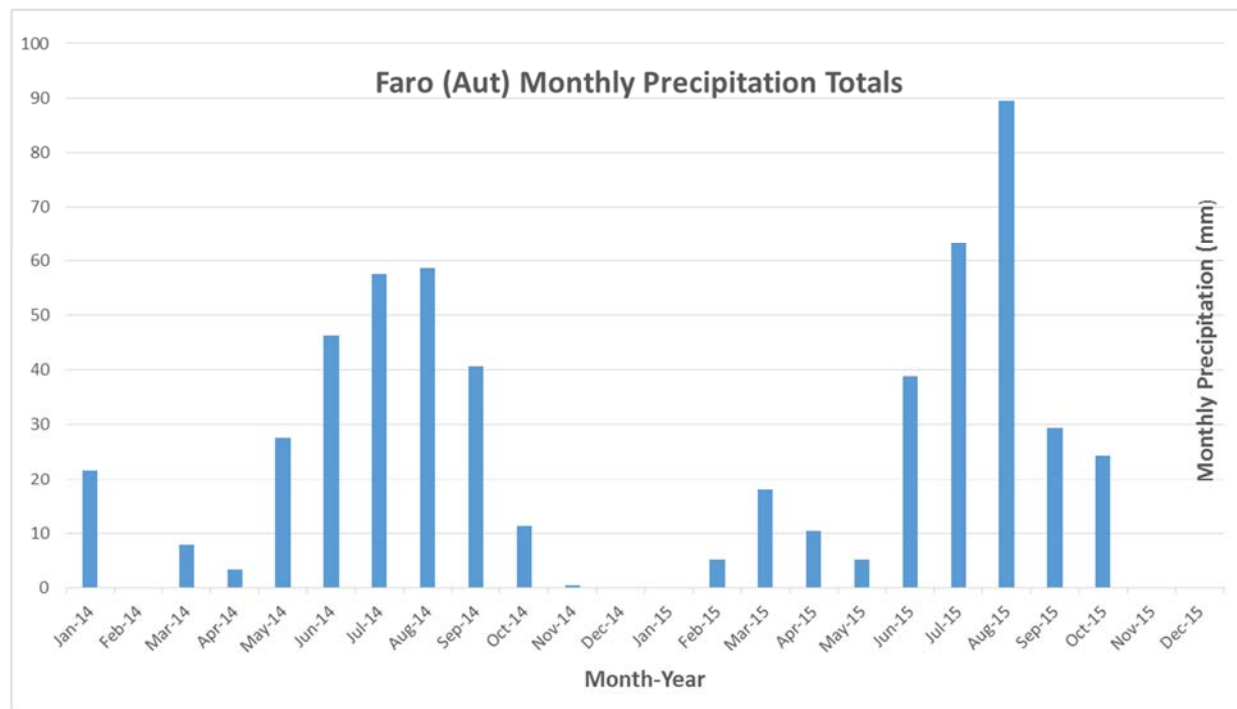
Figure 3-3. Faro (Aut) Monthly Precipitation Values for 2014 and 2015.

Although there is a slight difference in the distribution of the monthly precipitation between the two years, the totals are similar; 275 mm for 2014 and 284 for 2015.
