YUKON GOVERNMENT – YUKON ENERGY, MINES & RESOURCES
ASSESSMENT & ABANDONED MINES, ROOM 2C, 2ND FLOOR, ROYAL CENTER
P.O. BOX 2703, WHITEHORSE, YUKON Y1A 2C6

HAZARDOUS MATERIALS CLASSIFICATION FARO MINESITE YUKON

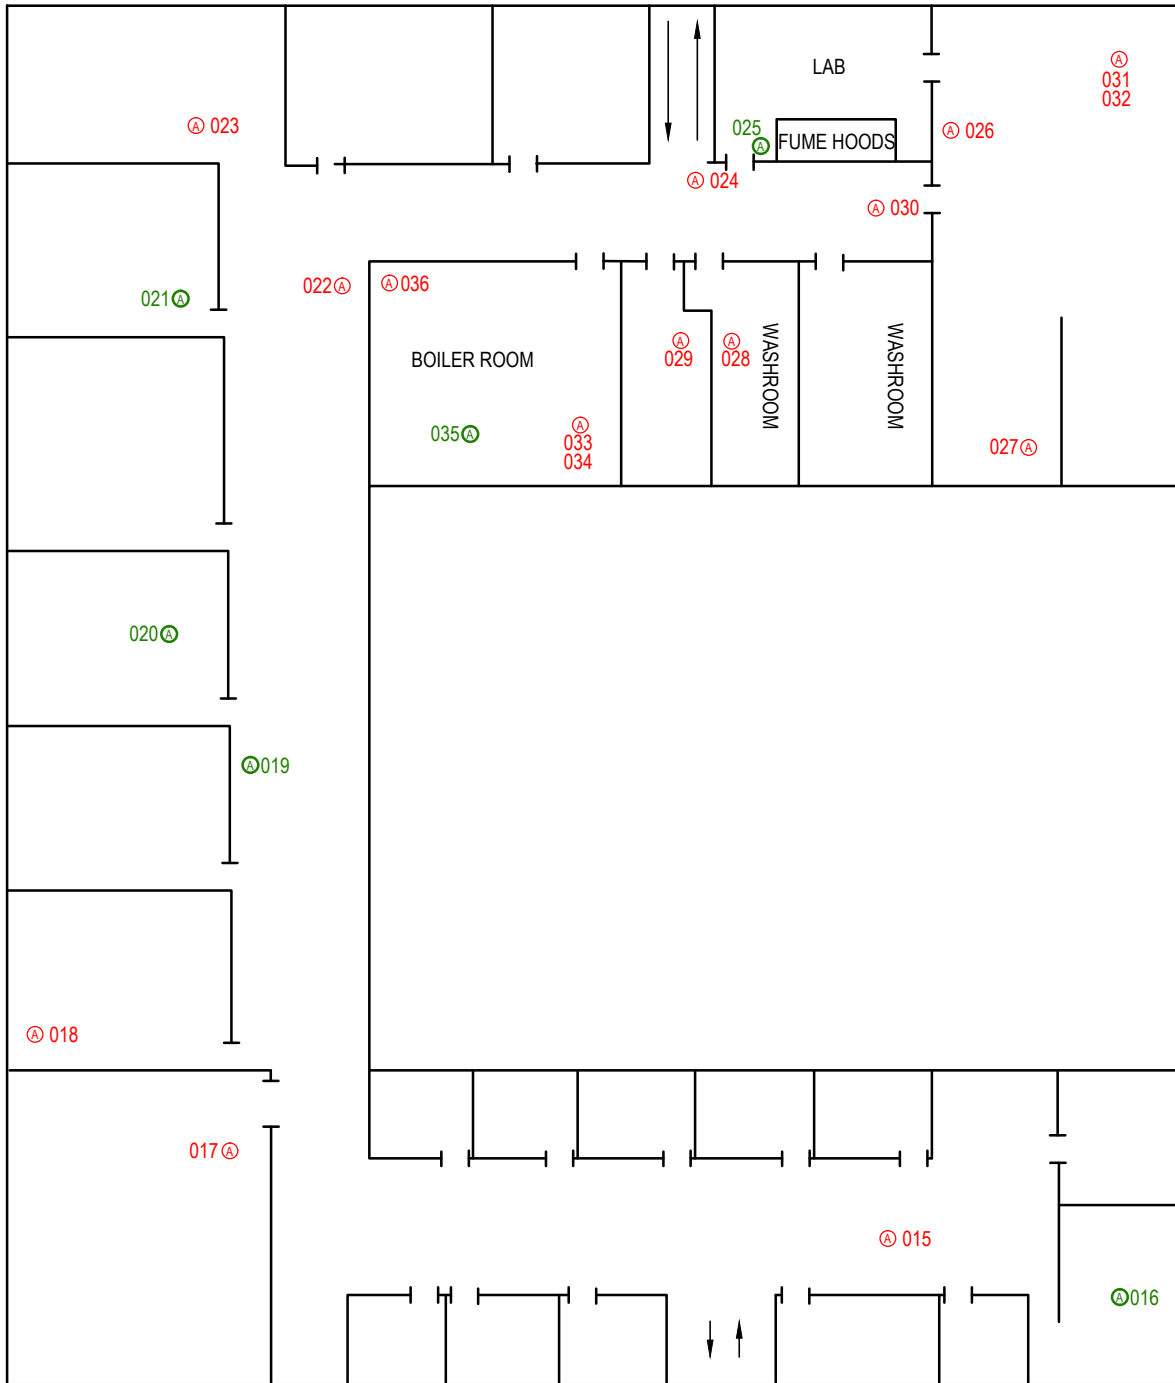
C:\Whitehorse\Drawings\Farol\W23101482\Faro Mine Site Hazardous Waste Classification\W23101482 Fig.2_R0.dwg [FIGURE 2] December 05, 2011 - 8:28:39 am (BY: BUCHAN, CAMERON)

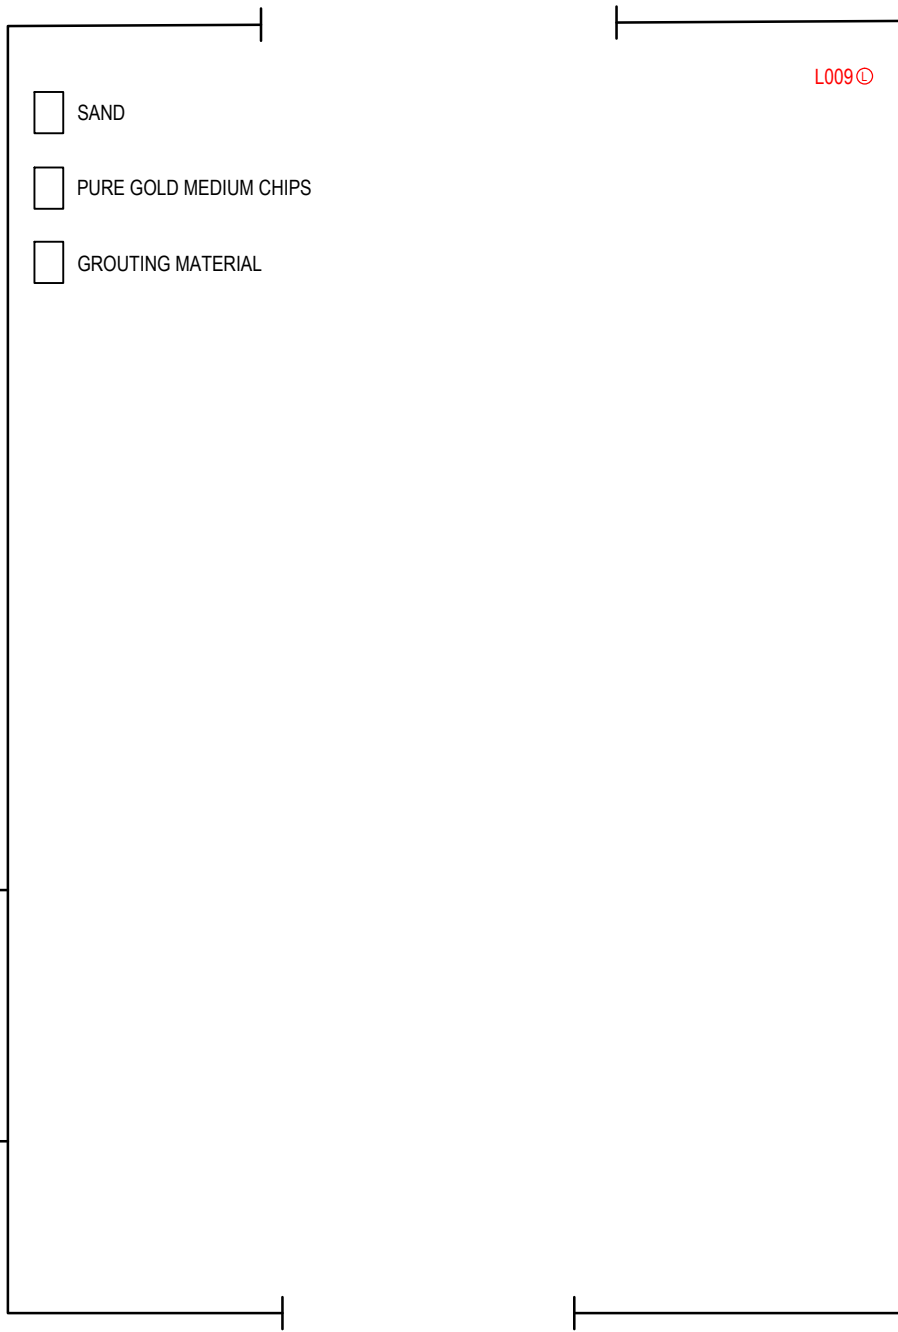
C:\Whitehorse\Drawings\Farol\W23101482\Faro Mine Site Hazardous Waste Classification\W23101482_Fig.2_RO.dwg [FIGURE 5] December 05, 2011 - 8:29:27 am (BY: BUCHAN, CAMERON)
