Government of Yukon  
Energy Mines and Resources  
Assessment and Abandoned Mines

**Implementation of Immediate Actions at the Former Clinton Creek  
Asbestos Mine Site**

January 18, 2014

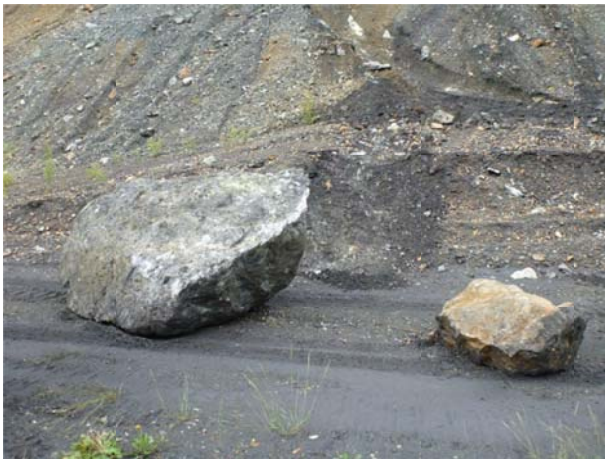
Photo 7 – Rock removed from slope above road

On the waste rock pile, an erosion gully had exposed a large rock above the road which poses a threat to the travelling public. This rock was removed with the use of the excavator and was rolled to a location

below the road. After the removal operation was completed the road was cleaned and the rock placed to one side away from the travelled portion of the road. The work was completed by the excavator.

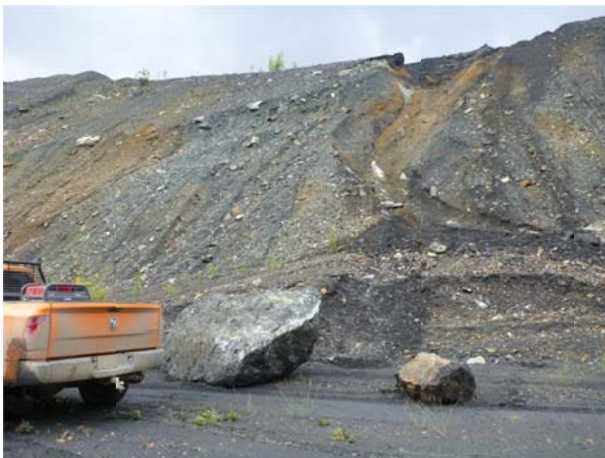
Photo 8 – Rock removed from slope and area it came from

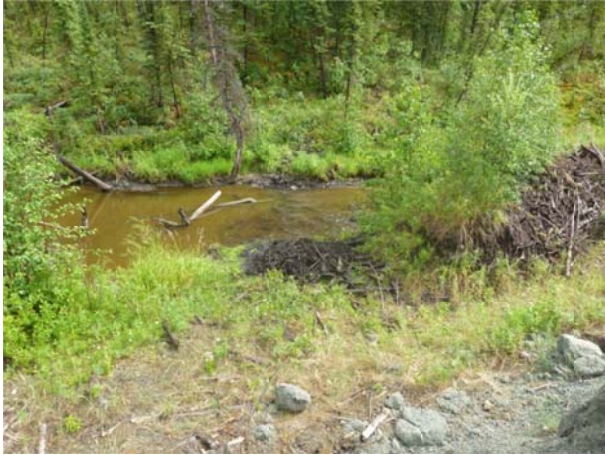
Photo 12 – Lower Beaver Dam Removed

Removal of the beaver dams was done by hand, utilising labourers provided by BEL. Dam materials were removed by hand using pike poles, mattocks and shovels. Materials removed were placed above the high water mark at the side of the stream. The recommendations of the design report were followed.

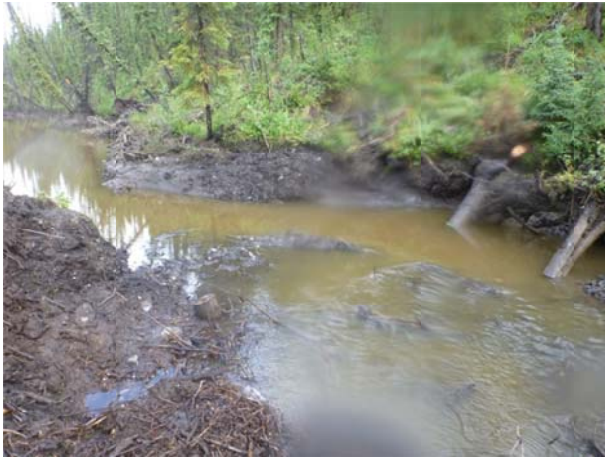
Photo 13 - Upper Beaver Dam Removed

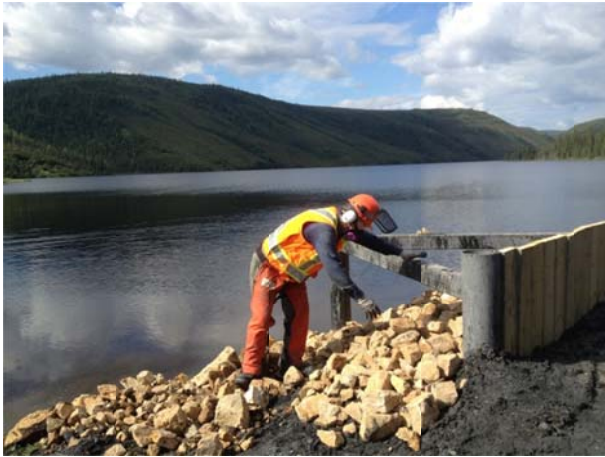
Some erosion protection has been placed around the foundation of the abutments however some consideration should be given to improving this. During a high flow event there is a possibility that the materials around the abutment may erode and potentially destabilize the structure. Some materials are located nearby and a further quantity is located near the entrance to the site. Some analysis and design work should be undertaken to assess stream flow velocities, soils properties, rip rap sizing, and extents of the protection. There is a possibility that the materials at the connection between the pipe and the abutment could erode faster due to the flow being directed to this area by the floating pipe.

Photo 21 Placing rip rap around north abutment

- Assess erosion around the abutments by looking for settlement of the rip rap around the base of the abutments. Particular attention should be paid to the area at the connection of the abutment and the log boom.
- View erosion along both shores up and down stream of the abutments. Pictures must be taken to analyse yearly changes of the shorelines.
- Volume of materials directed to shore by the log booms should be monitored for scheduling purposes and to ensure timely cleaning. Materials directed to shore should be removed by hand using ropes and saws or axes if necessary.

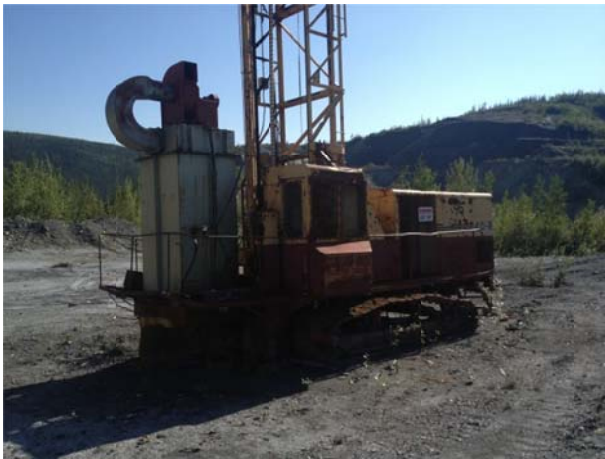
Photo 34 - Sign and evidence of ladder removed from abandoned drill

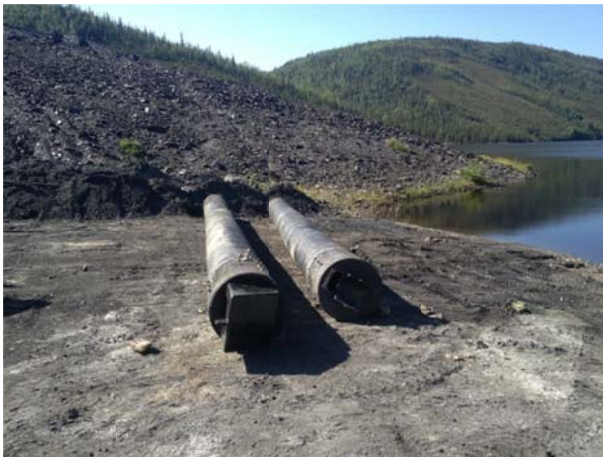
- **July 31:** Two more caps were installed and the pipes were placed in the water.
- **August 1:** It was discovered that the sealant had not sealed the end caps and that the pipes were partially filled with water. The pipes were pumped out, removed, and placed on the shore.

Photo 43 - Log-booms on shore after removal from water

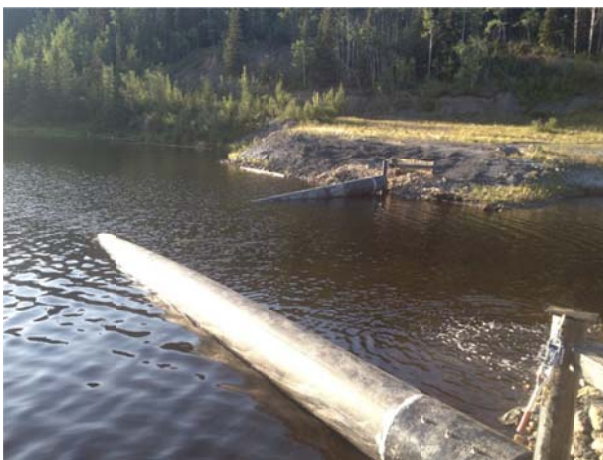
Photo 44 - Log-booms in place showing settlement in the water

- Monitor floating depth of the pipe to record freeboard from the water to the top of the pipe. This will allow an assessment of the degree of saturation of the flotation foam or whether the end cap seals are water tight.

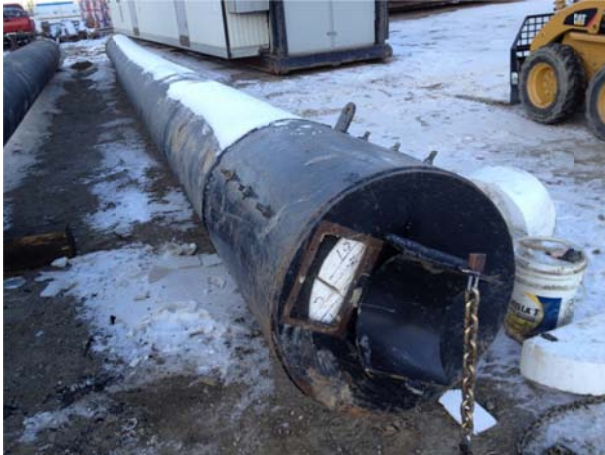
Photo 46 – Flotation foam installed in pipes

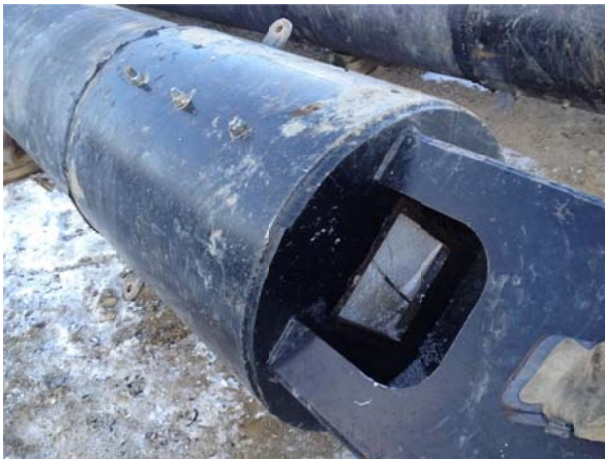
Photo 49 - Foam installed in pipe and end cap installed
