Re: EBA Engineering Report “Mount Nansen Instrumentation Inspections and Installation” (November 2012)

MOUNT NANSEN INSTRUMENTATION INSPECTIONS AND INSTALLATION

REPORT

NOVEMBER 2012
ISSUED FOR USE
EBA FILE: W23101555

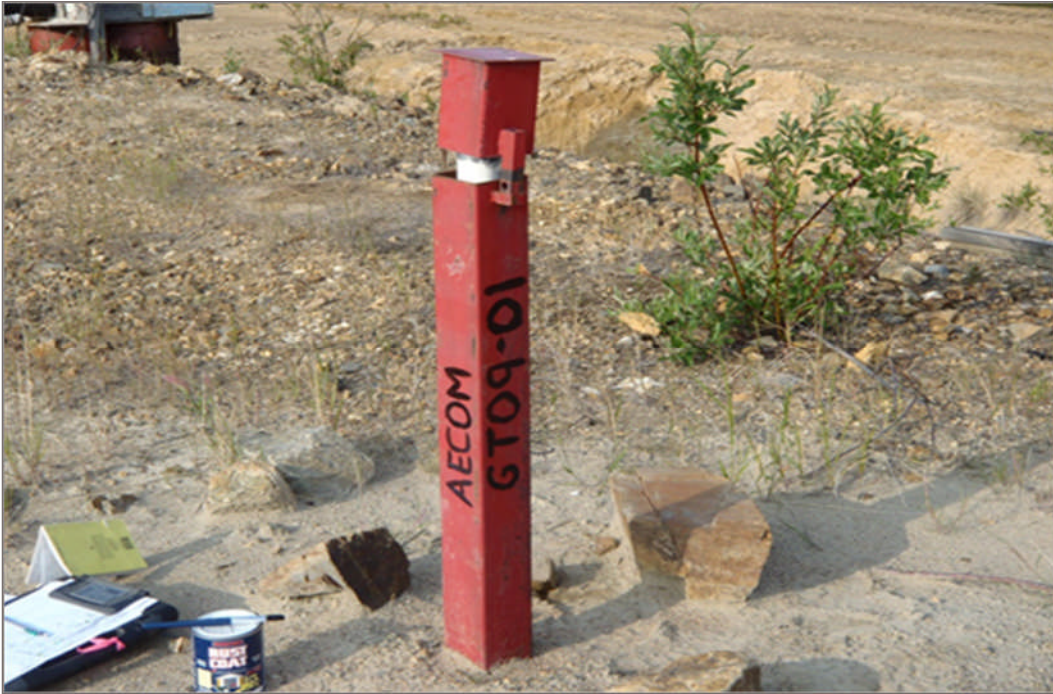
Photo 1: Example of a labelled borehole casing (July 18, 2012)

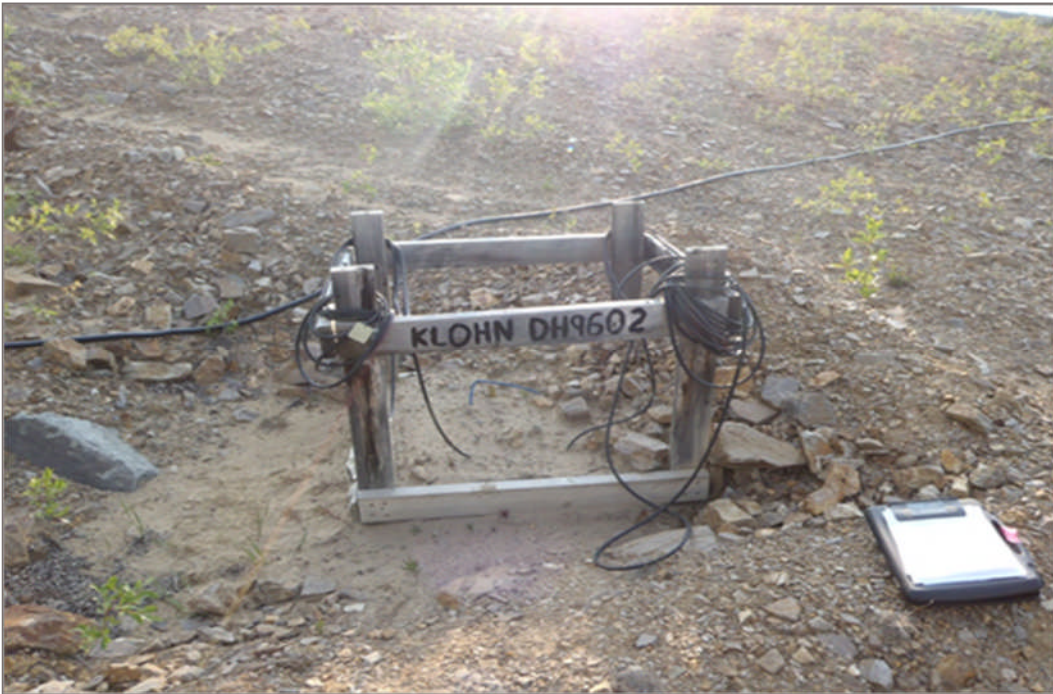
Photo 2: Example of a labelled wooden frame (July 18, 2012)

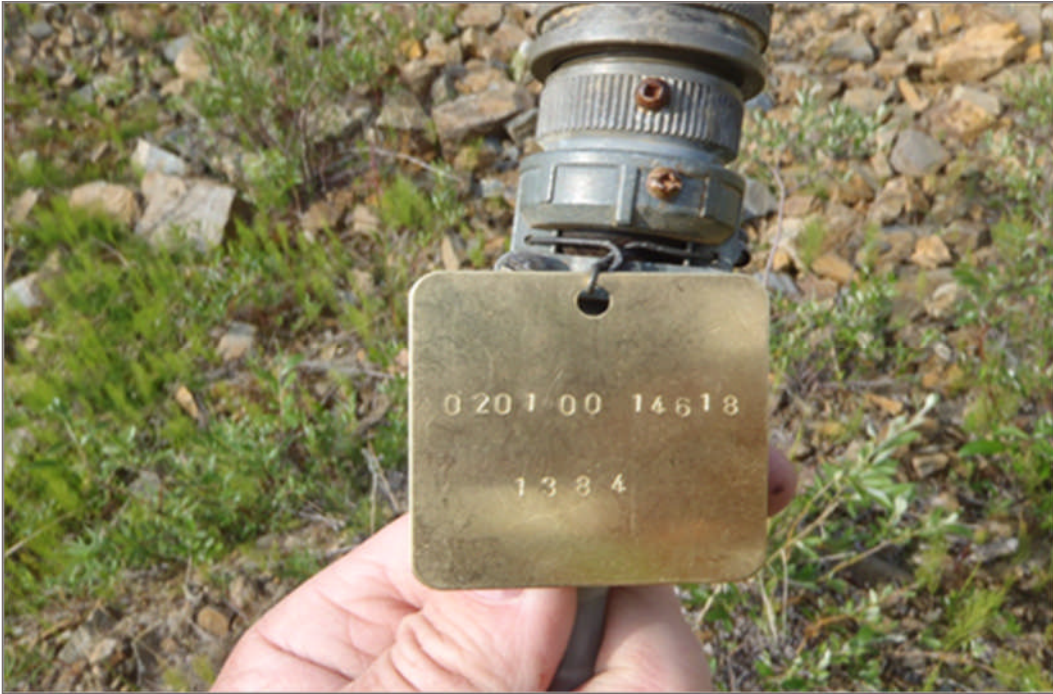
Photo 3: Example of a thermistor cable connector labeled with a brass tag and stamped with the consultant's project number (top) and the individual instrument number (bottom), July 18, 2012

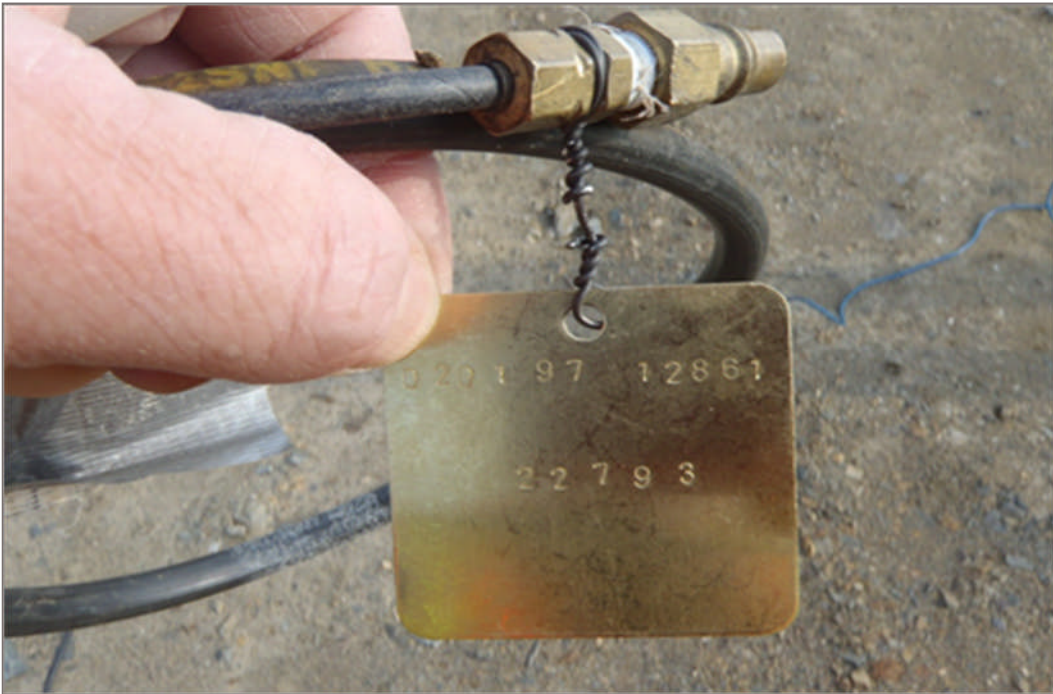
Photo 4: Example of a pneumatic piezometer cable connector labeled with a brass tag and stamped with the consultant's project number (top) and the individual instrument number (bottom), July 18, 2012

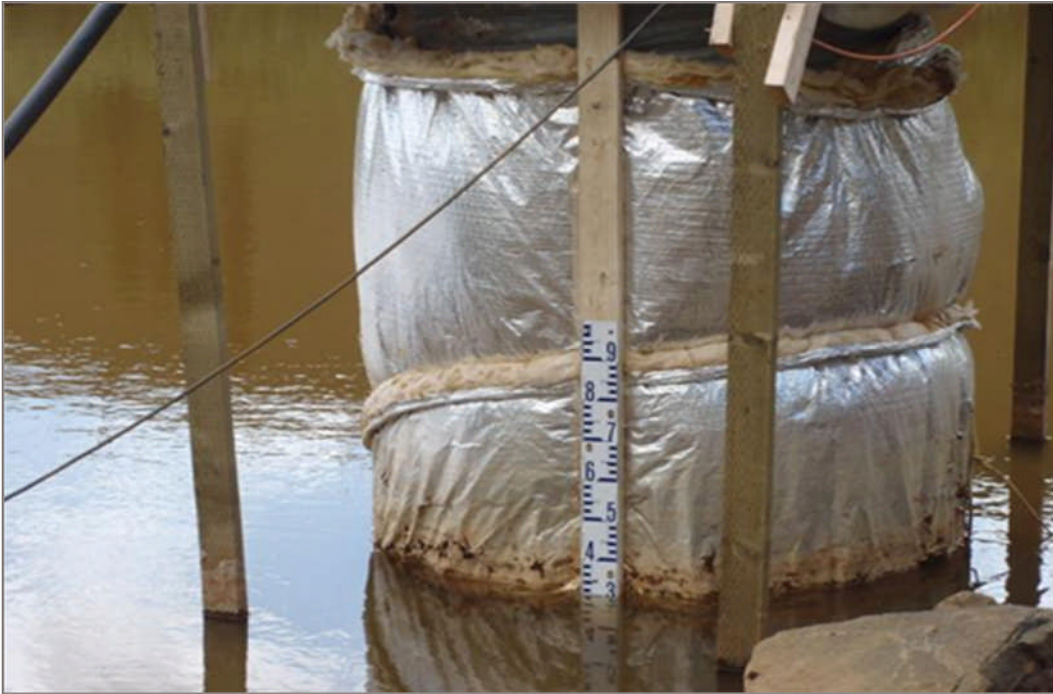
At the request of AAM the one metre staff gauge installed during the scoping visit to Mount Nansen was re-installed on the culvert supporting the pump house on July 18, 2012 (Photograph 5). The gauge was mounted on a two by four inch timber that was attached to the culvert by two bolts and secured with nuts and washers on the inside of the culvert. Copper pipe spacers were used between the culvert and the two by four inch timber to prevent squashing the insulation wrapped around the culvert which may loosen over time. The staff gauge needs to be surveyed to establish an elevation of the gauge. The staff gauge can easily be read with the naked eye to the nearest centimetre from the edge of the seepage pond. The distance between the top of the metal gauge and the top of the two by four inch timber is 0.801 m. Information about the type of staff gauge installed is provided in Appendix B.

Photo 5: Re-installed Staff Gauge in the Seepage Pond. Installed July 18, 2012

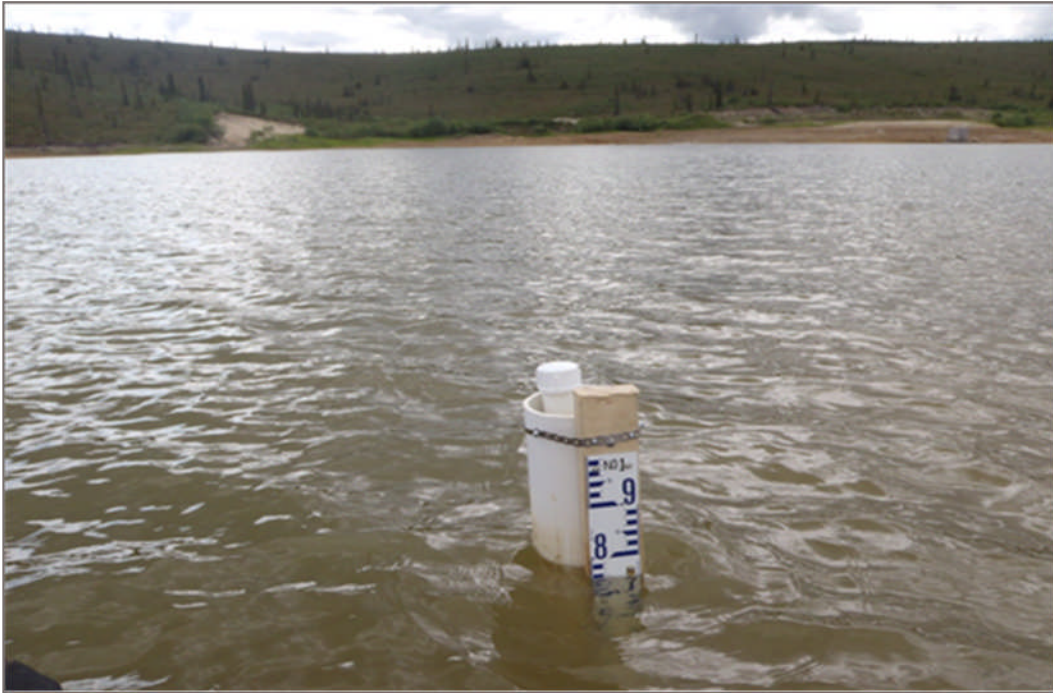
The two one metre staff gauges that were installed in the tailings pond in May and later failed, could not be found in July using the boat that was taken to site as the water was too turbid. The field crew tried unsuccessfully to ‘fish’ for the staff gauges at the bottom of tailings pond. Two new staff gauges were installed on one of the water monitoring wells in the east end of the tailings pond. The casing of the well was not labelled but is believed to be MW09-05/06. Two staff gauges were attached to a length of two by four inch timber which was driven into the tailings with a sledgehammer and then secured to the well casing with a nut and bolt and a modified hose clamp (Photograph 6). The upper gauge has been labelled “No. 1” and the lower gauge (almost entirely submerged in the tailings) has been labelled “No. 2”. The distance between the top of the metal gauge and the top of the timber is 0.106 m. The staff gauge needs to be surveyed to establish an elevation of the gauge. The staff gauge can be read to the nearest centimetre from the closest shoreline of the pond using either binoculars or a digital camera with a zoom feature. If the water in the tailings pond is not surrounding the gauge and a gauge reading cannot be obtained then one of two methods can be used to obtain a reading.

Photo 6: New staff Gauge Installed in the Tailings Pond, attached to a Monitoring Well (July 18, 2012)

- Method 1: The tailings around the bottom of the gauge can be shovelled away from the staff gauge to see if there is any standing water around the gauge. If there is standing water around the gauge then a water elevation can be read from the gauge.
- Method 2: A surveyed water elevation can be obtained using a rod and level and two people. This will allow the water elevation to be calculated against the known elevation of the staff gauge. More details about this method are provided in Appendix C.
