Mount Nansen Mine Site, Yukon

Mill Area Geochemical Characterization
Summary of 2010 Field Investigations

Lorax Environmental Services Ltd.

December 2010

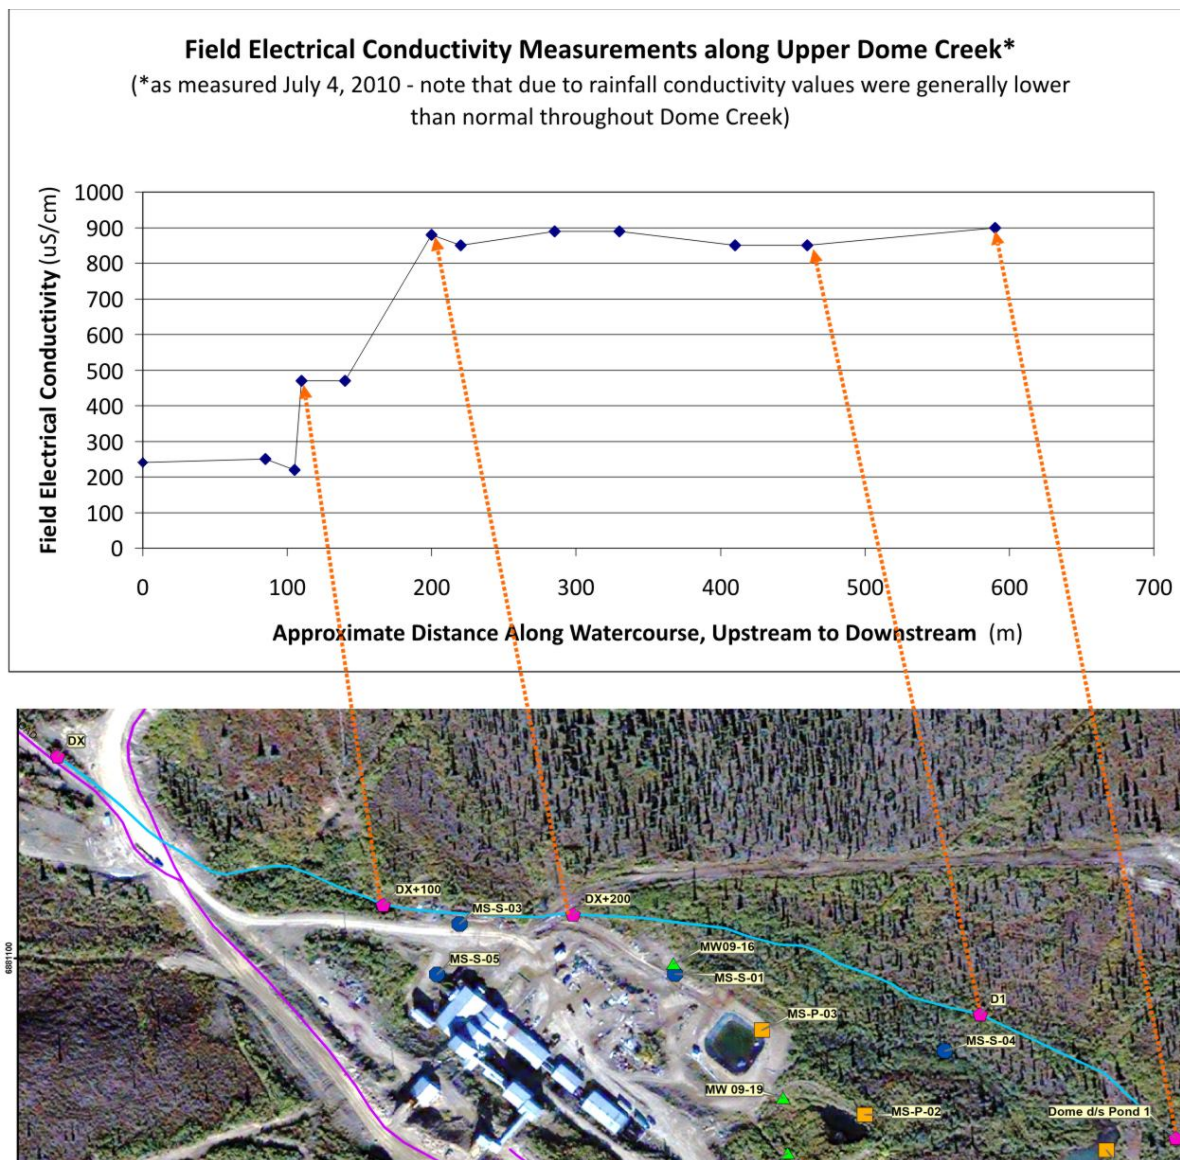
Figure 3-3. Field electrical conductivity measurements along upper Dome Creek on July 4, 2010.

Two major electrical conductivity inflections were identified. Figure 3-3 illustrates the results along with a site photo cross-referencing the location of certain key readings. As can be seen, conductivity rises to elevated levels just up-gradient of the main mill area. From these results, interim points at approximately 110m and 200m along the reach (stations DX+100 and DX+200) were selected for detailed water quality sampling the following day.

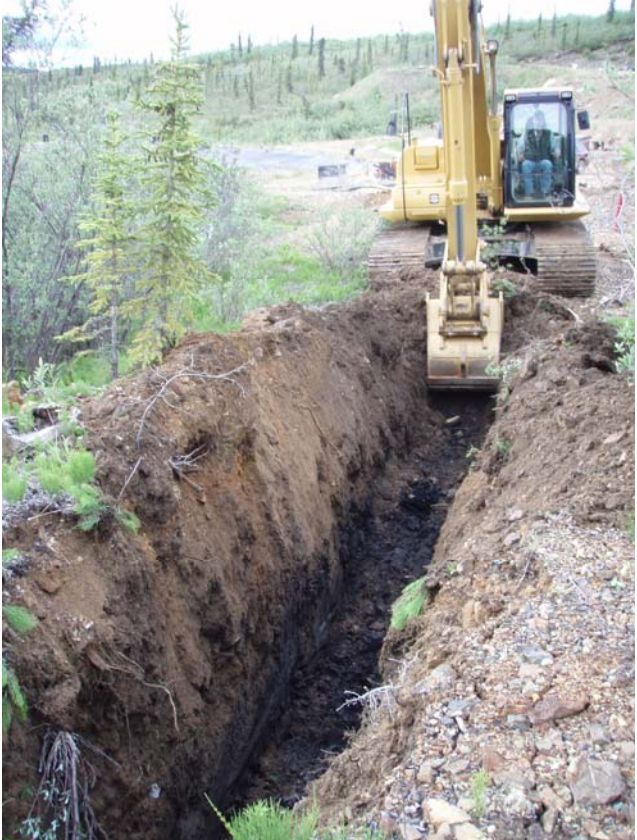
Photo No. 567	Date 4-Jul-10

Taken From N. end of Tr.	Looking Southwest	
Description Excavator and trench MS-10-01

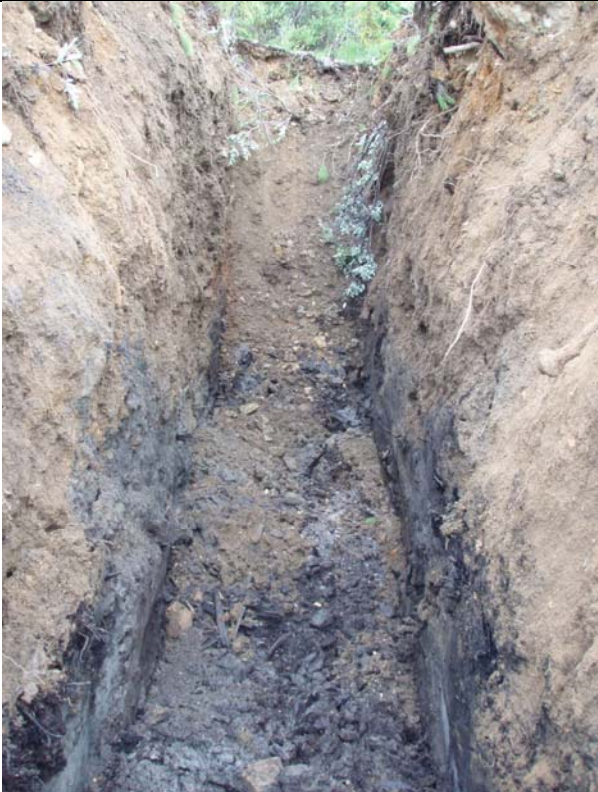
Photo No. 570	Date 4-Jul-10

Taken From Mid-trench	Looking Northeast		
Description Trench MS-10-01, looking to northeast

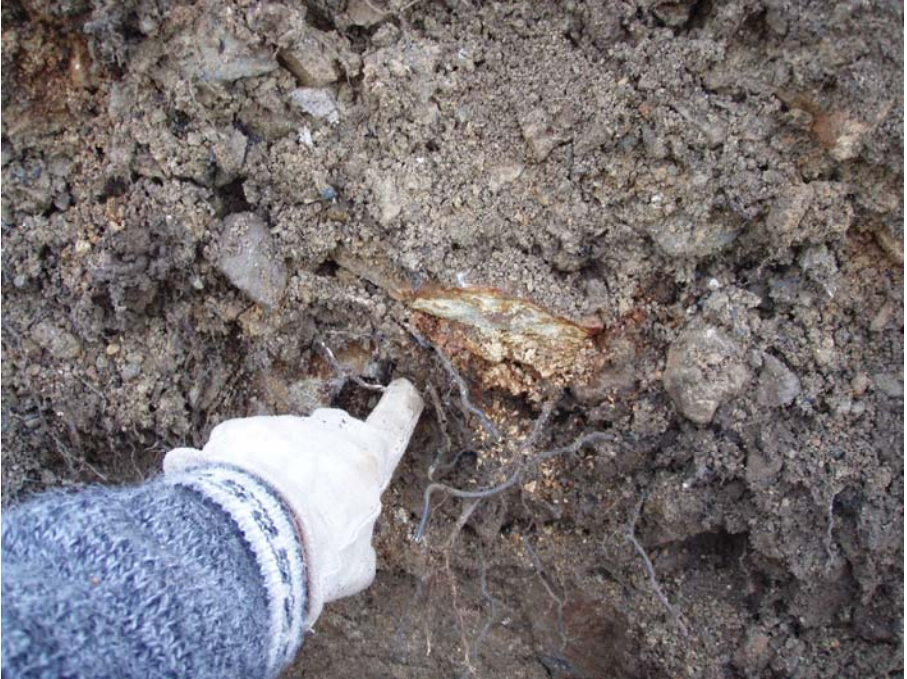
Photo No. 572	Date 4-Jul-10

Taken From Mid-trench	Looking	
Description Trench MS-10-01, Stn 0+06m / 0.8m depth. Evidence of localized leaching.

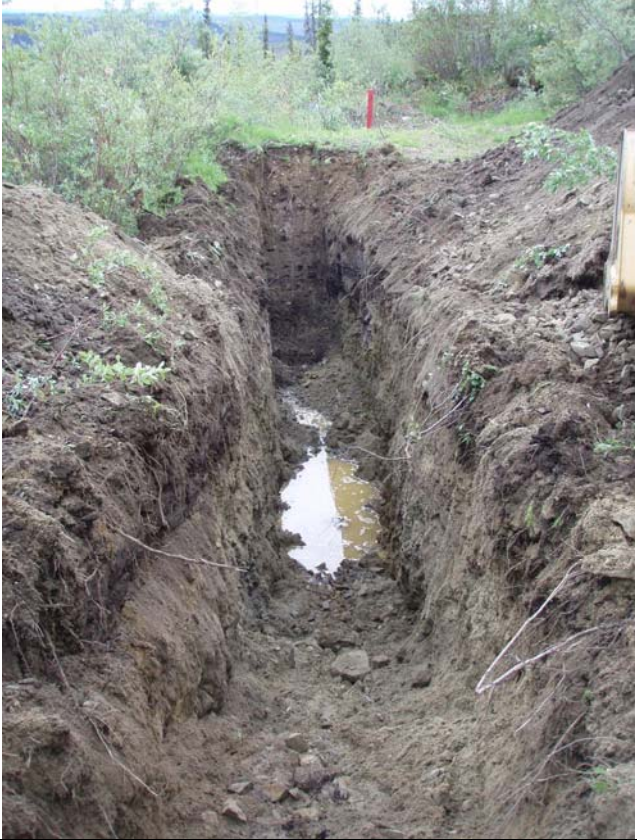
Photo No. 578	Date 4-Jul-10

Taken From NW end of Tr.	Looking Southeast	
Description Trench MS-10-02A

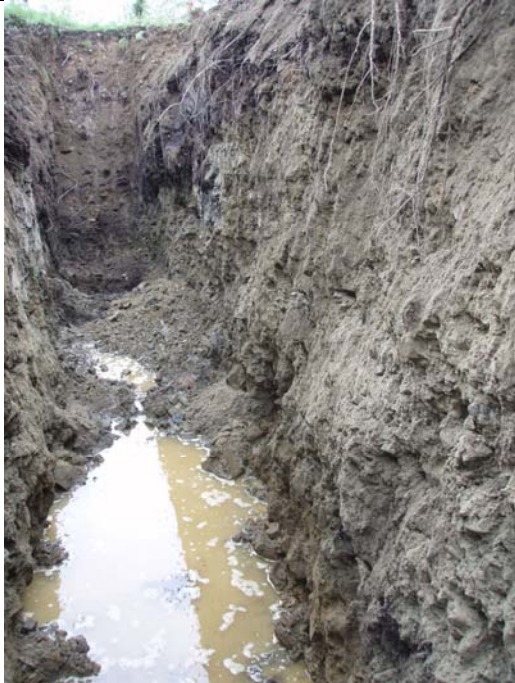
Photo No. 577	Date 4-Jul-10

Taken From Mid-trench	Looking Southeast	
Description Trench MS-10-02A, south wall and ponded seepage

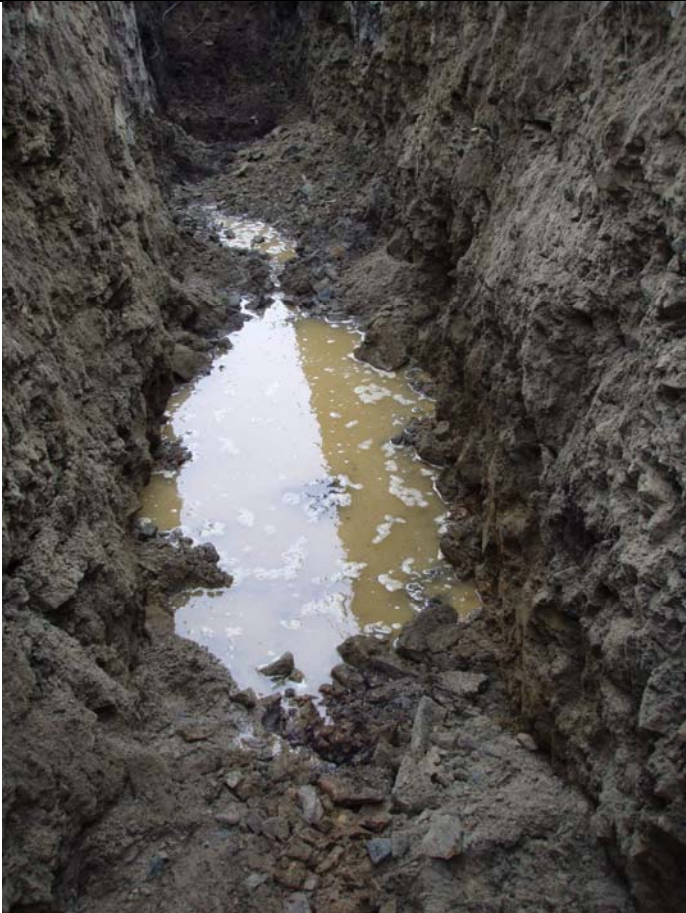
Photo No. 576	Date 4-Jul-10

Taken From Mid-trench	Looking Southeast	
Description Trench MS-10-02A, trench floor and ponded seepage

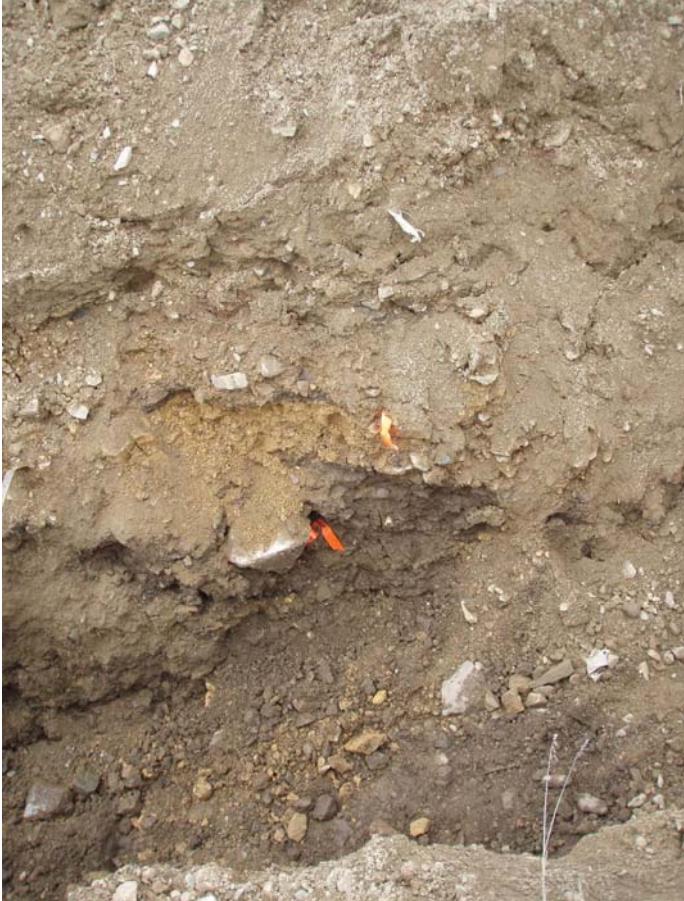
Photo No. 585	Date 4-Jul-10

Taken From Mid-trench	Looking Northeast	
Description Trench MS-10-03, northeast wall showing site of sampling

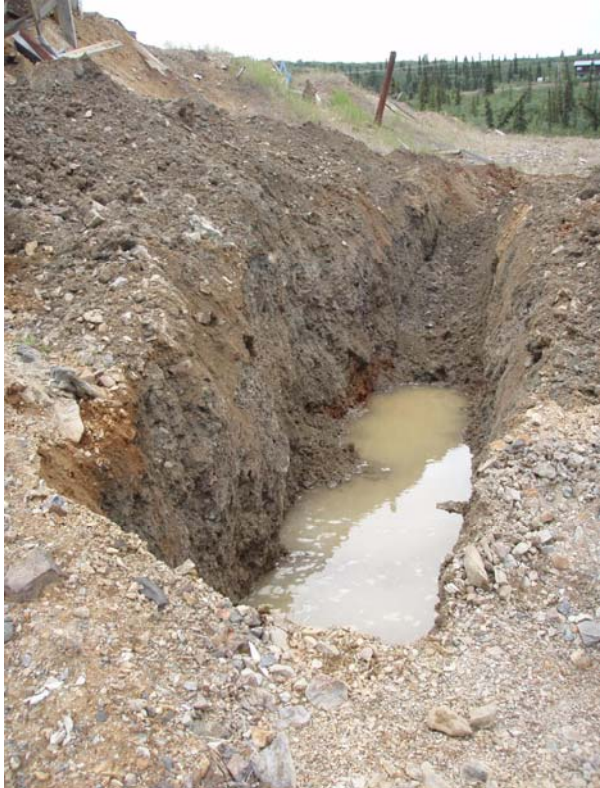
Photo No. 586	Date 4-Jul-10

Taken From SE end of Tr.	Looking Northwest	
Description Trench MS-10-04

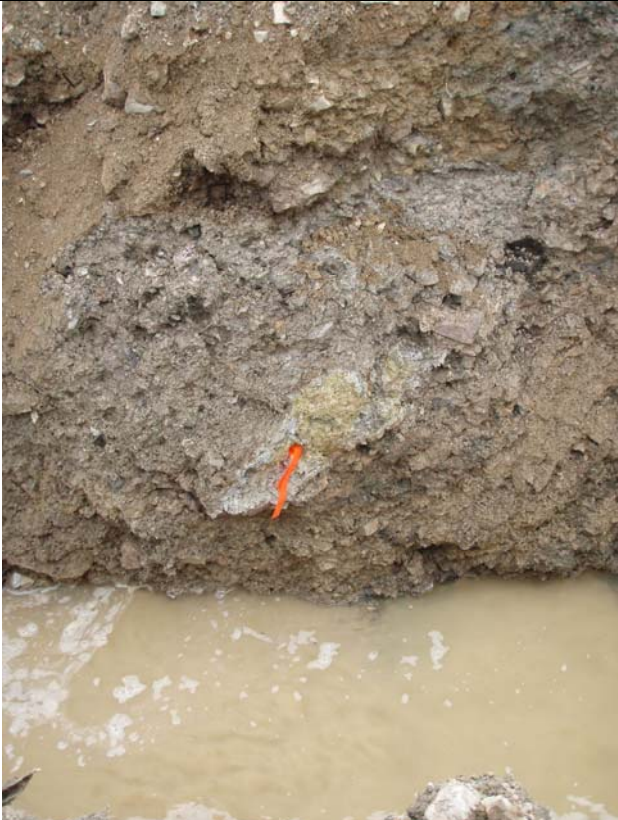
Photo No. 587	Date 4-Jul-10

Taken From Mid-trench	Looking Northeast	
Description Trench MS-10-04, area of sample MS-10-04A

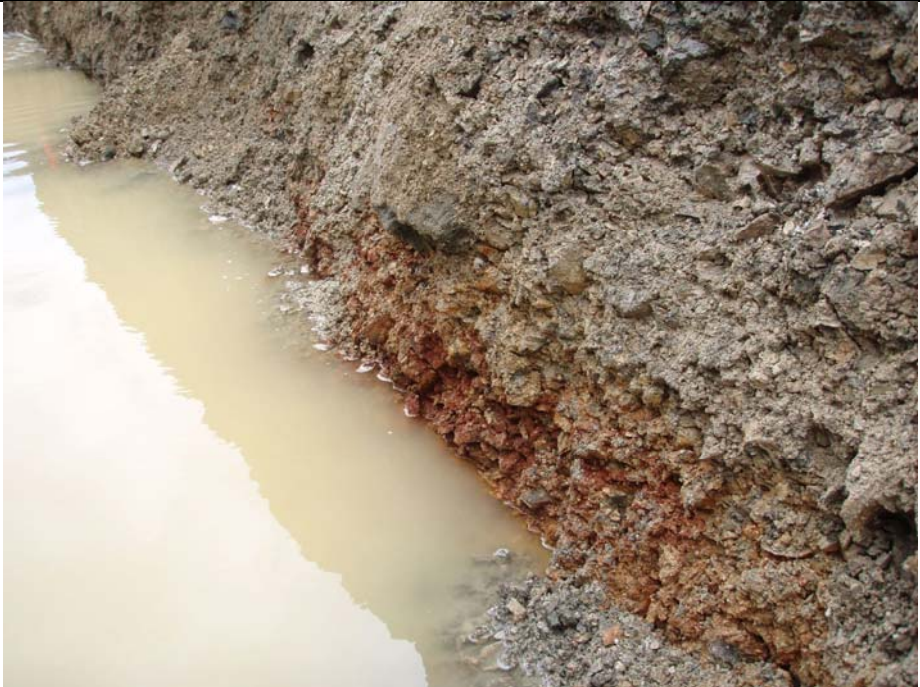
Photo No. 588	Date 4-Jul-10

Water intercepted in trench, pH 6.75 (check sample yielded 6.84pH), conductivity 1740 uS/cm. This water appears to form part of seep MS-S-01, which daylights approximately 15m downgradient and to south. Red-stained seepage line approximately 2m below surface.

Taken From Mid-trench	Looking Northeast	
Description Trench MS-10-04, dark red-stained horizon indicating seepage line. Approximately 2m below ground surface.

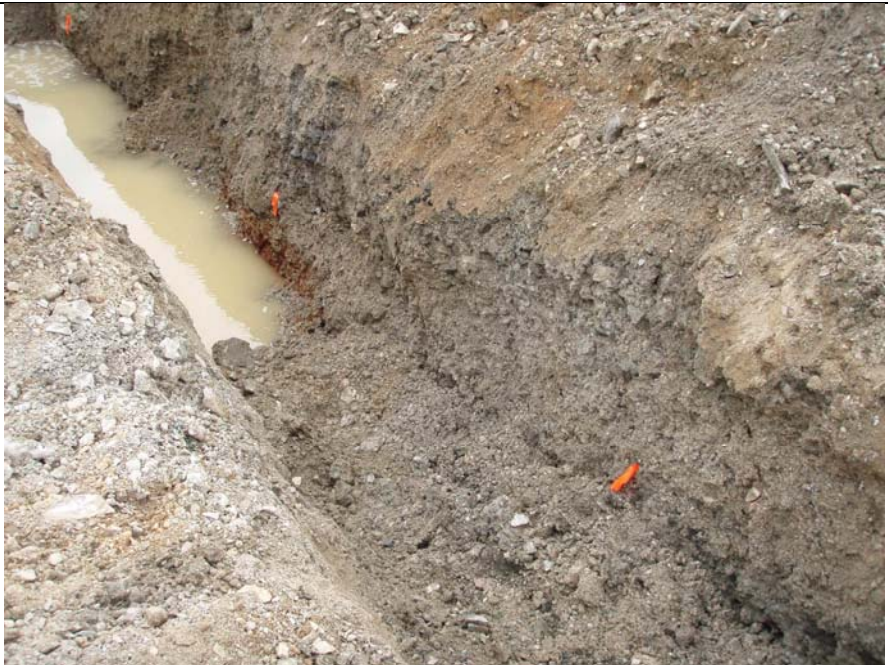
Photo No. 589	Date 4-Jul-10

Taken From Mid-trench	Looking Southeast	
Description Trench MS-10-04, area of sample MS-10-04B (sample taken between the two orange flags in foreground)

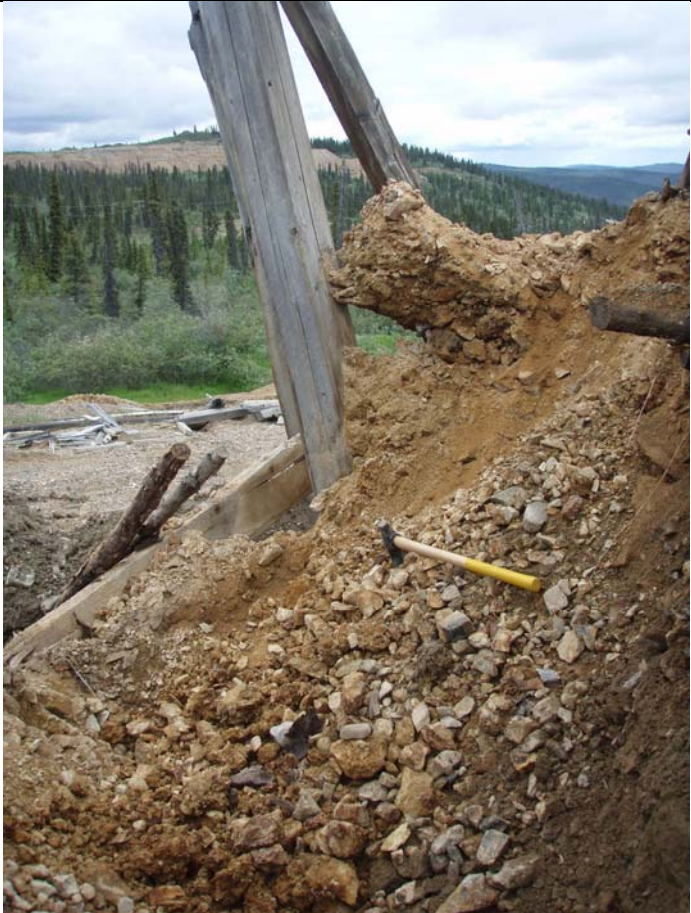
Photo No. 590	Date 4-Jul-10

Taken From E end of Tr.	Looking East	
Description Trench MS-10-05, possible area of old ore loadout structure. Area of sample MS-10-05A. Appears to be area of ore spillage extending to north and south, 15m total extent, 1-2m deep veneer.

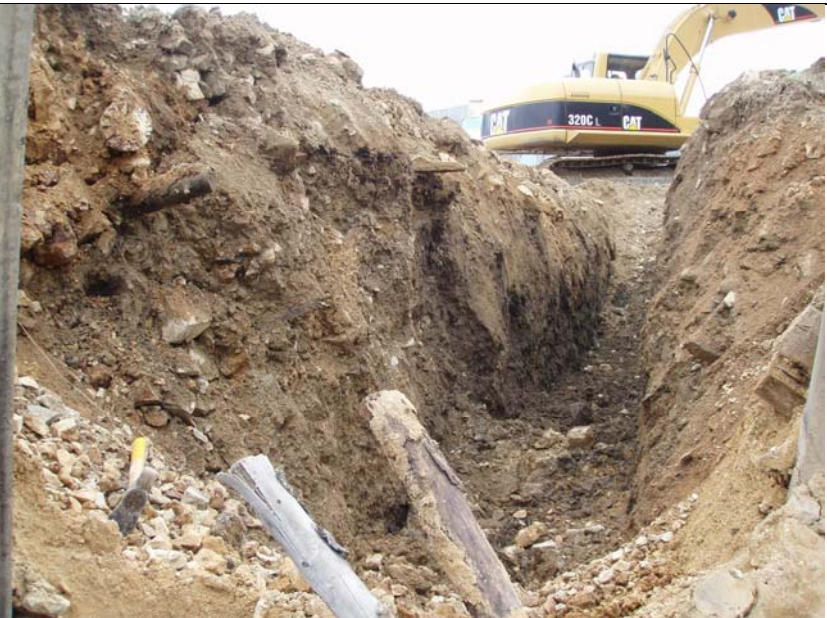
Photo No. 591	Date 4-Jul-10

Taken From E. end of trench	Looking West	
Description Trench MS-10-05, from 1m off of east end of trench. Ore zone in foreground.

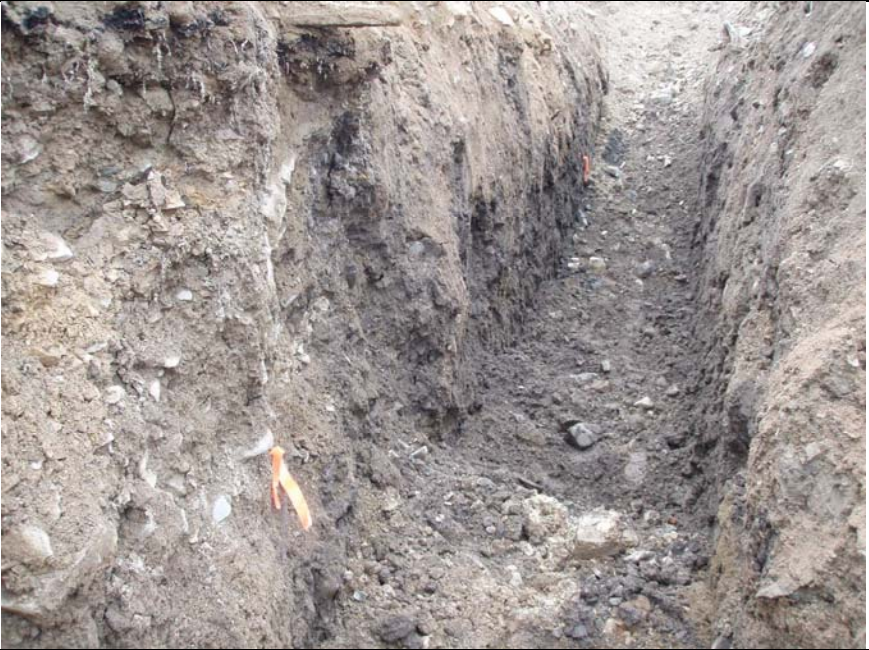
Photo No. 592	Date 4-Jul-10

Taken From Mid-trench	Looking West	
Description Trench MS-10-05, area of sample MS-10-05B (between orange flags on trench wall).

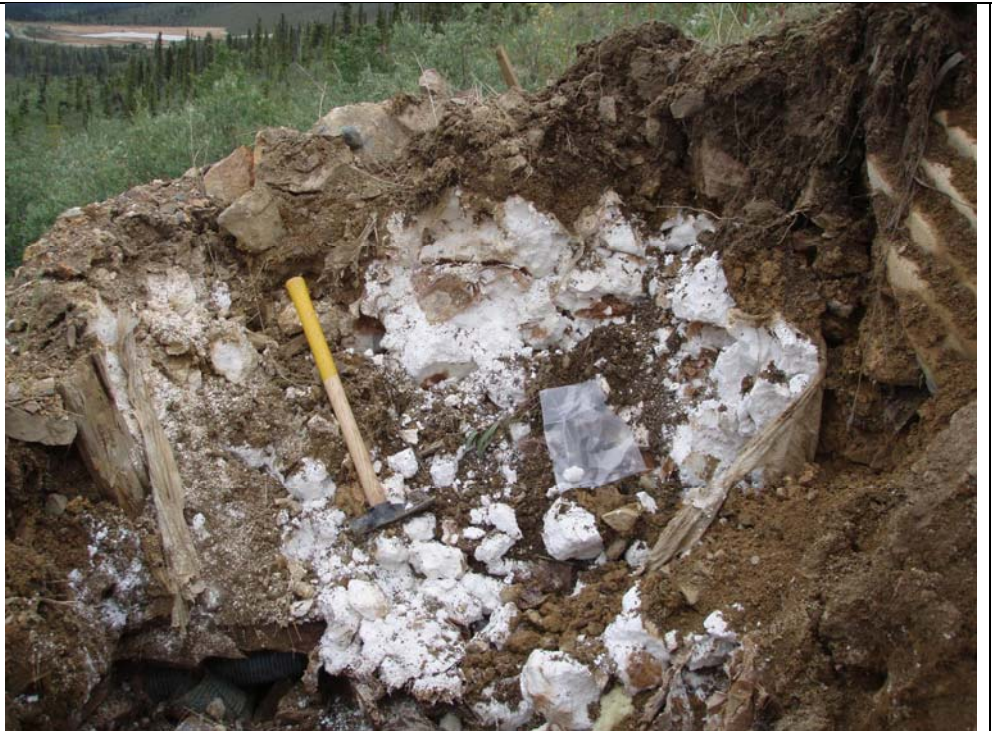
Granular white product, originating from ~25kg paper sacks and possibly palletized with plastic wrap encountered at southeast end (crest of platform). Small amount of product was solubilized with deionized water to yield pH of 9.5 and conductivity of 8470 uS/cm.

Photo No. 595	Date 4-Jul-10
Taken From ESE end of trench	Looking Southeast
<p>Description Trench MS-10-06, white product at ESE end of trench (thought to be ammonium nitrate). Product appears to have been in paper sacks, and possibly palletized with plastic wrap. Product shown in sample bag was solubilized with deionized water to yield pH of 9.5 and conductivity of 8470 uS/cm.</p>

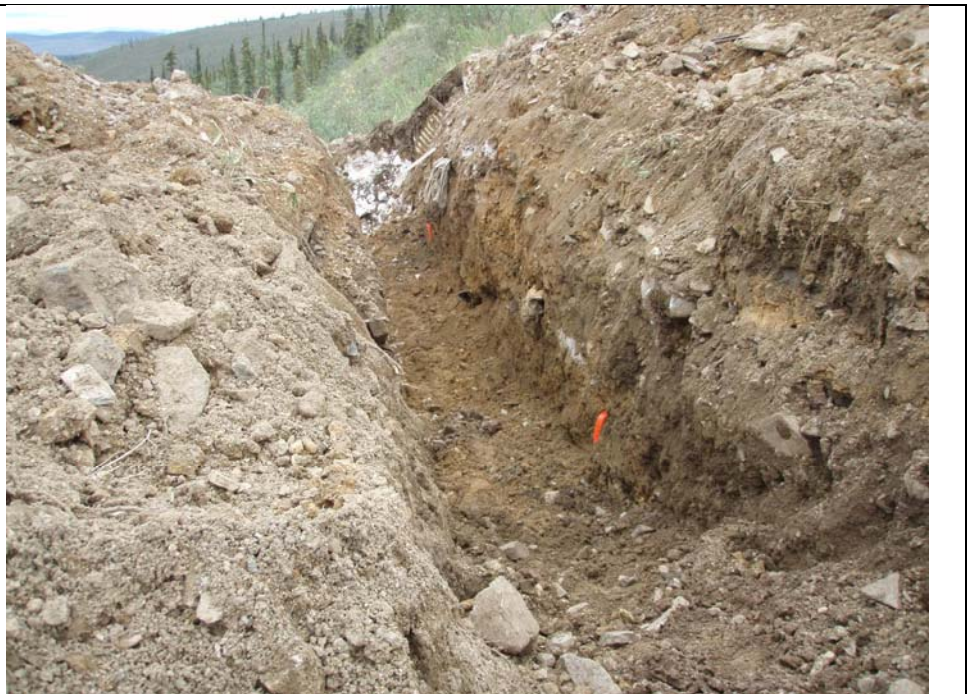
Photo No. 596	Date 4-Jul-10
Taken From NW end of trench	Looking Southeast
<p>Description Trench MS-10-06, showing area of sample MS-10-06 (between orange flags on trench wall).</p>

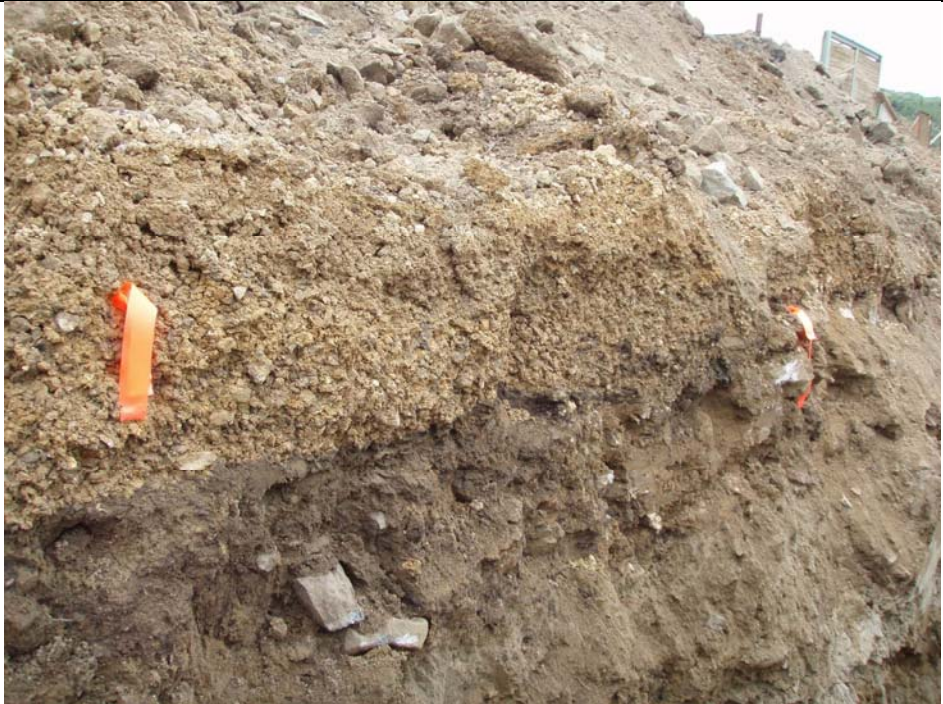
Photo No. 597	Date 4-Jul-10

Trench profile clearly shows an approximately 0.4m veneer of oxidized clayey rubble over main fill material in trench – veneer possibly spilled crushed ore that was locally graded over running surface of platform (*ICP analyses confirm, indicating 3600 ppb Au in veneer material, versus 20 ppb Au in underlying fill*). It was noted that this veneer material extends over much of the Crusher platform and on slope down to Mill platform.

Taken From SE end of trench	Looking West	
Description Trench MS-10-07. close-up of approximately 0.4m thick veneer of material (likely crushed ore) overlying main platform fill. Area of sample MS-10-07A shown between two orange flags.

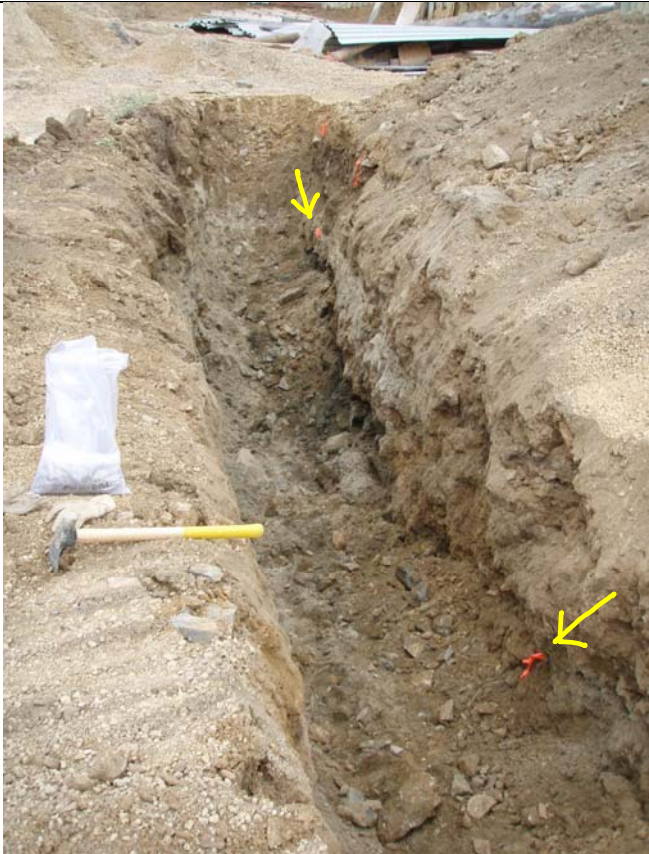
Photo No. 598	Date 4-Jul-10

Taken From NW end of trench	Looking Southeast	
Description Trench MS-10-07, showing area of sample MS-10-07B (between yellow arrows). Area of sample MS-10-07A is seen above the yellow arrow at the far end of the trench.

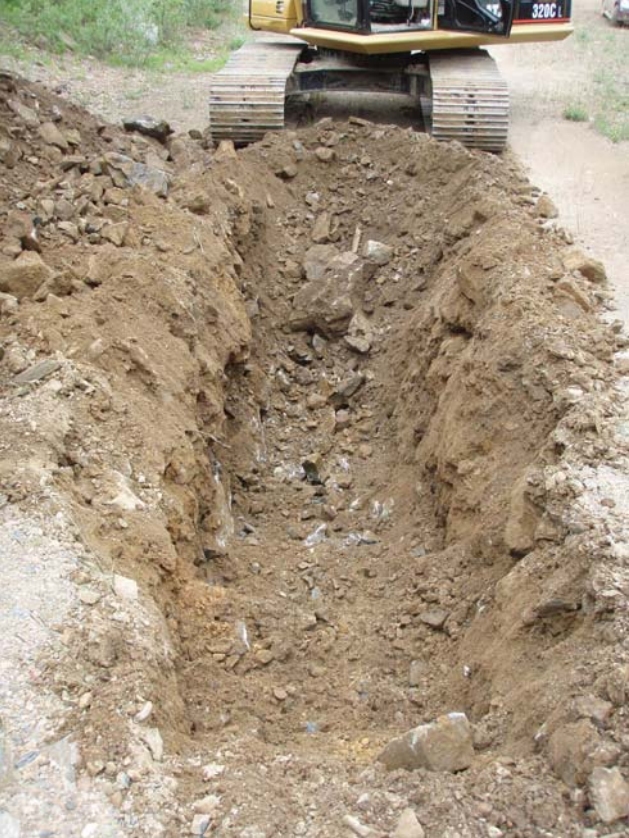
Photo No. 599	Date 4-Jul-10

Taken From NE end of trench	Looking Southwest	
Description Trench MS-10-08.

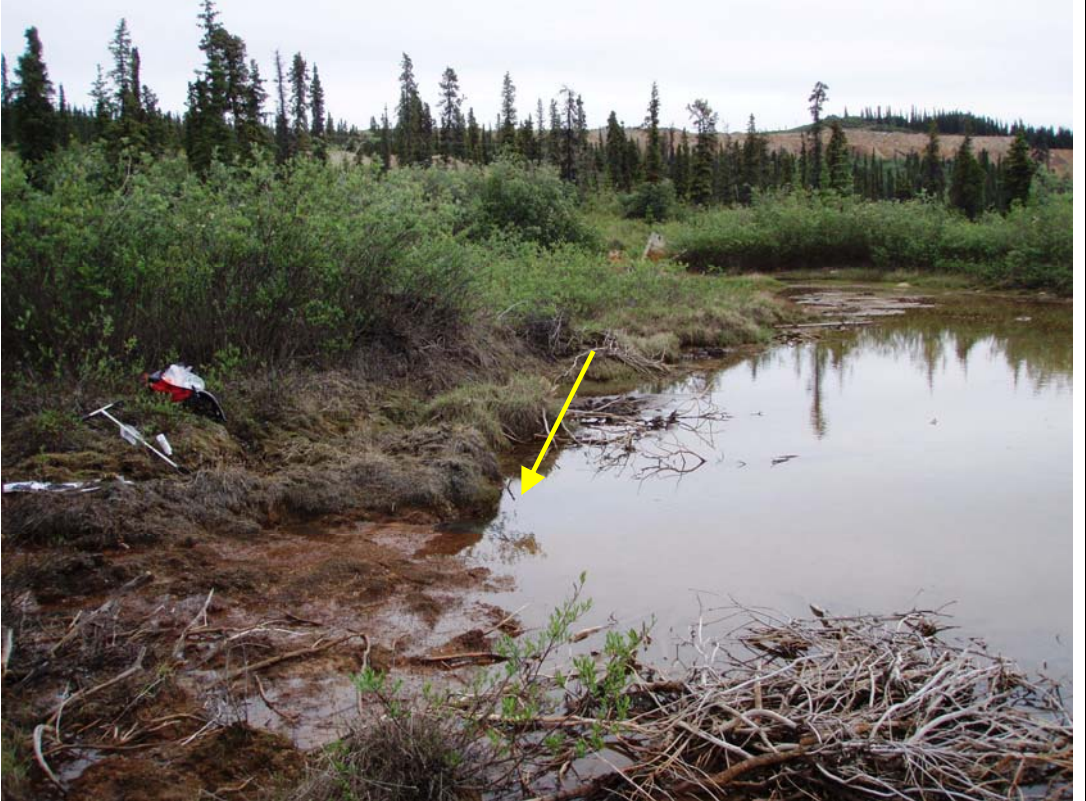
Photo No. 617	Date 5-Jul-10

Taken From Pond #1 old shack	Looking Northeast	
Description Area of Pond Sediment Sample Site MS-10-09 (yellow arrow).

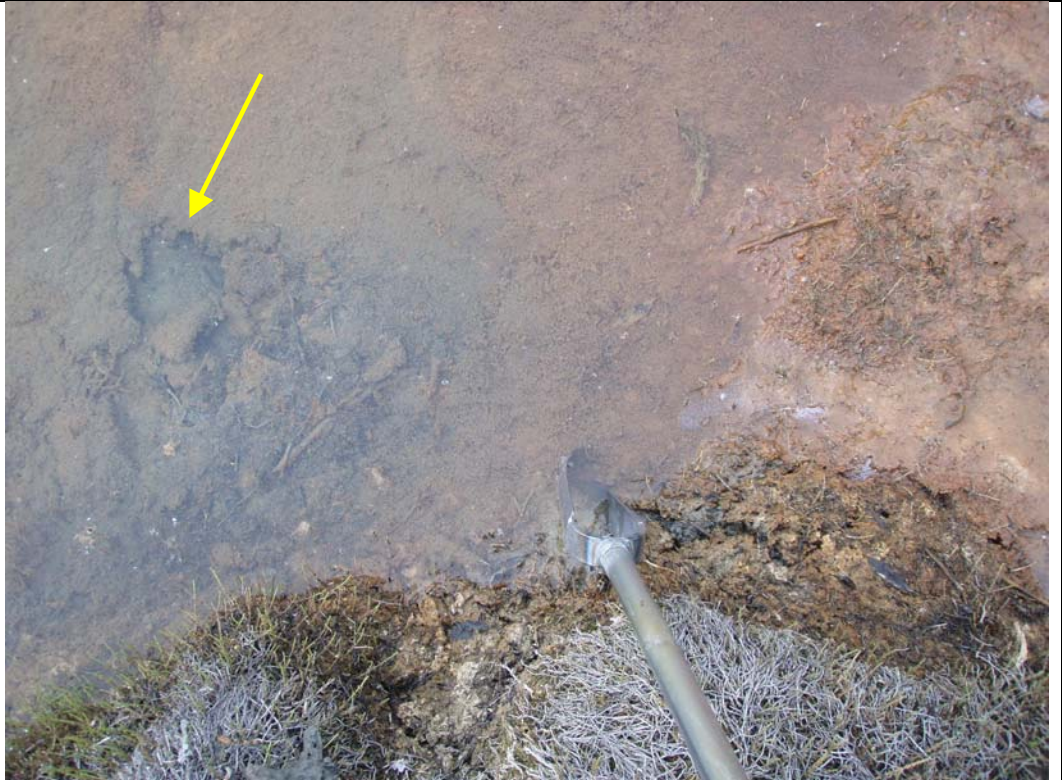
Photo No. 614	Date 5-Jul-10

Taken From Edge of Pond #1	Looking down	
Description Pond Sediment Sample Site MS-10-09 (yellow arrow) showing thin surficial tan-orange mud underlain by grey sediment.

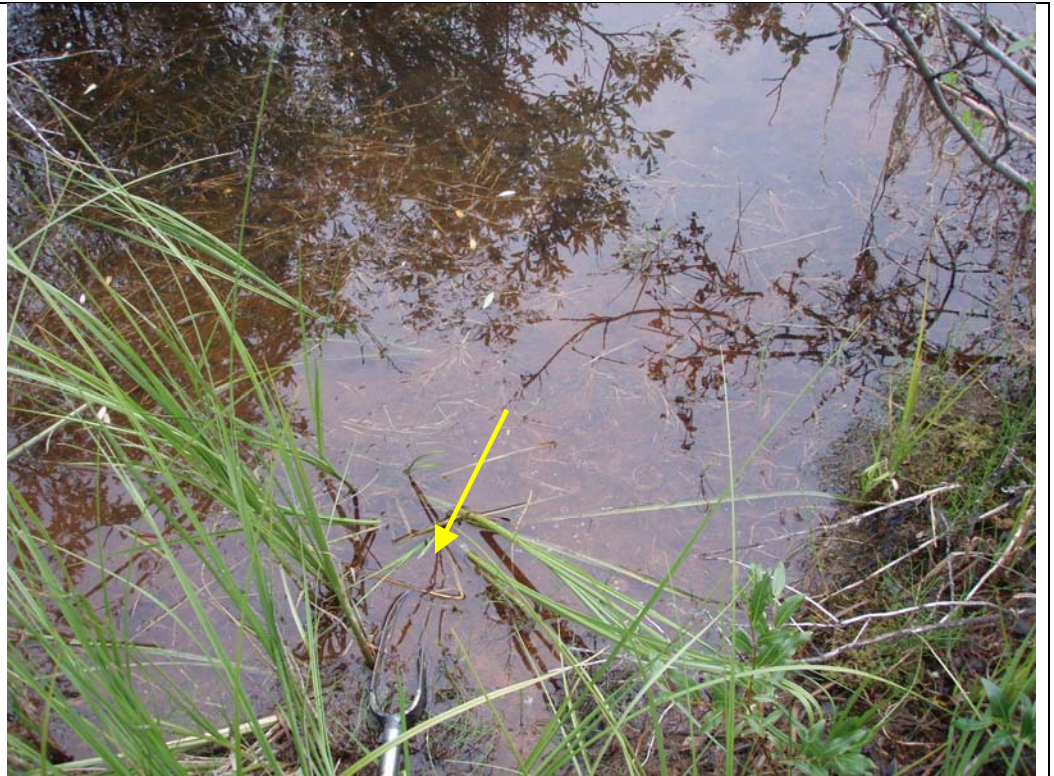
Photo No. 620	Date 5-Jul-10
Taken From Edge of Pond #2	Looking down
Description Area of Pond Sediment Sample Site MS-10-10 (yellow arrow).

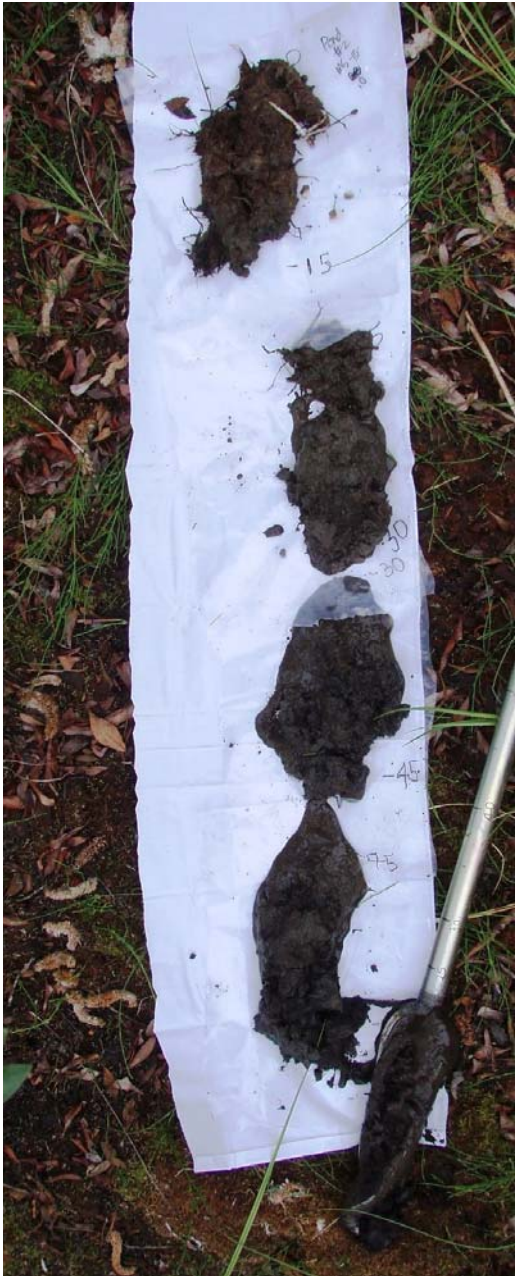
Photo No. 624	Date 5-Jul-10

cm 0	<p>0-15cm: sandy silt and organic debris, minor rust-coloured precipitate</p>
Taken From NA	Looking NA		15	
Description Pond Sediment Sample Site MS-10-10 (Pond #2), core profile and description.			75	<p>75cm: End of hole, unable to pull auger from any deeper. Last core section shows sediments continue.</p>

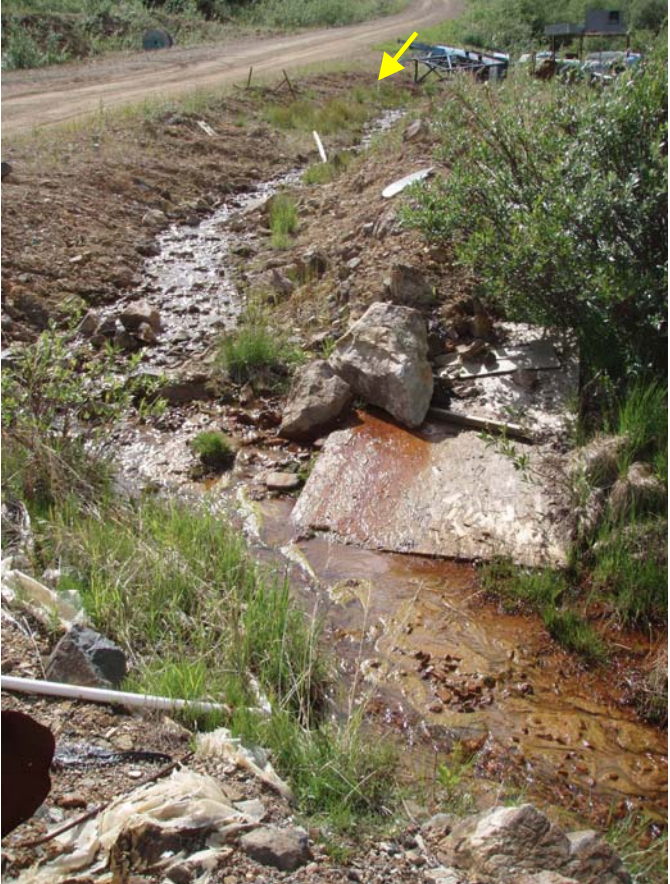
Photo No. 564	Date 4-Jul-10

Taken From Waypoint 435	Looking West	
<p>Description Channel draining seep MS-S-03, immediately before flowing under a scrap metal pile (photo 563). Seep daylights at location shown by yellow arrow.</p>

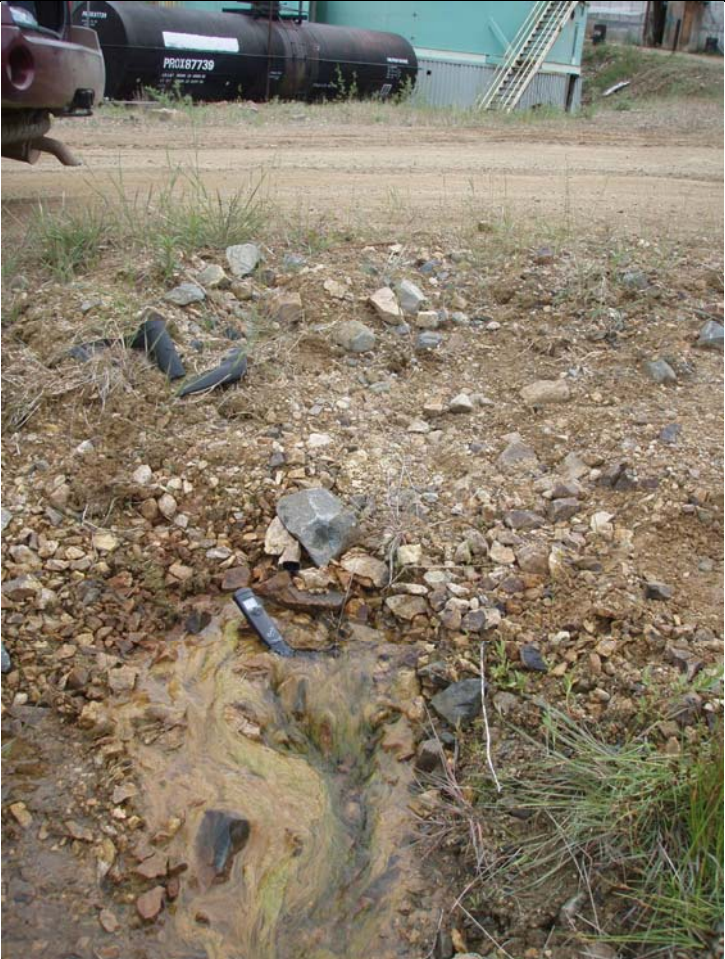
Photo No. 583	Date 4-Jul-10

Taken From MS-S-03	Looking Southwest	
Description Seep MS-S-03, daylighting on shoulder of access road to Mill, with distinctive stringy gelatinous algae.

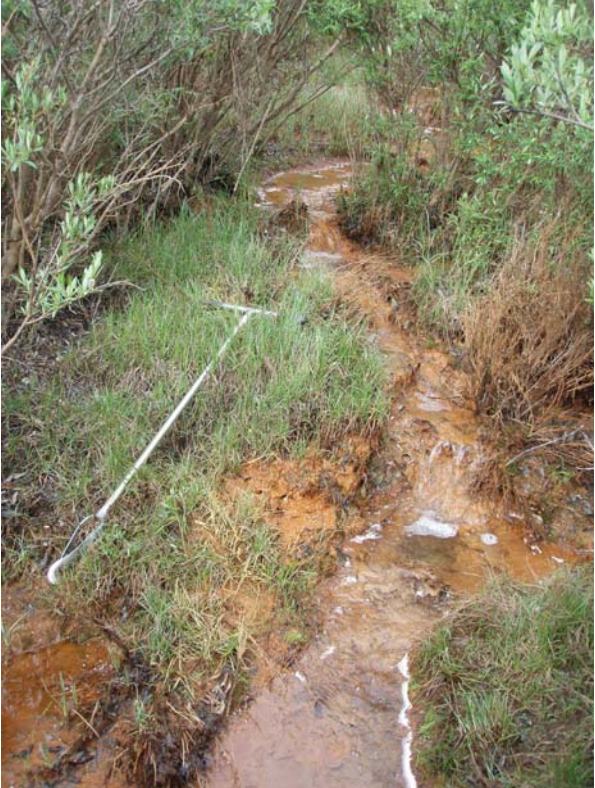
Photo No. 619	Date 5-Jul-10

Red-stained high-volume flow approximately 25m southwest of main Dome Creek channel (photo 619). Upstream evidence of high flows and/or over-ice flows (photo 582), as demonstrated by substantial deposits of orange precipitate overlying ground vegetation.

Taken From MS-S-04	Looking Northwest		
Description Seep MS-S-04 sample site.

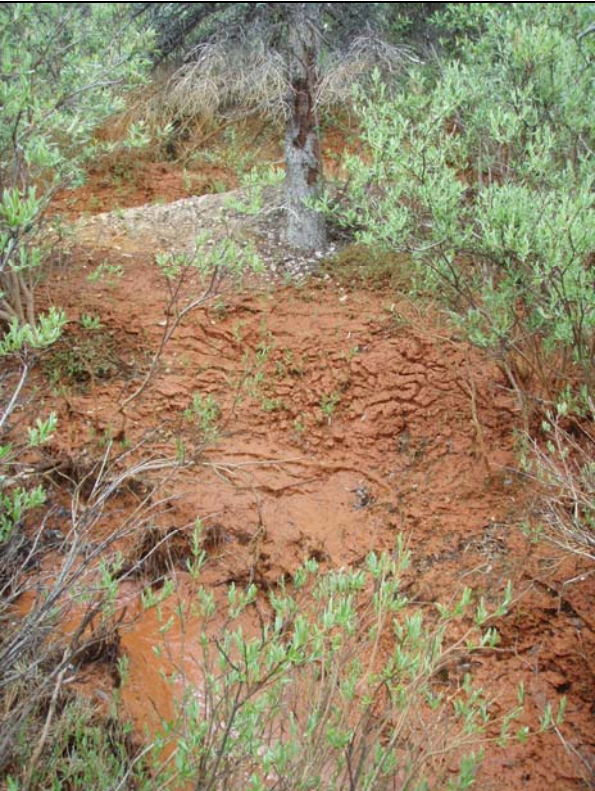
Photo No. 582	Date 4-Jul-10

Taken From Upstream of MS-S-04	Looking Northwest		
Description Terrain upstream of seep MS-S-03, showing extensive orange precipitate overlying ground vegetation – indicating recent deposition, possibly from over-ice flow during winter/spring.

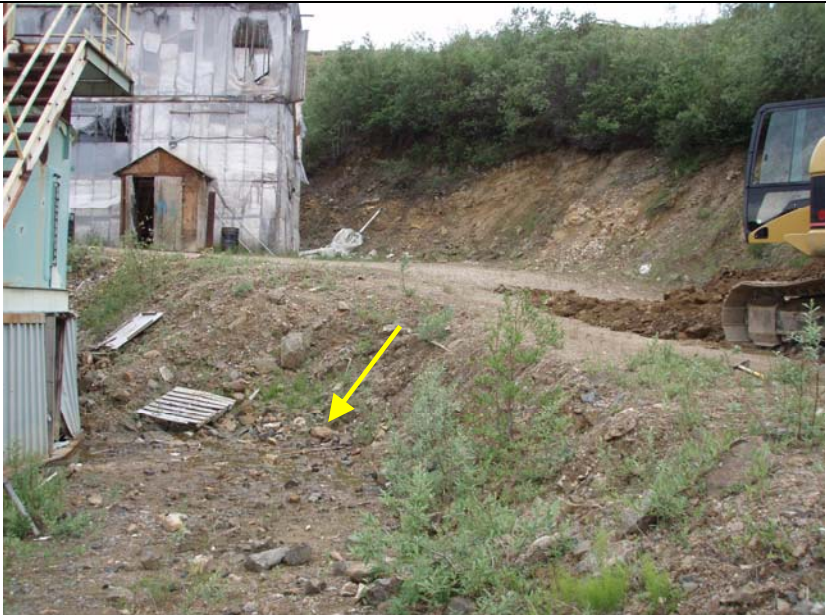
Photo No. 601	Date 4-Jul-10

Taken From Mill Platform adjacent to clarifier/thickener	Looking Southwest	
Description Seep MS-S-05 sample site (yellow arrow). Excavator is completing trench MS-10-08 (dry trench) on extreme right hand side of photo.

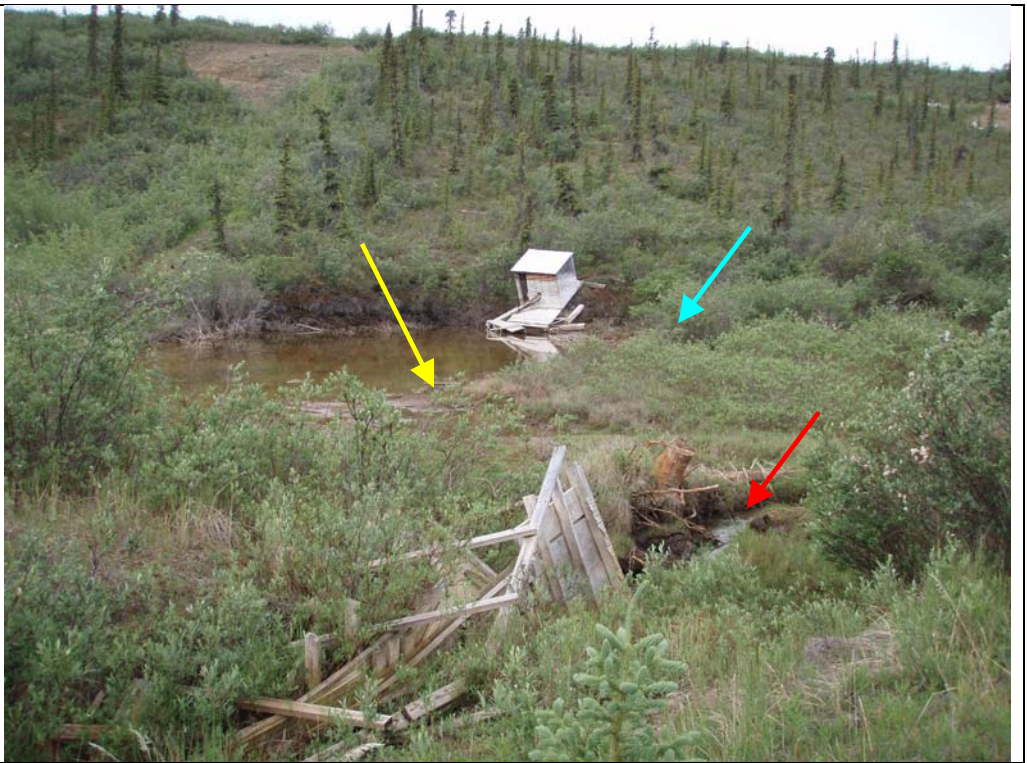
Photo No. 611	Date 5-Jul-10

Taken From 10m Northwest of Dome Creek	Looking Southwest	
<p>Description Pond #1, approximately 250m below mill site. Yellow arrow: location of water sample MS-P-01; Red arrow: Dome Creek, flowing right to left through remnant wooden control structure; Blue arrow: area of tributaries into pond and sediment sample MS-10-09.</p>
