**Government of Yukon, Energy, Mines and Resources
Mount Nansen Tailings Dam
2008 Geotechnical Inspections**

Project No.: 2940 040 00 (4.6.1)

Date: November, 2008

Re: Mount Nansen – 2008 Geotechnical Inspections

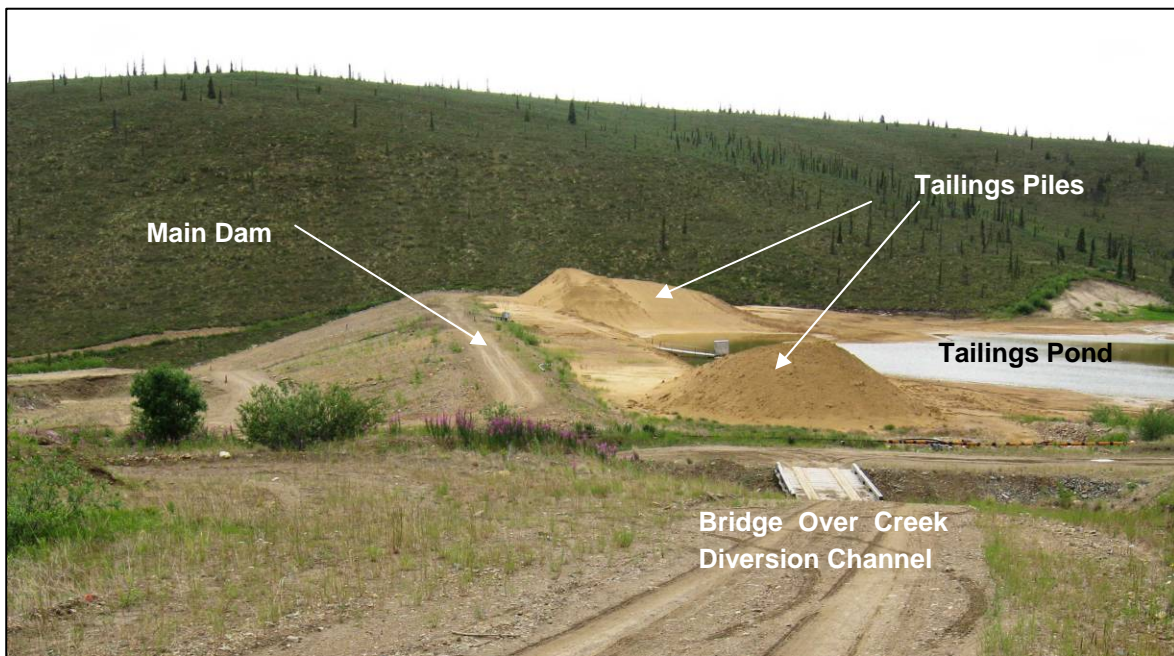
Figure 06 View S at Main tailings Dam From Access Road

Overall, the tailings dam as shown in Figure 06 is in good condition. Also, seen in Figure 06 are piles of tailings sand that were pushed up in the winter of 2008 during additional investigations of the tailings by the Government of Yukon (personal communication, H. Copeland). The tailings pond elevation was surveyed at the time of our inspection and found to be 1096.3 m¹ (Figure 07). This level is considerably lower than previously reported and results in a freeboard of approximately 3 m. The exposed tailings beach is about 25 m wide at its closest point to the upstream edge of the dam (Figure 08) at which point it drops at about 1H:1V into the pond excavated to create the tailings piles at the north and south abutments. The crest is about 5 to 7 m wide with downstream side slopes estimated to be in the order of 3.5 H:1V as seen in Figures 09 and 10.

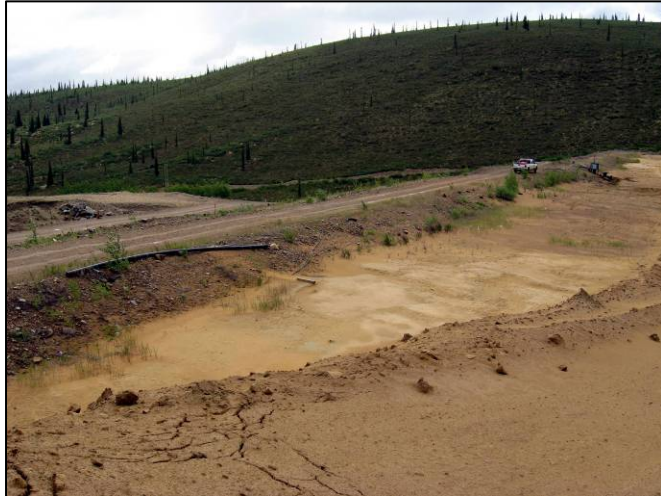
Figure 11 View SE at Main Dam Upstream Slope

The upstream slope from the crest to the tailings beach is about 2.5H:1V and about 1.2 m high (Figure 11). Vegetation is sparse consisting of occasional saplings and there are no signs of rodent burrowing. An erosion gully meanders through the tailings beach from the seepage pond discharge structure to the tailings pond, although this is of no consequence to the stability of the dam (Figure 12). The dam crest above the sand fill consists mainly of coarse gravel and small cobbles. The crest elevation is generally level until the mid point where fill has been added over the seepage pond return lines (Figure 09). The crest south of the line crossing is visibly lower than the north section.

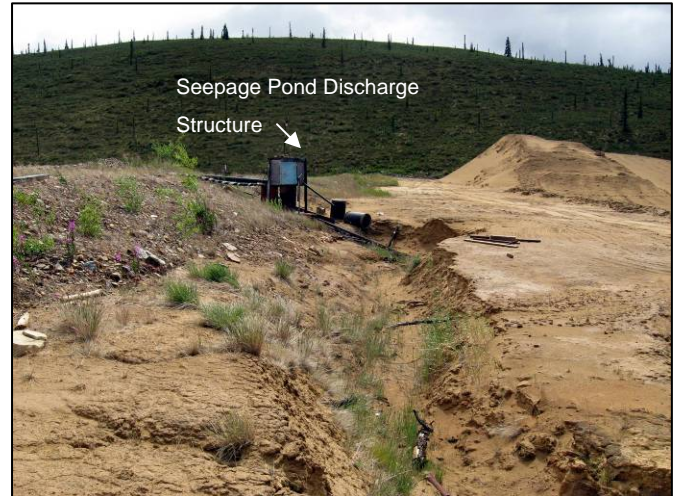
Figure 12 Erosion Gully in Tailings Beach

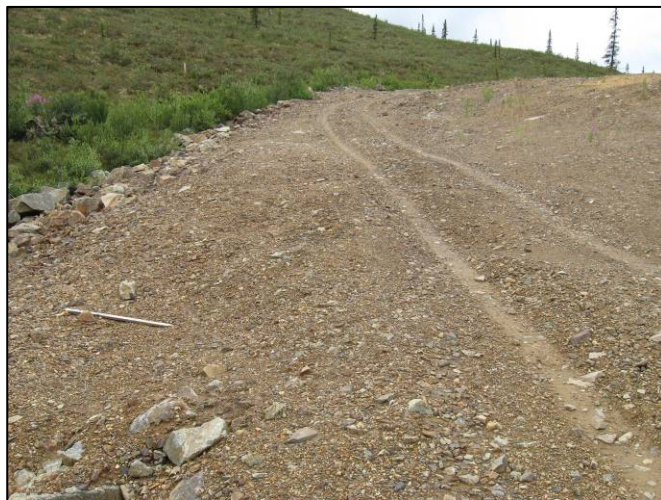
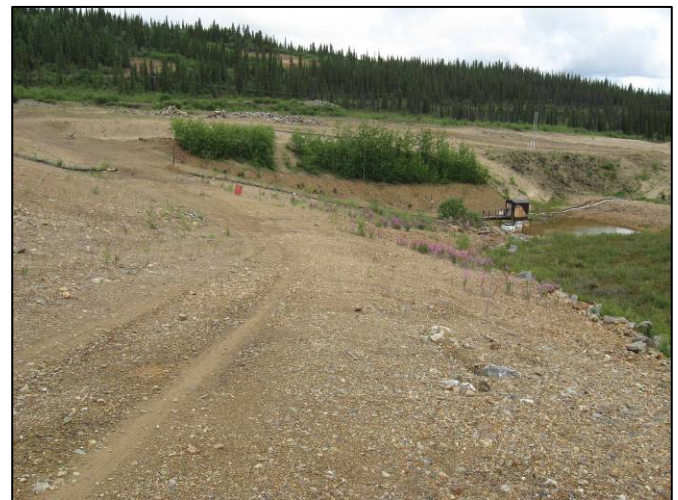
A stabilizing berm was constructed in 1997 to address stability and seepage (piping) concerns associated with higher than expected pond levels. It was reported that seepage was daylighting as high as elevation 1083 m on the downstream face of the dam. The berm was constructed along the toe of the southern half of the tailings dam to about elevation 1088 m. The top of the berm now serves as an access road from the south abutment to the seepage pond pumphouse (Figures 13 and 14).

Figure 13 View S at Stabilizing berm from WP 22

Figure 14 View N at Stabilizing berm from WP 22

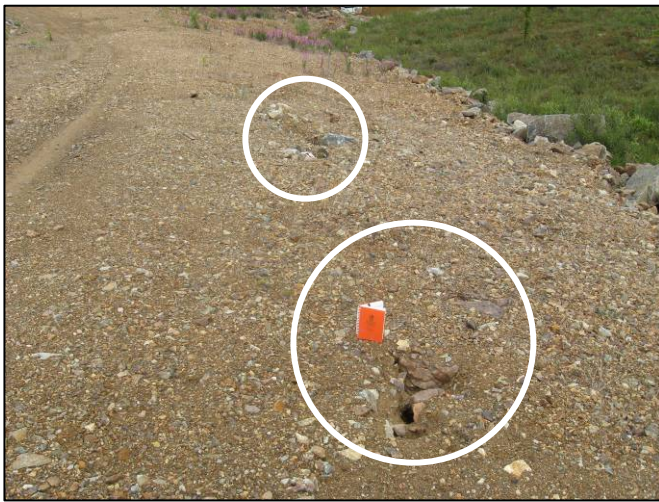
Figure 16 Spreading of Fill at WP 22 (View N)

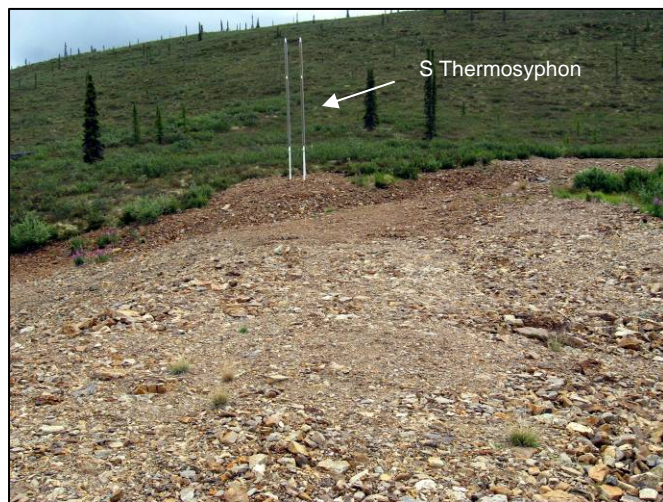
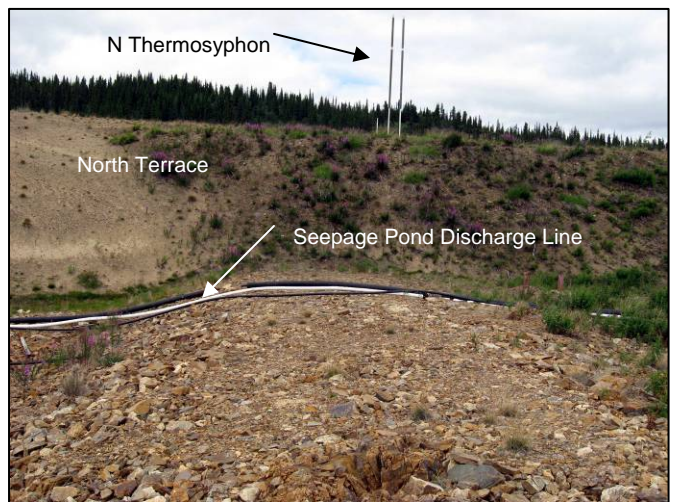
The seepage dyke is in good condition with no evidence of settlement or instabilities (Figures 20 and 21). The dyke is about 3.5 to 4 m high with upstream and downstream slopes of about 3H:1V that are well armoured with coarse gravel and cobble sized material. There is no engineered spillway and if the pond level were to rise to the dyke crest, water would spill over the north end of the dyke based on a 2008 centerline profile survey (Drawing 03). At the time of our inspection, the freeboard was estimated to be in the order of 2 m although iron staining on the upstream face indicates that water levels may previously have been about 0.5 m higher (Figure 18). Seepage water is collected year round in the pond and pumped over the dyke by the pumphouse shown in Figures 19 and 20. There are no means to regulate pond levels other than pumping which is regulated to maintain a fairly constant water level in the pond. Typically these rates average to about 1.9 L/sec (30 USGPM) to 4.7 L/sec (75 USGPM) during periods of significant precipitation. It takes about two days worth of seepage to fill the pond if pumping is stopped (personal communication, H. Copeland).

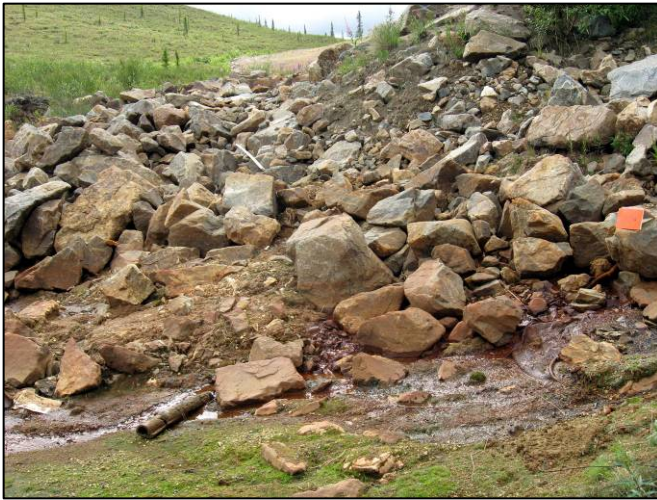
Seepage was observed entering the pond at two locations. The first is at the southwest corner of the pond where active seepage through the rock fill at the downstream edge of the stabilizing berm has caused iron staining of the rock (Figure 22). Seepage rates are estimated to be less than 4 L/min (<1 USGPM). The seepage water appears clear and the ground in the vicinity of the seepage is algae covered suggesting the flow at this location is nearly continuous throughout the year. The second location is at the northeast corner of the pond where flow is estimated to be in the order of 4 L/min (1 USGPM) at the toe of the north terrace slope (Figure 23). The seepage area is also covered in green algae. Subsequent examination of photos suggests that seepage may have been occurring in the past at a higher elevation at the top of the rock fill as evidenced by iron staining at this location (Figure 24). We are not aware of any water chemistry results associated with the individual seeps.

Figure 22 Seepage & Fe Staining at SW Corner of Pond

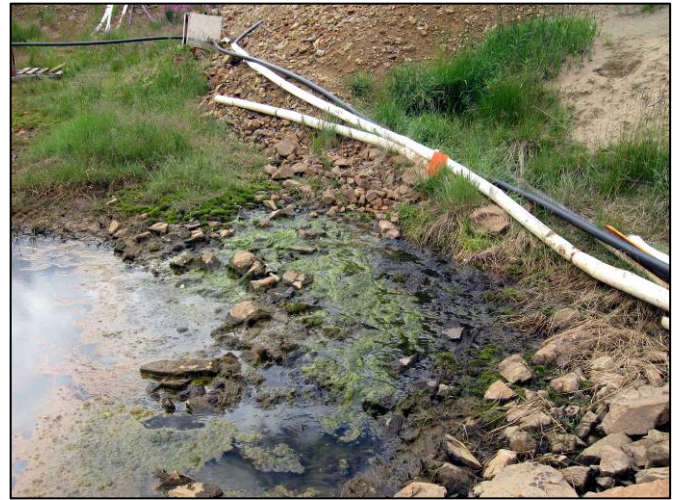
Figure 23 Seepage at NE Corner of Pond

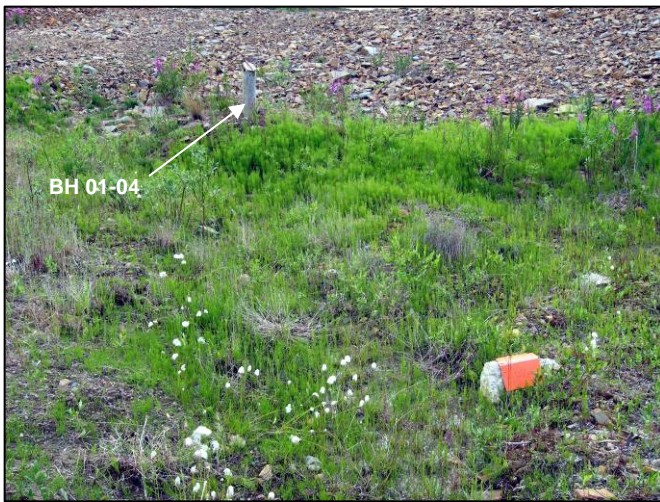
What appeared to be seepage was observed along the downstream toe of the seepage dyke, in particular along the southern half (Figure 25). No measurable flow was observed but the ground at the toe is very soft and wet with lush vegetation. A short distance downstream, water begins to collect in a meandering stream along what appears to be the original Dome Creek alignment (Figure 26). There is no visible seepage along the downstream toe of the northern half of the dyke where seepage pond water is pumped over the dyke where seepage pond water discharge sump as seen in Figure 27.

Figure 25 Soft ground at Toe of Seepage Dyke

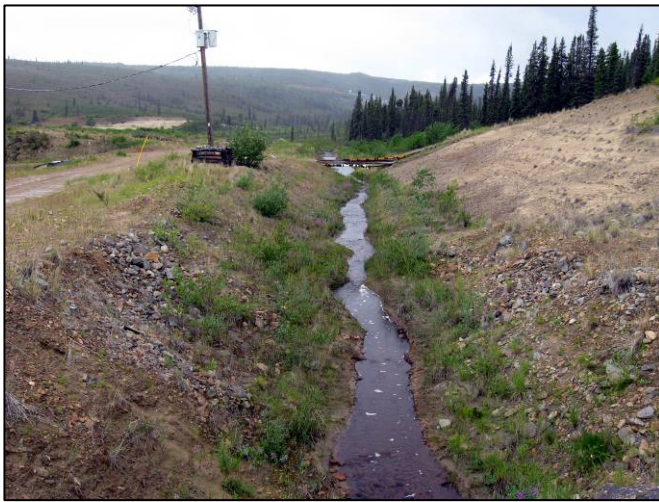
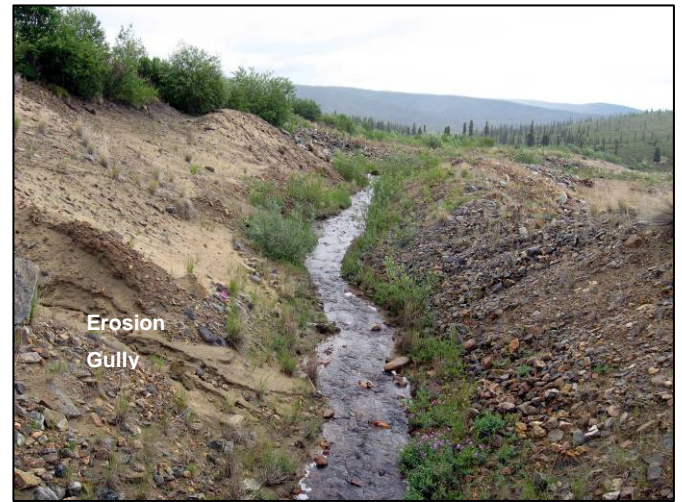
The channel upstream and downstream of the bridge is narrow (1 to 2 m) with steep banks made up of sandy gravel (Figures 38 and 39). There is little armouring on the north bank along this relatively flat stretch before the confluence with the spillway. Armouring on the south bank is more extensive consisting of coarse gravel and small cobbles. The natural bank consists mainly of fine grained sand. An erosion gully is visible on the left hand side of Figure 39 enters the diversion channel immediately downstream of the bridge. The bank at the bridge crossing has over-steepened sideslopes of about 1H:1V.

The overall condition of the tailings dam and seepage dyke at the time of our inspection was considered to be good. There do not appear to be any significant deformations of either structure that would indicate active instabilities. Seepage water at the toe of the rock fill at the edge of the seepage pond appears clean but it is important to recognize that this condition could worsen with increased water elevations in the tailings pond. Internal erosion of the earth fill dam associated with the toe seepage cannot be ruled out. Settlement of the south half of the tailings dam crest, as evidenced by surveys of monitoring pins and the centerline profile is of some concern and the cause should be investigated further, in particular to determine if it is associated with the observed toe seepage. Consideration should be given to restoring the design crest elevation in this area. The emergency spillway is in good condition although the constriction from widening the road approaching the south side of the bridge should be removed to restore full design hydraulic capacity.

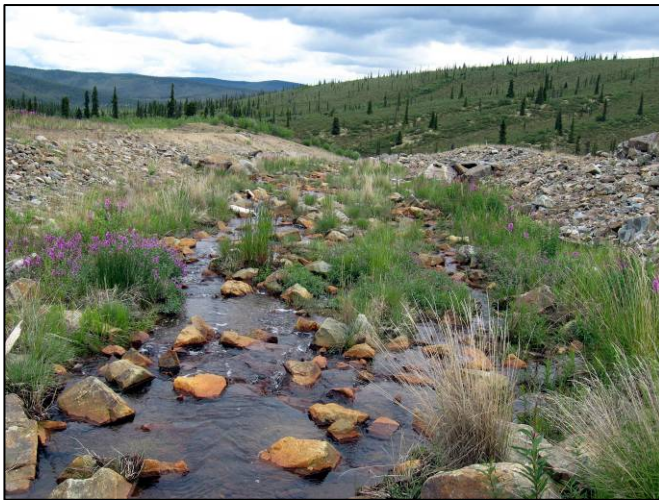
Figure 40 View D/S From Sta 0+810 (WP 51)

The diversion channel steepens considerably just downstream of the confluence with the tailings pond spillway (Figure 40). This section is heavily armoured and contains 13 drop structures constructed with large boulders. There are no signs of bank erosion and the drop structures are in good condition (Figure 41). Flow is contained within the armoured section and although not significantly restricted by the boulders; at the flow rates observed, water tends to flow around (rather than over) individual boulders. It is likely however, that more evident steps in the hydraulic profile would occur at higher flows.

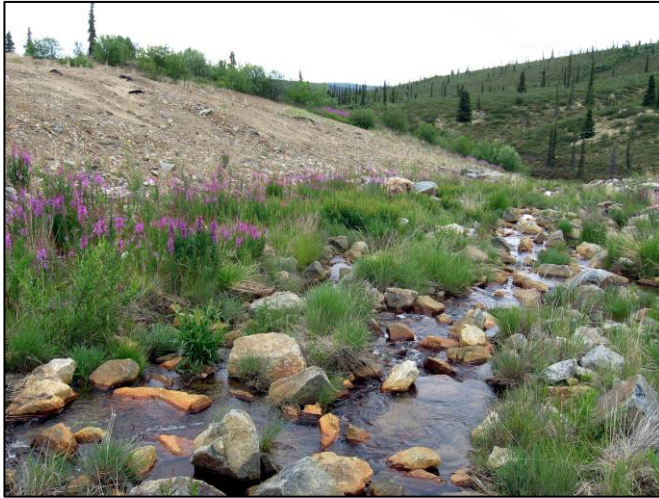
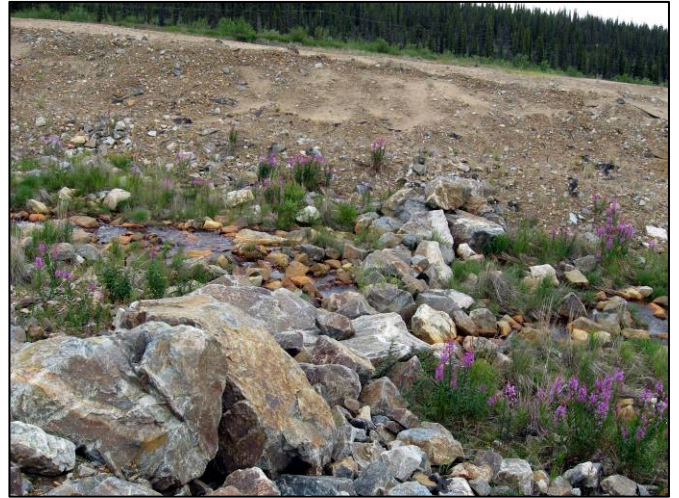
The armouring on the upper portion of the channel banks appears to have been pulled back downstream of about Station 0+920 (Figures 42 and 43). Geotextile can be seen along both the north and south banks and the channel would be susceptible to erosion above the armouring at higher flow depths (Figure 44). Iron staining is also evident along the entire stretch of the diversion channel that has been lined with rock (Figure 45).

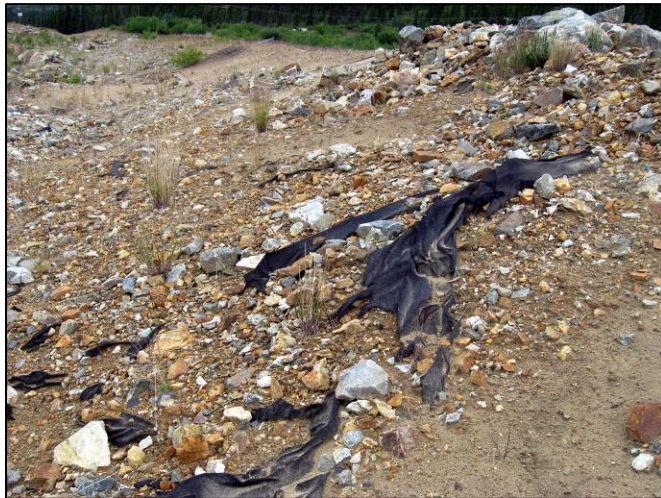
Figure 44 Exposed Geotextile on N Bank at Sta 0+920 (WP 57)

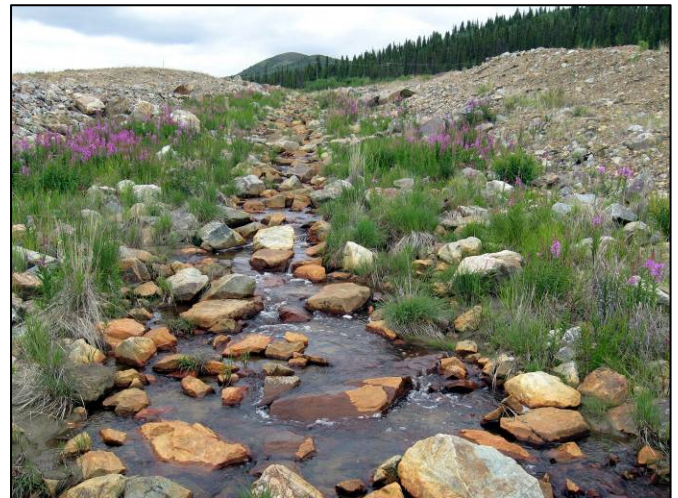
Figure 45 Iron Staining (View U/S From WP 59)

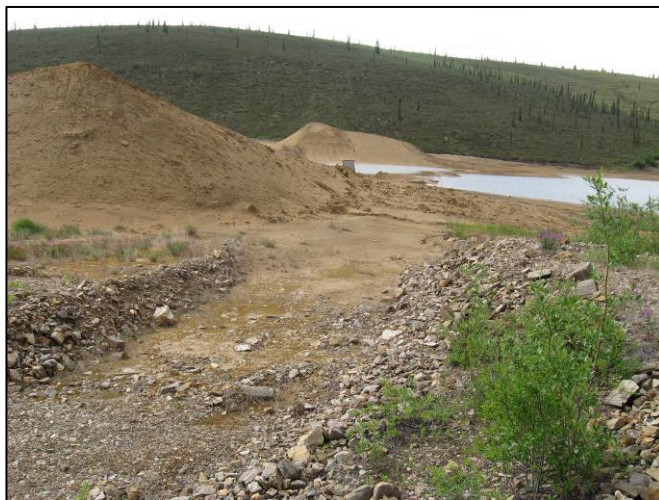
Figure 48 Spillway Entrance

The tailings pond spillway is in good condition although it does not appear to have been recently operational. The spillway entrance is formed by waste rock and gravel banks in the northeast corner of the tailings pond (Figure 48). Beyond the limits of the pond, the spillway channel has been cut into the north terrace and is flanked by the access road on the north side. The bend in the access road at the south bridge abutment has been widened into the spillway channel creating a constriction (Figure 49). A survey of the channel indicates that the high point of the spillway is just upstream of the road crossing at elevation 1098.5 m. Sideslopes are in the order of 2H:1V with the exception of steeper slopes where the road fill encroaches.

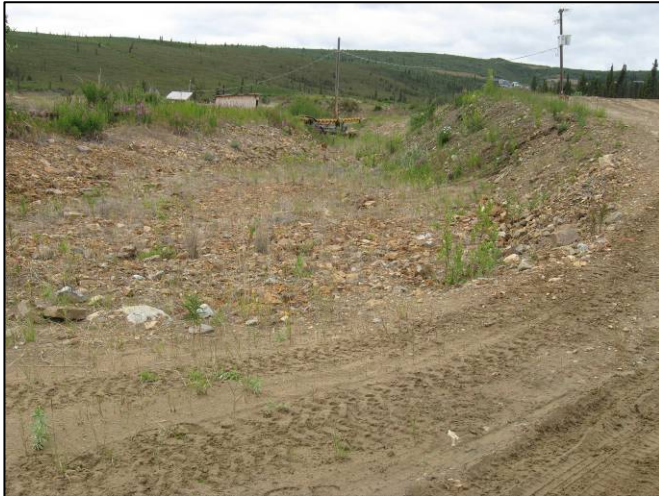
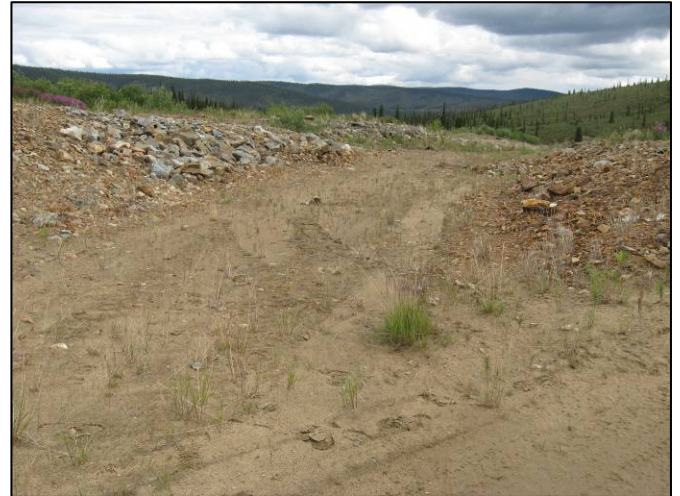
The material lining the spillway bed consists of coarse gravel (Figure 50). Coarser rock fill has been used to armour the banks as seen in Figure 51. The channel bedding material downstream of the road crossing consists of sand; however, it is possible that the sand has been deposited over the coarser bedding material. Vegetation consisting of saplings, shrubs and grasses are becoming established in the spillway, in particular in the section between the inlet and road crossing.
