**GOVERNMENT OF YUKON**

# **Mount Nansen Tailings Dam**

## **Dam Safety Review**

307071-00856-00-SS-REP-0001

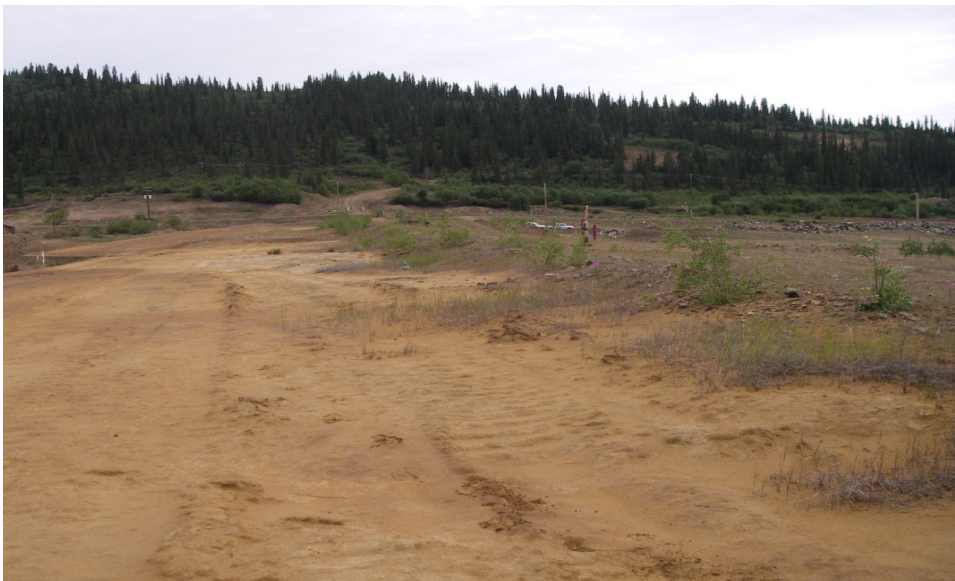
**Photo A Upstream Face of Tailings Pond Dam**

The upstream face of the dam appeared to be in good condition during the inspection, with no signs of erosion or slumping. A depression near the centreline of the dam was noted; however, AAM personnel indicated that the depression is a remnant from the removal of the tailings reclaim pump shack and inlet. The upstream slope was largely free of vegetation other than some spare grass and low shrubs.

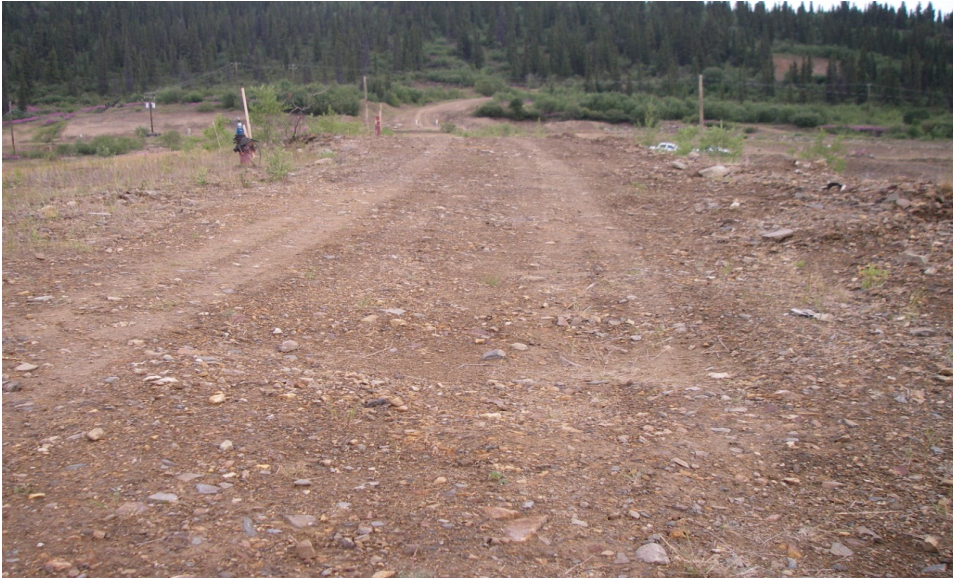
**Photo B Crest of Tailings Pond Dam**

The crest of the dam also appears to be in good condition, with no signs of large scale rutting, settlement, or slumping; however, the grade of the crest is irregular and in several places, the creation of drill pads has reduced the elevation of the crest. The irregularity in the crest makes identifying settlement, potentially due to internal erosion of the dam from piping, difficult to detect. The crest of the dam is also largely free of vegetation, other than some spare grass and low shrubs.

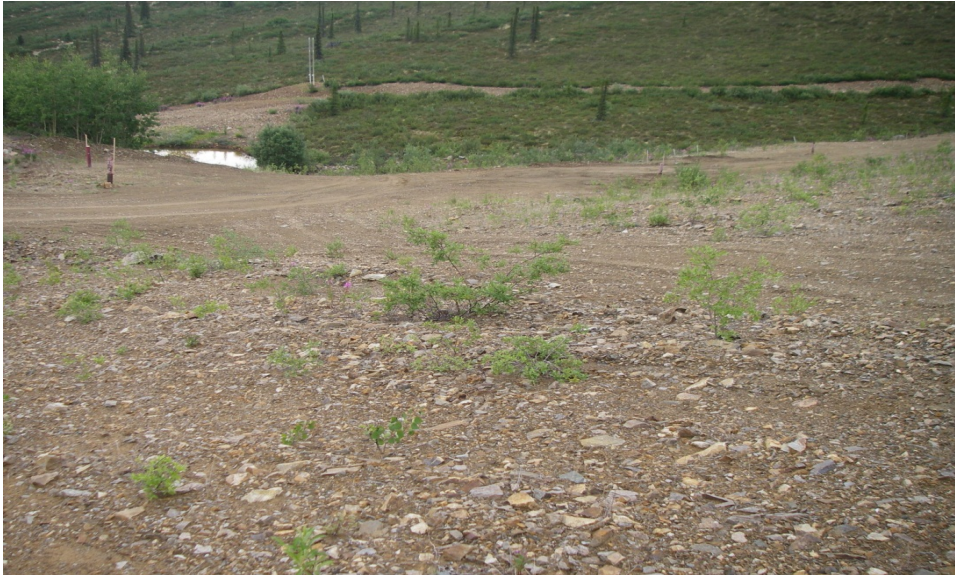
**Photo C Downstream Face of Tailings Pond Dam**

The downstream face of the dam also appears to be in good condition, with no signs of large scale slumping erosion visible at the time of inspection. No seepage, other than the regular seepage from the toe of the dam into the seepage control pond, was noted. Site staff noted that seepage is occasionally observed on the face of the dam, near the toe; none was visible during the WorleyParsons' inspection.

One issue noted during the inspection is that uncontrolled vehicle access down the downstream face is allowed and some rutting was noted. Vehicle access down the middle of the dam face should be closed off and restricted to emergency situations. Access down to the seepage pond on either side of the dam face is acceptable.

The downstream face is largely free of vegetation, other than some spare grass and low shrubs.

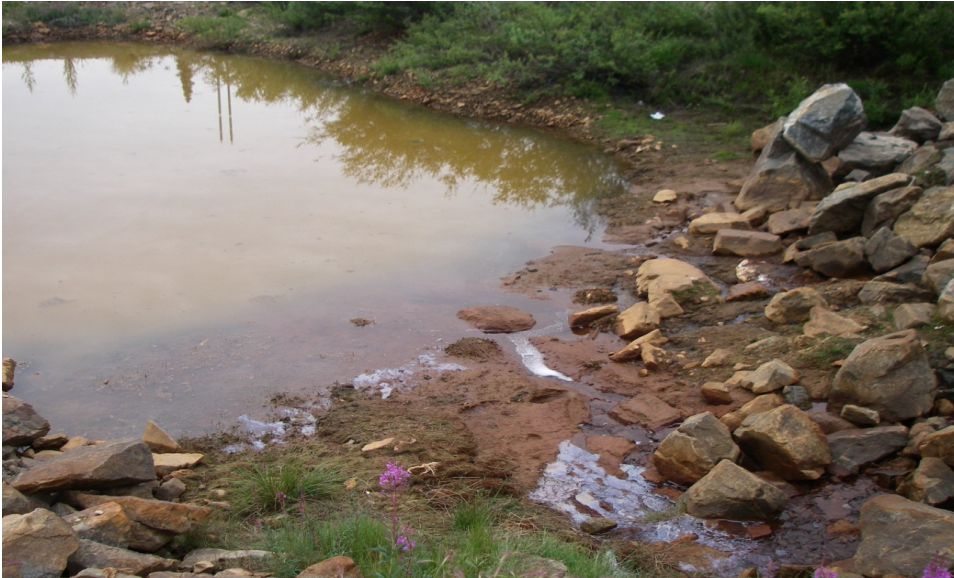
**Photo D Seepage from toe of dam into seepage pond**

The seepage pond and dyke appear to be in good shape. Some seepage was noted issuing from the toe of the dam during the inspection; however, site personnel noted that the quantity of seepage was not unusual. The seeps were observed to be clear and did not appear to contain sediment. Suspended sediment was noted in the seepage pond, as well as rust discoloration on the rocks and boulders at the toe of the dam; site personnel noted that the suspended sediment in the seepage pond is typical. Based on the clear nature of the seeps observed, and the location of the suspended sediment in the seepage pond (near the far end, away from the active seeps, see Photo D), it is likely due to the presence of colloidal sized particles which will not settle out.

No signs of slumping or erosion were noted on the dyke.

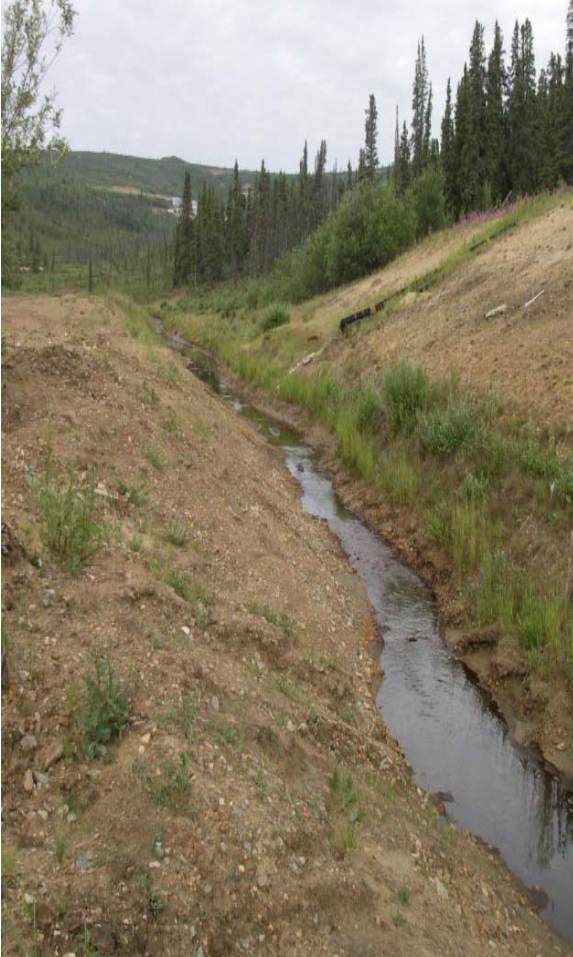
**Photo E Dome Creek Diversion Channel**

The diversion channel (Photo E) is located along the north side of the tailings pond and diverts water from the interception ditch and Dome Creek and conveys flow downstream of the tailing dam. The channel base width is approximately 1 m to 2 m with a depth of approximately 2 m. The channel has an average longitudinal slope of less than -0.5%. The channel's south bank is generally steeper than the north bank with slopes around 2H to 1V but with some steeper sections up to 1H to 1V.

A small flow was observed in the channel at the time of inspection. Sediment has accumulated in the channel and no ditch armouring was observed. The channel appears to have sufficient cross sectional area and slope to pass the 200-year instantaneous peak flow ( $3 \text{ m}^3/\text{s}$ ); however, localized erosion may occur during freshet and other high-flow events.

There is currently little evidence of the originally designed gravel layer along the channel. During a storm event, the flow velocity may be in the range of 0.75 to 1 m/s, so some erosion of accumulated sediment and bank material may occur. Installation of a gravel layer or other erosion control product is recommended as a long term solution to ditch erosion; however, in the short term, targeted channel maintenance to repair areas where erosion has occurred following a storm event can be considered.

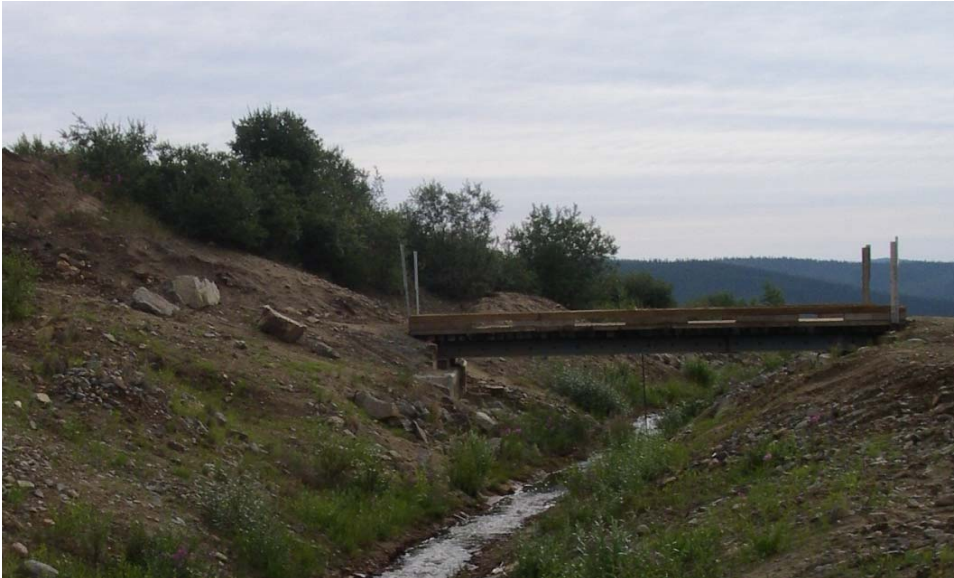
**Photo F Bridge at Downstream End of Diversion Channel**

A bridge (Photo F) is located at the downstream end of diversion channel and consists of a wood deck over steel beams that rest on cement lock blocks. In its observed state, the bridge would not restrict the passage of the flood flow.

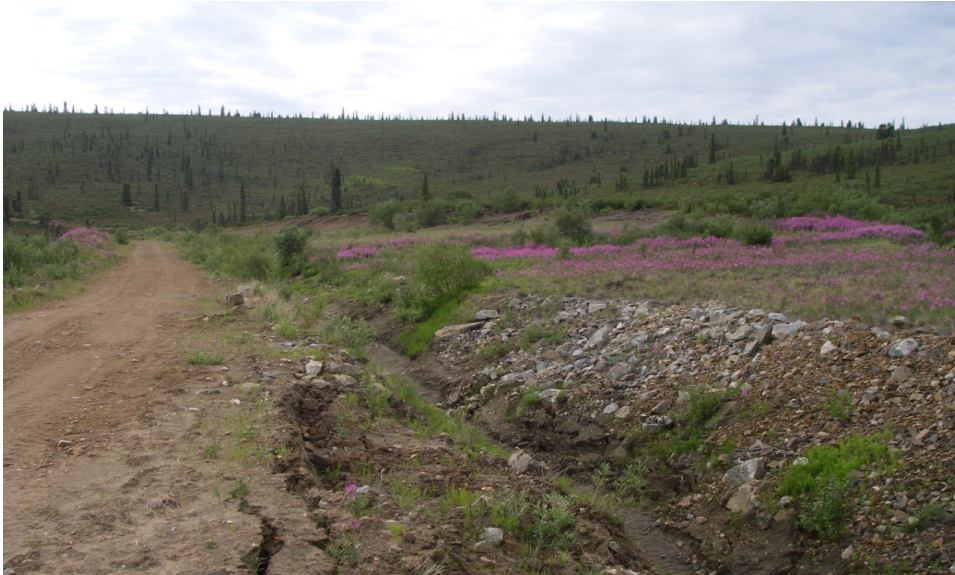
**Photo G Interception Ditch**

The interception ditch (Photo G) picks up flow from a small portion of the catchment to the south of the tailings pond. The ditch was not flowing at the time of inspection. The extensive vegetation growth on the downslope side of the interception ditch suggests there is significant seepage loss out of the channel or groundwater flow bypassing the channel.

The capacity of the channel has been reduced by deposited sediment. The reduced capacity of the ditch still appears sufficient to convey the relatively small peak flows expected in the interception ditch. The east bank of the ditch is over-steepened in some locations with tension cracks visible, indicating areas where future slope failure is likely to occur. Sediment was also observed entering the ditch from upslope along the west side of the channel. Ongoing maintenance will be required remove accumulated sediment and to repair areas infilled by slope failures.

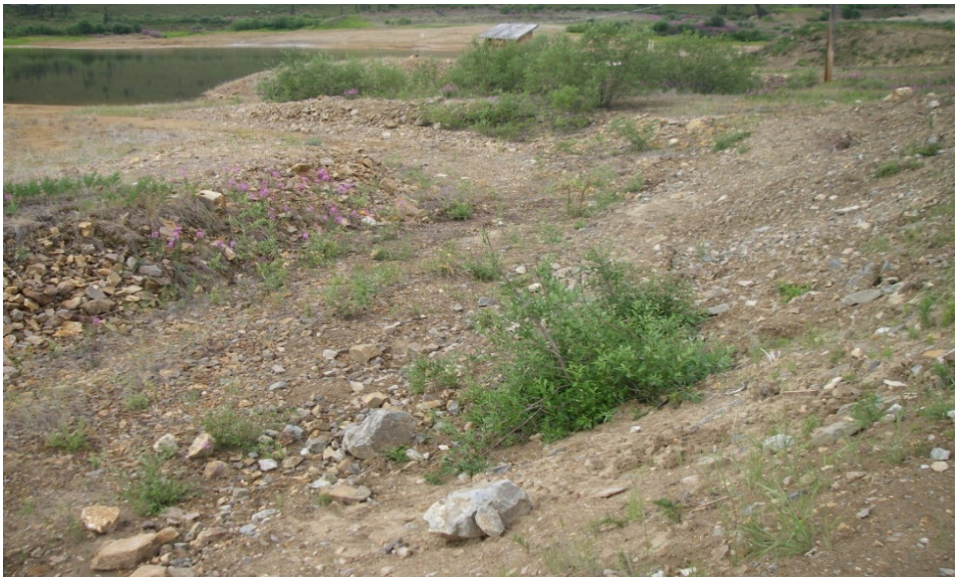
**Photo H Tailing Dam Spillway**

The emergency spillway (Photo H) consists of a channel (approximately 5 m to 6 m wide x 1 m to 2 m deep) located at the northeast corner of the tailings pond.

The emergency spillway channel is crossed by an access road approximately mid-way along the channel length. Visually, it was not apparent where the crest of the spillway was located. The emergency spillway is a relatively poorly-defined channel that curves around the access road. The emergency spillway channel had some, but insufficient, armouring. The dimensions of the emergency spillway appear sufficient to convey the attenuated flood flow. To date, no flow has been observed over the pond emergency spillway.

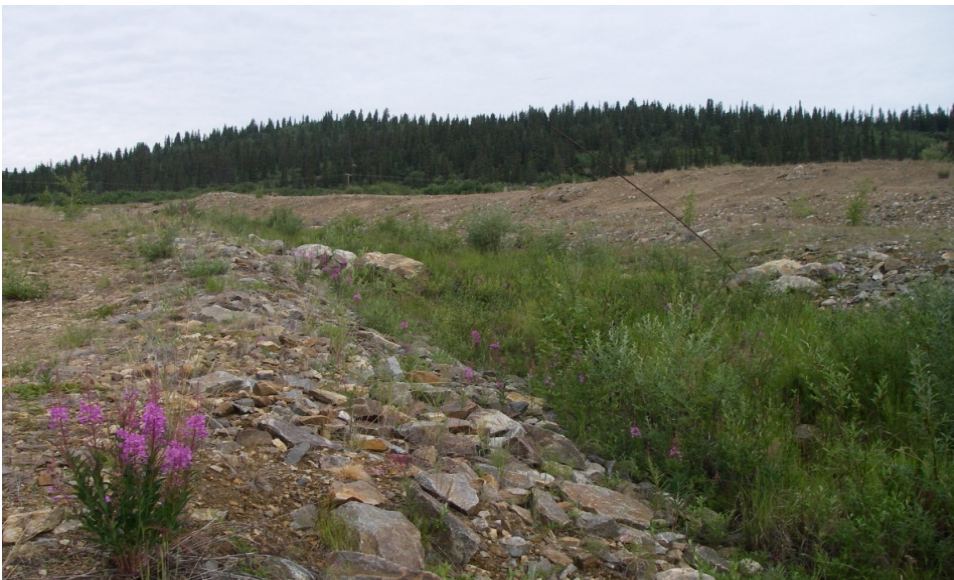
**Photo I Combined Spillway D/S of Tailings Pond**

The combined spillway is a relatively steep channel (approximately -10% slope) with riprap armouring and drop structures. Some vegetation growth was observed, as well as a small volume of flow in the channel. During freshet 2013, a small length of the north channel bank had been eroded away; no geosynthetic filter layer was seen, confirming EBA's assertion that construction of the spillway channel was not consistent along its length. The spillway has sufficient cross section area and slope to convey the IDF ( $3 \text{ m}^3/\text{s}$ ); however, areas with inadequate armouring may be eroded during high flow events.

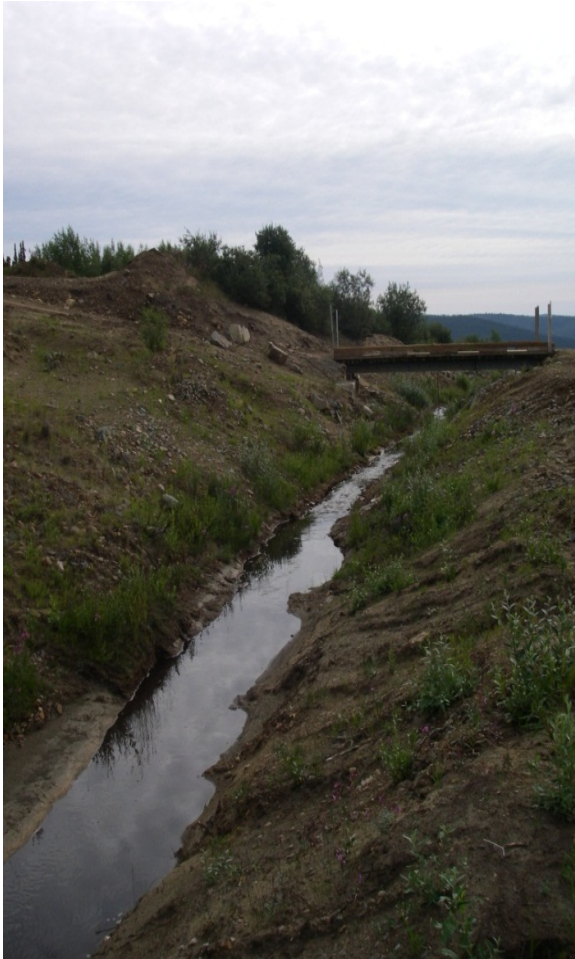
**Photo J Bridge across Diversion Channel**

A small bridge is located on the diversion channel upstream of the dam (Photo J). As is, the bridge is unlikely to impede flow; however, blockage of the diversion channel at the bridge would likely result in the diversion channel being overtopped and flow migrating into the emergency spillway and either into the tailings pond or down the combined spillway channel. Neither scenario is likely to result in failure of the dam structure; however, uncontrolled flow should be avoided to reduce the likelihood of unanticipated damage to critical infrastructure.

Currently, daily monitoring and frequent channel maintenance, reduces the potential for blockage of the diversion channel. In the long term, it is recommended that AAM consider constructing one or possibly two high-flow diversion spillways on the diversion channel, upstream of the bridge, to safely and controllably convey high flows from the diversion ditch into the tailings pond. The crest elevation of these diversion spillways should be set such that they only convey flow should the diversion channel become blocked or a flow event greater than the IDF occurs. Construction of a diversion structure will not reduce the potential for the diversion becoming blocked, but it provides a controlled location, or locations, for the ditch to spill without causing significant damage. The diversion(s) would consist of a weir on the south bank of the diversion channel with a crest elevation above the anticipated 200-year flow level; an armoured spillway should be constructed between the weir structure and the tailings pond.

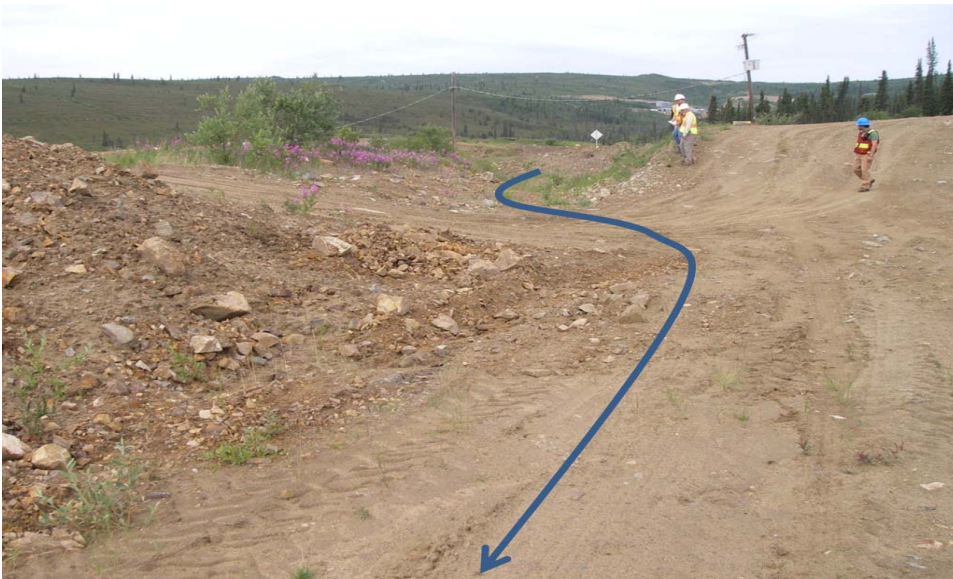
**Photo K Emergency Spillway Channel at Access Road Crossing**

The emergency spillway currently has a poorly defined channel and due to the access road across the channel, the flow path is not straight to the combined spillway as it curves slightly around the access road (Photo K). Within the emergency spillway channel, it is recommended that a trapezoidal shape channel be constructed and that the flow path be realigned to provide a relatively straight course, in order to reduce the potential for bank erosion. The realigned and reshaped emergency spillway can still allow for vehicle access to the dam crest and seepage pond, by reducing the side slopes of the spillway channel in the vicinity of the access road.

The dam emergency spillway has sufficient capacity for the IDF flow; however, the sparse vegetation should be removed and the armouring in some section of the emergency spillway channel requires improvement (Photo K). With the shallow gradient of the spillway, even the sparse vegetation growth slightly reduces the flow capacity. To reduce erosion during a major storm event, either a suitably designed gravel / riprap armour layer should be placed along the length of the channel, or an alternative erosion control product can be installed.

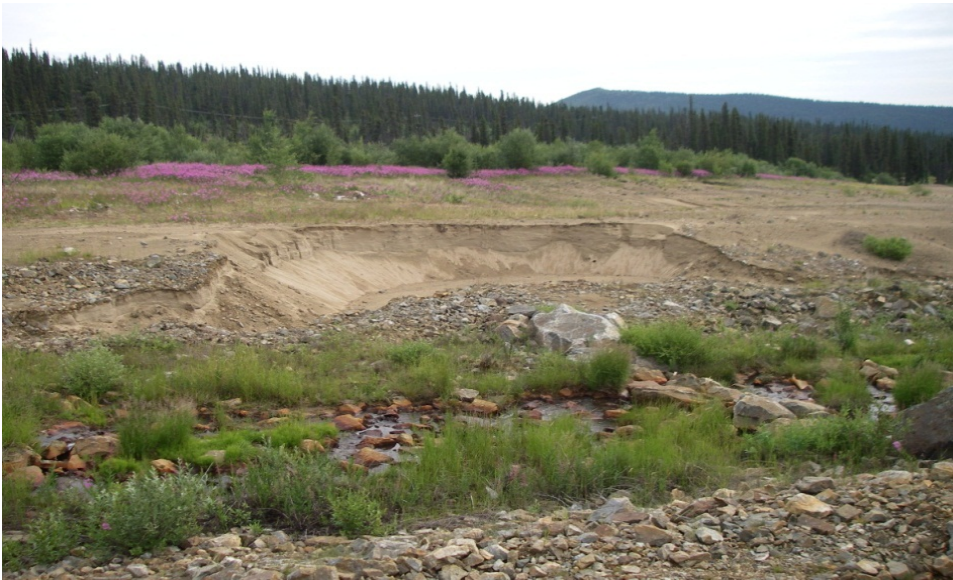
**Photo L Slope Failure on Combined Spillway**

EBA's recommended upgrades were partially completed; however, EBA observed that the spillway restoration was not completed in a consistent manner, with the geotextile coverage, filter gravel thickness and riprap thickness varying along the spillway. During the 2013 DSR inspection, the combined spillway appears to have sufficient cross-sectional area and energy dissipation (drop structures) to convey the IDF flow; however, an inadequate or poorly-installed filter layer and riprap has resulted in a recent ditch slope failure, and these failures will likely continue to occur in the future.

This failure, or similar failures in the future, are unlikely to impact the safety of the dam structure, but may contribute to a short-term increase in sediment loading to Dome Creek. These isolated failures should be repaired as they occur, or alternatively, a uniformly constructed filter layer with riprap armouring should be installed, including a suitable anchor trench for any geotextile liner, along the entire length of the combined spillway.

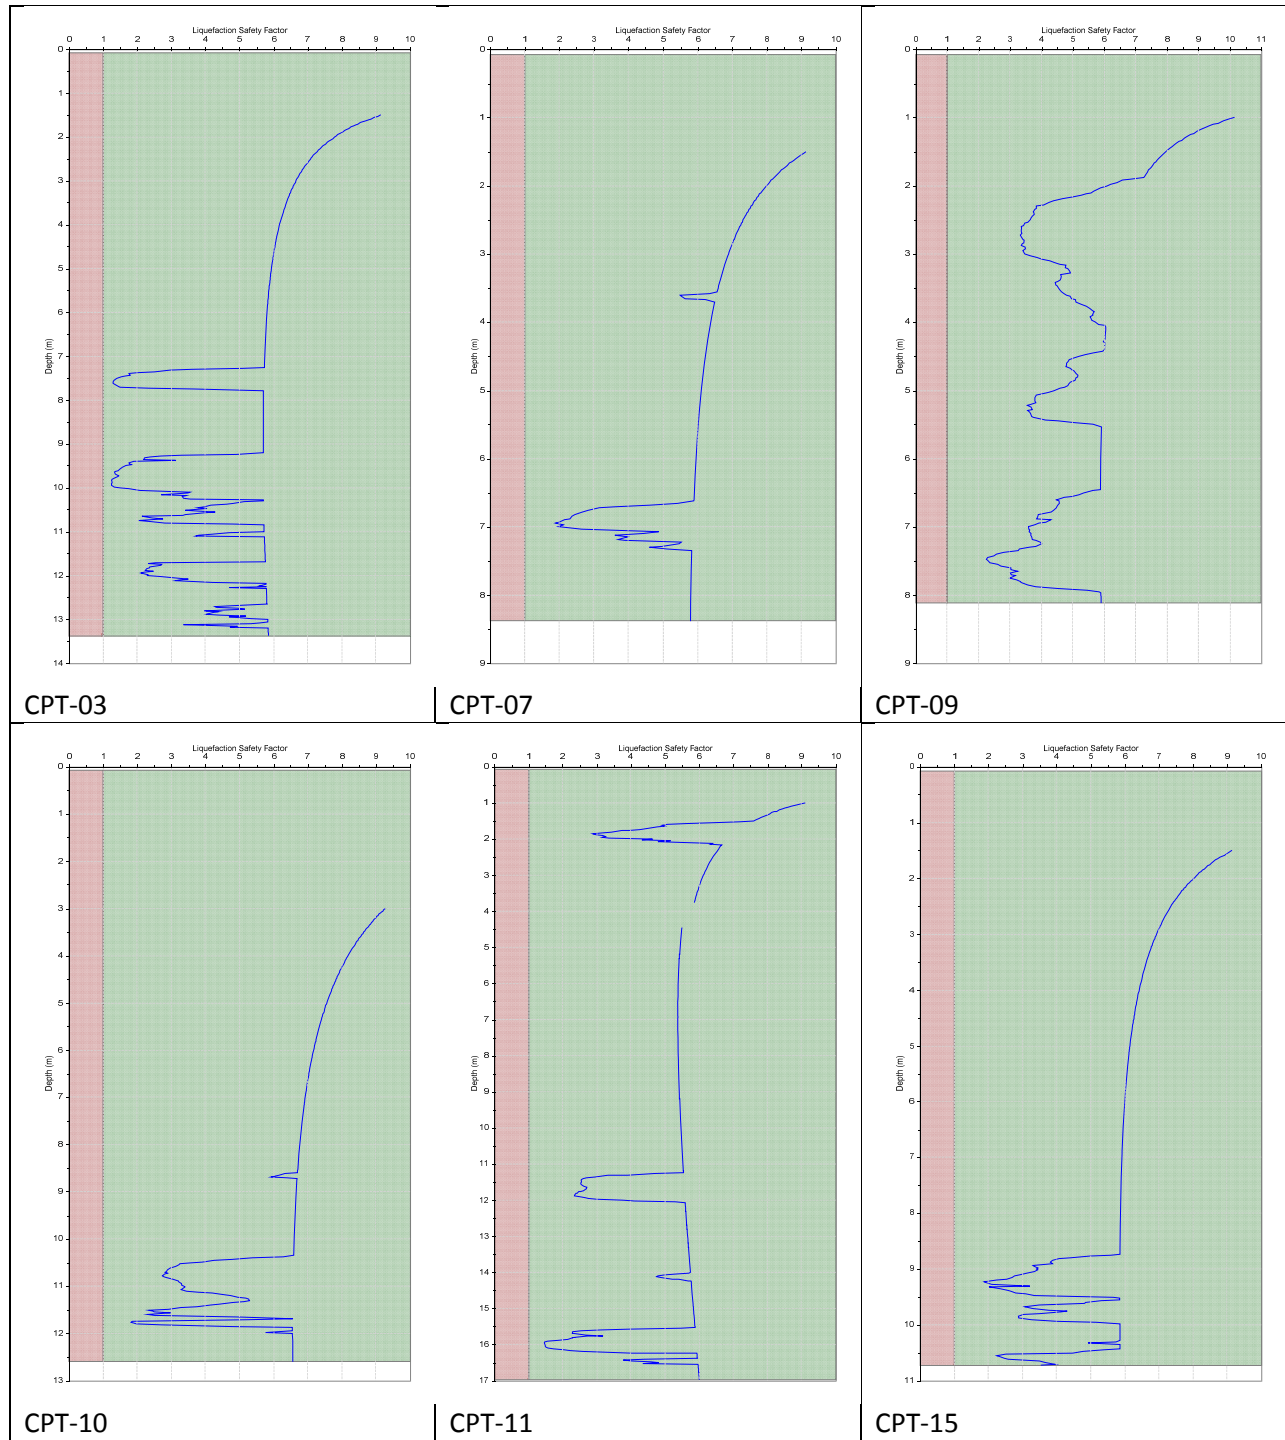
**Figure 3 – Soil Liquefaction Assessment**

- Within the foundation soils underneath the dam crest at CPT-10 and CPT-11, and underneath the downstream buttress berm at CPT-3, CPT-7, and CPT-15;
- At the north side native ground near CPT-9; and
- Within some sporadic zones (0.5 m to 0.8 m in thickness) in the dam fills at CPT-03 and CPT-11.

The liquefaction analysis was conducted using the software NovoCPT (Novo Tech Software Ltd. 2012). The procedure followed is based on the recommendations proposed by Robertson and Cabal (2009). Given the results in terms of Liquefaction Safety Factor shown in Figure 3, Appendix 1, the foundation soils and the dam fill are considered to not be susceptible to liquefaction during the design seismic event.

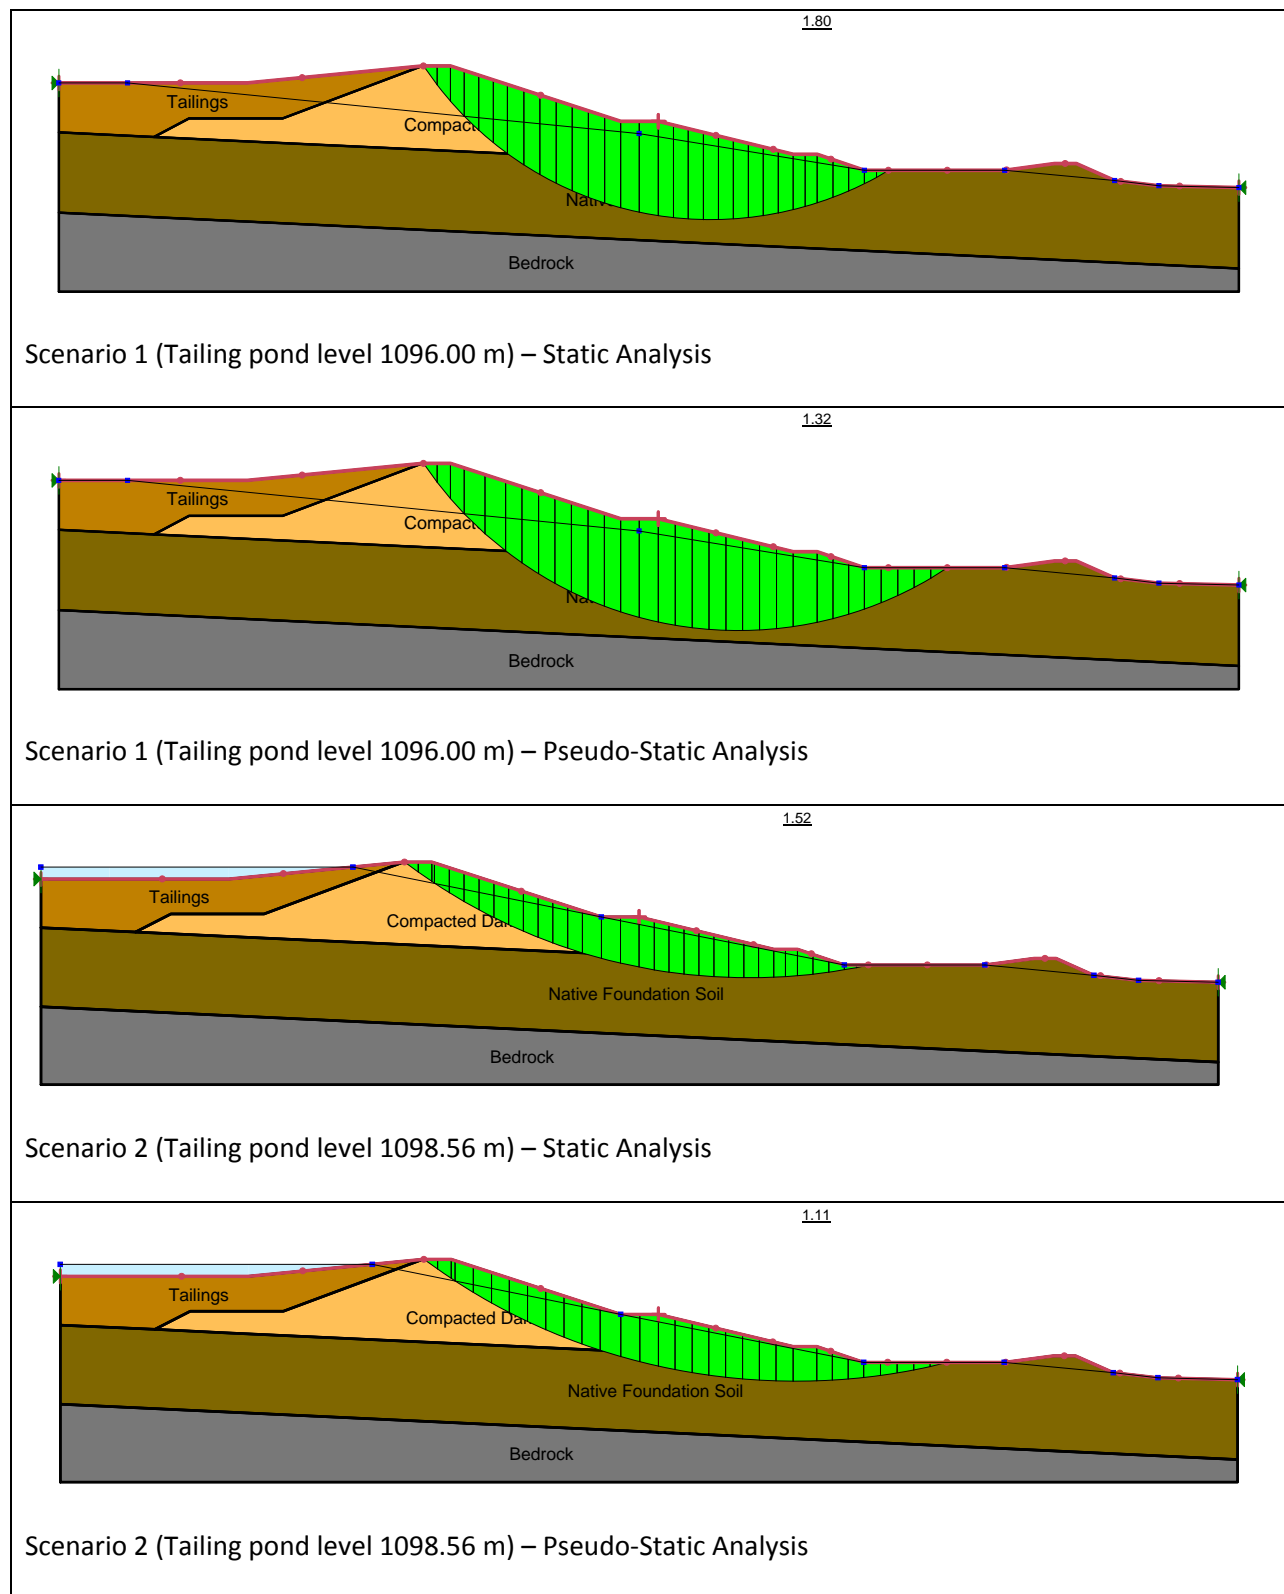
**Figure 6 – Slope Stability Assessment**

The results of the analysis indicate that the dam exceeds the CDA Guidelines (2007) minimum factors of safety criteria for both static and seismic loading conditions and for both seepage scenarios. The results of the analyses are summarized in Table G and presented in Figure 6, Appendix 1.

<b>Loading Condition</b>	<b>Factor of Safety</b>
Scenario 1	Static long-term	1.80
	Seismic pseudo-static	1.32
Scenario 2	Static long-term	1.52
	Seismic pseudo-static	1.11
